Historic Landscape Report  
**CANFIELD PARK**  
**DENISON PARK**  
Corning, New York

Prepared By:  
State University of New York  
College of Environmental Science & Forestry  
Faculty of Landscape Architecture      Syracuse, New York  
Research Assistant Kenneth J. Allen  
Project Director George W. Curry

**September, 1994**

**CANFIELD PARK**  
**EXISTING CONDITIONS**  
**1994**

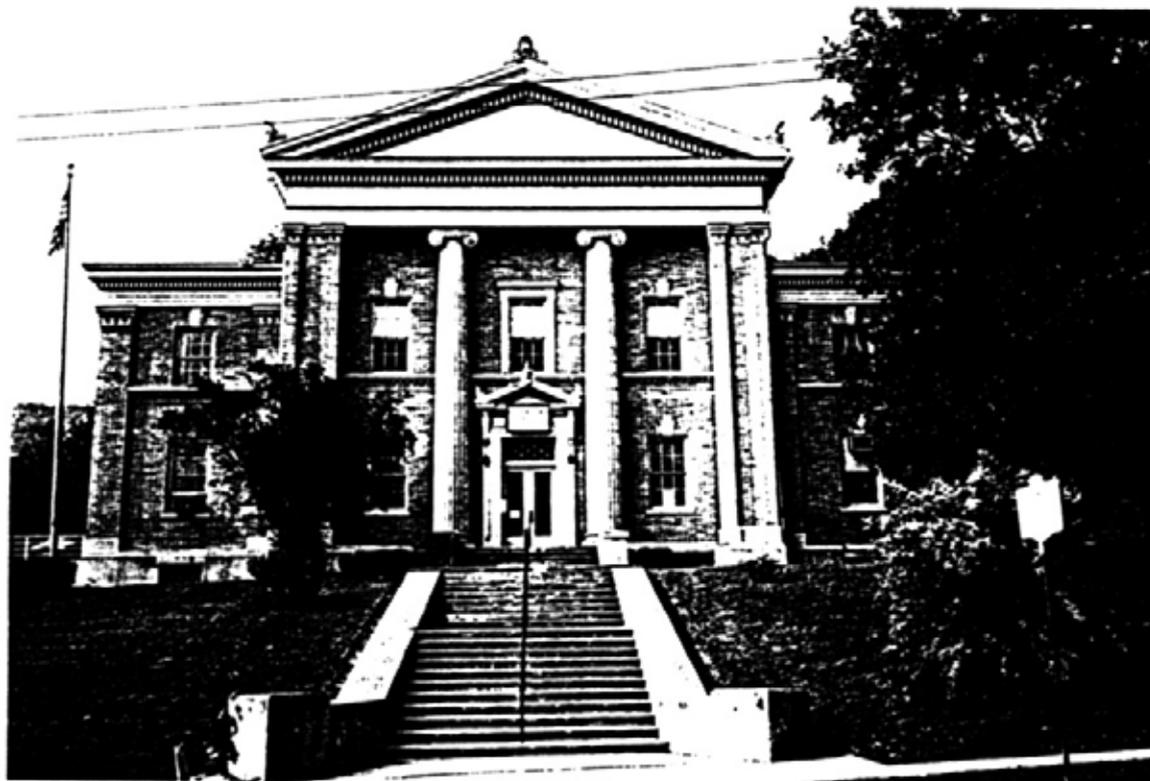
The Steuben County Court House has not been seriously altered since it was erected in 1903. Currently, there is a small wooden entry way that was added to the north corner of the western wall. Otherwise, the building is existing as described in the previous period's **Buildings and Structures** section and in Appendix C.

Figure 1.14: Canfield Park, court house, facing southwest (K. Allen. SUNYCESF, 1994).

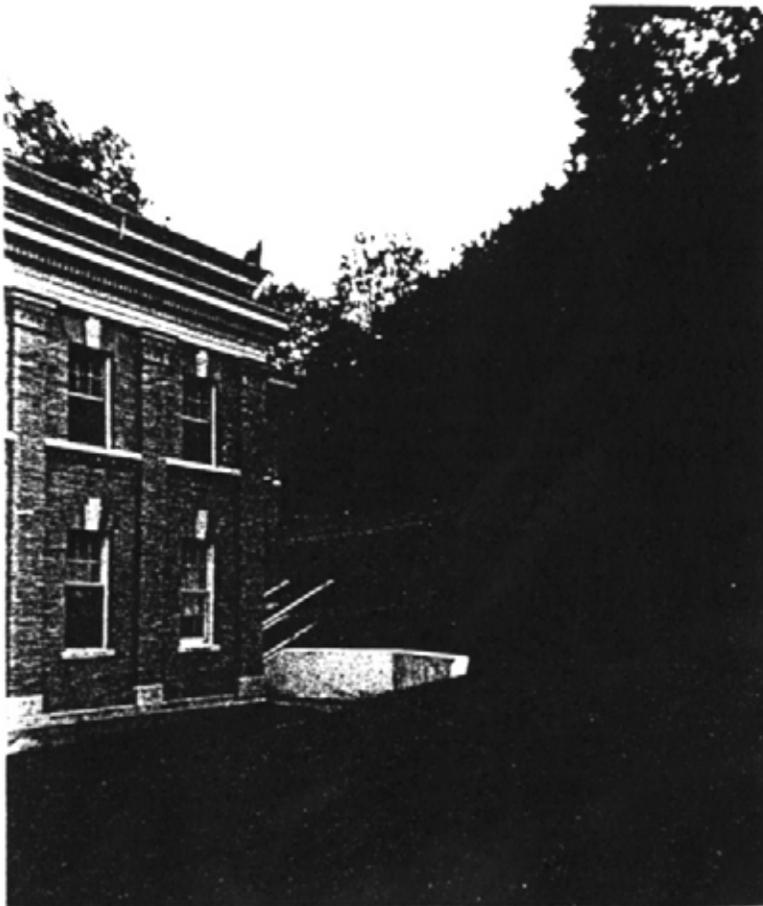
The western concrete retaining wall exists today but it has been modified and possibly replaced. The wall that stands today is made up of three segments and it measures 14 feet in

length. According to the 1994 Site Survey, the southeastern pointing wall is 3.5 inches high and gradually becomes 2.8 feet in height. The second segment is 10 feet in length, has 2.45 feet of exposed wall at its far end and is located in an east, southeast direction. The third segment of the wall connects with the staircase perpendicularly so that the 14 1/2 foot long section is parallel to the southern wall of the court house. The final segment terminates with a height of 2.45 feet. The wall is painted white. It should be noted that existing conditions photographs (taken on 9/8/94) indicate that the wall is higher than indicated on the 1994 site survey. However, field measurements were not taken. All other dimensions, materials, specifications and characteristics are unknown or unrecorded.

Figure 1.15: Canfield Park, retaining wall, facing southeast (K. Allen. SUNYCESF, 1994).

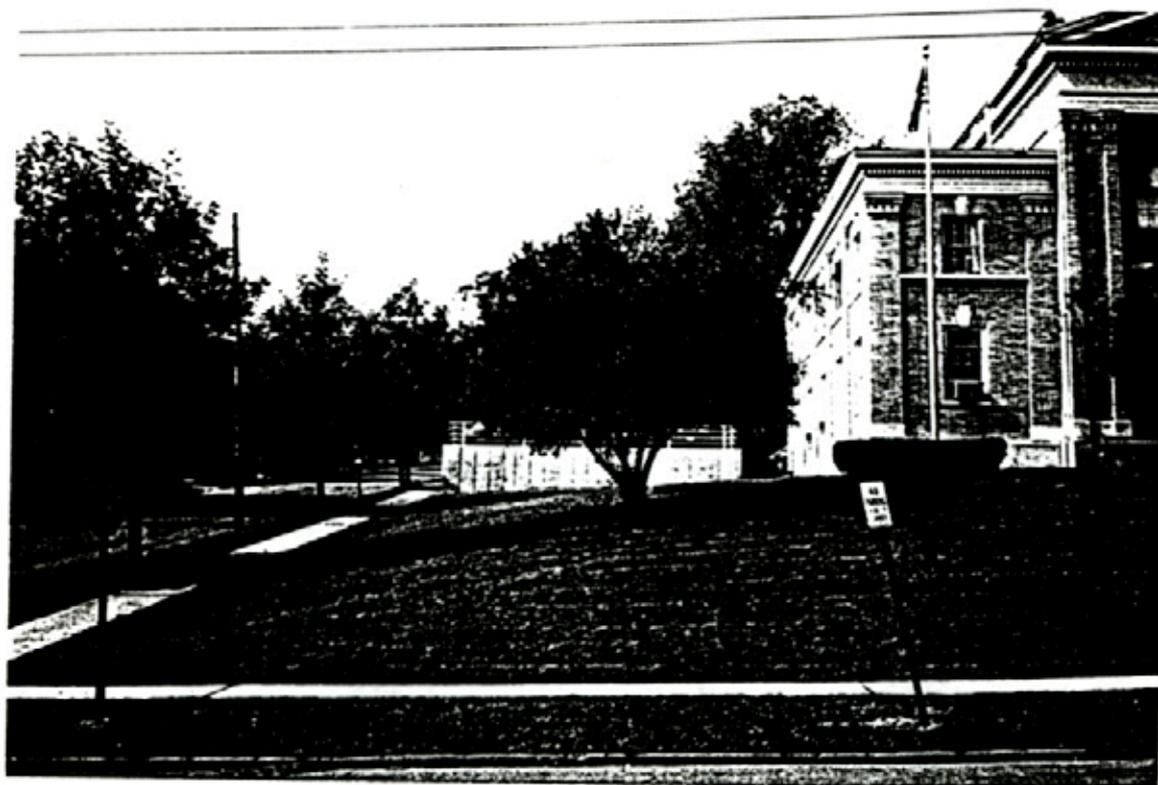
The parking area to the southeast of the court house is supported by a three sided 2 1/2 foot thick retaining wall. At its highest point the wall is 7.76 feet. The rectangular wall system faces north and is both parallel and perpendicular to the court house and roads. The western segment is 18 feet in length. The northern segment is 42 feet in length and the eastern segment is 27 feet in length. The wall system is topped with a heavy railing. The rail measures 18 feet in length along the western segment, 42 feet along the northern segment and 27 feet along the eastern segment. The other dimensions and character of the railing were not recorded.<sup>86</sup> All other dimensions, materials, specifications and characteristics are unknown or unrecorded.

Figure 1.16: Canfield Park, east retaining wall, facing south (K. Allen. SUNYCESF, 1994).

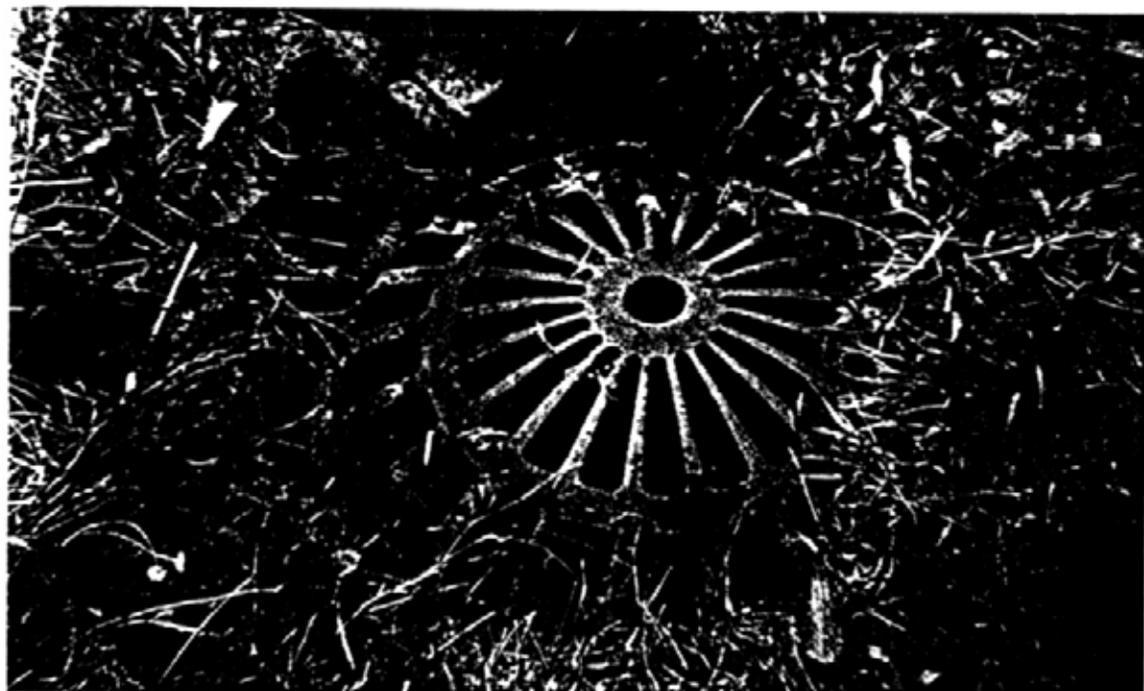
There are six catch basins within the block. Two of the six were found to be covered with historic dome shaped, heavy iron grates. The historic grates are approximately 3 feet in diameter and a dark brown rust color. One is located approximately 40 feet to the west of the northwest corner of the court house. The other is approximately 5 feet north of the northeast corner of the court house. The grate that catches the water from the concrete gutter on the west side of the court house is metal and rectangular with holes that are approximately 1 inch in diameter. It is not known if this grate dates back to the original construction. A third grate is located 20 feet to the west of the corner of First and Pine Street. Another grate is located 10 feet to the southeast of the bollards behind the parking area. The exact dimensions of the grates were not measured in the field and the 1994 Site Survey by Hunt Engineers and Architects exaggerates the measurements. The final grate is found 192 feet to the west of the corner of First and Pine Street within the lawn area next to the road. All other dimensions, materials, specifications and characteristics are unknown or unrecorded.

Figure 1.17: Canfield Park, historic drain grate, west of court house (K. Allen. SUNYCESF, 1994).

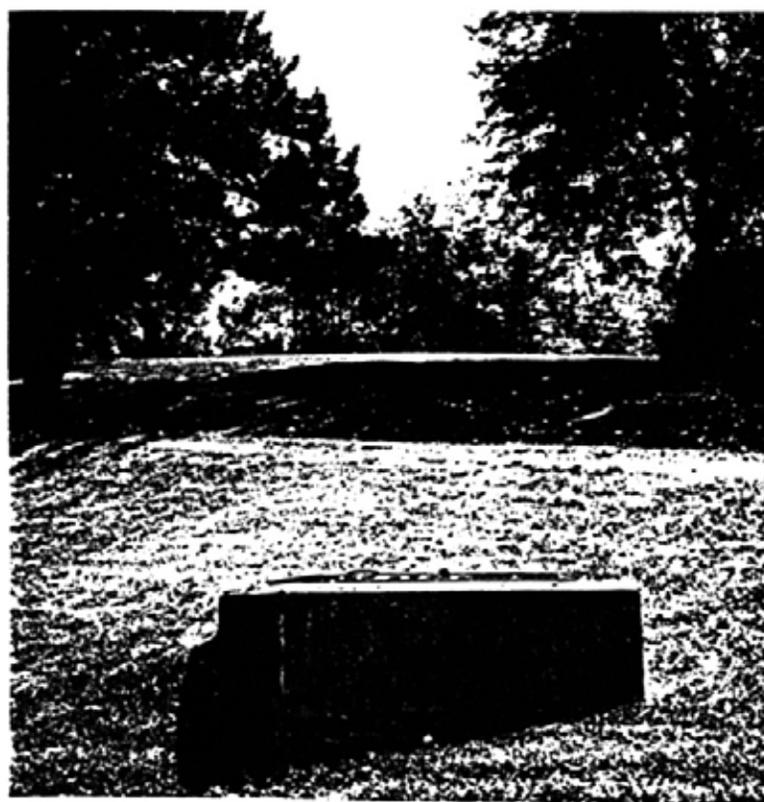
There is a concrete vault with a door located 35 feet to the east of the northwest corner of the block. The length is 7 feet and the width is 5 feet. The northern portion of the vault is waist high while the southern portion is nearly buried in the slope. The other dimensions and purpose of the vault are unknown. All other dimensions, materials, specifications and characteristics are unknown or unrecorded.

Figure 1.18: Canfield Park, vault, facing southeast (K. Allen. SUNYCESF, 1994).

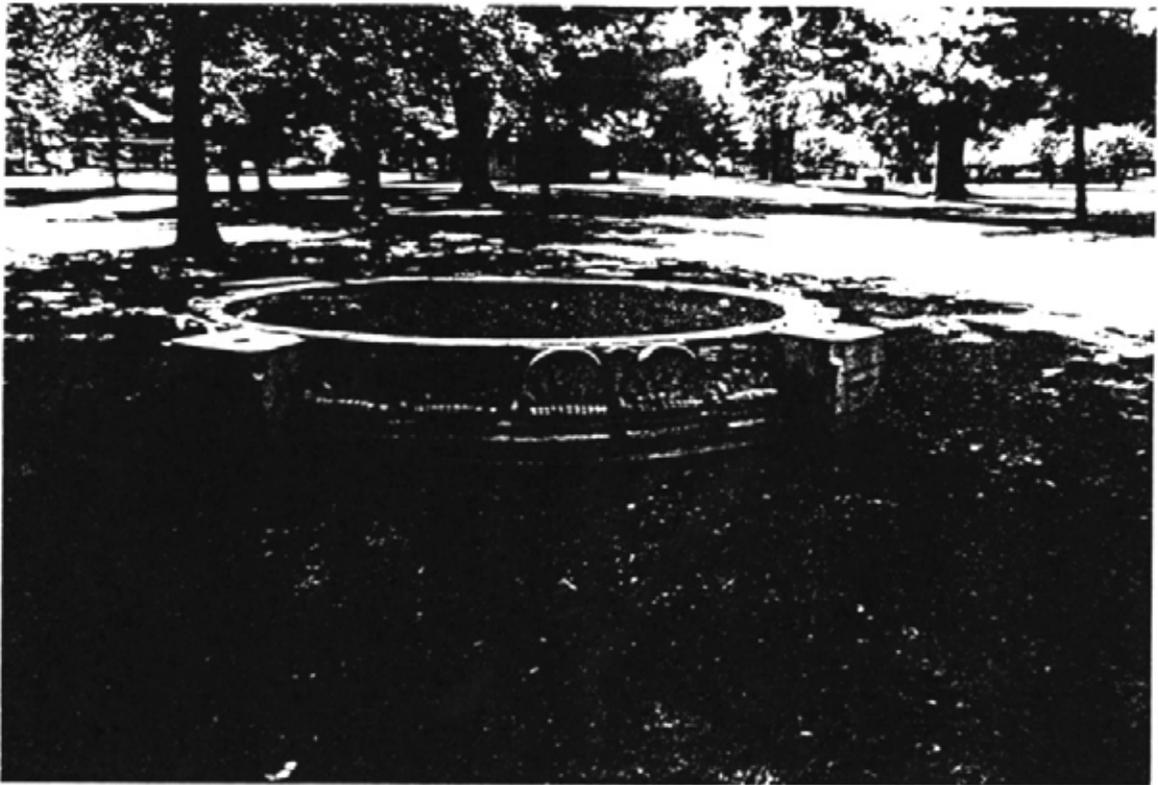
Figure 2.23: Denison Park, remains of fountain (K. Allen. SUNY CESF, 1994).

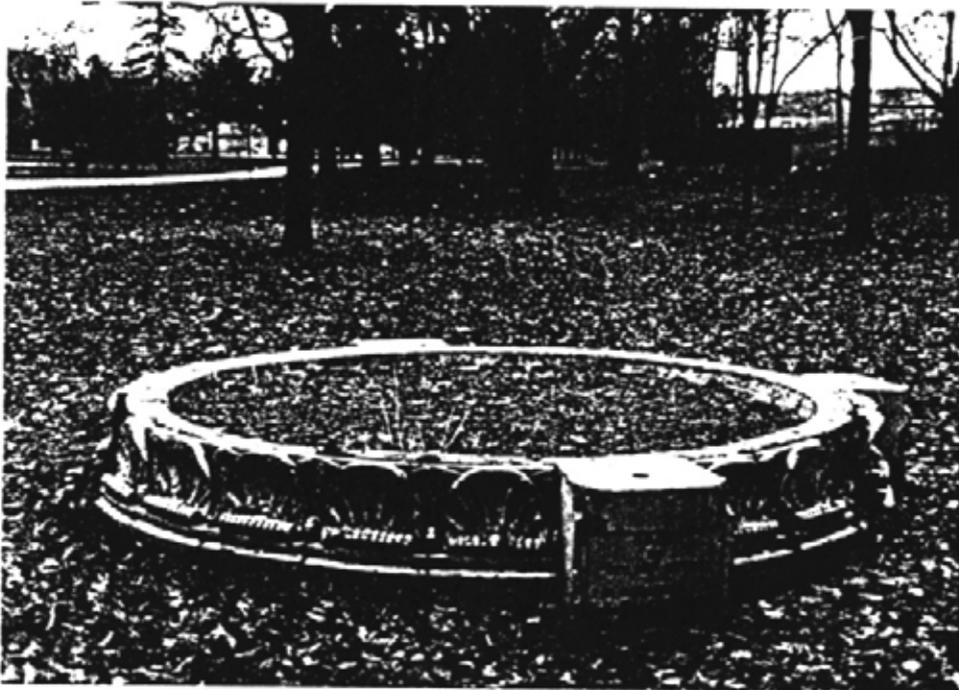
Figure 2.59: Denison Park, remains of Fountain, facing northwest (MSRA).

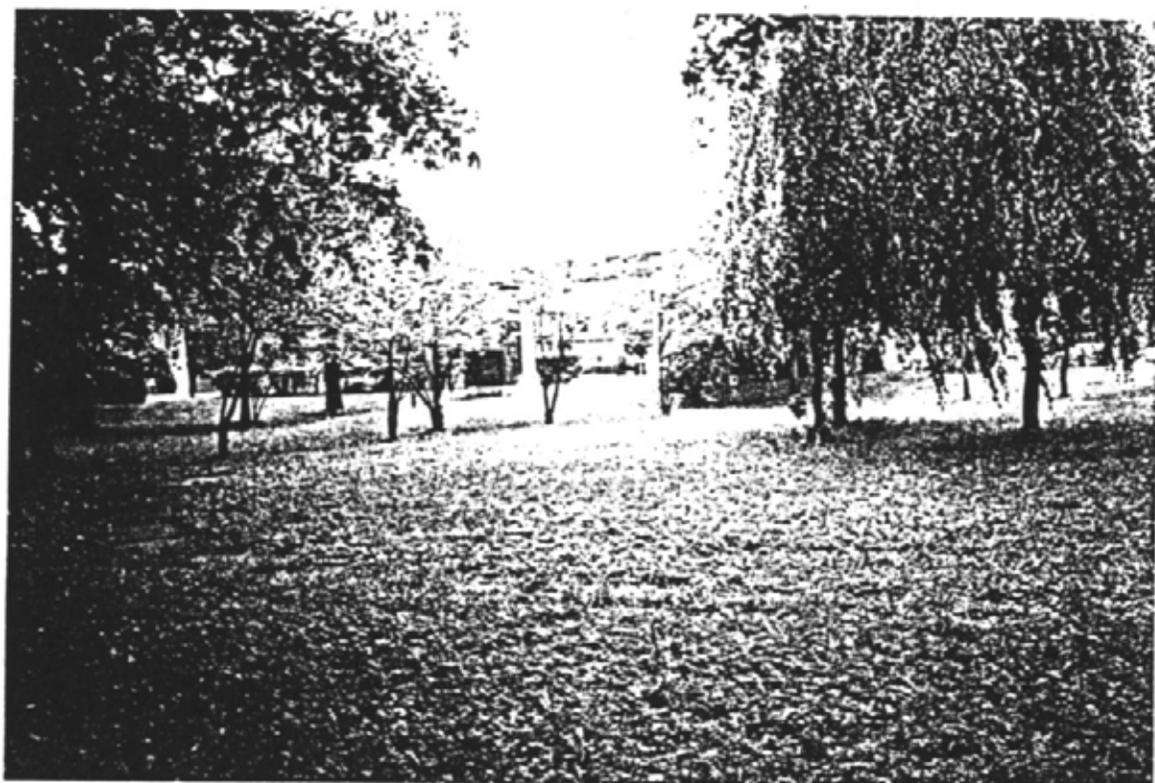
Figure 2.61: Denison Park, remains of walk surrounding the Wading Pool, facing southwest (K. Allen. SUNY CESF, 1994).
