Cultural Landscape Treatment
Home of Franklin D. Roosevelt National Historic Site
Concept Development

Faculty of Landscape Architecture
Preservation Studio
State University of New York
College of Environmental Science and Forestry

Faculty of Landscape Architecture
Preservation Studio 2006
State University of New York
College of Environmental Science and Forestry

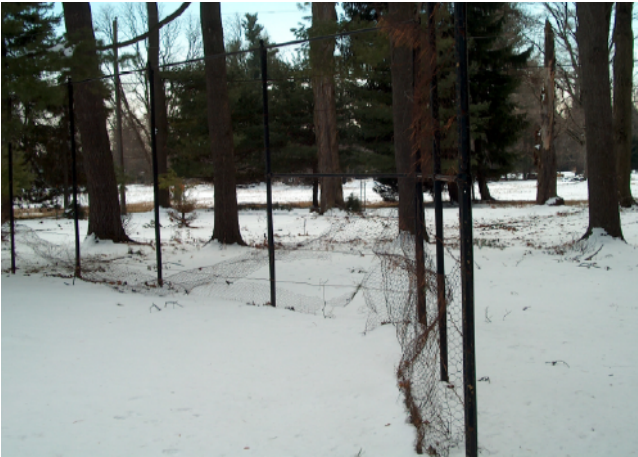
1.32 Tennis Court Restoration

1.32. The metal backstop frames should be repaired in kind, and painted black. The backstops should be striped of the remaining broken chicken wire which should be replaced in kind. An archeological study to determine the original surface, probably clay, should be conducted and the results used to reconstruct the court to the exact dimensions of the original design. The original court was, 130 feet long (N/S) by 52 feet wide (E/W).

Existing condition of tennis court backstop.

The metal backstop frames should be repaired and repainted in kind. A paint sample should be taken to determine the exact color. The backstops will be striped of the remaining chicken wire and replaced, in kind. The original surface, clay, should be reconstructed to the exact dimensions described in the CLR.

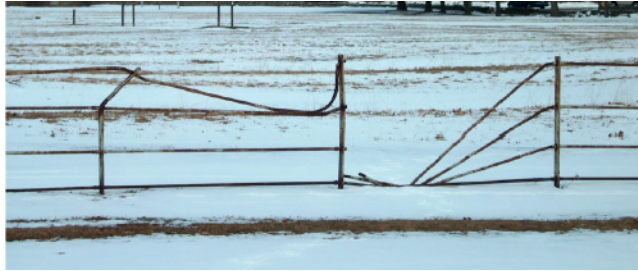
1.45 Library Fence Repair

1.45. The missing pieces of the historic fence and recent damage detract from the historic character of the fence. Reconstruct the areas of fence around the perimeter of the north avenue lot that have been removed after the period of significance. The library fence has been damaged in two new places. The fence should be repaired in kind. A paint analysis is suggested to determine the original color of the paint. If returning to the old walk as the primary circulation path, the portion of the fence that is removed should be used to replace the damaged sections.

New damage to the steel pipe fence.

Replace, in kind, the areas of fence around the perimeter of the north avenue lot that were removed after the period of significance. The library fence has been damaged in a two new places. The fence should be repaired in kind. A paint analysis is suggested to determine the original color of the paint. If returning to the old walk as the primary circulation path, remove and place in storage, the portion of the fence as necessary.

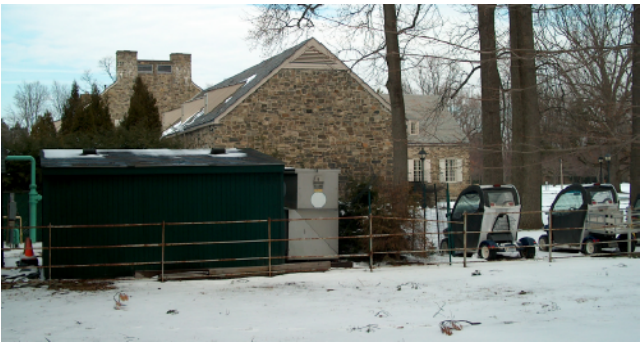
1.28 Library Maintenance Area Relocation

View of maintenance area.

The two air conditioning towers are contemporary features that are necessary for the library. Remove these features from their current location, as they should not be visible to the visitors. Cluster the towers with the HVAC Unit adjacent to the new visitor's parking lot, so that there is only one cluster of intrusion on the landscape.

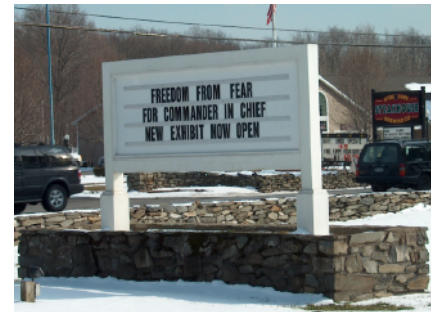
1.43 Library Entrance Sign Replacement

Library entrance sign in 2004.

The existing sign is very generic in appearance and should be removed. The new sign's size, shape, materials and location should reflect the historic character of the original sign, as seen in the CLR (3.17). The typography should be clear, and direct the visitor to the new entrance.

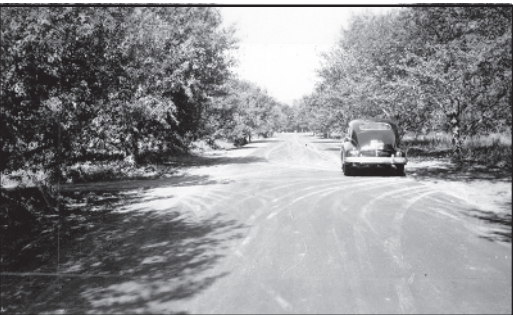
Low-headed, open bowl style of pruning of orchard trees prior to removal of lower scaffold branches.

Many of the orchard trees along the old Library Entrance Road appear mis-shapen due to the removal of the lower scaffold branches to facilitate the passage of contemporary large vehicles and equipment through the orchard. It is recommended that, with the consultation of an orchard specialist, new in-kind replacement trees might be custom-propagated to match the form of the old trees in a low-headed, open bowl pruning style which would have been characteristic of a farm orchard during the period of interpretation.

The orchard trees along the old Library entrance drive have lost the form of low-headed trunks, probably 18" - 36" in height and the open bowl style of pruning that would have been characteristic of a farm orchard during the treatment period. Many of the trees appear misshapen by the removal of one or more of the scaffold branches reflecting the contemporary high pruning method used to facilitate the passage of large vehicles and equipment through the orchard. With the consultation of an orchard specialist, new in-kind replacement trees should be custom-propagated to match the form of the old trees that retain a low-headed, open bowl pruning style. The low branching form of orchard trees is an important historic characteristic of the treatment period that should be restored and maintained.

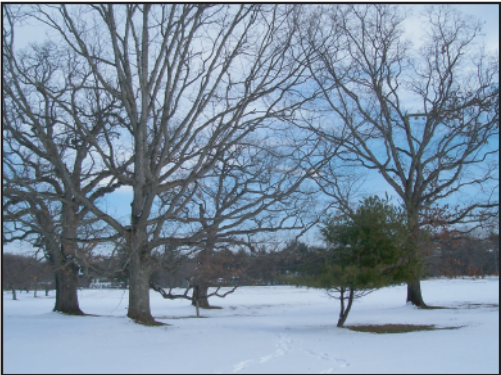
1.13 Field Oak Trees

White Pine encroaching on field Oak trees.

The small White Pine planted beneath one of the large White Oaks in the North Avenue Lot should be carefully removed from this location where it is encroaching on the canopy of one of the large Oak trees. The Pine will eventually crowd the Oak and visually detract from the historic trees.

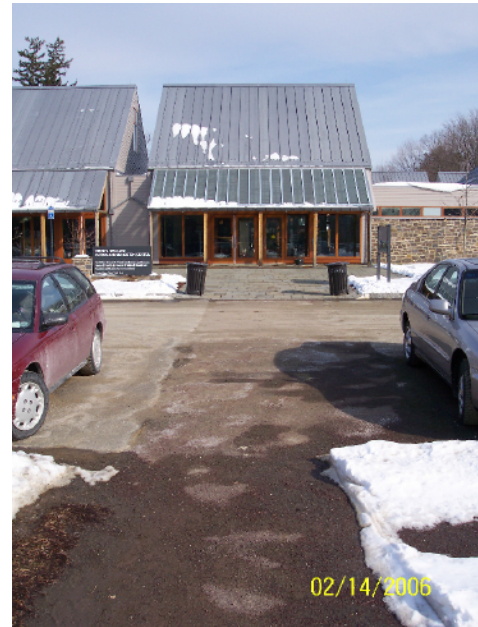
1.48 Visitor Parking Area

The pedestrian median.

A pedestrian median walkway was created in the middle of the new parking lot. This feature is not visually distinct from the surrounding parking lot. The answer to this problem is a change in materials. A brick walkway in a herringbone pattern would make that walk visually distinctive to the pedestrian eye.

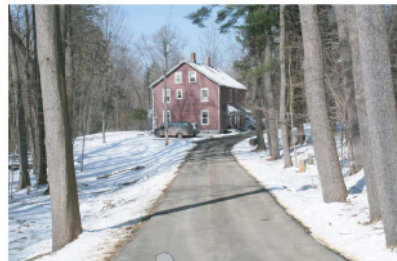
4.2 Duplex Compound Subspace

View North Toward Duplex Lot

The Duplex Lot is in decent condition, and should be maintained to remain this way. To reflect the historic character of the site, automobiles should be stored behind the house out of sight until further actions can be taken, and the temporary storage structure should be removed.

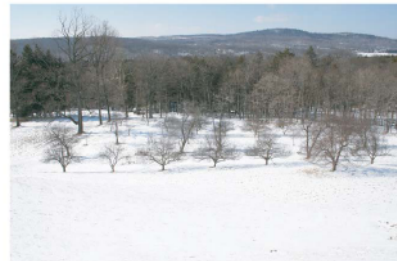
4.5 Lower Orchard

View West Over Lower Orchard

The orchard located behind The Home is in serious disrepair compared to its original form. The lower orchards' original grid and plantings need to be replaced and maintained.

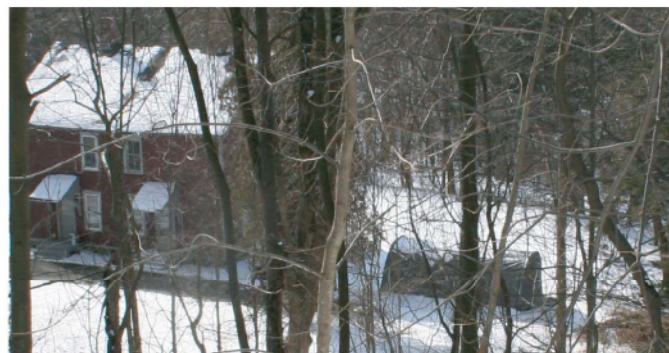
4.11 Site of Duplex Garage

The garage no longer exists and needs to be rebuilt. There are no permanent structures located in the area that the garage stood. Upon further research a match may be found to the garage, or if nothing is found, a garage similar in historic character may be constructed.
