Cultural Landscape Treatment
Home of Franklin D. Roosevelt National Historic Site
Concept Development

Faculty of Landscape Architecture
Preservation Studio
State University of New York
College of Environmental Science and Forestry

Faculty of Landscape Architecture
Preservation Studio 2006
State University of New York
College of Environmental Science and Forestry

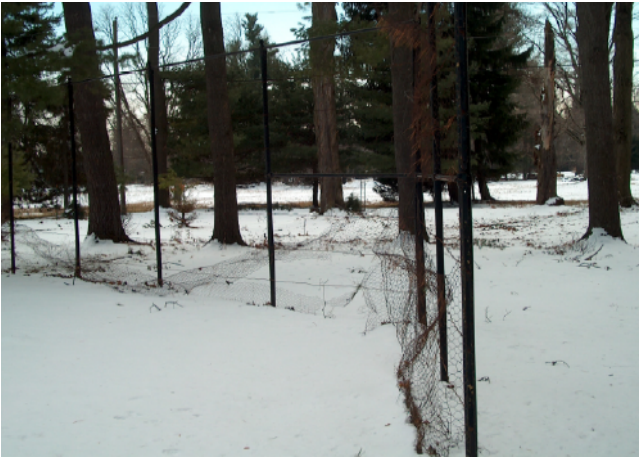
1.32 Tennis Court Restoration

Existing condition of tennis court backstop.

The metal backstop frames should be repaired and repainted in kind. A paint sample should be taken to determine the exact color. The backstops will be striped of the remaining chicken wire and replaced, in kind. The original surface, clay, should be reconstructed to the exact dimensions described in the CLR.

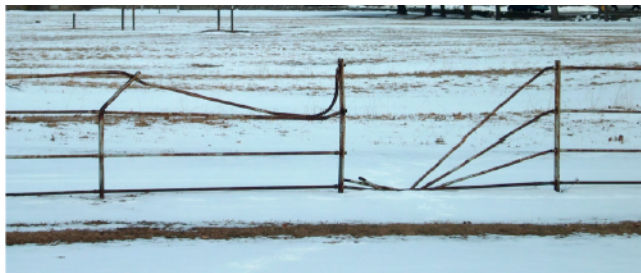
1.45 Library Fence Repair

New damage to the steel pipe fence.

Replace, in kind, the areas of fence around the perimeter of the north avenue lot that were removed after the period of significance. The library fence has been damaged in a two new places. The fence should be repaired in kind. A paint analysis is suggested to determine the original color of the paint. If returning to the old walk as the primary circulation path, remove and place in storage, the portion of the fence as necessary.

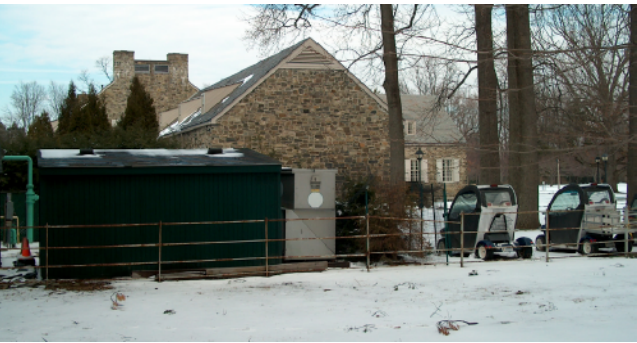
1.28 Library Maintenance Area Relocation

View of maintenance area.

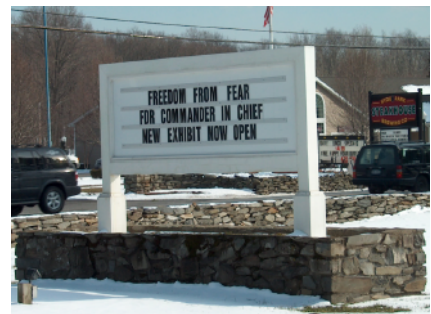
1.43 Library Entrance Sign Replacement

Library entrance sign in 2004.

The existing sign is very generic in appearance and should be removed. The new sign's size, shape, materials and location should reflect the historic character of the original sign, as seen in the CLR (3.17). The typography should be clear, and direct the visitor to the new entrance.

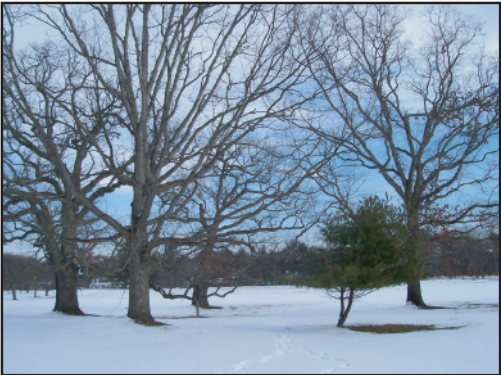
1.13 Field Oak Trees

White Pine encroaching on field Oak trees.

The small White Pine planted beneath one of the large White Oaks in the North Avenue Lot should be carefully removed from this location where it is encroaching on the canopy of one of the large Oak trees. The Pine will eventually crowd the Oak and visually detract from the historic trees.

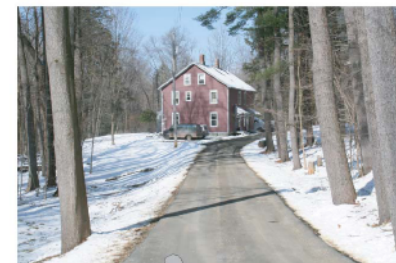
4.2 Duplex Compound Subspace

View North Toward Duplex Lot

The Duplex Lot is in decent condition, and should be maintained to remain this way. To reflect the historic character of the site, automobiles should be stored behind the house out of sight until further actions can be taken, and the temporary storage structure should be removed.

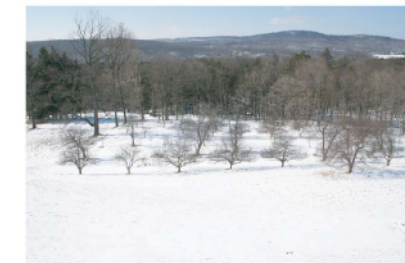
4.5 Lower Orchard

View West Over Lower Orchard

The orchard located behind The Home is in serious disrepair compared to its original form. The lower orchards' original grid and plantings need to be replaced and maintained.

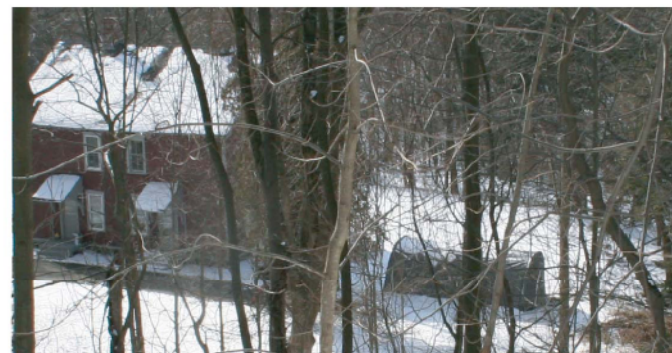
4.11 Site of Duplex Garage

The garage no longer exists and needs to be rebuilt. There are no permanent structures located in the area that the garage stood. Upon further research a match may be found to the garage, or if nothing is found, a garage similar in historic character may be constructed.
