**From Design to Construction: Lessons Learned about Bioretention Performance**  
**The Edna Bailey Sussman Foundation Internship Report**  
**December 2015**

Tom Baker, MLA Candidate  
State University of New York College of Environmental Science and Forestry  
Department of Landscape Architecture

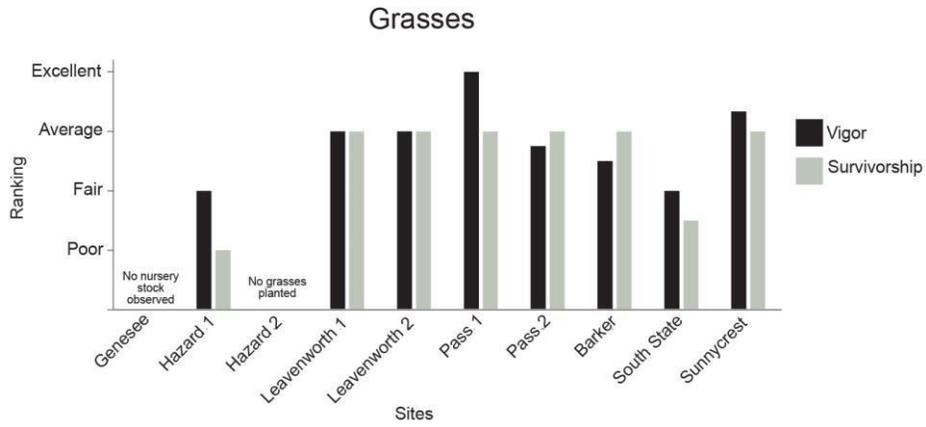
**Figure 1. Average vigor and survivorship of grasses among sites.**

At the ten sites, a total of 49 nursery stock species were originally planted including six species of trees, 10 species of small trees/shrubs, 17 species of perennials, 12 species of grasses, and four species of groundcover. Vegetation vigor and survivability varied between sites (Figure 1, Figure 2, Figure 3). Of the originally planted nursery stock, six were not observed at the time of the study, due to either lack of surviving or not being planted. Total species per site ranged from two to 15. Two species were common among six sites, one common among five sites, four common among four sites, four common among three sites, 12 common among ten sites, and 26 found only at one site.

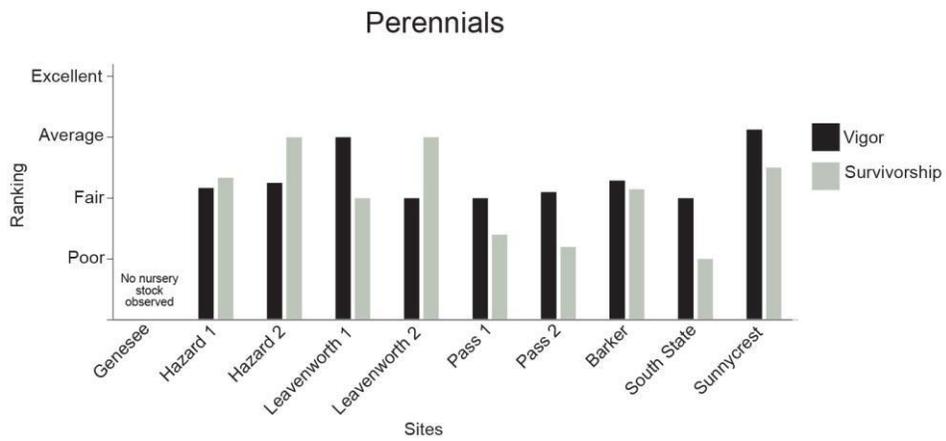
**Figure 2. Average vigor and survivorship of perennials among sites.**

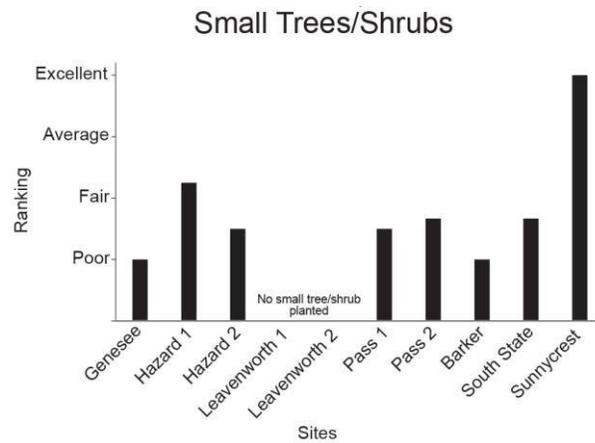
**Figure 3. Average vigor small trees/shrubs among sites.**

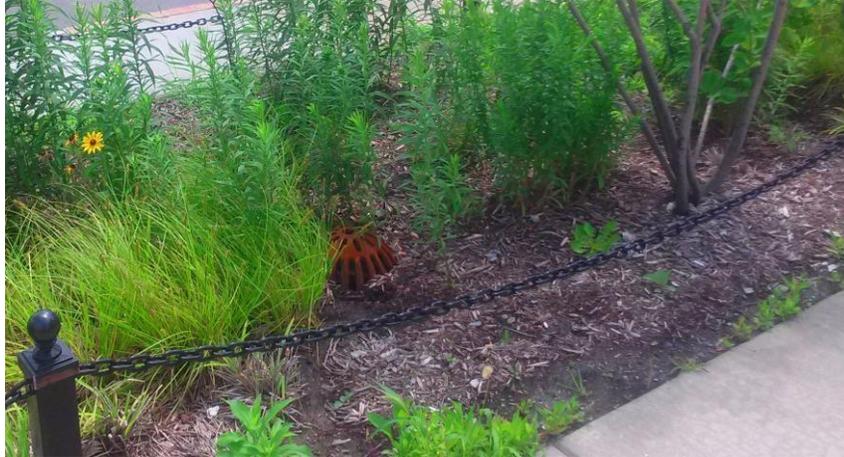
**Figure 4. Lack of sediment removal from South State resulting in homogenous topography and sediment build-up around site emergency overflow.**

*V. angustifolium* ‘Top Hat’ standing but dead, and one grass (*S. scoparium*). *C. caroliniana* and *S. scoparium* were in very poor health and only one individual of *S. scoparium* was observed. The rest of East Genesee was established with volunteer species. Chavez et al. (2015) showed similar results when reviewing vegetation survivorship within seven bioretention cells in Oklahoma. Their 2015 study showed an overall decline in nursery stock species which gave way to volunteer species recruitment. South State showed consistently low plant vigor and survivability, which can in part be attributed to sediment build up. South State shows evidence of

water transporting mulch and sediment throughout the site, specifically built up around the emergency overflow, which created a topographically homogenous site.

Variable design, construction, and maintenance practices related to overall vegetative success. Specifically, poor practices were observed in regards to inlet design, vegetation placement, and removal of sediment. In the case of this study, initial vegetation survivability was poorly considered with installed soil pH considerably higher than species needs. The findings of this study call for increased coordination through the phases of design, construction, and maintenance. Further, concern of low maintenance resources calls for more consideration of less complex planting designs (fewer number of plant species, ease of maintenance). In regards to sedimentation, designs should consider more aggressive weir structures to capture inflow of sedimentation. Such structures will reduce sedimentation buildup in the cells while making sedimentation removal easier.

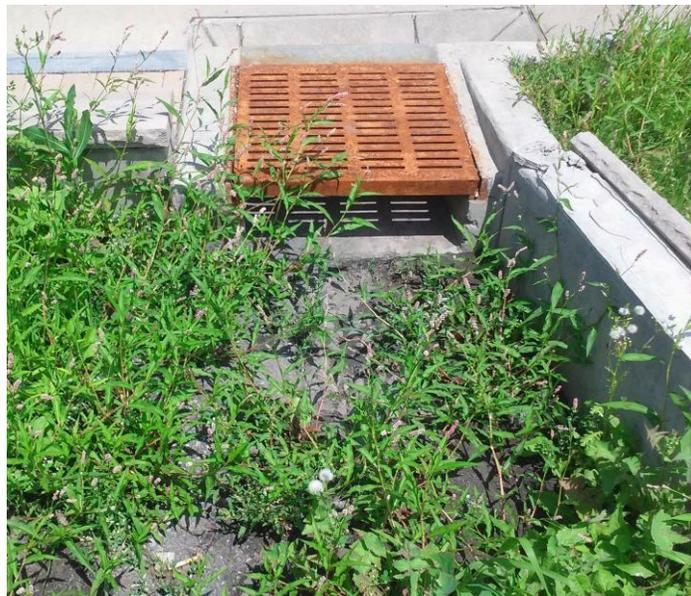
Similar to Cosgrove and Bergstrom (2003) and Chavez et al. (2015), vegetation survivability varied in relation to maintenance and design specifications. Among sites with poor maintenance and inadequate site design, species survivability and distribution was low when compared to original planting specifications. East Genesee and South State showed a lack of post installation maintenance, specifically in regards to removal of sediment build up. Large amounts of sediment buildup were evident across the surface East Genesee and South State and around emergency overflows (Figure 4, Figure 5). Three of seven nursery stock species were observed at East Genesee including two woody plants (*V. angustifolium* ‘Top Hat’ and *C. caroliniana*), with

**Figure 5. Sediment build-up around the inlet of East Genesee, resulting in poor vegetation establishment and a compacted surface layer.**

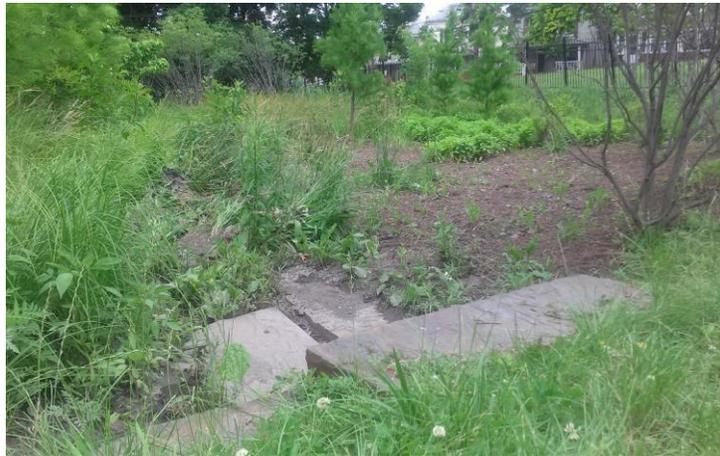
Pass 1 and Pass 2 showed low vegetation survivability around inlets and areas of high erosion. Both sites showed evidence of high water velocity entering the site through inlets and creating surface preferential flow paths and soil and mulch erosion around inlets (Figure 6, Figure 7). Pass 2 also exhibited erosion on banks (Figure 8). The cause of erosion was identifiable to water velocity near inlets, but the cause of erosion on the slopes was unclear. Due to a serious lack of vegetation and severe displacement of soil, erosion on the slopes was likely occurring well before the start of this study.

**Figure 6. Erosion and preferential surface flow path from inlet at Pass 1, resulting in poor vegetation vigor and survivability.**

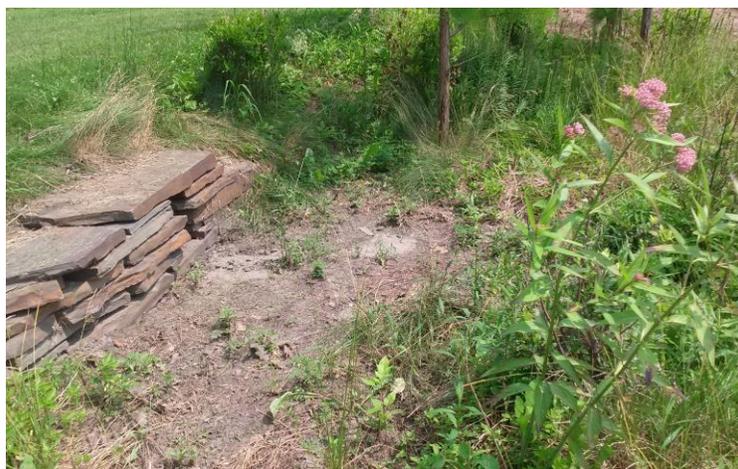
**Figure 7. Erosion surrounding inlet from Pass 2, resulting in poor vegetation vigor and survivability.**

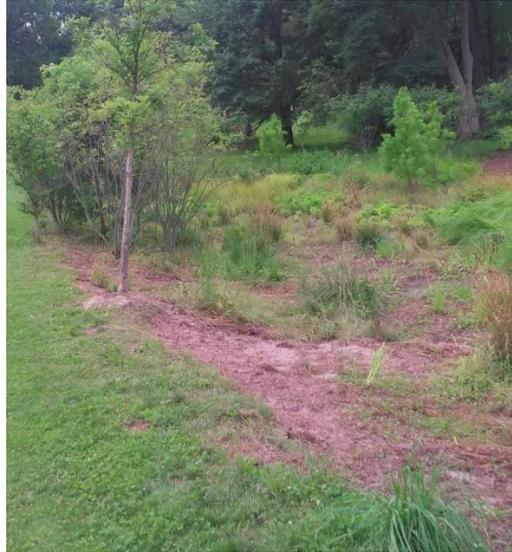
**Figure 8. Erosion on bank of Pass 2, resulting in poor vegetation vigor and survivability.**
