**HISTORIC LANDSCAPE REPORT  
FOR  
MEADOW CROFT**

Former Summer Home  
of  
John Ellis Roosevelt

A project  
submitted in partial  
fulfillment of the requirements for the  
Master of Landscape Architecture Degree

State University of New York  
College of Environmental Science and Forestry  
Syracuse, New York  
May 1991

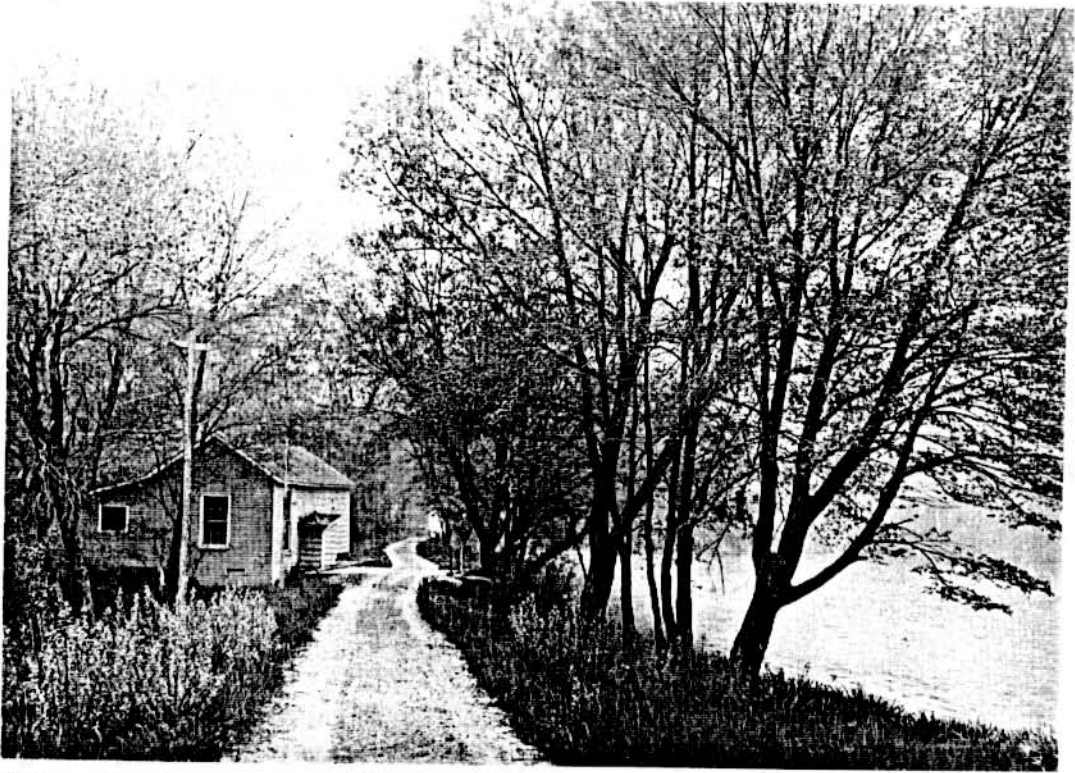
Fig. 2.5 View of water-powered mill house located on the southern end of Lotus Lake c. 1900. (Nassau County Museum Reference Library "NCMRL")

Unlike many country gentlemen who established summer estates in the area, Robert did not make a major transformation to the landscape in creating his pleasure grounds, he instead chose to adapt his estate to the existing conditions. Robert transformed the farm into a country estate, but still maintained many of the previous features, functions, and uses. The farm house was converted into a guest house and, for his family, Robert constructed an Italianate style villa, which was sited on a bluff overlooking the lake that he named Lotus Lake, most likely after the varieties of water lilies found in it. Many of the out-buildings were converted to house the activities of his fish hatchery and the old mill was retained to run water-powered machinery (Figure 2.5).

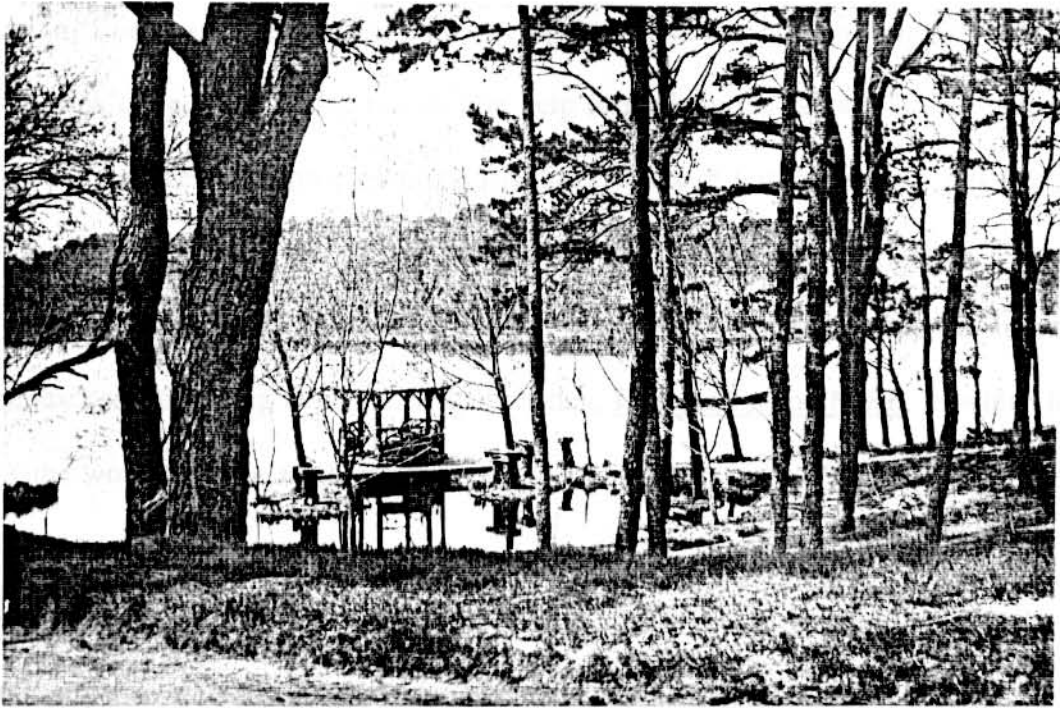
Fig. 2.7 Rustic Island Summer House on Lotus Lake c. 1890. (Bayport Heritage Association)

rustic summer house reached by a man-made land bridge (Figure 2.7). This was not a typical design style in Sayville for a country seat during the early Victorian period. Many other estates in the area were laid out following the more picturesque design style dictated by A.J. Downing, having a large manicured lawn on which were clustered a variety of specimen trees that enframed vistas to the residence. Instead, Robert chose a design layout for his country seat derived from the more natural rustic style commonly found in the Adirondacks and elsewhere, although he did maintain a few semi-formal carpet beds which he laid out in a style similar to what he described in Five Acres Too Much:

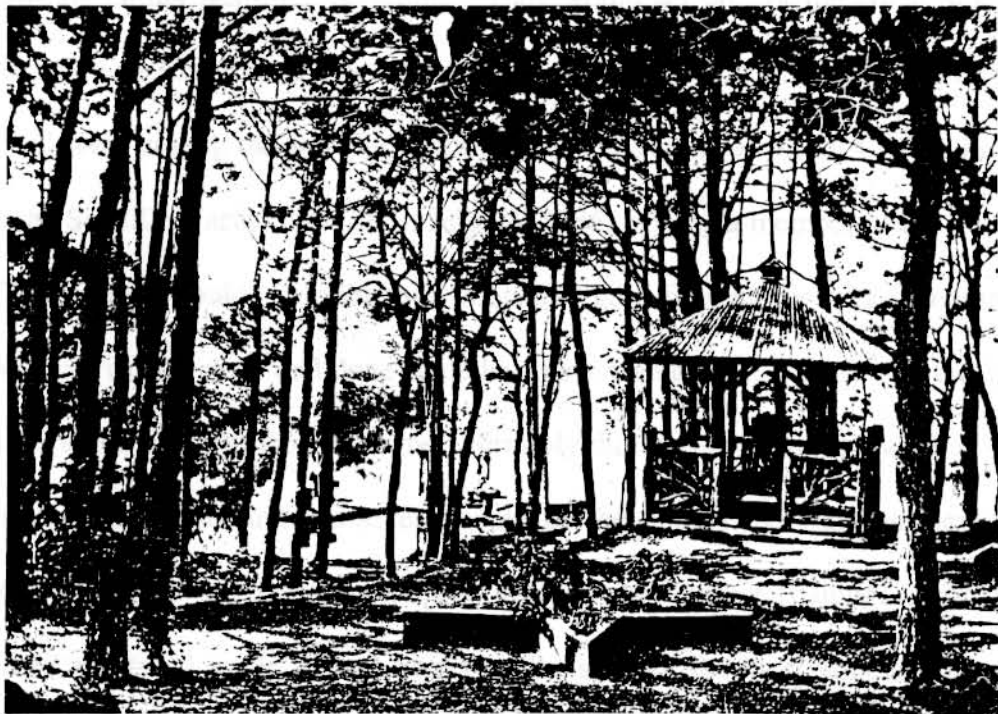
Fig. 2.8 Robert created a star-shaped perennial flower bed along side a rustic summer house similar to the description in his book, c. 1890. (Theodore Roosevelt Association)

"It is well known that, according to the highest standard of the art, the great point in laying out a garden is to avoid the monotony of tame regularity; and in that line little more could be done. There were beds shaped like stars and ellipses, worms and circles, triangles and octagons; some were round on one side and flat on the other; some had big heads and little tails, and other diminished to nothing at each end; there were sinuosities and projections, sharp points and easy curves, imitation bays and promontories; large beds suddenly contracted, narrow ones expanded; what promised to be a long stretch was broken off unexpectedly, and there certainly was no danger of monotony." (Roosevelt, p. 112) [Figure 2.8]

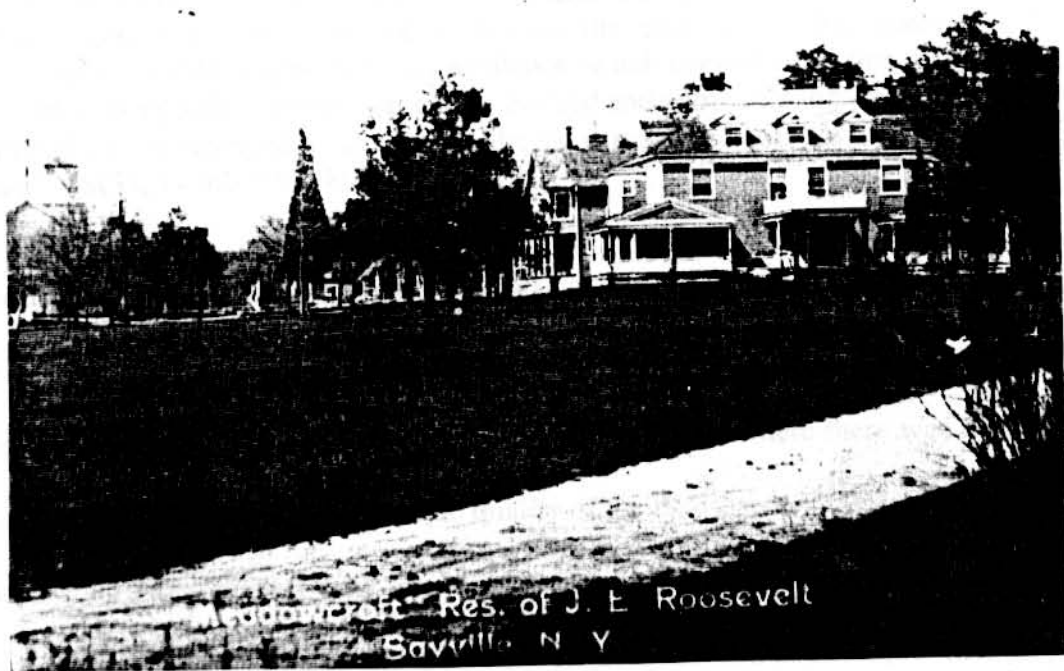
Fig. 2.14

The entry drive circled around the front lawn, leading to the porte chere and was flanked on one side by ornamental shrubs. (Postcard View, Bayport Heritage Association)

Especially important to the setting of the house was the approach, the most commonly advocated being a slow, long, curving drive which provided fine picturesque vistas to the house as it circled around the large open lawn scattered with artfully placed specimen trees often in clusters. Meadow Croft's approach adhered to these basic principles, but the house's location set far back off the road in the midst of a tidal meadow allowed John to enhance it even further (Figure 2.14).

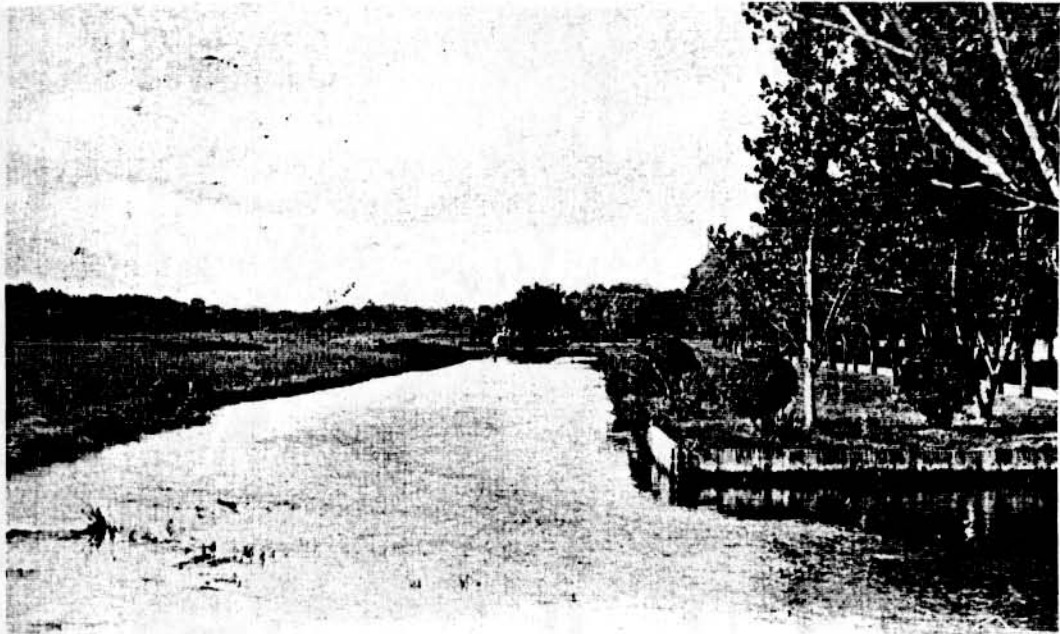
The dredged canal on the west side of the entry drive, with its original bulkheading, c. 1900. (Bayport Heritage Association)

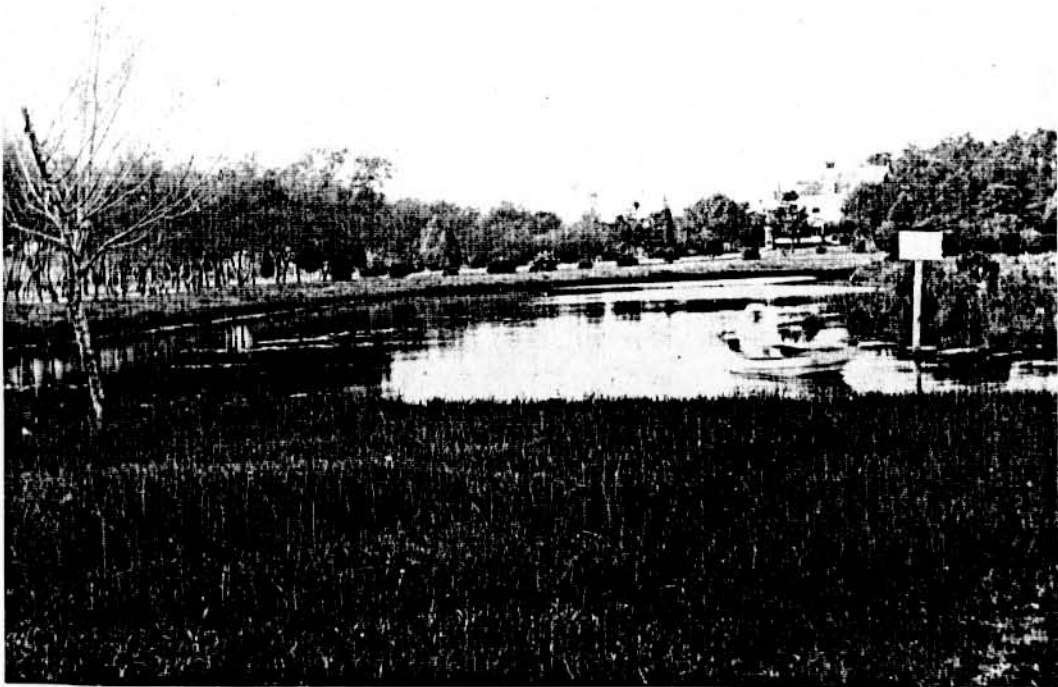
Fig. 2.17

The pond-like canal on the east side of the entry drive provided a picturesque foreground for views to the estate, as well as recreational opportunities, c. 1900. (Bayport Heritage Association)

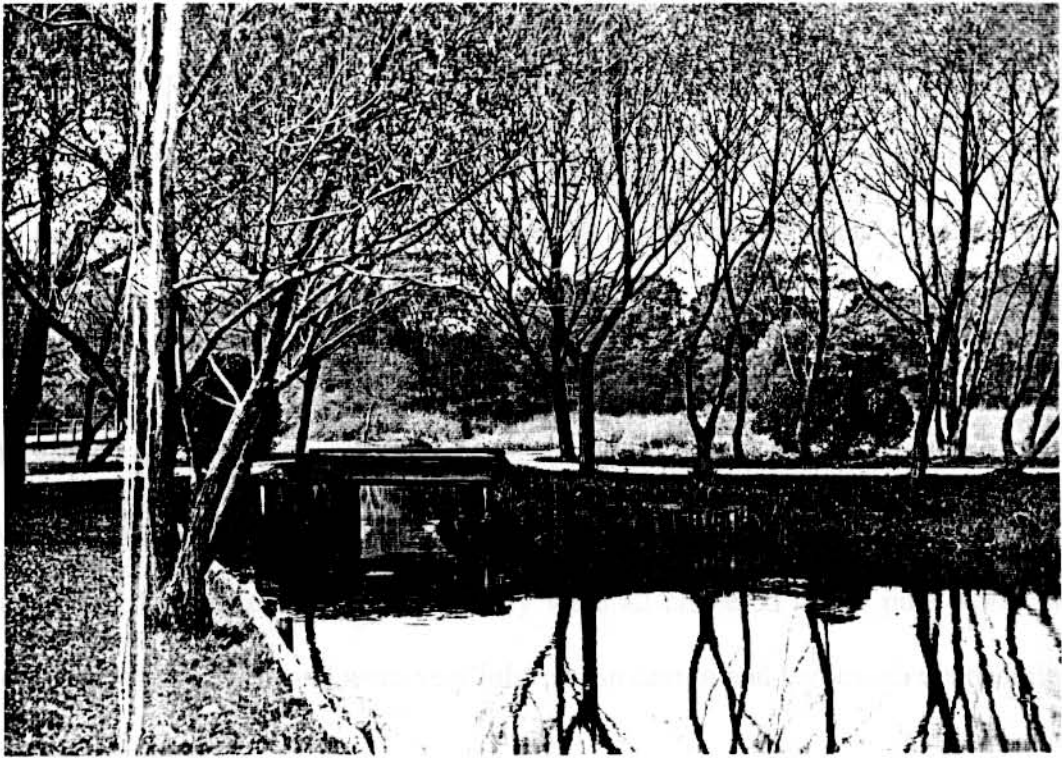
Fig. 2.18 Both the entry drive bridge and the surrounding bulkheading were constructed of wood, but the bridge was eventually replaced by concrete, c. 1900. (Bayport Heritage Association)

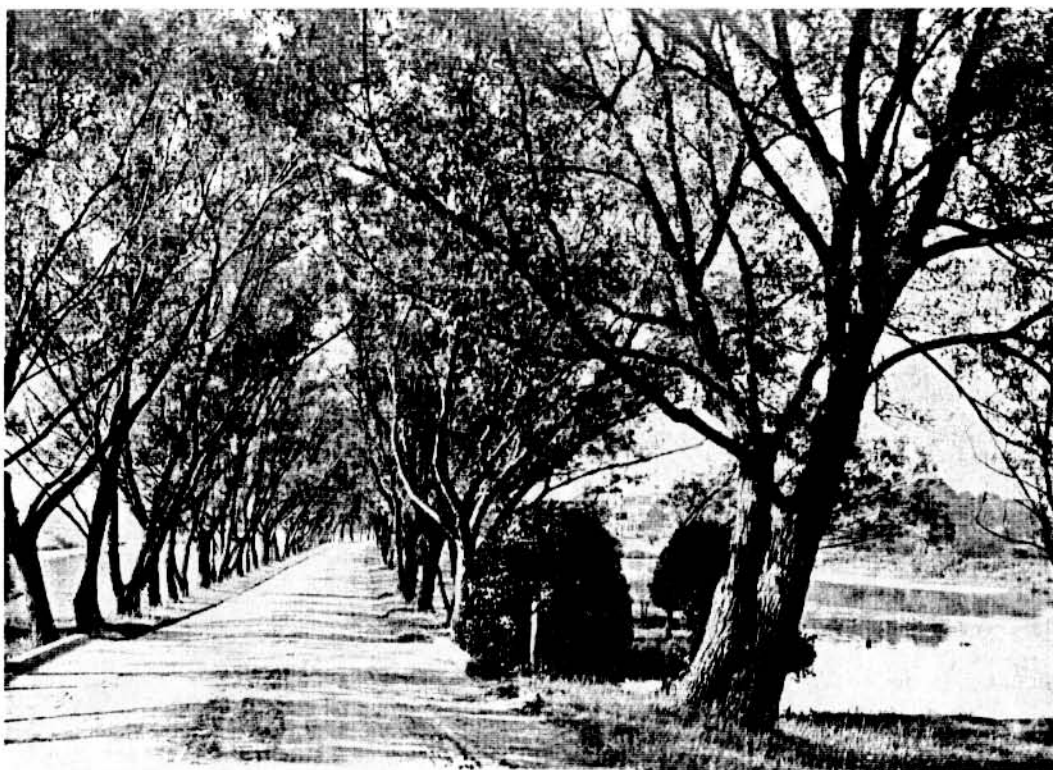
Fig. 2.20 The entry drive lined on either side by a row of white willows, c. 1905. (NCMRL)

in the drive (SCN, June 9, 1894) [Figure 2.20]. At this point, the servants would continue on straight to the service area of the residence, and a guest or family member would bare right circling around the large open lawn, lined with flowering shrubs on the outside, to the porte cochere.

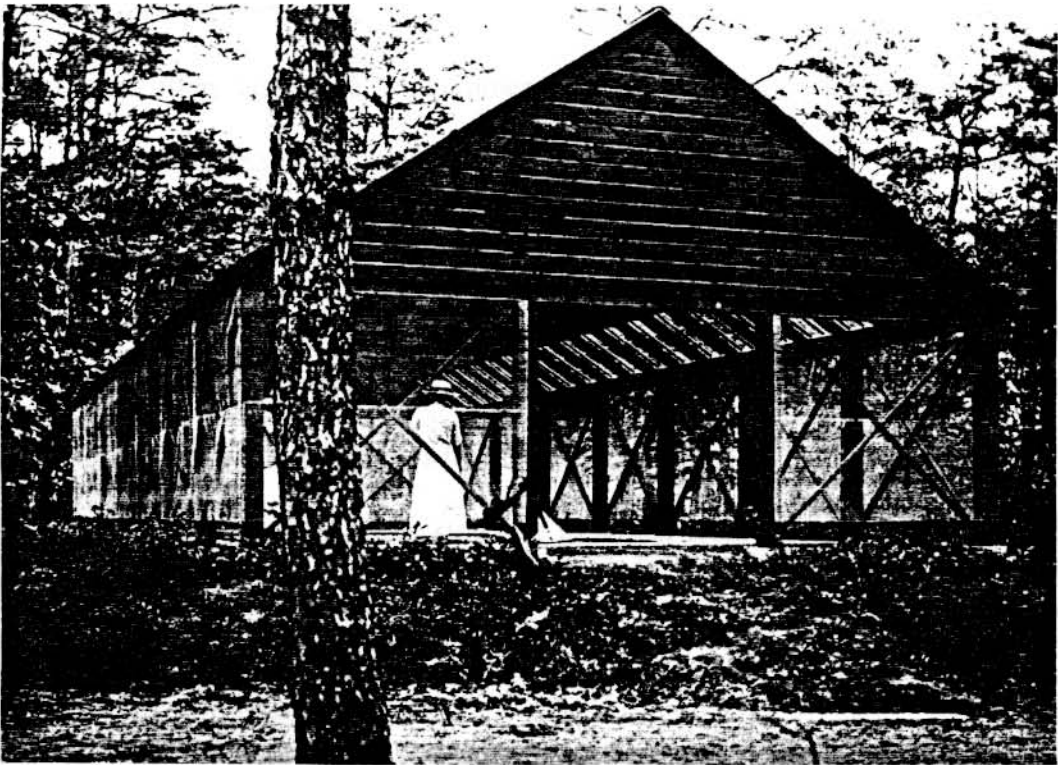
Fig. 2.22a The in-ground pool pavilion structure c. 1895 is believed to be one of the first pools of its type on Long Island. (Theodore Roosevelt Association)

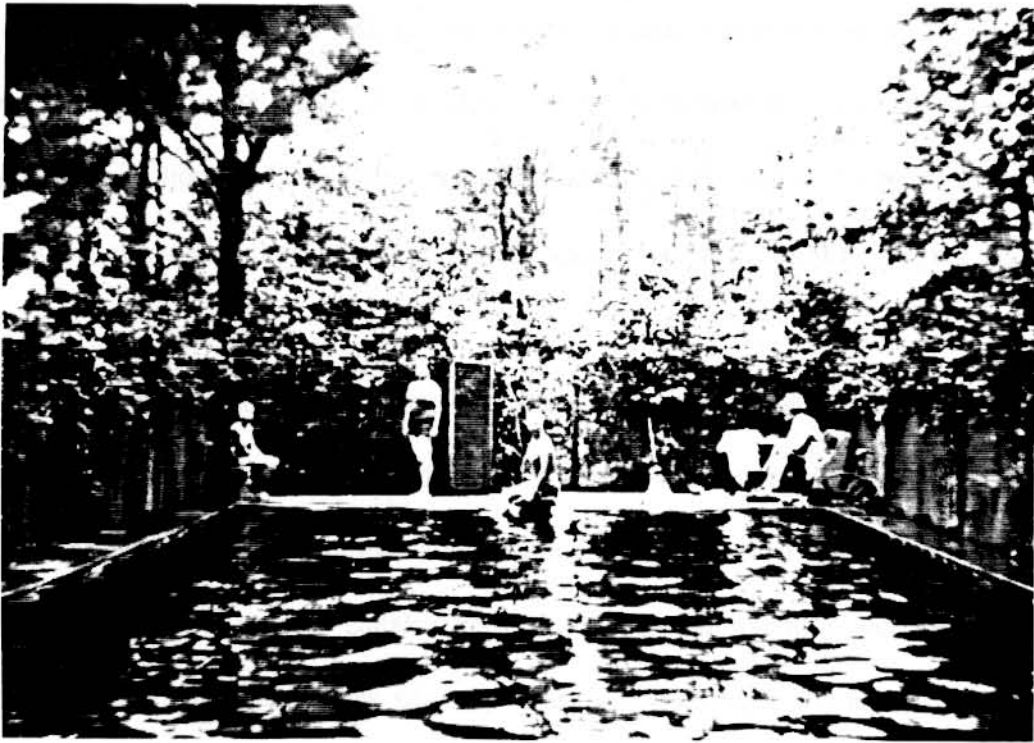
Fig. 2.22b A view of the pool in its later years after the pavilion was removed.

a luxury and used quite often during the hot summer months. The pool's location within this wooded area possibly explains the elimination of the pavilion structure in later years, as it may have been damaged by one of the closely surrounding pines during a storm (Figure 2.22b).

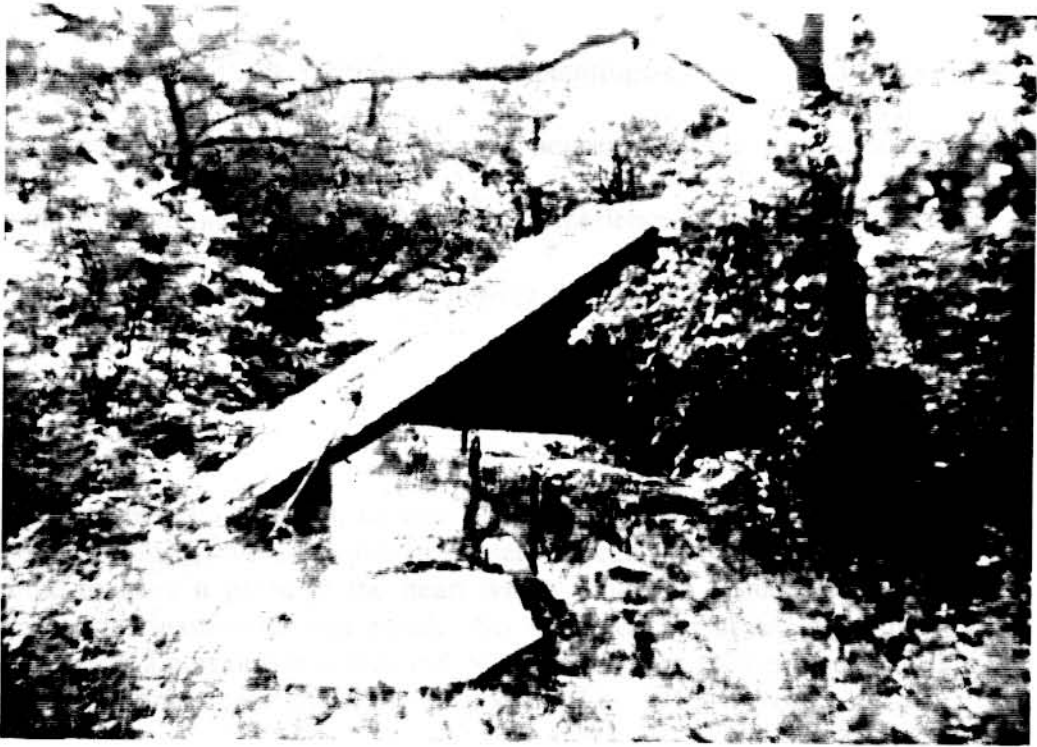
Fig. 2.23 The wooden frame boat house structure was probably constructed in the mid 1890's after the canal was dredged, c. 1895. (Bayport Heritage Association)

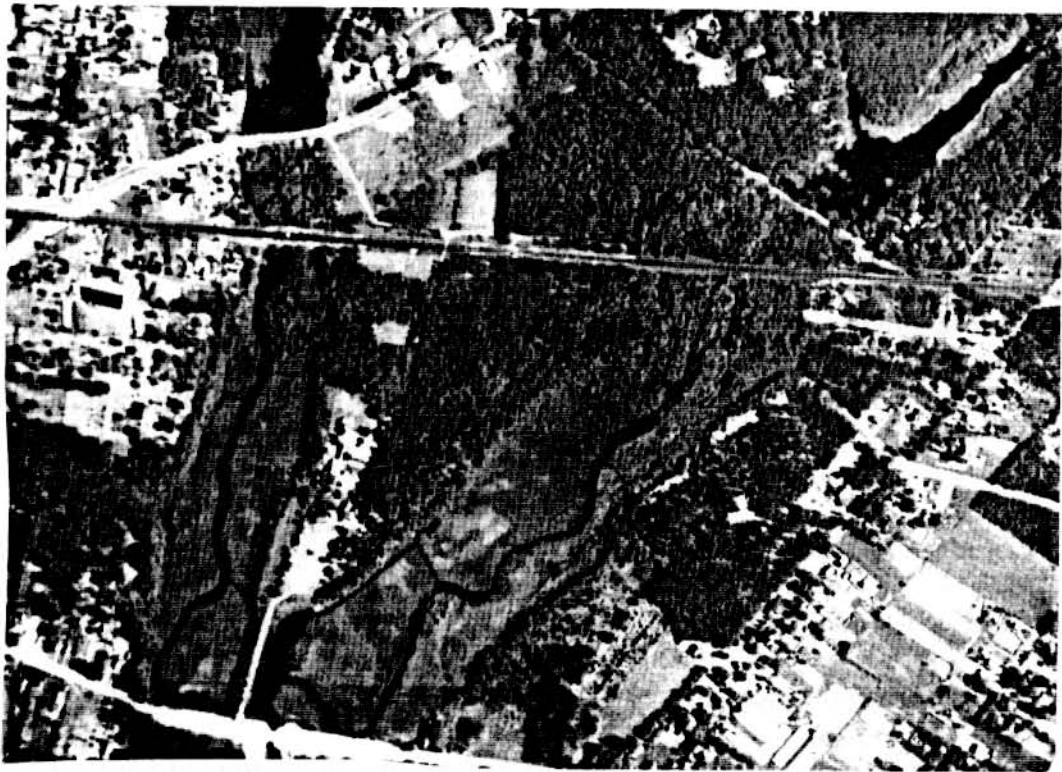
Fig. 2.28b

A 1938 aerial photo enlargement provides a better perspective of the layout and the geographic location and relationship of the Roosevelt Family Compound.

John was not the only family member who purchased a portion of his father's Lotus Lake Estate. In 1899, his brother, Robert B. Roosevelt, Jr., purchased a portion of land on the west side of Lotus Lake and proceeded to construct his own country house which he named "The Lilacs" (SCDP). Although not much detailed information exists about the estate, it was laid out in a similar fashion as his brother's, but it was not as elaborate. Together all three estates encompassed over 230 acres of land on which a variety of recreational opportunities existed. The three estates were linked by a unique, circulation system consisting of a roadway, hiking path, and canal allowing all of the estates to be reached by the use of any one (Figure 2.28 a & b).

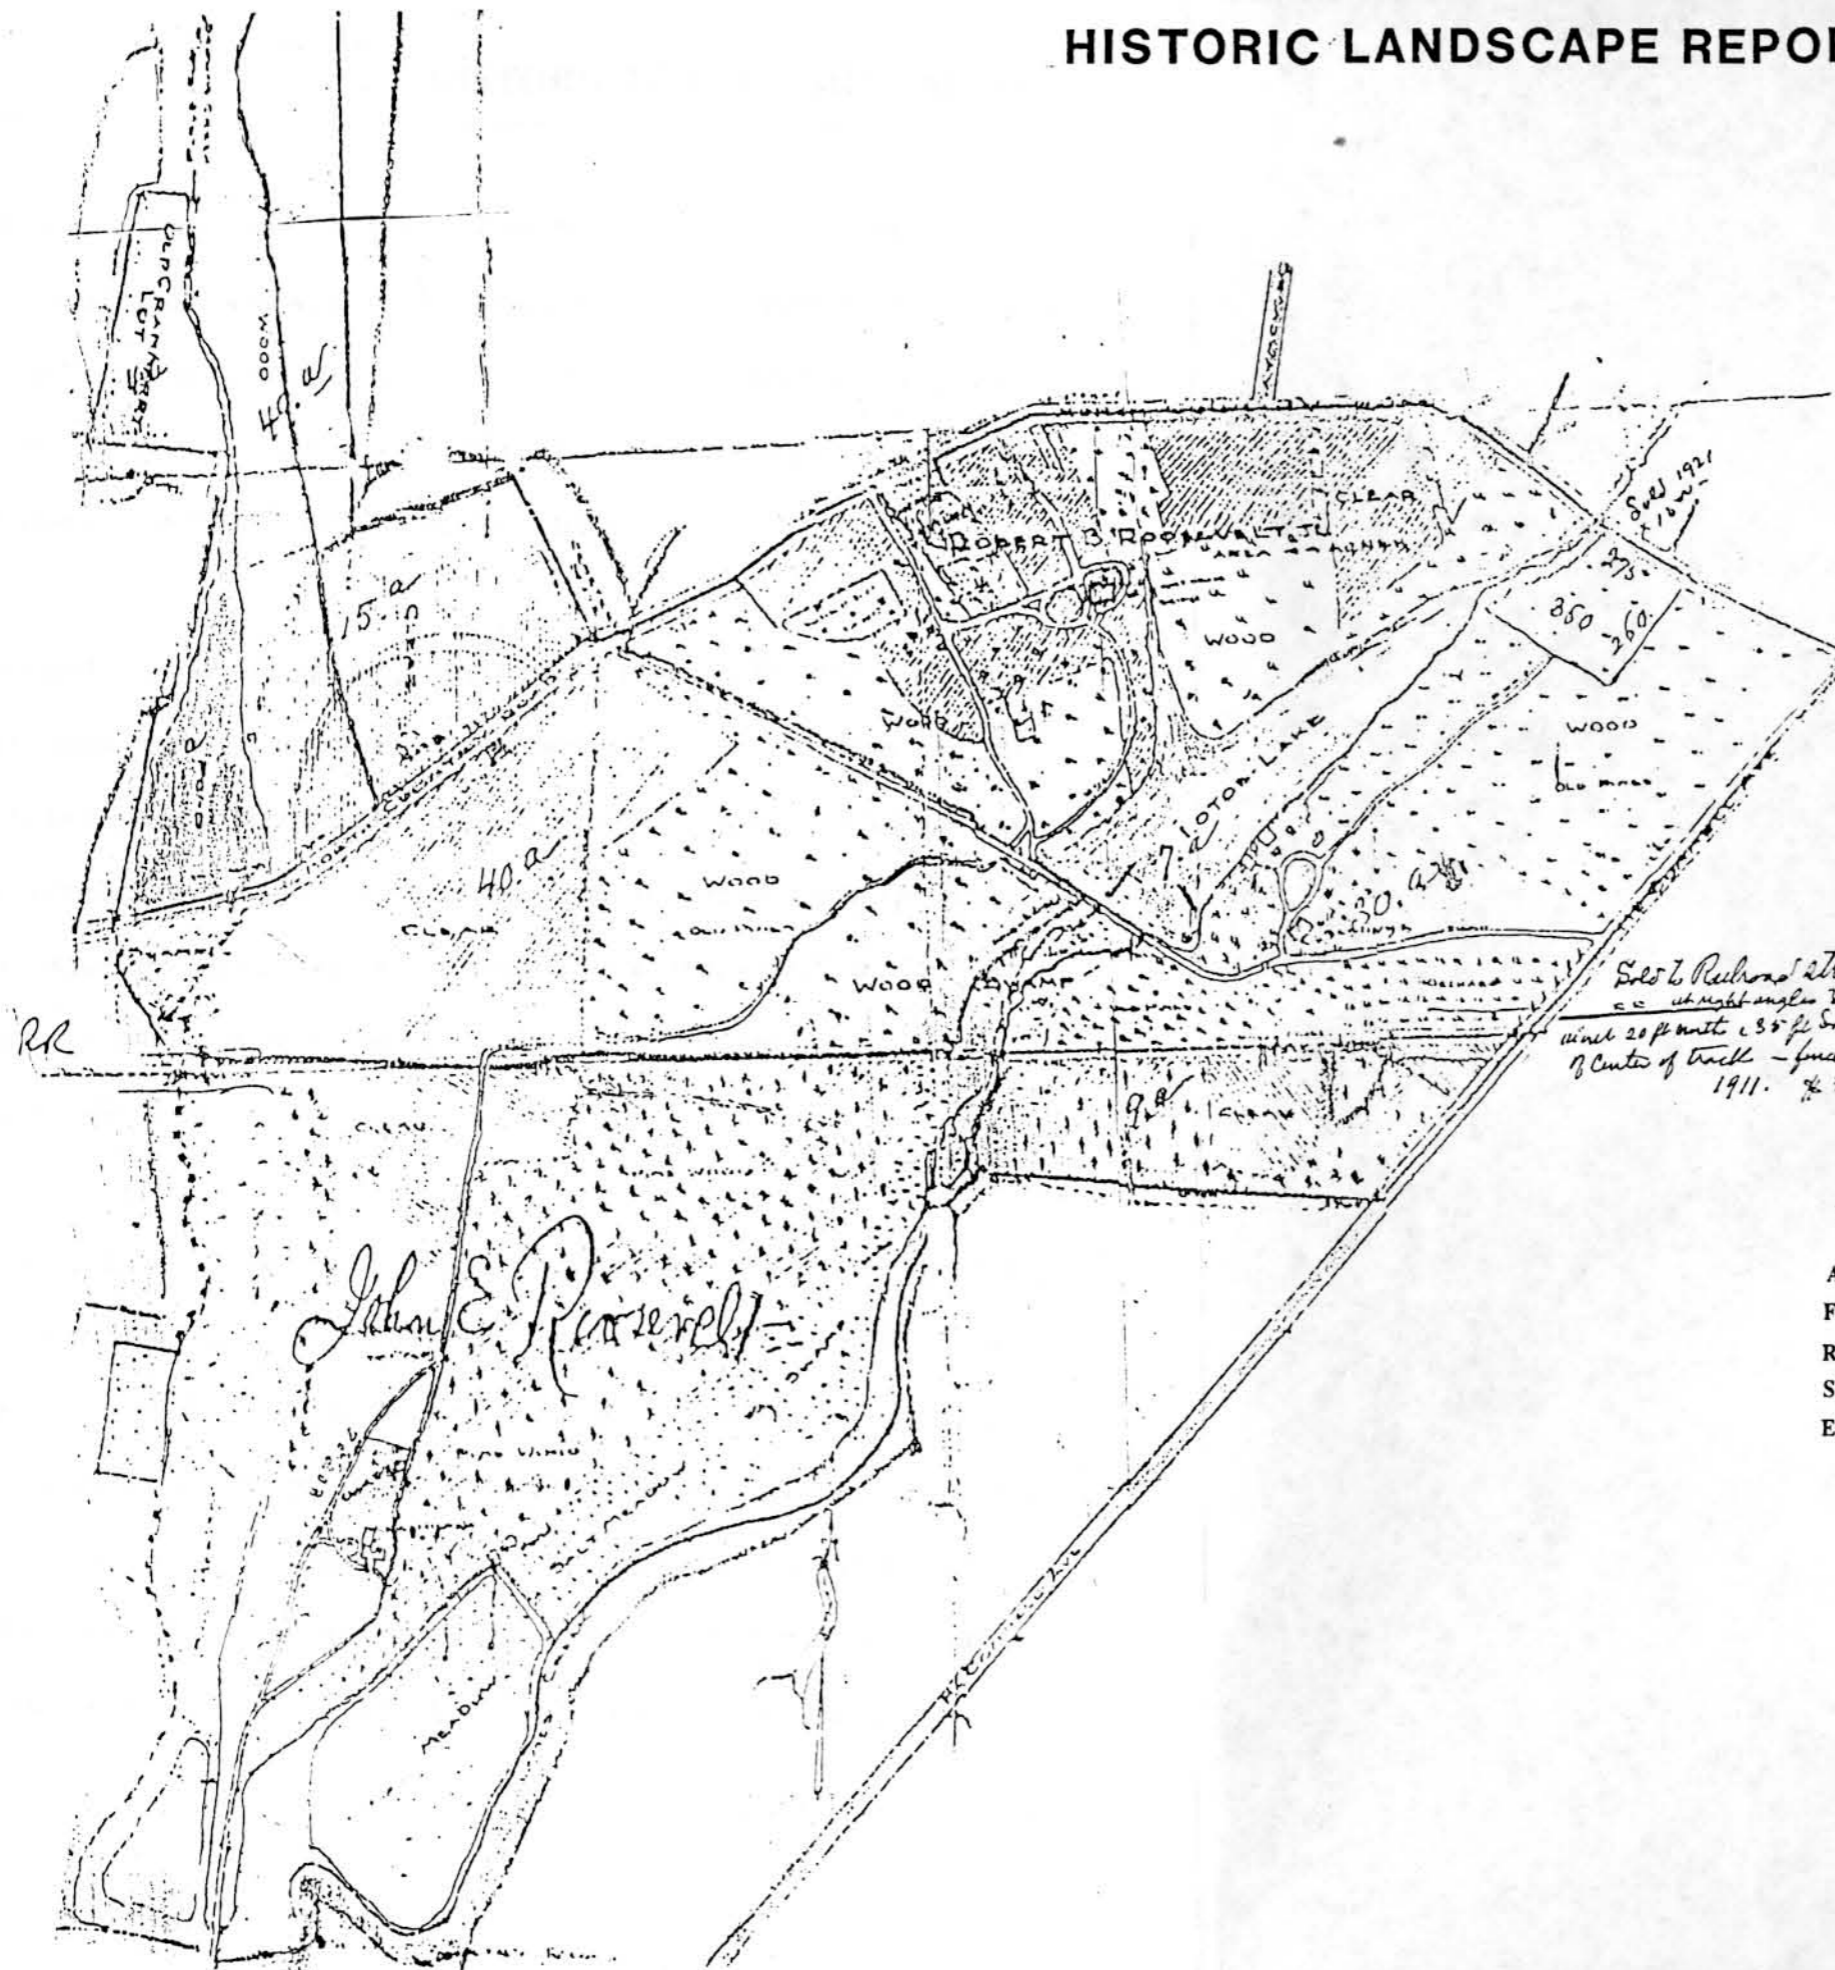
## ROOSEVELT PROPERTY

AN ENLARGED PROPERTY MAP SHOWING THE ENTIRE ROOSEVELT  
FAMILY COMPOUND DRAWN IN 1906 JUST AFTER THE DEATH OF  
ROBERT B. ROOSEVELT, SR. THIS IS THE ONLY MAP FOUND  
SHOWING THE DETAIL AND LAYOUT OF ALL THREE ROOSEVELT  
ESTATES.

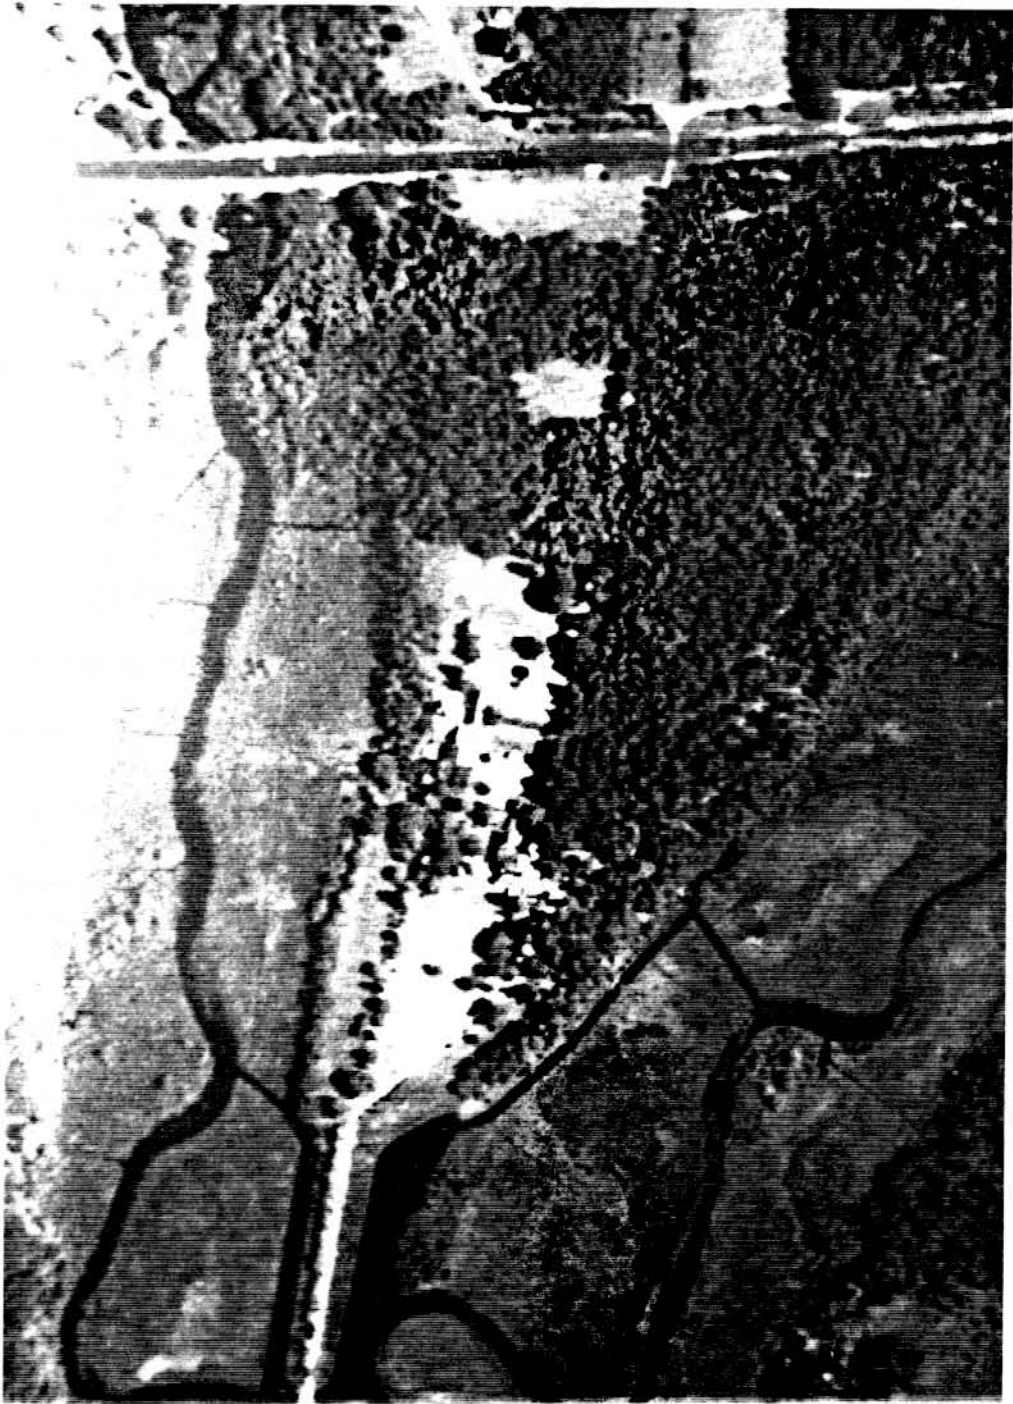
Fig. 2.31 1938 Aerial photograph of Meadow Croft one year before John Ellis's death. Barring any minor alteration, it is the basic layout which John created and maintained throughout his life.

During this period, 1915-1939, in which his daughter Jean maintained Meadow Croft, there are few records or ledger entries as in earlier years suggesting the fact that there were no substantial additions to the estate (Figure 2.31). In the mid-1920's, Michael J. Loughlin was hired to be the superintendent of the grounds at Meadow Croft and lived in the caretakers cottage where he supported his family while running a small scale substance farm. On the farm he raised turkeys, ducks, and cows, while growing hay and a variety of vegetables which the Roosevelt's would often purchase during their summer retreats (Loughlin).

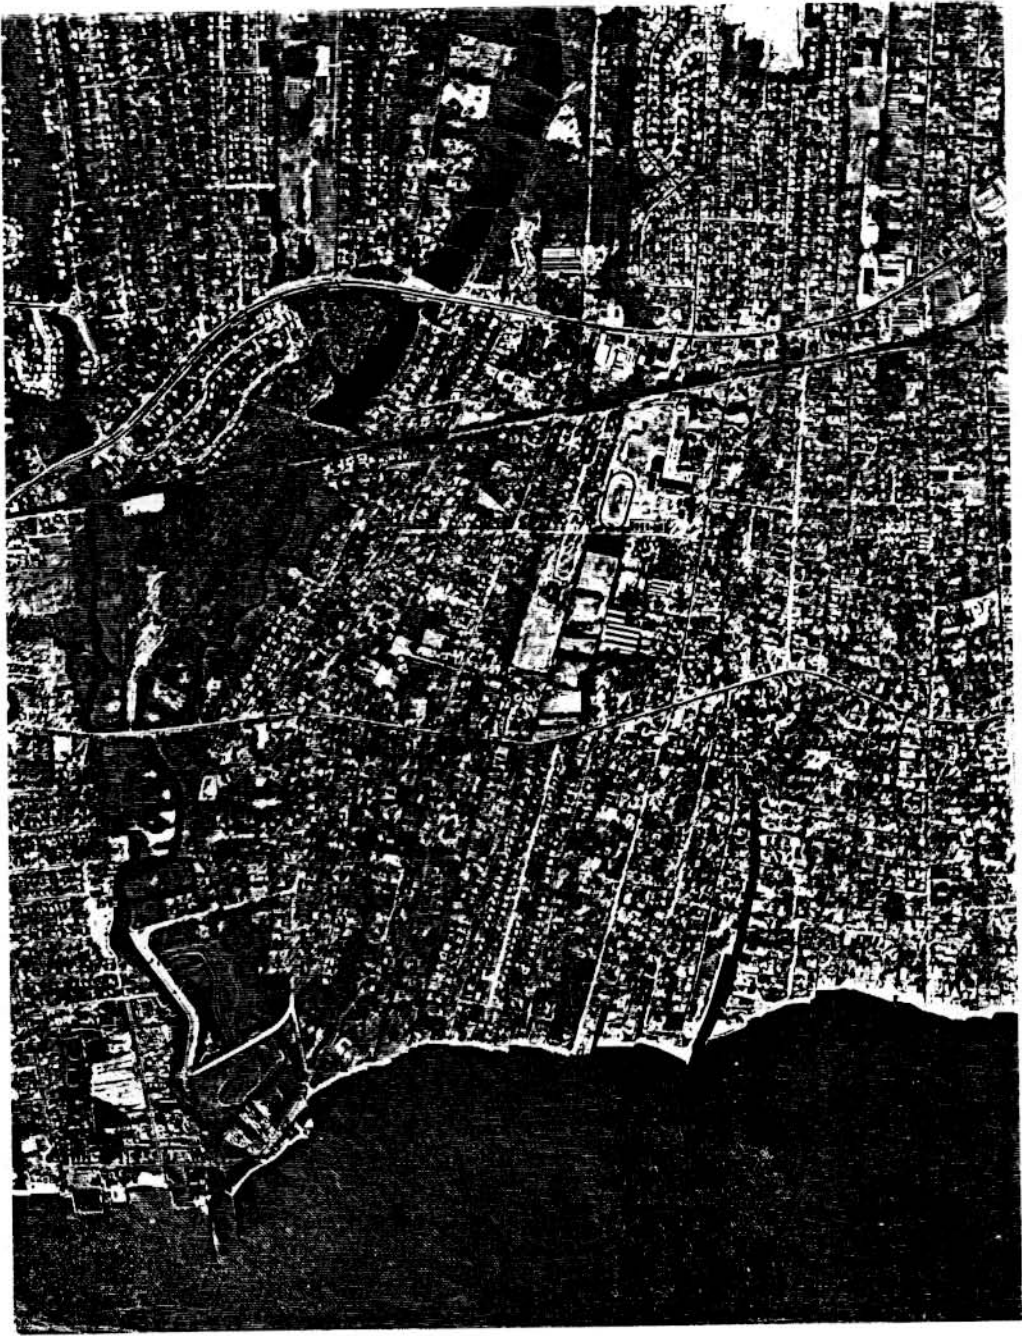
Fig. 3.1

1988 aerial photograph of Meadow Croft and the surrounding dense residential community. The Sans Souci Preserve extends from the Great South Bay up along Brown's River to Meadow Croft and continues to the headwaters of the river's east branch. (Suffolk County Planning Dept.)

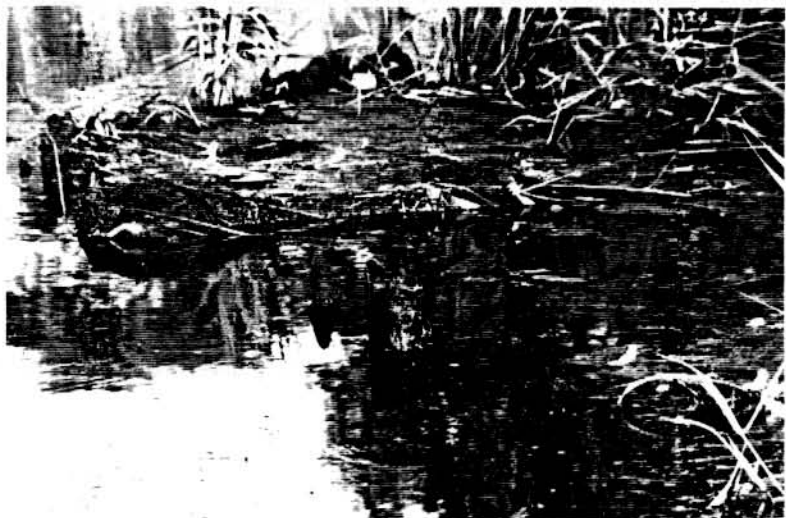
Fig. 3.4a - The remnants of the bulkheading along the east side of the bridge, near Middle Road.

The remaining 3"-4" rough vertical timber pillows are only visible above the water line at low tide. Although their condition is quite poor, the remnants combined with historical photographic evidence should supply enough information so that the exact location and style of the bulkheading can be determined (Figure 3.4a). The depth of the artificial water bodies ranges with the tides from under 1' to 2+', but it is possible that these areas were at one time deeper and have slowly been filling in with sediment over the years. The islands and surrounding wetlands that were once covered with low growing salt meadow grasses, which were harvested seasonally, have been invaded by phragmites, leaving only the inner portions in their original condition. The phragmites have begun to extend out into the canals making them narrower than they were originally; but, the front pond has remained very close to its original form (Figure 3.4 c & d).

Although most of the original bulkheading is gone, the canals and ponds John Ellis had dredged still remain in their original alignment. There are only the slightest deteriorating remnants of the original wooden bulkheading that extended along much of the canal's shoreline.

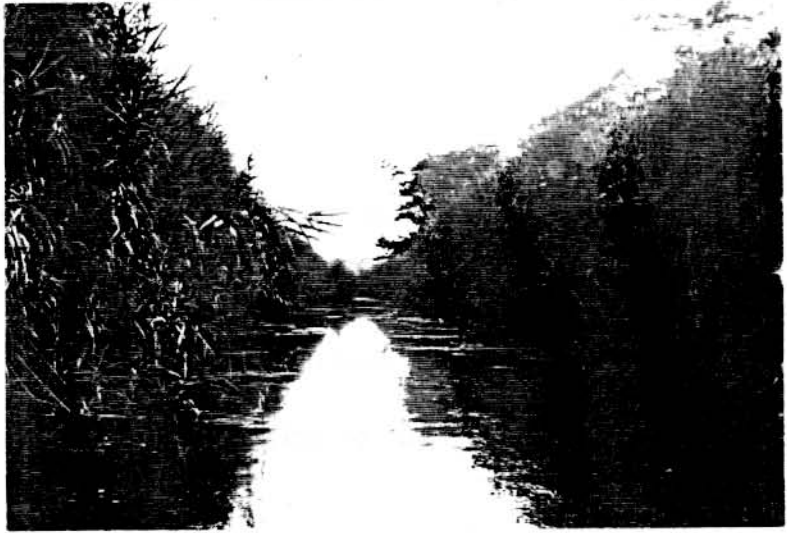
Fig. 3.4c - The front pond on the east side of the entry drive still maintains its original configuration but is surrounded by phragmites which block views to and from the residence.

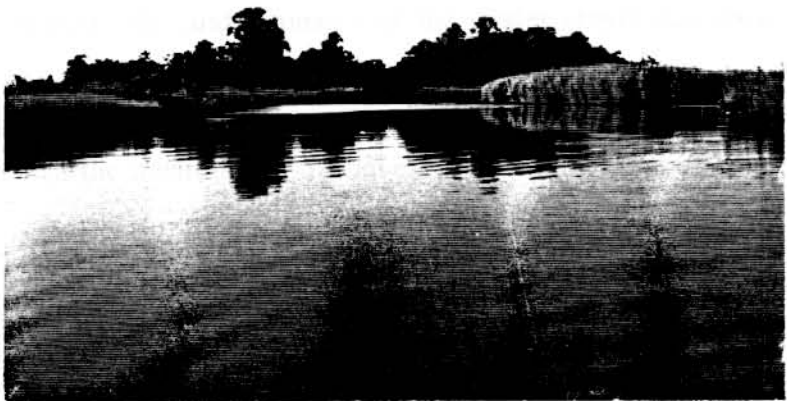
Fig. 3.5 - A view down the entry drive which is flanked to the east by a catalpa.

On both sides of the formal entry drive, which extends across the wetland meadows, stand catalpa trees (*Catalpa speciosa* Warder). The one on the east side is in good condition, but has become overgrown with vines; while the catalpa on the west side has been knocked down and is alive but declining (Figure 3.5). There is a 3' drop in elevation from the Middle Road entrance to the bridge which crosses over the river; and along either side of this drive, there is a steep slope that leads to the deteriorating wooden bulkheading at the shoreline. The 6" vertical pylons had head in place horizontal timbers, but have deteriorated to the point where they no longer provide sufficient retention of the ground behind them. Thus, much of the surrounding area has begun to erode away, washing down into the river. The vegetation on these banks is

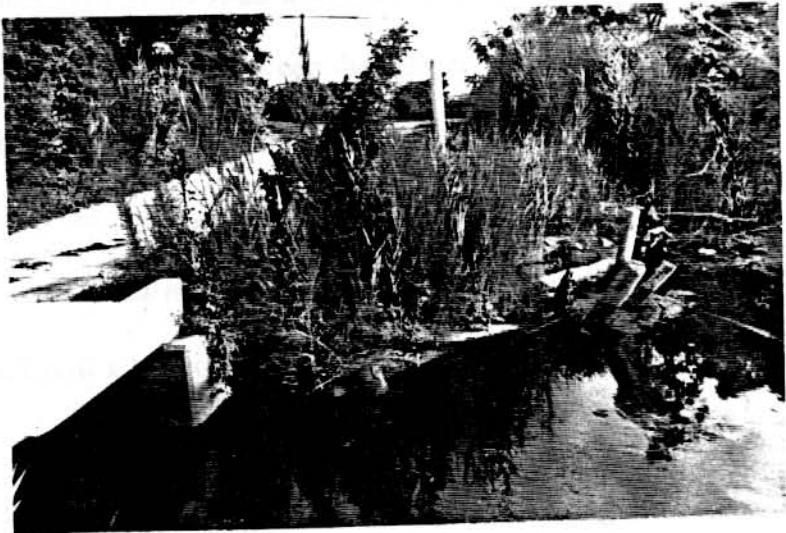
Fig. 3.7 - The concrete bridge is in excellent condition while the entry gate is in need of repair in order to make it more secure.

The 17' 3" wide, 12' long concrete bridge that crosses over Brown's River appears to be in sound condition and is in no need of structural repairs. On the north side of the bridge is a chain link fence and gate, installed by the County after its purchase, intended to provide security for the estate from trespassers, but in its present condition can be easily penetrated (Figure 3.7).

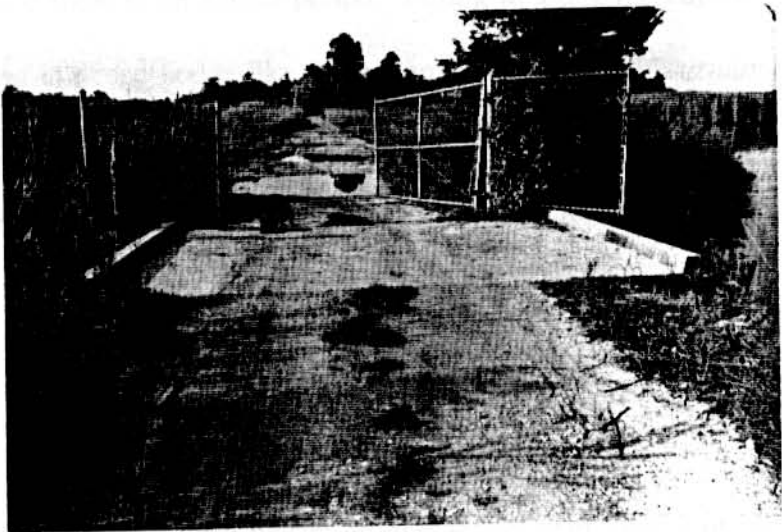
Fig. 3.8 - A view south toward the entrance across the boggy, overgrown side lawn.

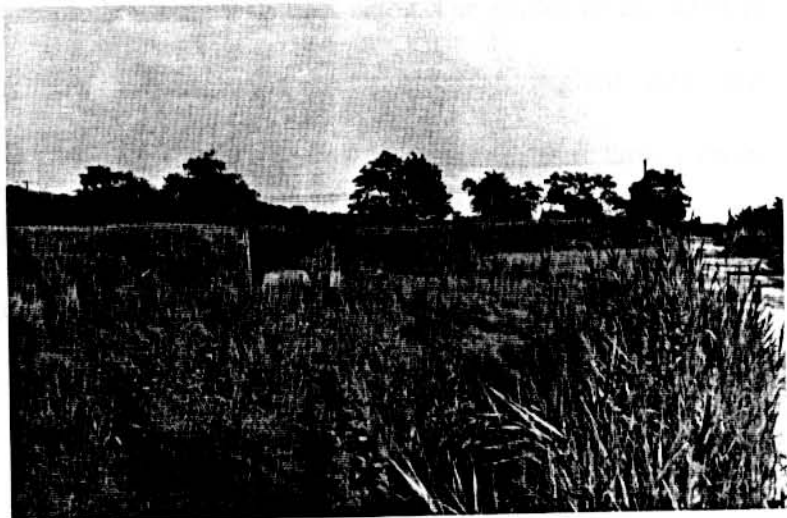
The formal entry drive leads to a fork in the road where it continues curving off to the right and the service access drive proceeds straight. Between the service road and the adjacent west canal the land extending from the forks down to the auto house is composed of a dense cover of a variety of successional woody trees and shrubs: pitch pine (*Pinus rigida* Mill.), red cedar (*Juniperous virginiana* L.), arrowood (*Viburnum dentatum* L.), swamp maple (*Acer rubrum* L.), bayberry (*Myrica pensylvanica* L.), and a host of native vines and grasses (Figure 3.10).

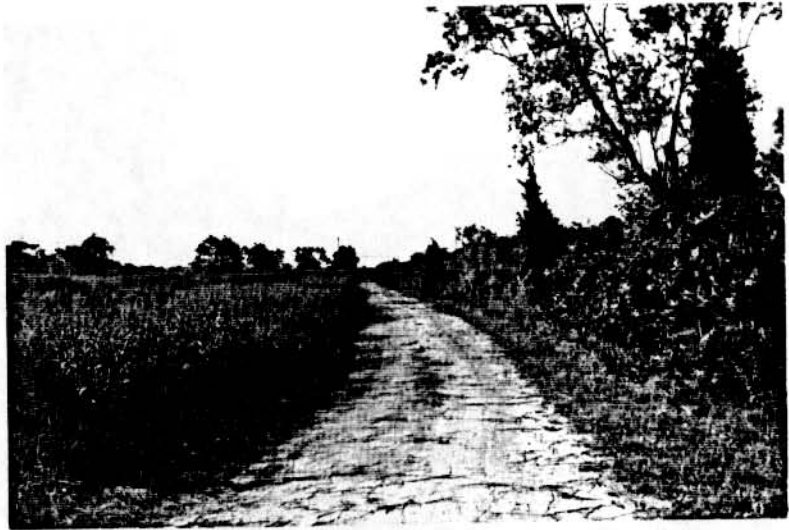
The roadway on the north side of the bridge, which ranges from 10' to 15' wide, has eroded to the point which makes it nearly impassable by automobile. The pavement consists of a sandy base intermixed with larger gravel (fill) and remnants of the oyster shells that once covered the roadway when the estate was maintained by the Roosevelts. The strips of land on either side of the driveway are just above the mean tide water level; and, although the drive is firm, the side edges are soft and boggy and, at high tide, become almost submerged and cannot be safely passed over on foot. The shore line edges are relatively straight when compared to the irregular edges of the surrounding islands and are covered with vegetation that consists of native salt marsh vegetation dominated by salt meadow grass (*Spartina patens* Ait.) and phragmites (See Figure 3.8). Further north down the driveway there is a steady transition from wetland meadow grasses to woody shrubs and trees, such as marsh elder with occasional red cedars (*Juniperous virginiana* L.) and shining sumac (*Rhus copallina* L.). Along either side of the road there are also a few remnant willow stumps which are set back 5' off the road and are approximately 10' on center. There are no original willows, but rather saplings/sprouts that have grown from the stumps of the downed white willows (*Salix alba* L.). (Figure 3.9).

Fig. 3.9 - Looking south down the entry road only a portion of a white willow remains.

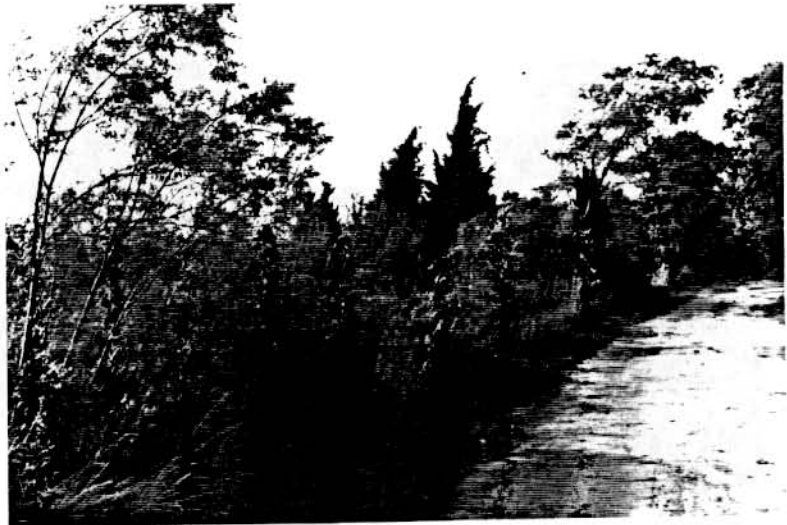
Fig. 3.10 - Along the west side of the drive there is a dense cover of successional vegetation.

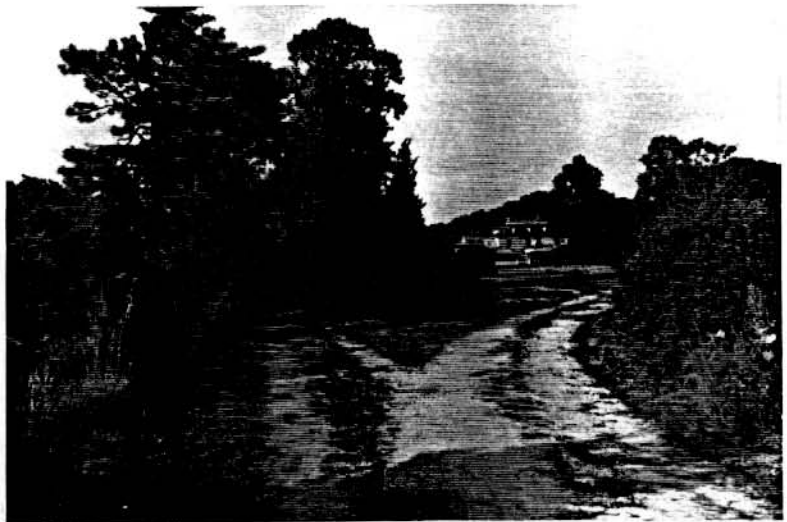
Directly in between the road forks, a circular mass of bayberry surrounding a red cedar has replaced a white willow which stood there in an earlier period. Filling in along the edge of the formal drive and the dredged pond is dense hedge-like formation of arrowood (*Viburnum dentatum* L.) that stands 7' tall blocking views in and out of the estate. Also extending along the shoreline of the pond is a dense mix of bayberry and a variety of other tidal wetland species (Figure 3.11).

Fig. 3.11 - A view of the estate from the road branch in the entry drive.
