**HISTORIC LANDSCAPE REPORT  
FOR  
MEADOW CROFT**

Former Summer Home  
of  
John Ellis Roosevelt

A project  
submitted in partial  
fulfillment of the requirements for the  
Master of Landscape Architecture Degree

State University of New York  
College of Environmental Science and Forestry  
Syracuse, New York  
May 1991

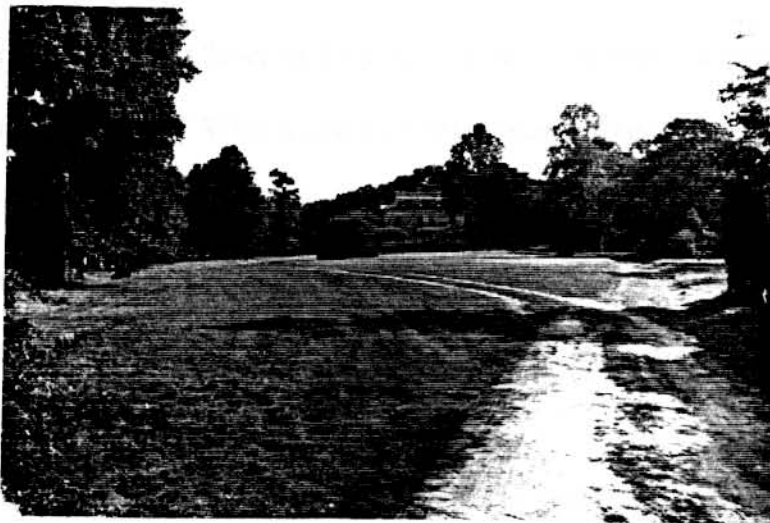
Fig. 3.12 - The formal front lawn extends right up to the foundation of the residence.

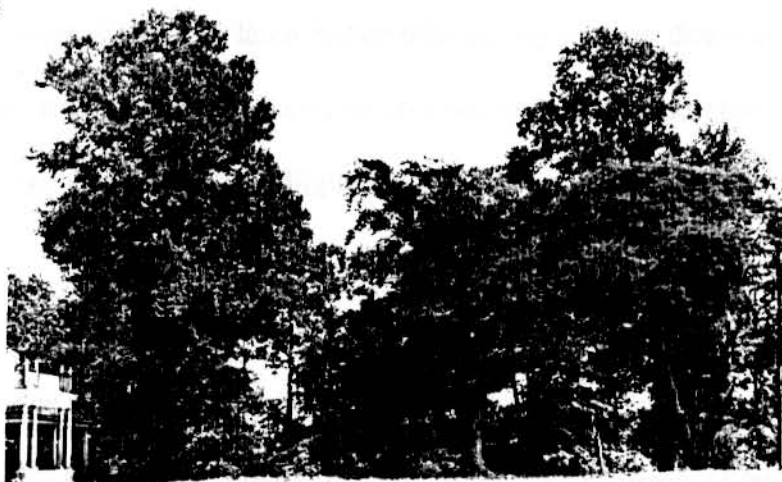
A large open formal lawn, bounded on the west by the service access road, slopes up to the residence from the entry drive which circles around its east side. The center of the lawn is clear of trees except for a mass of bayberry that surrounds the stump of an original cedar tree located near the middle (Figure 3.12). Lining the west edge of the lawn are four large evenly spaced tulip trees (*Liriodendron tulipifera* L.) that range in caliber from 95" to 120". They are all in good condition and under no stress, but are in competition with a variety of smaller native trees that have invaded the lawn around them, including red cedars and norway maples (Figure 3.13).

Fig. 3.13 - The four large tulip trees which line the entry drive.

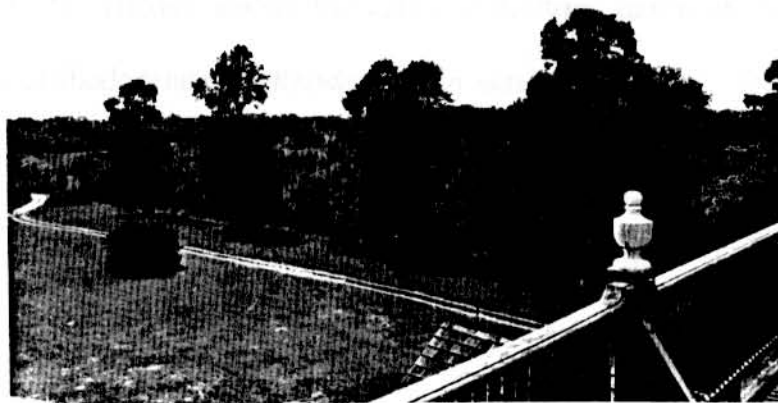
Fig. 3.14 - A view of the tulip, beech, and cherry trees from left to right.

Near the middle of the lawn a red cedar stump has been circled by a mass of bayberry and a large choke cherry (*Prunus virginiana* L.). Closer to the house stand three trees: a tulip tree, a purple beech (*Fagus sylvatica* 'atropunicea' West.), and a cherry (*Prunus virginiana* L.). Except for the tulip tree, the trees seem to be suffering from root damage caused during the restoration of the underground utilities in 1988. Many limbs have been broken off and the beech tree seems to have declined with many branches dying back from the tip (Figure 3.14).

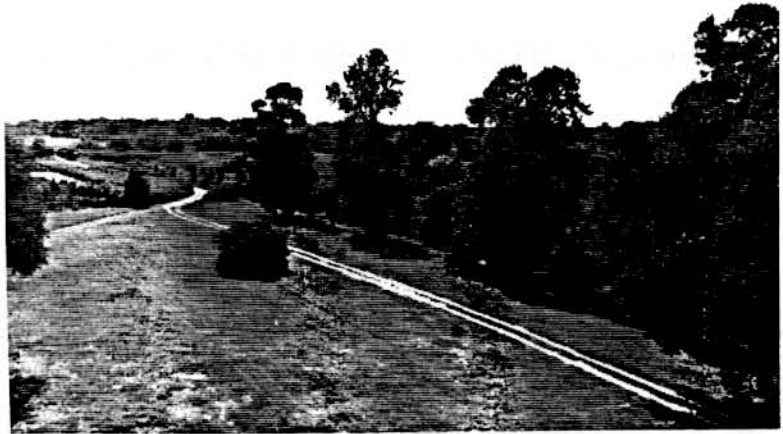
The lawn is dominated by fescue grasses and, in the area of recent construction, consists of a thin cover of weeds. Across the west side of the lawn another road has developed, an "outlaw road", from automobiles cutting across the lawn rather than trying to pass down the almost impassable servant's drive, which is characterized by overgrown vegetation and eroded ruts that are up to 1' below the existing lawn elevation (Figures 3.15, 3.16).

Fig. 3.15 - The "Outlaw Road" that cuts across the middle of the lawn.

The original network of drives are all intact except for the circular service drop-off on the west side of the residence, and a small turn-around near the east corner of the porte cochere. Although the drop-off has not been used in some years, a circular depression still delineates the drive's original alignment. The condition of the drives is consistent throughout the property; they are compacted and eroded well below their original elevation, which was crowned slightly above the adjacent lawn. All the drives have a consistent width of +/- 12' wide, except where vegetation has begun to block the path, as is the case with the rear entry drive. An "outlaw" road has developed across the middle of the front lawn as a result of the lack of access along the

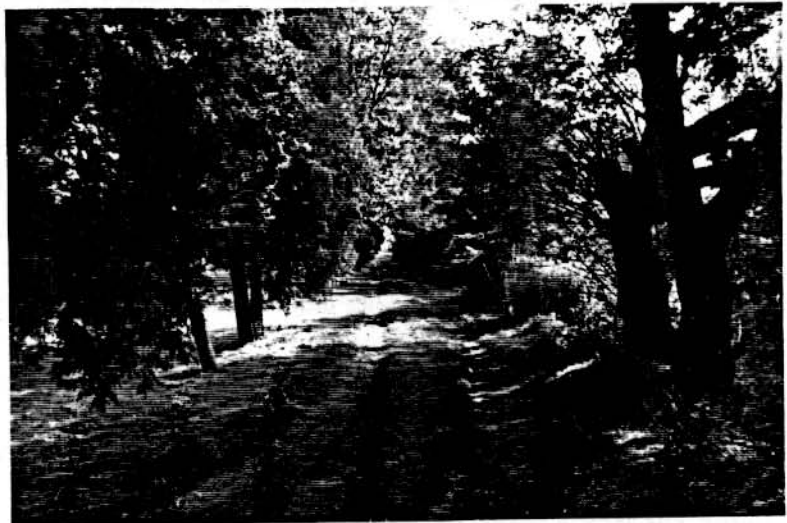
Fig. 3.16 - A view south down the service drive, lined on both sides with a variety of non-historic overgrown native species.

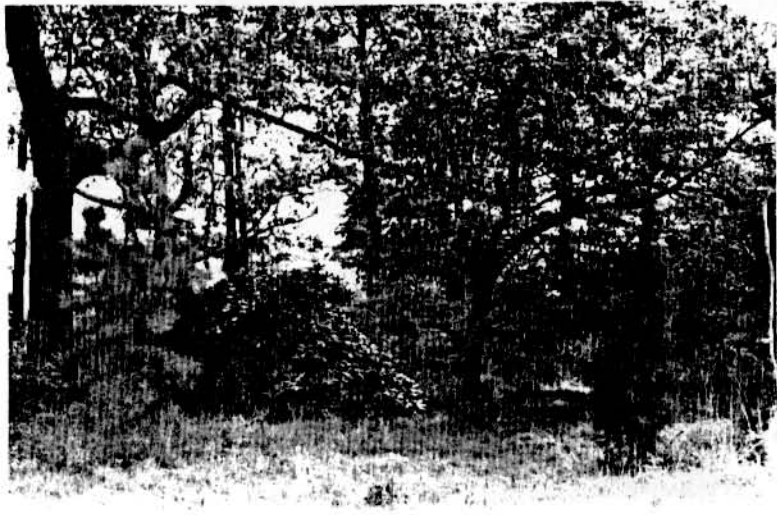
Along the entry drive on the east side there is another lawn area which extends approximately 50' to the woodland edge that borders the east canal. The woodland is dominated by white oaks (*Quercus alba* L.) but also contains a mix of some black pines (*Pinus thunbergiana* Parlat), maples (*Acer species* L.), and sour gum (*Nyssa sylvatica* Marsh), while the understory consists of bayberry, post oak, and pitch pines (*Pinus rigida* Mill.) which also have begun to invade the lawn (Figure 3.17). Hidden among the native understory shrubs at the lawn's edge are several large masses of rhododendrons (*Rhododendron maximum* L.) and a few Japanese dogwood trees (*Cornus kousa* Miq.) which, along with the surrounding lawn, are being invaded by the more aggressive bayberry shrubs (Figure 3.18).

Fig. 3.18 - A rhododendron and dogwood located in the understory on the east side of the front lawn.

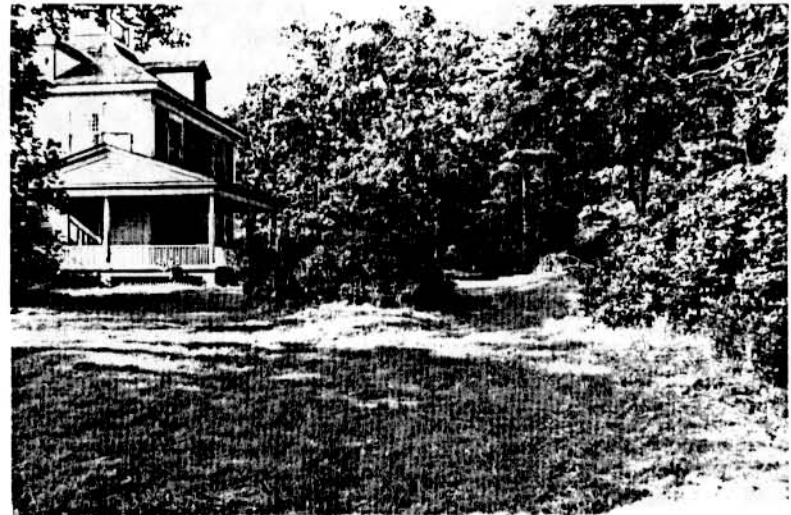
Fig. 3.19 - The fork in the road on the approach to the porte cochere where an old white pine has been replaced by a mass of bayberry.

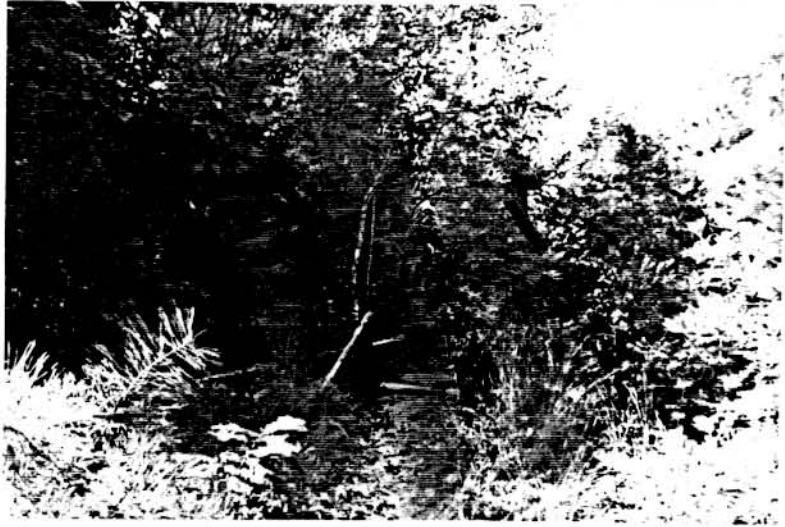
Fig. 3.24 - The original entrance path that leads up to the in-ground pool has become overgrown and the concrete slab that marks the entrance is buried under the brush.

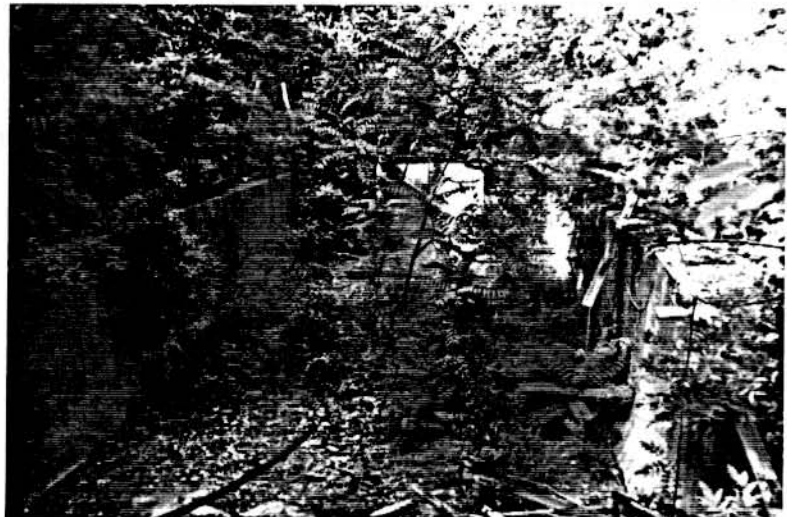
Fig. 3.26 - The remnants of the stairs located in the pool's northeast corner.

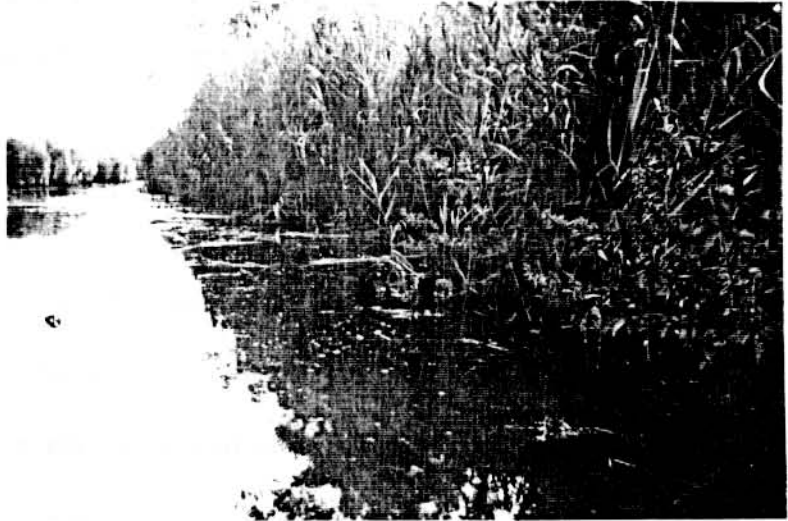
Just to the south of the boat house across the clearing is a barely detectable narrow path running parallel to the shoreline that leads to the remnants of the wooden foot bridge, which crossed over the canal connecting to the adjacent island. Although the bridge has collapsed and lies at the bottom of the canal, there are still several of the original pylons extending out of the water that indicate the bridge was once approximately 8' wide (Figure 3.27).

Fig. 3.27 - The location of the wooden foot bridge that crossed over the east canal. All that remain are some of the decomposing timber posts, approx. 2' on center extending slightly above the water.

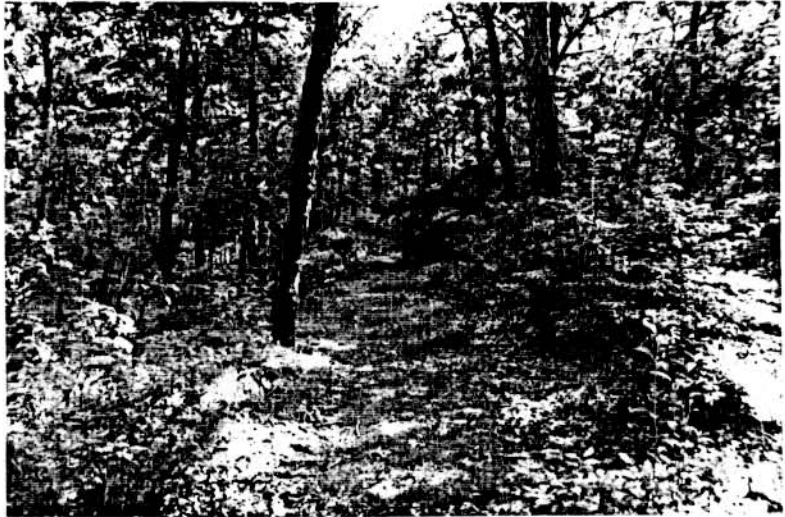
From the boat house location north, the original path that connects from Meadow Croft to Lotus Lake continues down through the woods northward running parallel to the shore and continues up to the tracks (Figure 3.28). In most places, the compacted dirt path is still well-defined but many trees have fallen across it making some points impassable. Along the path approximately 50 yards north of the boat house is the burial site and headstone of a Roosevelt family pet, a Cairn Terrier named Billy, that died on July 3, 1924 (Figure 3.29). Throughout most of the woodland in this area, there is a dense understory of native trees and shrubs with many standing and fallen (dead) trees, but there are also several clearings where cut and broken wood is piled to suggest the locations were used for cutting fire wood in the recent past. This woodland, bound on the east by the marsh and Brown's River and on the west by the rear entry road, extends south from the tracks to the east side of the house where a slight depression indicates it lead to the porte cochere.

Fig. 3.28 - A portion of the original path that extended from the boat house at Meadow Croft across the tracks to Lotus Lake.

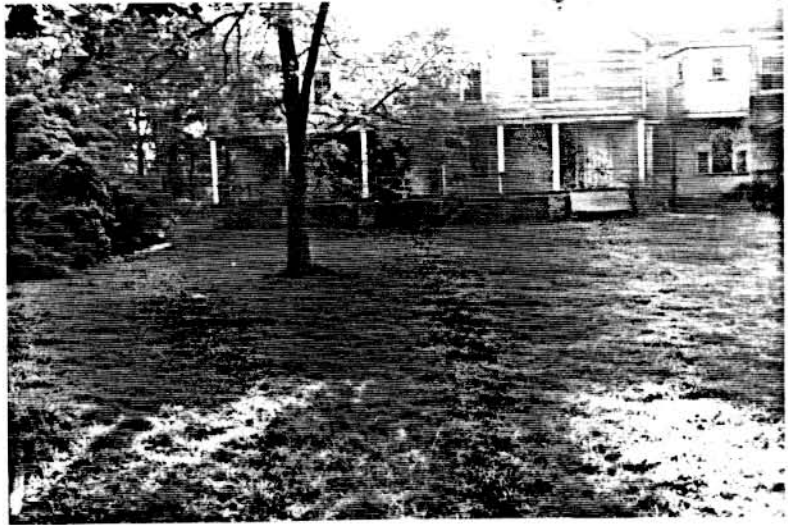
From the porte cochere, a drive, barely visible on the ground, continues to the west side of the house, where it reconnects with the service road at a fork where a large linden (*Tilia cordata* Mill.) stands, and continues on into the rear of the estate. There is the remnant of the circular service drop off (seen on old maps) directly adjacent to the west rear porch, consisting of a slight circular depression with a rise of ground at the center, indicating a road which connected to the other drives (Figure 3.30).

Fig. 3.30 - A view of the west rear porch; directly west of the porch is a slight circular depression which delineates the original road alignment of the service drop-off, the maple tree stands approximately at its center.

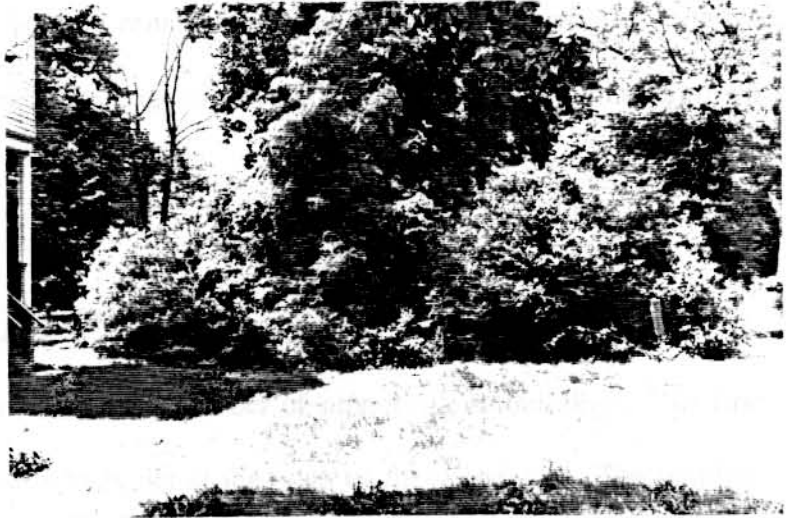
Just to the north of the circle is a 20' x 60' garden plot which extends from the rear porch west toward the auto house (Figure 3.31). Buried 6"-1' below the grass is a slate path, 2' wide, leading from the steps to the garden. The garden is overgrown with shining sumac (*Rhus copallina* L.), wisteria (*Wisteria floribunda* Willd.), and trumpet vine (*Camposis radicans* L.), which are all growing on a wooden lattice trellis that extends along the north side of the garden and ranges from 3' to 7' tall. The trellis, constructed of 1" x 2" wooden strips in a grid pattern with 4" open squares, is suspended on locust post spaced 5' on center. Although the locust post seemed to be quite old, possibly dating from the early 1900's, the trellis's construction indicates that it is probably a later addition (1930's) [Figure 3.32]. Around the other three sides of the garden are 3' tall locust posts spaced 5' on center and also portions of a privet hedge (*Ligustrum amurense* Carr.) which surrounded the garden. Scattered throughout the interior are patches of common periwinkle (*Vinca minor* L.), but there is no recognizable pattern to the garden or indication of what other plants were grown. Based on Barney Loughlin's remembrances, there

Fig. 3.31 - A view of the garden's east side: the rear porch steps exit onto a slate path extending along the garden's south side.

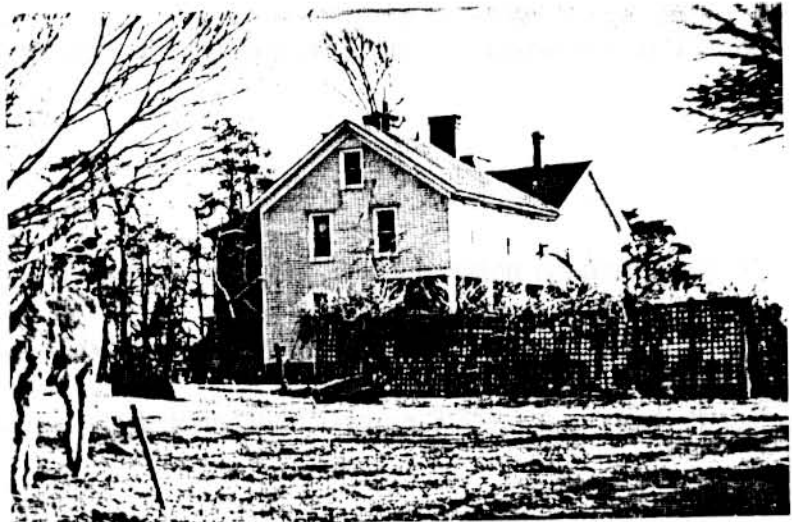
Fig. 3.32 - The trellis which borders the garden's north side is only visible during the winter months, when the vines are dormant.

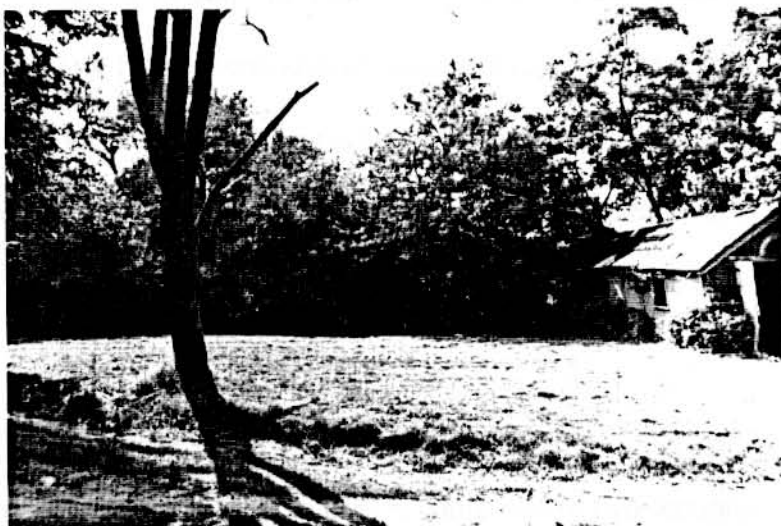
Fig. 3.34 - The stuccoed auto house has begun to lean due to the boggy soil on which it stands.

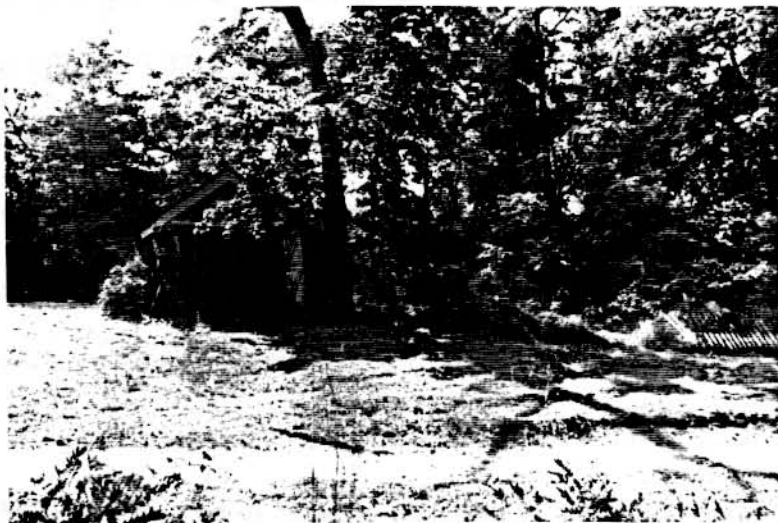
Along the west side of the entry road are a number of supporting outbuildings. The first is the wood frame stuccoed auto house which sits at the edge of the woodland. The building served as a location to both repair and store automobiles. The rear portion of the structure is sinking into the wetland that borders its western side causing the entire auto house to lean (Figure 3.34).

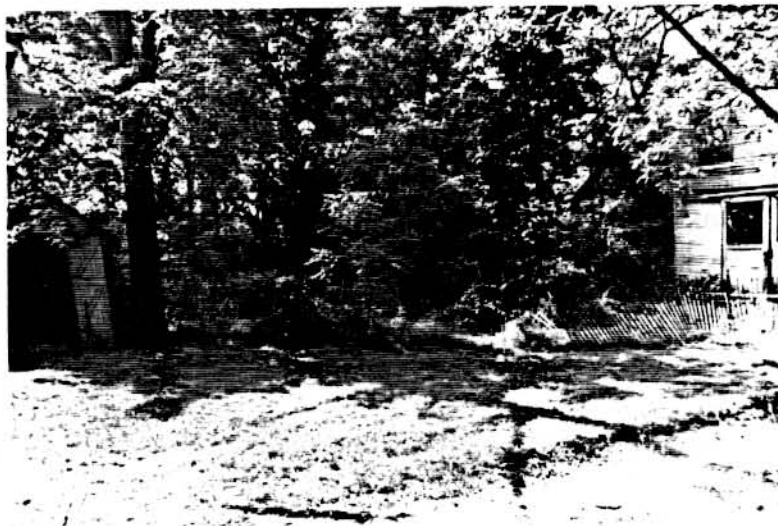
Directly adjacent to the auto house on the north side is a depression approximately 3' deep where the wooden ice house once stood; but the area is now overgrown with brush and there is no visual evidence of its original brick foundation (Figure 3.35). A portion of the

Fig. 3.35 - Only a slight depression overgrown with vegetation marks the location of the ice house.

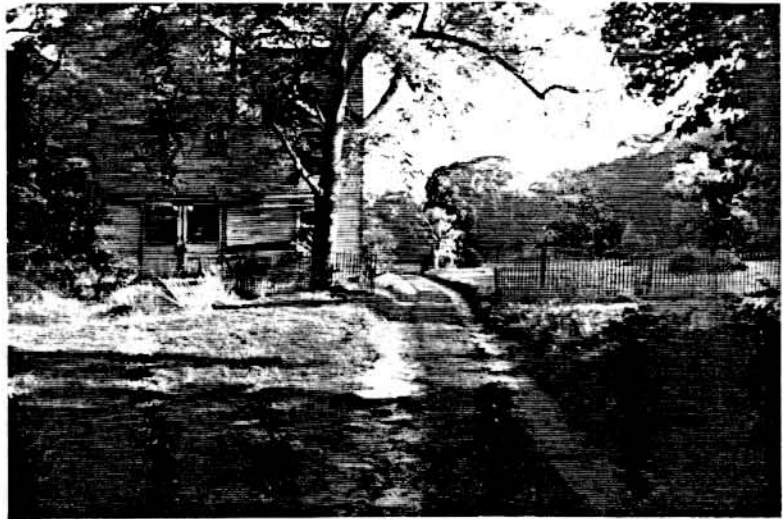
partially collapsed carriage house, which served as both the coachmen's quarters and a stable, remains standing just to the north with a 12' x 12' concrete slab at its south facing entrance (See Figure 3.36). An understory of brush and vines has begun to fill in on the building's west side, along with an overstory of catalpa, oak, and pines, and a lone tulip tree, which possibly marks the west boundary of a horse corral.

Fig. 3.36 - A view of the Carriage House's south side and the road which circled around the rear fields providing access to the caretaker's cottage.

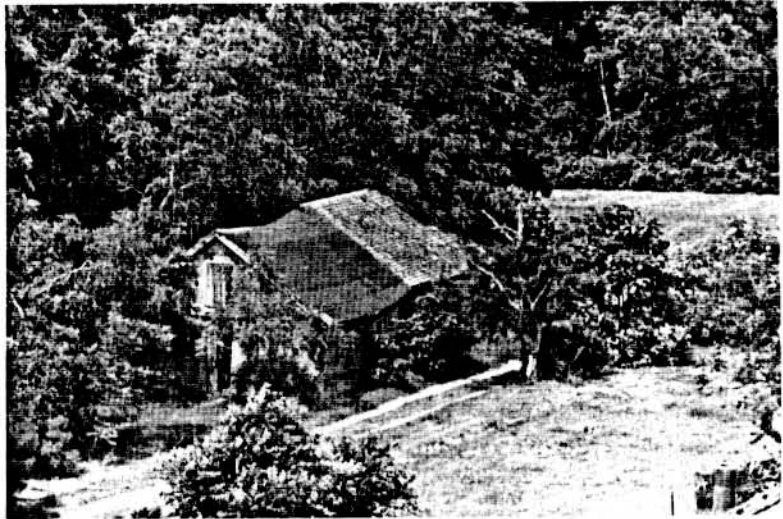
Almost directly behind the carriage house to the north is the barn, which also has a south facing entrance, but is in much better structural condition. The barn is composed of two sections: the front wooden structure and a slightly larger wood and stucco addition in the rear, which served to shelter both livestock and hay (Figure 3.37). The area west of the barn is in a similar overgrown state as that of the carriage house, but it is slightly more open and has a line of locust posts from a fence that seems to have extended from the barn down along the edge of the wetland and back, creating a large fenced-in area, probably utilized as an animal corral. This area has now filled in with a variety of native trees dominated by catalpa (*Catalpa speciosa* Warder) and black walnut (*Juglans nigra* L.) [Figure 3.38]. There are no remnants of the original Woodward barn (torn down in the 1930's) which stood in between the carriage house and barn, only a dense woodland.

Fig. 3.37 - The barn, which lies directly north of the carriage house, had a later stuccoed addition, which is delineated by its cedar shingled roof.

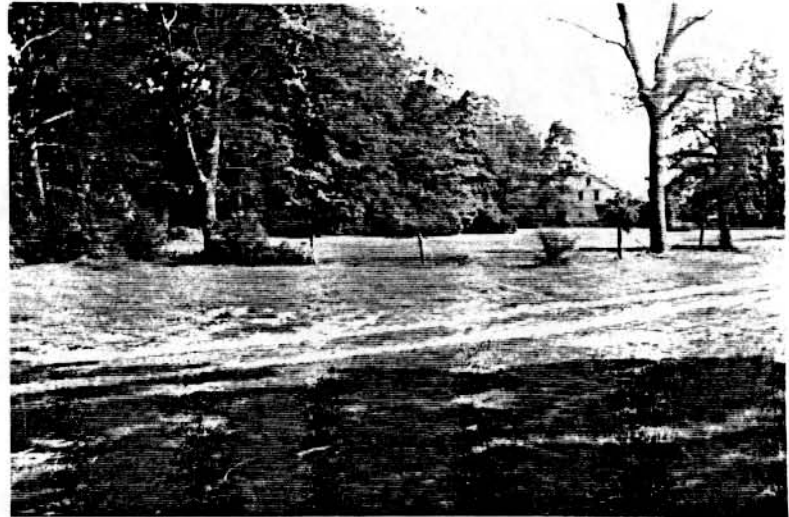
connected by remnants of a wire fence which originally surrounded the rear half of the field and cottage. The middle of the barn to the west and a large dogwood tree to the east mark the fence line which crossed the field, dividing it in half (Figure 3.40). The fence then continued north to the cottage where it ended. The original fence was not a wire fence, but a simple locust post fence topped with a horizontal wooden rail. The rear fields are relatively level and open, though they are dominated by a variety of wild grasses and weeds. Located in the southern half of the field are the remnants of the pump house, which is now represented by a depression measuring 4' x 6' and a surface scattering of brick and concrete debris overgrown with vegetation.

Fig. 3.40 - A view of the rear fields and the surrounding locust posts.

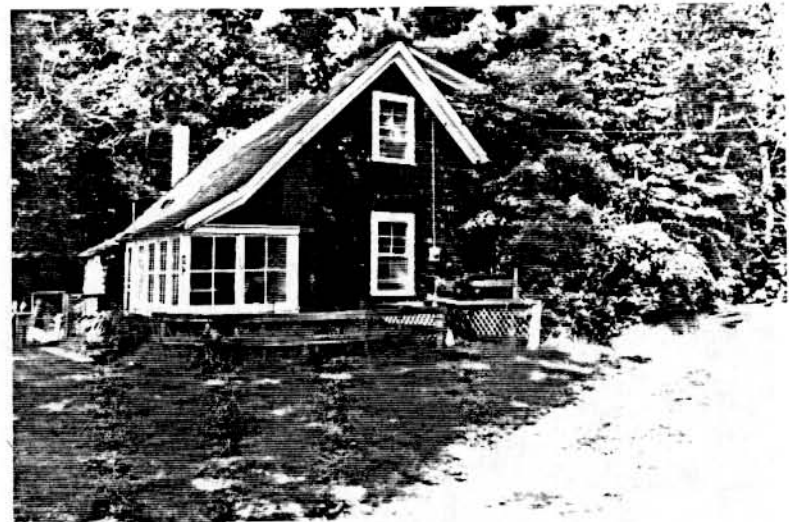
Toward the rear of the fields is the caretakers cottage which originally had its front entrance facing the rear entry road; the cottage was modified at some point and reoriented and is now facing west. The cottage stands just south of the property's original 1891 northern property line (Figure 3.41). Along this line extends a man-made depression measuring 3' deep along with remnants of a fence that were most likely an early marker of the property boundary. The west side of the cottage faces out onto an additional field which extends west down to a woodland edge and is bordered by an invading edge of shining sumac (*Rhus copallina* L.) to the north. This field was connected with the field behind the barn, but a strip of vegetation divides them now (Figure 3.42). The drive that curves around the cottage and connects to the rear entry road creates the cottage's south and east boundary, along which a 3' tall locust post and wire fence and an overgrown hedge of cedars stand blocking views to the cottage (Figure 3.43). Surrounding the cottage are several large trees including spruce (*Picea abies* L.), white pine (*Pinus strobus* L.), oak (*Quercus alba* L.), and locust (*Robinia species* L.). There are also

Fig. 3.41 - The Caretaker's Cottage: the west side which is now the entrance was originally the rear of the cottage before the addition of the sun room was made.

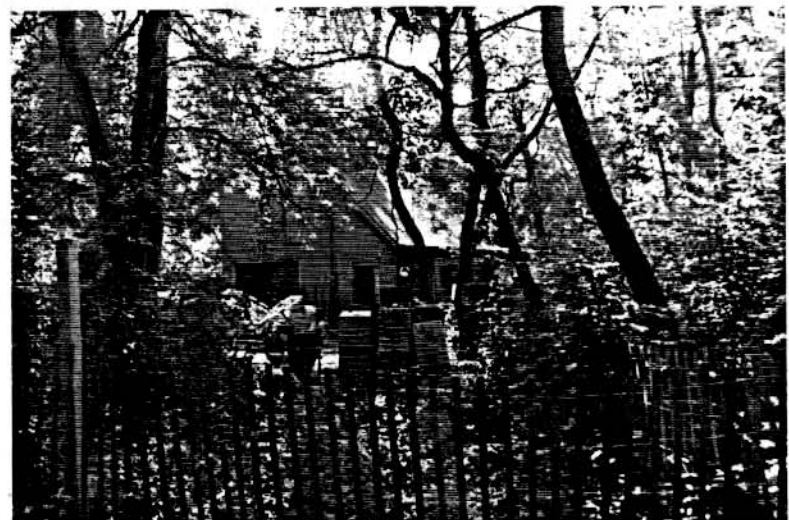
Fig. 3.44 - The two story 1950's wood frame structure which presently houses livestock lies just north of the cottage.

The remainder of the Meadow Croft estate is presently owned by Barney Loughlin and is actively maintained for livestock and a vineyard. The livestock, horses and a mule, are housed in a two-story wood structure constructed by Loughlin in the 1950's, a short distance through the woods north of the cottage (Figure 3.44). The area is surrounded by dense woods except for a small field which is used for grazing. A dense stand of native woodland separates the two original clearings within which is located the headstone of another Roosevelt family pet, "Humbug" (Figure 3.45). The 30 year old "faultless horse", as the headstone states, is believed to have been buried in this location by Gladys, John's daughter, along with other horses and family pets that passed away. The vineyard lying to the north, which is located on an original farm field historically used as a pasture, was increased in size during the Spring of 1990, from its original dimensions of 350' x 150' to 390' x 180' (Figure 3.46). The rear entry road is the eastern boundary of the Loughlin property and is presently a county-owned right of way that terminates at an historic gate on the property's northern boundary.

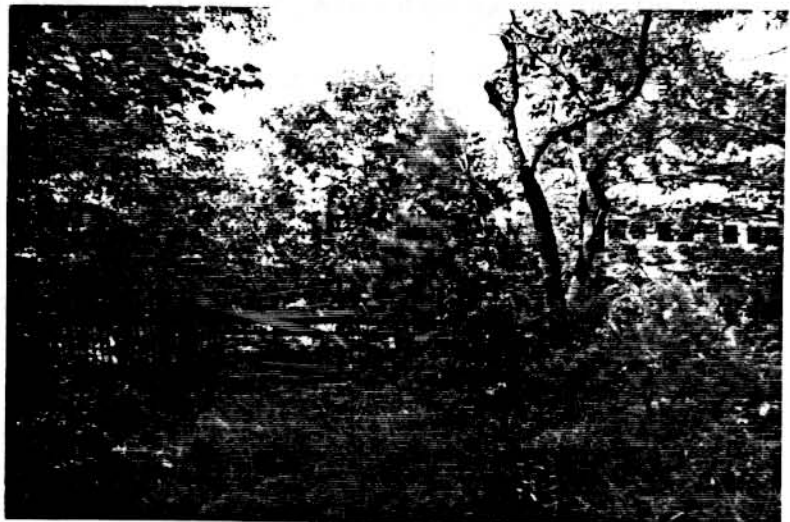
Fig. 3.48 - The other half of the rear entry gate was located in the woods adjacent to the road.

of the original hinge that held the second gate up which was located in the adjacent woods (Figure 3.48). The entrance obviously has not been used for some time for there are a number of trees and shrubs which have filled in the opening.

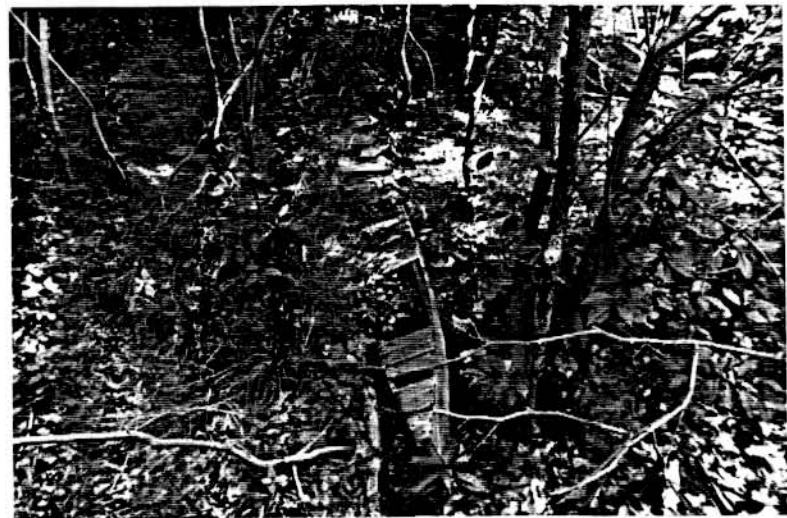
Fig. 3.50 - The wood hull of a boat 20 feet in length was located north of the barn partially buried.

The second is the partially buried remains of a 20' long wooden boat hull found in the woods northwest of the barn, which has not yet been excavated. It is of the size and style of what could be a portion of one of the catamaran-style boats John Roosevelt built (Figure 3.50).

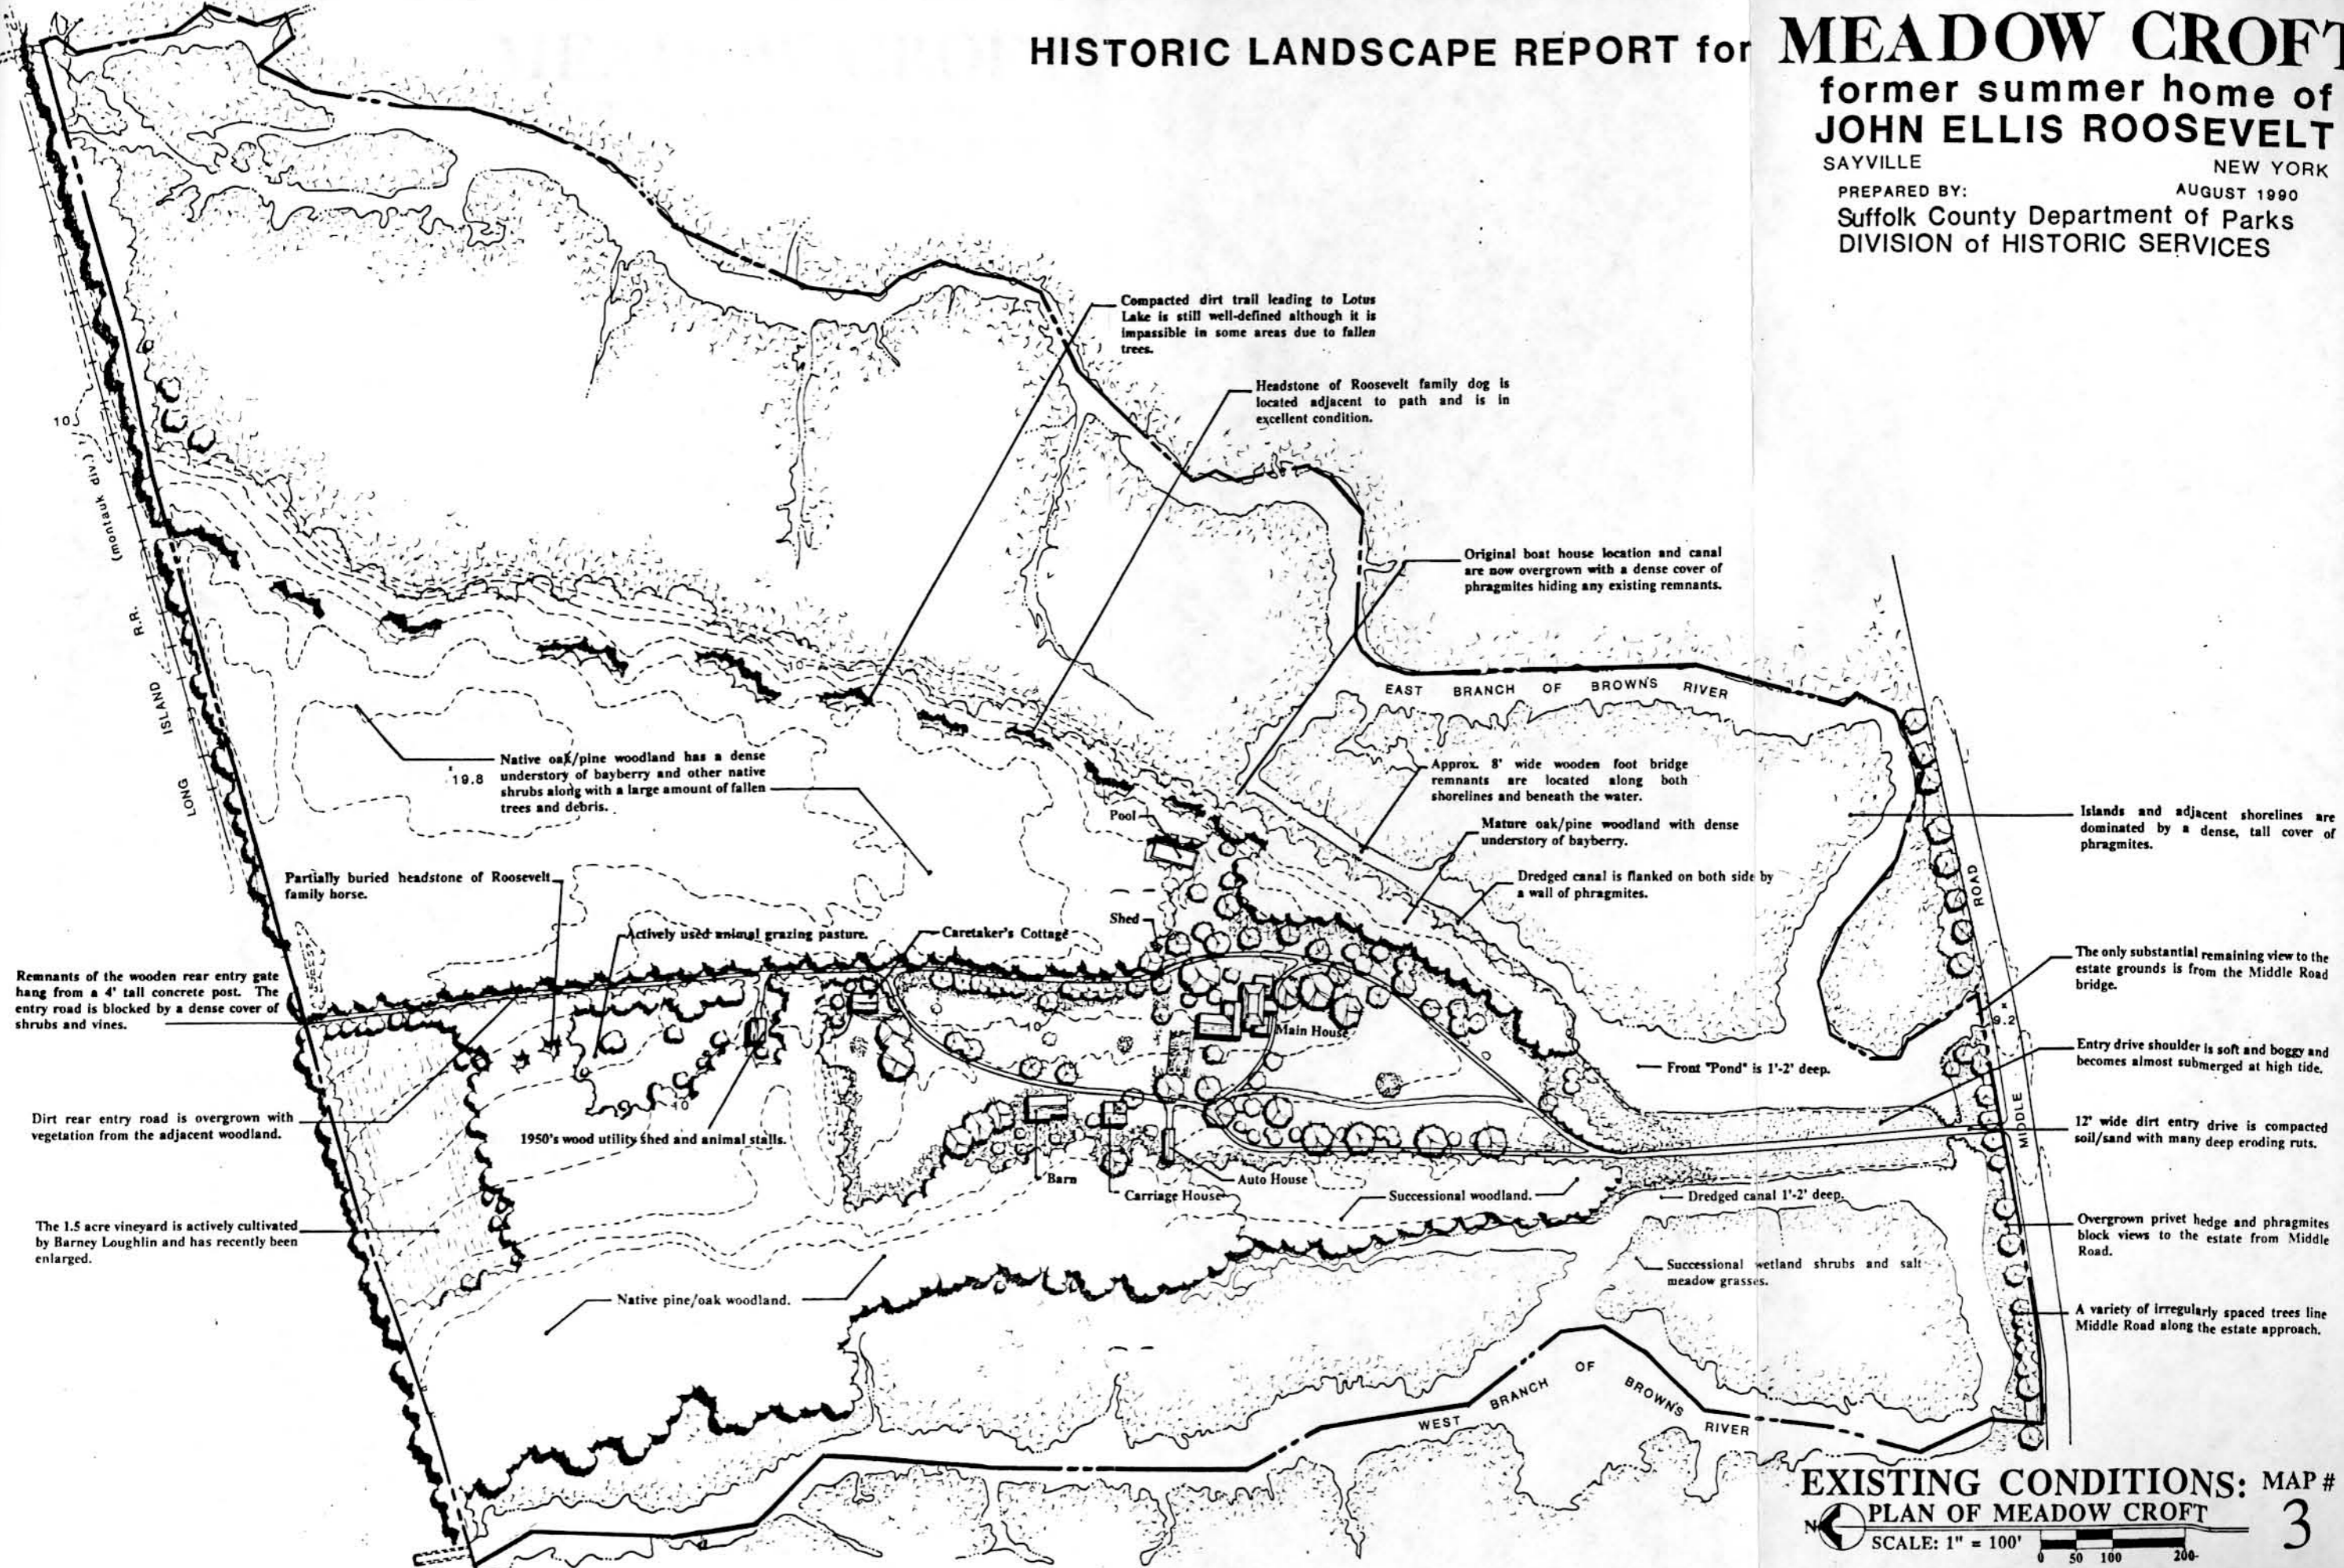
EXISTING CONDITIONS: MAP #  
PLAN OF MEADOW CROFT  
SCALE: 1" = 100' 0 50 100 200  
3

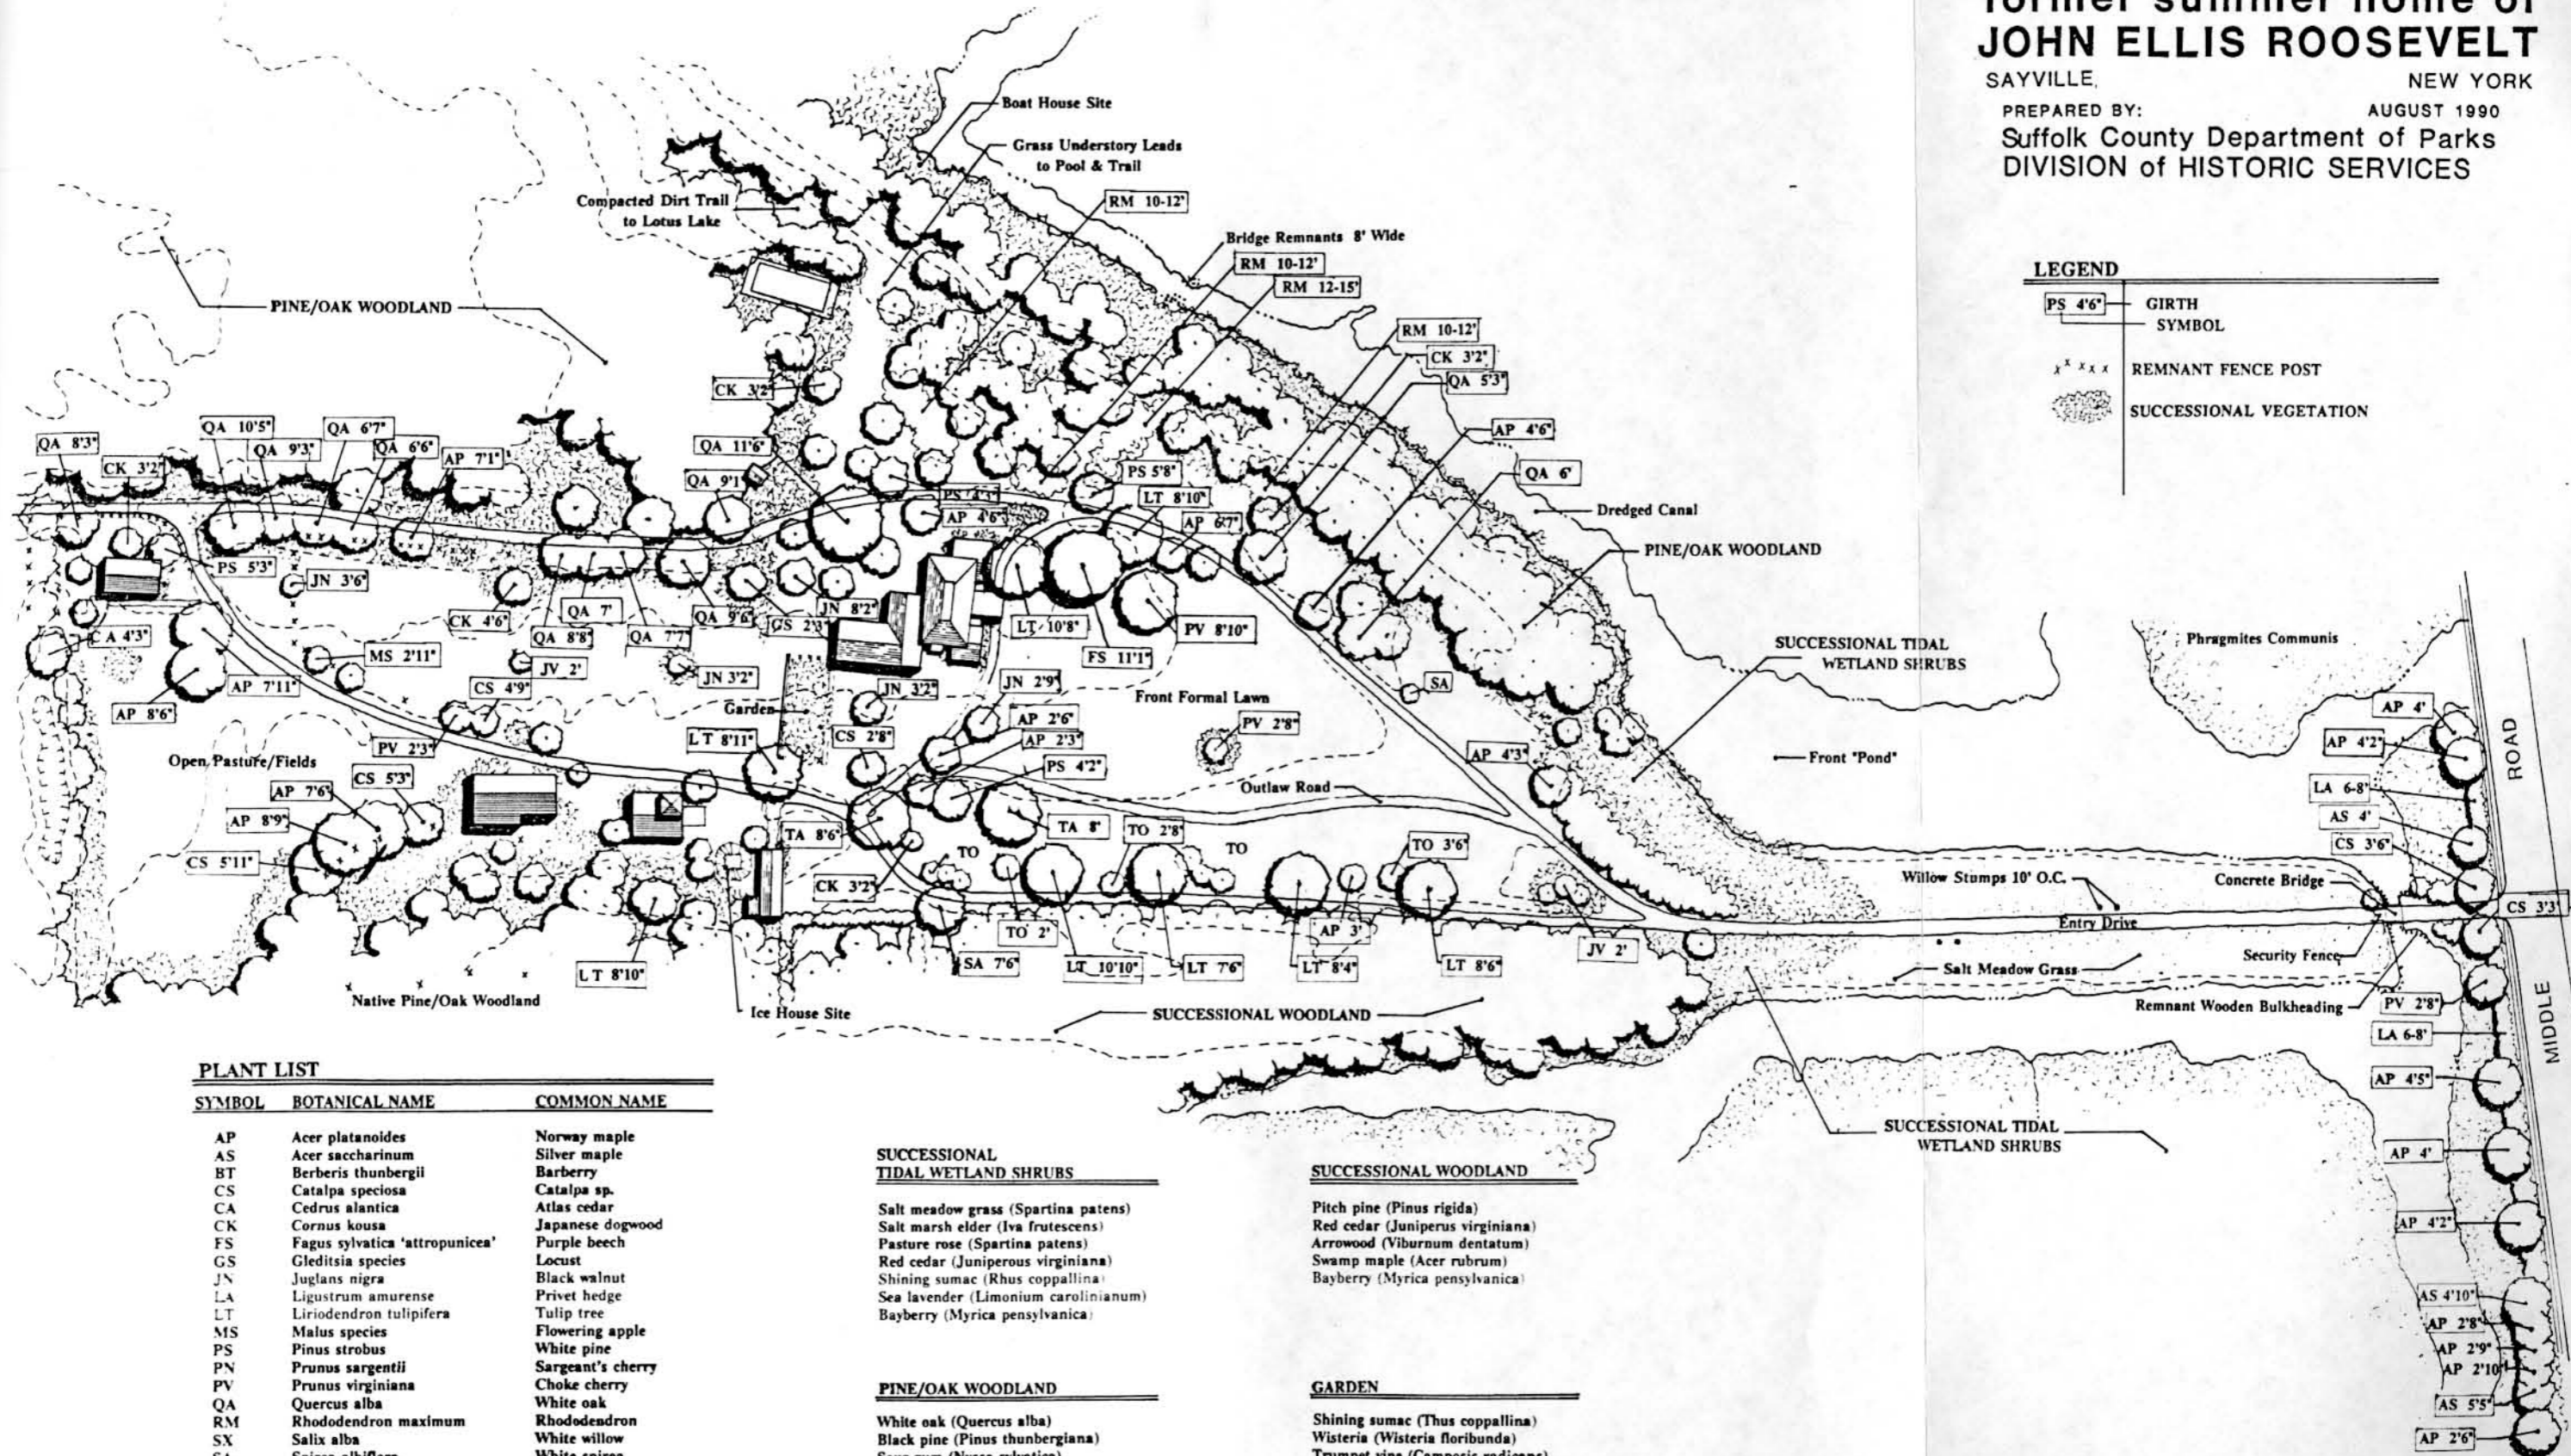
EXISTING CONDITIONS: MAP #  
DETAILED PLAN OF ESTATE 4  
SCALE: 1" = 50'  
0 50 100
