## Cultural Landscape Report Fort Ontario State Historic Site Oswego, New York

Part 1: Site History, Existing Conditions, Analysis and Evaluation

A thesis

Landscape Architecture

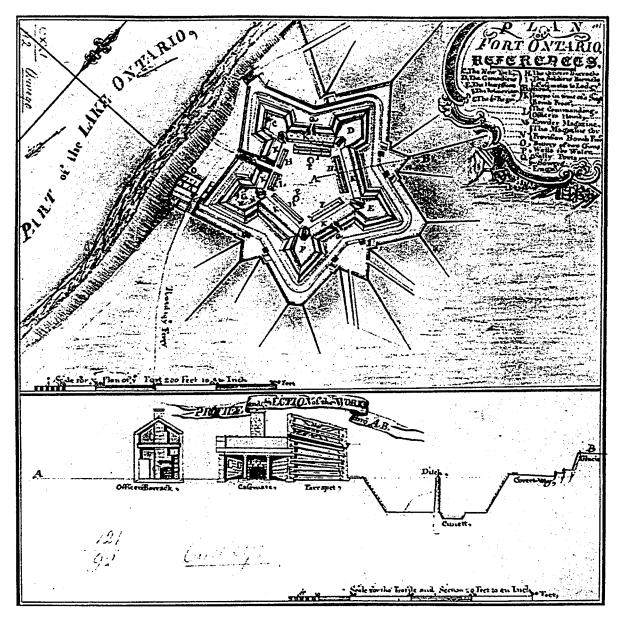
Fig. 1.20. Plan, "Plan of Fort Ontario," showing plan and section/elevation of the second Fort Ontario, Thomas Sowers, 1759. Reproduced from Willard B. Robinson's book *American Forts: Architectural Form and Function* (Chicago: University Press Illonois, 1972), 41. Original in British Museum, London. Annotated by R. Hetzler, SUNY ESF, 2001.

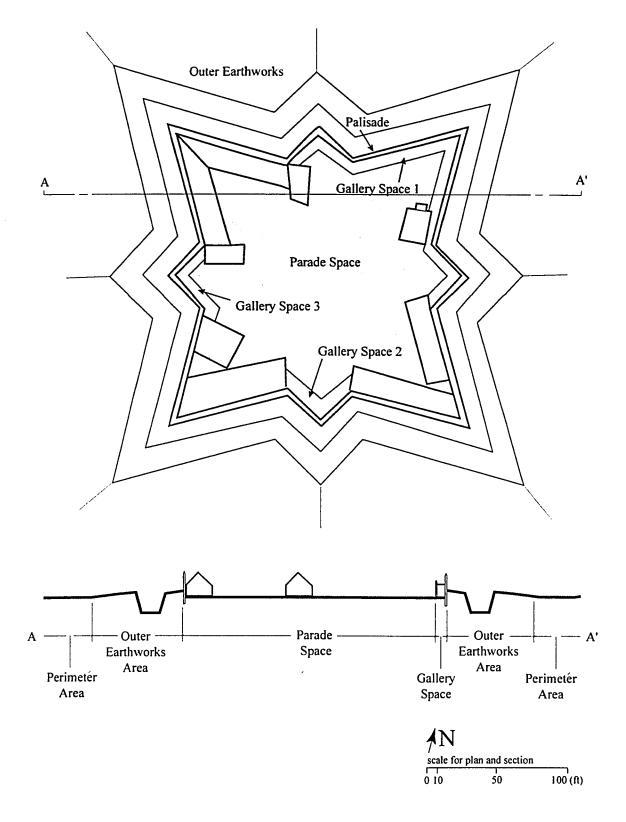
Fig. 1.44. Plan and section of Core Fortification area showing Parade space and Gallery spaces of Core Fortification area. Based on plan "Plan of Oswego with its Forts as Beseiged by the Marquis of Montcalm August 1756," Patrick Mackellar, 1756 and "Plan of Oswego showing the State of that Garrison as it was on the 24th of May, 1756," Charles Demter, 1756. Graphic produced by R. Hetzler, SUNY ESF, 2003.

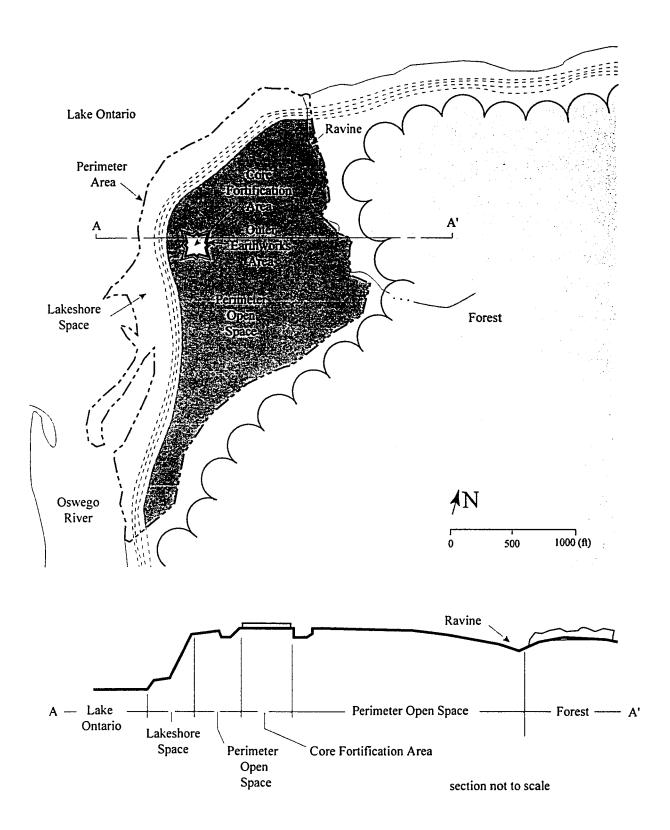
Fig. 1.46. Plan and section of perimeter area showing perimeter open space and lakeshore space. Based on plan "Plan of Oswego showing the State of that Garrison as it was on the 24th of May, 1756," Charles Demter, 1756. Graphic produced by R. Hetzler, SUNY ESF, 2003.

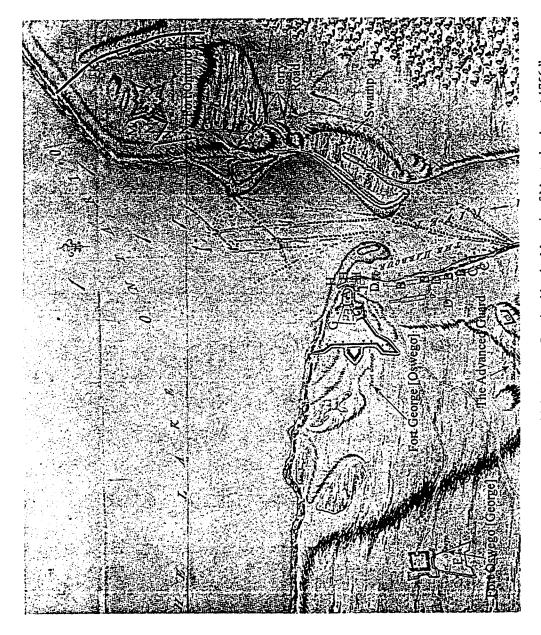
Fig. 1.47. Plan, "Plan of Oswego with its Forts as Beseiged by the Marquis of Montcalm August 1756," showing ferry road and buildings and structures around mouth of the Oswego River, Patrick Mackellar, 1756. Reproduced from Stanley Pargellis' book Military Affairs in North America 1748-1765 (Archon Books, 1969), 210. Annotated by R. Hetzler, SUNY ESF, 2001.

A. Block House B. Traders Houses C. Hospital and Bolting House D. Bake House E. Ditch within Fort Oswego made the  $13^{th}$  of August F. Retrenchment at D. Fort laid out the  $14^{th}$  in the Morning G. Batterys of Pork Casks made the  $13^{th}$  in the Evening H. Carpenters Houses I. Smith's Shop K. Parallel begun by the French in the Evening L. Batterys against Fort Ontario M. Approaches made the  $13^{th}$  in the Night N. Battery en Barbette made the  $13^{th}$  at Night against Fort George P. Dock.

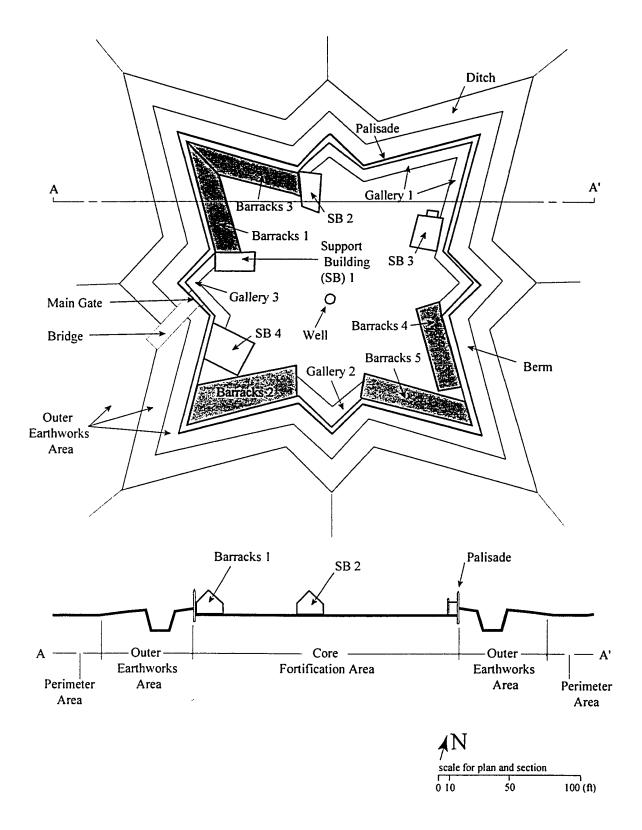
Fig. 1.49. Plan and section of Core Fortification and Outer Earthworks area showing various buildings, structures and small-scale features. Based on plan "Plan of Oswego with its Forts as Beseiged by the Marquis of Montcalm August 1756," and plan "Plan of Oswego showing the State of that Garrison as it was on the 24th of May, 1756," Charles Demter, 1756. Graphic produced by R. Hetzler, SUNY ESF, 2003.

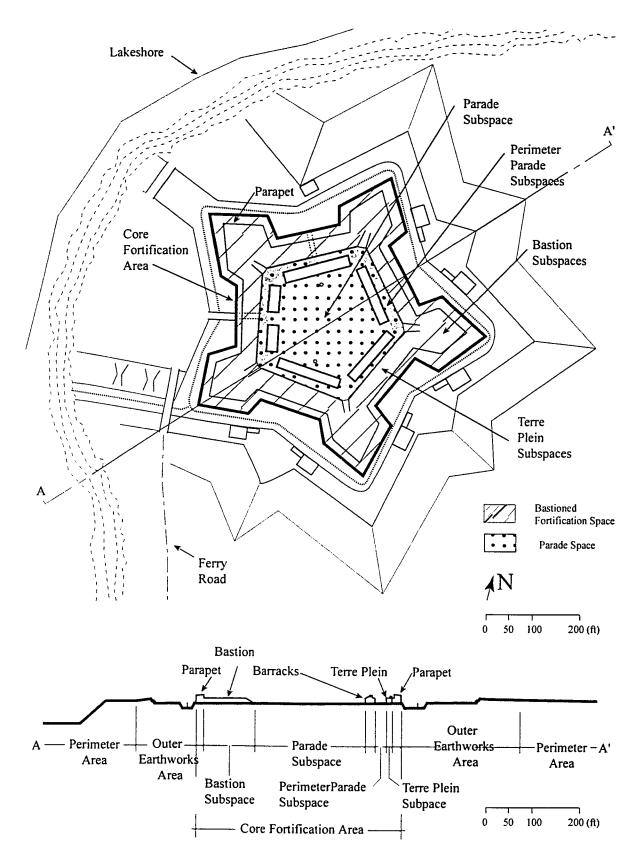
Fig. 1.53 Plan and section of second Fort Ontario showing spaces and spaces of Core Fortification Outer Earthworks areas. Based on plan "Plan of Fort Ontario and its Environs," Captain Thomas Sowers, 1763. Graphic produced by R. Hetzler, SUNY ESF, 2003.

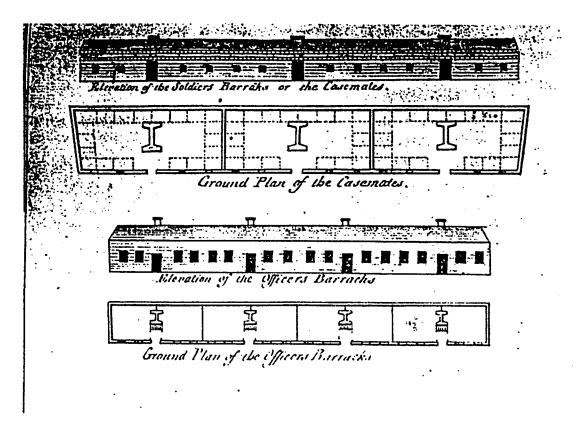
Fig. 1.63. Detail, "Plan of Fort Ontario with the several Alterations and Additional Works proposed by the Chief of Engineers," showing section/elevation of Officers' Barracks and Casemates, unknown author, 1759. Reproduced from copy on file at Fort Ontario State Historic Site.

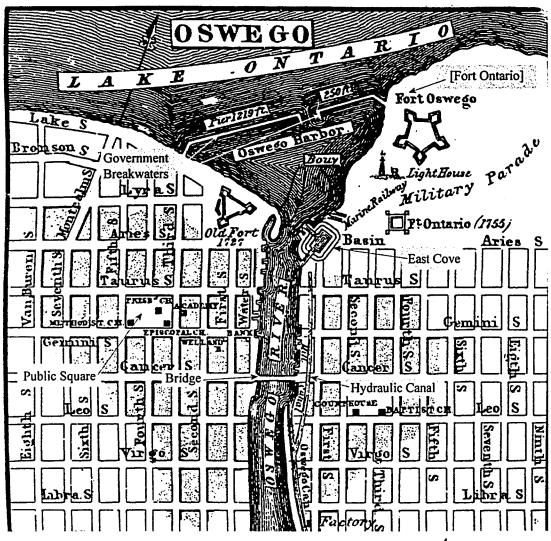
Fig. 2.5. Plan, "Oswego-Lake Ontario," showing portions of East and West Oswego, Gordon's Gazetteer 1836. Reproduced from copy on file at Fort Ontario State Historic Site. Annotated by R. Hetzler, SUNY ESF, 2002.

The bridge was constructed of wood at the Cancer Street location and completed in December of 1822 (see fig. 2.5, p. 123).

day Syracuse with the Oswego harbor. 18 Providing a less expensive and quicker route to the Midwest than that provided by the Erie Canal, the Oswego Canal was quickly utilized by large numbers of immigrants migrating west. As these immigrants settled the western territories, a greater demand for raw and manufactured goods was created thus increasing the flow of goods through Oswego. In anticipation of the opening of the Oswego Canal, and that of the Welland Canal in Canada, Oswego experienced a building boom from 1826 to 1829. During that time 113 dwellings, forty-four stores, fourteen shops, three mills, one furnace, one storehouse, four taverns and one hotel were constructed. 19 Development of Oswego's outer harbor also began during this period with the construction of two breakwaters at the river's mouth (see fig. 2.5, p. 123).

A marine railway was constructed prior to 1839, exact date unknown, and was located east of the Core Fortification (see fig. 2.5, p. 125). No other information was found during the research regarding the characteristics of the feature. Further, no other documentation of the feature was found during this and subsequent historic periods.

The lighthouse was constructed in 1821 and was located south of the Core Fortification (see fig. 2.5, p. 123). It was octagonal, approximately 10' in diameter and 30' to 40' high. It was constructed of stone. No other information was found during the research regarding the characteristics of the feature.

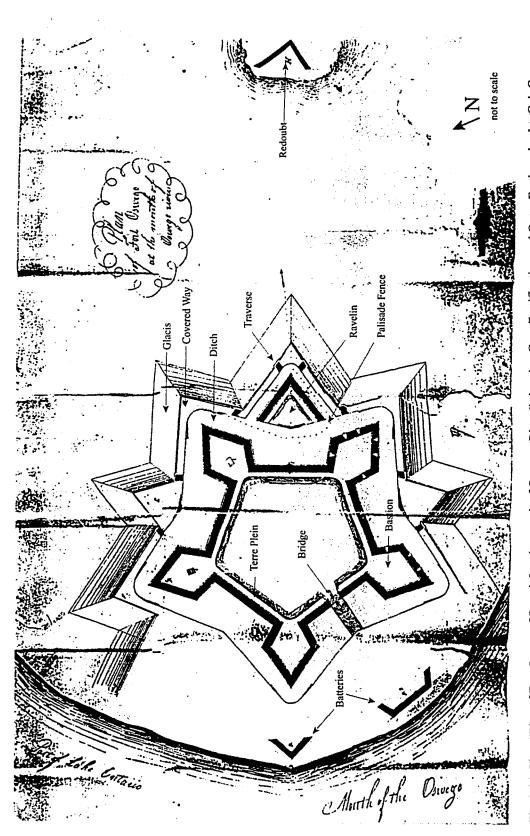
Fig. 2.14: Plan, "Plan of Fort Oswego [Ontario] at the mouth of Oswego River," showing Core Fortification and Outer Earthworks, Lt. Col. George A. Mitchell, 1812. Reproduced from copy on file at Fort Ontario State Historic Site. Altered and annotated by R. Hetzler, SUNY ESF, 2002.

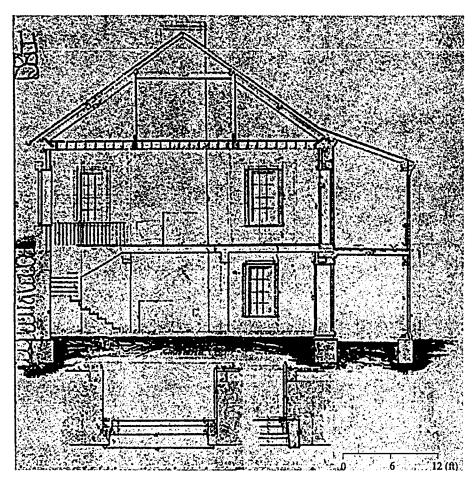
Fig 3.4. Plan, portion of "Fort Ontario Soldiers' Barracks as Designed by Board of Engineers, Sept. 1839," showing side section-elevation of the Enlisted Men's Barracks, unknown author, 1839. Reproduced from copy of original on file at Fort Ontario State Historic Site. Original located in RG 77, National Archives, Washington, D.C.

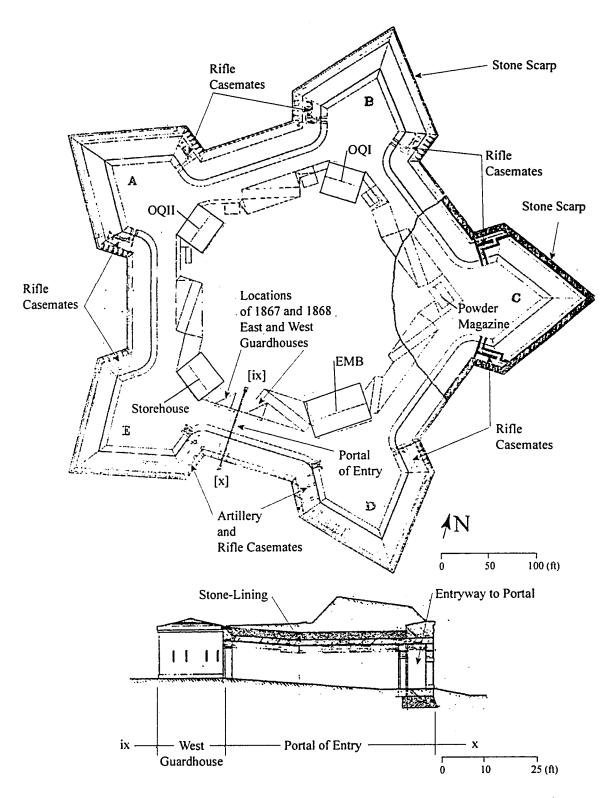
Fig 3.5. Plan, portion of "Plan of Fort Ontario: Made in Accordance with Hd. Qr. Circular of Mar. 5th 1868" and "Sections and Elevations Showing Details of Fort Ontario: Made in Accordance with Hd. Qr. Circular of Mar. 5th 1868," showing stone Scarpl, rifle and artillery casemates, guardhouse and Portal of Entry, William P. Judson, 1868. Reproduced from copy of original on file Fort Ontario State Historic Site. Original located in RG 77, National Archives, Washington, D.C. Annotated by R. Hetzler, SUNY ESF, 2002.

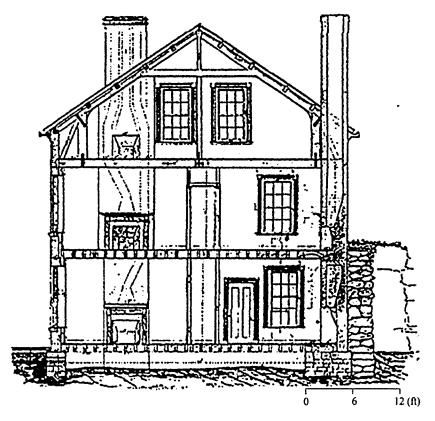
Fig. 3.12. Plan, portion of "Officers' Quarters" showing section-elevation of Officers' Quarters I, Montgomery C. Meigs, 1839. Reproduced from copy on file at Fort Ontario State Historic Site. Original located in RG 77, Dr. 4, Sh. 3, National Archives, Washington, D.C. Annotated by R. Hetzler, SUNY ESF, 2002.

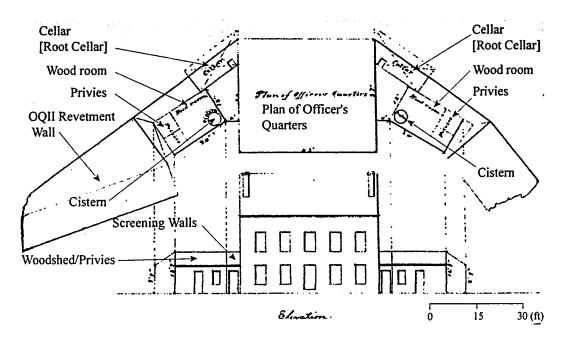
Fig. 3.13. Plan, "Plan of Officers' Quarters I" showing plan and elevation of OQII, Woodshed/ Privies, Revetments and root cellars, Lt. Leadbetter, 1843. Reproduced from copy on file at Fort Ontario State Historic Site. Original located in in RG 77, National Archives, Washington, D.C. Annotated by R. Hetzler, SUNY ESF, 2002.

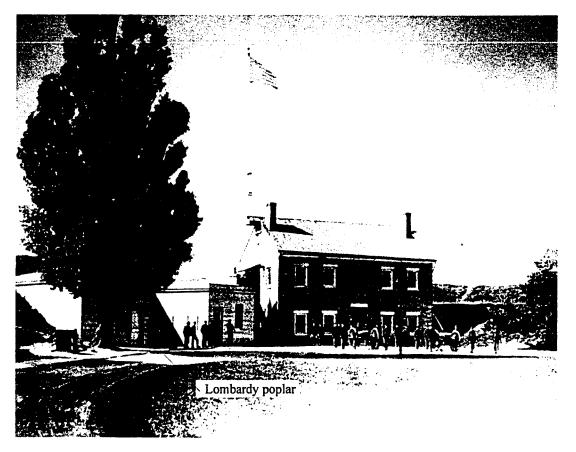
Fig. 3.23. Untitled view of Storehouse with Guardhouses with Lombardy poplar looking southwest from Parade, 1890. Photograph courtesy of Fort Ontario State Historic Site. Annotated by R. Hetzler, SUNY ESF, 2002.

One Lombardy poplar (Populus nigra) was planted prior to 1869, exact date unknown.<sup>203</sup> It was located between the East Guardhouse and the Enlisted Men's Barracks (EMB). It was approximately 15 to 18" (dbh) and was approximately 30 to 35' high (see fig. 3.23, p. 187).

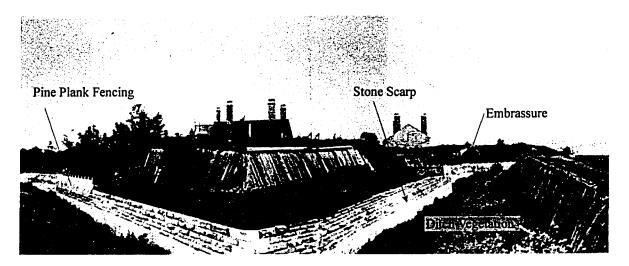
Fig. 3.27. Untitled view of Ditch vegetation, stone Scarp and breach fencing looking northwest from Glacis, c. 1900. Photograph courtesy of Fort Ontario State Historic Site. Annotated by R. Hetzler, SUNY ESF, 2002.

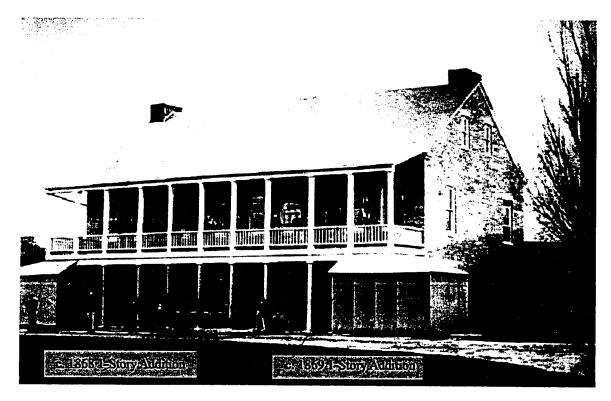
Fig. 3.29. "Enlisted Mens Barracks," looking southeast from Parade and showing c. 1868 and c. 1869 1-story additions, U.S. Army Signal Corps, 1870. Photograph courtesy of Fort Ontario State Historic Site. Annotated by R. Hetzler, SUNY ESF, 2002.

The EMB was constructed c. 1842 and was built into Bastion D and flanked by the turf-covered slopes of the Parade Wall (fig. 3.29); additions were constructed c. 1868, 1869, 1885 and 1893.<sup>221</sup> Circa 1841-42 it was rectangular, 2 ½-stories tall, 10 bays wide by 2 bays deep (62' x 39') with entries symmetrically placed on the first and second floors within the third and eighth bays of the north elevation. It was aligned along an E/W axis. It was constructed of coursed-ashlar, Onondaga limestone, surmounted by a metal, side-gabled roof and characterized by a prominent 2-story frame portico, whitewashed, with a tin shingle, shed roof; <sup>222</sup> in 1887 the tin roof of the EMB was replaced with a standing-seam, tin roof; in 1889,

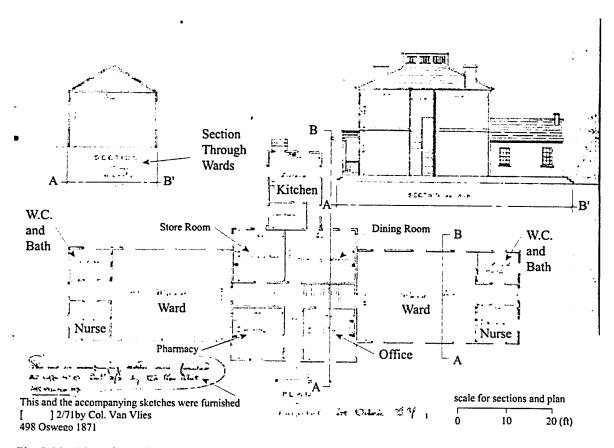
Fig. 3.38. "Plan of Hospital" showing plan, elevation and section of New Post Hospital, Col. Van Vlies, c. 1871. Reproduced from copy on file at Fort Ontario State Historic Site. Original located in RG 77, Dr. 24, National Archives, Washington, D.C. Annotated by R. Hetzler, SUNY ESF, 2002.

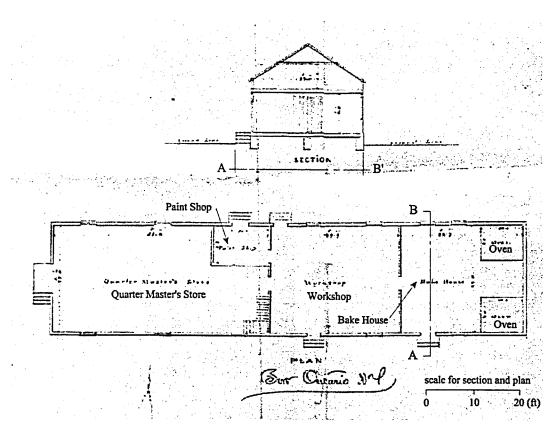
Fig. 3.41. "Plan and Section of Quartermaster's Store/Workshop/Bake House," unknown author, c. 1869. Reproduced from copy on file at Fort Ontario State Historic Site. Original located in National Archives, Washington, D.C. Annotated by R. Hetzler, SUNY ESF, 2002.

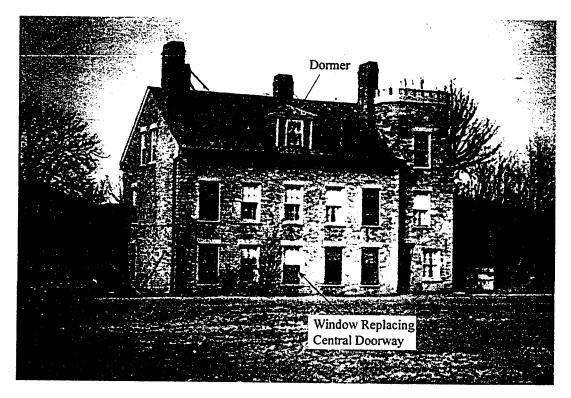
Fig. 4.2. Untitled view of OQI looking north from Parade following its conversion to apartments, c. 1927. Photograph courtesy of Fort Ontario State Historic Site. Annotated by R. Hetzler, SUNY ESF, 2002.

OQI was constructed c. 1841-44 and built into Bastion B with an addition constructed in 1884 and a porch added c. 1891; it was altered c. 1927. Circa 1927, the porch was removed, the entry on the south elevation was removed and replaced with a window, and a dormer was constructed on the south face of the gabled-roof (see fig. 4.2, p. 231). After 1927 the main entry to the building was located on the south elevation of the 1884 addition. No other information was found during the research regarding the feature.

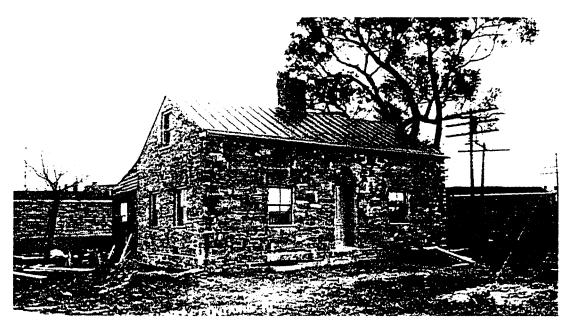
Fig. 4.19. Untitled view of N.C.O. Quarters looking north, 1907. Photograph courtesy of Fort Ontario State Historic Site.

No information was found during the research regarding changes to the N.C.O. Quarters which was constructed c. 1821 (fig. 4.19).

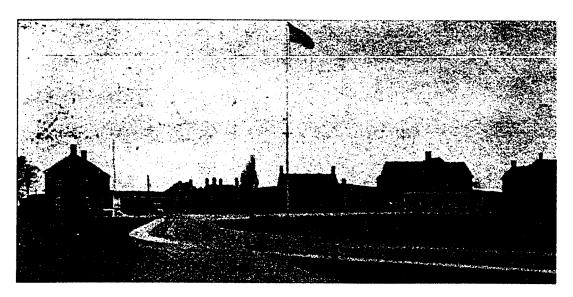
Fig. 4.28. Untitled view of Parade Ground flagpole looking north from Parade Ground driveway, c. 1906. Photograph courtesy of Fort Ontario State Historic Site. Annotated by R. Hetzler, SUNY ESF, 2002.

The Parade Ground flagpole was installed c. 1903-1905 and was located at the west end of the Parade Ground (see fig. 4.28, p. 287).<sup>249</sup> It was 50' high. It was made of wood and painted white with a black base. No other information was found during the research regarding the feature.

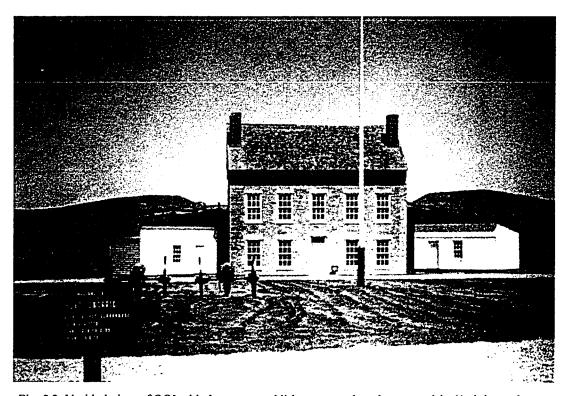
Fig. 5.2. Untitled view of OQI with three-story addition removed, and two woodshed/privies and Revetments looking north from Parade driveway, c. 1970. Photograph courtesy of Fort Ontario State Historic Site.

In 1967, jurisdiction of the historic Site was transferred from the SED to the Division of Parks within the Conservation Department of New York State.<sup>34</sup> Under its jurisdiction, a five-year plan was developed to improve interpretative programs, vehicular and pedestrian circulation, and to make the historic Site more representative of a civil war era fortification. The plan included a proposed 14,000 square foot visitor center, a new vehicular and pedestrian circulation system, and the reconstruction or removal of various buildings and structures associated with OQI.<sup>35</sup> By 1970, most of the plan was realized with the construction of two woodshed/privies, replacement of two Revetments, the construction of two new parking lots, a new roadway and a walkway, and the removal of a 3-story addition constructed onto OQI in 1884 (fig. 5.2).<sup>36</sup> The visitor

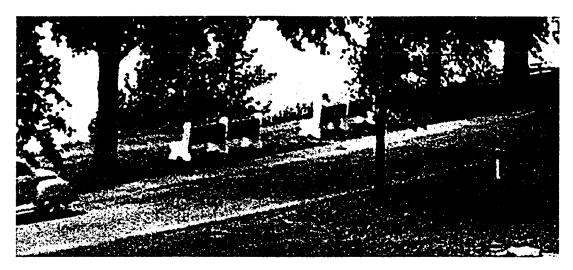
Fig. 5.22. Untitled view of benches looking northwest from Ramparts, c. 1955. Photograph courtesy of Fort Ontario State Historic Site.

Approximately 23 benches were installed c. 1955 and were located along the Fort driveway (fig. 5.22). They were rectangular approximately 3' wide, approximately 5' long and approximately 3 ½' high. They were made of concrete and wood; the concrete ends were painted white. No other information was found during the research regarding the features.

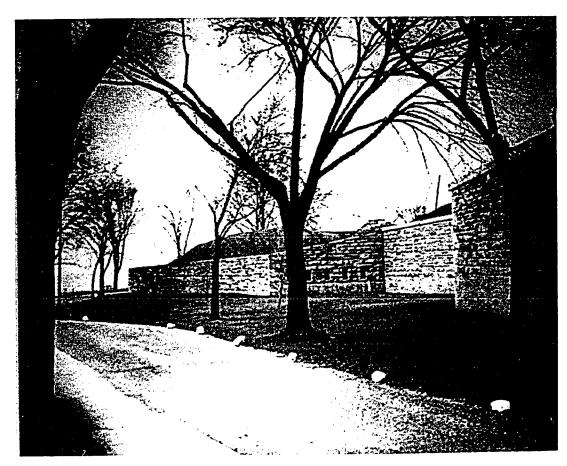
Fig. 5.23. Untitled view of decorative stone along Fort driveway looking north from Fort driveway, c. 1959. Photograph courtesy of Fort Ontario State Historic Site.

A row of decorative stones was placed prior to 1953 and was located along the Fort driveway and Portal parking lot; they were removed c. 1968 (see fig. 5.23, p. 337).<sup>239</sup>

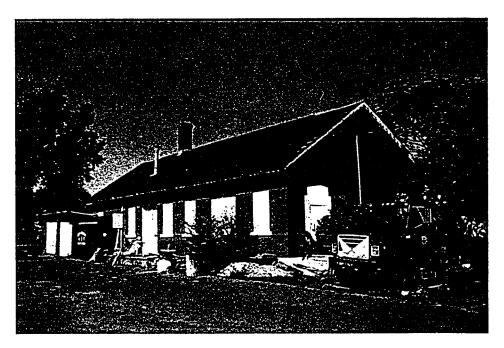
Fig. 6.13. Building 34 looking west from Parks and Recreation building. Photograph by R. Hetzler, SUNY ESF, 2002.

Building 34 was constructed c. 1903-1905 and is located southeast of the Skateboard Park (fig. 6.13). It is rectangular, 40' x 50', and aligned along an E/W axis. It is 1-story tall, representative of the Academic Revival style, constructed of red brick and surmounted by a side-gable roof; an area of turf containing annual and perennial grasses and low growing herbaceous vegetation is located to the north of the building, and an asphalt parking lot is located to the south, east and west of the building. The building and a portion of the parking lot to the south and west of the building are surrounded by a chain-link fence; the height of the fence is 7' to 8'. It is currently used by the City of Oswego Traffic Section.

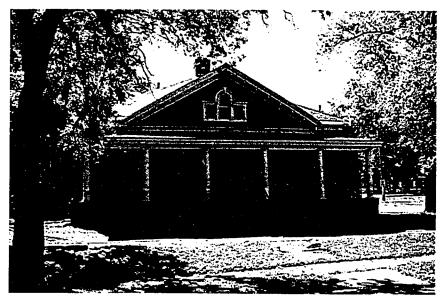
Fig. 6.19. Building 22 looking southwest from Seventh Street Entrance Road. Photograph by R. Hetzler, SUNY ESF, 2001.

Building 22 was built c.1903-1905 and is located at the south corner of the intersection of the Seventh Street entrance and Secondary Parade Drive (fig. 6.19). It is 47' x 59' square and aligned along a NW/SE axis. It is 1-story tall, representative of the Academic Revival style, constructed of red brick and surmounted by a hipped roof with a shed roof, entry portico; walkways and areas of turf containing annual and perennial grasses and low growing herbaceous vegetation surround the building. It is currently used by Safe Haven Incorporated.

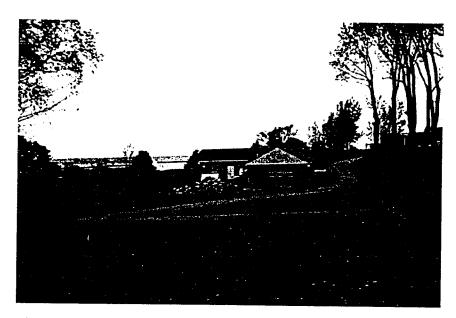
Fig. 6.43. Maintenance road looking southwest from small cottonwoods. Photograph by R. Hetzler, SUNY ESF, 2001.

The maintenance road was constructed in 1968 and is located along the east edge of the maintenance space (see fig. 6.43, p. 379). It is generally linear, extends from the 4th Street entrance through the picnic space and maintenance space where it terminates at the Site manager parking lot. It is 12' wide, 450' long

and is generally aligned along a N/S axis. The surface is asphalt paving.

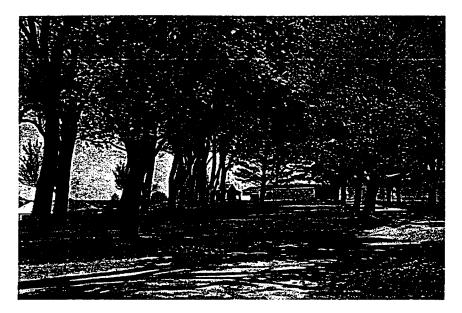
Fig. 6.53. Picnic space topography looking north from East Fourth Street entrance. Photograph by R. Hetzler, SUNY ESF, 2002.

The picnic space topography was generally flat with an approximately 1% grade change sloping downwards from the northern to the southern edge of the space (see fig. 6.53, p. 386).

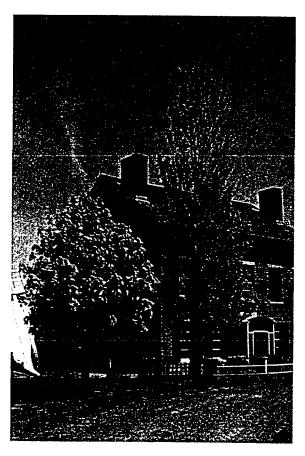
Fig. 6.56. Lombardy poplar and horse chestnut looking north from circular drive. Photograph by R. Hetzler, SUNY ESF, 2002.

Three Lombardy poplars (Populus nigra 'Italica') were planted c. 1992. One is located between the East Guardhouse and the Enlisted Men's Barracks (EMB); the other two are located south of Officers' Quarters #1 (OQI) (fig. 6.56). They range from 15 to 18" dbh and are approximately 35 to 40' high.

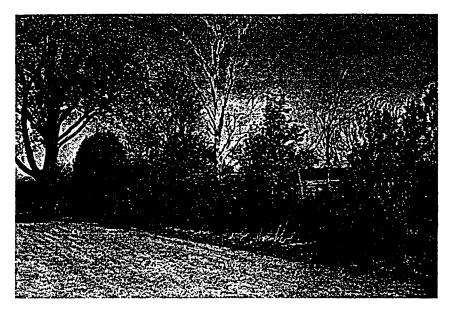
Fig. 6.60. Boundary vegetation looking north from east edge of overlook space towards. Photograph by R. Hetzler, SUNY ESF, 2002.

A combination of herbaceous and woody vegetation has been established on either side of the boundary fence defining the boundaries between the POA Parcels 1 and 2 and the current Site boundaries (see fig 6.60, p. 392). The linear strips of vegetation are approximately 5' wide on each side of the fence and vary from 12' to 40' high. The woody vegetation includes cherry (Prunus var.), eastern cottonwood (Populus deltoids), maple (Acer var.) and staghorn sumac (Rhus typhina).

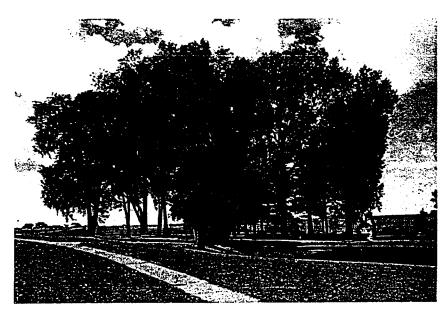
Fig. 6.61. Cemetery trees looking northwest from public access road. Photograph by R. Hetzler, SUNY ESF, 2001.

A combination of sixteen eastern cottonwoods (Populus deltoides), three Siberian elms (Ulmus pumila) and seven red maples (Acer rubrum) were planted prior to 1941, exact date unknown. They are located within and to the east and south of the cemetery space (fig. 6.61). They range from 1' to 6' dbh and are approximately 50' to 80' high.

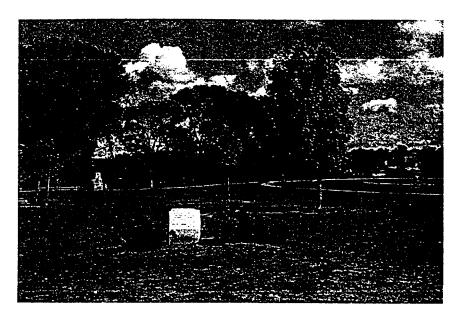
Fig. 6.62. Overlook trees in background, with Safe Haven monument, arborvitaes and planting bed in foreground looking east from public access road spur. Photograph by R. Hetzler, SUNY ESF, 2001.

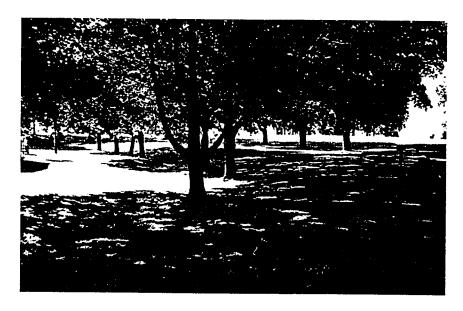
A combination of twenty Norway maples (Acer platanoides) and two Siberian elm (Ulmus pumila) were planted c. 1905. They are located on either side of the portion of the Parade Ground driveway removed c. 1968 (see fig. 6.64, p. 395). They range from 1' to 2' dbh and are approximately 40 to 60' high.

Fig. 6.64. Parade road trees looking northwest from entrance space. Photograph by R. Hetzler, SUNY ESF, 2000.

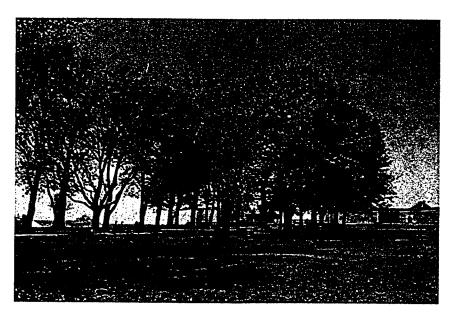
Sixteen Norway maples (Acer platanoides) were planted c. 1940. Fifteen are located in three rows parallel to the seasonal access road; one row is 37' from the east edge of the road; one row is 10' from the east edge of the road and extends into the visitor space; one row is 5' from the west edge of the road; and one tree is located at the center of the picnic space (see fig. 6.68, p. 399). The maples range from 18" to 32"

dbh and are approximately 40' to 45' high.

Condition: Good

Fig. 6.68. Picnic space maples looking north from boundary cottonwoods. Photograph by R. Hetzler, SUNY ESF, 2002.

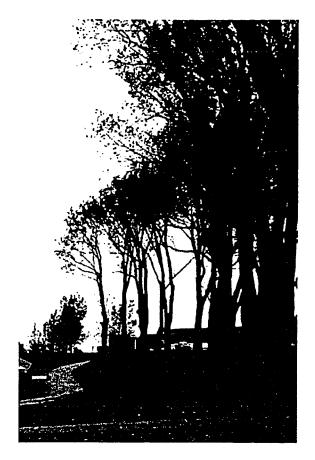
Twenty-two eastern cottonwood (Populus deltoides) were planted prior to 1924, exact date unknown. They are located along the west edge of the picnic space and extend into the visitor space (see fig. 6.69, p. 400). The cottonwoods are planted in a row, range from 28" to 35" dbh and are approximately 60' high.

Condition: Good

Fig. 6.69. Picnic space cottonwoods looking north over maintenance road. Photograph by R. Hetzler, SUNY ESF, 2001.

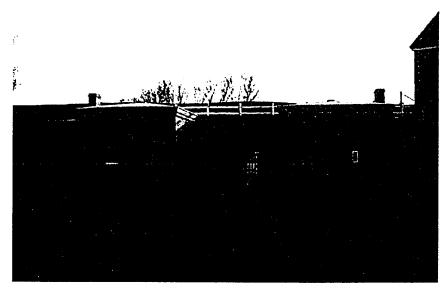
The East and West Guardhouses were constructed in 1867 and 1868 respectively, and are built into the Ramparts on either side of the Portal of Entry (fig. 6.70). The mirror-image buildings are rectangular, 1-story tall, 2 bays wide by 2 bays deep (18'x 20') with an entry placed within the first bay closest to the Portal of Entry of the north elevation. They are aligned along an N/S axis. They are constructed of coursed ashlar Onondaga limestone and surmounted by a standing-seamed, metal hipped roof.

Condition: Fair

Fig. 6.70. East and West Guard Houses looking south from interio parade. Photograph by R. Hetzler, SUNY ESF, 2001.

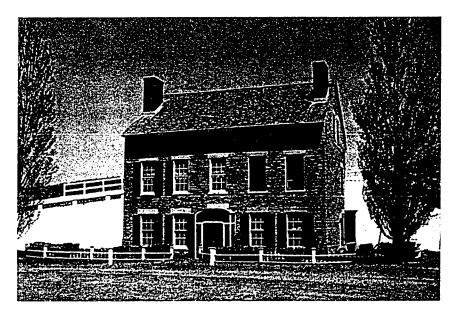
OQI was constructed c. 1841-1843 and is built into Bastion B and flanked by the OQI Revetments (fig. 6.74). It is rectangular, 2 ½-stories tall, 5 bays wide by 3 bays deep (42' x 38') with an entry centrally placed on the first floor within the third bay of the south elevation; an entry placed on the first floor within the north bay of the east elevation; and an entry placed on the first floor within the north bay of the west elevation. It is aligned along an E/W axis. It is constructed of coursed ashlar Onondaga limestone and surmounted by a wood shingle, side-gabled roof.

Condition: Good

Fig. 6.74. OQI looking northwest from interior Parade. Photograph by R. Hetzler, SUNY ESF, 2002.

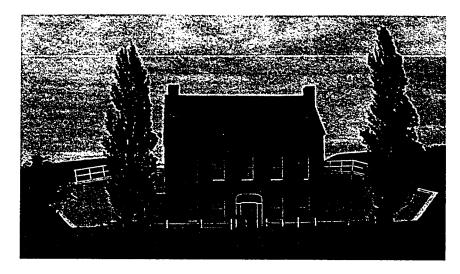
Two OQI Revetments were reconstructed in 2000 and are built into the Parade Wall flanking OQI (see fig. 6.75, p. 405). They are L-shaped and approximately 58' long. Each Revetment consists of two sections; a main body and a wing. The main body of the Revetment is located closest to OQI, is approximately 42' long and generally 15' high; the wing is located at the end of each Revetment, furthest from OQI, is approximately 16' long with its top edge sloping down from the top of the Parade Wall to the ground plane of the Parade. The Revetments are generally aligned along an E/W axis. They are constructed of wood planking and timber and whitewashed; a wooden fence surmounts each Revetment.

Fig. 6.75. OQ1 Revetments looking northwest from interior Parade. Photograph by R. Hetzler, SUNY ESF, 2002.

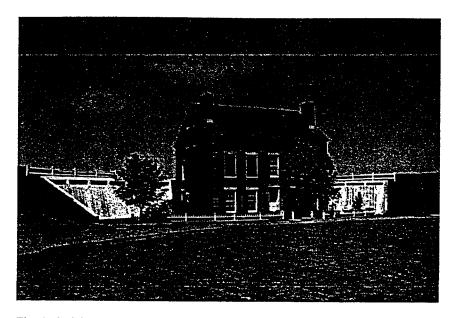
Two OQII Revetments were reconstructed in 1984-85 and are built into the Parade Wall flanking OQII (see fig. 6.78, p. 407). They are L-shaped and approximately 76' long. Each Revetment consists of two sections; a main body and a wing. The main body of the Revetments are located closest to OQII, are approximately 53' long and generally 15' high; the wings are located at the end of each wall furthest from OQII, are approximately 23' long with their top edge sloping from the top of the Parade Wall, approximately 15' high, to the ground plane of the Parade. The Revetments are generally aligned along an NE/SW axis. They are constructed of wood planking and timber supports and whitewashed; a wooden fence surmounts each Revetment.

Condition: Good

Fig. 6.78. OQII revetments looking northwest from interior parade Photograph by R. Hetzler, SUNY ESF, 2002.

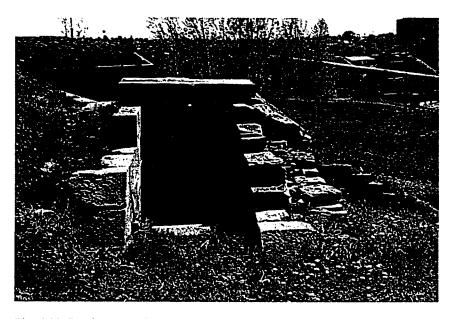
Bastion A south Casemate entrance was constructed c. 1863-1872 and is built into the earthen Parapet along the south Flank of Bastion A (see fig. 6.88, p. 414). It is rectangular, approximately 8' 8" deep, 15' long with the roof of the entry approximately 3' above the surrounding ground plane and an entry placed on the north elevation; the threshold of the entry is located 4' below the surrounding ground plane and is reached by descending a limestone staircase 12' in length. The entrance is surmounted by limestone blocks and generally aligned along a N/S axis. It is constructed of limestone. The door of the entry is 3' 6" wide, 5' 10" high and is constructed of pine pickets spaced approximately 4" apart with a solid board backing; the door is not painted.

Condition: Good

Fig. 6.88. Bastion A south casemate entrance looking southeast from Bastion A parapet. Photograph by R. Hetzler, SUNY ESF, 2001.

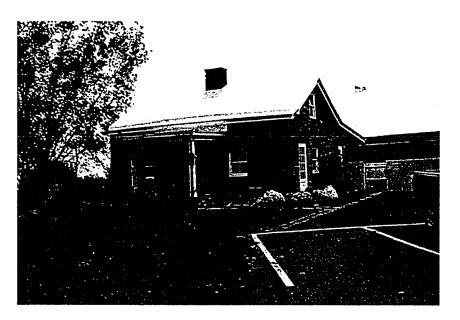
The 1-story addition was constructed in c. 1851 and is located parallel to and adjoining the north elevation of the original portion of the Site manager's house. It is rectangular, 1-story tall, 3 bays wide by 2 bays deep (45' x 25') with an entry placed within the south bay of the east elevation. It is aligned along an E/W axis. It is constructed of coursed ashlar Onondaga limestone and surmounted by a standing-seamed, tin, shed roof painted red-brown.

Condition: Good

Fig. 6.94. Site manger house looking northwest from Site manager parking lot. Photograph by R. Hetzler, SUNY ESF, 2001.

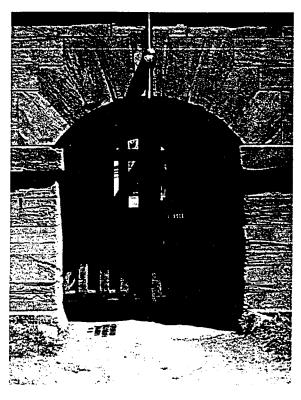
The main gate was installed in 1877 and is located at the south end of the Portal of Entry (see fig 6.102, p. 426). It is generally rectangular, aligned perpendicular to the Portal of Entry when closed, 15' wide and 12' high. It is constructed of wood and is painted green.

Fig. 6.102. Main gate looking north from seasonal access road. Photograph by R. Hetzler, SUNY ESF, 2002.

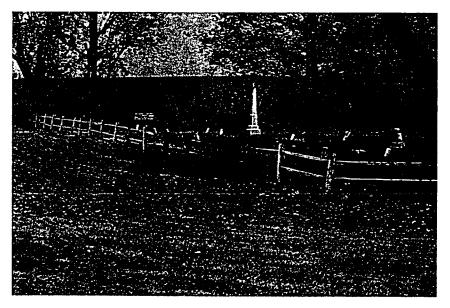
The cemetery fence was installed c.1965 and is located along the south, east and west edges of the cemetery space (fig 6.110). It consists of 10' sections and has posts that are 3' 6" high with an overall length of approximately 400'. It is constructed of cedar and is not painted. There is an approximately 25' opening in the southwest run that allows access to the cemetery.

Condition: Good

Fig. 6.110. Cemetery fence looking north from post cemetery walkway. Photograph by R. Hetzler, SUNY ESF, 2002.

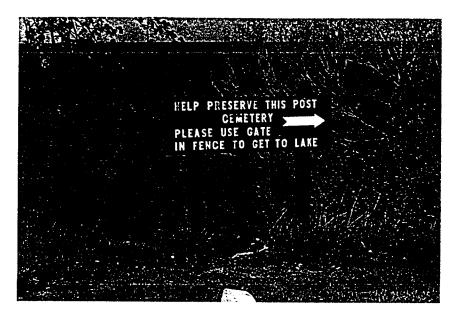
Fig. 6.111. Cemetery sign looking north from overlook space. Photograph by R. Hetzler, SUNY ESF, 2002.

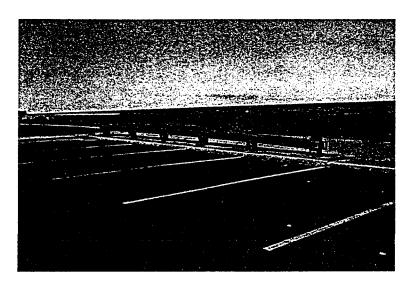
The timber railing was installed in 1968 and is located along the north edge of the overlook parking lot (fig. 6.118). It is linear, aligned along a NE/SW axis, approximately 9' long and 2' high. It is constructed of wood planks and 10" square posts placed 8 feet o.c.; it is painted brown.

Condition: Good

Fig. 6.118. Timber railing looking northwest from overlook parking lot. Photograph by R. Hetzler, SUNY ESF, 2001.

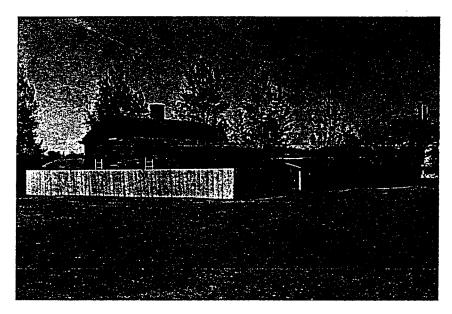
Fig. 6.126. Manager's fence looking southwest from seasonal access road. Photograph by R. Hetzler, SUNY ESF, 2002.

The manager's fence was installed 1995 and is located north of the Site Manager's House (fig. 6.126). It consists of three sections; one linear, aligned along an E/W axis and 48' long; the second U-shaped, aligned along a NW/SE axis and 100' long; and the third aligned along an E/W axis and 28' long; the fence varies from 5' 4" to 6' 2" high with its highest point located at the most western extension. The fence is constructed of pine-boards, 8" to 10" wide and 7/8" thick, which are whitewashed. There are two openings, approximately 3' 6", one located between the first and second sections and one between the second and third sections.

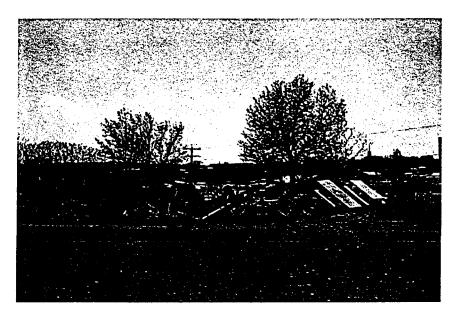
Fig. 6.131. Debris pile looking south from maintenace space. Photograph by R. Hetzler, SUNY ESF, 2002.
