**CULTURAL LANDSCAPE REPORT
FOR
THE EDISON NATIONAL HISTORIC SITE:
Laboratory Unit**

A project submitted in partial fulfillment of the requirements for
the
Master of Landscape Architecture Degree

Laboratory Unit

Prepared for the U.S. Department of Interior
National Park Service, N.A.R.O.
Cooperative Agreement: CA1600-1-9013, 1991-1992\

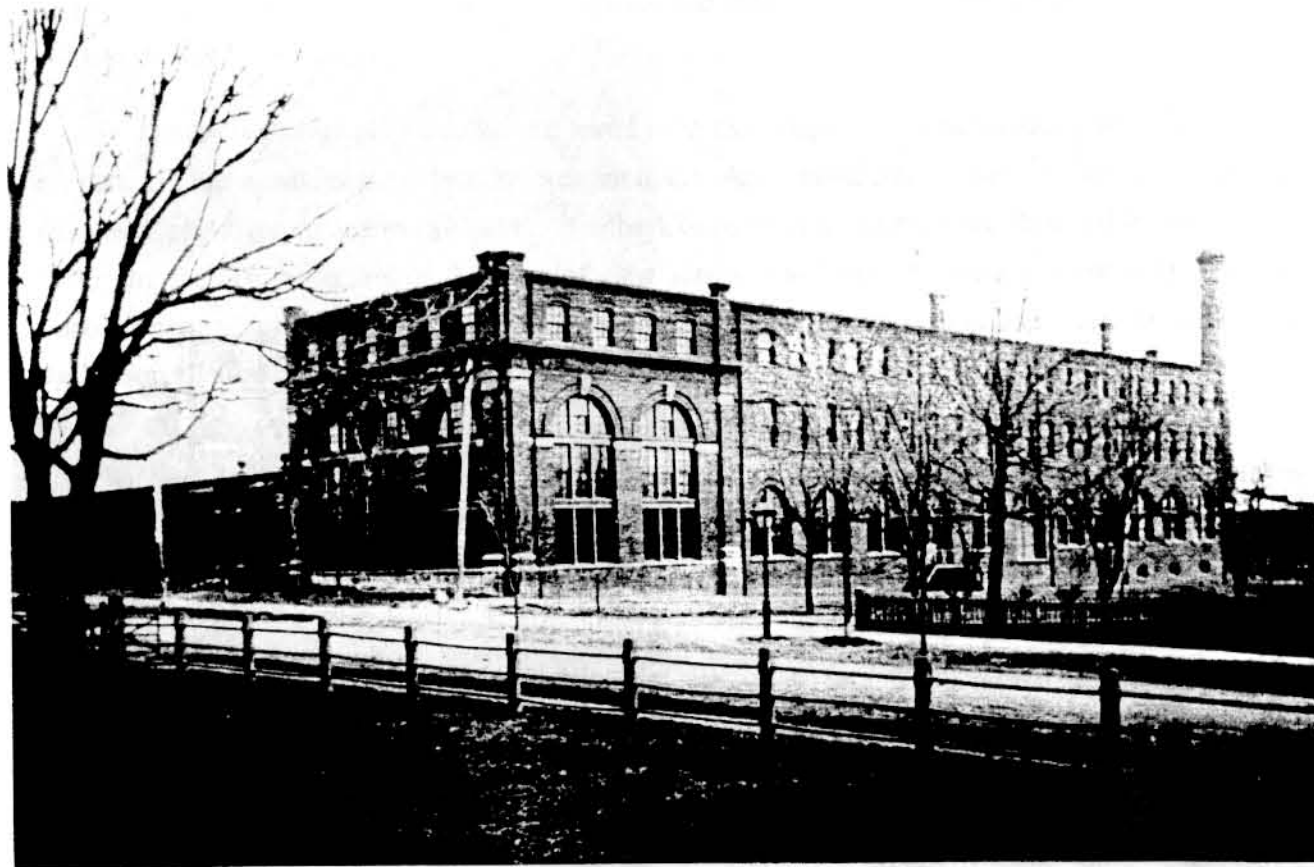
[A3] Figure 1.3. View northeast of the Edison Laboratories. The intersection of Valley Road and Lakeside Avenue is located in the center of the photograph. Lakeside Avenue extends into the background of the photo with its stately lined trees. [Source: Neg. No. 10.381/ 8, E.N.H.S. Archives]

trees, similar to Valley Road. (see photo [A3], page 22.) During this period of history, Lakeside Avenue continued westerly across Valley Road and into Llewellyn Park. Where Lakeside Avenue crossed Valley Road, a set of gates was erected across Lakeside Avenue and its neighboring sidewalks.

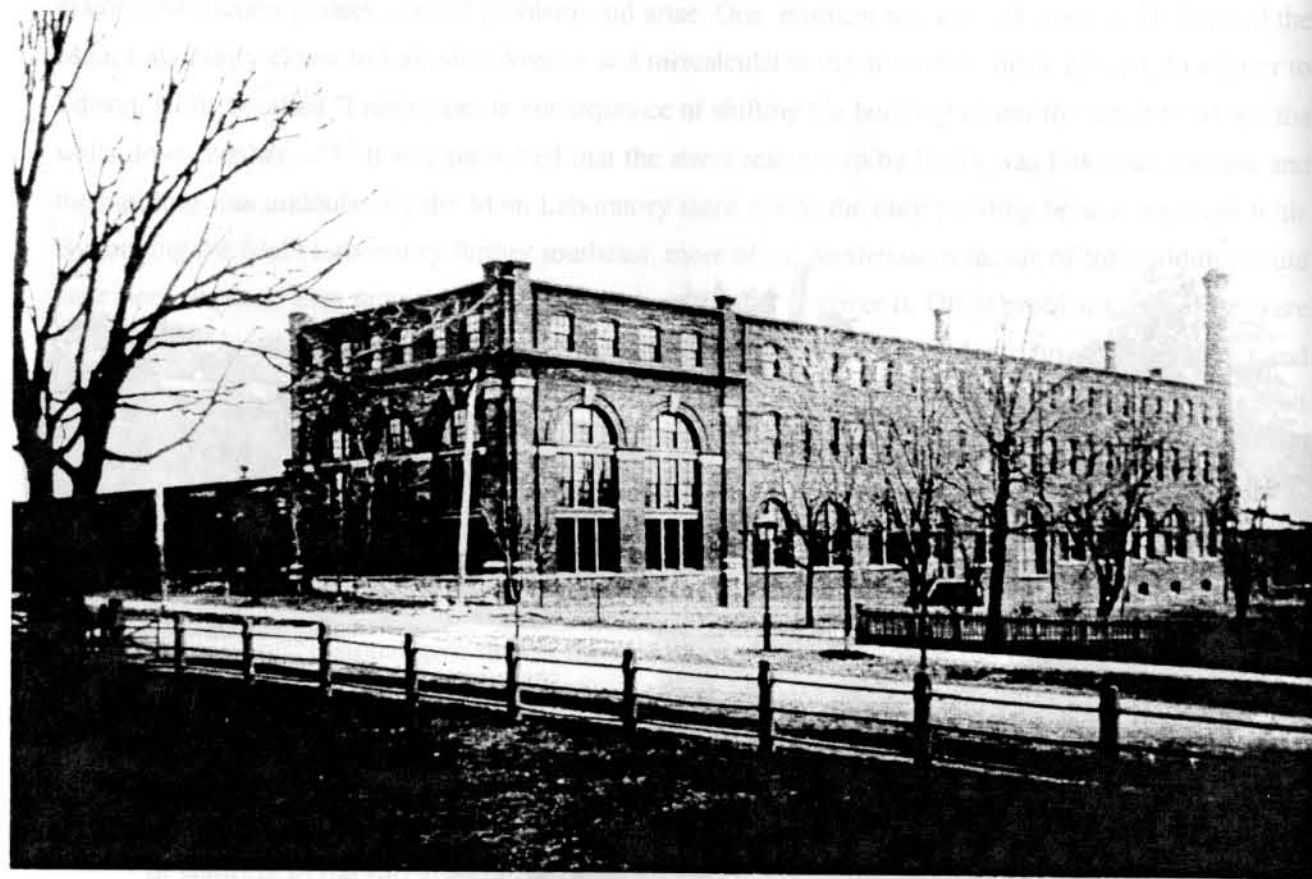
[A3] Figure 1.8. View northeast of the Edison Laboratories. Notice the small plants planted along the western facade of the Physics Laboratory (Bldg. No. 1)[Source: Neg. No. 10.381/ 8, E.N.H.S. Archives]

In addition to the successional growth, several mature trees were scattered throughout the West Orange plant (See photo [A9], page 33.) Several of these trees were located at the southwest corner of the Edison Laboratories site. These trees grew along eastern edge of the sidewalk that ran parallel with Valley Road and were directly west of the Main Laboratory's library facade. In addition to the trees, the western elevation of the Edison Laboratories contained small flowering plants located along the western foundation of the Physics Laboratory (Building No. 1). (see photo [A3], page 34.)

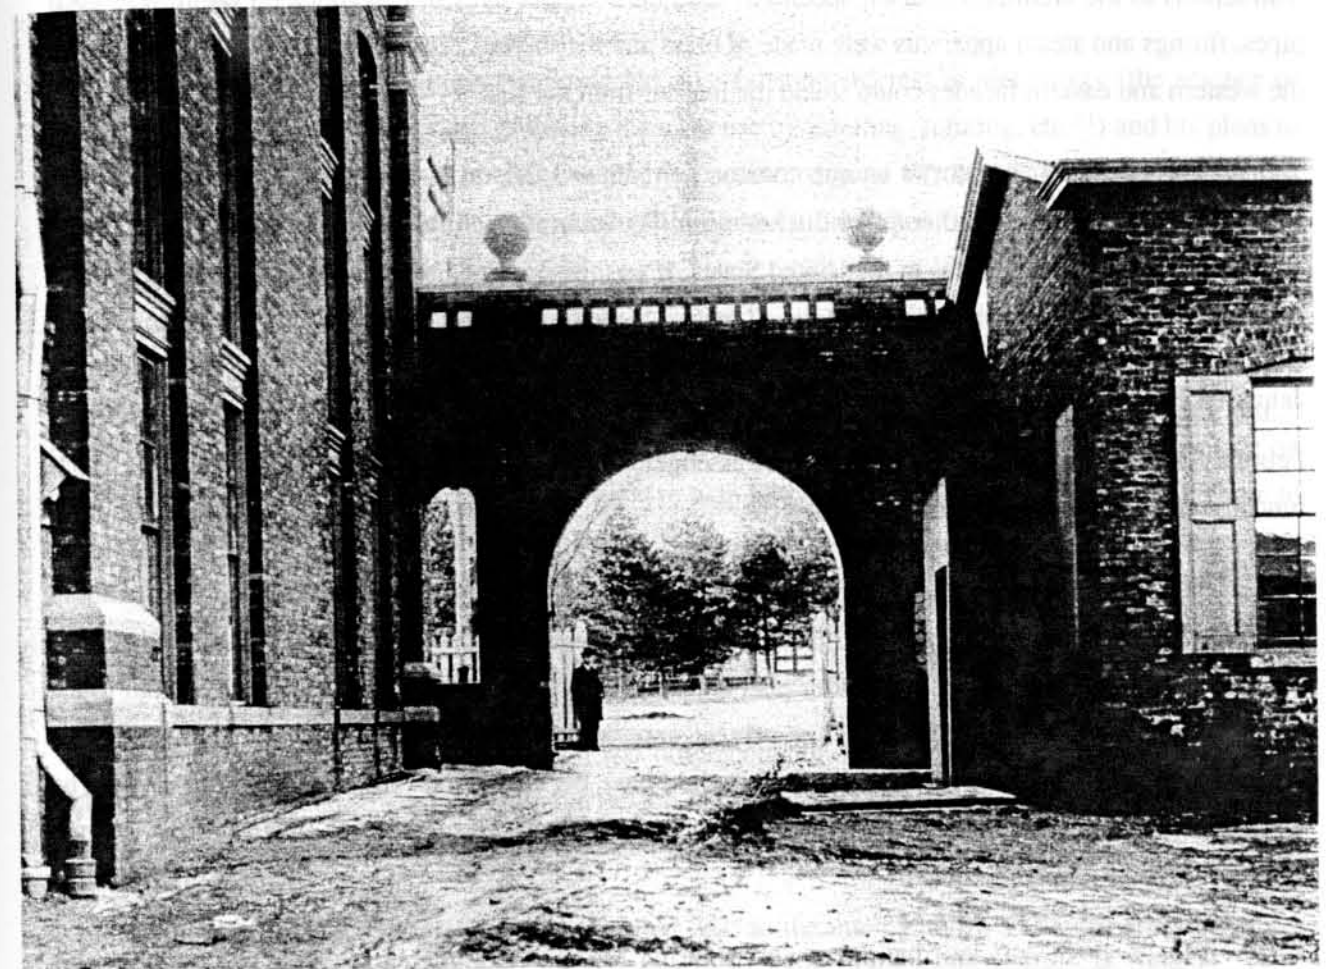
[A1] Figure 1.9. View west from within the Edison Laboratories' courtyard. The building on the left of the photo was the Physics Laboratory (Bldg. No. 1)[Source: Album #64, E.N.H.S. Archives]

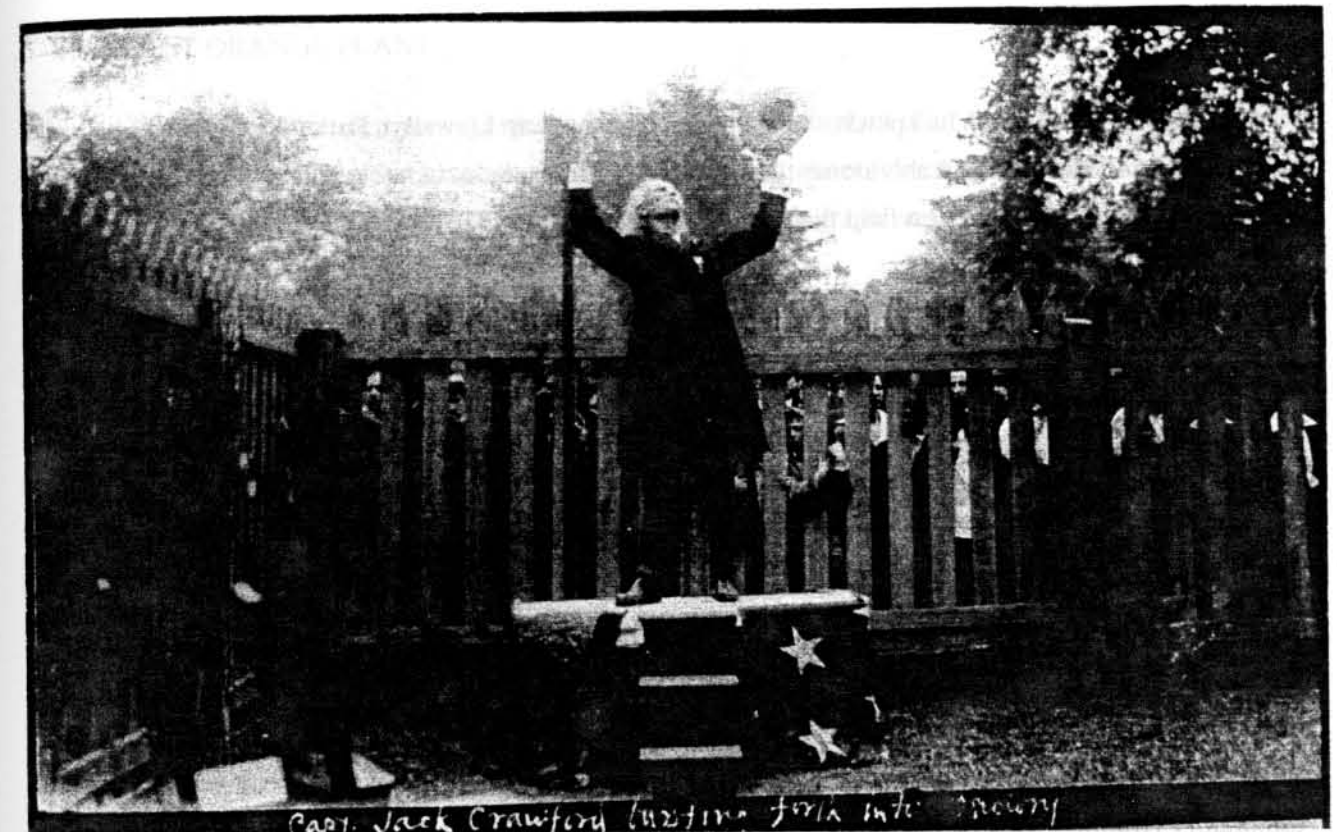
[C4] Figure 1.19 "Capt. Jack Crawford bursting forth into [unidentifiable]." View of the interior corner of Lakeside Avenue and Valley Road. [Source: E.N.H.S. Archives]

The picket fence that surrounded the Edison Laboratories site was installed in September of 1888, by Williams & Woodruff, a local woodworking company.⁹⁵ (see photo [C4], page 53.) The fence was constructed out of wood slats that were about 2"x6" spaced every 9". The smoothly cut slats were about 6'-6 1/2' in height, and the tops of each slat came to a point. The roughly cut posts that supported the fence were located behind the fence and were thus, hidden from view along Valley Road. At the main entrance of the Edison Laboratories the fence contained two points of entry. Adjacent to the Gate House (Building No. 9) was the larger point of entry, which consisted of two gates that swung toward the Edison Laboratories site. This access point was the main entrance and exit for deliveries and visitors of the site that came in large numbered groups.⁹⁶ Next to the two gates was a third, narrower gate. This second

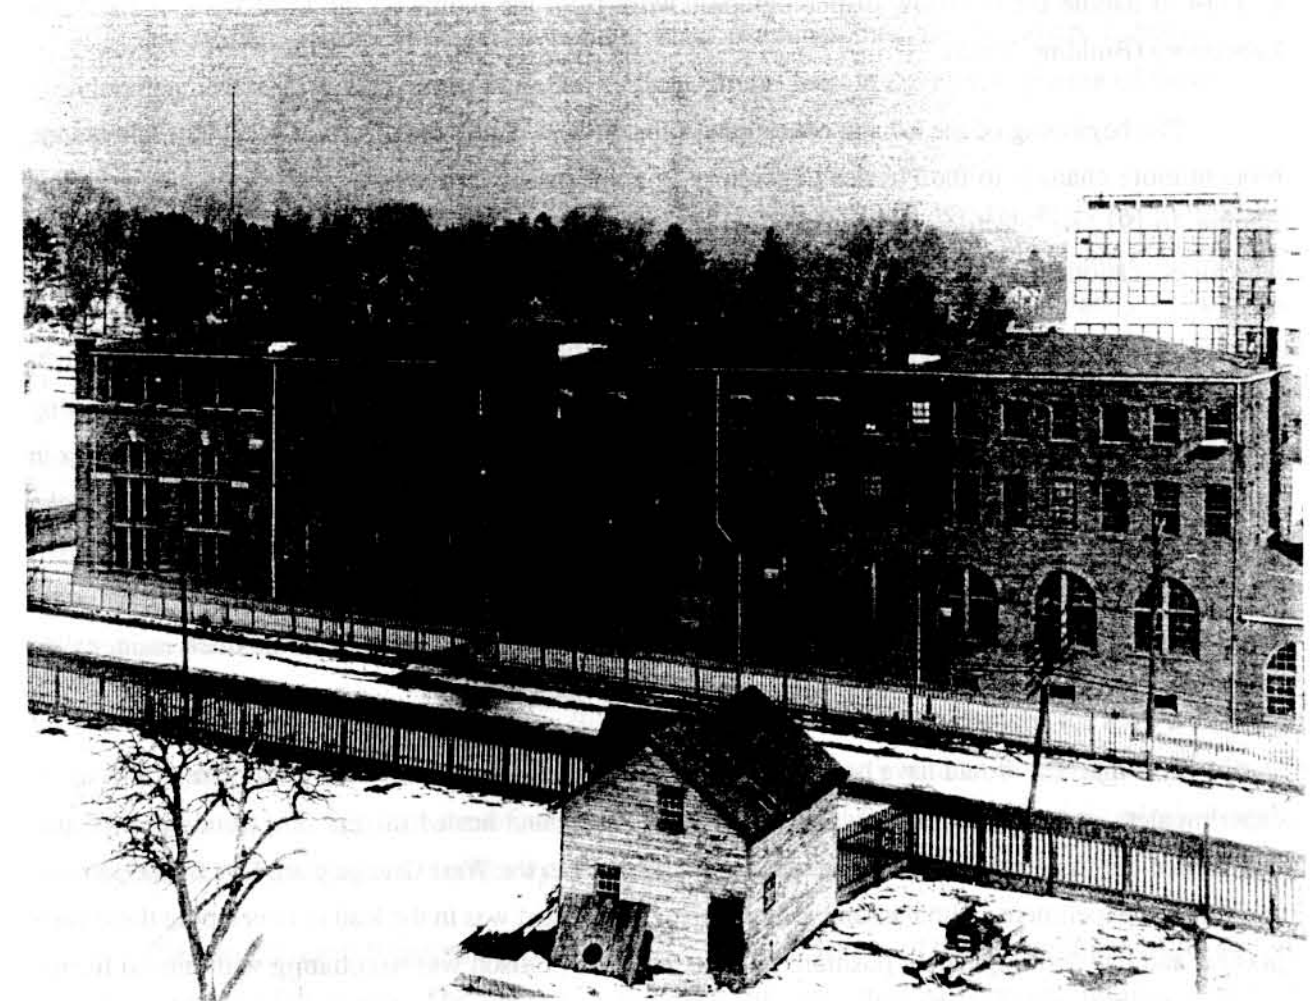
[B6] Figure 1.25. (1911) View of the Main Laboratory (Building No. 5) from Lakeside Avenue. The entrance into the Main Laboratory from Lakeside was located within the sixth arched window from the Main Laboratory's left corner (including the two large arched windows). [Source: E.N.H.S. Archives]

The Main Laboratory (Building No. 5) - The main entrance to the Main Laboratory led to the doorway of the library. In 1903-1904 M.A. Rosanoff found Edison "in a small reception room" in the library. This room could have been on either side of the doorway. In photographs taken in 1912 one can see through the passageway behind the main door leading to the Main Laboratory all the way to the window that looked onto Lakeside Avenue. Pictures taken in 1915 show that a vestibule has been erected in this passageway with a doorway leading to the doorway of the library. The vestibule appears to be made out of wood panels and does not reach to the ceiling. People entering the building and going to the storeroom and machine shop filter left of the vestibule. The purpose of this structural change is to provide a waiting room for visitors to Edison in the library and to separate these visitors from laboratory staff making their way to the machine shops and storeroom.¹²⁰ During this period the Lakeside Avenue entrance to the Main Laboratory was boarded across and the stairway removed. (*See photo[B6], page 75*)

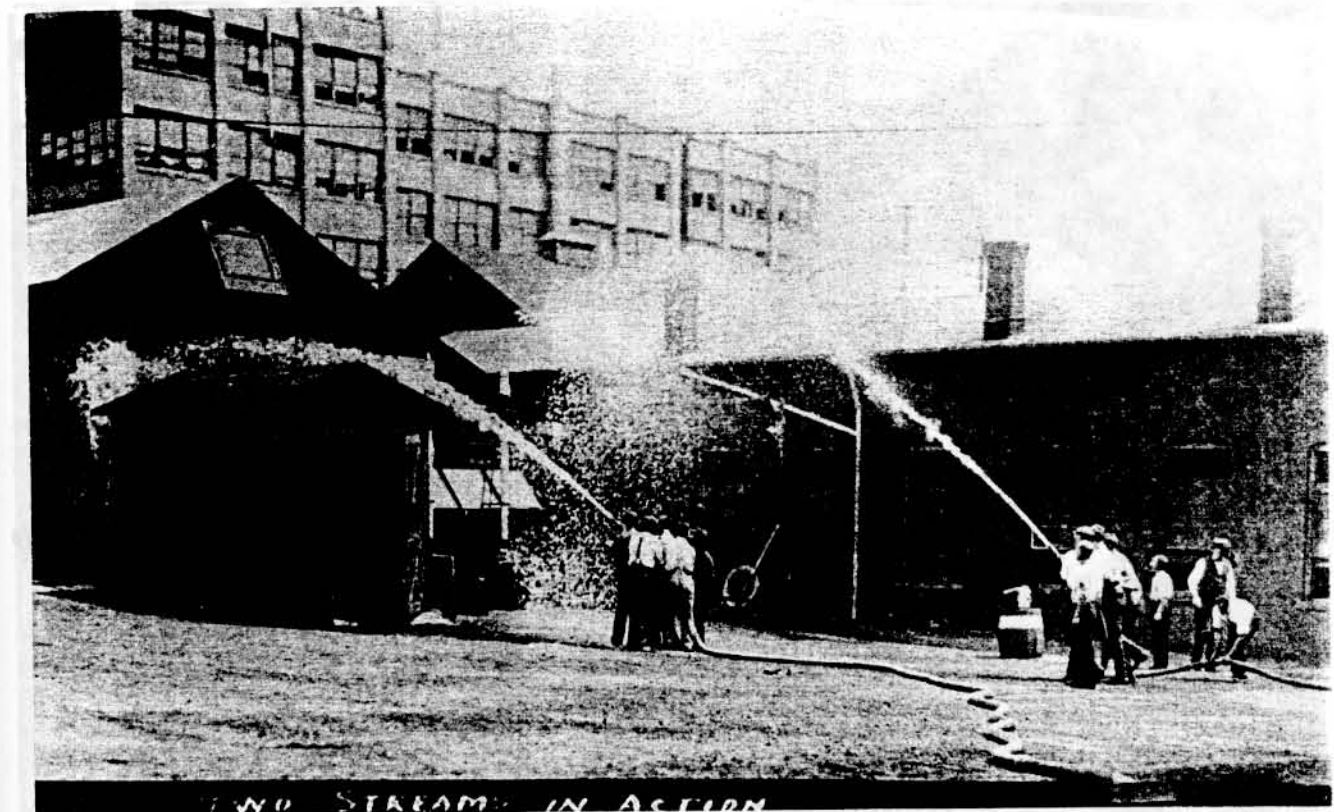
[B21] Figure 1.29. "Two Streams in Action," fire drill in 1913. View northeast from within the courtyard. The building that is being hosed down is the Garage/ Experimental Studio (Building No. 11). The ramp way into the building was hidden from view by the wooden shed. [Source: Album #10, E.N.H.S. Archives]

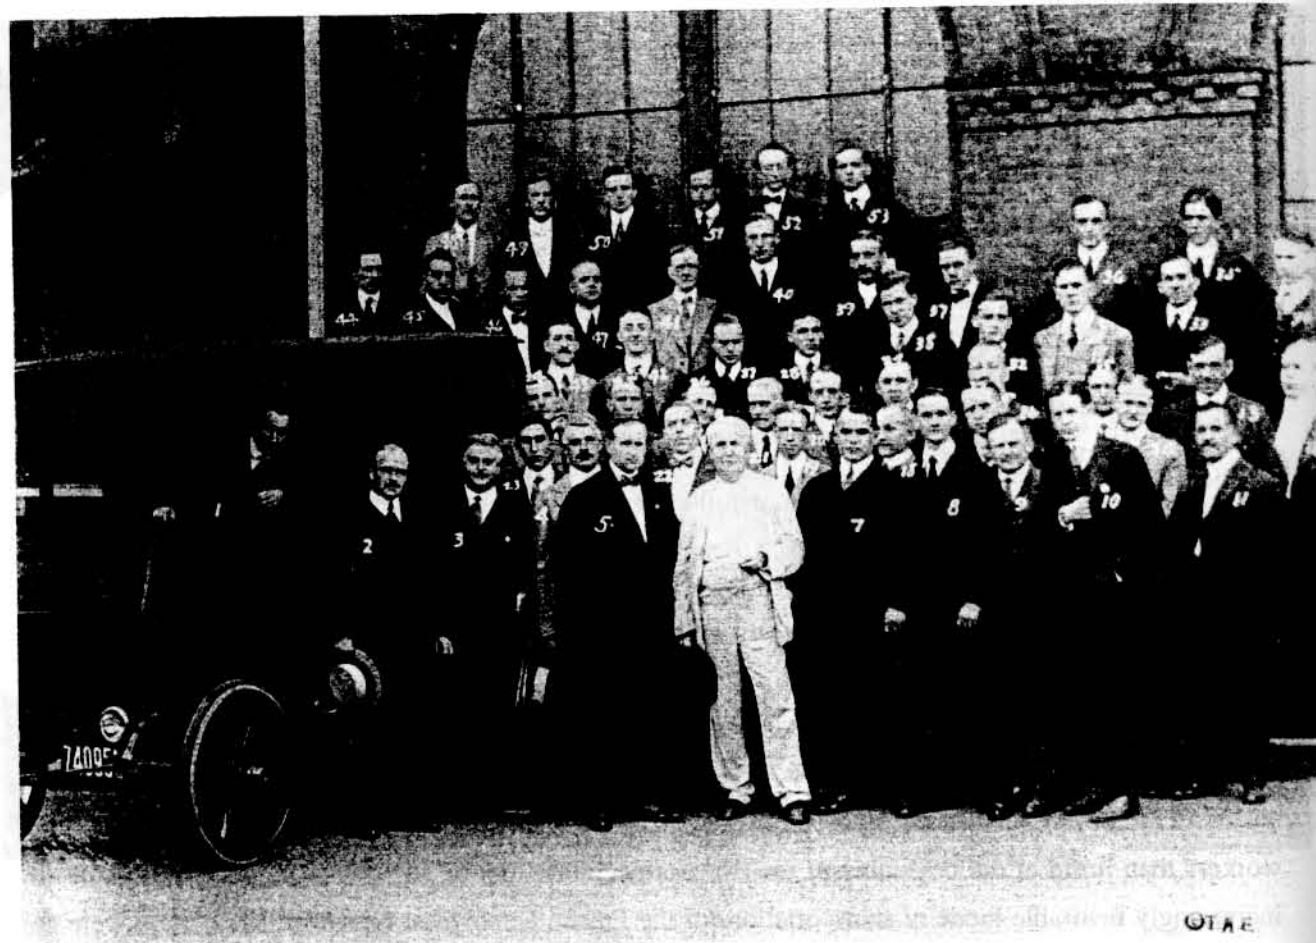
[C2] Figure 1.35. "Edison Battery Salesmen," the Main Laboratory (Building No. 5) in background. (1915) The surface of the courtyard during the Edison Laboratories second period had eroded to a hard, semi-permeable surface. [Source: Album #10, E.N.H.S. Archives]

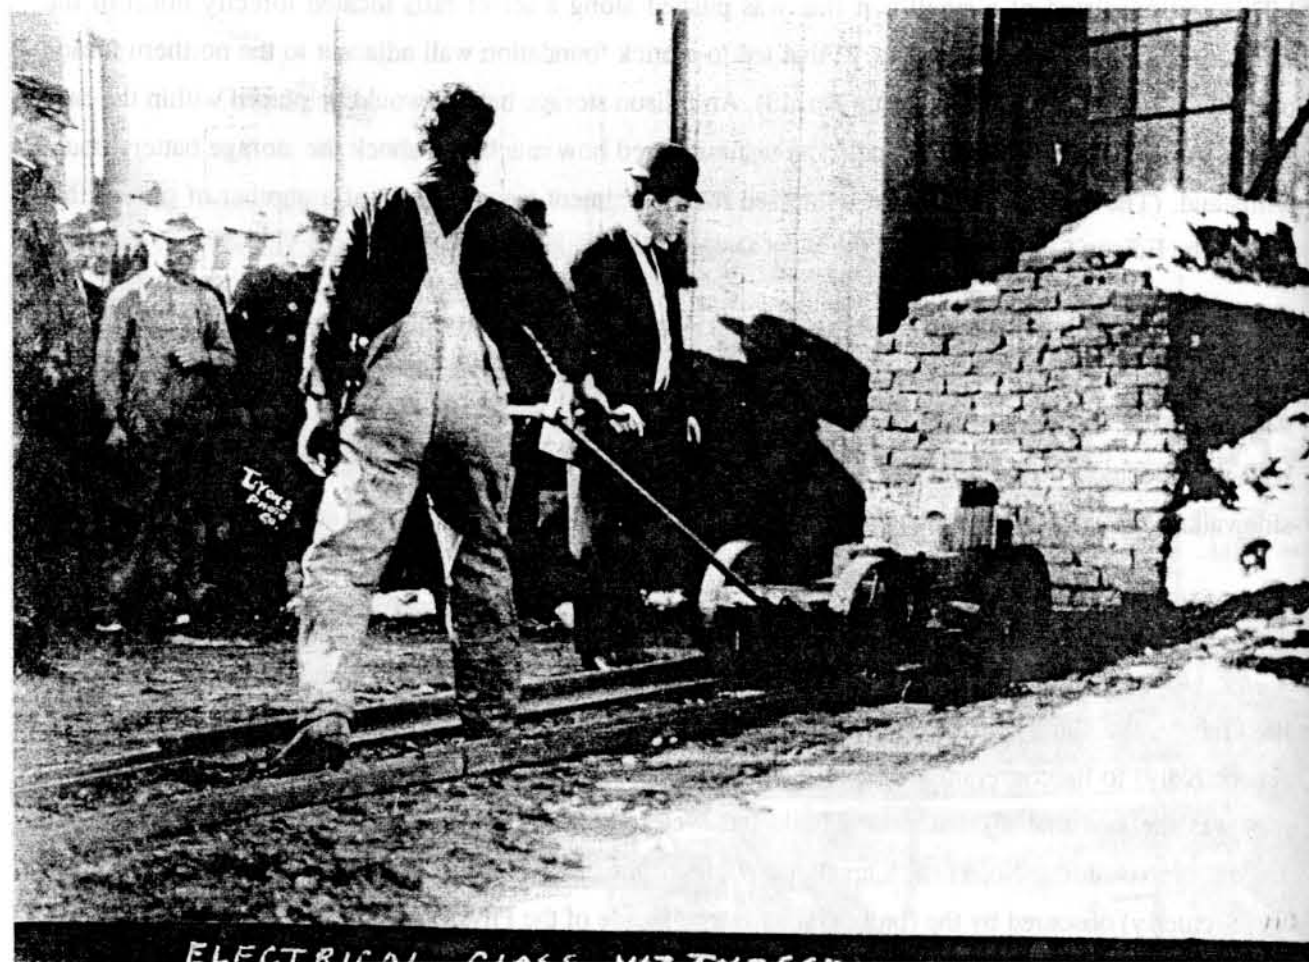
[B10] Figure 1.38. "Electrical Class Witnessing 'Bumping Test'." (1911) View Southwest toward the Experimental Studio (Building No. 13). [Source: Album #10, E.N.H.S. Archives]

Navy. After arriving by train, they were given a tour of the West Orange plant and witnessed several experiments. One of the experiments they witnessed was the "Bumping Test." (See photo [B10], page 96) This test consisted of a small cart that was pushed along a set of rails located directly north of the Chemical Laboratory (Building No. 2) that led to a brick foundation wall adjacent to the northern facade of the Experimental Studio (Building No. 13). An Edison storage battery would be placed within the cart, which would be pushed into the wall. The test measured how much of a shock the storage battery could withstand. (The electrical class that witnessed this experiment was only one of a number of groups that visited the Edison Laboratories and the West Orange plant)

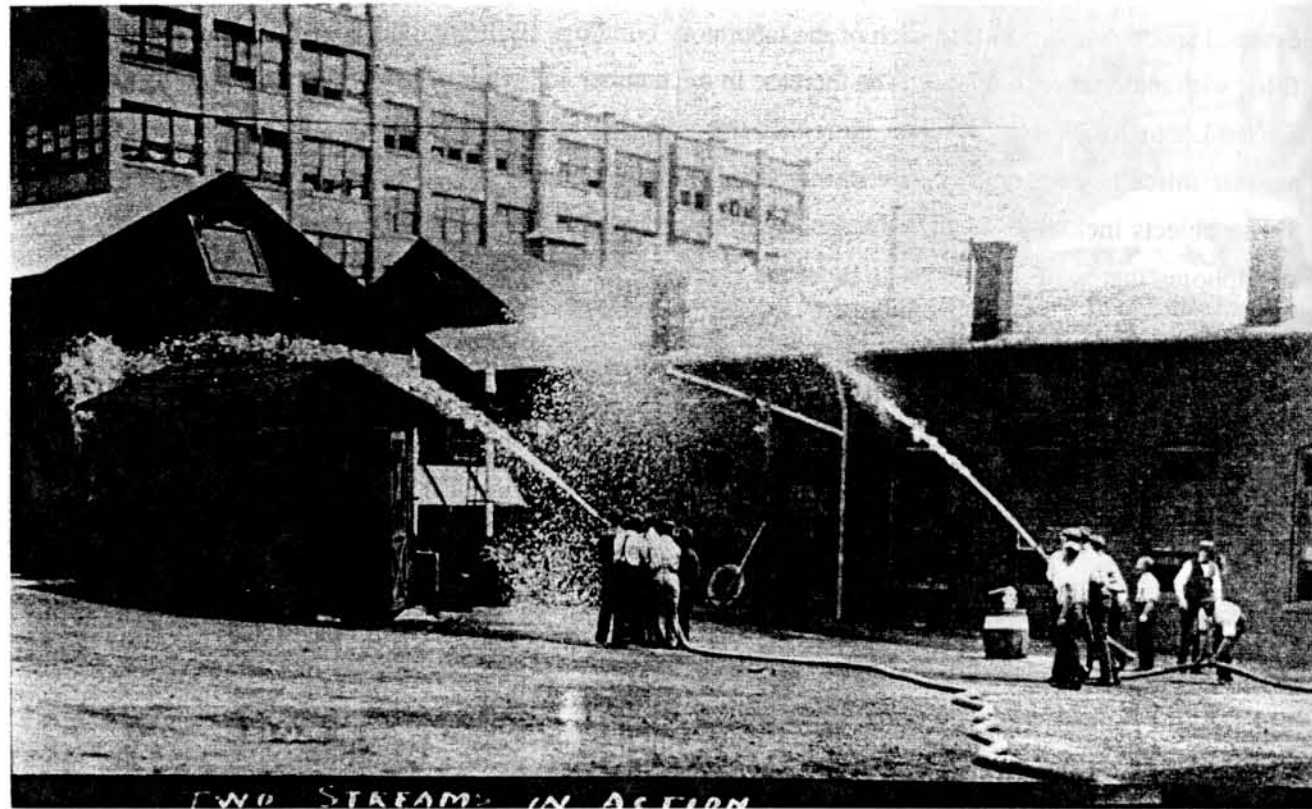
[B21] Figure 1.39. "Two Streams in Action," fire drill in 1913. View northeast from within the courtyard. The miscellaneous objects stored outside of the laboratory buildings was typical during the Edison Laboratories' second period of history. [Source: Album #10, E.N.H.S. Archives]

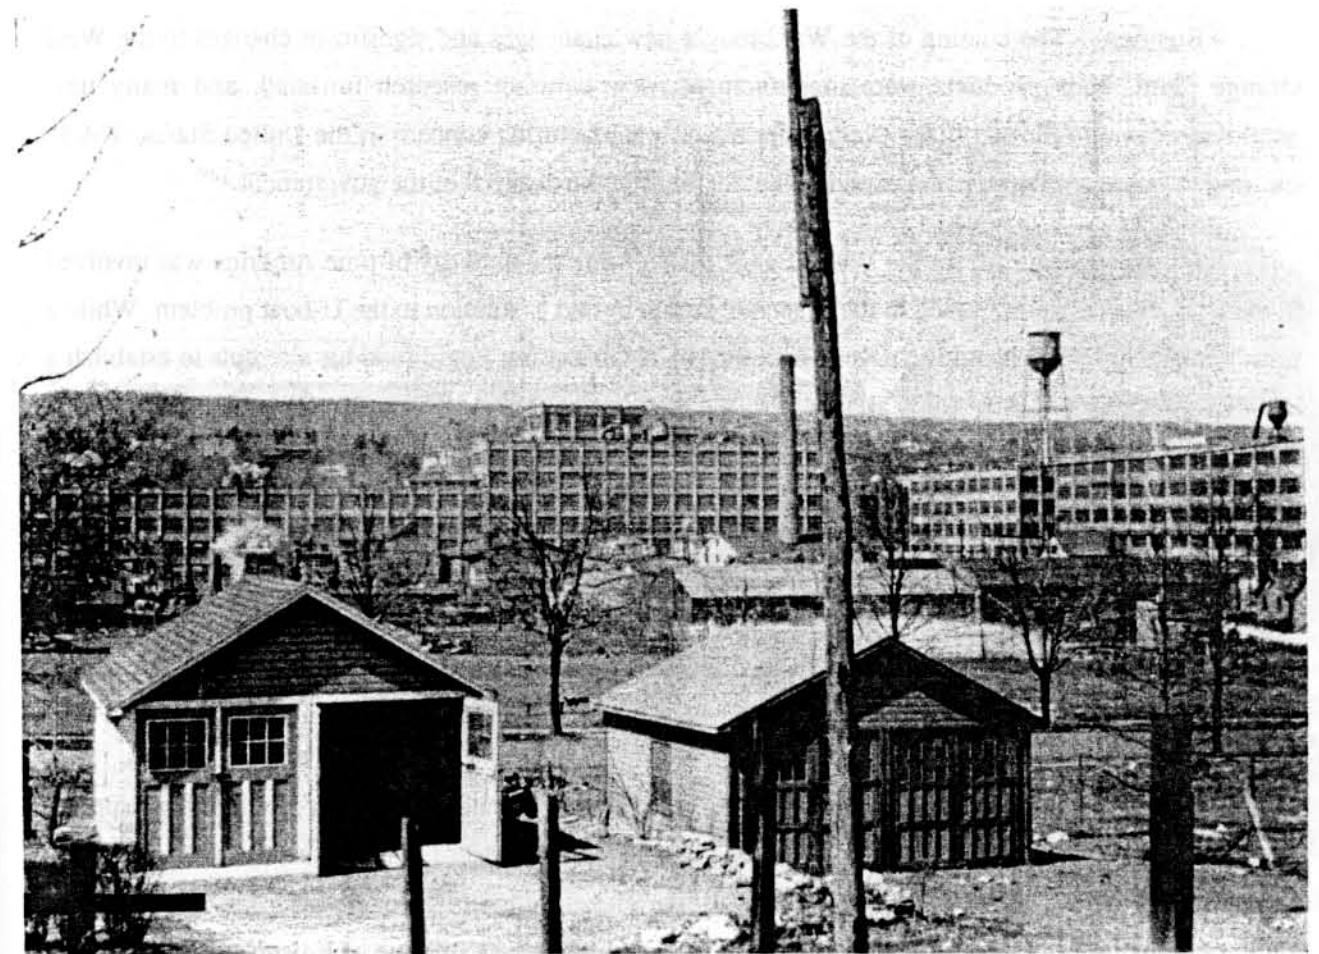
[C13] Figure 1.40. View northwest of West Orange plant from Watchung Avenue. (Ca. 1927)
 Notice the mist that rises from within the fenced yard located near the center of the photograph. [Source:
 Photo Album #16, E.N.H.S. Archives.]

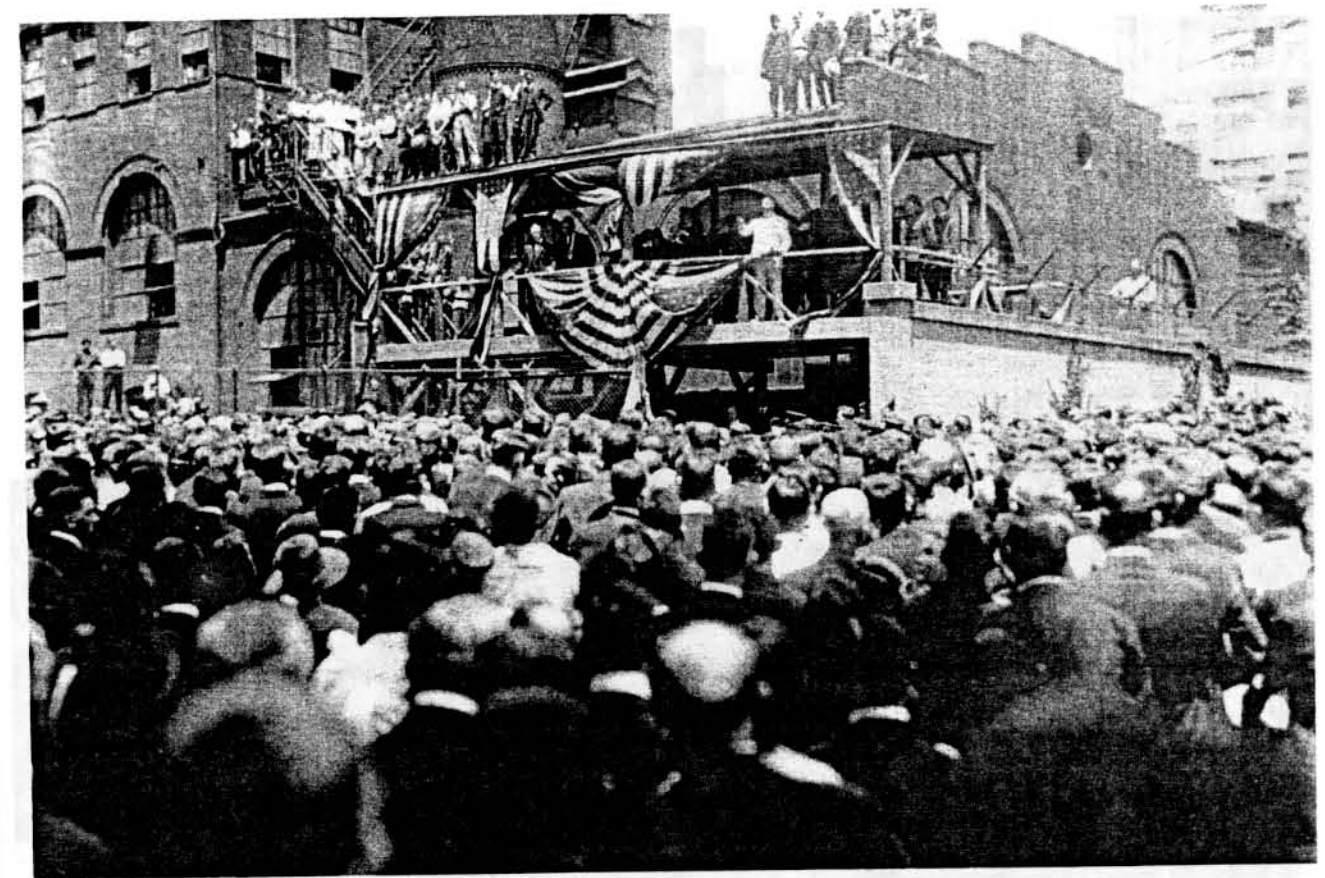
[C12] Figure 1.47. View north of the bandstand and Power House (Building No. 6) from Lakeside Avenue. (1918) Notice the ivy that partially covers the concrete wall on the right of the photo. [Source: Album #15, E.N.H.S. Archives]

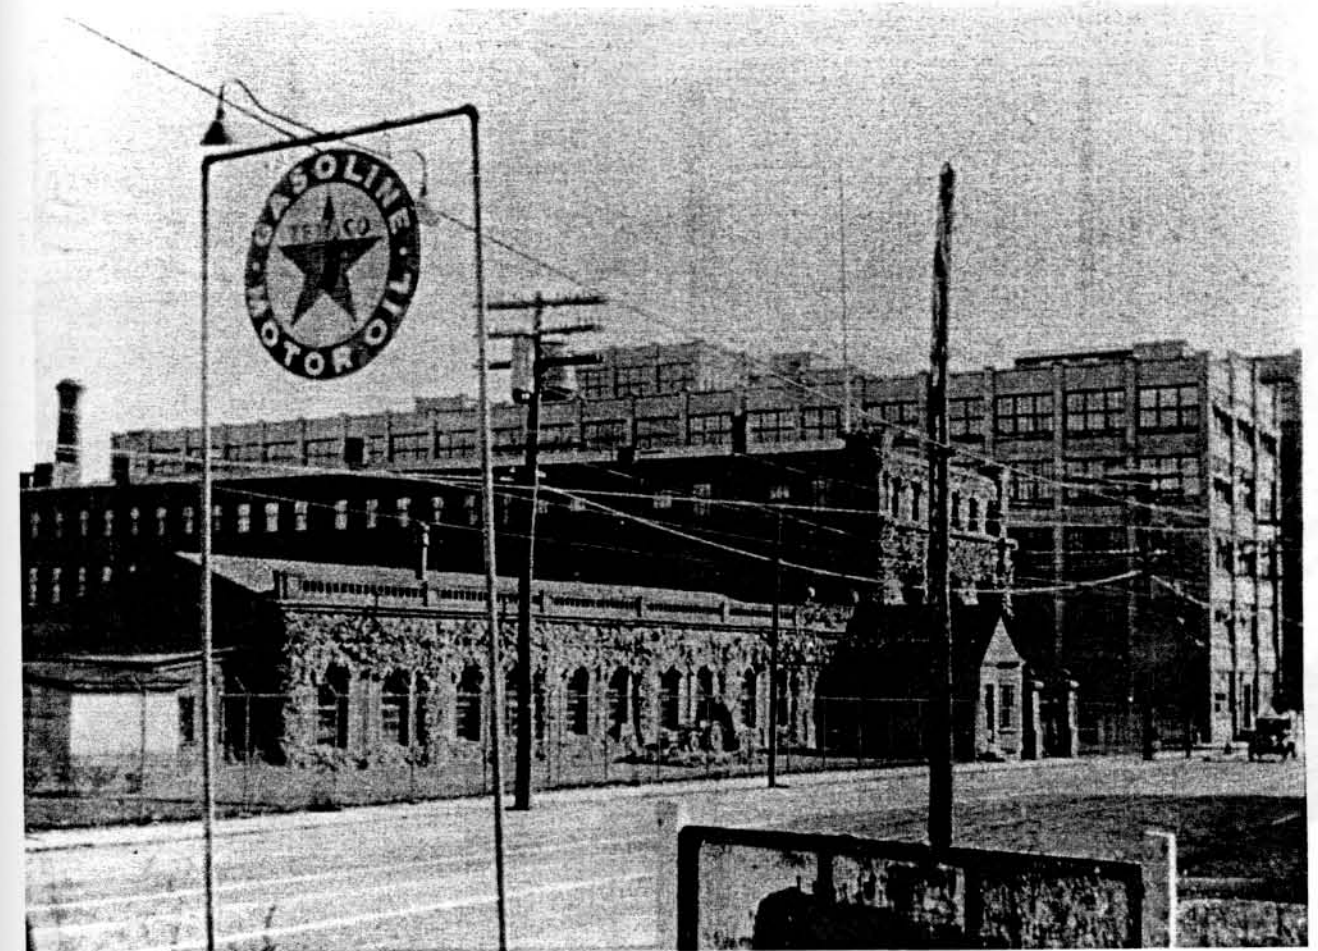
[C18] Figure 1.49. View southeast of the Edison Laboratories from across Valley Road. (Ca. 1927) Notice the small plantings that surround the railroad truck located near the bottom-center of the photo. [Source: Album #16, E.N.H.S. Archives]

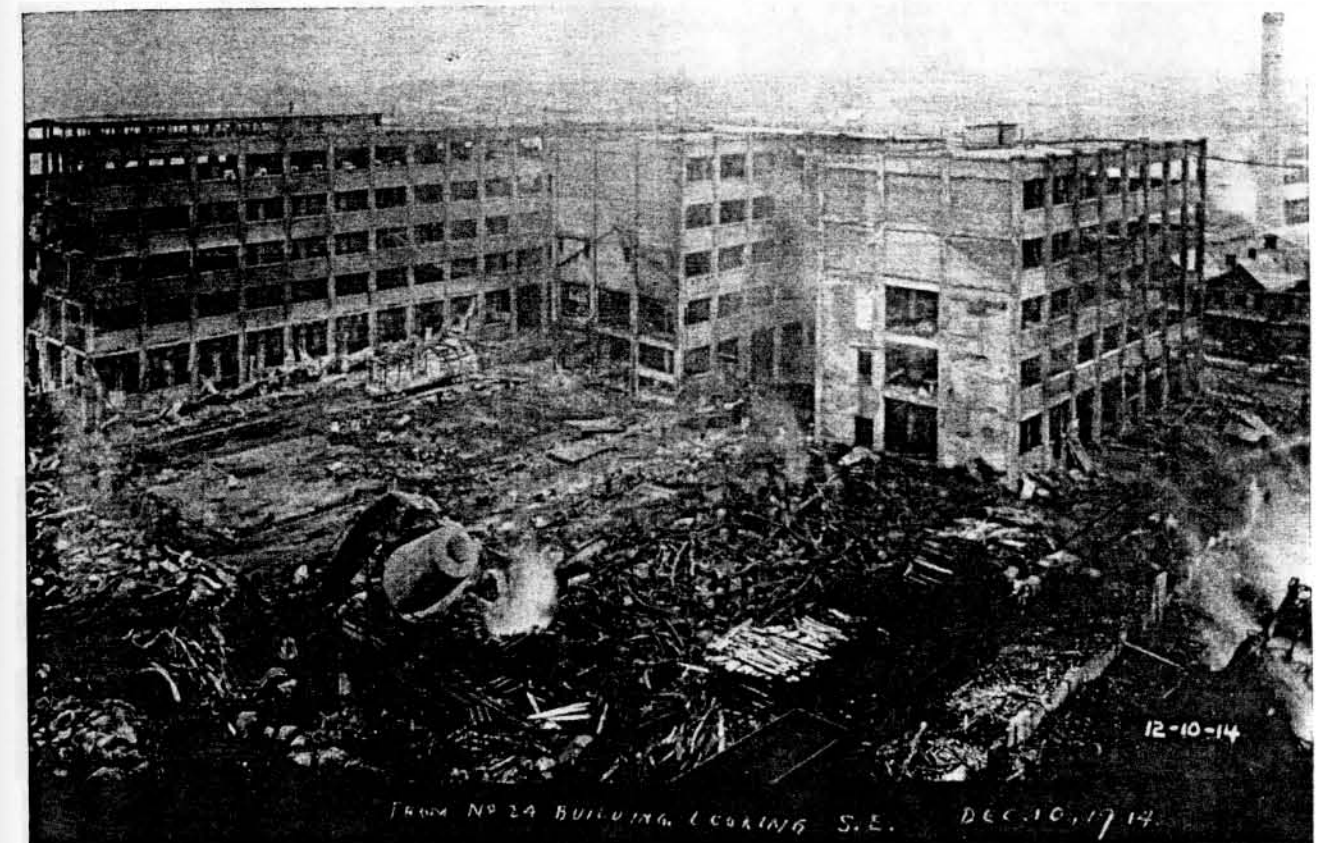
[B32] Figure 1.52. "From No. 24 Building Looking S.E., Dec. 10, 1914." Notice that the major damage the concrete buildings suffered was the destruction of their (wood) window frames, which allowed the fire to spread and destroy their interiors. [Source: Album #10 E.N.H.S. Archives]

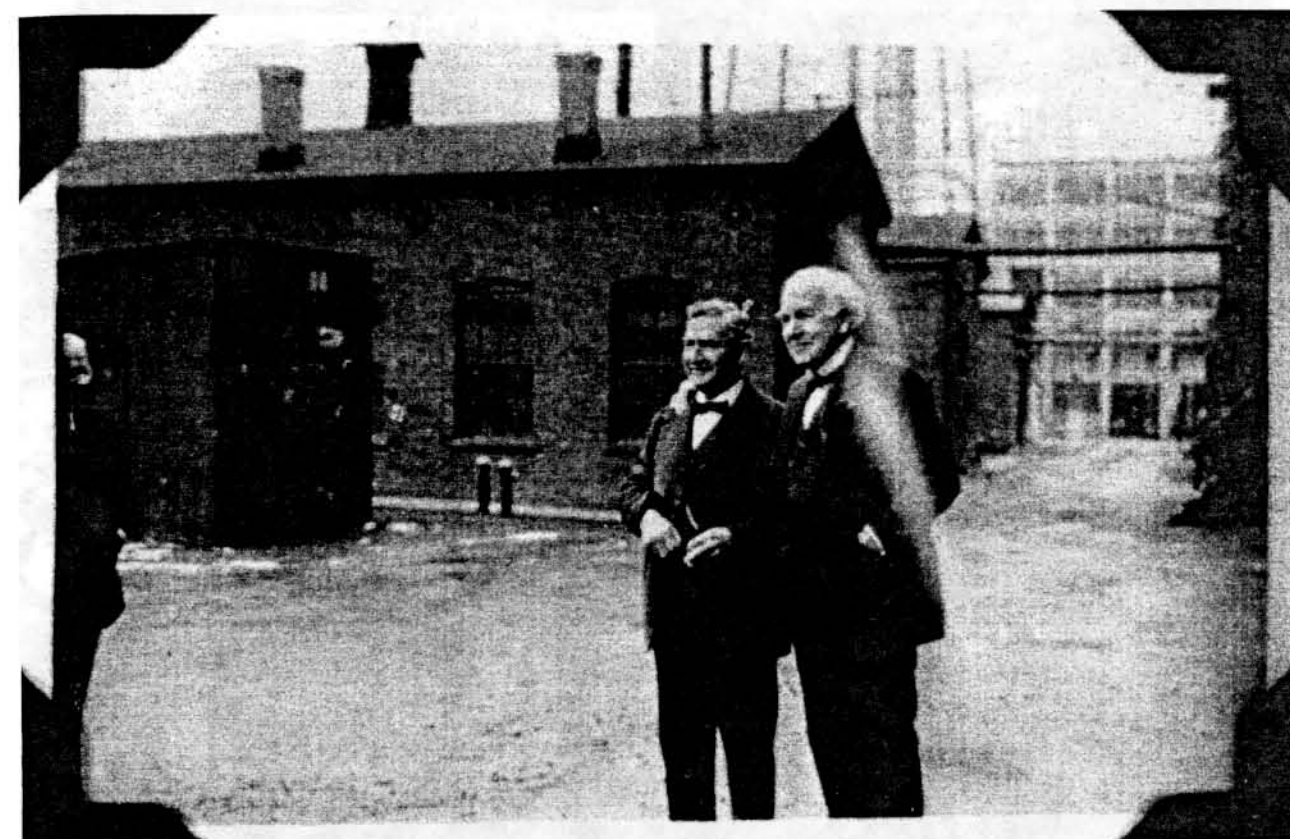
[C14] Figure 1.58. "Edison on his 80th Birthday." (1927) View east of the Chemical Laboratory (Building No. 2). Notice that the Experimental Record Shed (Building No. 14) is a darker color in this photo. [Source: Album #16, E.N.H.S. Archives]

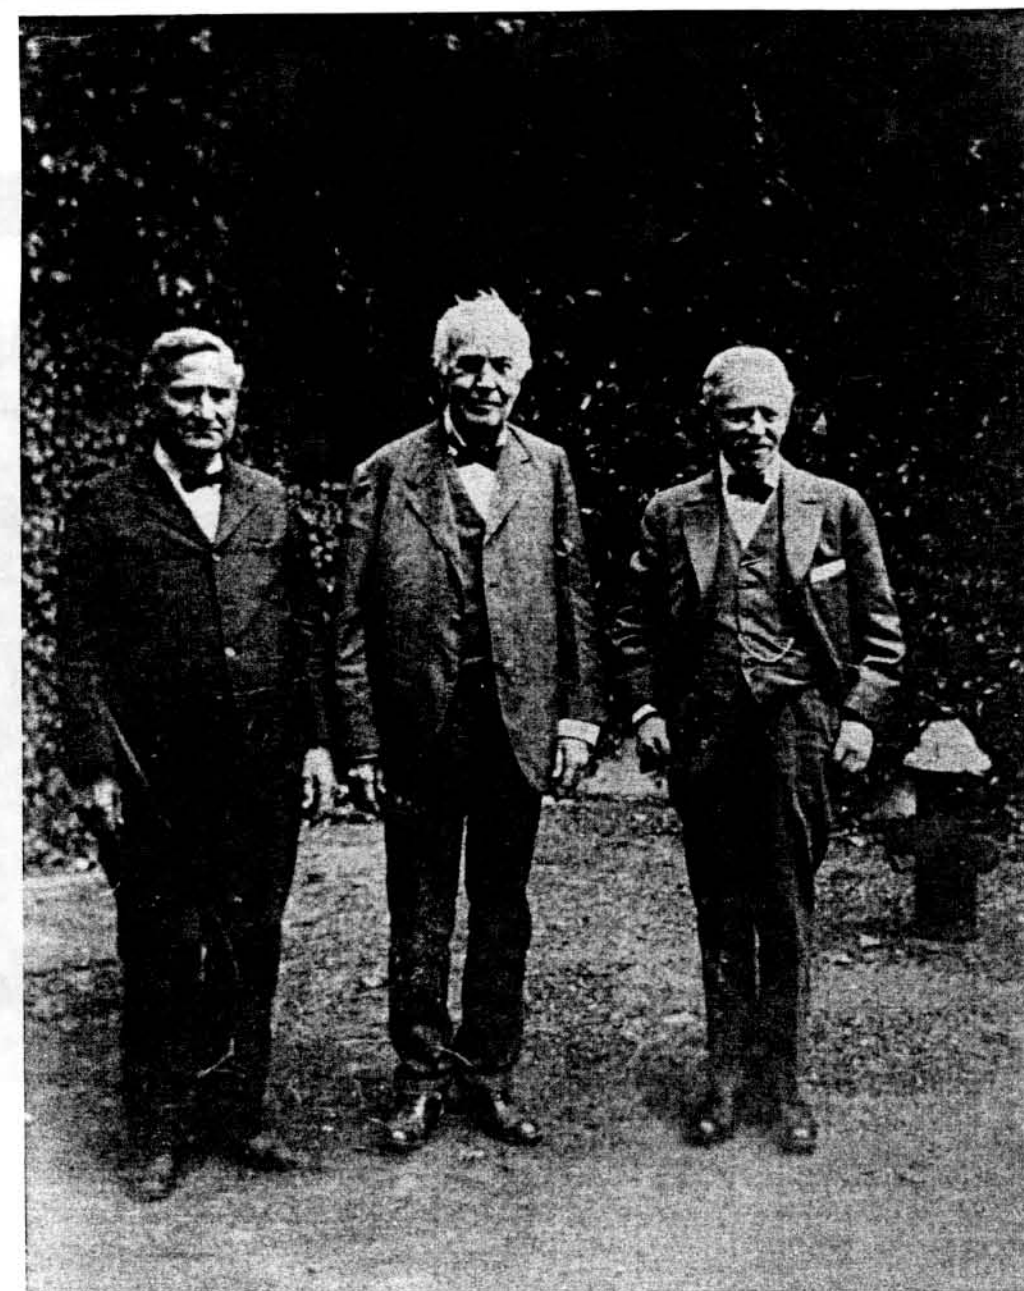
[C15] Figure 1.64. "Ott, Edison & Meadowcroft." (1930) View north of the Physics Laboratory (Building No. 1) and the Small Storage Vault (Building No. 8) from within the Courtyard. The fire hydrant located in the background was previous located at the Small Storage Vault's northeast corner. [Source: Album #16, E.N.H.S. Archives]

By 1927, the Edison Laboratories' water supply system was further modified. In 1926, a 75,000 gallon water tower was erected east of the Metallurgical Building (Building No. 4). The water tower was 132' in elevation and was built for emergency use.¹⁷⁸ In addition, several above ground water valves were installed by 1927. Two of these valves were located within the Edison Laboratories' courtyard, at the southwest corner of the Chemical Laboratory. (See photo [C14], page 142) The valves provided the Edison Laboratories site with emergency access to additional water.

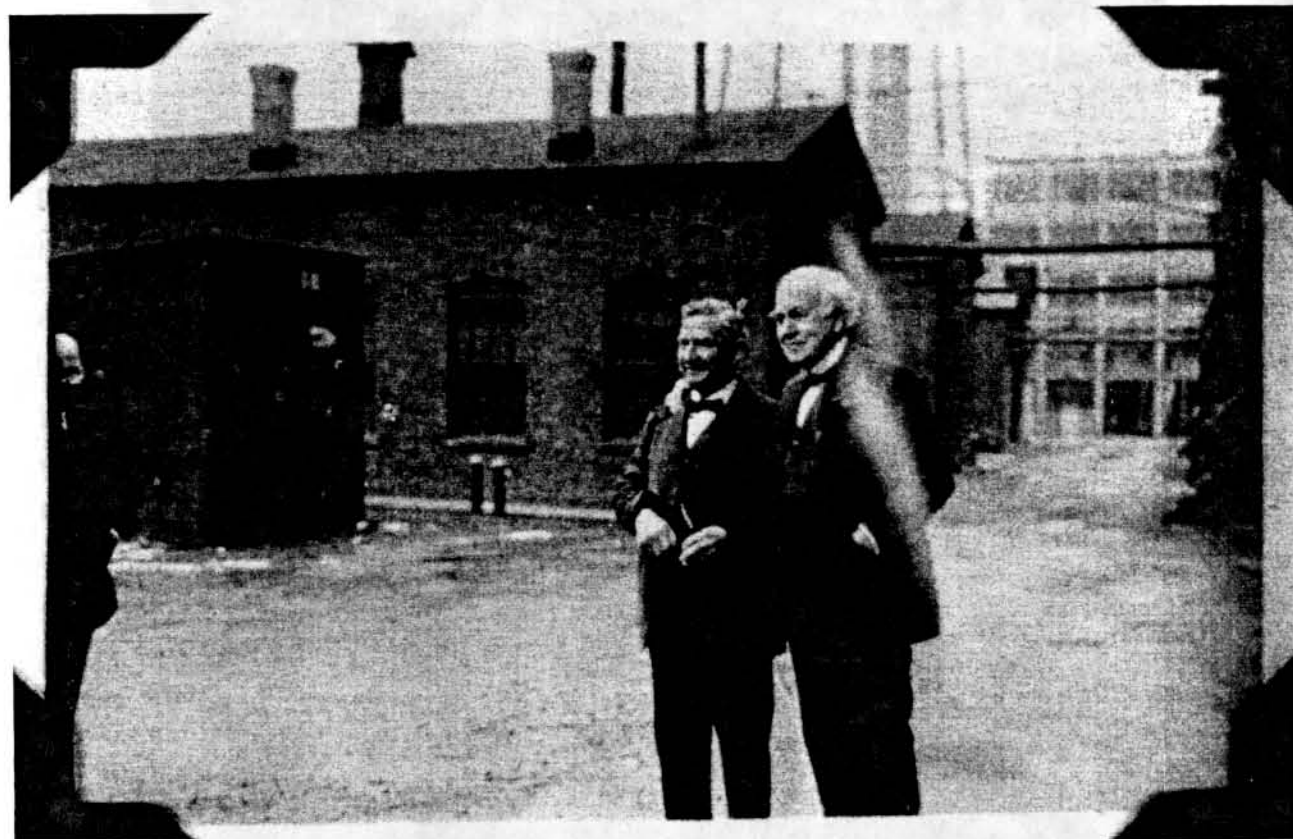
[C14] Figure 1.65. "Edison On His 80th Birthday." (1927) View east of the Chemical Laboratory (Building No. 1) from within the courtyard. The two objects standing under the Chemical Laboratory's window (Building No. 2) were above ground water valves. Notice the concrete foot drain that extends along the foundation of the Chemical Laboratory [Source: Album #16, E.N.H.S. Archives]

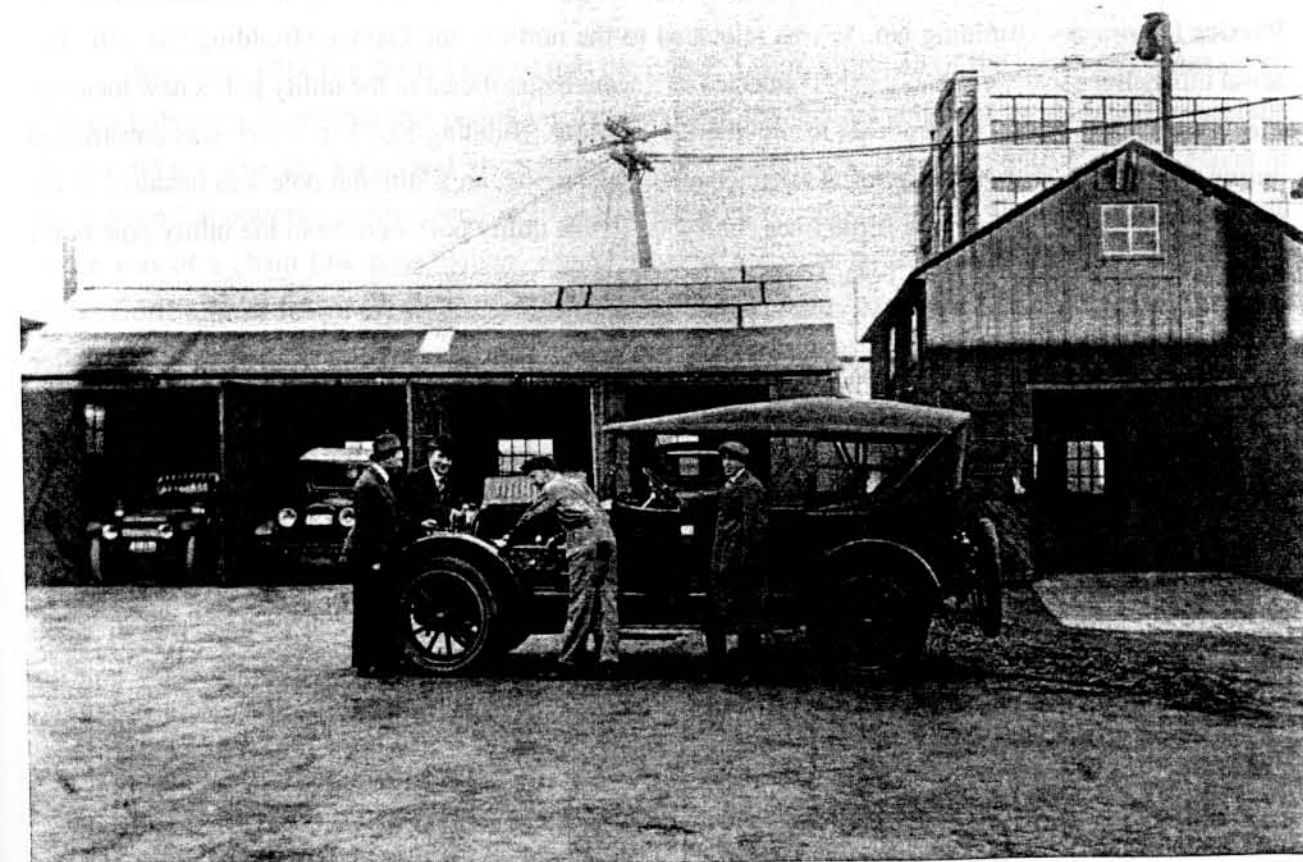
[C8] Figure 1.66. View north of the Garage (Building No. 10) and the Garage/Experimental Studio (Building No. 11) from within the courtyard. (1917) The utility pole located in the background was previously located at the northeast corner of the Physics Laboratory (Building No. 1). [Source: Album #42, E.N.H.S. Archives]
