**CULTURAL LANDSCAPE REPORT
FOR
THE EDISON NATIONAL HISTORIC SITE:
Laboratory Unit**

A project submitted in partial fulfillment of the requirements for
the
Master of Landscape Architecture Degree

Laboratory Unit

Prepared for the U.S. Department of Interior
National Park Service, N.A.R.O.
Cooperative Agreement: CA1600-1-9013, 1991-1992\

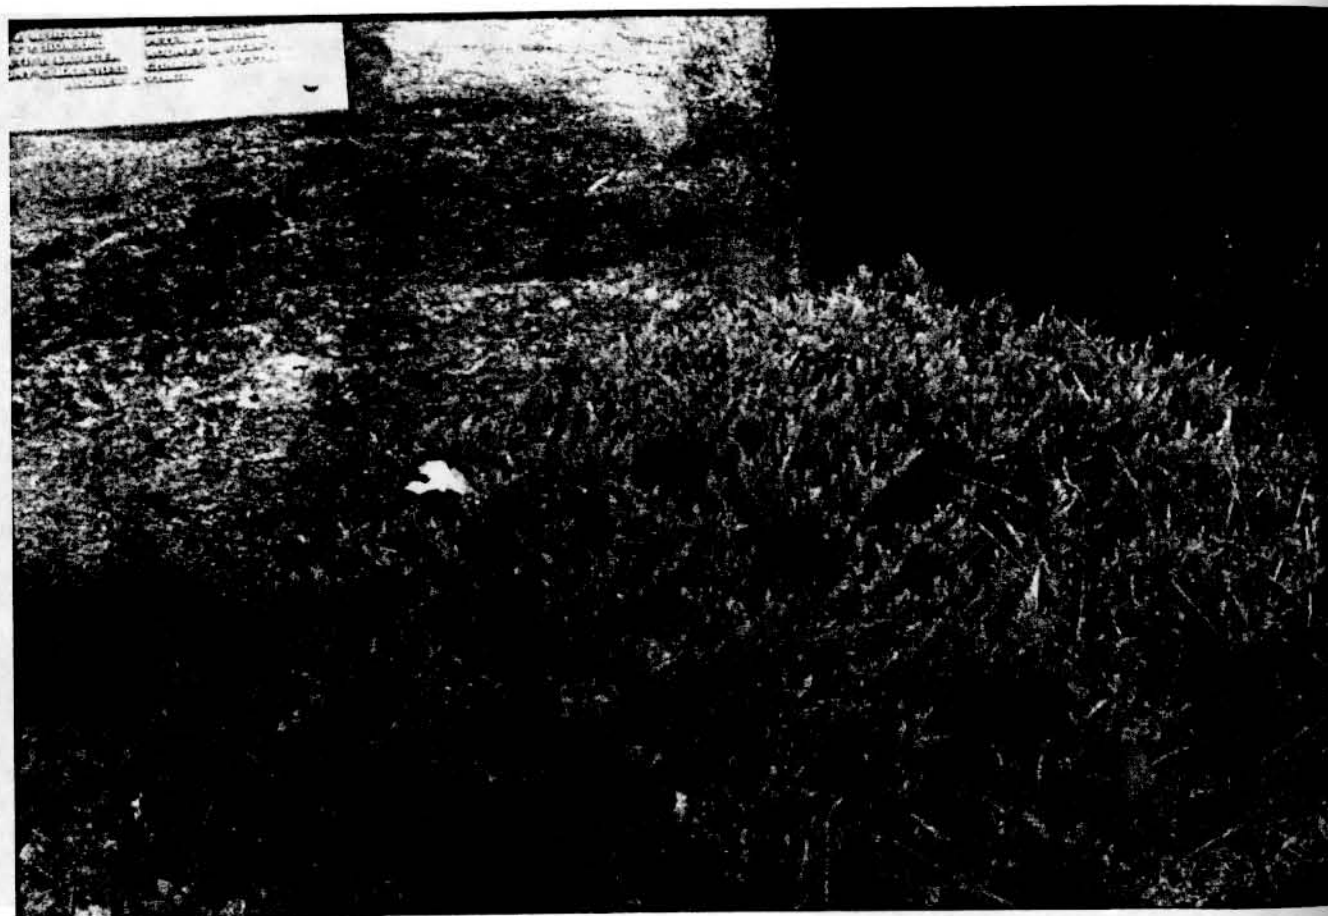
Figure 3.33. [Source: Photo taken by author, Nov. 1991]

The majority of the vegetation that is present at the Edison Laboratories today consists of plantings that were introduced after the period of significance. This vegetation includes: the yews and the underlying groundcover south of the Power House (See Figure 3.20); the foundation plantings along the southern foundation of the underground vault and the eastern and western edges of the ramps that lead down to the underground vault (See Figures 3.24-3.26); the row of privets that run parallel to the northern foundation of the underground vault (See Figure 3.27); the row of arborvitae north of Bldg. No. 2-4 (See Figure 3.27); the spruce trees and cherry tree that exist along the western edge of the site (See Figures 3.28-3.29); the groundcover that surrounds each "railroad truck" monument (See Figure 3.30); the row of privets that exist along the southwestern edge of the entrance corridor to the E.N.H.S. (See Figure 3.31); the roses planted south of the Small Storage Vault (See Figure 3.32); and the yew hedge that surrounds the memorial at the northwestern corner of the Edison Laboratories site, including the juniper that is planted adjacent to the memorial (See Figures 3.33-3.34)

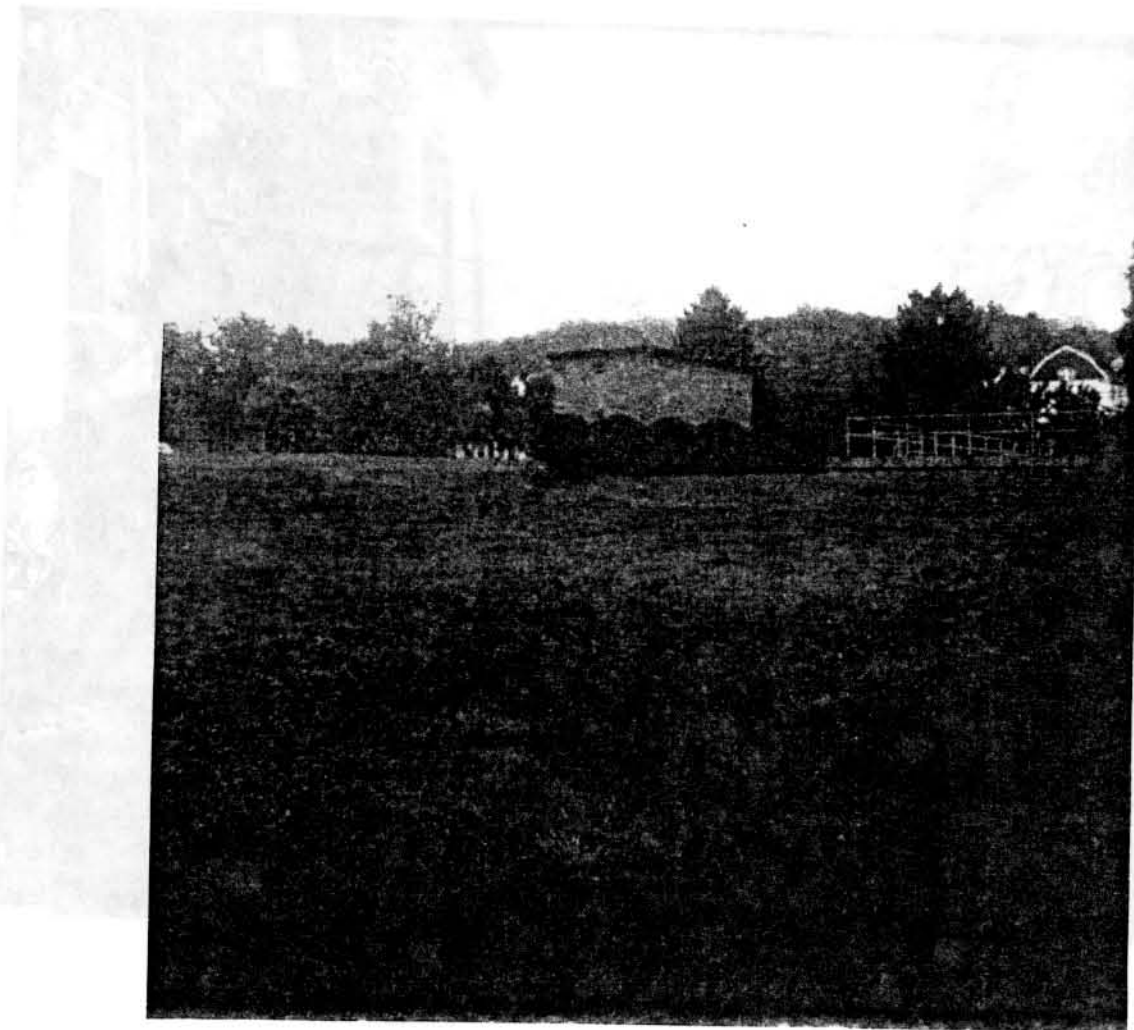
Figure 3.50. [Source: Photo taken by author, Nov. 1991]

The Garage/ Experimental Studio was moved in 1940 to Greenfield Village, Dearborn, Michigan, while the Garage was destroyed. Both were removed in order to provide room for the underground storage vault, that is still present. Although the location of the underground vault is further north than the historic locations of the Garage/ Experimental Studio and Garage, the ramps that lead down into the vault extend into the historic locations. (See Figures 3.3.49-3.50)
