CULTURAL LANDSCAPE REPORT FOR THE MANSION GROUNDS

MARSH-BILLINGS-ROCKEFELLER NATIONAL HISTORICAL PARK

VOLUME III: TREATMENT

MARSH-BILLINGS-ROCKEFELLER
NATIONAL HISTORICAL PARK
WOODSTOCK, VERMONT

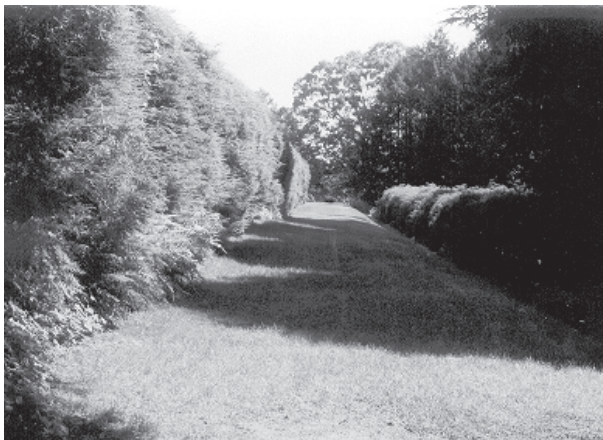
Figure 3: Historic view looking east through the Long Terrace space (SO-4) illustrating enclosed character defined by large perimeter hemlock hedges (V-49) during the late Rockefeller era, summer 1994. Olmsted Center for Landscape Preservation.

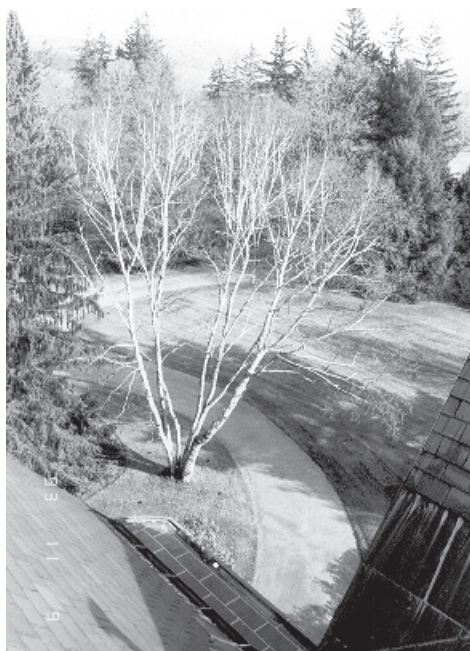
Figure 4: Historic view of the main entrance drive (C-1) looking northeast from the Mansion roof showing sharp lawn/road edge during the late Rockefeller era, November 1993. Olmsted Center for Landscape Preservation.

C-1: Main Entrance Drive: Maintain uniform appearance of drive across both inactive (between circle and Elm Street) and active (circle) sections, and maintain historic drive edge aligned with the outside edge of the catch basins (the edges were restored in 2002 by removing approximately one foot of encroached turf). Consider addition of inconspicuous steel edging (similar to that used on the Secondary Entrance Drive) in order to retain and mark the sharp edge between the lawn and graded roadbed that was characteristic of the Rockefeller era. [Figure 4]

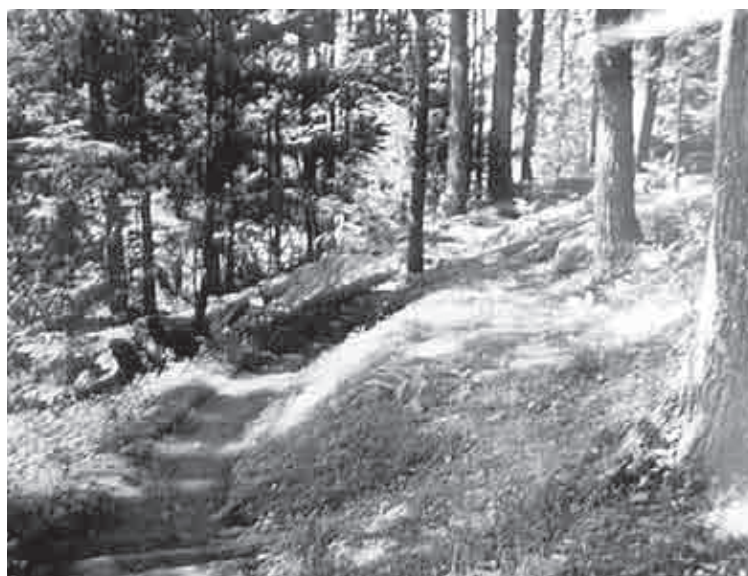
Figure 7: Historic view of the Waterfall Garden path (C-29), illustrating well-maintained condition and open understory in the Hillside Gardens characteristic of the Rockefeller era, c.1992. Courtesy of Mimi Bergstrom, Woodstock, Vermont.

Paths: C-27 *Lily Pond Path*, C-28 *Waterfall Garden Path*, C-29 *Lily Pond Waterfall Path*, C-30 *Upper Hillside Path*, C-31 *Arboretum Path*: Keep paths clear of encroaching vegetation and path surfaces clear of leaf litter and other debris. This will most likely require regularly scheduled clearing throughout the summer and fall (rather than just annual clearing). Where paths have a moss-covered surface or moss edges (primarily in the Waterfall Garden), pedestrian use should be restricted to avoid damage to the mosses. Repair deteriorated stone and log steps, and replace in-kind when deteriorated beyond repair. During the Rockefellers' tenure, the hill paths were well maintained with raked or swept surfaces and little encroaching vegetation [Figure 7].

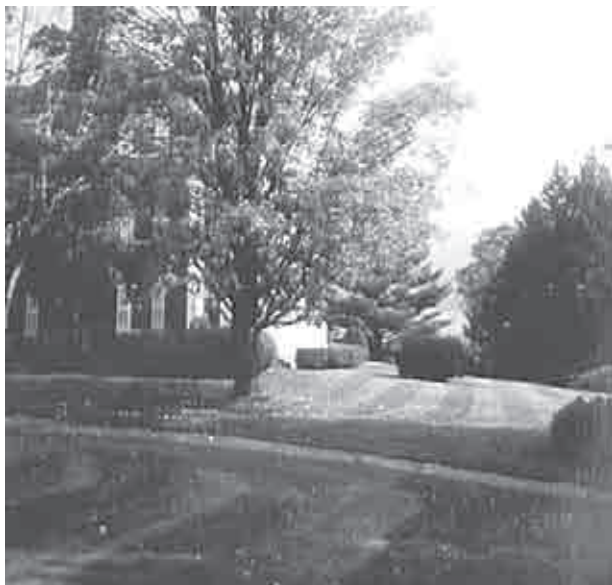
Figure 8: Historic view looking east across the Mansion lawn (V-1) illustrating class ‘A’ level of maintenance characteristic of the Rockefeller era, c.1992. Courtesy of Mimi Bergstrom, Woodstock, Vermont.

level of maintenance of the Mansion and swale lawns, in keeping with conditions during the Rockefeller era. [Figure 8] Maintenance should minimize the use of pesticides, in keeping with the park’s Integrated Pest Management (IPM) program. In summer 2002, the lawn was restored to its class “A” level of maintenance. If in the future class “A” cannot be maintained sustainably (without extensive use of ecologically damaging products and/or practices), a lower level of maintenance would be appropriate provided the historic height and coverage of the lawn is maintained. The lowering of the level of maintenance would be a reversible change, allowing for potential future restoration to “Class A,” but should be restricted, if possible, to less visible areas of lawn. These areas would include the outer (southern and eastern) portions

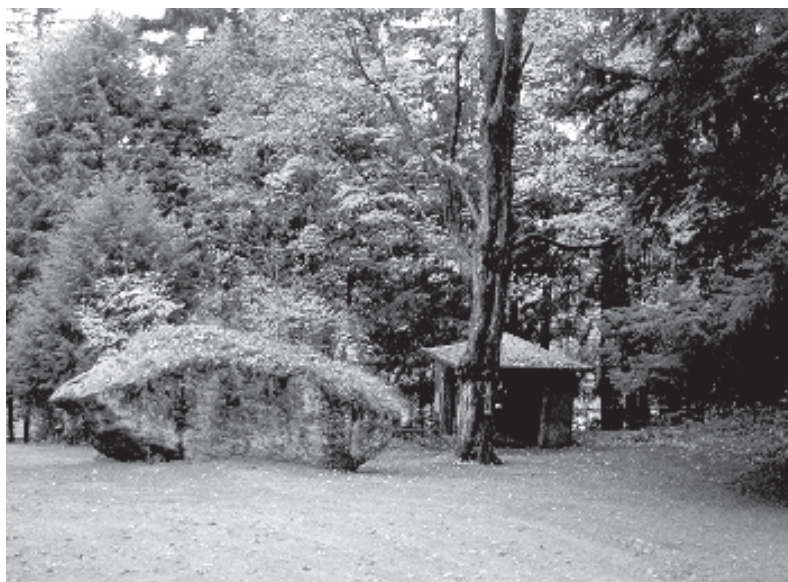
Figure 9: View south of the sugar maple in the Mansion lawn grove (V-3) adjoining the Mansion lawn boulder (NS-1), October 2000. The tree was removed in fall 2000. SUNY ESF.

V-3: Mansion Lawn Grove: Plant a sugar maple (*Acer saccharum*) off the southwest corner of the Mansion lawn boulder, with exact location to be determined through examination of remains from the historic tree. [Figure 9] This sugar maple was removed in fall 2000. A mature red oak in this grove was recommended for removal at the same time, but remains standing. Preservation of this tree is the preferred treatment, given that it does not pose a significant threat to surrounding buildings

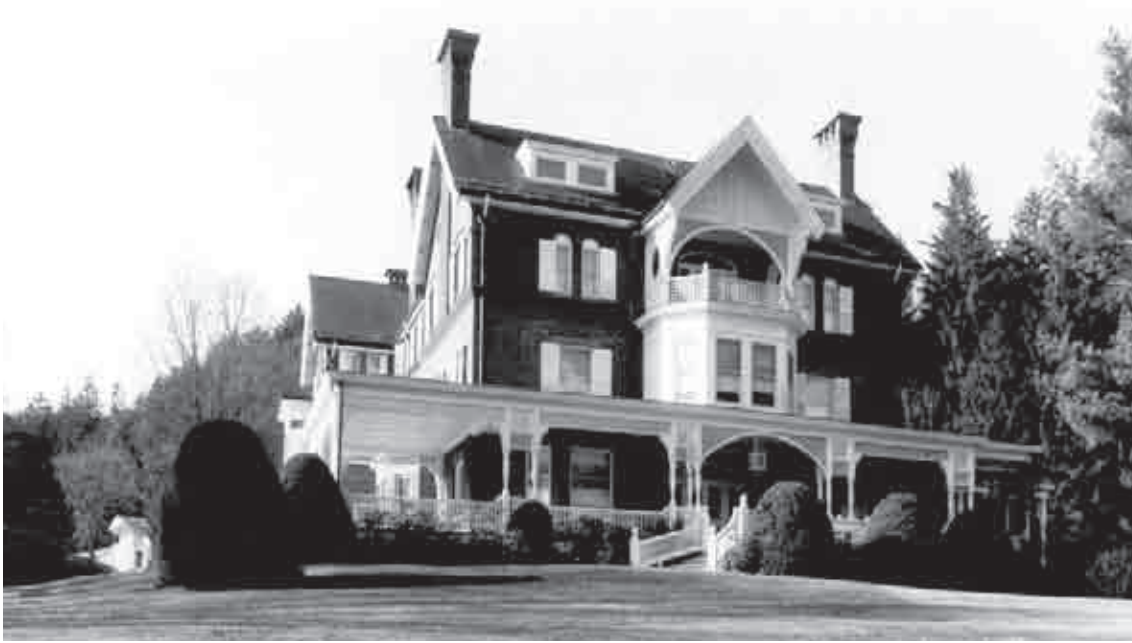
Figure 13: Historic view of the foundation shrubs (V-25) and lawn yews (V-26) along the east front of the Mansion during the late Rockefeller era, November 1993. Olmsted Center for Landscape Preservation.

V-25: *Mansion Foundation Shrubs*: Maintain manicured appearance and existing size and shape of clipped and natural-form deciduous and evergreen shrubs, allowing recent replacement plant material to reach a size no greater than that present during the 1992-1997 period. [Figures 12, 13, and 14] In general, keep shrubs below the height of the verandah railing (east/south

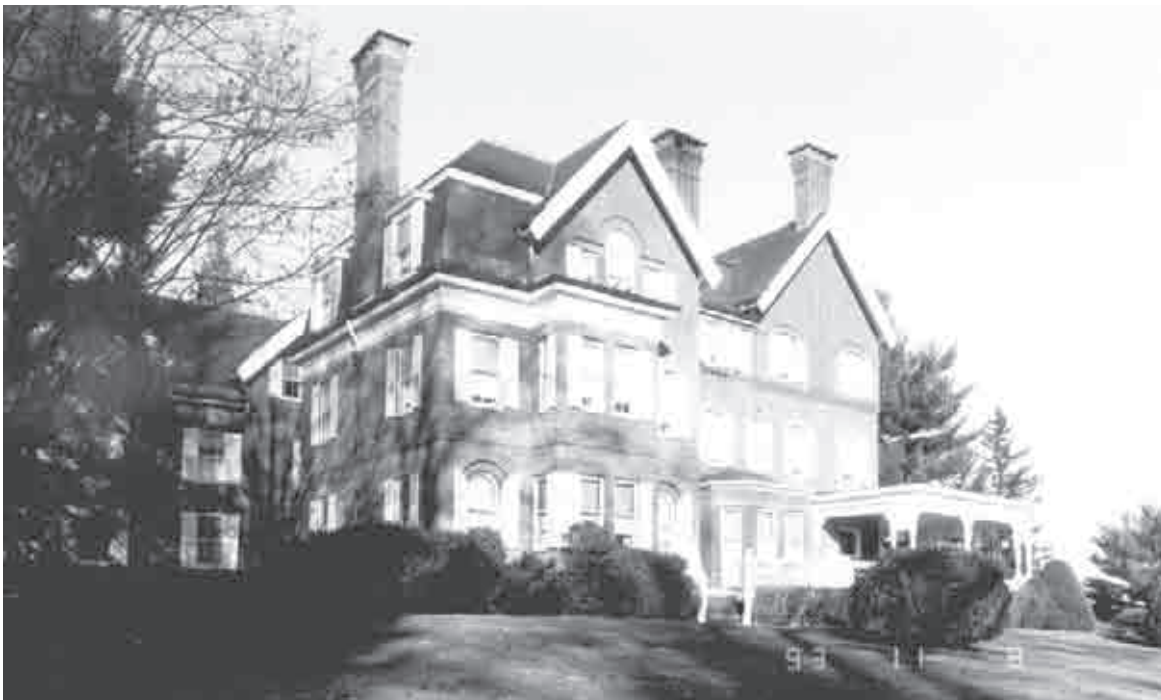
Figure 14: Historic view of the foundation shrubs (V-25) and lawn yews (V-26) along the south and west sides of the Mansion during the late Rockefeller era, November 1993. Olmsted Center for Landscape Preservation.

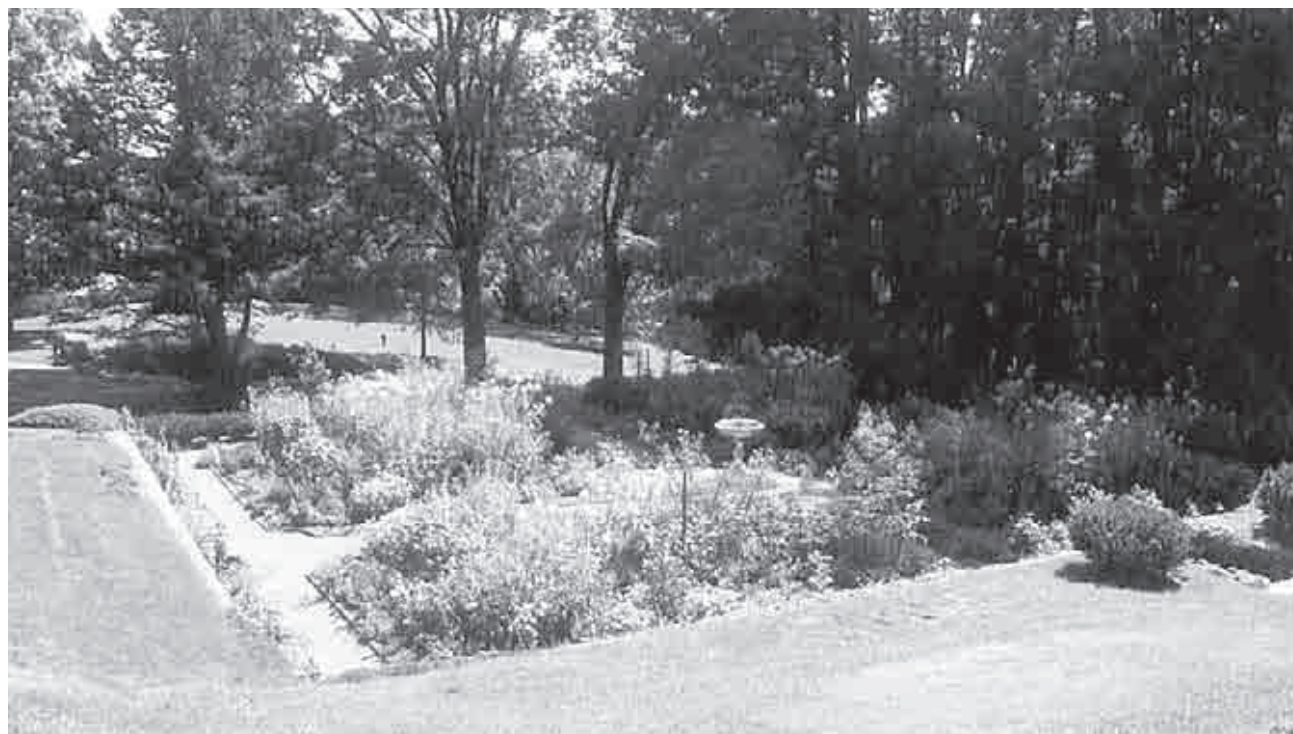
Figure 16: Historic view of the Flower Garden (V-55) looking southeast during the late Rockefeller era, summer 1994. Note shade from hemlocks along south (right) side of garden. Olmsted Center for Landscape Preservation.

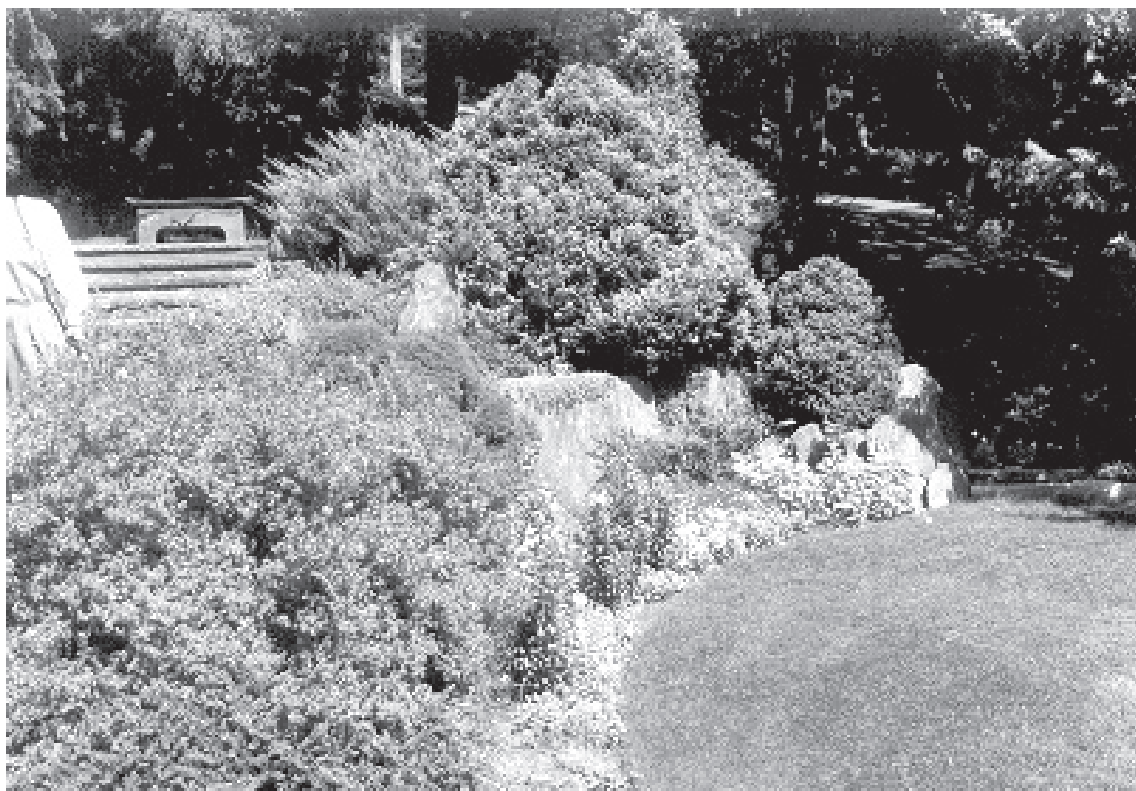
Figure 21: Historic view of the rock garden (V-58) along the upper pool terrace steps during the late Rockefeller era, summer 1994. Olmsted Center for Landscape Preservation.

V-58, V-61, V-62: *Rock Gardens*: Develop planting plans for all rock gardens. Retain existing configuration of beds, rock placement, woody plant material, and alpine character. [Figure 17] Maintain existing size of woody plant material. Replace herbaceous plants in-kind as necessary. Typical herbaceous plant material used during the late Rockefeller era included: *Aruncus*, *Astilbe*, *Asarum*, *Campanula*, *Epimedium*, *Iris*, *Phlox*,

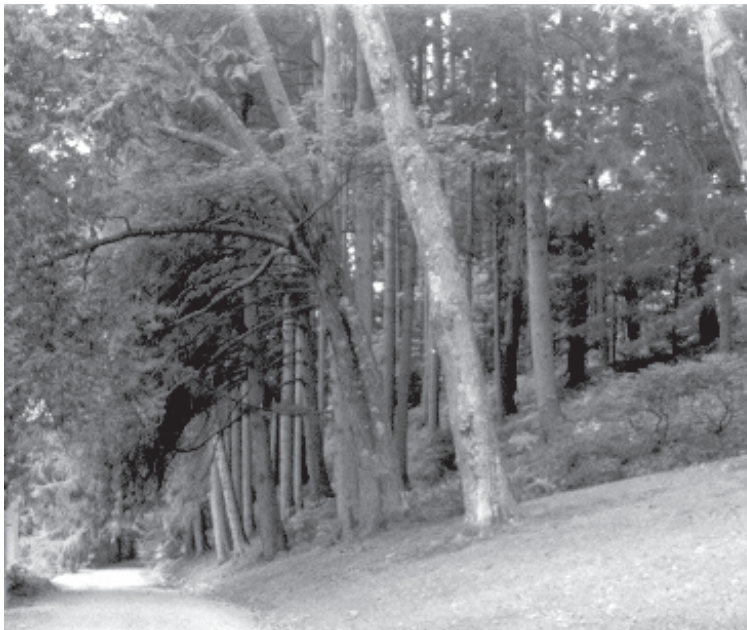
Figure 18: Historic view looking west from the Belvedere drive through the c.1874 Norway spruce plantation (V-68) showing open understory characteristic of the late Rockefeller era, November 1993. Olmsted Center for Landscape Preservation.

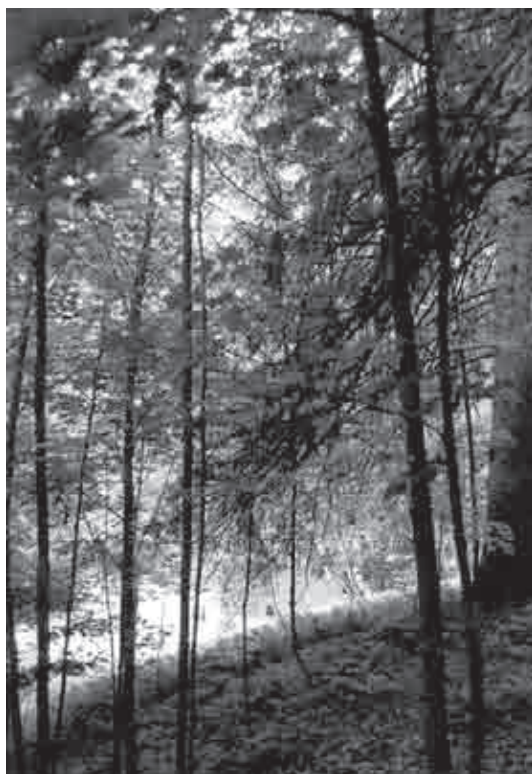
Figure 19: View southeast through the plantation on the east hillside below the Lily Pond illustrating heavy successional hardwoods growth and death of lower limbs on historic Norway spruces due to shading, September 2002. SUNY ESF.

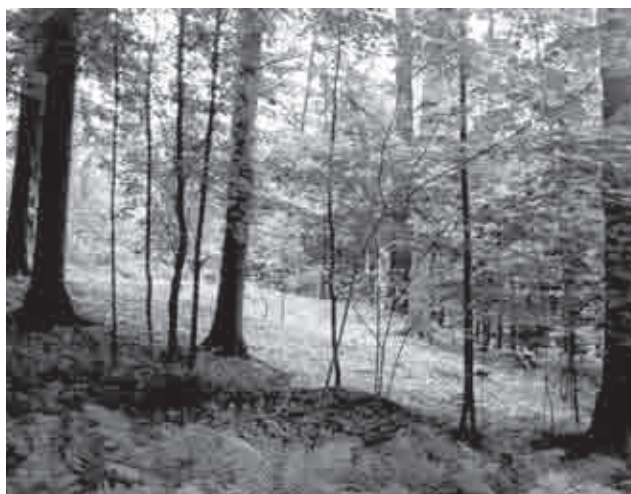
Figure 20: Naturalized plantation on hillside east of Bungalow where historic white pines have been removed, leaving sufficient space for replacement planting, September 2002. Note successional hardwoods that have grown up along the edges of the open space. SUNY ESF.

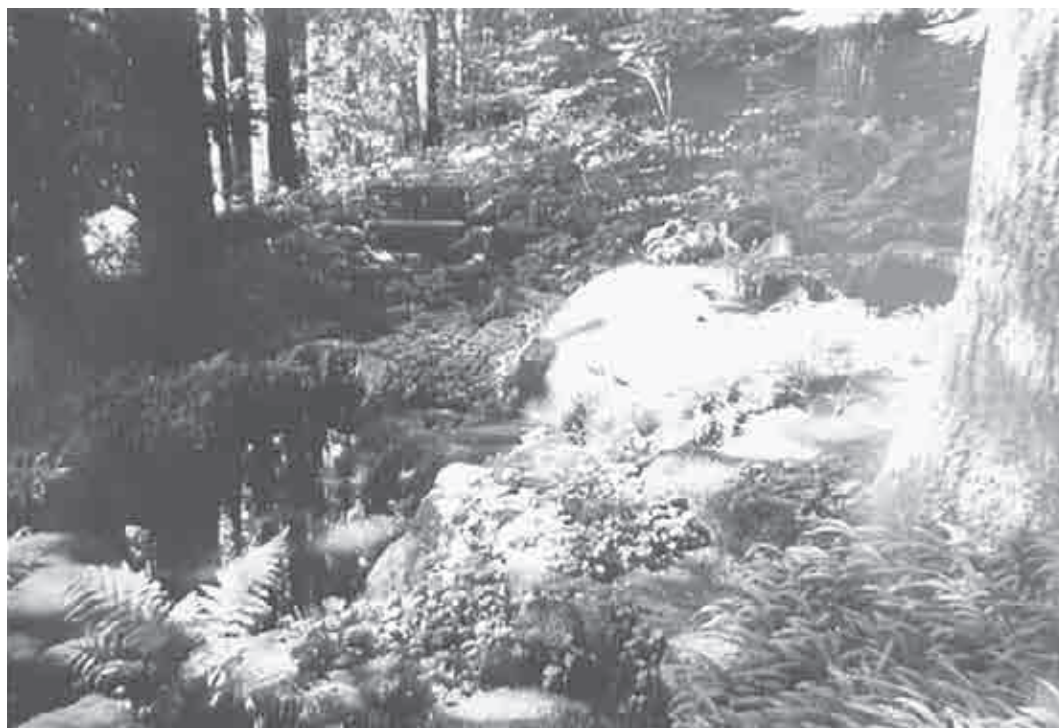
Figure 22: Historic view looking west across the upper part of Waterfall Garden showing historic character of woodland plantings (V-78) and sunlight-dappled conditions during the late Rockefeller era, c.1992. Courtesy of Mimi Bergstrom, Woodstock, Vermont.

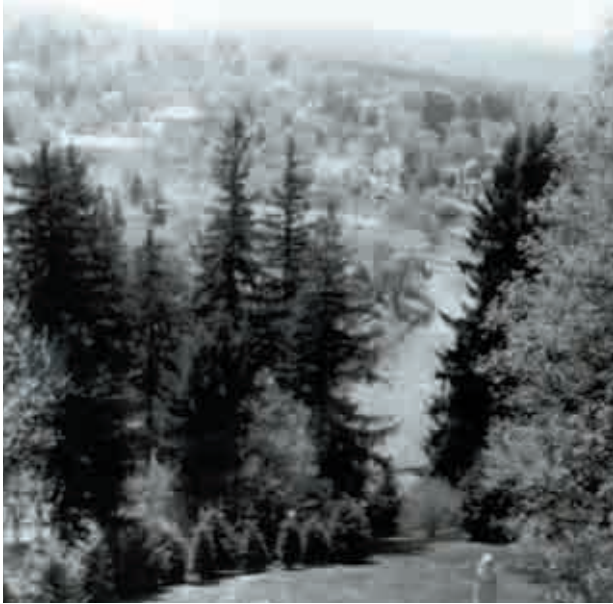
Figure 23: The Ottauquechee River vista (VV-2) showing historic condition with view of river through the perimeter plantations, view south from Mansion, May 1977. Billings Family Archives.

visible from the second and third floor rooms (including the Rockefellers' bedroom) on the south side of the Mansion. Maintain sufficient height on the vegetation within the vista clearing to screen the view of River Street from the Mansion. The vista clearing was maintained during the Rockefeller era as a narrow opening in the perimeter plantation, with hemlocks and other shrubs used to screen River Street. This vista became more enclosed in later years, but the river probably remained visible. [Figure 23]

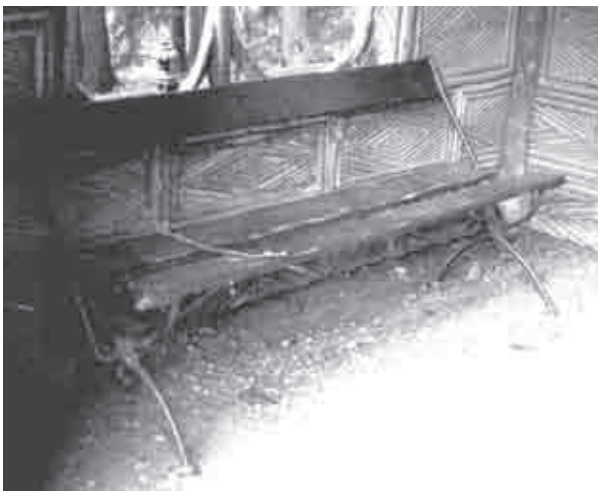
Figure 25: A historic lawn seat in the Upper Summerhouse, a model for the general lines of new benches that would be compatible with the historic character of the landscape, 2001. This particular seat has an unusual movable back. SUNY ESF.

The historic lawn seat in the Upper Summerhouse provides a good model for a compatible design (the Rockefellers set out several benches similar in overall form and detail to this example, which probably dates from the late nineteenth or early twentieth century). [Figure 25] Designs similar to this, with simple rod frames and painted wood-slat seats and backs, would be most appropriate when sited adjacent to plantings or buildings (such as the Carriage Barn) and not as isolated features. Where benches must be placed in an open area, such as in the lawn along the Mansion-Flower Garden walk, the backs should be omitted in order to make the benches less conspicuous.
