REHABILITATION TREATMENT PLAN *for the* MATILDA JOSLYN GAGE PROPERTY

REHABILITATION TREATMENT PLAN
FOR THE MATILDA JOSLYN GAGE PROPERTY
IN FAYETTEVILLE, NEW YORK

A capstone studio
Submitted in partial fulfillment
Of the requirements for the
Master of Landscape Architecture Degree
State University of New York
College of Environmental Science and Forestry
Syracuse, New York
May 2004

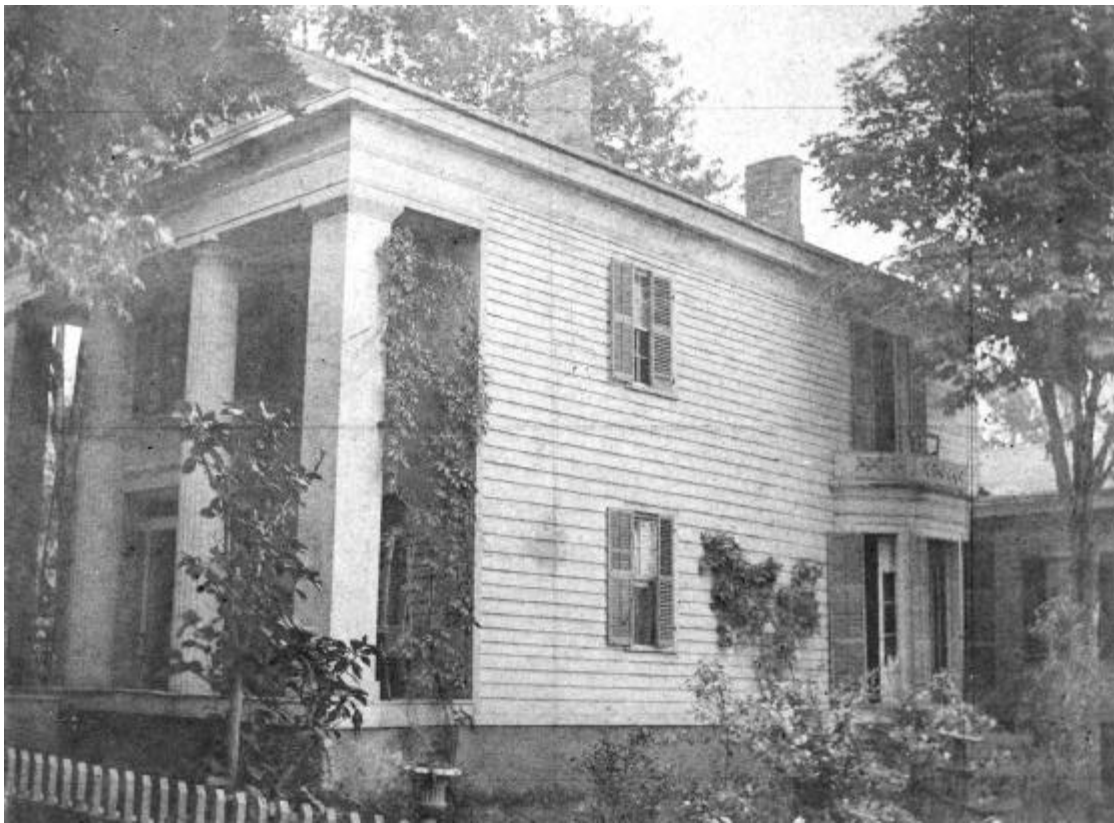
Figure 1.3: View east of front portion of Gage house. Reproduced 1887 photograph taken by L. Frank Baum. Matilda Joslyn Gage Foundation archival collection, Fayetteville NY, 2004.

Besides the white picket fence that defined the property edge, other small-scale features found within the property included a large urn located in the north yard and a retaining wall located within the south yard along Walnut Street [See figure 1.3 on page 9].

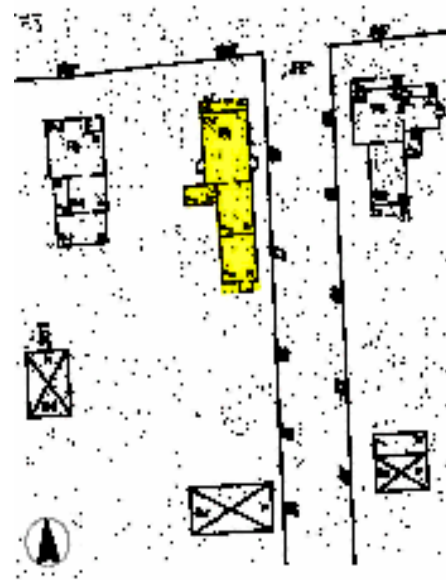
Figure 1.7: Map of the Gage property in 1904. Reproduced from 1904 Sanborn map.

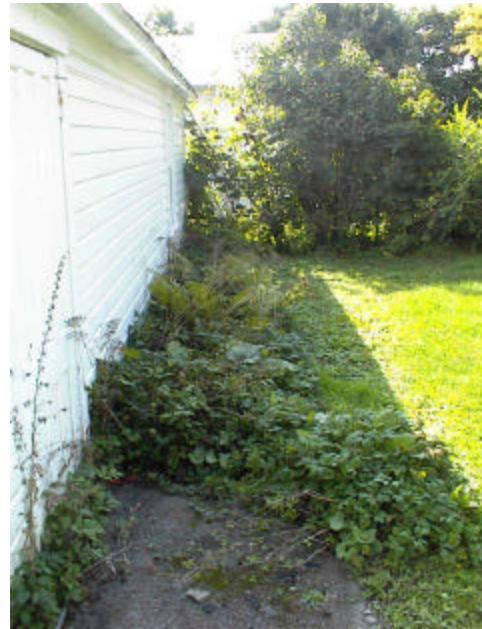
Figure 4.1: View west along north foundation of garage. Photograph by M. Commisso, SUNY-ESF. 2004.

Condition: Fair

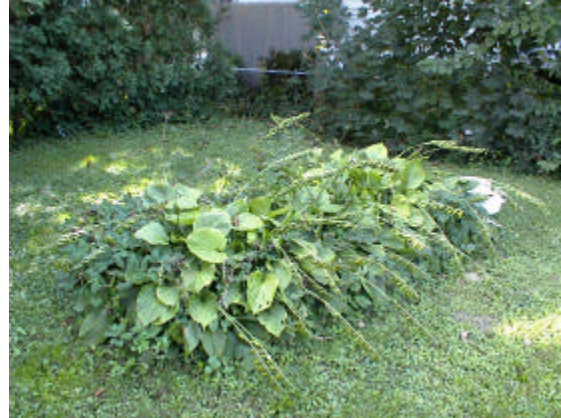
Figure 4.6: View of concrete basin surrounded by hosta. Photograph by M. Commisso, SUNY-ESF, 2004.
