Cultural Landscape Report for Fort Tilden

GATEWAY NATIONAL RECREATION AREA ROCKAWAY BEACH, NEW YORK

By Christina Selvek and John Auwaerter George W. Curry, Project Director State University of New York College of Environmental Science and Forestry

Olmsted Center for Landscape Preservation National Park Service, Boston, Massachusetts, 2005, Revised 2013 This report was developed by the Olmsted Center for Landscape Preservation in partnership with the Department of Landscape Architecture at the State University of New York College of Environmental Science and Forestry, Syracuse, New York. The Olmsted Center promotes the stewardship of significant landscapes through research, planning, and sustainable preservation maintenance. The Center accomplishes its mission in collaboration with a network of partners including national parks, universities, government agencies, and private nonprofit organizations. Techniques and principles of preservation practice are made available through training and publications. The Olmsted Center perpetuates the tradition of the Olmsted firms and Frederick Law Olmsted's lifelong commitment to people, parks, and public spaces.

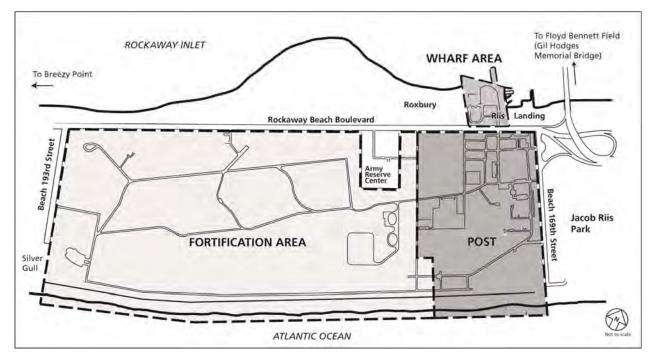
Figure 0.2. Diagram of Fort Tilden illustrating local setting and boundaries, and three character areas: fortification area, post area, and wharf area (part of Riis Landing). The outer dashed lines represent NPS property boundaries. (SUNY ESF)

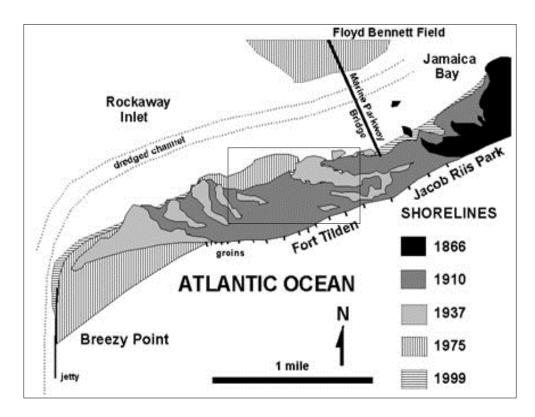
Figure 1.1. Diagram of westward drift of the Rockaway Peninsula (Rockaway Beach), 1866-1999, with location of Fort Tilden indicated by the rectangle. (US Geological Survey, New York City Regional Geology, "Breezy Point, ca.2000, annotated by SUNY ESF)

Until the late nineteenth century, the site of Fort Tilden was open water south and west of shifting barrier beaches that characterized the south shore of Long Island and separated Jamaica Bay from the Atlantic Ocean. The barrier beaches naturally drifted westward due to sand deposition from the ocean currents, with significant shifts often occurring during major storms. The largest of the barrier beaches near the site of Fort Tilden was known by the native Canarsie people as Recko[u]wacky, translated as meaning "neck of land," "lonely place," and "place of waters bright." From this, Europeans derived the name Rockaway, with the barrier beach known both as Rockaway Peninsula and Rockaway Beach. At the west end of the peninsula was the Rockaway Inlet, the channel where Jamaica Bay opened into the Atlantic Ocean. Between 1888 and 1911, concurrent with increased development on Rockaway Peninsula and efforts to improve Jamaica Bay into a major port, the barrier beach was engineered to stabilize its ocean shore through the construction of stone and wood groins.² This effort resulted in accelerated westward drifting of the barrier beach, resulting in the extension of Rockaway Peninsula by more than two miles after 1866 (fig. 1.1).³

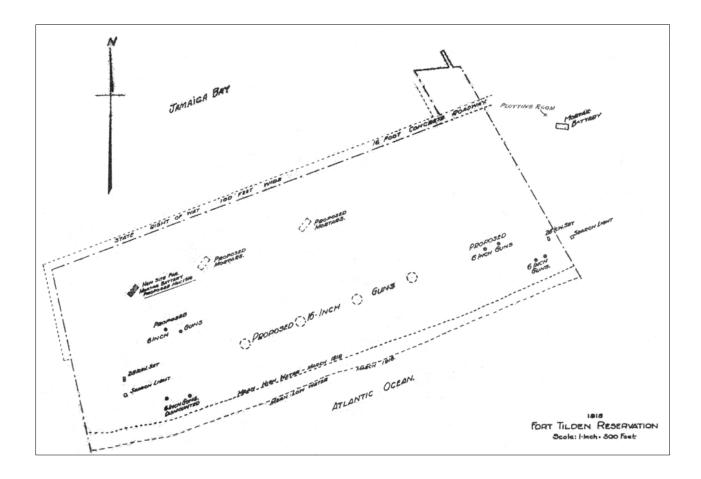
Figure 1.5. Map of the initial layout of fortifications at Fort Tilden, 1918. Note how the eastern boundary of the reservation originally was in line with the eastern boundary of the wharf area, with the mortar battery outside of the boundaries on the Rockaway Naval Air Station. (Library of Congress)

Congress votes on February 1st to appropriate \$51,000,000 for coastal defenses, of which \$2,000,000 is appropriated for establishing Fort Tilden. Contracts were let to the firm of William D. Cederhurst of Long Island to provide an artificial layer of bedrock at the battery sites. On February 8th, eleven carloads of cut bluestone arrive and forty horsedrawn and motor trucks with 150 workmen cart the stone to the fort to build foundations and platforms to hold the six-inch gun emplacements (fig. 1.5).

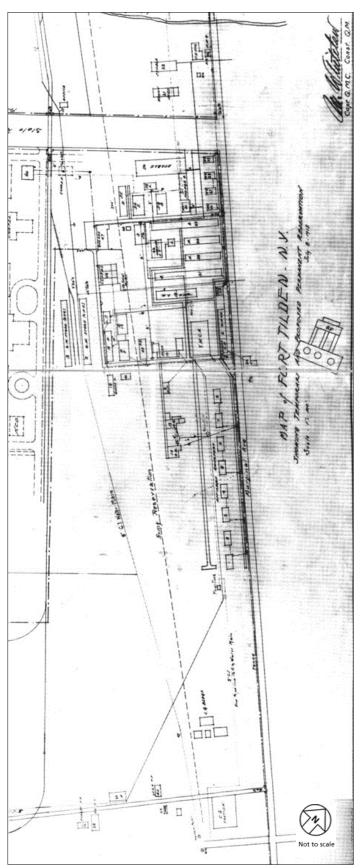
Figure 1.6. Map of the post (northeast corner) of Fort Tilden, 1918. Features shown in dashed lines indicate unrealized plans for the post The map also shows the location of the 12-inch mortar battery, east of the post within the Rockaway Naval Air Station. The dashed boundary line indicates the original east boundary of the Army reservation. (Library of Congress)

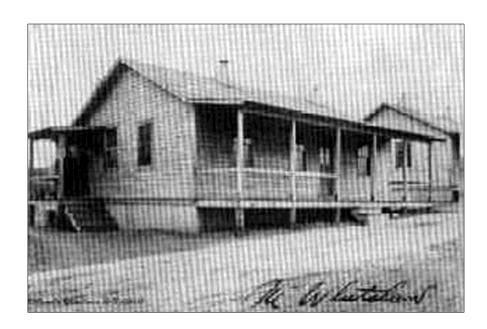
Figure 1.8. View of officer quarters, typical of the temporary frame construction built during World War I, c.1919. (National Archives).

- Oct. By the end of October, the Army completes construction of seven officer's quarters, two enlisted men's barracks, seven non-commissioned officers' quarters, one headquarters building, one hospital, one commissary, two mess halls, one lavatory, one stable and wagon shed, and a number of roadways (fig. 1.8).³⁷

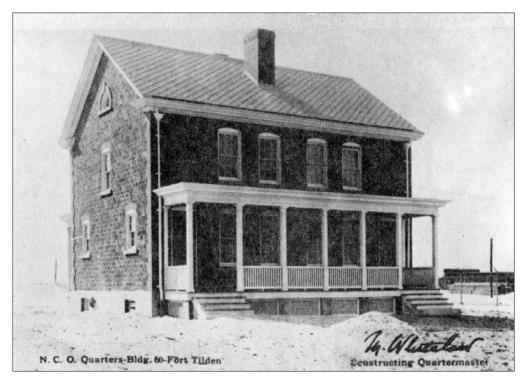
Figure 1.10. The Double Non-Commissioned Officer (NCO) quarters (Building 60), looking northwest soon after its completion, c.1919. (National Archives)

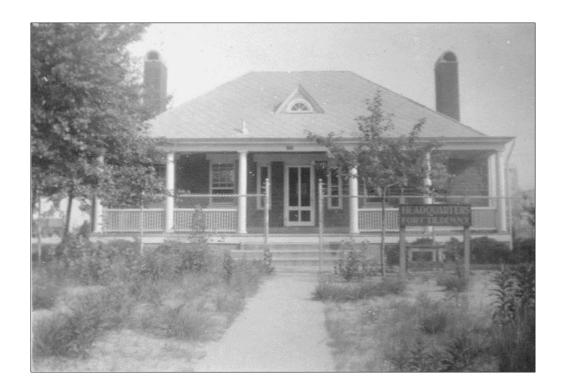
Figure 1.11. The Headquarters Building (Building 49, later the Artillery Engineer Signal Office and Engineer's Office Building 201) in the wharf area, built in 1919, photographed c.1937. Note the beach grass and young trees planted during the interwar period. (Gateway Museum Collection, GATE 4197)

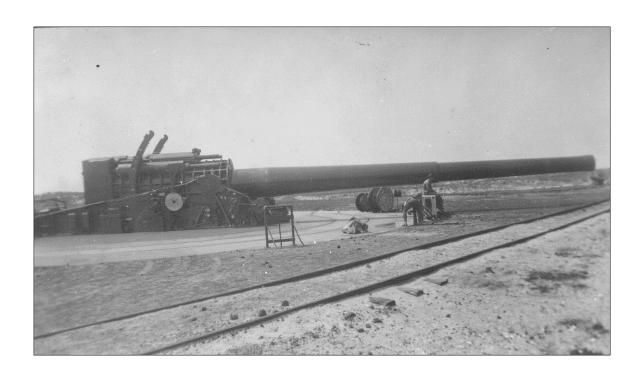
Figure 1.12. One of two sixteen-inch gun on concrete platforms that comprised Battery Harris, looking southwest across the narrow-gauge rail line, 1930. These guns were designed to hit targets at sea and in the air. (Gateway Museum Collection, GATE 533)

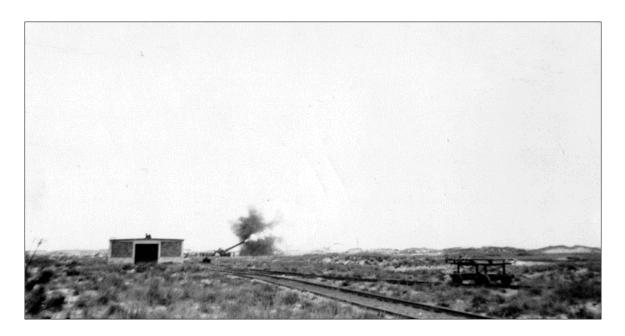
Figure 1.13. Battery Harris firing a sixteen-inch gun, looking southeast, c.1930. In the foreground are an ammunition magazine and standard gauge rail line. Note the beach grasses and low dunes along the Atlantic Ocean. (Gateway Museum Collection, GATE 13125)

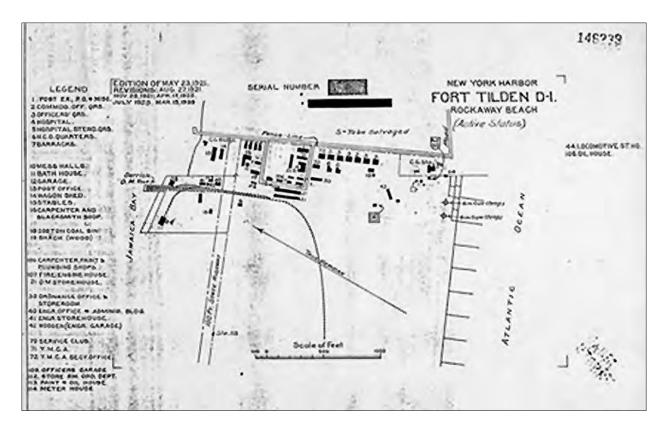
Figure 1.14. US Army map of the post and wharf area drafted in 1929 and revised in 1935 showing minimal change to the landscape since World War I (compare with Figure 1.6; note different orientation). Battery East remains south of the post. (Library of Congress)

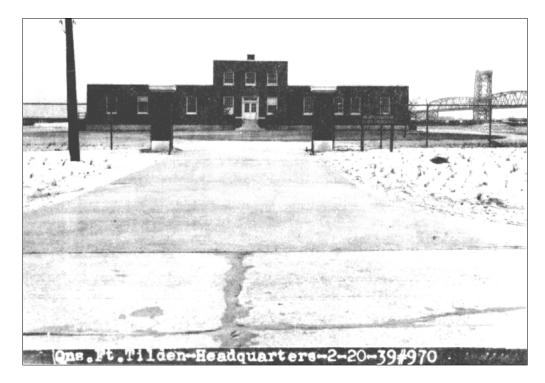
Figure 1.15. The Headquarters/Ordnance (Building 20), 1939, looking north from Rockaway Beach Boulevard. The Ordnance Building served as Fort Tilden's headquarters during World War II. Note the circular concrete drive and lawn, pair of brick entrance gate piers, chain link fencing, and newly planted grasses in the foreground. (National Archives)

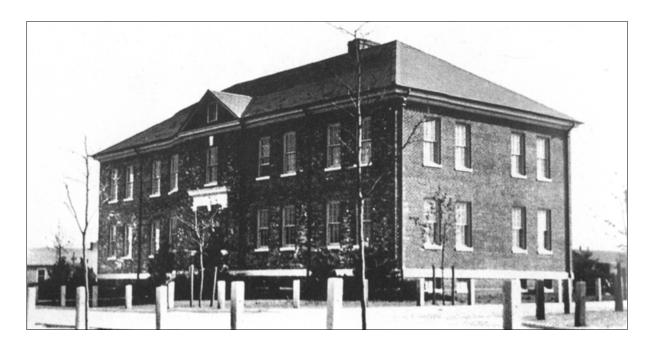
Figure 1.16. Looking southeast at the front of Barracks/Administration Building, (Building 1), 1941. Note the newly planted trees and bollards lining the roadway and parade ground. In the left background is a Series 700 temporary officer's quarters (T-170). (National Archives)

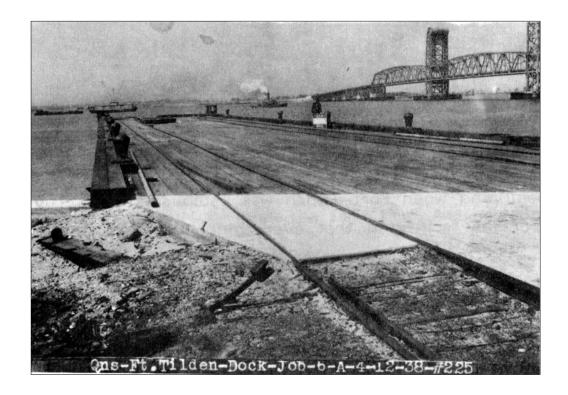
Figure 1.17. Looking northward towards Jamaica Bay from the dock at present day Riis Landing, c.1938. Note the rail lines used to transport supplies to the post and fortifications. (National Archives)

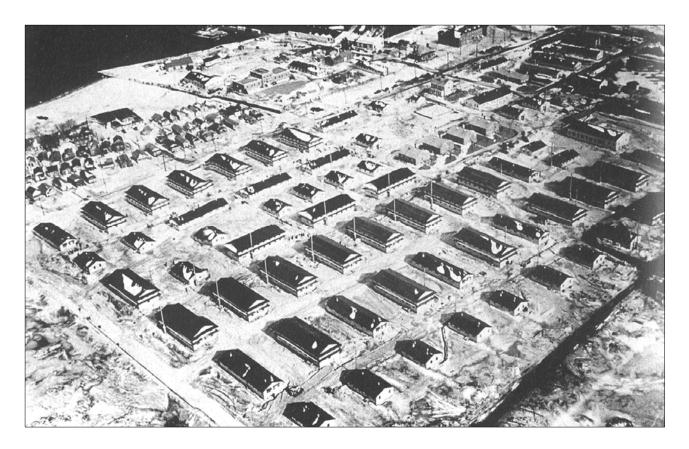
Figure 1.20. Aerial photograph of Fort Tilden looking northeast over the recently redeveloped post, c.1941. In the foreground is the complex of Series 700 temporary-style barracks and mess halls. At the top of the photograph, the ordnance building, roundhouse, repair shops, various engineer offices, dock, and rail lines make up the wharf area. Bordering the wharf is the new US Coast Guard Station and to the west is the Roxbury bungalow colony. In the upper right hand corner is the parade ground, which at the time was still not completed and contained several World War I structures. (National Archives)

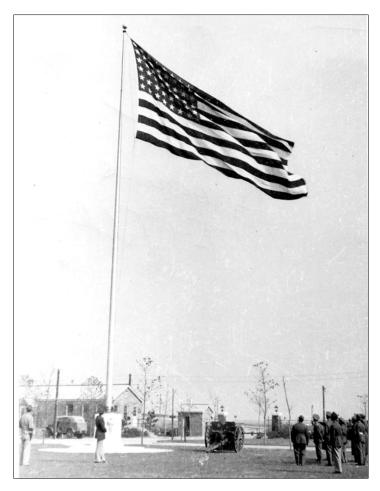
Figure 1.22. The parade ground with flagpole (Building 28) and cannon, looking east toward Jacob Riis Park, c.1941. In the background are young London Plane trees along Davis Road, and gate 9. This gate was used as the main entrance to the fort. It is flanked by two brick entrance piers with lanterns. The main gate booth (Building 41) and the quartermaster's office (Building 16) are located to the left of the gate. (Gateway Museum Collection, GATE 13098)

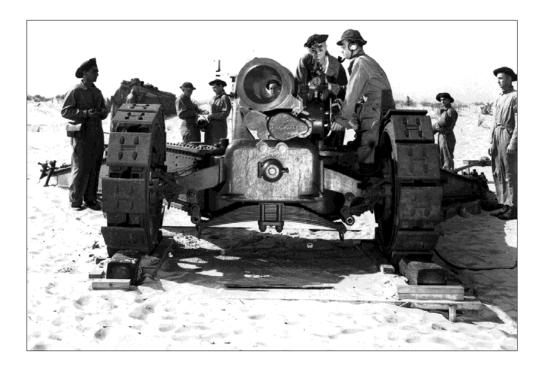
Figure 1.23. Soldiers and movable 155mm GPF gun, looking southeast toward the ocean, c.1941. Note sandy ground and beach grass in the background. (Gateway Museum Collection, GATE 19013)

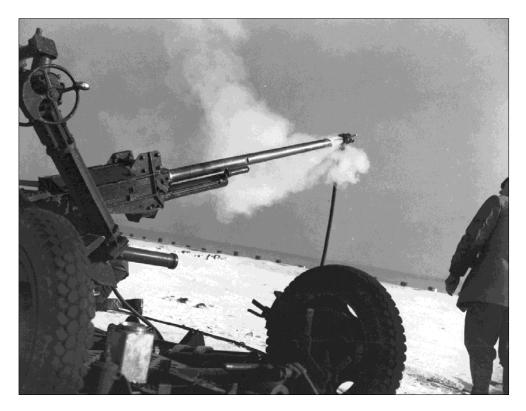
Figure 1.24. A moveable 37mm anti-aircraft gun stationed along the Atlantic beach, c.1941. (Gateway Museum Collection, GATE 19026)

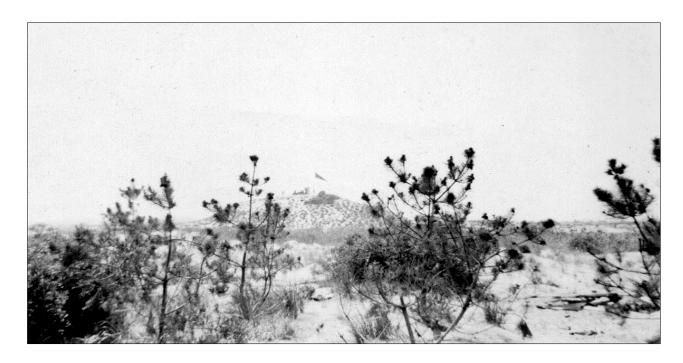
Figure 1.25. Casemated and earth covered Battery Harris, looking east, c.1942. The pine trees in the foreground, probably surrounding Battery Kessler, were planted to stabilize soils and/or camouflage the defensive works. (Gateway Museum Collection, GATE 1312)

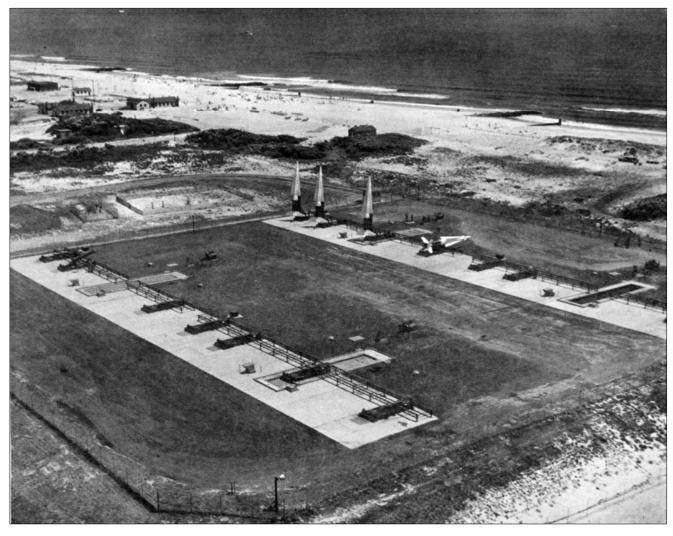
Figure 1.26. The Nike NY-49 launch site at Fort Tilden, looking southeast showing Hercules modifications, 1959. A sentry booth (Building 309) is located at the entrance to the launch area. In the background there are some remaining World War II structures located along the beach. These structures are as follows from left to right: officer's bath house (Building 34, later 18), officer's latrine (Building 23, later 17), officer mess hall (Building 24, later 16), enlisted men's mess hall (Building 25, later 15), and generator shelter (Building T-198). Directly east of the Nike area is the Harbor Entrance Command Post (HECP) (later Building 13). (US Army)

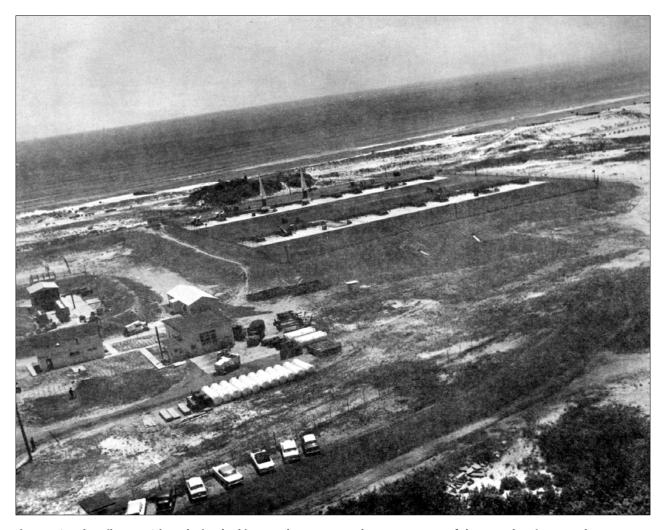
Figure 1.27. The Nike NY-49 launch site, looking southwest across the western part of the post showing Hercules modifications, 1959. Directly south of the Nike site is a mound of sand and vegetation camouflaging Battery Construction 220 (Building 315). To the left are Nike support structures (Buildings 302, 303, 304, 305, 307 and 309), all constructed during the 1950s. In the upper right of the photo are the target butts for the rifle range. (US Army)

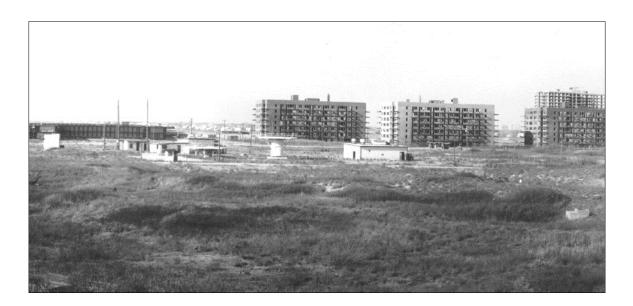
Figure 1.28. Nike NY-49 missile tracking station #2, looking southwest, 1970, three years after the site was decommissioned. Beginning from left to right, the photo illustrates structures 518, 517, 516, 515, T-522, Radar Tower 525 (with radar unit and dome removed), and 526. The high-rise buildings in the background, instrumental in the movement to preserve Fort Tilden as open space, were begun in c.1962 and construction was halted in 1963. (Gateway Museum Collection, GATE 20979)

The area surrounding Fort Tilden underwent some significant changes during this period. Most notably, all of the land west to Breezy Point (Rockaway Point) and north of Fort Tilden including Roxbury was acquired by Northern Properties for \$17.5 million to erect a high-rise development with a projected population of 220,000. Residents in the Breezy Point and Roxbury communities formed a cooperative and acquired their land for \$11.5 million. Northern Properties advanced its construction plans for the open land immediately west of Fort Tilden. Here, construction was begun on several high-rise apartment buildings, but the project soon came to a halt when the city announced in 1963 plans to acquire the property as parkland (fig. 1.28). The shells of the buildings would remain standing for a decade and a half. ⁹⁷

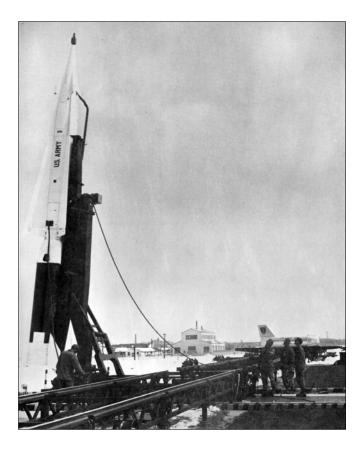
Figure 1.29. Nike Hercules missile in launch position, on eve of being decommissioned, looking east towards the post, 1967. The Ordnance Repair Shop (Building 46, later 9) and the bowling alley (Building T-179, later T-8) are in the background. (US Army)

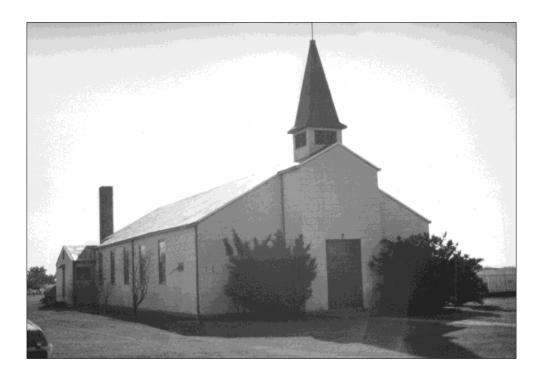
Figure 1.33. The Fort Tilden Series 700 chapel built in 1941, looking southeast, c.1974. The large yews may date to the Cold War when the building was purportedly shifted to its present location. (Gateway Museum Collection, GATE 20996)

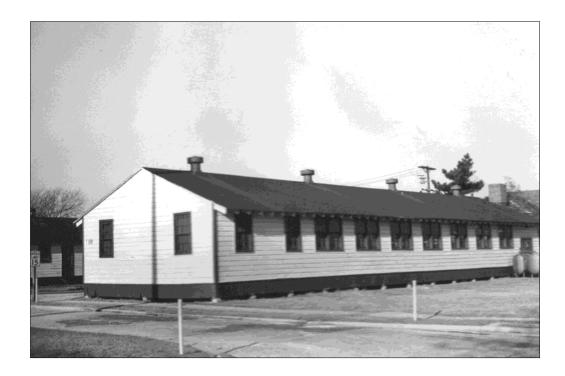
Figure 1.34. The former Provost Marshall building (Building T-128) on the parade ground, typical of the many Series 700 standard Army buildings of the World War II era at Fort Tilden, c.1974. This and most other frame buildings were demolished in the 1980s. (Gateway Museum Collection, GATE 20980)

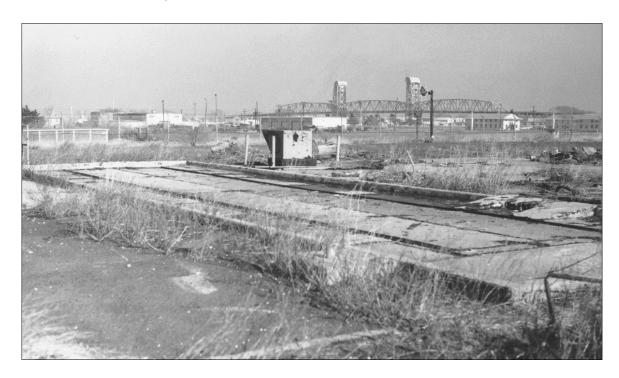
Figure 1.35. Abandoned Nike missile silo, ventilator shaft, and security lighting in launch area about seven years after 1967 decommissioning of the Nike NY-49 complex, looking northeast, c.1974. The US Army Reserve Center is in the left background, with two-story cantonment barracks and the Marine Parkway Bridge visible in the right background. (Gateway Museum Collection, GATE 22027)

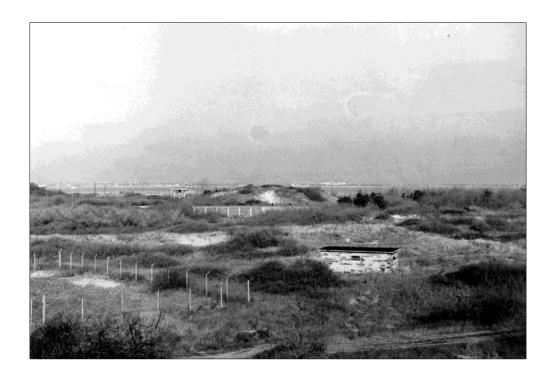
Figure 1.36. Looking northwest from Battery Kessler towards Nike missile tracking station #1, c.1974. The fencing for RF MAST and Oil Storage (Building 322) are in the foreground. Battery Harris Magazine (Building 414) and Bombproof Fire Control Building (Building 314) are just south of the tracking station. Successional woody vegetation was beginning to take over, but the open grasslands typical of the military era remained in large part at this time. (Gateway Museum Collection, GATE 21046)

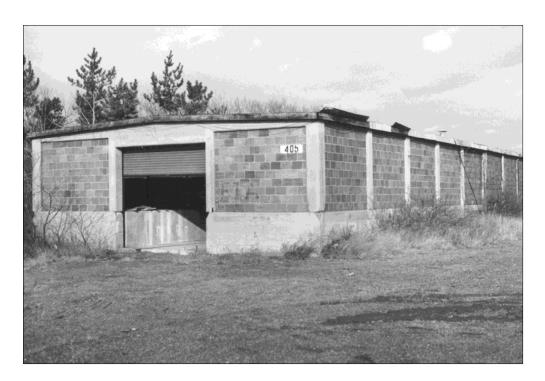
Figure 1.37. Magazine for Battery Harris (Building 405), built c.1923, looking northeast, c.1974. Note World-War II era pines in background; rail tracks ran through the overhead door. (Gateway Museum Collection, GATE 20984)

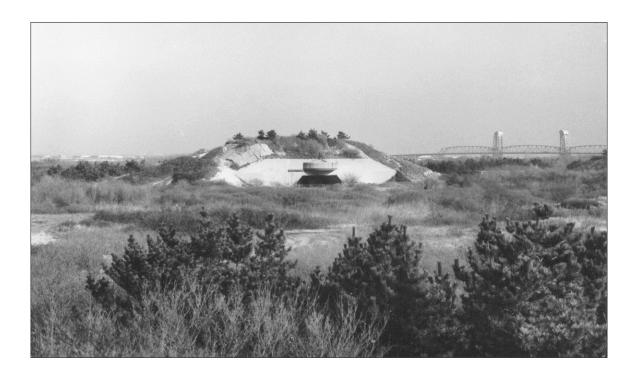
Figure 1.38. Battery Harris East (Building 406), with earthen and concrete casemate constructed in 1941-42, looking northeast with the Marine Parkway Bridge in the background, c.1974. The sixteen-inch guns had been removed in c.1949. Note open grasslands and pines on top of casemate and in foreground, planted by the Army most likely during World War II. (Gateway Museum Collection, GATE 21047)

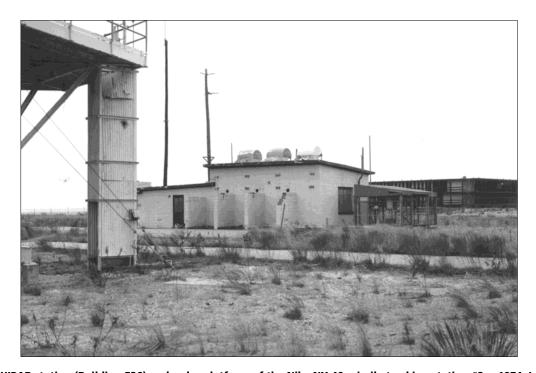
Figure 1.39. HIPAR station (Building 526) and radar platform of the Nike NY-49 missile tracking station #2, c.1974. In the background are the Silver Gull cabanas, acquired by NPS as part of Gateway National Recreation Area. In the 1980s, NPS redeveloped the tracking station site as the Fisherman's Parking Area, retaining only the HIPAR station. (Gateway Museum Collection, GATE 21034)

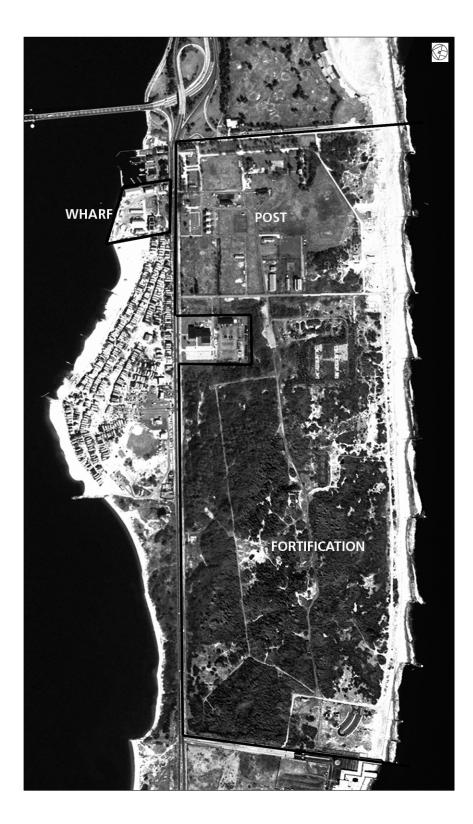
Figure 2.1. Current (c. 2001) aerial photograph of Fort Tilden illustrating large-scale landscape patterns and surrounding network of roads, community of Roxbury (north), and golf course and beach at Jacob Riis Park (east). Note large areas of open ground in the post, compared with the mostly wooded conditions of the fortification area. The boundaries of Fort Tilden are indicated by the black line. (Gateway National Recreation Area, annotated by SUNY ESF)

and 1974 (fig. 2.2, see also fig. 2.1). The landscape of 309 acres fronting on the Atlantic Ocean consists of scattered buildings, lawn, ball fields, parking areas, paved roads, and large areas of successional woodlands surrounding abandoned gun batteries and other military structures. Once containing more than 160 buildings and structures at its height during World War II, Fort Tilden today contains approximately thirty maintained buildings (Drawing 2.1). The U. S. Army Reserve Center on Rockaway Beach Boulevard, a 1950s-era group of buildings on approximately eight acres retained by the military after the park was created in 1974, is the only remaining active military use within the original limits of Fort Tilden. It presently houses the 449th Maintenance Company.

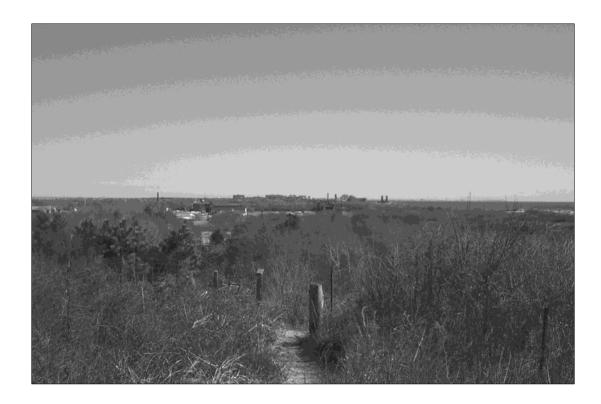
Figure 2.2. View looking across the wooded Fort Tilden landscape from the observation area on top of Battery Harris East, 2005. The post area is visible in the middle foreground, with highrises at Far Rockaway in the distance. The wooded character of the landscape has developed largely since the Army decommissioned Fort Tilden in the early 1970s. (SUNY ESF)

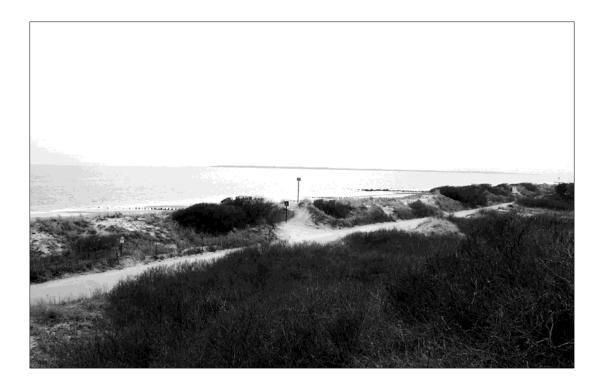
Figure 2.3. View looking southwest across Shore Road at the sand dunes, grasslands, and engineered ocean beach with stone and wood groins, 2005. In the distance is Sandy Hook, New Jersey. (SUNY ESF)

The mile long beach access is a large draw for visitors and local fisherman. (Fig. 2.3) Public access to the remainder of the fortification area, aside from the Fisherman parking area through gate 8 at Beach 193rd Street, is restricted due to the numerous abandoned buildings and structures, but visitors are permitted along the nature trail extending from the beach up to the wildlife-viewing platform on top of Battery Harris East. Access to the remainder of the site is by the network of concrete and asphalt-paved roads that form two rectangular loops through the fortification area, with several spurs and connecting legs. Shore Road retains its original concrete pavement, while most of the other roads are paved in asphalt. The road circuit in the fortification area connects with the post area at two points: Shore Road and Range Road. The rail lines that originally ran from the wharf area, through the post area, and to Battery Harris and its magazines, remains, but is almost entirely concealed by vegetation.

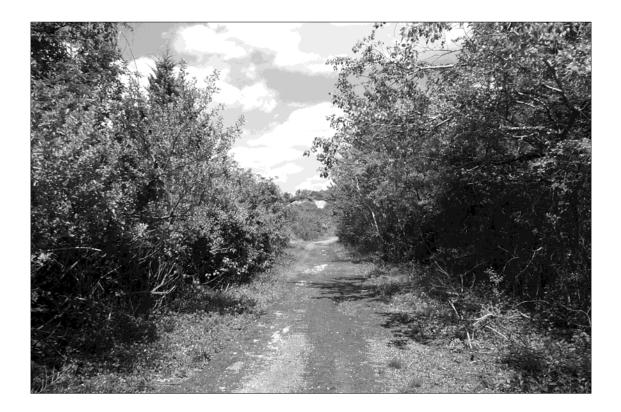
Figure 2.4. View looking east along Range Road illustrating character of successional woods that have grown up on much of the site, 2005. (SUNY ESF)

Overall, the maintained, open landscape of the military era prior to 1974, with its numerous military structures, planted beach grasses, black pine, and Russian olive, has naturally reverted into a young maritime forest (fig. 2.4). This ecologically rich area now contains several vegetation types including beachgrass dunes, grasslands, phragmites, high and low thickets, and coniferous and deciduous forests. These communities provide feeding and nesting habitats for a variety of marsh and shore birds, including green herons and clapper rails. The landscape evokes a strong feeling of abandonment and time passage, and at the same time, the resiliency of natural systems.

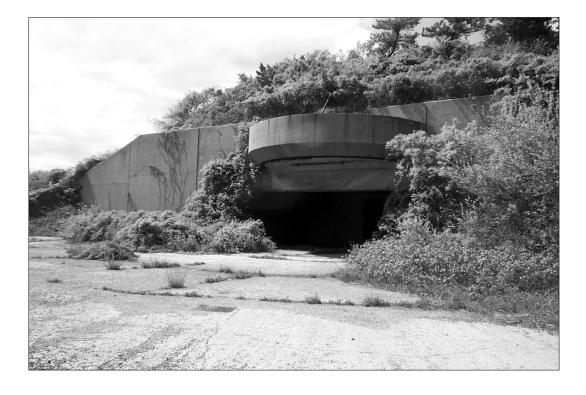
Figure 2.5. The casemate of Battery Harris West, view looking northwest from Range Road, 2005. (SUNY ESF)

From a cultural resource perspective, the dual emplacements of Battery Harris, built in 1922 and with massive concrete and earthen casemates added in 1941, are the most prominent features within the fort's landscape (fig. 2.5). The casemates are clearly visible to visitors along Range Road. There are no interpretive markers, but standard brown NPS signs identify the structures. Other military structures, such as the bombproof magazine (Building 411), fire control and plotting room (Building 413), mining casemate (Building 511), and Battery Harris magazine (Building 401) have been covered with successional vegetation and are not visible or accessible to the public (fig. 2.6). The former Nike missile launch pad, which is fenced off from the rest of the fortification area and retains few above-ground resources, is part of the park's maintenance area and is also not accessible to the public.

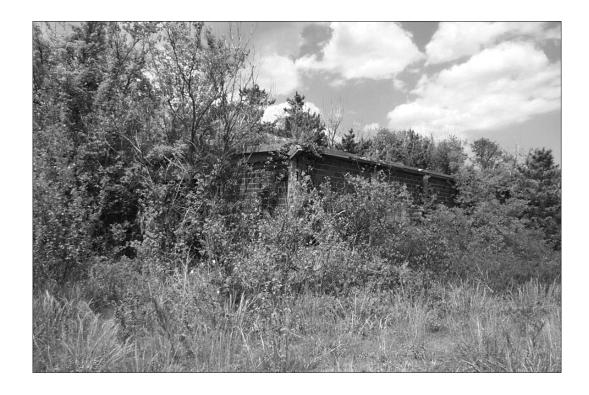
Figure 2.6. An abandoned magazine (Building 401) associated with Battery Harris, view looking northeast from Range Road, 2005. (SUNY ESF)

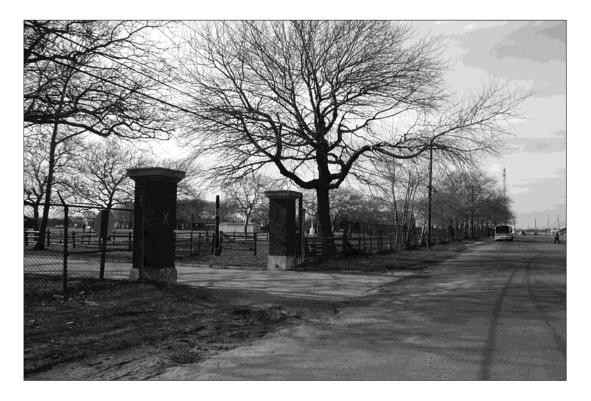
Figure 2.7. Looking north along Beach 169th Street at the former main entrance (gate 10) to Fort Tilden in the post area, 2005. Behind the gate is a horse corral used by the New York City Police Department, site of the World War II-era officer's club. (SUNY ESF)

From Rockaway Beach Boulevard and Beach 169th Street, which together form the north and east sides of the post area, visitors can enter through four different gates (Gates 2, 18, 9 and 10) that are still flanked by brick piers and chain link fencing built by the Army (fig. 2.7). The main park entrance is Heinzelman Road (at gate 2), lined in part by London Plane trees planted during the World War II era (fig. 2.8).

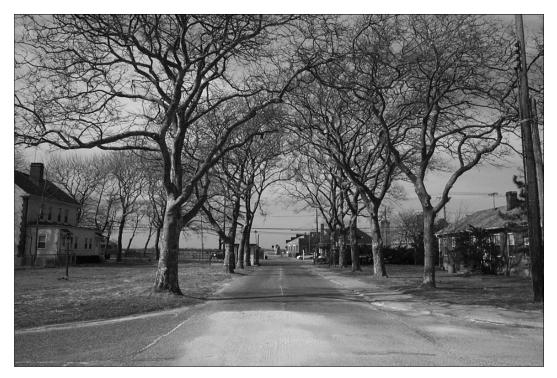
Figure 2.8. Looking north at gate 2, the primary park entrance to Fort Tilden within the post area, along Heinzelman Road, 2005. The building at left (Building 106) is the only structure in the post area dating from the initial World War I development of Fort Tilden; the London Plane trees flanking the road were planted during World War II. (SUNY ESF)

Across Rockaway Bay Boulevard from the post is the wharf area of Fort Tilden, also known as the Quartermaster area or Post Engineer area, which once served as the industrial and administrative center of the fort (see fig. 2.8). As with the post, many of the World War II-era buildings and structures have been demolished; only eight of the twenty-two buildings remain. Since 2000, efforts have been underway to redevelop the wharf area and the adjoining former Coast Guard Station Rockaway into a federally-funded transportation hub, known as Riis Landing, named after nearby Jacob Riis Park. As a result of this project, a parking lot and new dock were completed in c.2003 as part of a ferry terminal intended to provide service to Manhattan (fig. 2.12). The new ferry dock (and all of the old slips on the east side of the wharf area) is on the Coast Guard property and was not historically part of Fort Tilden. The original Fort Tilden wharf (Building 209) was located along the north seawall; today, only the pilings remain.

The entrance to the wharf area is at gate 1, opposite the primary entrance to the post area at Heinzelman Road (gate 2) (see fig. 2.8). Remaining in the asphalt roadbed are rails from the tracks that extended from the wharf through the post area to the fortifications. Along the east side of the road is the World War I-era administration building, recently altered and now leased to a concessionaire as part of the Riis Landing operation, and behind it, a concrete and terra-cotta tile warehouse dating from the same period (see fig. 2.8). To the west is the former World War II-era ordnance and administration building (Building 219), built by the WPA in 1937-38 and set facing a circular drive and lawn (fig. 2.13). Today, the stylized Georgian Revival-style brick building it is used by the park as a storage and maintenance facility. To the rear of this building are two World War II-era maintenance buildings that are in dilapidated condition.

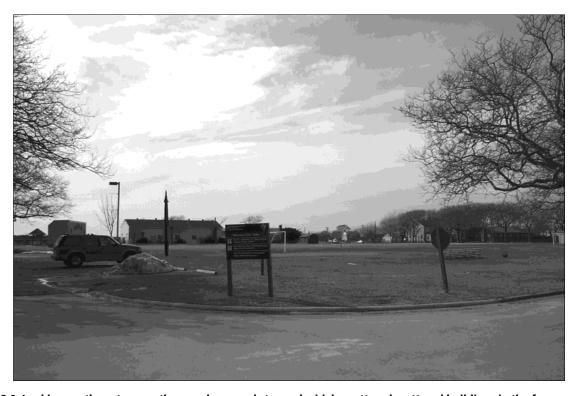
Figure 2.9. Looking northwest across the parade grounds toward widely-scattered scattered buildings in the former barracks area, 2005. (SUNY ESF)

The former ceremonial heart of Fort Tilden, the parade grounds, borders the east side of Heinzelman Road (fig. 2.9). Once enclosed by buildings except along a portion of the east side, the rectangular field is today loosely defined by scattered buildings, along with roadside London Plane trees along the east and south sides. The World War II-era flagpole remains at the northeast corner, but the canon that once accompanied it has disappeared. The landscape of the parade grounds is dominated by Georgian Revival-style Building I, formerly a barracks, hospital, and Cold War-era administration building (fig. 2.10). It was constructed in 1937-38 by the Works Progress Administration, and today serves as the Fort Tilden visitor center. Along the east side on the site of the officer's club is a horse corral used by the New York City Police Department (see fig. 2.7). West of the parade grounds is the portion of the post that once contained a dense complex of barracks and officers' quarters. Today, only a row of four brick officers' quarters, one barracks, and the recreation center remain from the World War II landscape of this area. The building sites are today used as ball fields and community gardens.

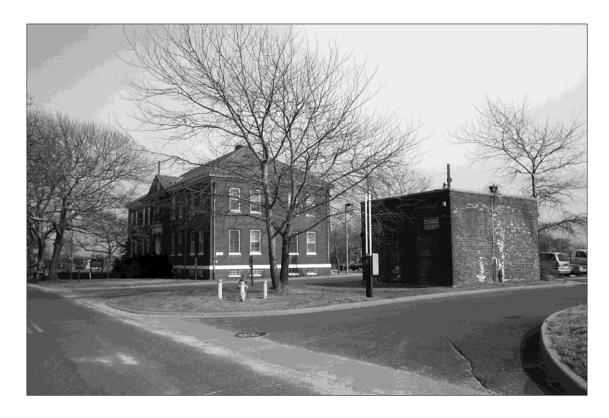
Figure 2.10. The administration building (Building 1), built by the WPA in 1937-38, looking east, 2005. The building in the foreground is a transformer station erected around the same time. (SUNY ESF)

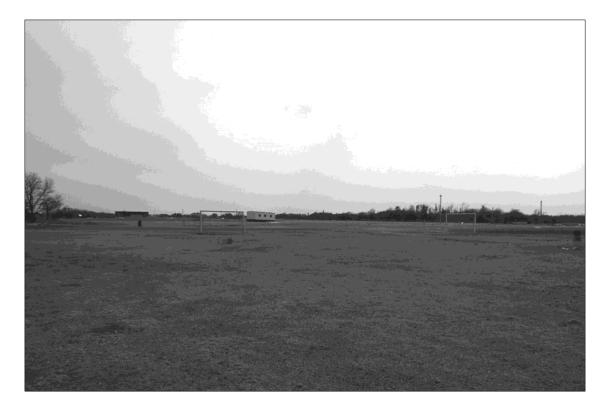
Figure 2.11. Ball fields, formerly the drill grounds, looking south from the chapel, 2005. (SUNY ESF)

South of the barracks area is the chapel, a former warehouse renovated as the home of the Rockaway Artists' Alliance, a new parking lot, and a warehouse and ordnance shop, both abandoned. East of here is a large field that served as the drill grounds (fig. 2.11). To the south is the beachfront of the post area, containing several one-story masonry buildings used by the Army as officer facilities. Aside from the officer bathhouse, today maintained as a park bathhouse, these

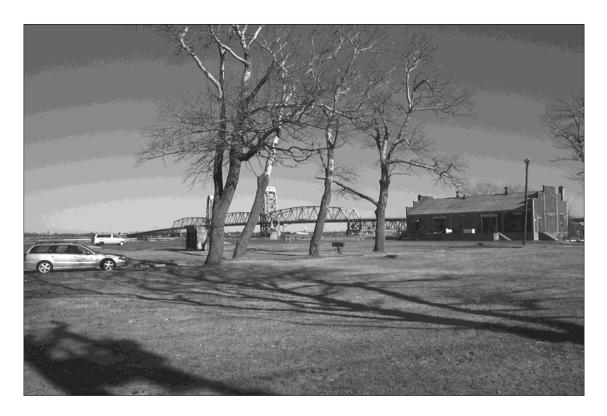
Figure 2.12. Looking northeast across open ground and recently completed parking lot built for Riis Landing, 2005. This area was the site of a dense complex of buildings during World War II. In the right background is a World War I-era warehouse, and to the left, the Gil Hodges Memorial Bridge, completed in 1937. (SUNY ESF)

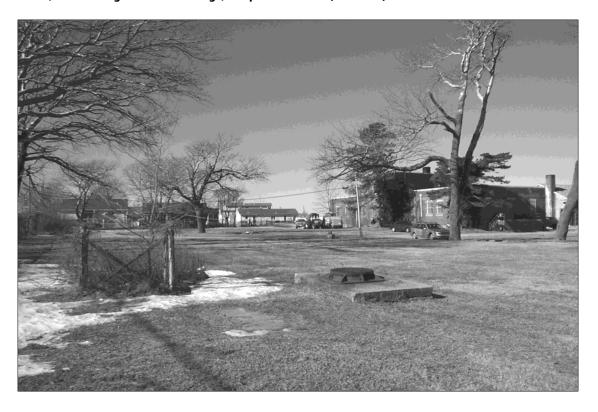
Figure 2.13. Looking west across lawn in front of the former World War II ordnance and administration building facing Rockaway Beach Boulevard (left), 2005. The building is now a park maintenance and storage facility. In the background is the community of Roxbury. (SUNY ESF)

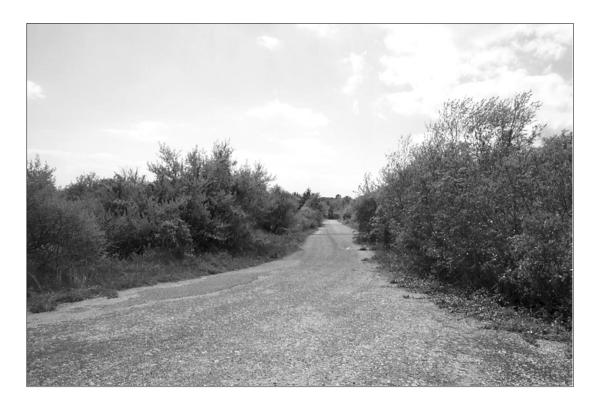
Figure 3.1: Range Road (C-1) looking west from Battery Harris magazine (Building 401), 2005. (SUNY ESF)

C-1. Range Road (including entrance Gate 8) (fig. 3.1)

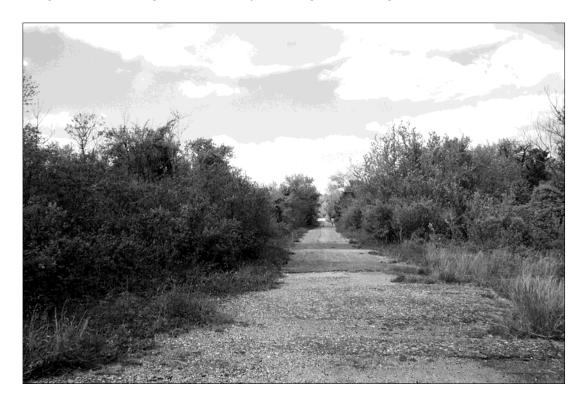
Figure 3.2. East Road (C-2) looking northward from Battery Harris magazine (Building 401), 2005. (SUNY ESF)

C-2. East Road (including entrance gate 5) (fig. 3.2)

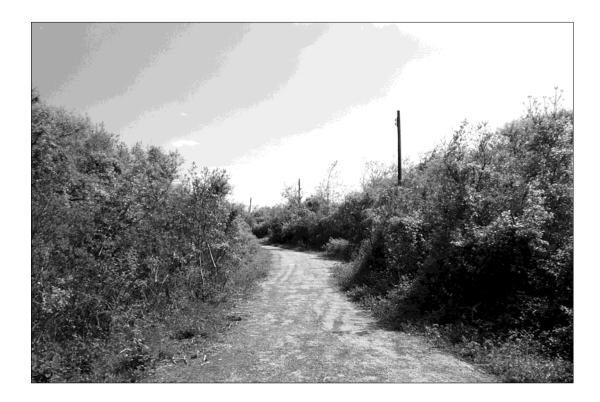
Figure 3.3. West Road (C-3) looking southeast toward Marshall Road showing remnant telephone poles (SSF-5) from site of Nike missile tracking station 1, 2005. (SUNY ESF)

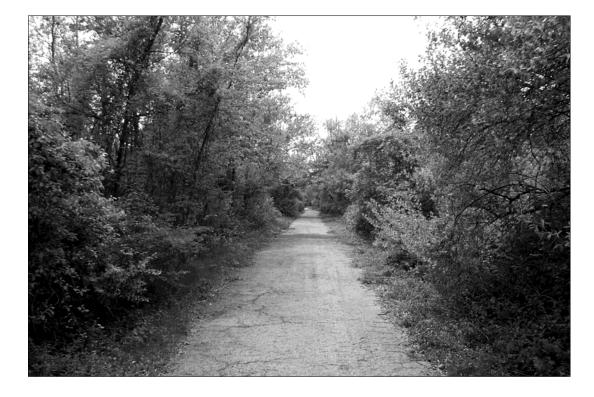
Figure 3.4. Marshall Road (C-4) looking west from Building 402, 2005. (SUNY ESF)

C-4. Marshall Road (fig. 3.4)

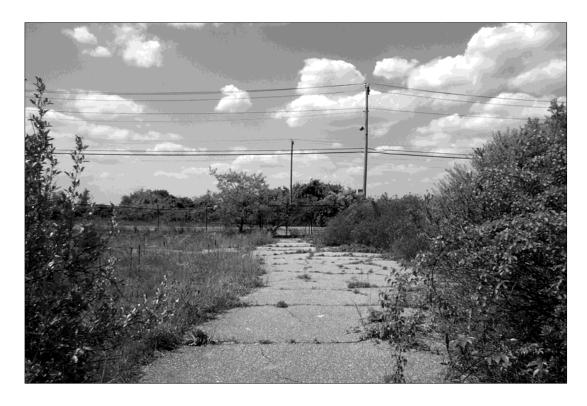
Figure 3.5. Motor Pool Service Drive (C-7) looking north to former entrance gate six at Rockaway Bay Boulevard, 2005. At left is the site of the Motor Pool Building (A-3). (SUNY ESF)

C-7. Motor Pool Service Drive (including Gate 6) (fig. 3.5)

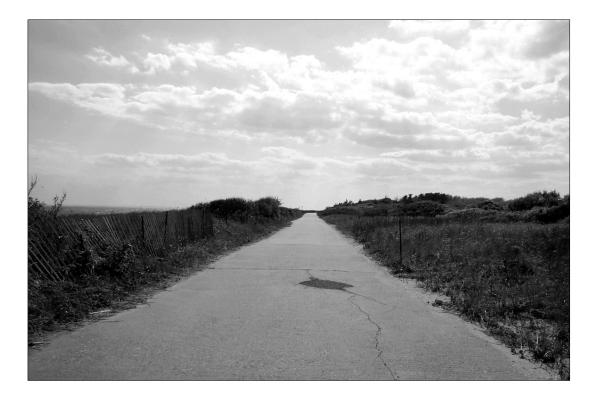
Figure 3.6. Shore Road (C-8) looking west between Battery Construction 220 and Battery Kessler, 2005. (SUNY ESF)

C-8. Shore Road (fig. 3.6)

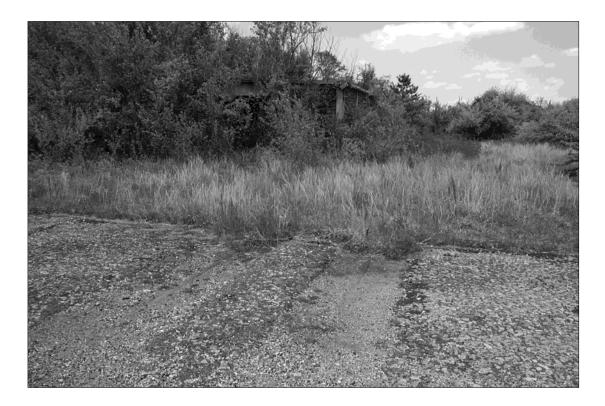
Figure 3.7. Standard-gauge railroad (C-7), view of tracks across East Road looking east to Building 401, looking east, 2005. (SUNY ESF)

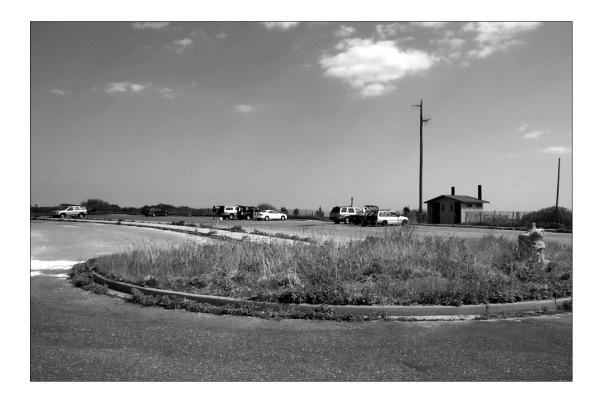
Figure 3.8. Fisherman Parking Lot (C-10) looking south with the NPS comfort station (B-12) at right, 2005. (SUNY ESF)

C-10. Fisherman Parking Lot (fig. 3.8)

B-6. Fisherman Parking Lot Comfort Station (see fig. 3.8)

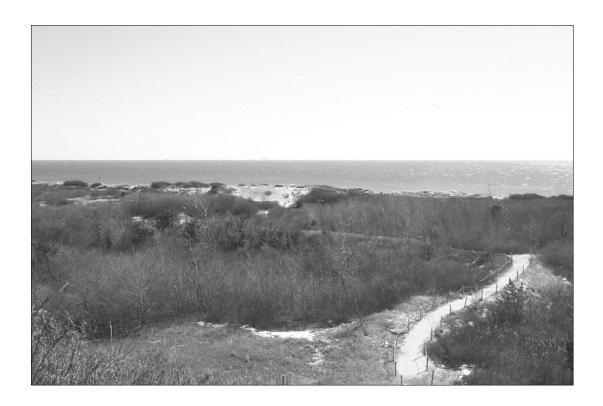
Figure 3.9. The Fort Tilden nature trail (C-11) looking southeast from Range Road, 2005. (SUNY ESF)

C-11. Fort Tilden Nature Trail (fig. 3.9)

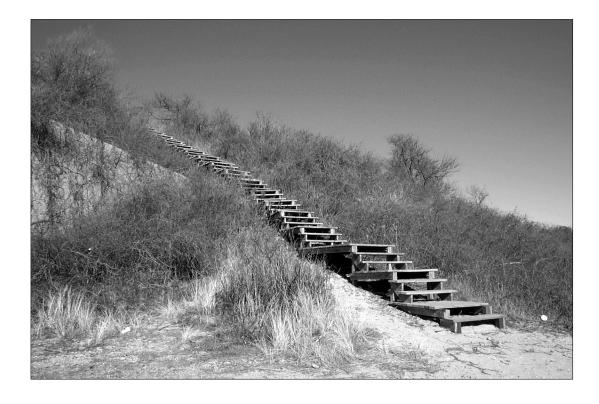
Figure 3.10. Wood stairway (C-12) leading to Battery Harris Observation Platform, looking northeast from Range Road, 2005. (SUNY ESF)

C-12. Battery Harris Observation Stairway and Platform (fig. 3.10)

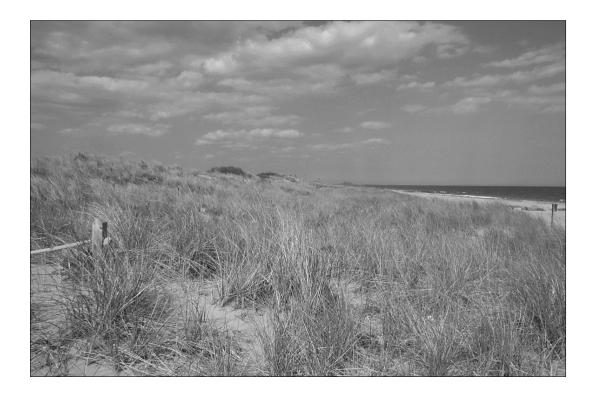
Figure 3.11. Typical beach grasses (VG-1), looking east along the Atlantic shoreline, 2005. (SUNY ESF)

VG-1. Beach Grasses (fig. 3.11)

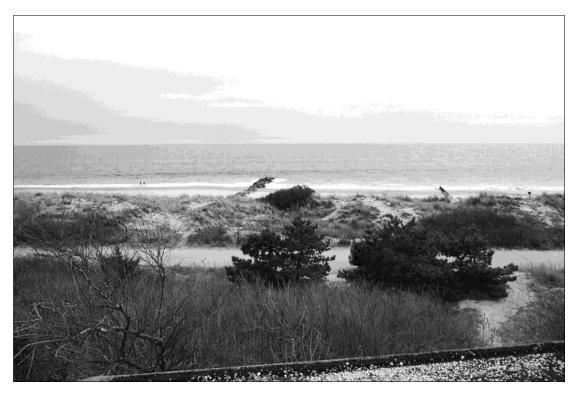
Figure 3.13. Stone groin and remnant wood groin/bulkhead (B-1) along the ocean beach of the fortification area, view from Battery Construction 220 (B-315), 2005. (SUNY ESF)

<u>Post-Historic and Existing Condition</u>: Since 1967, the beach has remained relatively stable due to the groin fields (see B-1). The NPS has encouraged accumulation of sand dunes along the beach through addition of snow fencing. Maritime deciduous woods, which may have begun to grow during the historic period, spread across the fortification area.

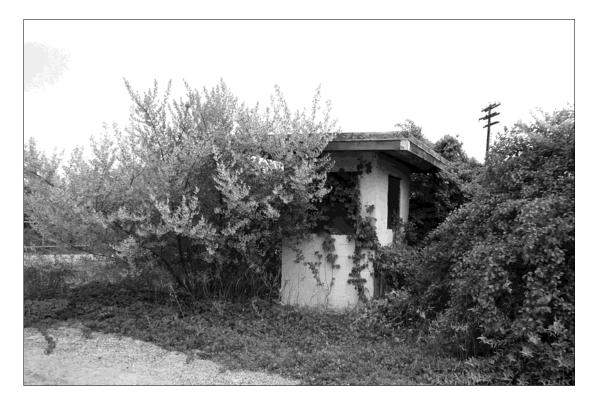
Figure 3.14. Nike launch pad sentry booth (B-301), looking west, 2005. (SUNY ESF)

B-301. Nike NY-49 Launch Area Sentry Booth (fig. 3.14)

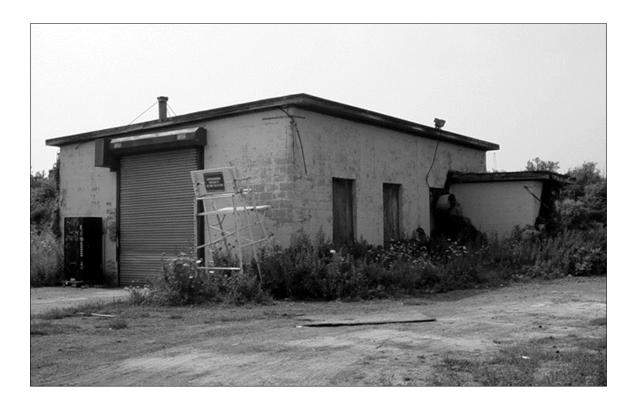
Figure 3.15. Park maintenance building (B-302), former Nike missile assembly building, looking southwest, 2004. (Pia Hermoso, GATE)

B-302. Nike NY-49 Missile Assembly Building (NPS Maintenance) (fig. 3.15) Historic Condition: The Nike Missile Assembly Building was built in c. 1953-55 as a component of the Nike missile launch area.

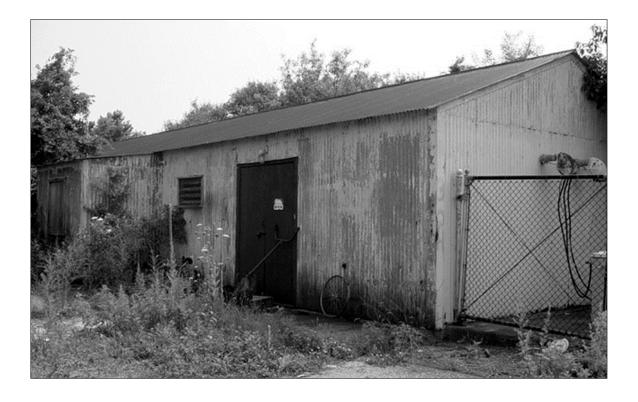
Figure 3.16. Park maintenance building (B-304), former Nike generator building, looking southwest, 2004. (Pia Hermoso, GATE)

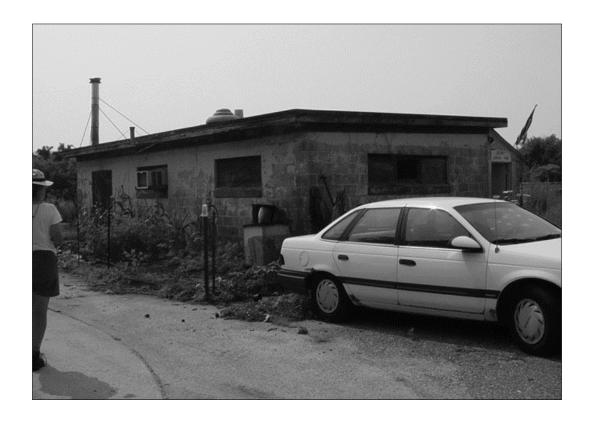
Figure 3.17. Park maintenance building (B-305), former Nike area latrine and barracks, looking southwest, 2004. (Pia Hermoso, GATE)

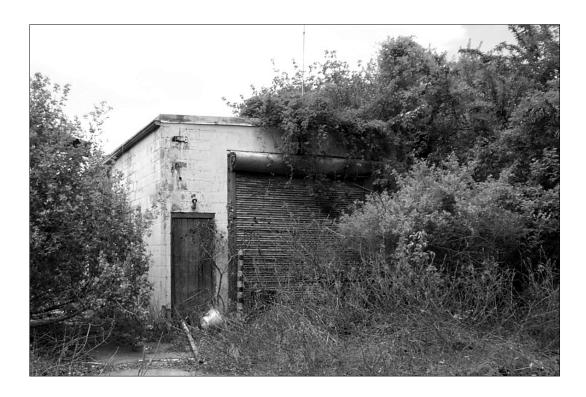
Figure 3.18. Park maintenance building (B-307), former Nike missile warhead assembly building, looking west, 2005. (SUNY ESF)

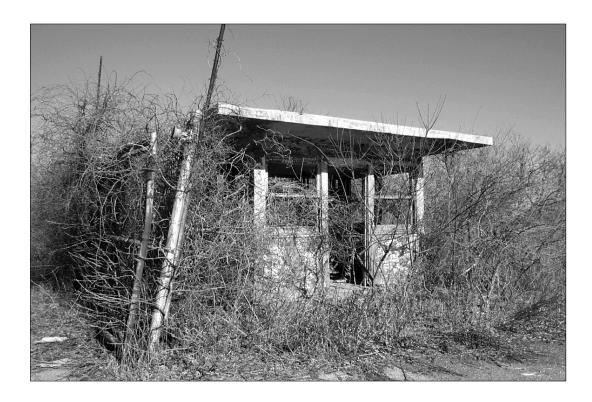
Figure 3.19. Nike missile sentry booth (B-309), looking northwest, 2005. (SUNY ESF)

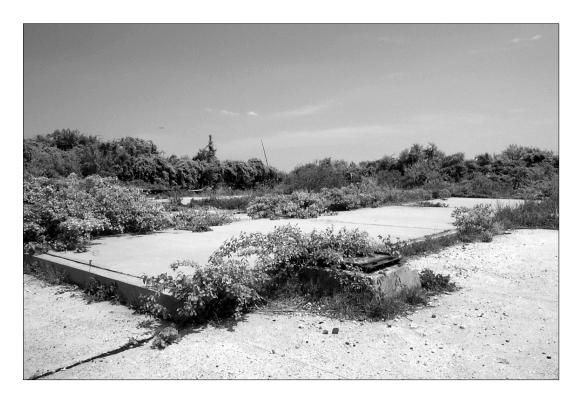
Figure 3.20. A representative Nike missile silo and entry hatch, one of four (B-310-313), looking northwest, 2005. (SUNY ESF)
