Cultural Landscape Report for Fort Tilden

GATEWAY NATIONAL RECREATION AREA ROCKAWAY BEACH, NEW YORK

By Christina Selvek and John Auwaerter George W. Curry, Project Director State University of New York College of Environmental Science and Forestry

Olmsted Center for Landscape Preservation National Park Service, Boston, Massachusetts, 2005, Revised 2013 This report was developed by the Olmsted Center for Landscape Preservation in partnership with the Department of Landscape Architecture at the State University of New York College of Environmental Science and Forestry, Syracuse, New York. The Olmsted Center promotes the stewardship of significant landscapes through research, planning, and sustainable preservation maintenance. The Center accomplishes its mission in collaboration with a network of partners including national parks, universities, government agencies, and private nonprofit organizations. Techniques and principles of preservation practice are made available through training and publications. The Olmsted Center perpetuates the tradition of the Olmsted firms and Frederick Law Olmsted's lifelong commitment to people, parks, and public spaces.

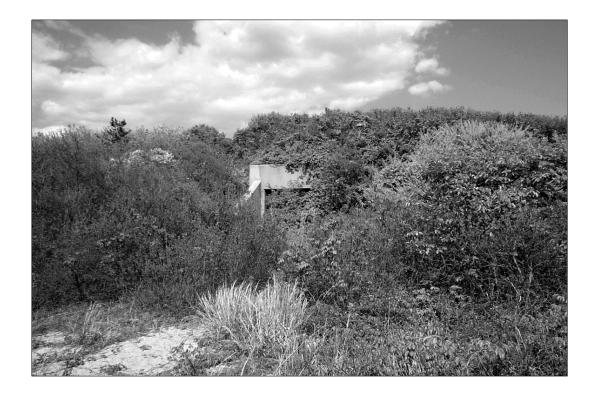
Figure 3.22. Battery Kessler (B-321), view of earthen cover and west entrance looking northeast from Shore Road, 2005. (SUNY ESF)

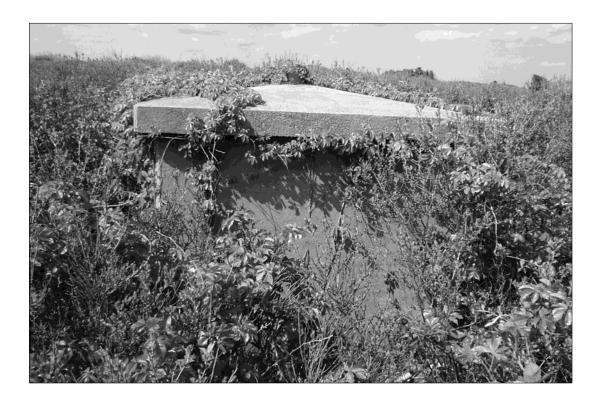
Figure 3.23. The telephone pit (B-323), looking southwest, 2005. (SUNY ESF)

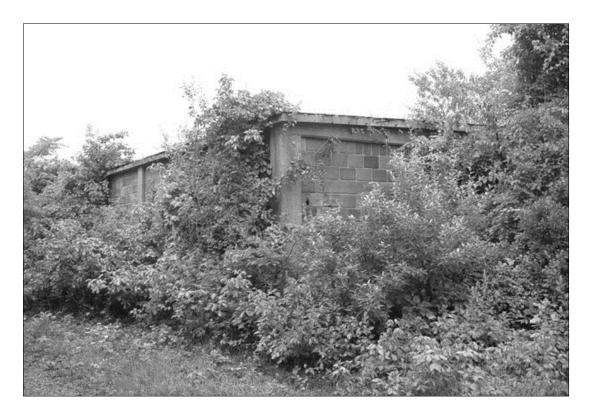
Figure 3.24. Battery Harris magazine (B-414), looking west from Range Road, 2004. Vegetation is concealing the entrance for the railway at right. The other three magazines(B-401, 405, 409) are the same design. (Pia Hermoso, GATE).

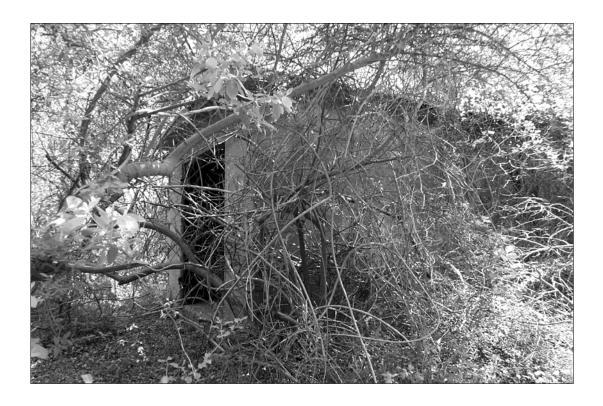
Figure 3.25. Anti-Aircraft Battery #3 support building (B-402), looking south from Marshall Road, 2005. (SUNY ESF)

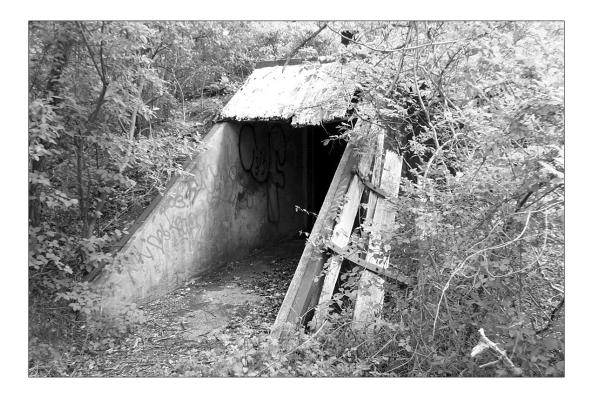
Figure 3.26. Entrance to one of two Igloo Magazines (B-403), view from Center Road, 2005. (SUNY ESF)

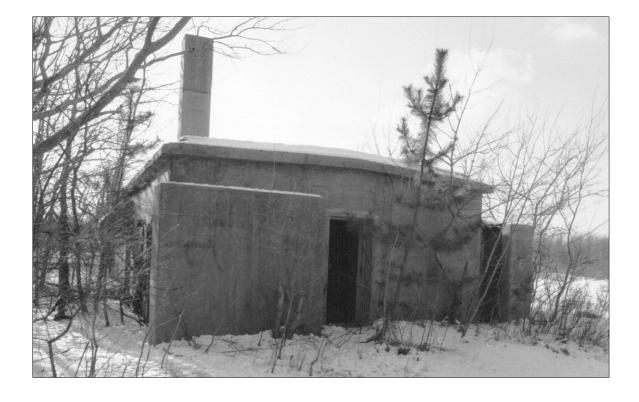
Figure 3.28. Power plant #3 (B-408), looking from Center Road, c.1996. The building is today (2005) more heavily covered in vegetation. (National Park Service, List of Classified Structures)

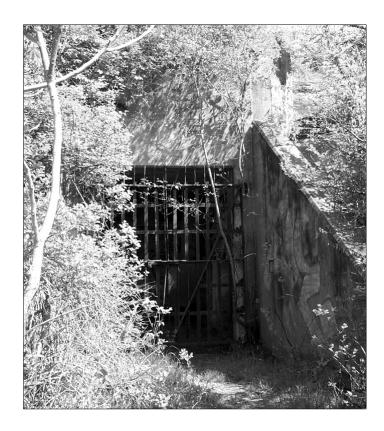
Figure 3.29. Gated entrance to earth-covered Mine Casemate and Plotting Room (B-511), 2005. (SUNY ESF)

B-511 (LCS 008408). Mine Casemate and Plotting Room (fig. 3.29)

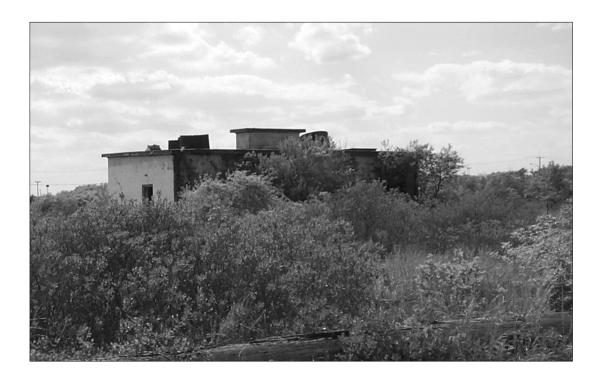
Figure 3.30. Nike NY-49 HI PAR Building (B-526), the only remaining building in missile tracking station #2 (Fisherman Parking Lot), 2005. (SUNY ESF)

B-526. Nike NY-49 HIPAR Building (fig. 3.30)

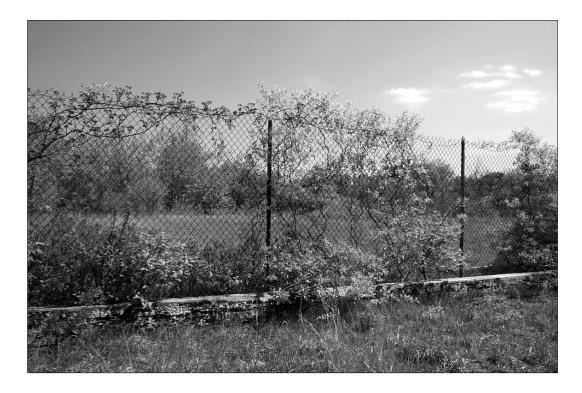
Figure 3.31. Typical chain-link fencing (SSF-1) found throughout the fortification area, view looking at portion around Nike missile launch pad installed in ca. 1955, 2005. (SUNY ESF)

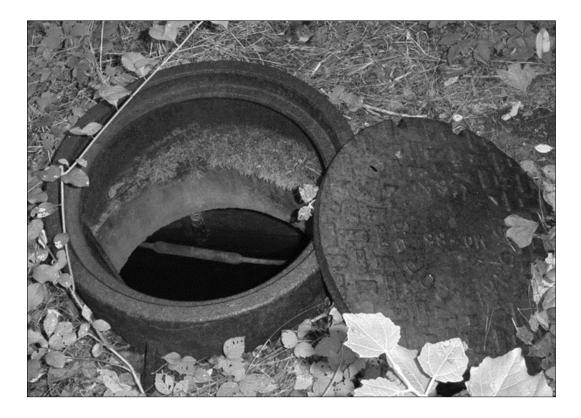
Figure 3.32. Manhole cover along underground utility vault northeast of Battery Harris magazine (Building 409), 2004. (Pia Hermoso, GATE)

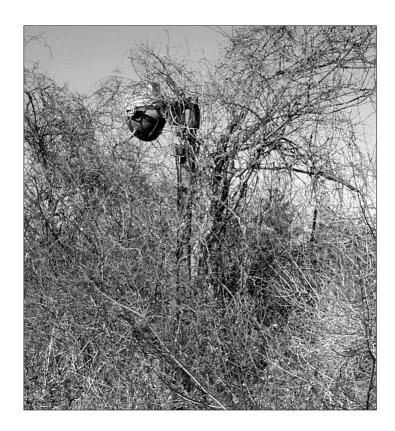
Figure 3.33. Typical Nike missile launch pad security light (SSF-4) showing overgrown conditions, 2005. (SUNY ESF)

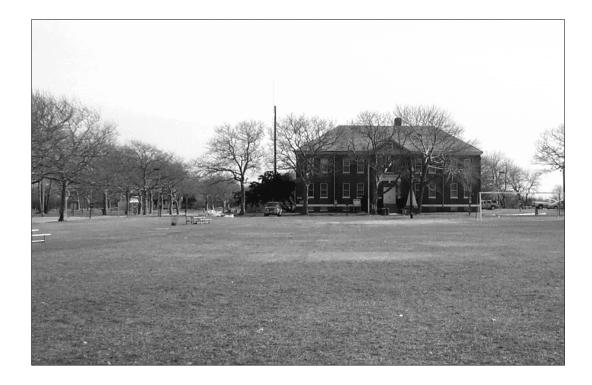
Figure 3.34. Looking south through the parade ground to administration building (Building 1) and roadside London plane trees, 2005. The area to the left was lined by buildings during World War II. (SUNY ESF)

Parade ground (Figure 3.34, 3.35)

Parade ground lawn (see Figure 3.34, 3.35)

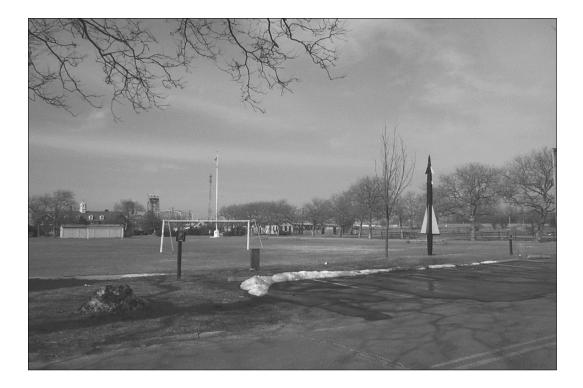
Figure 3.35. Looking northeast across the parade ground from the administration building (Building 1), 2005. Most of the perimeter of the parade ground was lined by buildings during World War II; the London plane trees from that era remain. The former US Coast Guard Station Rockaway and Gil Hodges Memorial Bridge are visible in the background. (SUNY ESF)

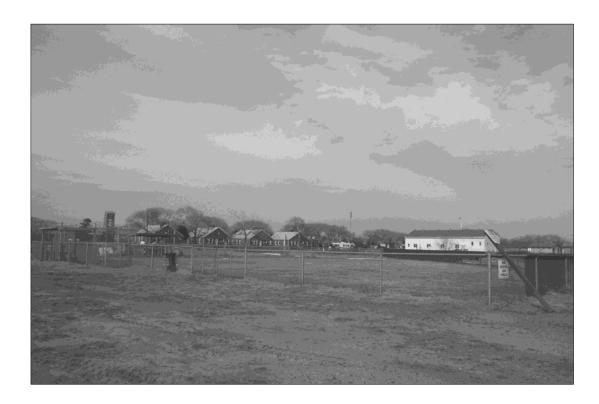
Figure 3.36. Looking northeast across former barracks area (present Little League fields) located west of the parade ground, showing remnant buildings, 2005. These include a row of brick officer's quarters (Buildings 133-136) and the recreation hall (Building T-149, white building). (SUNY ESF)

Rockaway Little League Baseball Diamonds (former barracks area) (Figure 3.36)

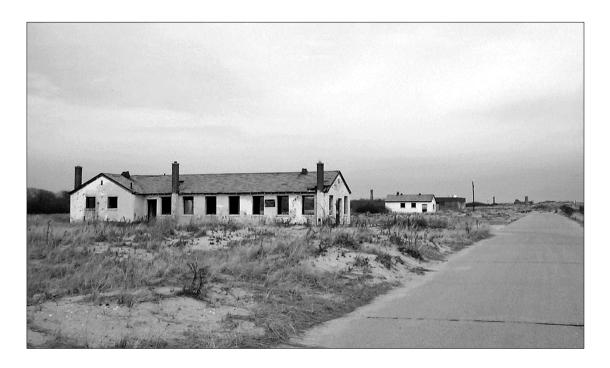
Figure 3.37. Looking east along Shore Road at the post beachfront area, with shell of the former Officer's Mess (Building 16) in the foreground and the current park bathhouse and latrine (Buildings 17, 18, formerly the officers' bathhouse and latrine) in the background, 2005. (SUNY ESF)

Beachfront area (Figure 3.37)

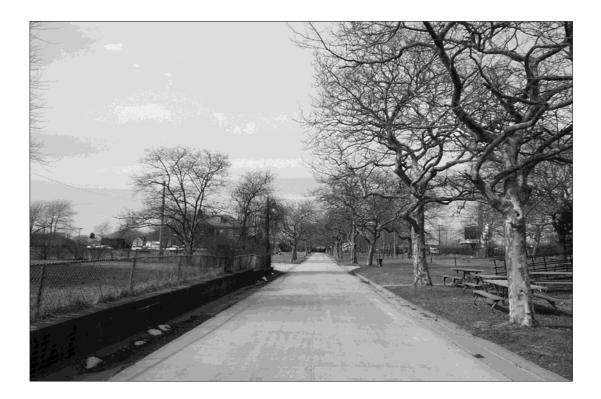
Figure 3.38. Davis Road, looking north from former Commanding Officer's Quarters (Building 22) illustrating World War Ilera road (repaved in asphalt), concrete gutters, and London plane trees, along with NPS picnic tables, 2005. Both sides of the road were lined by buildings during World War II. (SUNY ESF)

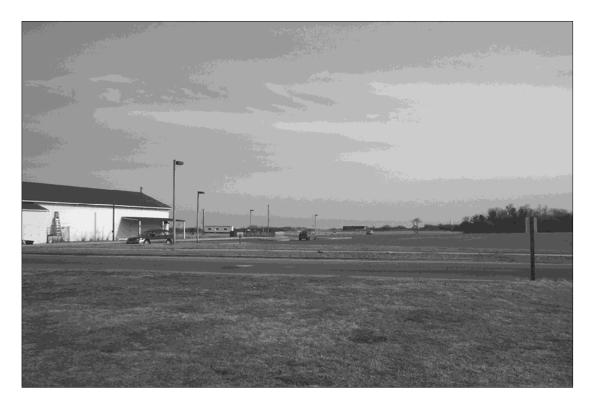
Figure 3.39. Large parking lot at Rockaway Art Alliance Building (T-7), looking south across Haan Road toward former drill ground, 2005. (SUNY ESF)

Rockaway Artists' Alliance parking lot (Figure 3.39)

Successional woods (see Figure 3.39)

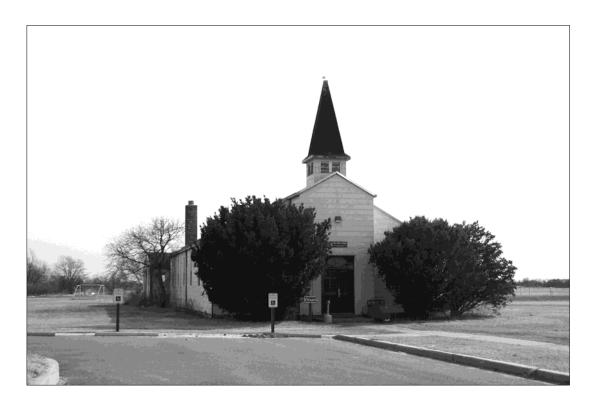
Figure 3.40. The Series 700 Fort Tilden chapel (T-3), looking south from Heinzelman Road where it was relocated during the Cold War, 2005. The yews date to the Cold War, and the curbs along the road are an NPS addition. (SUNY ESF)

Chapel yews (Figure 3.40)

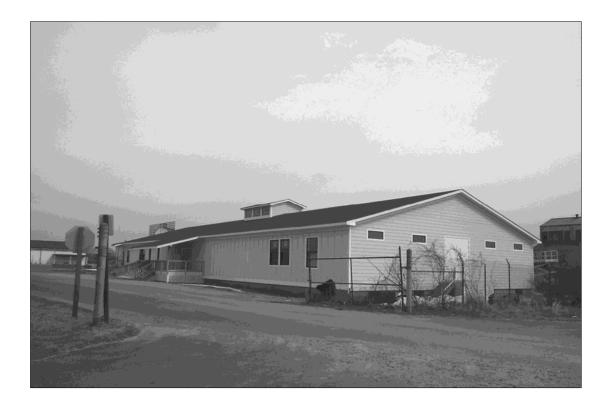
Figure 3.41. The Rockaway Arts Alliance building (Building T-7, former Quartermaster Warehouse), a Series 700 building built in ca. 1941 and renovated in 2004, looking southeast from Haan Road, 2005. (SUNY ESF)

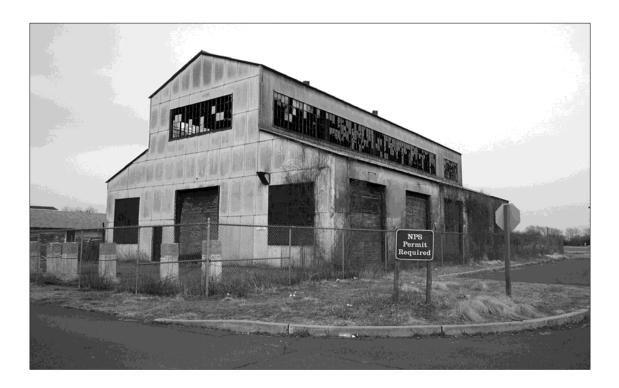
Figure 3.42. The World War II-era Ordnance Repair Shop (Building 9) with NPS parking area at right, 2005. This building, along with nearby warehouses (Buildings T-6, T-7) formed an industrial complex at the western side of the post. (SUNY ESF)

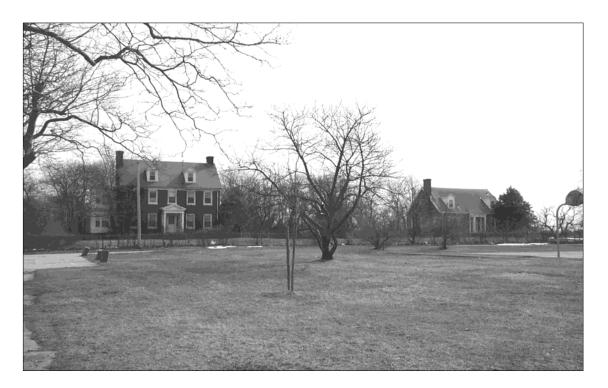
Figure 3.43. World War II-era officer quarters, looking southwest with former Commanding Officer's Quarters (Building 22) on the left (with recent vinyl windows and siding) and a smaller officer's quarters (Building 23) on the right, 2005. At right is a Cold War-era tennis-basektball court. (SUNY ESF)

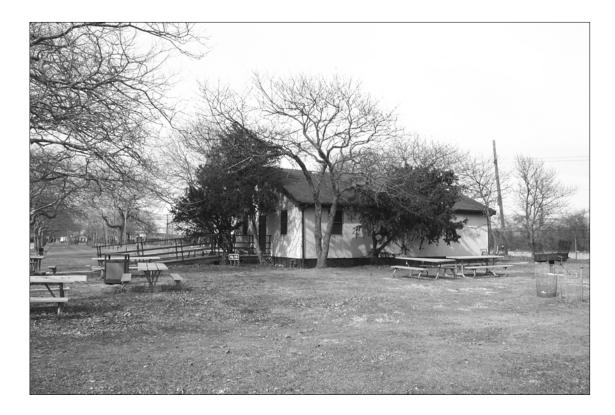
Figure 3.44. Senior citizens' center (Building T-25, former World War II-era officer's quarters), renovated in the 1980s, looking southeast from Davis Road, 2005. The yews probably date from the World War II era. (SUNY ESF)

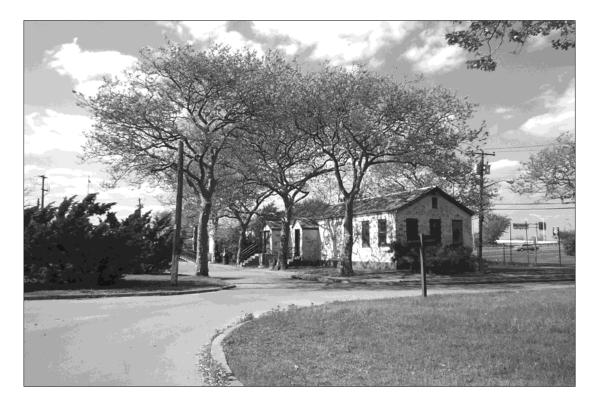
Figure 3.45. The World War II-era post (mail) office (Building 102) at the entrance to the post between Gates 18 (left) and 9 (right), looking northeast from Davis Road, 2005. At left are remnant foundation plantings from the World War II-era Provost Marshall building (T-168). (SUNY ESF)

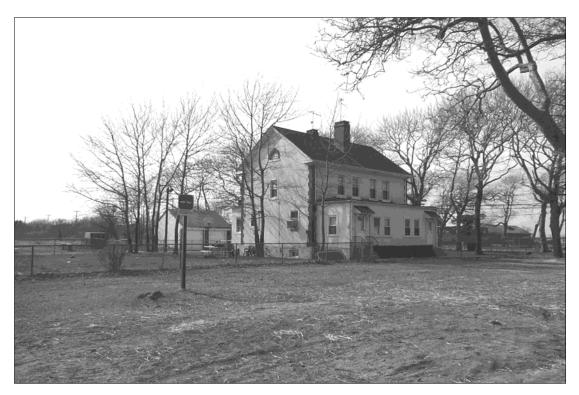
Figure 3.46. Officer quarters built in 1919 (former Double NCO, Building 106), looking northwest from Heinzelman Road, 2005. The front porch was originally open; the vinyl windows are a recent addition. Thisis the only remaining World War lead building in the post. (SUNY ESF)

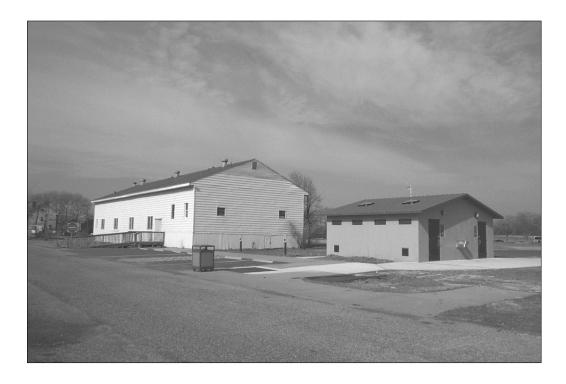
Figure 3.47. The World War II-era Series 700 recreation building (T-149) with newer siding and windows, and an NPS comfort station on the site of the World War II-era guard house (T-157), looking northeast with the parade ground in background, 2005. (SUNY ESF)

B-3 NPS Comfort Station (see Figure 3.47)

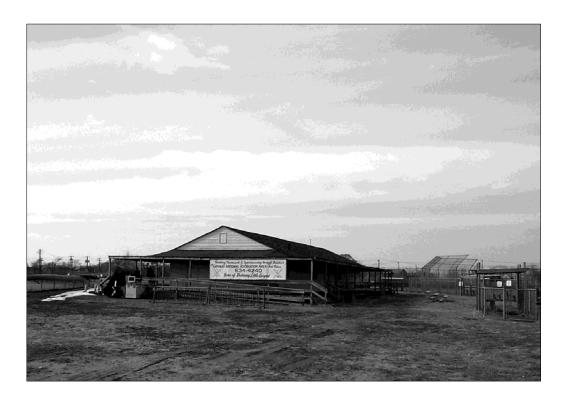
Figure 3.48. The Rockaway Little League clubhouse (T-162), the only remaining Series 700 building from the World War II-era barracks complex west of the parade ground, looking north, 2005. (SUNY ESF)

(Figure 3.48)

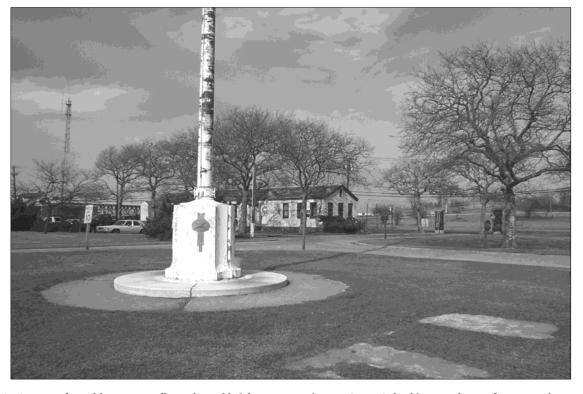
Figure 3.49. Base of World War II-era flagpole and brick entrance piers at Gate 10, looking north east from parade ground, 2005. Gate 10 once served as the main entrance to the post; the piers originally had lanterns on top. The concrete pads at lower right once support artillery displays. (SUNY ESF)

Basketball hoops
Entrance gate piers (Figure 3.49)
Fire hydrants
Parade ground missile (see Figure 3.34)
NPS Park and traffic signs

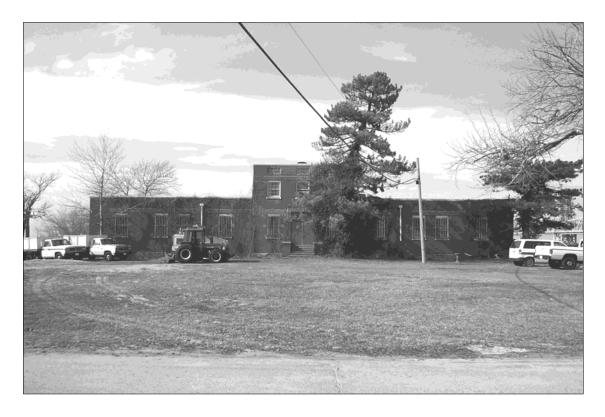
Figure 3.50. The WPA-built ordnance-administration building (Building 20, now storage) completed in 1937, looking north across Dunn Circle and lawn showing remnant ornamental plantings, 2005. (SUNY ESF)

Ordnance building (Building 219) front lawn space (Figure 3.50)

Ordnance building (Building 219) lawn (see Figure 3.50) Ordnance building (Building 219) conifers (see Figure 3.50) Goethals Road poplars Specimen deciduous trees (Buildings 201, 219)

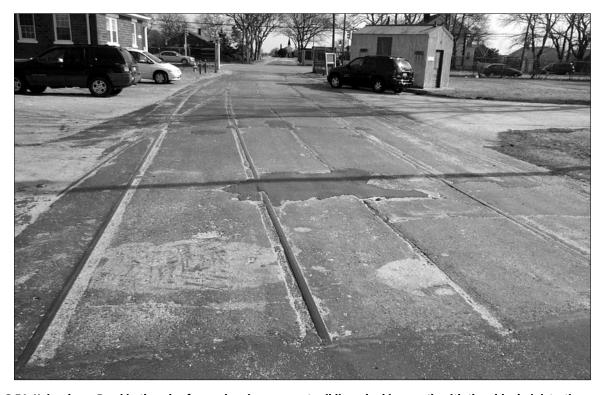
Figure 3.51. Heinzelman Road in the wharf area showing remnant rail lines, looking south with the old administration building at left, 2005. (SUNY ESF)

Dunn Circle (see Figure 3.50)
Goethals Road
Heinzelman Road (north)
Remnant railroad tracks (Figure 3.51)
New Riis Landing parking area (Figure 3.52)
Building 201 entrance walk
New walk to ferry dock

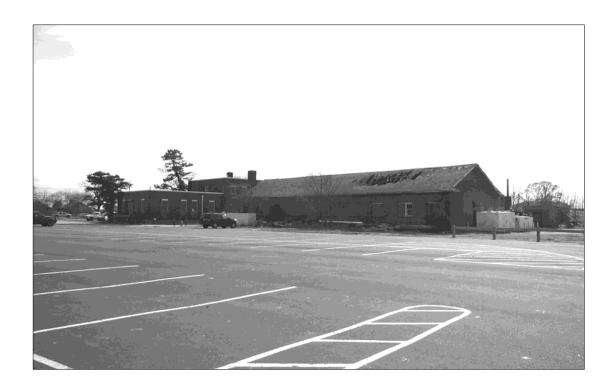
Figure 3.52. Riis Landing parking lot, completed in c.2004 on site of several World War II-era buildings and rail lines in the wharf area, looking northeast toward rear of Building 20 (storage, former administration building) at left and garage T-184 to right, 2005. (SUNY ESF)

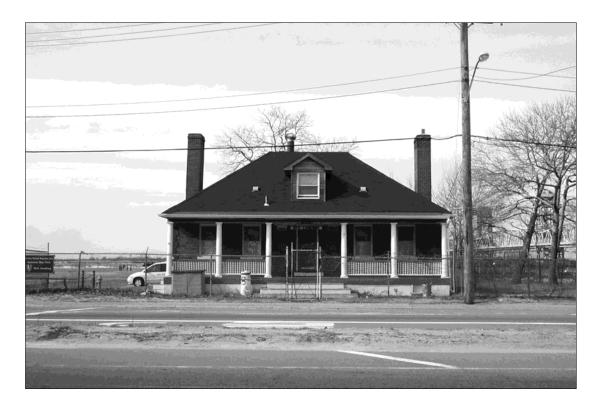
Figure 3.53. Building 49 (currently leased), the World War I-era headquarters building, looking north showing replacement dormer and new windows, 2005. The chain-link fence dates to the World War I-II era. (SUNY ESF)

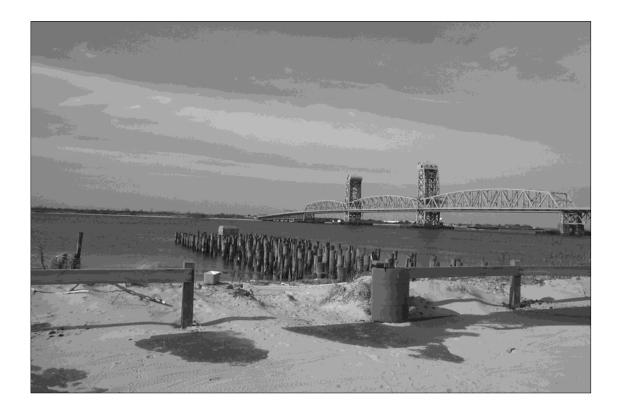
Figure 3.54. Remnant pilings from the Fort Tilden wharf (Building 209), looking northeast from the new Riis Landing parking area, 2005. (SUNY ESF)

Wood railings at Riis Landing parking area (see Figure 3.54)

To date, there has not been a comprehensive archeological survey undertaken for the wharf area. As with the fortification area, there is little probability of prehistoric resources given that the site was open water into nineteenth century. However, there may have been earlier barrier islands; coring samples undertaken in 1921 near Battery Harris revealed evidence of an earlier beach, with charcoal and wood traces in sands ten feet below sea level. Historic-period archeological remains of undetermined significance exist throughout the wharf area, most relating to demolished Army buildings and structures. The remnant pilings of the wharf are an archeogical resource.

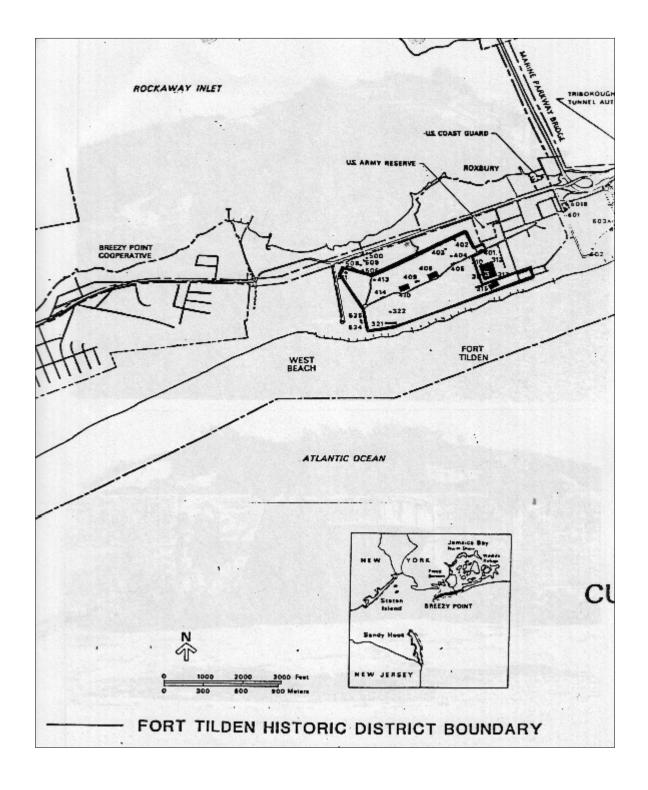
APPENDIX E. NATIONAL REGISTER DISTRICT MAP OF FORT TILDEN, 1984

Heavy black line denotes National Register district boundary (fortification area)
