CULTURAL LANDSCAPE REPORT FOR
THE HOME OF FRANKLIN D. ROOSEVELT
NATIONAL HISTORIC SITE

Kristin Theresa Baker

Master of Science in Landscape Architecture Degree

May 1999

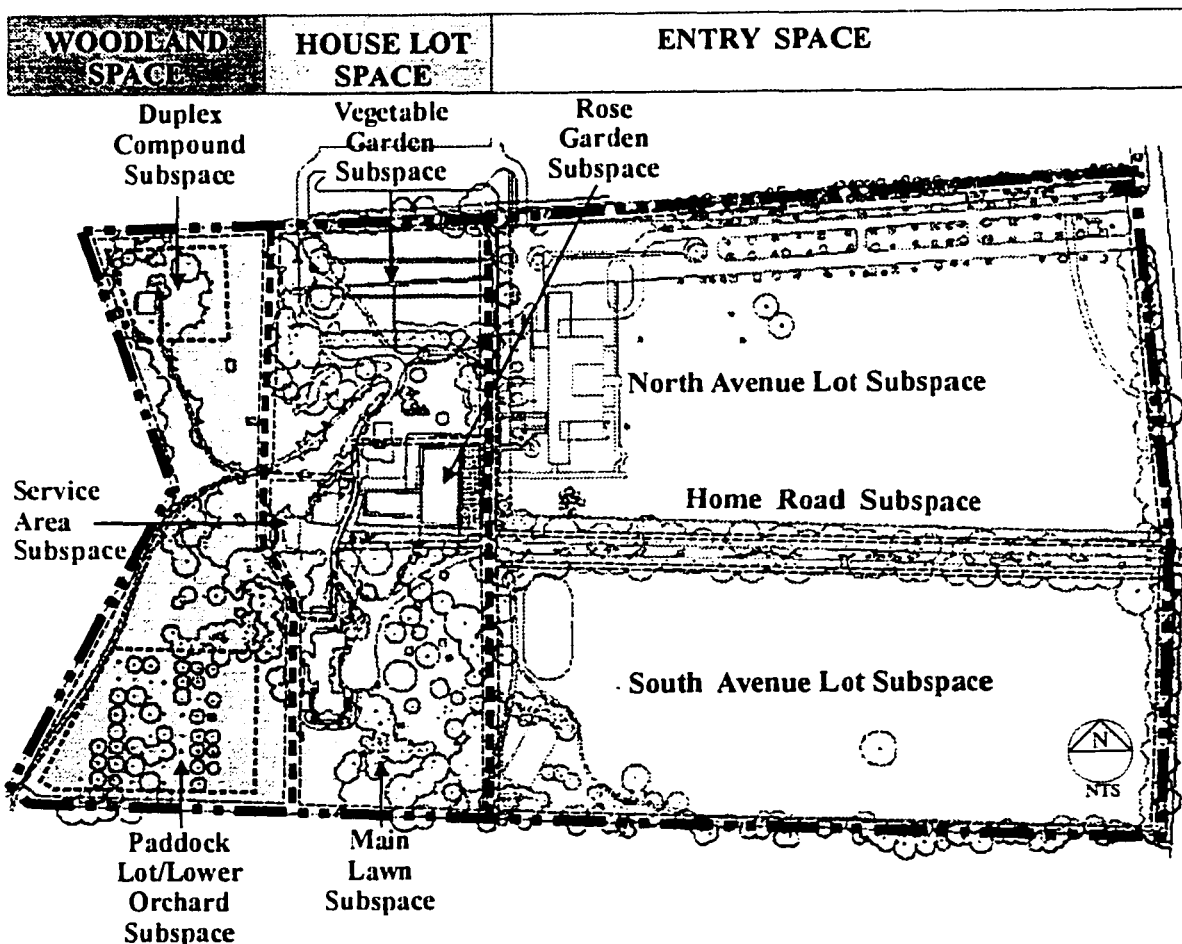
Figure 0.3: Diagram of spaces and subspaces of the Home of Franklin D. Roosevelt NHS. (K. Baker and G. Dallmann, SUNY CESF, 1998, based on the 1946 USGS map).

ENTRY SPACE - This section provides detailed information on the character-defining features within the fields and entrance road located east of the house, and includes: the **North Avenue Lot Subspace**, **Home Road Subspace**, and **South Avenue Lot Subspace** (figure 0.3).

HOUSE LOT SPACE - This section provides detailed information on the character-defining features surrounding Springwood, and include: the **Main Lawn Subspace**, **Service Area Subspace**, **Rose Garden Subspace**, and **Vegetable Garden Subspace** (see figure 0.3).

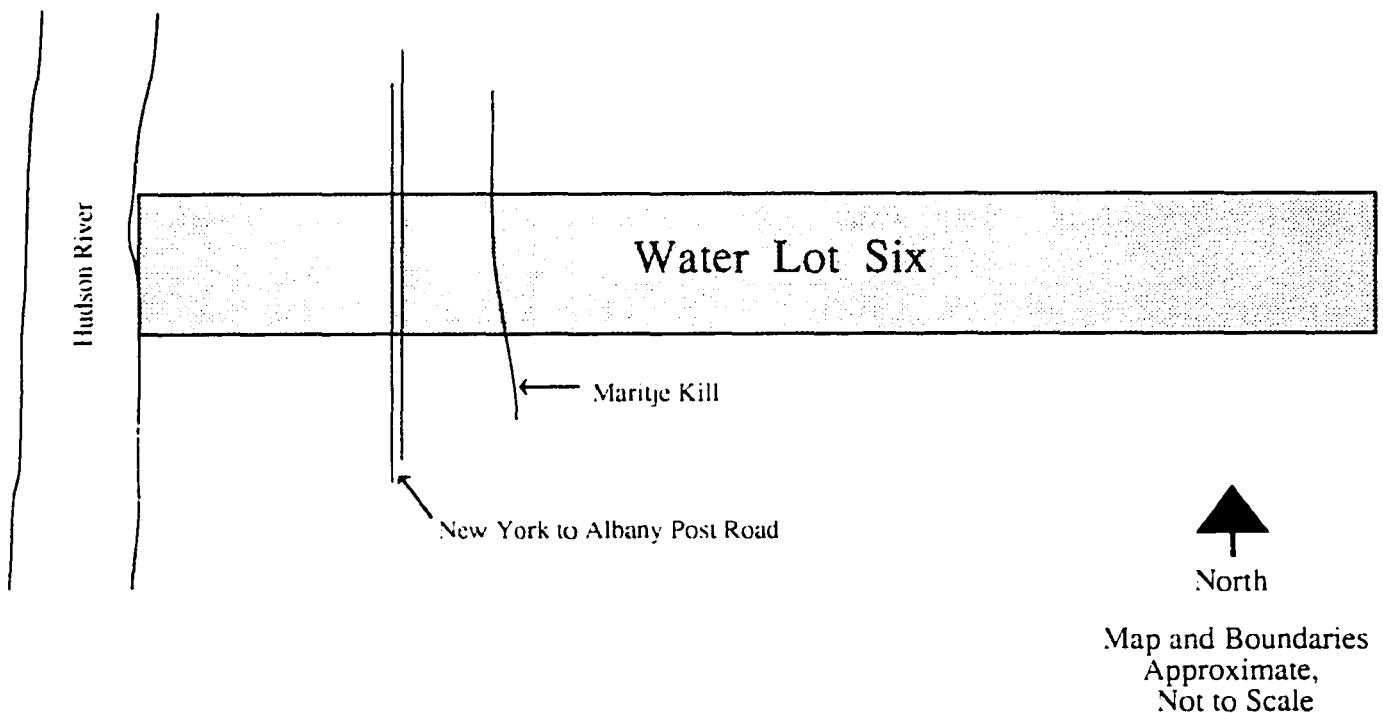
Figure 1.3: Diagram of Water Lot Six. (K. Baker, SUNY CESF, 1998).

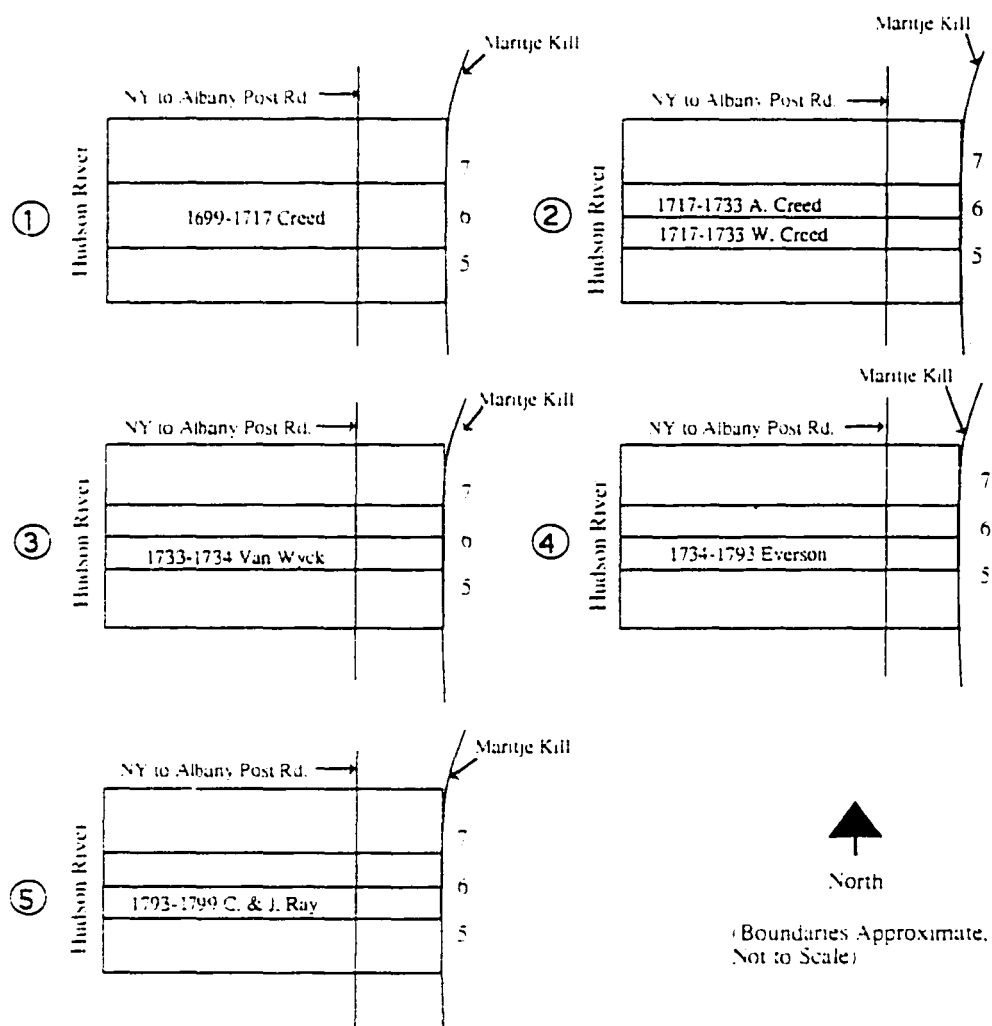
Figure 1.4: Changing ownership of Water Lot Six, 1697-1799. (K. Baker, SUNY CESF, 1998).

Water Lot Six was owned by William Creed from 1699 until his death in 1717, when it was divided in two sections for his grandsons, Augustine Creed taking the north half and William Creed taking the southern portion (figure 1.4). William did nothing to his property, and in 1733 sold it to Theodorus and Cornelius Van Wyck (see figure 1.4).²⁶ The entire patent land changed hands so many times between 1699 and 1730 that in 1734 a meeting was held in New York City of all people claiming title to any land in the Patent. At this meeting, the claims were adjusted and a Deed of Partition was signed by all members in the partnership; it was then that the Van Wycks exchanged their southern portion of Water Lot Six with John Everson for land he owned elsewhere in the patent (see figure 1.4).²⁷

In 1772 John Everson died and left the property to his widow, Elza Ray Everson. Twenty-one years later, in 1793, wishing to liquidate her estate, she sold her half of Water Lot Six to her nephews, Cornelius and John Ray (see figure 1.4). The development of the Water Lot Six property was believed to have begun in the 1790s during the ownership of the Everson/Rays. The entrance road, which ran from Albany Post Road to the house, was created in c. 1790s and lined with an allee of trees in 1793.²⁸ Like many homes in the Hudson River Valley, the house was located at the top of a steep bluff overlooking the Hudson River. The exact date the house was constructed is not known, although it may have existed as early as 1793. The original house was thought to have been a Federal-style farmhouse.²⁹ The building was rectangular, 46 feet long (N/S) by 39 feet wide (E/W), two-and-one-half stories, and may have been sided with clapboard.³⁰

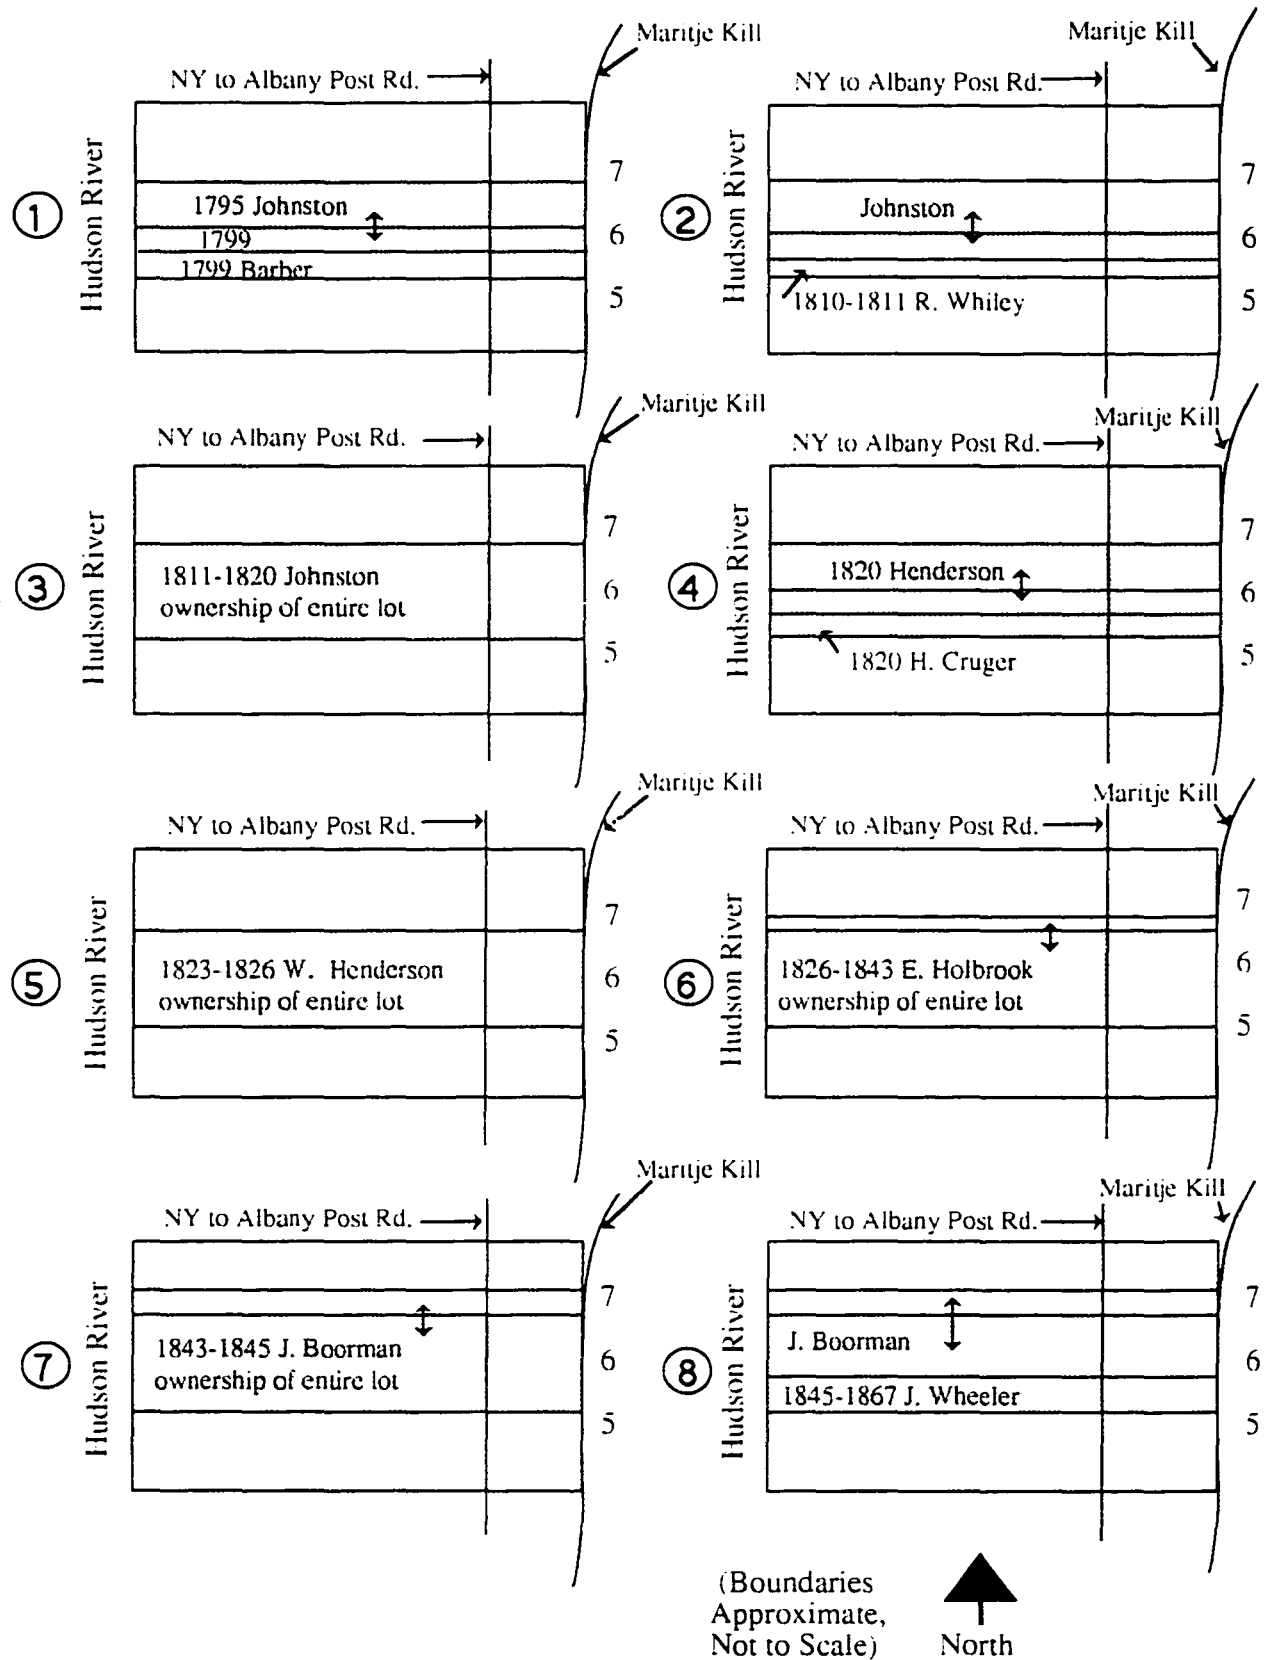
Figure 1.7: Changing ownership of Water Lot Six, 1799-1845. (K. Baker, SUNY CESF, 1998).

In 1799 Cornelius Ray divided the southern portion of Water Lot Six into two parcels (bounded by the Hudson River on the west and Maritje Kill to the east) and sold both portions (figure 1.7). It is unclear if the Rays kept the land from Maritje Kill to the east, or sold that land as well. In any case, the 76 acres of the south half of the southern portion of Lot Six were sold to Mrs. Anne Crooke Barber, who also owned Water Lot Five to the south (see figure 1.7).³³ The 80-acre north half of the southern portion of Water Lot Six was sold to John Johnston on the same day in 1799. Johnston, a lawyer who later became the presiding judge of the Court of Common Pleas of Dutchess County, already owned and had built his home, Bellefield on the 175-acre northern portion of Water Lot Six, which he purchased in 1795.³⁴ Mrs. Barber sold the south half of the southern portion of the property to Captain Richard Whiley in 1810 (see figure 1.7).³⁵ Within a year, Whiley sold the land to John Johnston, which gave Johnston ownership of the entire Water Lot Six from the Hudson River to Maritje Kill (see figure 1.7).³⁶ Most likely it was then that the property became known as the Bellefield farm.

In 1820 John Johnston divided and sold off the 76-acre southern portion of Water Lot Six to Henry Cruger. A second sale in 1820, to William Henderson, consisted of the 80-acre north half of the southern portion of Water lot Six, as well as the northern portion of Water Lot Six, including Bellefield, for a total of 252 acres (see figure 1.7).³⁷ In 1823 Henderson purchased the 76-acre southern portion from Cruger, and Water Lot Six was once again under one ownership (see figure 1.7).

Ephraim Holbrook, a retired New York City merchant, purchased all of Water Lot Six from the Hudson River to Maritje Kill from William Henderson in 1826, and later acquired 153 acres of land to the north on Water Lot Seven to increase his land holdings to 405 acres (see figure 1.7).³⁸ The Holbrooks were full-time residents on the farm and active in local affairs. Holbrook served as a vestryman for the church, was a member of Hyde Park's town board of tax assessors, and was an overseer for maintaining the New York and Albany Post Road from the Poughkeepsie town line north to the village of Hyde Park.³⁹

Seventeen years later, in 1843, James Boorman, a very successful businessman and one of the leaders in the organization of the Hudson River Railroad, purchased the 405 acres from Ephraim Holbrook, including the Bellefield farm (see figure 1.7).⁴⁰ In 1845 Boorman sold 94 acres (including the 76-acre southern section plus 18 acres from the northern half) of Water Lot 6 and the house attributed to the Eversons/Rays, to his son-in-law, Josiah Wheeler, for \$1 (see figure 1.7).

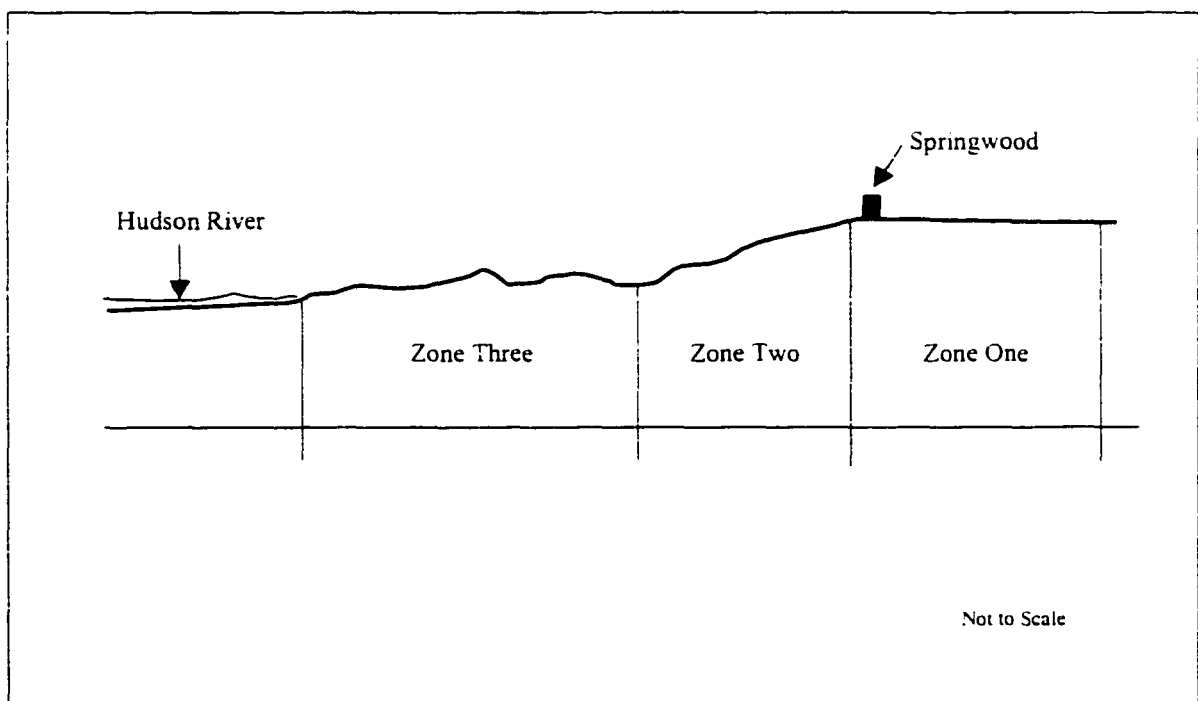
Figure 1.8: Topography of the Wheeler property. (K. Baker, SUNY CESF, 1998).

The acreage of this site consisted of three major topographical zones: a relatively flat plateau extending from the Albany Post Road west for approximately 1500 feet to a north/south running ridge; the ridge slope; and the land extending from the bottom of the ridge to the Hudson River (figure 1.8).⁴⁵

Springwood was located along the western edge of the plateau at the ridge line overlooking the Hudson River to the west. The top of this ridge line was approximately 180 feet above sea level and extended north and south for many miles along the eastern side of the Hudson River. The land sloped downward from this ridge line and the land between river and high plateau consisted of rough terrain with rocky ridges and deep ravines running parallel to the river. The highest elevation of the property was at the entrance to the property at the Albany Post Road, and the lowest elevation was at the Roosevelt Cove area and along the Hudson River shoreline.

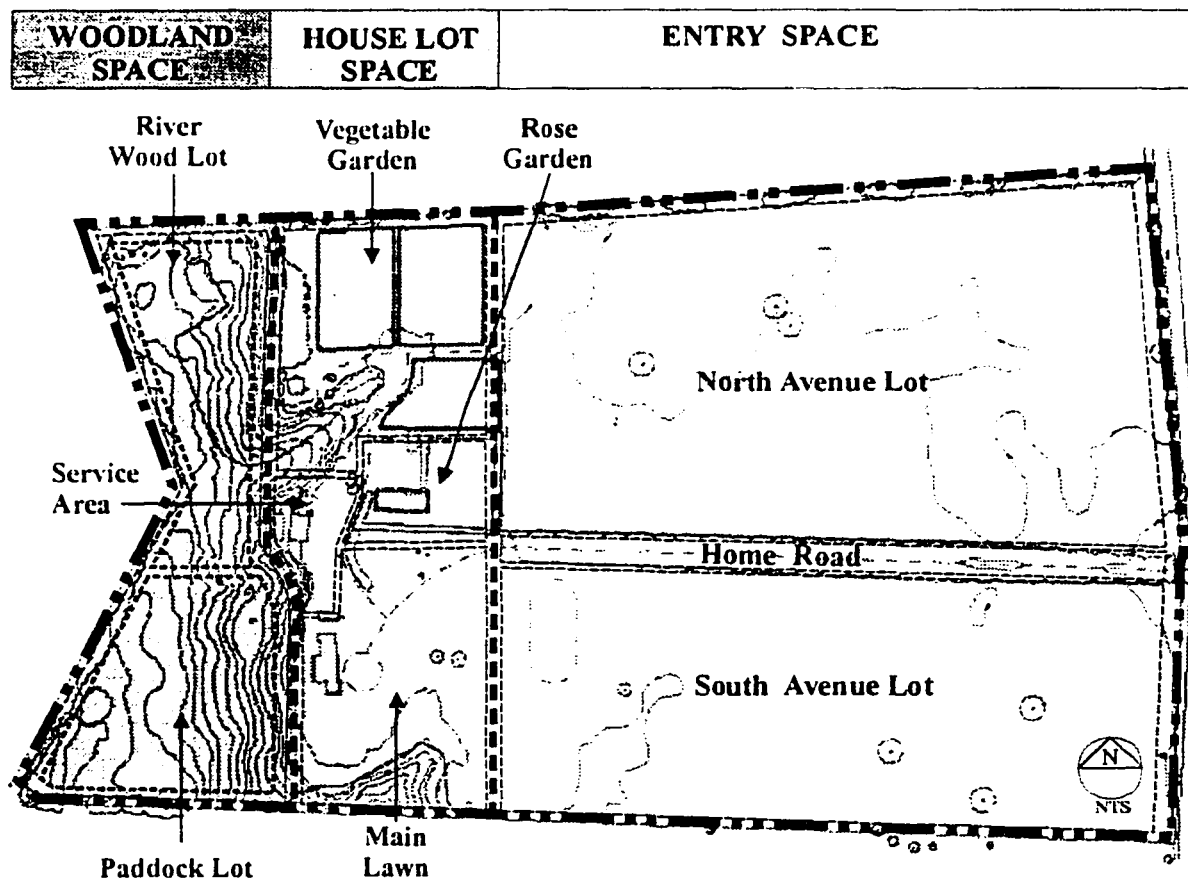
Figure 1.9: Organization of spaces within the Wheeler property. (K. Baker and G. Dallmann, SUNY CESF, 1998, based on the 1946 USGS map).

The Wheeler property consisted of three spatial divisions. The **Entry Space** was part of the flat upper plateau and located between the Albany Post Road to the east and the estate road to the west (figure 1.9). It was approximately 30 acres in size and square in shape. This space was defined to the north by vegetation along the property line, but the definer to the south is unknown. Vegetation along the Post Road somewhat limited views to the east. The **House Lot Space** was also located within the upper plateau, between the estate road to the east and the top of the north/south ridge line to the west (see figure 1.9). It was approximately 9.3 acres in size and rectangular in shape. The definer of the space to the north is unknown, but it was defined to the south by vegetation along the ridge. The **Woodland Space** consisted of the land from the ridge line to the east and the Hudson River shoreline to the west (see figure 1.9). The space was approximately 50.5 acres in size and rectangular in shape. The definers of the space to the north and south were not distinguishable because the woodland continued onto both properties. Whether this area was farmland, woodland, or a combination of both is unknown, but within the woodland were areas of thick vegetation that created a dense canopy with no views to the sky or out of the space.

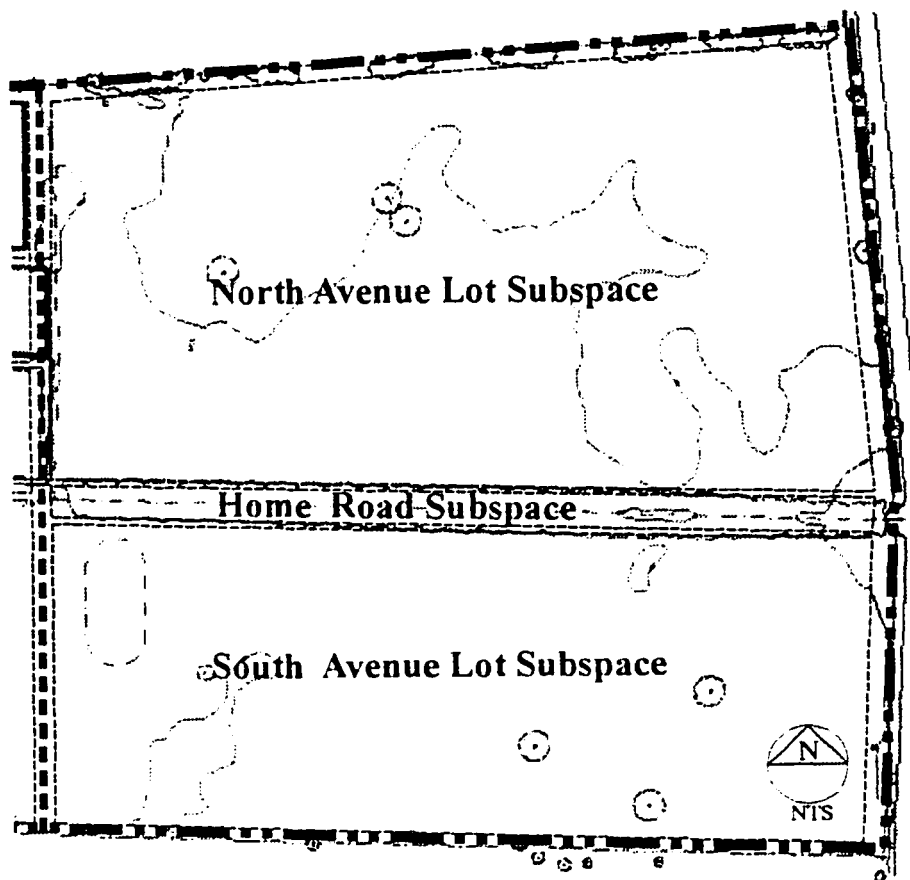
Figure 1.10: Spatial organization of the Entry Space including subspaces: the north avenue lot, home road, and the south avenue lot. (K. Baker and G. Dallmann, SUNY CESF, 1998, based on the 1946 USGS map).

Within the entry space there were three smaller subspaces: the north avenue lot, the home road, and the south avenue lot (figure 1.10). The *North Avenue Lot Subspace* was located in the northern part of the entry space. The rectangular space was 17 acres and approximately 1,200 feet long (E/W) and 640 feet wide (N/S). The space was defined to the north by the vegetation along the Boorman property, to the south by the tree allée along the home road, to the east by trees and a stone wall along the Post Road, and to the west by the estate road and vegetable garden subspace. The ground was flat and consisted of field crops, species unknown, and white oak trees that were objects within rather than definers of the space. Views out of the space were partially screened to the south and the east across Post Road, but open to the sky.

The second space, the *Home Road Subspace*, was in approximately the center of the entry space (see figure 1.10). The long, narrow rectangular space was 1.5 acres and approximately 1,200 feet long (E/W) and 40-60 feet wide (N/S). It was defined to the north and south by the trees of the allée, to the east by the Post Road, and to the west by the estate road. The ground was flat and consisted of both grass and compacted soil. Views out of the space were open.

The third subspace, the *South Avenue Lot Subspace*, was located in the southern part of the entry lot (see figure 1.10). The rectangular space was 12.5 acres and approximately 1200 feet long (E/W) by 480 feet wide (N/S). It was defined to the north by the tree allée along the home road, to the south the definer is unknown, to the east by trees along the and a stone wall Post Road, and to the west by the main lawn subspace. A trotting course was located in the northwest section of the space and formed an internal subspace. The ground was flat and consisted of field crops and white oak trees that were objects within rather than definers of the space. The view out of the space was partially screened to the north and the east across Post Road, but open to the sky.

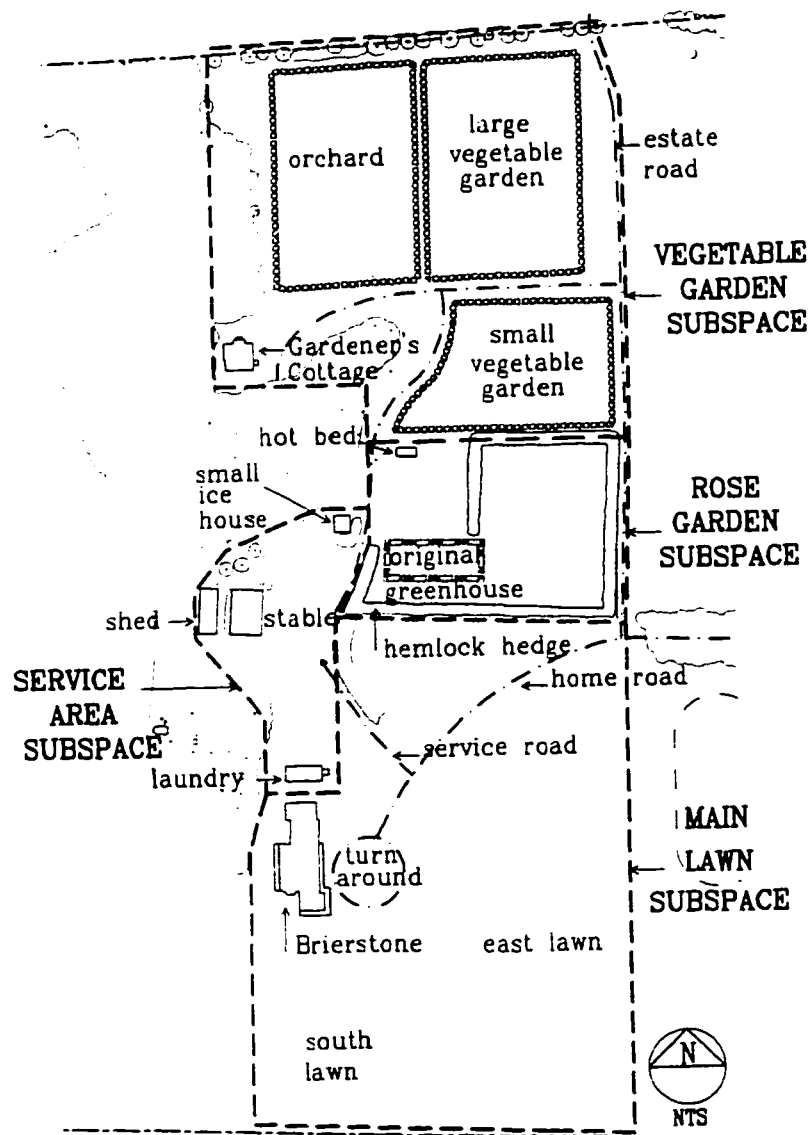
Figure 1.11: Spatial organization of the House Lot Space including the subspaces: main lawn, service area, rose garden, and vegetable garden. (K. Baker and G. Dallmann, SUNY CESF, 1998, based on the 1946 USGS map).

Within the house lot space there were four smaller subspaces including: the main lawn, the service area, the rose garden, and the vegetable garden (figure 1.11). The **Main Lawn Subspace** was located directly west of the south avenue lot subspace and included the main house. The rectangular space was 2.9 acres and approximately 460 feet long (N/S) by 400 feet wide (E/W). It was defined to the north by the hemlock hedge, to the south by the vegetation along the ridge, to the east by the field crops of the south avenue lot subspace, and to the west by the plateau ridge line. Within the space were two internal subspaces, the east lawn and south lawn. The ground of the east lawn was relatively flat or slightly undulating and may have consisted of grass and specimen trees that were objects within rather than definers of the space. The location and canopy these trees created are unknown. The ground of the south lawn was flat and may have consisted of grass. Views out of the space were fairly open to the Hudson River to the west and to the sky.

The **Service Area Subspace** was located directly north of the main house (see figure 1.11). The roughly rectangular space was .3 acres and approximately 280 feet long (N/S) by 80 feet wide (E/W). It was defined to the north by the small ice house, to the south by the main house, to the east by the service road and hemlock hedge, and to the west by the shed. Within the space were other buildings that formed internal subspaces between them. The ground was flat and consisted of both grass and compacted soil, and later gravel. Views out of the space were heavily screened, but open to the sky.

The **Rose Garden Subspace** was located northeast of the main house (see figure 1.11). The rectangular space was .44 acres and approximately 160 feet long (N/S) by 220 feet wide (E/W). It was defined to the north by the hemlock hedge, to the south and east by the hemlock hedge, and to the west by the hemlock hedge and greenhouse. The configuration of the garden during this period is unknown. Views out of the space were heavily screened, but open to the sky.

The **Vegetable Garden Subspace** was located northeast of the main house and directly north of the rose garden (see figure 1.11). The square space was 3.4 acres and

approximately 400 feet long (N/S) by 400 feet wide (E/W). It was defined to the north by the a fence along the property boundary line, to the south by the hemlock hedge, to the east by the estate road, and to the west by vegetation along the ridge line. Within the space were three internal subspaces including the small vegetable garden, large vegetable garden, and orchard. The small vegetable garden was located in the southern section of the space. The ground was flat and consisted of fruits and vegetables, exact species unknown. The large vegetable garden was located in the northeastern section of the space. The ground was flat and plantings consisted of fruits and vegetables, exact species unknown. The orchard was located in the northwestern section of the space. The ground was flat and most likely consisted of grass or meadow grass and fruit trees that created a regular, enclosed canopy. The views out of the space were partially screened, but open to the sky.

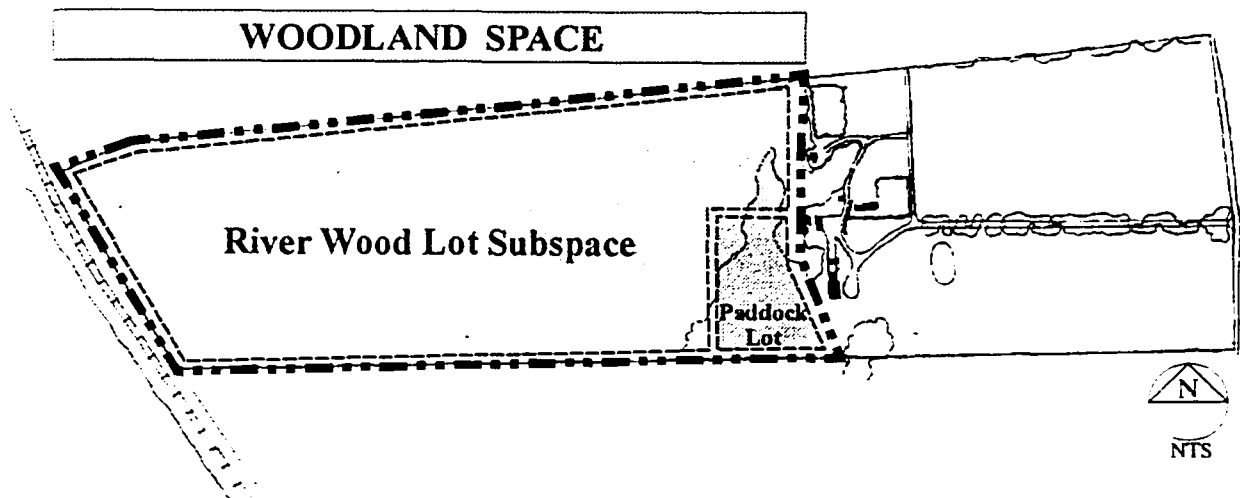
Figure 1.12: Spatial organization of the Woodland Space including subspaces: the paddock lot and river wood lot. (K. Baker and G. Dallmann, SUNY CESF, 1998, based on the 1946 USGS map).

Within the woodland space there were two smaller subspaces including the paddock lot and the river wood lot (figure 1.12). The *Paddock Lot Subspace* was located directly west of Brierstone. The space was rectangular, approximately 1.5 acres, and 360 feet long (N/S) by 240 feet wide (E/W). The definer of the paddock lot to north is unknown, but it was defined to the south by the trees along the property boundary, to the east by the ridge, and to the west by the vegetation of the wood lot. From the ridge line eastward, the ground was downward sloping and undulating. Views out of the space were partially screened by the vegetation to the south and west and the steep hill to the top of the ridge to the east, but open to the sky.

The second space, the *River Wood Lot Subspace*, was located to the west of the paddock lot subspace (see figure 1.12). The rectangular space was 49 acres, approximately 2,600 feet long (E/W) by 1,000 feet wide (N/S). The definers of the space to the north and south were not distinguishable, but defined to the east by the paddock lot and ridge line and to the west by the Hudson River. The ground varied from flat to undulating to deep ravines, and consisted of rock outcrops, understory vegetation and trees. The exact composition of the vegetation and the type of canopy it created is unknown. Views out of the space were heavily screened.

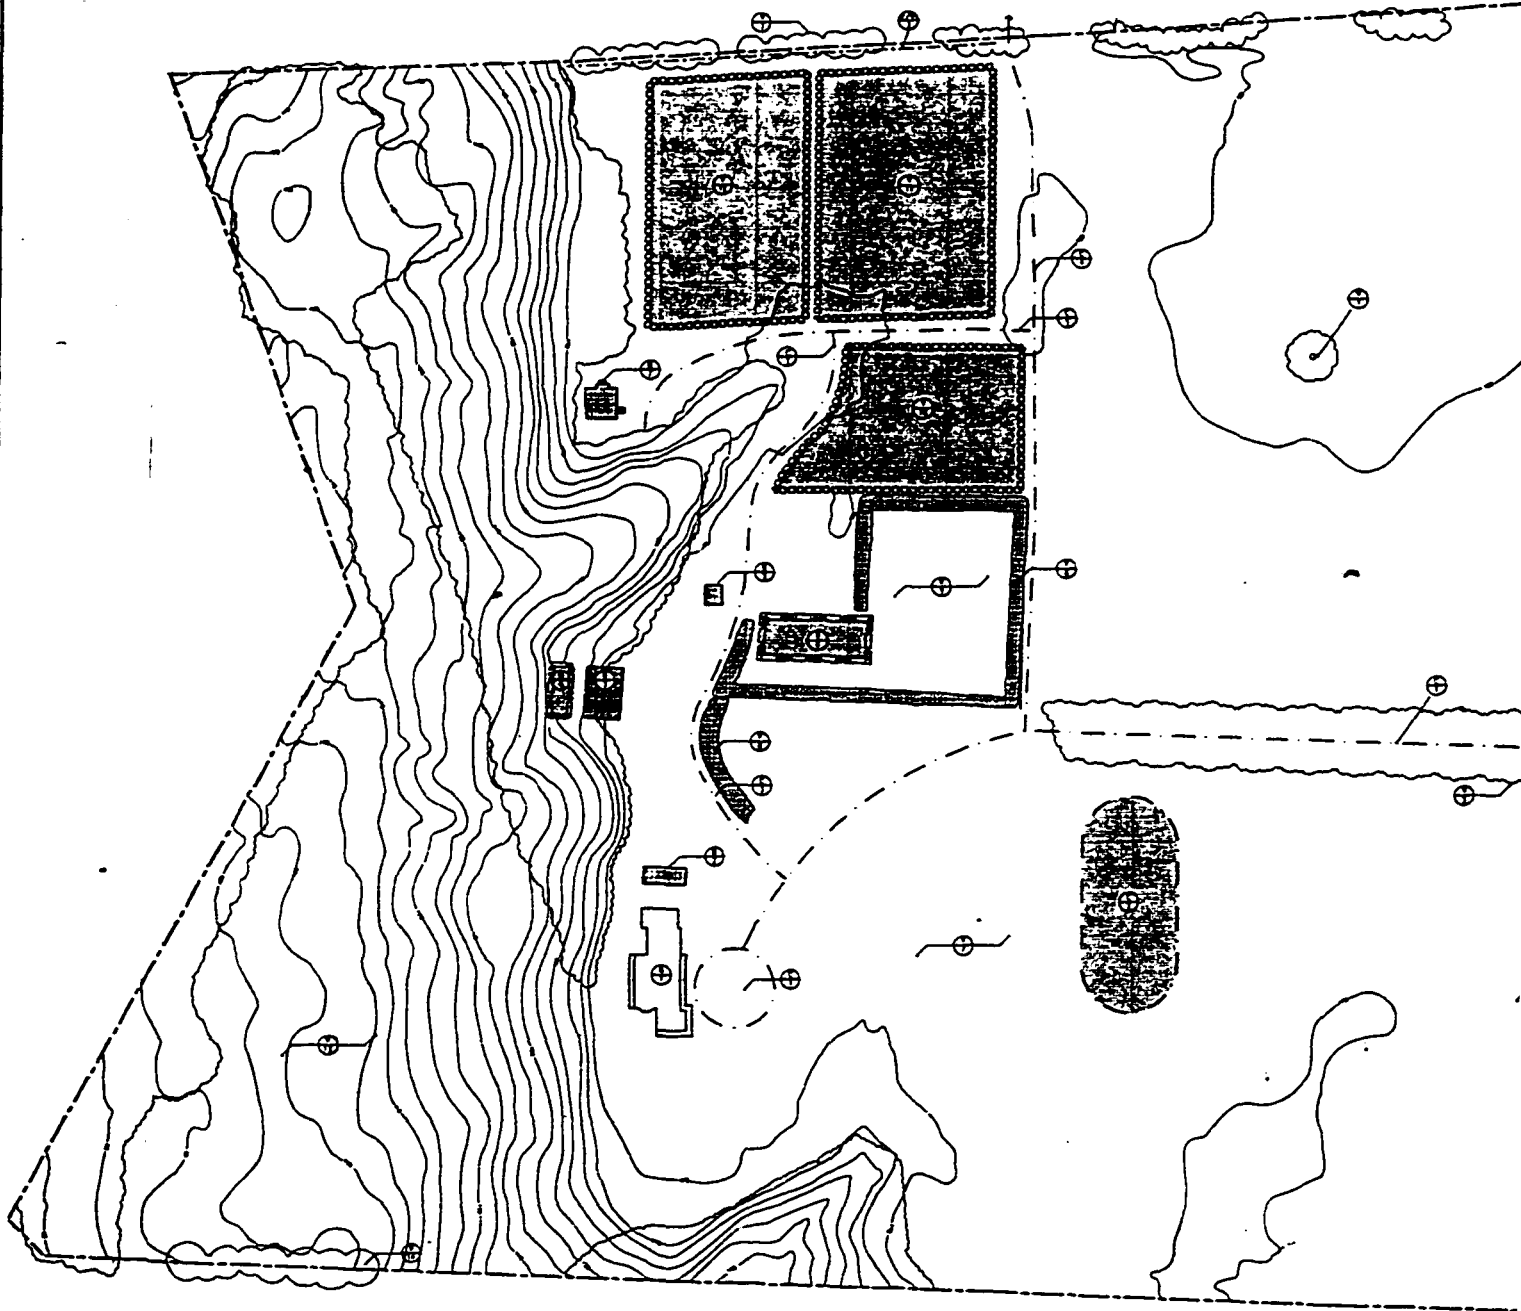
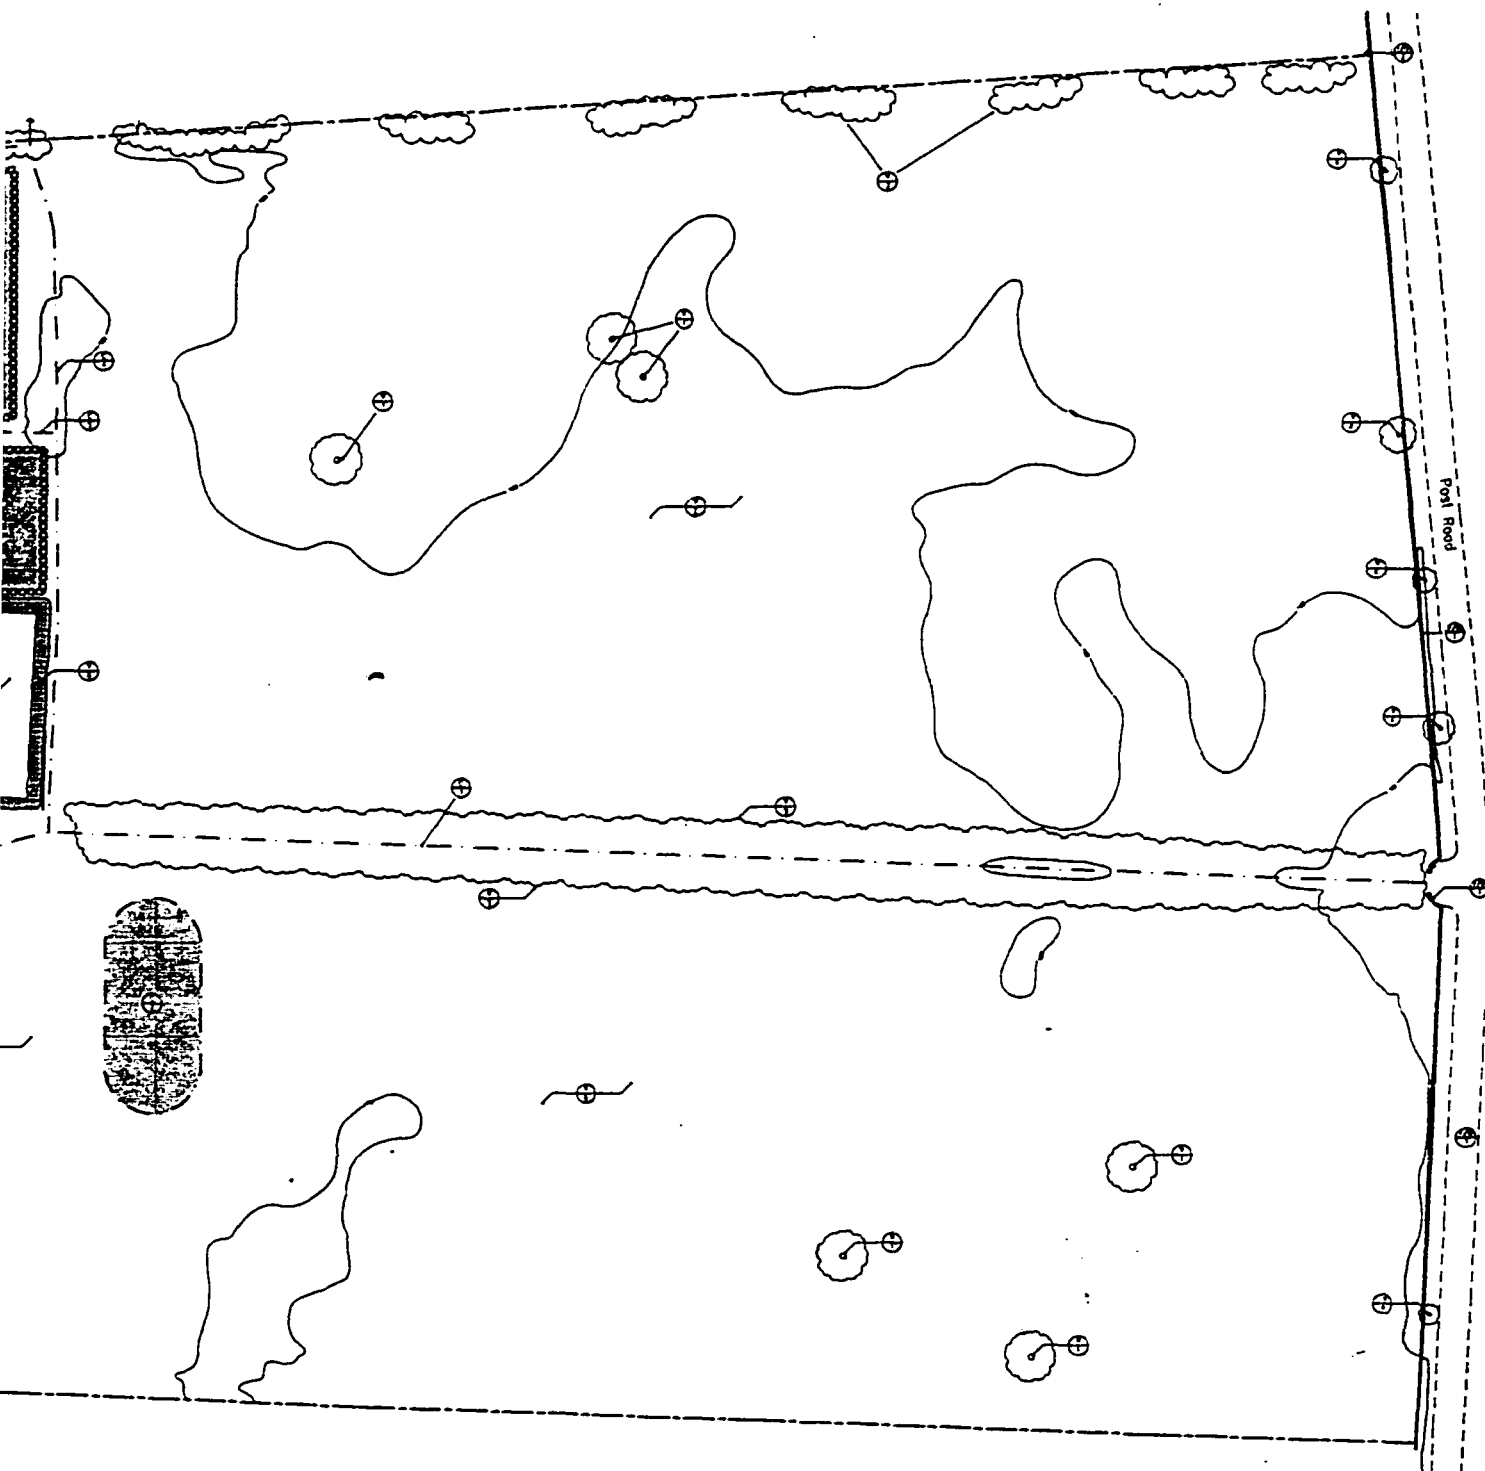
EARLY PROPERTY/WHEELER OWNERSHIP 1845-1867

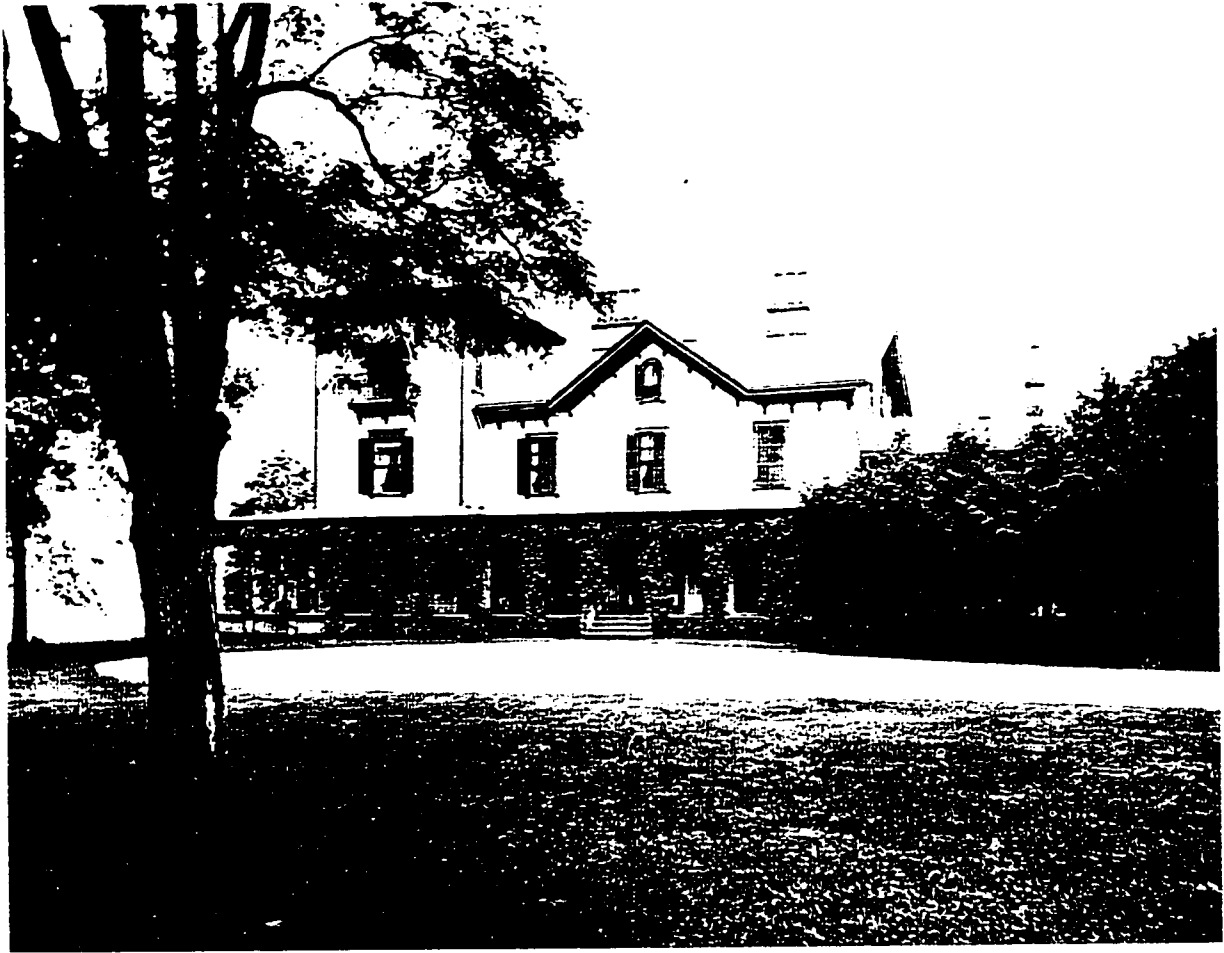
Figure 2.3: The east elevation of Springwood, 1881. (Franklin D. Roosevelt Library, Px 47-96:3562).

In 1867 James Roosevelt purchased the 110-acre Wheeler estate for the sum of \$40,000 (figure 2.1). That fall he brought his wife Rebecca and son Rosy to the estate, renaming it 'Springwood' (figure 2.2 and figure 2.3).

Specimen trees within the east lawn in 1900, date of planting unknown, included 7 American elms (*Ulmus americana*), 4 maples (*Acer* spp.), 1 honeylocust (*Gleditsia triacanthos*), and 1 Camperdown elm (*Ulmus glabra* 'Camperdownii') (see figure 2.3 and see Early Roosevelt Ownership period plan).³² Additional deciduous and evergreen plants were located within the east lawn, but their species could not be verified for this report.

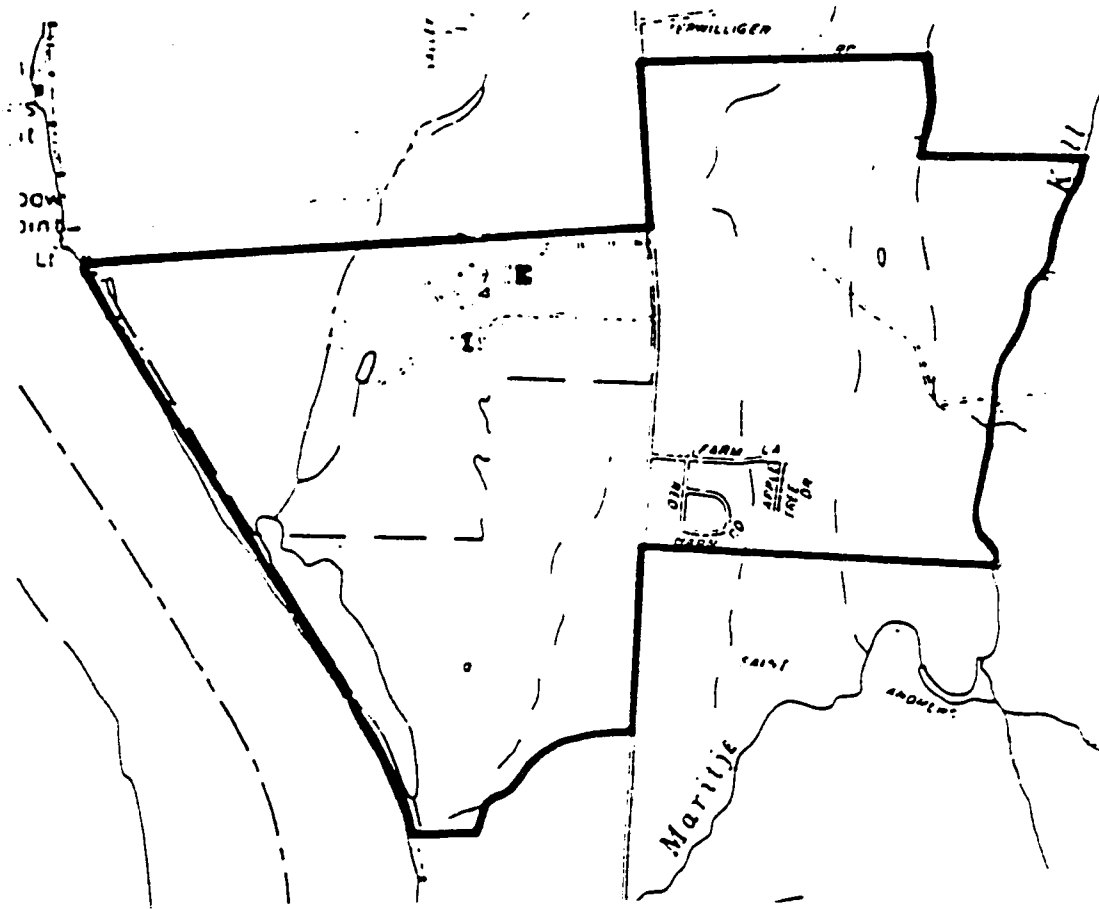
Figure 2.4: James Roosevelt's land holdings at the time of his death in 1900. (R. Kennen Moody, "FDR and His Neighbors," 1981, from Lacy, "Cultural Landscape Inventory").

James Roosevelt expanded his Hyde Park land holdings from a 110-acre estate to a 750-acre tract of land. In 1867 he purchased a portion of Water Lot Five to the south, also known as the Boreel property. This tract of land included 234 acres of Lot 5 and the building known as the "Red House," which James gave to his son Rosy in 1878. In 1868 James acquired 134 acres of land located east of the Red House, across Albany Post Road. In 1871 he once again increased his land holdings with the purchase of 182.65 acres east of Springwood and the Newbold/Morgan Estate (north of Springwood) and directly across Albany Post Road. Finally, in 1886, James purchased 100 acres of river frontage to the south to give him a total of 750 acres (figure 2.4).

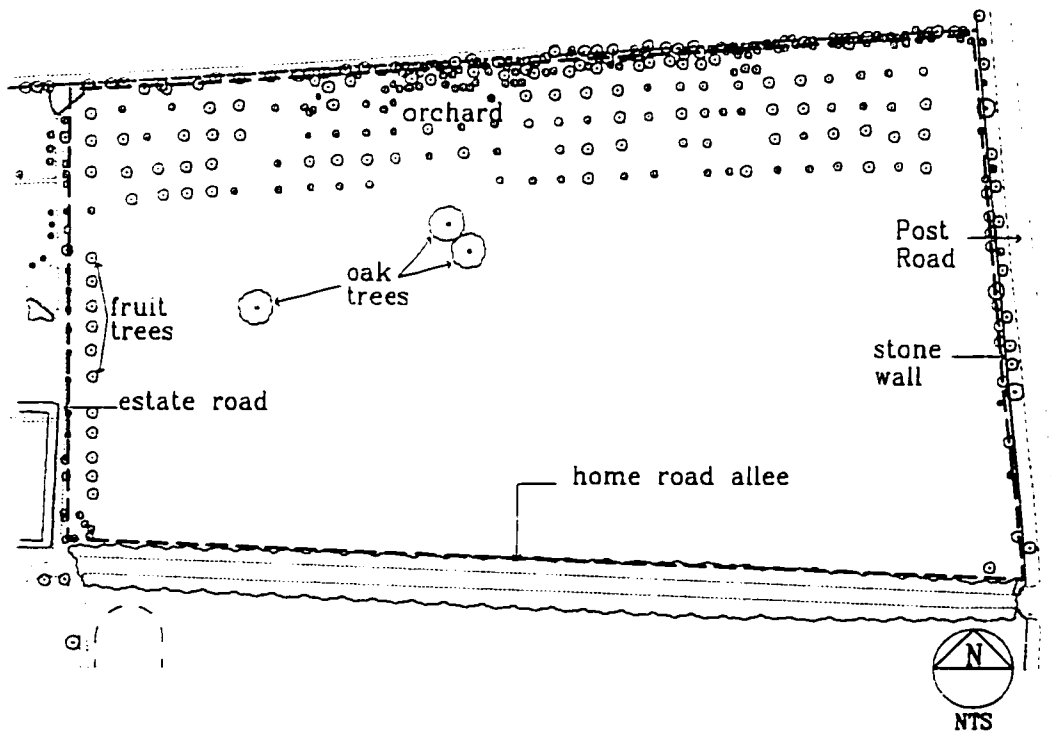
The space was altered during this period, although the exact date is unknown. An orchard was planted along the entire northern edge of the north avenue lot, creating an internal space within the lot. This orchard was rectangular in shape and contained approximately 3 acres (figure 2.5). It was defined to the north by vegetation along the property line, to the south by the north avenue lot space, to the east by the stone wall and trees along the Albany Post Road, and to the west by the estate road. The orchard screened views to the north. The ground within the north avenue lot was flat and planted with field crops.

Figure 2.5: Spatial organization of the north avenue lot and home road subspaces. (K. Baker and G. Dallmann, SUNY CESF, 1998, based on the 1946 USGS map).

An orchard may have been planted during the Early Roosevelt Ownership Period, exact date unknown, although this is unconfirmed.²⁶ It was located along the northern border of the north avenue lot. Four rows of trees extended from the Albany Post Road west to the estate road, and the total size of the orchard was approximately 1,040 feet long (N/S) by 120 feet wide (E/W) (see figure 2.5). The exact species of fruit trees are unknown.

Fruit trees were located adjacent to the estate road in the western section of the north avenue lot (see figure 2.5). The exact species is unknown.
