CULTURAL LANDSCAPE REPORT FOR
THE HOME OF FRANKLIN D. ROOSEVELT
NATIONAL HISTORIC SITE

Kristin Theresa Baker

Master of Science in Landscape Architecture Degree

May 1999

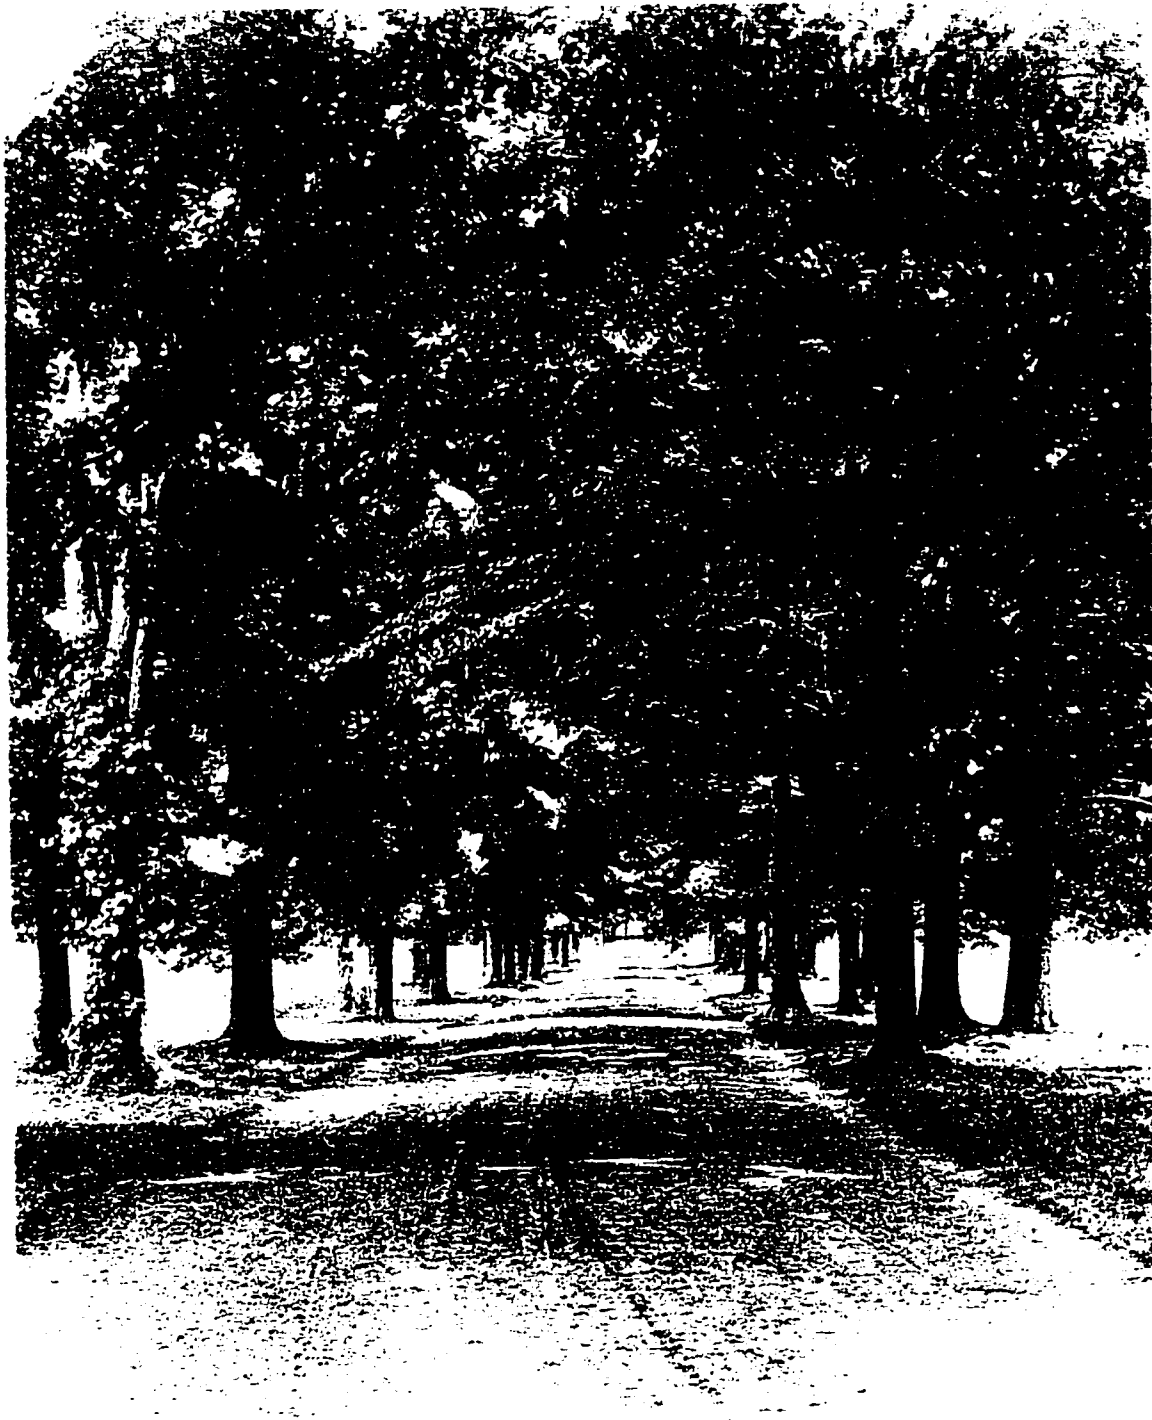
During this period the home road allée consisted of two, and in some cases three, irregular rows of trees located on either side of the road (figure 2.6). The trees were spaced in a random fashion instead of regular rows. The allée was a mix of deciduous and evergreen trees including white pines (*Pinus strobus*) and maples (*Acer* sp.) (figure 2.7). The understory was maintained as lawn.

Figure 2.6: View east of the home road and allée, 1898. (Franklin D. Roosevelt Library, NPx 72-199:4).

The home road was approximately 15 feet wide with a compacted soil or crushed gravel surface (see figure 2.6). The grass adjacent to the road was neatly edged.

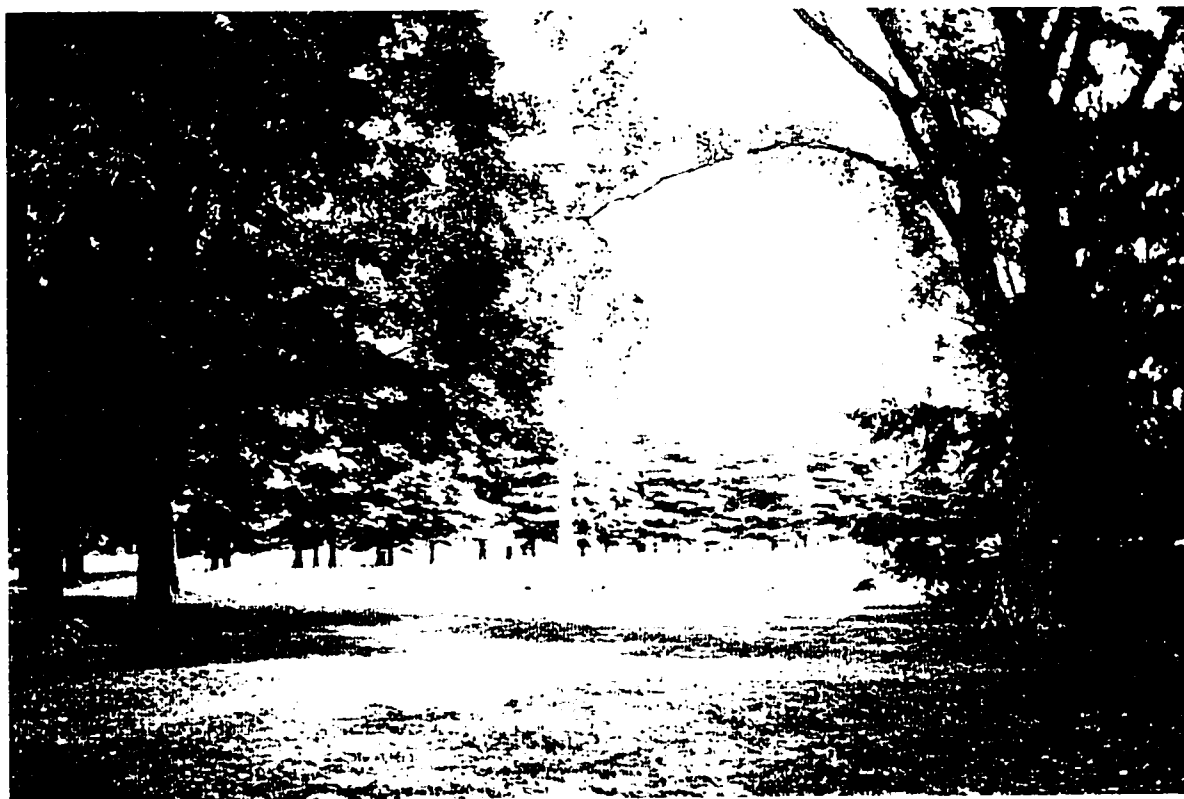
Figure 2.7: View northeast of the home road allée, 1897-98. (Franklin D. Roosevelt Library, Px 49-48:25).

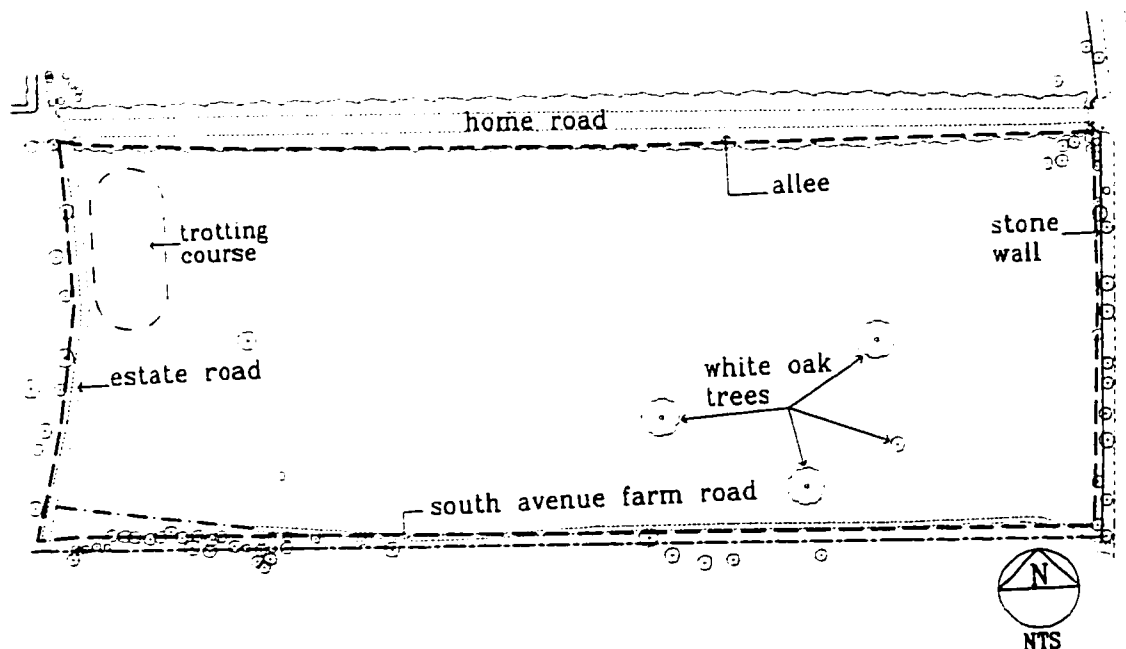
Figure 2.9: South avenue lot subspace. (K. Baker and G. Dallmann, SUNY CESF, 1998, based on the 1946 USGS map).

The topography of the south avenue lot was altered with the addition of the estate road, but because the ground was relatively flat, this feature only slightly altered the grade of the south avenue lot (figure 2.9).

The trotting course, located in the northwest section of the south avenue lot, was used during this period, although its alignment and material are unknown (see figure 2.9).

The estate road may have been expanded during the Early Roosevelt Ownership period, exact date unknown. It was located along the eastern border of the south avenue lot subspace and ran in a north-south direction between the entry and house lot spaces to connected the Roosevelt, Rosy Roosevelt, and Newbold properties (see figure 2.9). The alignment, dimensions, and materials of the estate road are unknown.

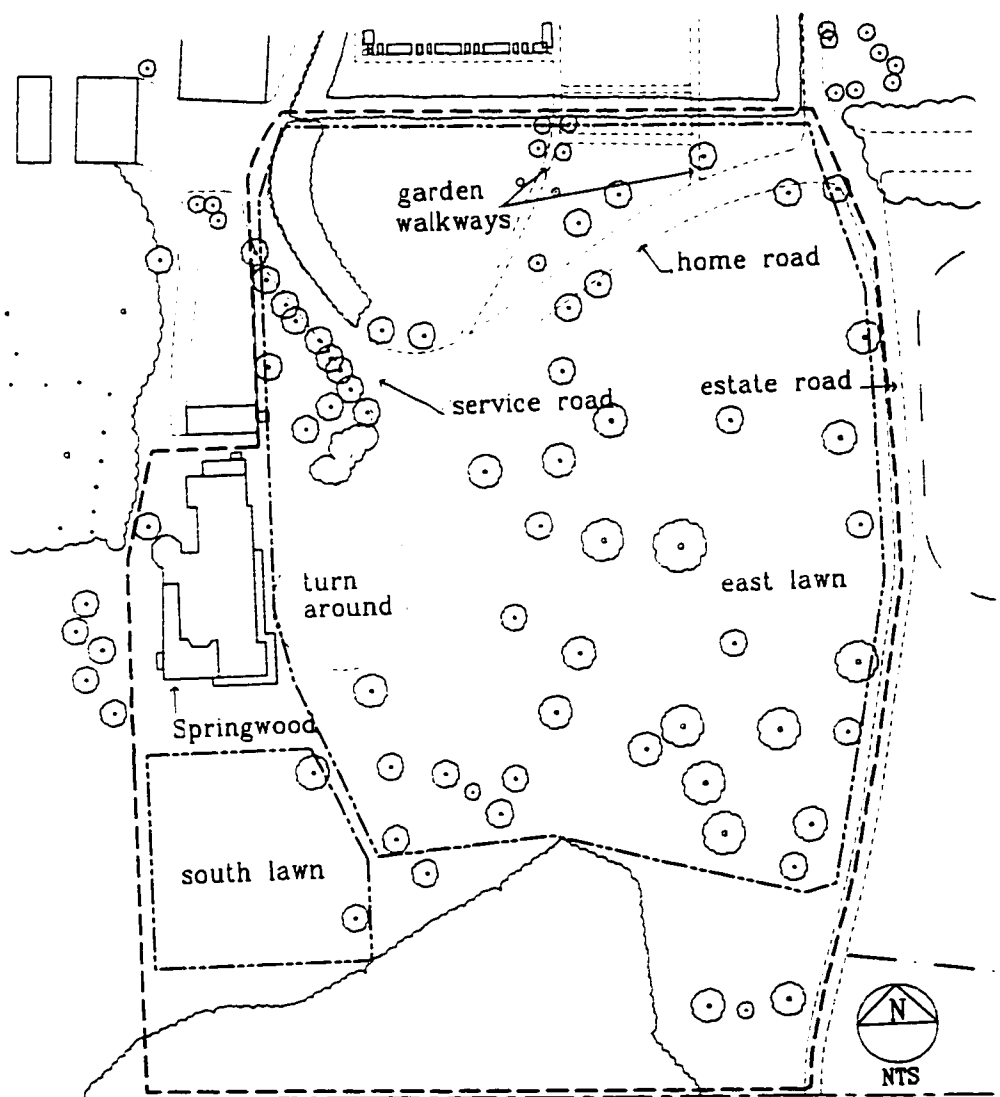
The main lawn subspace was altered slightly during the Early Roosevelt Ownership Period. The planting of specimen trees on the east lawn formed an irregular canopy (figure 2.10). Views were partially open to the sky.

Figure 2.10: Spatial organization of the main lawn subspace. (K. Baker and G. Dallmann, SUNY CESF, 1998, based on the 1946 USGS map).

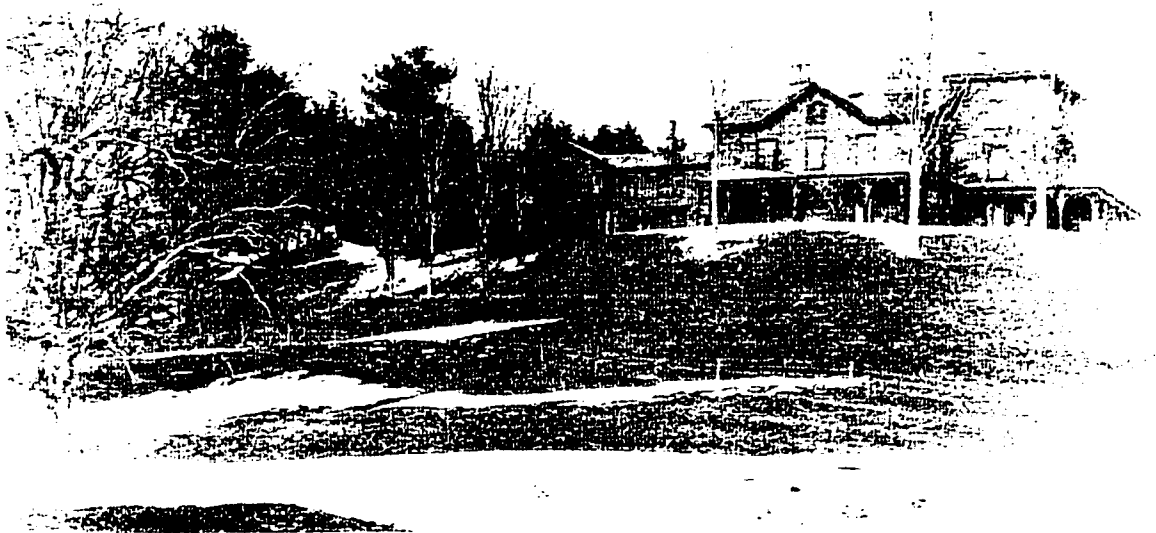
Figure 2.13: The west elevation of Springwood, pre-1887. (The Home of Franklin D. Roosevelt NHS, R-1950).

Trees west of the house in 1900, date of planting unknown, along the top of the ridge line included black locust trees (*Robinia pseudoacacia*) (see figure 2.13). An oak tree or horsechestnut (*Aesculus hippocastanum*) was located at the southwest elevation of Springwood (see figure 2.15).¹¹

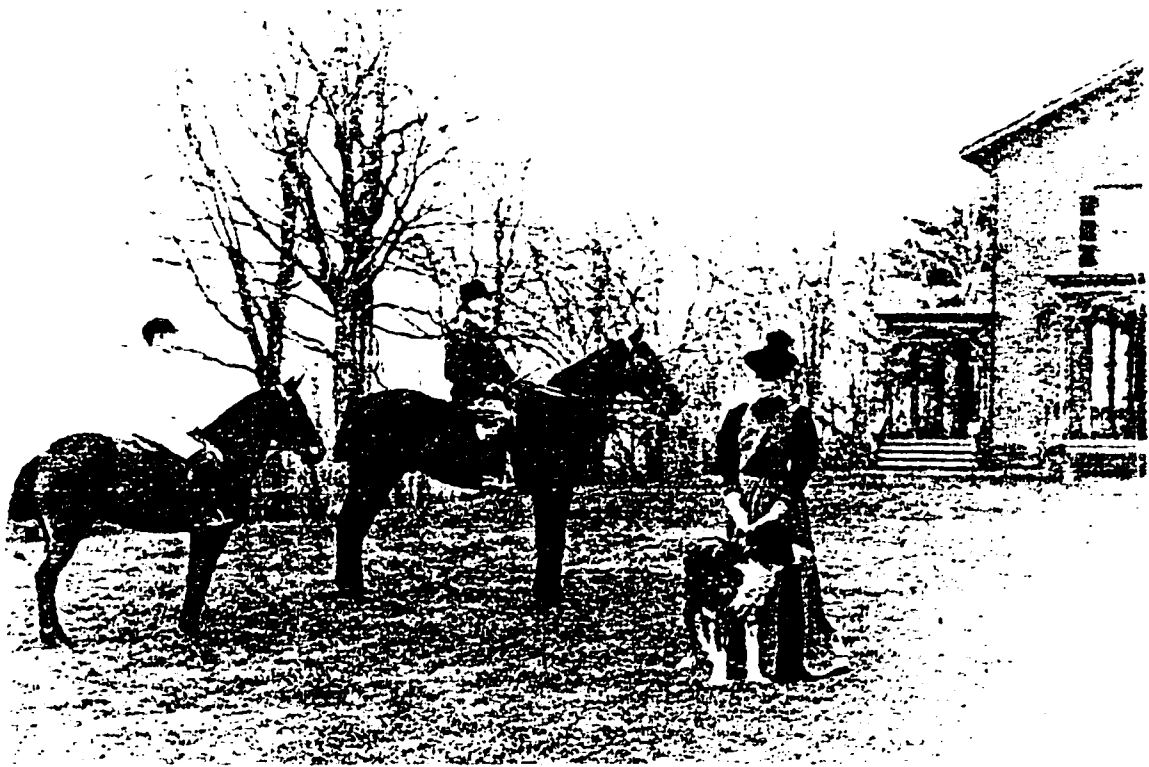
Springwood (HS 01) underwent various changes during this ownership period. It was enlarged in 1887 by an addition on the west elevation. The addition was a single-story deep bay that extended to the rear of the house. A smoking room was also constructed in 1887 on the west elevation. The addition was octagonal and one-story high. Sometime between 1881 and 1887, Springwood's color was changed to a darker color, exact date and color unknown (figure 2.13 and see figure 2.3). The veranda was enlarged in 1893 to surround the southwest section of the house. It then formed a continuous piazza from the dining room door on the west elevation, around the south elevation, to the front, or east elevation (figure 2.14 and figure 2.15 and see Early Roosevelt Ownership period plan).

Figure 2.14: The south elevation of Springwood (right rear of photograph), before the enlargement of the porch, Franklin, James, and Sara Roosevelt pictured, Dec. 1891. (Franklin D. Roosevelt Library, NPx 58-233 (18)).

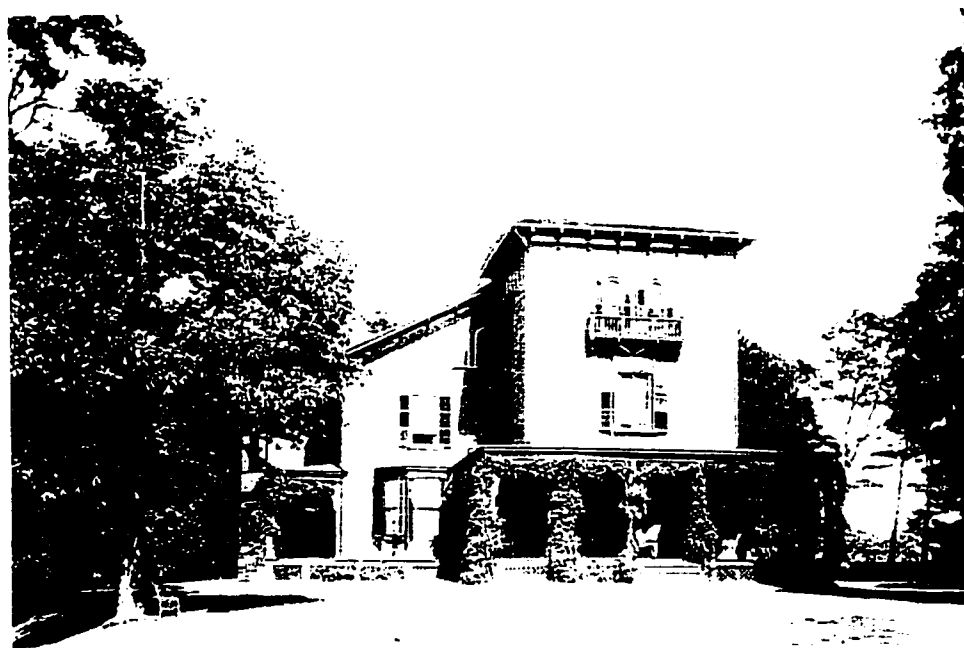
Figure 2.15: Springwood's south elevation, after enlargement of the porch, Oct. 1900. (Franklin D. Roosevelt Library, NPx 48-22:3790 (373)).

Vines in 1900, date of planting unknown, grew thick on Springwood's eastern and southern piazza in 1900, but the species of these vines is unknown (figure 2.17 and see figure 2.15).

A lawn bench in 1900, exact date unknown, was located on the south lawn, under the oak/chestnut tree (see figure 2.15). The dimensions and materials are unknown, but it may have been made of wrought iron.

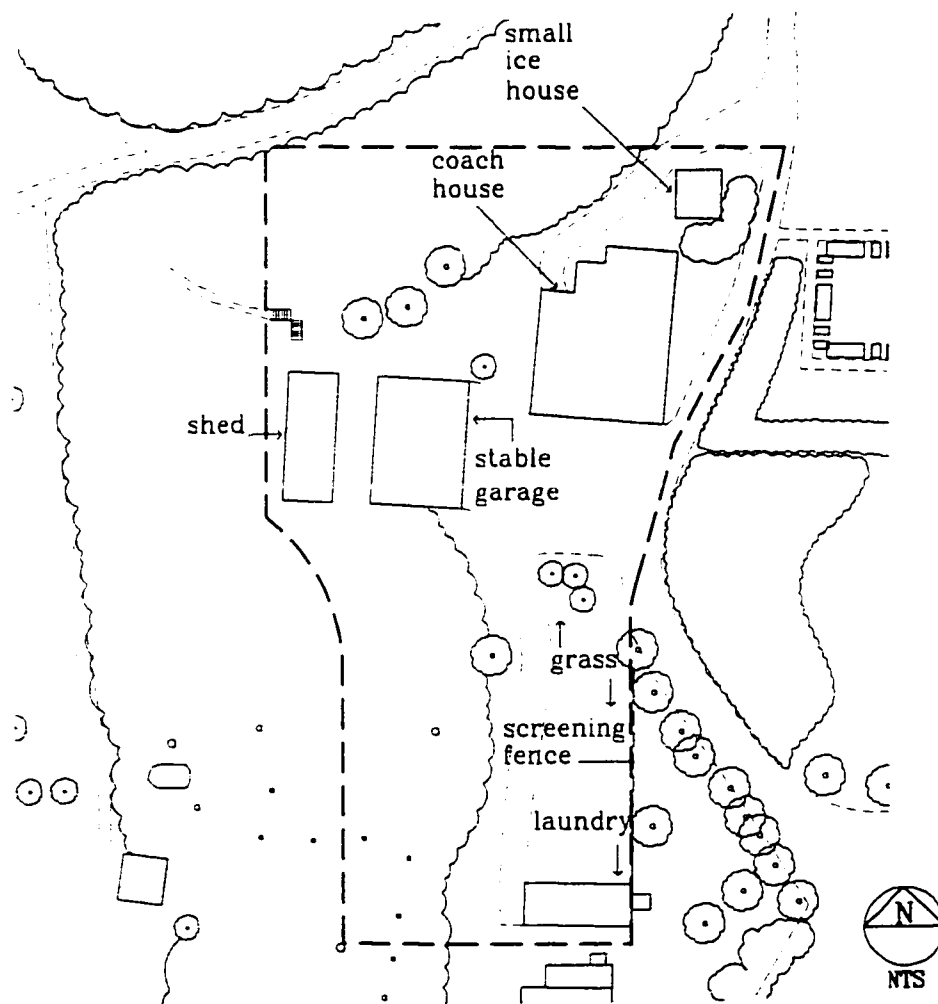
The addition of a coach house south of the small ice house created internal subspaces within the service area (figure 2.18). The ground was either compacted soil or gravel, and although the overhead plane was open, buildings and surrounding vegetation limited the views from this space.

Figure 2.18: Spatial organization of the service area subspace. (K. Baker and G. Dallmann, SUNY CESF, 1998, based on the 1946 USGS map).

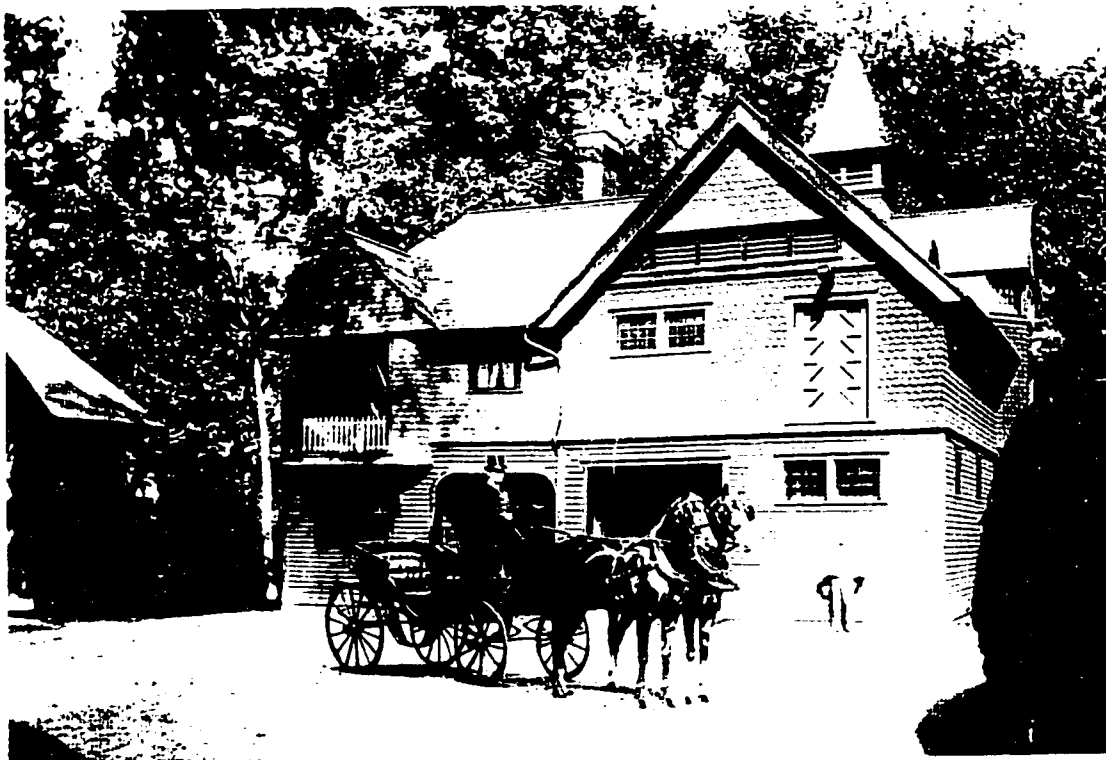
Figure 2.19: The south elevation of the coach house, carriage driver not identified, 1890. (Franklin D. Roosevelt Library, NPx 47-96: 3566).

A coach house (HS 03) was constructed in 1886, located 190 feet north of Springwood and west of the original stable (see Early Roosevelt Ownership period plan). The building was L-shaped, with the eastern elevation 61 feet long (N/S) by 23 feet 4 inches wide (E/W), and two stories high. The western elevation was 42 feet 10 inches long (N/S) by 21 feet 6 inches wide (E/W), and two stories high. The overall width of the coach house was 44 feet 10 wide. This adaptation of the Queen Anne-style building was sided with weatherboard and shingles and painted red and gray (figure 2.19 and 2.20).³⁶ Whimsical details on the coach house included a turreted cupola, rounded oriel with a dormer gable that represented the roof gable, and half-timbering in the upper-story doorways.³⁷ It had a cross-gabled roof with wood shingles, color unknown. Two entry doors were located on the west elevation, and two double doors on the north and south elevations. It was used to house saddle horses, racers, and additional carriage horses, and included a storage and tack room on the ground floor, and six box stalls on the second floor. The southwest corner of the coach house also contained an additional underground ice house, possibly because the small ice house was no longer large enough to hold the ice needed. The coach house was designed by F.C. Withers, a Newburgh, New York, architect.

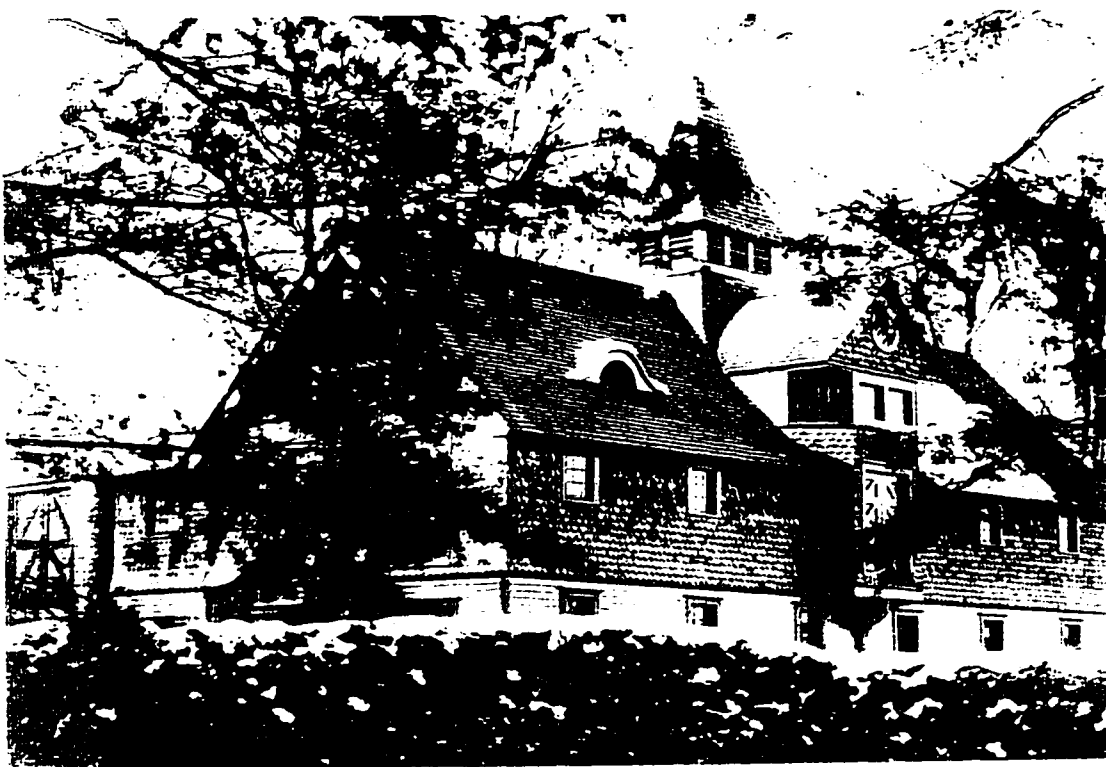
Figure 2.20: The east elevation of the coach house, 1890. (Franklin D. Roosevelt Library, NPx 47-96: 2793).

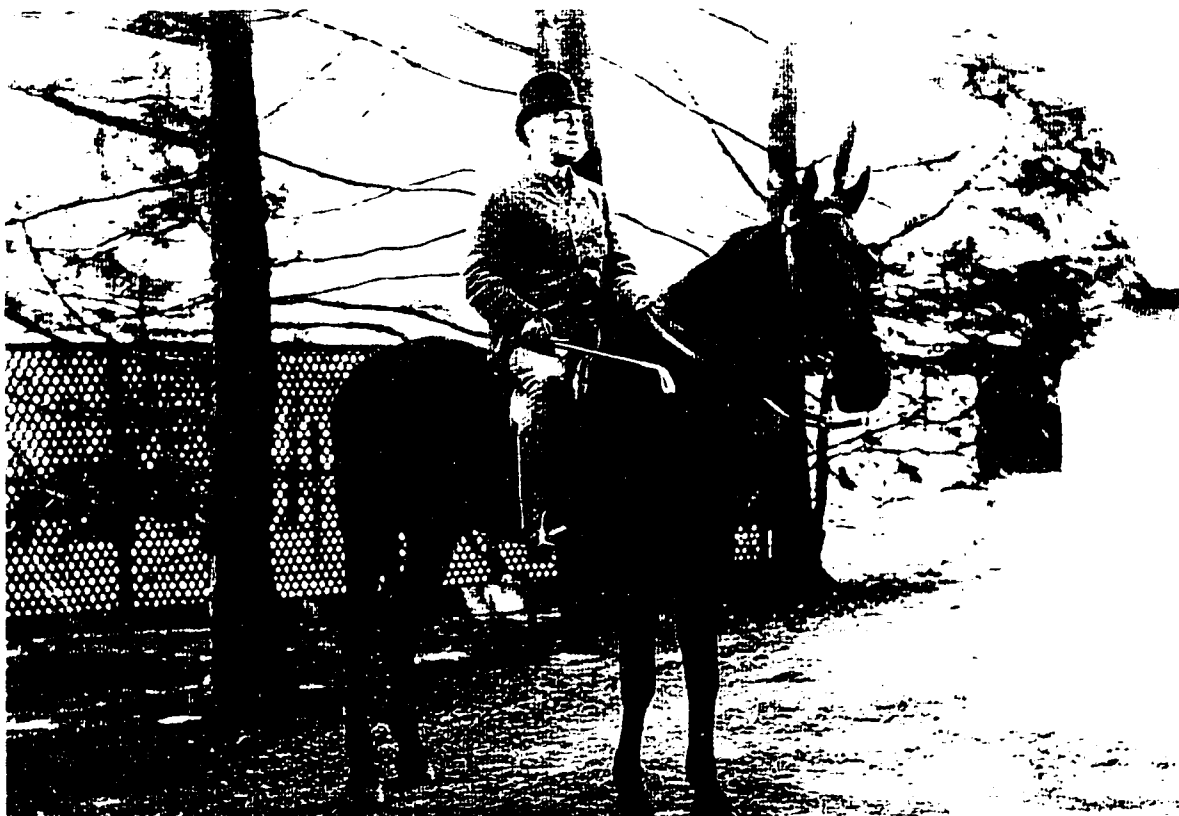
A screening fence, construction date unknown, was located at the northeast corner of Springwood and extended to the southeast corner of the laundry. It continued from the northeast corner of the laundry, northward for approximately 80 feet (figure 2.21 and see Early Roosevelt Ownership period plan). It screened the service area from the main drive and front lawn. Both sections of this fence were constructed in a diagonal, lattice-like fashion. The fence was approximately 80 feet long and 7 feet high. It was constructed of wood, color unknown.

Figure 2.21: Screening fence, James Roosevelt pictured, 1889. (Franklin D. Roosevelt Library, NPx 47-96:150).

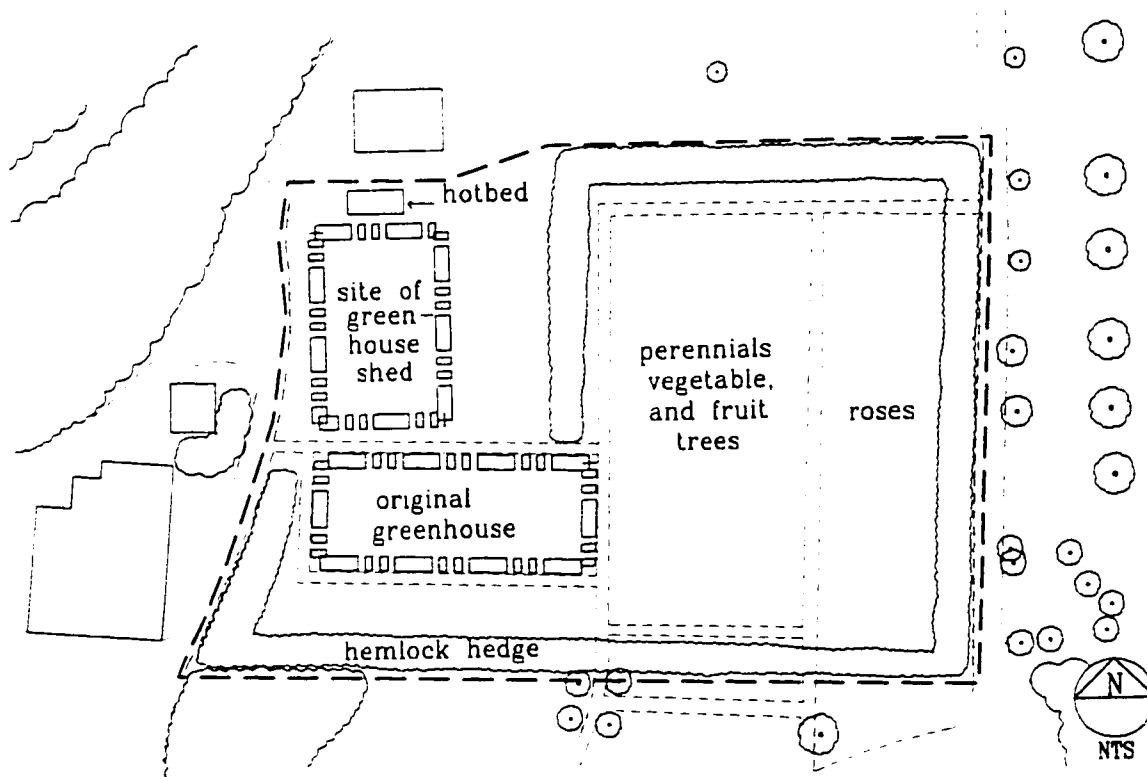
During the Early Roosevelt Ownership Period the rose garden contained two internal subspaces. The first (from east to west) was rectangular in shape and the ground was flat and covered with roses (figure 2.22). The second subspace was located in the center of the garden. It was rectangular in shape and the ground was flat and contained of vegetables and fruit trees that were objects in rather than definers of the space and formed an irregular canopy. Views out of the rose garden were screened.

Figure 2.22: Spatial organization of the rose garden subspace. (K. Baker and G. Dallmann, SUNY CESF, 1998, based on the 1946 USGS map).

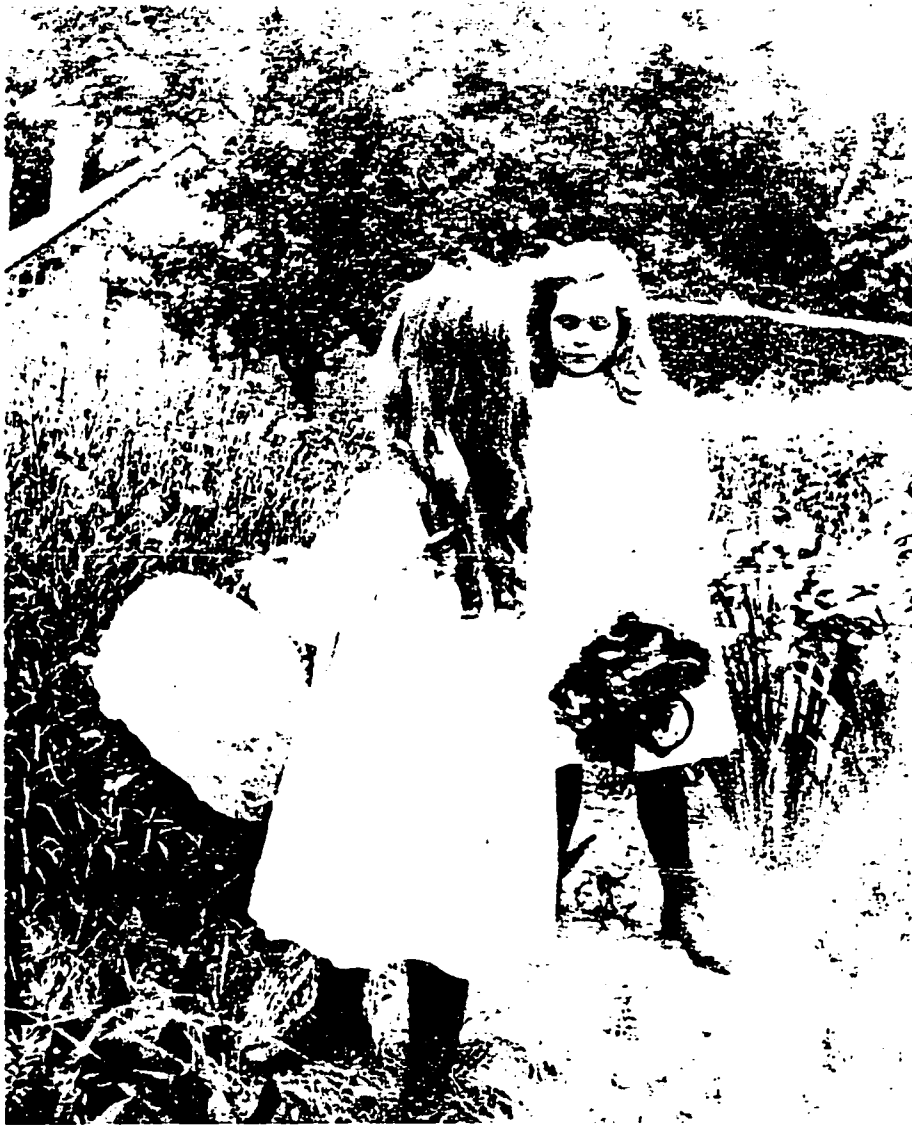
As mentioned in the previous chapter, the greenhouse consisted of two sections, one larger than the other (figure 2.23 and figure 2.24). Grape vines grew up the inside to the top of the structure, and in back were shelves for strawberries grown in the fall and winter.³⁹ William Plog referred to this part of the greenhouse as the grapery, although it is unclear if it was the smaller or larger of the two sections. The other section was "...a regular rose pit...(that) was dug out and the rose house built over it."⁴⁰ There were also climbing roses in this greenhouse.⁴¹ In September 1867 a heating machine was added to the greenhouse, and in 1872 the greenhouse was rebuilt after it was destroyed by fire.

Figure 2.23: Garden and east elevation of the original greenhouse (left rear of photograph), children not identified, no date. (The Home of Franklin D. Roosevelt NHS, no #).

The exact number and spacing of these fruit trees is unknown, but there were at least two trees during this period (figure 2.28 and see figure 2.23).

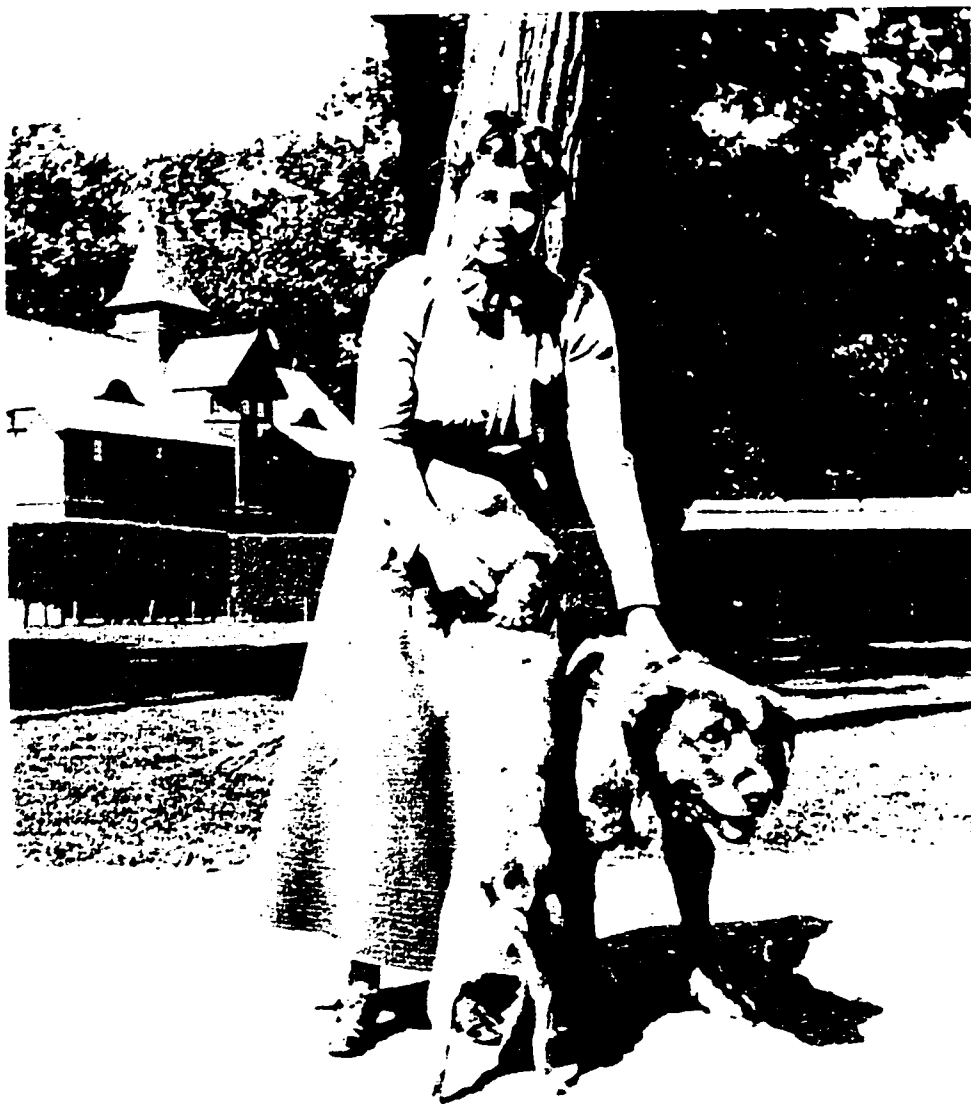
Figure 2.24: Top of the greenhouse (right rear of photograph) and the hedge cut flat, woman not identified, no date. (The Home of Franklin D. Roosevelt NHS, #R-D).

The location, size, and configuration of the hemlock hedge (*Tsuga canadensis*) did not change during this period (see Early Roosevelt Ownership Period Plan). During this period the hemlock hedge was approximately 7 to 9 feet high and trimmed flat on top, width unknown (see figure 2.24). Heavy snow caused damage to the plants, so gradually the hedge was trimmed into a point so snow would roll off.⁴⁴ Three entrances into the rose garden existed during this period, two along the south section of the hedge, and one at the northeast corner on the east side.⁴⁵ In 1900 these entrances were wide with no overhead plane (figure 2.27 and see figure 2.16).

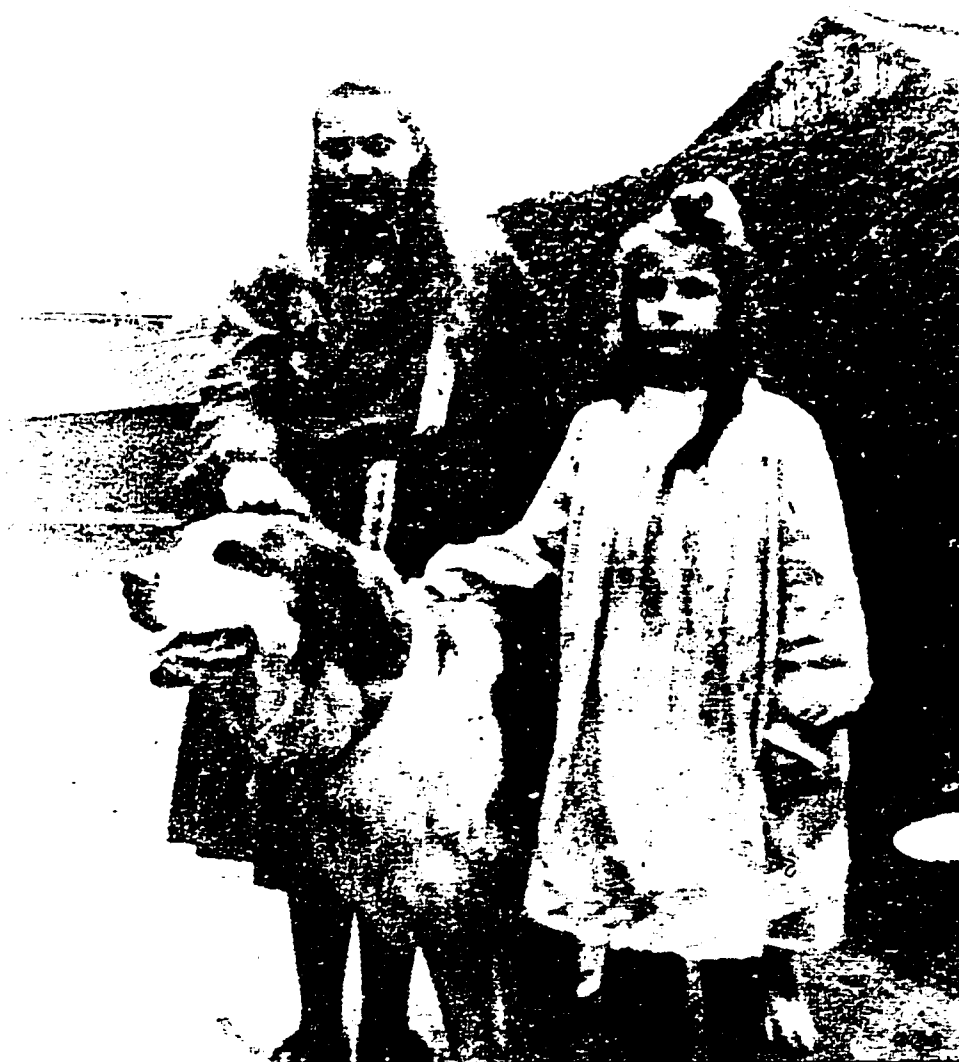
A greenhouse shed was constructed during this period, exact date unknown, north of the greenhouse in the northwest corner of the rose garden (figure 2.25 and figure 2.26).⁴² It was oriented in an approximate north-south direction, was rectangular and one story high. It had a gabled roof covered corrugate with metal, color unknown. The exact shape, size, materials, and color of the building are unknown.

Figure 2.25: Greenhouse shed (left rear of photograph), children not identified, date unknown. (The Home of Franklin D. Roosevelt NHS, no #).

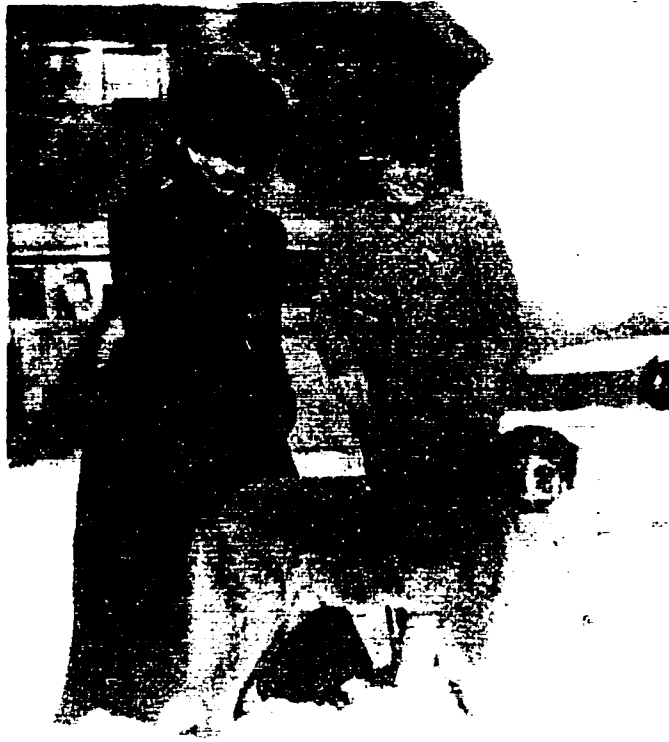
Figure 2.26: Greenhouse shed (right rear of photograph), Sara and James Roosevelt, pictured, December 1898. (Franklin D. Roosevelt Library, NPx 58-233 (18)).

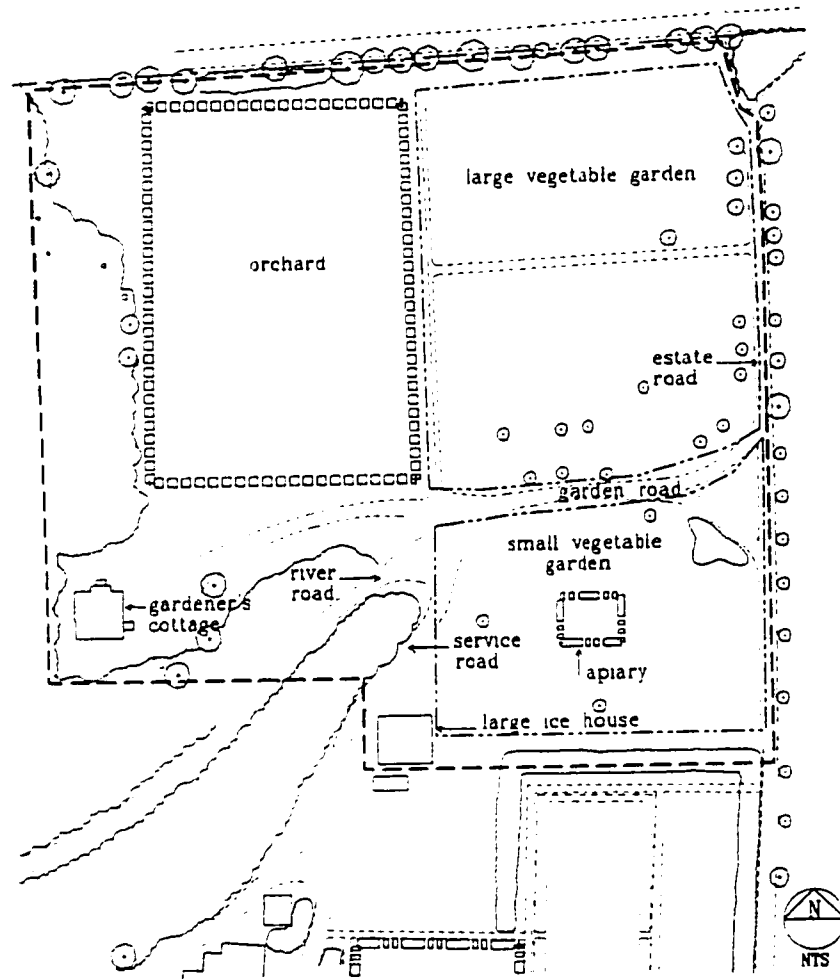
The vegetable garden subspace was defined to the north by vegetation along the Morgan Property line, and to the east by trees planted along the estate road (figure 2.29). The ground consisted of grass, vegetable beds, and compacted soil or gravel roads that crossed the garden.

Figure 2.29: Spatial organization of the vegetable garden subspace. (K. Baker and G. Dallmann, SUNY CESF, 1998, based on the 1946 USGS map).

A large ice house (HS 09) was constructed in 1898, 360 feet northeast of Springwood, near the northwest corner of the rose garden (see figures 2.27 and 2.29). The building was rectangular, 30 feet long (E/W) by 18 feet wide (N/S), and 19 feet high. The salt-box-style large ice house was sided with clapboard and painted gray, with a red cupola and shingled gable. It had a front-gabled roof with wood shingles, color unknown.⁵⁰ Three stacked doors were located in the center of the east elevation, and an entry door was in the center of the west elevation.

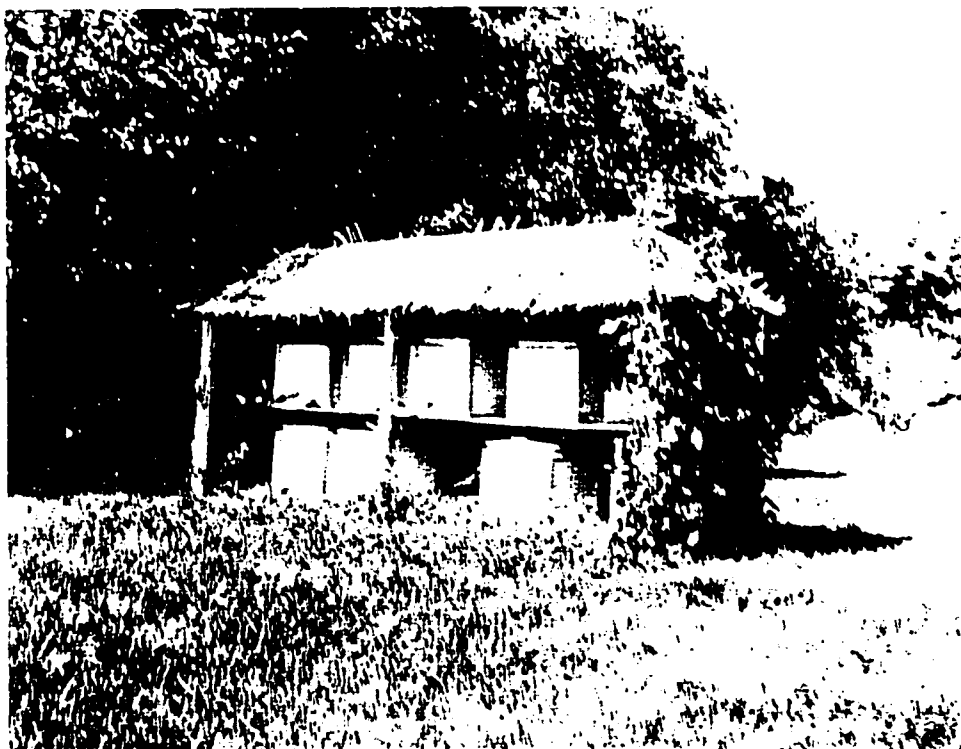
An apiary (a structure to hold beehouses) was constructed during the Early Roosevelt Ownership Period, exact date unknown. It was located in the center of the small vegetable garden, approximately 60 feet north of the hemlock hedge. The structure was rectangular, approximately 10 feet long by 4 to 5 feet wide and 6 to 7 feet high (figure 2.30). The apiary was constructed of wood and stabilized with round, rough-cut posts 4 to 5 inch diameter. The color of the structure is unknown, but it was probably unpainted. It had a hipped roof with a ridge constructed of small branches lashed together, color unknown. Both of its longer sides were open and a shelf was located at an approximate 2 to 2 1/2 foot height. The apiary contained approximately 16 hives.

Figure 2.30: The apiary, no date. (The Home of Franklin D. Roosevelt NHS).

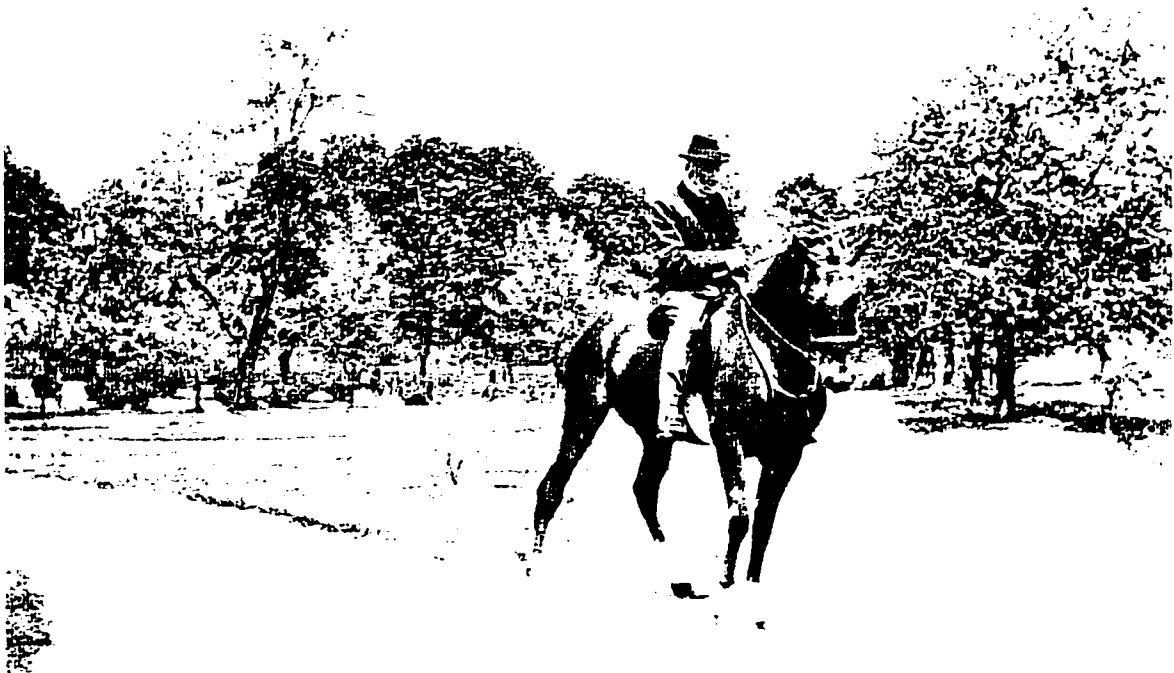
The large vegetable garden was located north of the small vegetable garden and extended to the northern property line. The garden contained the usual garden vegetables and an unidentifiable mix of hardwood trees, and small, shrub-like vegetation (figure 2.31). Many of these trees probably bore fruit such as apples and pears.⁵² On April 22, 1900, a letter from Sara Roosevelt to FDR makes reference to "...one tiny new peach tree full of blossoms."⁵³ It is unknown where this tree was located, although it may have been among of the fruit trees within the hemlock hedge garden or the vegetable garden.

Figure 2.31: The estate road, the large vegetable garden (rear), and the picket fence (far rear), James Roosevelt pictured, April 1900. (Home of Franklin D. Roosevelt NHS, no #).

The post and wire fence, constructed by the Wheelers and located along the northern property line, was reconstructed during the Early Roosevelt Ownership Period, exact date unknown. The new fence was a picket-style fence, but its dimensions are unknown (see figure 2.31).

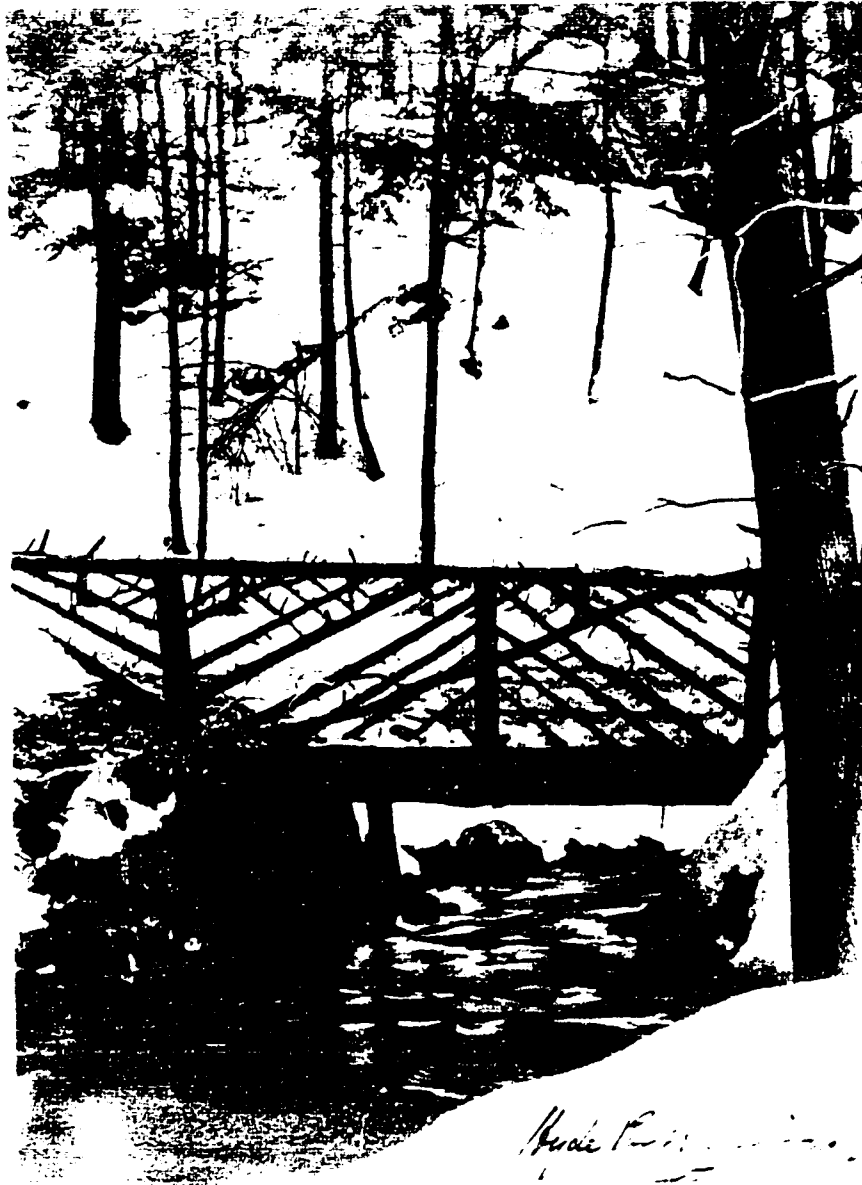
This bridge was approximately 10 feet wide with rustic wood railings approximately 3 feet wide, made out of pieces of wood 2 to 3 inches diameter used as top and bottom fence rails. Vertical wood posts were placed approximately every 5 feet. The ends of this bridge tapered from 3 feet high to the ground. Smaller pieces of wood, 1 to 2 inches in diameter, were placed diagonally between the horizontal rails. Stone was used to support the underside of the bridge and wooden planking was used as decking (figure 2.38 and figure 2.39).

Figure 2.38: Rustic bridge located in the river wood lot, no date. (Franklin D. Roosevelt Library. NPx 47-96:2797).

Figure 2.39: Rustic bridge located in the river wood lot, no date. (Franklin D. Roosevelt Library, NPx 47-96:2795).

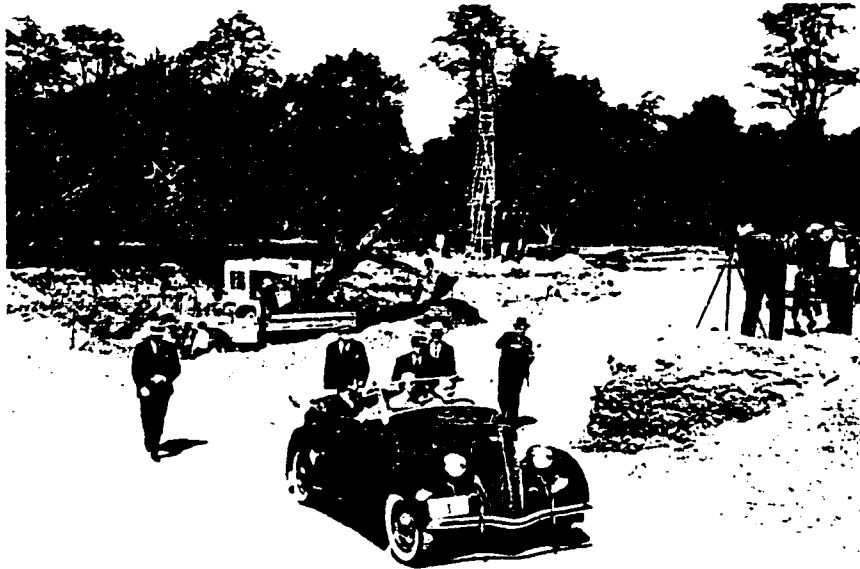
Figure 3.10: FDR inspecting the construction of the Franklin D. Roosevelt Presidential Library built in the north avenue lot, Sept. 23, 1939. (Franklin D. Roosevelt Library, NPx 48-22:3711 (260)).

The Franklin D. Roosevelt Library was constructed in 1939-1941 on the site of 16 acres of the north avenue lot selected by the Roosevelts (see figure 3.9 and the Late Roosevelt Ownership period plan). The library (HS 02) was located in the western section of the north avenue lot. The building was U-shaped, 140 feet long (N/S), 120 feet wide (E/W), and two stories high. The Dutch Colonial Revival library was constructed of local brown-colored fieldstone, the President's favorite building material, by John McShain of Philadelphia (figure 3.10, 3.11, and 3.12).²⁶ It had a cross-gabled roof formed by the two wings, with gray slate shingles. The main entrance was located at the center of the east elevation within the "U," along with the entrance courtyard. The cost of the building was \$344,642.21, which was paid for by funds raised from private sources through the Franklin D. Roosevelt Library, Inc.. On July 4, 1940, the library was completed and turned over to the National Archives and Records Service, General Service Administration, and dedicated by FDR on June 30, 1941.
