CULTURAL LANDSCAPE REPORT FOR
THE HOME OF FRANKLIN D. ROOSEVELT
NATIONAL HISTORIC SITE

Kristin Theresa Baker

Master of Science in Landscape Architecture Degree

May 1999

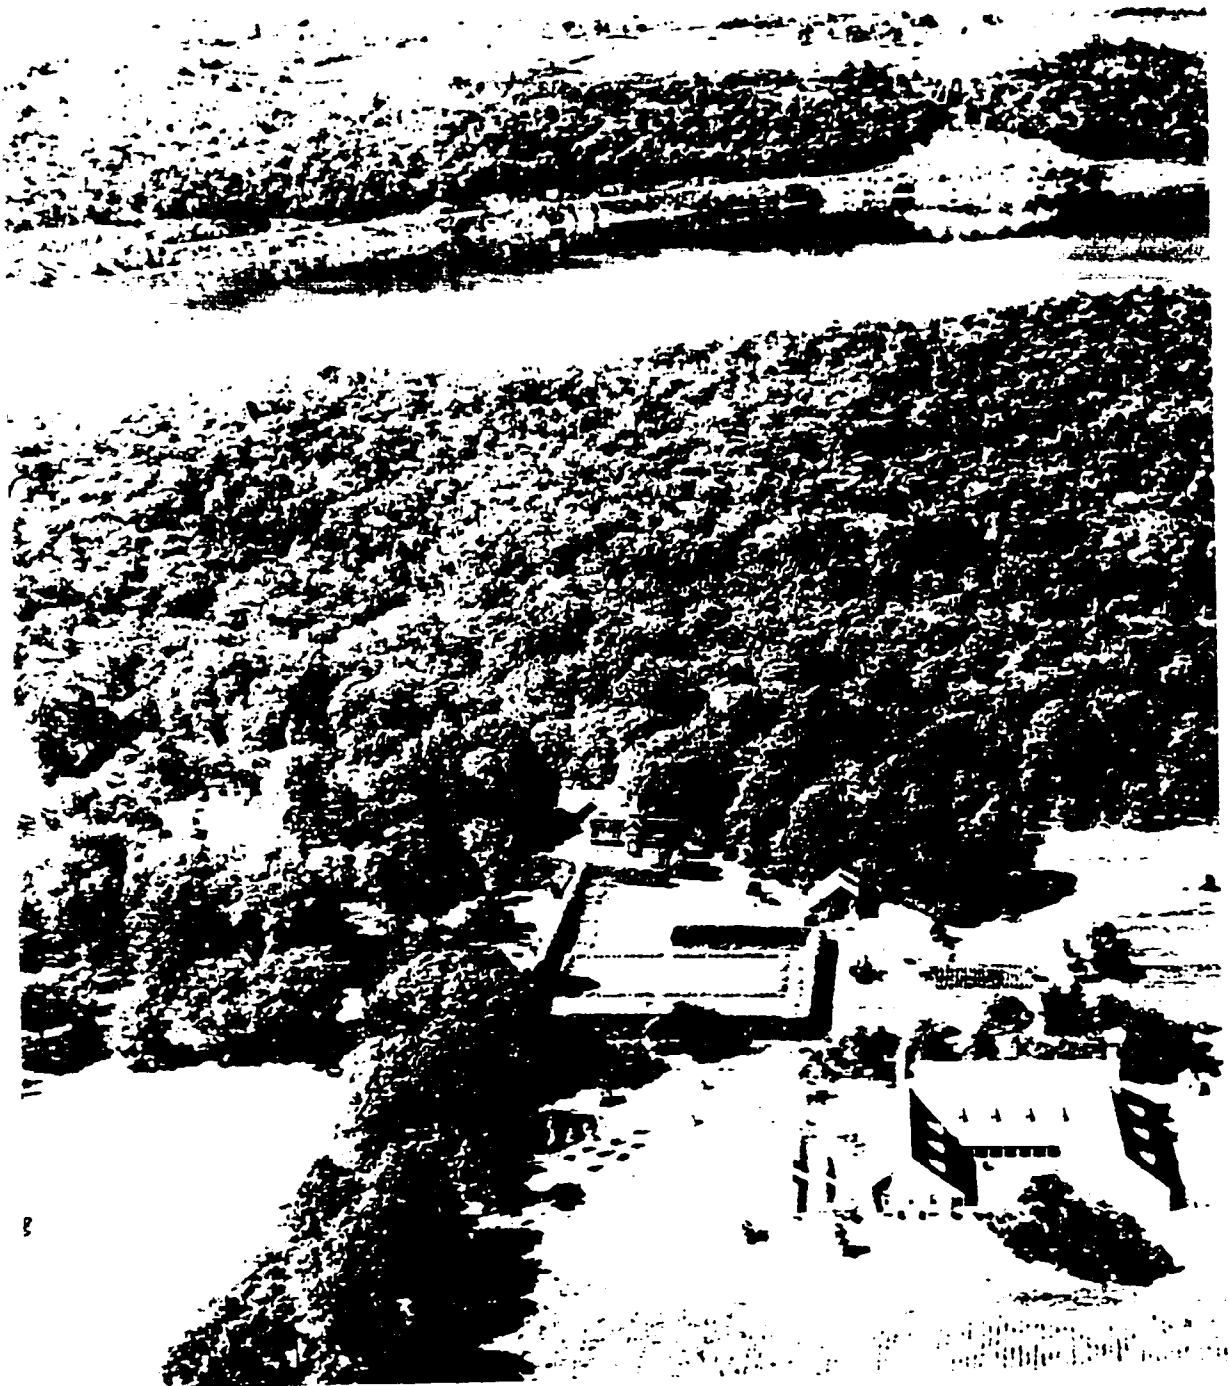
Figure 3.12: Aerial view of the library and estate of Franklin D. Roosevelt, 1942. (Franklin D. Roosevelt Library, NPx 48-22:3790 (388)).

Field crops grown within the north avenue lot continued to be used as a source of revenue for the farm. These crops were discussed in many of the Roosevelt family letters. In 1902 and 1917 Sara Roosevelt wrote: "We cut first hay." "...I hope to get in the hay north of the avenue...", and "...a lot of wheat, rye and hay are being drenched by the rain."³¹ FDR also wrote that "The corn also on the avenue is the best in the County."³² In 1942, corn was grown in rows perpendicular to the Library's east elevation (see figure 3.12).

A sunken sculpture garden was constructed in c. 1939-1941 adjacent to the library's south elevation (see figure 3.12 and Late Roosevelt Ownership period plan). The garden was rectangular and approximately 80 feet long (E/W) by 40 feet wide (N/S), depth unknown. Steps were located in the center of the southern portion of the garden, material unknown. The garden appears to have been a combination of retaining walls, grass, and vegetation, although materials and species are unknown. The focal point of the garden was a bust of FDR in the northern portion, near the library's south elevation. The shape, size, and materials of the bust are unknown.

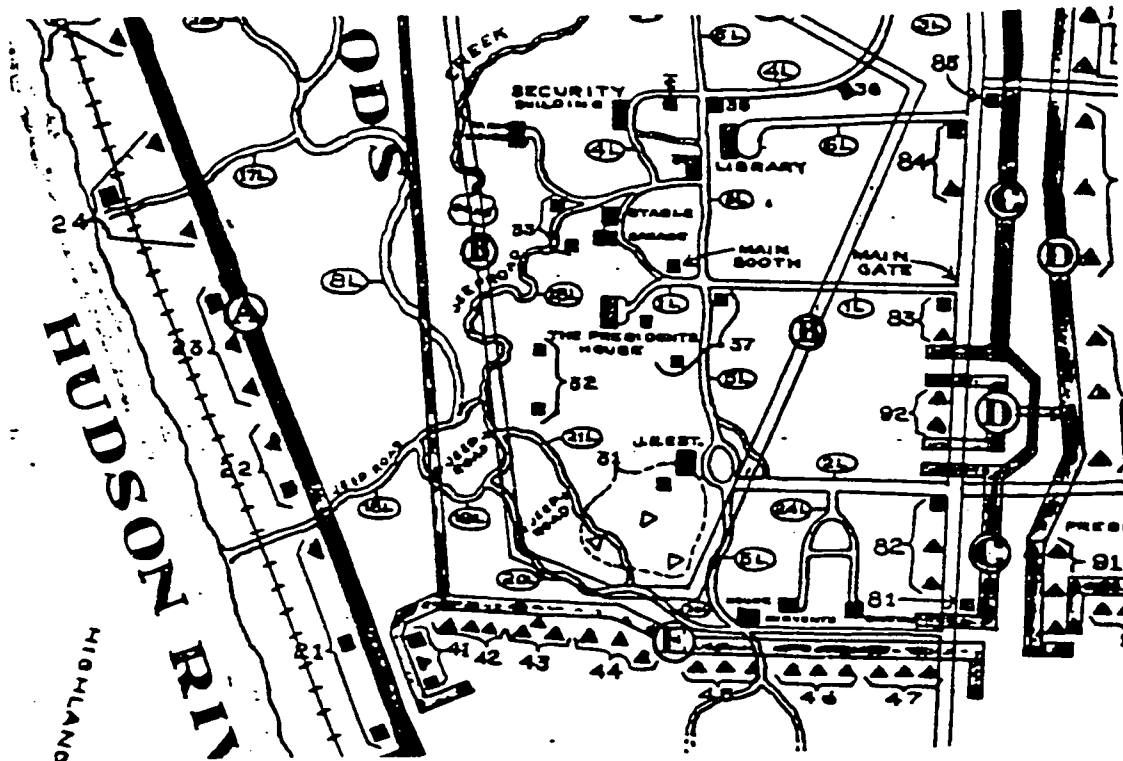
Figure 3.13: Location of Battalion guard houses (indicated with small squares) west of the Albany Post Road. (Crash, Post and Road diagram, drawn by the White House Signal Det., no date, Home Franklin D. Roosevelt NHS).

Two guard houses were constructed in c. 1942 after the attack on Pearl Harbor, exact date unknown, by the 240th Battalion. The buildings housed the Military Police stationed on the property to protect the President and his family (figure 3.13 and Appendix H). One of the guard houses was located at the entrance near the Albany Post Road, and the other was located at the northwest corner of the north avenue lot, adjacent to the estate road. No documentation was located on these specific buildings, however it can be presumed they were similar to the other guard houses on the property. These buildings were square, approximately 5 feet by 5 feet, and 10 feet high (figure 3.14). The guard houses were sided with clapboards and painted green. They had both front-gabled and side-gabled roofs, material and color unknown. A door was located in the center of the front elevation.

Two guard houses, constructed in c. 1942, were located along the home road (see figure 3.13). One of the buildings was located at the entrance of the home road; the second near the intersection of the home and estate road. Their shape, size, materials, and color were the same as the other guard houses located on the property (see north avenue lot subspace for description).

Three guard houses, constructed in c. 1942, were located in the main lawn area. Two guard houses were located on the east lawn, exact location unknown. The third, the Main Booth, was located south of the hedge where the home road and service road intersected (figure 3.34 and see figure 3.13). Their shape, size, materials, and color were the same as the other guard houses located on the property (see north avenue lot subspace for description).

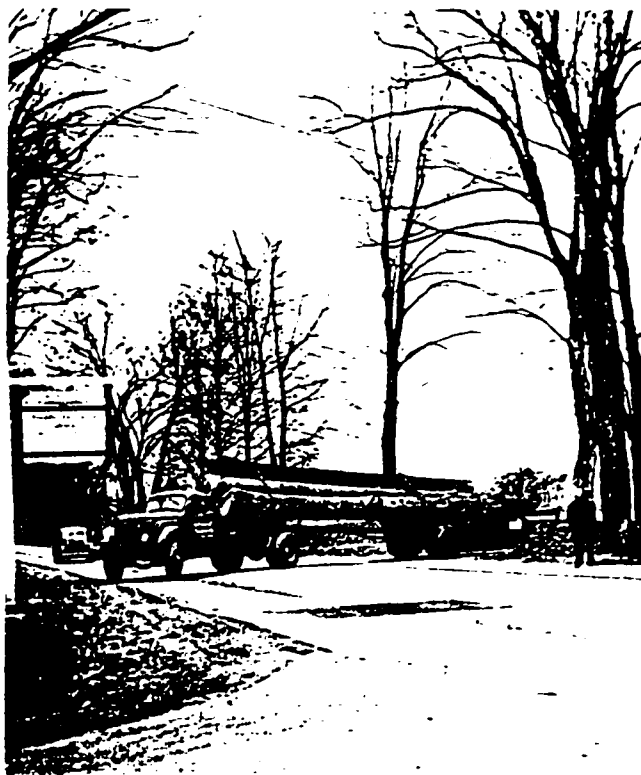
A library entrance sign was constructed in c. 1939-1941 north of the entrance/exit road (figure 3.17). The sign was of a square vertical post approximately 5 inches long by 5 inches wide, and 8 to 10 feet high. A horizontal arm was connected to the top of the vertical post and extended approximately 3 to 4 feet from the post. The sign was attached to this horizontal arm and was approximately 4 feet long and 3 to 4 feet high. The top of the sign had a graphic representation of the presidential library, and the entire sign was painted white with black lettering that read "Franklin D. Roosevelt Library." Additional writing on the sign could not be determined. Both the post and horizontal members were white.

Figure 3.17: Library entrance sign, c. 1939-1945. (Franklin D. Roosevelt Library, NPx 61-119 (5)).

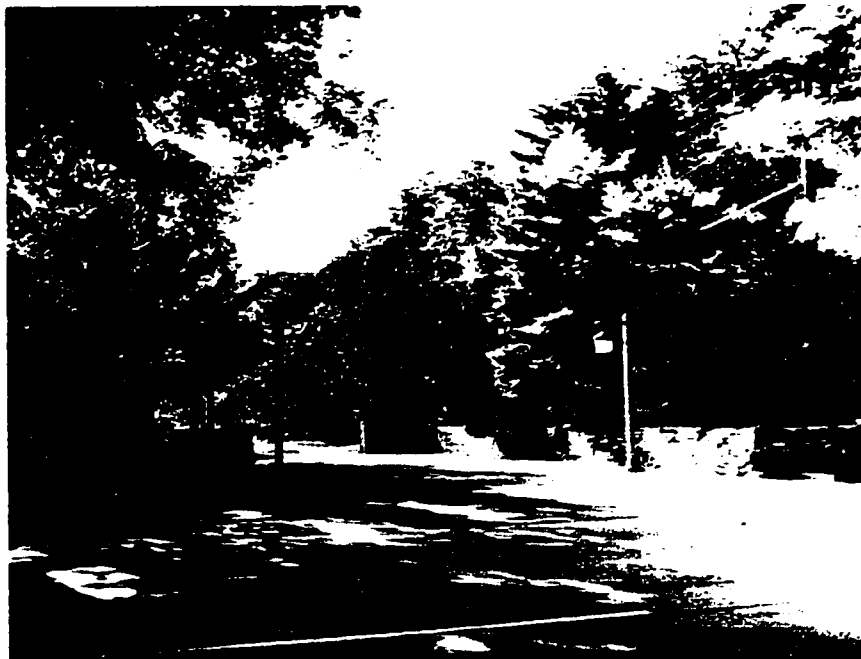
Two light poles were constructed in c. 1939-1941. They were located east of the gate house and north and south of the library entrance/exit road (figure 3.18). The light posts were approximately 10 feet high with a horizontal arm extending 1 1/2 feet from the main post. From that arm hung a four-sided lantern-shaped light approximately 6 to 8 inches long and 4 to 6 inches wide. The light posts were constructed of wood and painted white.

Figure 3.18: Lights adjacent to the entrance/exit road. 1946. (Franklin D. Roosevelt Library, NPx 48-22:3790 (119)).

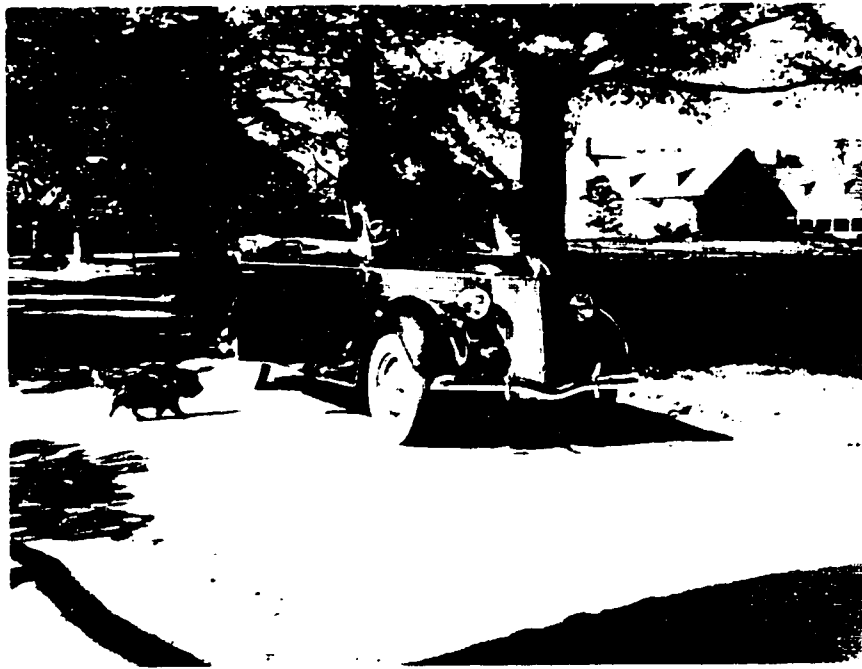
The library fence was installed in c. 1939-1941 along the library property's northern, southern, and western borders (figure 3.19). The library fence was 4 feet high and approximately 1,160 feet long along the northern and southern boundaries, and 330 feet in length along the western boundary. It was constructed of metal posts spaced 8 feet apart with 1-inch diameter horizontal rails, 1 1/2 feet apart. Its color is unknown.

Figure 3.19: View from the home road north to the library fence (right rear of photograph), FDR (in car) and his dog, Fala, pictured, 1944. (Franklin D. Roosevelt Library, NPx 78-36(44)).

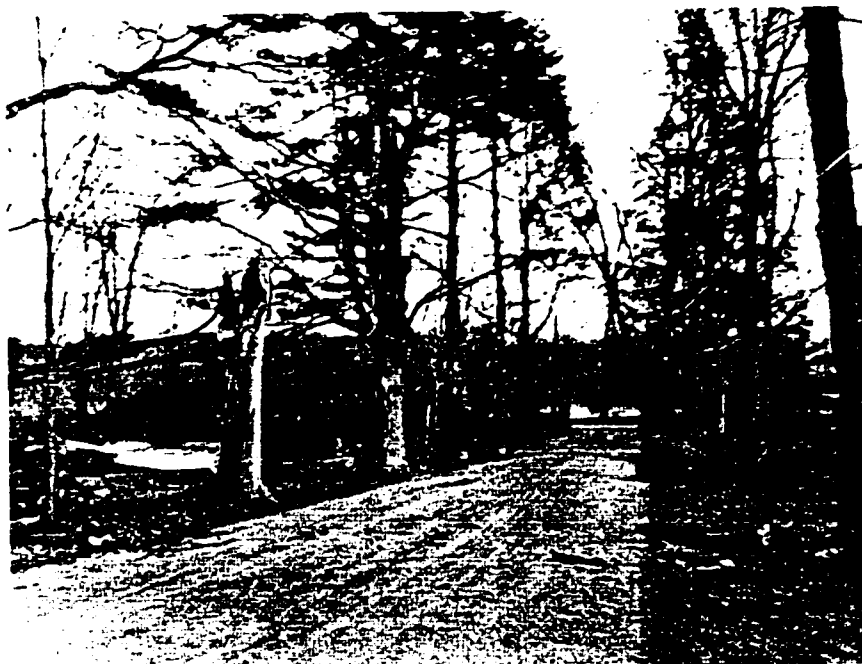
Figure 3.20: Storm damage to home road tree allée, 1913. (Franklin D. Roosevelt Library, NPx 47-96: 2952).

The home road allée was damaged extensively by severe winds in 1913 (figure 3.20). At the start of this period, double rows of trees were located on each side of the road, but by the end of the period the road was lined with only one row of trees (figure 3.21). The small diameter of some of the trees in 1945 indicates that as trees died and were removed, some were replaced. In 1945 many of the trees were large with spreading habits. Trees within the allée in 1945 included 1 cucumbertree (*Magnolia acuminata*), 1 Norway spruce (*Picea abies*), 3 Eastern hemlocks (*Tsuga canadensis*), 5 American elms (*Ulmus americana*), 13 white pines (*Pinus strobus*), and 74 maples (*Acer* spp.). The combination of the evergreen and deciduous trees formed a dense canopy of varying textures. The understory was maintained as lawn.

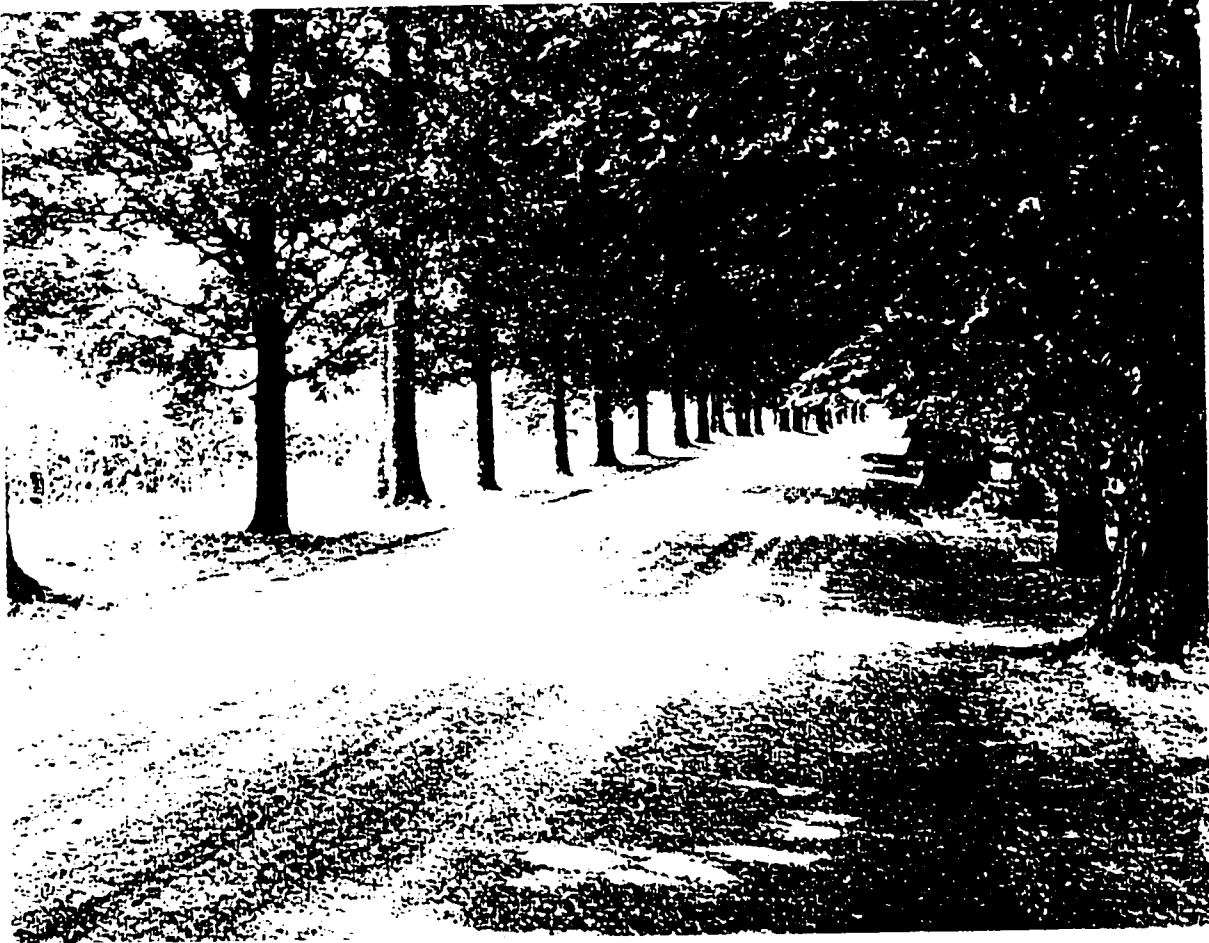
Figure 3.21: View east of home road tree allée and home road, 1943.
(Franklin D. Roosevelt Library, NPx 48-22: 3853 (18)).

The home road, in 1945, was 13 1/2 feet wide near the Albany Post Road and widened to 20 feet at the intersection of the estate road. The road had a crushed stone or gravel surface and no edging (see figure 3.21).

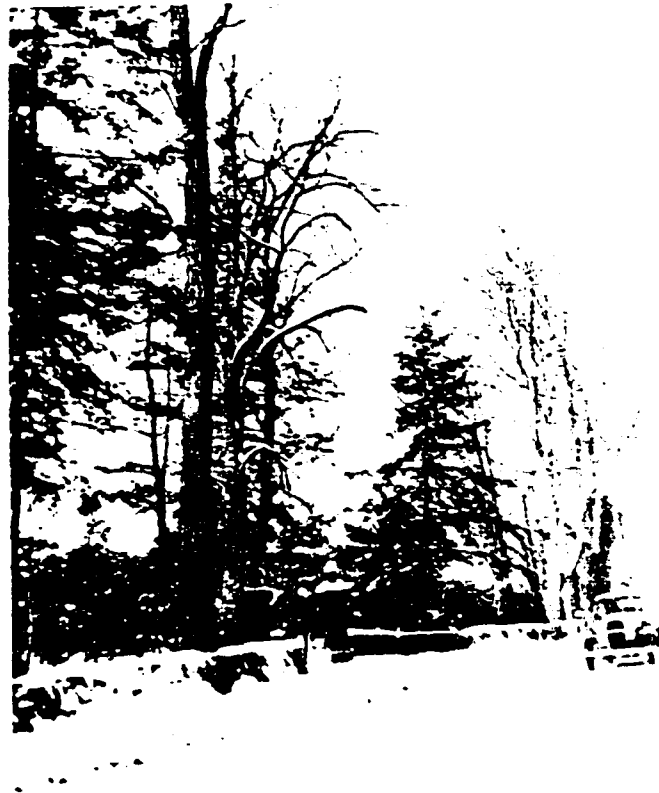
The gate posts and gate, brought to the site by FDR's father in 1867, continued to flank the home road (figure 3.22). They were located approximately 10 feet west of the stone wall that lined the Albany Post Road. It is unknown if these gate posts were moved to accommodate the ever-widening Albany Post Road.

The stone wall, curved westward to join the gate posts to give the wall a curvilinear, half circle shape (see figure 3.22 and Late Roosevelt Ownership period plan). It is unclear if

Figure 3.22: Gate posts and gate, stone wall, and white pine hedge, no date.
(Franklin D. Roosevelt Library, Px 77-144 (5)).

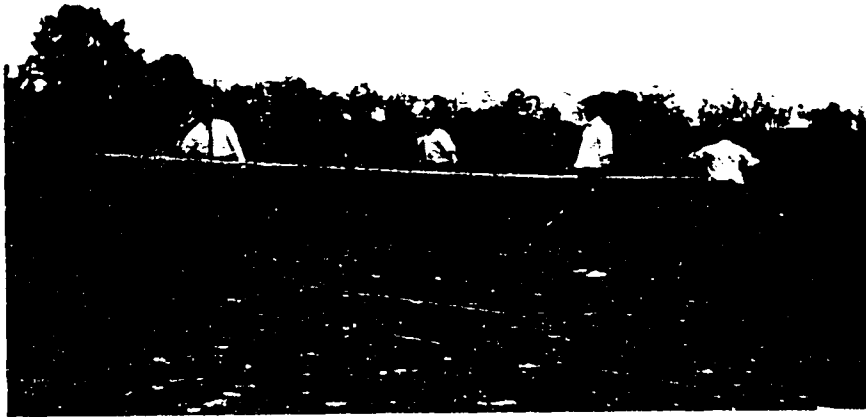
A tennis court (HS 32) was constructed in c. 1920. It was located in the southwest corner of the south avenue lot, and oriented in a southwest by northeast direction (figure 3.22 and see figure 3.16). It was rectangular and 130 feet long (N/S) by 52 feet wide (E/W). The backstops for the tennis court were made of iron pipes and knuckle joints, and covered with chicken wire, color unknown. The surface was clay (figure 3.24).³⁸

Figure 3.24: Tennis court located in the south avenue lot, FDR (left) and men not identified pictured, 1920. (Franklin D. Roosevelt Library, NPx 47-96: 4863 (176)).

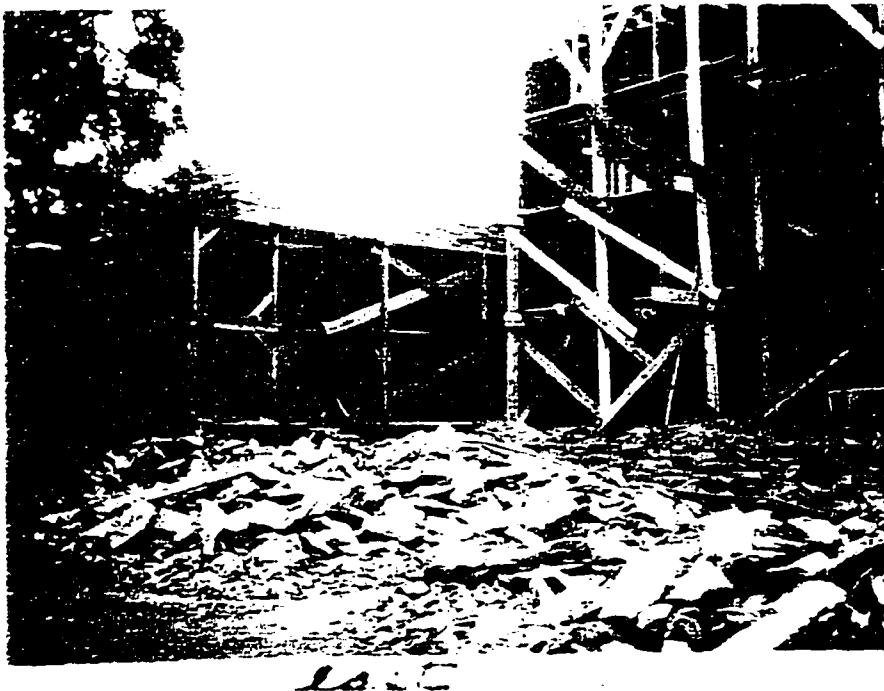
Figure 3.28: Reconstruction of Springwood, south tower and south wings, 1915. (Franklin D. Roosevelt Library, NPx 47-96:4068).

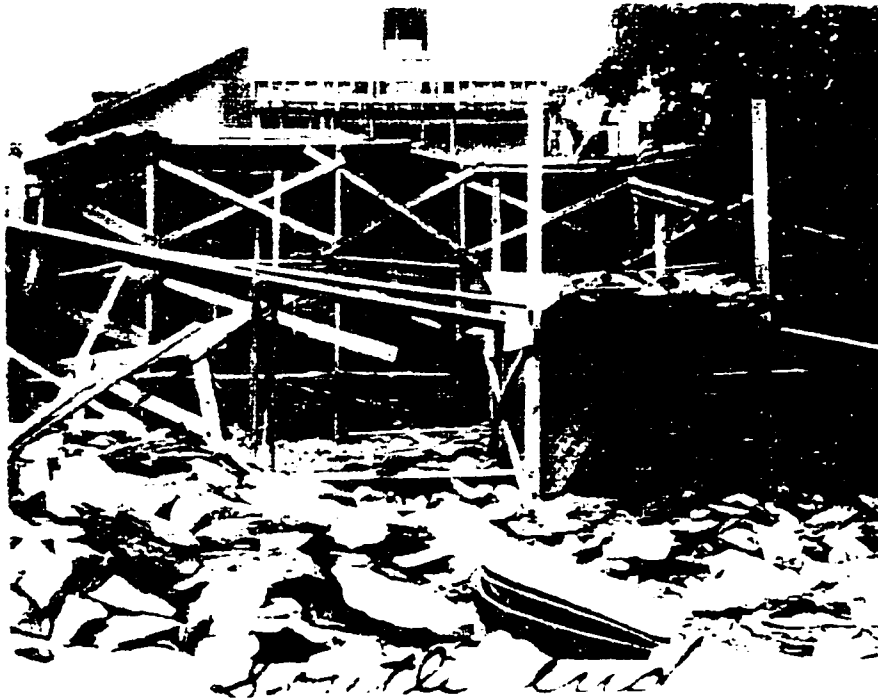
Figure 3.29: Reconstruction of Springwood, south tower, 1915-1916. (Franklin D. Roosevelt Library, NPx 47-96:4067).

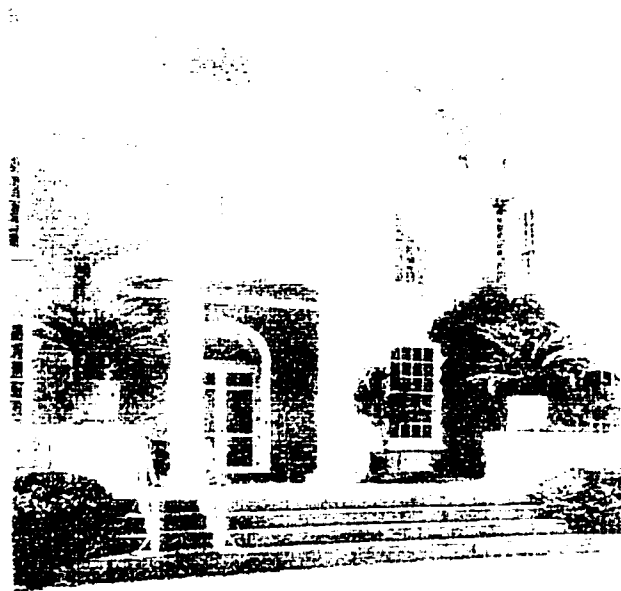
A set of handrails was probably added shortly after FDR contracted polio and returned to Hyde Park in the spring of 1922, exact date of installation is unknown. They were located at the southern edge of Springwood's front terrace steps (figure 3.31 and figure 3.32). The handrails were 3 feet apart and 3 1/2 feet high. They were constructed of wood and bolted to the terrace steps. The southern rail was longer and extended past the balustrade. The handrails were painted white and the top rail portion was unpainted wood.

Figure 3.31: Handrails for FDR on the front terrace steps, 1941. (The Home of Franklin D. Roosevelt NHS).

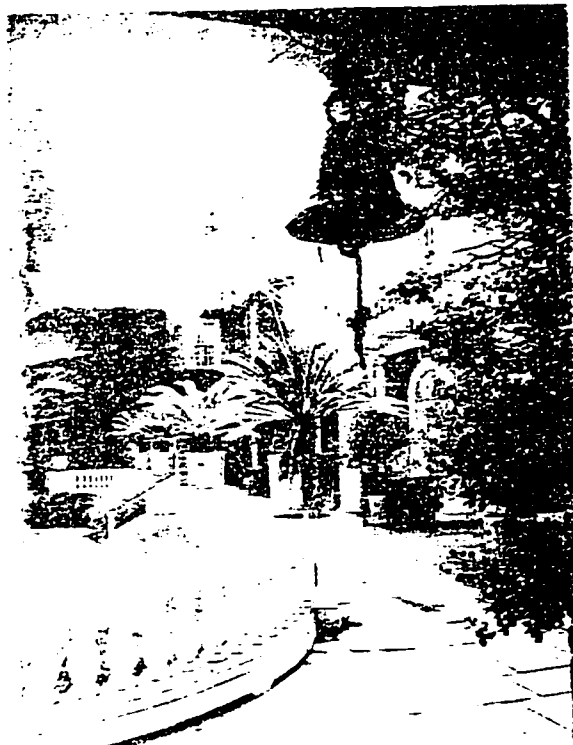
Figure 3.32: Handrails and potted plants located on Springwood's front terrace, 1941. (The Home of Franklin D. Roosevelt NHS).

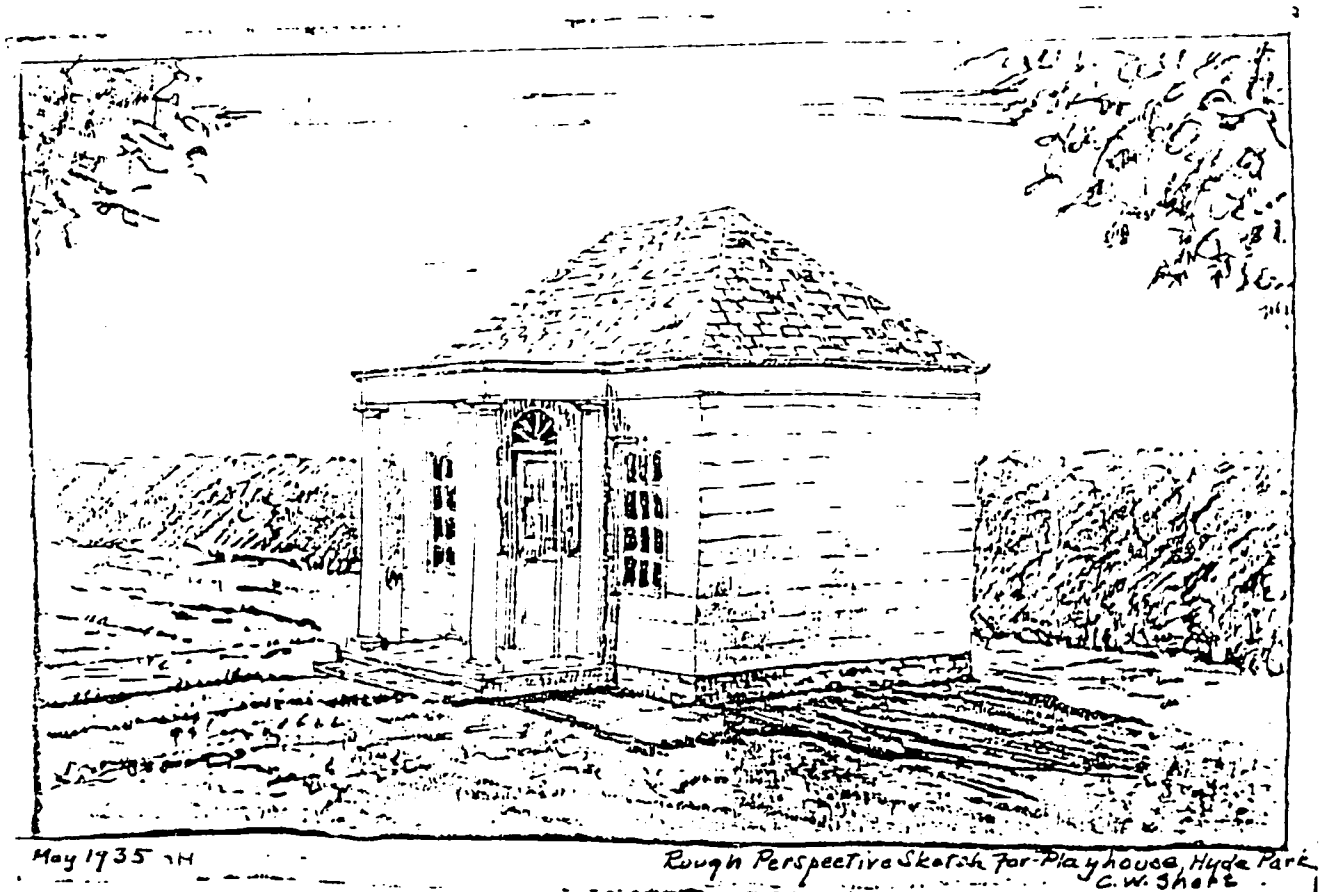
Figure 3.33: Swan Cottage Playhouse, May 1935. (Chief of Maintenance files, the Home of Franklin D. Roosevelt NHS).

A playhouse named Swan Cottage was constructed by Sara Roosevelt in May of 1935 for her great-grandchildren Curtis (Buzz) and Eleanor (Sistie). It was located approximately 270 feet east of Springwood on the west side of the estate road, approximately 40 feet from the southwest corner of the tennis court.⁴⁷ The building was rectangular, 17 feet 4 inches long, 11 feet 3 inches wide, and approximately 15 feet high (figure 3.33). The Swan Cottage playhouse was sided with clapboard and painted off-white. It had a hipped roof with a ridge with wood shingles, color unknown. A door was located in the center of the east elevation and faced the tennis court. In 1935 water was installed in the playhouse.⁴⁸

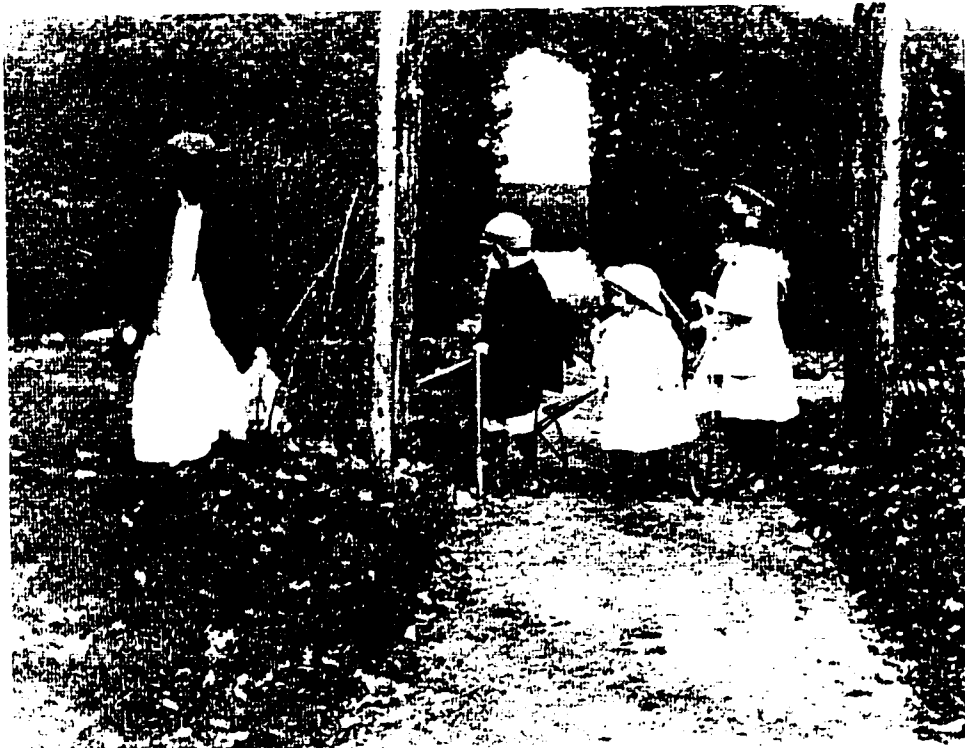
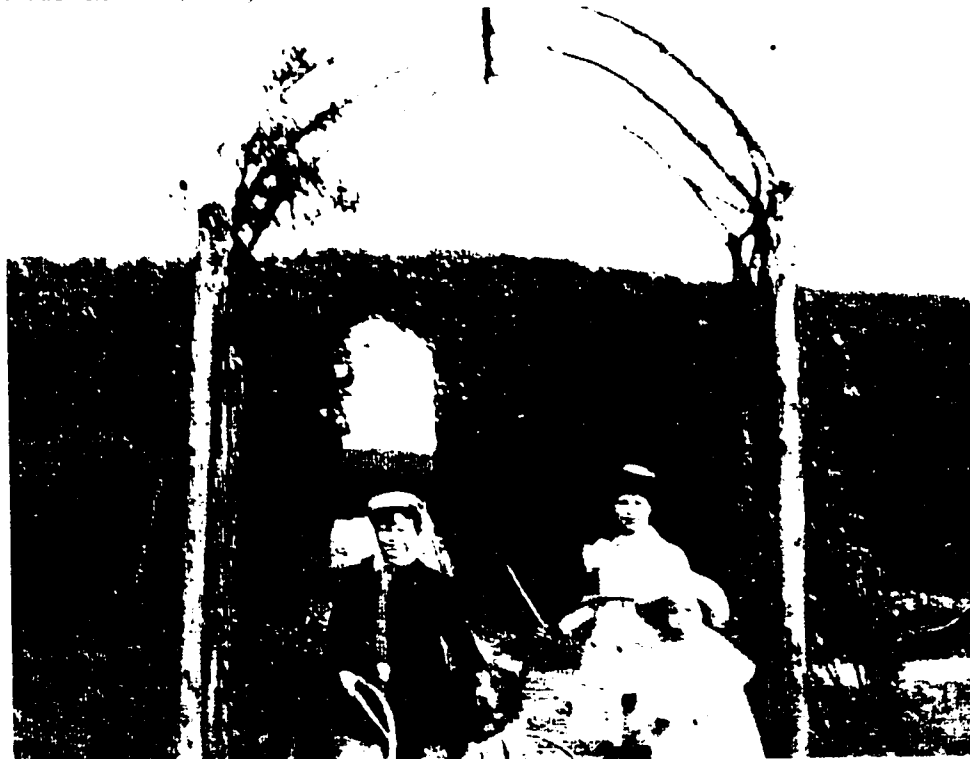
Figure 3.40: Climbing roses on the rose arbor south of the hemlock hedge. Sara, James, Elliott, and Anna Roosevelt pictured, 1912. (Home Franklin D. Roosevelt NHS, no #).

Figure 3.41: Climbing roses and rose arbor south of the hemlock hedge. James, Anna, and Elliott Roosevelt pictured, 1912. (Home Franklin D. Roosevelt NHS, no #).

A rose arbor was constructed sometime between 1901 and 1905, exact date unknown.⁵⁴ It was located approximately 20 feet from the south side of the rose garden hedge and spanned the eastern walkway to the rose garden (see figure 3.40 and 3.41). The arbor was constructed of cedar posts and three, approximately 7-foot-high vertical members anchored into the ground. The outside posts were approximately 4 to 5 inches in diameter and the inner post was approximately 3 inches diameter. At a 7-foot height, these vertical members were connected to a horizontal member approximately 3 inches in diameter that extended an inch or

The hemlock hedge was moderately changed during this period, dates unknown. Archways were formed by the hemlock trees over the two southern entrances to the garden. These entrances were narrower in width than in the previous period (see figures 3.40 and figure 3.41). The entrance at the northeast corner of the garden did not have an overhead archway. The top of the hedge was trimmed to a point during this period so snow could roll off (figure 3.70). In 1945 the hedge was approximately 10 feet wide by 14 feet high.⁷⁵

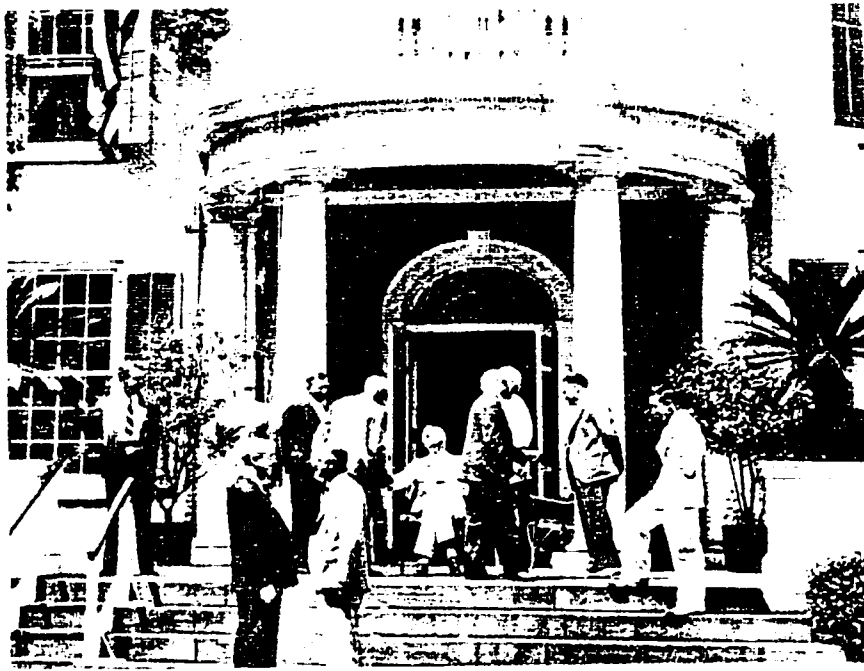
Potted plants were also part of the Roosevelt landscape throughout this period. Six Sago palm trees and an unknown number of small trees were brought out seasonally and placed on the east front terrace (figure 3.47, figure 3.48, and see figures 3.31 and 3.32). The Sago palms in wooden planters (description in Furnishings and Objects section) were placed in the greenhouse during the fall and winter months. The trees in the planters were approximately 4 feet in height.

Figure 3.48: Potted trees and Sago Palms located on Springwood's front terrace, September 16, 1938. (Franklin D. Roosevelt Library, NPx 69-177).

The planters that held the Sago Palms and small trees on the front terrace were constructed in c. 1915 (see figures 3.31, 3.32, and 3.48). They were round, approximately 1 1/2 feet in diameter, and 1 1/2 to 2 feet high. The planters were constructed of wood, painted gray or green, had cast iron handles on each side, and stood on 4 cast iron legs.

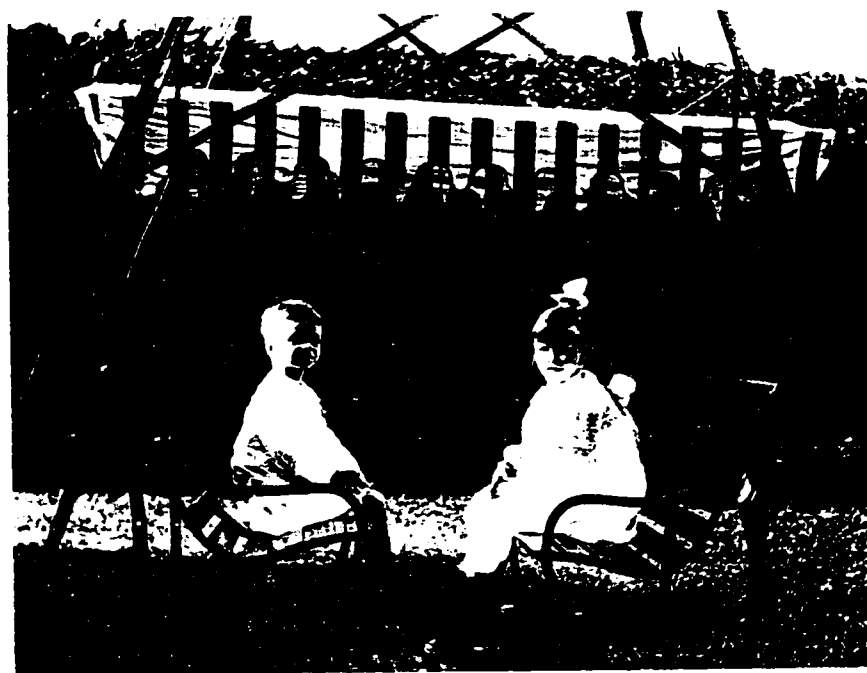
Play apparatus for the Roosevelt children was located throughout the main lawn area. A rope swing with a wood seat, which was tied to a branch of a tree, located on the east lawn south of the hemlock hedge in c. 1909, exact date of installation and location unknown. A movable swing was located on the east lawn south of the hemlock hedge in c. 1911, exact date of installation and location unknown (figure 3.51).⁵⁵ It had a triangular metal frame that held a metal and wood bench swing. A striped cloth canopy was attached to the top of the swing, exact color unknown.

Figure 3.51: The movable swing near the hemlock hedge, James and Anna Roosevelt pictured, 1912. (Franklin D. Roosevelt Library, NPx 47-96: 4804 (148)).

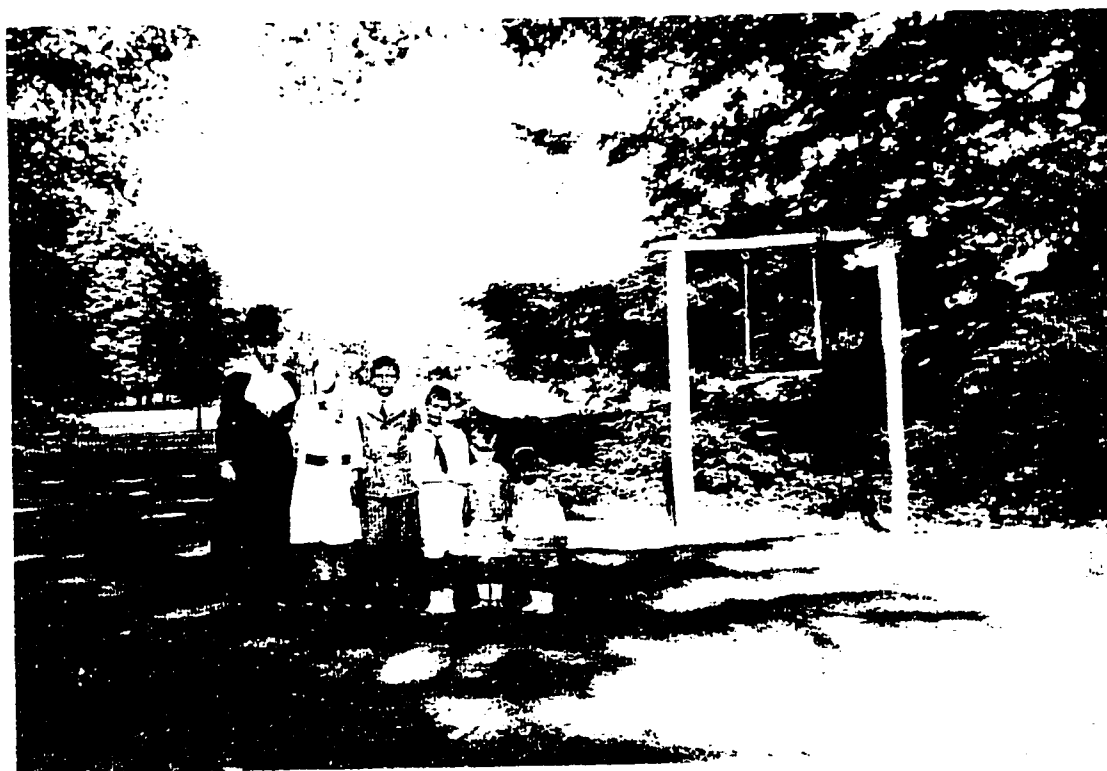
A play structure was constructed in c. 1918 on the east lawn northwest of the tennis court, exact date unknown. It was a post and lintel structure, with a bar hanging from the top of the apparatus (figure 3.52 and figure 3.53). The structure was approximately 6 to 7 feet high by 5 feet wide. The metal bar, which was connected by two ropes from the top of the apparatus, was approximately 3 feet above the ground. The play structure was removed during this period, exact date unknown. A drawing of a structure similar to this one later appeared in a children's picture book, showing two rings with which FDR would pull himself up (figure 3.54).⁵⁶ The play structure was probably removed by the mid-to late 1930s.⁵⁷

Figure 3.52: The play apparatus on the east lawn. Sara, Anna, James, Elliott, Franklin Jr., and John Roosevelt pictured, c. 1918. (Franklin D. Roosevelt Library, NPx 48-22:3623 (7)).

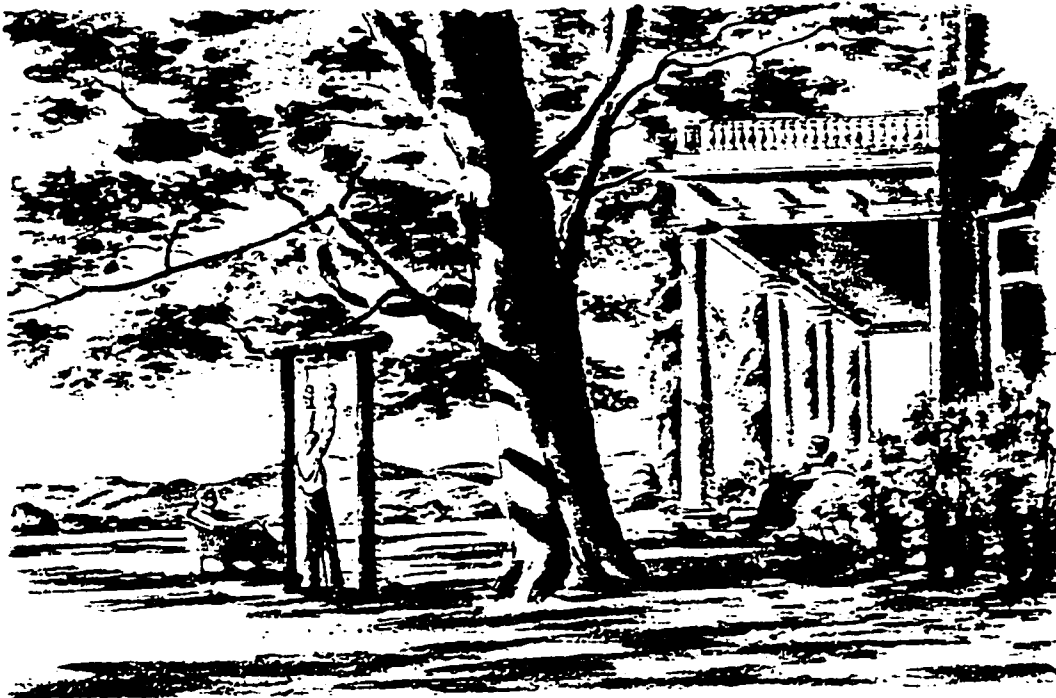
Figure 3.54: Play/exercise apparatus. (Drawing by Olin Dows from his book, *Franklin Roosevelt at Hyde Park*).

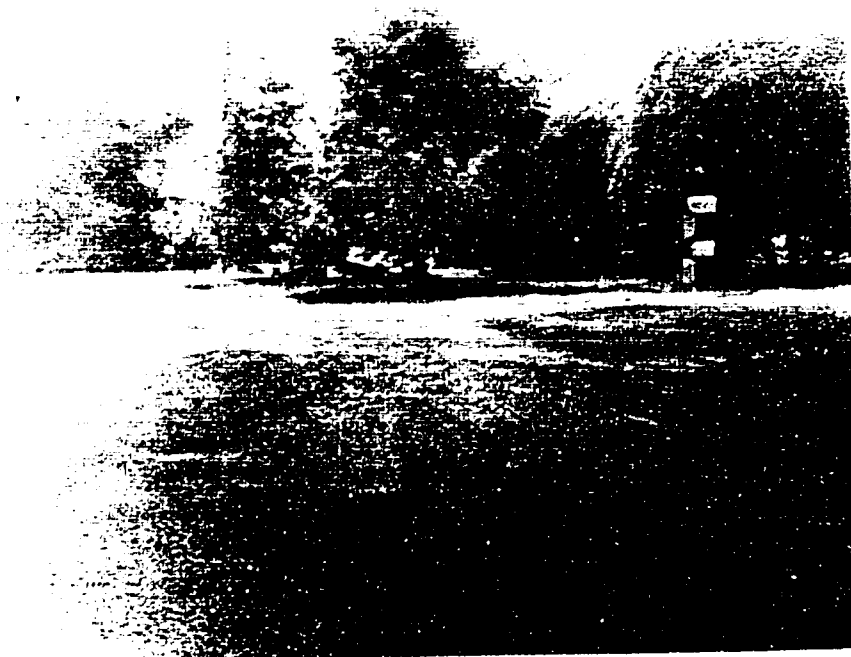
An electric eye, was installed by the Secret Service in c. 1942. It was located at the southeast corner of the hemlock hedge and pointed north up the estate road (figure 3.57). The apparatus was approximately 4 to 5 feet high and constructed of a metal post housing the electrical system (figure 3.58 and 3.59). One of the 'eyes' was located approximately 2 1/2 feet off the ground, with another located above the first at the top. Its color is unknown.

Figure 3.57: Electronic eye (right side of photograph) located at the northwest corner of home and estate road, no date. (Franklin D. Roosevelt Library, NPx 80-26: 44 (10)).

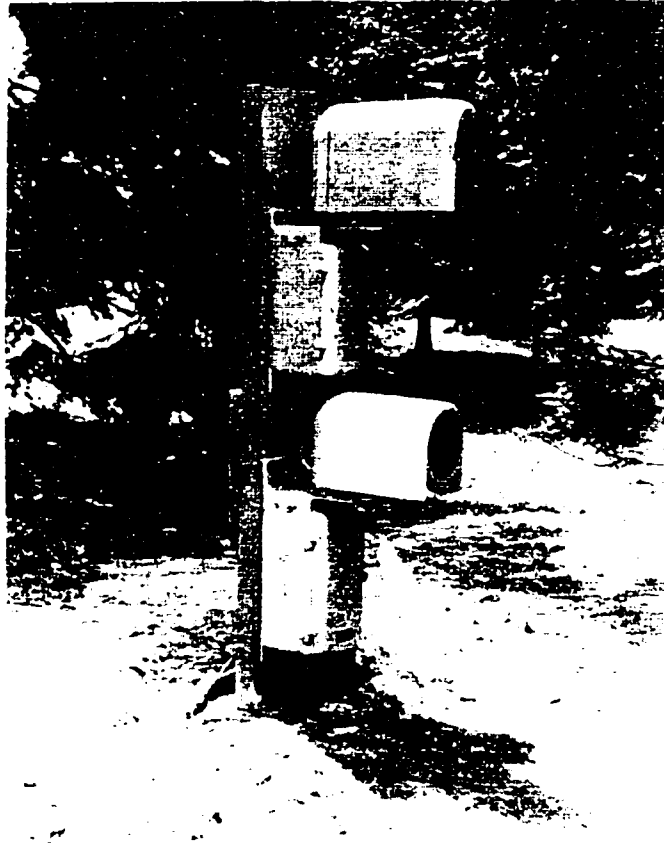
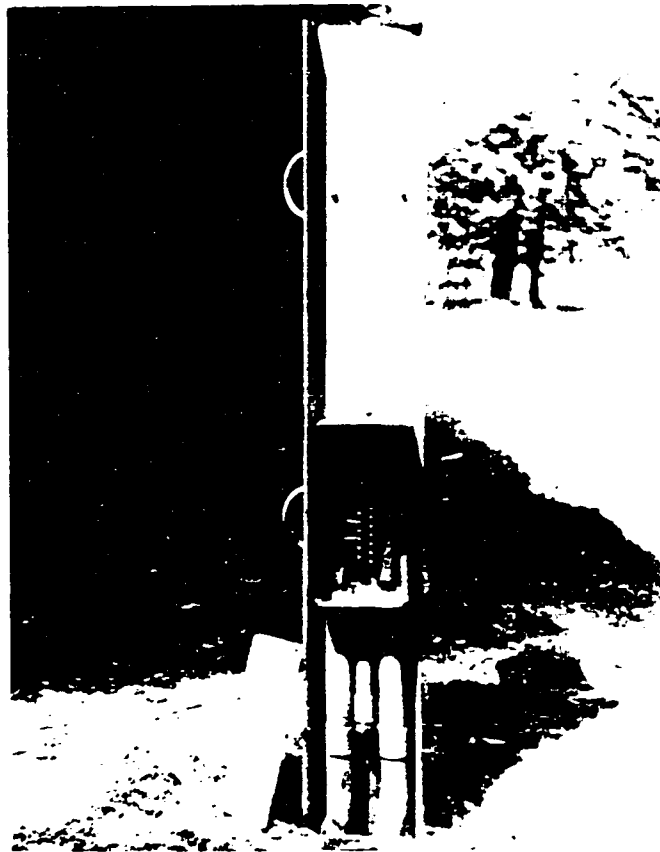
Figure 3.58: Electronic eye located at the northwest corner of home and estate road, no date. (Franklin D. Roosevelt Library, NPx 80-26: 44 (11)).

Figure 3.59: Electronic eye located at the northwest corner of home and estate road, no date. (Franklin D. Roosevelt Library, NPx 80-26: 44 (4)).

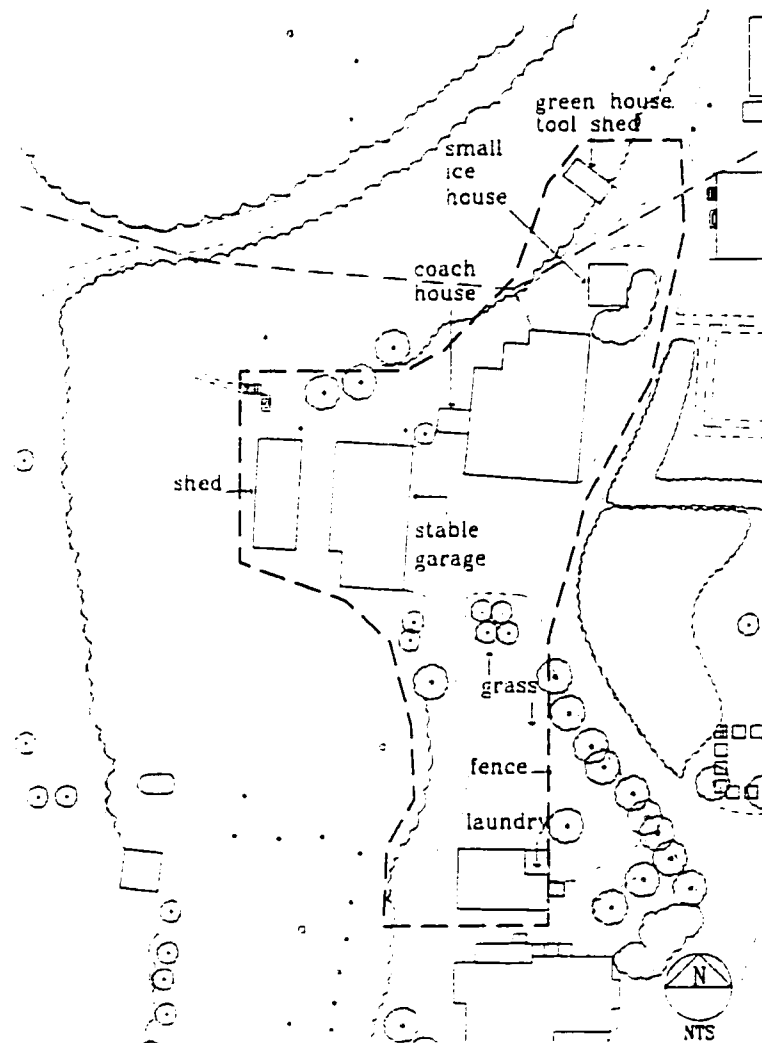
The service area subspace was altered in 1911 with the construction of a greenhouse tool shed. The addition of the building enlarged and redefined the space to the north (figure 3.60).

Figure 3.60: Spatial organization of the service area subspace (K. Baker and G. Dallmann, SUNY CESF, 1998, based on the 1946 USGS map).

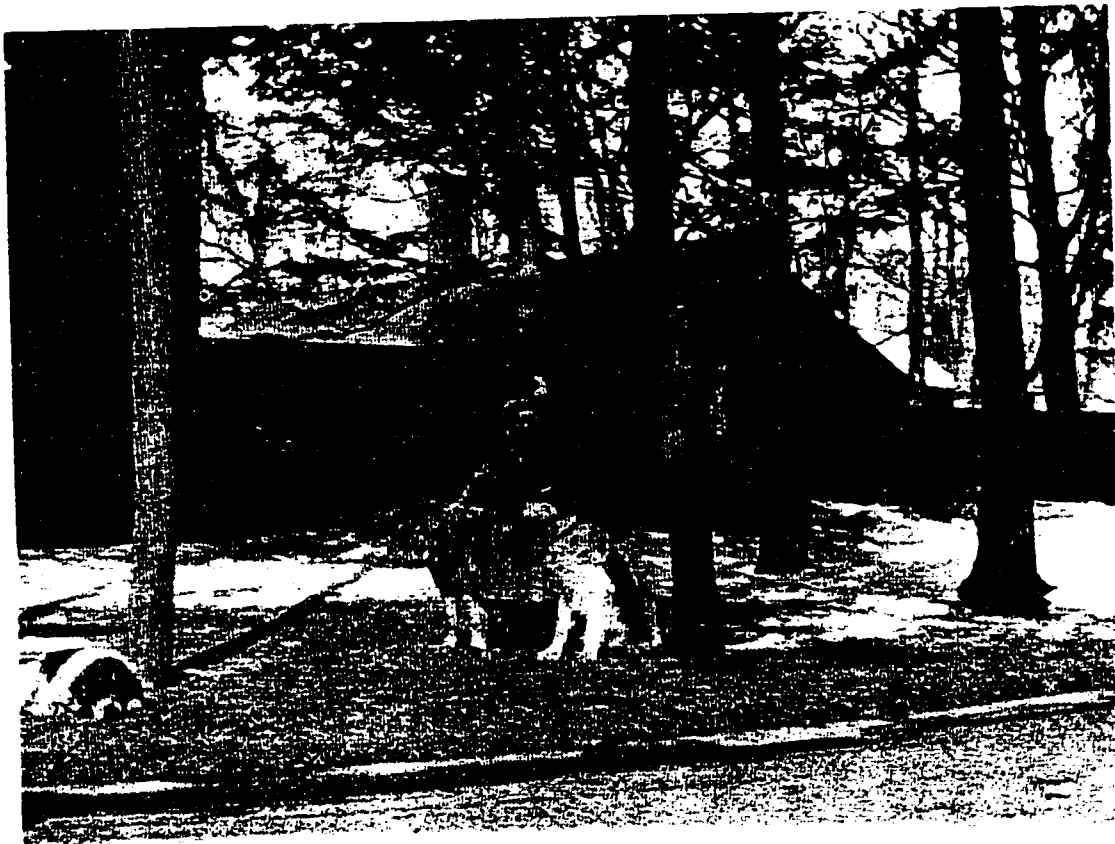
The laundry (HS 12) was painted dark green or dark gray with red trim in 1911.⁶⁰ It was enlarged sometime before 1915, exact date unknown (figure 3.61). The shed and porch addition was located on the north elevation. The addition was rectangular, 30 feet long (E/W) by 10 feet wide (N/S) and was one story high. The addition was sided with clapboard, color unknown. The roof line was extended to include this addition and had wood shingles, color unknown. Three doors were located on the south elevation, two on the west elevation, and

Figure 3.61: East elevation of the enlarged laundry and service fence, child not identified, no date. (The Home of Franklin D. Roosevelt NHS, no #).

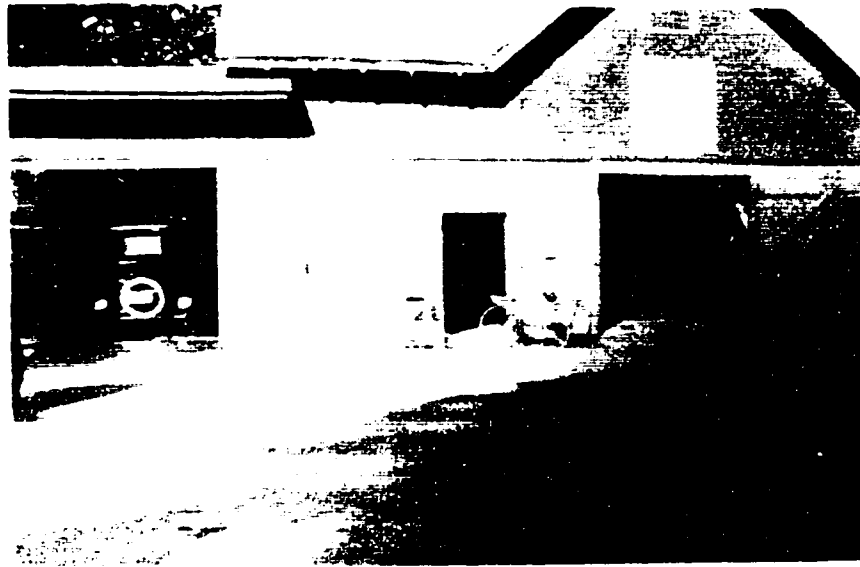
The stable (HS 04) was enlarged in 1910 on the south elevation to serve as a garage for the family's automobile. The garage addition was rectangular, 14 feet long (N/S) by 25 wide (E/W) and one story high (figure 3.62).⁶² The addition was sided with clapboard, color unknown. It had a shed roof with wood shingles. A double door was located at the center of the addition's east elevation. The full basement of the original portion of the stable was used for the driving horses and trotters, the ground floor for the car, and the second story was the coachman's living quarters.

Figure 3.62: East elevation of the stable with the garage addition (left side of photograph), no date. (Franklin D. Roosevelt Library, NPx 47-96: 2322).

Much of the service area was grass that extended from the laundry to within approximately 40 feet of the coach house (see figure 3.62).
