CULTURAL LANDSCAPE REPORT FOR
THE HOME OF FRANKLIN D. ROOSEVELT
NATIONAL HISTORIC SITE

Kristin Theresa Baker

Master of Science in Landscape Architecture Degree

May 1999

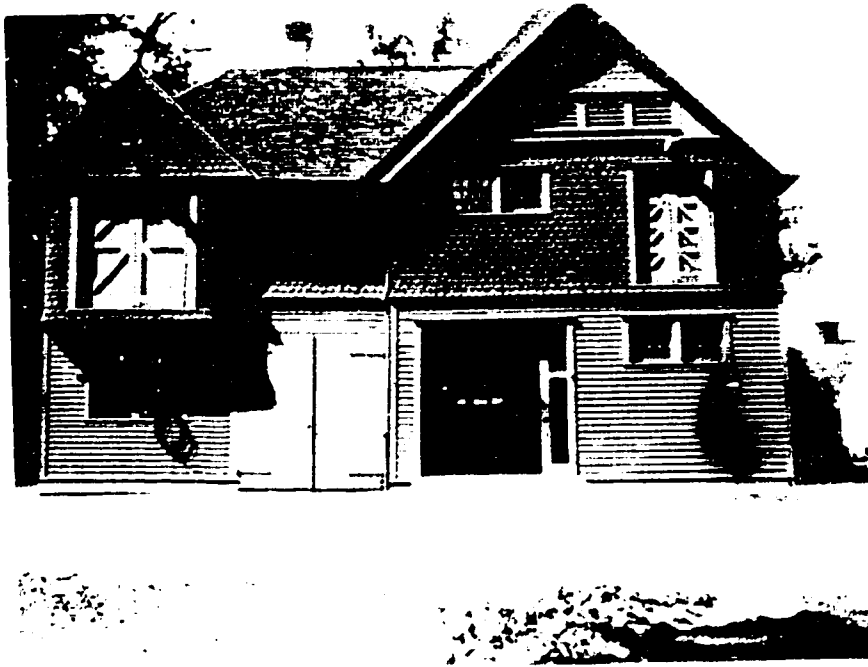
The coach house (HS 03) was enlarged sometime before 1924, exact date unknown. The sleeping porch addition was located on the second story of the west elevation. The addition was rectangular, 12 feet 4 inches long (E/W) by 10 feet 2 inches wide (N/S), and supported by two wood posts approximately 6 to 8 inches in diameter (figure 3.63).⁶⁸ The addition was sided with clapboard and painted gray. It had a flat roof with wood shingles, color unknown.

Figure 3.63: South elevation of the coach house before sleeping porch addition, no date. (Franklin D. Roosevelt Library, NPx 47-96: 2947).

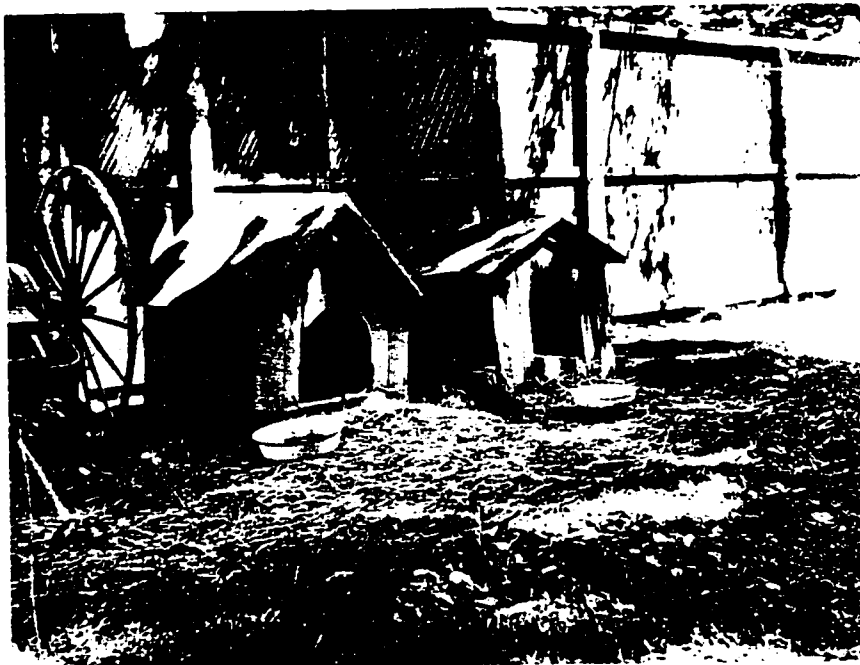
Figure 3.64: Screening fence (rear), doghouses, and laundry lines located in service area, no date. (Franklin D. Roosevelt Library, NPx 48-22: 4091 (25)).

Horse carriages were located within the service area, to the north of the laundry, along the service area fence (see figure 3.64).

Laundry lines for hanging/drying clothes were located into the grass section of the service yard (see figure 3.64). The exact configuration of these lines is unknown.

Two dog houses were constructed in the Late Roosevelt Ownership Period, exact date unknown. They were located directly adjacent to the screening fence near its northern end (figure 3.64). The structures were square, approximately 3 feet by 3 feet, and 3 feet high. The doghouses were constructed of wood, color unknown. They had front-gabled roofs, material and color unknown. A door was located in the center of the west elevation of each.

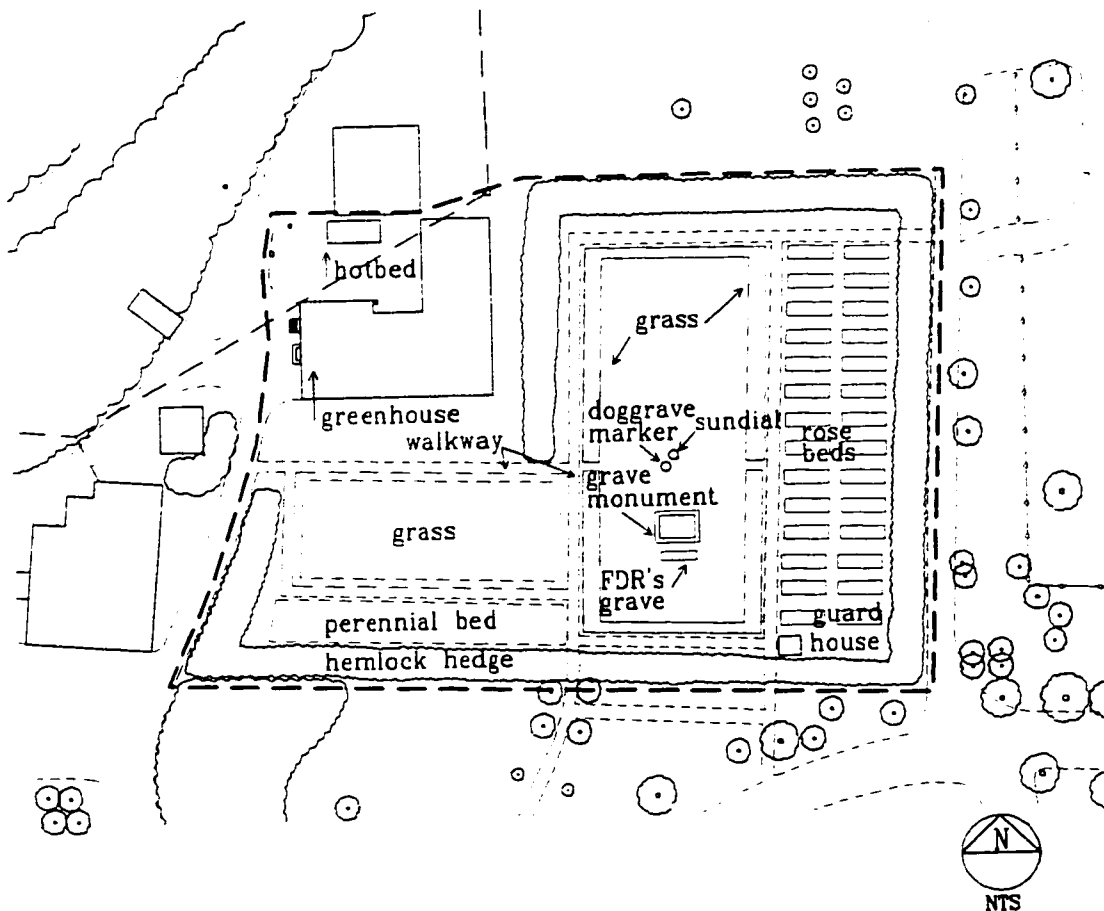
Figure 3.66: Spatial organization of the rose garden subspace. (K. Baker and G. Dallmann, SUNY CESF, 1998, based on the 1946 USGS map).

garden. It was rectangular in shape and the ground was flat and consisted of a grass bordered with perennial flower beds and surrounded by a crushed gravel walkway. The third subspace was located at the southwest section of the space. It was rectangular in shape and the ground was flat and consisted of a grass area surrounded by a crushed gravel walkway and flanked with a perennial flower bed to the south. Views out of the space were heavily screened, but open to the sky (figure 3.66).

The original 1850s greenhouse was removed in 1908. A new greenhouse (HS 11) was constructed in 1906, 290 feet northeast of Springwood and within the northwest section of the rose garden (see figures 3.12, 3.16, and 3.66). The building was L-shaped with an overall size of 68 feet long and 30 feet wide (east-west section) and 60 feet long and 30 feet wide (north-south oriented section), and consisted of four sections (see Appendix I and figure 3.67). The largest of these sections, the rose house, was oriented in an east-west direction and located along the southern elevation of the greenhouse. The rose house was rectangular, 68 feet 10 inches long by 18 feet 4 1/2 inches wide and 14 feet high. The second section, the potting shed, was located north of and adjacent to the rose house and was oriented a east-west direction. It was rectangular, 25 feet 11 inches long by 12 feet 6 inches wide and approximately 11 feet high. The third section, the fern house, was located north of and adjacent to the rose house and east of the potting shed. The fern house was rectangular, 18 feet 7 inches long by 9 feet wide and approximately 11 feet high. The forth section, the carnation house, was oriented in a north-south direction. It was rectangular, 60 feet 5 1/2 inches long by 24 feet 4 inches wide and 14 feet high. The greenhouse had a cross-gabled glass roof. The potting shed had a north sloping shed roof, materials and color unknown. Doors were located on the west elevation of the rose house and potting shed, and in the center of the north elevation of the carnation house.

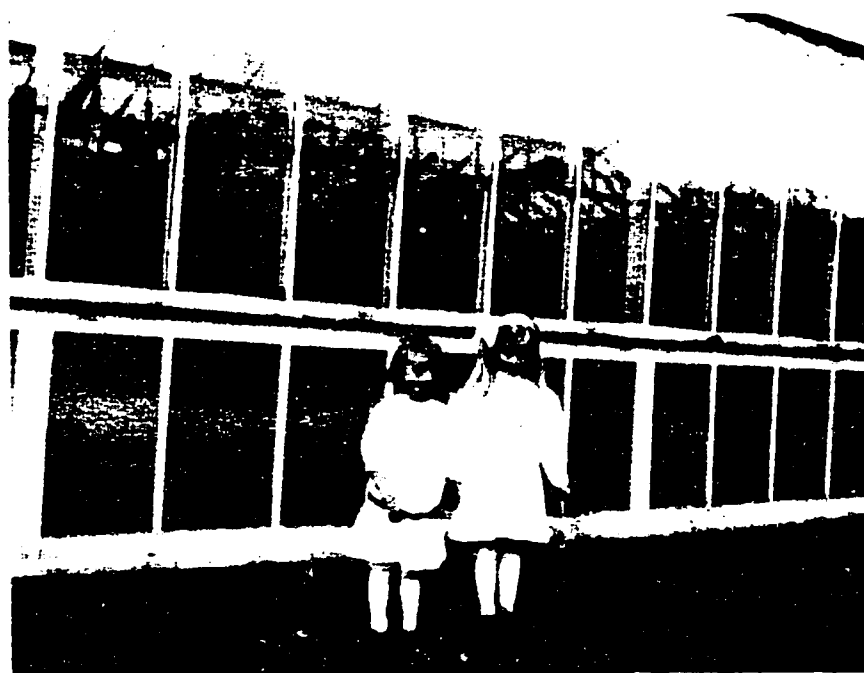
Figure 3.67: South elevation of greenhouse, James and Anna Roosevelt pictured, no date. (Franklin D. Roosevelt Library, NPx 48-22:3619 (231)).

The greenhouse was constructed by Charles Mitchell of Poughkeepsie, New York, at a cost of approximately \$3,700.⁷⁰ The rose house contained approximately 300 rose bushes used for cuttings for the house. The carnation house also was used for plants requiring winter storage, like the Sago Palms. The fern house was used to grow ferns that were used to decorate the living room of the house.⁷¹ The greenhouse was painted three times between 1906 and 1912.⁷²

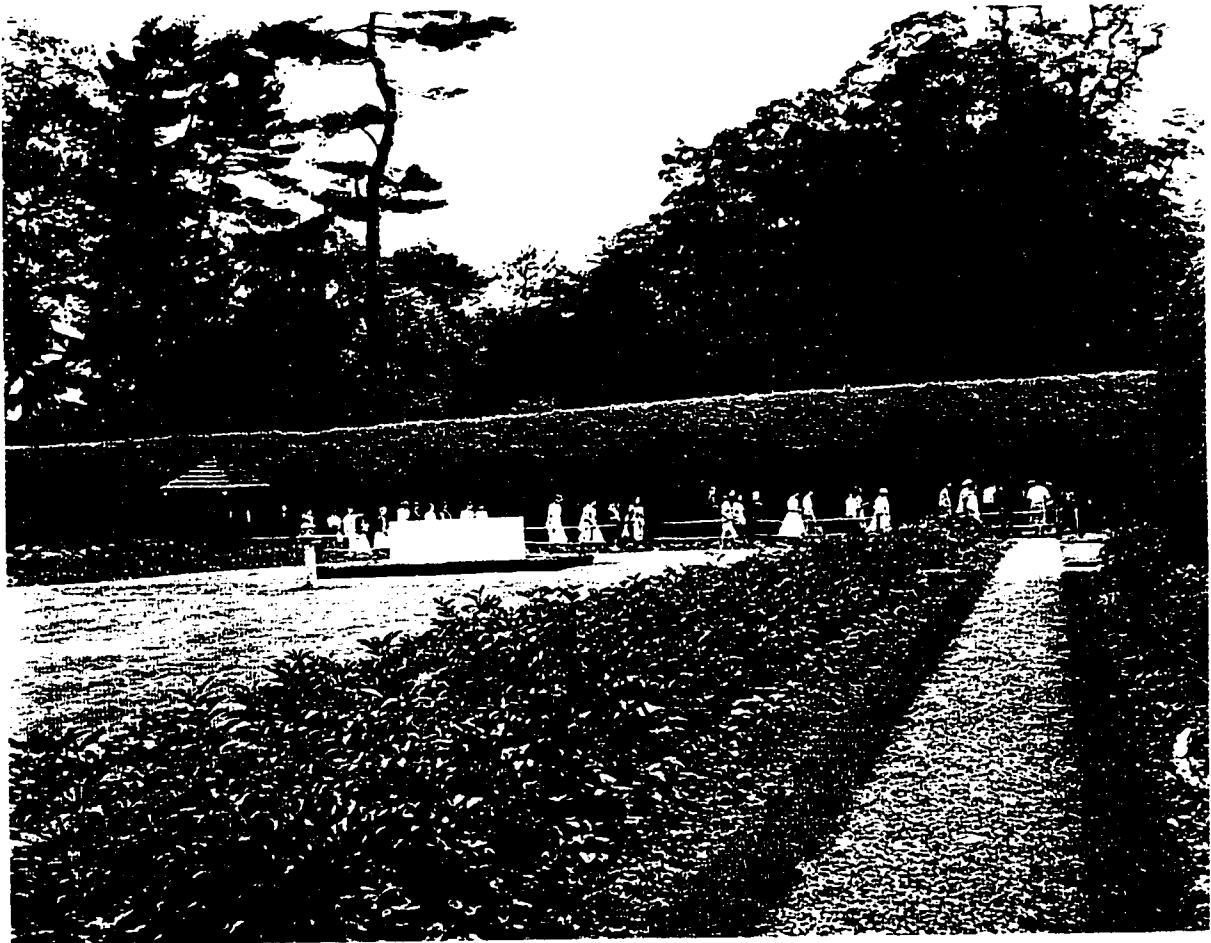
Figure 3.68: Grave site guard house and fence, 1955. (The Franklin D. Roosevelt Library, NPx 56-151 (1)).

A grave site guard house was constructed in c. 1945 adjacent to the garden's southeastern entrance and directly adjacent to the hedge.⁷⁴ The building was square, approximately 8 feet (N/S) by 8 feet (E/W) and 11 to 12 feet high (figure 3.68). The guard house was sided with clapboards, color unknown. It had a pyramidal-hipped roof with wood shingles, color unknown. A door was located in the center of the west elevation.

Due to the monument's weight and the instability of the gravesite's soil, the monument was not placed directly over the grave as FDR wanted. Instead it was placed alongside and to the north of the grave (see figure 3.68). The sundial in the center of the garden was moved slightly north to accommodate the change in the monument's location. The president's burial plot was an "international grave," as soil was flown to Hyde Park from Pan-America to cover the grave.⁸⁰

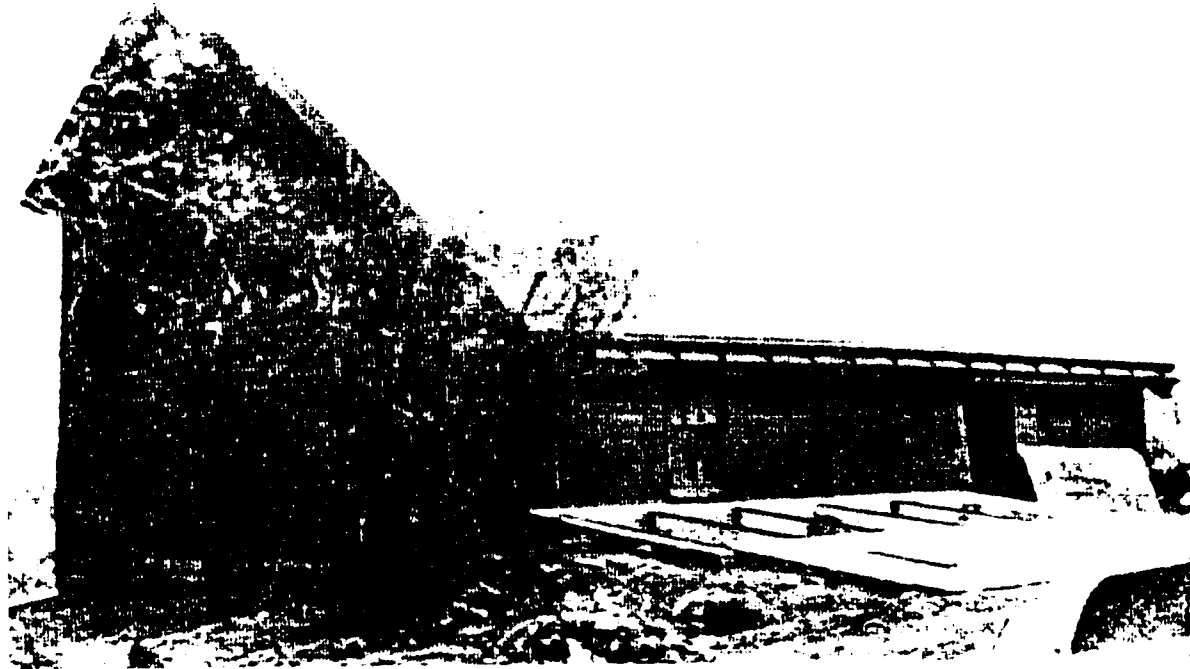
Figure 3.69: Hot bed and addition to south elevation of the large ice house, c. 1946. (Franklin D. Roosevelt Library, Px 91-158 (2)).

The hot bed was used during this period. It had wooden framed glass top, color unknown (figure 3.69).

The large ice house (HS 09) was enlarged between 1899 and 1932, exact date unknown.⁸² The shed addition was located on the south elevation and was rectangular, 30 foot long (E/W) by 11 feet wide (N/S), and varied from approximately 7 feet to 15 feet high (see figure 3.69). It gave the ice house overall dimensions of 30 feet by 30 feet.⁸³ The addition was sided with clapboard and was painted gray. Its had a steeply sloped roof with wood shingles, color unknown, that formed a continuous roof line with the original structure. A door was located near the northeast corner of the addition's east elevation and a sliding door was in the center of the south elevation.

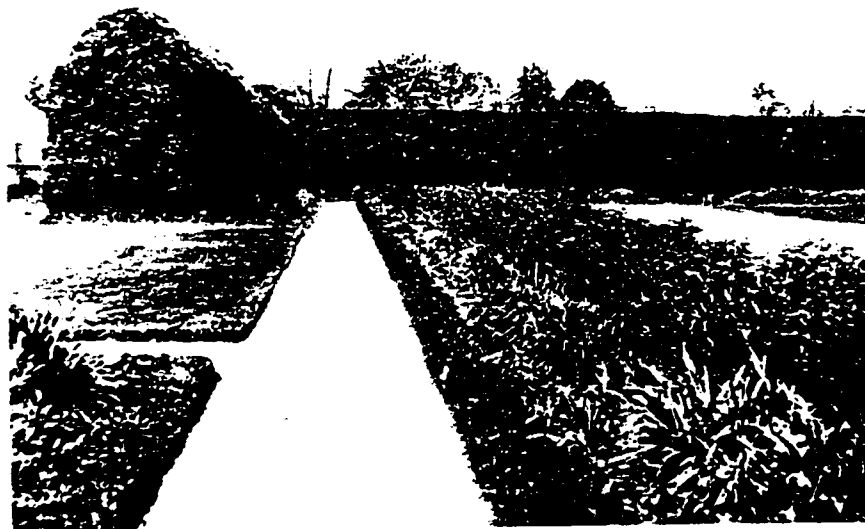
Figure 3.70: Hemlock hedge and rose garden, no date. (Franklin D. Roosevelt Library, NPx 80-165 (9)).

The hemlock hedge was moderately changed during this period, dates unknown. Archways were formed by the hemlock trees over the two southern entrances to the garden. These entrances were narrower in width than in the previous period (see figures 3.40 and figure 3.41). The entrance at the northeast corner of the garden did not have an overhead archway. The top of the hedge was trimmed to a point during this period so snow could roll off (figure 3.70). In 1945 the hedge was approximately 10 feet wide by 14 feet high.⁷⁵

The pathways within the garden may have been affected by the removal of the original greenhouse and creation of a new one, although no sources have been located for verification. After 1912 the pathways were located between the rose beds and the central grassy area of the garden. The pathway also surrounded the central area as well as the rectangular space where the old greenhouse was located. The pathways were 3 feet wide with a stone dust surface (see figures 3.70 and 3.71).

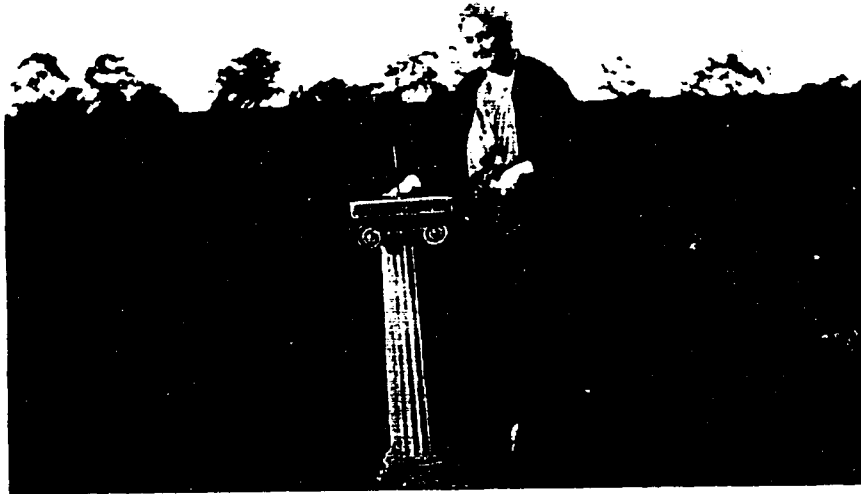
Figure 3.74: Sundial in the rose garden, Sara Roosevelt pictured, 1930. (Franklin D. Roosevelt Library, NPx 47-96: 2733).

A sundial was probably installed in the garden after its change in 1912. It was located in the center of the garden until FDR's death in 1945 and was then moved slightly to the north, 1 foot north of the dog grave marker, to accommodate FDR's grave monument (figure 3.74 and figure 3.75). The base of the sundial was cut stone, 3 feet high, and white in color. A metal "dial" was located on top of the stone base, but its dimensions and color are unknown.

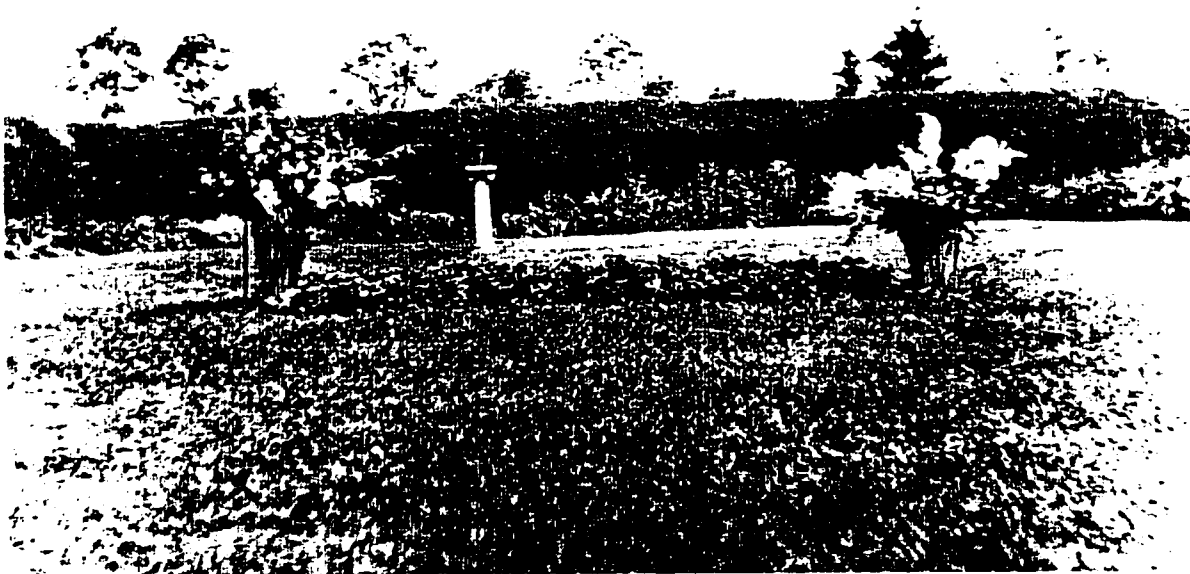
Figure 3.75: Sundial and FDR's grave in the rose garden, 1945. (Franklin D. Roosevelt Library, NPx 56-249 (2)).

FDR died in Warm Springs, Georgia, on April 12, 1945 and on April 15 he was buried in the rose garden (see figure 3.4). In her booklet about FDR, Eleanor Roosevelt recalled, "The place he looked upon as the most beautiful was the rose garden...and this was where he wished to be buried."⁷⁸ For five months his grave was adorned only with flowers, as his grave monument was being constructed according to his written wishes (see figures 3.71 and 3.75). The grave site was protected by the 1235 Military Police Battalion during that time.

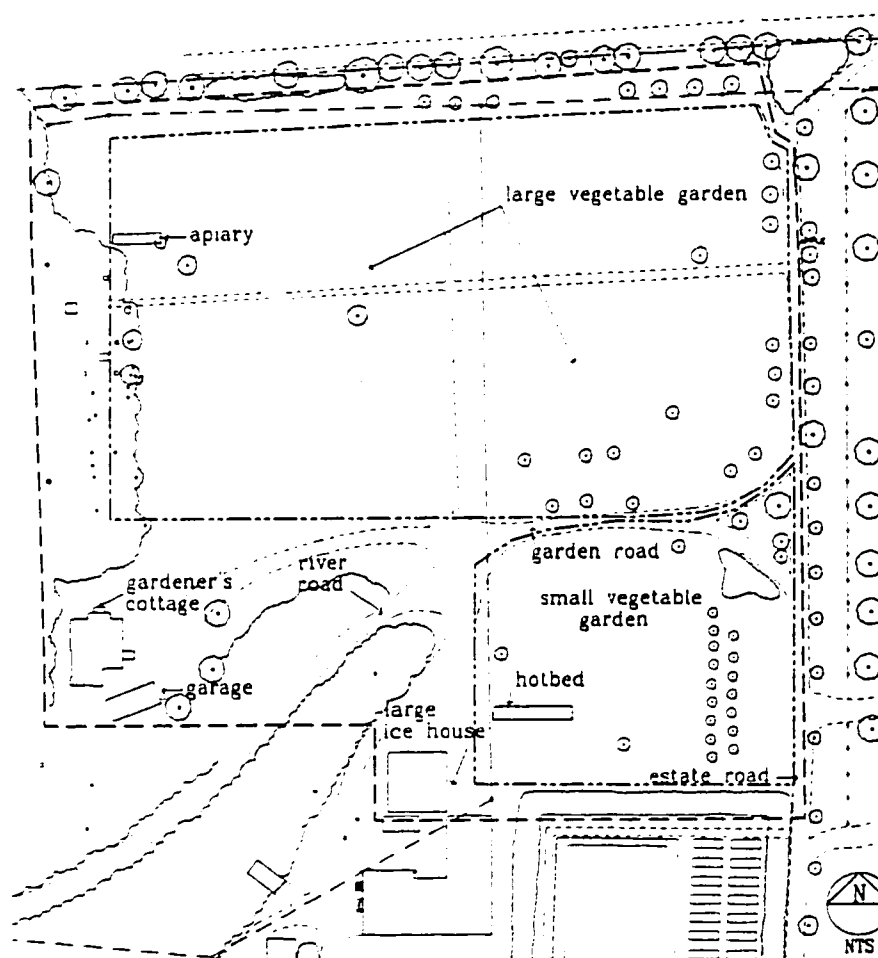
Figure 3.76: Spatial organization of the vegetable garden subspace. (K. Baker and G. Dallmann, SUNY CESF, 1998, based on the 1946 USGS map).

The vegetable garden subspace was altered during the Late Roosevelt Ownership Period, exact date unknown, with the removal of the orchard and expansion of the large vegetable garden, and the addition of a number of service and garden roads (figure 3.76). The small vegetable garden was altered with the addition of trees to the space which acted as objects within rather than definers of the space.

A gardener's garage (HS 16) was constructed in 1906 400 feet north of Springwood and 20 feet southeast of the gardener's cottage (see figure 3.76 and Late Roosevelt Ownership period plan). The building was rectangular, 11 feet 4 inches long (E/W) by 9 feet wide (N/S) and 12 feet high. The garage was sided with clapboard, color unknown. It had a front-gabled roof, material and color unknown. A double door was located in the center of the west elevation. The garage was enlarged in 1916. The addition was located on the east elevation and was rectangular, 16 feet 7 inches long (E/W) by 11 feet 4 inches wide (N/S) and 12 feet high.⁸⁴ It was sided with clapboard, color unknown. It had a gabled roof, material and color unknown. A door was located in the center of the addition's northeast elevation. It was used by William Plog as an "out shed."⁸⁵

A hot bed (HS 26) was constructed in 1920, 30 feet northeast of the large ice house (see figure 3.76). It was rectangular, 43 feet long by 7 feet 4 inches wide, and 6 inches high on the north side, sloping to ground level on the south side. It was constructed of concrete. It is unknown if this hot bed was covered.

Two garden roads crisscrossed in approximately the center of the large vegetable garden. The north-south road began near the river road, and the east-west road began at the estate road (see figure 3.76). The roads were approximately 6 feet wide with a compacted soil or gravel surface and no edging. Another road crossed the garden in a diagonal line beginning at the intersection of the river road and north-south service road and ran to the northwest corner of the garden. The road was approximately 6 to 8 feet wide with a compacted soil or gravel surface and no edging.

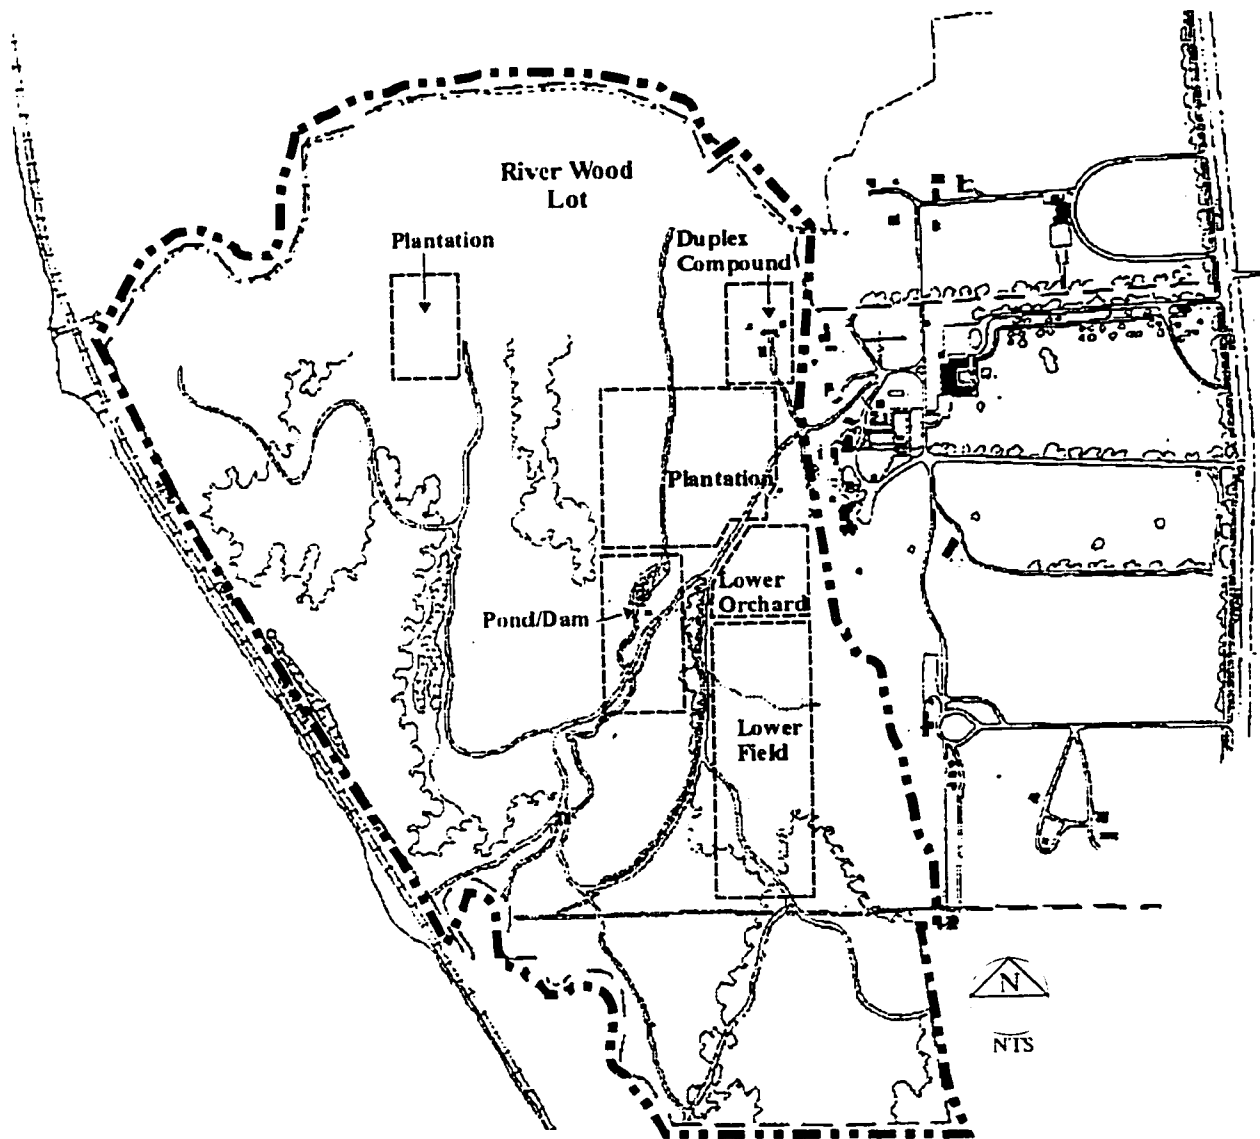
Figure 3.80: Spatial organization of Woodland Space. (G. Dallmann, SUNY CESF, 1998, based on the Home of Franklin D. Roosevelt NHS, *Master Plan*, 1977).

Two subspaces were formed during this period. The *Lower Orchard Subspace*, was created in 1916 and located in the land that was once part of the paddock lot subspace (figure 3.80). The north-south orientation of the trees created even rows and a regular, partial overhead canopy of uniform texture. The remaining acreage to the north of the orchard, which was once part of the paddock lot, was incorporated into the river wood lot subspace. The *Plantation Subspaces* included land that was once part of the river wood lot subspace (figure 3.80). The plantations were located in various of areas west of Springwood and within the river wood lot subspace. The subspaces were defined to the north, south, east, and west by the vegetation of the river wood lot subspace. The ground was a combination of flat areas, steep hills, and deep valleys. The dense wooded area surrounding the space limited views into and out of the area.

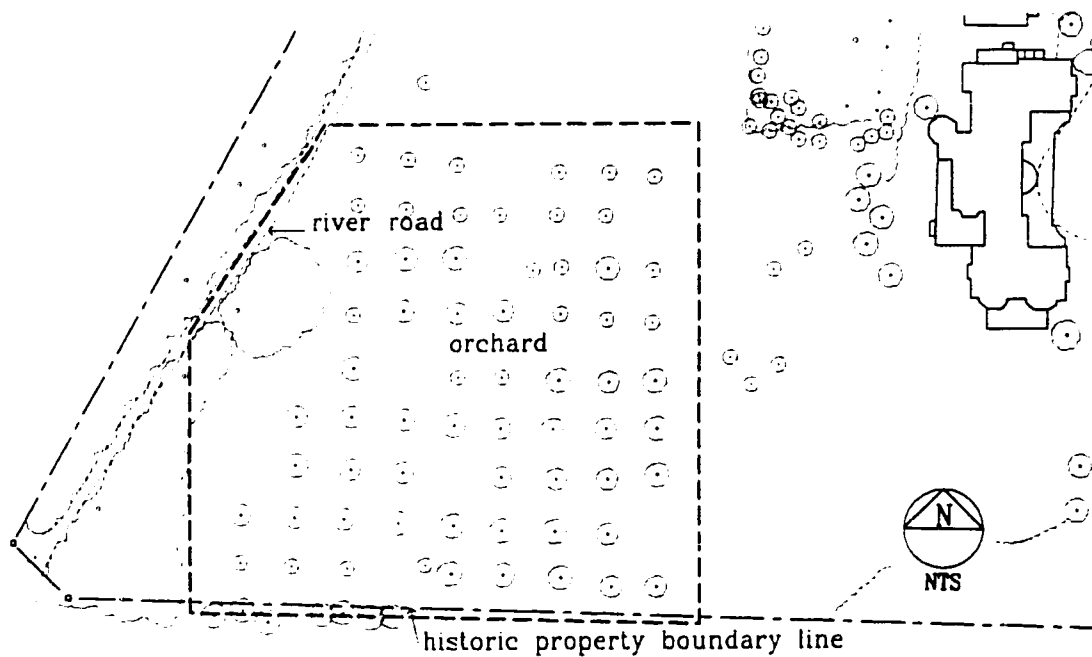
Figure 3.81: Paddock lot/lower orchard subspace. (K. Baker and G. Dallmann, SUNY CESF, 1998, based on the 1946 USGS map).

A lower orchard was planted in 1916 at the bottom of the ridge to the west of Springwood (figures 3.81 and 3.82). The trees within the orchard were planted in rows extending in north-south and east-west patterns. Sixty-two apple trees were located within the orchard, including Macintosh (*Malus* "Macintosh") and Golden Delicious (*Malus* "Golden Delicious").

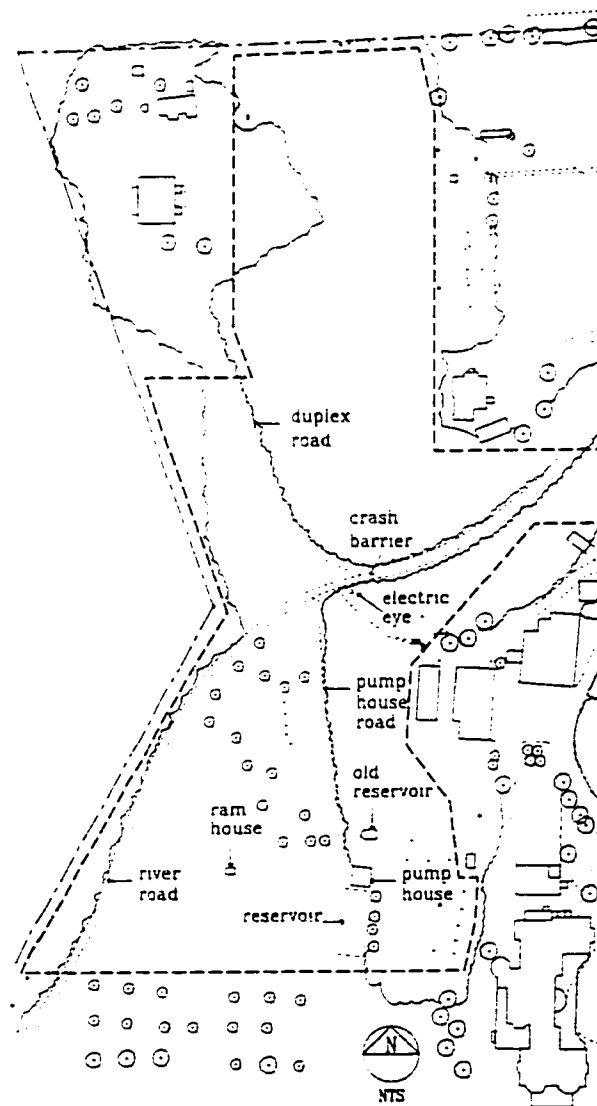
Figure 3.83: Spatial organization of the river wood lot subspace. (K. Baker and G. Dallmann, SUNY CESF, 1998, based on the 1946 USGS map).

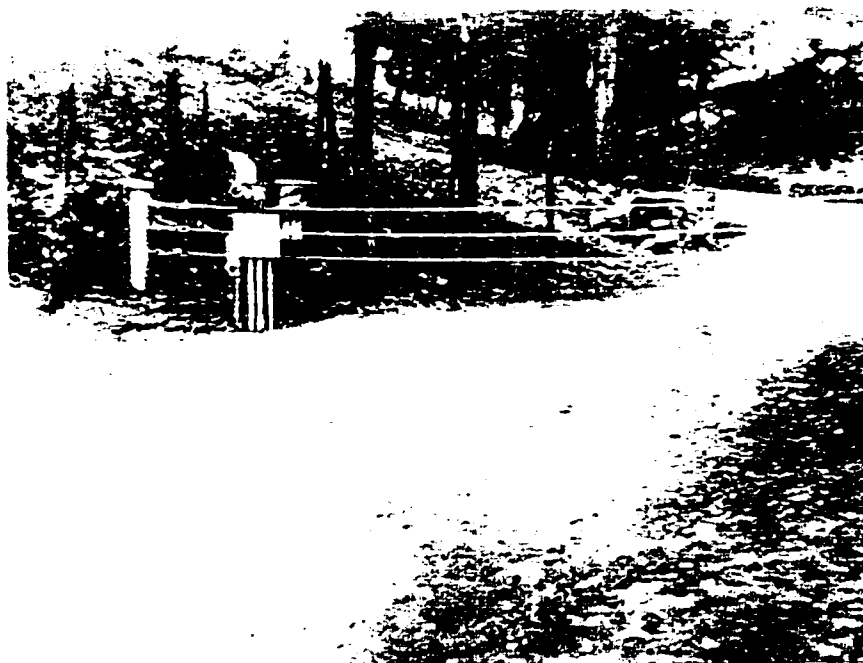
Figure 3.84: Crash barrier at the intersection of the river and duplex road, no date. (Franklin D. Roosevelt Library, Px 80-26 (2)).

A crash barrier, described previously in the home road subspace, was located east of the river road and duplex road intersection (figure 3.84).

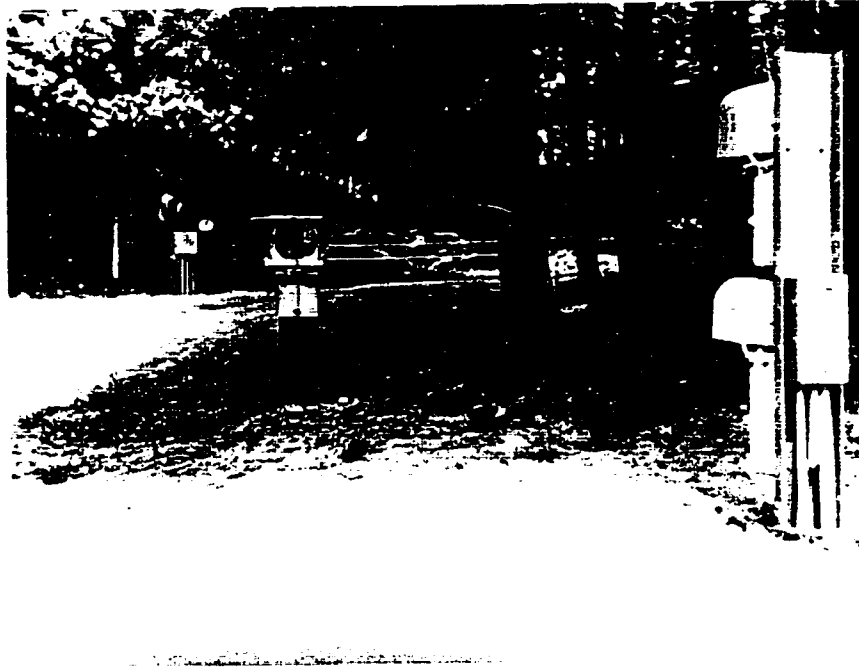
Figure 3.85: Electronic eye and crash barrier at the intersection of the river and duplex road, no date. (Franklin D. Roosevelt Library, Px 80-26:44 (8)).

An electronic eye, described previously in the main lawn subspace, was installed southwest of the crash barrier (figure 3.85).

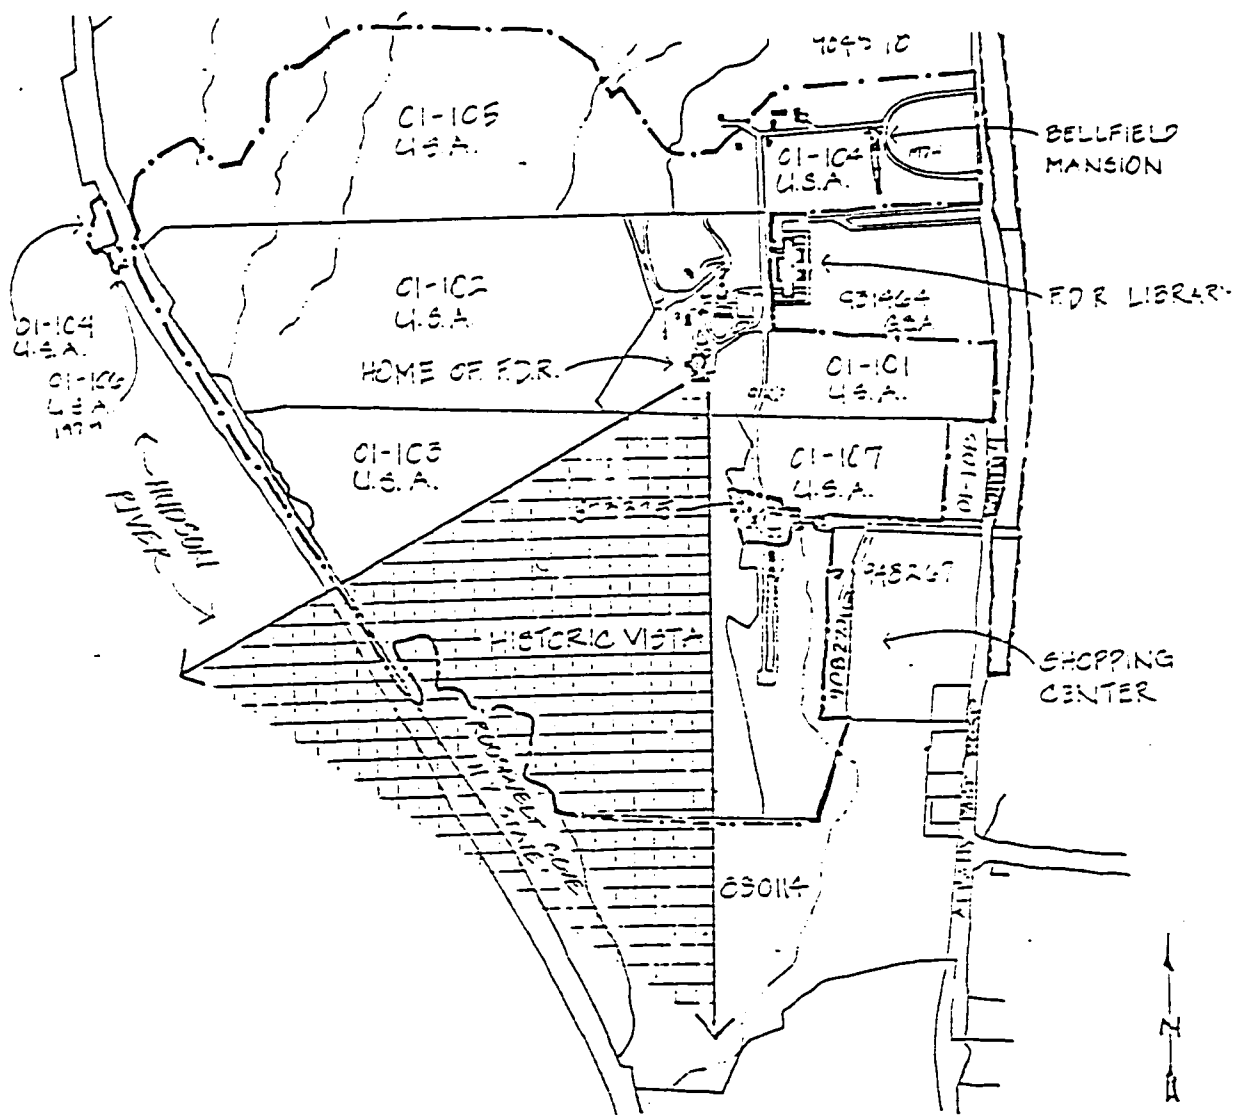
Figure 4.3: Boundary changes/lands added to the site 1945-1997. (Land Protection Plan, 1985).

In 1998, 35 acres to the south of the lower field, were purchased by the Open Space Institute to secure the viewshed from the Home of FDR to the Hudson River, but it has not yet been transferred to the NPS. As of 1998, the Home of Franklin D. Roosevelt National Historic Site owns 292.84 acres (Figure 4.3).²⁰

Although the Home of FDR National Historic Site initially was composed of 33.23 acres; additional properties that were given to, or acquired by the NPS, expanded the size of the site to 292.84 acres. On December 29, 1952, the FDR Foundation gave the United States 60.46 acres (01-102) between the NPS property and the river. In 1964, 94 acres (01-103),

formerly part of James Roosevelt Roosevelt's estate or the Boreel tract, were added to the site by condemnation. Between 1974 and 1975, Gerald Morgan gave the NPS 76.20 acres (01-104, 01-105, and 01-106) of the Bellefield estate, located adjacent to the Home's northern boundary. On June 7, 1984, the Trust for Public Land purchased 26.22 acres (01-107) of land surrounding James Roosevelt Roosevelt's "Red House." In 1989, a small parcel of 2.5 acres (01-108) of James Roosevelt Roosevelt's land which fronted Route 9 was added to the site.

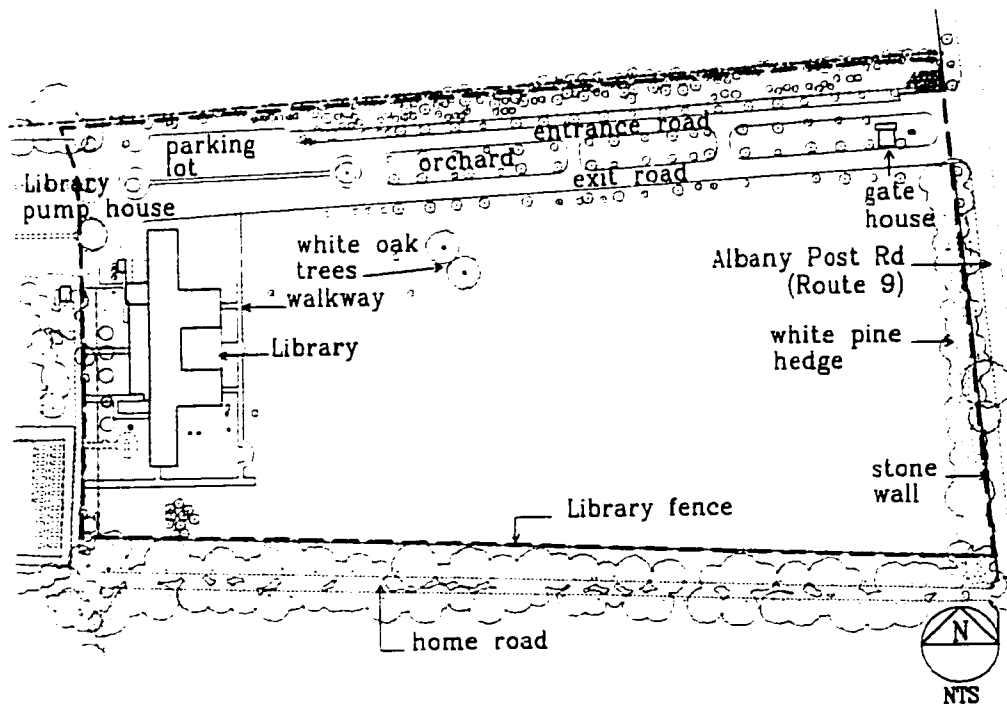
Figure 4.4: Spatial organization of the north avenue lot and home road subspaces. (K. Baker and G. Dallmann, SUNY CESF, 1998, based on the 1994 HPI map).

The space was altered in 1971 with the construction of two wings to the library, which further screened views to the west. The spatial configuration of the north avenue lot subspace is unchanged in terms of its shape, size, and defining edges (figure 4.4). The white pine hedge along the eastern portion of the north avenue lot has matured over the years and views are now semi-open off-site to Albany Post Road. Trees within the field continue to be objects in rather than definers of the space.

The library (HS 02), constructed in the Late Roosevelt Period, had two wings added in 1971 dedicated to Eleanor Roosevelt (see figure 4.4). The additions were located on the north and south elevations. They were rectangular, 80 feet long (N/S) by 35 feet wide (E/W) and two stories high. The additions gave the building a total length of 320 feet. They were constructed of local brown-colored fieldstone. The roof was gabled and therefore gave the entire library a double cross-gabled roof with gray slate shingles.

Vegetation within the north field currently includes four large white oak trees (*Quercus alba*). The eastern two trees date back to the Pre or Early Roosevelt Ownership Period, and the smaller two were planted during the Late Roosevelt Ownership Period (see figures 4.4 and 4.9 and see Existing Conditions plan). Three red oak trees (*Quercus rubra*) that were planted during the Late Roosevelt period remain today and are located east of the library (figure 4.11).

An exit road was constructed in 1948 as part of the parking lot enlargement. It was located between the southern two rows of apple trees in the orchard (figure 4.14, 4.16, and see figure 4.4). This road was 840 feet long and 18 feet wide with a black asphalt surface. Concrete curbing was located along the entrance and exit roads where it joined the Albany Post Road, but does not line the entire length of the roads. The addition of this second road changed the circulation pattern so each road became one-way. Three u-turn lanes were constructed to connect the entrance and exit roads. The surface of these roads was asphalt.

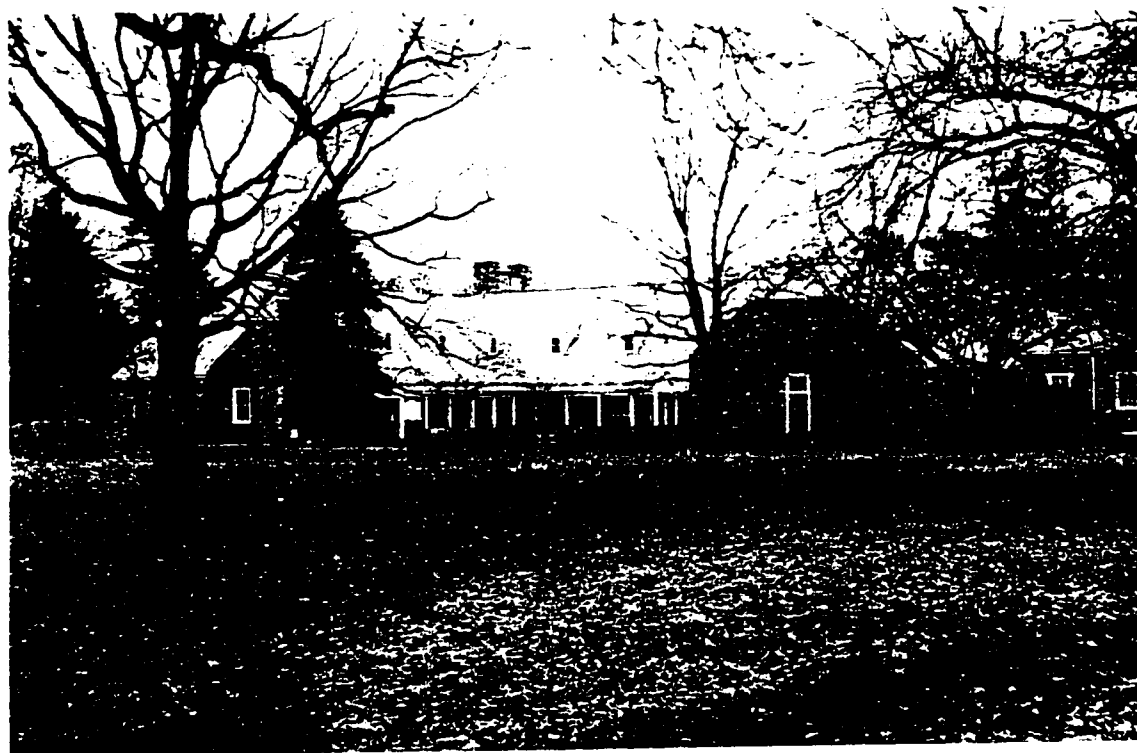
Figure 4.5: Franklin D. Roosevelt Library, east elevation, 1998. (photograph by author).

The existing condition of the library is as described above (figure 4.5).

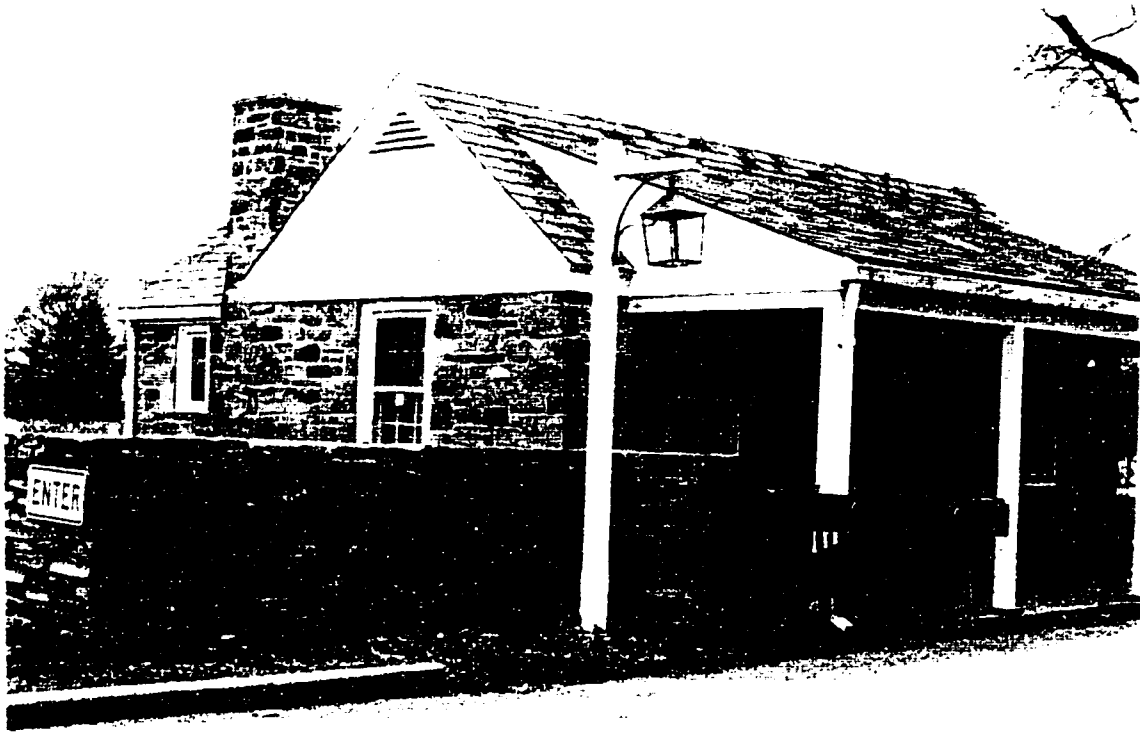
Figure 4.6: Library gatehouse, north and east elevation, 1997. (photograph by author).

The gate house (HS 25), constructed in the Late Roosevelt Ownership Period, was not used past 1948, after a new ticket booth was built. At one time there were plans to eliminate the gate house, but the importance of this building was realized and saved from demolition. It is unknown if any physical changes occurred during this period as no information was found on the gate house. The library established a photo workspace center in the gate house in 1995-1996.

The existing condition of the gate house is as described above (figure 4.6).

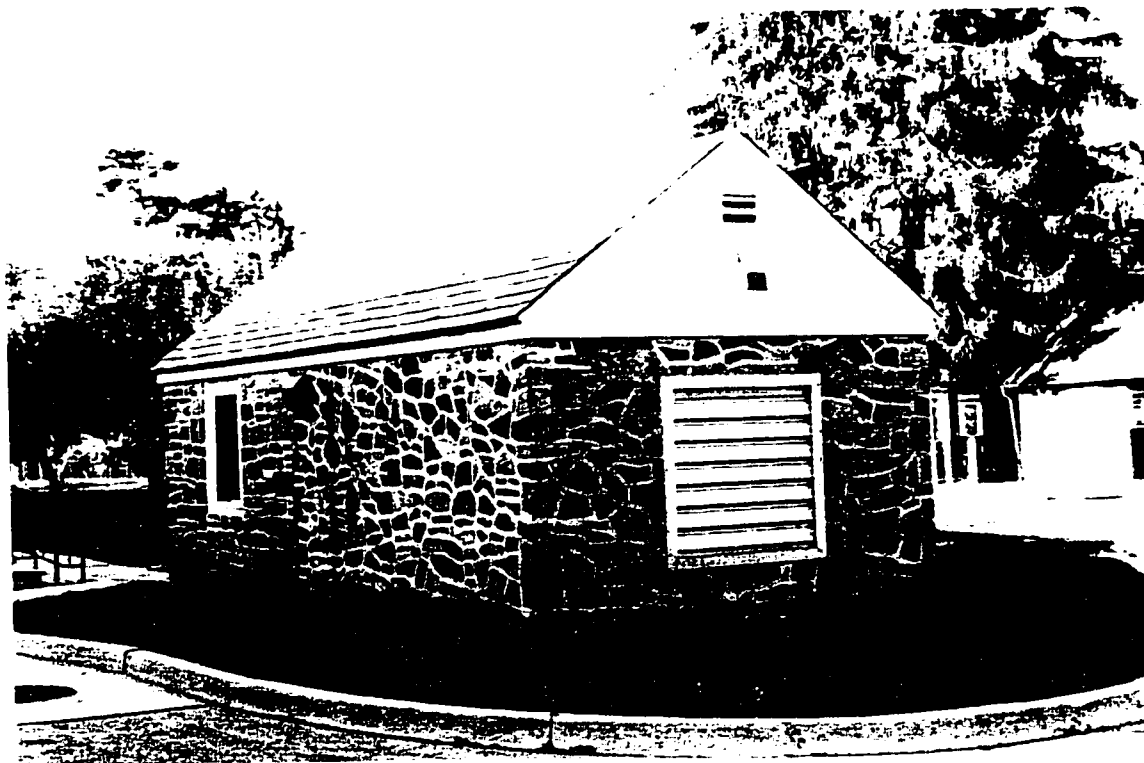
Figure 4.7: Library pump house, north and east elevation, 1997. (photograph by author).

The pump house (HS 24) was enlarged in c. 1971 at the time of the library's expansion. The addition was located on the north elevation, and was square, 10 feet long (N/S) by 10 feet wide (E/W) and approximately 9 feet high. The pump house had an overall dimension of 20 feet long (N/S) by 10 feet wide (E/W). The addition was constructed of local brown-colored fieldstone, but the shape and binding materials of the fieldstone were different from the original. It had a front-gabled roof with gray slate shingles.

The existing condition of the pump house is as described above (figure 4.7).

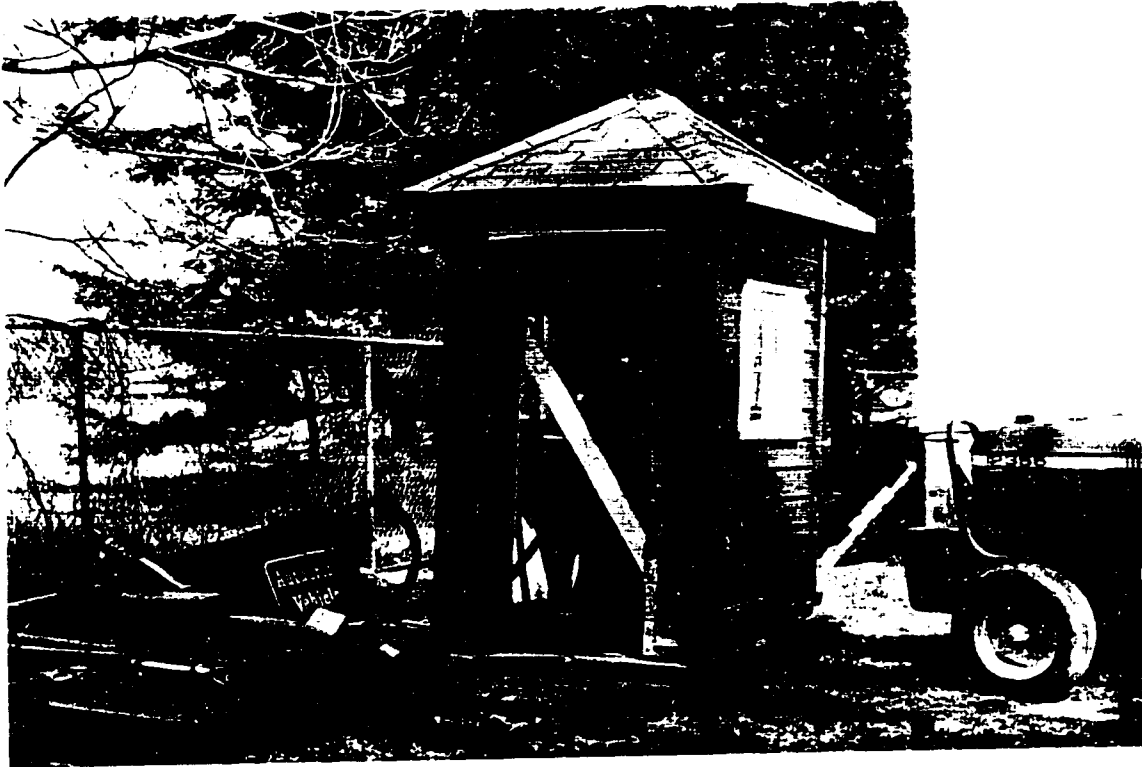
Figure 4.8: Guard house stored in the Bellefield maintenance area, 1998.
(photograph by author).

The existing condition of the guard house is as described above (figure 4.8).

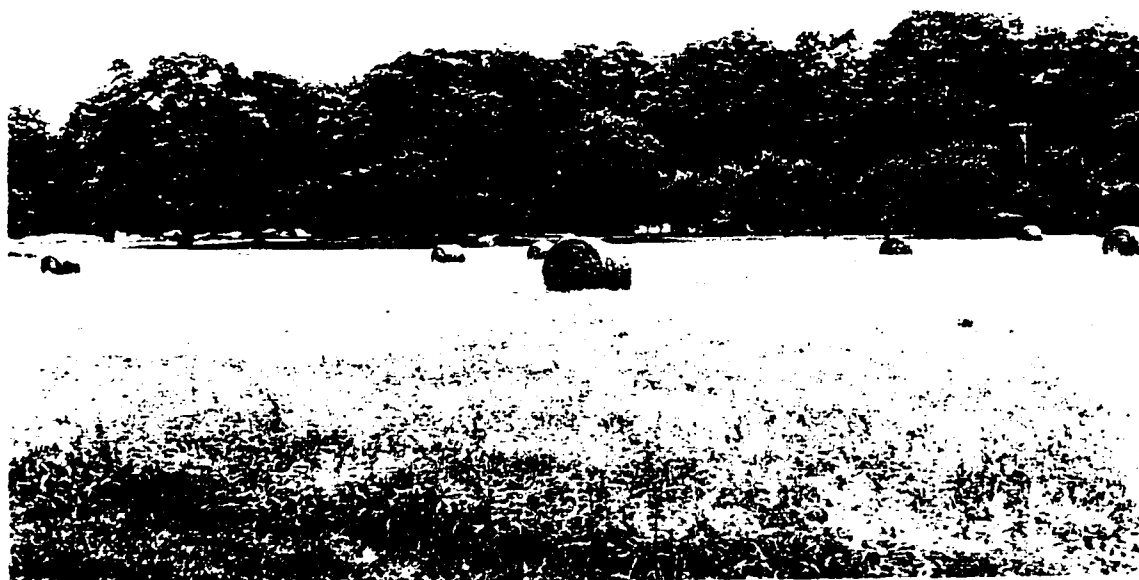
Figure 4.10: Orchard, view looking east, 1998. (photograph by author).

Currently 80 apple trees (*Malus* sp.) are in the orchard, approximately one-quarter of then extant from the Late Roosevelt Ownership Period (figure 4.10).
