CULTURAL LANDSCAPE REPORT FOR
THE HOME OF FRANKLIN D. ROOSEVELT
NATIONAL HISTORIC SITE

Kristin Theresa Baker

Master of Science in Landscape Architecture Degree

May 1999

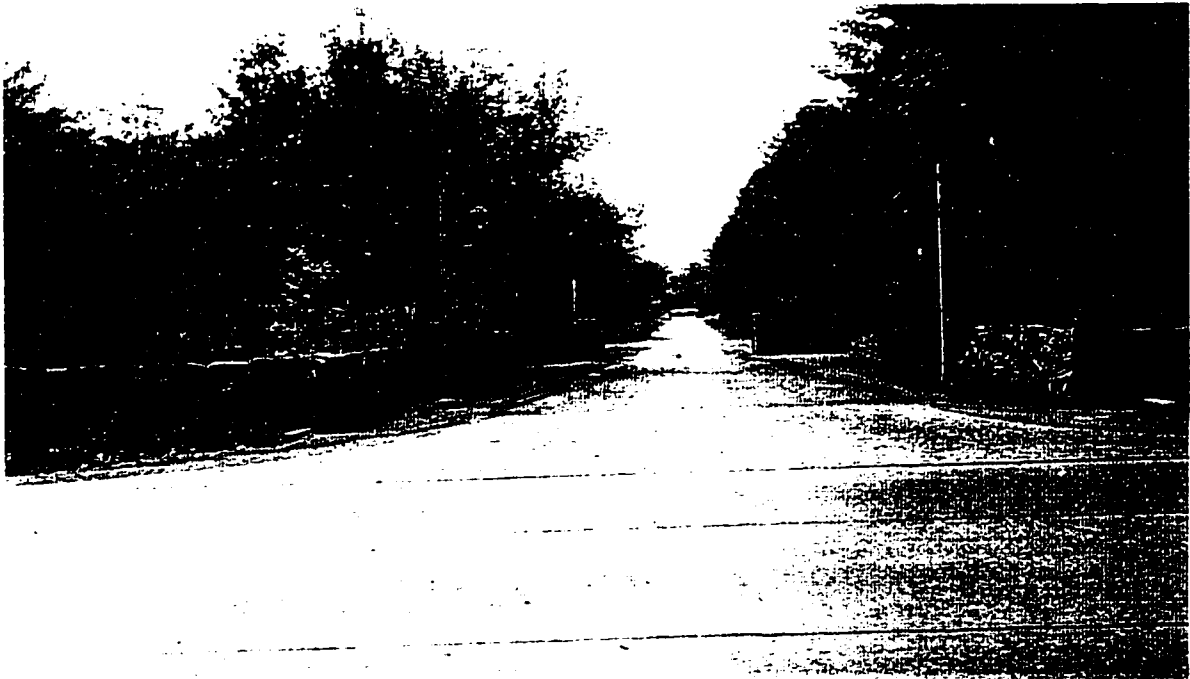
Figure 4.13: Entrance road, view looking west, c. 1945-47. (The Home of Franklin D. Roosevelt).

The entrance/exit road, constructed in the Late Roosevelt Ownership Period, served as the main entry/exit circulation route to and from the site from 1945 until 1947 (figure 4.13). It was located between the northern two rows of fruit trees in the orchard, was 18 feet wide and approximately 900 feet in length, and had an asphalt surface (figure 4.15).

Two lights were located near the gate house, north and south of the library entrance/exit road, in 1946 (see figure 4.13). They were removed and relocated westward to accommodate the widening of the entrance road in 1948. Two identical lights were added in 1948 on either side of the exit road (see figures 4.14).

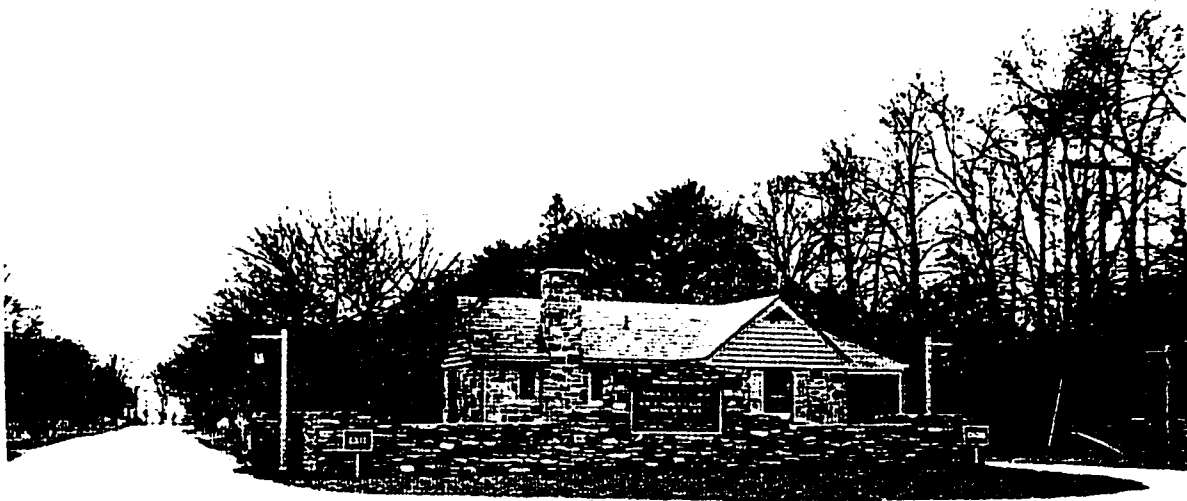
Figure 4.14: Exit road and entrance sign, view looking west, 1950. (Franklin D. Roosevelt Library, NPx 64-348).

An exit road was constructed in 1948 as part of the parking lot enlargement. It was located between the southern two rows of apple trees in the orchard (figure 4.14, 4.16, and see figure 4.4). This road was 840 feet long and 18 feet wide with a black asphalt surface. Concrete curbing was located along the entrance and exit roads where it joined the Albany Post Road, but does not line the entire length of the roads. The addition of this second road changed the circulation pattern so each road became one-way. Three u-turn lanes were constructed to connect the entrance and exit roads. The surface of these roads was asphalt.

An entrance sign for the library and National Historic Site was constructed in 1948. It was located in the center of the 1948 entrance/exit road wall. This sign extended upward and formed a 'step' approximately 4 feet long by 1 foot wide and 3 to 4 feet high (see figures 4.14 and 4.22). The sign was removed in c. 1979.

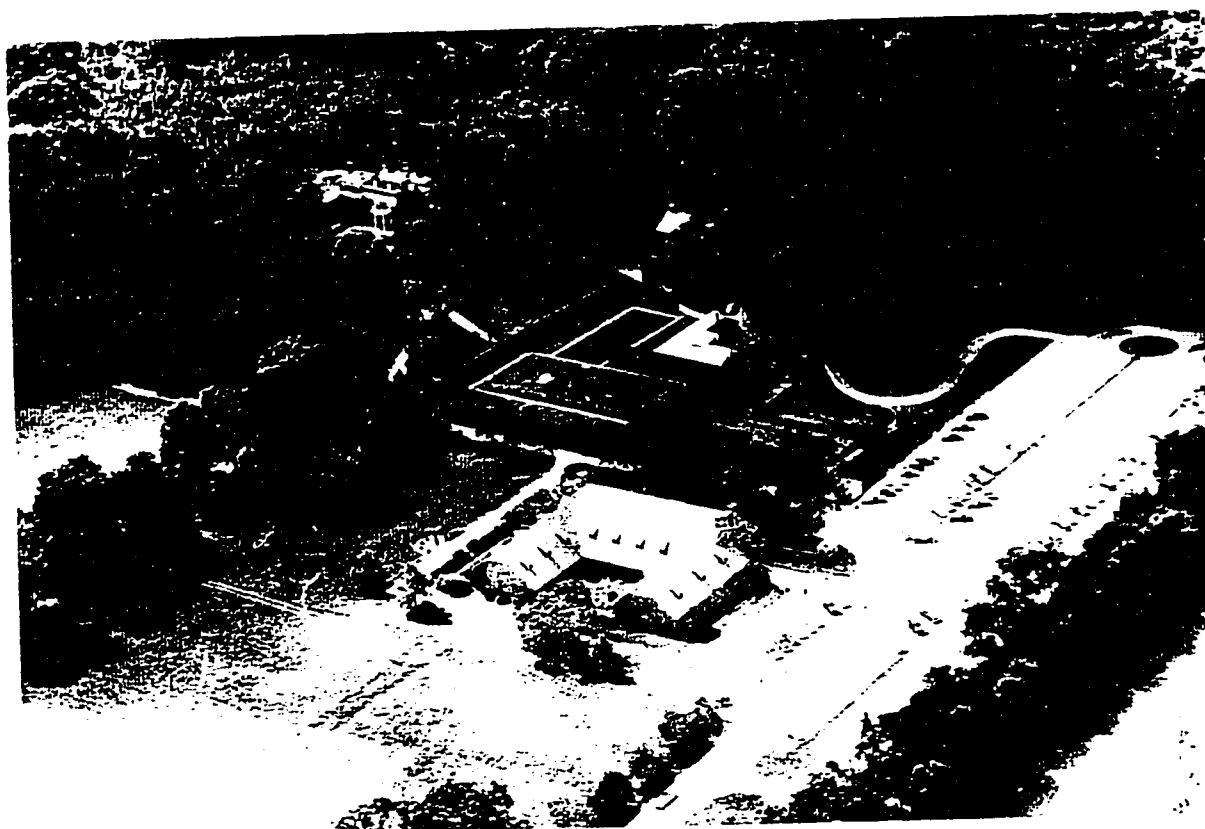
Figure 4.18: Aerial view of site, 1953. (Franklin D. Roosevelt Library, NPx 54-307).

The 1941 parking lot was removed and reoriented with parking spaces located north and south of both sides of the entrance and exit roads. A drop-off area was located between the library and the exit road (figure 4.18). The parking lot was reconfigured again in 1971, when additions were made to the library's north and south elevations. To accommodate this expansion, the drop-off area and the parking spaces south of the exit road were eliminated. This parking lot extended to the northern property boundary and was approximately 80 feet (N/S) by 180 feet (E/W) and contained 51 parking spaces. It had an asphalt surface and was edged with concrete curbs.

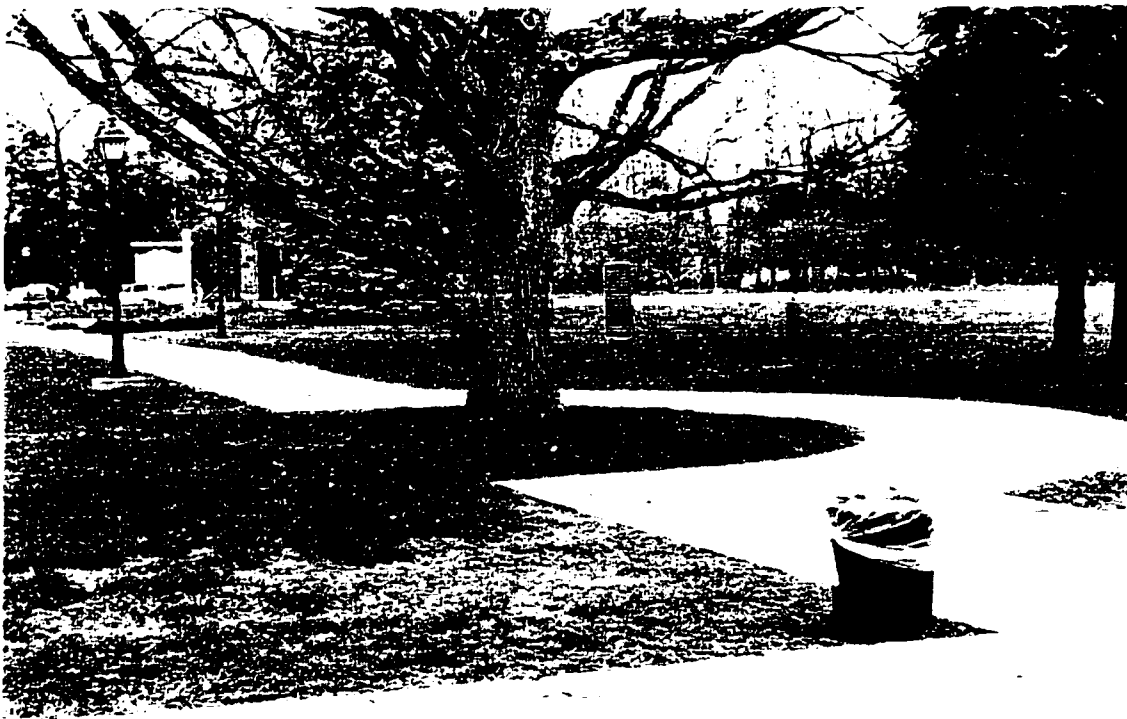
Figure 4.19: Flagstone walkway located east of the library, 1998. (The Home of Franklin D. Roosevelt NHS).

The existing condition of the walkway is as described above (figure 4.19).

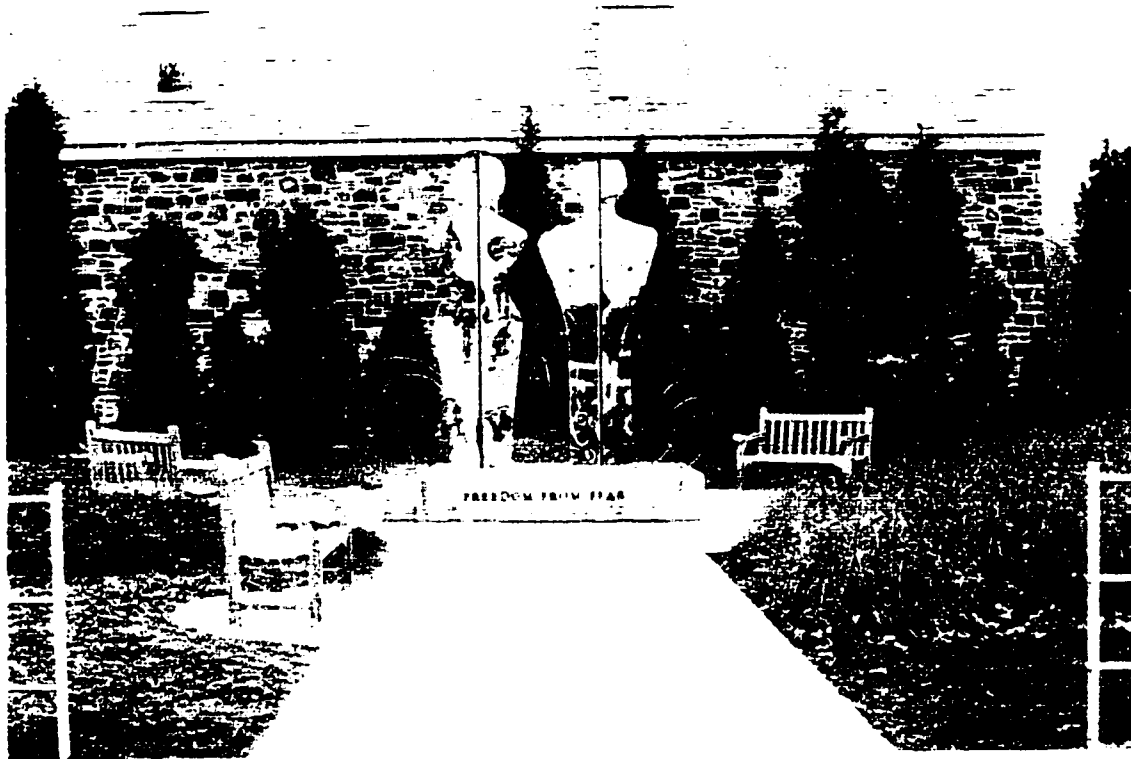
Figure 4.20: Walkway and Freedom of Fear sculpture located at the library's southwest elevation, 1998. (The Home of Franklin D. Roosevelt NHS).

Another walkway was installed in c. 1994. It was located at the southwest corner of the library and terminated at a sculpture. The walkway was approximately 8 feet wide and terminates in an oval approximately 28 feet long (N/S) by 26 feet wide. The sculpture was located in the center of the oval. The walkways surface was gray colored concrete.

The existing condition of the walkway is as described above (figure 4.20).

A Freedom of Fear sculpture, created by one of Winston Churchill's granddaughters, Edwina Sandys, was installed in 1994 near the library's southwest elevation (see figure 4.20). It includes two figures, one male and one female, that are 9 to 10 feet high. They were constructed from pieces of the Berlin wall and were surrounded by a spiraling, oversized barbed wire painted orange.

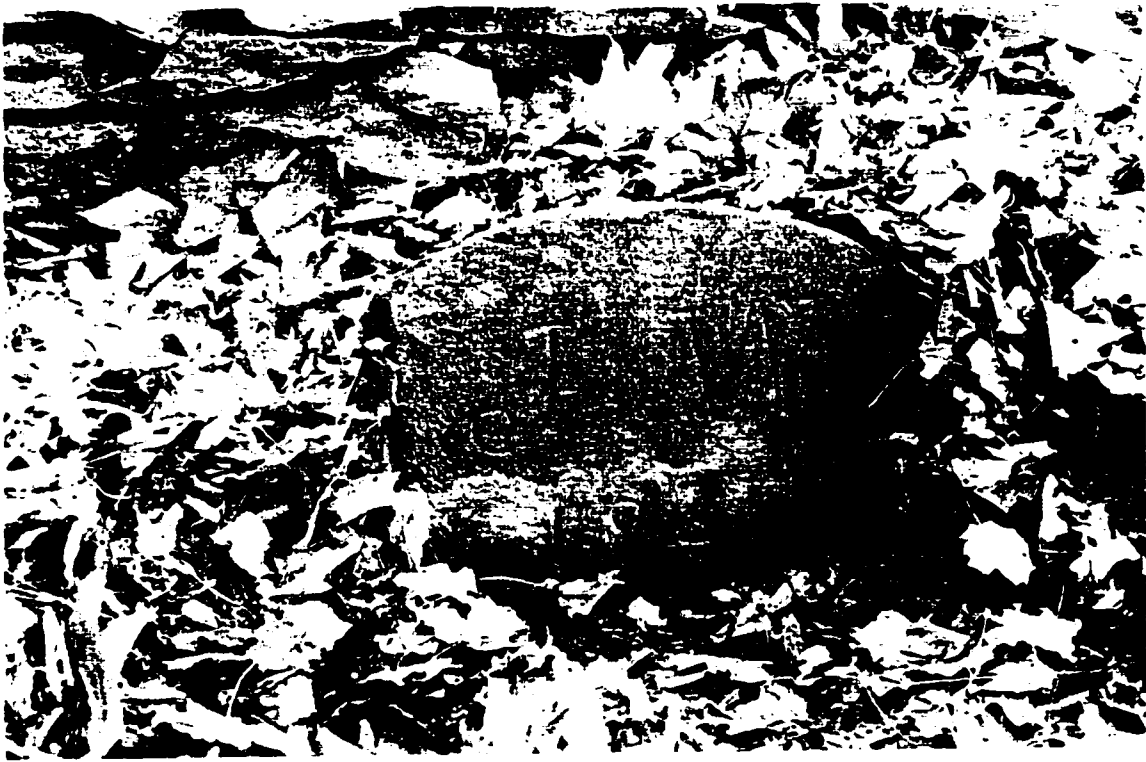
Figure 4.24: The Josiah Wheeler boundary marker located west of the stone wall, 1998. (photograph by author).

The Josiah Wheeler boundary marker, installed in 1866, is located near the intersection of the Albany Post Road and the library entrance road and resembles its historic appearance (figure 4.24).

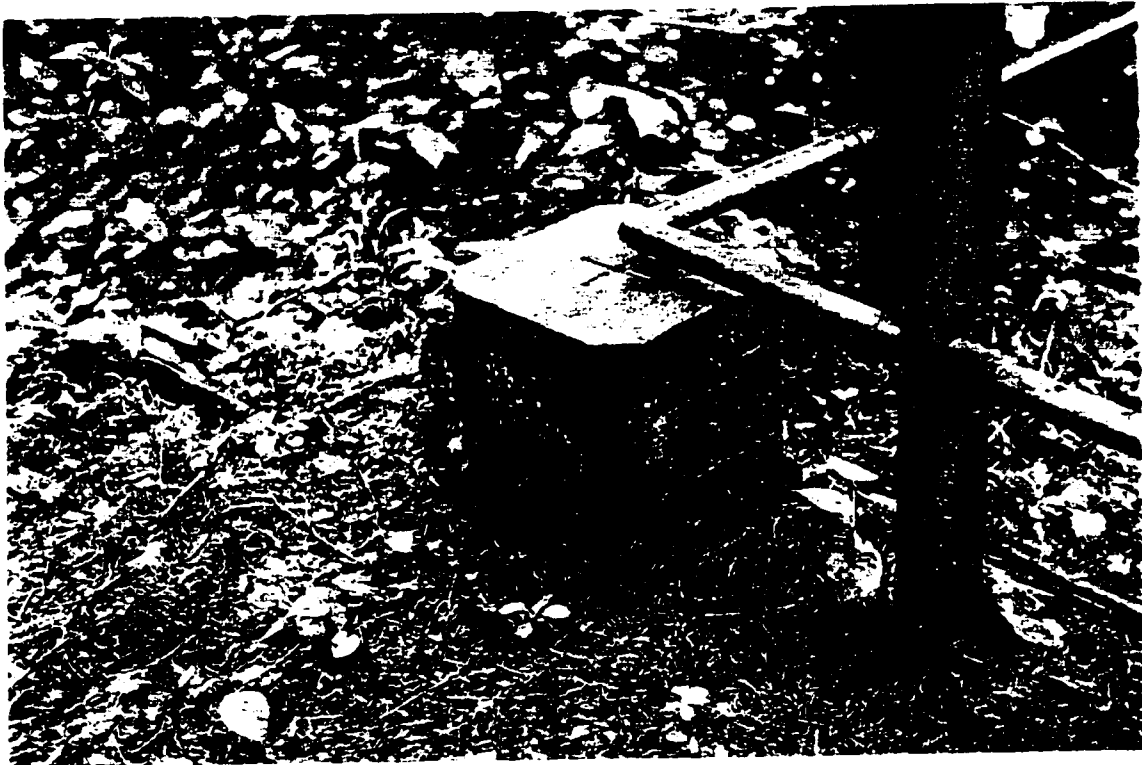
Figure 4.25: Library boundary marker located north of the home road, 1998. (photograph by author).

The three remaining boundary markers are located at the northeast, southeast, and southwest corners of the north avenue lot (figure 4.25).

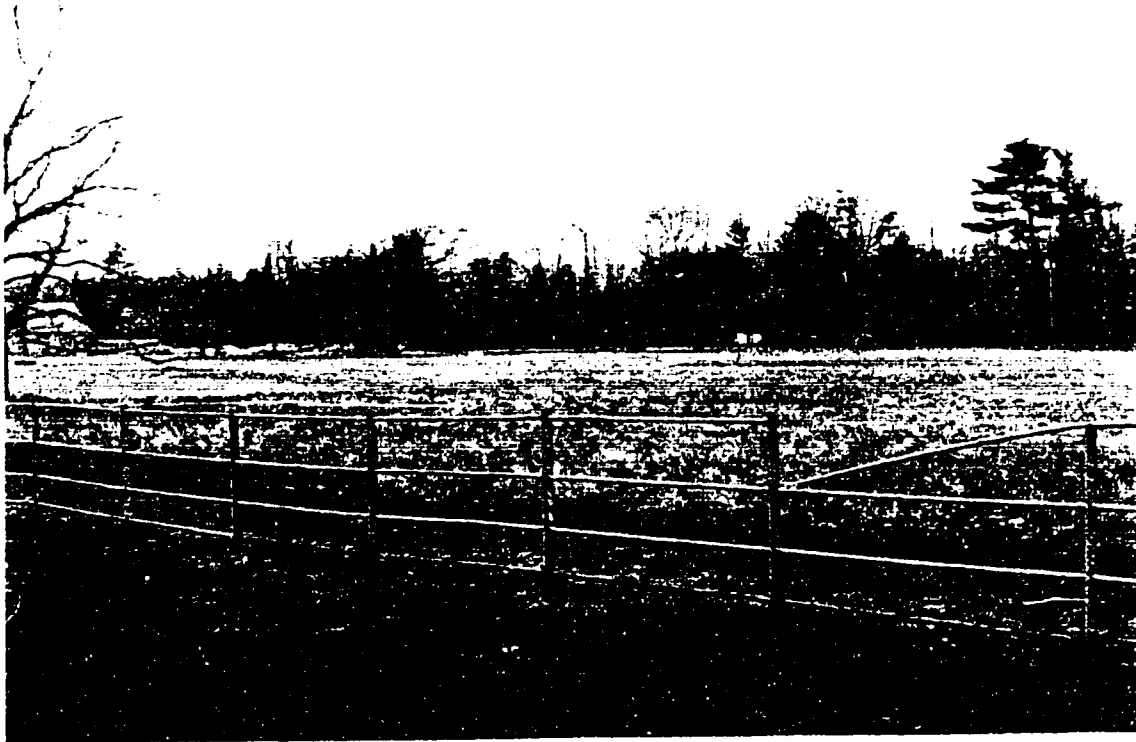
Figure 4.26: Library fence located at the southern portion of the north avenue lot, 1997. (photograph by author).

A metal fence was placed around the perimeter of the north avenue lot in 1941 to establish a barrier and delineator between the library and the Roosevelt home. The northern section of the west fence was removed, probably in 1948, with the construction of the visitors parking area. The section of fence along the northern boundary was removed in the late 1970s.²² The remaining fence was located along the library's southern and western boundary and was approximately 1,160 feet in length along the southern boundary and 330 feet in length along the western boundary.

The existing condition of the fence is as described above (figure 4.26).

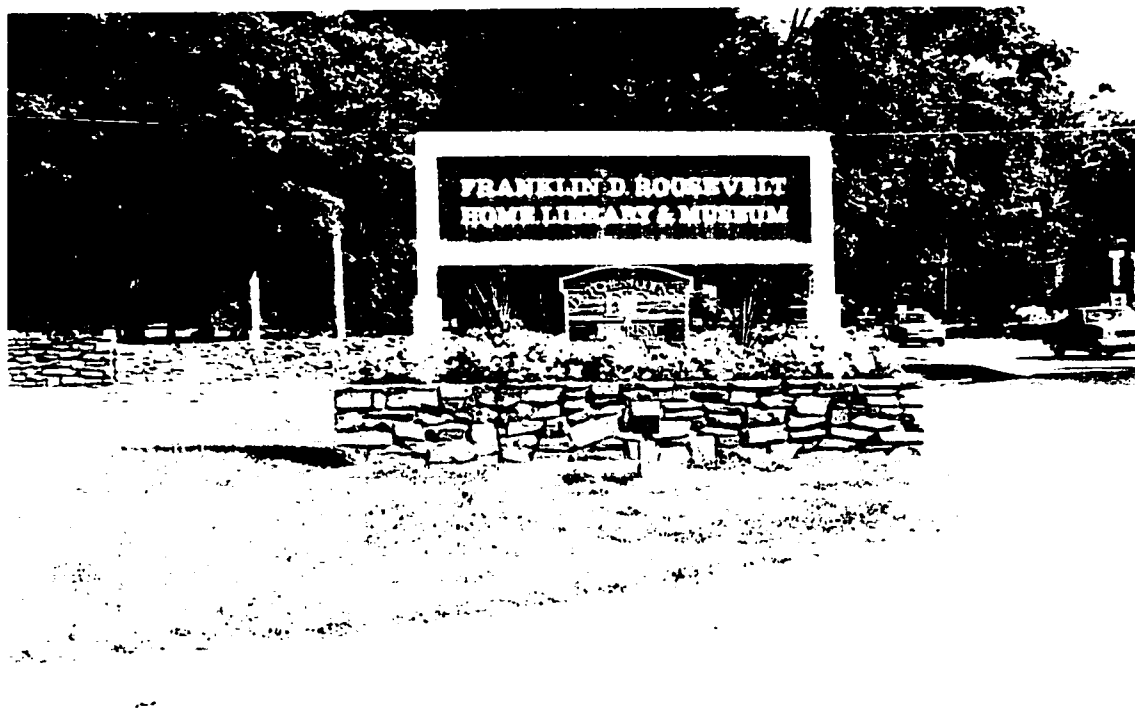
Figure 4.27: Entrance sign for the FDR Home, library, and museum, 1997. (photograph by author).

A replacement entrance sign/planter was constructed in c. 1979 located 25 feet east of the library gate house. The sign was 11 feet long (E/W) and 12 1/2 feet high (N/S). It was constructed of wooden posts painted white, with a wooden sign painted black with white letters that was 3 1/2 feet high by 8 feet wide. It was placed within a brown-colored fieldstone planter. The planter was 15 feet long (E/W), 5 feet wide (N/S), and 2 feet 8 inches high (see Appendix N). A smaller, Dutchess County Tourism Location sign was added, date unknown, between the top of the planter and the bottom of the sign. This sign was approximately 2 feet wide and 2 feet high.

The stone planter is planted with annual flowers (figure 4.27). The existing condition of this entrance sign/planter is as described above.

Spotlights, date of establishment unknown, are located to the north and south of the site identification sign (see figure 4.27). These metal spotlights are approximately 1 foot high with a square, metal light housing.

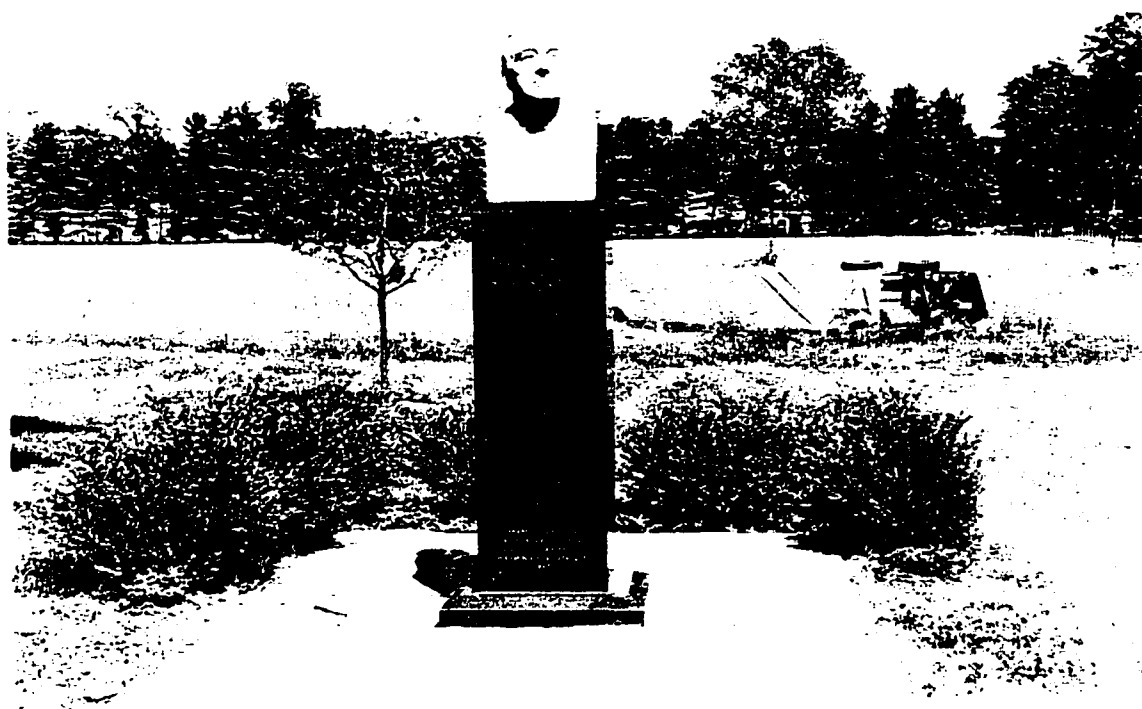
Figure 4.28: Bust of FDR located at the southeast corner of the library walkway, 1998. (photograph by author).

The existing condition of the bust of FDR is as described above (figure 4.28).

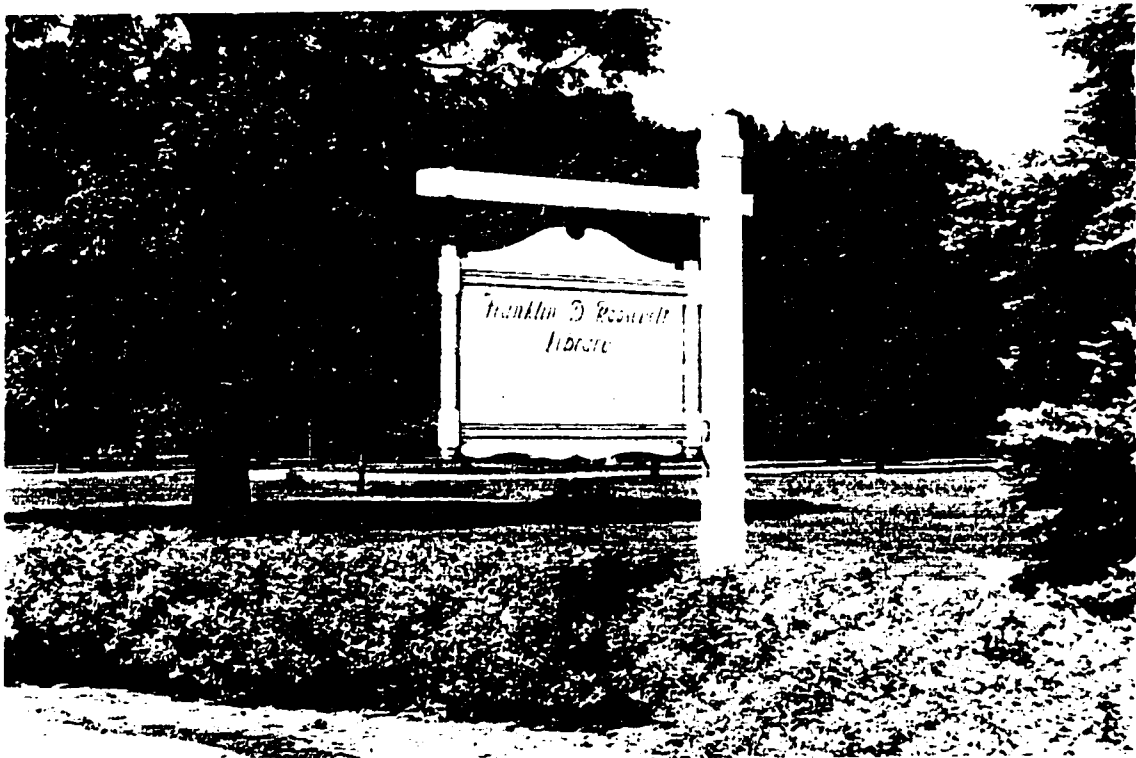
Figure 4.29: Museum identification located east of the library, 1998. (photograph by author).

The existing condition of the museum identification sign is as described above (figure 4.29).

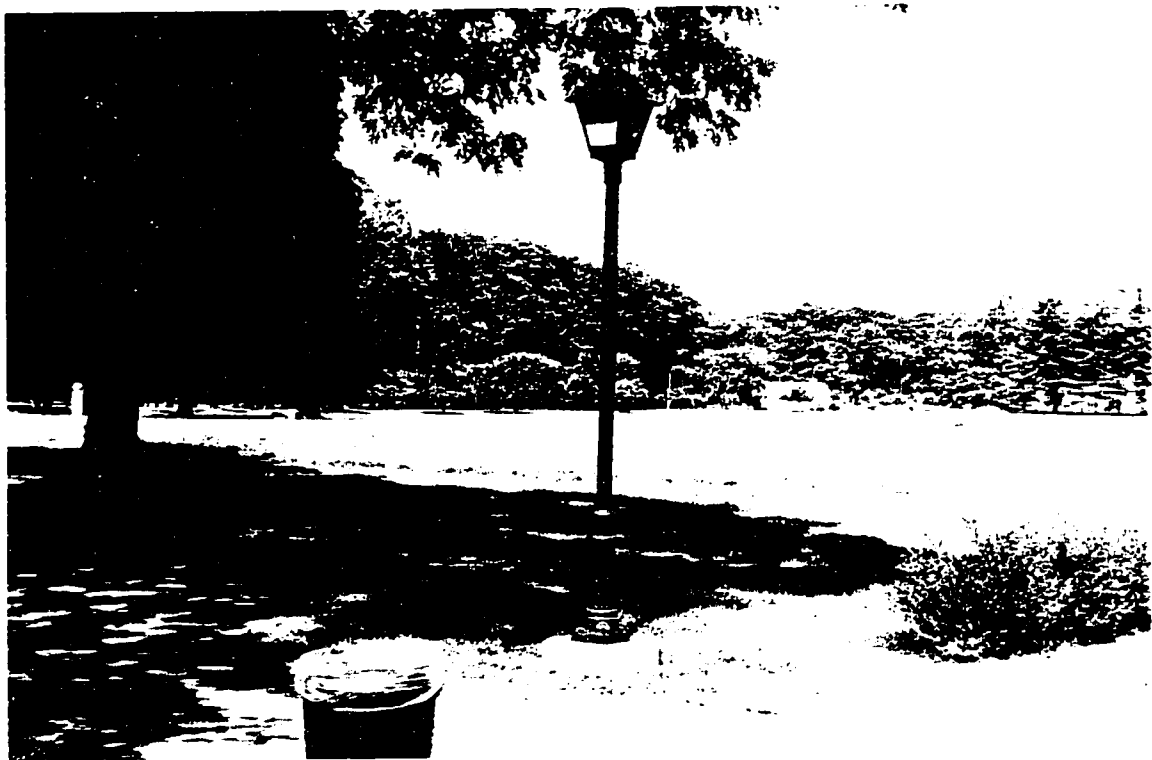
Figure 4.30: Light located east of the library, 1998. (photograph by author).

Library lights were installed for the library, exact date unknown. Fifteen lights were located east and south of the library. They were located on a gray concrete base approximately 1 foot in diameter and 6 inches high. The light posts were round, vary from approximately 3 to 5 inches in diameter, and are 9 feet high. The light fixtures were four sided lantern-shaped lights approximately 6 to 8 inches long and 4 to 6 inches wide. The light fixtures and posts were black.

The existing condition of the library lights is as described above (figure 4.30).

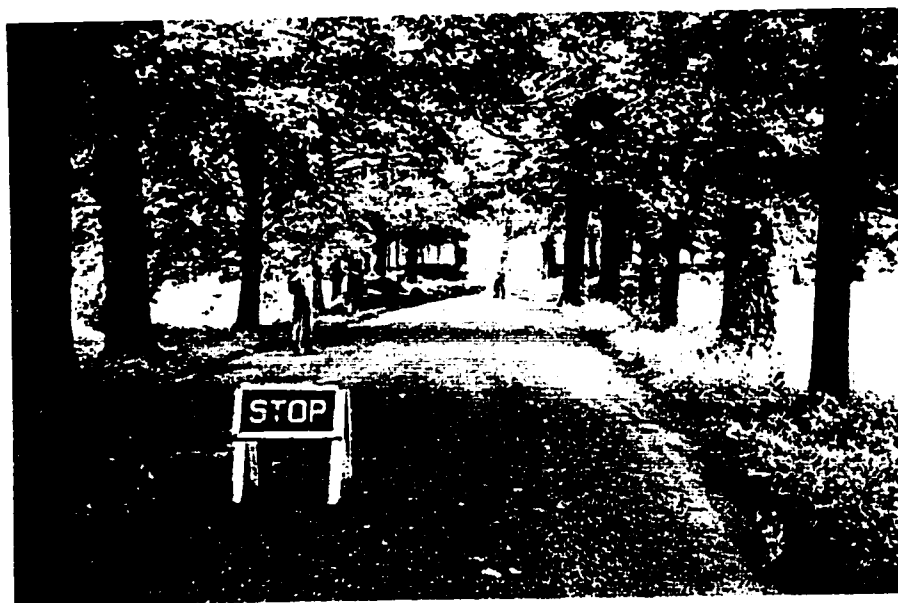
Figure 4.31: Storm damage to trees along the home road, 1946. (The Home of Franklin D. Roosevelt NHS R-362).

A number of trees within the home road allée were lost to storm damage in 1946, although the exact number and location of these trees are unknown (figure 4.31). Trees that were removed because damage or disease were not replaced for approximately the first 20 years of this period. Since the 1960s efforts are underway to replace historic trees lost during this period. The large cucumber magnolia (*Magnolia acuminata*) at the west end of the entrance road had its leader branch topped in c. 1967, but the tree continued to live and survives today.²³

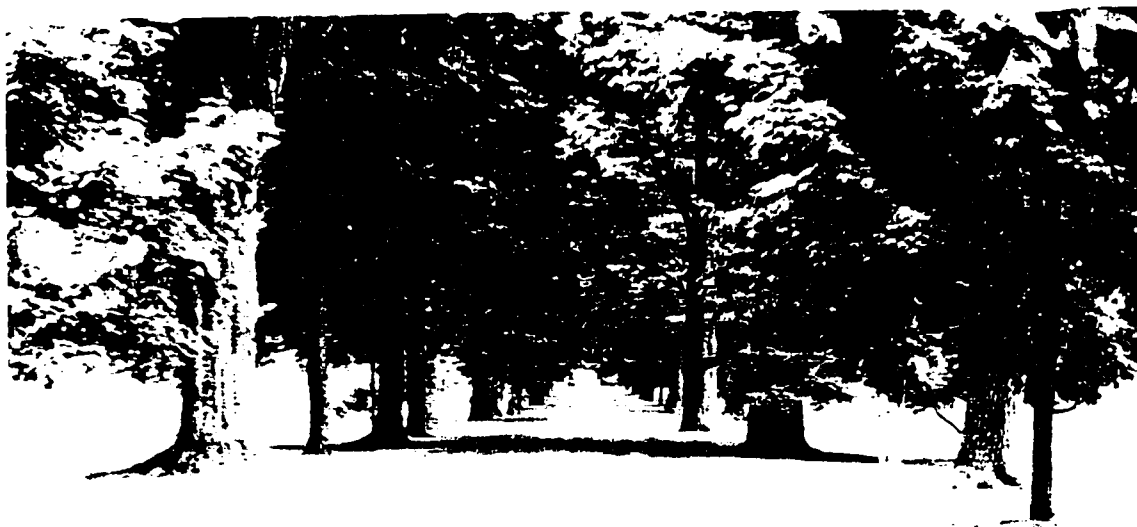
Figure 4.32: Home road allée, view looking east, 1997. (photograph by author).

The existing condition of the trees within the home road allée include the 1 cucumber magnolia (*Magnolia acuminata*) 56 sugar maples (*Acer saccharum*), 20 of which may be historic; 20 white pines (*Pinus strobus*); 2 elms (*Ulmus* sp.); and 1 eastern hemlock (*Tsuga canadensis*) (figure 4.32 and see Existing Conditions plan). These trees form an open and irregular canopy that is relatively unchanged in terms of the number and types of plants, and create varying textures between the evergreen and deciduous vegetation.

The home road was closed to vehicles during this period, date unknown. The road was no longer edged and was approximately 15 feet wide, with a gravel and grass surface (see figure 4.32).

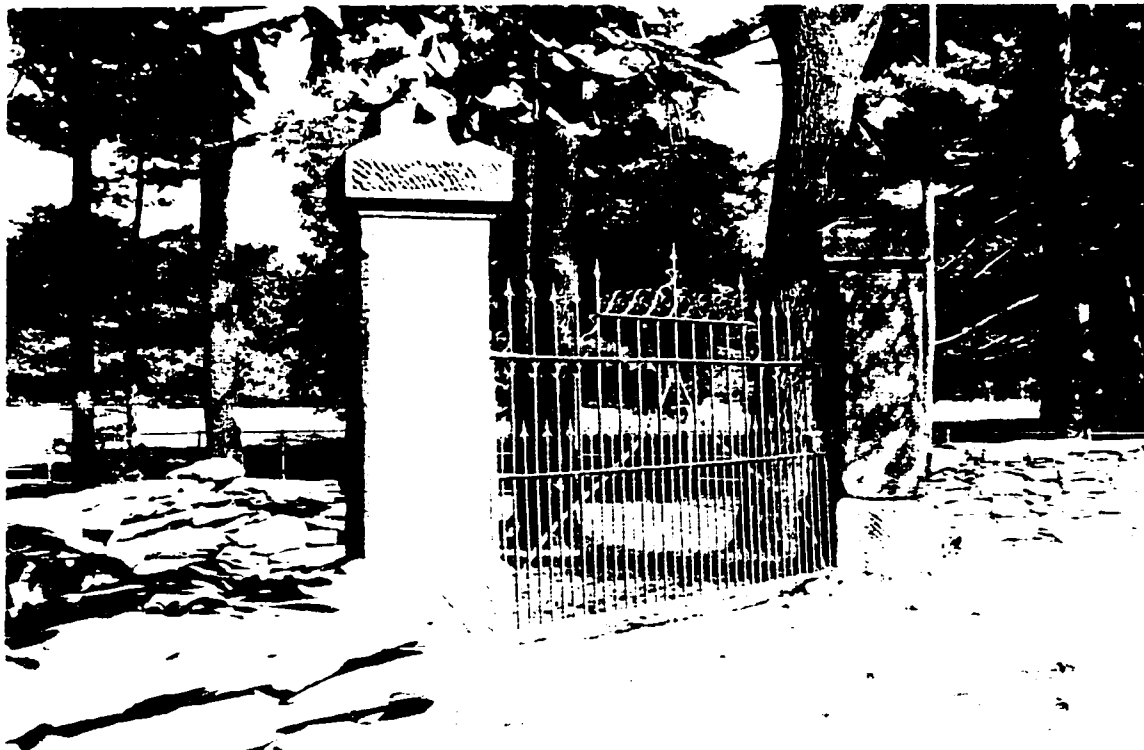
Figure 4.33: Gate post and gate located at the home road entrance, 1997. (photograph by author).

The brownstone gate posts and gate are still located north and south of the home road (figures 4.33). The gate posts sustained some damage during this period. A chain was added, date unknown, that encircles the northern gate post and connects to the gate to keep it shut. It has worn away a portion of the gate post. In addition the lower hinge and a portion of the brownstone on the southern gate post was sheered off, date unknown (figure 4.34). The area where the latch attached to the northern gate post was also broken off (figure 4.35). The gate is rusted.

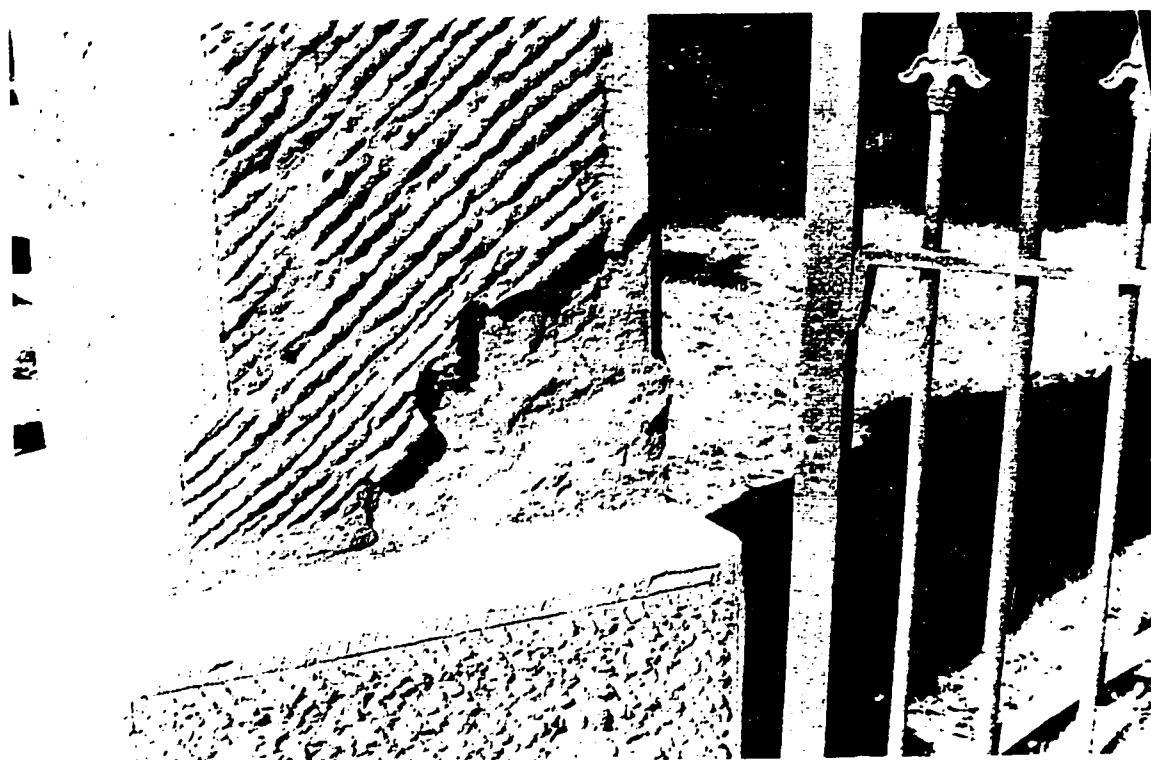
Figure 4.34: Damage to the southern gate post, 1997. (photograph by author).

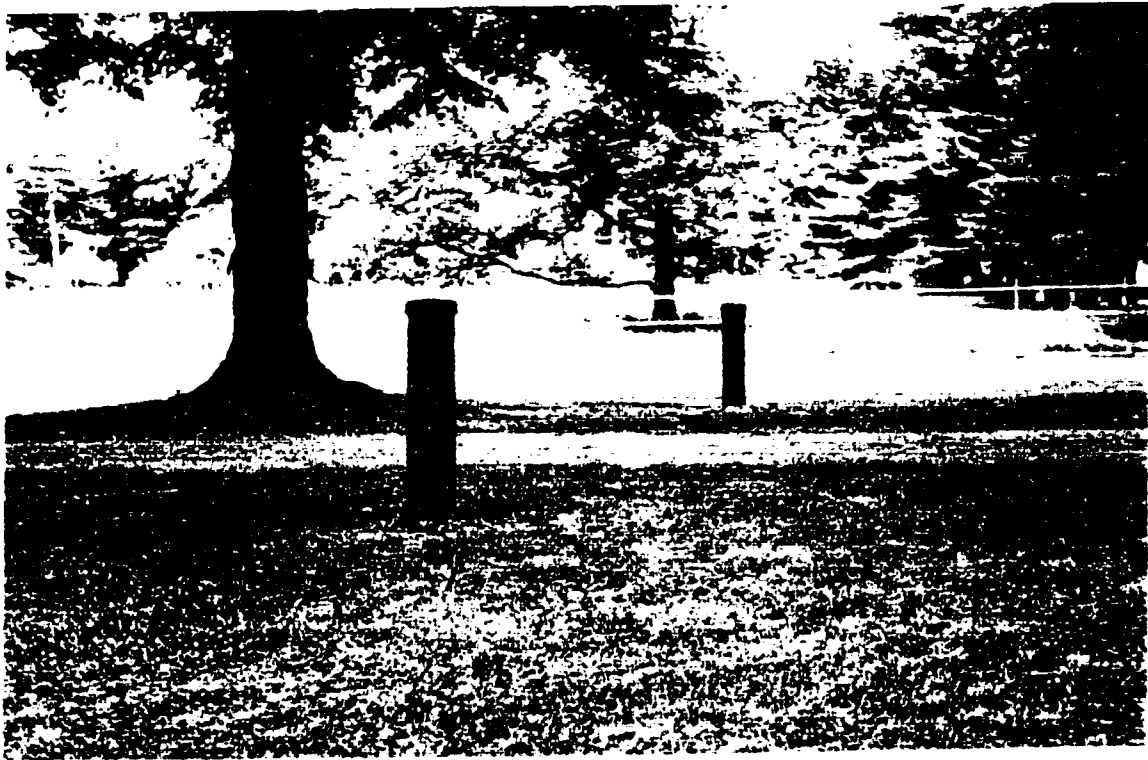
Figure 4.36: Crash barrier posts located west of the gate posts, 1997. (photograph by author).

The posts from the crash barriers are currently located on either side of the home road, approximately 30 feet from the main gate posts (figures 4.36 and see Existing Conditions plan). These posts are round, 2 1/2 feet high and 6 inches in diameter, and made of metal that is now rusted (figure 4.37). Three round eyelets that once held cables for the barrier are located on the post in a row from top to bottom.

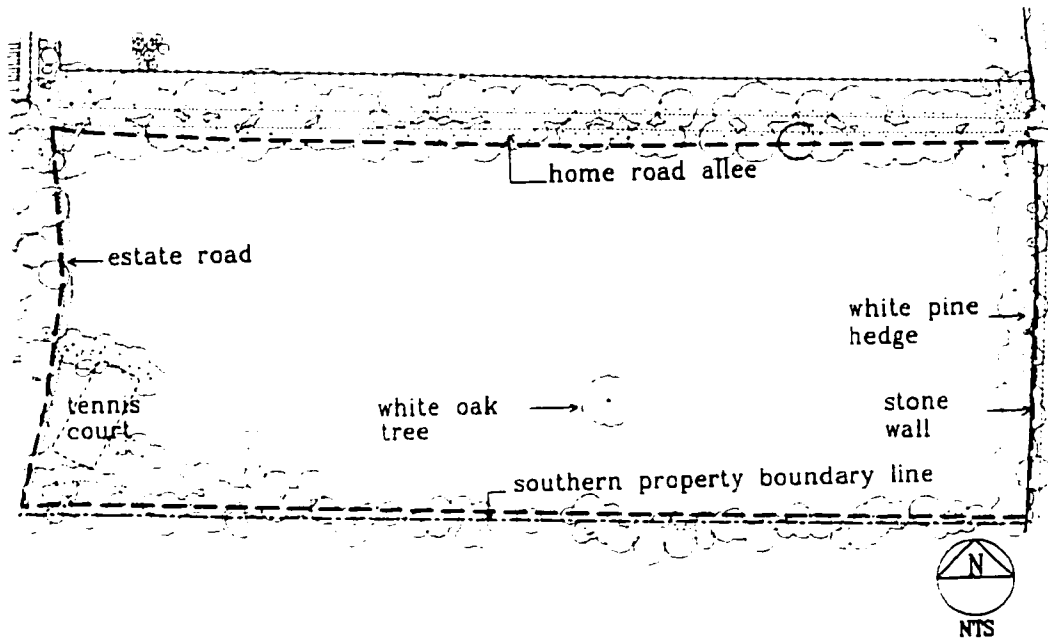
Figure 4.38: Spatial organization of the south avenue lot subspace. (K. Baker and G. Dallmann, SUNY CESF, 1998, based on the 1994 HPI map).

The south avenue lot space is unchanged in terms of its definers, including the home road vegetation to the north and vegetation along its southern border (figure 4.38). Mature trees along the Albany Post Road define the area to the east, and vegetation along the southern portion of the west boundary mark it to the west. The trees surrounding the entire south avenue lot in this area have matured, partially eliminating views off site in all directions. The ground is covered with high meadow grass and there are open views to the sky.

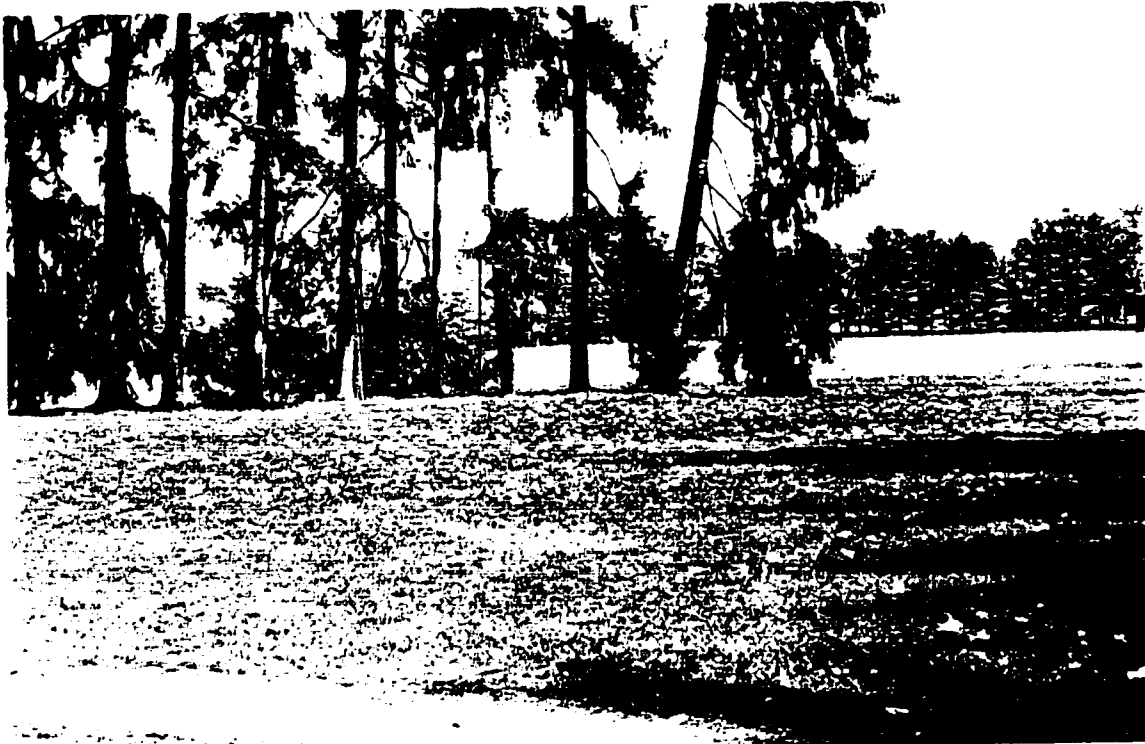
Figure 4.39: Tennis court, view looking northeast, 1997. (photograph by author).

The paint on the backstops has chipped and they are in poor condition. The chicken wire backstops are also rusted. The existing condition of the tennis court is as described above (figures 4.39, 4.40, 4.41).

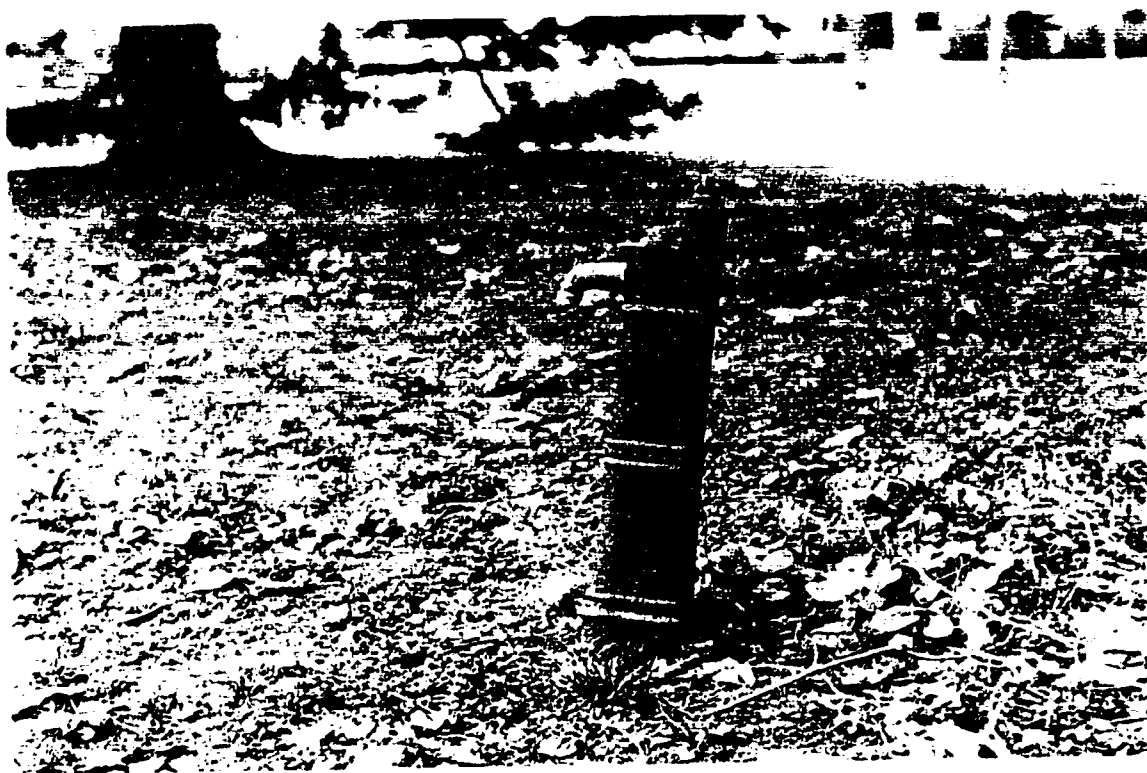
Figure 4.42: Water faucet located northwest of the tennis court, 1998.
(photograph by author).

The faucet lost its valve and its metal casting is rusted (figure 4.42). The existing condition of the water faucet is as described above.

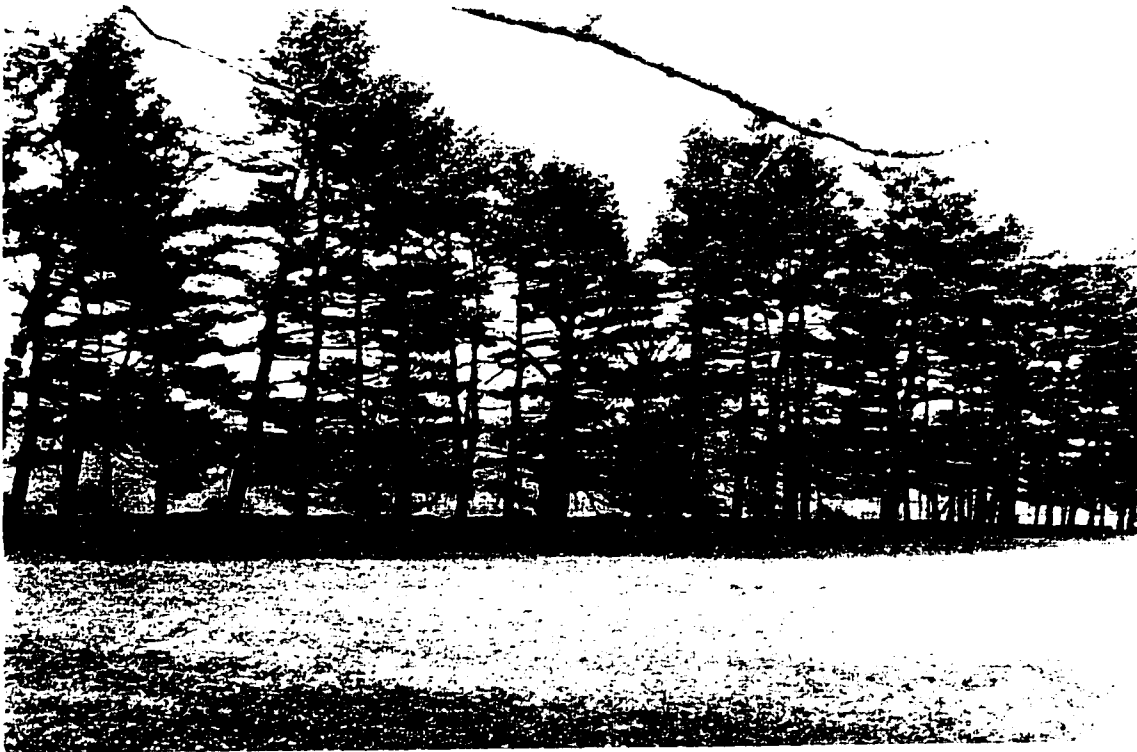
Figure 4.43: White pine hedge located adjacent to the Albany Post Road, 1997. (photograph by author).

The white pine hedge (*Pinus strobus*) planted by FDR to screen the property from the Albany Post Road remains today. During the NPS Ownership Period individual trees within the hedge were removed as they died and were not replaced. The trees within the hedge are large with a broad canopy. Approximately half the historic trees remain, and the hedge still retains its general character and purpose as a partial screen from the Albany Post Road (figure 4.43).

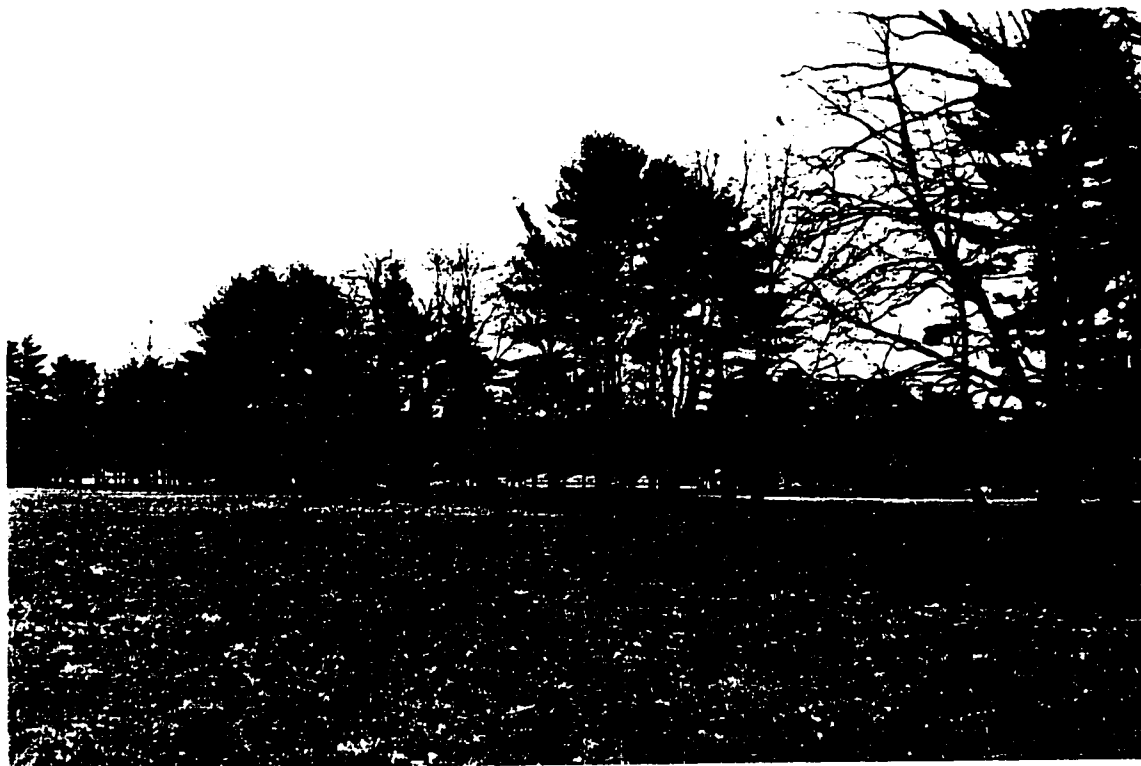
Figure 4.44: Trees located along the southern boundary, view looking east, 1997. (photograph by author).

Many of the trees along the southern border planted by FDR in the south avenue lot remain today (see Existing Conditions plan). Although some of the trees have been lost and not replaced, the arrangement of the existing trees is only slightly changed and the mature vegetation still provides a partial screening and a more dense canopy. This vegetation includes mass groupings of plants such as white pines (*Pinus strobus*), black locusts (*Robinia pseudoacacia*), and cedars (species unknown). Individual plantings of white oaks (*Quercus alba*), red oak (*Quercus rubra*), black walnut (*Juglans nigra*), sugar maple (*Acer saccharum*), and black cherry (*Prunus serotina*) were also located near the southern border (figure 4.44).

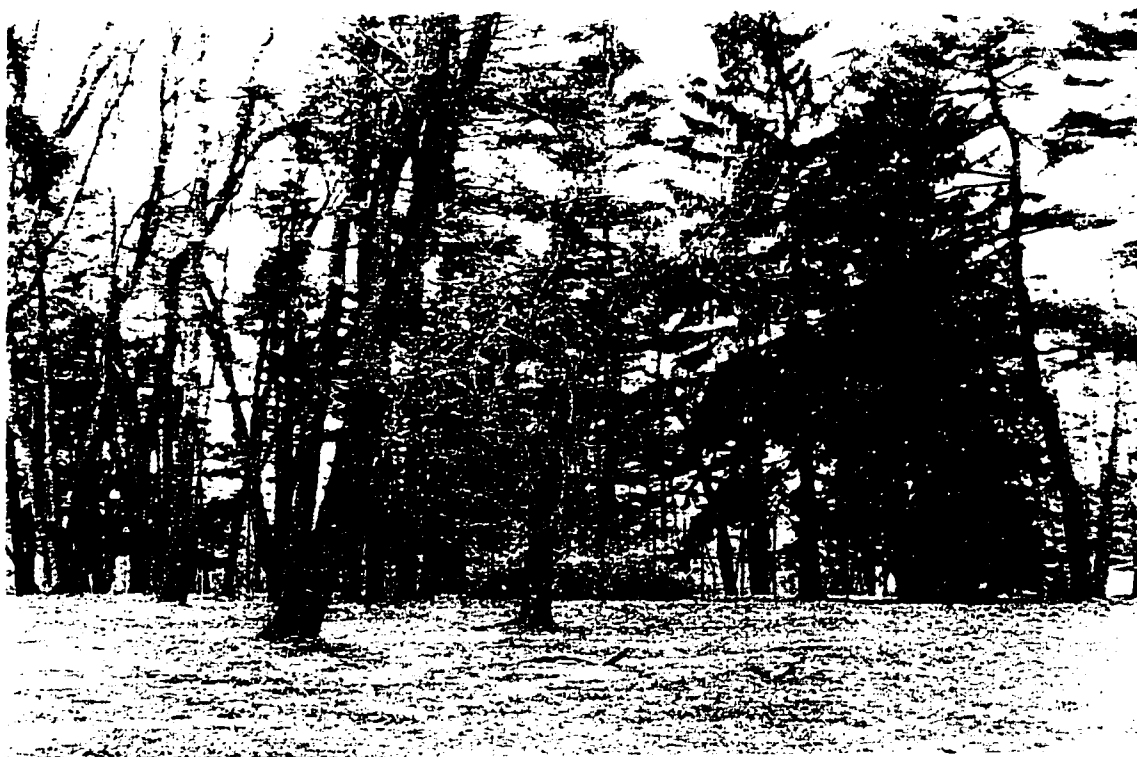
Figure 4.45: Trees located adjacent to the tennis court, view looking southwest, 1997. (photograph by author).

Some of the trees adjacent to the tennis court were lost and not replaced during this period. The arrangement of the existing trees is unchanged and the mature vegetation still provides a partial screening but with a less dense canopy. Extant vegetation located near the tennis court from the Late Roosevelt Ownership Period includes a mass planting of Norway spruce (*Picea abies*) and a mass of white pine (*Pinus strobus*), as well as a magnolia (*Magnolia* sp.) and black cherry trees (*Prunus serotina*) (figure 4.45 and see Existing Conditions plan).
