CULTURAL LANDSCAPE REPORT FOR
THE HOME OF FRANKLIN D. ROOSEVELT
NATIONAL HISTORIC SITE

Kristin Theresa Baker

Master of Science in Landscape Architecture Degree

May 1999

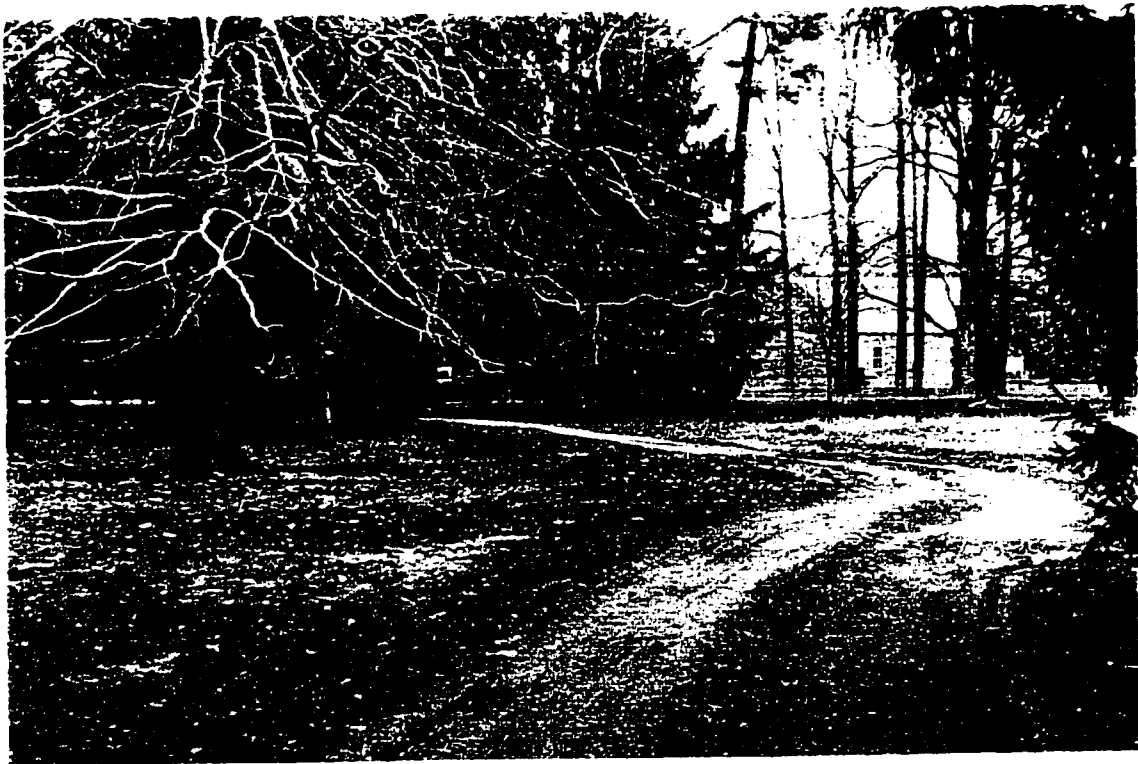
Figure 4.46: Estate road, view looking north, 1997. (photograph by author).

The estate road was realigned during this period, exact date unknown (see Existing Conditions plan). As the canopy of a low branching beech tree within the main lawn grew, the estate road was relocated slightly to the east (figure 4.46).

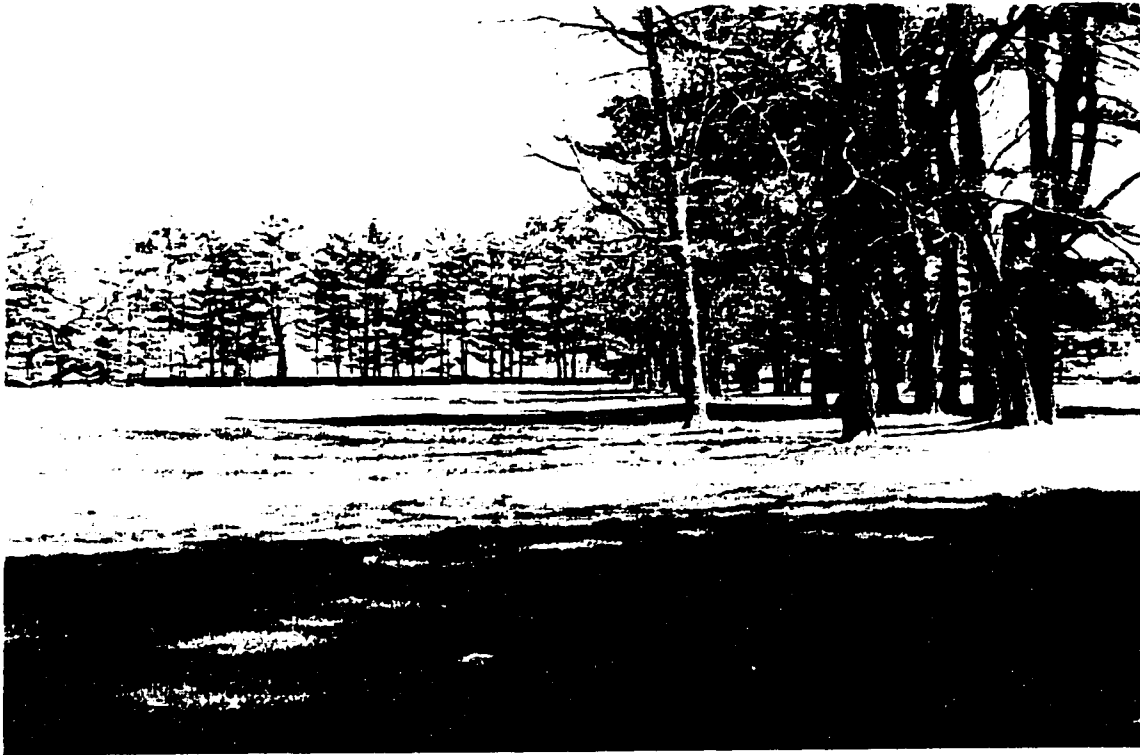
Figure 4.47: Site of the south avenue farm road, view looking east, 1997. (photograph by author).

The south avenue farm road was abandoned during this period, exact date unknown. The depression of the south avenue farm road is visible, but the road was not maintained and reverted to meadow grass (figure 4.47).

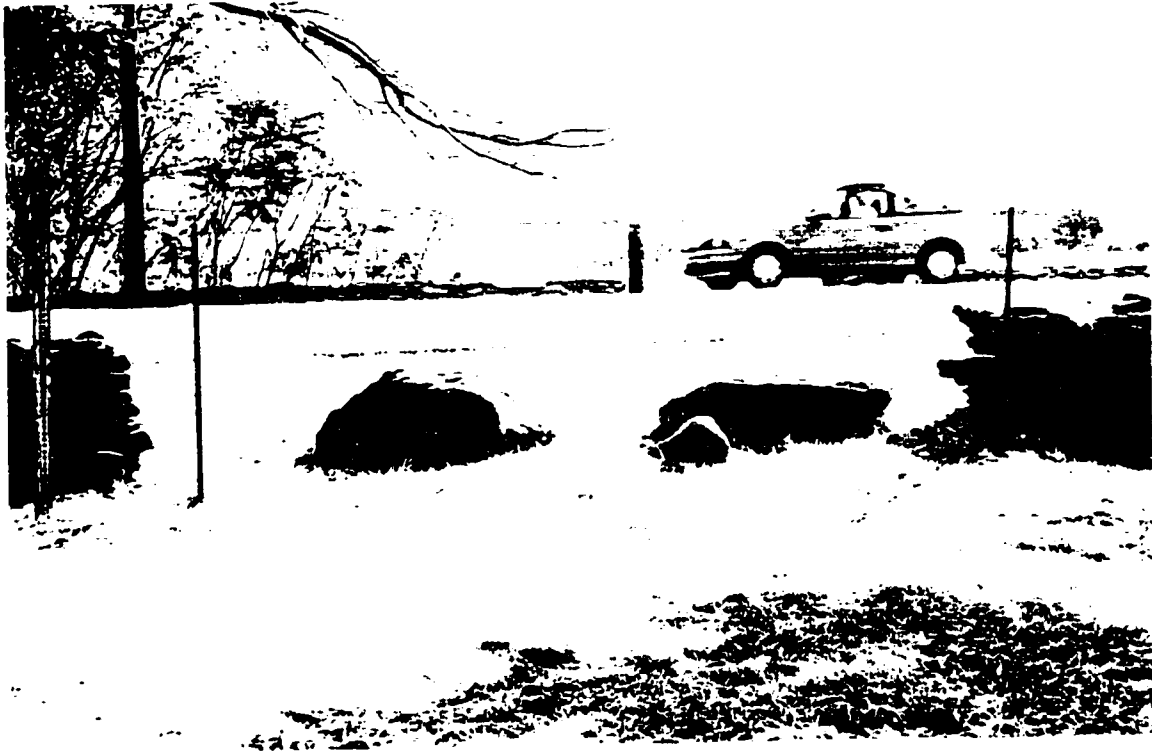
Figure 4.48: Gap in the stone wall where the south avenue farm road joined the Albany Post Road, 1997. (photograph by author).

The stone wall, constructed in the Early Property Ownership Period, lines the Albany Post Road. At the point where the southern boundary transects the wall is an approximate 10-foot gap where the south avenue farm road formerly joined the Albany Post Road. Two large stones were placed within this gap to keep vehicles from entering the property (figure 4.48).

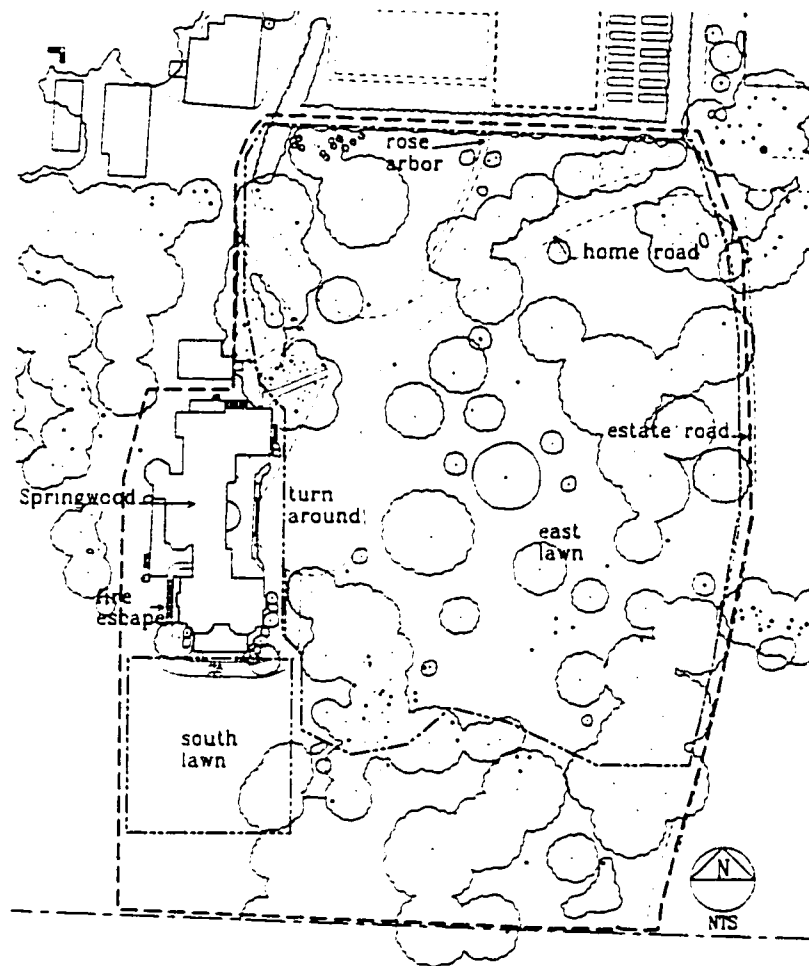
Figure 4.49: Spatial organization of main lawn subspace. (K. Baker and G. Dallmann, CESF, 1998, based on the 1994 HPI map).

The spatial configuration of the main lawn space is unchanged in terms of its shape, size, defining edges, and materials. The canopy is irregular and more open to the sky (figure 4.49).

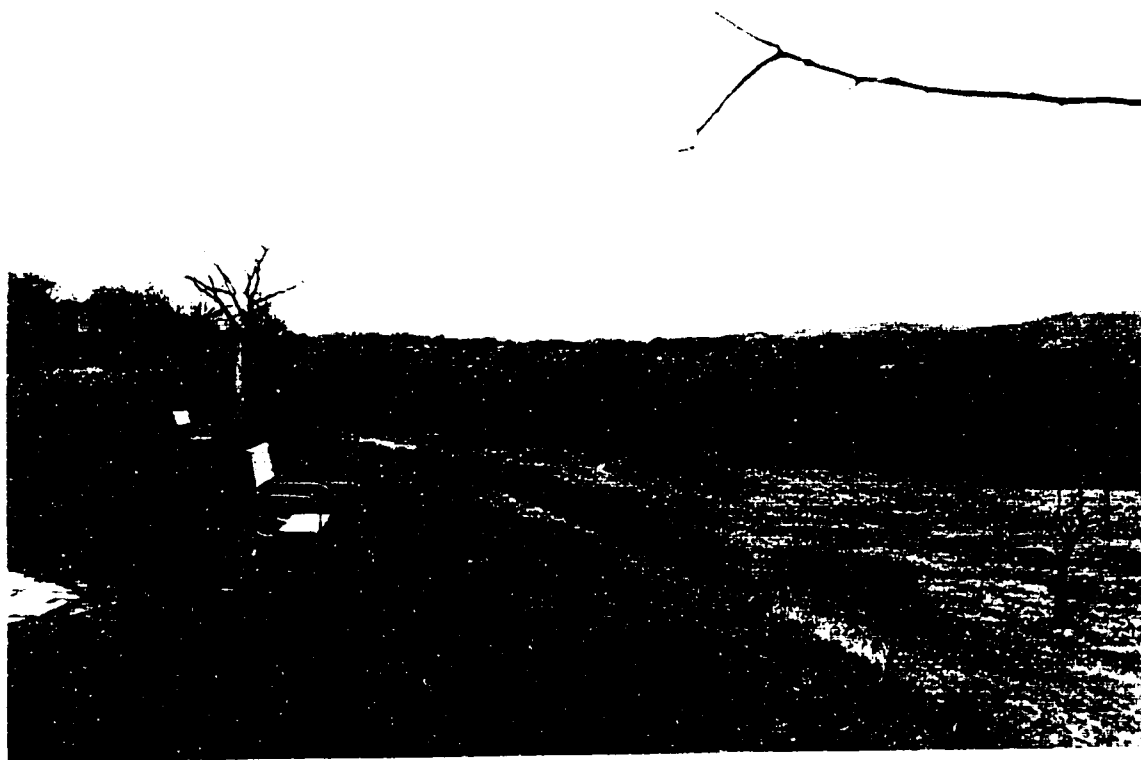
Figure 4.52: View looking towards the Hudson River, and benches and fire hydrant located on south lawn, 1998. (photograph by author).

The vista FDR and his father wished preserved was in fact obscured from 1945 on because the National Park Service no longer owned the land needed to maintain it. The field to the south of the house was left unmanaged and reverted back to its natural vegetative state (figure 4.50). It stayed this way until 1959, when an area was cut through the newly grown vegetation to re-create the vista from Springwood to the Hudson River and Hudson Bridge. After this vegetation was cleared, the river could be seen from the house but the vista was not in the original, historic alignment (figure 4.51). The cleared area was then left unmaintained so vegetation would grow back to fill in the re-created vista.²⁴ The meadow has since been restored to its original state (see lower field subspace for more information), but as the vegetation south of the lower field reached its mature size, the vista to the Hudson River was totally eliminated (figure 4.52).

Fire hydrants were added to the property in 1958-59 and four fire hydrants are located within the main lawn area. One fire hydrant was located south of Springwood, one directly east of Springwood, one at the northwest corner of Springwood, and the last was north of Springwood near the service area fence. The metal fire hydrants were 1 1/2 feet high and painted red (see figure 4.52).

Two benches were installed during this period, exact date unknown (see Existing Conditions plan). They were located on the south lawn, near the top of the ridge. These benches were 5 feet long and constructed of metal legs with wood seats and backrests. The metal portions of the benches were painted black, and the wood seats and backrests were unpainted (see figure 4.52).

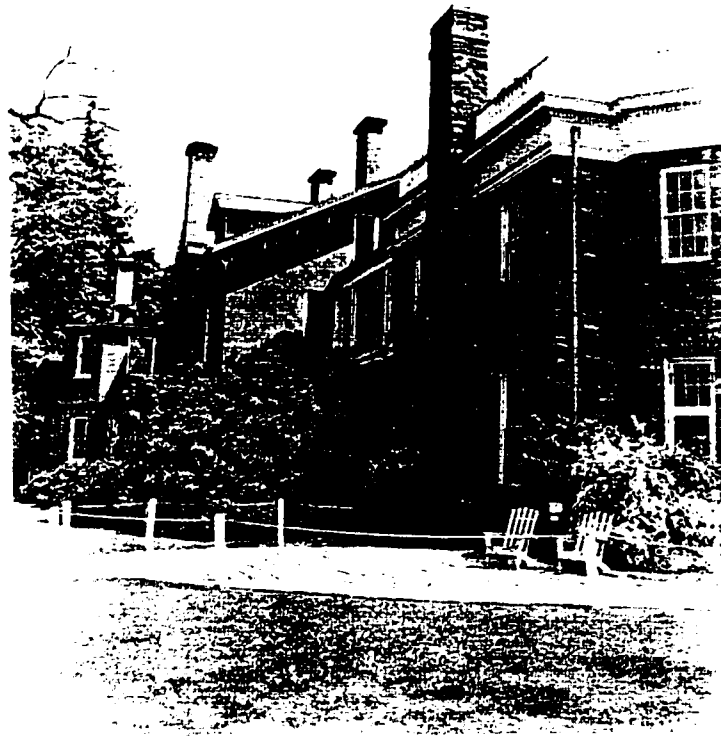
Figure 4.53: Springwood, west elevation, before construction of the fire escape and including lawn furniture and the new walkway, c. 1947-48. (The Home of Franklin D. Roosevelt NHS, R-25).

Springwood (HS 01) was altered in 1949 when a fire escape was added to the west elevation to facilitate visitor circulation (figure 4.53 and figure 4.54).²⁵ The fire escape stairs were installed from the second story to the west porch, where visitors would exit at ground level. The staircase was set on metal supports and constructed of metal railings with open 3-foot-wide risers, color unknown.

Nonhistoric Adirondack chairs were placed near the south porch between 1946 and 1948 (see figure 4.53). These chairs were made of wood and had low reclining seats and high fan-shaped backrests. Their color is unknown, although they appeared to be white. They were removed at sometime during this period, exact date unknown.

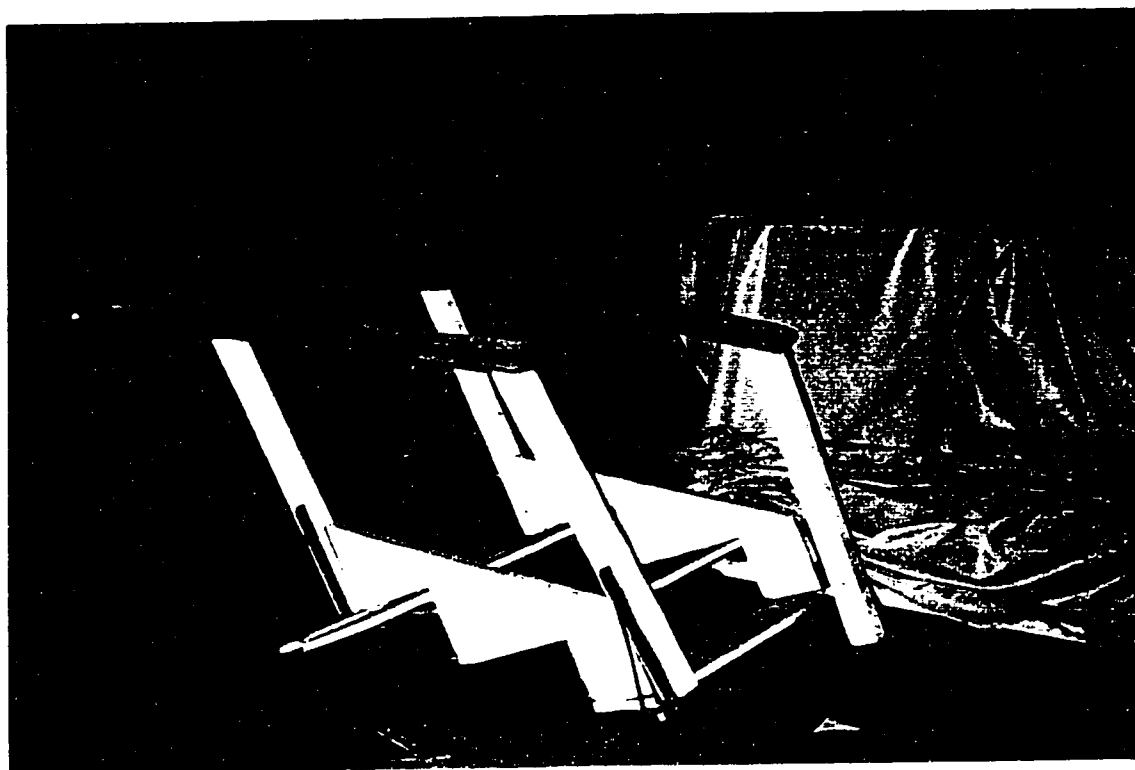
Figure 4.56: Historic handrails stored in the coach house, 1998. (photograph by author).

The hand rails located on the front terrace steps were removed, exact date unknown. They are now in the site's museum collection (figure 4.56).

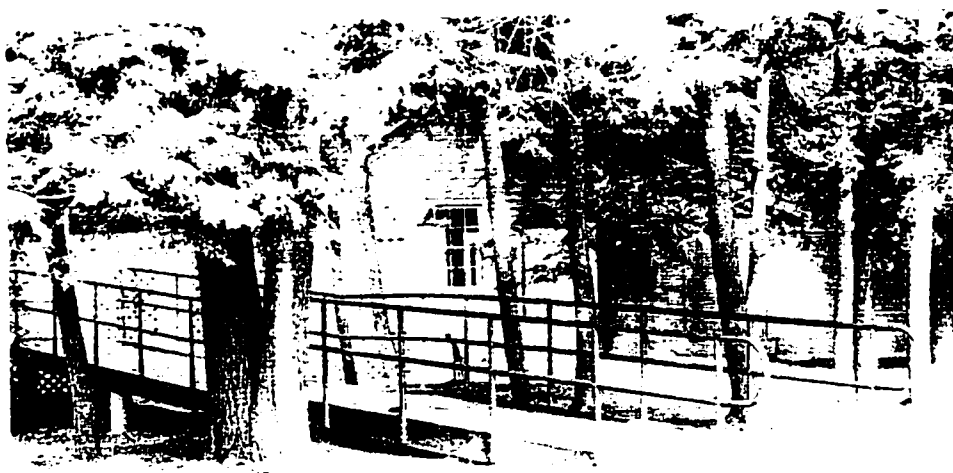
Figure 4.57: Wheelchair ramp located on Springwood's east elevation, 1997. (photograph by author).

A wheelchair ramp, date unknown, was added to the east elevation of Springwood. The ramp is approximately 42 feet long by 4 1/2 feet wide (figure 4.57). It is constructed of metal railings and a wood deck. The railings are painted black and the deck is unpainted.

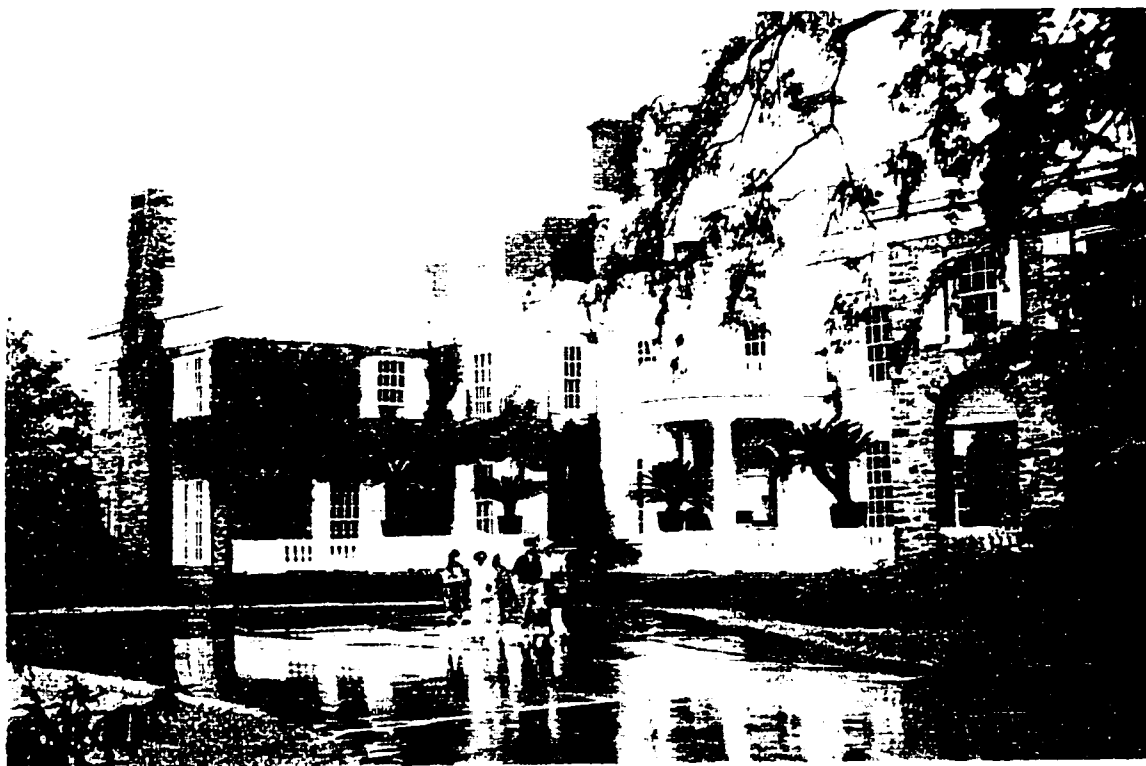
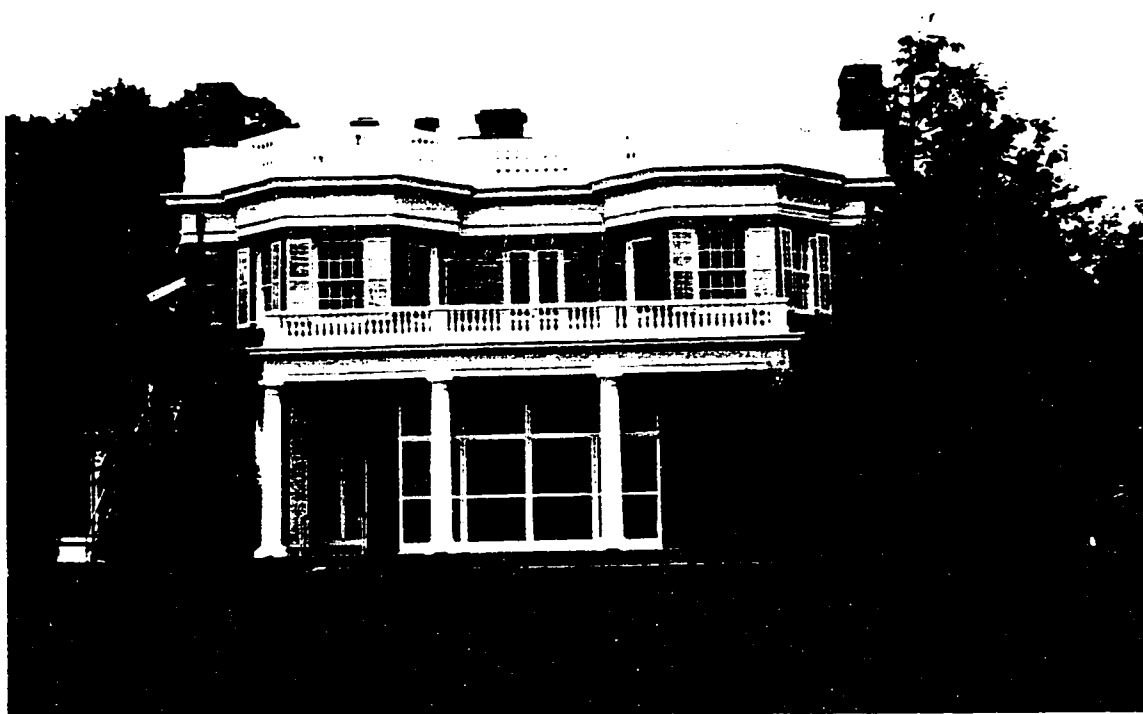
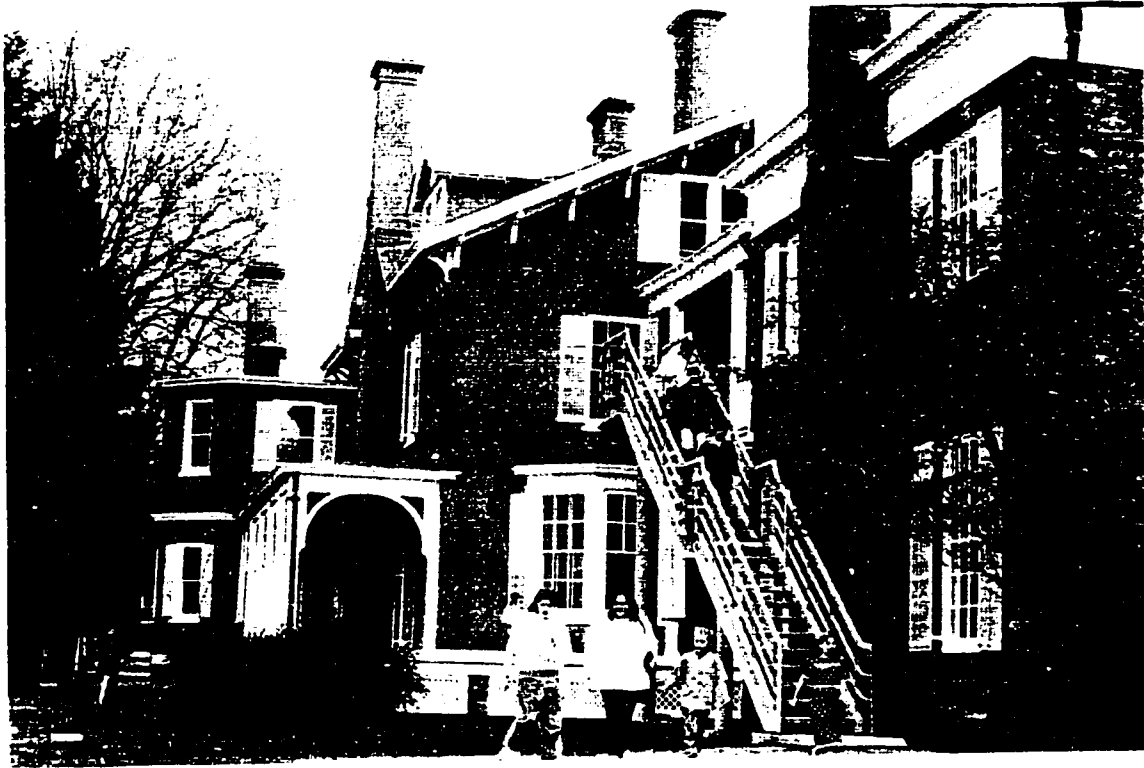
The house is open to the public year-round. The utilities are housed in the basement of Springwood, and the third floor is used for museum storage. Half of the servants' wing is used for interpretive staff offices. The existing condition of Springwood is as described above (figures 4.58, 4.59, 4.60).

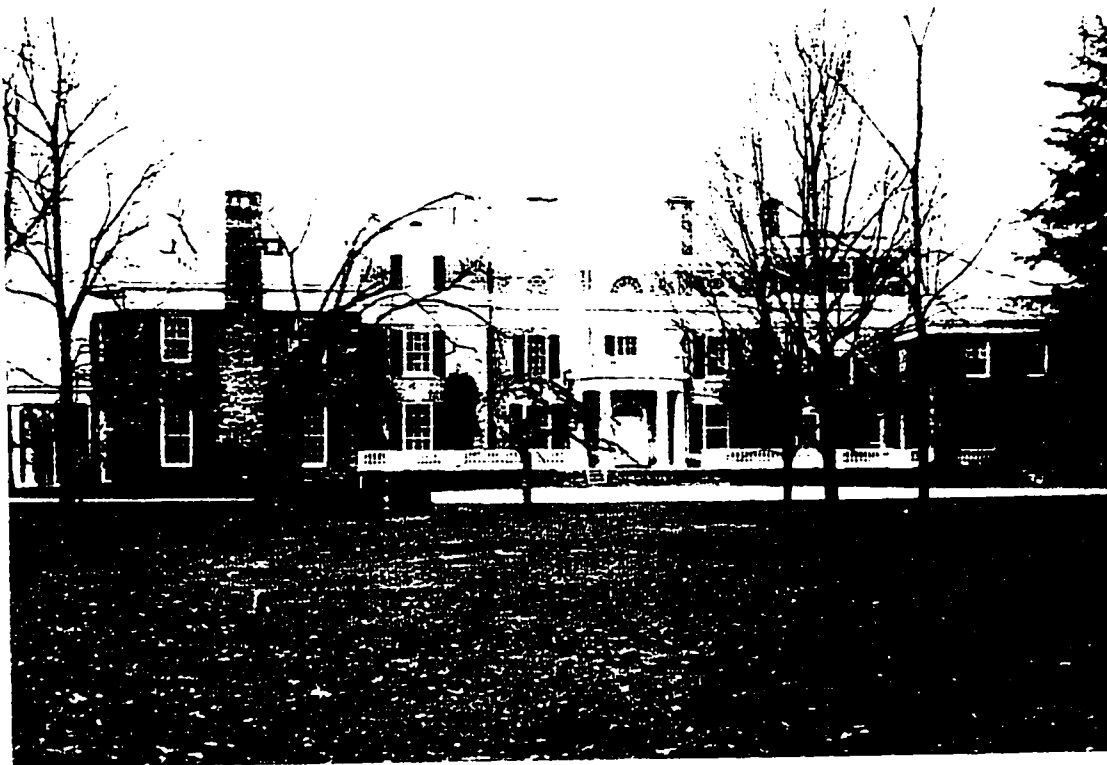
Figure 4.63: Springwood, east elevation, and vegetation on the east lawn, no date. (Franklin D. Roosevelt Library, NPx 78-16).

A large number of the main lawn trees underwent changes throughout this period. Trees lost from 1945 until the 1960s were either not replaced, replaced in kind, or were replaced with a different species. The changes in the east lawn created quite a different character (figure 4.63). For instance, in 1963 a large American elm (*Ulmus americana*) was replaced by a sugar maple (*Acer saccharum*) that still exists. All 11 American elms were lost to Dutch elm disease during the 1960s and 1970s. Four were replaced in the 1980s with disease-resistant elm trees. Other replacement trees were planted in close proximity to the location of the original plants. Dutch elm disease killed the last elm in 1988, which was replaced with a disease-resistant elm tree.²⁸

The historic euonymus (*Euonymus fortunei*) plants along the front terrace were replaced in the 1960s with yews (*Taxus* sp.) (figure 4.73). Wooden platforms were placed over the yews during the winter months to prevent snow damage.³¹ A five-leaf aralia (*Akebia quinata*) at the southeast corner of Springwood is thought to have been there in the 1960s.³² Also located along Springwood's southeast corner are spireas (*Spiraea x vanhouttei*) and two varieties of mockorange (*Philadelphus x virginialis* and *Philadelphus coronarius*). In the southwest corner is a barberry (*Berberis thunbergii*), a spirea (*Spiraea x vanhouttei*), and a crabapple tree (*Malus pumila*). Two barberry shrubs (*Berberis thunbergii*) are located along Springwood's west elevation. In the 1970s yews (*Taxus* sp.) were planted around the fire hydrants on the main and south lawn, but were removed in 1996 (see figure 4.63).

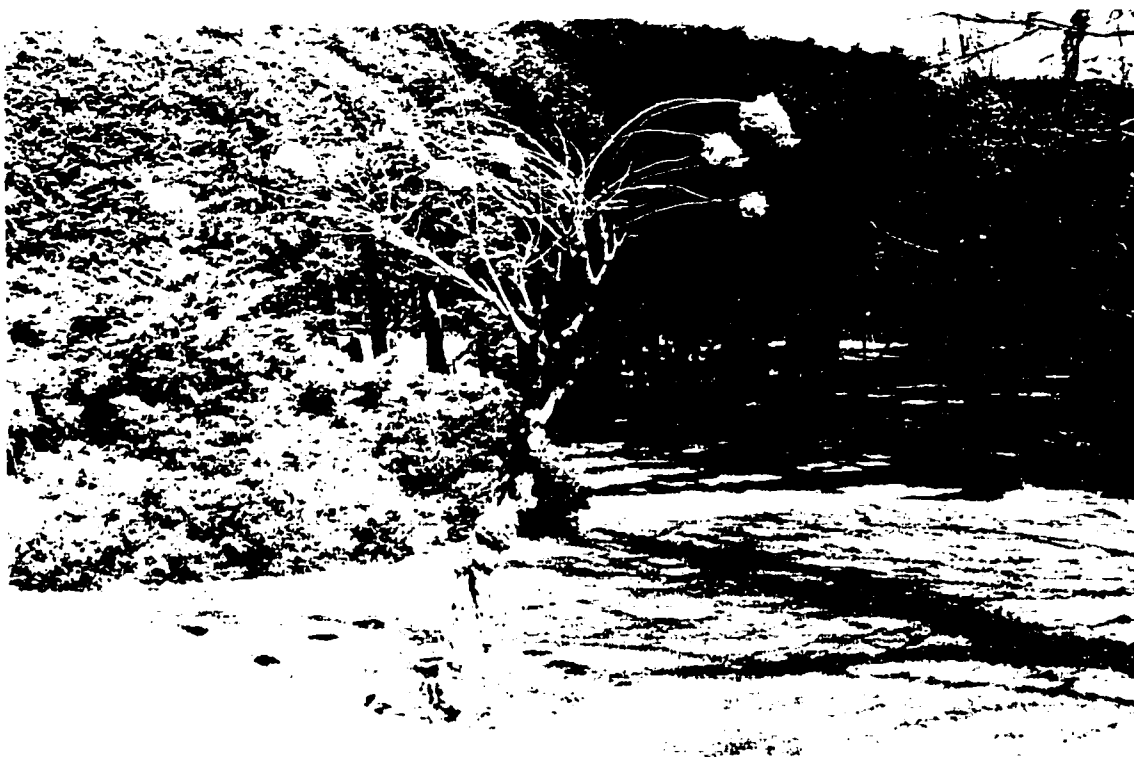
Figure 4.70: Pee Gee hydrangea, extant from the Late Roosevelt Ownership Period, 1997. (photograph by author).

The shrubs within the main lawn area also changed during this period. The Pee Gee hydrangea on the west side of the garden walkway was removed by 1960 and was not replaced. An extant shrub from the Late Roosevelt Period includes the one remaining 1 Pee Gee hydrangea (*Hydrangea paniculata* 'Pee Gee') located east of the garden walkway (figure 4.70).

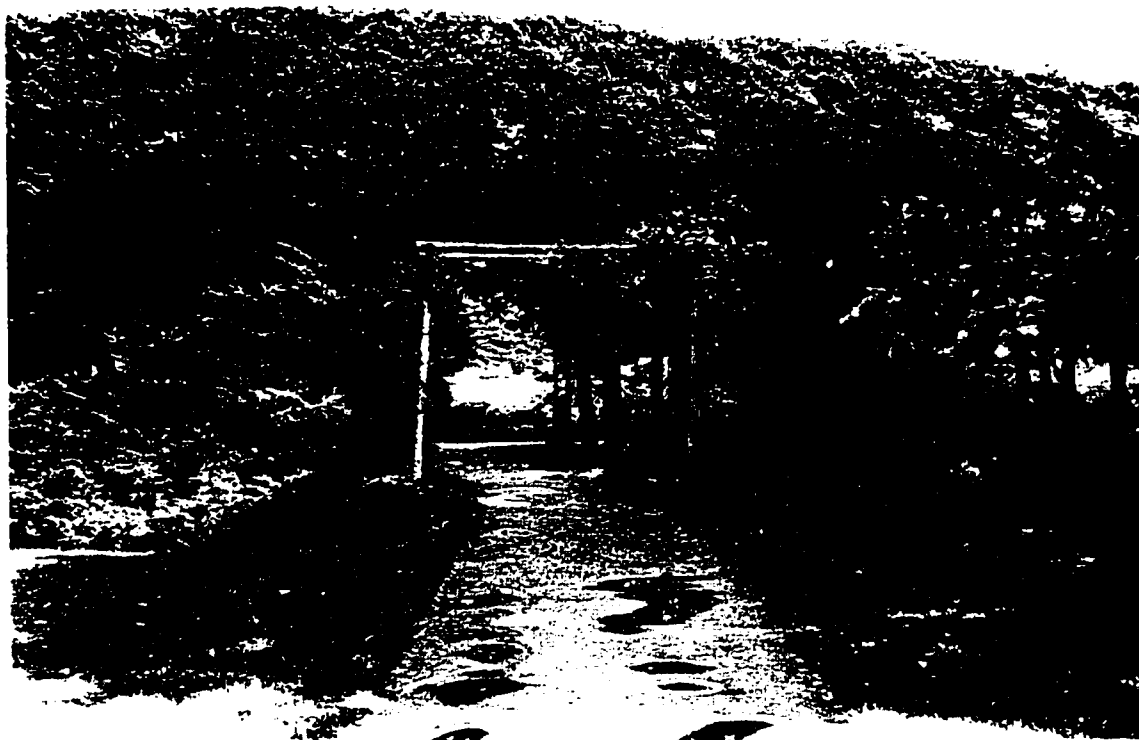
Figure 4.71: Roses and junipers located near the rose garden, south of hemlock hedge, 1997. (photograph by author).

Two climbing roses are still located on either side of the rose arbor, but it is unknown whether they are historic (figure 4.71). Junipers (*Juniperus* sp.), added by the NPS, are located between the rose arbor and the hedge.

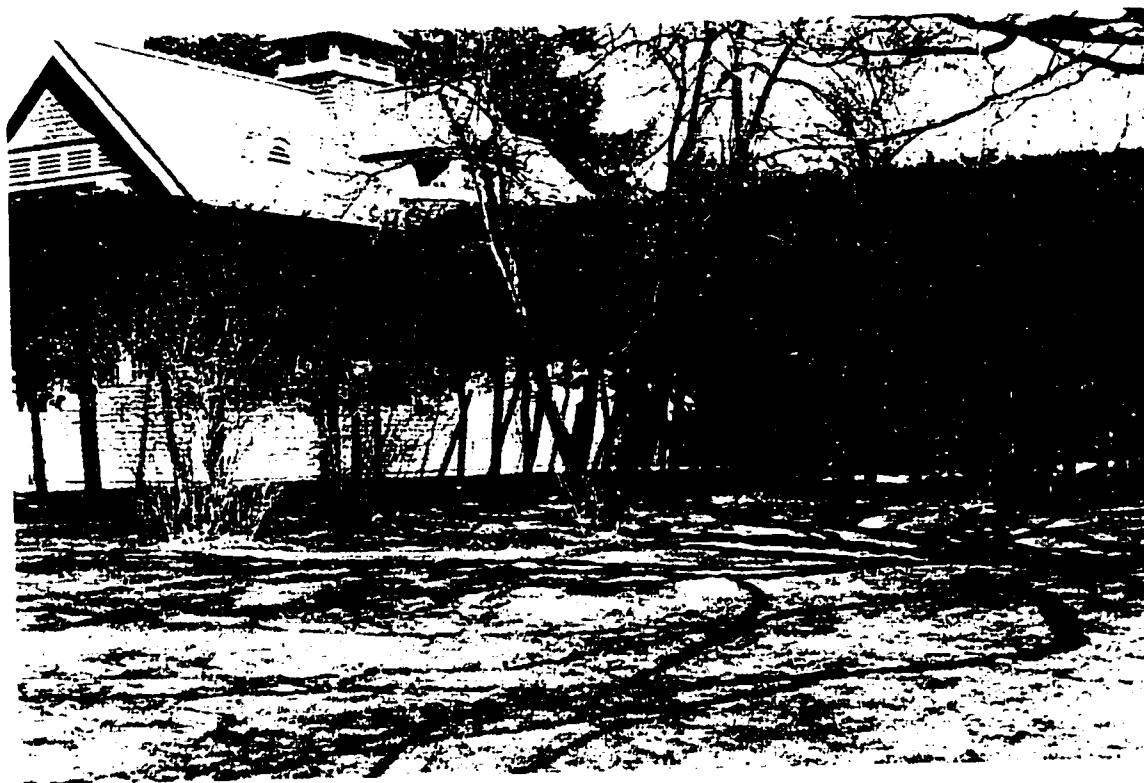
Figure 4.72: Mockorange plants located south of the hemlock hedge, 1998. (photograph by author).

A group of mockorange plants (*Philadelphus coronarius*), date of installation unknown, is located at the southeast corner of the hemlock hedge. These plants were probably installed during the Late Roosevelt Ownership Period, and documented only as 'shrubbery' in 1946 (figure 4.72 and see Late Roosevelt Ownership period plan).

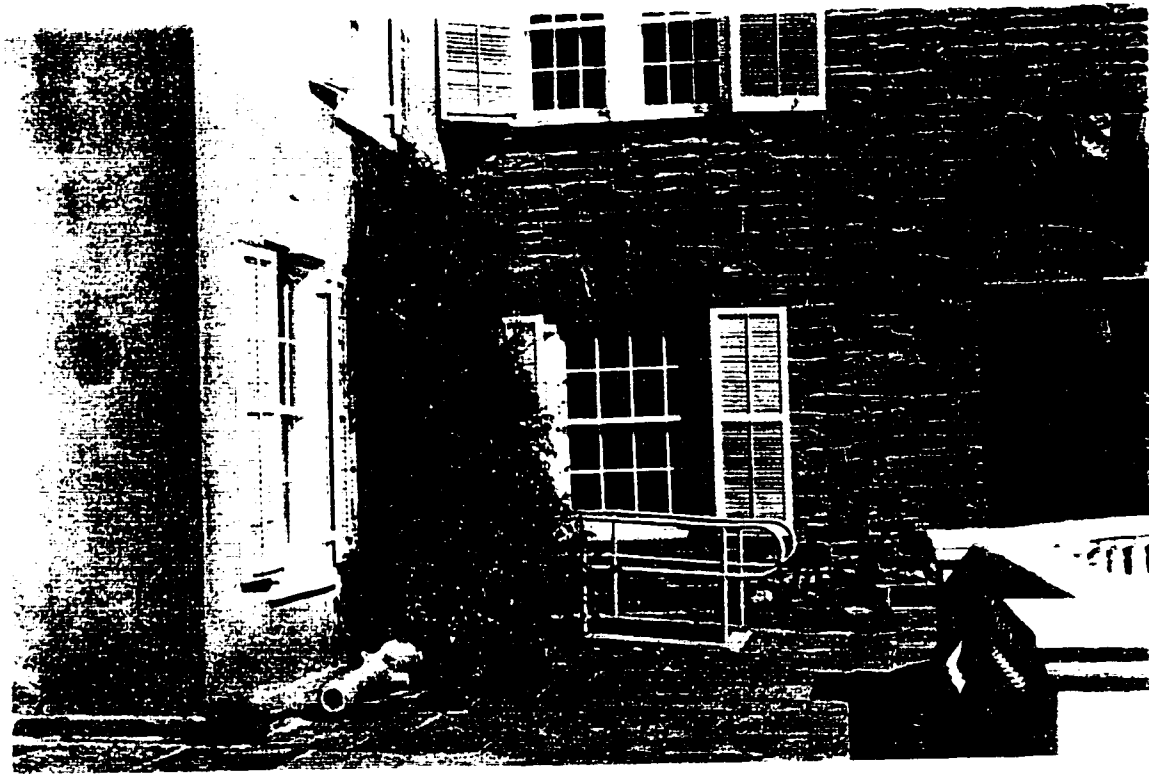
Figure 4.74: Japanese honeysuckle located on Springwood's east elevation, 1997. (photograph by author).

Vines from the Late Roosevelt Ownership Period include Virginia creeper (*Parthenocissus quinquefolia*), located on Springwood's eastern elevation, just south of the main entrance. Japanese honeysuckle (*Lonicera japonica*) is located on the east elevation, north of the entrance (figure 4.74).

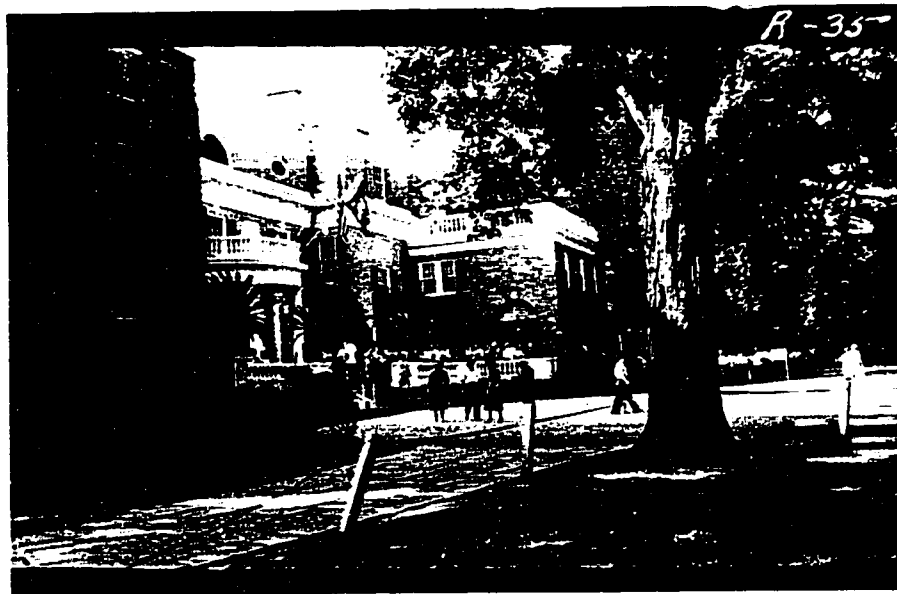
Figure 4.76: Flagstone walkway located along Springwood's east elevation, c. 1947-1948. (The Home of Franklin D. Roosevelt NHS, R-35).

A flagstone walkway was constructed sometime between 1946 and 1949. The walkway's exact dimensions are unknown, but it connected the turnaround to the south side of Springwood and was constructed of flagstone, color unknown (figure 4.76 and see figure 4.53). In 1981 the walkway was crushed by fire trucks during the fire at Springwood. It was replaced in 1982 and is located from the turnaround to the south side of Springwood. The walkway was 10 feet wide and extended 60 feet along the south elevation ending in a semicircle near the fire escape stairway at the southwest corner of the house. It was constructed of tan-colored rectangular flagstones of varying sizes.

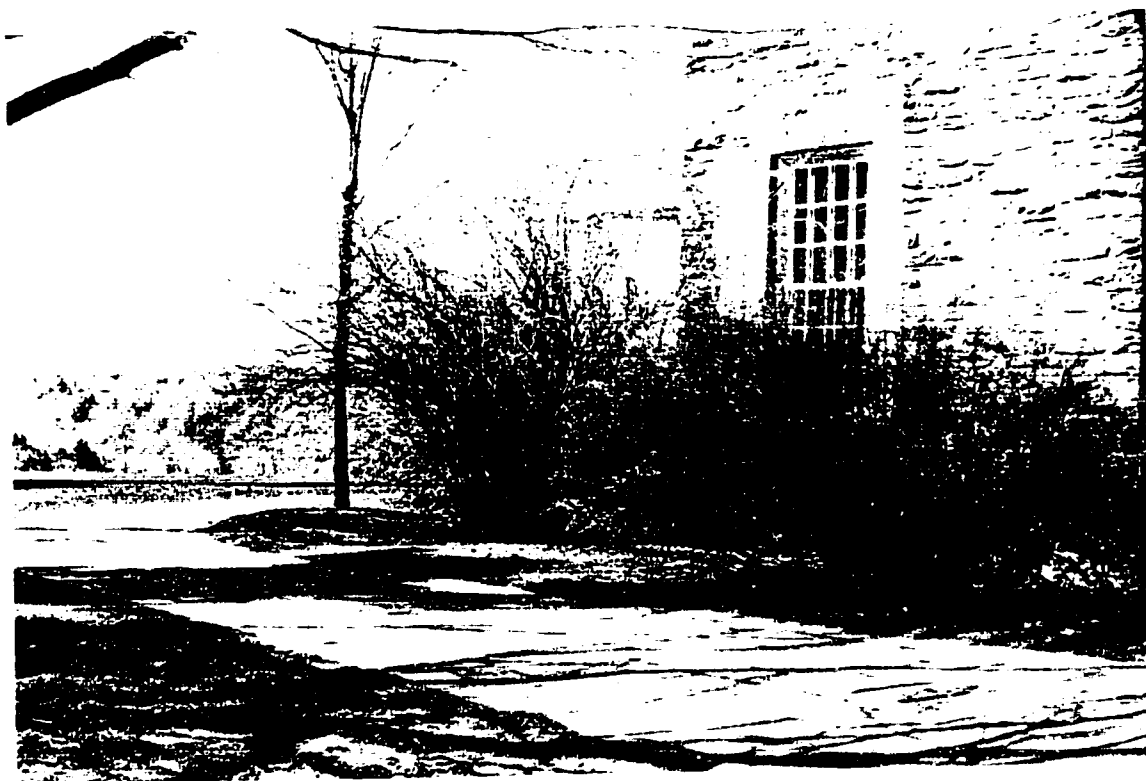
Figure 4.77: Flagstone walkway located along Springwood's south elevation, 1997. (photograph by author).

The existing condition of the flagstone walkway is as described above (figure 4.77).

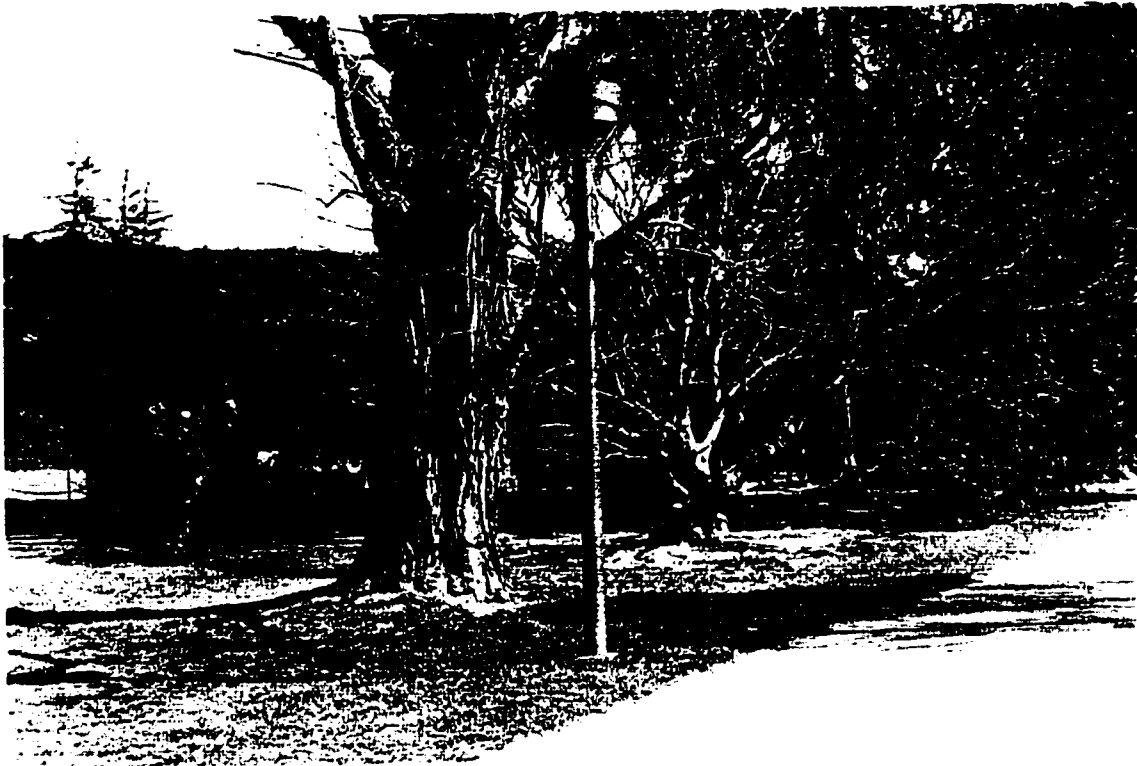
Figure 4.83: Existing light fixture, 1997. (photograph by author).

A light fixture was installed during this period, exact date unknown. It was located along the home road between the two paths to the rose garden. The light fixture was made of brown metal, approximately 10 feet high, and had a 1-foot in diameter round light at the top of the pole (figure 4.83).

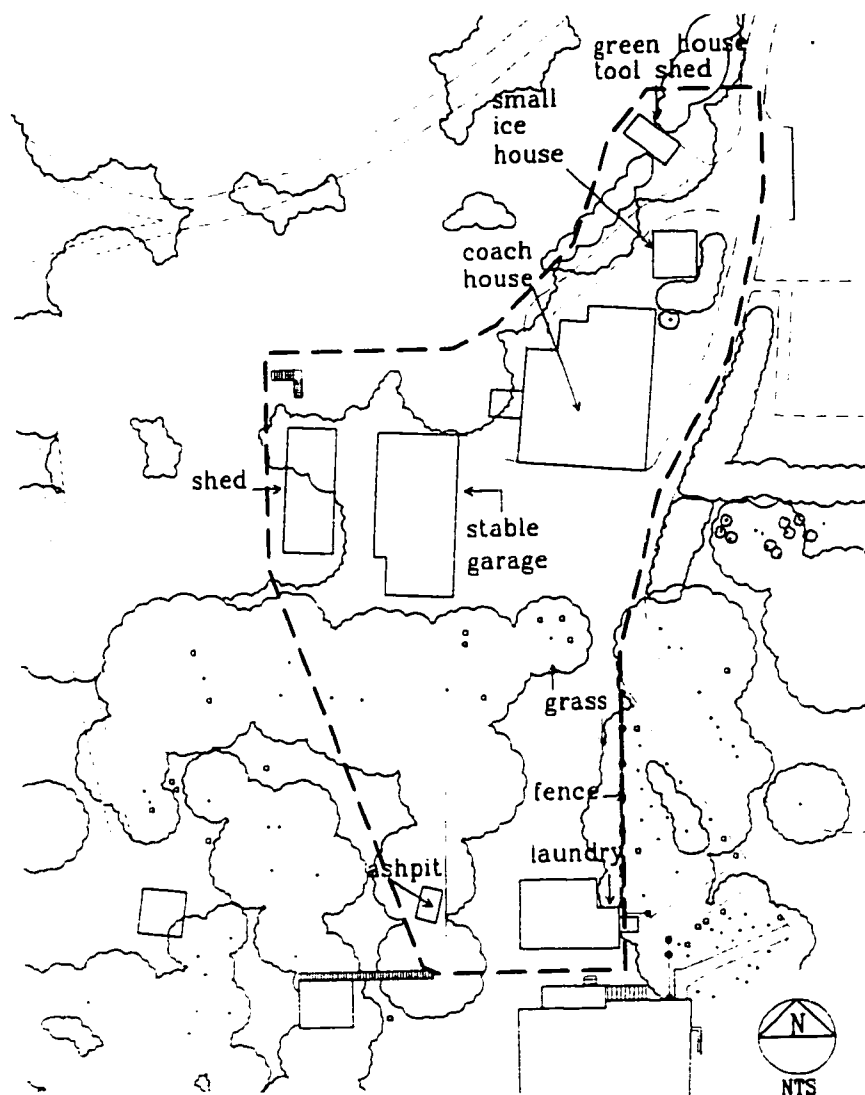
Figure 4.84: Spatial organization of the service area subspace. (K. Baker and G. Dallmann, SUNY CESF, 1998, based on the 1994 HPI map).

The spatial configuration of the service area is relatively unchanged in terms of the definers of the space (figure 4.84). The ground is still flat, but the central grassy area was replaced with gravel and the service area road was replaced with asphalt. Views out of the space are still limited but open to the sky.

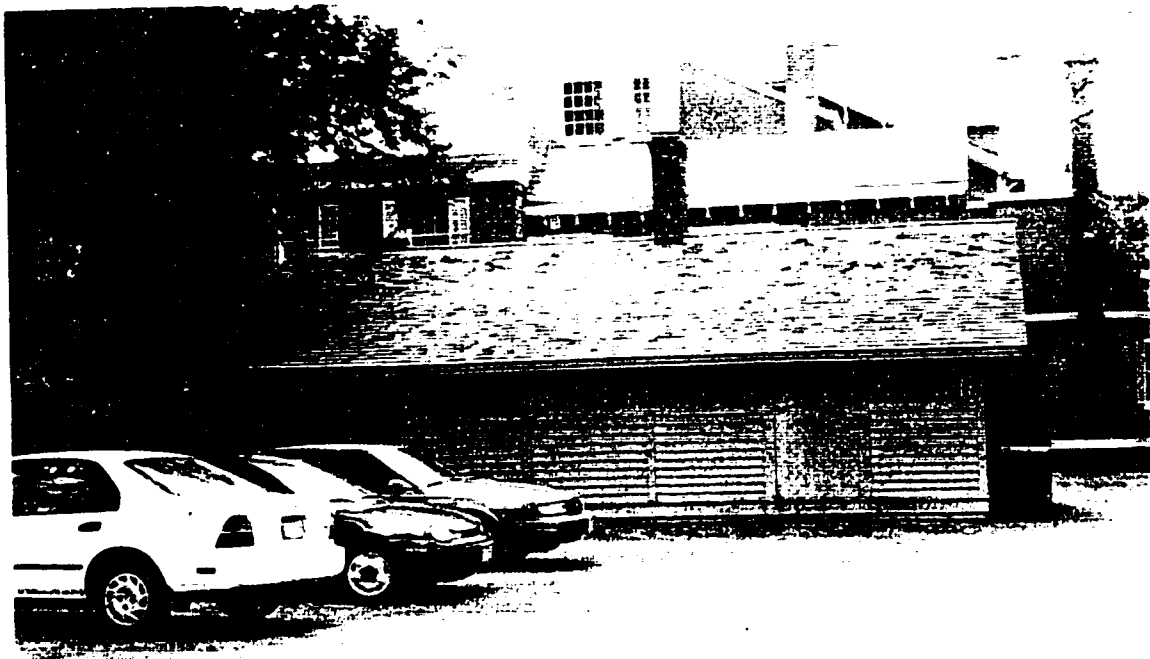
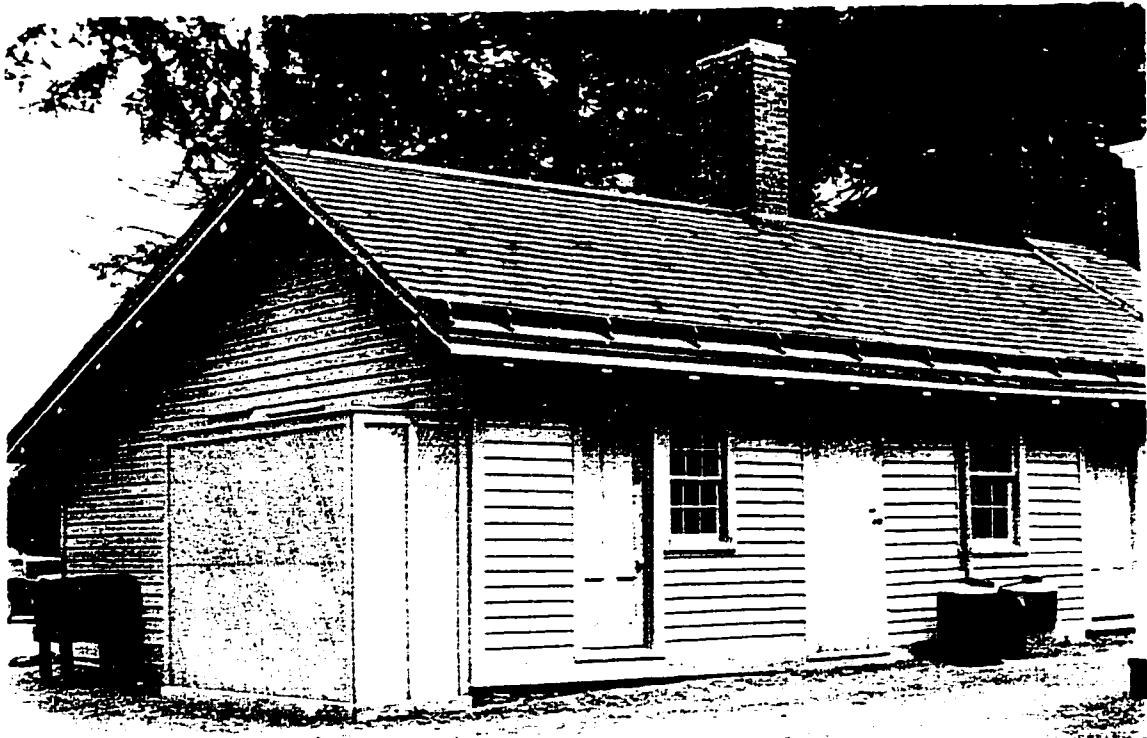
The laundry (HS 12) was routinely maintained between 1945 and 1959. This included rebuilding the chimney, replacing, in kind, the wood shingle roof, and repainting.³⁵ The lattice privacy fence on the laundry's western elevation was removed sometime between 1946 and 1972, exact date unknown, and was replaced by 1989.³⁶ Between 1983 and 1997 the laundry was repainted gray, the chimney repaired, and the roof replaced with new wood shingles.³⁷ One room of the laundry is currently being used for storage.

The existing condition of the laundry is as described above (figures 4.85 and 4.86).

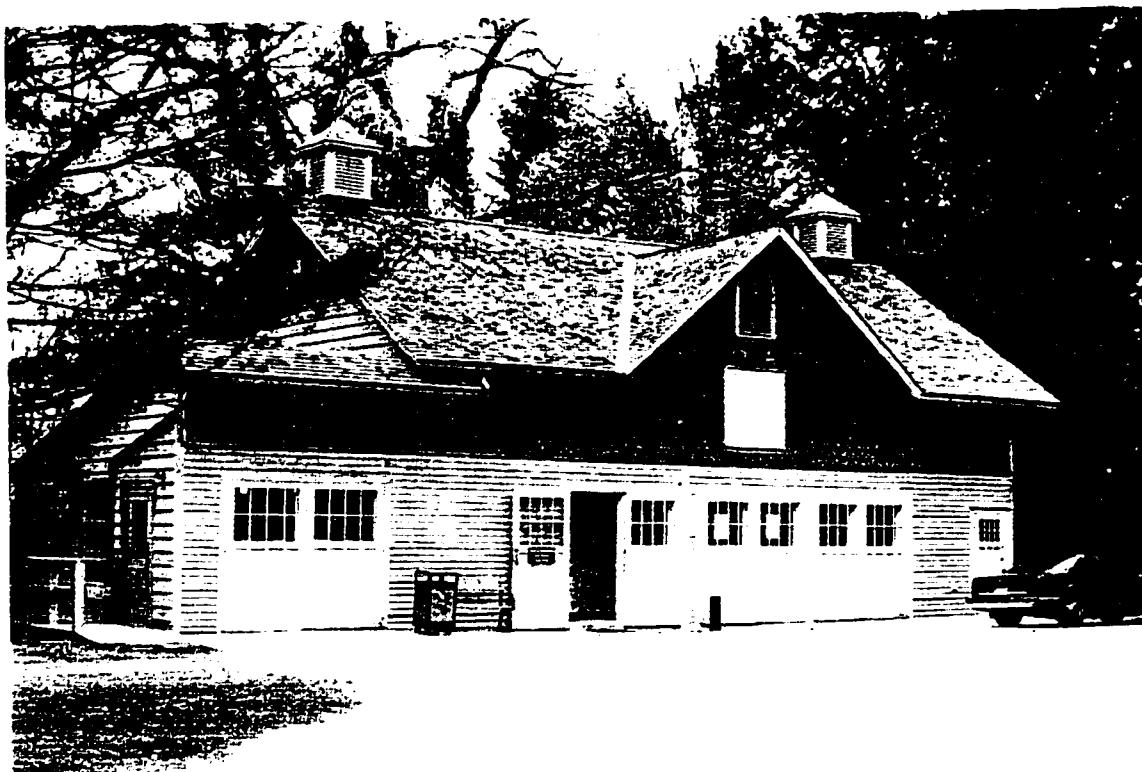
Figure 4.87: Tourist Information Center, east elevation, with bench and trash receptacle, 1997. (photograph by author).

The stable/garage (HS 04) was routinely maintained between the 1940s and 1960s, and included the installation of a new slate roof.³⁸ In 1971 a fire destroyed the stable/garage, leaving only the stone foundation. The stable/garage was rebuilt in 1974 with a balloon frame and steel I-beam construction, and its exterior was rebuilt to replicate the garage's original appearance, except the slate roof was replaced with wood shingles.³⁹ The garage was converted in 1985 to its current use as a Tourist Information Center that includes a bookstore and public restrooms (figure 4.87).⁴⁰

A bench was installed during the NPS Ownership Period, exact date unknown, adjacent to the east elevation of the stable/garage/Tourist Information Center. The bench was 5 feet long and constructed of metal legs with a wooden seat and backrest. The metal portion of the bench was painted black, and the wooden seat and backrest were unpainted (see figure 4.87).

A trash receptacle was installed during the NPS Ownership Period, exact date unknown, adjacent to the east elevation of the stable/garage/Tourist Information Center. The trash receptacle was rectangular, approximately 2 feet by 2 feet, and 3 1/2 feet high. It was constructed of metal and hard plastic and was black and brown (see figure 4.87).
