CULTURAL LANDSCAPE REPORT FOR
THE HOME OF FRANKLIN D. ROOSEVELT
NATIONAL HISTORIC SITE

Kristin Theresa Baker

Master of Science in Landscape Architecture Degree

May 1999

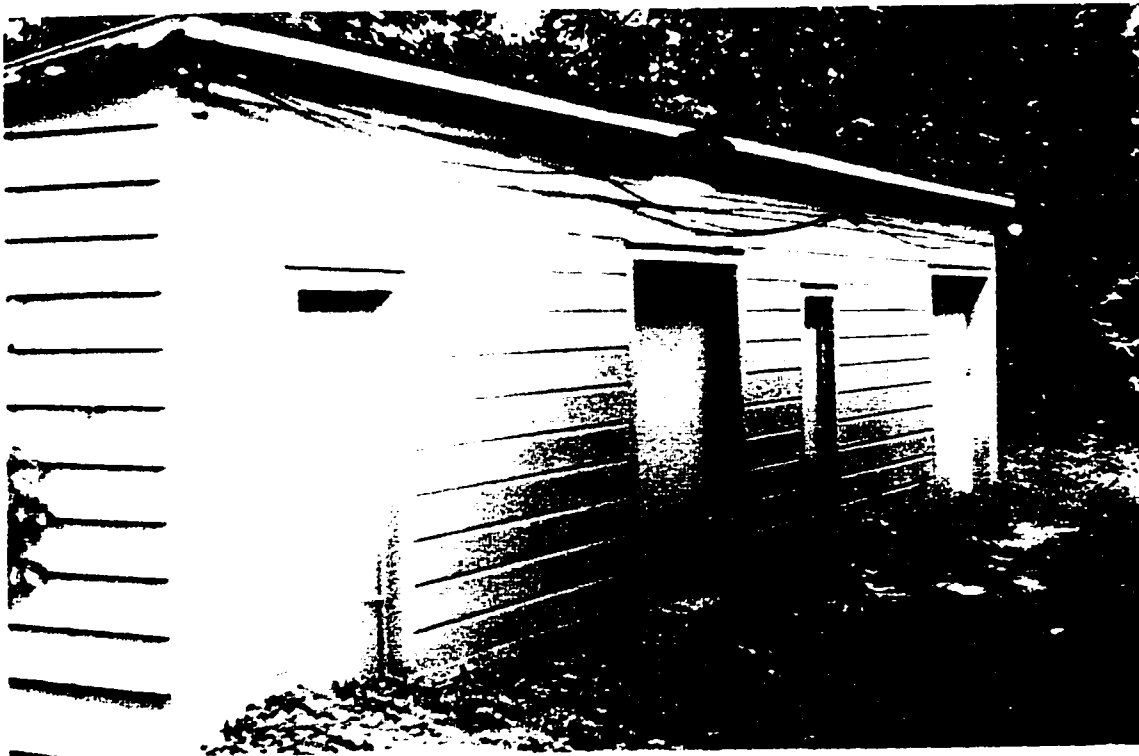
Figure 4.88: Shed located west of the Tourist Information Center, east elevation, 1997. (photograph by author).

The shed (HS 05) (west of the Tourist Information Center) was routinely maintained and repainted at various points during the NPS Ownership Period. Ultimately it was painted to its historically accurate color, rifle gray. The roof is covered with composition roll-roofing material, color unknown.⁴¹ The rear stone foundation was stabilized in 1991 to compensate for a bow in its wall.⁴²

The existing conditions of the shed is as described above and is used for storage (figure 4.88).

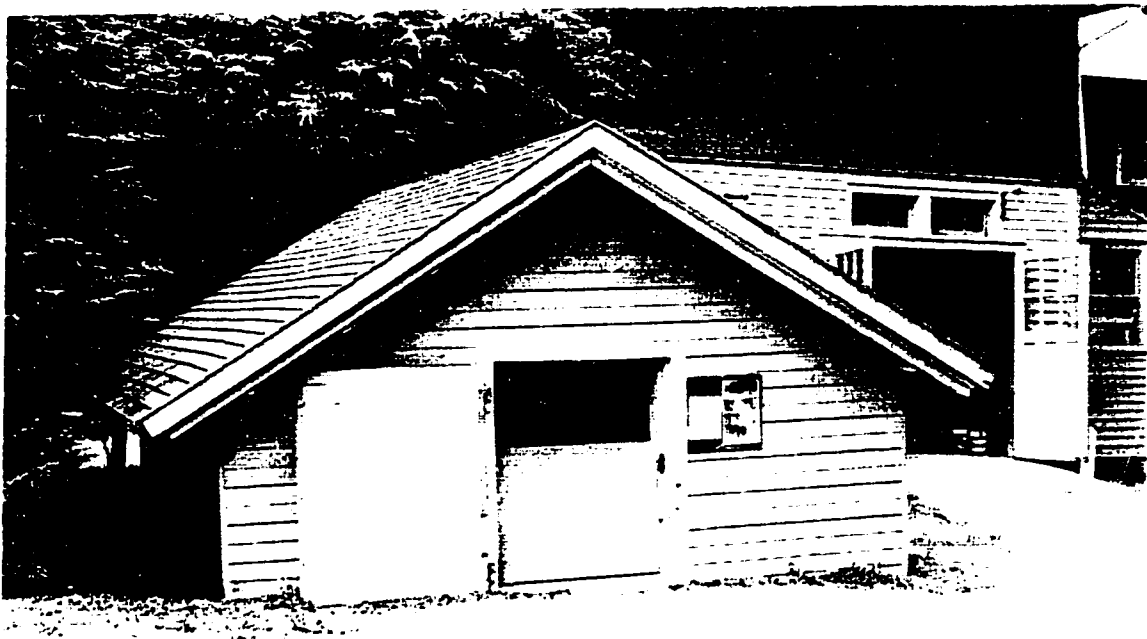
Figure 4.89: Small ice house, north elevation, 1997. (photograph by author).

The small ice house (HS 06) deteriorated severely between 1941 and 1959 with the collapse of the interior foundation. It was restored sometime between 1959 and 1960, using as much of the original material as possible.⁴³ Areas of deteriorated siding were replaced, as was the upper roof, which was replaced in kind. The small ice house was routinely maintained from 1960 on, including the in-kind replacement of its roof and was repainted.⁴⁴

The existing conditions of the small ice house is as described above and is used as an exhibit (figure 4.89).

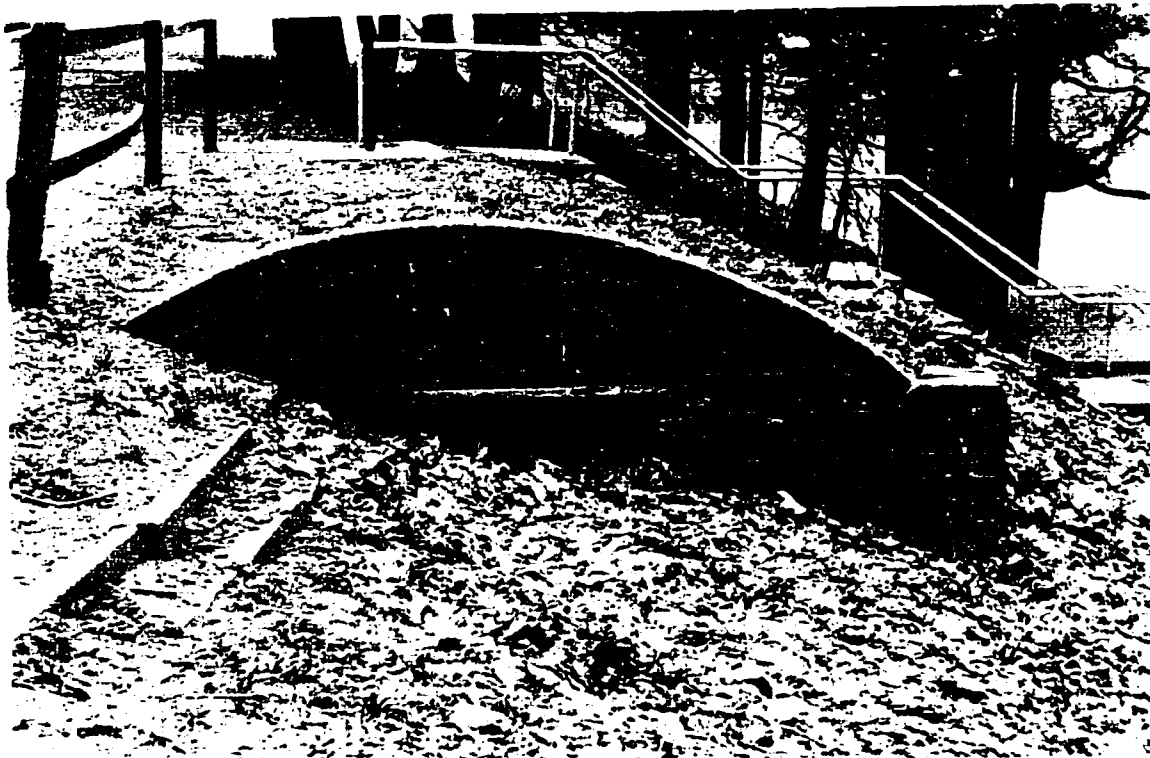
Figure 4.92: Ash pit, north elevation, and rail fence, 1998. (photograph by author).

The ash pit, from the Late Roosevelt Period, exists in its historic location west of the laundry (figure 4.92). Its brick roof is caving in.

A rail fence was constructed during the NPS Ownership Period, exact date unknown. It was located near the ash pit and along the ridge line, 20 feet east of the laundry (figure 4.98 and see figure 4.92). The fence was 18 feet long and 3 1/2 feet high. It was constructed of square vertical posts that were 3 1/2 feet high spaced 6 feet apart, and 6-foot-long horizontal rails spaced 1 foot apart.

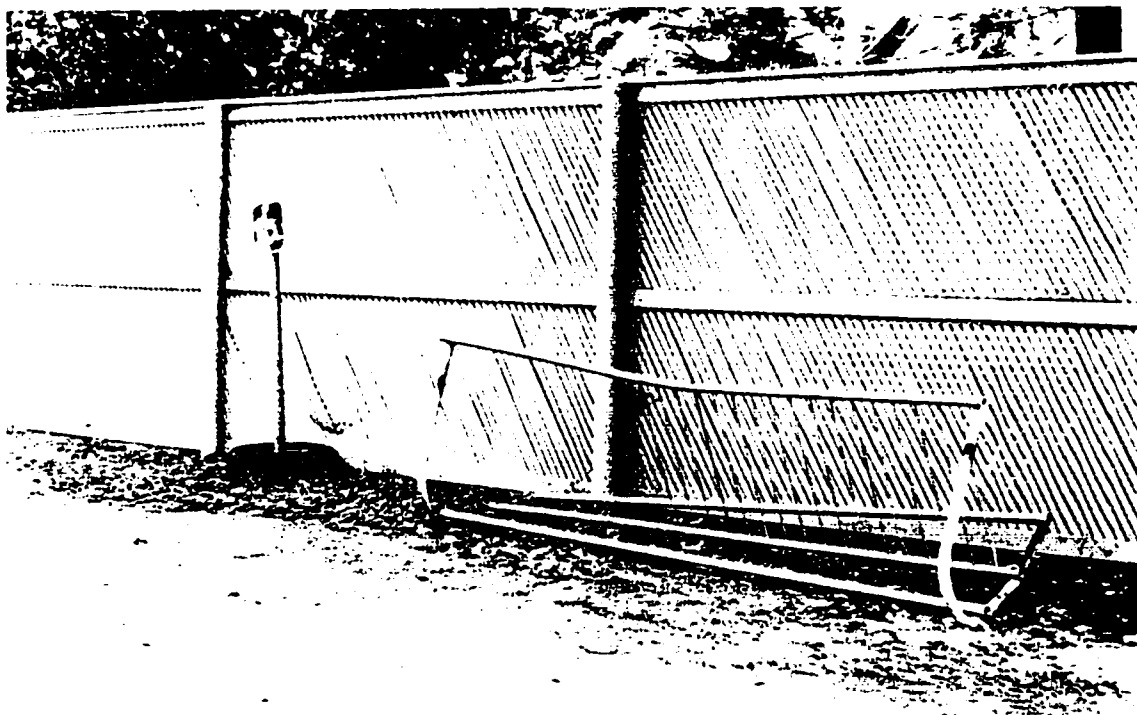
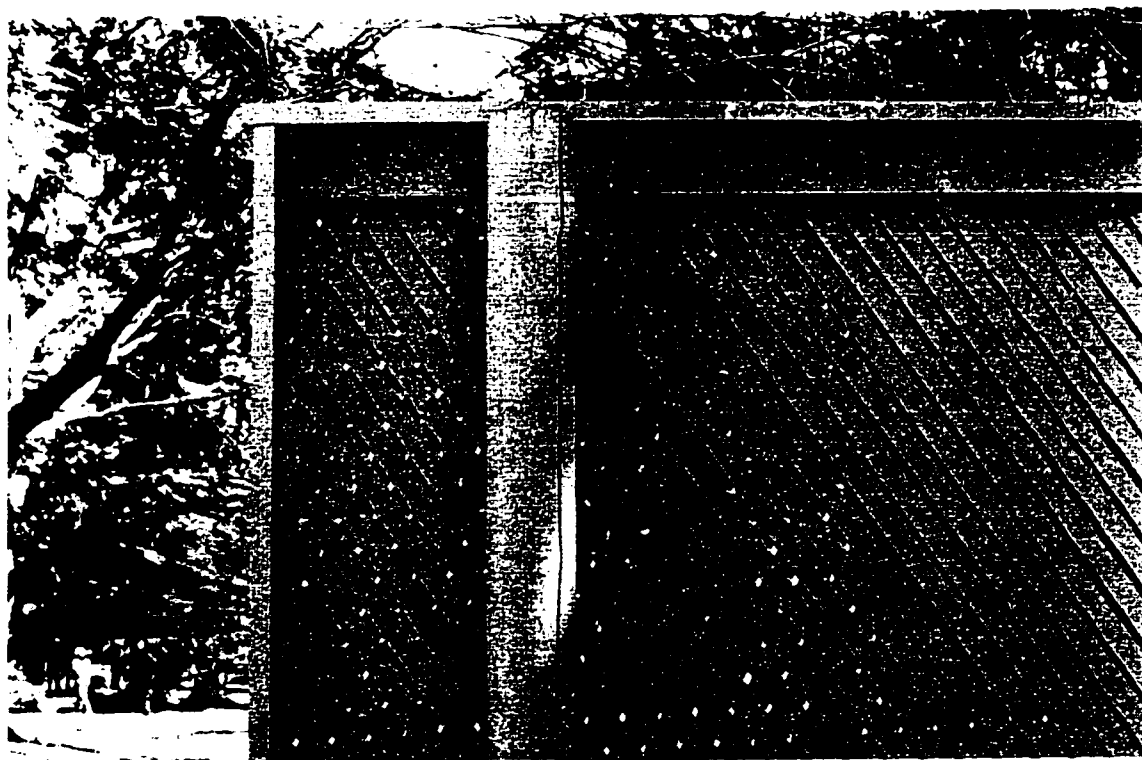
The entire northern portion of the screening fence was replaced during this period, exact date unknown. It looks similar to how it appeared during the Late Roosevelt Ownership Period, but it is not identical. The vertical replacement posts are cut straight across the top, where the original posts were cut at an angle. One of the original posts remains, but the remainder of the fence is nonhistoric. The lattice fencing is more closely spaced, but is similar to the fence's historic appearance.

The northern section of the fence is 69 feet long and 6 feet high and painted gray (figure 4.94 and figure 4.95). The southern section of the fence and gate, located between the laundry and Springwood's northern porch, remains as it was during the Late Roosevelt Ownership (figure 4.96 and figure 4.97). The fence and gate are white.

A vehicular handicap parking sign was installed during the NPS Ownership Period, exact date unknown, adjacent to the service area fence (see figure 4.94). The sign was mounted on a 4-foot-high metal tube that was anchored in a car tire.

A bicycle rack was installed during the NPS Ownership Period, exact date unknown, adjacent to the service area fence (see figure 4.94). The bike rack was 10 feet long, 3 feet high, and constructed of metal tubing.

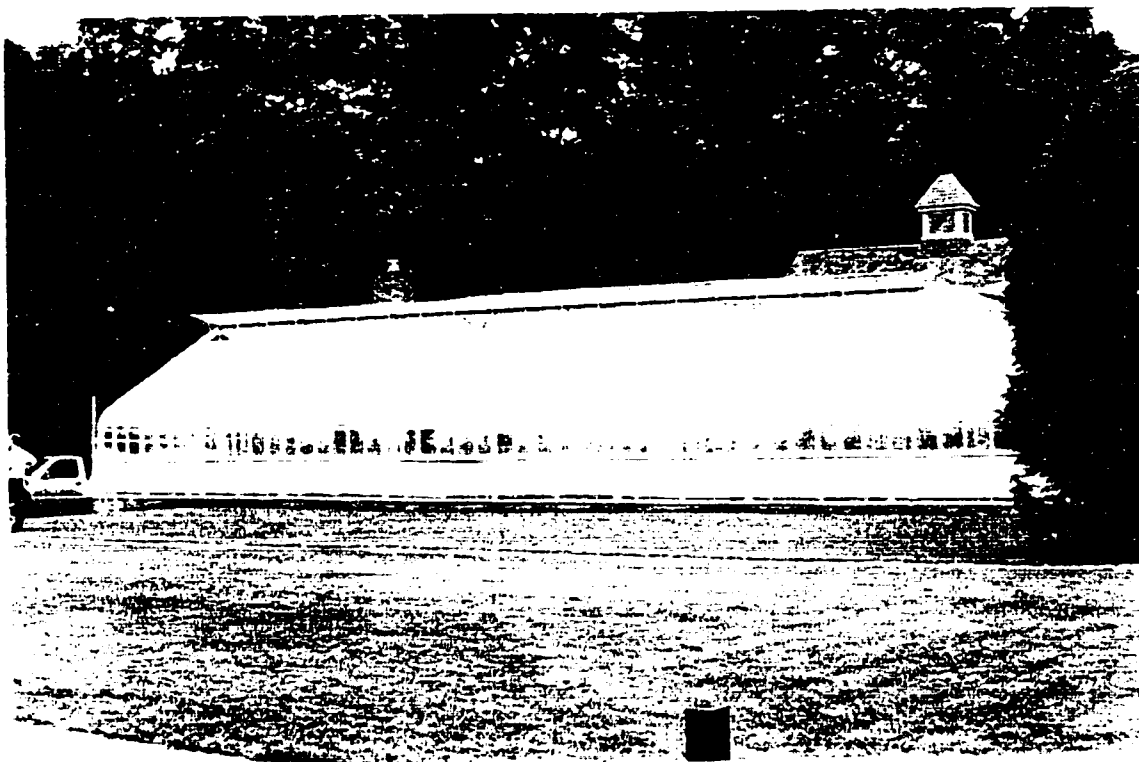
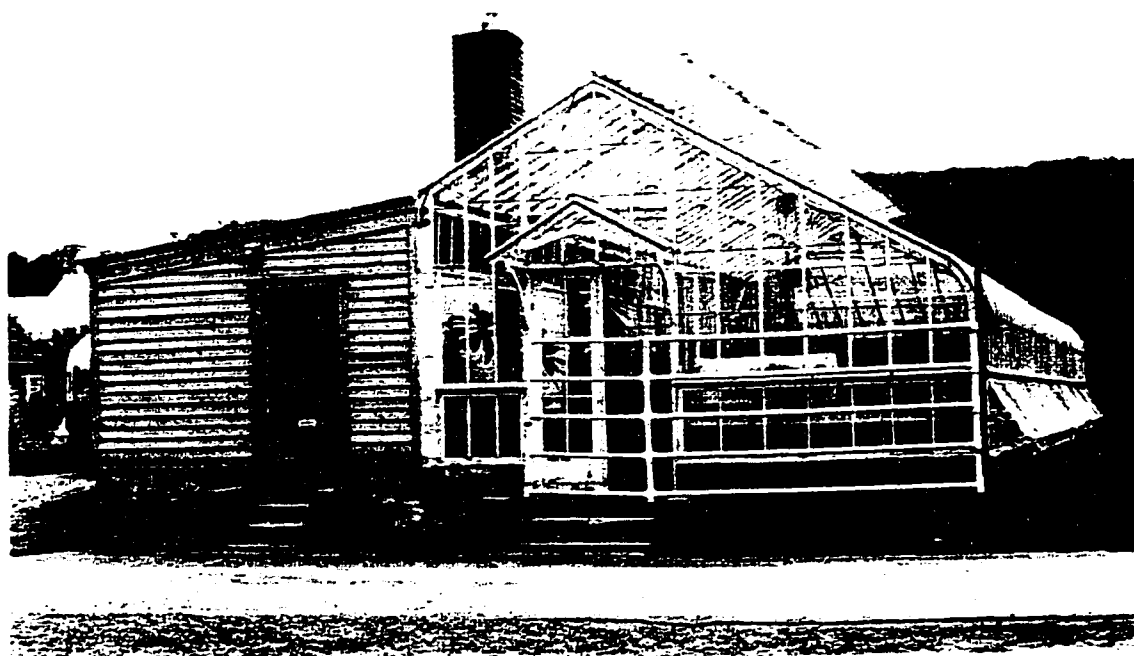
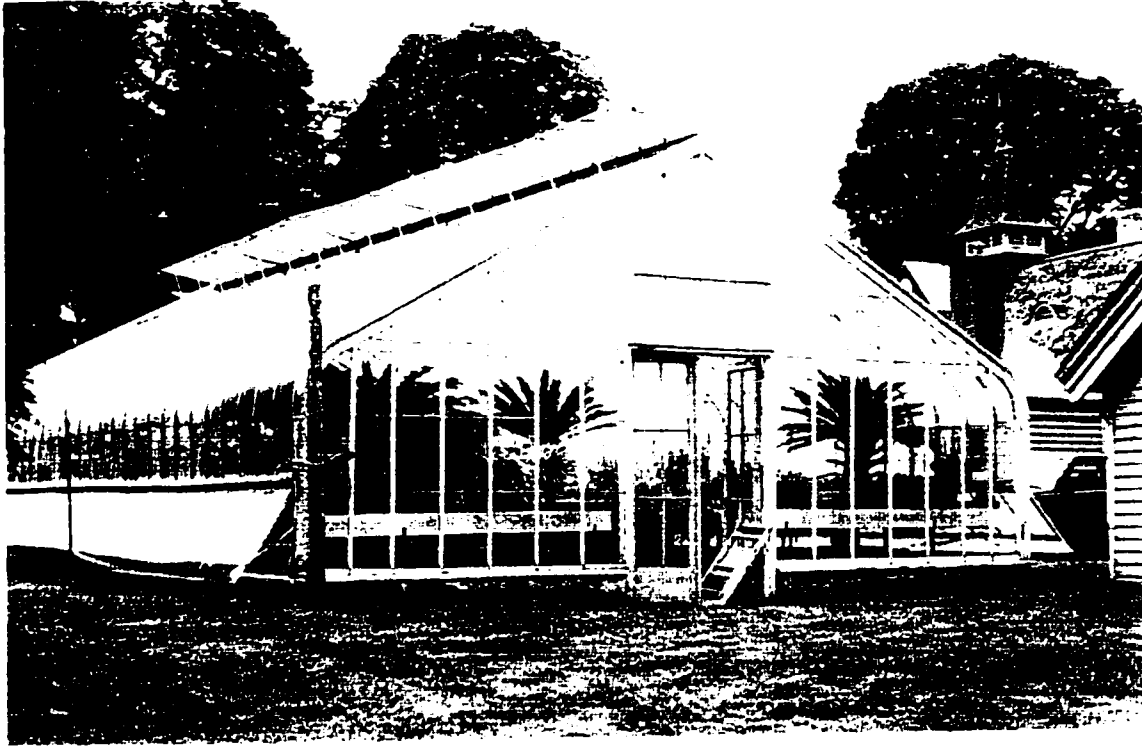
The greenhouse (HS 11) was maintained and restored throughout the NPS Ownership Period. Work on the greenhouse included repainting, reglazing the glass, and replacing broken panes.⁴⁸ All the windows were removed and replaced or reglazed between 1989 and 1990, and any deteriorated wooden support structures were replaced.⁴⁹

The greenhouse is being used in similarly to how it was used in the Late Roosevelt Ownership Period (figure 4.100, 4.101, and 4.102). The Sago palms are kept there in the winter months, and rose and carnation plants are grown as cutting flowers for Springwood and the Vanderbilt Mansion. One-third of the cutting rose's stock is replaced every four years, as the rose plants lose their ability to produce large numbers of flowers.⁵⁰

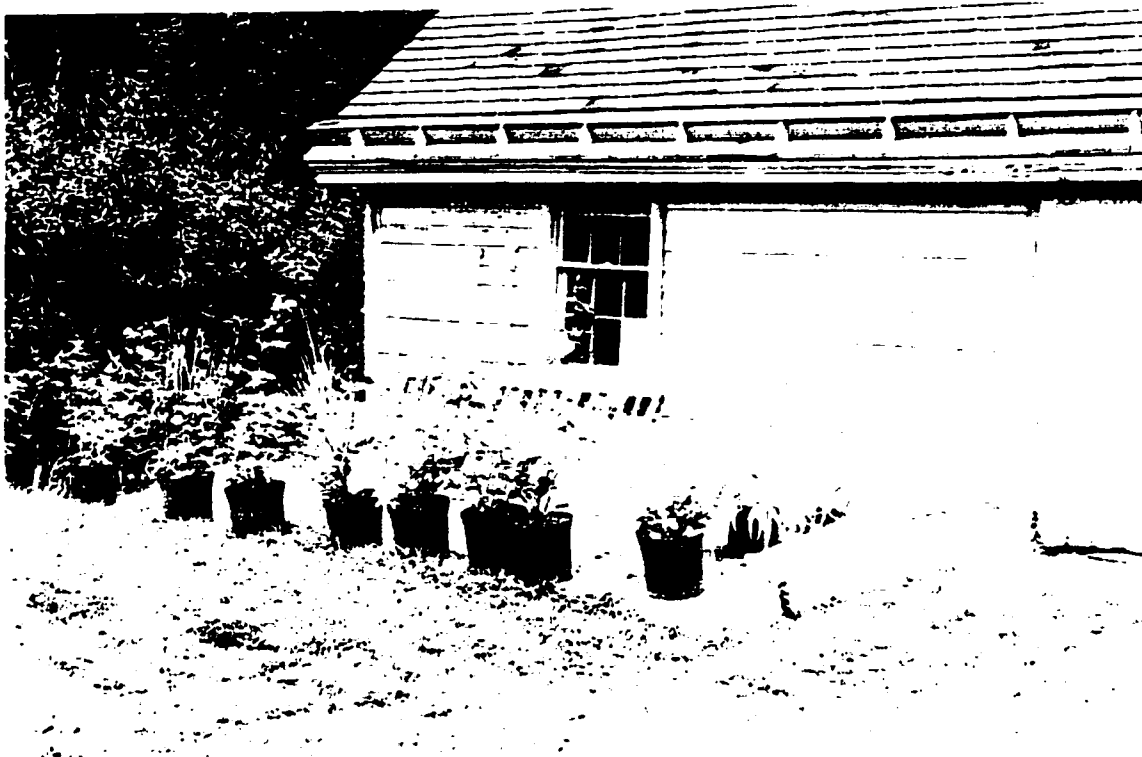
Figure 4.103: Hotbed located north of the greenhouse, 1997. (photograph by author).

The hot bed (HS 10), constructed in the Early Property Ownership Period, was located to the north of the greenhouse and used in summer months by the National Park Service employees as a holding place for greenhouse plants (figure 4.103). The hot bed's wooden framed glass top was removed during the NPS Ownership Period, date of removal unknown.

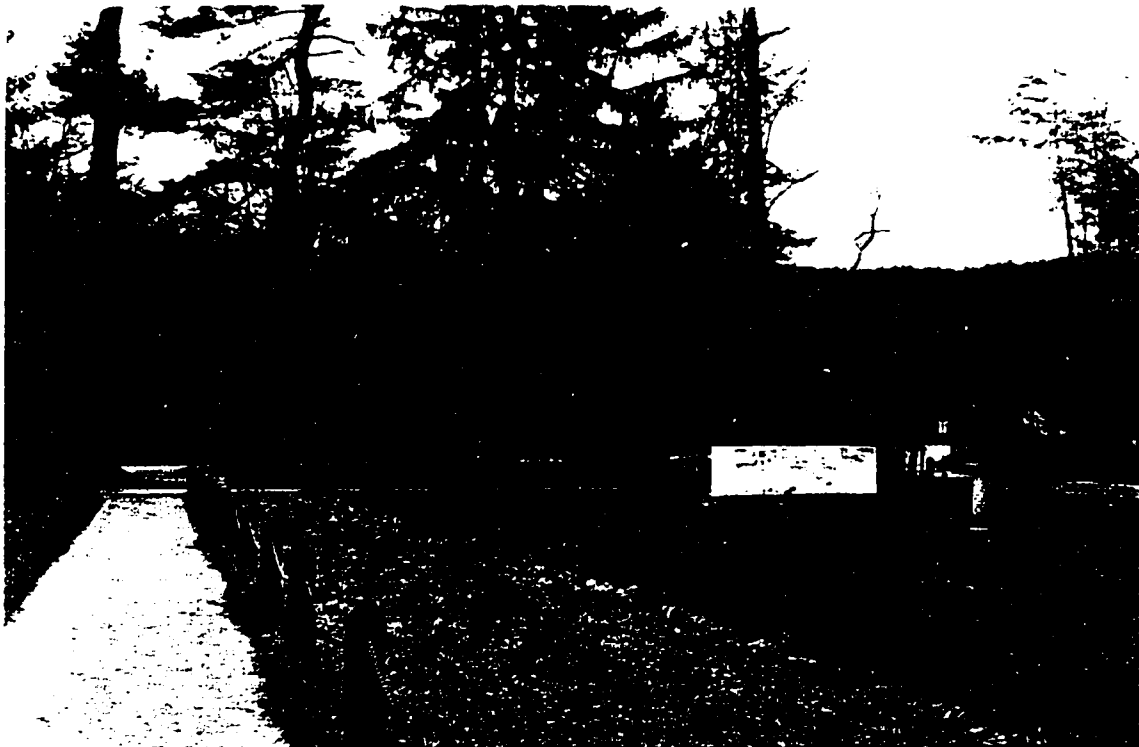
Figure 4.107: Damage to hemlock trees located between the southern garden entrances, 1998. (photograph by author).

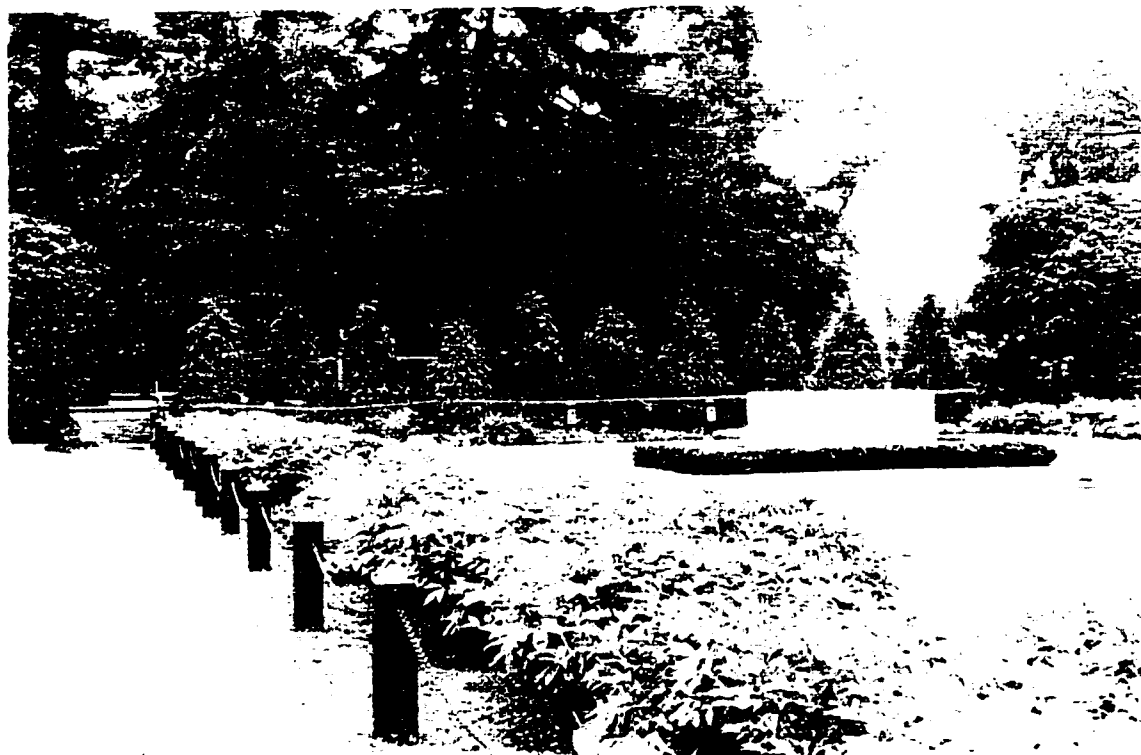
Figure 4.108: Replacement of the southern portion of the hemlock hedge, and the post and chain fence, 1998. (photograph by author).

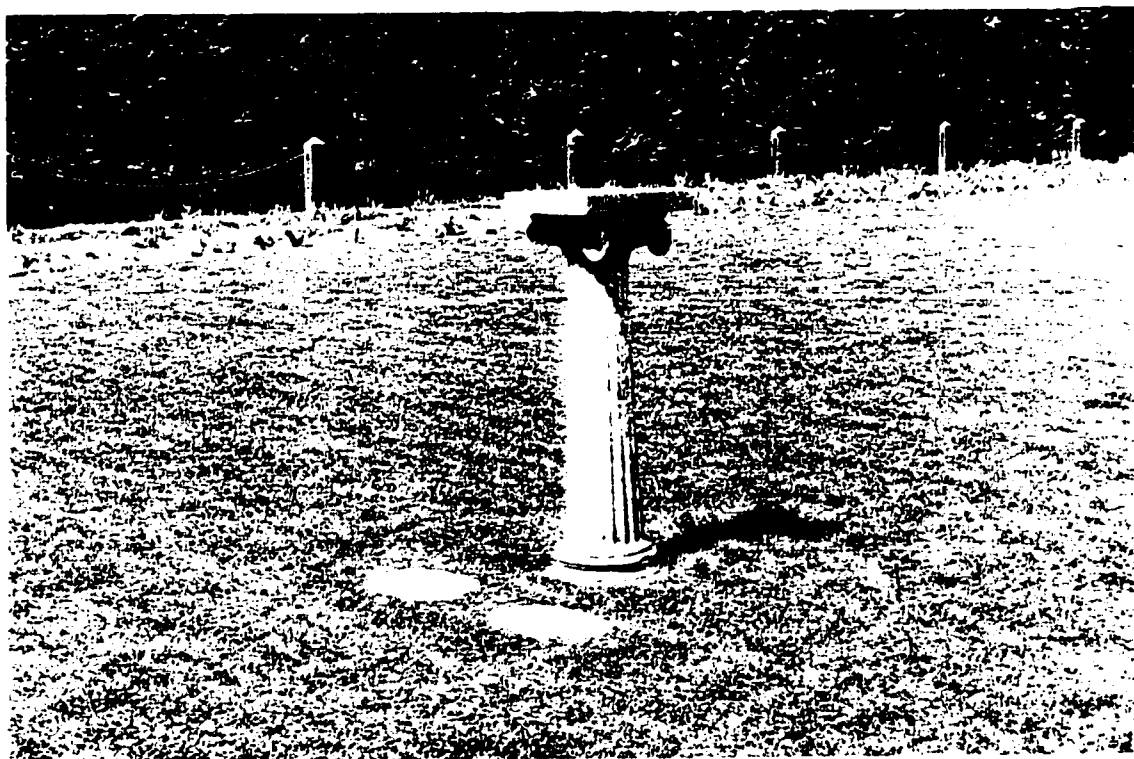
Figure 4.113: Sundial and dog grave markers located in the center of the rose garden, 1997. (photograph by author).

The sundial, during the NPS Ownership Period, was located in the center of the garden, north of FDR and Eleanor Roosevelt's grave monument (figure 4.113). The top, metal "dial" part of the sundial was removed, exact date unknown, and the stone base was in poor condition.

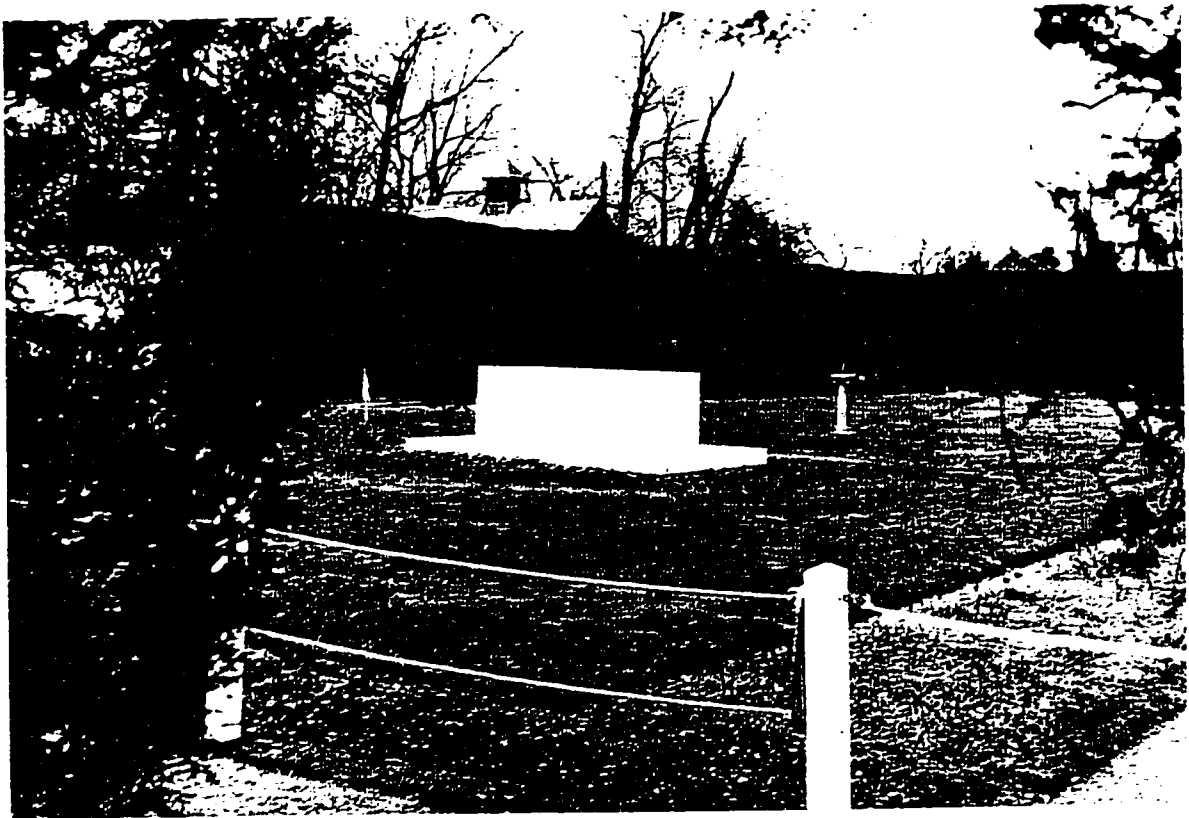
Figure 4.116: Fence located near the southern walkway. April 12, 1946. (Franklin D. Roosevelt Library, Px 53-227 (707)).

A fence was constructed in 1946 to keep visitors away from FDR's grave. It was located along the north side of the southern walk within the rose garden, between the eastern and the western entrance (figure 4.116). This fence was constructed of 3-foot-high wooden posts placed at approximately 5 to 6 foot intervals.⁵⁵ They were white in color and joined with two horizontal lengths of rope. By 1969, exact date unknown, the fence was eliminated, providing visitors access to the entire garden.

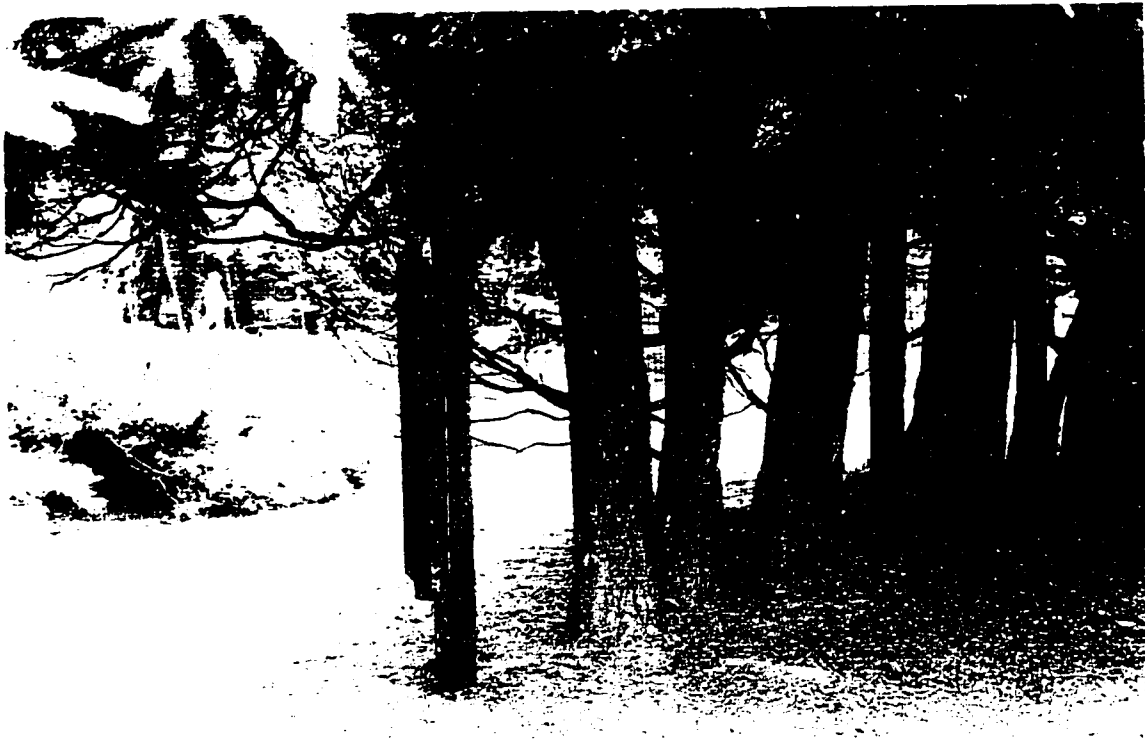
Figure 4.117: Deer fence located within the hemlock hedge. 1997.
(photograph by author).

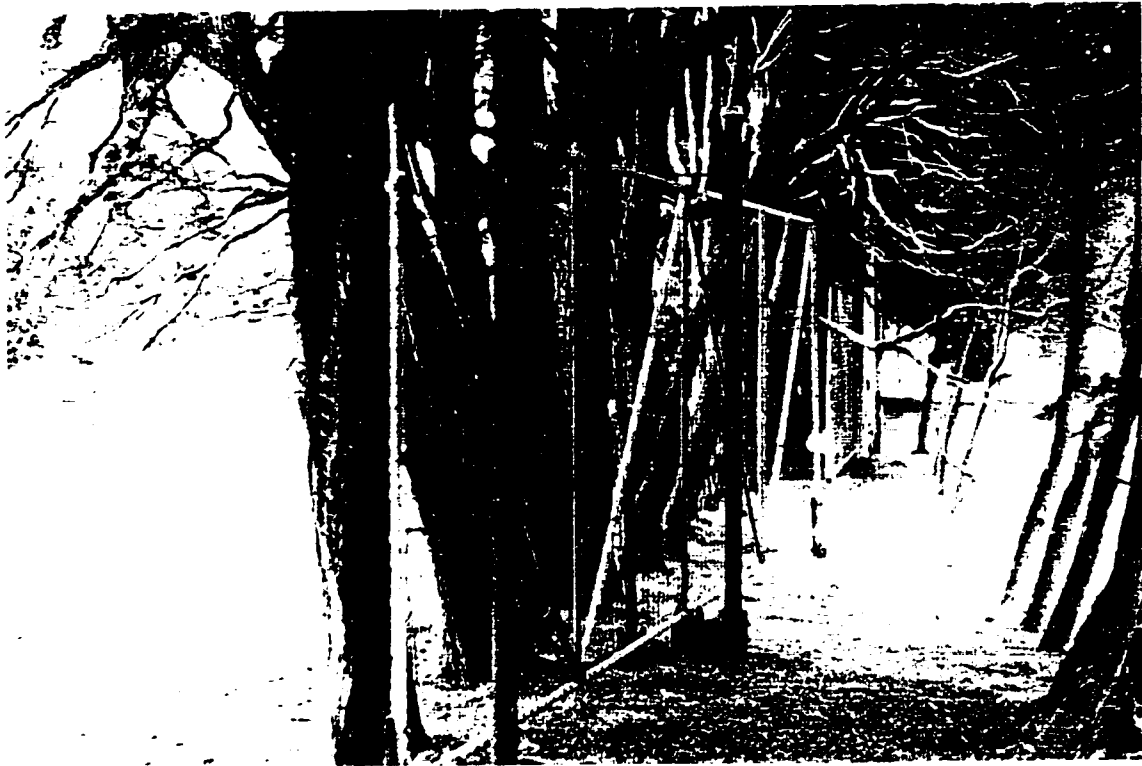
Figure 4.118: Deer fence gates at south the entrance to the rose garden, 1997.
(photograph by author).

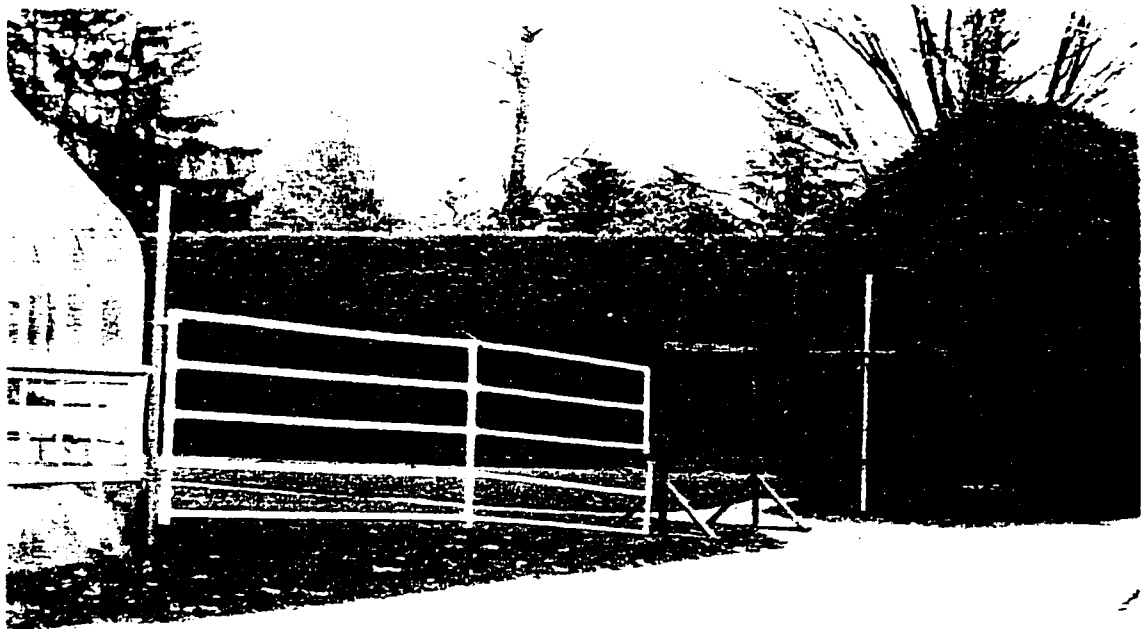
Figure 4.119: Deer fence gates at the west entrance to the rose garden, 1997.
(photograph by author).

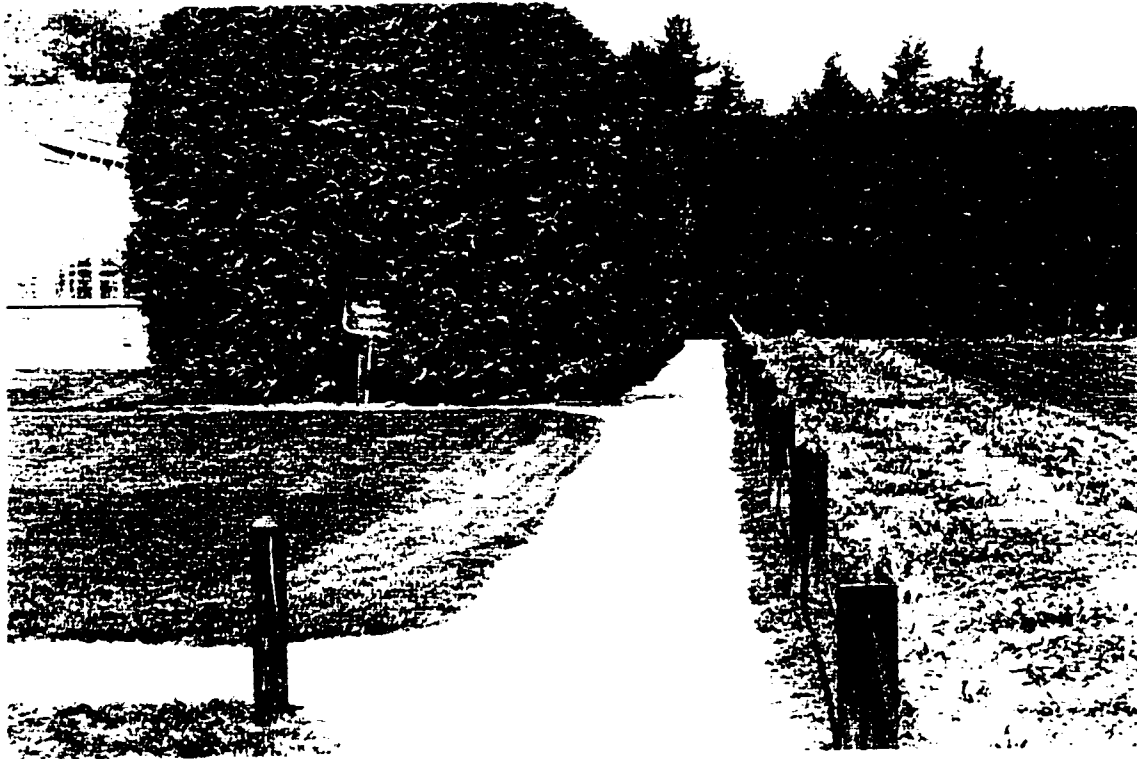
An information sign was installed in 1997 within the portion of the hedge east of the greenhouse (figure 4.120). The metal sign was 1 1/2 feet high, 1 foot 2 inches wide, and attached to a 4-foot-high square wood post anchored into the ground. The sign was brown with white letters.

Figure 4.120: Information sign within the hemlock hedge, garden walkways, and fence, 1997. (photograph by author).

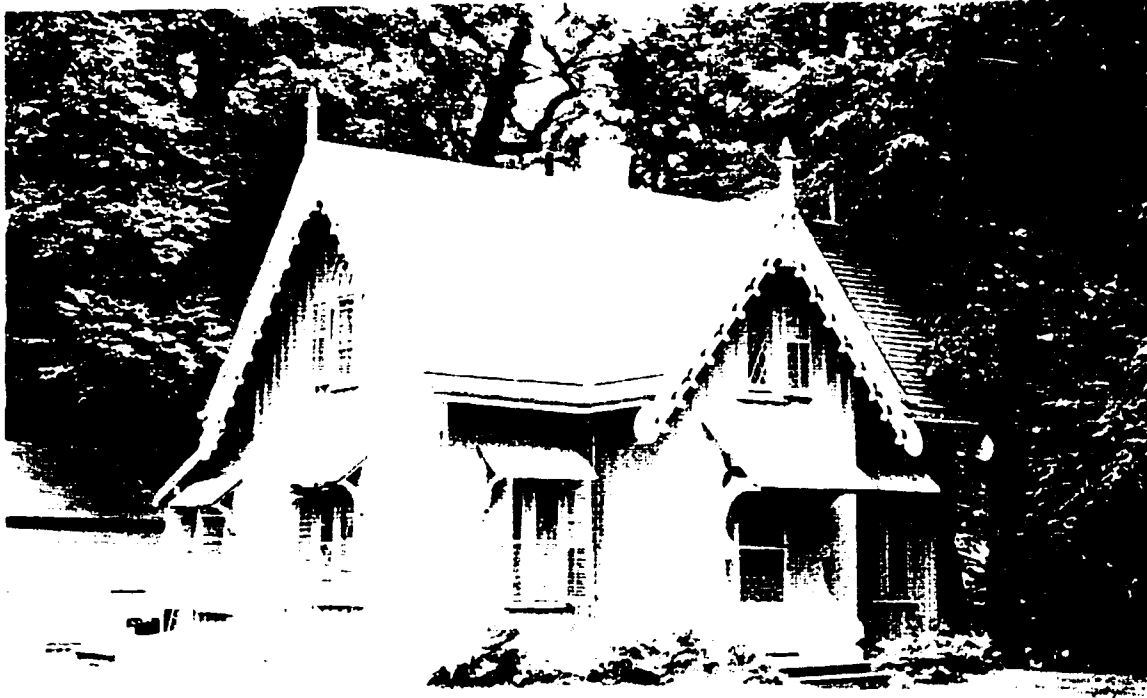
The gardener's cottage (HS 15) was routinely maintained throughout the NPS Ownership Period. This work included repainting, chimney repair and replacement, and window repair and replacement.⁵⁶

The existing condition of the gardener's cottage is unchanged from the historic period and it is currently used as offices for the National Park Service Public Safety staff (figure 4.122).

Figure 4.122: Gardener's cottage, north and east elevations, 1997. (photograph by author).

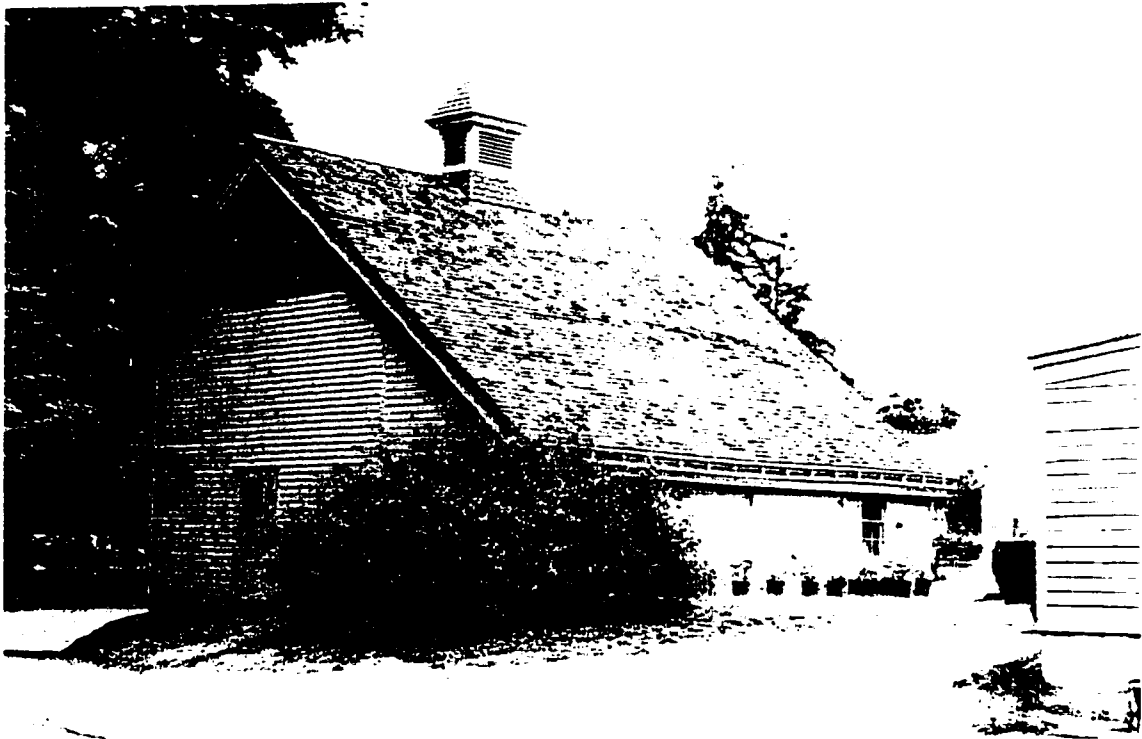
The large ice house (HS 09) was enlarged in 1950. The pump house addition was located near the northwest corner of the north elevation. The addition was square, 9 feet (N/S) by 9 feet (E/W), and one story high. The addition was sided with clapboard, color unknown. It had a north sloping shed roof, materials and color unknown. A door was located on the east elevation. The wood shingled roof of the large ice house was replaced in 1950 with asphalt shingles, color unknown.⁵⁷ The large ice house was restored between 1968 and 1970, including replacing the asphalt shingles with wood, color unknown, and repairing to the siding and cornices.⁵⁸ The pump house addition was removed in 1978.⁵⁹

The existing condition of the large ice house is as described above and is used for storage (figure 4.123).

Figure 4.123: Large ice house, south and west elevations, 1997. (photograph by author).

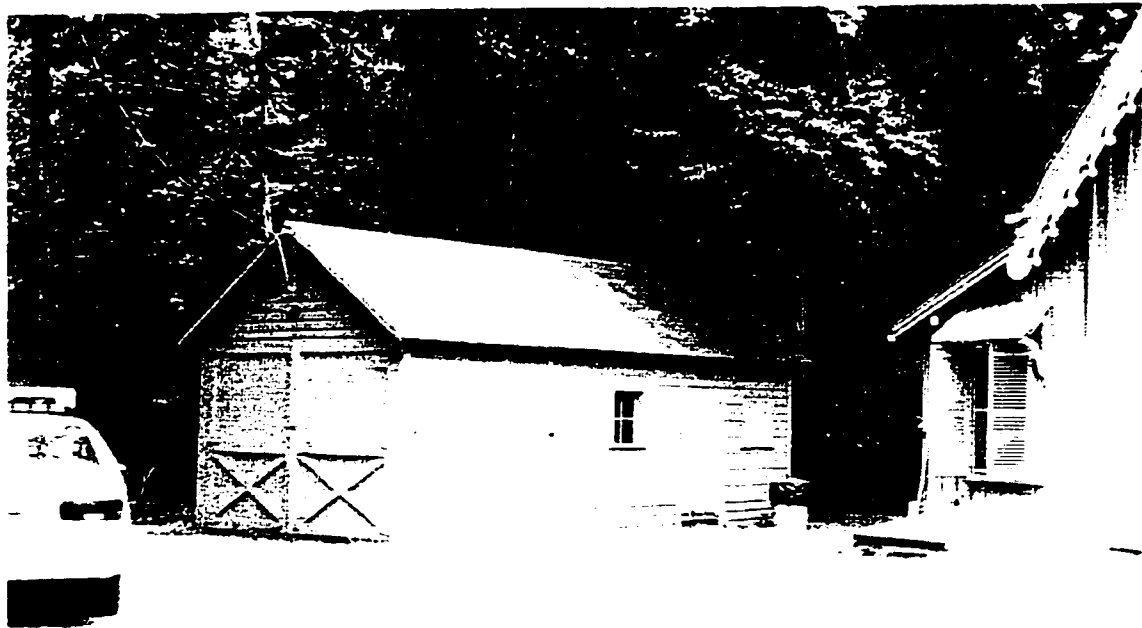
The gardener's garage (HS 16) was routinely maintained throughout the NPS Ownership Period. This work included repainting and replacing the roof. The gardener's garage was structurally stabilized and rehabilitated in 1993.⁶⁰ The building was gray and its roof had gray asphalt shingles.

The existing condition of the garage is as described above and is used for storage (figure 4.124).

Figure 4.124: Gardener's garage, north and east elevations, 1997. (photograph by author).

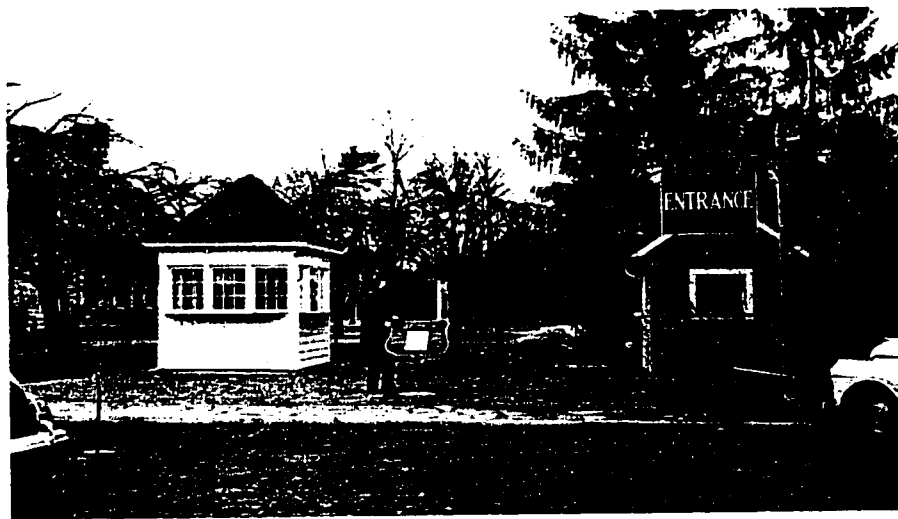
A ticket booth was constructed in 1948 and located 80 feet west of the library (figure 4.125 and figure 4.126). The building was rectangular, 10 feet long (N/S) by 8 feet wide (E/W), and sided with clapboard painted a light color, exact color unknown.⁶¹ The asphalt shingled, front-gabled roof was light in color, exact color unknown. A door was located near the southwest corner of the west elevation. In 1951 the ticket booth was enlarged with an addition 20 feet long (N/S) by 10 feet wide (E/W) on its west elevation which gave the ticket booth 20 foot by 20 foot in size overall (figure 4.127 and see Appendix P).⁶² It was sided with clapboard and the entire roof was reconstructed with a black asphalt, front-gabled roof. A door was located in the center of the south elevation. Between 1965 and 1994, exact date unknown, the color of the ticket booth was changed from the light color to red.

Figure 4.125: Ticket booth (right hand side) and card stand (left), north elevations, c. 1948. (The Home of Franklin D. Roosevelt NHS, neg. series 430-432).

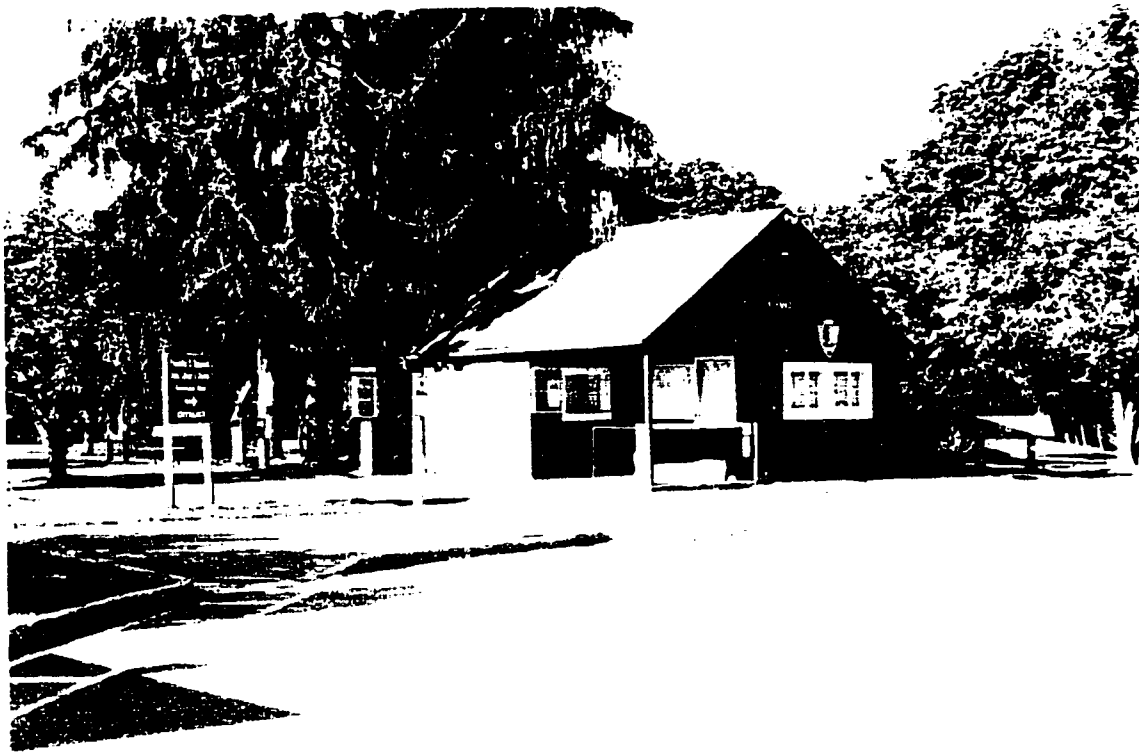
The existing condition of the ticket booth is as described above, and it is used for ticket sales for tours of both Springwood and the library (figure 4.128).

Figure 4.128: Ticket booth, north and east elevations, phone booth, trash receptacle, and information sign, 1997. (photograph by author).

A phone booth was installed during the NPS Ownership Period, exact date unknown. It was located at the southeast corner of the ticket booth (see figure 4.128). It was 4 feet tall and stood on a square metal post.

Two types of trash receptacles were installed during this period, exact date unknown. One type of receptacle was located 15 feet south of the ticket booth (see figure 4.128). It was square, 2 feet by 2 feet, approximately 3 1/2 feet high, and black and brown in color. It was constructed of metal and hard plastic. Two of the other receptacles were located in the grassy area that separated the 1948 and mid-1980s parking lots. They were round, 2 feet in diameter, 3 feet high, and constructed of gray metal.

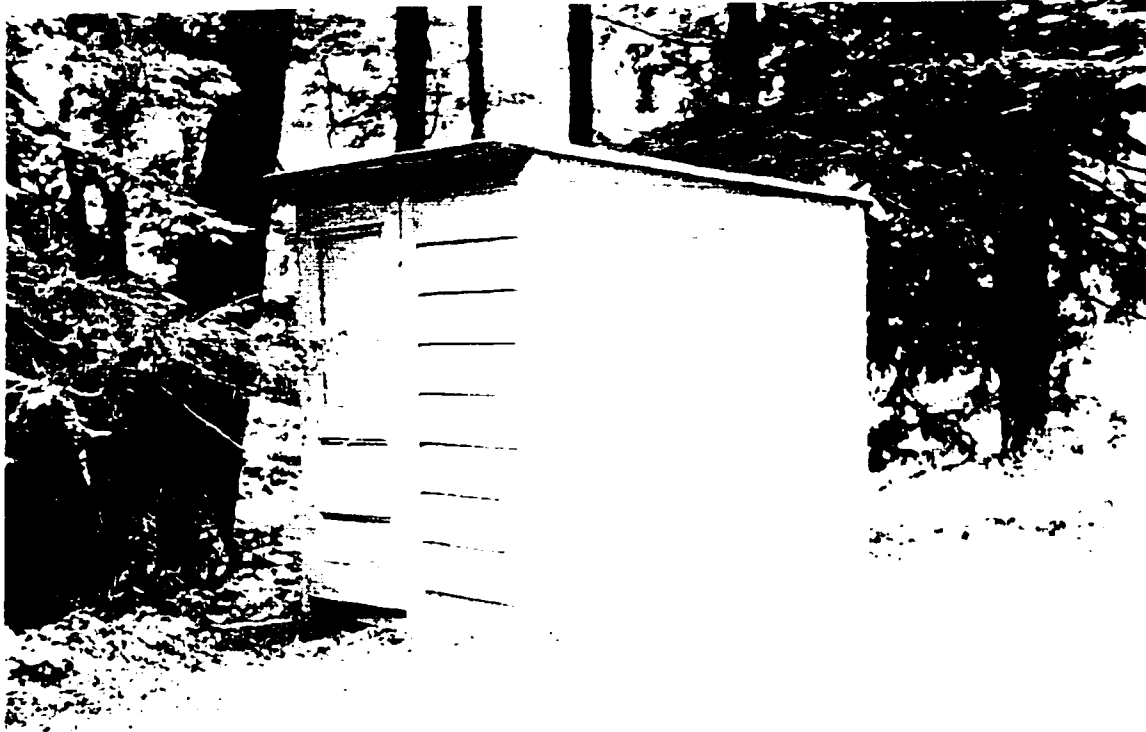
The fire hose structure, in 1948, was located west of the visitors parking area (figure 4.130). The fire hose structure was relocated 60 feet north of the gardener's cottage, exact date unknown. During its relocation the structure was reoriented so its door was on the south elevation (figure 4.131). It was painted gray and its roof covered with gray asphalt shingles.

Figure 4.131: Fire hose structure, south and east elevations, 1997. (photograph by author).

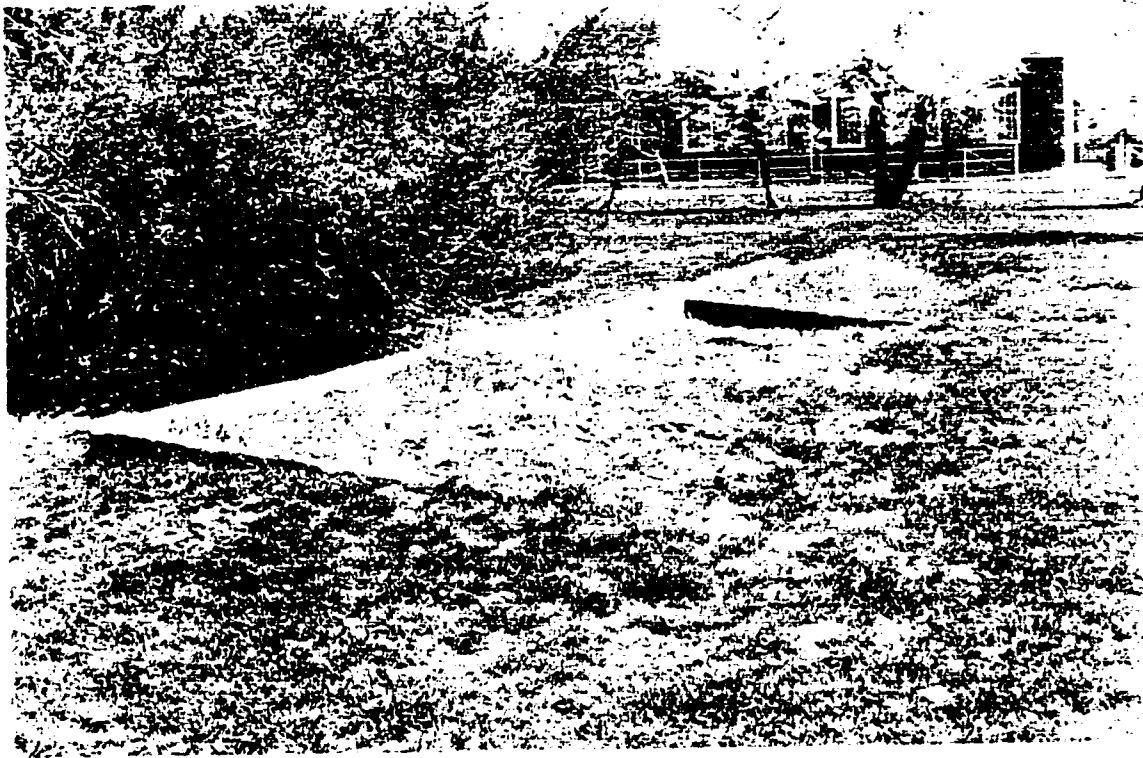
The hot bed (HS 26), constructed in the Late Roosevelt Ownership Period, is currently used in the summer by National Park Service employees as a holding place for greenhouse plants (figure 4.132).

Figure 4.132: Hot bed located in the small vegetable garden. 1997.
(photograph by author).
