CULTURAL LANDSCAPE REPORT FOR
THE HOME OF FRANKLIN D. ROOSEVELT
NATIONAL HISTORIC SITE

Kristin Theresa Baker

Master of Science in Landscape Architecture Degree

May 1999

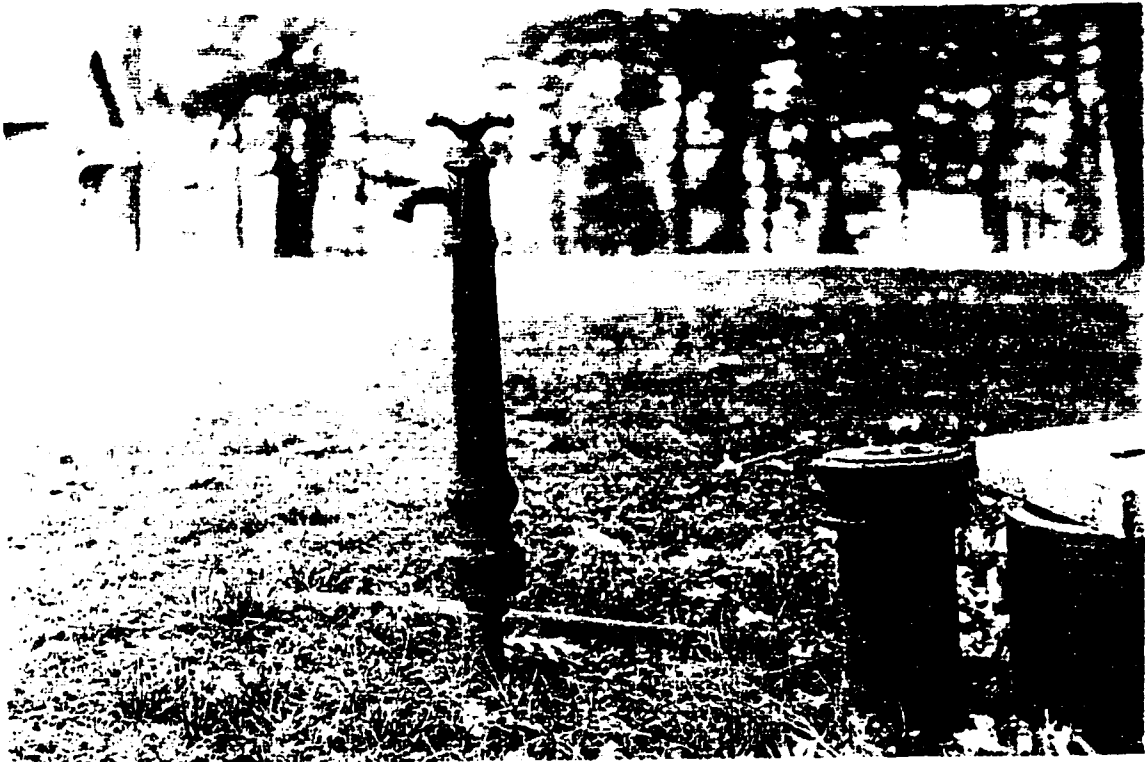
The water faucet, installed in the Late Roosevelt Ownership Period, is located 130 feet north of the large ice house (figure 4.133). The faucet is painted green.

Figure 4.133: Water faucet located in the small vegetable garden, 1997. (photograph by author).

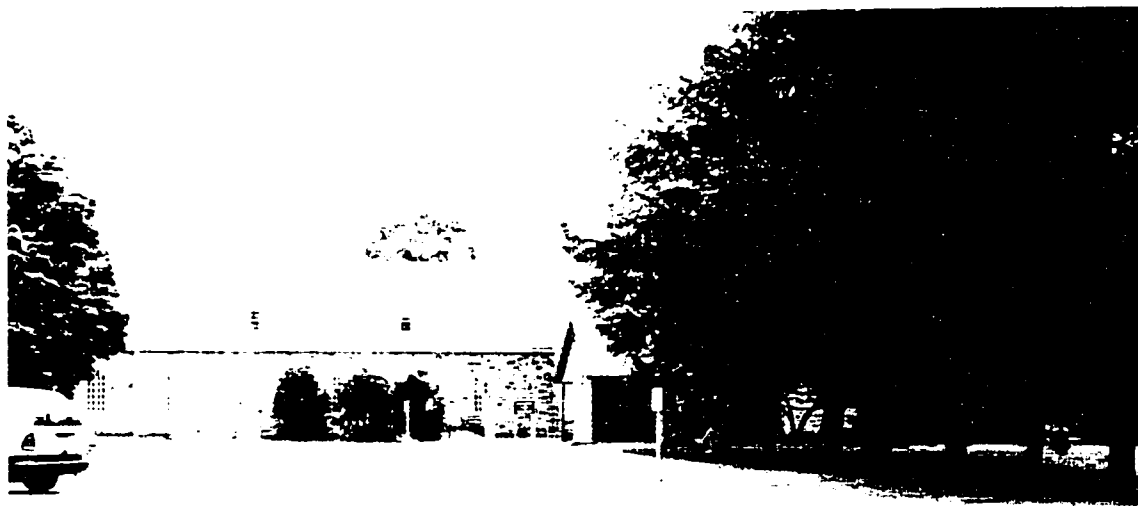
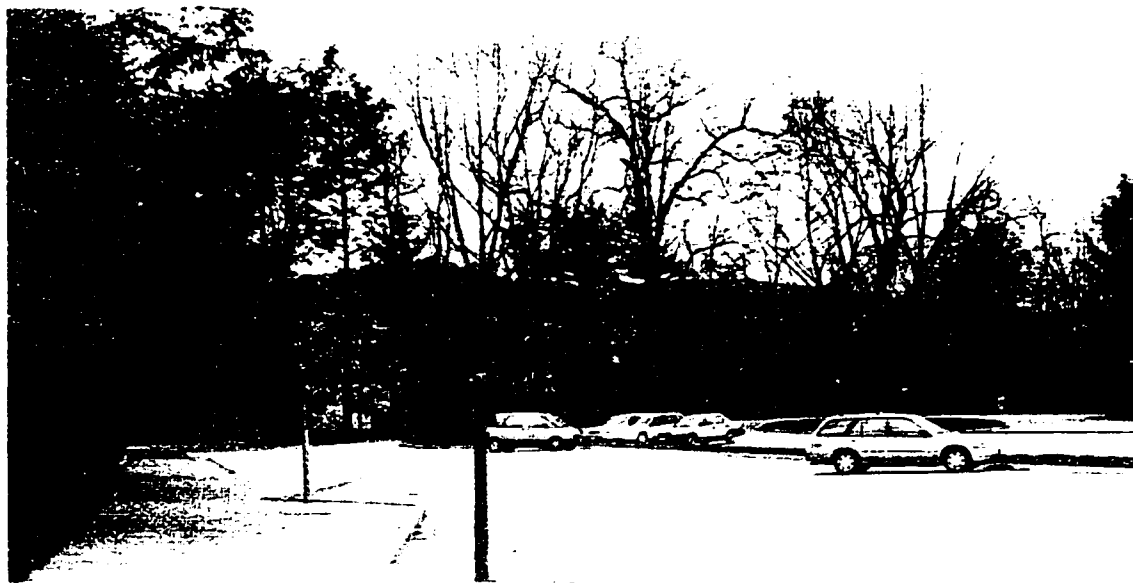
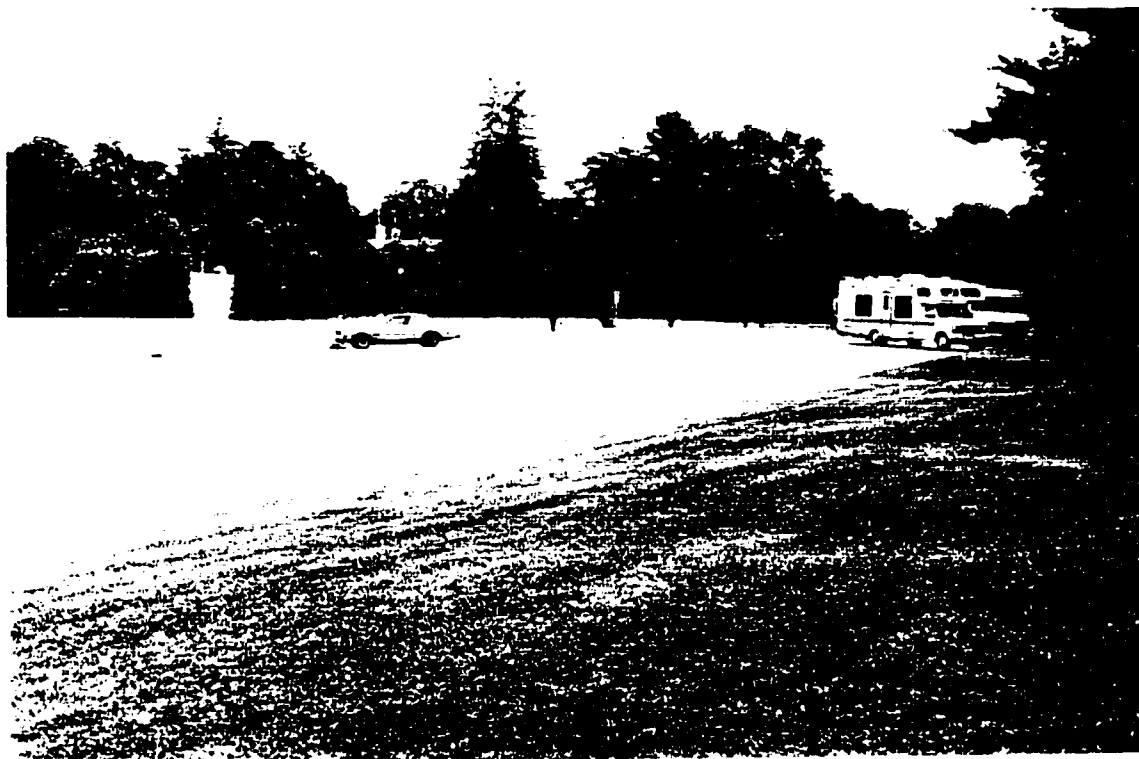
The existing condition of the parking lot is approximately 400 feet long (E/W) by 240 feet wide (N/S). It contains approximately 161 parking spaces and 17 spaces for buses or large recreational vehicles (figure 4.144, 4.145, and 4.146 and see Existing Conditions plan). It has an asphalt surface and concrete curbing.

Figure 4.144: Visitors parking area, view looking east, 1997. (photograph by author).

Figure 4.145: Visitors parking area, view looking west, 1997. (photograph by author).

Figure 4.146: Visitors parking area, view looking north, 1997. (photograph by author).

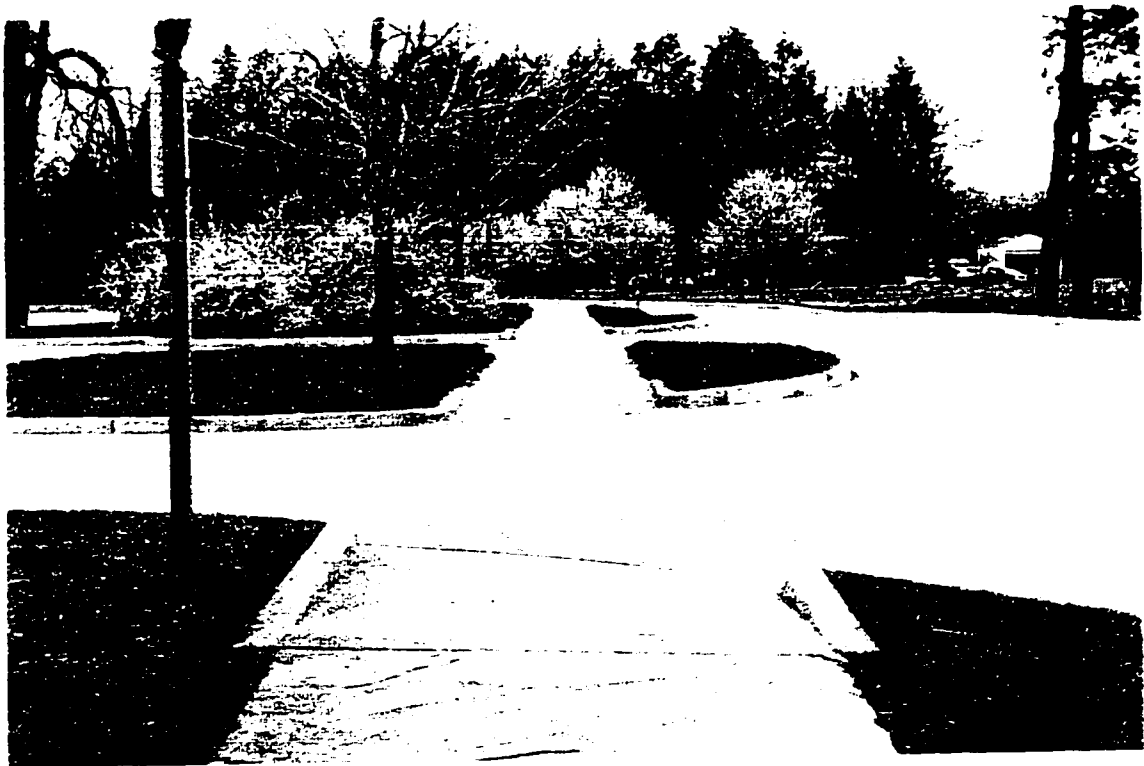
A flagstone walkway was constructed in 1948. It was located north of the ticket booth and extended northward through the grassy islands in the visitors parking area. The walkway was 6 feet wide and constructed of brown-colored flagstone.

The existing condition of the flagstone walkway is as described above (figure 4.147).

Figure 4.147: Flagstone walkway in visitor parking area, 1997. (photograph by author).

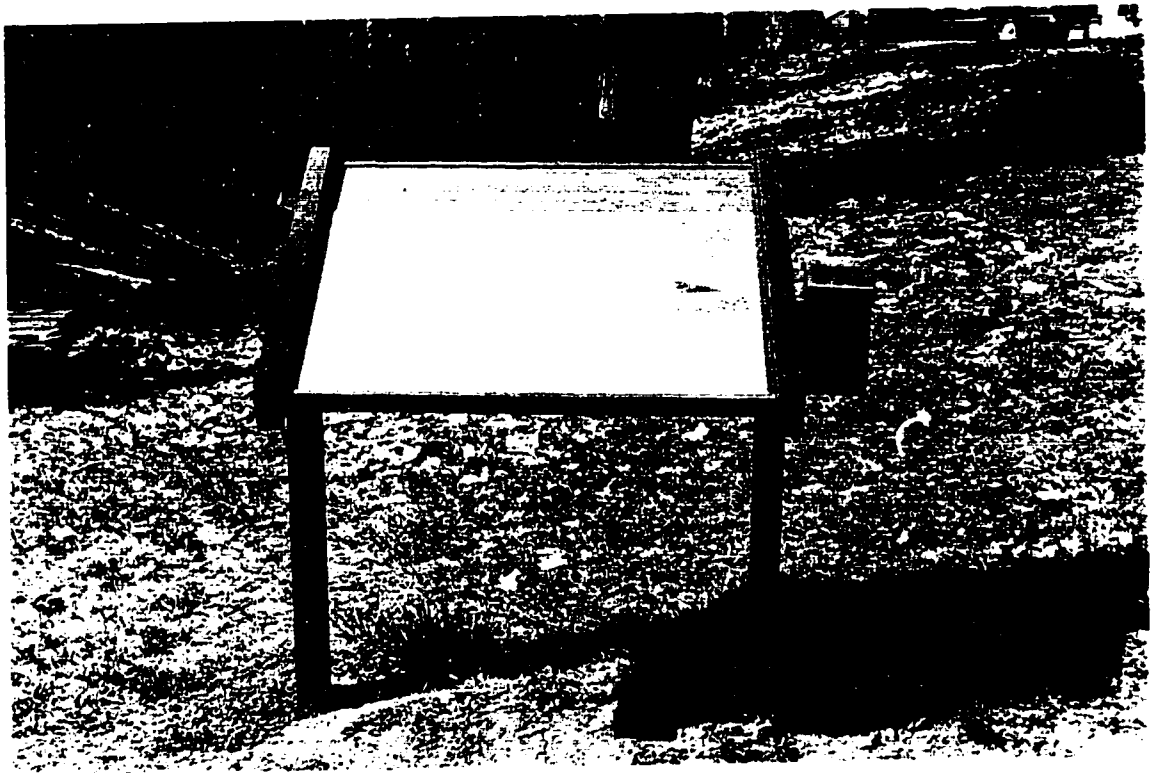
An information sign of the Roosevelt Woods Trail was located at the start of the river road (figure 4.150). The entire sign was 3 feet high and 3 feet long. The map of the Roosevelt Woods Trail was 3 feet long and 2 1/2 feet wide and set within a metal frame. The sign sat on two metal rectangular posts. A metal box, containing maps of the trail, was attached to the sign's northern side.

Figure 4.150: Information sign for the Roosevelt Woods Trail, 1997.
(photograph by author).

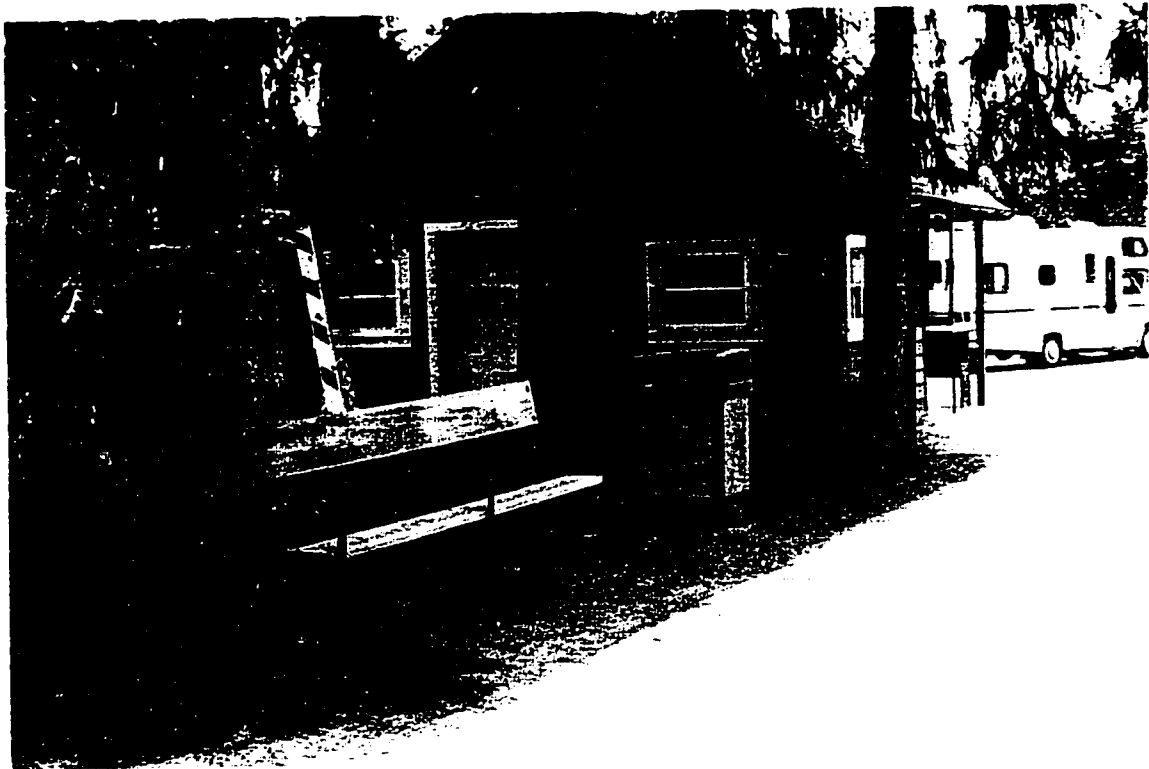
Two benches were installed during this period, exact date unknown. One bench was located at the southeast corner of the ticket booth, and the other 20 feet west of the ticket booth (figure 4.151). The benches were 5 feet long and constructed of metal legs and wooden seats and backrests. The metal portions of the benches were painted black, and the wooden seats and backrests were unpainted.

Figure 4.151: Bench and trash receptacle located south of the ticket booth, 1997. (photograph by author).

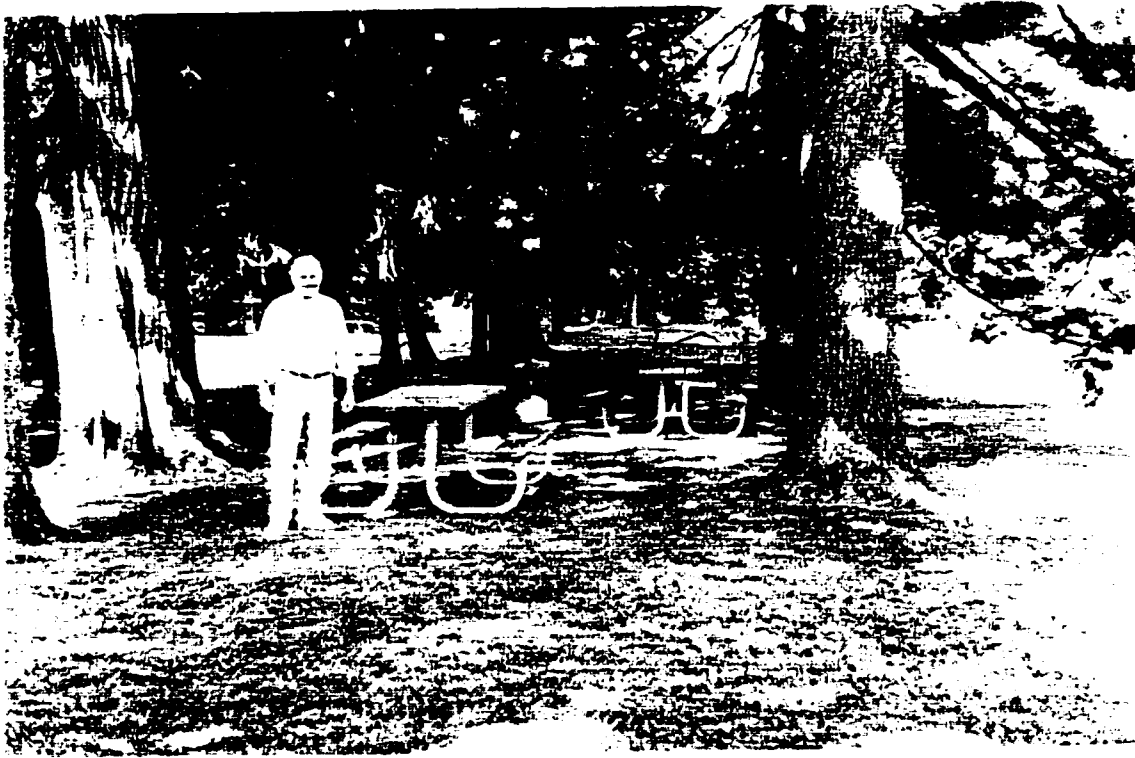
Picnic tables were installed during this period, exact date unknown. They were located in the grassy area that separated the 1948 and mid-1980s parking lots (figure 4.152). These tables were 6 feet long by 4 feet wide, the seats were 1 1/2 feet high, and the top of the table was 3 feet high. They were constructed of unpainted wood and gray metal.

Figure 4.152: Picnic tables located in grassy area between parking lots, 1997. (photograph by author).

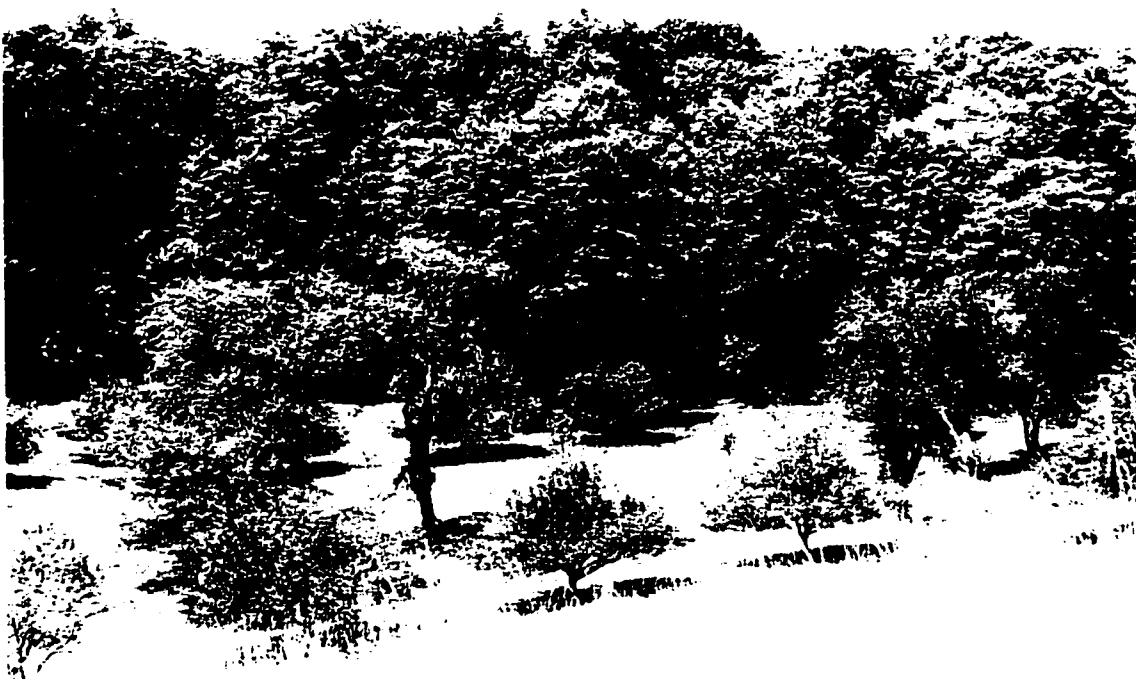
Currently, many of the trees are in decline, and the area became overrun with poison ivy (figure 4.154 and figure 4.155).

Figure 4.154: Lower orchard, view looking southwest, 1997. (photograph by author).

Figure 4.155: Lower orchard, view looking northwest, 1997. (photograph by author).

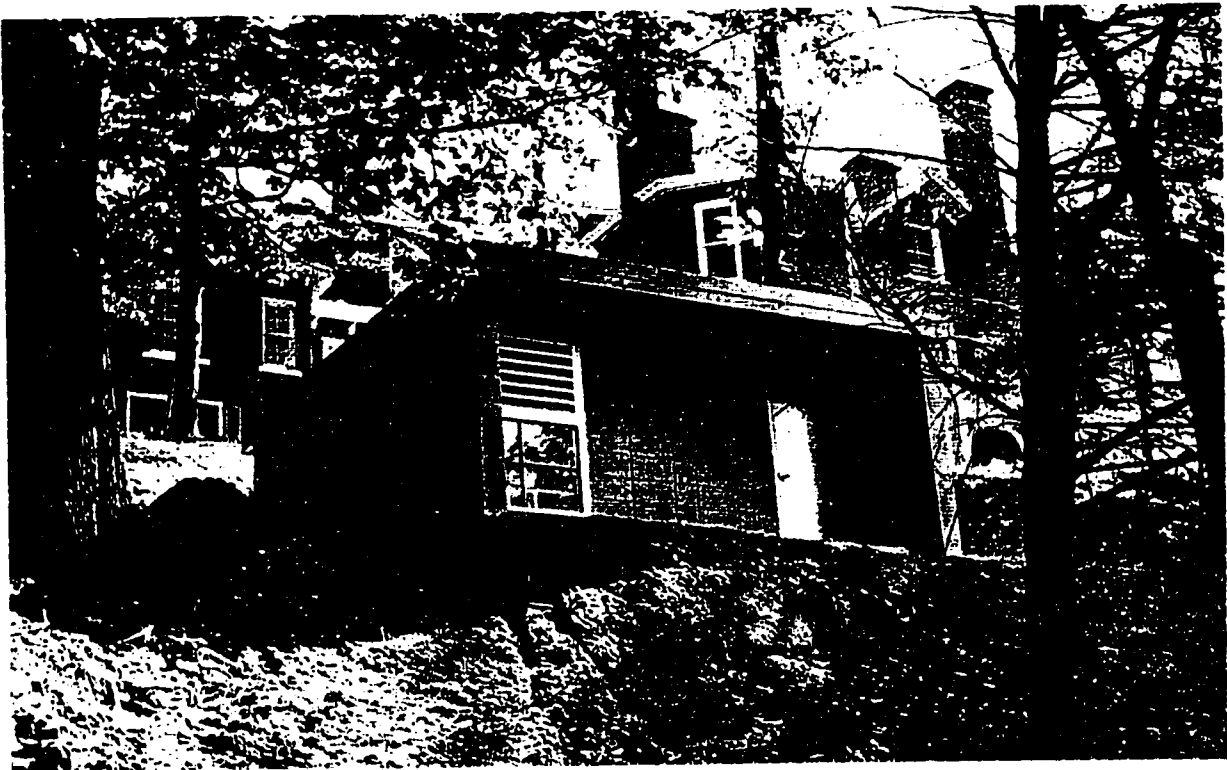
A furnace house was constructed in 1958 located 80 feet west of Springwood, on the ridge slope (figure 4.157). It was almost square in shape, 14 feet 8 inches (N/S) by 16 feet 8 inches (E/W). The east side of the structure was built into the slope and extended westward over the slope on concrete supports. The structure was rectangular, 16 feet 8 inches long (N/S) by 14 feet 8 inches wide (N/S) and 7 feet high. The furnace house was constructed of concrete block and painted gray. It had a flat roof with tar and gray gravel. A door was located near the northwest corner of the west elevation. A stairway was located from the top of the ridge to the north side of the structure. It was approximately 40 feet long and 4 feet wide. The stairs were constructed of concrete with metal tubing handrails. The furnace house was enlarged, date unknown. The addition was located on its west elevation and was rectangular, 14 feet 8 inches long (N/S) and 4 feet wide (E/W), and 7 feet high. The addition was constructed of wood and painted gray. It had a flat roof with tar and gray gravel. The door was located near the northwest corner of the north elevation.

Figure 4.157: Masonry furnace house, view looking east, 1958. (The Home of Franklin D. Roosevelt NHS).

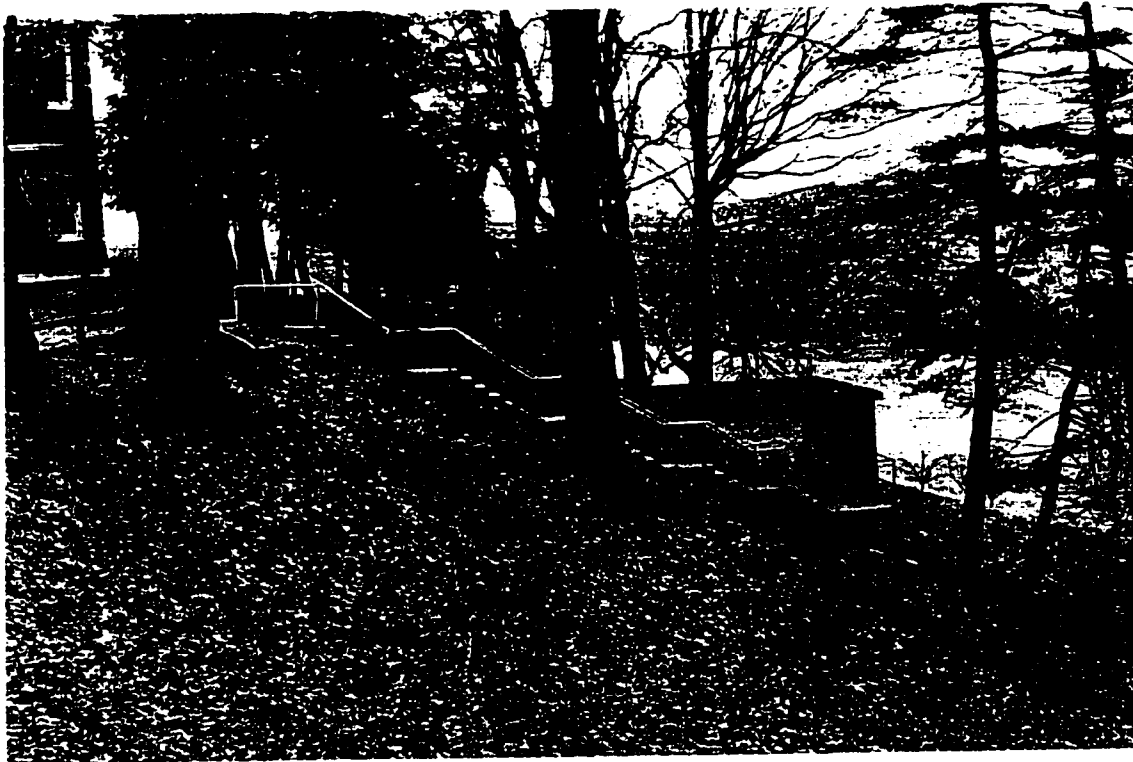
The existing condition of the furnace house is as described above (figure 4.158).

Figure 4.158: Masonry furnace house, north elevation, 1998. (photograph by author).

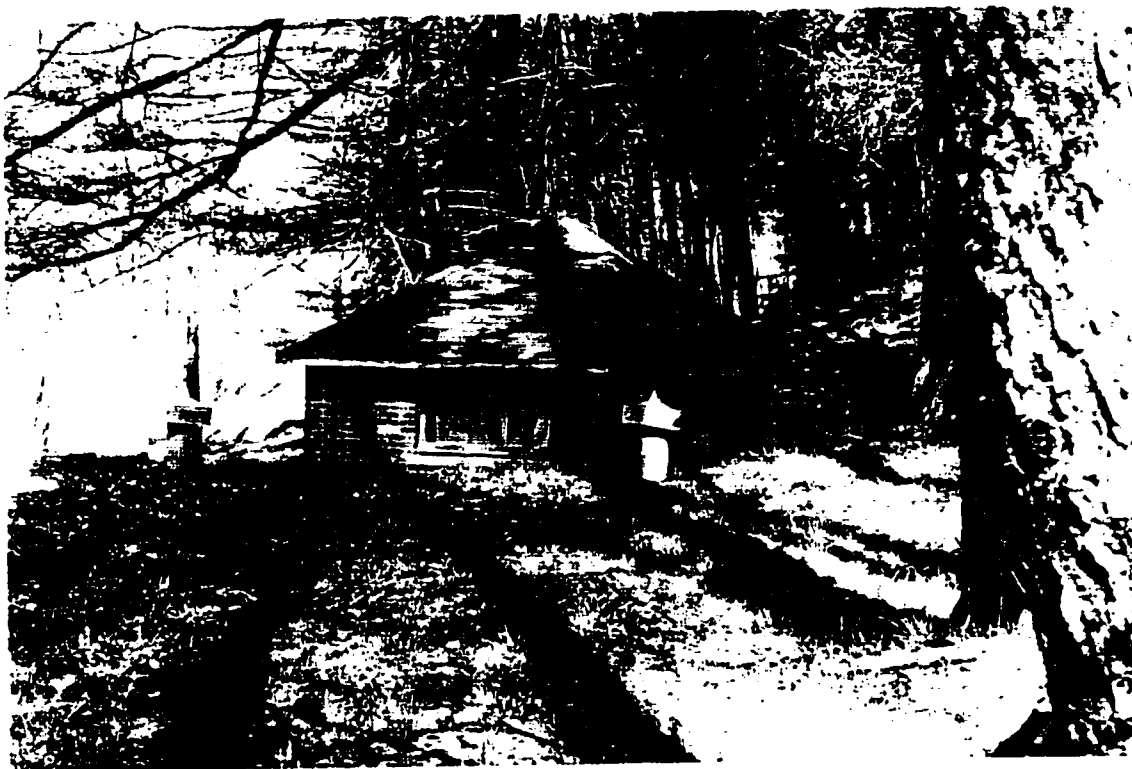
The existing condition of the pump house is as described above (figure 4.159).

Figure 4.159: Pump house, south elevation, 1998. (photograph by author).

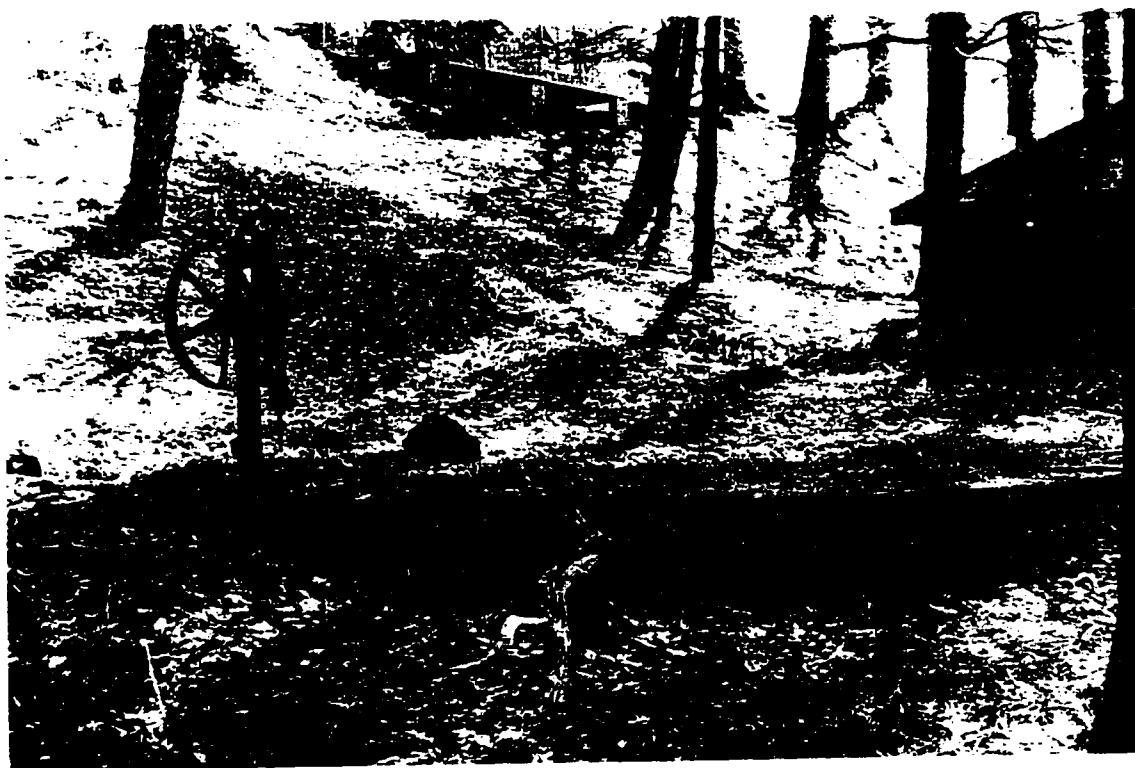
Currently the old reservoir, extant for the Late Roosevelt Period, exists in its historic location north of the pump house (figure 4.160).

Figure 4.160: Old reservoir, 1998. (photograph by author).

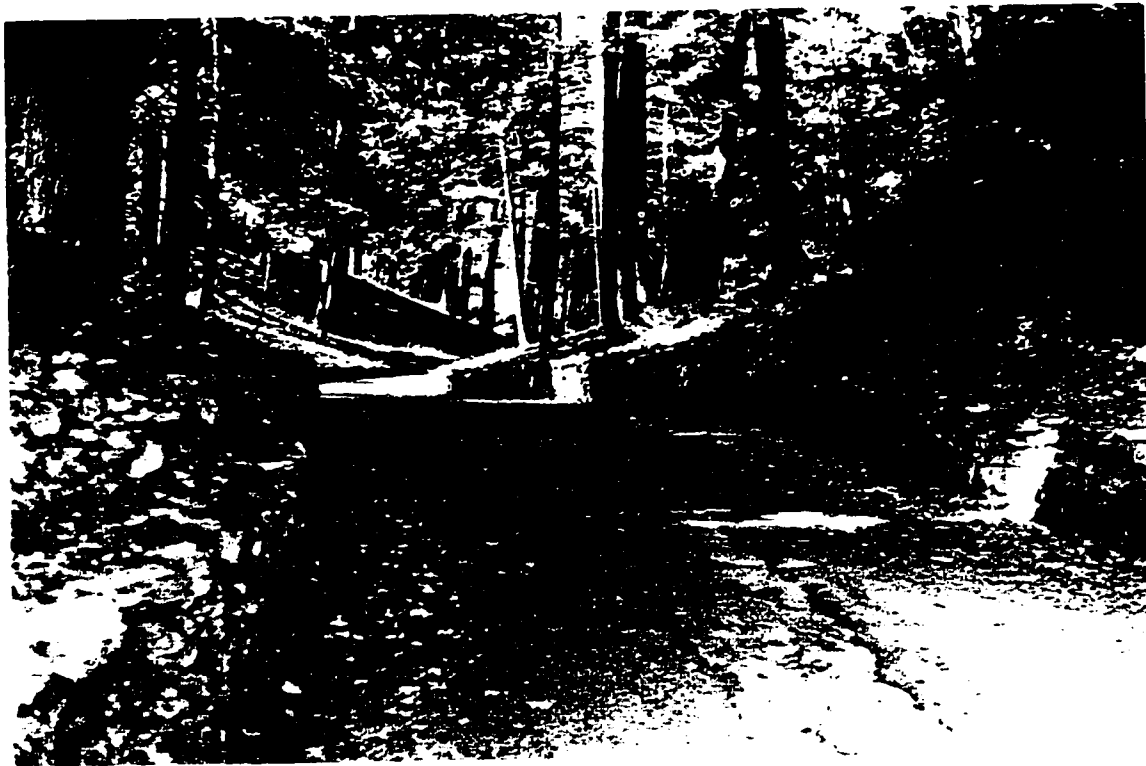
The existing conditions of the river road are as described above (figure 4.161).

Figure 4.161: River road, view looking west, 1997. (photograph by author).

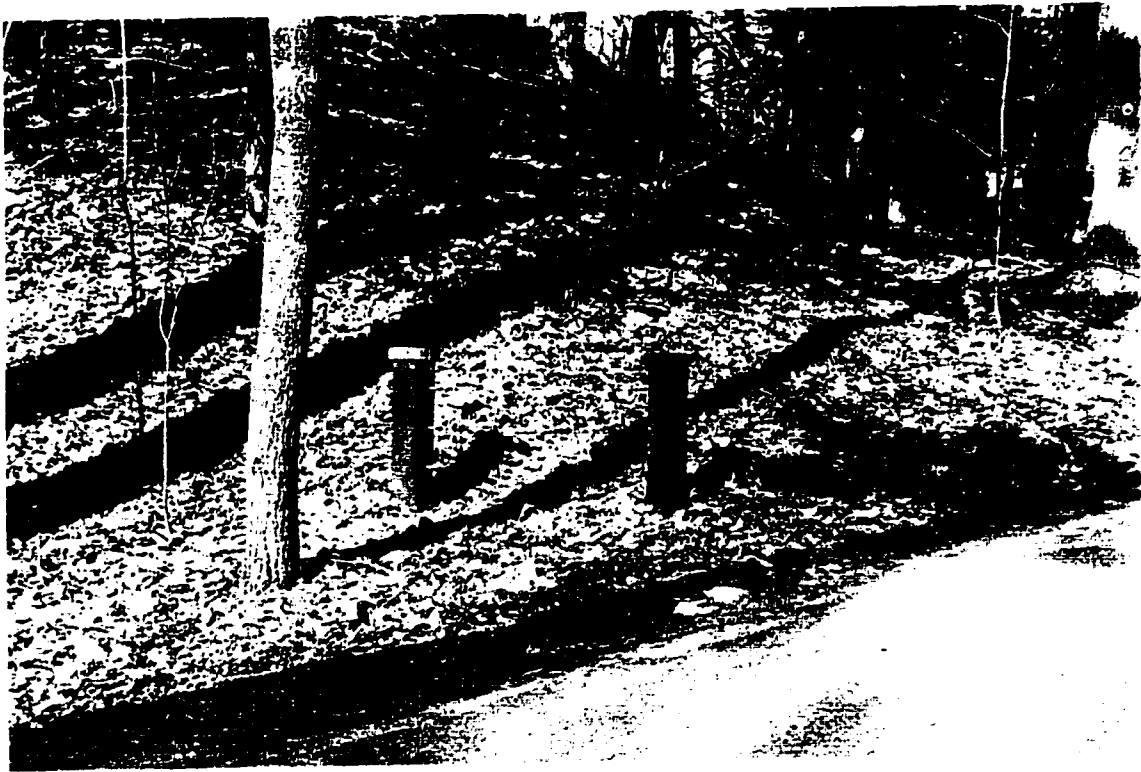
The posts from the crash barriers currently remain on either side of the river road just east of where it splits for the duplex (figure 4.162). The posts are rusted.

Figure 4.162: Posts from the crash barrier, river road, 1998. (photograph by author).

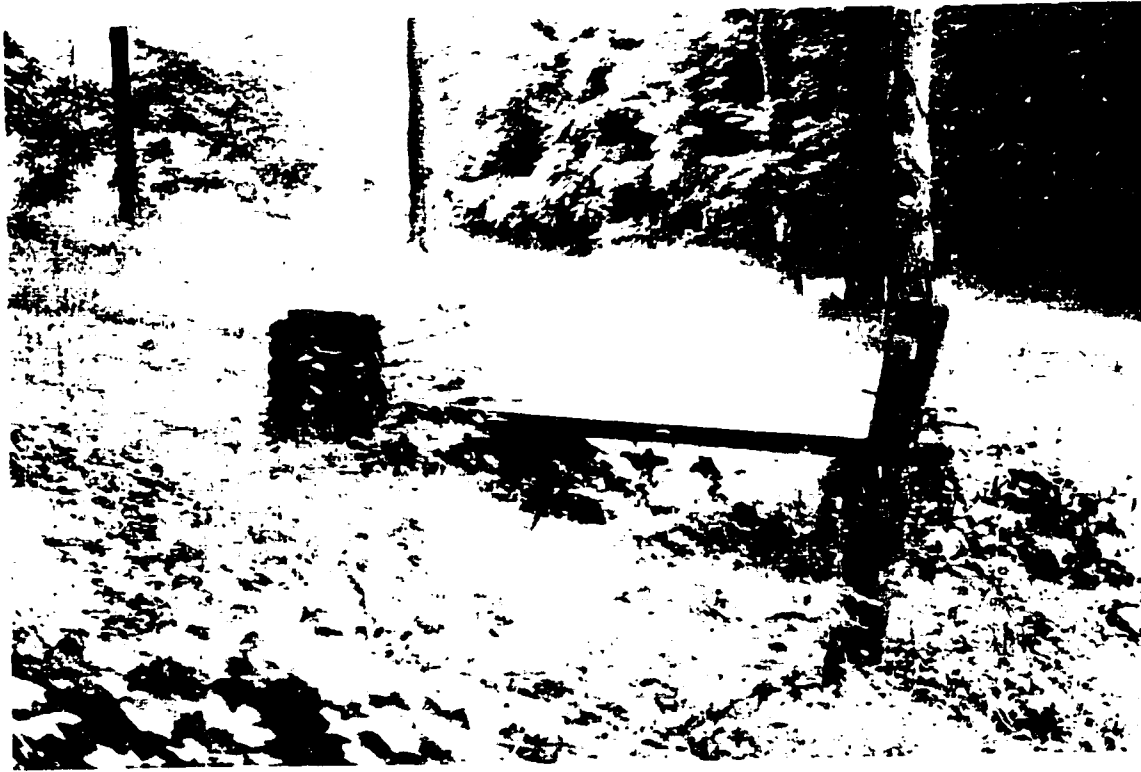
An interpretive audio station was constructed between 1966 and the early 1970s to provide visitors with a self-guided tour (see Appendix R). It was one of two on the property and was located on the east bank of the pond. The audio station was rectangular and 11 1/2 feet long. The audio station had two sections, a bench and a stone audio housing unit. The bench was rectangular, 8 feet long by 1 foot 4 inches wide and 1 1/2 feet high. The bench was constructed of eight wood pieces 8 feet long by 2 inches wide. The bench was set on two stone forms that were 1 foot 2 inches square and 1 1/2 feet high. It was constructed of brown-colored stone. The stone audio housing was adjacent to the bench and was 2 feet 2 inches square and 2 feet 9 inches high. The speaker and activating button were located in the center of the unit. The audio portion of the interpretive station including the speaker was dismantled, date unknown.

The existing condition of the interpretive audio station is as described above (figure 4.163).

Figure 4.163: Interpretive audio station, 1997. (photograph by author).

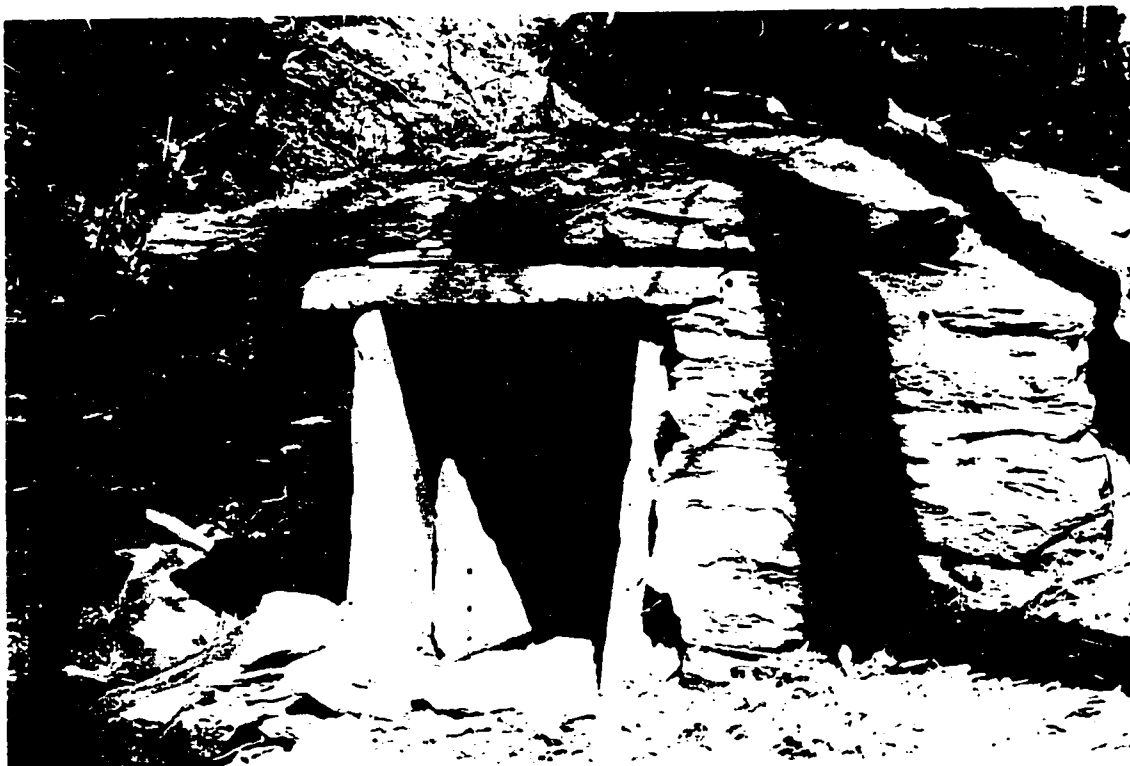
Currently the exterior of the ram house (HS 30) is extremely deteriorated (figure 4.164).⁶⁸

Figure 4.164: Ram house, south elevation, 1998. (photograph by author).

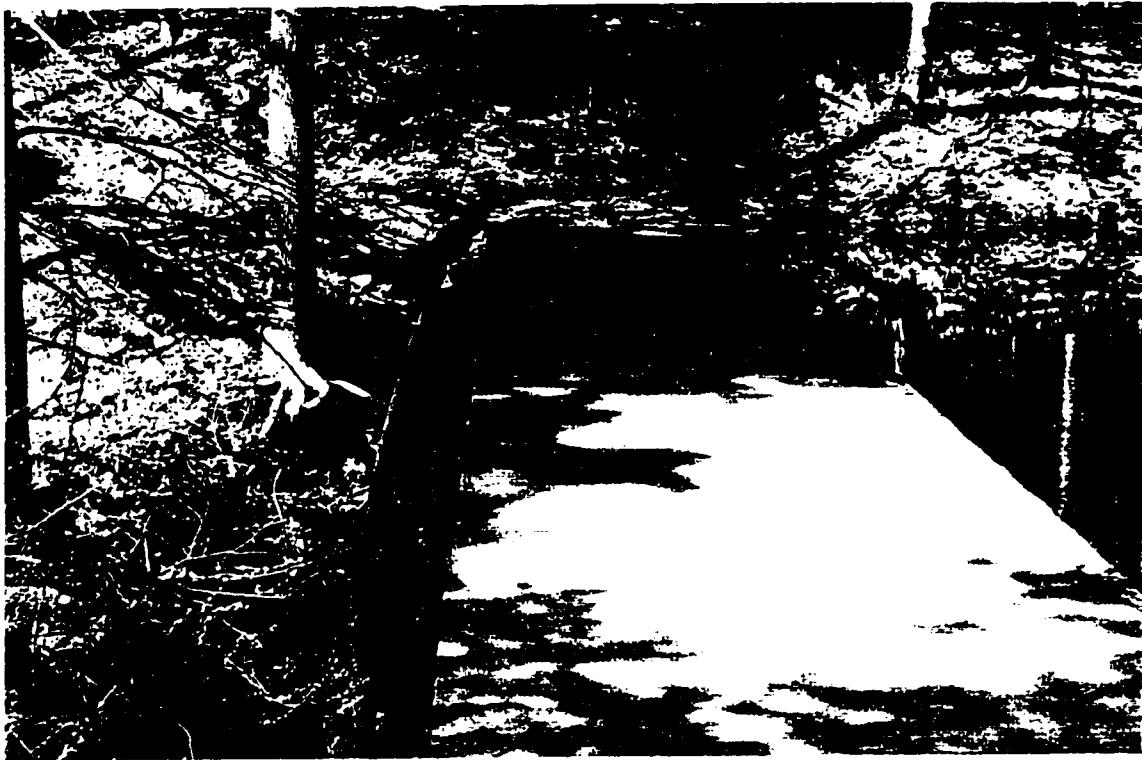
The dam (HS 31) was rehabilitated in 1972 which included installing a new sluice gate and repairing the dam wall.⁶⁹ The dam was repaired again that year after the pond was allowed to fill back up and water flowed around its sides. The repairs included extending the west side of the dam 12 feet and the east side 6 feet. The extensions were constructed of local brown-colored fieldstone. Two inches were removed from the top of the dam and a new concrete top constructed.⁷⁰

The existing condition of the dam is as described above, although the dam is leaking around the eastern support wall and is again in need of repair (figure 4.165 and figure 4.166).

Figure 4.165: Dam, south elevation, 1998. (photograph by author).

Figure 4.166: Top of the dam and sluice gate, 1998. (photograph by author).

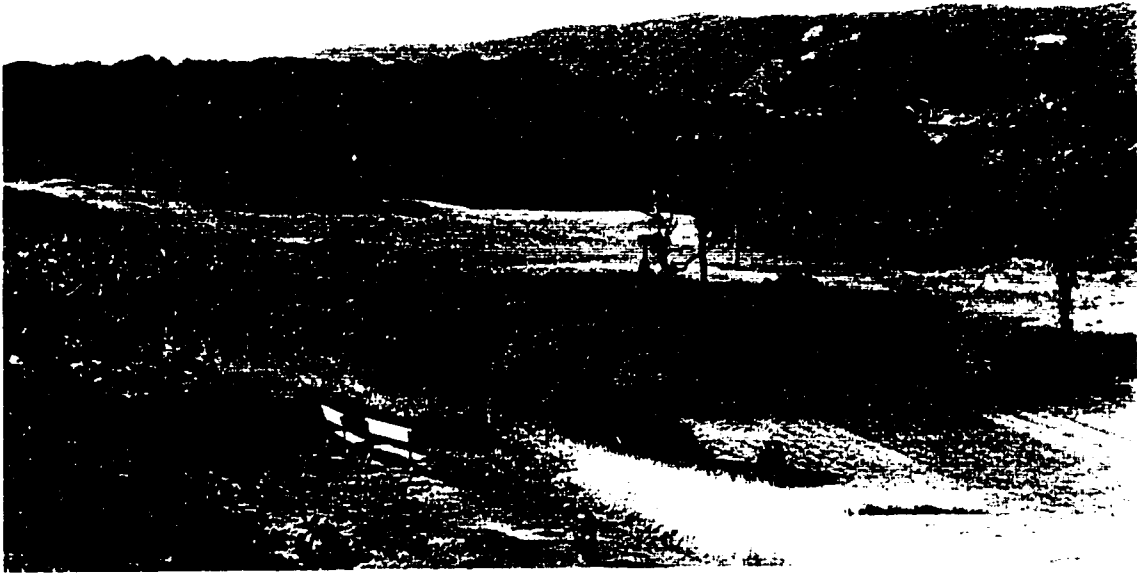
The existing condition of the lower field is as described above (figure 4.169).

Figure 4.169: The lower field, 1998. (photograph by author).

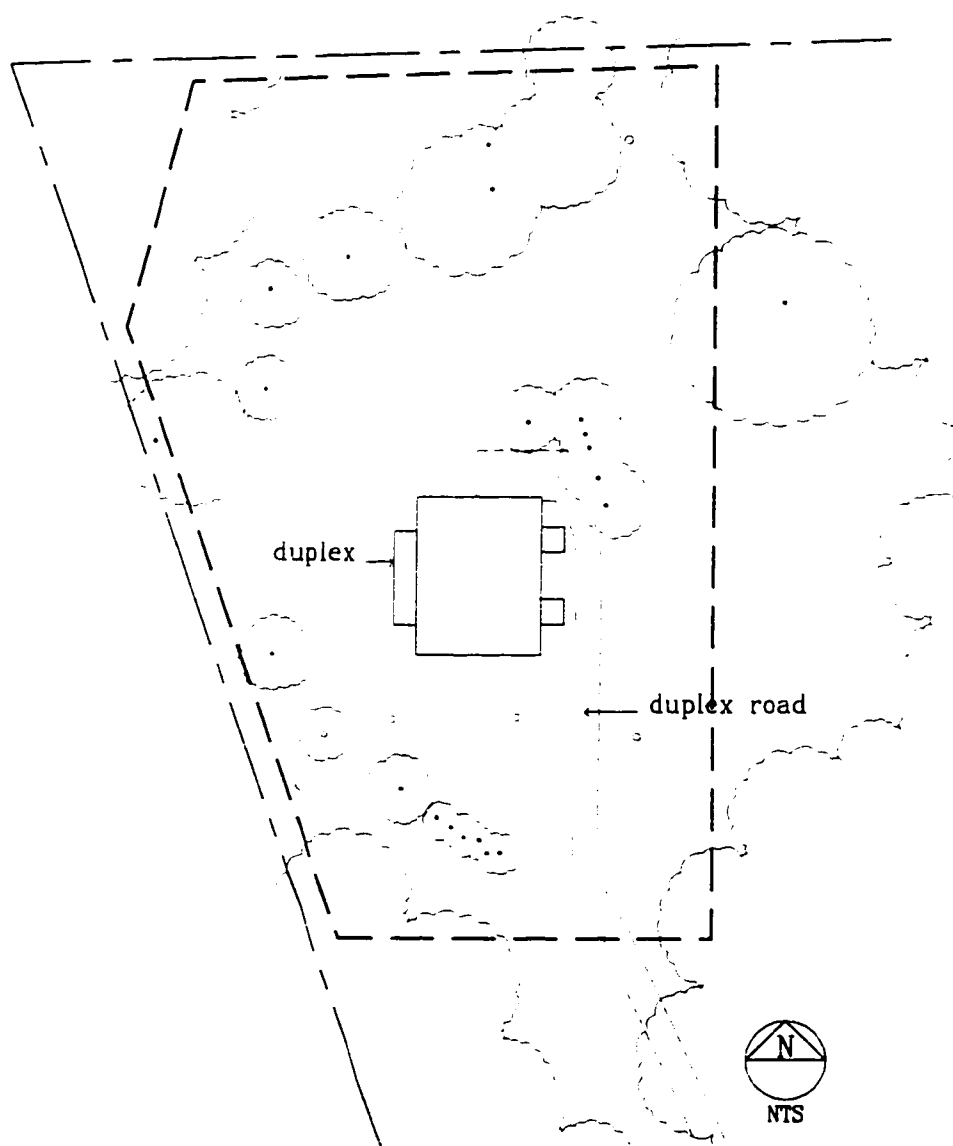
Three of the buildings within the space were removed between 1946 and 1960, eliminating the internal subspaces in the duplex compound subspace (figure 4.170). Despite this, the overall spatial configuration of the duplex compound subspace is unchanged in terms of its shape, size, and defining edges.

Figure 4.170: Spatial organization of the duplex compound subspace. (K. Baker and G. Dallmann, SUNY CESF, 1998, based on the 1994 HPI map).

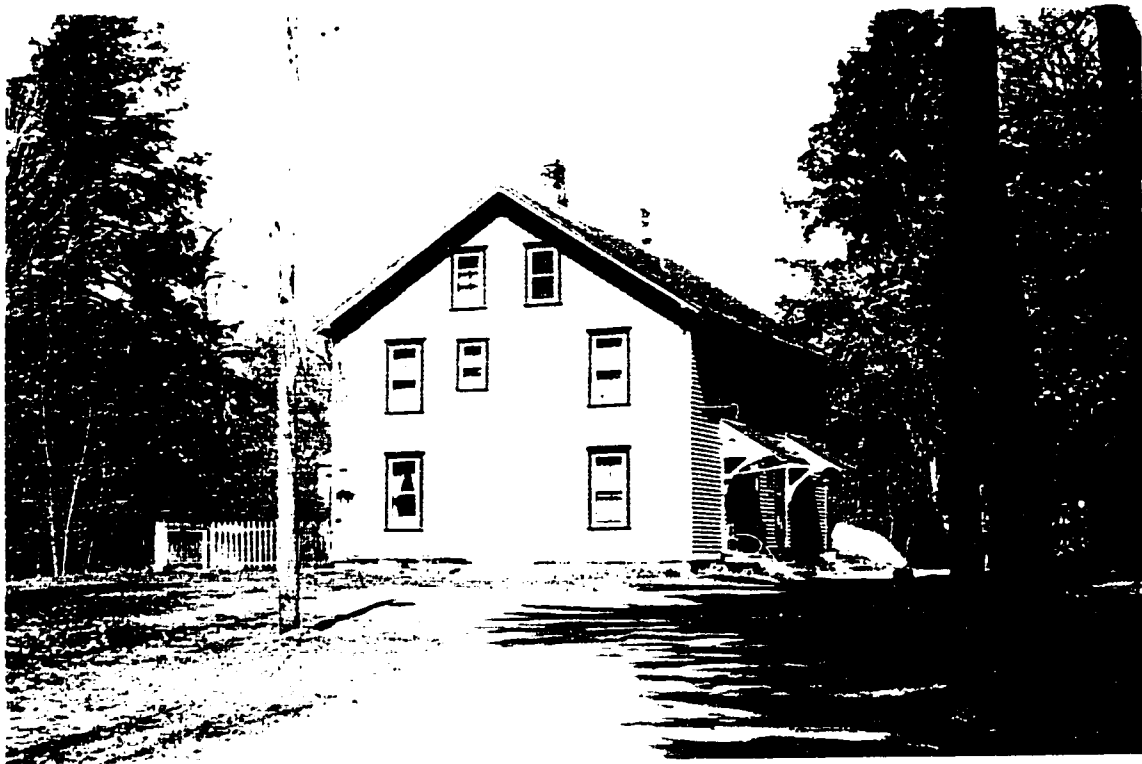
The duplex is currently gray with black trim. Its roof has black asphalt shingles. The duplex is used as a private residence for National Park Service staff (figure 4.171).

Figure 4.171: South elevation of the duplex, 1998. (photograph by author).

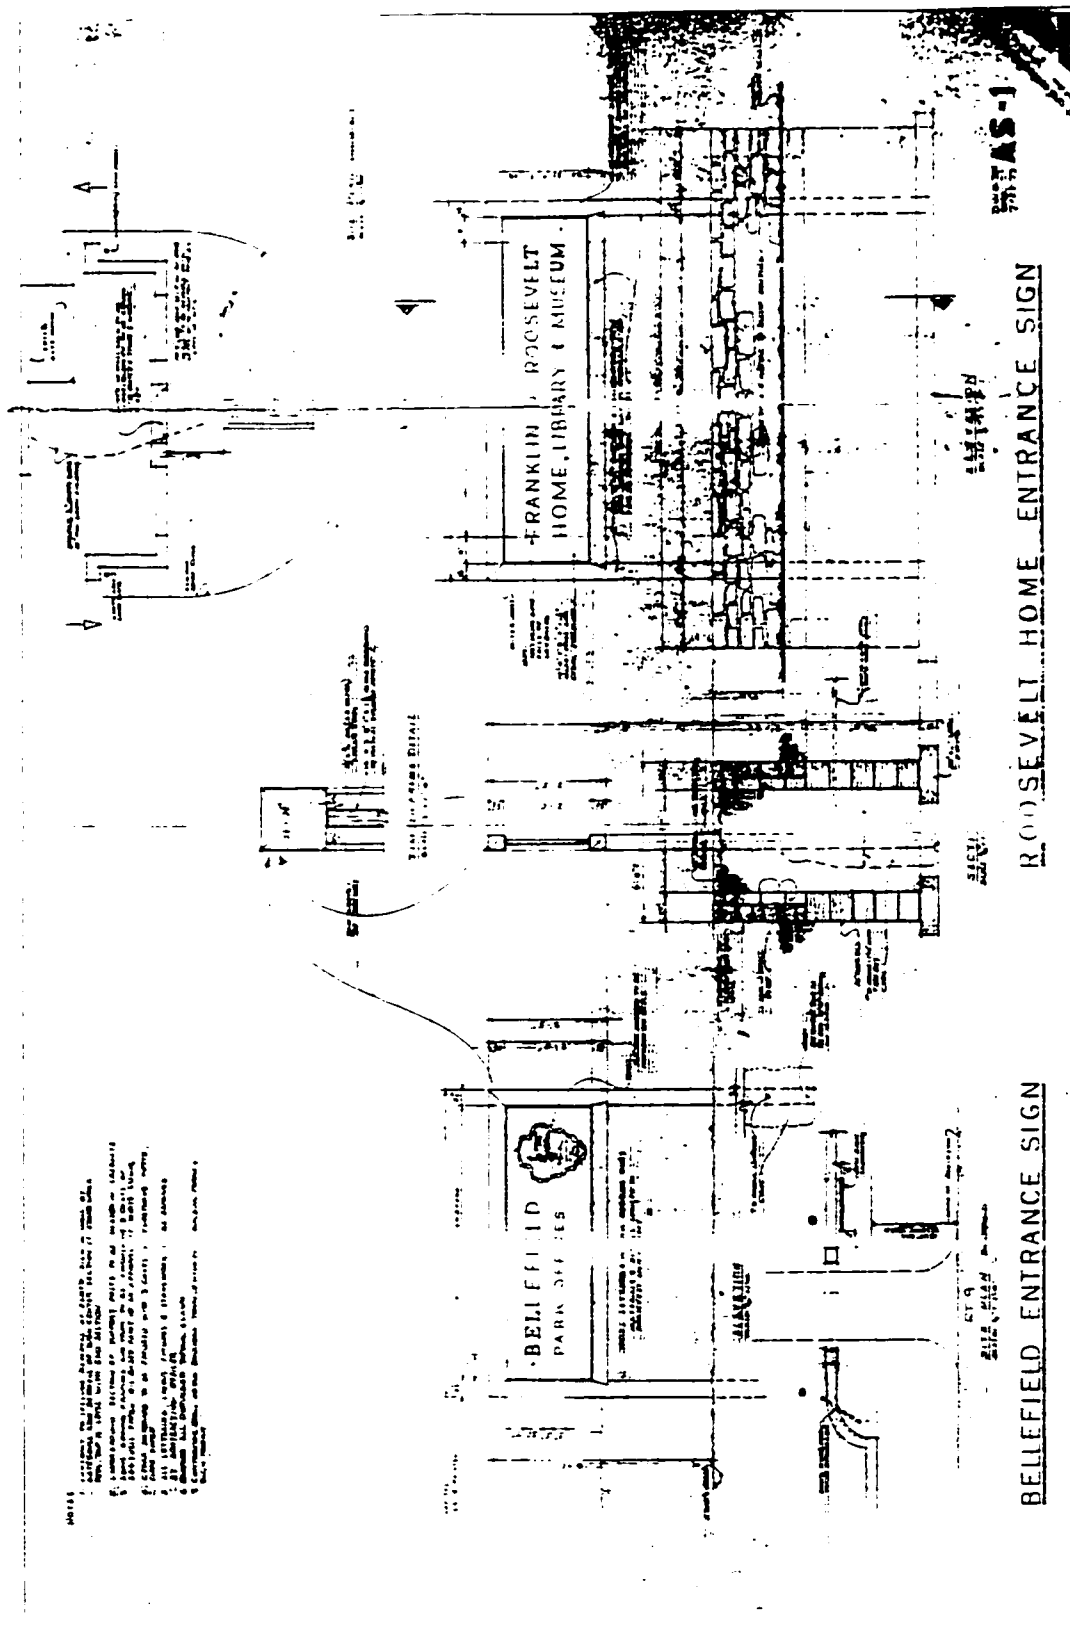
APPENDIX N: PLAN OF ENTRANCE SIGN PLANTER

Source: Lynch and Cornacchini Architects, Vanderbilt Place, Hyde Park, NY, 12538, Drawing No. AS-1, July 25, 1979. The Home of Franklin D. Roosevelt National Historic Site, # 1795-281-0001.
