CULTURAL LANDSCAPE REPORT FOR
THE HOME OF FRANKLIN D. ROOSEVELT
NATIONAL HISTORIC SITE

Kristin Theresa Baker

Master of Science in Landscape Architecture Degree

May 1999

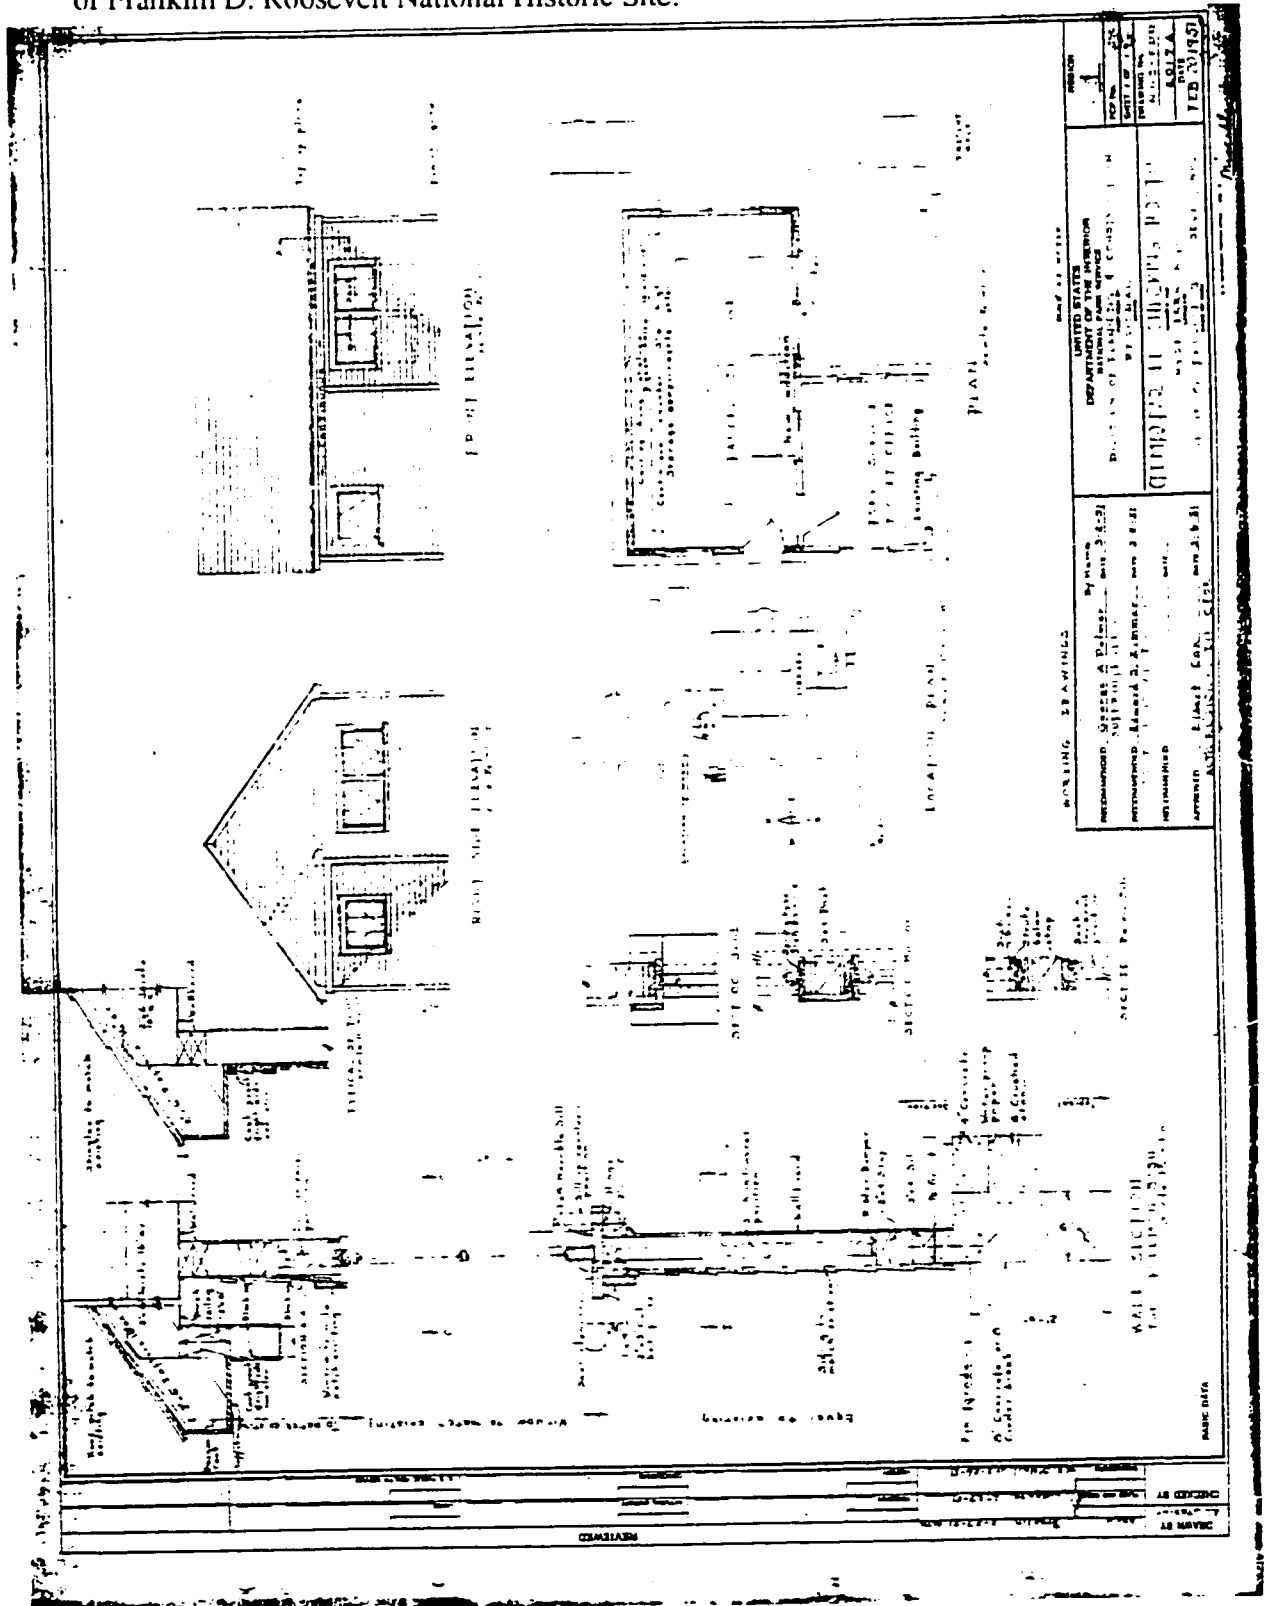
APPENDIX P: PLAN OF TICKET BOOTH ENLARGEMENT

Source: United States Department of the Interior, National Park Service, Division of Planning and Construction, Drawing No. NHS-FDR/3025, February 20, 1951, The Home of Franklin D. Roosevelt National Historic Site.

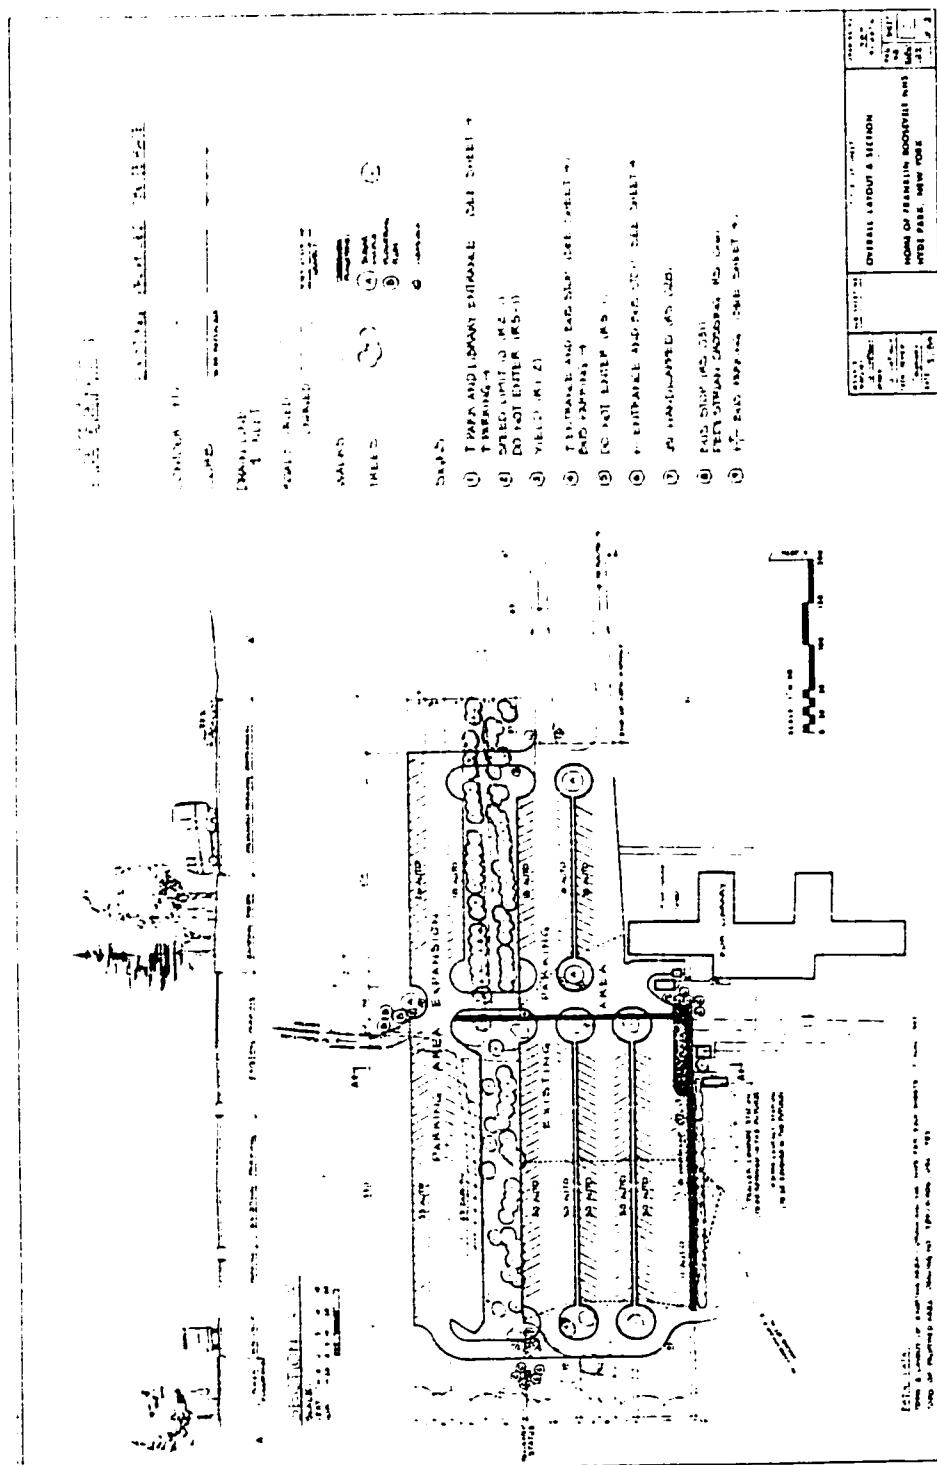
APPENDIX Q: EXPANSION OF VISITOR PARKING AREA

Source: United States Department of the Interior, National Park Service, Drawing No. 384/41,007A, May 1984, The Home of Franklin D. Roosevelt National Historic Site.

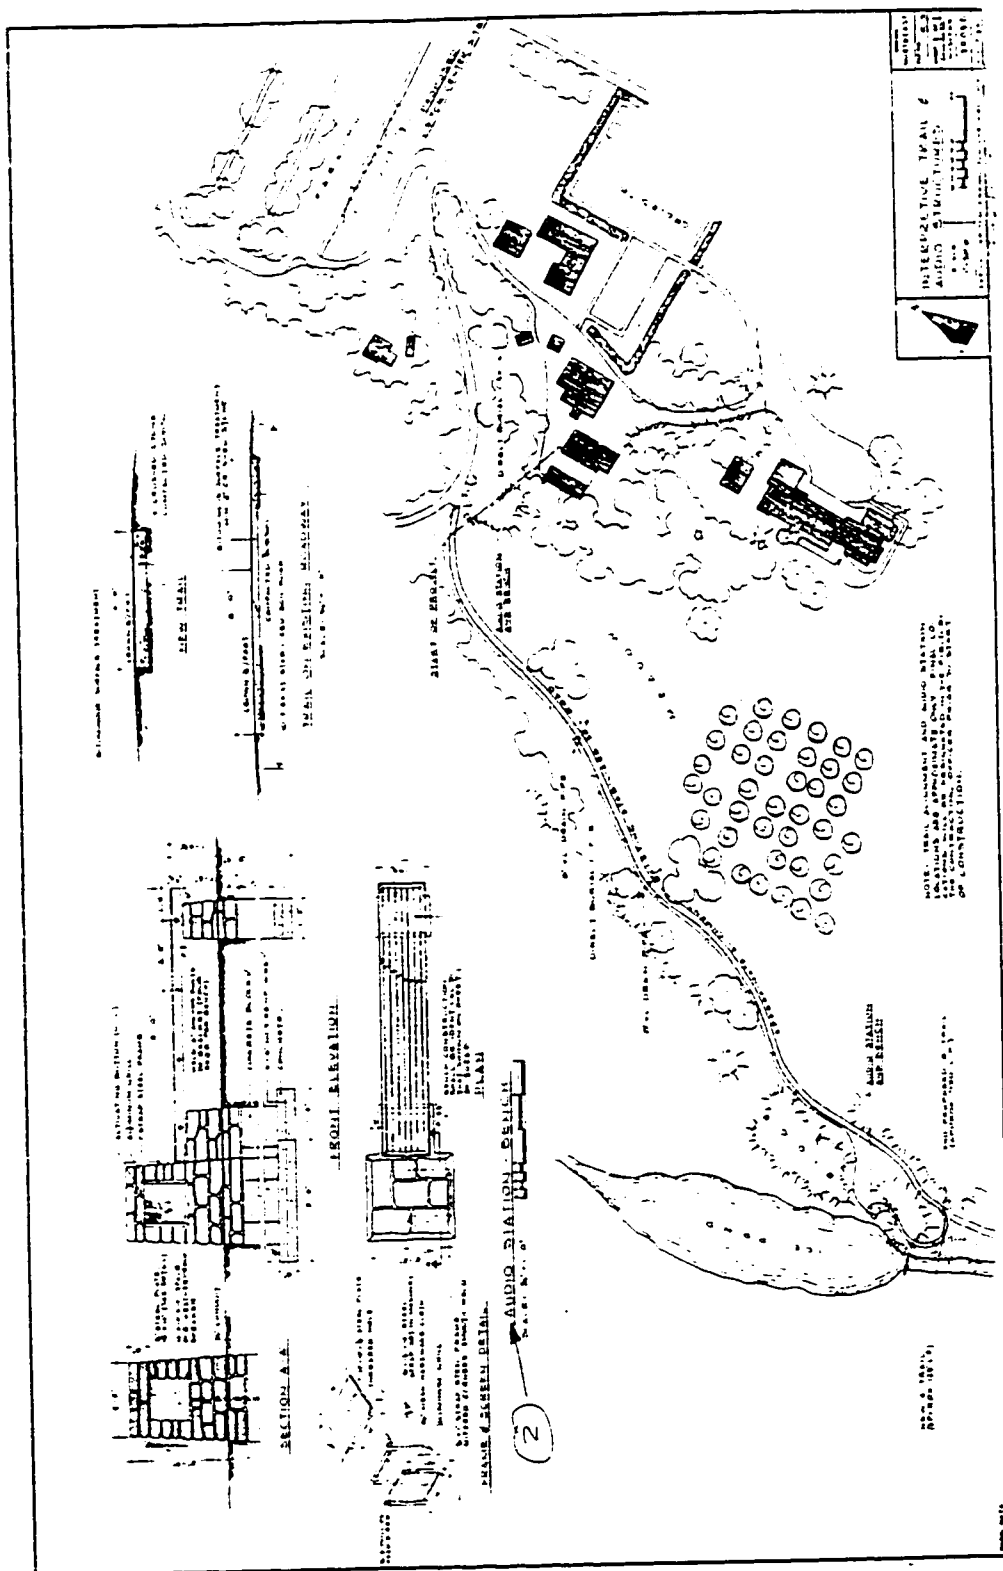
APPENDIX R: PLAN OF AUDIO INTERPRETIVE STATION

Source: National Park Service, Drawing No. NHS-FDR/30:098, July 1966, The Home of Franklin D. Roosevelt National Historic Site.
