Cultural Landscape Report  
**OAKWOOD  
CEMETERY**

Syracuse

New York

A thesis  
submitted in partial fulfillment  
of the requirements for the  
Master of Landscape Architecture Degree

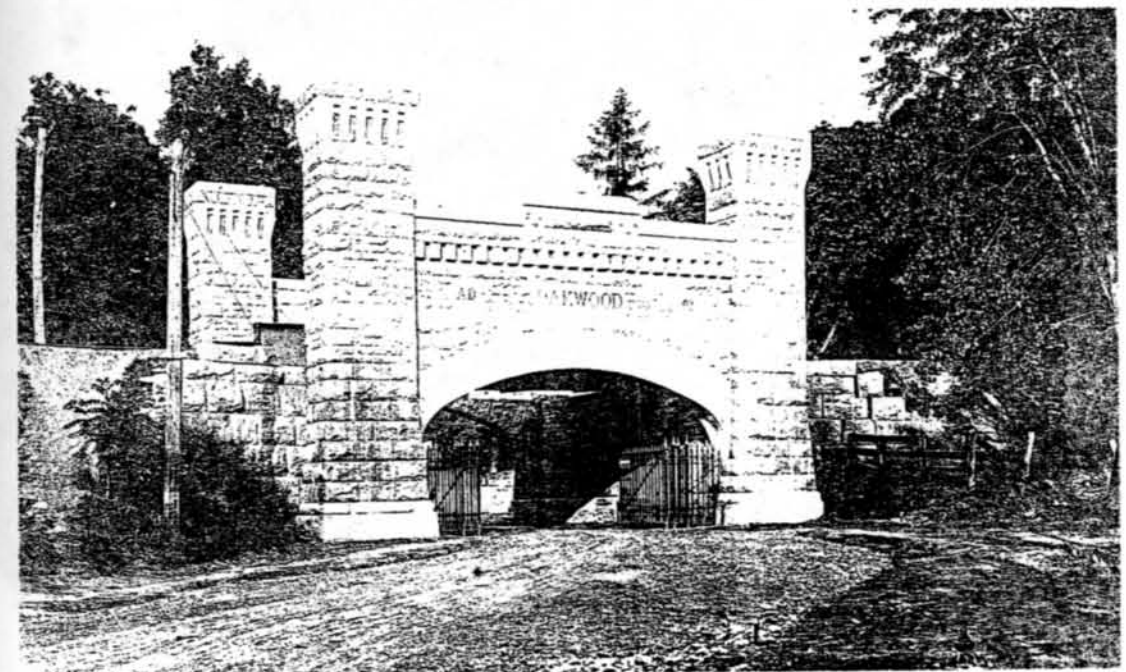
Figure 3.12 View of 1902 Gate and Bridge, circa 1902 (Oakwood Cemetery Association).

**1902 Gate and Bridge:** The Gate and Bridge, constructed in 1902 replaced the original Gate and Bridge on the western boundary of the cemetery (see figure 3.4). A circa 1902 photograph illustrates the Romanesque Gate and Bridge designed by the architecture firm, H. Q. French and Company of New York City (see figure 3.12). The 1902 Gate and Bridge was a Romanesque style structure that "... included a twenty-five foot wide arch under which visitors used to enter the cemetery grounds, and over which--between pairs of stone abutments with square corner piers--trains from the Delaware, Lackawanna & Western railroad once passed."<sup>101</sup> The 1902 Gate and Bridge included an iron fence and gate located on the west side of the bridge (see figure 3.12).
