CULTURAL LANDSCAPE REPORT FOR POPLAR GROVE NATIONAL CEMETERY

PETERSBURG NATIONAL BATTLEFIELD

DINWIDDIE COUNTY, VIRGINIA

Olmsted Center for Landscape Preservation
National Park Service, Boston, Massachusetts 2009

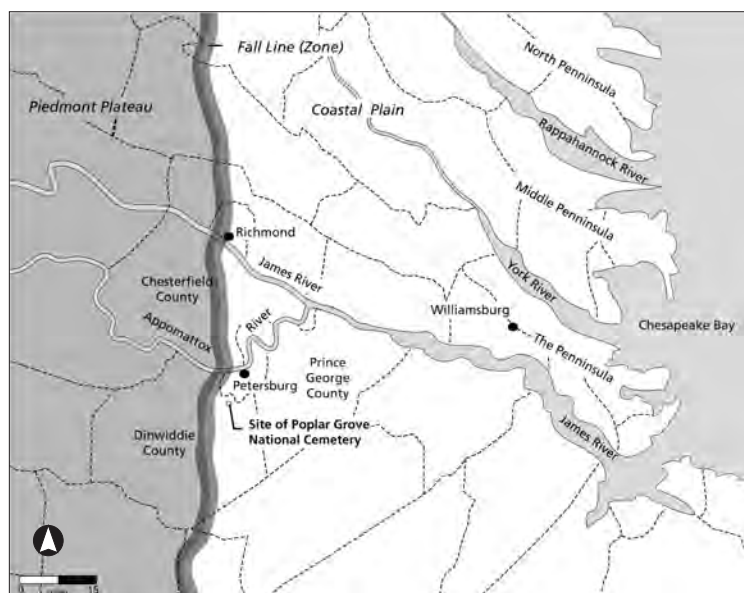
Figure 1.1: Physiographic regions illustrating general area of the Fall Line (Fall Zone) in relation to Poplar Grove National Cemetery and current county boundaries. (SUNY ESF.)

Poplar Grove National Cemetery is just east of the Fall Line within the western extreme of the Coastal Plain (fig. 1.1). The Fall Line in the region generally corresponds with elevations between 170 and 250 feet, with lower areas part of the Coastal Plain and higher areas as part of the Piedmont Plateau.² Near Poplar Grove, the geology of the Fall Line is most visible in the landscape west of Petersburg along the Appomattox River, a major tributary of the James River that flows into the Chesapeake Bay. Here, the Appomattox

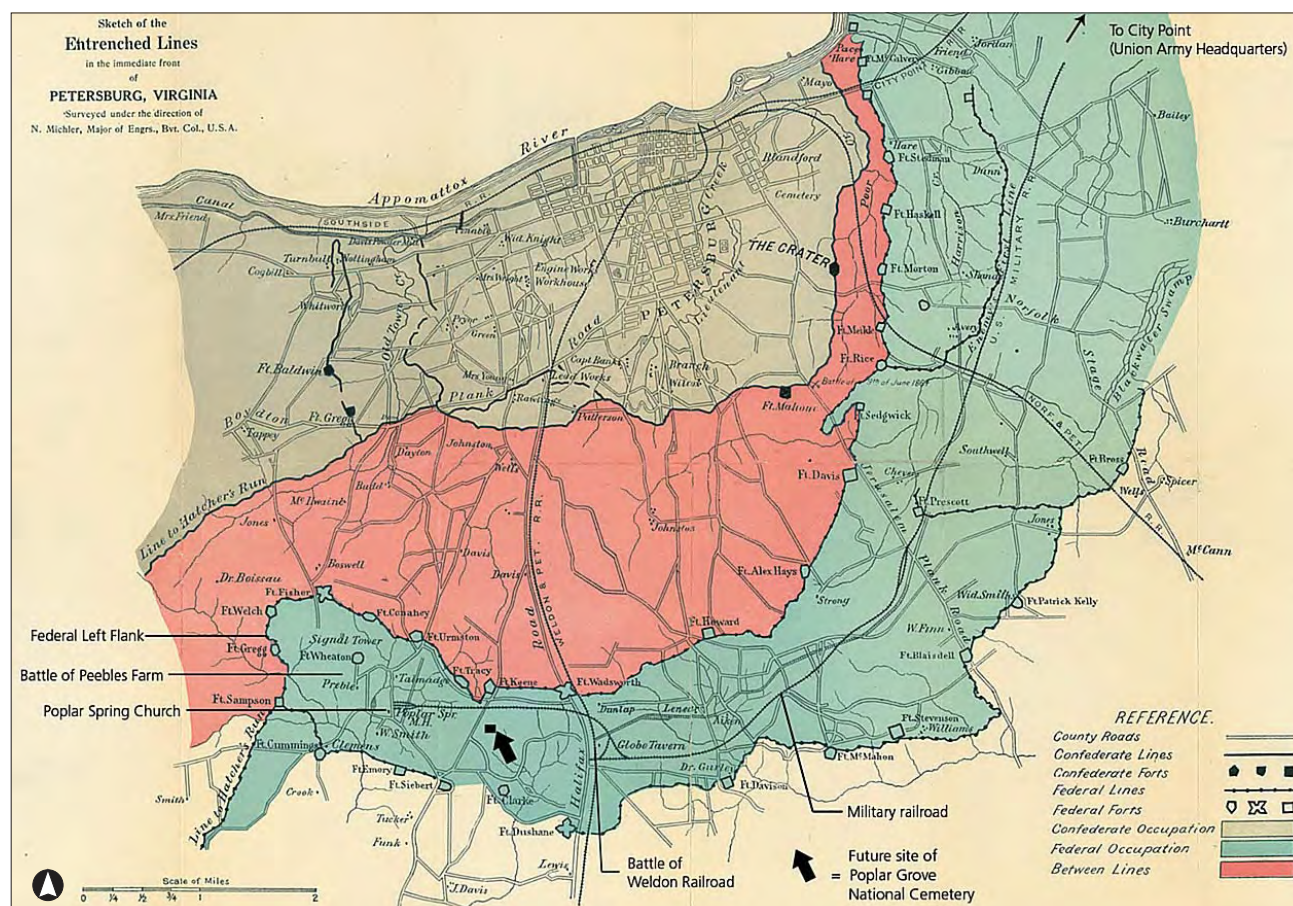
Figure 1.5: *Map of the Entrenched Lines* in the Petersburg Campaign redrawn from a survey by Brevet Colonel N. Michler, 1864-65 (Petersburg: T. S. Beckwith & Co., c.1890). The map does not show the location of military camps or all farms. (Copyright The Library of Virginia, annotated by SUNY ESF.)

On September 29, 1864, the Union Army gained control of territory two miles to the west of the Globe Tavern in the Battle of Peebles Farm, near Poplar Spring Church (fig. 1.6). By October 2, they had extended the siege lines to Peebles Farm following high ground formed by the watershed divide and soon extended the military supply railroad, requiring clearing through dense pine forest (fig. 1.7). The railroad brought troops and supplies to extend the siege fortifications still further west. Peebles Farm became the main Union camp, centered at Fort Wheaton. Near here, a signal tower was erected to facilitate communications in the ongoing construction of the encircling siege line (see fig. 1.5). Unimpeded by major battles, the Union Army

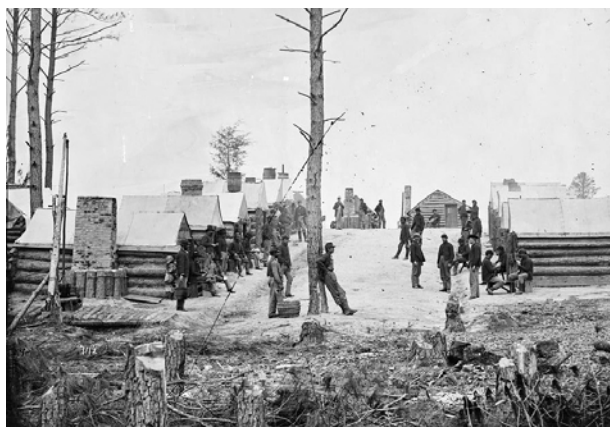
Figure 1.9: Camp of Oneida, New York Independent Cavalry Company in Petersburg showing quarters constructed of logs, with stumps from slashed pine forest in foreground, March 1865. (Library of Congress American Memory Collection, digital image LC-DIG-cwpb 03713.)

The war and in particular the construction of the siege lines had a devastating impact on a broad swath of landscape. Fields were destroyed, forests slashed, and extensive areas were excavated for the construction of a wide variety of military structures built of earth and timber (fig. 1.8). The soft, deep soils proved easily workable and helped speed construction of the fortifications. Camps for the troops were set up within the occupied zones, with canvas tents as well as more permanent structures built of logs harvested from the extensive slashing operations (fig. 1.9).

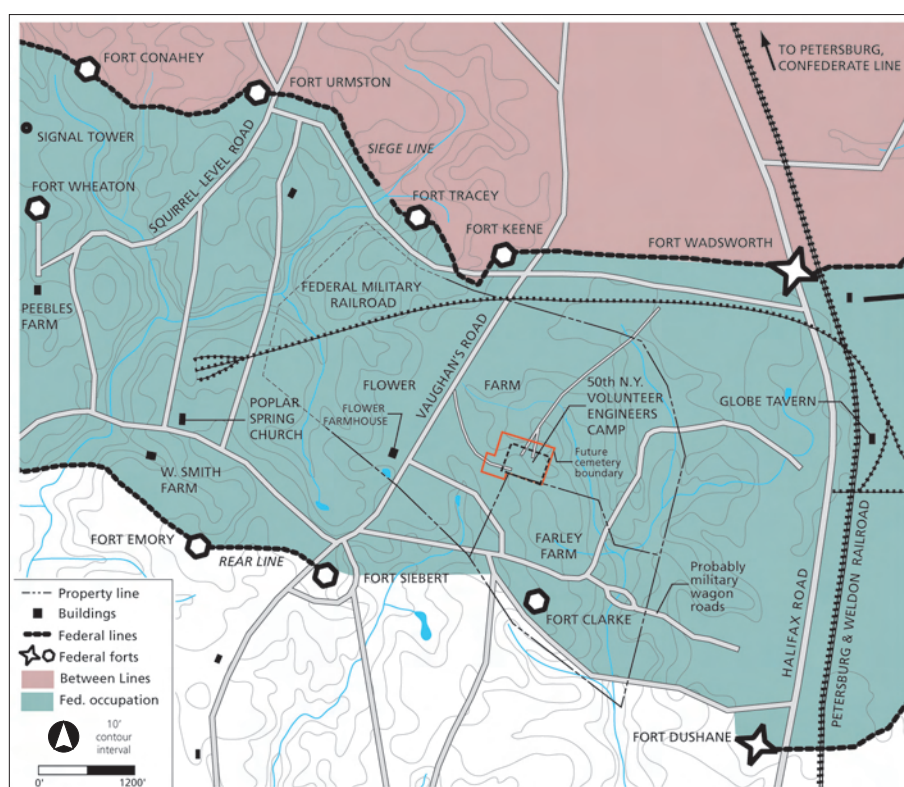
Figure 1.10: Map of the Federal Left Flank in the vicinity of the camp of the 50th New York Volunteer Engineers, based on Michler 1864-1865 survey. The Flower farmhouse was shown in a different location on other Civil War maps. (SUNY ESF)

later followed by another four companies, relocated their camp to the Flower farm due west of the Globe Tavern between Vaughan Road and Halifax Road (fig. 1.10).³¹ This location was roughly a mile and a half east of the main Union camp at Fort Wheaton. It is not known why the engineers selected this site in particular, although its position within the protected zone

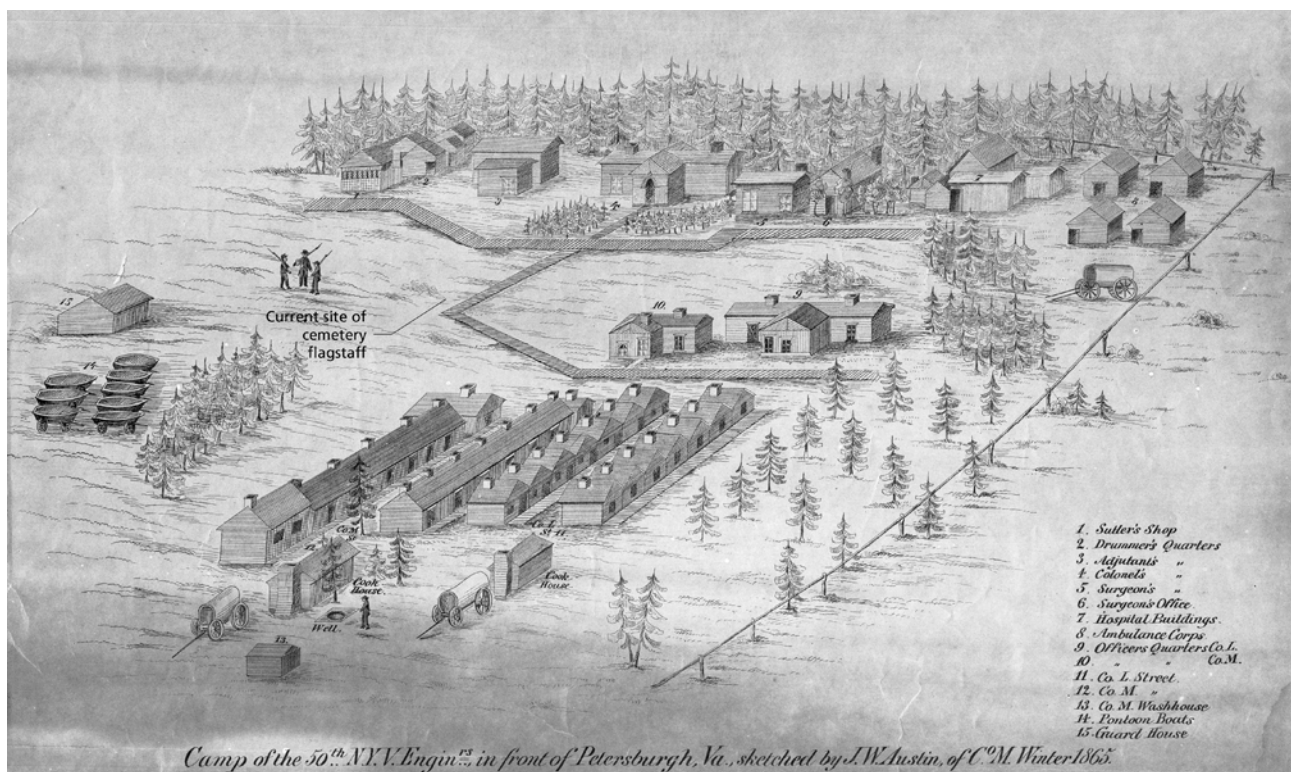
Figure 1.11: Perspective drawing of the engineers' camp looking southwest toward Vaughan Road, circa January 1865. The camp at the time was under improvement and additional buildings would be added through the next few months. (Copyright Virginia Historical Society, image 1999.161.535, annotated by SUNY ESF.)

Under the command of Brigadier General Ira Spaulding, the engineers built their camp in a rectilinear plan with the main officers' quarters and hospital on the west, officers' quarters and barracks on the east, and parade grounds in the middle with its center near the existing cemetery flagstaff (fig. 1.11). Buildings were connected by plank walks, and the camp was enclosed by a rail fence; there may also have been an orchard.³⁵ The main road to the camp was probably from the north in the direction of the military railroad. The road cut across small ravines and wetlands, requiring the construction of earthen causeways.³⁶ A second road probably entered from the southwest from Vaughan Road. The engineers initially erected elaborate tents that they replaced with timber buildings, including a church and additional barracks added in the last months of the camp. Overall length of the camp proper from east to west was less than 500 feet—an area smaller than later

During the lull in construction of the siege fortifications in the late fall and winter of 1864-1865, the engineers replaced their tents—the evergreen facades had probably turned brown within a few weeks—with elaborate timber buildings. The drawing of the camp made in January 1865 (see fig. 1.11) shows the Colonel's Quarters in place of the headquarters tent, and a new Surgeon's Quarters to the north. Over the next few months, another three matching buildings were built around the courtyard. Measuring approximately twelve feet wide by fifteen feet long, each building was sheathed in half logs with a classical façade of pilasters and pediments executed in twigs (figs. 1.14, 1.15). Lattice fences and archways spanned the buildings to enclose the courtyard. The Colonel's Quarters building

The eastern side of the camp was occupied by additional officers' quarters and rows of barracks, with cookhouses, a well, and washhouses to the east, and a storage area for pontoon boards to the south (see fig. 1.11). Due east of the church was the officers' quarters for Company L, a log building with a pedimented entrance facing east on axis with Company L Street, which was lined by log barracks (fig. 1.19). South of it was the officers' quarters for Company M, a similar,

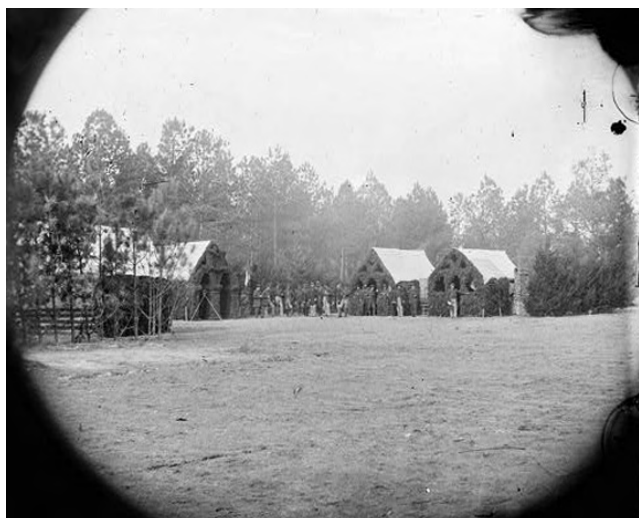
Figure 1.12 (left): Looking northwest into the officers' quarters courtyard of the engineers' camp showing initial tent structures, circa October 1864. The headquarters tent is the one in the middle with the paired arched entrance. (Library of Congress, American Memory Collection, digital image LC-DIG-cwpb-00513.)

The main officers' quarters were the most elaborately designed in the camp aside from the church. In its initial development in the fall of 1864, the area was comprised of four small officer tents and a headquarters tent that defined a small courtyard. Each tent was approximately six feet wide by twelve feet deep with facades made of a timber frame or lattice, on which evergreen boughs were twined and clipped, as in topiary (fig. 1.12). The headquarters tent was the most decorative, featuring a double Gothic-arched entrance complete with pilasters and the U.S. Army Corps of Engineers insignia executed in relief of clipped evergreens (fig. 1.13). The courtyard was delineated by an evergreen hedge, which was apparently made of cut young pine trees or boughs staked in the ground. To the north was the surgeon's office, along with hospital and ambulance corps buildings.

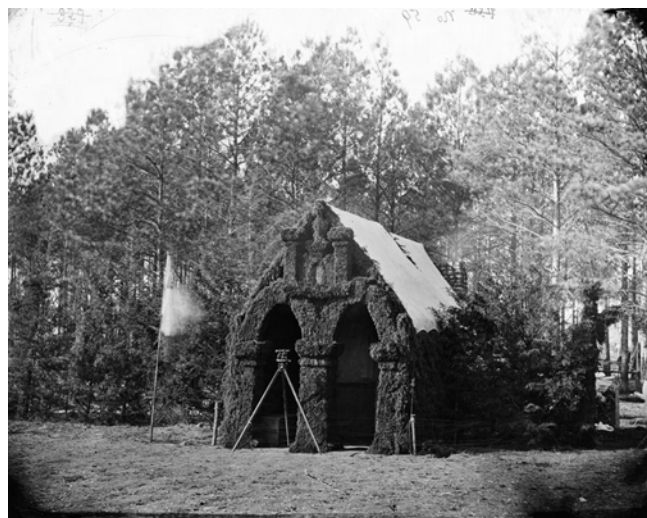
Figure 1.13 (right): Looking southwest at the headquarters tent, photograph by Timothy O'Sullivan, November 1864. (Library of Congress American Memory Collection, digital image LC-DIG-cwp-4a39989.)

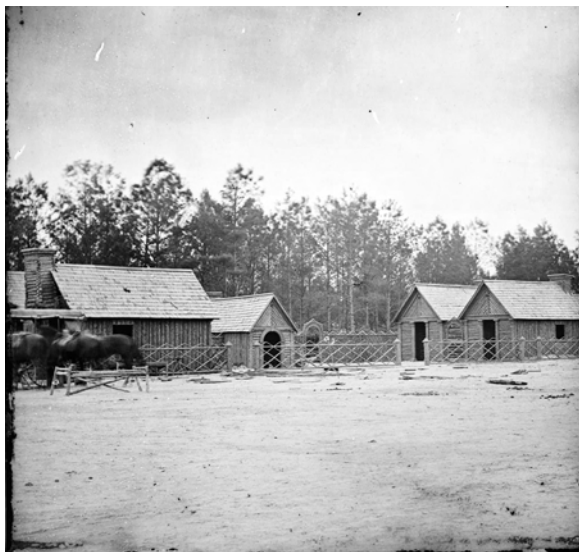
Figure 1.14 (left): The rebuilt officers' quarters courtyard, view looking northwest from parade grounds, circa December 1864. (Library of Congress American Memory Collection, digital image LC-DIG-cwp-02846.)

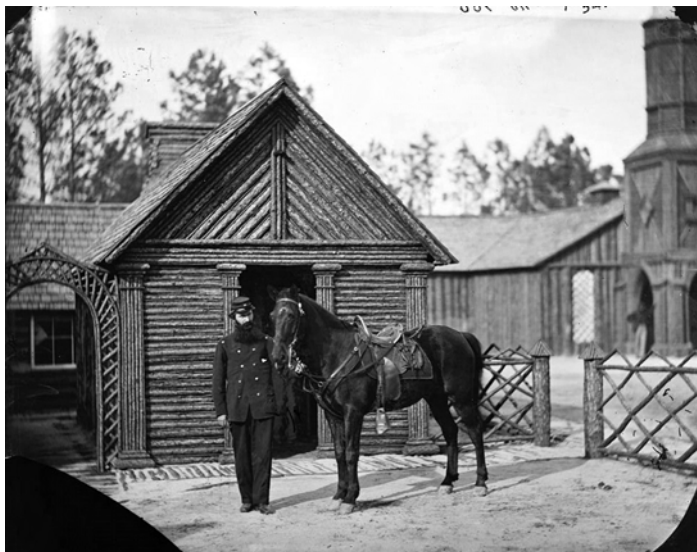
Figure 1.15 (top right): The Surgeon's Quarters in the officers' quarters courtyard showing rustic details, fencing, and corduroy walks, view looking northeast, March 1865. (Library of Congress American Memory Collection, digital image LC-DIG-cwpb 03905.)

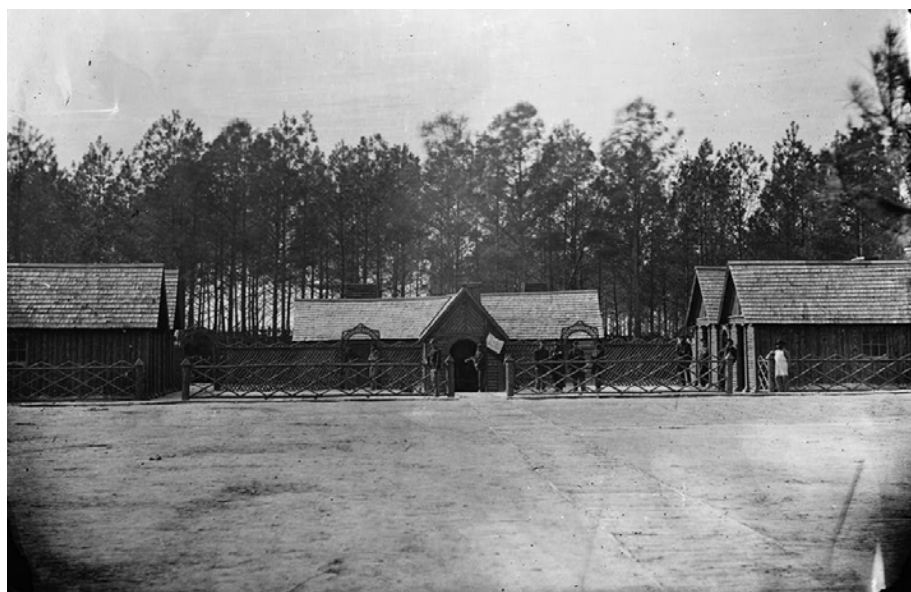
Figure 1.16 (lower right): The officers' quarters courtyard, view looking west showing corduroy walk extending through the parade grounds on axis with the Colonel's Quarters, March 1865. (Library of Congress American Memory Collection, digital image LC-DIG-cwpb 03906.)

with its projecting central wing with an arched entrance was the centerpiece of the courtyard (fig. 1.16). To the north of the officers' quarters were the ambulance corps and hospital buildings within a hedge-enclosed yard, with a rustic entrance arch and flagstaff at the entry road.³⁸

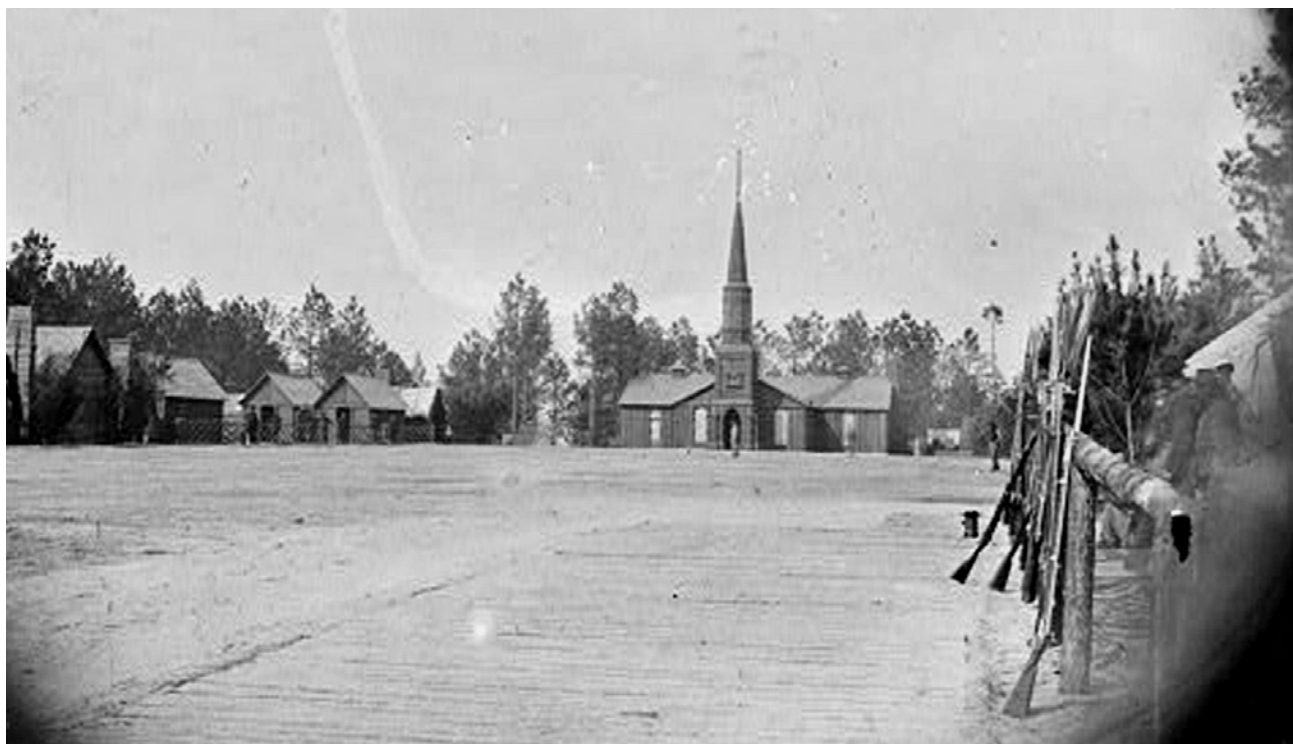
Figure 1.17: Poplar Grove Church looking north across the parade grounds, March 1865. At right is a log fence, corduroy walk, and pine hedge along the barracks area. (Library of Congress American Memory Collection, digital image LC-DIG-cwpb-04329.)

Purportedly to keep the men occupied during the winter months, General Spaulding gave the authorization on January 20, 1865 to begin construction of an elaborate central meeting hall on the north side of the parade grounds (fig. 1.17).³⁹ The engineers named the building Poplar Grove Church in honor of the congregation of nearby Poplar Spring Chapel, which was occupied by the Union Army since its victory at the Battle of Peebles Farm ("Grove" was substituted for "Spring" probably to distinguish the new building from the old). Construction was completed within two months, and on March 4, 1865, the Reverend Mr. Duryea of New York dedicated the building. It served both recreational and

The Gothic, rustic-style church was designed by Brevet Major Michael H. McGrath, an architect-builder from Painted Post, New York who commanded the engineers' Company F.⁴¹ McGrath designed the building in the plan of a modified cross, with a seating capacity for approximately 225 people. The entire structure was built of timber and featured a central tower with a spire that reached nearly sixty feet in height, shingled gable roofs with ridge ventilators, timber end chimneys, and vertical half-log walls (fig. 1.18). The main entrance, a Gothic-arched opening with recessed plank doors, was in the base of the tower, and four floor-length windows lined the façade, each with twig-lattice for muntins and cloth for glass. The tower featured two square base stages that tapered to an octagonal lantern with diamond-shaped twig-work. From here rose a spire topped by a mast. At the front of the tower was the Corps of Engineers insignia executed in twigs. The interior featured a

rostrum, clay fireplaces at either end, rustic twig chandeliers, and three-leg stools on half-log floors.⁴² An inscription over the rostrum dedicated the building to the members of Poplar Spring Church.⁴³

Figure 4.4: Photographs of the engineers' camp in 1865 and the cemetery in 1932 showing the same loblolly pines sixty-six years later. The few loblolly pines that remain today are a living connection to these landscapes. (Details of photographs from Library of Congress and National Archives in figs. 1.17 and 1.65.)

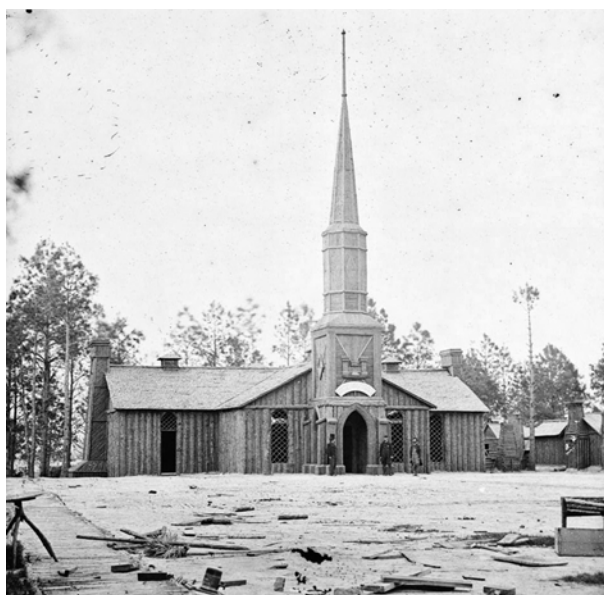
Figure 1.18: Poplar Grove Church nearing completion, looking northeast from the officers' quarters, circa February 1864. Note loblolly pines in the background, corduroy walk to the left, and other buildings at right. (Library of Congress American Memory Collection, digital image LC-DIG-cwpb 00990.)

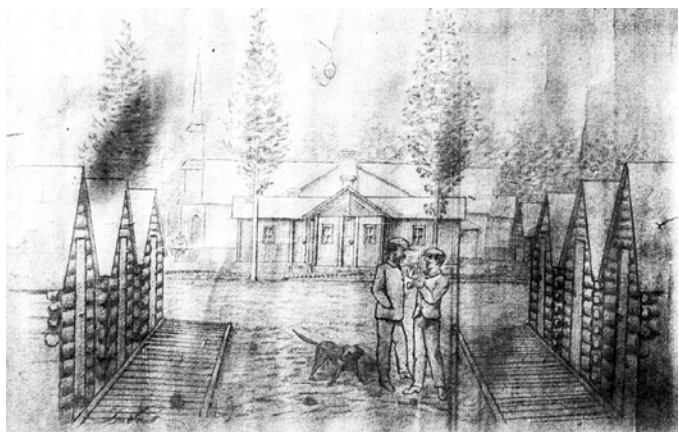
Figure 1.19: Unattributed sketch looking west through the log barracks of Company L toward Company L Officers' Quarters with Poplar Grove Church in the background, circa March 1865. (Courtesy of the Stettner family, Petersburg National Battlefield archives.)

but smaller building than Company L's. The northern two rows of barracks belonging to Company L each consisted of seven connected log cabins with gable roofs. To the south were two additional rows of barracks of long, gabled buildings rather than small cabins. These barracks were enclosed by a log rail fence and evergreen hedges, and were connected by plank walks (see fig. 1.17).⁴⁴ A drawing of the camp made after March 1865 shows many additional rows of barracks extending to the south of the Company L and M barracks, probably for the other four

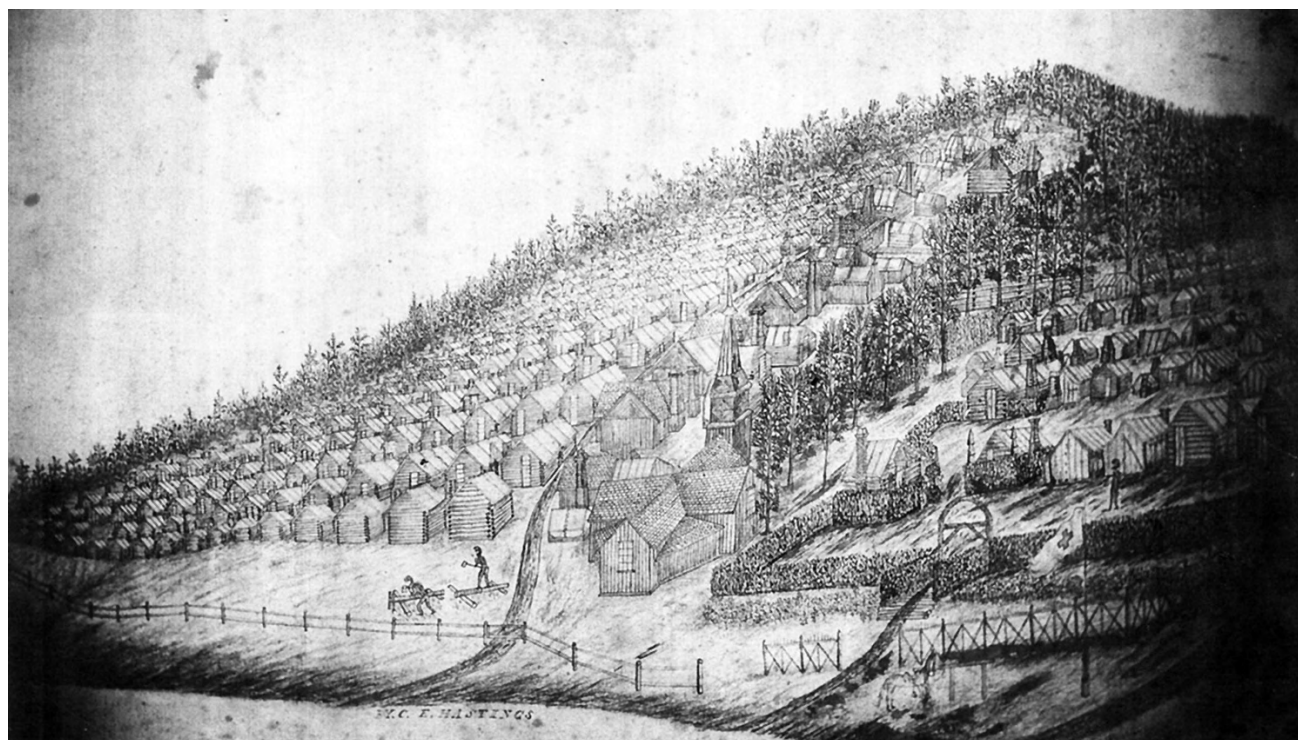
Figure 1.20: The engineers' camp in a drawing by C. E. Hastings looking southeast, c.1865. Poplar Grove Church is in middle foreground; the officers' quarters courtyard on the right, and lines of barracks to the left. Visible at the lower right is the hedge-enclosed entrance yard and flagstaff at one of the two north entrances to the camp. This drawing is an exaggerated perspective and may show more barracks than actually existed. (Courtesy of the Stettner family, Petersburg National Battlefield archives.)

companies that occupied the camp (fig. 1.20). The drawing also shows the flagstaff and hedge-enclosed courtyard at the hospital entrance west of the church, the officers' quarters courtyard, enclosing fence, and pine woods, among other features. .

36 The 1864-65 Michler survey does not show the engineers' camp or roads leading to it. The existence of a road leading north is based on the Hastings drawing of the engineers' camp (see fig. 1.20) and by a causeway indicated through the ravine floor to the north of the cemetery on the c.1866 "Plan of the Locality of U.S. Nat. Cemetery at Poplar Grove" (see fig. 1.24).

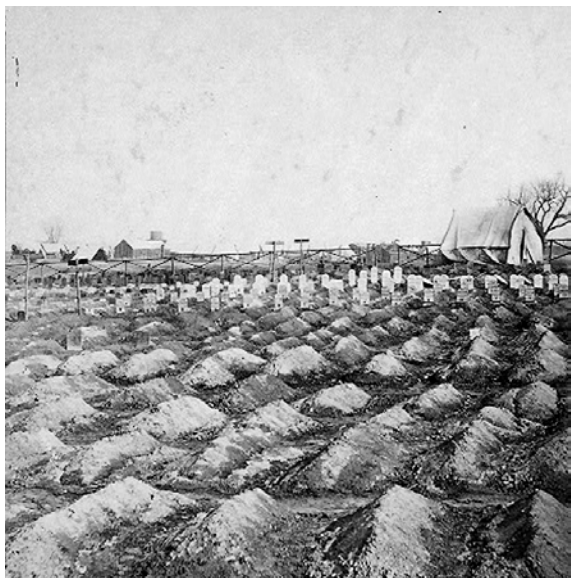
Figure 1.22: Union Army hospital cemetery at City Point, Virginia, c.1865. Note grave mounds, white-painted headboards, and enclosing fence. (From a stereograph by Mathew B. Brady, Collection of the New-York Historical Society.)

unadorned field, marked by grave mounds and white-painted headboards, and enclosed by a wood fence (fig. 1.22).

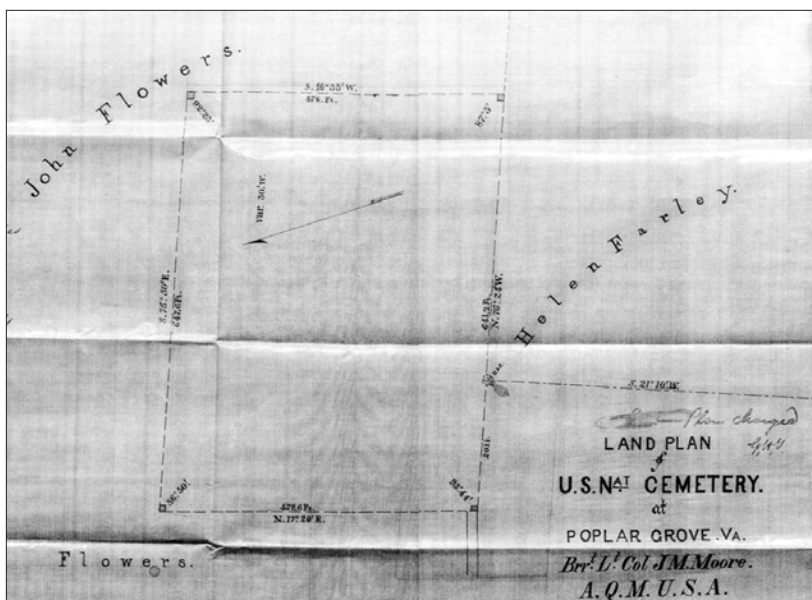
Figure 1.23: Detail, Quartermaster survey of site for Poplar Grove National Cemetery by G. H. Thomson, made soon after the site was selected by Lieutenant Colonel James M. Moore, circa May 1866. The property at the time was owned by Reverend Thomas Britton Flower, not "John Flowers" (sic). Note approach road at bottom right of parcel and annotation indicating one-acre addition made in 1867. (Records of the Quartermaster General, Entry 576, Poplar Grove National Cemetery Records, box 56, National Archives I.)

The site for the new cemetery was a rectangular parcel surveyed at 7.2 acres and centered at the middle of the camp's parade grounds. Initially designed to accommodate 5,000 graves, Poplar Grove ranked among the larger national cemeteries established in the Virginia district.¹⁹ The parcel measured approximately 645 feet on the north and south, and 475 feet on the east and west sides, and was accessed by a drive at the southwest corner, probably following a pre-existing entry to the camp from Vaughan Road (see figs. 1.23, 1.24). The parcel was situated entirely within the property belonging to Thomas B. Flower and probably

Despite the continuing difficulties with the purchase, Superintendent Miller received instruction from Lieutenant Colonel Moore on November 25, 1867 to add the one-acre parcel that Miller had earlier suggested as the site for a lodge. At the time, the configuration of the addition had not been determined, but within a few months, a new survey was completed showing an 'L'-shaped one-acre extension at the southwest corner of the original cemetery plot (see fig. 1.23). The size of the cemetery with the addition was 8.13 acres.⁵⁶

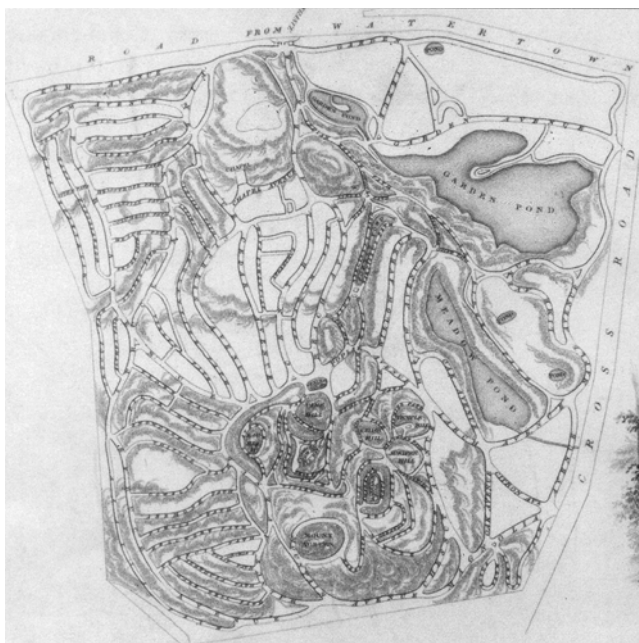
Figure 1.26: Plan of Mount Auburn Cemetery, the prototype American rural cemetery, showing naturalistic design. (Cornelia Walter, *Mount Auburn: Illustrated in Highly Finished Line Engraving*, 1847.)

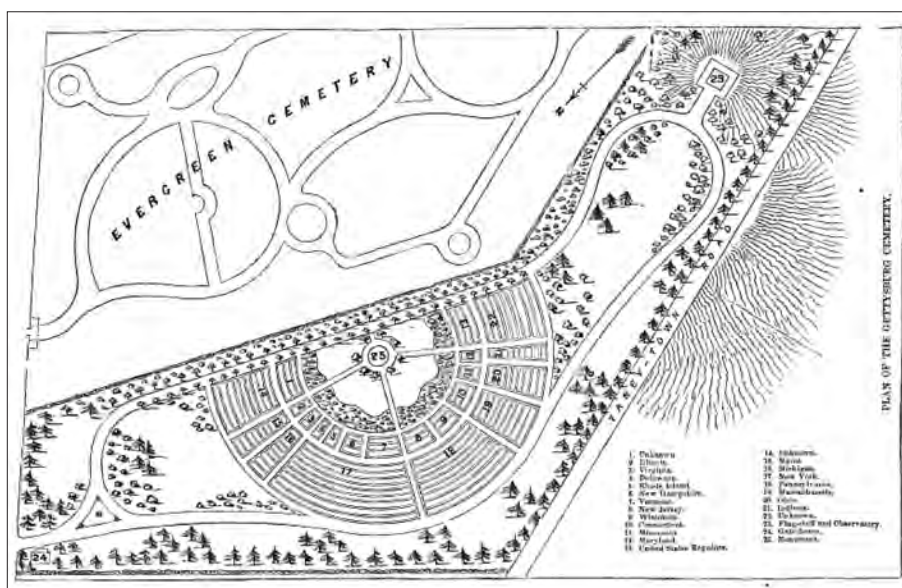
Figure 1.28: Plan of Gettysburg National Cemetery, designed by William Saunders in 1863, showing circular burial grounds surrounded by a picturesque landscape with curving drives. Gravesites were organized by state within the concentric circles, facing the central monument. Adjoining Evergreen Cemetery was a pre-existing rural cemetery. (*Harpers New Monthly Magazine*, August 1866.)

While the design of the first national cemeteries reflected these precedents, many traced their stylistic origin to Gettysburg National Cemetery, designed in 1863 by landscape gardener William Saunders of the U.S. Department of Agriculture.²⁵ His plan for the cemetery, near the battlefield and adjoining a decade-old rural cemetery outside the village of Gettysburg, featured an overall informal, picturesque landscape much like the style found in rural cemeteries, but with the burial plots at the center arranged in a contrasting geometric form with concentric half circles facing a central monument (figs. 1.28, 1.29). Saunders' design was

in keeping with the recently introduced lawn style, with its winding approach drives, broad sweep of lawn framed by naturalistic plantings of trees, and overall simplicity.²⁶ Yet the stark geometry of the burials, perimeter stone wall, and uniform design of the gravestones for soldiers and officers alike, consisting of continuous curb-like markers, clearly set the cemetery apart from the surrounding civilian

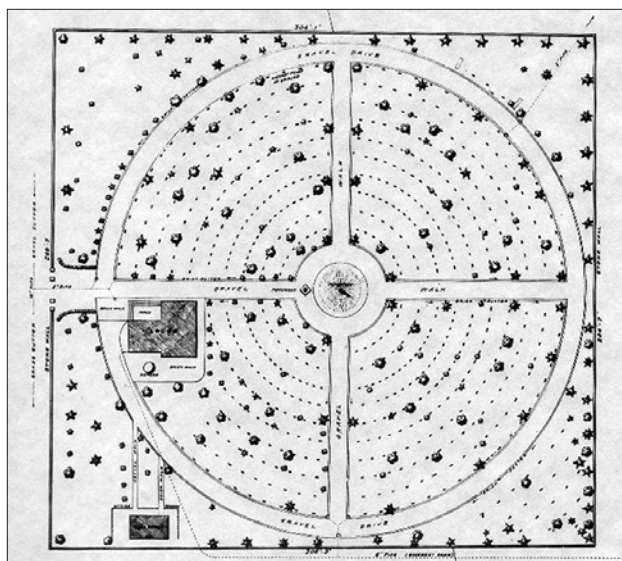
Figure 1.31 (left): Plan of Glendale National Cemetery, established in 1866 just prior to Poplar Grove, showing circular burial plan, from an 1892 survey. (Records of the Quartermaster General, RG 92, Entry 691, National Archives I.)

The small Glendale National Cemetery, established in 1866 east of Richmond, consisted of a two-acre rectangular parcel with a circular burial plan, an outside circular drive, two cross-axis drives, and a central flagstaff (fig. 1.31). In contrast, the larger City Point National Cemetery located east of Petersburg, established in 1866, consisted of a seven-acre parcel with a rectangular burial plan, two small circular elements in the center for a flagstaff and monument, and a circular entrance area

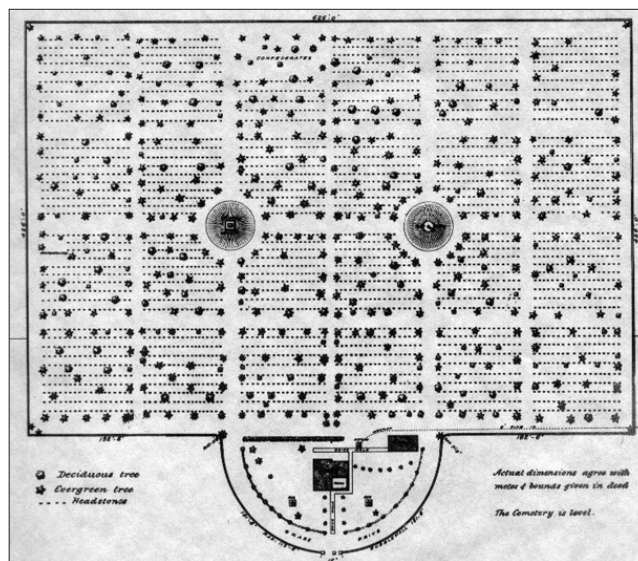
Figure 1.32 (right): Plan of City Point National Cemetery, commenced at the same time as Poplar Grove in 1866, showing a linear burial plan with central circular elements for a flagstaff and a monument, from an 1892 survey. (Records of the Quartermaster General, RG 92, Entry 691, National Archives I.)

outside the burial grounds (fig. 1.32). In keeping with General Orders Nos. 33 and 75, and with the Congressional act of July 17, 1862, these and all other national cemeteries were initially developed with uniform white-painted headboards with black lettering, and white-painted wood paling fences around the perimeter, similar to Alexandria National Cemetery (see fig. 1.30). As part of the initial development under the burial corps, the graves were generally mounded to allow for settling, the grounds were sodded, and the drives were surfaced in gravel. A central flagstaff, often placed upon a circular mound and adjoining one or more gun monuments, was generally part of the initial development as well.

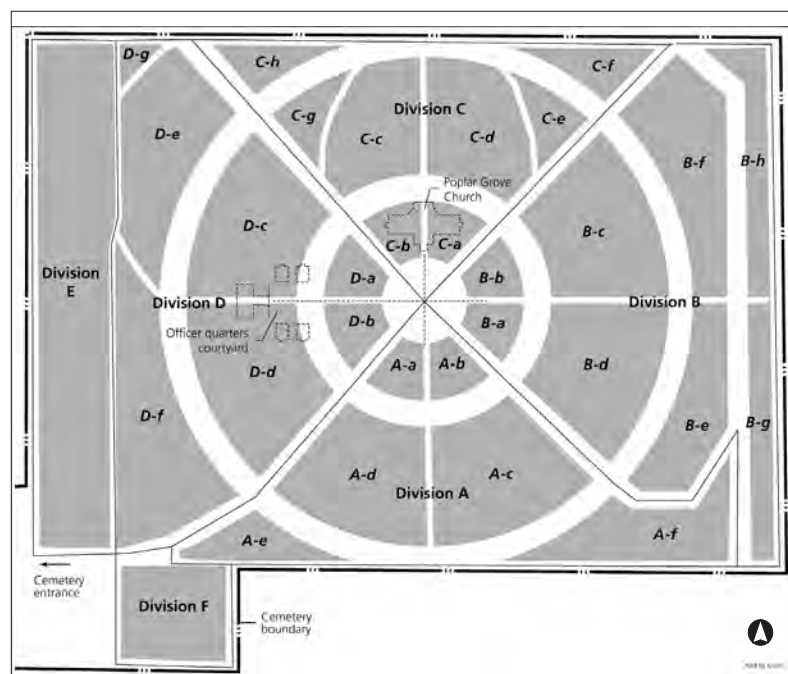
Figure 1.34: Diagram of burial grounds showing organization into divisions and sections, and approximate relationship to pre-existing officers' quarters courtyard and Poplar Grove Church. Division F is within the acre added to the original cemetery parcel. (SUNY ESF)

The circular plan with room for approximately 5,000 graves was centered at a point on axis with the entrance to Poplar Grove Church and the center of the officers' quarters courtyard. The circle was slightly off-center within the entire cemetery parcel, creating a larger area for burials along the west side (fig. 1.34). The center of the cemetery was planned as an open circle for a flagstaff, with the church building located to its north.³¹ Extending out from the center, the plan was divided in eight radiating segments organized into four larger areas known

as “divisions” and lettered A through D; each division was in turn subdivided into smaller areas known as “sections.” Graves were planned in concentric circles radiating out from the center, with rows ten feet apart and individual graves generally spaced at five feet.³² All grave markers were intended to face the flagstaff, with the inscriptions visible when viewed from the center.³³ On the east and west sides, the graves transitioned to parallel rows, following the rectangular property boundaries.

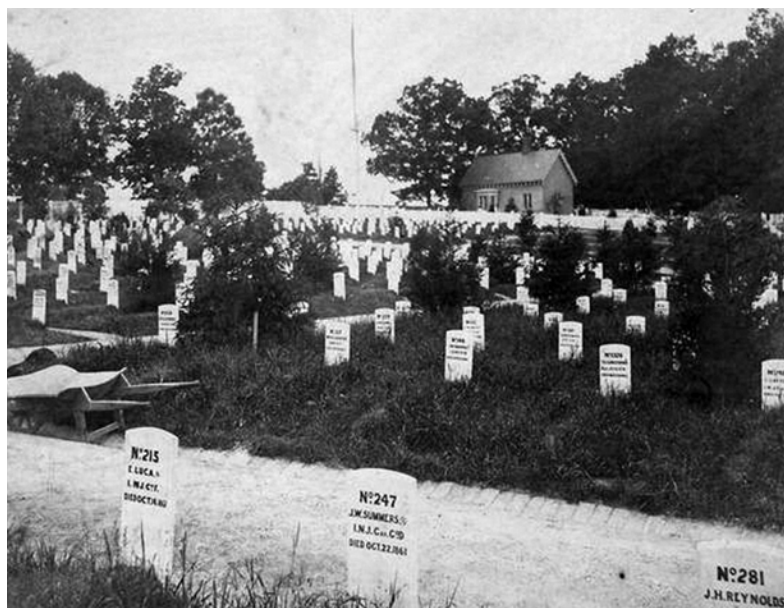
Figure 1.35: Example of standard white-painted wooden headboards used in initial national cemetery development, in a c.1865 photograph of the Soldiers' Home National Cemetery, Washington, D.C. by Titian Ramsay Peale. This cemetery, like Poplar Grove, was under the supervision of Lieutenant Captain James M. Moore. Also note grave mounds and brick gutters along the gravel drives. (United States Sanitary Commission Records, New York Public Library Digital Gallery, digital ID 1150094.)

the soil, the grave mounds were covered in sod brought in from various locations in the vicinity.⁴⁴ Each grave was marked by a typical white-painted headboard, similar to those used on the battlefields and the cemeteries established during the war, such as Soldiers' Home in Washington, D.C. (fig. 1.35). They were made of pine with black lettering noting the name and rank of the soldier, if known, and, unlike those at Soldiers' Home, also noting the place from where the body was taken. ⁴⁵ Most of the graves contained one body, but some of the unidentified graves had the remains of more than one soldier, some with up to six.⁴⁶

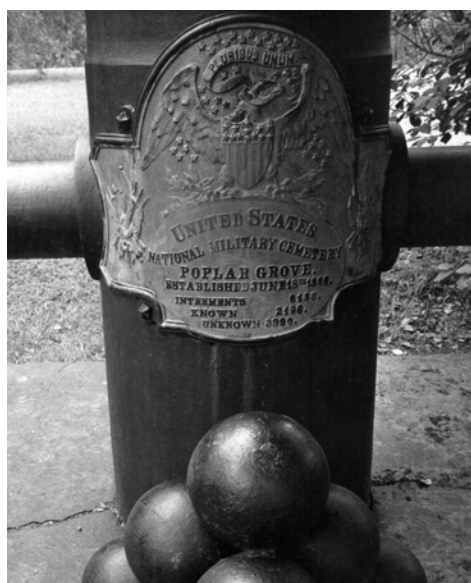
Figure 1.36: Bronze shield on the northern gun monument installed in c.June 1869, from a 1968 photograph. This was apparently the only sign within the cemetery at the time. (Photograph by Fred Bell, 2 June 1968, Poplar Grove administrative records, Petersburg National Battlefield.)

With the disbanding of the burial corps at Poplar Grove National Cemetery on June 30, 1869, the cemetery with its 6,136 interments was officially complete. It was probably at this time that the gun monument located north of the circle, in front of the site of Poplar Grove Church, was ornamented with a standard eagle-emblazoned bronze shield providing the name of the cemetery, its date of establishment, and a tally of the burial record (fig 1.36).

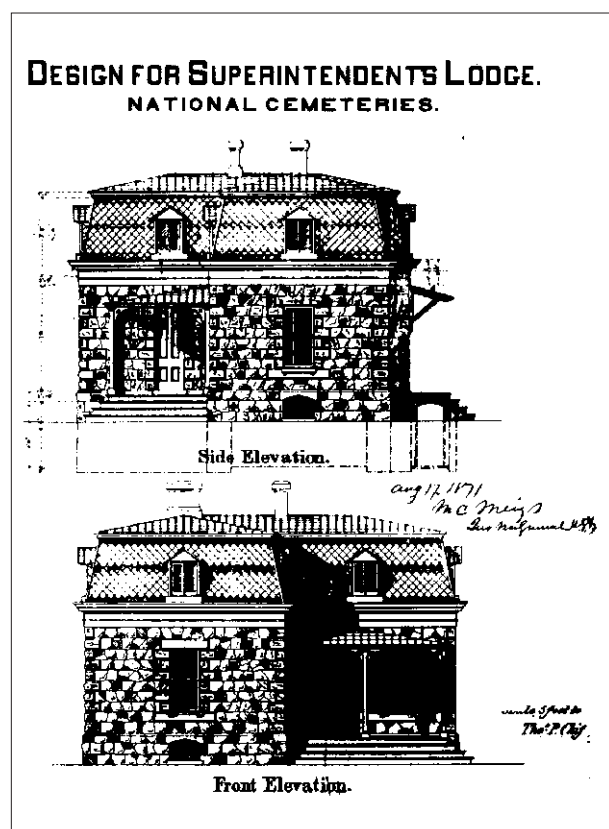
Figure 1.38: Prototype of a national cemetery lodge designed by Quartermaster General Montgomery Meigs, from a version dated August 17, 1871. (National Archives, from U.S. Department of Veterans Affairs Facilities Management website, <http://www.va.gov/facmgt/historic/Meigs>.)

plans for substantial stone lodges to be built at each national cemetery. Meigs’ prototype, first produced in 1870, was for a small, one and one-half story building in the fashionable Second Empire Style. A second version Meigs produced in 1871 featured quarry-faced ashlar stone walls, a polychrome slate Mansard (French) roof, pedimented dormers, a front porch, and casement windows (fig. 1.38).¹⁹ The building style, contemporary and characteristically urban, stood in stark contrast to the Gothic and Egyptian Revival styles popular in rural cemeteries prior to the war. Meigs-designed lodges were built, with modifications, at most of the national cemeteries in the Virginia district under the supervision of Lieutenant Colonel James M. Moore, the first built in 1870 at Richmond and Cold Harbor, and the last completed at Seven Pines in 1874.²⁰ The lodge at City Point near Petersburg, built in 1871, was typical of the modifications to the Meigs prototype, with double-hung sash, a monochrome slate roof, and slightly different proportions (fig. 1.39). As with all lodges, the City Point building was

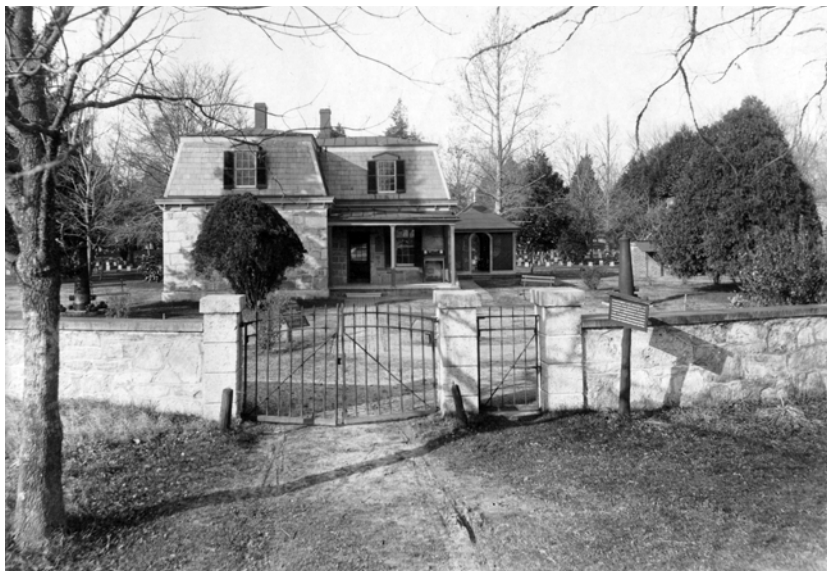
Figure 1.39: The main entrance to City Point National Cemetery, a second-class cemetery, showing Meigs-style lodge built in 1871, photographed 1902. Also note the stone wall and iron gates (c.1875), gun monuments (c.1869), lattice well house (c.1871, to right of lodge), and iron tablets (c.1882). (Records of the Quartermaster General, RG 92, Still Pictures Division, National Archives II.)

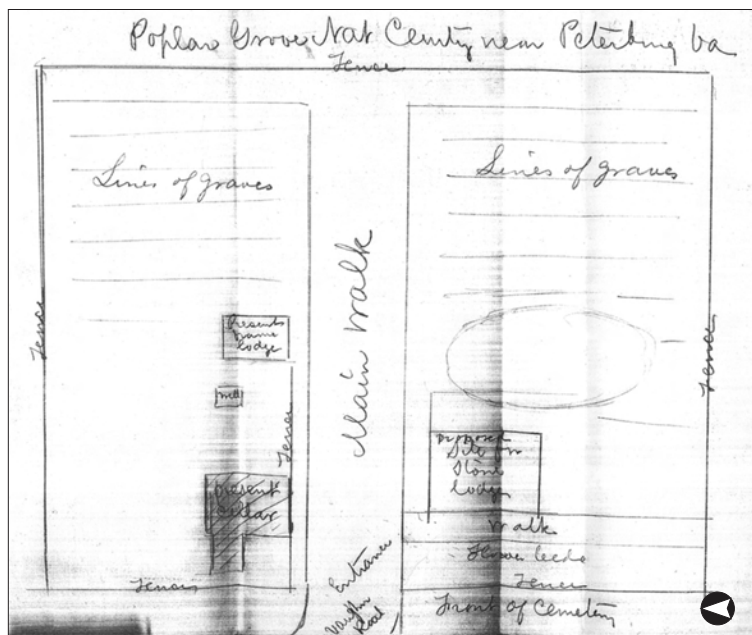
Figure 1.40: Sketch made in August 1871 for the site of the new stone lodge, showing "present cellar" on opposite side of the entrance drive (main walk) that was begun the year before. Also shown is the "Present frame lodge" above (east of) the cellar hole. The location of the fence and drive at the top of the drawing are not accurate. (Records of the Quartermaster General, Entry 576, Poplar Grove National Cemetery Records, box 57, National Archives I.)

Dobbyn and requiring construction to be completed by October 31, 1870. The site selected for the lodge was in the one-acre addition on the north side of the main drive adjacent to the frame lodge. By August 31, 1870, Dobbyn commenced work on the project, but within a short time defaulted on the project, leaving a cellar hole, mounded earth, and lumber.²¹ In April 1871, the Quartermaster's office advertised for new bids using the same plan. The low bid for the plan as specified, using brick, came in at \$2,892.00, but a bid by Kyran A. Murphy substituted stone for brick at a lower cost of \$2,700.00. Murphy was most likely working at the time on the new lodge at City Point National Cemetery, which used the same stone (see fig. 1.39). Because of Murphy's low bid, he was awarded the contract for Poplar Grove and plans were changed to stone.²² On August 3, Stark Frank, an agent with the Quartermaster's office, inspected the existing cellar hole, which had filled with water, and determined that the lodge

should be instead built on the opposite side of the entrance drive (fig. 1.40).

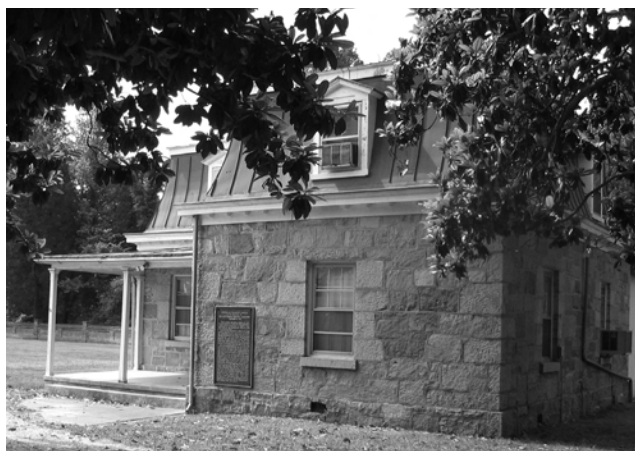
Figure 1.41: The Poplar Grove lodge, built in 1871-1872, view of the front façade looking southeast from a recent photograph (2006). The building historically had dark trim and a monochrome slate roof with diamond-shaped slates. The tablet affixed to the building, installed in c.1913, contains Lincoln's Gettysburg Address. (SUNY ESF.)

in diamond-shaped monochrome gray slate, six-over-six double-hung sash windows, a front porch with simple squared posts, overhanging eaves ornamented by dentils, and rough-faced ashlar with varying shades of grays and browns (fig. 1.41). Work on finishing the interior lasted into the spring, and in April 1872, Miller moved into the lodge. Soon after this, he moved the old frame lodge to the rear of the new lodge for use as a kitchen and storage room.²⁴ The grounds surrounding the lodge were probably improved soon after the building's completion. Chief among these was the addition of a circular turn-around measuring ninety feet across, with a planted

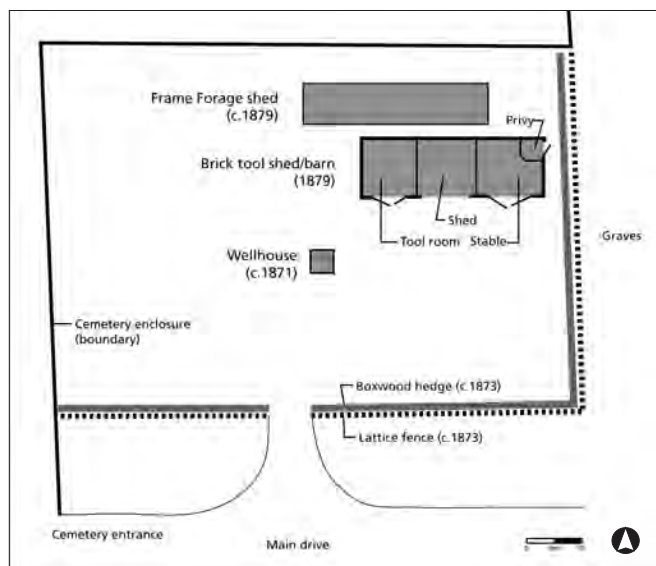
Figure 1.42: Diagram showing the layout of the Poplar Grove service area by 1880. The location of the earlier (pre-1879) frame sheds is not known. (SUNY ESF.)

The grounds across the main drive from the lodge, where the original cellar hole was located, were developed into the cemetery's service yard, initially known as the wood yard. Here, the cemetery horse (used for lawn mowing) was stabled, and fuel wood, building materials, and equipment, such as lawn mowers, scythes, and wheelbarrows, were kept. The first structure in the yard was probably the toolshed built by Superintendent Miller in 1869, followed by a twenty-foot deep well with a lattice well house and pump, probably built together with the lodge in 1871. This well house was most likely the same design as the one built at City Point National Cemetery—a square structure with a pyramidal hipped roof and arched openings (see fig. 1.39). In 1873, a frame building known as the tool house, with stable and privy under one roof, was constructed in the yard, and additional

small shacks were also added over the years. Shortly after the addition of the tool house (also known as the barn), the service yard was screened off from the rest of the cemetery by a six-foot high wooden lattice fence, inside of which was planted a boxwood hedge. In 1879, the numerous wooden buildings in the service yard were replaced with a three-bay brick tool house with an open central bay flanked by sets of swinging doors, and a privy at the side (fig. 1.42). Apparently the feed room in the new tool house was not adequate, and Superintendent Miller built a frame forage shed at the rear, probably out of materials salvaged from the old service buildings.²⁵
