CULTURAL LANDSCAPE REPORT FOR POPLAR GROVE NATIONAL CEMETERY

PETERSBURG NATIONAL BATTLEFIELD

DINWIDDIE COUNTY, VIRGINIA

Olmsted Center for Landscape Preservation
National Park Service, Boston, Massachusetts 2009

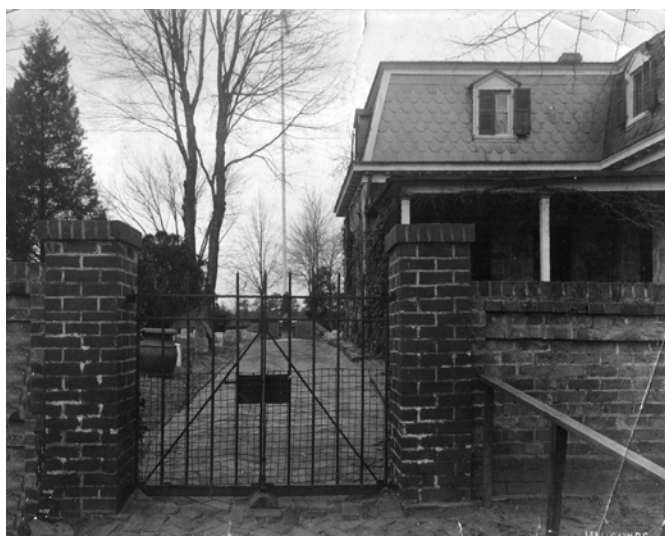
Figure 1.43: Cold Harbor National Cemetery, a typical third-class cemetery (1.4 acres) photographed 1902, showing an inclosure wall executed in brick and a single gate. This photograph also shows the lodge (1870), central entrance drive (c.1866), and in the distance, the flagstaff and flagstaff mound (c.1866). (Records of the Quartermaster General, RG 92, Still Pictures Division, National Archives II.)

About the same time that Quartermaster General Montgomery Meigs developed plans for cemetery lodges, he was also working on plans for perimeter walls. The Act of February 22, 1867 had specified that all national cemeteries be enclosed by a perimeter fence, known as an inclosure, made either of iron or masonry. The legislation called for these iron or stone fences for symbolic reasons, as well as for the practical function of keeping out livestock from adjoining farms. In addition, the iron and stone fences were envisioned as an improvement over the old wood paling fences, which required continual repair and painting, and were subject to breakage from livestock. On August 12, 1870, Meigs filed plans for a prototype flat-top stone wall approximately five feet high with dividing pilasters and coping stones.²⁶ As with the lodges, the walls as built varied in proportions and materials, using either stone, or brick with brick or stone coping. Over the course of the next five years, enclosing walls were completed at all Virginia national cemeteries, along with iron gates for the main entrances. The larger cemeteries, such as Richmond, generally were outfitted with central vehicular gates flanked on both sides by smaller gates for pedestrians, while the smaller cemeteries, such as Cold Harbor and City Point, had either a single vehicular gate or just one pedestrian gate (fig. 1.43, see also fig. 1.39).

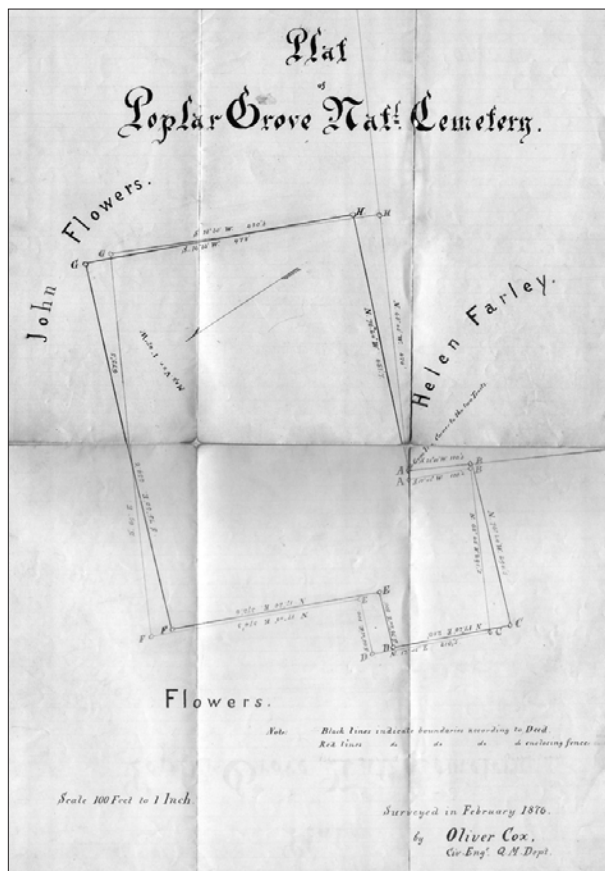
Figure 1.45: Survey of Poplar Grove National Cemetery made in February 1876 showing discrepancy between boundaries plotted in the original deed (dark line), and the actual boundary represented by the perimeter fence (lighter line). (Records of the Quartermaster General, Entry 576, Poplar Grove National Cemetery Records, box 57, National Archives I.)

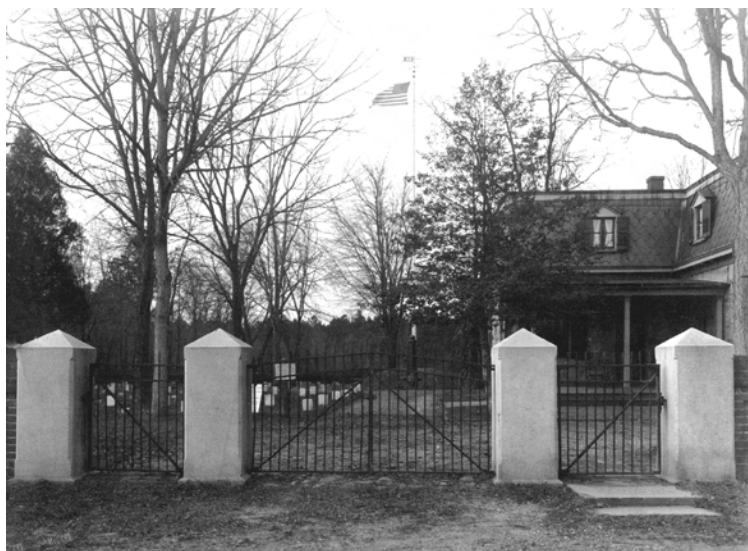
Figure 1.46: The granite and iron entrance gate at Fort Harrison National Cemetery near Richmond, installed in c.1876 and photographed in 1902. The same style gate was built at Poplar Grove in 1876. (Records of the Quartermaster General, RG 92, Still Pictures Division, National Archives II.)

The wall is well built, of the correct materials, and presents a very good appearance. The stone caps at the pilasters give strength and protection to the work and improve the general appearance of the wall. The gate

*parts are of good granite neatly cut and well set and the gates are strong. . . The ground on both sides of the wall has been graded to conform with the ground line of the wall at all points, thus giving the entire wall a uniform height of four feet six inches (4' 6") above the surface. Care has been taken to provide drainage outlets at all proper points, and to grade the ground in their vicinity as to permit discharge of all surface water from the cemetery grounds.*³⁵

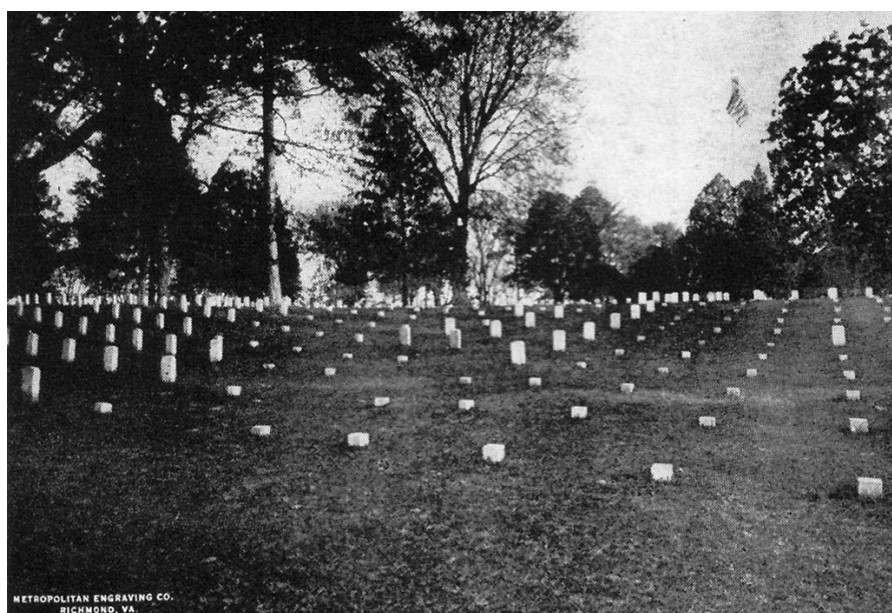
Figure 1.47: A later photograph showing the two types of grave markers installed in 1877, view southeast from the north side of the cemetery, c.1930. (Metropolitan Engraving Company, reproduced from *The City of Petersburg: Metropolis of Southside Virginia*, Louise Studio, c.1930.)

Although the new headstones continued the same white tablet form in the landscape, the substitution of blocks for the headstones at the unknown graves—amounting to over sixty percent of all grave markers—changed the uniformity of the circular plan (fig. 1.47). The new stones made clearly visible the enormous number of soldiers who died on the battlefield without proper identification and registration.

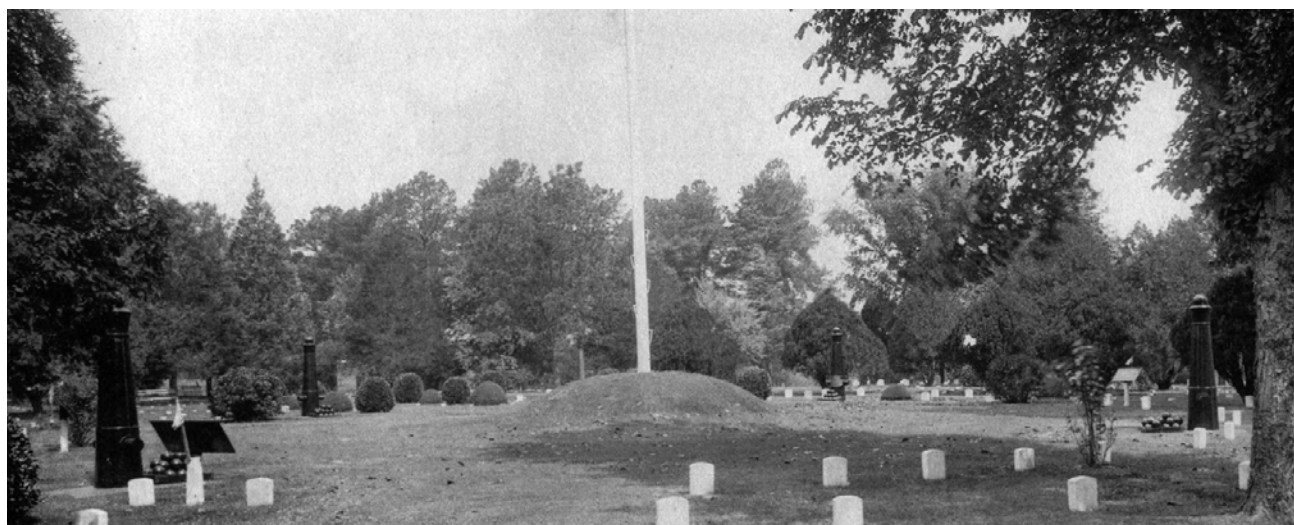
Figure 1.48: Photograph of the center of the cemetery taken in c.1895 showing the turf drives, looking northwest with one of the radial drives in the foreground. This photograph also shows the flagstaff mound (by this time without plantings), gun monuments, and numerous clipped shrubs that were maintained at this time. The iron tablet next to the gun at left contained text from the 1867 national cemetery act. (From *The Artwork of Petersburg, Virginia*, 1903.)

newly cut over with the lawn mower and looked very fine. . . It is very gratifying to see with what ease and efficiency the machine does its work. . . the grass need never be higher at any time than two or three inches.” The brick gutters, however, proved to be an impediment to the operation of the new lawn mower. By October 1878, all of the gutters, including those along the main drive, were filled with earth and turfed to facilitate mowing.⁵⁴ With the covering of the brick gutters, the cemetery lawn extended over the entire cemetery landscape without interruption. As a result, the drives largely became undefined areas of open lawn between the cemetery divisions and sections (fig. 1.48).

- There is a lack of graphic documentation on the landscape adequate to return to a character prior to c.1929. The earliest photographs show only the cemetery center (c.1895) and the main entrance (1904) (see figs. 1.48, 1.55). The 1892 Quartermaster General plan of the cemetery (see fig. 1.51) shows the location of woody vegetation, but does not indicate species, scale, or the distinction between trees and shrubs. It also does not indicate the location of flowerbeds. By 1892, there had already been much change in the vegetation, notably through the removal of the sylvan hall of elms. Returning to the dense planting scheme of c.1892 or earlier would also likely pose an impractical maintenance burden.

of second circular drive, for a total of twenty-four boxwoods. Clip these into low mounds, approximately three feet high, as shown in a 1939 photograph (fig. 4.28, see also fig. 1.48). Because there is no historic documentation for this exact planting, this is considered a compatible new addition that recalls the earlier plantings. The new plantings reinforce the center and the symmetry of the landscape by marking the filled-in drive north of the flagstaff. The shrubs will also help orient visitors to the layout of the cemetery.

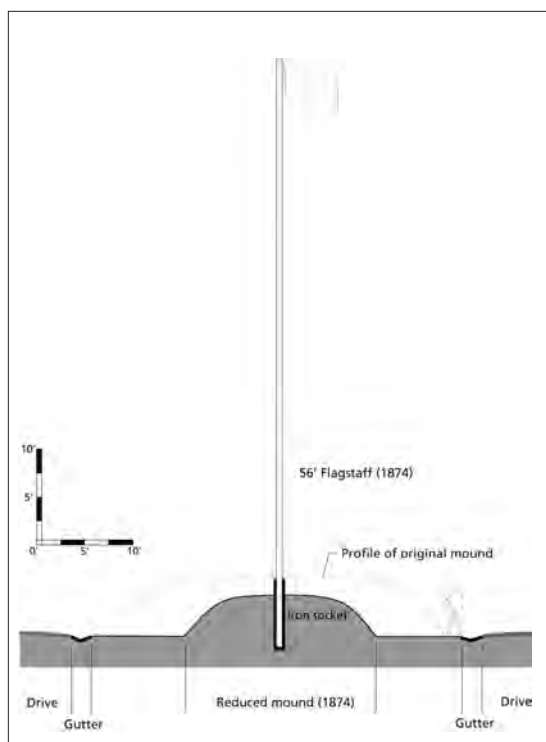
Figure 1.49: Section showing the scale of the reduced mound and flagstaff in 1874 compared to the original mound. (SUNY ESF)

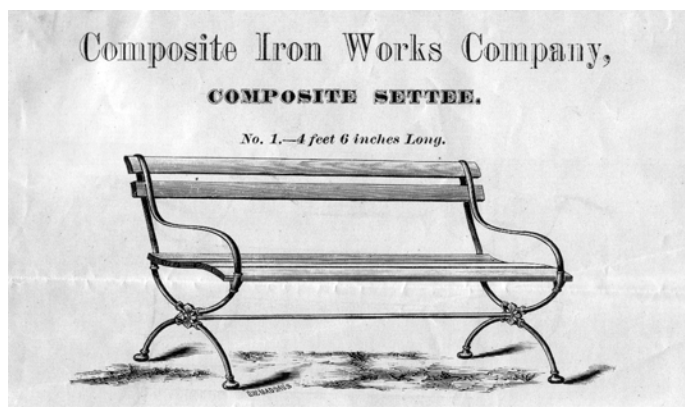
Figure 1.50: Proposal for the "Composite Settee" submitted to the Quartermaster General's Office in June 1877 by the Composite Iron Works Company of New York City. (RG 92, Records of the Quartermaster General Entry 689, National Archives I.)

bid was submitted by The Composite Iron Works Company of New York City for the "Composite Settee," at a cost of \$3.00 each (fig. 1.50). This may have been the selected bid. Twenty settees, very similar to the Composite design but without the arms, were installed at Poplar Grove along the drives by the fall of 1878. Each measured approximately four feet long and had a slender cast-iron frame with a tie rod between the legs, and wood-slat back and seat, painted dark green.⁵⁹

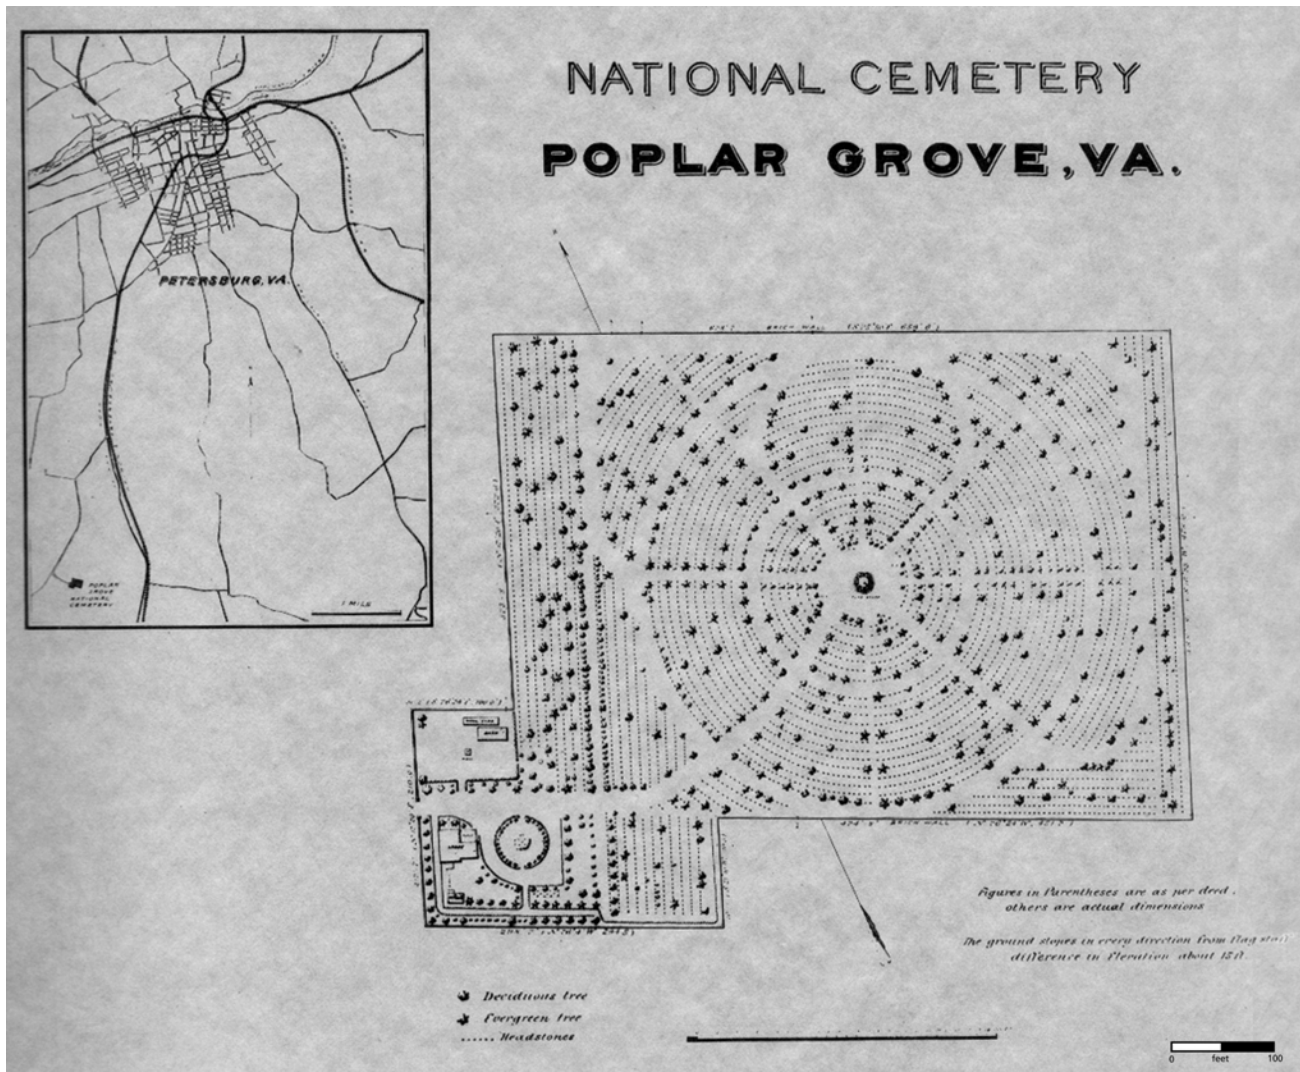
Figure 1.51: Plan of Poplar Grove drawn by the Office of the Quartermaster General, May 18, 1892, from a bound document of similar plans produced for all national cemeteries in 1892-1893. The notes at the right refer to the topography and boundaries of the cemetery; those at the left are a key to coniferous and deciduous trees, and headstones. (RG 92, Records of the Quartermaster General Entry 691, National Archives I.)

of a systematic documentation of the national cemetery system. The plan showed the local context, drives and walks, inclosure walls, central flagstaff and flagstaff mound, buildings, and trees and shrubs (fig. 1.51, see also fig. 1.48 dating to roughly the same time).⁷⁷

Construct a walk along the west side of the lodge to provide a new route to the public restroom building in place of the existing non-historic dirt path along the east side of the building. The proposed walk follows the general alignment of a walk that is shown on the 1892 Quartermaster General plan of the cemetery (see fig. 1.51). Locating the walk on this side of the lodge will avoid introduction of a new circulation feature within the assembly area. The new walk is proposed to tie into the existing historic concrete walk along the north side of the restroom

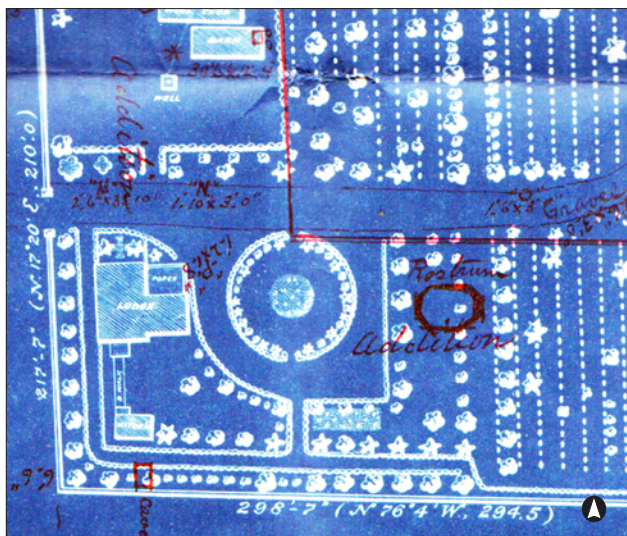
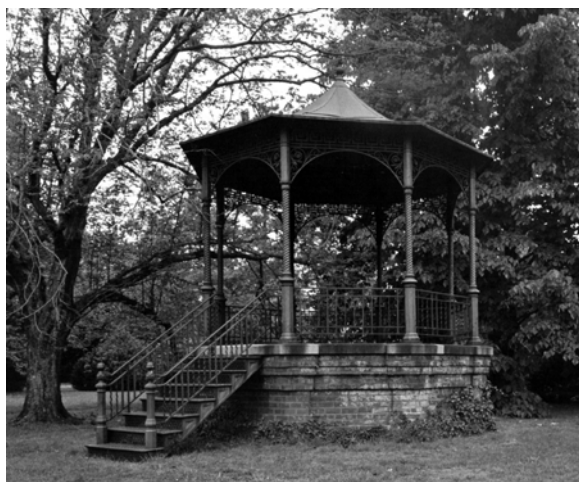
Figure 1.54 (right): The Poplar Grove rostrum completed in 1897, looking east from a 1967 photograph by Fred Bell. According to National Cemetery regulations, the structure would have been painted black with a light blue ceiling and a red roof. (Poplar Grove administrative files, Petersburg National Battlefield.)

rostrum at Poplar Grove, but it was not until the summer of 1896 that the Quartermaster's office approved the project. The Poplar Grove rostrum, an iron structure completed on January 2, 1897, was a standard design that matched the rostrums at Fredericksburg, Richmond, and Yorktown National Cemeteries, among others. It was sited in the open area between the graves in Division F and the circular turn-around (fig. 1.53). From here, orators could address people gathered in the turn-around. It was an octagonal pavilion with cast-iron posts and wrought-iron ornamentation, set on a raised brick foundation, measuring fourteen feet in diameter with a ceiling height of ten and one-half feet (fig. 1.54).⁸⁶

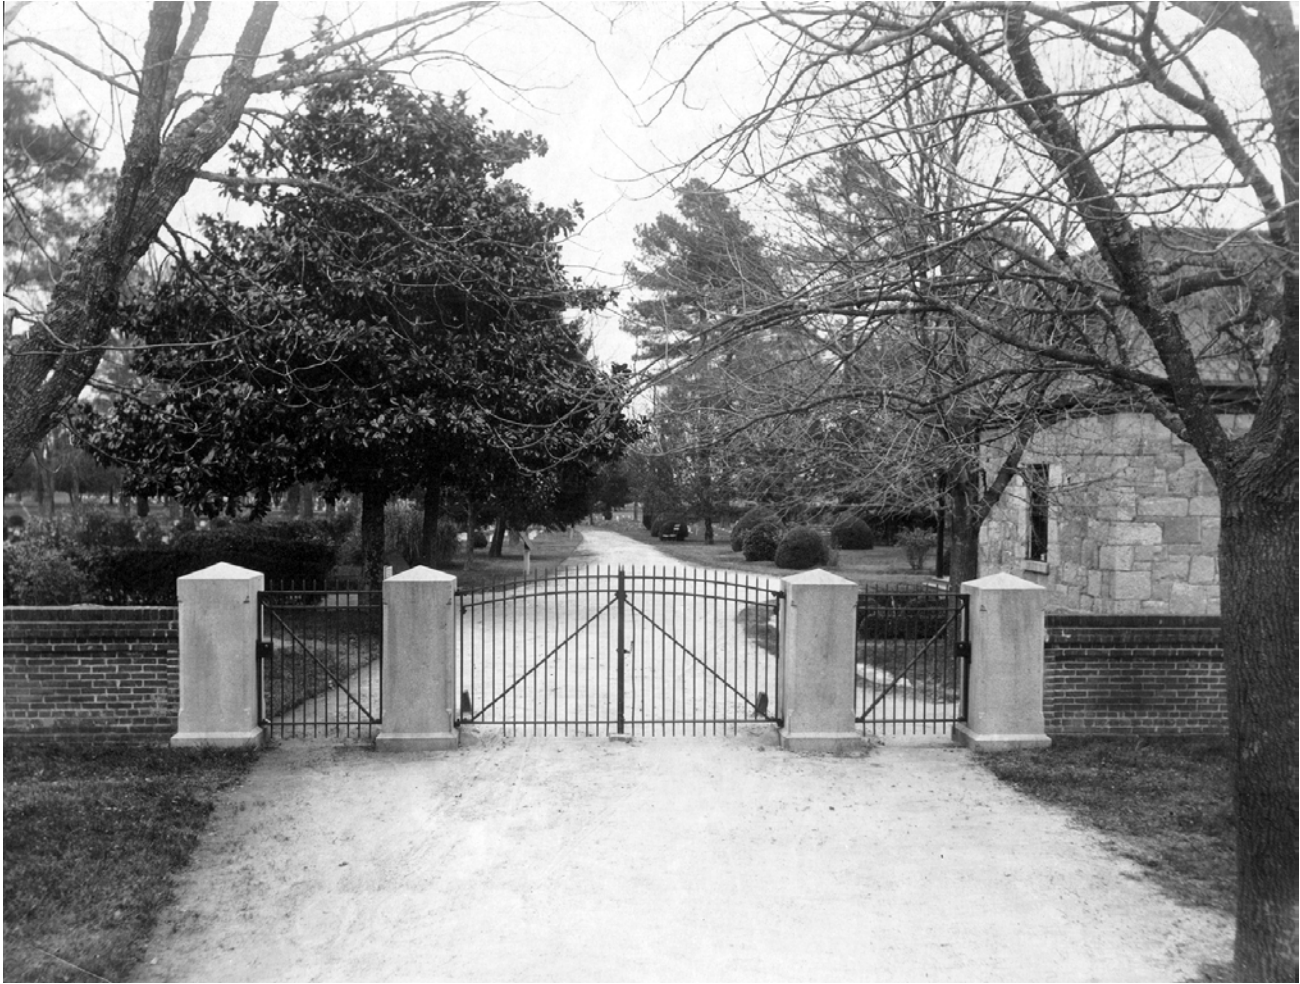
Figure 1.55: Photograph of Poplar Grove National Cemetery looking east into the cemetery at the entrance gate, 1904. (Records of the Quartermaster General, RG 92, Still Pictures Division, National Archives II.)

Soon after the turn of the century, each of the national cemeteries was photographed, with Poplar Grove photographed in 1904 from the entrance gate (fig. 1.55). Taken in late fall or winter, the photograph captured the main drive with its recent gravel surface, the 1876 entrance gates and brick inclosure wall, the 1872 lodge with its stone walls, slate roof, and darkly painted trim, and the grass-covered circular turn-around, ringed by clipped boxwoods. The photograph also shows loblolly pines in the background (remnants from the landscape of the engineers' camp), an arborvitae hedge surrounding the service yard, and two magnolias at the entrance to the service yard. Also barely visible along the drive are an iron tablet and a settee.

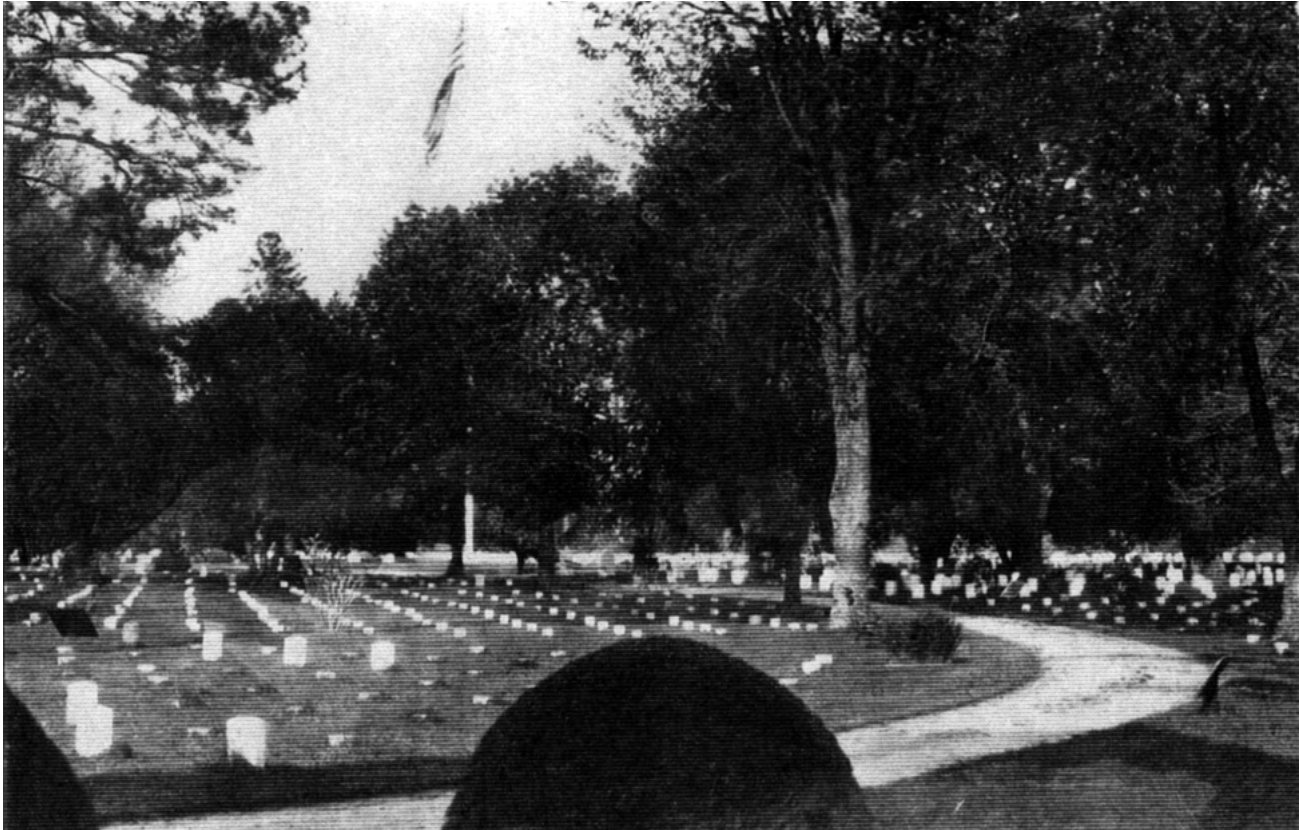
Figure 1.57: View from the rostrum looking northeast along the main drive toward the new iron flagstaff, c.1914. This photograph shows one of the Bivouac of the Dead tablets along the main drive at the right. The dark mounds in the foreground are sheared boxwood shrubs. (*War Diary of Luman Harris Tenney 1861-1865*, 1914).

A photograph of Poplar Grove taken in c.1914 shortly after the new flagstaff was installed captured the cemetery at what was most likely the height of its development, although the cemetery lacked some features and ornamental plantings it once had during Superintendent Miller’s tenure in the 1870s (fig. 1.57). The photo illustrated the graveled main drive, mature specimen trees, neatly sheared boxwoods and other scattered shrubs, iron tablets, and the new flagstaff in the distance. The lawn had been recently mown, although trimming had not been completed around the grave markers. One year after this photograph was taken on August 2, 1915, a tornado swept across the cemetery, ripping down 110 trees (approximately half of the trees in the cemetery), breaking forty-seven headstones, and damaging the roof on the forage room addition on the toolshed-stable.⁹⁹ Plans were soon underway to correct the broken headstones, and during the summer of the following year, the Quartermaster office installed replacements

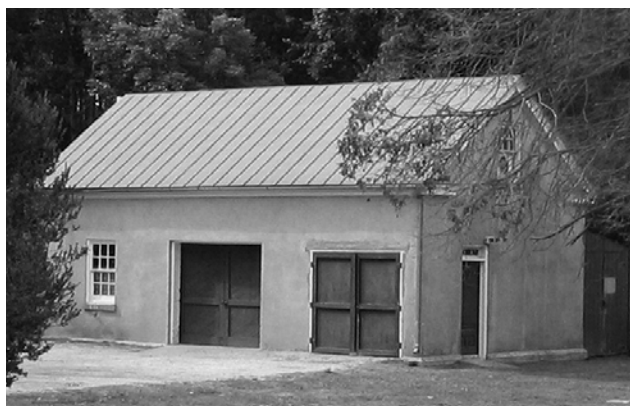
Figure 1.60 (bottom left): The stable-garage (outbuilding) completed in 1929, looking northwest from a recent photograph, 2006. The set of garage doors to the right is a later alteration. (SUNY ESF.)

In the service yard, the 1879 toolshed-stable and adjoining forage shed and tin-roofed shed were demolished in 1929 for construction of the new stable-garage. Completed at a cost of \$3,950 on October 10, 1929, the one and one-half story building was constructed of brick with a workroom and stall, and a loft for storage (fig. 1.60). Following the completion of the two new buildings, the lodge was modernized through several projects completed between 1930 and 1932 that included new utilities, removal of the slate roof and replacement with tin (matching the two new buildings), reconstruction of the front porch floor in concrete, and replacement of brick front walk with concrete.¹¹² It was probably also at this time that the trim was changed from a dark color to white, matching the trim on the garage and public restroom building.

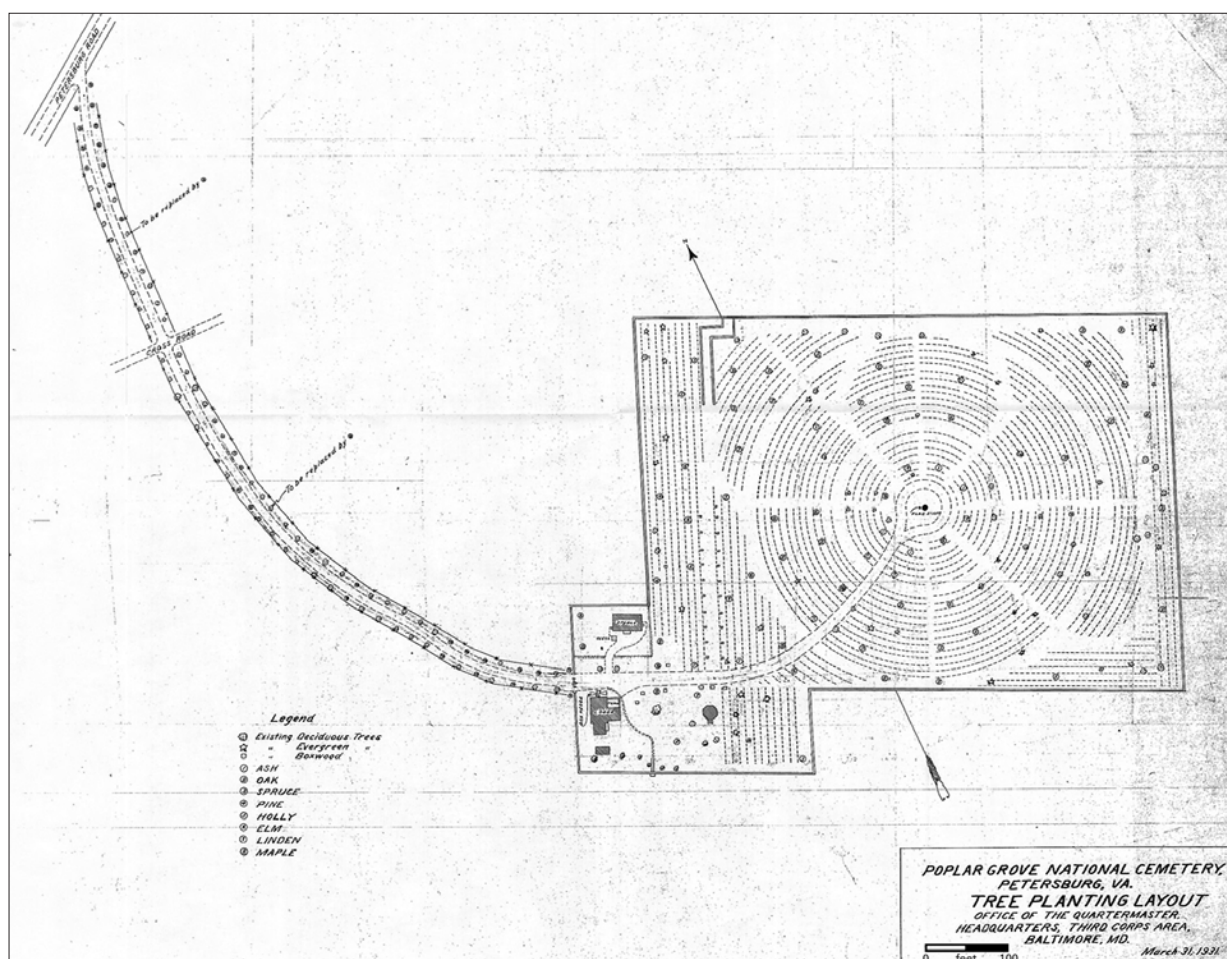
Figure 1.62: Planting plan for Poplar Grove National Cemetery and the approach road, March 31, 1931. The plan indicates existing and proposed specimen trees. (RG 79, Entry 5, Records of the War Department Relating to National Parks, 1892-1937, box 50, National Archives II.)

The spring following the installation of the flagstaff, the Quartermaster Third Corps in Baltimore finalized a tree planting plan for the cemetery, the first since the tornado of 1915 resulted in the loss of 110 trees. Dated March 31, 1931, the plan called for planting of 101 new trees that would reestablish an even distribution across the landscape and a continuous allee along the approach road (fig. 1.62). The plan also documented eighty surviving mature trees within the

cemetery, plus thirty-four boxwood shrubs, the Maltese cross boxwood hedge in front of the lodge, and an arborvitae hedge screening the service yard. Trees were specified for planting in the walks between the rows of headstones, using eight species: European mountain ash (10 specimens), pin oak (20), Norway spruce (6), Austrian pine (4), American holly (6), American elm (20), American linden (12), and Norway maple (23). The contract for the trees was awarded to the nursery of Henkels & McCoy, "Landscape Contractors – Tree Surgeons – Road Builders," of Germantown, Pennsylvania, who completed the planting on May 18, 1931. While the specifications allowed changes based on field conditions, the plan was apparently executed without substantial modification.¹¹⁴

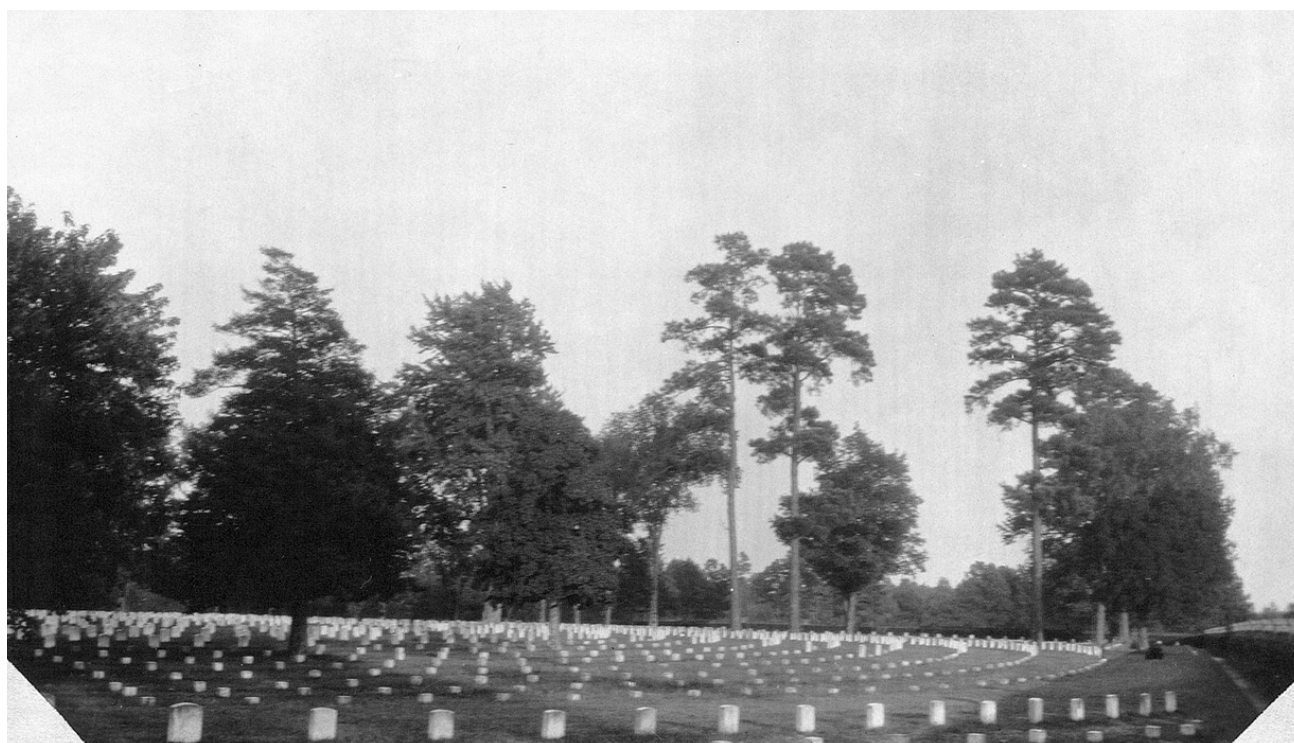
Figure 1.63: Photograph of Poplar Grove taken from the near the rostrum looking east along the ivy-covered inclosure wall, from a tree inspection report, February 1932. The caption in the report reads: "Characteristic pines and hollies at Poplar Grove, Petersburg, Va." (RG 92, Entry 1891, Office of the Quartermaster General, Correspondence, Geographic File, 1922-1935, box 1773, National Archives II.)

In February 1932, a forester with the Office of the Inspector General visited Poplar Grove in its last year under War Department administration. The report focused on plans for improving vegetation and caring for eighty of the 101 trees that had survived from the new plantings the previous year. The report also documented general conditions, including a photograph looking east from near the rostrum (fig. 1.63).¹¹⁸ The photograph showed widely spaced trees, including several tall loblolly pines—remnants from the engineers' camp—mown lawn, ivy growing on the brick perimeter wall, headstones, and the blocks marking unknown graves. Although generally well maintained, upon closer inspection the photograph reveals that the tablets and blocks were stained, some were leaning or sunken, and the surrounding grass was not closely trimmed.

The condition of the grave markers documented in the forester's photograph apparently spurred action on their improvement beginning in the spring of 1932. At this time, the newly-appointed cemetery superintendent, Walter Pearce, reported: "...Headstones, Is in poor alinement, Many of them was never aligned, and to line them now will be a job, Those that need lowering, raising and striating up will be attended to soon" [sic].¹¹⁹ Over the course of the next year, cemetery laborers worked on aligning and cleaning the stones, although the work remained incomplete. To advance the work, in the fall of 1932 the Quartermaster Depot

Figure 3.3: Historic view of the burial grounds in 1932, taken from near the rostrum looking east along the south wall showing the upright headstones and blocks defining grass drives and walks, and widely spaced specimen trees. (Repeat of fig. 1.63, National Archives II.)

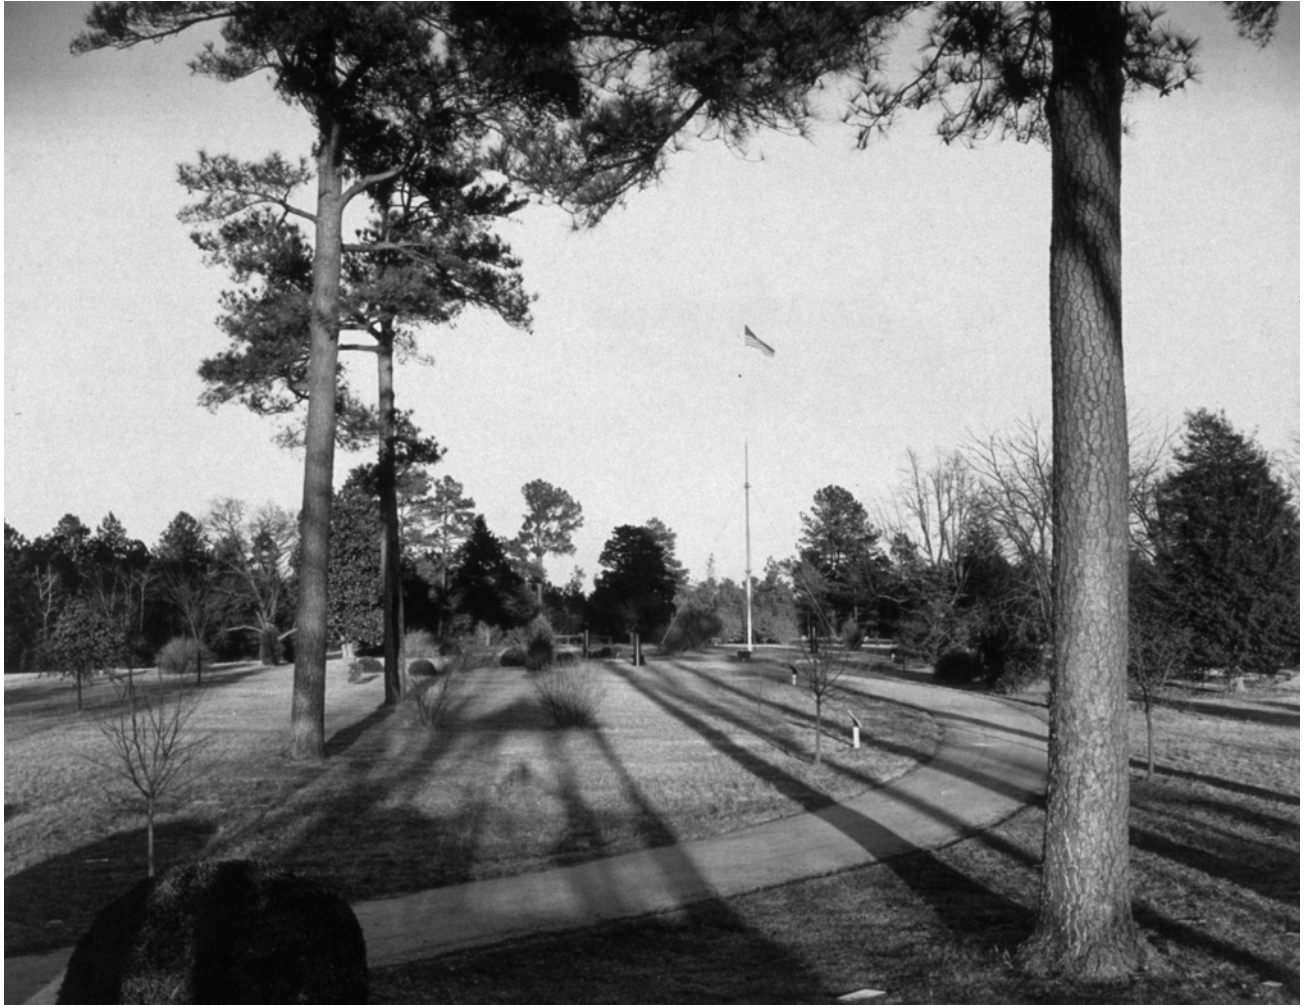
Figure 1.68: A 1939 photograph looking northeast toward the flagstaff from the rostrum showing the change in character with conversion of the headstones and blocks into flat markers. Several of the markers are visible at the lower right. Note the remaining tablets and gun monuments. (Copyright The Library of Virginia, from Virginia Room Exhibit at the 1939 World's Fair, image /WF/05/06/017.jpg.)

Return the approach road to its historic asphalt surface to give it more defined and well-maintained character. The 1931 specifications prepared by the Third Corps Area of the Quartermaster General were for a four-inch-stone base and two-inch emulsified asphalt penetrating wearing surface. As shown on a 1939 photograph of the main drive that was resurfaced at the same time (see fig. 1.68), this asphalt weathered to a gray color, and featured no curbs or other edging. The road was specified for a twelve-foot width; this remains the approximate existing width, except for the widened strip between the parking lot and gates. Return this widened strip to twelve feet and taper out to align with the inside edge of the outer (pedestrian) granite piers. The pavement should have straight, well-defined edges for a well-kept appearance. Maintain the shoulders as stabilized turf that can accommodate limited traffic. The 1931 work specified twelve-inch earthen (grass-covered) shoulders. Expand these to four feet for an overall width of twenty feet (twelve-foot pavement and four-foot shoulders on each side) sufficient to allow two oversized vehicles to pass.

Return the main drive to its historic asphalt surface to give it more defined and well-maintained character. The 1931 specifications prepared by the Third Corps Area of the Quartermaster General were for a four inch-stone base and two-inch emulsified asphalt penetrating wearing surface. As shown on a 1939 photograph (see fig. 1.68), this asphalt surface weathered to a gray color, and had no curbs or other edging. The road was specified at ten feet in width, approximately the same as the existing surface except where it has been widened near the lodge and service yard. Remove the existing asphalt to return the pavement to the historic grade level with the turf. Resurfacing of the main drive should be coordinated with resurfacing of the approach road (CSA Task 6).

Figure 4.28: A 1939 photograph showing low, clipped mounded boxwood shrubs along the east-west walk west of the flagstaff that date to the historic period. One of the historic iron tablets is visible at the right side of the photograph. (Detail of fig. 1.68, copyright Library of Virginia.)

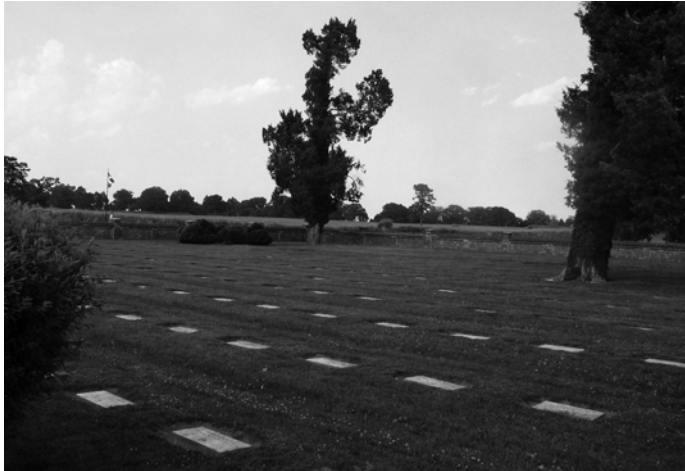
Figure 1.69: Replacement flat markers at Yorktown National Cemetery installed in c.1940, looking northeast from a recent photograph, 2006. In the background is the Revolutionary War battlefield. (SUNY ESF.)

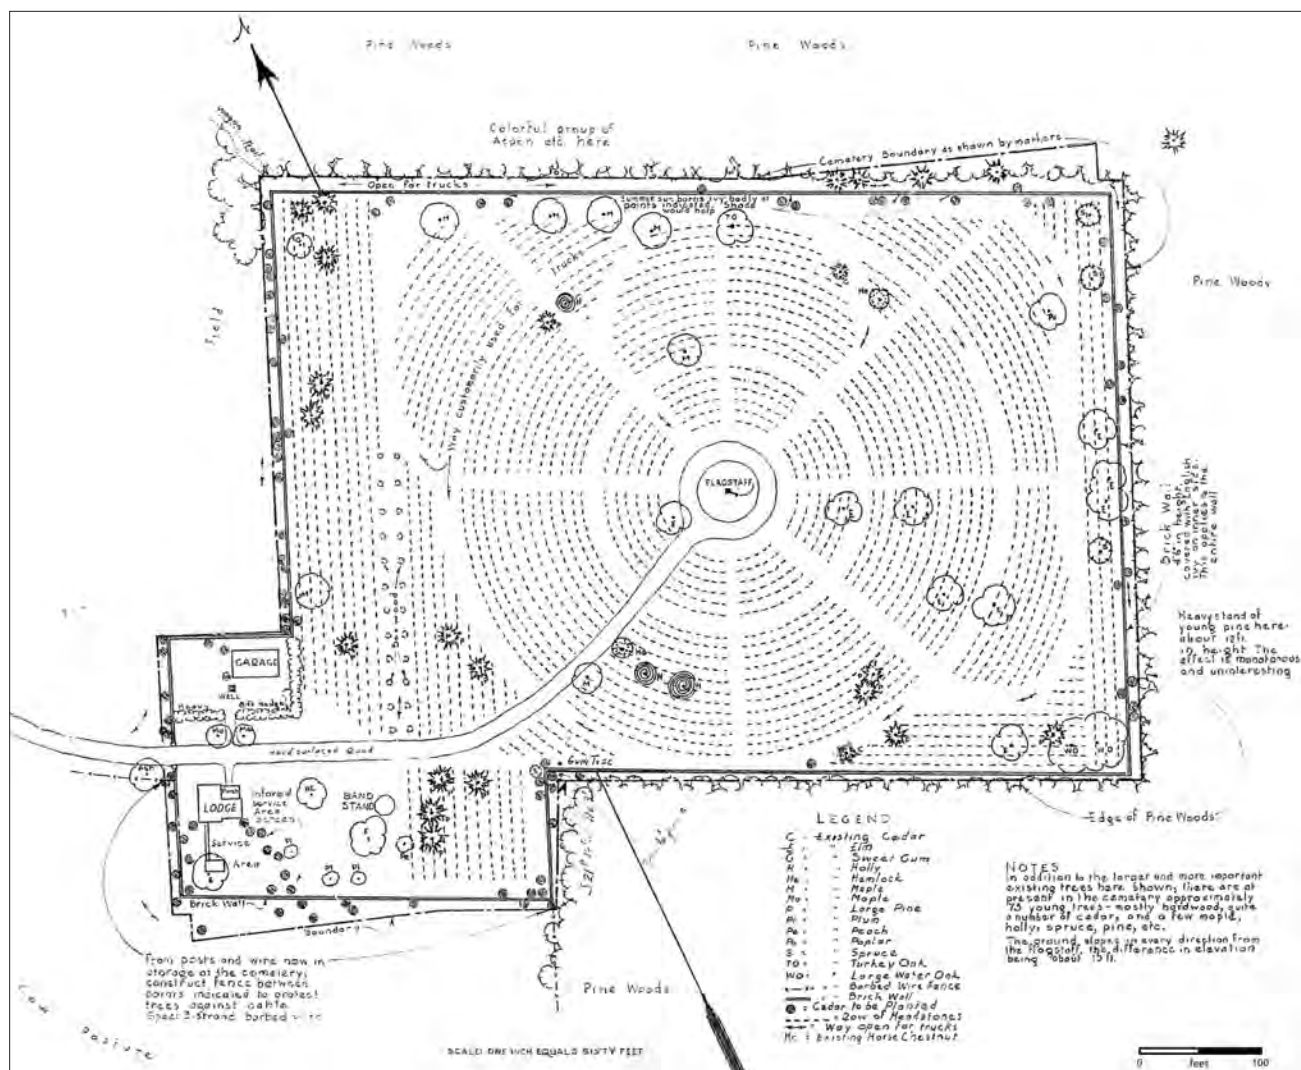
Figure 1.70: "Proposed Planting at Poplar Grove National Cemetery," 1937. The plan for planting 115 red-cedar trees also documented existing conditions except for young trees planted in 1931. (National Park Service Branch of Plans and Design, 29 May 1937, drawing PETE 325-8041, National Park Service Technical Information Center.)

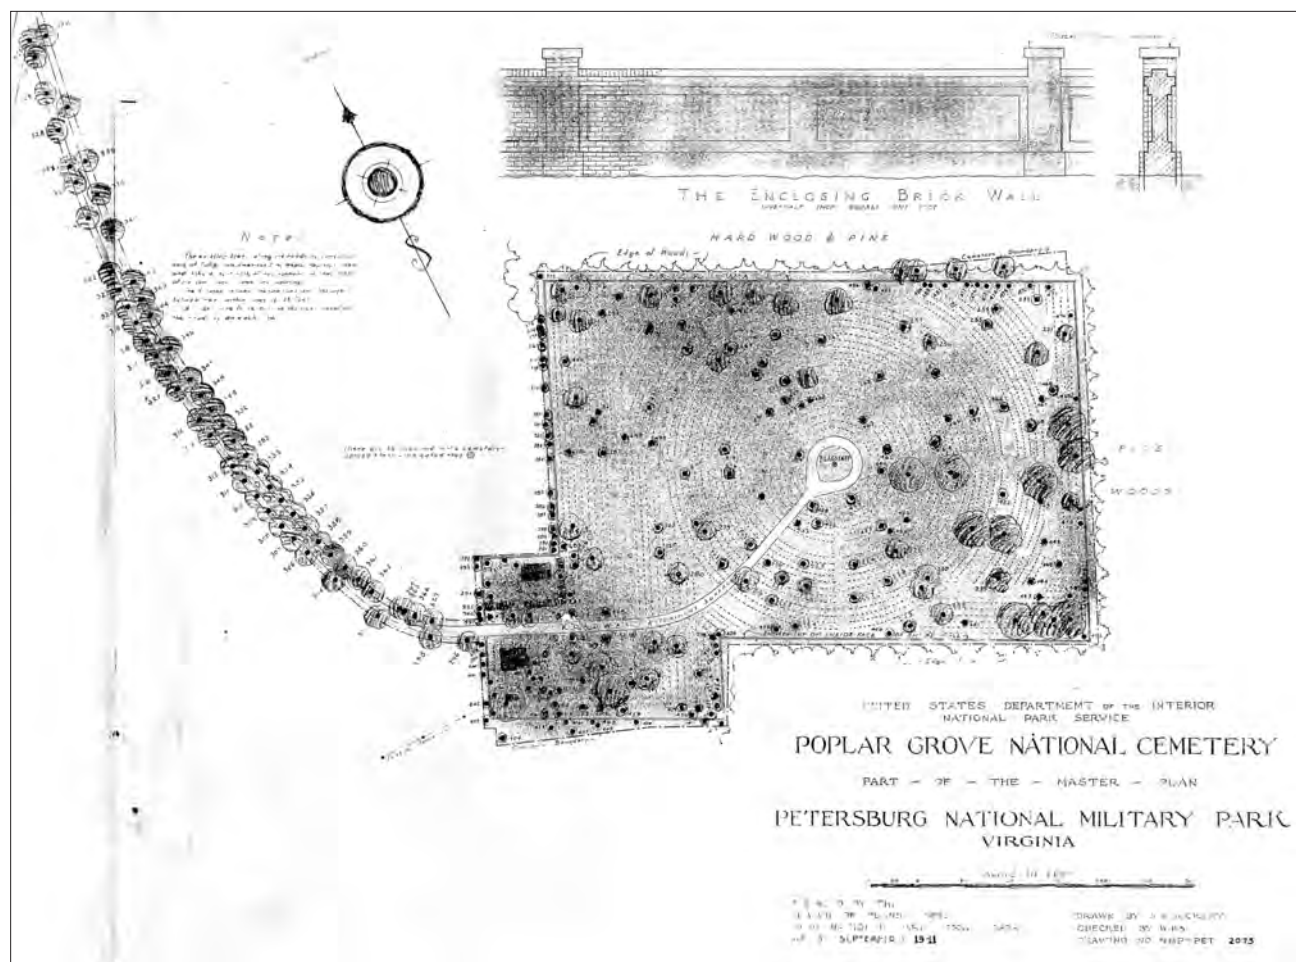
Figure 1.71: Rendered existing conditions plan of Poplar Grove completed for the Petersburg National Military Park master plan, c.1941. (National Park Service Branch of Plans and Design, from data as of September 1, 1941, drawing PETE 325-2073, National Park Service Technical Information Center.)

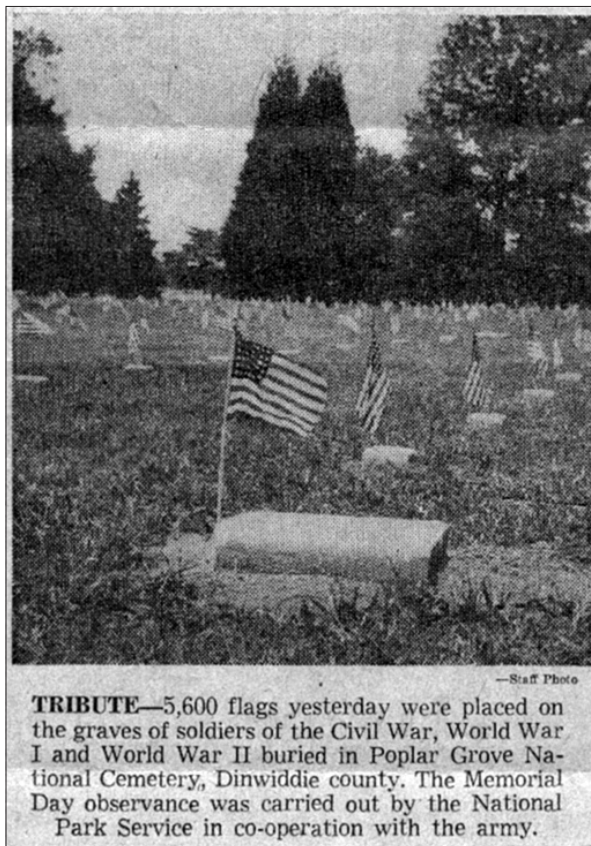
Figure 1.72: Item in *Richmond Times-Dispatch* on Memorial Day Services at Poplar Grove, May 29, 1957, illustrating recent work that included repositioning the headstones and blocks slightly above grade. (Clipping in RG 79, Series A58, Box 537, Poplar Grove National Cemetery, National Archives II.)

painting the entrance gate, tree trimming, and a general leveling and clean-up of the grounds. The work included addressing the condition of the grave markers in fulfillment of the MISSION 66 prospectus. The park did not heed Staff Historian Roy Appleman's suggestion, made in his letter to the Regional Director, that "... the only course is to raise the headstones and set them upright like they were originally."⁶¹ Rather than use new stones, Appleman had recommended that the old stones be set with iron pins in new foundations, at an estimated cost of \$2.00 per headstone. Instead, the park simply raised the existing flat headstones and blocks about two inches above grade. Despite previous problems with settling, the headstones were just set on the ground. Around this time, the park replaced a number of broken stones and blocks with contemporary government flat markers. Much of the work had been completed by Memorial Day in preparation for a ceremony carried out by the park in cooperation with Fort Lee, at which time American flags were placed at each grave marker (fig. 1.72).⁶²

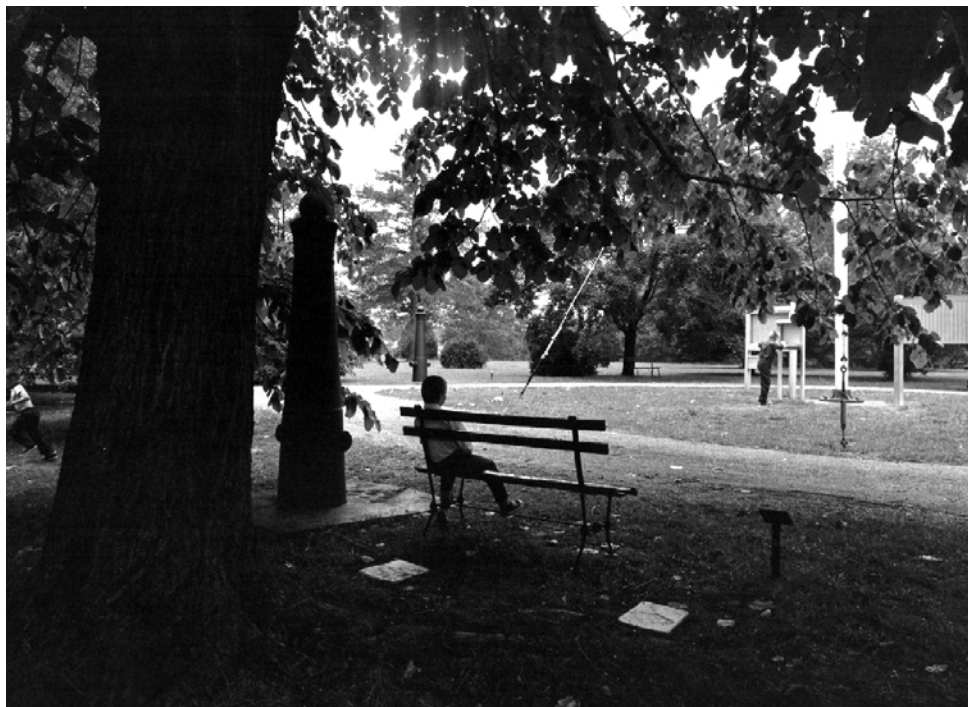
Figure 1.73: View northeast across the center of the cemetery in July 1968 showing the signs near the flagstaff installed in c.1957. Also visible are small signs in the foreground identifying the radial drives (installed c.1957). Note that the shot had been removed from in front of the gun monuments. The identity of the people is not known. (Photograph by Fred Bell, June 2, 1968, Poplar Grove administrative records, Petersburg National Battlefield.)

the new plan named the radiating drives (except for the main drive) by letters A through F. Small iron tablets with the letter designation were installed at the head of the drives on the innermost circular drive (see fig. 1.73).⁶⁴

Over the course of the two decades following the 1957 improvements, little additional work was undertaken at the cemetery. The park continued to maintain most of the features remaining from the War Department era, including the four gun monuments, settees, and flagstaff anchored by guy wires (see fig. 1.73).

Figure 4.29: A 1968 photograph showing a remaining c.1877 wood-slat and iron frame settee (left), and example of a contemporary bench with similar design. (Left: detail of fig. 1.73, Petersburg National Battlefield; right: item AL006, "Traditional Garden Bench," Benches.com, www.benches.com.)
