CULTURAL LANDSCAPE REPORT FOR POPLAR GROVE NATIONAL CEMETERY

PETERSBURG NATIONAL BATTLEFIELD

DINWIDDIE COUNTY, VIRGINIA

Olmsted Center for Landscape Preservation
National Park Service, Boston, Massachusetts 2009

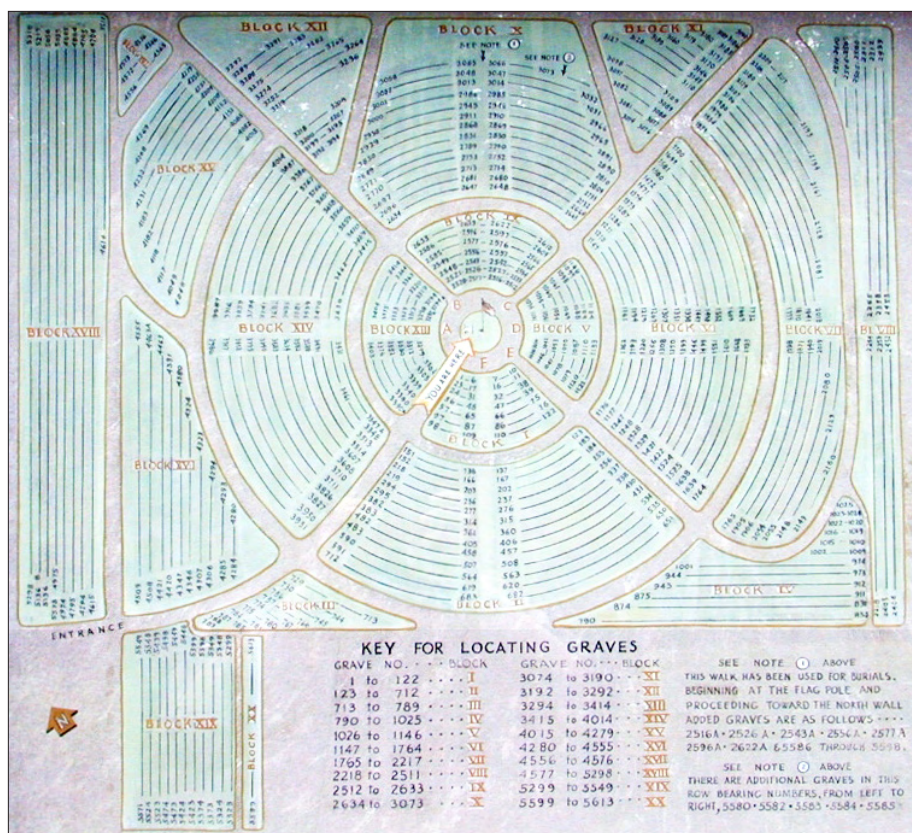
Figure 1.74: Plan of Poplar Grove showing the c.1957 organization by block, and naming of radiating drives by letter. This plan was posted, along with interpretive text and a drawing of Poplar Grove Church, in one of the aluminum-frame signs installed to either side of the flagstaff in c.1957. (Petersburg National Battlefield.)

upright position. The new organization did away with the division and section designations and reordered the cemetery into twenty "Blocks" identified by Roman numerals (fig. 1.74). Ten of the blocks incorporated more than one section, and a new block (Block XX) was created for the row of recent burials on the east end of Division F (Block XIX). In addition to redesignating the divisions and sections,

the new plan named the radiating drives (except for the main drive) by letters A through F. Small iron tablets with the letter designation were installed at the head of the drives on the innermost circular drive (see fig. 1.73).⁶⁴

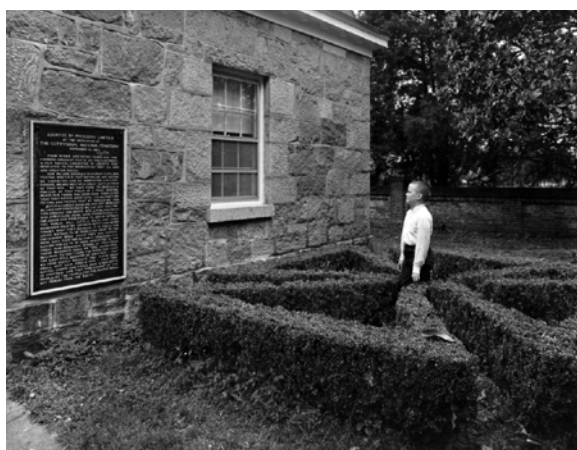
Figure 1.75: A 1968 photograph looking southwest at the Maltese cross hedge (c.1871), with the Gettysburg Address on the lodge wall added in c.1903. The identity of the boy is not known. (Photograph by Fred Bell, June 2, 1968, Poplar Grove administrative records, Petersburg National Battlefield.)

The park maintained the existing trees and shrubs, including the arborvitae hedge around the service yard, and the boxwood Maltese cross hedge in front of the lodge (fig. 1.75). New trees were planted in keeping with the existing informal arrangement, and included mostly holly, red maple, yellow birch, and willow oak. The gravestones, despite the work done in 1957, continued to sink and heave, and by the early 1970s, many had once again become obscured by grass. Cars drove over the graves along the main entrance drive when passing in opposite directions, and mowers continued to batter the edges of the stones.⁶⁵

- **Vegetation: Maltese Cross Hedge (non-existing historic feature)**
Replant a boxwood (*Buxus sempervirens*) hedge in the outline of a Maltese cross (5th Corps badge) in front of the lodge. This hedge, which was removed in c.1985, occupied the present lawn strip between the lodge and the main drive, with approximate overall dimensions of ten feet square. As shown in a 1968 photograph (see fig. 1.75), each section of the hedge was clipped in a rectangular profile, approximately thirty inches high by eighteen inches wide. Maintain the ground surrounding the hedge as lawn, and mulch the understory of the hedge with natural, dark mulch.

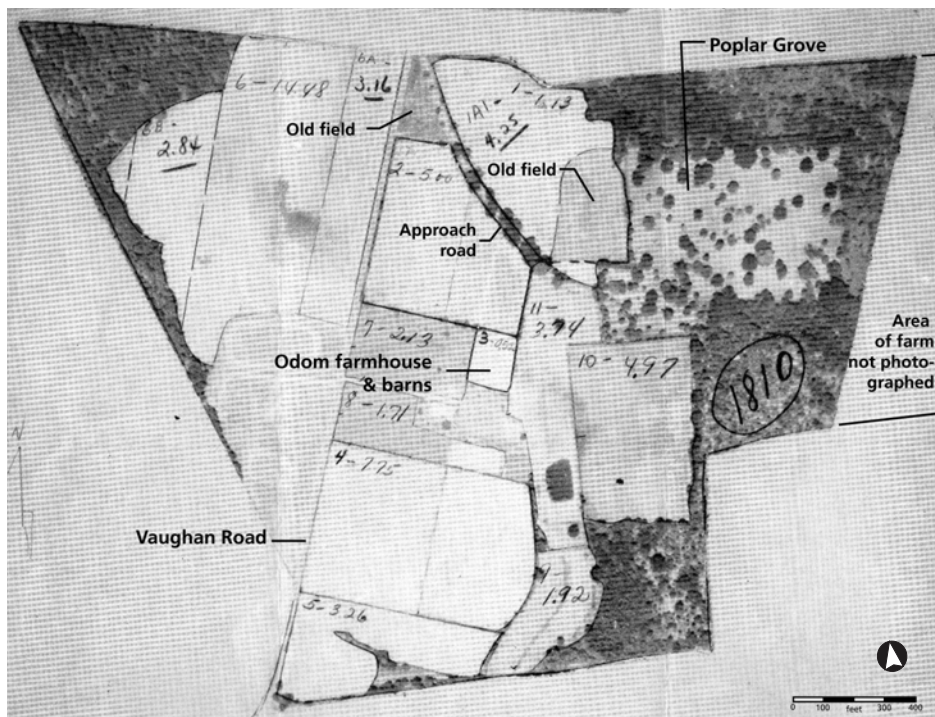
Figure 1.76: A 1969 aerial photograph of the Odom Farm that surrounded the national cemetery. The photograph does not include the eastern part of the farm (to right of the cemetery). (Poplar Grove administrative records, Petersburg National Battlefield.)

land was owned by the Odom family and known by the 1970s as “Beau Vista Farms.”⁶⁶ Lester G. and Roberta E. Odom had acquired the ninety-acre farm from Russell and Audrey Garner in 1954.⁶⁷ A 1969 aerial photograph of the farm documented the acreage of the farm’s fields surrounding the cemetery (fig. 1.76). Two years later in 1971, Lester Odom

Figure 3.1: Historic natural systems and spatial organization characteristics in the setting of Poplar Grove National Cemetery, shown on a c.1969 aerial photograph taken prior to suburban development in the early 1970s. These conditions approximate those of the historic period, 1866-1931. (Detail of fig. 1.76, Petersburg National Battlefield, annotated by SUNY ESF.)

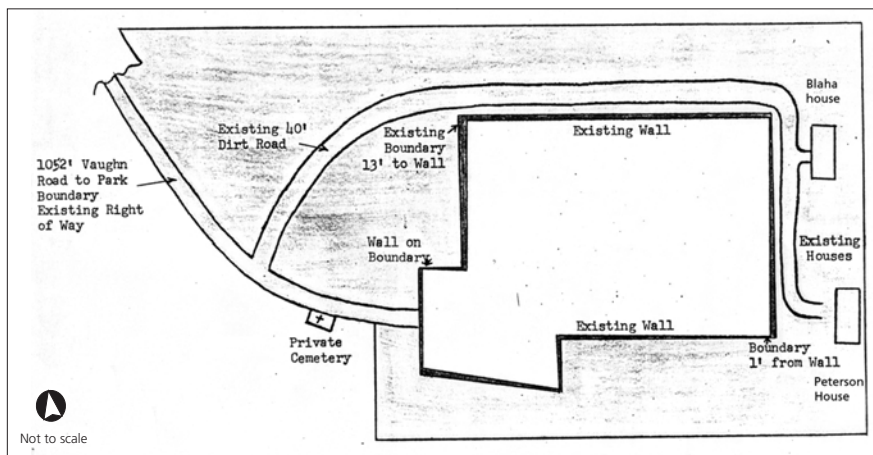
Figure 1.77: Sketch made by park staff in 1977 showing the Blaha and Peterson houses and access drive built in c.1972. The shaded area was proposed for park acquisition in 1977. (Poplar Grove administrative records, Petersburg National Battlefield, annotated by SUNY ESF.)

small cemetery along the approach road, which she did, according to the deed, “expressly for the purpose of providing to the heirs of Lester Grady Odom, deceased, and their descendents, grantees herein, a place for maintaining a family cemetery” (fig. 1.77).⁶⁹ Around the same time, Mrs. Odom subdivided two lots along the north and east sides of the national cemetery and sold them to Anthony Blaha and Ronald Peterson, each of whom built single-family houses on the property, within seventy-five feet of the east wall. To access these houses, a driveway was built off the cemetery approach road, along the edge of an old field bordering the west side of the cemetery, extending along the full length of the cemetery’s north side, and turning south to follow the cemetery’s east wall.⁷⁰

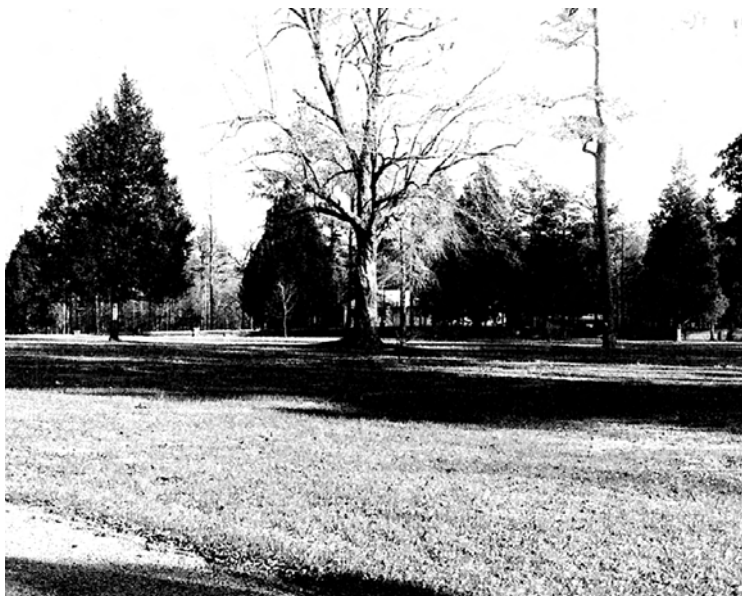
Figure 1.78: View looking east across the cemetery from the main entrance drive toward the Peterson house built in c.1972, photographed 1978. (File PETE D-58, National Park Service Technical Information Center.)

most of the woods were cleared for the access drive, leaving a thin hedgerow that opened up views of the drive, power line, and wetlands and fields to the north. Trees were also cleared around the two houses, which broke up the wooded enclosure and made the houses visible from within the cemetery (fig. 1.78). Despite this development, the rural setting

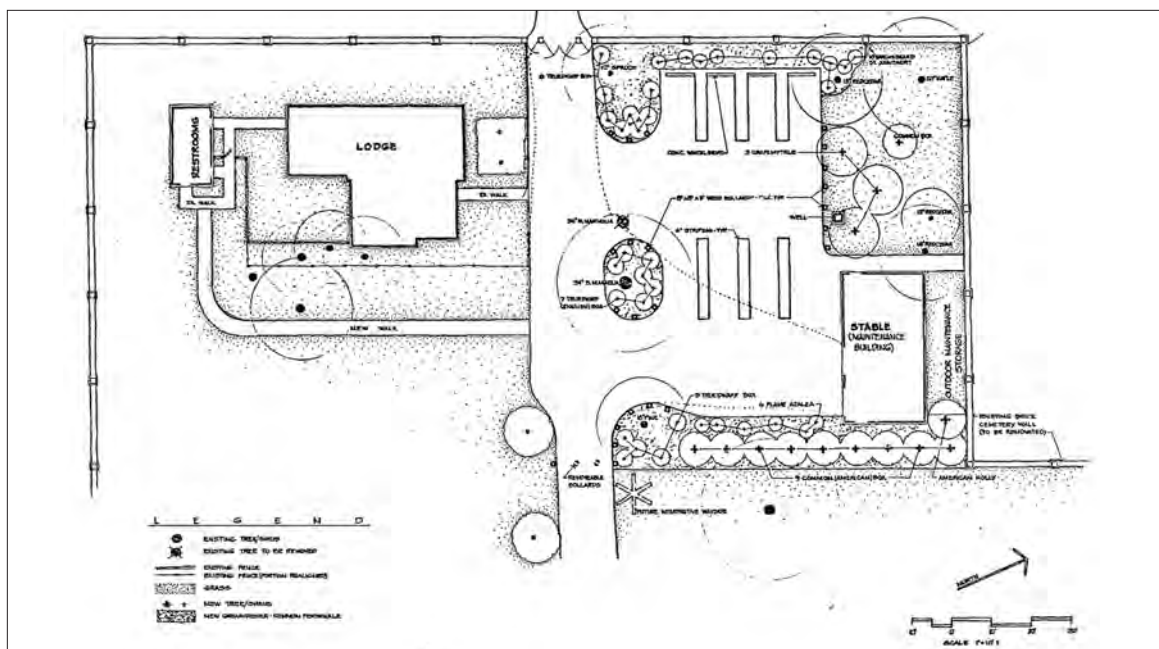
Figure 1.79: Plan completed in 1977 for redesign of the cemetery entrance area. (Livas & Associates, Architects, "Visitor Park & Grounds Improvement, Poplar Grove National Cemetery," August 1977, Drawing PETE 325-41012, National Park Service Technical Information Center.)

A scope of work was soon developed by the National Park Service's central design office, the Denver Service Center, with final design scheduled for 1979 and construction the same year.⁷⁵ Details of the project, developed in 1977 by Livas & Associates Architects of Norfolk, Virginia, included setting the headstones and blocks one and one-half inches above grade on concrete foundations to prevent subsidence; installing granite paving around the flagstaff and one remaining gun monument; closing the main drive to vehicles by placing bollards east of the service yard; installing an interpretive wayside near the service yard; repairing the inclosure wall, lodge, stable, restrooms, and rostrum; and redesigning the entrance and service yard into a temporary visitor parking lot, with the long-term goal of creating parking outside of the cemetery (fig. 1.79). Plantings were only proposed around the new parking lot, pending further research on historic plantings and possible disturbance that tree plantings could cause to the graves.⁷⁶ Funding for

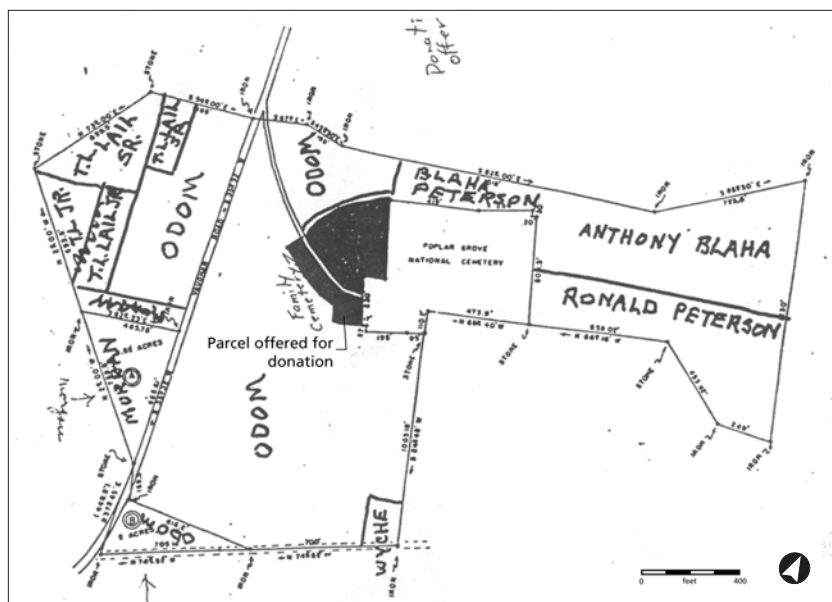
Figure 1.80: Survey of the Odom farm showing subdivisions and plot (shown in black) offered for donation by Roberta Odom in 1987. (Poplar Grove administrative records, Petersburg National Battlefield.)

between the west wall of the cemetery and the private driveway to the Blaha and Peterson houses, and a strip along and including a section of the approach road and Odom cemetery, extending one hundred feet south of the road (fig. 1.80). The remainder of the approach road extending out to Vaughan Road was not included in the proposal. Roberta Odom offered the property as a donation, in return for the park's commitment to maintain her family's small cemetery plot. According to Deckert, the 3.7 acres

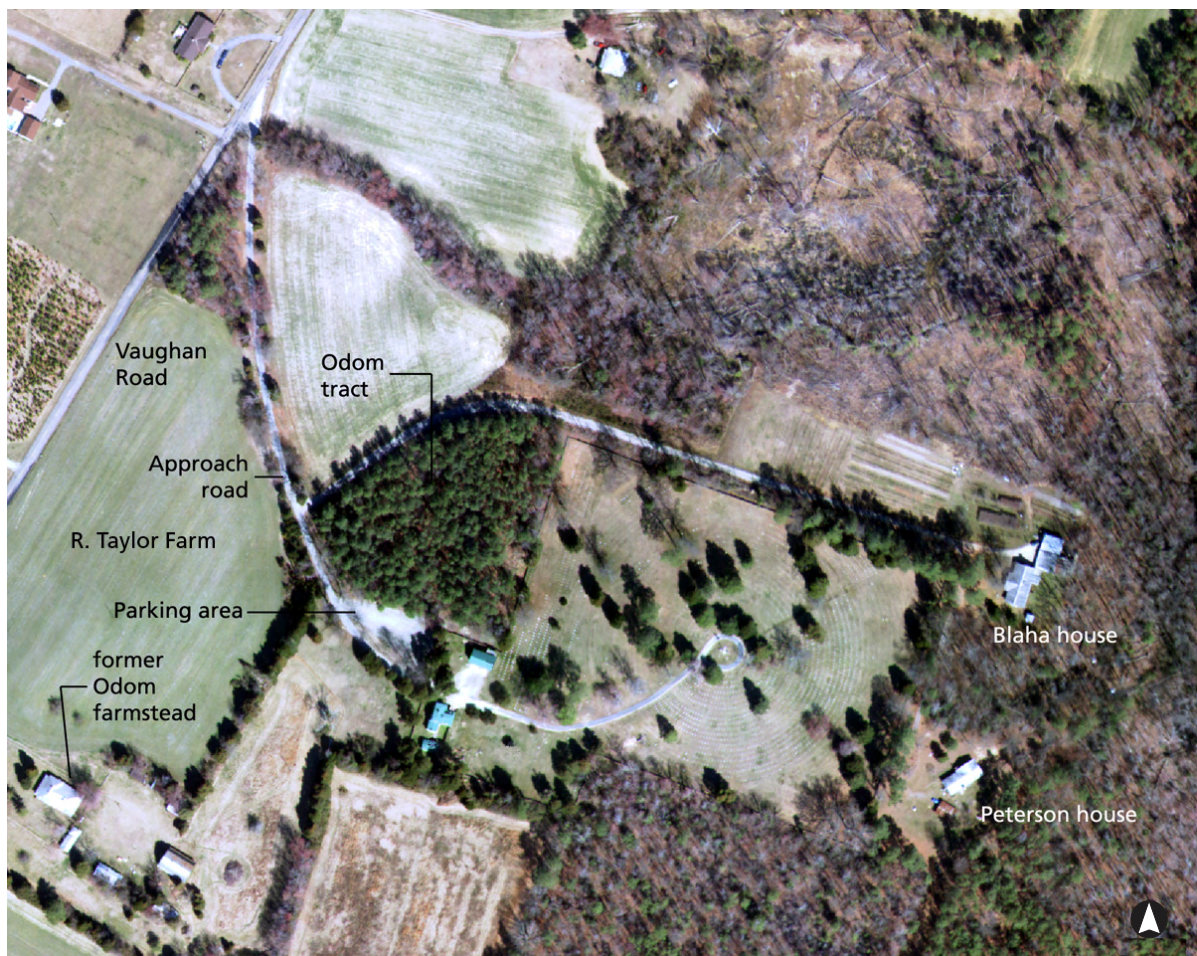
Figure 1.81: Aerial photograph of Poplar Grove National Cemetery and its setting, spring 2004.
(Poplar Grove GIS database, Petersburg National Battlefield, annotated by SUNY ESF.)

Despite this, the park managed the 3.7-acre parcel as park land. In c.1995, the park built a small visitor parking lot on the parcel along the north side of the approach road, adjoining the cemetery gates (fig. 1.81). Beyond the parking lot were young, dense woods of loblolly pine that had grown up since the driveway

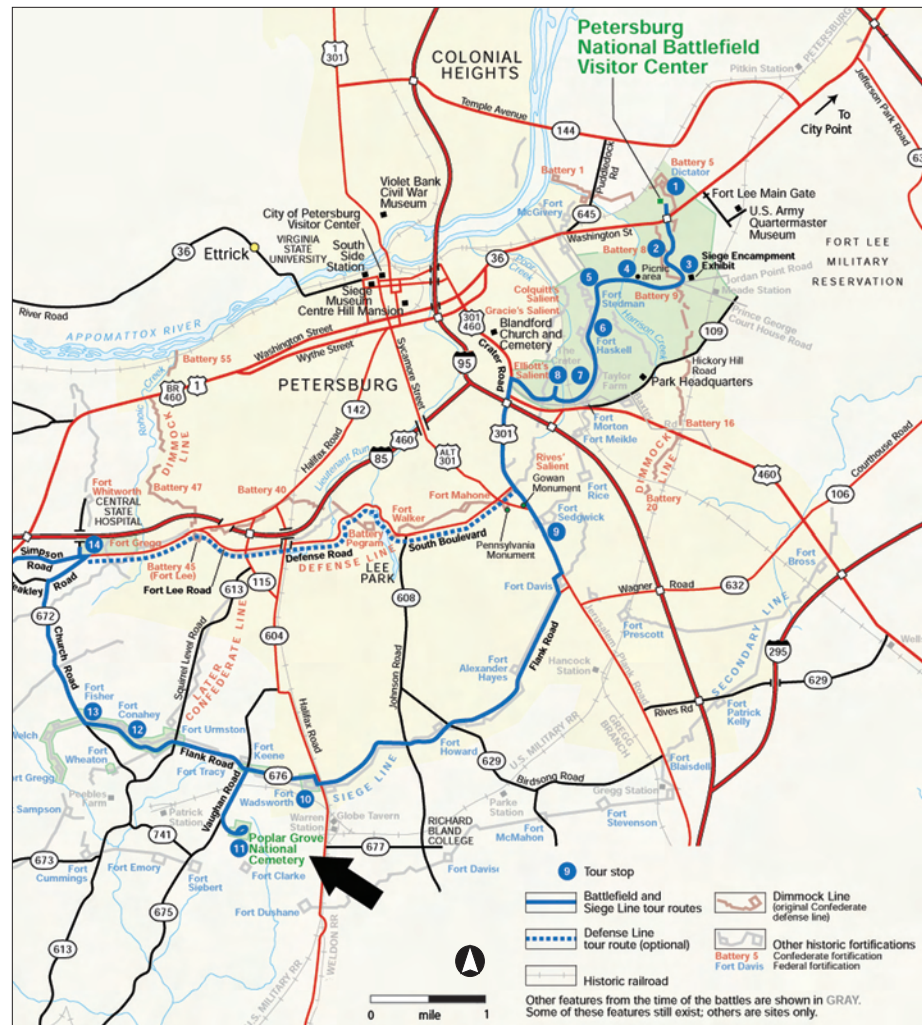
Figure 2.1: Map of Petersburg National Battlefield showing park lands and the Siege Line Tour in relation to the city of Petersburg (yellow area) and Poplar Grove National Cemetery (indicated by black arrow). (Petersburg National Battlefield park brochure, 1996, annotated by SUNY ESF.)

Poplar Grove National Cemetery is in the Rohoic District of Dinwiddie County, approximately one-half mile south of the Petersburg city boundary and roughly halfway between Interstate 85 to the west and Interstate 95 to the east (fig. 2.1). While much of Dinwiddie County is rural in character, the area surrounding Poplar Grove is a suburban patchwork of woods, farms, residential development,

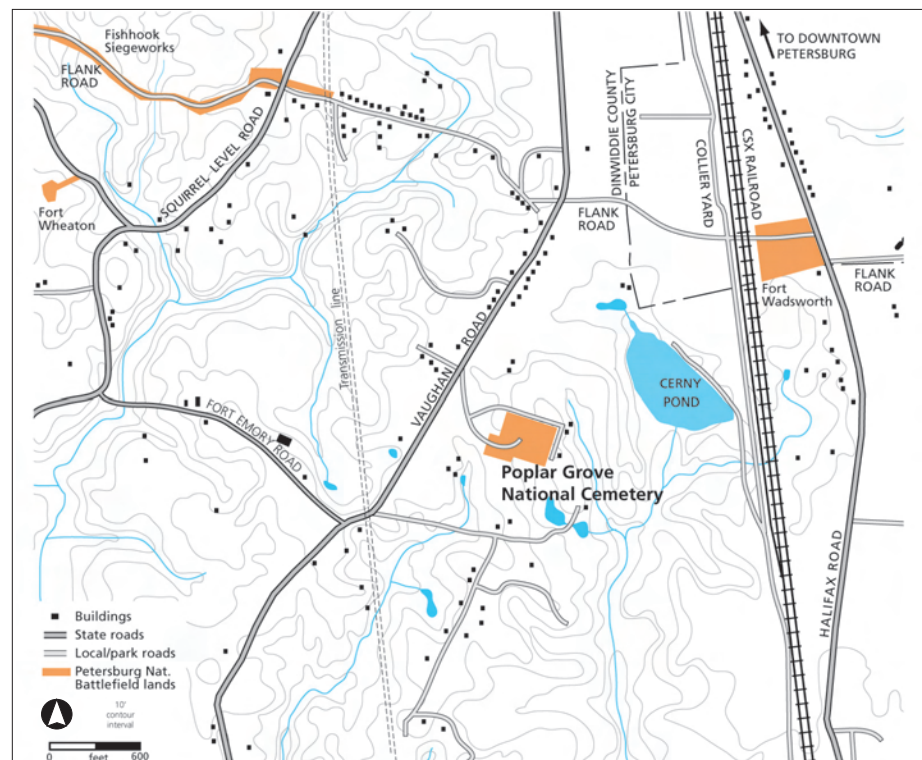
Figure 2.2: The setting of Poplar Grove National Cemetery showing city boundary, roads, rail line, suburban development, and park lands. (SUNY ESF.)

The landscape of the Siege Line Tour near Poplar Grove is characterized by secondary roads, cultivated fields, woods, and suburban houses (figs. 2.2, 2.3). Northeast of the cemetery is Cerny Pond, a ten-acre water body constructed after 1955. Beyond the pond and about 2,500 feet east of the cemetery is the CSX "S" Line railroad and Collier Yard. This line was the Petersburg & Weldon Railroad during the Civil War and later became the Atlantic (Seaboard) Coast Line Railroad. It is a 126-mile corridor between Petersburg and Raleigh, North Carolina that is currently being studied for reconstruction as part of the Southeast High Speed Rail Corridor.³ The railroad and much of the modern development in the vicinity are not visible from within the cemetery.

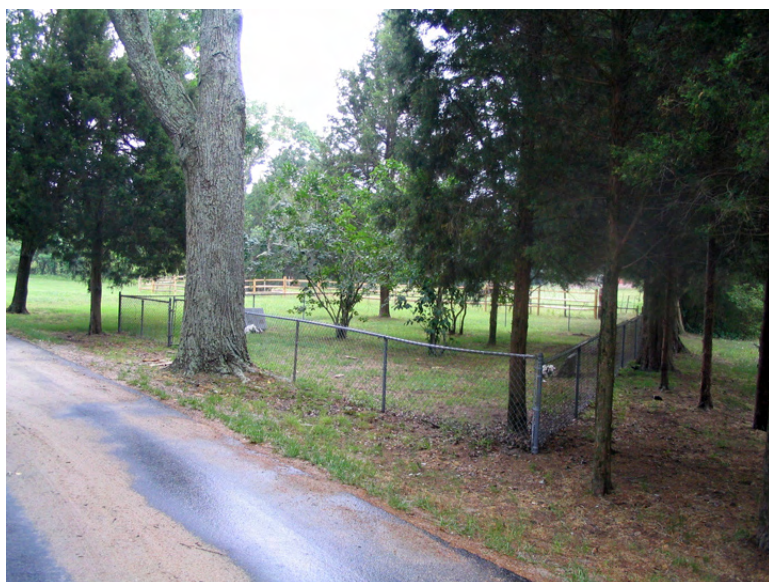
Through the National Park Foundation-owned Odom tract, the approach road is lined by woods and remnant allee trees (fig. 2.12). On the south side of the road approximately 200 feet west of the cemetery gates is a small (0.05 acre) family burial plot established by the Odom family in 1971 (fig. 2.13). Surrounded by a cyclone fence, the cemetery contains two headstones, one with two graves dating to 1971 and 1981, and the other with two graves dating to 1971 and 1993. A government-issued grave marker is located at the foot of the grave of Lester Grady, who served in the Navy. The cemetery was acquired by National Park Foundation as part of the Odom tract in 1991 based on the condition that family members would be allowed access to the cemetery, and on the intent that the park would maintain the cemetery according to National Park Service standards.

Figure 2.13 (top): The Odom cemetery, looking southeast from the approach road. The split-rail fence is on the adjoining R. Taylor farm. In front of the cemetery is a remnant allee tree. (SUNY ESF, 2006.)

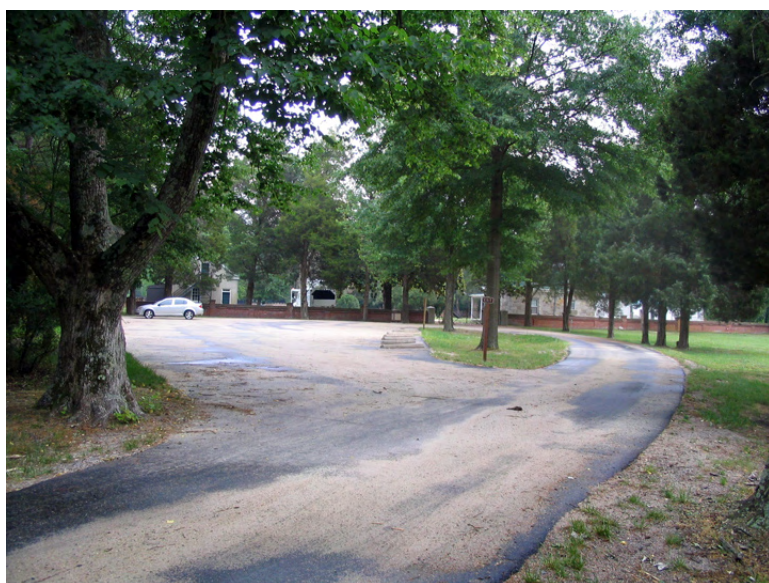
Across from the Odom cemetery is the visitor parking lot, which dominates the view upon approach to the cemetery gates (fig. 2.14). Built by the park in c.1995, the lot has an irregular boundary measuring 175 feet long by forty feet wide, with separate entry and exit points at the east and west ends, and a narrow island separating the lot from the approach road. The parking lot is unmarked and can accommodate two buses and approximately ten cars.

Figure 2.14 (bottom): The visitor parking lot, looking east from the approach road toward the cemetery gates. (SUNY ESF, 2006.)

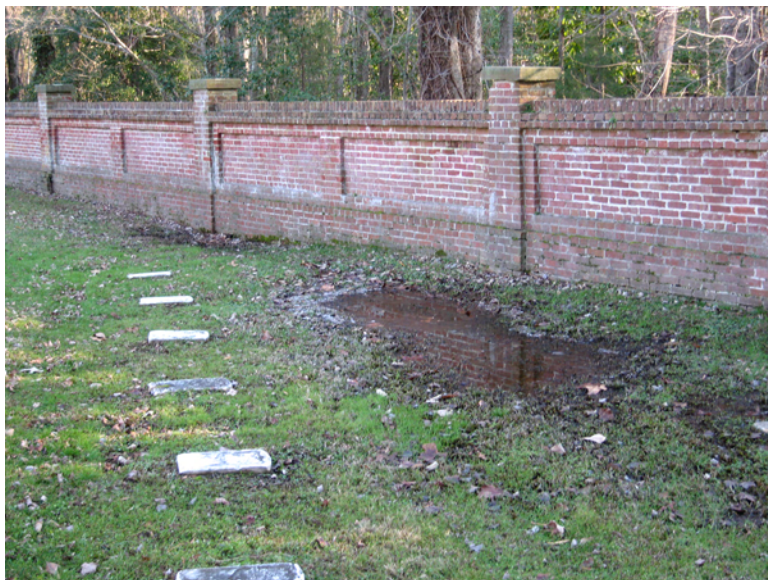
Poplar Grove National Cemetery is enclosed by a four-foot high red brick wall that measures 2,700 feet long. Known in national cemeteries as the inclosure wall, the structure was completed in 1876 and is divided into 132 twenty-foot long sections divided by piers capped with sandstone caps (fig. 2.15). Portions of the wall are in poor condition due to loose and deteriorated mortar and settling. At eight low points, there are openings in the wall that drain the cemetery through grass swales. Several openings contain brick or concrete scuppers that extend beyond the wall. The opening with the greatest drainage, at the lowpoint of the cemetery (northwest side) feeds into a concrete spillway or ditch that runs through a concrete culvert below the private driveway into wetlands to the north (fig. 2.16). The ditch does not adequately drain the interior of the cemetery, leading to standing water remaining within the burial grounds after periods of rain. Similar problems occur at another drainage opening along the south side of the wall.

Figure 2.15 (top): The inclosure wall, looking along the south side of the cemetery at Block II. This view shows an area of poor drainage. (SUNY ESF, 2006.)

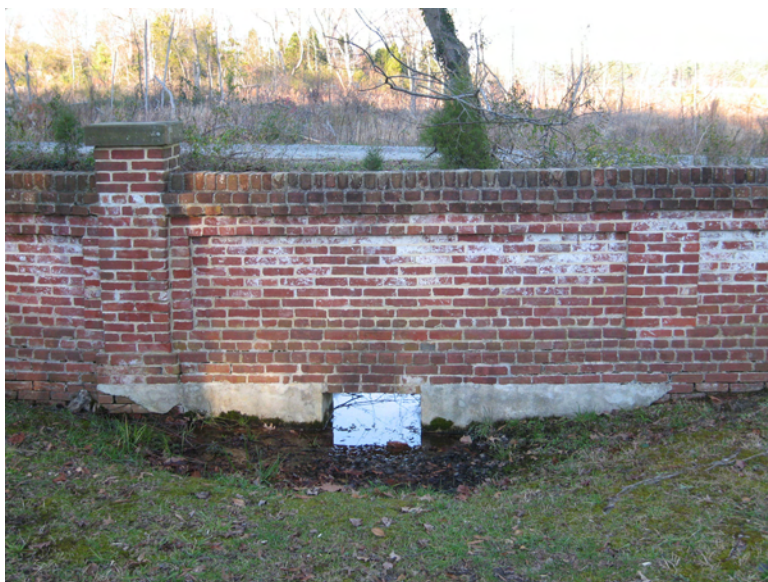
Figure 2.16 (middle): The drainage opening at the cemetery lowpoint in Block XVIII, looking north with the Blaha driveway in the background. (SUNY ESF, 2006.)

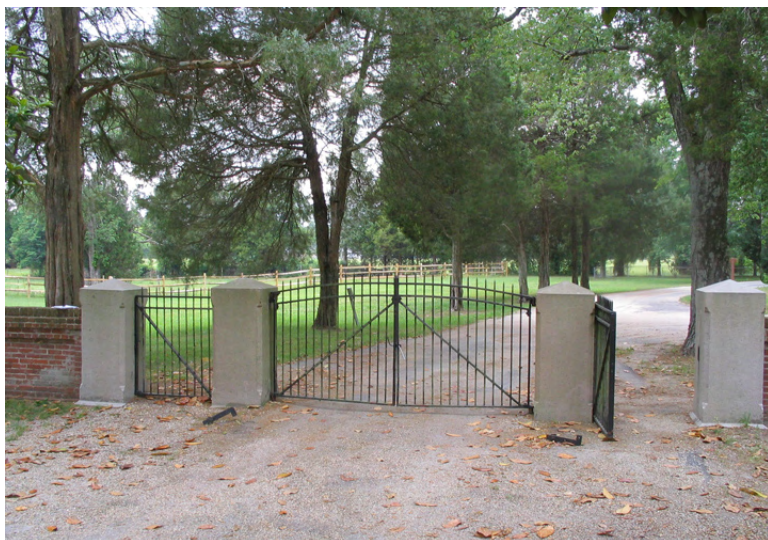
The cemetery entrance gate, built as part of the inclosure wall in 1876, consists of individual wrought-iron swinging gates hung from granite posts with chamfered edges and

Figure 2.17 (bottom): The cemetery entrance gate, looking west from inside the cemetery. (SUNY ESF, 2006.)

pyramidal tops (fig. 2.17). The structure has a central vehicular entrance with paired gates, flanked on each side by pedestrian entrances with single gates. The vehicular gates swing inward to iron stops. Cast metal shields with the inscription “U.S. National Cemetery,” added in c.1935, are affixed to the piers to either side of the vehicular entrance (fig. 2.18).

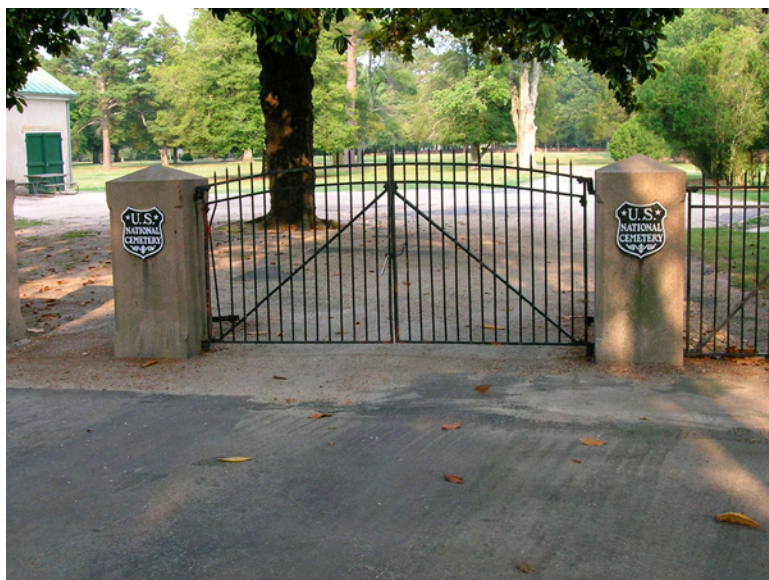
Figure 2.18 (top left): The cemetery entrance gate looking east into the cemetery showing plaques added after 1933. (SUNY ESF, 2006.)

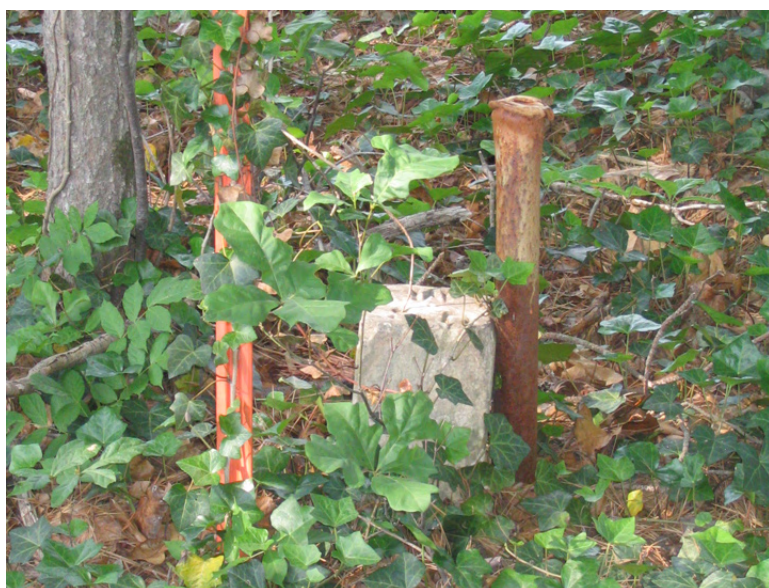
Figure 2.19 (bottom): A typical stone boundary marking a corner of the federal property, with later pipe and stake markers. (SUNY ESF, 2006.)

are marked by stone boundary posts installed in 1877, along with later pipes and orange stakes (fig. 2.19). The outside face of the wall abuts a cleared area of approximately five feet. Beyond this cleared area are naturalized plantings and woods (fig. 2.20). The woods on portions of the west and south sides of the cemetery provide solid walls of vegetation, while the woods on the north and east are thin and allow screened views to the adjoining houses, fields, and driveway. The woods consist primarily of loblolly pine, red maple, sumac, sweet-gum, and oak. Several large loblolly pines along the north enclosure are declining or dead. English ivy, escaped from plantings on the interior face of the inclosure wall made in c.1888, is a common ground cover in these woods along with poison ivy. There are some Eastern red-cedars outside of the wall that are remnants of a 1937 planting, notably near the entrance gates and south of the lodge grounds.

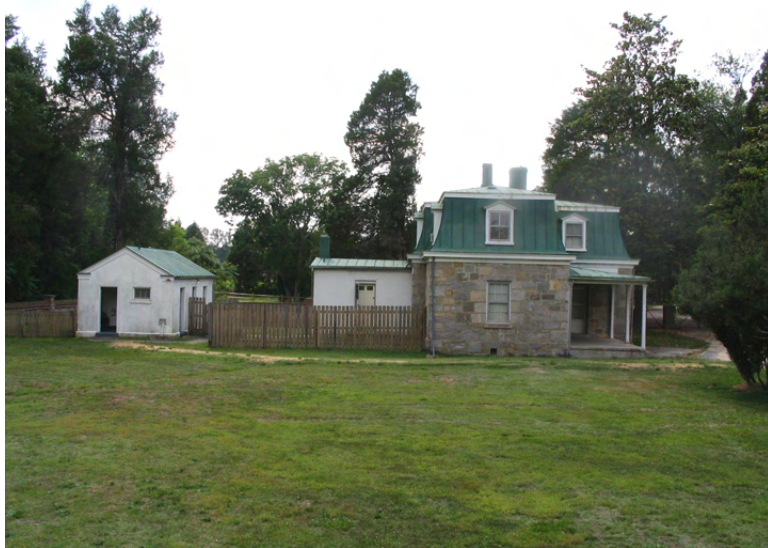
Figure 2.21 (top): The east side of the lodge with its rear kitchen wing addition, and the restroom building looking across the lodge grounds from the rostrum. The front of the lodge faces the main drive at right. (SUNY ESF, 2006.)

Just inside the main entrance gates is the lodge and its adjoining grounds that serves as the cemetery's assembly area. The lodge is a one and one-half story Second Empire-style stone residence constructed in 1871-1872 according to a standardized plan developed by Quartermaster General Montgomery Meigs (fig. 2.21). The 'L'-plan building, with overall dimensions of twenty by thirty-three feet, has dressed random-course ashlar walls, six-over-six sash windows, an open front porch, and a green-painted standing-seam metal roof that replaced an earlier slate roof. Affixed to the front of the building is a standard plaque with Lincoln's Gettysburg address added in c.1913. At the rear of the lodge is a one-story stuccoed kitchen wing built in 1914. Since 2001, the lodge has been used as an occasional public contact station rather than a residence.

building constructed in 1929 according to plans by the Quartermaster General Third Corps Area, Baltimore (see fig. 2.21). The white-painted stucco-faced tile building, measuring twenty-four by fourteen, has a green-painted standing seam metal gable roof with eaves returns, three-light single sash windows, four-light paneled doors, a utility room, and separate rest rooms for men and women. The building's septic field is located in the lawn to the east. The restrooms are screened from the rear yard of the lodge by a wood plank privacy fence, and a concrete walk connects through this yard to a rear entrance on the lodge. An earthen path built on fill provides the primary public route to the restrooms. This path blocks the drainage swale that extends from the lodge downspouts to the nearby drain opening in the inclosure wall.

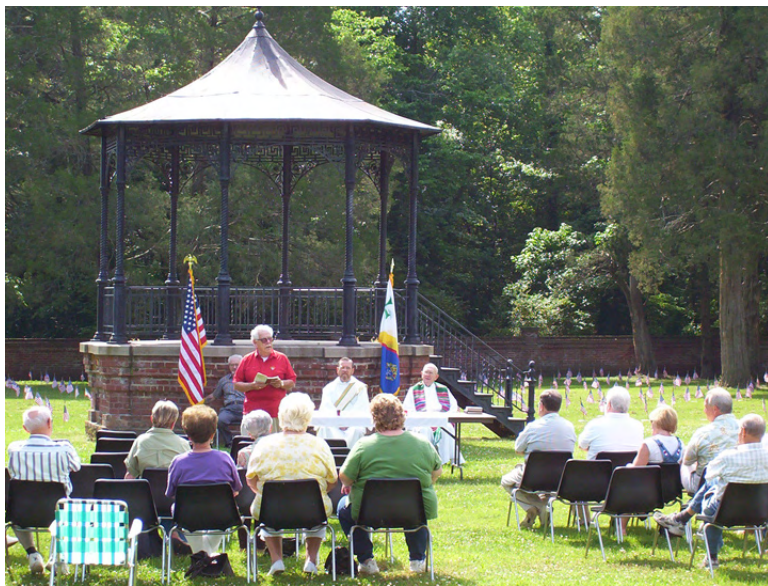
Figure 2.22 (bottom): The rostrum, looking southeast from the main drive during a Memorial Day ceremony. (Betsy Dinger, Petersburg National Battlefield, 2005.)

At the east side of the lodge grounds is a bandstand, known in national cemeteries as a rostrum. Completed in 1897, the rostrum reflects the Aesthetic Movement in its decoration. It is an octagonal structure sixteen feet in diameter, with a six-foot high brick base, iron steps, and a cast- and wrought-iron superstructure with a concave metal roof (fig. 2.22). The grounds between the rostrum and the lodge consist of open lawn that is used as an assembly area. There are no trees or shrubs here except for two large boxwoods that are remnants of once extensive plantings in the area.

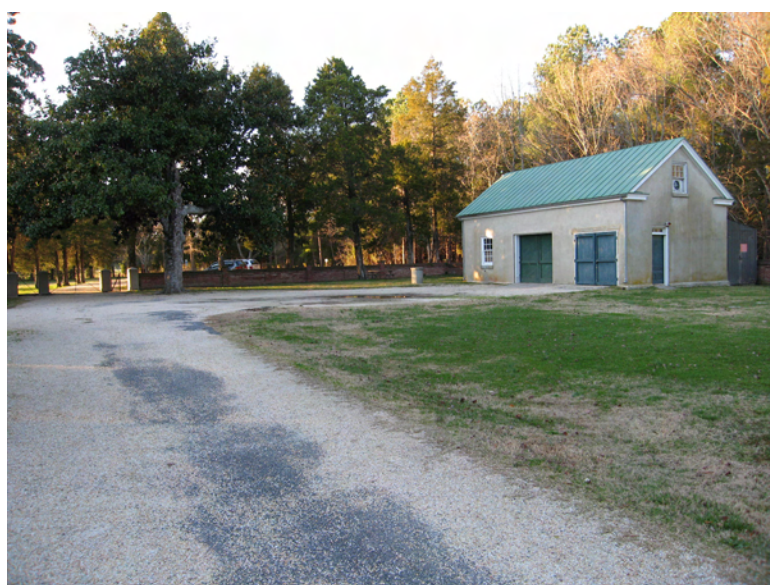
Figure 2.23: The garage and service yard, looking west from the burial grounds toward the cemetery entrance gate. (SUNY ESF, 2006.)

same time as the restroom building and in a similar Colonial Revival style, according to plans by the Quartermaster General Third Corps Area, Baltimore (fig. 2.23). Originally designed as a stable and garage with a loft, it is a one-story building measuring thirty-eight feet by twenty-two feet, with two sets of swinging garage doors, six-over-six sash windows, unpainted stucco siding, and a standing-seam metal gable roof with eaves returns. At the rear of the building is a later frame shed addition. The garage is presently used for storage and to house the cemetery's maintenance equipment.

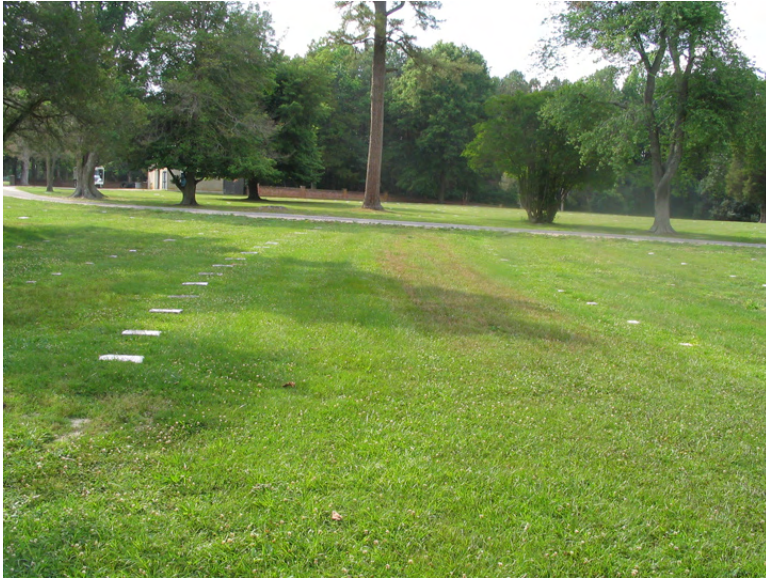
Figure 2.24 (top): Characteristic turf drive and walks, looking northwest toward the main drive in Division A between sections e and d (Blocks II and III). The wider space is a drive, the narrower space between the rows of grave markers are walks. (SUNY ESF, 2006.)

The drives (circulation between original grave sections) and walks (the narrower circulation between the grave rows) are all turf, except for the main drive, which has been paved in asphalt since 1931. The turf drives and walks blend in with the larger lawn and are therefore difficult to discern in the landscape (fig. 2.24). All of the original drives and walks remain, except for the central walk in Block IX (north of flagstaff), which was filled with graves between 1896 and 1918. The radiating drives with the exception of the main drive are designated by letters, A through F. The main drive is approximately eleven feet wide and has a

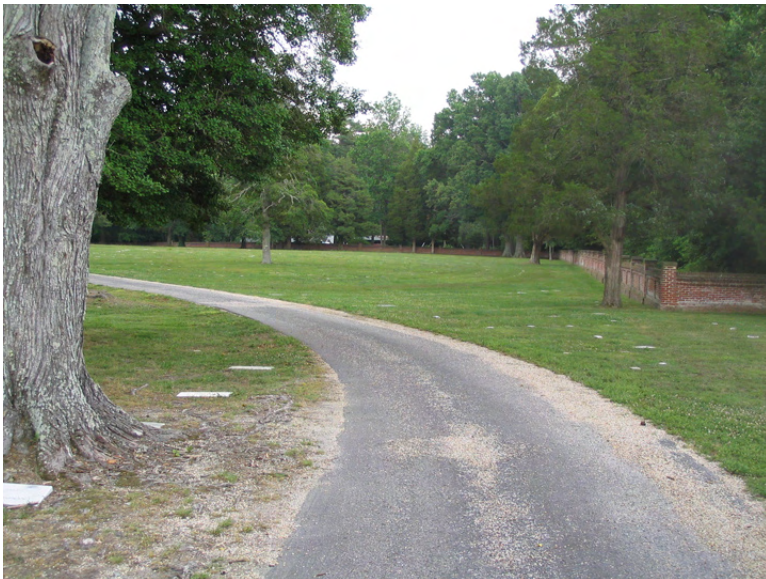
Figure 2.25 (bottom): The main drive, looking east from near the rostrum showing asphalt paving with gravel surface coat. (SUNY ESF, 2006.)

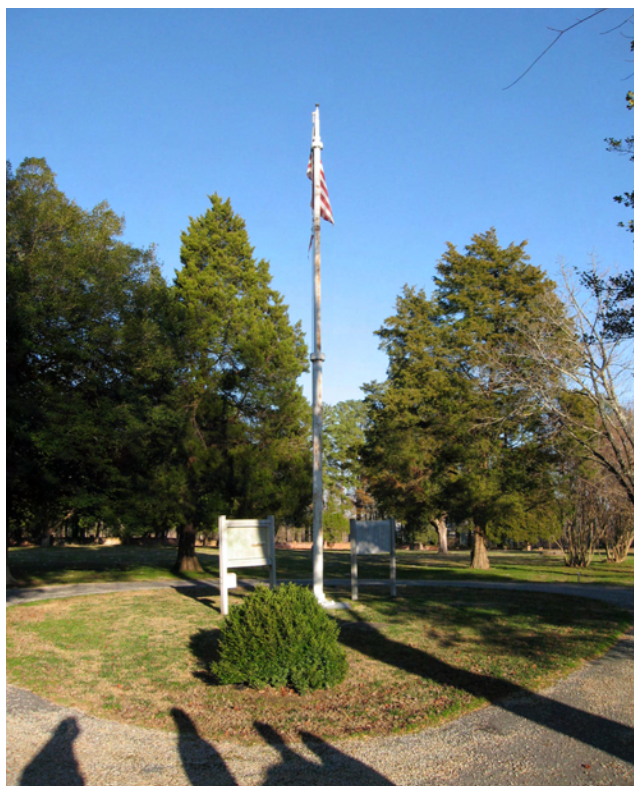
The center of the cemetery is the ceremonial and symbolic heart of Poplar Grove. It consists of a forty-foot wide circular lawn with a forty-foot tall white-painted iron flagstaff at its center (fig. 2.26). This flagstaff, lower in height than the surrounding trees, consists of three sections connected by bolted flanges, an iron base and square concrete pad, and a small ball finial. As originally installed in 1930, this pole was approximately twice that height and was secured with

Figure 2.26 (left): The center of the cemetery, looking northeast from the main drive showing the flagstaff, teardrop-shaped loop in the main drive, and interpretive signs. The boxwood shrub in the foreground conceals a contemporary floodlight. (SUNY ESF, 2006.)

four cable guy wires. The flagstaff is illuminated by a contemporary floodlight concealed by a boxwood shrub at the head of the main drive. To either side of the flagstaff are interpretive signs in brushed aluminum frames installed in c.1957, measuring fifty-seven inches wide and eighty inches tall. One sign contains the burial register, the other an illustrated plan of the cemetery by block, with text on the history of the cemetery and a drawing of Poplar Grove Church, the namesake of the cemetery. The church faced the flagstaff to the north in Block IX prior to its removal in 1868.

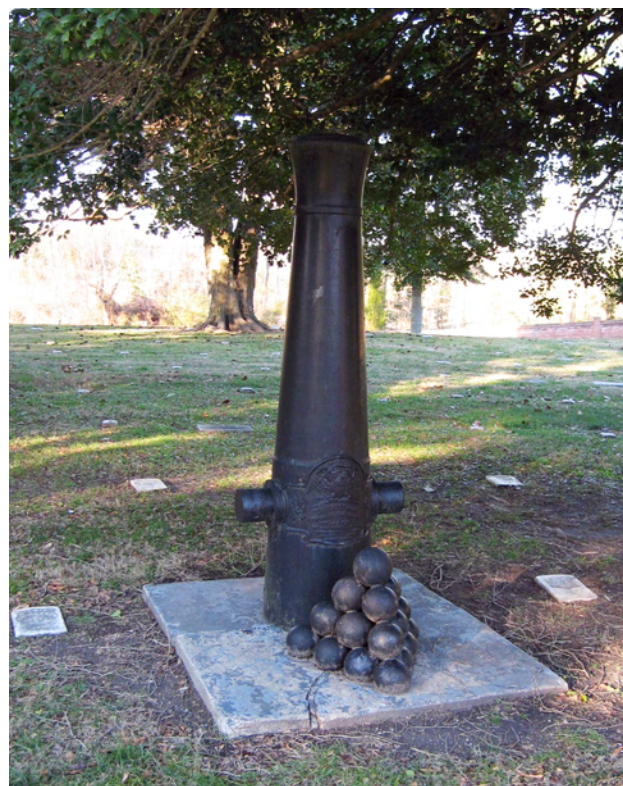
Figure 2.27 (right): The remnant gun monument with its painted-over bronze plaque and missing cannonball cap, view looking northwest. (SUNY ESF, 2006.)

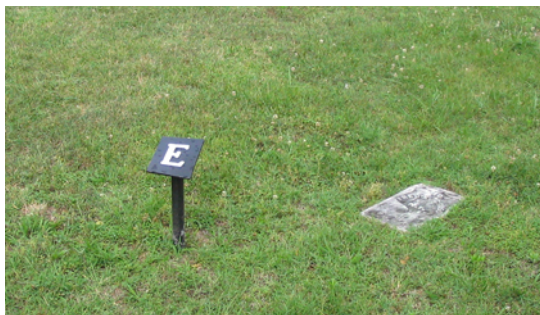
Figure 2.28: One of the metal signs along the central circular loop of the main drive identifying radial drive "E." (SUNY ESF, 2006.)

markers, installed in c.1957, measure four by five inches and are mounted on a low pipe pole.

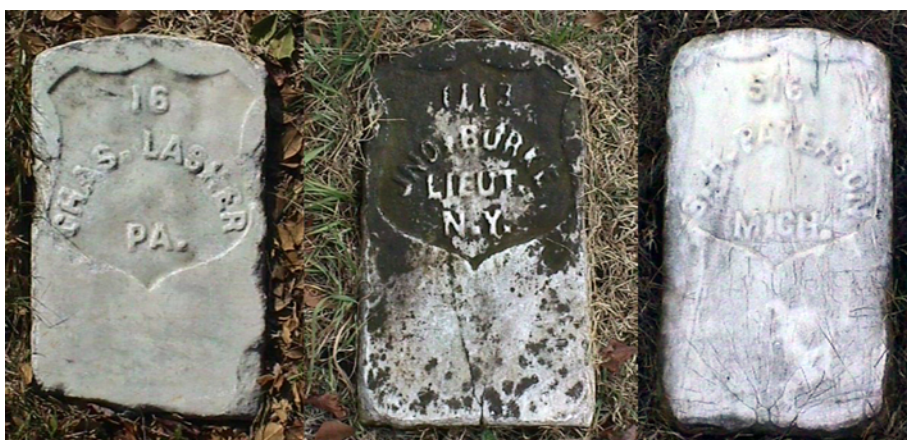
Figure 2.30: Representative second-generation recessed-shield headstones, showing condition issues and two different types of fonts. The stones at left and right are categorized by the park as style A; the one in the middle with the cambered font, style B. The headstone at left replaced an unknown block. (Petersburg National Battlefield, 2005.)

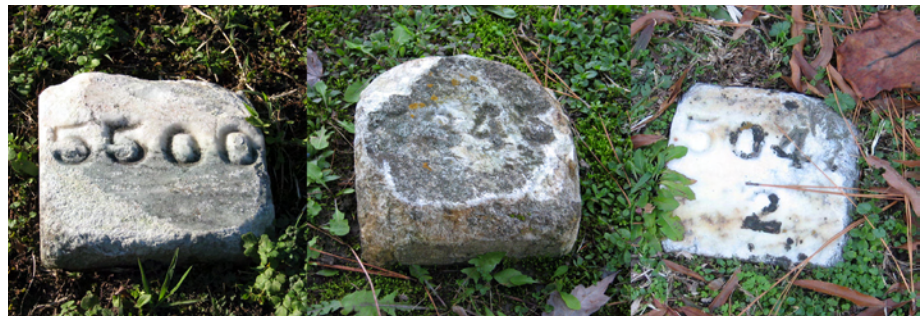
Unknown Blocks (fig. 2.31)

The 3,277 blocks at Poplar Grove, installed along with the headstones in 1877, mark unknown graves that are located throughout the cemetery. The blocks are set either flush or slightly above grade. Each block is a post of Vermont white marble measuring six inches square and thirty inches long, originally specified for installation at four inches above grade. The inscription, limited to the grave number and the number of remains in the grave if more than one, is inscribed in the top of the block.

Figure 2.31: Representative unknown blocks installed in 1877 and transformed into flat markers in 1934. The block at right marks a grave containing two remains. (Petersburg National Battlefield, 2005.)

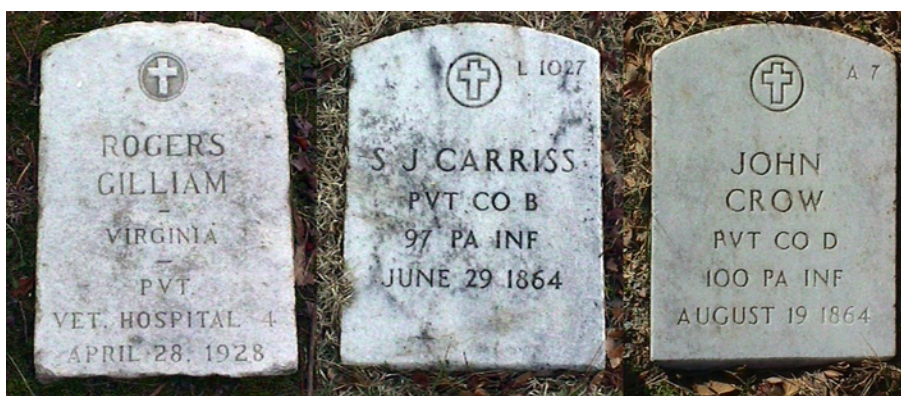
General Headstones (fig. 2.32)

headstones). Scattered around the cemetery, the General headstones are white marble cambered-profile tablets, measuring thirteen inches wide, four inches thick, and approximately eighteen inches long (twenty-four inch base removed). The incised inscription, without a shield, includes an emblem of faith at the top, followed by the name, rank, and date of death. The General headstones dating prior to World War II have a different font than those used after the war and do not have the grave number inscribed on the front. The latter headstones have the grave number inscribed in the upper right corner.

Figure 2.32: General headstones introduced in 1922, showing pre-World War II design (left) transformed to a flat marker, and post-war design (current Veterans Administration standard) installed as replacement flat markers at Civil War graves. (Petersburg National Battlefield, 2005.)

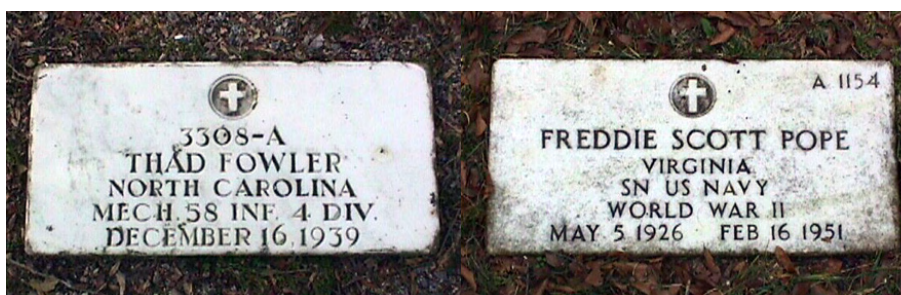
Government Flat Markers (fig. 2.33)

The approximately 216 flat markers at Poplar Grove, installed between c.1939 and c.1980, mark the graves of World War I and II veterans, and were also installed as replacements for headstones and blocks on earlier graves.¹⁰ The flat markers are scattered around the cemetery, with a concentration of new burials in Block XX. These markers are white marble and measure twenty-four inches long, twelve inches wide, and four inches thick, oriented with the long side at the top of the grave. The inscription includes an emblem of faith at the top for known burials, followed by the name, state, regiment, and date of death. Those installed prior to c.1945 have a stylized font and the grave number below the emblem of faith; later flat markers have a different font and the grave number at the upper right corner.

Figure 2.33: Government flat markers installed at Poplar Grove beginning in c.1939, showing font used prior to c.1945 (left) and later font (right). (Petersburg National Battlefield, 2005.)

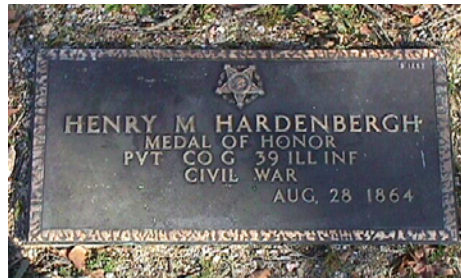
Medal of Honor Flat Markers (fig. 2.34)

There are two Medal of Honor flat markers at Poplar Grove, installed as replacements for earlier government Civil War headstones at some point after 1940. They are flat markers made of bronze, measuring twenty-four inches long, twelve inches wide, and three-quarters inch thick, set on a concrete foundation. The marker has a raised, polished narrow border and inscription, with the Medal of Honor symbol at the top of the grave.

Figure 2.34: One of two Medal of Honor markers, installed as a replacement after 1940. (Petersburg National Battlefield, 2005.)

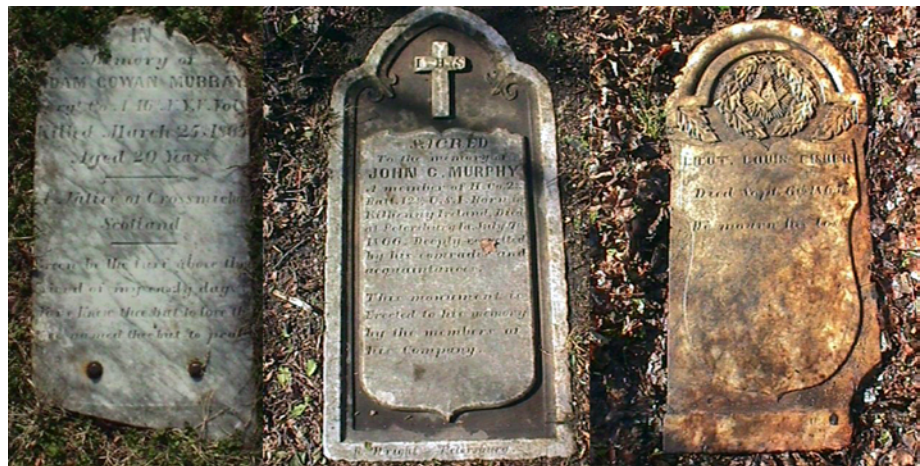
Figure 2.36: Examples of non-government headstones installed after 1877, showing variations in profile and inscriptions. (Petersburg National Battlefield, 2005.)

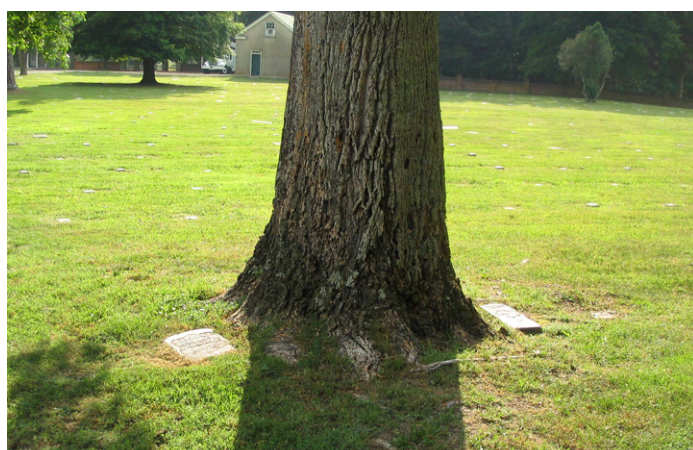
Figure 2.38 (bottom): A large sweet-gum tree within a grave row in Block XIV, looking west showing heaving of adjoining headstones. (SUNY ESF, 2006.)
