CULTURAL LANDSCAPE REPORT FOR POPLAR GROVE NATIONAL CEMETERY

PETERSBURG NATIONAL BATTLEFIELD

DINWIDDIE COUNTY, VIRGINIA

Olmsted Center for Landscape Preservation
National Park Service, Boston, Massachusetts 2009

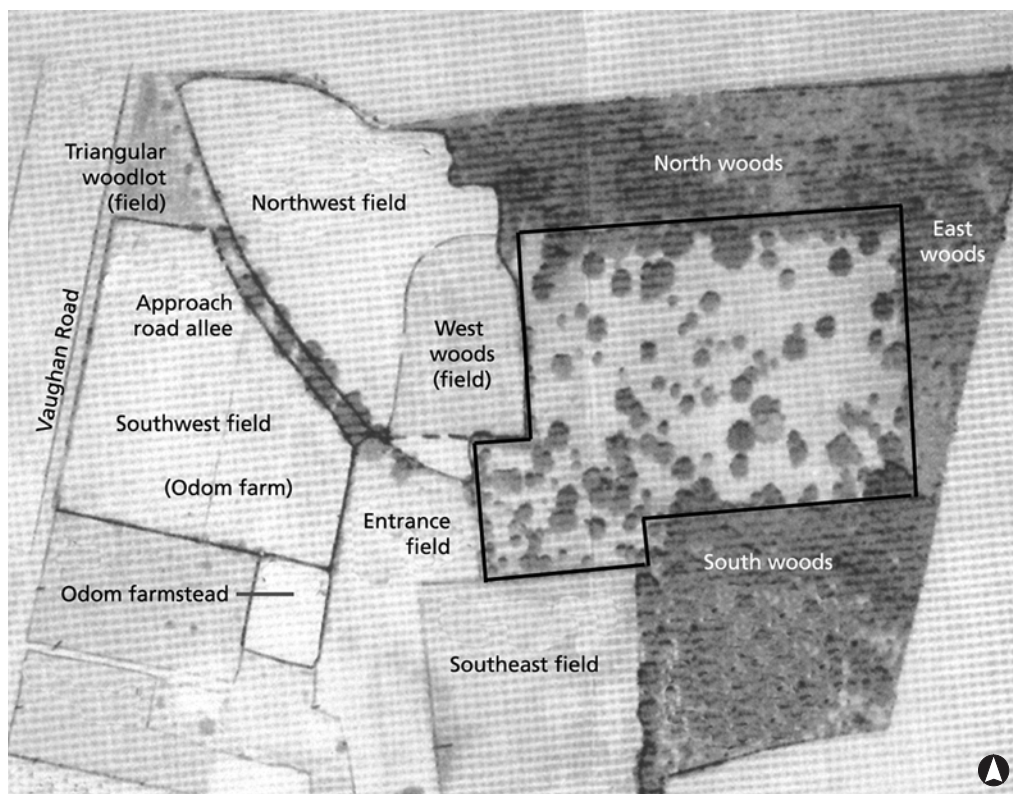
Figure 3.2: Existing natural systems and spatial organization characteristics in the setting of Poplar Grove National Cemetery, shown on a 1994 aerial photograph. These conditions approximate existing conditions. (Detail, USGS aerial photograph, 1994, annotated by SUNY ESF.)

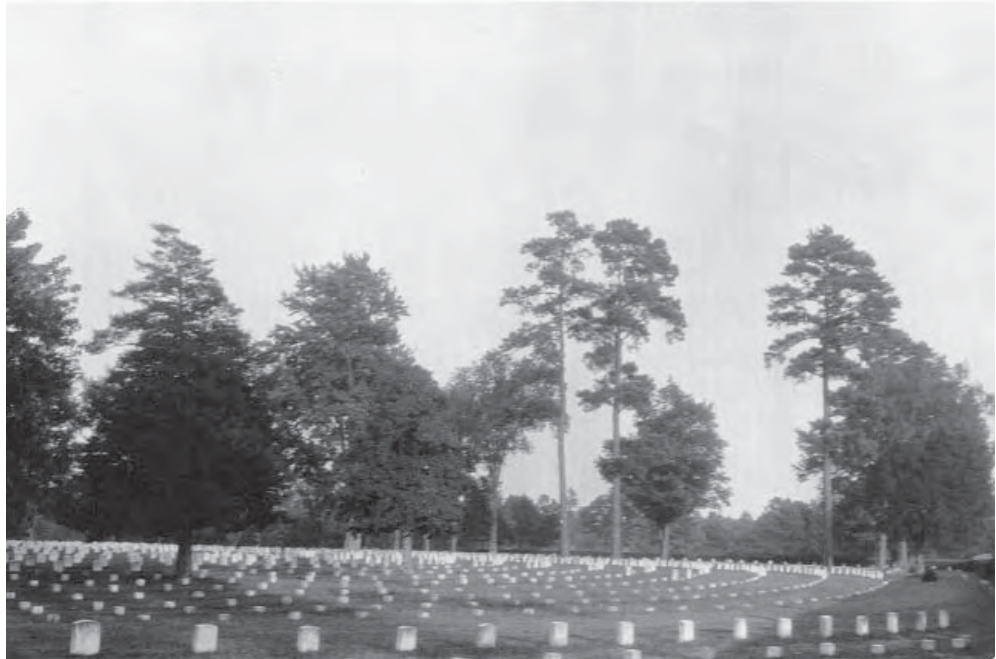
Figure 3.4: Existing view of the burial grounds looking in the same direction as figure 3.3., illustrating changes to the landscape from alteration of the grave markers in 1934. (SUNY ESF, 2006.)

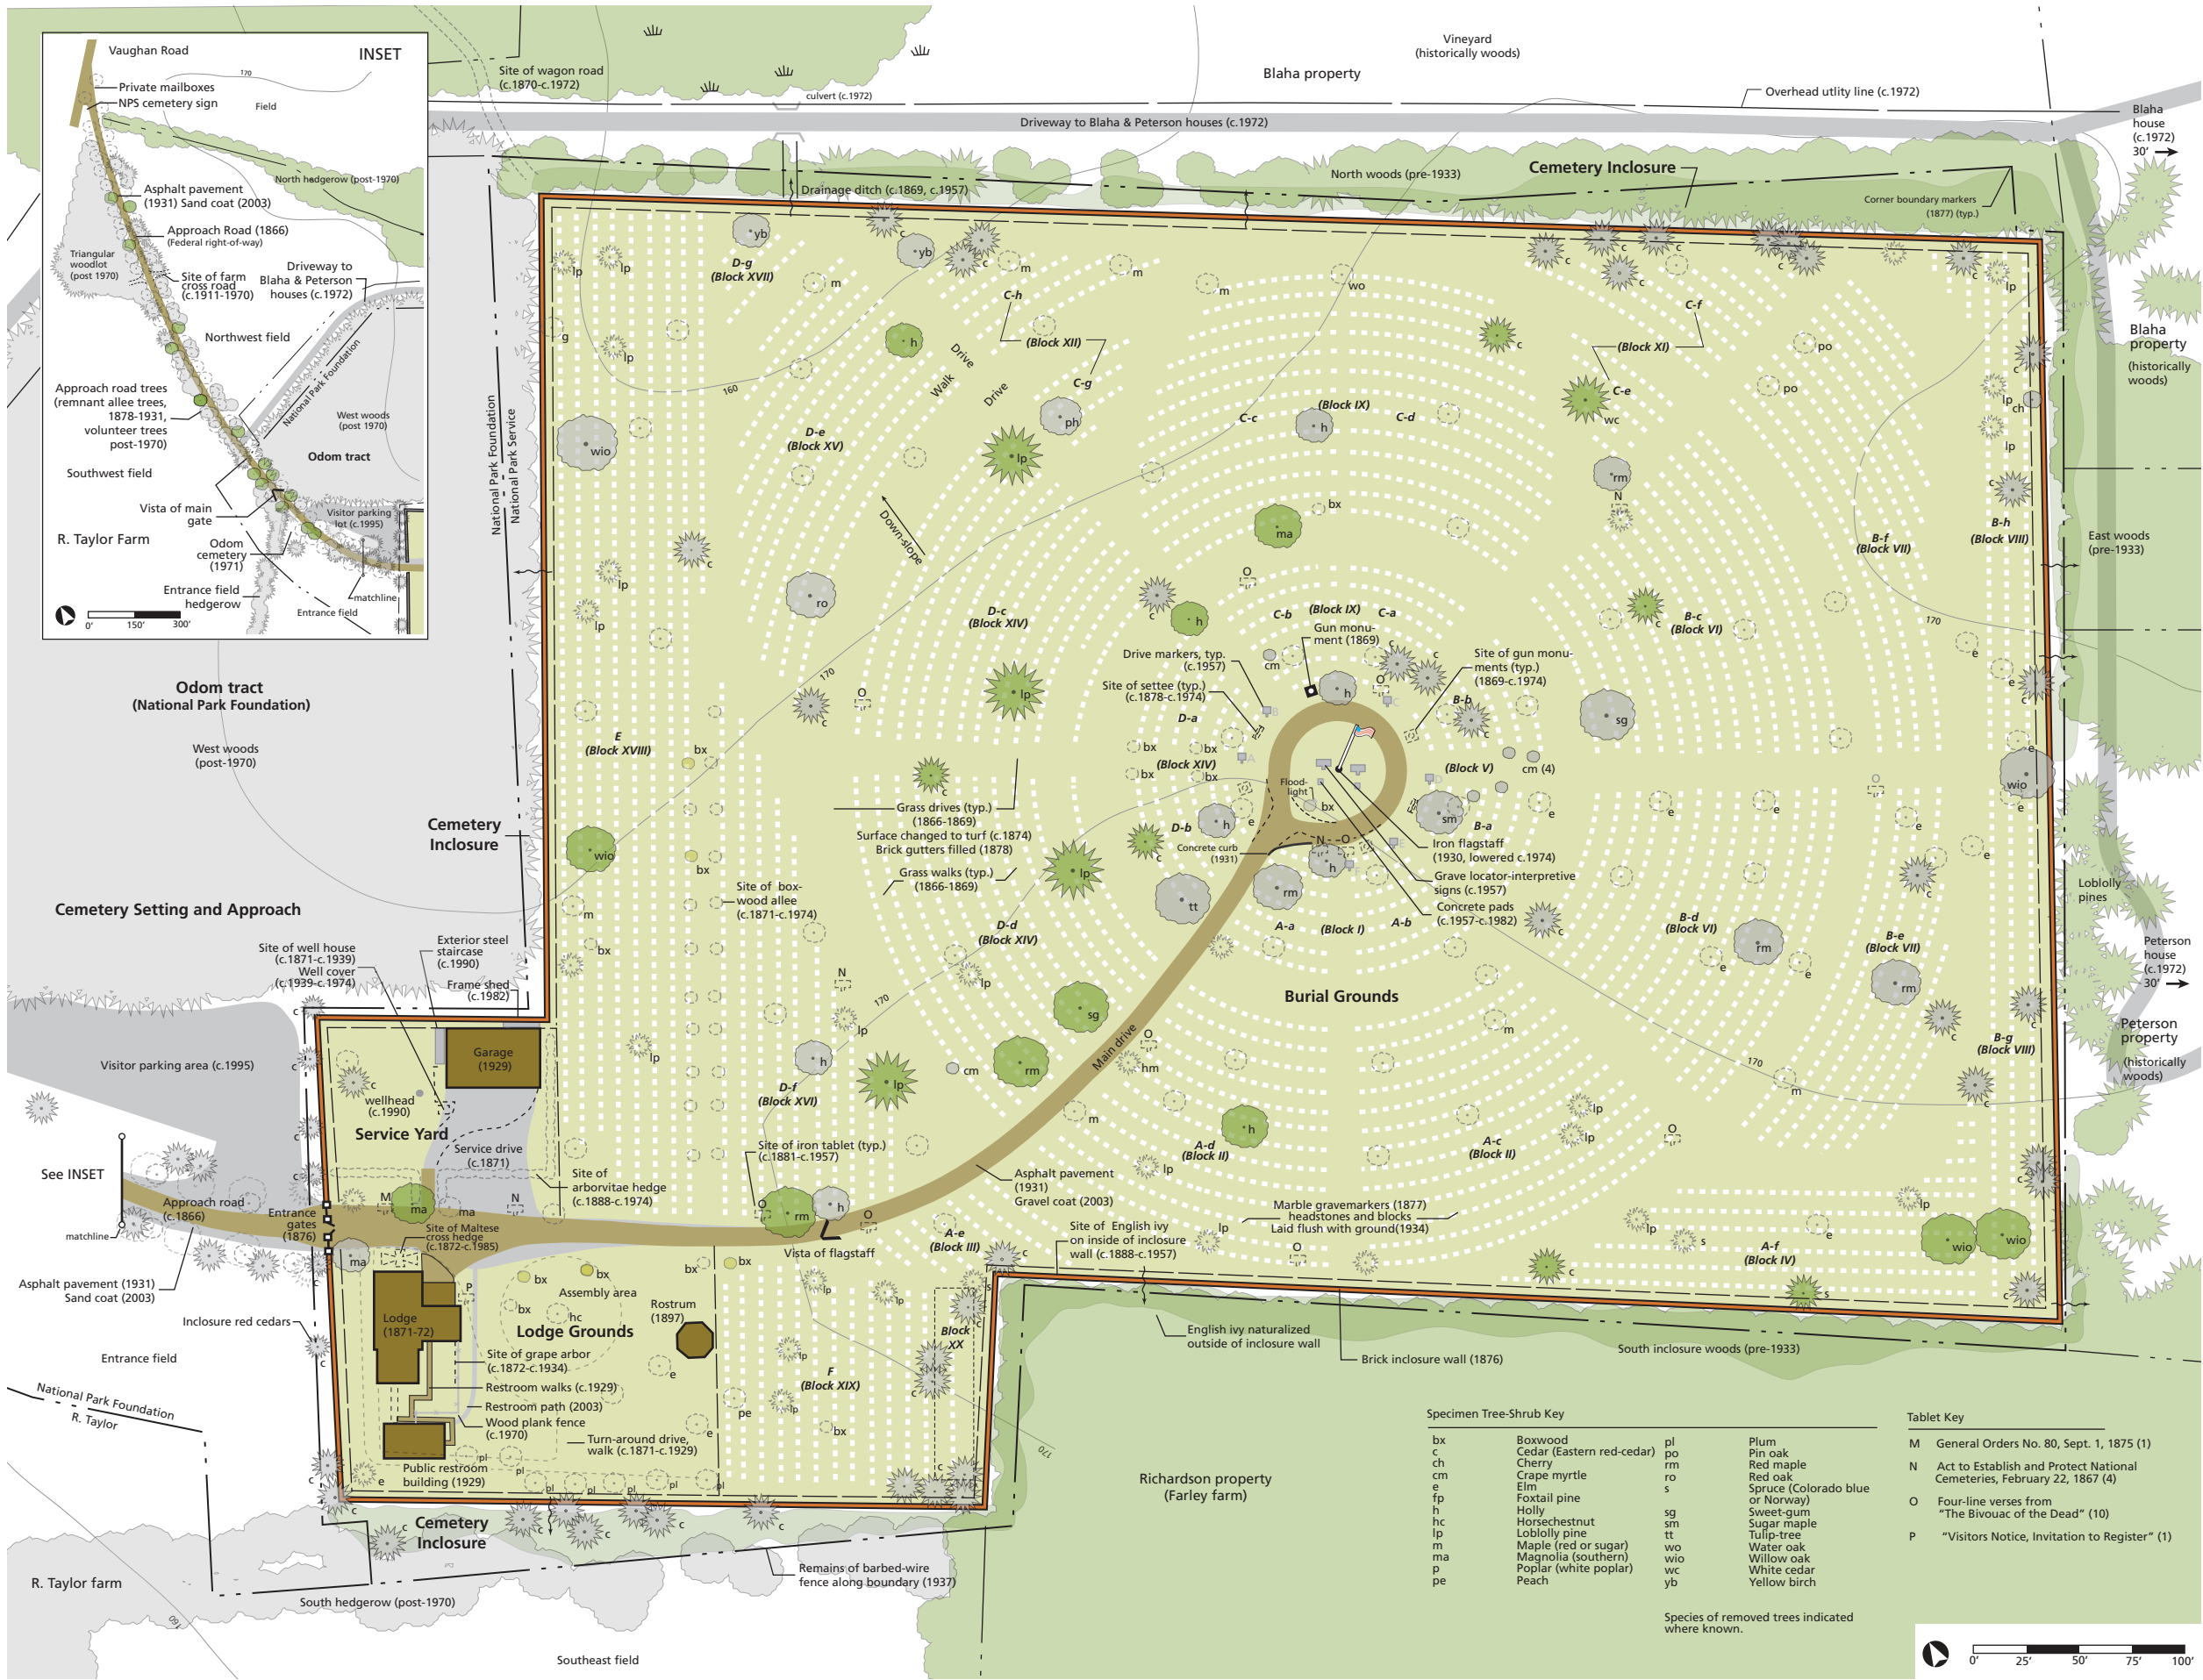
Drawing 3.1

- Plan shows character-defining features removed since the end of the historic period (1933) by dashed lines.
- Vegetation extant in c.1933 is approximate, based on 1931 War Department planting plan; species shown where known.
- Dates in brackets indicate date of initial construction and removal where applicable.
- All features shown in approximate scale and location.

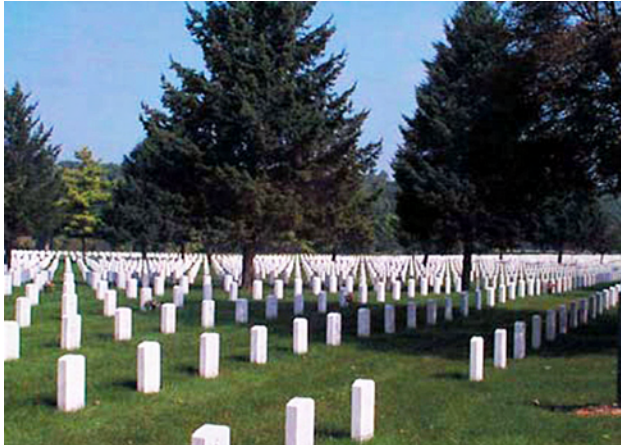
Figure 4.2: Illustration from the National Cemetery Administration's "Operational Standards and Measures" showing standards for "headstones, markers and niche covers that do not show evidence of debris or objectionable accumulations" and "proper height and alignment for each headstone is maintained." This image also shows standards for lawn maintenance. (Department of Veterans Affairs, National Cemetery Administration, "National Shrine Commitment Operational Standards and Measures," Version 2.0, October 2004. The identity of the cemetery is not indicated.)

oldest cemeteries such as the Civil War-era Richmond National Cemetery (fig. 4.1). The Operational Standards and Measures are the most current in a long line of published national cemetery standards going back to the beginning of the twentieth century under War Department administration. These outline requirements ranging from the percentage of lawn that must be weed free, to the percentage of headstones that must not show evidence of debris or objectionable accumulations (fig. 4.2).¹⁰

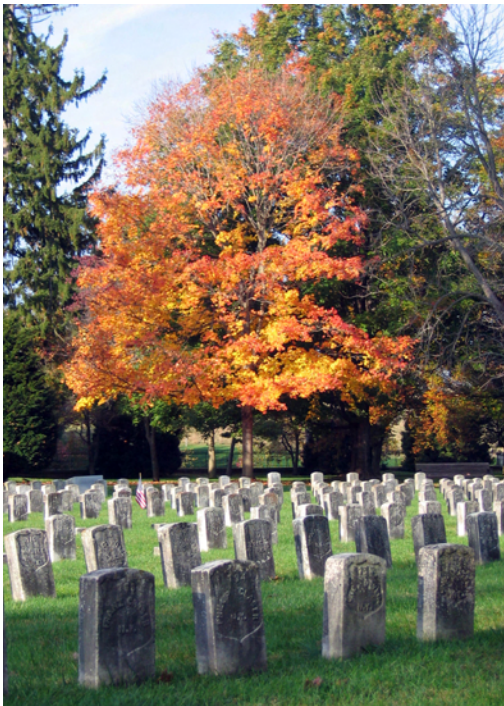
Figure 4.3: Recent photograph of Antietam National Cemetery showing level of maintenance at a National Park Service-administered national cemetery. Note the difference in maintenance of the headstones compared with figures 4.1 and 4.2. (Undated photograph by Keith Snyder, image 20060829 152450, Antietam National Battlefield website.)

figs. 4.1, 4.2). The National Park Service, in contrast, generally does not routinely align and clean its headstones, or maintain lawns to the same uniform quality (fig. 4.3). The National Cemetery Administration also generally prioritizes contemporary cemetery operations over preservation of historic landscapes as evident by its practice of removing trees from the burial grounds without replacement.¹⁸

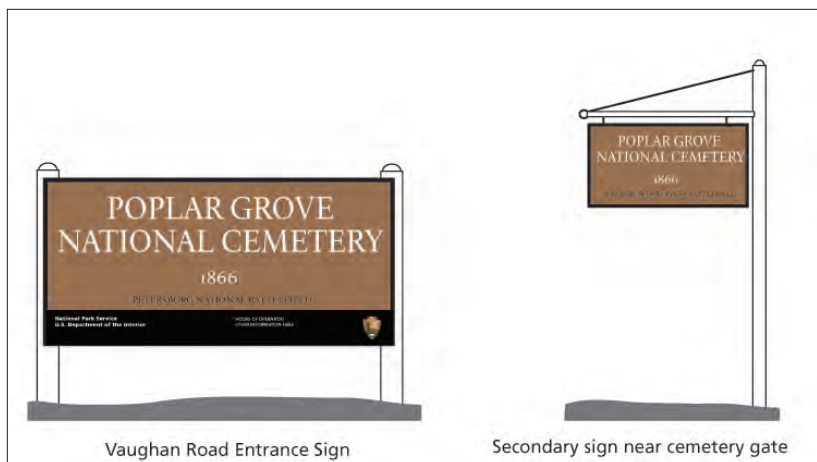
Figure 4.6: Suggested designs for signs at Vaughan Road and at the entrance gate (not to scale). (SUNY ESF)

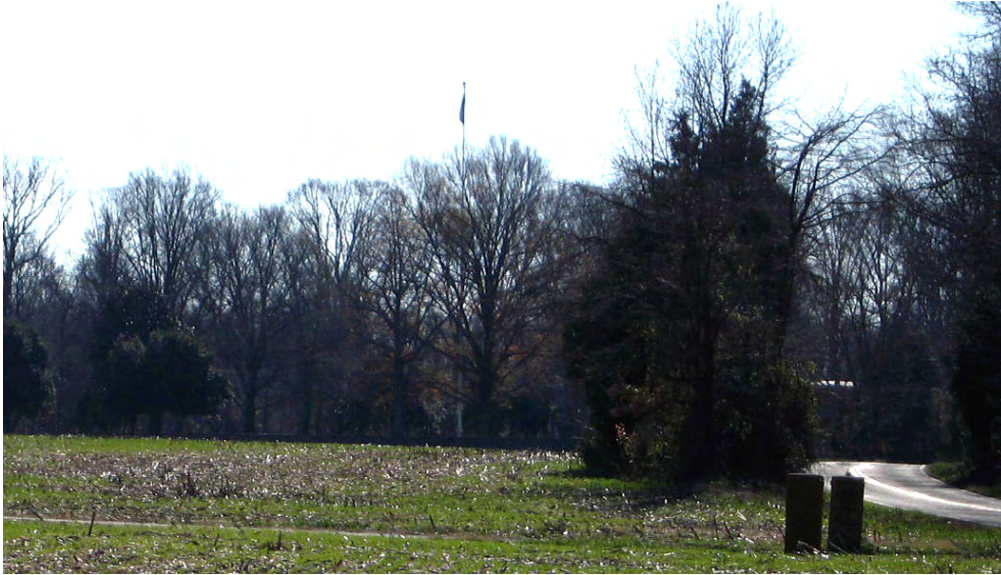
Figure 4.7: View upon the approach to Glendale National Cemetery showing the rural setting and view of the cemetery flagstaff rising above the tree canopy, a landscape similar to what existed historically at Poplar Grove. The field extends to the cemetery inclosure wall, which is not visible in this photograph. (SUNY ESF, 2006.)

The approach road to Poplar Grove National Cemetery historically featured a view of the cemetery with the flagstaff rising above the tree canopy, looking east across the northwest field toward the brick inclosure wall. A similar view remains at Glendale National Cemetery near Richmond (fig. 4.7). To reestablish the view and field along the west side of the cemetery, clear the non-historic successional west woods on the Odom tract. Eastern red-cedar trees along the edge of the woods along the inclosure wall, planted by the National Park Service in 1937, may be retained if they are in good condition. Maintain the cleared area, which has partly an uneven topography, as cultivated field and/or meadow. Preserve the northwest field (R. Taylor farm) as an open field through acquisition or easement.

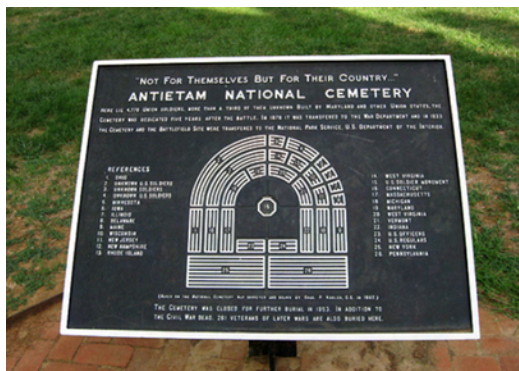
Figure 4.8: Example of an appropriate style for a new sign that would be part of an information wayside within the lodge grounds. (National Park Service, Antietam National Cemetery website.)

Design the new wayside in a manner that recedes in the landscape and reflects the historic precedent of cast-metal signs (tablets). An appropriate model is the wayside at the National Park Service-administered Antietam National Cemetery (fig. 4.8). This sign relates to the historic style of signs at national cemeteries through its use of cast metal with raised letters, but is distinguished by a different finish. The Poplar Grove wayside should include a graphic plan of the cemetery and a brief account of its history and significance, as well as operational information if necessary. The

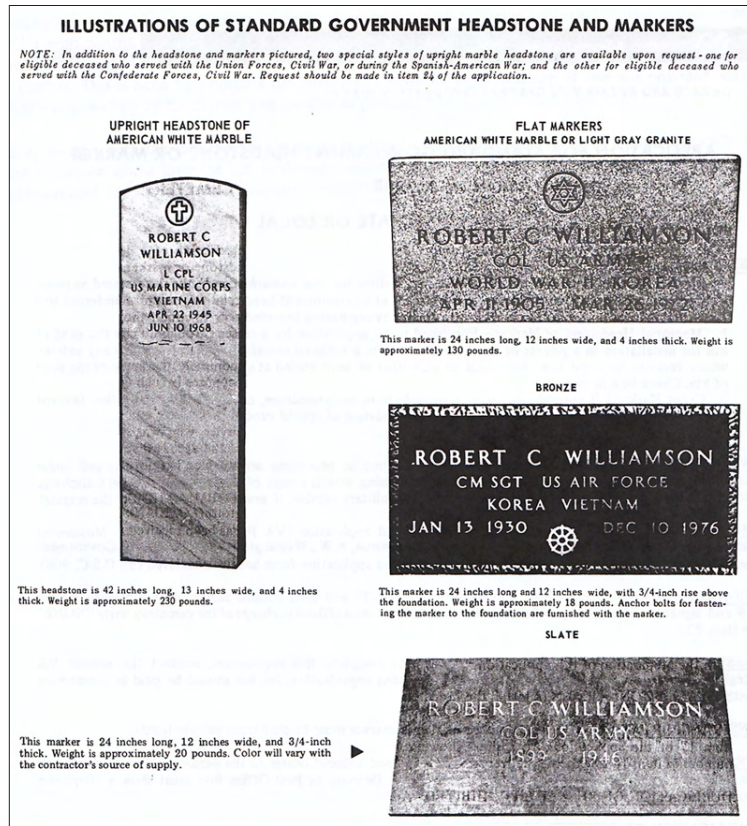
Figure 4.9 (top): Current standard government headstones and markers showing equivalent of the General used historically at Poplar Grove. The marble and bronze flat markers were used after 1933. (Department of Veterans Affairs, Department of Memorial Affairs, *Headstones and Markers*, manual M40-3, December 1, 1982, Figure F.1.)

- Standard Government Headstones and Markers: World War I and later veterans. Upright headstone (equivalent to the General used at Poplar Grove 1922-c.1933): white marble, forty-two inches long, thirteen inches wide, four inches thick (fig. 4.9).³² (Flat markers were used at Poplar Grove after 1933.)

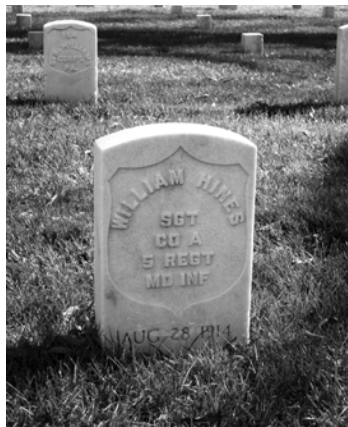
Figure 4.10 (middle): Example of recently installed government historical style stone "XB" at Glendale National Cemetery, with added inscription for the regiment within the shield and the date of burial below the shield. Note that the grave number, historically within the shield, was not replicated. This headstone is close to the second-generation recessed-shield headstones, but is three inches thick rather than four. (SUNY ESF, 2006.)

- Historical Styles: Civil War Union and Spanish-American War. White marble, cambered top, raised lettering inside a recessed shield; XA: twelve inches wide, three inches thick, forty-two inches long; XB: thirteen inches wide, three inches thick, forty-two inches long (fig. 4.10); and XC: ten inches wide, three inches thick, and thirty-nine inches long.³³

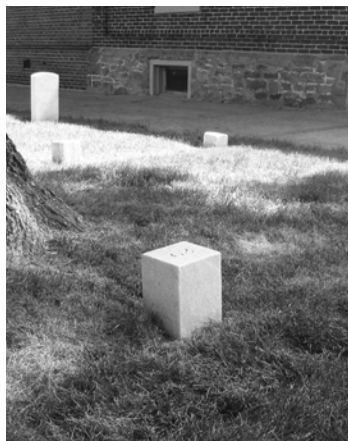
Figure 4.11 (bottom): Reproduction unknown block at Seven Pines National Cemetery. The font used for the grave number does not match the historic font; in addition, this block was installed higher than it was historically. An historic block is visible in the background. (SUNY ESF, 2006.)

- Blocks ("6x6x30 unknowns"): Civil War Union unknown burials. The National Cemetery Administration does not presently have a contract for this type of marker, but they can be ordered off-contract by special request with inscriptions (fig 4.11).³⁴

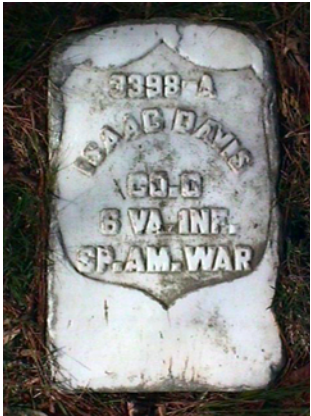
Figure 4.12 (top), Figure 4.13 (middle), figure 4.14 (bottom). (Petersburg National Battlefield, 2005.)

The second-generation recessed-shield headstone original to grave #3398-A (Isaac Davis, Spanish-American War veteran, style A) will be replaced with an upright first-generation recessed-shield headstone that replicates the existing inscription (fig. 4.14)

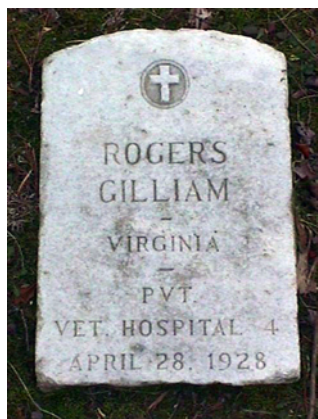
Figure 4.16. (Petersburg National Battlefield, 2005.)

The General headstone installed in 1928 at grave #5603 (Rogers Gilliam) will be replaced with a current standard upright General headstone with the same inscription (fig. 4.16).

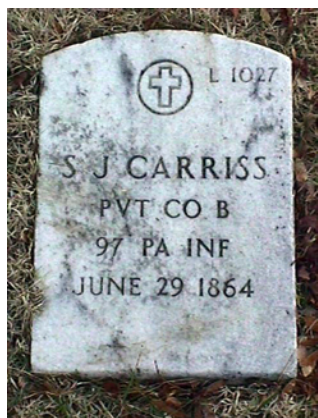
Figure 4.17. (Petersburg National Battlefield, 2005.)

The General headstone installed in c.1980 as a flat marker replacement at grave #1027 (S J Carriss, PA) will be replaced with an upright recessed-shield headstone with the inscription limited to the content contained on the first-generation headstones (grave number, name, state) (fig 4.17).

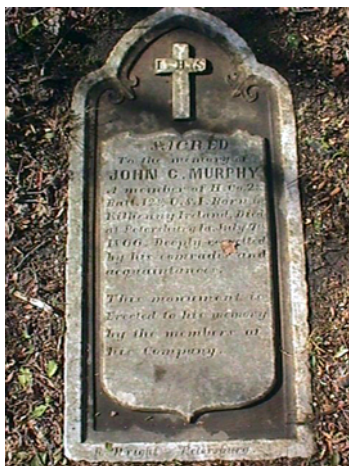
Figure 4.22 (Petersburg National Battlefield, 2005.)

The non-government headstone at grave #22 (John C. Murphy) installed in c.1868, will be conserved and set upright on a new plinth or other footing (fig. 4.22).

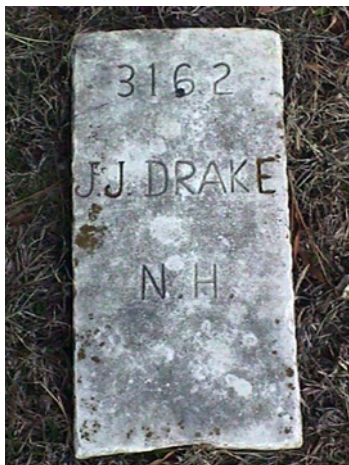
Figure 4.23 (Petersburg National Battlefield, 2005.)

The non-government replacement stone at grave #3162 (J. J. Drake, Civil War veteran), will be removed and replaced with an upright recessed-shield headstone with the same inscription (fig. 4.23).

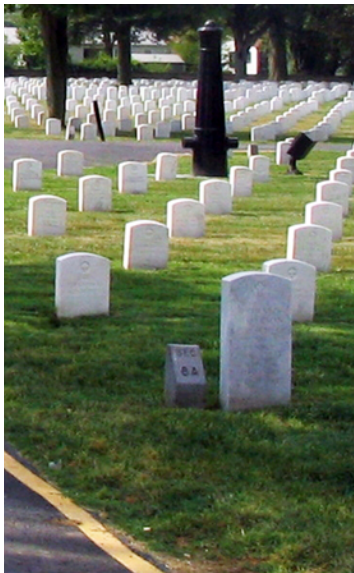
Figure 4.24: Granite section marker at the Civil War-era Richmond National Cemetery. The age of this section marker is not known. (SUNY ESF, 2006.)

No documentation was found on the style of historic division-section markers at Poplar Grove. Therefore, the new markers should be considered a compatible new addition to the landscape. Install low granite posts with angled tops inscribed with the division letter and section number. This type of section marker is used at the Civil War-era Richmond National Cemetery (fig. 4.24). Given the radial plan of the cemetery, the most visible place for the grave markers is at the front of each section along the circular drives, facing the center. For rectangular sections, install the marker in the middle of the section along the adjoining drive. Installing multiple posts around each section (e.g., at the corners of each section) is not recommended because of the potential to clutter the landscape.⁴¹

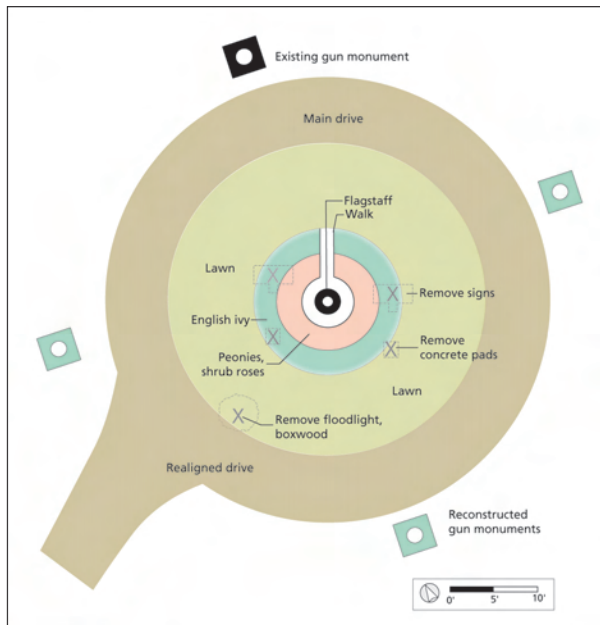
Figure 4.25: Diagram of the central circle showing proposed treatment in tasks BG Tasks 5 and 6. This drawing also shows the realigned circular loop of the main entrance drive as recommended in BG Task 4. (SUNY ESF.)

the flagstaff, approximately six feet in width (sixteen-foot overall diameter including the base of the flagstaff), with low-maintenance plant materials. Include a narrow walk on the north side for access to the halyard and an access pad around the flagstaff. The most appropriate material for the walk and the pad would be concrete with a coarse aggregate, allowed to weather.

Suggested plantings for the central bed include a simple border of English ivy (used historically along the inclosure wall) or similar evergreen groundcover, with an inner circle of long-lived low-maintenance flowering plants such as peonies and ever-blooming shrub roses (see fig. 4.25). Peonies and roses were used historically at Poplar Grove. Roses were traditionally used in cemetery landscapes as symbols of divine mercy, while evergreen ivy symbolized eternal life.⁴²

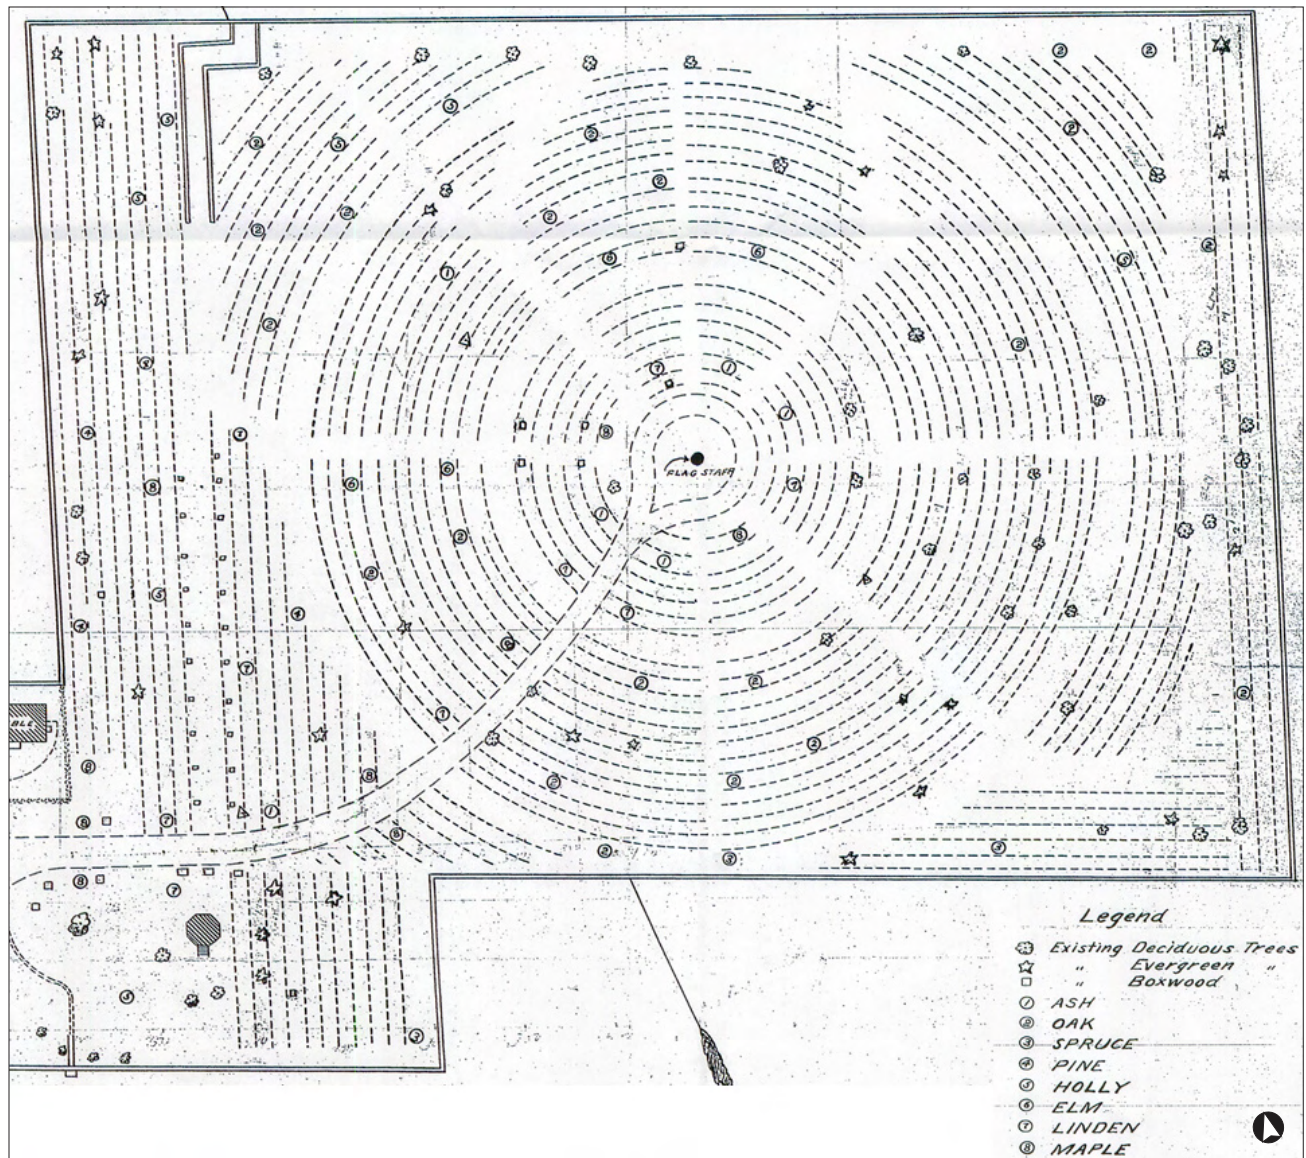
Figure 4.26: The 1931 War Department planting plan for Poplar Grove that serves as the basis for reestablishing the historic character of specimen trees and shrubs within the burial grounds in BG tasks 7 and 8. The ash specified was European mountain ash; oak, pin oak; pine, Austrian pine; spruce, Norway spruce; and maple, Norway maple. This plan does not identify the species of preexisting trees. (Detail of fig. 1.62, National Archives.)

The recommended treatment for specimen trees within the burial grounds is to reestablish the character represented by War Department's 1931 plan, "Tree Planting Layout" (fig. 4.26). The intent of this treatment is to reestablish the overall even distribution of a diverse collection of coniferous and deciduous trees that existed at the end of the War Department period. Literal implementation of this plan may not be necessary to enhance historic character. There are a number of contemporary issues that may require flexibility in location and species, particularly to ensure preservation of the graves and headstones. Sanctity of the graves and preservation of the markers shall always take precedent over planting of new specimen trees.

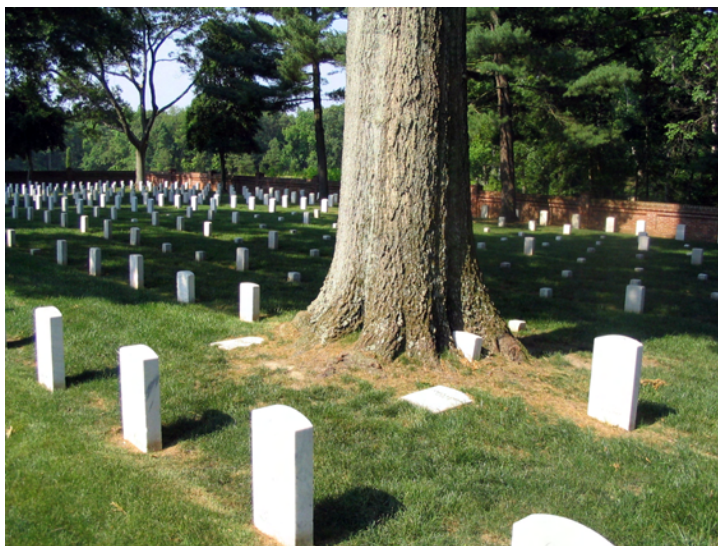
Figure 4.27: Alternative placement of headstones used to preserve and protect historic trees at Fort Harrison National Cemetery. It is recommended that a similar treatment be used when installing new markers at Poplar Grove if the historic marker placement conflicts with the location of mature, healthy specimen trees. (SUNY ESF, 2006.)

placement of the new markers, place the new headstones or blocks in front of or to the side of the tree. To avoid damage to the root systems, consider installing the headstones as flat markers. This is a practice used by the National Cemetery Administration at Fort Harrison National Cemetery near Richmond (fig. 4.27). When the tree is removed in the future, the markers can be returned to their intended location and position.

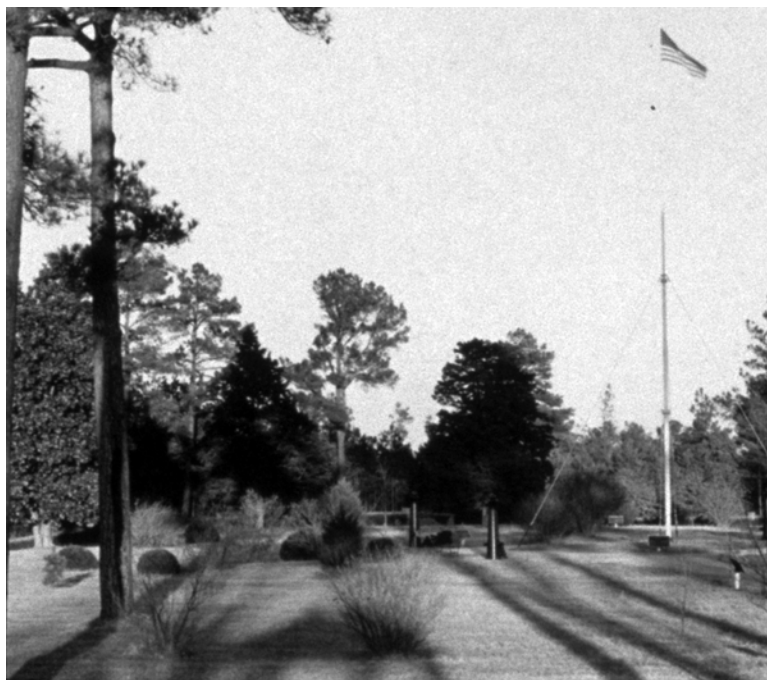
Figure 4.28: A 1939 photograph showing low, clipped mounded boxwood shrubs along the east-west walk west of the flagstaff that date to the historic period. One of the historic iron tablets is visible at the right side of the photograph. (Detail of fig. 1.68, copyright Library of Virginia.)

of second circular drive, for a total of twenty-four boxwoods. Clip these into low mounds, approximately three feet high, as shown in a 1939 photograph (fig. 4.28, see also fig. 1.48). Because there is no historic documentation for this exact planting, this is considered a compatible new addition that recalls the earlier plantings. The new plantings reinforce the center and the symmetry of the landscape by marking the filled-in drive north of the flagstaff. The shrubs will also help orient visitors to the layout of the cemetery.

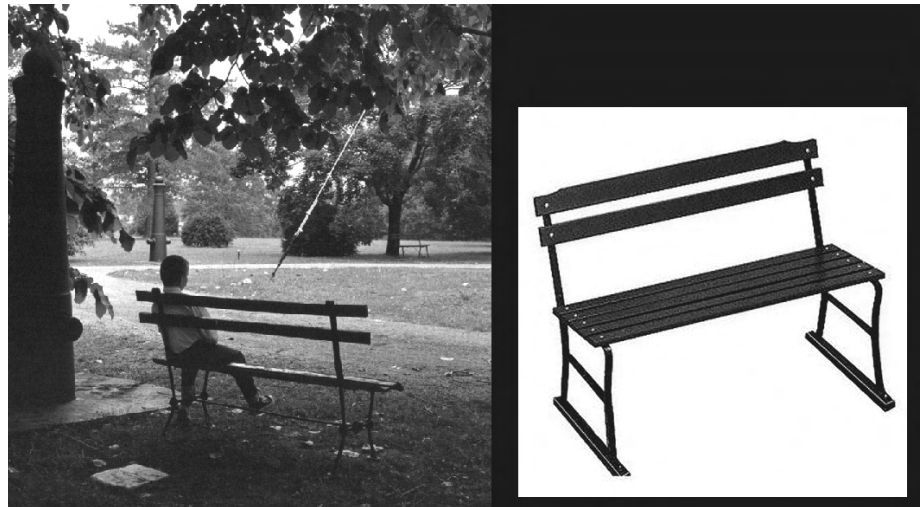
Figure 4.29: A 1968 photograph showing a remaining c.1877 wood-slat and iron frame settee (left), and example of a contemporary bench with similar design. (Left: detail of fig. 1.73, Petersburg National Battlefield; right: item AL006, "Traditional Garden Bench," Benches.com, www.benches.com.)

Install fourteen benches along the drives to reintroduce this feature to the landscape and provide visitors with resting places. Place four benches symmetrically around the central loop drive; eight along the third outer loop drive; and two along the main entrance drive. There were nine settees in 1929, down from twenty in 1888, but their locations are not known. The preferred treatment is to fabricate a replica of the 1877 settees based on photographic record or on a surviving settee at another national cemetery, or plans if they can be located. If this is not feasible, install a contemporary bench that recalls the design of the historic settee using a metal frame and painted wood slats (fig. 4.29). Following the 1931 National Cemetery Regulations, paint the benches bronze green.⁴⁵

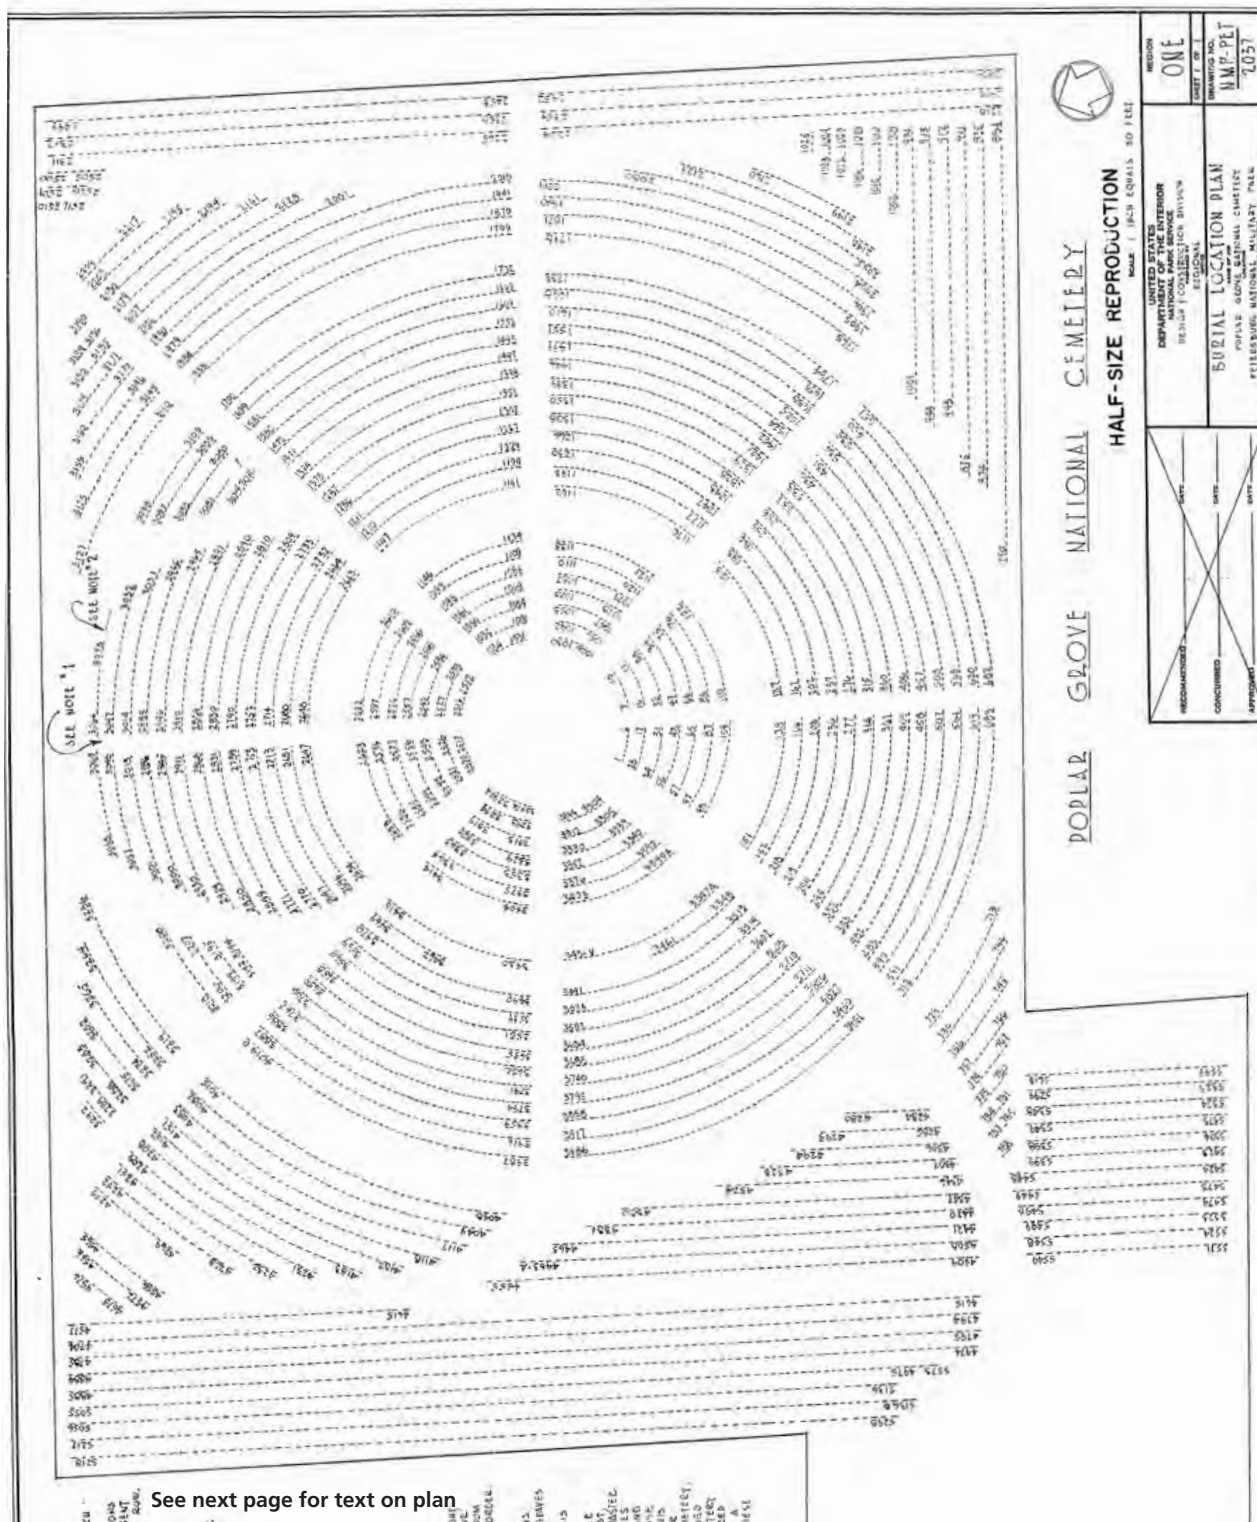
POPLAR GROVE BURIAL LOCATION PLAN, (C.1954)

Source: National Park Service, Technical Information Center, drawing NMP-PET 2037. (Plan does not show Division/Section or Block designations.)

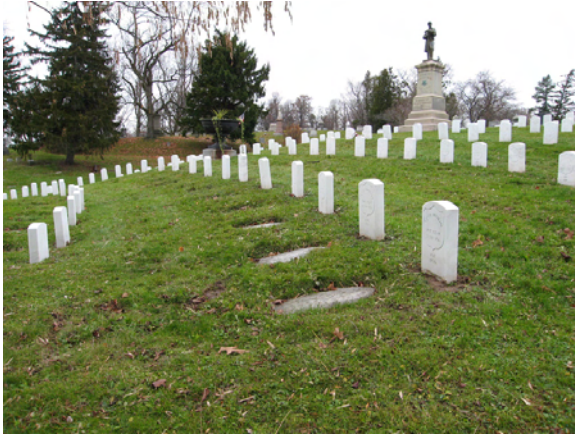
Figure J.1: Illustration of alternative A for the old markers implemented at the Soldiers Plot of Oakwood Cemetery, Syracuse, New York. The old headstones were laid flush with the ground and new government-issued headstones were installed at the top of the grave. Note that the old headstones recede in the landscape, but remain visible upon close inspection. (SUNY ESF, 2006.)

From a cultural landscape perspective, retention of the existing headstones alongside the new upright headstones will not have a marked visual impact because the old headstones in their position flush with the ground are inconspicuous. Only upon close inspection will the old headstones become visible. From an archeological perspective, this alternative will also not impact the underlying grave. There may be a curatorial concern about material conservation of the old

markers because the stone will continue to suffer from weathering (the horizontal position exposes the inscribed face of the stone to heavier weathering than the upright position). The alternative may also pose an additional maintenance burden to trim around both the upright and flush headstones.
