CULTURAL LANDSCAPE REPORT FOR SPRINGWOOD

Home of Franklin D. Roosevelt National Historic Site Volume II: Treatment

Hyde Park, New York

VOLUME II: TREATMENT

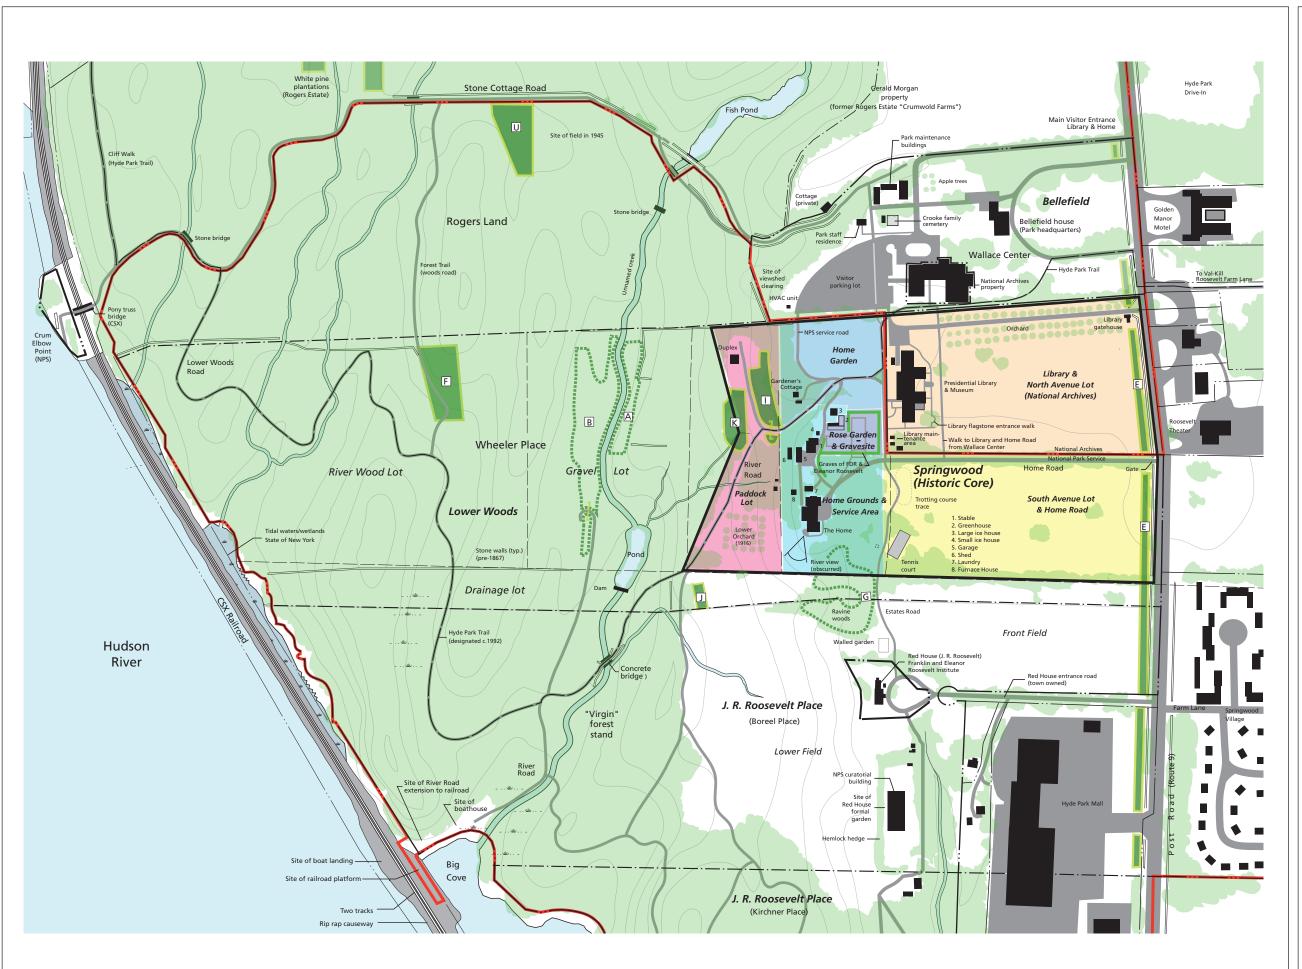
All features shown in approximate scale and location.
 Plan provides overview of existing (2009) conditions within the historic core (original 33-acre area surrounding the Home), with less detail in adjoining areas.

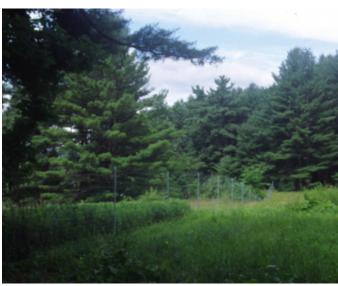
Figure 6: Recent photograph of site-wide deer fencing at The Mount, Lenox, Massachusetts showing inconspicuous design that visually recedes through open field conditions. (SUNY ESF.)

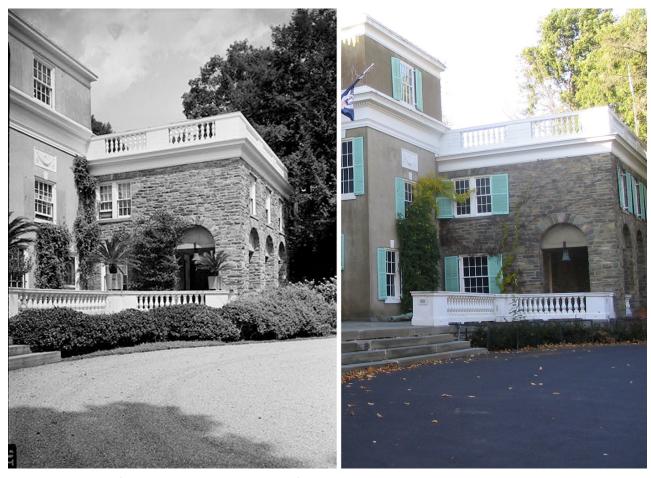
Figure 8: Comparison of paving character showing gravel-surfaced turn-around in July 1941 and the existing black asphalt that replaced it. These images also changes to the foundation shrubs. (Left: Digital image 115847pr, Historic American Building Survey, Library of Congress American Memory Collection; right: SUNY ESF, 2005.)

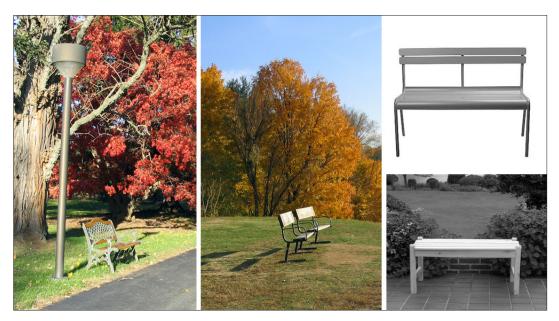
Figure 9: Existing park furnishings showing light standard and two styles of benches (left and center), and suggested bench styles that would be compatible with the historic character of the landscape. (SUNY ESF, 2005; right, bottom: WoodenBench.us, http://www.woodenbench.us; right top: Luxembourg Verbena Bench, http://www.conranusa.com.)

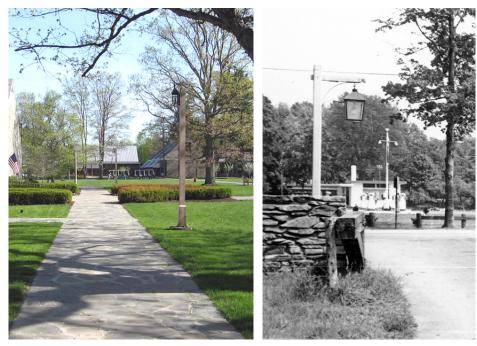
Figure 10: Recently installed light standards along the Library entrance walk (left) and historic light standards at the Library entrance. (Right: Photograph R78B, c.1946, Roosevelt-Vanderbilt National Historic Sites; left: SUNY ESF, 2007.)

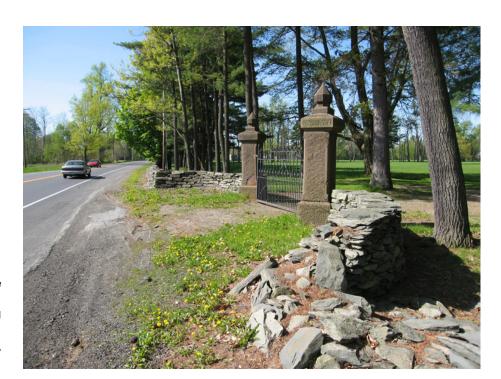
Figure 12: Recent view of the Home Road entrance looking south along the Post Road showing deteriorated condition of road shoulder, earthen roadbed, and stone wall. (SUNY ESF, 2007.)

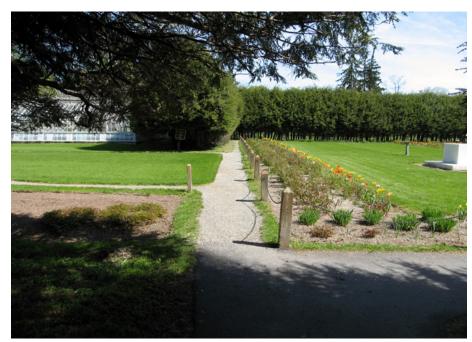
Figure 28: Recent view of the Rose Garden hedge looking north prior to replacement in fall 2008 showing overgrown and browsed conditions. Compare with same view in figure 29. Also note the changes in the walks, which are today surfaced in asphalt and coarse gravel, and lack the well-defined edges that existed historically. The narrow turf border between the walks and the flowerbeds has also eroded. (SUNY ESF, 2007.)

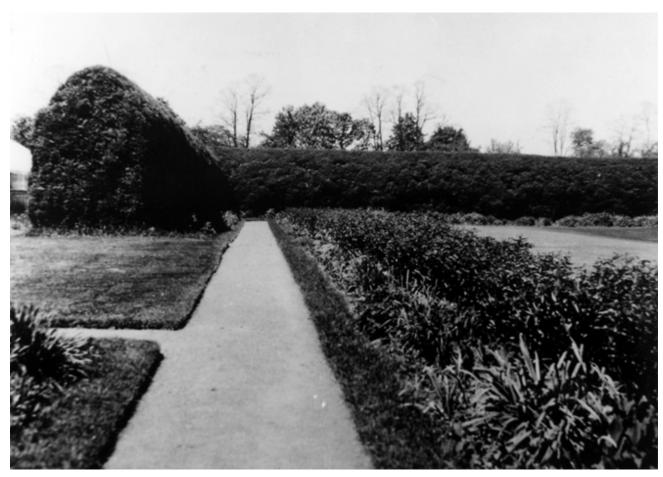
Figure 29: Historic view of the Rose Garden hedge in c.1942 looking north showing straight sides and battered top. Also note stone dust surface of walks, neatly edged into the lawn; and narrow turf strip between the herbaceous borders and the walks. (Photograph NPx 80-165 9, Franklin D. Roosevelt Library and Museum.)
