Landscape Treatment Proposals

Harriet Tubman National Historical Park Auburn, New York

Landscape Treatment Proposals for the Harriet Tubman National Historical Park Auburn, New York

Department of Landscape Architecture Cultural Landscape Preservation Studio 2017 State University of New York College of Environmental Science and Forestry

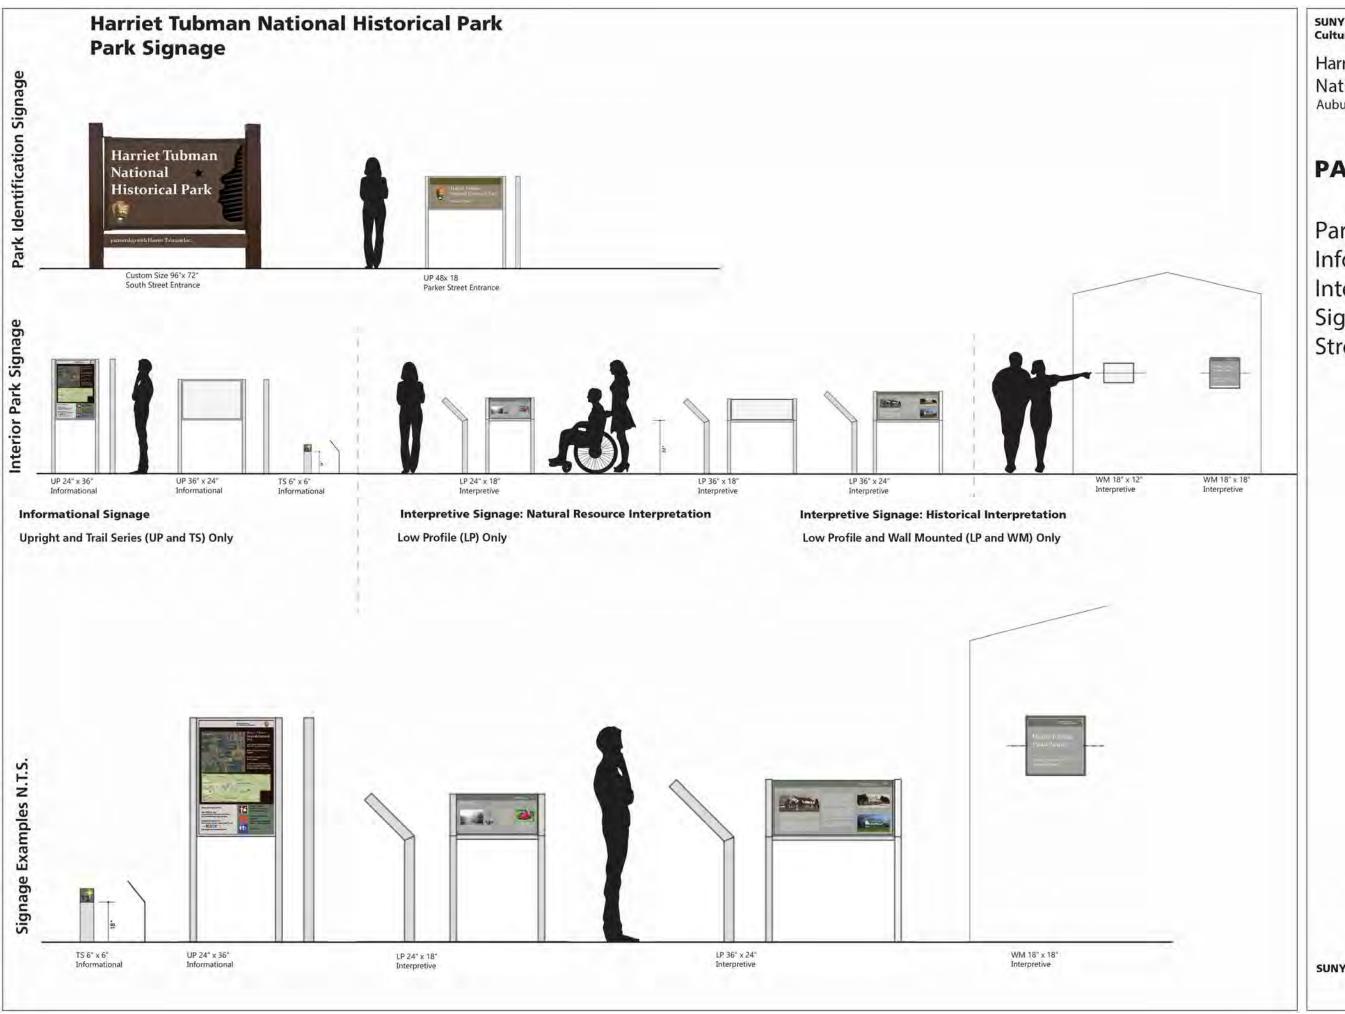
PARK SIGNAGE:

Free-standing interpretive signs would have one of three possible sign panel sizes [18"x24", 18"x36" and 24"x36"], mounted on a metal base through a direct embedment socket. Wall signs would be modest sized [12"x12" or 18"x18"] and installed without damaging building materials.

Given its size, urban neighborhood context, and limited special visitor services, a second less monumental park identification sign would be located at the Parker Street property. The upright sign panel would have similar content to its South Street counterpart; but it would be smaller [18"x48"] and made of metal rather than wood, with a direct embedment socket mount that would allow for ease of repairs, modifications or removal. Informational signs within the Park would include free-standing upright panels and trail markers. Free-standing interpretive signs would incorporate a low-profile 45-degree angle, which complies with ADA requirements; wall mounted panels would be sized for nominal text and graphics, and installed without damaging building materials. All freestanding signs would be mounted on a metal base
