Cultural Landscape Treatment
Home of Franklin D. Roosevelt National Historic Site
Concept Development

Faculty of Landscape Architecture
Preservation Studio
State University of New York
College of Environmental Science and Forestry

Faculty of Landscape Architecture
Preservation Studio 2006
State University of New York
College of Environmental Science and Forestry

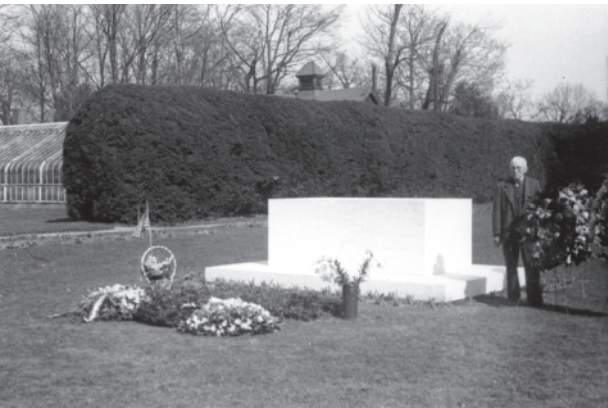
3.4 Remove the Gravesite Monument Yew Border

Gravesite Monument (HOFR Park Archives)

3.4 Remove the yew border (*Taxus spp.*) that surrounds the gravesite monument and replace with pansies each year in spring. Historically, pansies surrounded the gravesite monument. The yew border had been added after the period of significance.

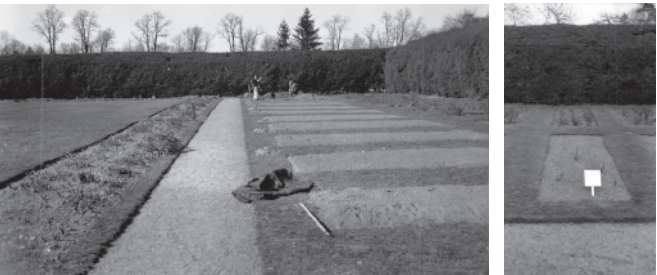
3.9 Restore the Rose Garden Rose Beds

Rose Garden Rose Beds (HOFR Park Archives 1946)

Reestablish the two missing rose beds along southern end of the Rose Garden. Replant the rose beds with roses as listed from the historic documentation. The grass edge of the rose garden rose beds should be maintained with a shovel cut edge. Many of the roses were fragrant hybrid perpetuals from the mid to late 1800s. Roses were aligned in three rows from east to west in each bed. Although the inventory indicates the names of historic roses in particular beds, it does not provide information to replicate all of the rose beds exactly. For example the inventory describes 11 rose beds; however, the 1946 USGS map shows 15 beds. Therefore, the rose garden rose beds should strive to capture the historic character by using the roses from the inventory.

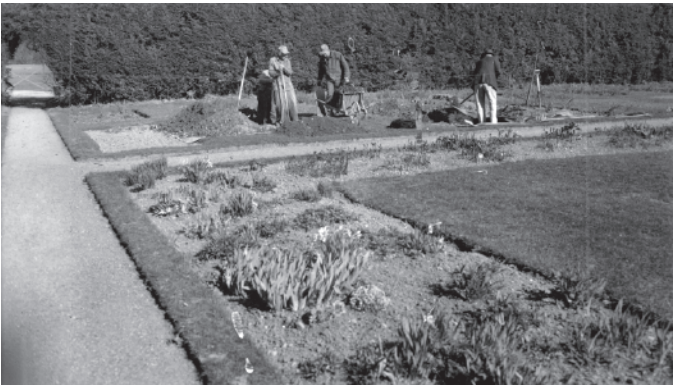
3.8 Restore the Herbaceous Beds

Rose Garden herbaceous beds (HOFR Park Archives 1946)

Reestablish the herbaceous beds with plant material from the historic plant inventory from the archives of April-September 1946. Apply a shovel-cut edge to the grass edge of the herbaceous bed. The inventory does not name varieties or cultivars. Selections should be made according to the color indicated in the inventory and what was generally available at the time to reflect the historic character of the herbaceous beds. The annual, bulbs, and perennials are spring and early summer bloomers. The emphasis on early-flowering plants could be due to the Roosevelt’s spending time in Bar Harbor, ME in July and August. Although the plants have their most colorful display early, the contrast in foliage textures of the iris, peonies, and other plants provides interest the rest of the season.

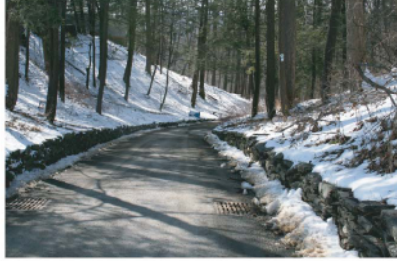
4.3 River Road

View Southwest Down River Road

The asphalt pavement that exists on River Road does not contribute to the historic character of the overall site and should be removed. Drainage issues also exist along River Road and should be examined to determine if measures can be made to resolve these problems.

Historically, River Road was a graded crushed stone road with native field stone retaining walls. A similar character should be carried throughout River Road, from its connection to Estate Road all the way to the Hudson River.

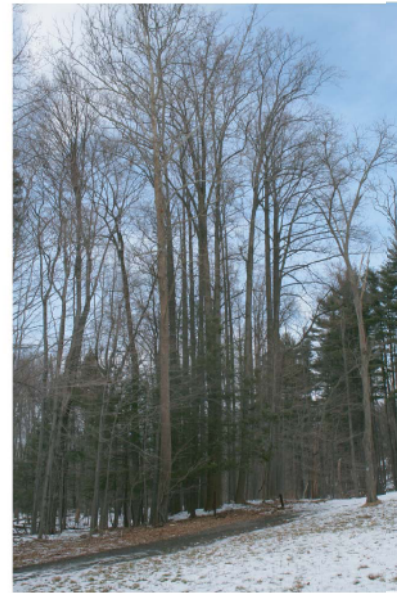
4.6 Tulip Poplar Plantation - Plot K

View of Tulip Poplar Plantation

The plantations that were planted in the early 1900's by the Roosevelt family have grown into maturity and are now established. To retain the historic characteristics of the plantation, the understory plants that have grown through must be removed. There are also drainage problems that need to be addressed.

To establish the desired historic character understory brush should be removed based on the forthcoming Forest Management Plan. The drainage issues that exist are due to the addition of the upper parking lot. The excess flow has created an eroded swale through the Tulip Poplar Plantation. Further research is recommended to obtain a long term answer to this erosion problem.

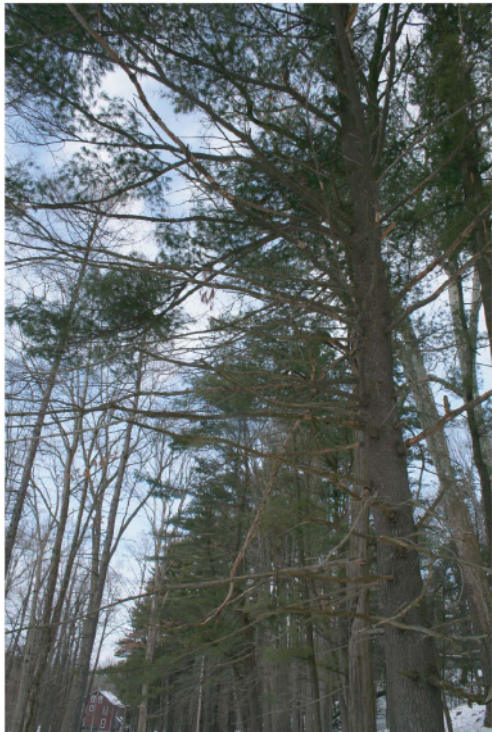
4.7 White & Scots Pine Plantation - Plot I

View of Pine Plantation I

The plantations that were planted in the early 1900's by the Roosevelt family have grown into maturity and are now established. To retain the historic characteristics of the plantation, the understory plants that have grown through must be removed.

To establish the desired historic character understory brush should be removed based on the forthcoming Forest Management Plan.'

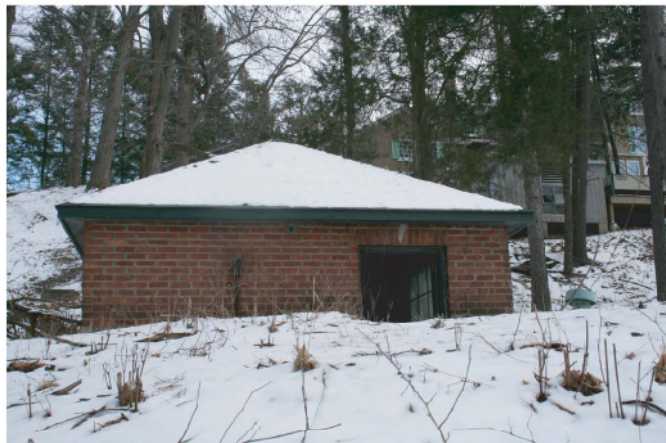
4.8 Ram House

View East up to Ram House

The Ram House is in need of repair to return it to its historic character. The original roof was removed and replaced with an asphalt shingle roof, the door was removed, and the interior is in pieces. A sod roof is needed to replace the existing roof, and a door is needed to provide security. The debris surrounding and inside the Ram House needs to be removed to restore the sites character.

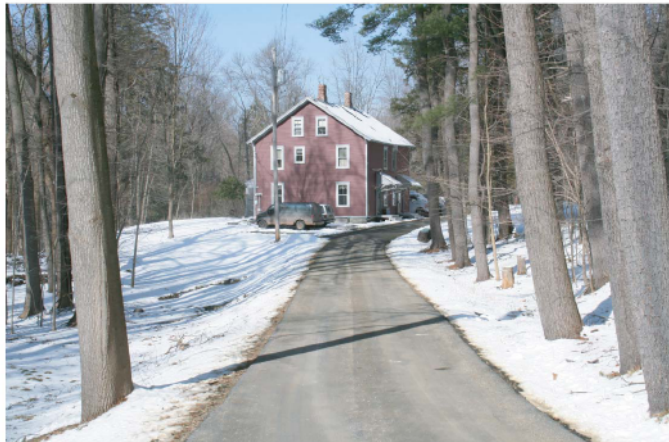
4.10 Duplex

View East Toward Duplex Residence

Research will be needed to determine if the paint is the historic color of the Duplex. The residence is in good structural condition, and has few problems. Proper and consistent signage is needed at the entrance to control user circulation and help to identify the history of the Duplex.

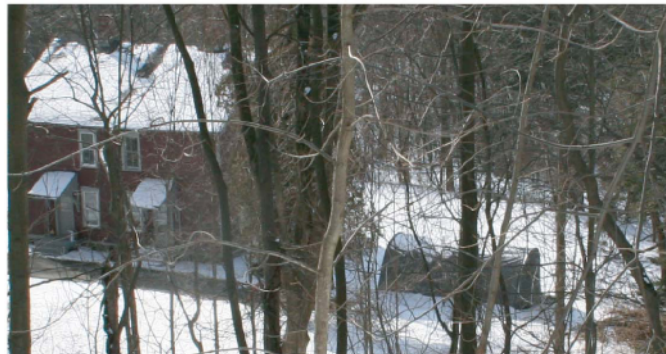
4.12 Site of Duplex Chicken Coop

The chicken coop no longer exists and needs to be reconstructed. There are no permanent structures located in the area that the chicken coop stood, but a temporary garage sits in the general area of where the Chicken Coop was located. Upon further research a match may be found to the Coop, or if nothing is found, a structure similar in historic character may be constructed.

The main reason for rebuilding of the Chicken Coop is to reflect the historic character of the site. Adding this feature and removing the temporary garage will add to the historic quality.

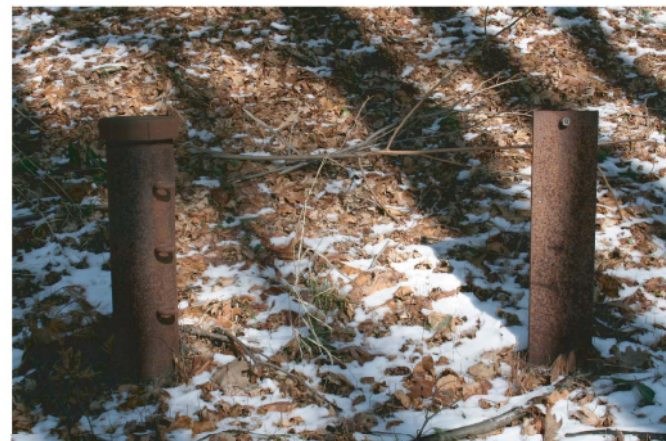
4.13 River Road Crash Barrier Posts

View of Crash Barrier Posts

The treatment recommended for the Crash Barrier Posts is reconstruction. To evoke a War-time feeling in the site the posts would be strung back up with wire, but allow room for visitor passing and interpretation.

The Crash Barrier Posts would contribute to the hitoric character of the site, and reflect the War-time feelings of the site during the period of interpretation. Original pictures exist showing the constructed gates that were held up by the posts.

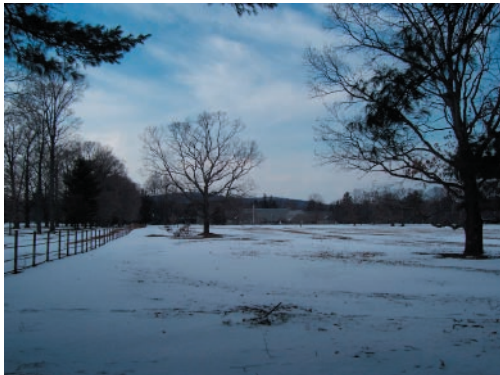
Figure 1.27 North Avenue Lot Subspace

Existing Conditions: The space was altered slightly in 1971 with the construction of two wings to the library. The enlarged library further screened views to the west. Despite this, the overall spatial configuration of the north avenue lot subspace is unchanged in terms of its shape, size, and defining edges. See Figure 1.27 North Avenue Lot Subspace.

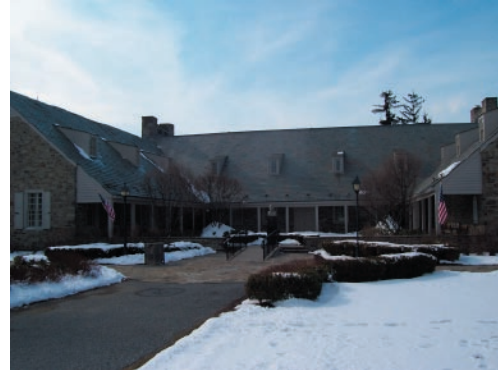
Figure 1.43 FDR Library

Existing Conditions: The library was enlarged with the addition of two wings in 1971. The additions were located on the north and south elevations. They were rectangular, 80 feet long (N/S) by 35 feet wide (E/W) and two stories high. The additions gave the building a total length of 320 feet. The additions were constructed of local brown-colored fieldstone. The roof was gabled and therefore gave the entire library a double cross-gabled roof with slate shingles which were gray in color. A door was constructed in the center of the north wing of the original structure, on the east elevation. The library exists and appears to be in good condition. See Figure 1.43 FDR Library.

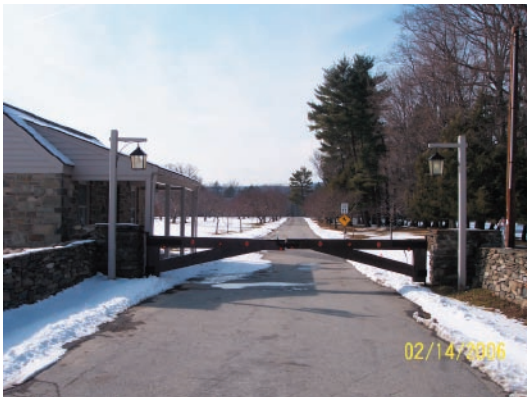
Figure 1.030 Gatehouse

Existing Conditions: The gate house exists, is unchanged from its historic condition, and appears to be in good condition. See Figure 1.030 Gate House.

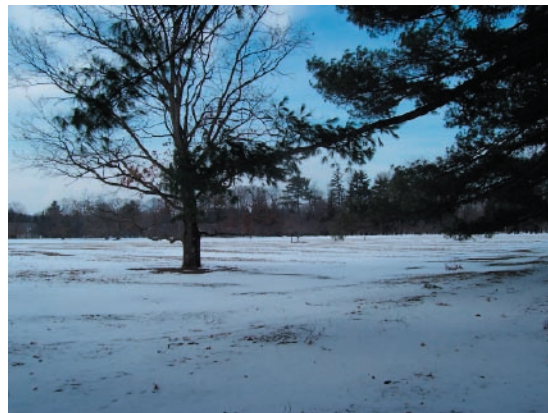
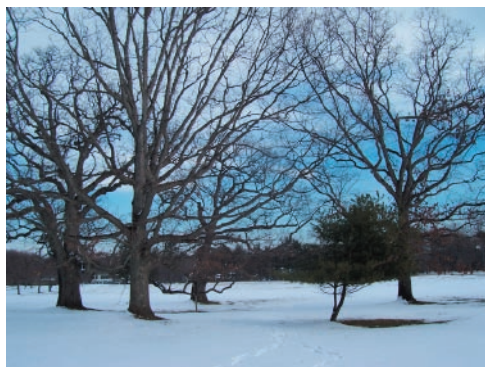
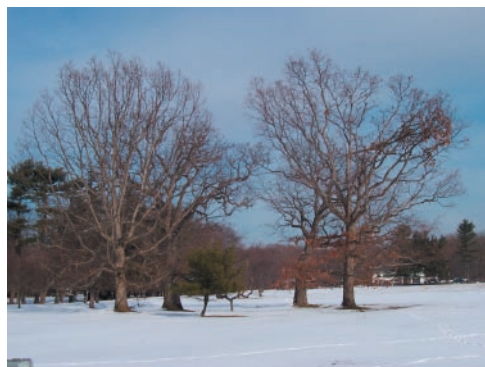
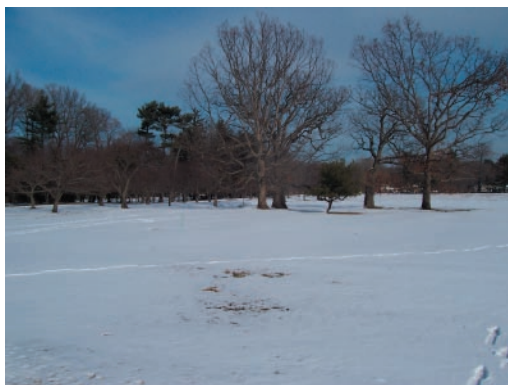
Existing Conditions: Two of the original white oak trees plus four trees planted during the Late Roosevelt Ownership Period, including two of the four oak trees located in the southeast corner, exist and are in fair condition. The three red oaks east of the library also exist and are in fair condition. The existing nine trees are large with a spreading habit. One of the two largest (approx. 5' in diameter) of the White Oaks is damaged with nearly half of the trunk missing due to storm damage. A 6" caliper White Pine has taken up residence beneath and encroaching on the canopy of one of the large White Oaks in the field to the east of the library. See Figures 1.28, 1.41, 1.91 and 1.95 Oak Trees.

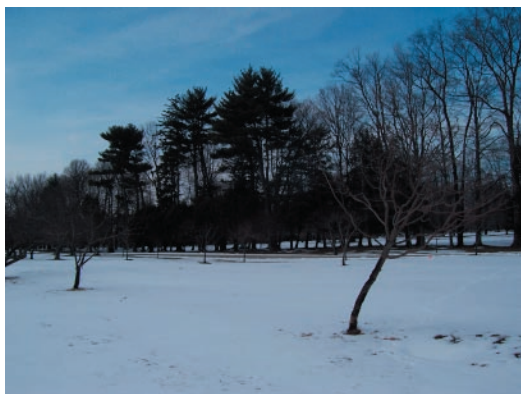
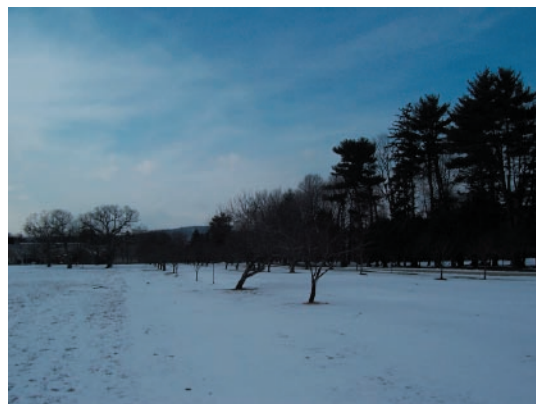
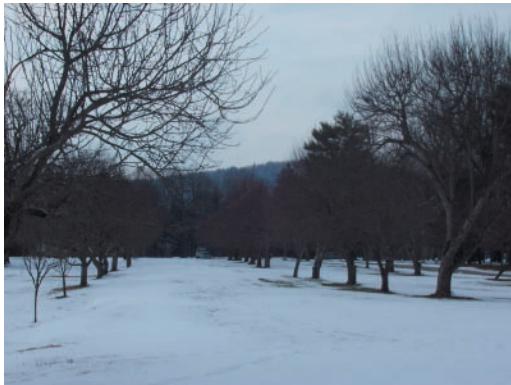
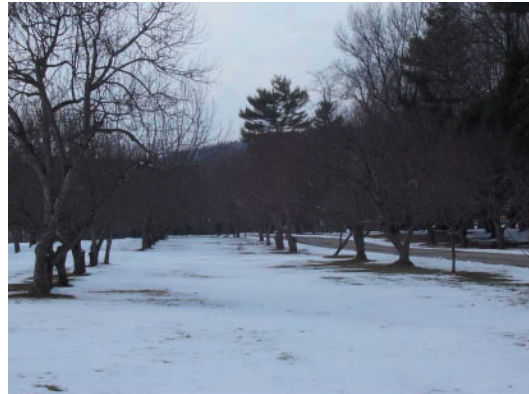
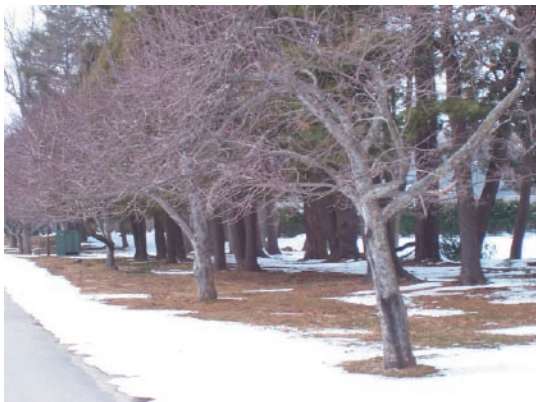
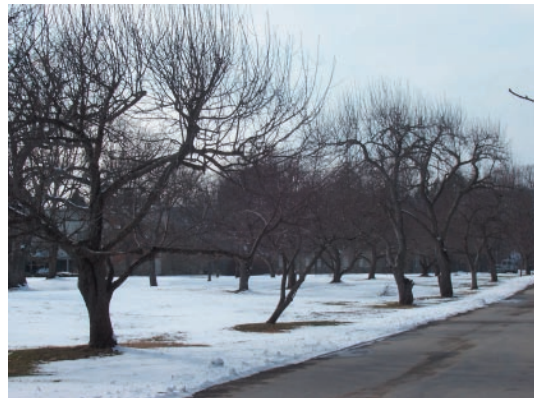
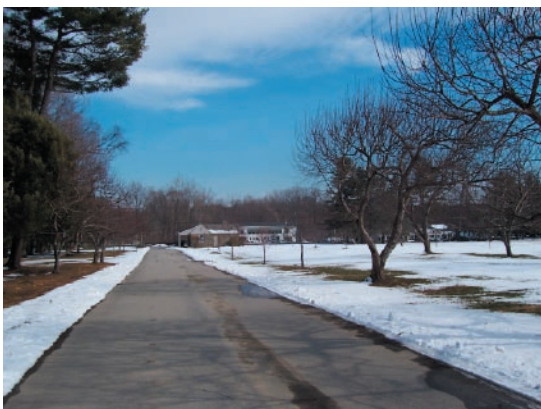
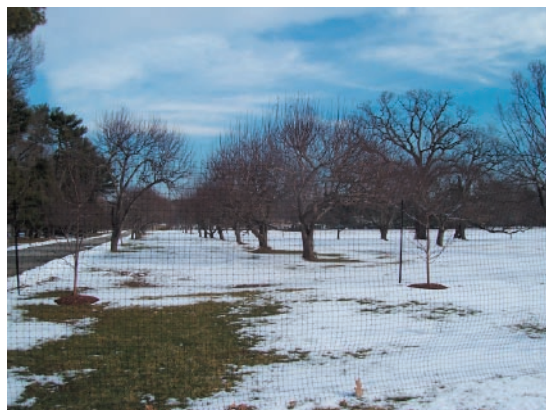
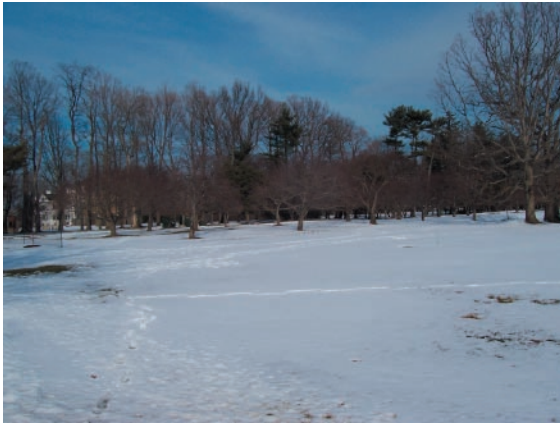
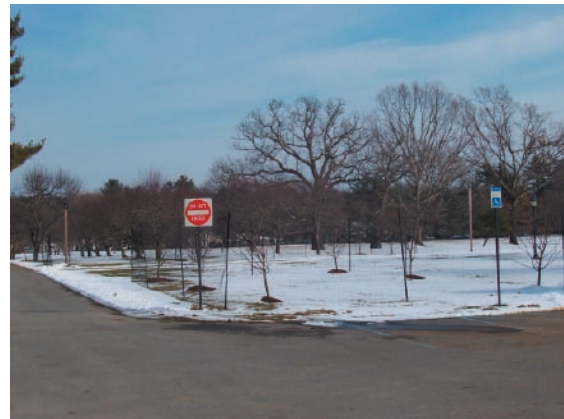
Existing Conditions: The orchard contains 80 fruit trees. Trees within the orchard have been removed and replaced since 1945, exact date unknown. The condition of the fruit trees in the orchard is undetermined, but are consistent with the characteristics of fruit trees during the period of significance. The orchard trees have been pruned highly to facilitate mowing beneath them. See Figures 1.33 - 1.36, 1.38 - 1.40, 1.44, 1.94 and 1.99 Orchard.

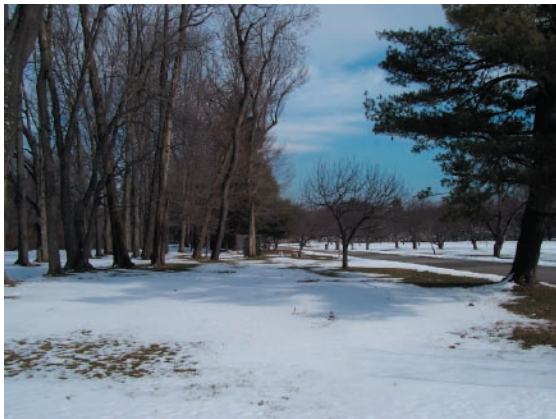
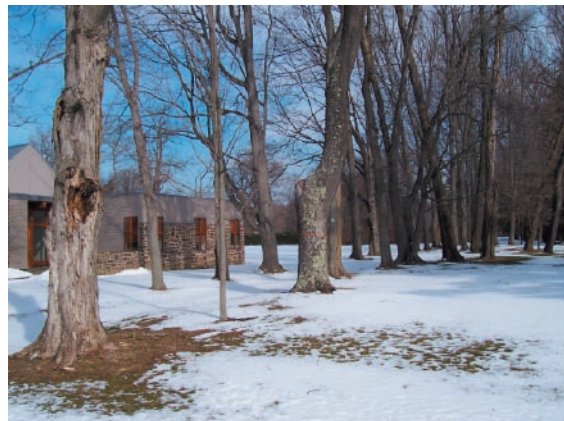
Existing Conditions: The historic tulip poplars still exist and are large in size and still serve as a screen. All the historic fruit trees located east of the estate road and west of the library were lost but replanted over the years, retaining a partial screen. The Norway spruce trees were removed in c. 1948. Trees located adjacent to the library were not identified for this project, but are contemporary additions to the property. A mixed grouping of trees exists along the northern edge of the north avenue lot screening the view toward Bellefield. See Figures 1.47 and 1.48 Trees.

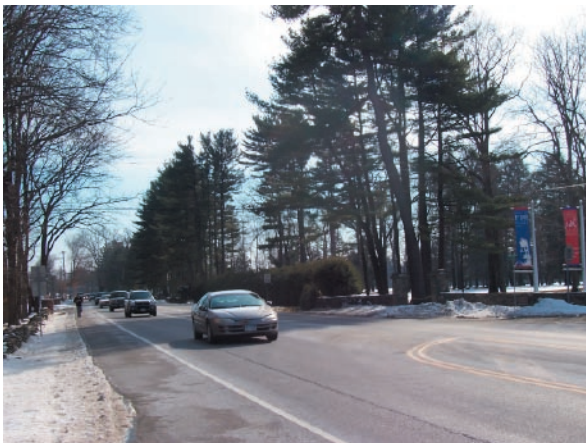
Figure 1.54 White Pine Hedge

Existing Conditions: Since 1945, exact date unknown, individual trees within the hedge died and were removed but not replaced. The remaining trees within the hedge are large with a broad canopy, although much more open to Albany Post Road due to their mature form and the loss of two of the three rows. Slightly more than half the historic trees remain, and the hedge still retains its general character and purpose as a screen from the Albany Post Road. The rows of White Pines toward the southern end of the hedge on the north avenue lot remain in the best condition and most consistent form and spacing. The white pine hedge exists and is in fair condition. See Figure 1.54 White Pine Hedge.

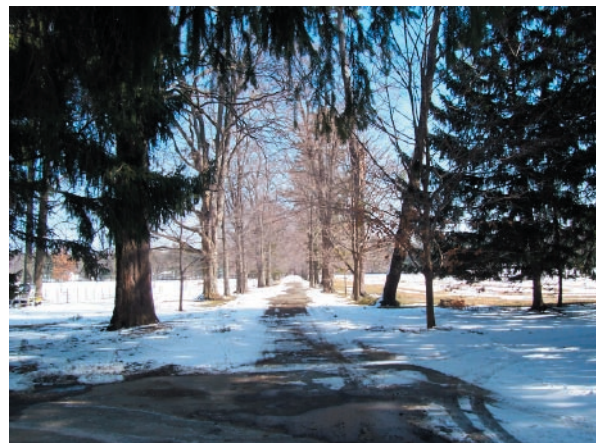
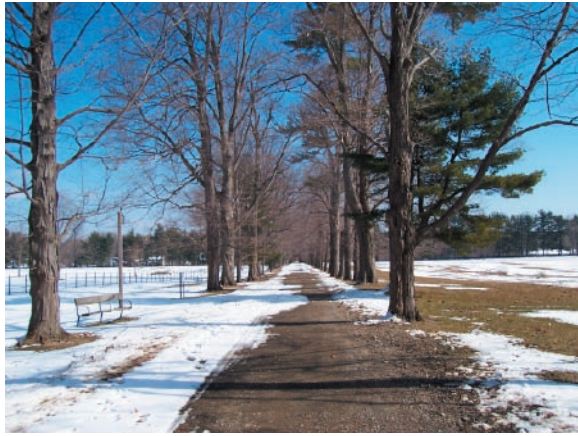
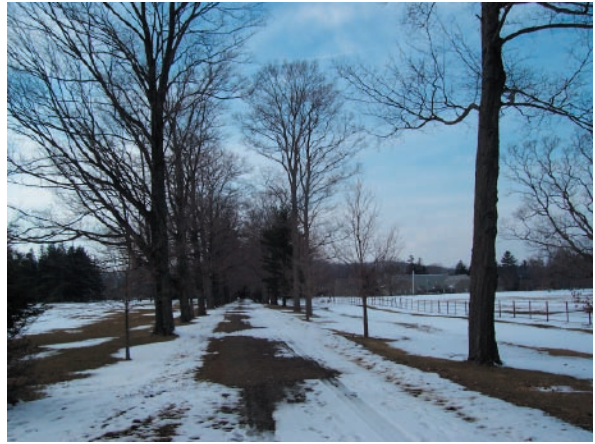
Existing Conditions: Due to the maturation and loss of the historic vegetation, some trees were removed and replaced in kind, but not in stature. These trees now form a much more open and irregular canopy. The allée is relatively unchanged in terms of the number and types of plants, still creating varying textures between the evergreen and deciduous vegetation. Edge definition of the Home Road allée has been lost due to lawn grass which has crept into the road space in an irregular fashion. The home road allée exists and is in fair condition. See Figures 1.08, 1.09 and 1.30 Home Road Allee.

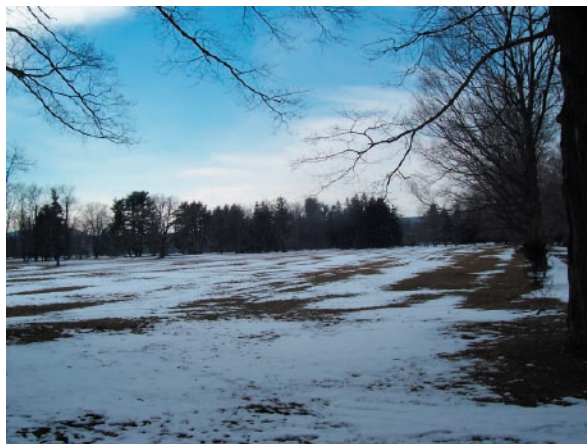
Figure 1.26 South Avenue Lot

Existing Conditions: The space was slightly altered during the NPS Ownership Period, exact date unknown, when the trotting course was left to revert to meadow grass. The spatial configuration of the south avenue lot subspace is unchanged in terms of its shape, size, and defining edges. See Figure 1.26 South Avenue Lot.

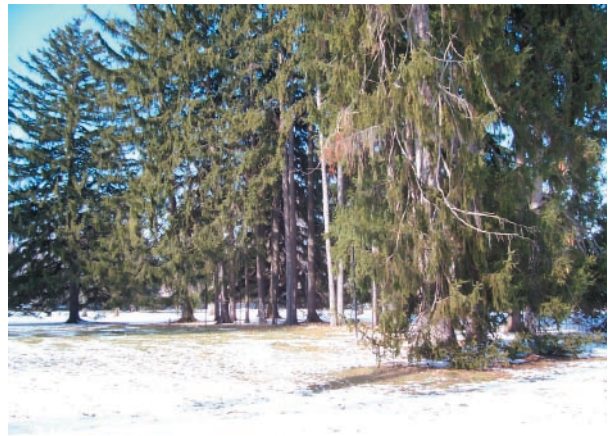
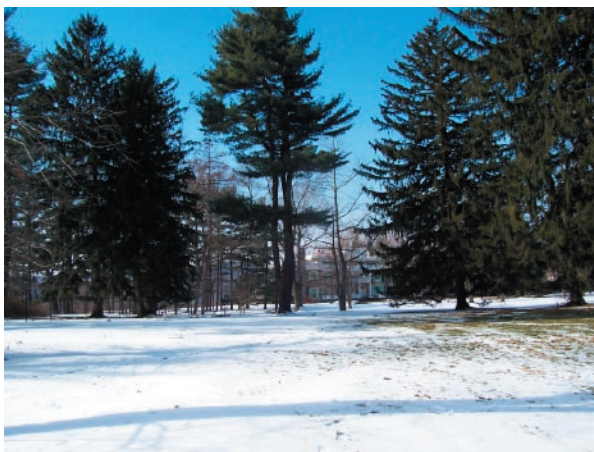
Existing Conditions: The tennis court's surface and net were removed between 1945 and 1966. The surface of the tennis court is grass, and the backstops are painted black but are deteriorated. The tennis court exists but is in poor condition. See Figures 1.13 and 1.14 Tennis Court.

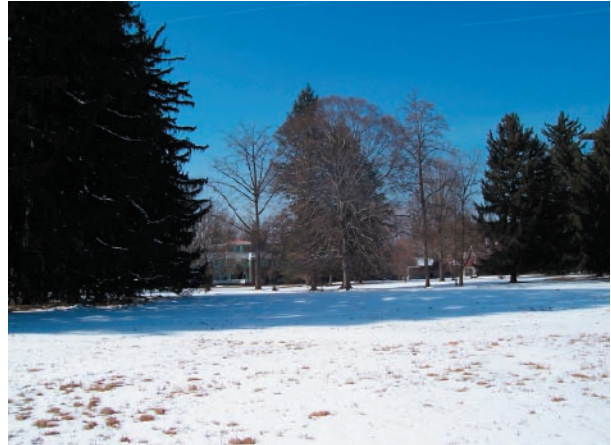
Figure 1.10 Trotting Course

Existing Conditions: The trotting course was no longer used or maintained during the NPS Ownership Period and as a result reverted to meadow grass. See Figures 1.10 - 1.12 Trotting Course.

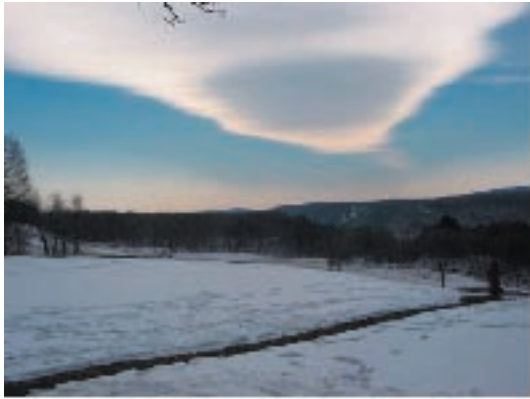
Figure 2.47 River View

Existing Conditions: The NPS did not own the property that secured the vista until 1998, and as this unmaintained vegetation reached its mature size, it eliminated the vista to the Hudson River. The vista from Springwood to the Hudson River no longer exists. See Figure 2.47 View.

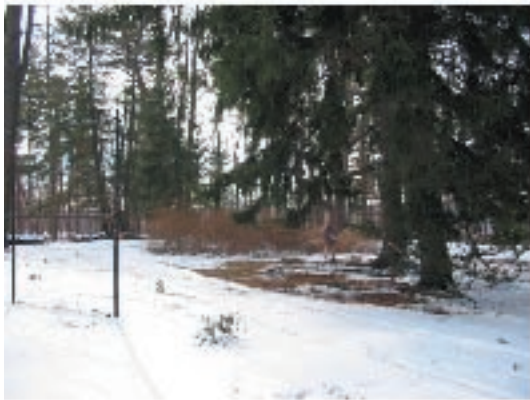
Figure 2.40 Original Location of the
Swan Cottage Playhouse

Existing Conditions: The Swan Cottage playhouse was removed and was relocated to Eleanor Roosevelt's home at Val-Kill after FDR's death in 1945. The playhouse exists and is located at the Val-Kill NHS. It appears to be in good condition. Original location is shown in Figure 2.40.

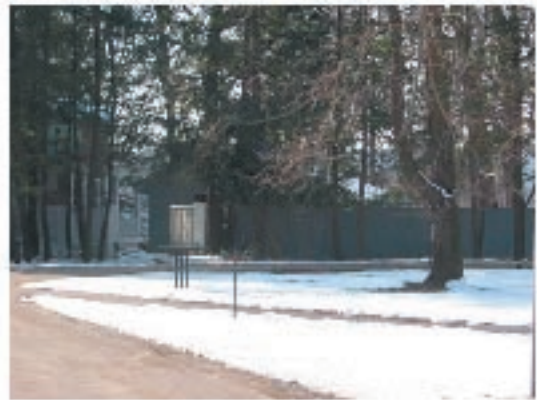
Figure 2.74 Original Location of the
Main Lawn Guard House

Existing Conditions: The guard houses were removed during the NPS Ownership Period, exact date unknown. In 1997 a guard house, reported to be from the site, was given to the NPS. This guard house has a pyramidal-hipped roof with gray asphalt shingles. This guard house is currently stored in the Bellefield maintenance area and is in poor condition. One of the previous locations of the Main Lawn Guard House is shown in Figure 2.74

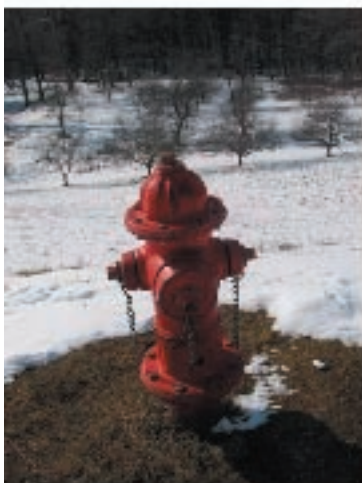
Figure 2.02 Fire Hydrant
on South Lawn

Existing Conditions: Fire hydrants were added to the property in 1958-59 and four of them are located within the main lawn area. One fire hydrant is located south of Springwood, one directly east of Springwood, one at the northwest corner of Springwood, and the last is north of Springwood near the service area fence. The metal hydrants are 1 1/2 feet high and red in color. The fire hydrants exist and are in good condition. See Figure 2.02.

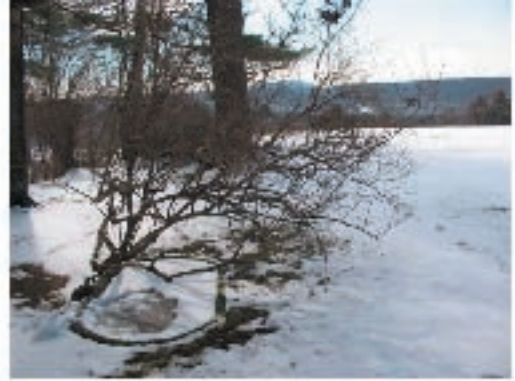
Figure 2.01 Pool/Fountain on South Lawn

Existing Conditions: The cherub located on the southern side of the pool/fountain has been removed, exact date unknown, and is now stored in the site's museum collection and is in good condition. The fountain basin is full of brackish water and almost entirely covered by a large shrub. The basin exists and is in fair condition. See Figure 2.01 Pool/Fountain.

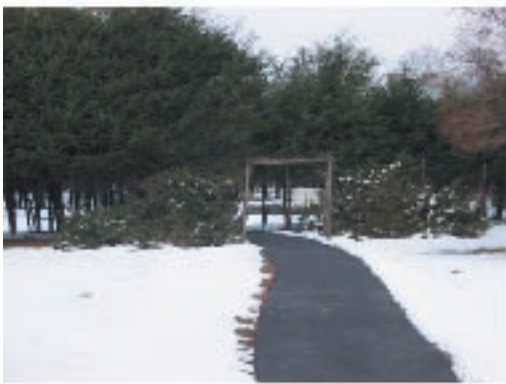
Figure 2.31 Rose Arbor

Existing Conditions: The rose arbor was removed and reconstructed at some point after 1954, exact date unknown. The arbor is in the same location as the historic arbor. The current structure is post and lintel in form with a span of 6 feet and a height of 7 feet. It is constructed of two vertical members and two horizontal overhead members and is 3 feet wide. The arbor exists and is in good condition. See Figure 2.31.

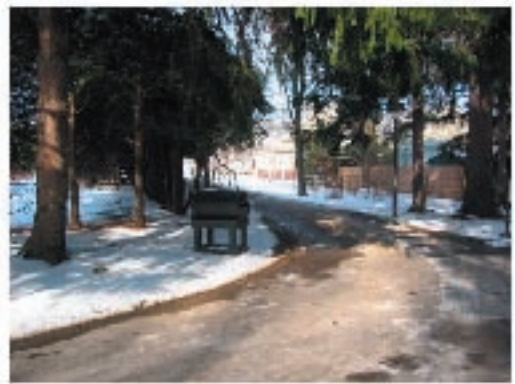
Figure 2.39 Original Location of Electric Eye

Existing Conditions: The electric eye was removed during the NPS Ownership Period, date of removal unknown. Original site of the Electric Eye at the intersection of Home Road and Estate Road is shown in Figure 2.39

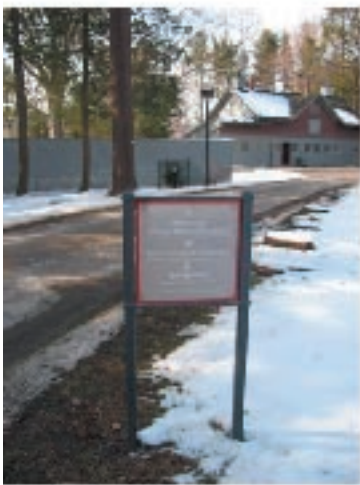
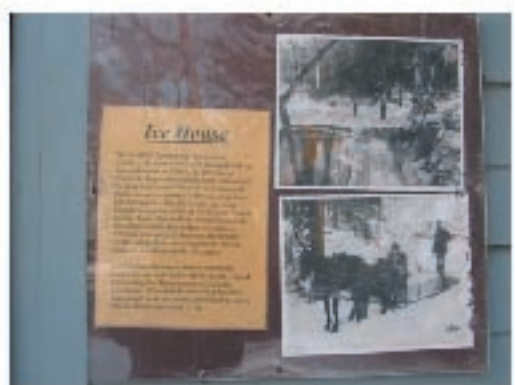
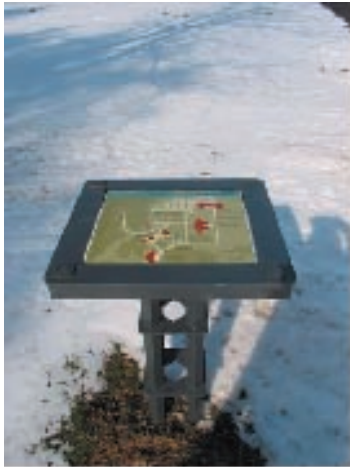
Existing Conditions: Three information signs of various sizes and materials were installed by the NPS, exact dates unknown. These signs are located near the northeast corner of Springwood, adjacent to the wheelchair ramp. The information signs exist and are in good condition. See Figures 2.03, 2.14 and 2.38. Also the NPS has labeled certain specimen trees with their scientific name for educational purposes, as shown in Figure 2.46.

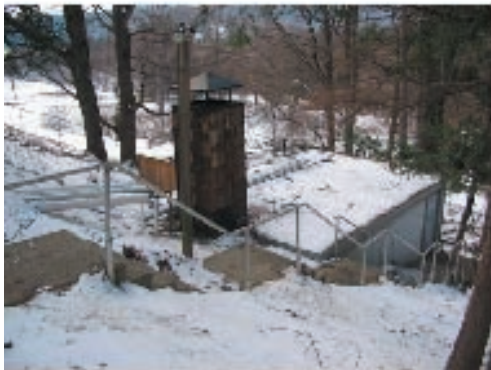
Figure 2.79 Southwest View at
NPS Furnace House

Existing Condition: This shed is set into the topography of the hillside slope west of the laundry. See Figure 2.79 NPS Furnace House.

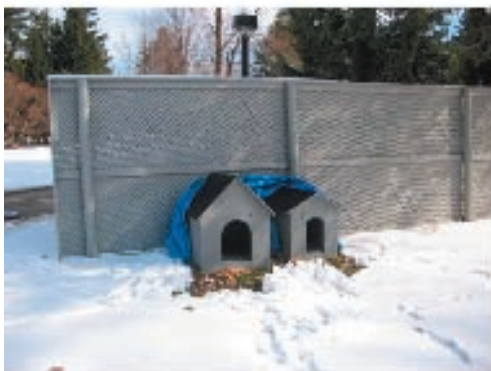
Figure 2.25 Reconstructed Dog Houses

Existing Conditions: The original doghouses were removed from the site, date of removal unknown. They were reconstructed by the NPS in 2002. See Figure 2.25 DogHouses.

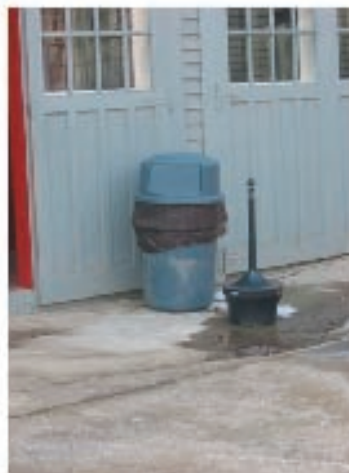
Figure 2.11 Trash Receptacles at
Stable/Tourist Center

Existing Conditions: The trash receptacle was installed during the NPS Ownership Period, exact date unknown. It is located adjacent to the east elevation of the stable/garage/Tourist Information Center. The trash receptacle was rectangular, approximately 2 feet long by 2 feet wide and 3 1/2 feet high. It is constructed of metal and plastic and is black and brown in color. The trash receptacle exists and is in good condition. See Figure 2.11 Trash Receptacle.

Although trash receptacles are necessary to support visitor needs, it does not contribute to the site because it did not exist during the period of significance. The current receptacles location, shape, size, and materials detract from the historic character of the period of significance.

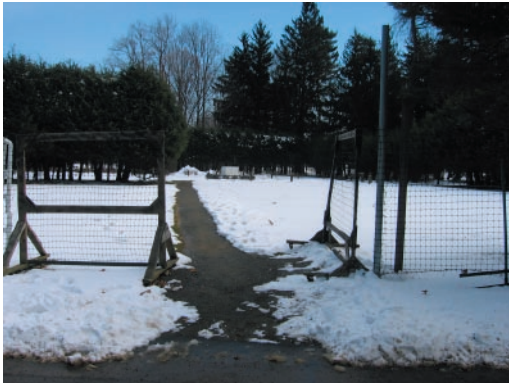
3.1 Deer Fence

Although a deer fence is necessary to protect the vegetation within the garden from deer, it does not contribute to the site because it did not exist during the period of significance. The current fence's location, size, shape, and materials detract from the historic character of the period of significance.

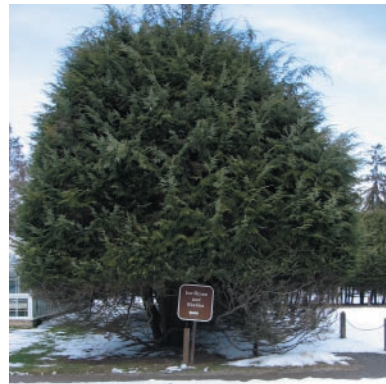
3.5 Information Sign

Existing Conditions: An information sign was installed in 1997 within the portion of the hedge east of the greenhouse. The metal sign is 1 1/2 feet high by 1 foot 2 inches wide and attached to a 4-foot-high square wood post anchored into the ground. The sign is brown with white letters. The information sign exists and is in good condition. See Figures 3.5 and 3.6 Information Sign.

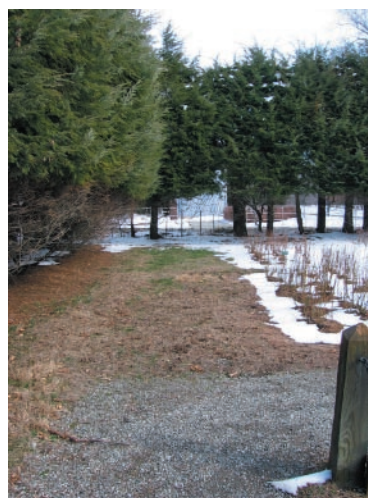
3.17 Garden Walkways

Existing Conditions: The garden walkways exist and are in good condition. The western most path is missing due to the overgrown hedge, and the north-eastern garden entrance and walk to the library are missing. See Figures 3.17, 3.22, and 3.33 Garden Walkways.
