Cultural Landscape Treatment
Home of Franklin D. Roosevelt National Historic Site
Concept Development

Faculty of Landscape Architecture
Preservation Studio
State University of New York
College of Environmental Science and Forestry

Faculty of Landscape Architecture
Preservation Studio 2006
State University of New York
College of Environmental Science and Forestry

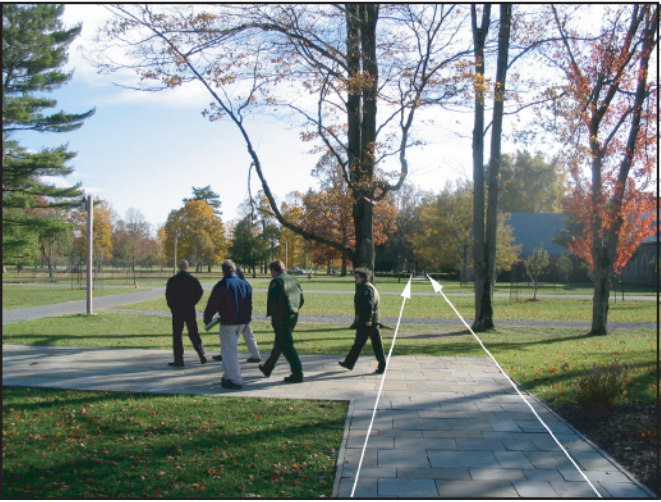
1.6 Restoration of the Old Library Walk and Circulation Pattern

New Library Walk

The old walk should be reestablished and extended as the main walkway between the Wallace Center and the Presidential Library. The use of this original circulation pattern is important in conveying the historic character of the site. The recommendation is to remove the new asphalt walkway and establish a direct axial connection between the old library walk and the Wallace Visitor Center path, removing the portion of the walk that jogs east to connect with the new walk. The walk should be widened using a dry laid stone method to distinguish between the old and new walk. It should extend straight to the Home Road. The opening in the sheep fence should be made to align with this walkway.

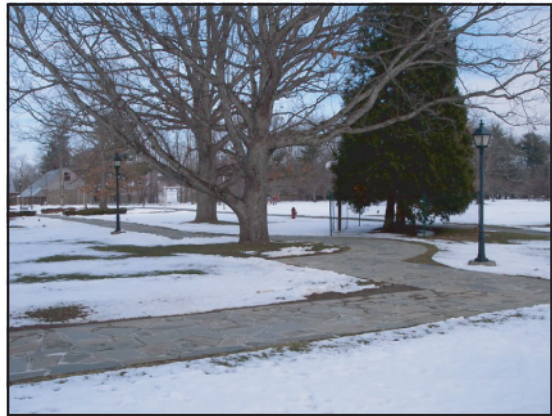
1.9 Making the Old Library Walk ADA Compliant

Old Library Walk

In accordance with ADA standards, all existing and newly constructed walks should be a minimum of 60 inches (5 feet) wide. This standard allows comfortable passage of two wheelchairs side by side on walkways. It is also important that, in altering an historic feature to accommodate ADA regulations, it be clear that new additions to the historic feature are not part of the original construction. This differentiation should be noticeable and can be accomplished by using the same kind of stone but in a dry laid technique (set in a substrate of sand) with swept joints.

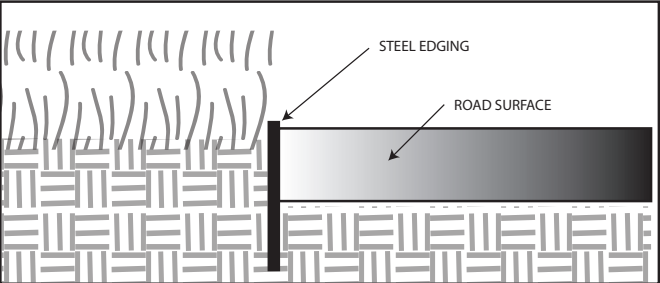
1.4 The Home Road

Metal edging along the Home Road.

Determine composition of the Home Road surface during the period of interpretation through an archeological study, probably a compacted soil surface composed of a clay soil with local brownstone. The Home Road should then be returned to the composition determined by the archeological study. The edge of the Home Road lawn should be cut back evenly along the hedgerow and metal edging installed to help maintain a clean edge along the Home Road.

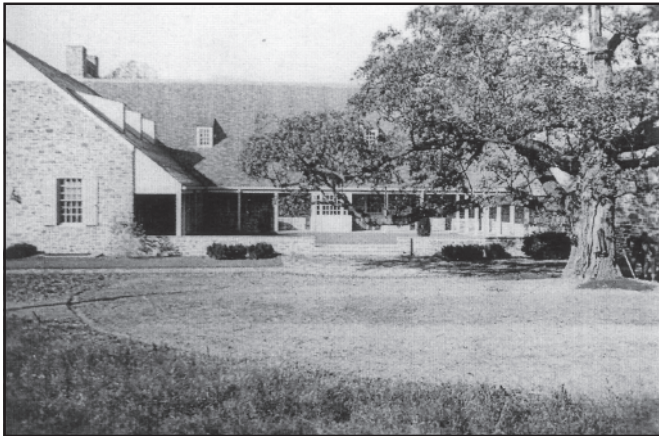
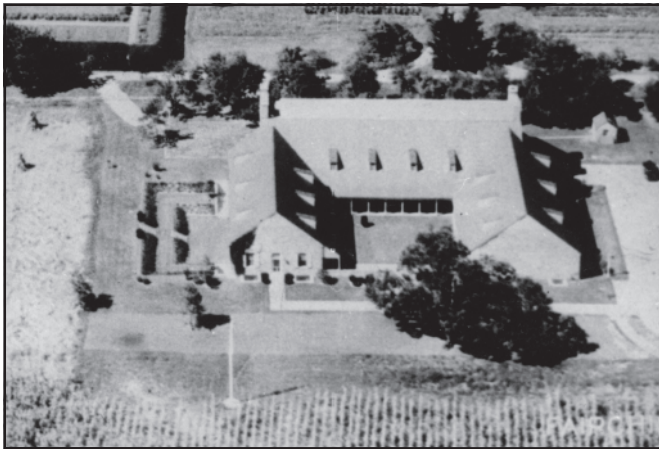
1.19 Library Courtyard Plantings

Library courtyard and Oak tree as shown in a 1945 photograph.

Library courtyard and Oak tree as shown in a 1945 aerial photo.

The courtyard should be returned to the simple mown lawn that was present during the treatment period. Plantings that were established in the courtyard after 1945 should be removed. The above photo, taken in 1945, shows clearly the historic character and appropriate treatment of the space. The large White Oak tree featured is no longer there, but should be reestablished in the same position shown in the photo along with the historic mowing pattern around the Oak.

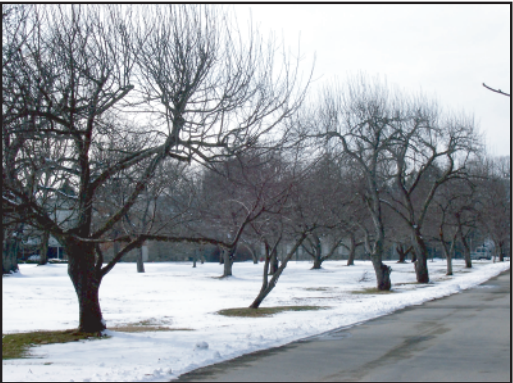
1.17 North Avenue Lot Orchard

Present form of orchard trees with high pruning.

The orchard trees along the old Library entrance drive have lost the form of low-headed trunks, probably 18" - 36" in height and the open bowl style of pruning that would have been characteristic of a farm orchard during the treatment period. Many of the trees appear misshapen by the removal of one or more of the scaffold branches reflecting the contemporary high pruning method used to facilitate the passage of large vehicles and equipment through the orchard. With the consultation of an orchard specialist, new in-kind replacement trees should be custom-propagated to match the form of the old trees that retain a low-headed, open bowl pruning style. The low branching form of orchard trees is an important historic characteristic of the treatment period that should be restored and maintained.

Many of the orchard trees along the old Library Entrance Road appear mis-shapen due to the removal of the lower scaffold branches to facilitate the passage of contemporary large vehicles and equipment through the orchard. It is recommended that, with the consultation of an orchard specialist, new in-kind replacement trees might be custom-propagated to match the form of the old trees in a low-headed, open bowl pruning style which would have been characteristic of a farm orchard during the period of interpretation.

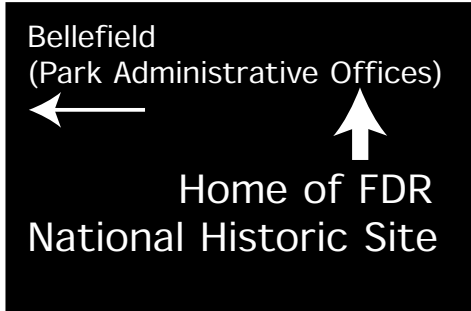
1.53 Directional / Informational Signs

Improved directional sign at Bellefield entrance drive.

Signage along the entry drive should be redesigned to inform and guide the visitor from the entrance on Albany Post Road to the Wallace Visitor's Center parking lot and entrance. The wayfinding system should be developed as a part of an over-all signage plan for the site using consistent and appropriate graphic and material treatments as well as effective lighting and placement throughout the site. Materials and typography should be clean and clear and sensitive to the historic context and setting.

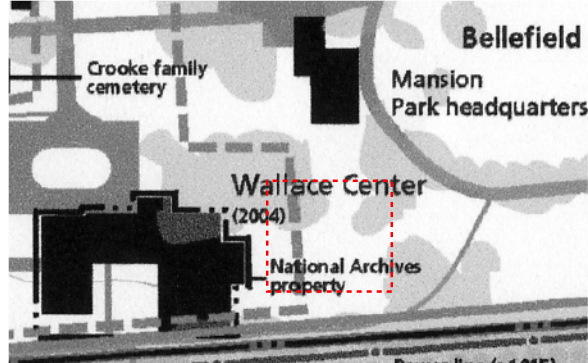
1.54 Special Functions

Special functions area east of the Wallace Visitor's Center

Special functions should be held in a dedicated area just off of the porch entrance on the east side of the Wallace Visitor's Center. This area is central and adjacent to the conference facilities at the Wallace Center and special functions tents will not detract from the historic character of the Library and its surrounding landscape.

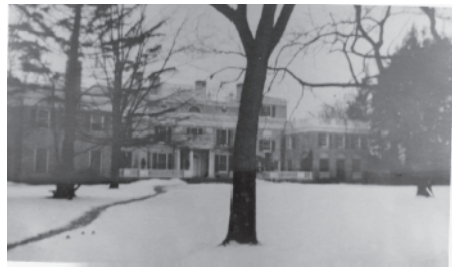
2.1 Boulevard Path

Historic Photo of Boulevard Path (HOFR Park Archives, 1940s)

Through implementation of a landscape tour, visitors should be routed over the original Boulevard Path in order to restore the compacted soil surface.

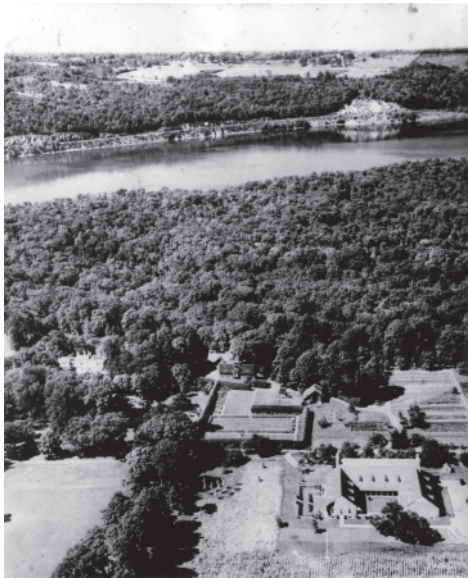
Reestablish Large Vegetable Garden

Large Vegetable Garden (HOFR Park Archives 1942-45)

The large vegetable garden space now can be rehabilitated and features reconstructed since the 1948 asphalt parking lot was removed in 2004 with the building of the Wallace Center.

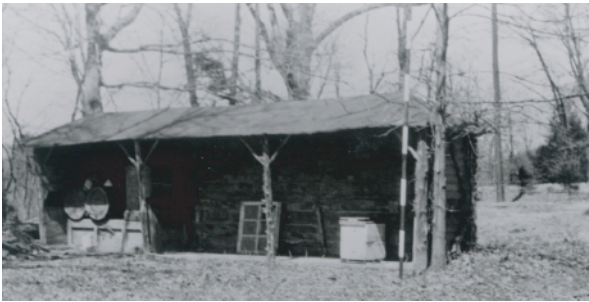
3.15 Reconstruct the Apiary

Apiary in the NW corner of large vegetable garden (HOFR Park Archives 1948)

Reconstruct the apiary. An apple tree sheltered its southeastern corner and it was protected on the western edge by the woods. Historic photographs and the 1946 USGS map show the apiary and its placement in the garden. The apiary was an important part of the garden’s function and added to the overall historic character.

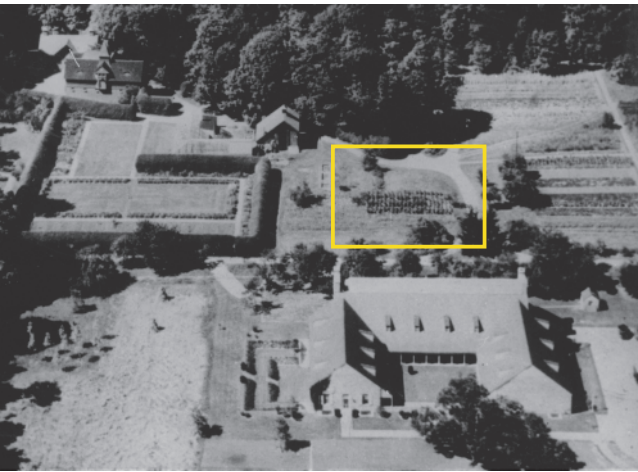
3.12 Reestablish the Tree Nursery

Small Vegetable Garden Tree Nursery (HOFR Park Archives aerial 1942)

Remove the apple and cherry trees that are dead or in very poor condition from the eastern edge of the garden. Restore tree nursery beds to their original location as seen in the 1942-1945 aerial photo. They can be used to grow on grafts of historic or in kind woody plant or for other plant material needed for the Home. The nursery in the small vegetable garden was centrally-located, near the River Road. It contained four rows of young trees laid out in a north-south direction.

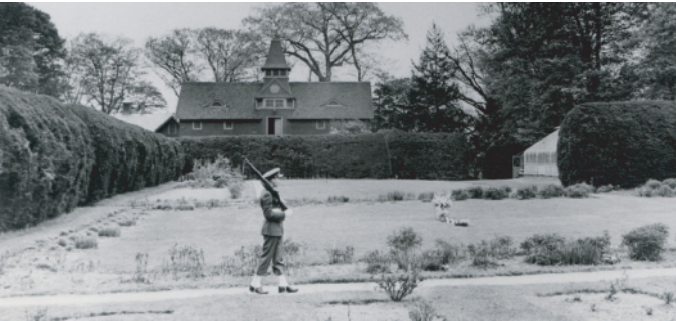
3.5 Replace Hemlock Hedge

Rose Garden hemlock hedge height (HOFR Park Archives 1946)

The NPS plans to replace the hemlock hedge in kind. At that time, reestablish the northeastern entrance from the Rose Garden to the Library through the replaced hemlock hedge. Once replaced, maintain the hemlock hedge at the historic height of 14 feet and width of 10 feet with overhead hemlock archways on the two southern and reestablished northeastern entrances to the Rose Garden. As seen in the photo, the top of the hedge should be pruned to a rounded point so that snow can roll off and not damage the hedge. Also, move the NPS Rose Garden water faucet (3.26) away from the hedge and path and replumb at the SE corner of the greenhouse. Remove the NPS orientation sign (3.27) that appears next to the NPS faucet at the edge of the hemlock hedge. Replace Rose Garden turf (3.10) as necessary after the hemlock hedge planting.

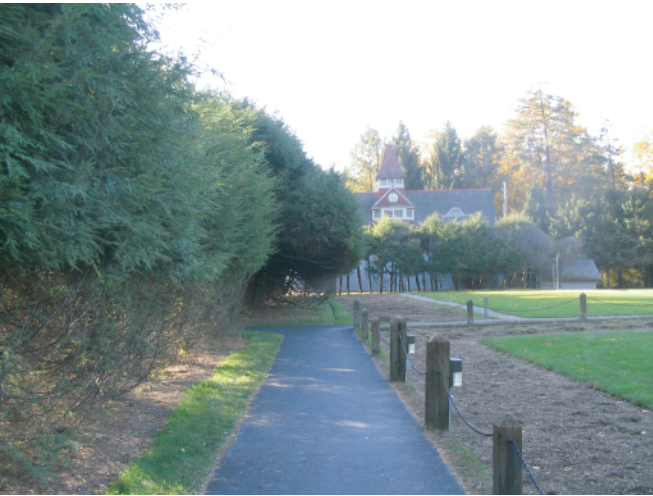
3.1 Rose Garden Walks

Rose Garden walks, post & chain fence, & gravesite lighting (SUNY-ESF 2005)

Once the hemlock hedge is replaced, the Rose Garden walks can be returned to their historic circulation pattern. First, confirm the historic placement of the garden walks with an archaeological survey. Reestablish the south-north walk at the western edge which the hedge has overgrown. Realign the east-west garden walk that begins at the western edge of the Rose Garden near the he greenhouse. Reestablish the east-west garden walk at the northern edge of the rose garden rose beds. Replace the asphalt garden walks with compacted stone dust as was used historically. Replace Rose Garden turf (3.10) as necessary after garden walk have been restored.

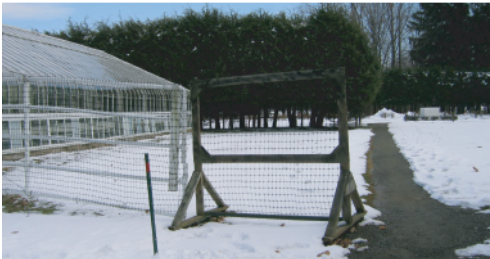
3.16 Deer Fencing

Rose Garden gate and fence (SUNY-ESF 2006)

Replace NPS deer fence and western movable wood and wire gates. The hemlock hedge needs to be protected from deer-browsing. Fencing should be installed that is compatible, yet distinguishable. One option is to fence the entire Rose Garden. Another option is to fence a larger area that includes newly planted material in surrounding areas thereby making the fencing continuous and of similar material.

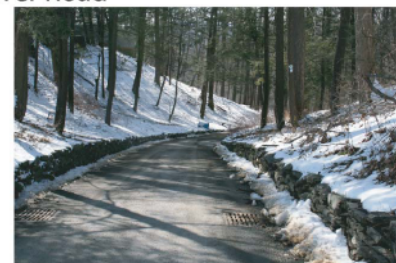
4.3 River Road

View Southwest Down River Road

The asphalt pavement that exists on River Road does not contribute to the historic character of the overall site and should be removed. Drainage issues also exist along River Road and should be examined to determine if measures can be made to resolve these problems.

Historically, River Road was a graded crushed stone road with native field stone retaining walls. A similar character should be carried throughout River Road, from its connection to Estate Road all the way to the Hudson River.

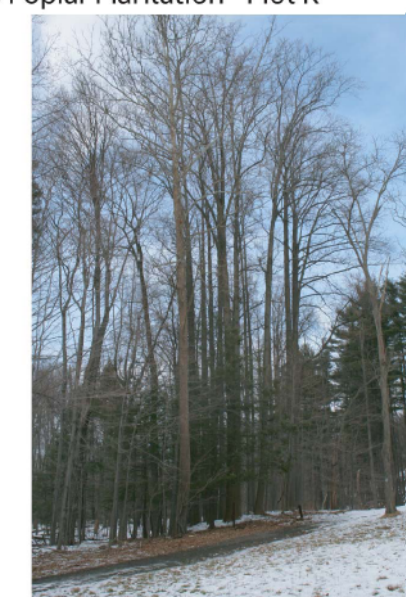
4.6 Tulip Poplar Plantation - Plot K

View of Tulip Poplar Plantation

The plantations that were planted in the early 1900's by the Roosevelt family have grown into maturity and are now established. To retain the historic characteristics of the plantation, the understory plants that have grown through must be removed. There are also drainage problems that need to be addressed.

To establish the desired historic character understory brush should be removed based on the forthcoming Forest Management Plan. The drainage issues that exist are due to the addition of the upper parking lot. The excess flow has created an eroded swale through the Tulip Poplar Plantation. Further research is recommended to obtain a long term answer to this erosion problem.

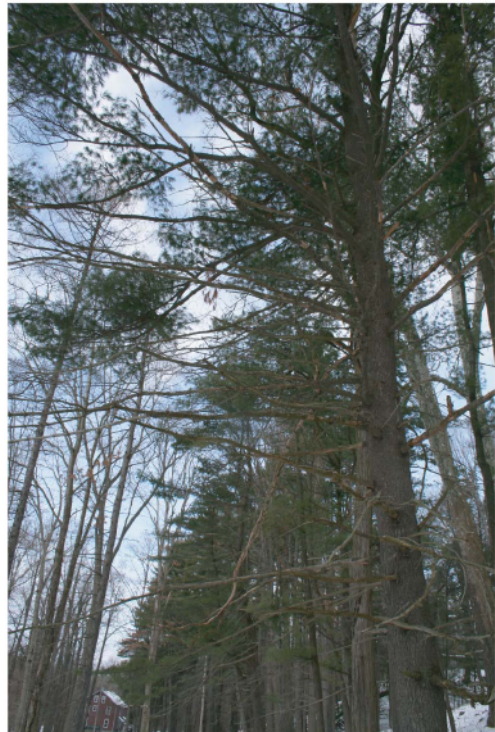
4.7 White & Scots Pine Plantation - Plot I

View of Pine Plantation I

The plantations that were planted in the early 1900's by the Roosevelt family have grown into maturity and are now established. To retain the historic characteristics of the plantation, the understory plants that have grown through must be removed.

To establish the desired historic character understory brush should be removed based on the forthcoming Forest Management Plan.'

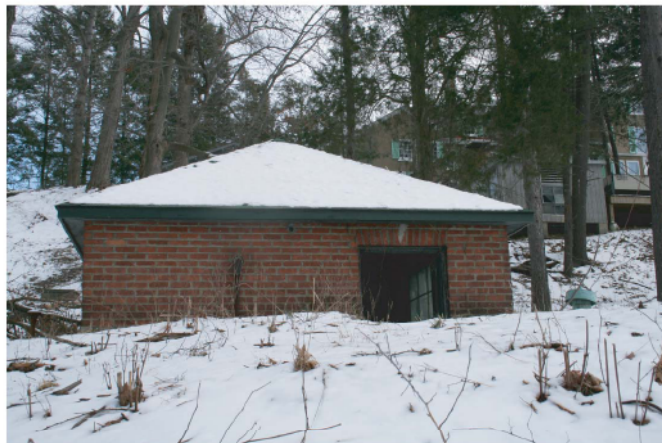
4.8 Ram House

View East up to Ram House

The Ram House is in need of repair to return it to its historic character. The original roof was removed and replaced with an asphalt shingle roof, the door was removed, and the interior is in pieces. A sod roof is needed to replace the existing roof, and a door is needed to provide security. The debris surrounding and inside the Ram House needs to be removed to restore the sites character.

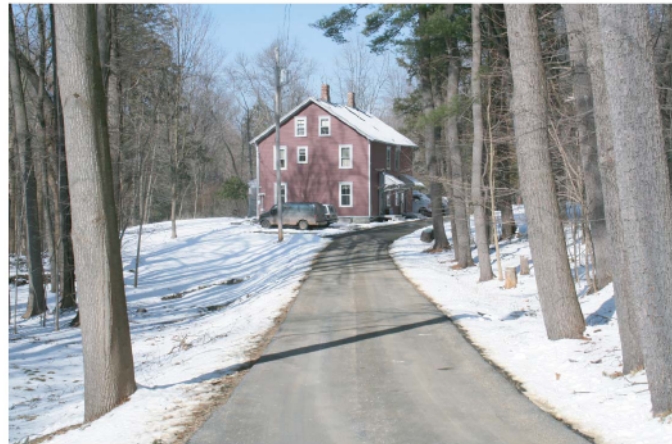
4.10 Duplex

View East Toward Duplex Residence

Research will be needed to determine if the paint is the historic color of the Duplex. The residence is in good structural condition, and has few problems. Proper and consistent signage is needed at the entrance to control user circulation and help to identify the history of the Duplex.

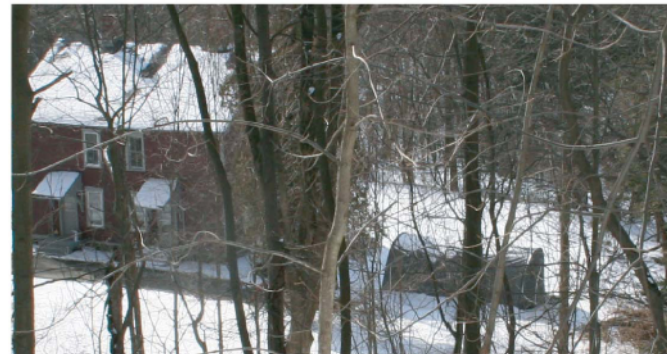
4.12 Site of Duplex Chicken Coop

The chicken coop no longer exists and needs to be reconstructed. There are no permanent structures located in the area that the chicken coop stood, but a temporary garage sits in the general area of where the Chicken Coop was located. Upon further research a match may be found to the Coop, or if nothing is found, a structure similar in historic character may be constructed.

The main reason for rebuilding of the Chicken Coop is to reflect the historic character of the site. Adding this feature and removing the temporary garage will add to the historic quality.

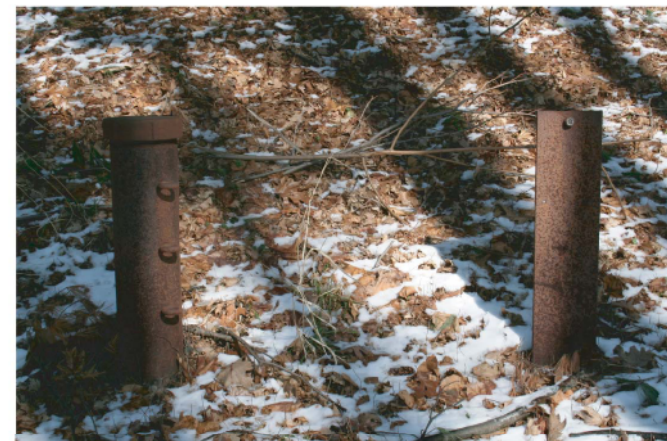
4.13 River Road Crash Barrier Posts

View of Crash Barrier Posts

The treatment recommended for the Crash Barrier Posts is reconstruction. To evoke a War-time feeling in the site the posts would be strung back up with wire, but allow room for visitor passing and interpretation.

The Crash Barrier Posts would contribute to the hitoric character of the site, and reflect the War-time feelings of the site during the period of interpretation. Original pictures exist showing the constructed gates that were held up by the posts.

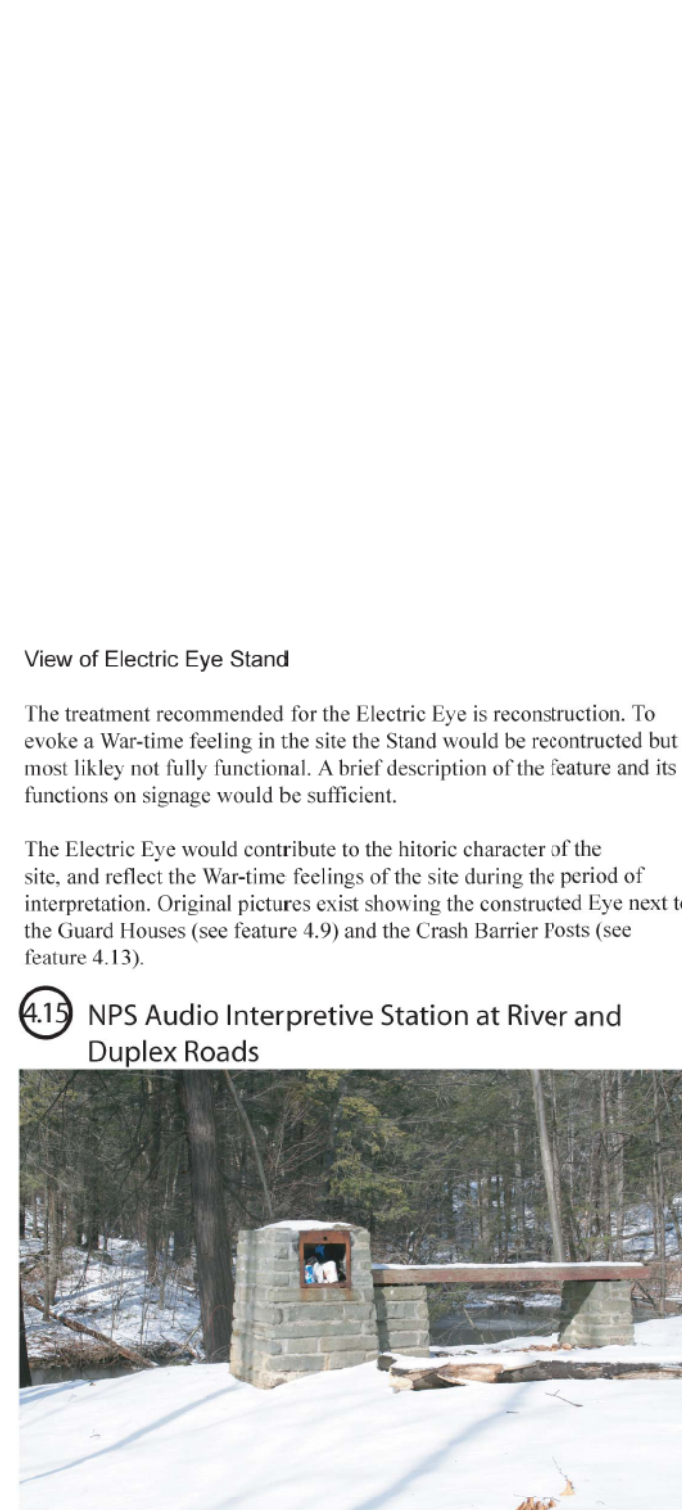
4.14 Site of River Road Electric Eye

View of Interpretive Station

The recommended treatment for the Interpretive stations are removal. The stations detract from the historic character of the site and no longer function properly. Replacement of the benches can be done by choosing benches that reflect the existing architecture and historic character of the site.

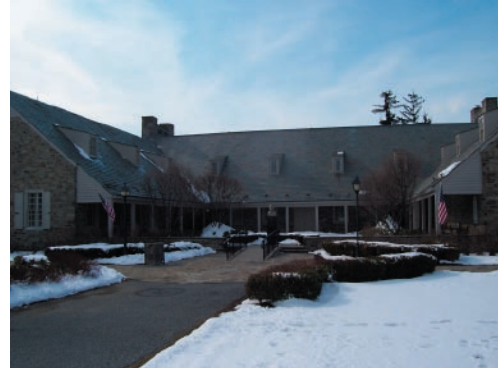
Figure 1.43 FDR Library

Existing Conditions: The library was enlarged with the addition of two wings in 1971. The additions were located on the north and south elevations. They were rectangular, 80 feet long (N/S) by 35 feet wide (E/W) and two stories high. The additions gave the building a total length of 320 feet. The additions were constructed of local brown-colored fieldstone. The roof was gabled and therefore gave the entire library a double cross-gabled roof with slate shingles which were gray in color. A door was constructed in the center of the north wing of the original structure, on the east elevation. The library exists and appears to be in good condition. See Figure 1.43 FDR Library.

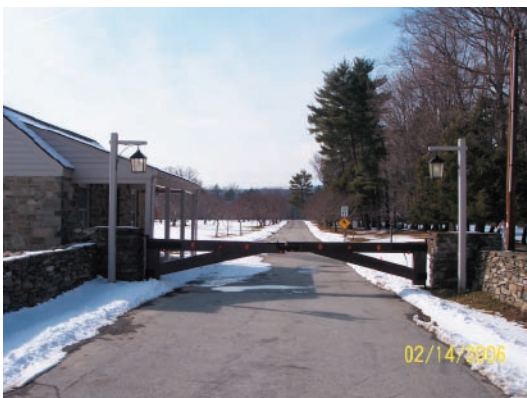
Figure 1.030 Gatehouse

Existing Conditions: The gate house exists, is unchanged from its historic condition, and appears to be in good condition. See Figure 1.030 Gate House.

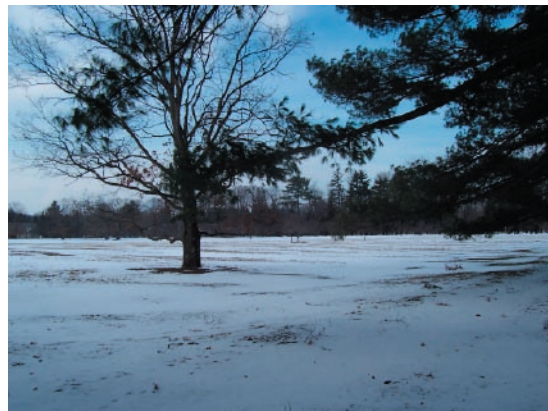
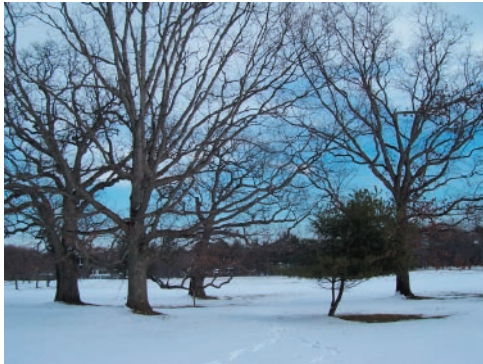
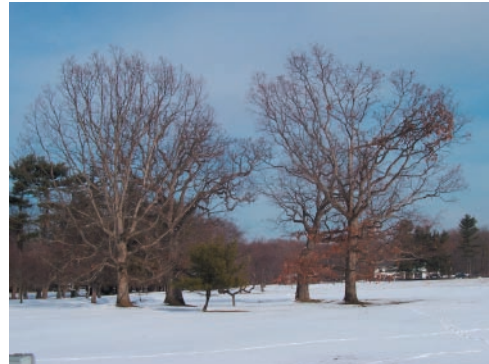
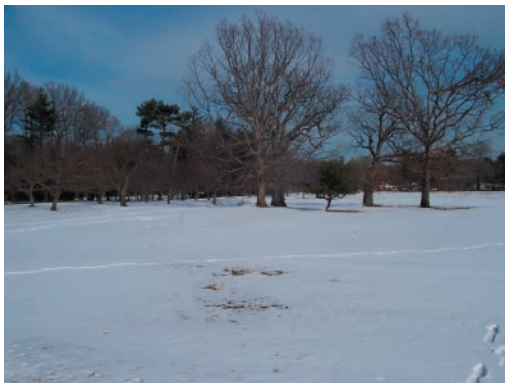
Existing Conditions: Two of the original white oak trees plus four trees planted during the Late Roosevelt Ownership Period, including two of the four oak trees located in the southeast corner, exist and are in fair condition. The three red oaks east of the library also exist and are in fair condition. The existing nine trees are large with a spreading habit. One of the two largest (approx. 5' in diameter) of the White Oaks is damaged with nearly half of the trunk missing due to storm damage. A 6" caliper White Pine has taken up residence beneath and encroaching on the canopy of one of the large White Oaks in the field to the east of the library. See Figures 1.28, 1.41, 1.91 and 1.95 Oak Trees.

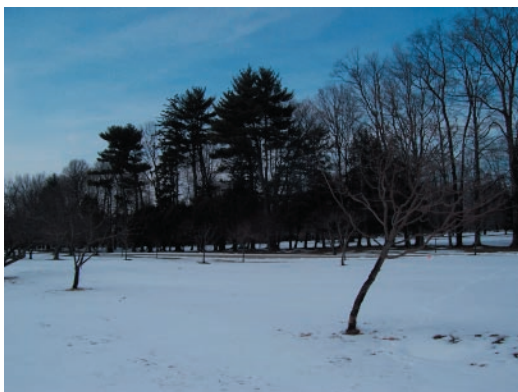
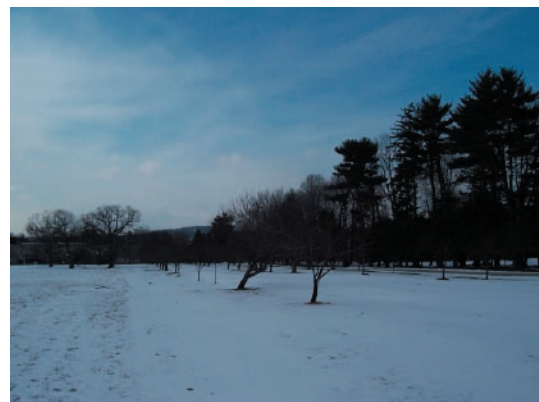
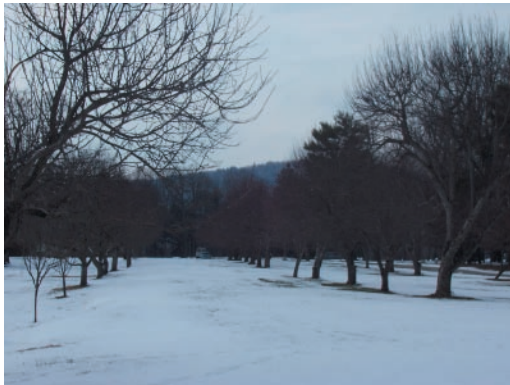
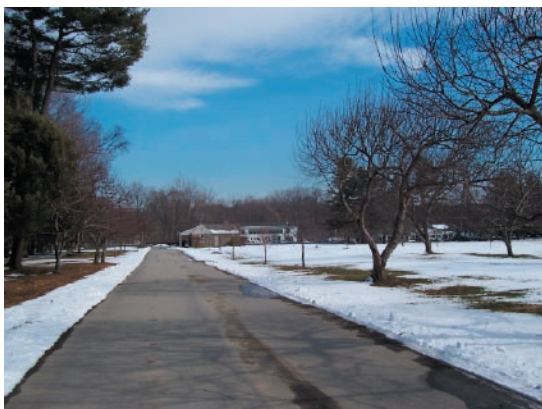
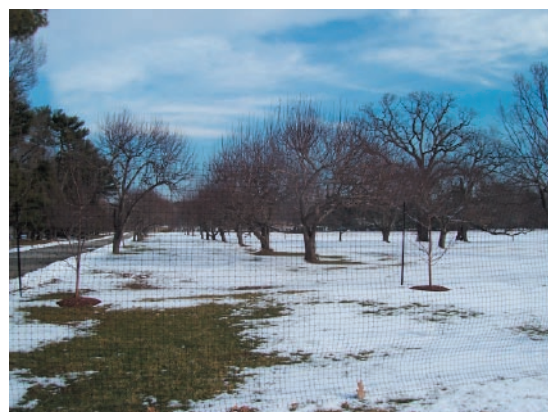
Existing Conditions: The orchard contains 80 fruit trees. Trees within the orchard have been removed and replaced since 1945, exact date unknown. The condition of the fruit trees in the orchard is undetermined, but are consistent with the characteristics of fruit trees during the period of significance. The orchard trees have been pruned highly to facilitate mowing beneath them. See Figures 1.33 - 1.36, 1.38 - 1.40, 1.44, 1.94 and 1.99 Orchard.

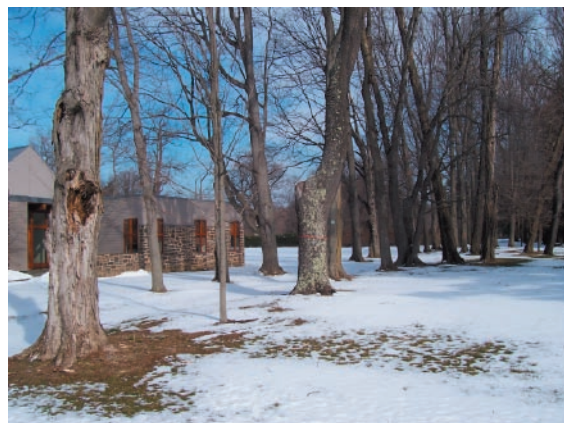
Existing Conditions: The historic tulip poplars still exist and are large in size and still serve as a screen. All the historic fruit trees located east of the estate road and west of the library were lost but replanted over the years, retaining a partial screen. The Norway spruce trees were removed in c. 1948. Trees located adjacent to the library were not identified for this project, but are contemporary additions to the property. A mixed grouping of trees exists along the northern edge of the north avenue lot screening the view toward Bellefield. See Figures 1.47 and 1.48 Trees.

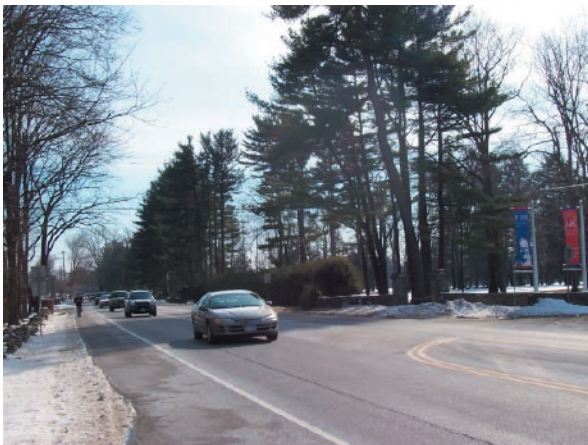
Figure 1.54 White Pine Hedge

Existing Conditions: Since 1945, exact date unknown, individual trees within the hedge died and were removed but not replaced. The remaining trees within the hedge are large with a broad canopy, although much more open to Albany Post Road due to their mature form and the loss of two of the three rows. Slightly more than half the historic trees remain, and the hedge still retains its general character and purpose as a screen from the Albany Post Road. The rows of White Pines toward the southern end of the hedge on the north avenue lot remain in the best condition and most consistent form and spacing. The white pine hedge exists and is in fair condition. See Figure 1.54 White Pine Hedge.

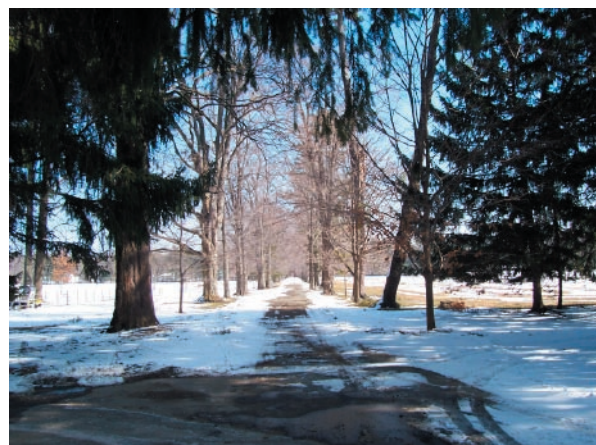
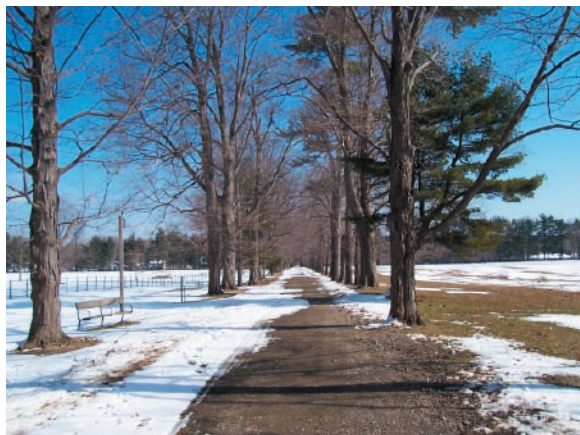
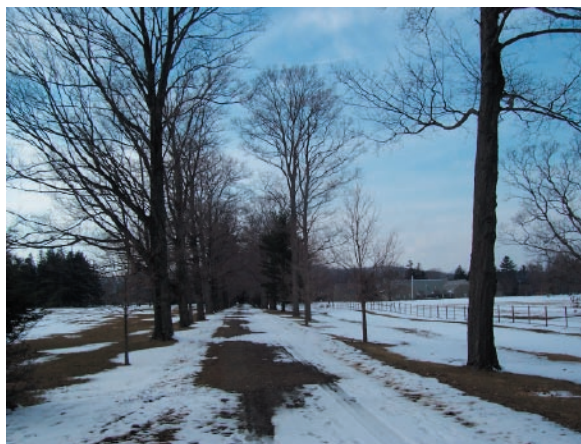
Existing Conditions: Due to the maturation and loss of the historic vegetation, some trees were removed and replaced in kind, but not in stature. These trees now form a much more open and irregular canopy. The allée is relatively unchanged in terms of the number and types of plants, still creating varying textures between the evergreen and deciduous vegetation. Edge definition of the Home Road allée has been lost due to lawn grass which has crept into the road space in an irregular fashion. The home road allée exists and is in fair condition. See Figures 1.08, 1.09 and 1.30 Home Road Allee.

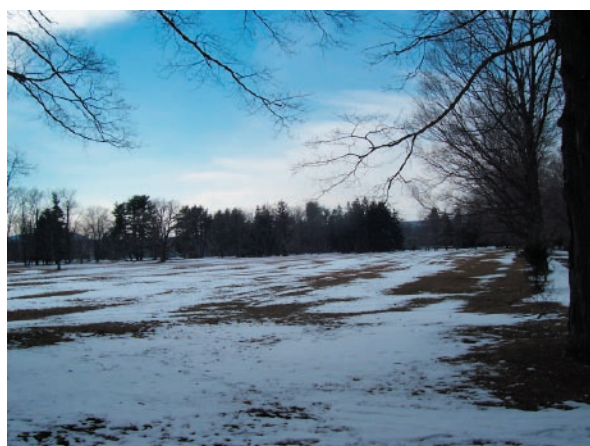
Figure 1.26 South Avenue Lot

Existing Conditions: The space was slightly altered during the NPS Ownership Period, exact date unknown, when the trotting course was left to revert to meadow grass. The spatial configuration of the south avenue lot subspace is unchanged in terms of its shape, size, and defining edges. See Figure 1.26 South Avenue Lot.

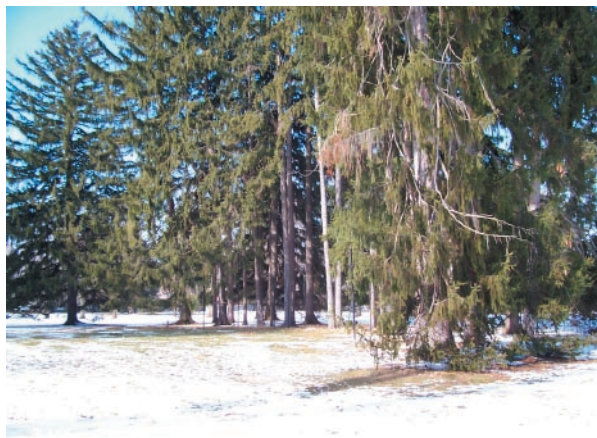
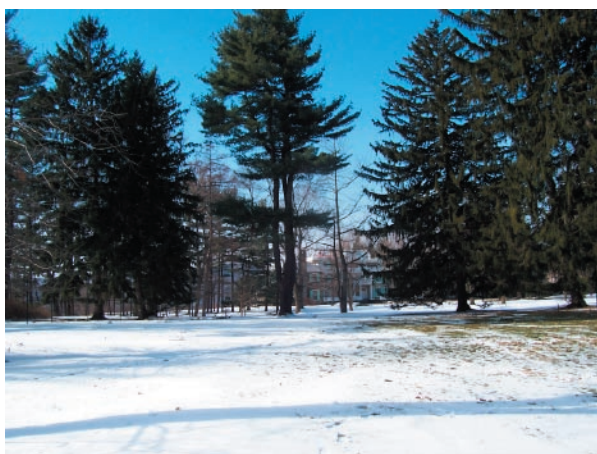
Existing Conditions: The tennis court's surface and net were removed between 1945 and 1966. The surface of the tennis court is grass, and the backstops are painted black but are deteriorated. The tennis court exists but is in poor condition. See Figures 1.13 and 1.14 Tennis Court.

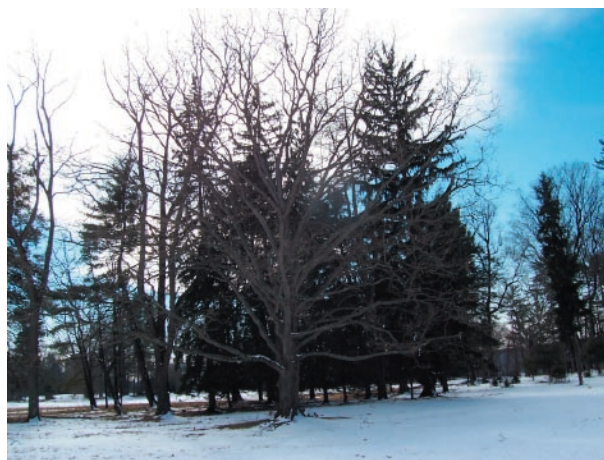
Figure 1.15 Oak Trees

Existing Conditions: Two of the historic oak trees are located in the south avenue lot. They are large with a spreading habit. One replacement red oak (*Quercus rubra*) was planted during the NPS Ownership Period, exact date unknown, in the eastern portion of the south avenue lot. The two historic white oak trees exist and are in fair condition. See Figures 1.15, 1.19 (approx. 17' circumference), 1.20, 1.21 and 1.23 (*Quercus rubra*) Oak Trees.

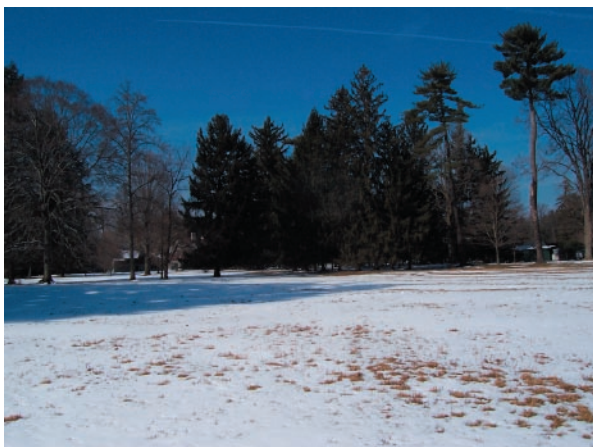
Figure 1.10 Trotting Course

Existing Conditions: The trotting course was no longer used or maintained during the NPS Ownership Period and as a result reverted to meadow grass. See Figures 1.10 - 1.12 Trotting Course.

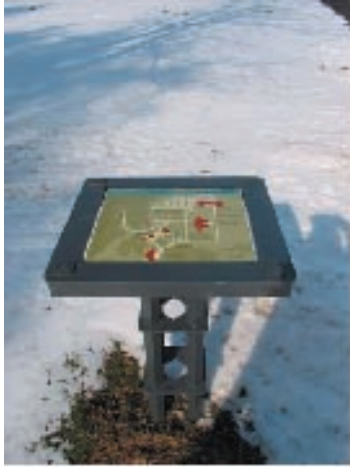
Existing Conditions: Three information signs of various sizes and materials were installed by the NPS, exact dates unknown. These signs are located near the northeast corner of Springwood, adjacent to the wheelchair ramp. The information signs exist and are in good condition. See Figures 2.03, 2.14 and 2.38. Also the NPS has labeled certain specimen trees with their scientific name for educational purposes, as shown in Figure 2.46.

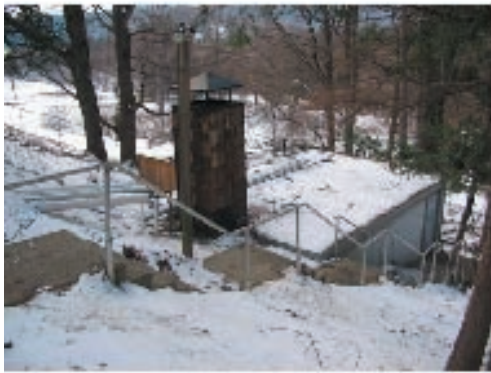
Figure 2.79 Southwest View at
NPS Furnace House

Existing Condition: This shed is set into the topography of the hillside slope west of the laundry. See Figure 2.79 NPS Furnace House.

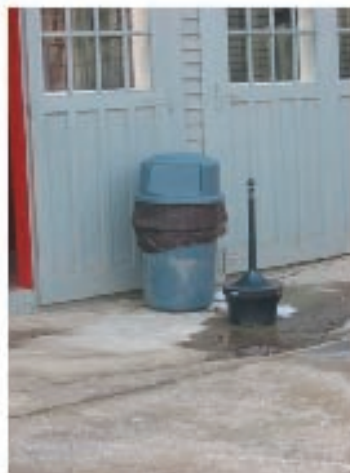
Figure 2.11 Trash Receptacles at
Stable/Tourist Center

Existing Conditions: The trash receptacle was installed during the NPS Ownership Period, exact date unknown. It is located adjacent to the east elevation of the stable/garage/Tourist Information Center. The trash receptacle was rectangular, approximately 2 feet long by 2 feet wide and 3 1/2 feet high. It is constructed of metal and plastic and is black and brown in color. The trash receptacle exists and is in good condition. See Figure 2.11 Trash Receptacle.

Although trash receptacles are necessary to support visitor needs, it does not contribute to the site because it did not exist during the period of significance. The current receptacles location, shape, size, and materials detract from the historic character of the period of significance.

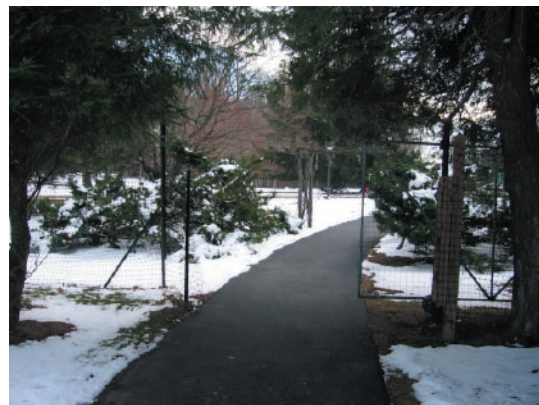
3.11 Deer Fence

Existing Conditions: The deer fence was installed in 1991 in the middle of the entire length of the hemlock hedge. The brown vinyl-coated mesh fence is 6 feet high. Gates are located at the two southern entrances and are constructed of silver metal frames and wire. They are on rollers that retract into the hedge during the day. The western entrance is closed off using a white metal gate attached to the greenhouse. This gate is approximately 15 feet long and constructed of 3 round vertical posts connected to 5 round metal horizontal pieces spaced 1 foot apart. The gate is 5 feet high. The remaining portion of the entrance is closed off using two movable wood sections of fencing painted brown that are 8 foot long by 6 feet high. The deer fence exists and is in good condition. See Figures 3.1, 3.11, 3.34 and 3.35 Deer Fence.

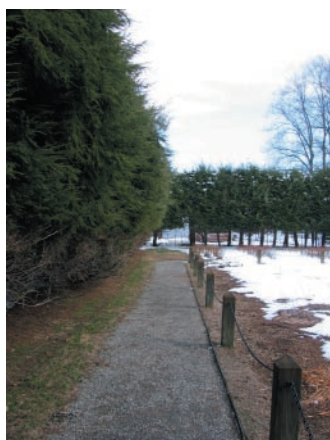
3.17 Garden Walkways

Existing Conditions: The garden walkways exist and are in good condition. The western most path is missing due to the overgrown hedge, and the north-eastern garden entrance and walk to the library are missing. See Figures 3.17, 3.22, and 3.33 Garden Walkways.

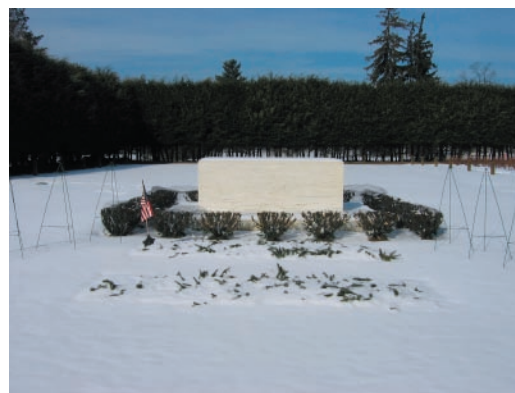
3.32 FDR and Eleanor Roosevelt's
Grave Monument and Rose Beds

Existing Conditions: The FDR grave monument has not changed in appearance from the Late Roosevelt Period, except for inscribing of Eleanor Roosevelt's date of death under her name. The grave monument exists and is in good condition. See Figure 3.32 FDR and Eleanor Roosevelt's Grave Monument.

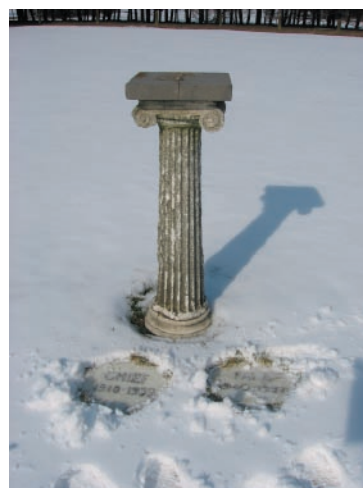
3.36 Dog Grave Markers
and Sundial

Existing Conditions: The metal dial was removed during the NPS Ownership Period, exact date unknown. The stone base is deteriorating. The sundial exists but is in poor condition. See Figure 3.36 Sundial.

Existing Conditions: An identical marker was installed in 1952 for FDR's Scottish Terrier, Fala, according to FDR's wishes before his death. The marker was located 1/2 foot east of Chief's marker and was inscribed, "Fala 1940-1952." The dog grave markers exist and are in good condition. See Figure 3.36 Dog Grave Markers.
