HEDGE MANAGEMENT PLAN FOR SAINT-GAUDENS NATIONAL HISTORIC SITE

CORNISH, NEW HAMPSHIRE

Olmsted Center for Landscape Preservation
National Park Service, Boston, Massachusetts, 2008

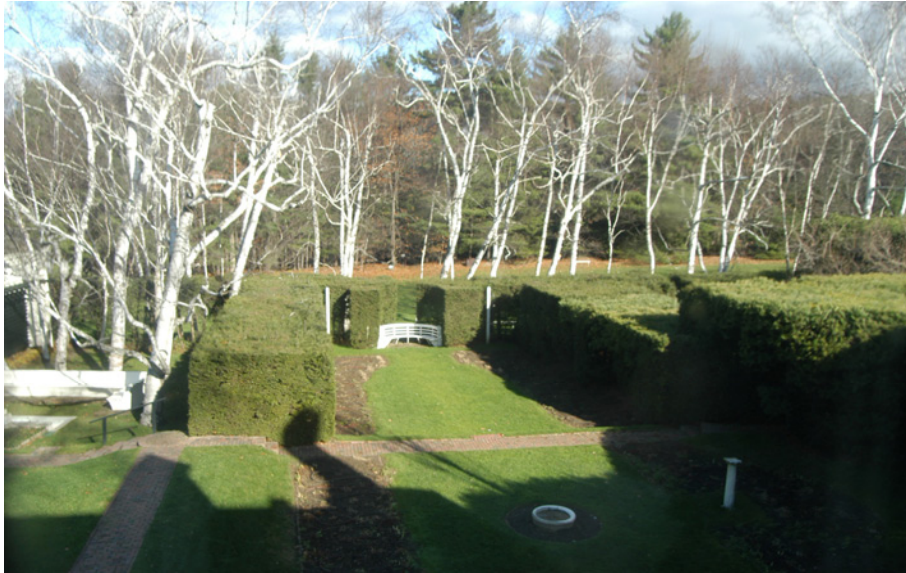
Figure 0.1: View looking east over the kitchen and Shaw hedges from a second floor window of Aspet, with the birch alley to the left and the mature woods south of Saint-Gaudens Road to the right, 2007 (Olmsted Center for Landscape Preservation).

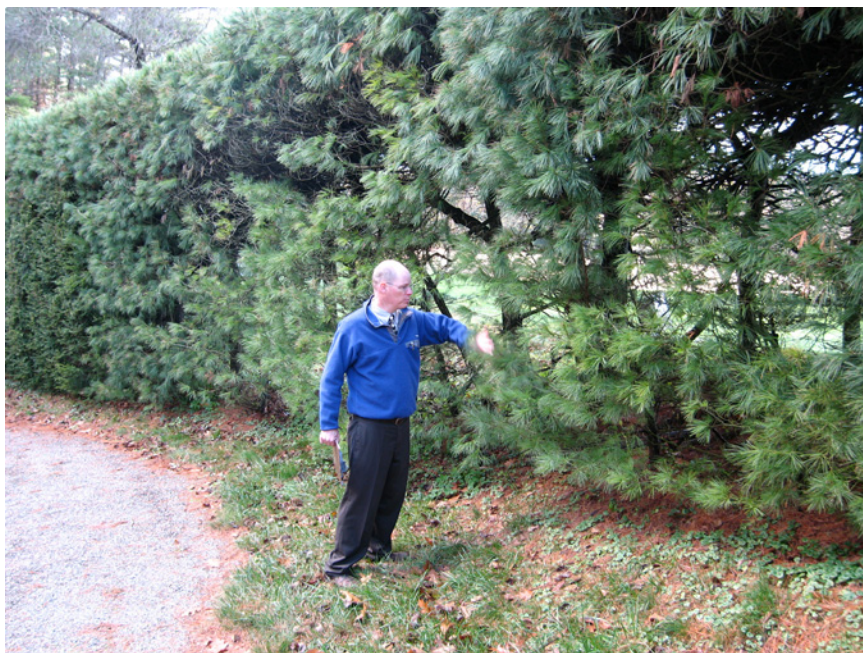
Figure 1.1: Example of interplanting in the horseshoe hedge, 2006. At right next to Superintendent BJ Dunn are white pine interplantings made in the late 1980s, and on the far left are older examples of hemlock infill within the original white pine hedge (SUNY ESF).

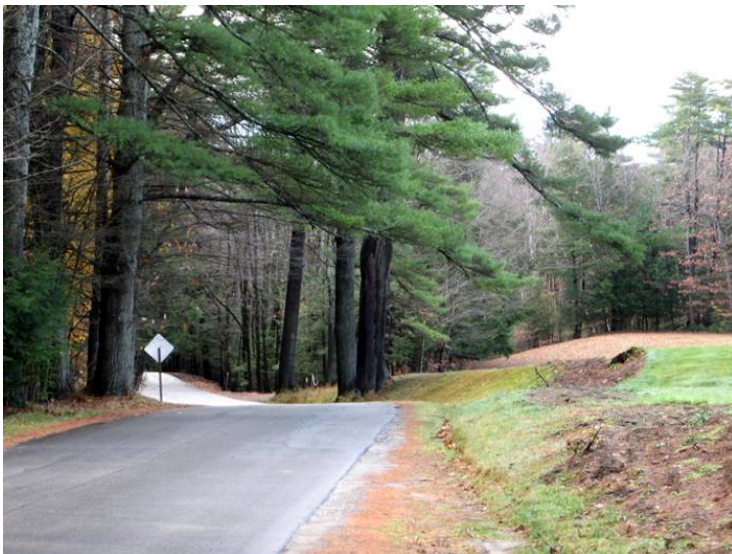
Figure 3.2: View looking west along Saint Gaudens Road showing site of west meadow hedge, 2006. The uphill alignment most likely dates to the c.1970 replanting. The mature white pines in the background are probably remnants of the original (c.1893-94) hedge (SUNY ESF).

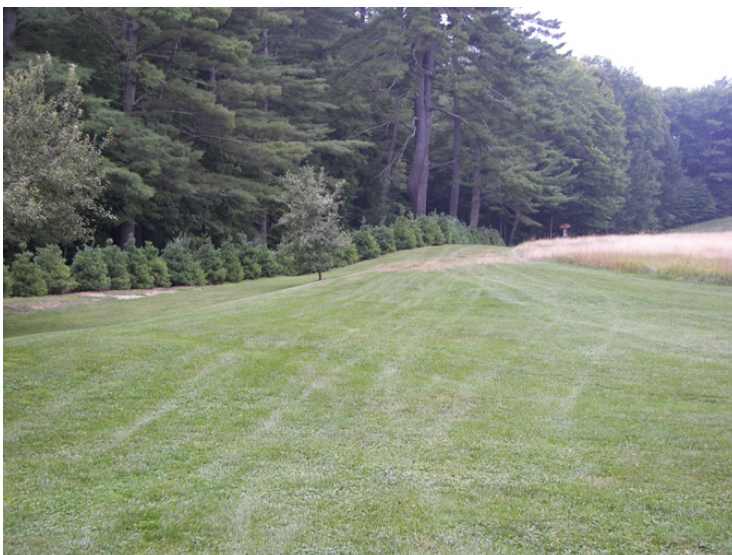
archeological investigation, the entire hedge was removed. In spring 2007, the hedge was replanted in pure white pine (Figure 3.3).

Figure 3.3: View looking southwest at the newly planted white pines in the west meadow hedge, 2007. Note height of adjoining woods along the south side of the road (Saint-Gaudens National Historic Site).

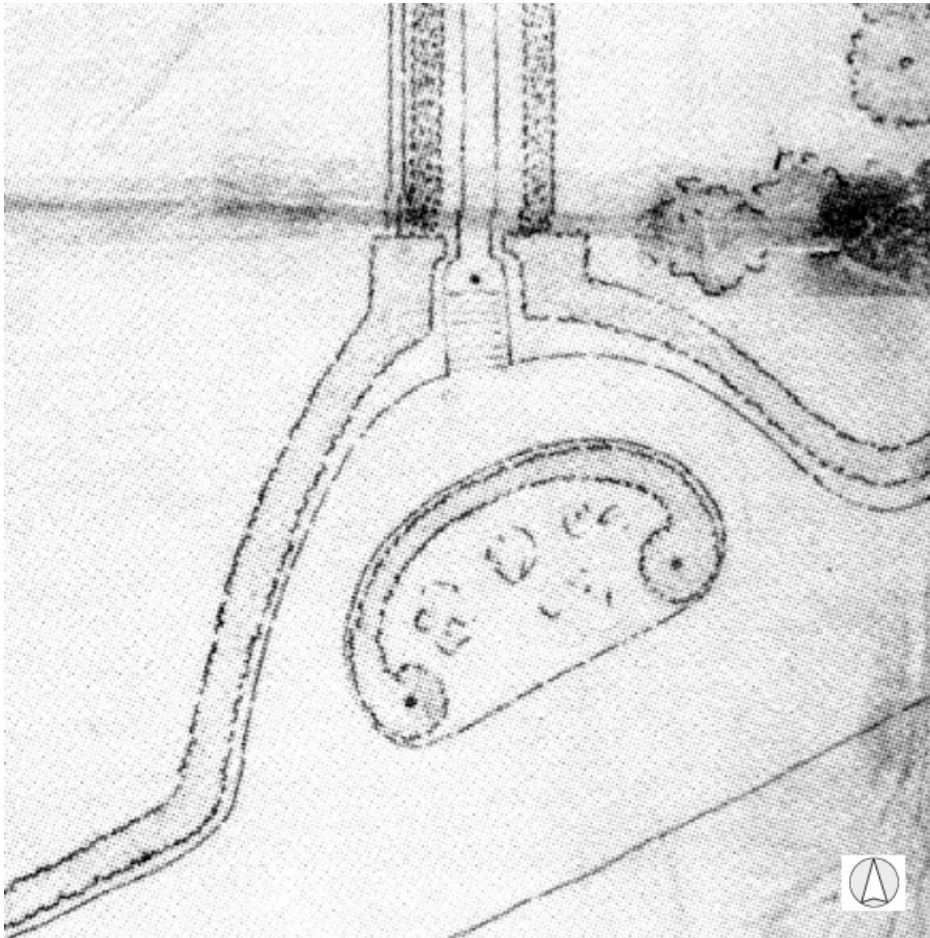
Figure 3.4: Detail of a 1904 plan of the grounds showing original design intent of the horseshoe hedge, showing scrolls on inner hedge and semi-rectangular termini of outer hedges at walk to Aspet. These details were apparently unintentionally lost as the hedge grew in width in later years (Saint-Gaudens National Historic Site).

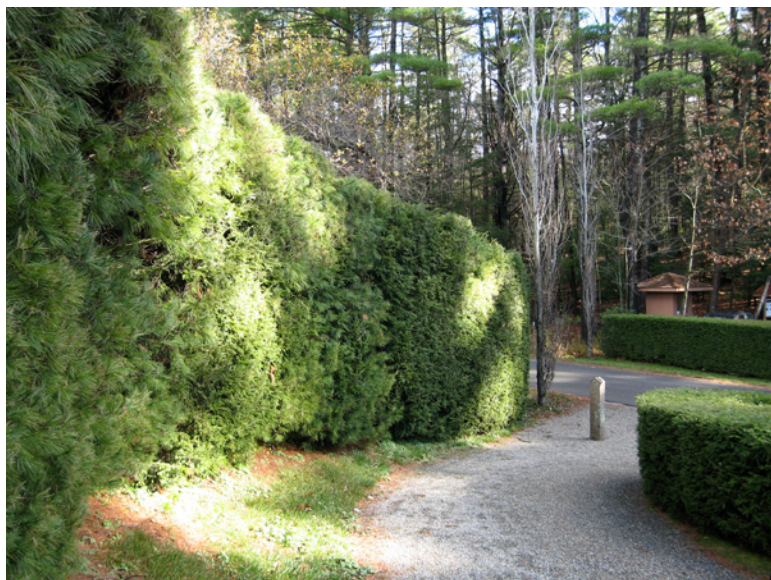
Figure 3.6: Horseshoe hedge, detail of east side of outer section (H-3) showing tapestry of white pine and hemlock, 2007 (SUNY ESF).

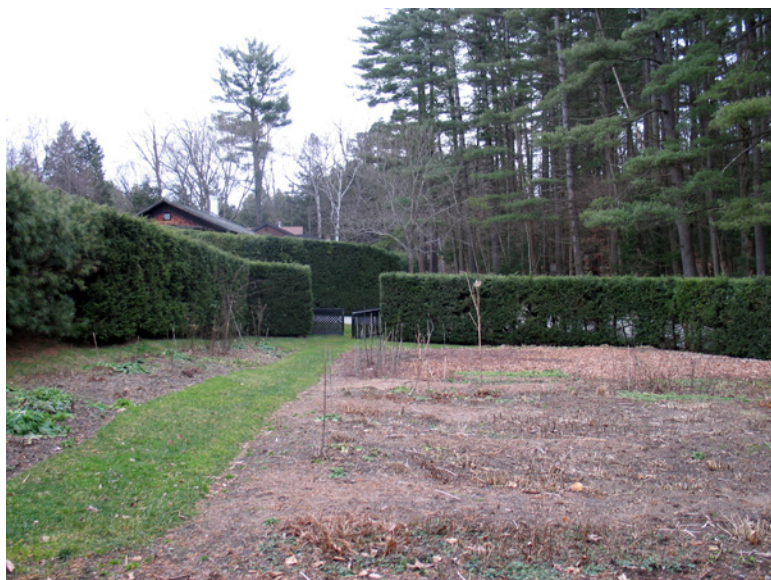
Figure 3.8: The cutting garden hedge, view looking east showing the opening at the service drive and the change from hemlock to white pine in section H-6 (left), 2006 (Olmsted Center for Landscape Preservation).

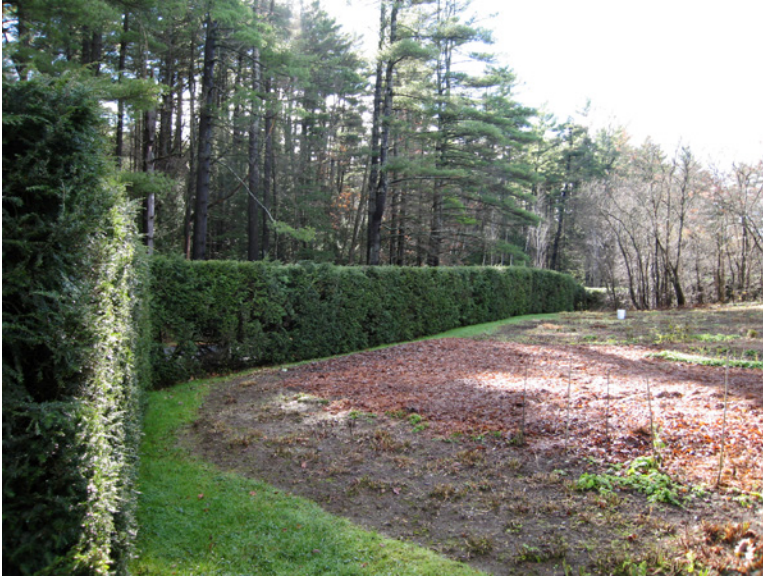
Figure 3.9: The cutting garden hedge, view looking west showing generally full side canopy on garden side of section H-5, with Japanese tree lilac grove in the background, 2006 (SUNY ESF).

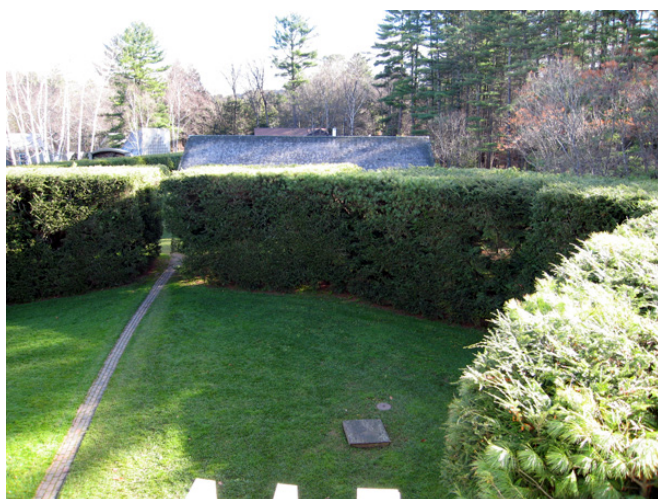
Figure 3.13: The kitchen hedge, view looking east from the second floor of Aspet showing general conditions, 2007 (SUNY ESF).

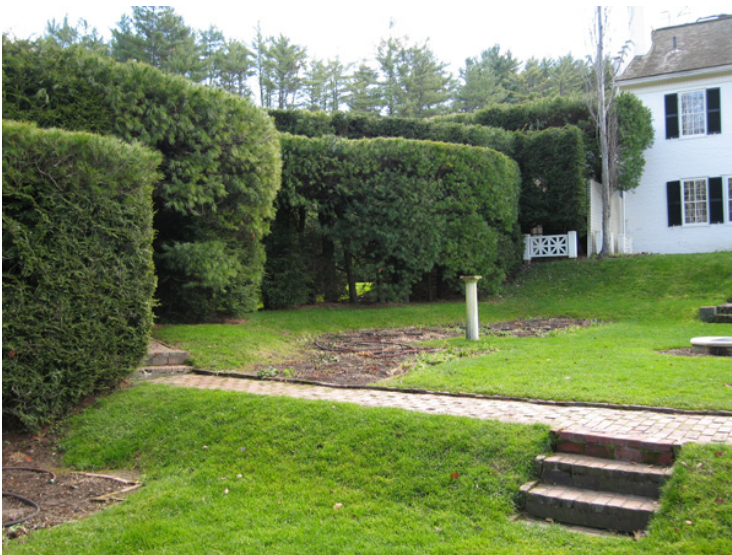
Figure 3.16: The kitchen hedge, view looking southeast at section H-8 extending above the terrace garden hedge (H-13) and stepping up adjacent to Aspet on the upper terrace, 2006 (SUNY ESF).

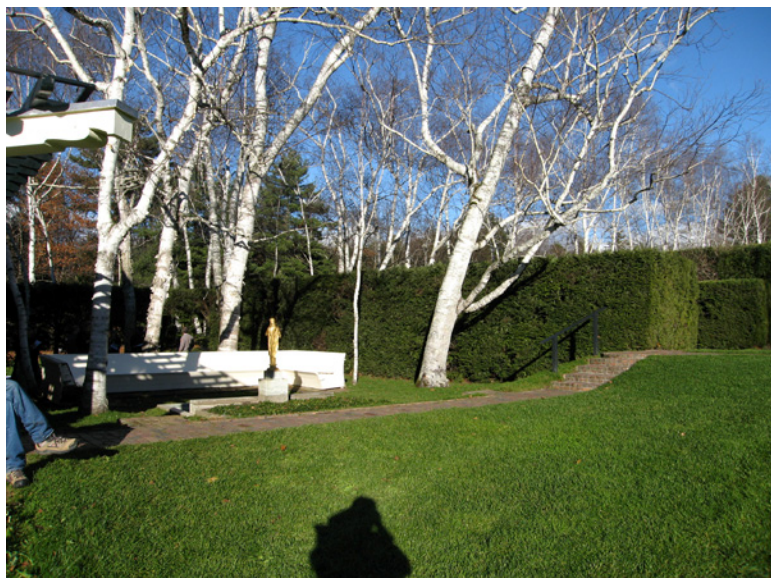
Figure 3.22: The Pan grove hedge, view looking northeast at section H-11 that forms the divide with the terrace garden, 2006 (SUNY ESF).

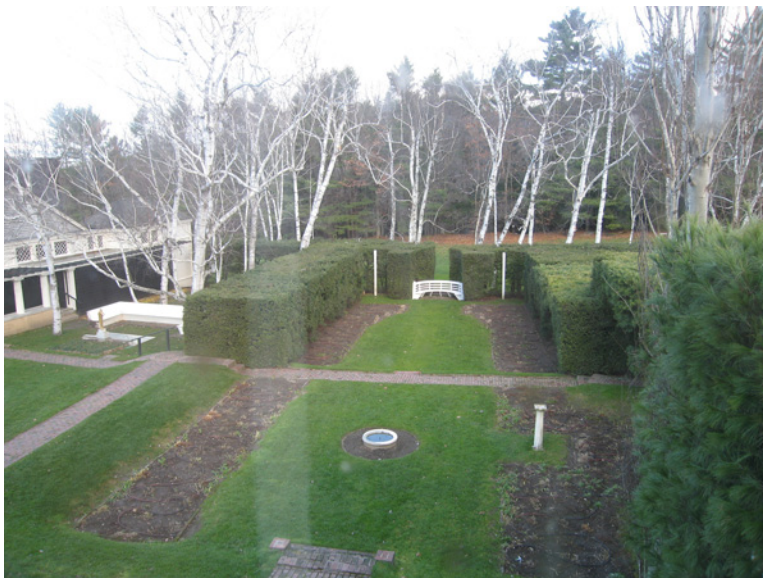
Figure 3.27: Overview of the terrace garden hedge on the lower terrace looking north from the second floor of Aspet, 2006. Note the Pan grove hedge to the left and Adams hedge to the right (SUNY ESF).

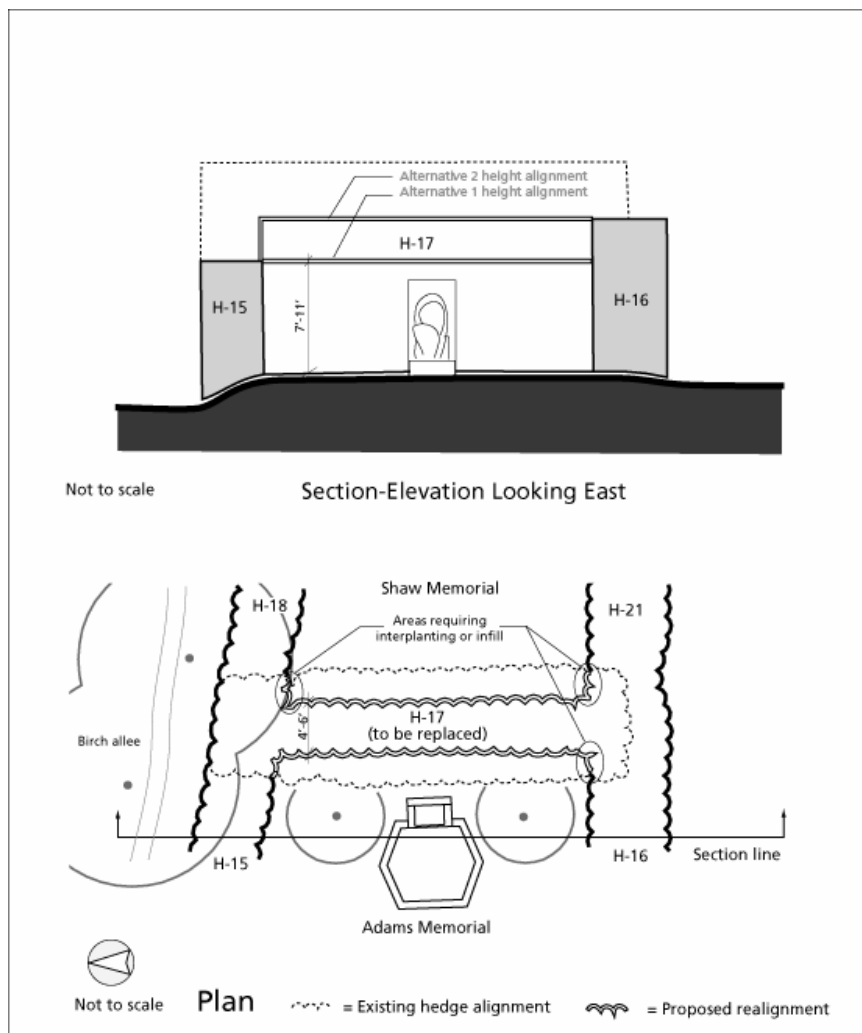
Figure 3.33: Plan and section-elevation detail of H-17 and adjoining sections in the Adams and Shaw hedges showing proportional relationships (SUNY ESF).

The existing location and alignment of this hedge is generally correct. The northern extension of H-17 over H-15 and H-18 (facing the birch allee) and over H-16 and 21 to the south appears to be a non-historic condition, and therefore this extension should be removed and the hedge kept to the interior sides of the adjoining hedges (Figure 3.33).

Section H-16 should align in height with section H-21 in the Shaw hedge and H-13 on the middle terrace of the terrace garden hedge, as it does now. Sections H-14 and H-15 should align in height with adjoining sections H-12 and H-15 bordering the birch allee. There are two alternatives for the alignment of section H-17 (see Figure 3.33):

extensions should be removed and the hedge kept to the interior face of the adjoining hedges (see Figure 3.33).

Section H-18 and 19 should align in height with section H-15, H-12, and H-10 in the adjoining hedges to the west that flank the birch alley; H-20 and 21 should align with H-16 to the west, as it does now. There are two alternatives for the height alignment of section H-17 (Figure 3.33; also discussed under Adams):

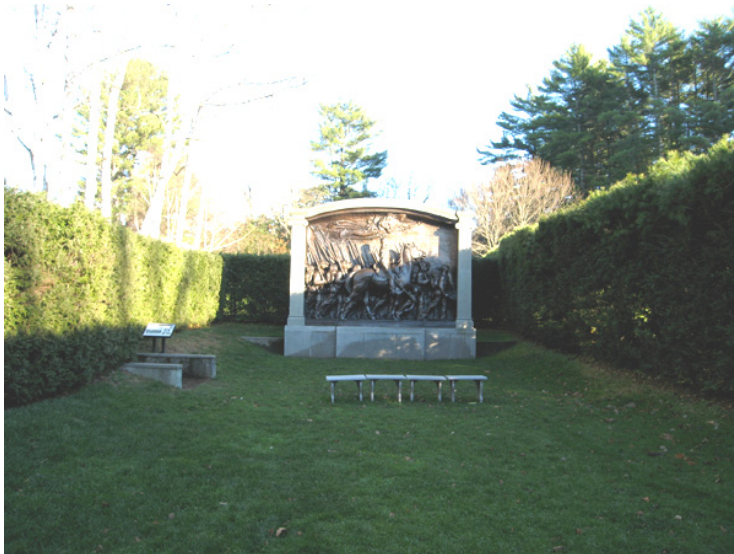
Section H-18, forming the north side of the Shaw along the birch allee, is pure hemlock planted in c.1950 (Figure 3.36). It is a single row with plants spaced between 2 and 6 feet. The section is 8 to 10 feet tall and 8 feet wide, and the east end of the section abuts a non-historic opening. It aligns in height with the adjoining north side of the Adams hedge (H-15), but is approximately 5 feet lower than the Adams-Shaw divide (H-17). The section has a full and dense canopy on the Shaw side, but a thinner side canopy on north side mostly due to shading from the birch allee (Figure 3.37).

Section H-21, forming the south side of the Shaw hedge except for the dogleg, is mixed hemlock and white pine dating to c.1893–94 with later infill plantings (see Figure 3.36). The section is a double row with the primary plants spaced 2 to 4 feet apart. The section is 10 feet tall and 6 to 8 feet wide, with a dense, full canopy. It is in alignment with the height of the dogleg (H-20) and south side of the Adams hedge (H-16), but is approximately 5 feet lower than the Adams-Shaw divide (H-17). The sunnier south side is predominantly white pine, while the

Figure 3.36: The Shaw hedge, view looking east showing H-18 and 19 to the left and background, and H-21 to the right, 2006 (SUNY ESF).

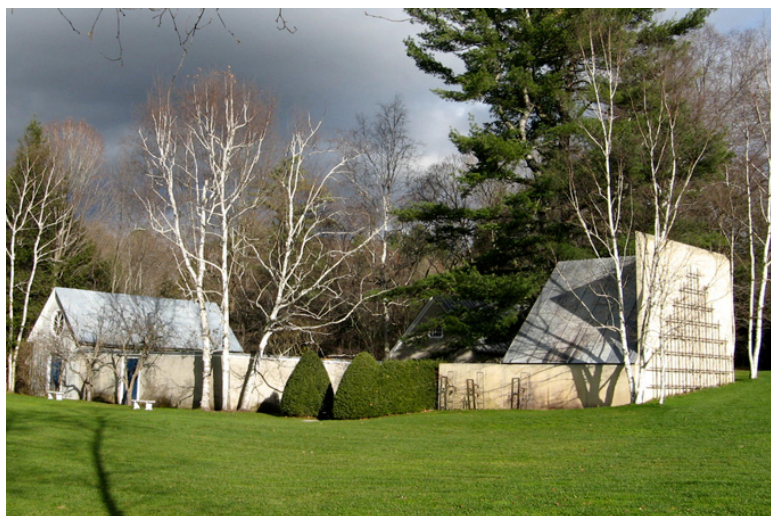
Figure 3.40: The galleries entrance hedge, view looking northeast with Farragut pavilion at right, 2006. Note height of linear section compared with cones. (SUNY ESF).

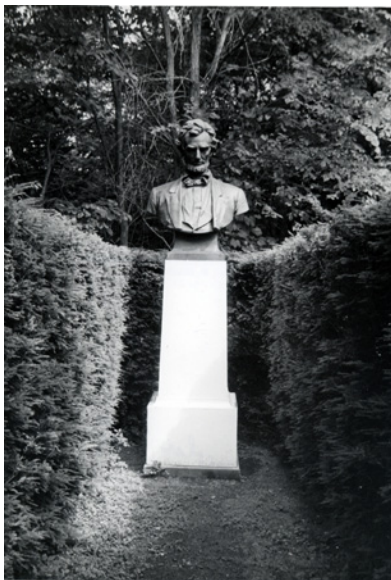
Garden, on axis with a walk extending from the Atrium. The walk was lined by hemlock hedges that were maintained at the height of the sculpture pedestal, approximately 5 feet tall (Figure 3.42). Hemlock hedges were also planted to frame the adjoining space between the walk and the Picture Gallery. The function of this adjoining room is not known, although it may have been intended as additional display space for sculpture.

Figure 3.42: The Lincoln bust hedge, view looking east from Atrium, c.1965 (Saint-Gaudens National Historic Site, photograph 1270).

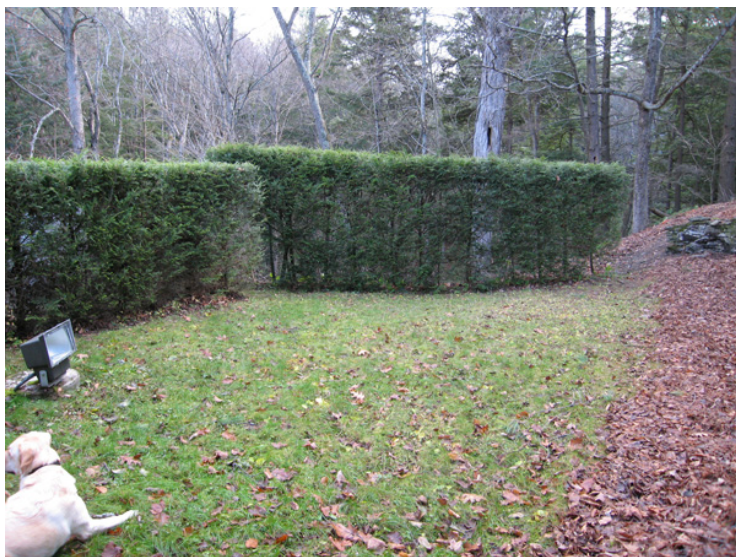
The Lincoln bust hedge is comprised of two adjoining sections of hemlock hedge (H_24, 25) clipped in a rectangular profile (Figure 3.43, Drawing 1). The hedge is situated in a triangular space between the buildings and mature woods that extend across the steep bank that leads to Blow-Me-Down Brook. Section H-24 is 'U'-shaped and frames the narrow 20 foot-long walk leading from the Atrium to the Lincoln bust. Replaced in c.1998, it is 5 feet tall (matching the height of the sculpture pedestal) and 2 feet wide, with a single row and 2 feet spacing between plants. It has a full but thin canopy facing the walk. The north and east (exterior) sides, which are not visible to the public, are mostly bare. These sides of the hedge apparently died off due to shade created by overgrowth of successional trees, vines, and shrubs (grape, honeysuckle, and walnut), which are now cut back from the hedge. Section H-25 frames the east side of the adjoining room to the south, between the Atrium and the Picture Gallery (Figure 3.44). It is 6 feet tall and 4 feet wide, with a single row and 2 foot-spacing between plants. It has a full but thin canopy except on the north side, which is not visible to the public. This side may have died back from competing vegetation, or from shade.

Figure 3.43: The north side of the Lincoln bust hedge, view looking east from Atrium showing encroachment of volunteer vegetation, 2006 (SUNY ESF).

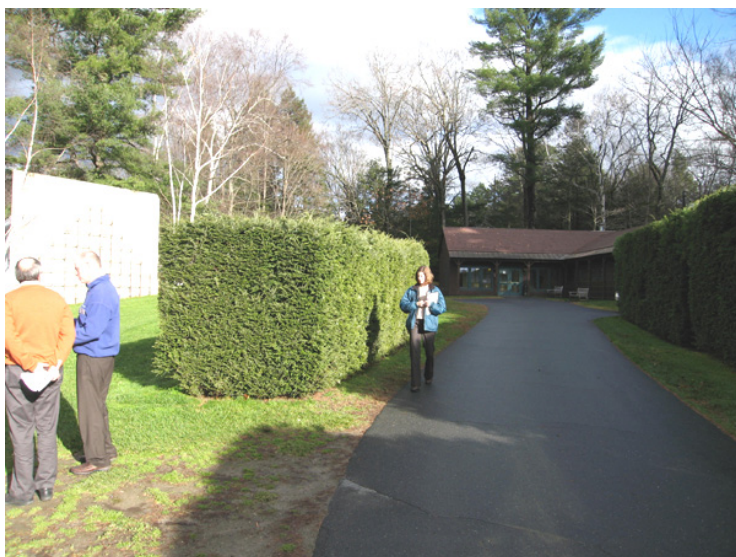
Figure 3.44: The Lincoln bust hedge, view looking east at sections H-25 and 26, 2006. The site of the south leg of H-26 removed in 2006 is the bed at right (SUNY ESF).

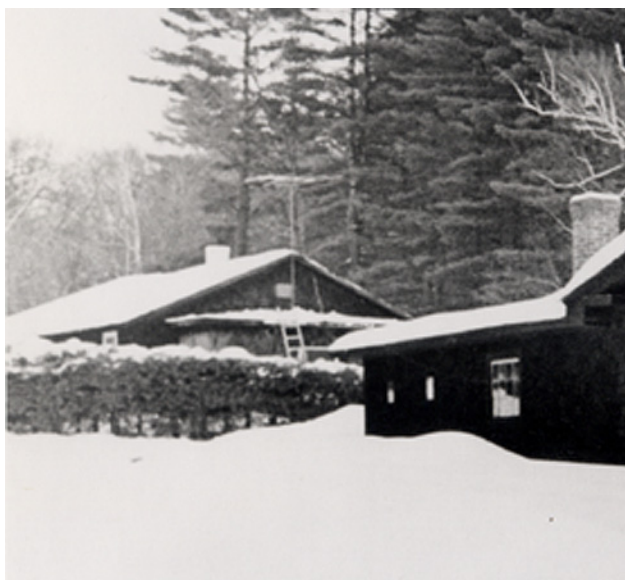
plants (Figure 3.45). It is in excellent condition, with a compact, full canopy. The hedge screens views from the visitor center (former maintenance building) to the north and west.

Figure 3.45: The visitor center hedge, view looking east with visitor center in the right background and Farragut pavilion to the left, 2006 (SUNY ESF).

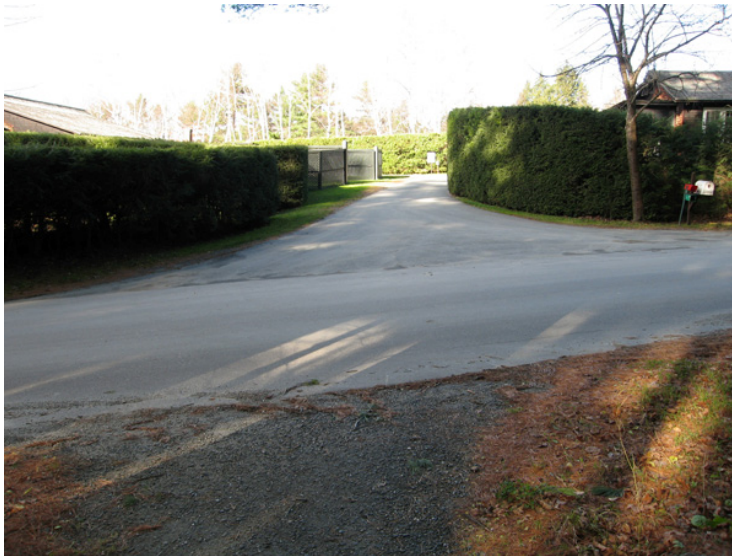
By the mid-1960s, the older section of the hedge extending along the service drive was being maintained at about the height of the eaves of the Caretaker's Cottage (Figure 3.46). In later years, this section grew upwards of 12 feet, concealing all but the upper gable of the cottage when looking from the exterior of the hedge. In c.1980, the section along the road (all or part of H-28) was replanted in hemlock.⁸² This section did not develop strongly most likely due to shade from the woods across the road. In c.2000, a small section of the hedge near the curve along the service drive was replaced due to snow damage.

Figure 3.46: The Caretaker's Cottage hedge, view looking east from the stable showing height after the historic period, c.1970. Note that the hedge was lower than the eaves of the cottage (Saint-Gaudens National Historic Site, photograph 20).

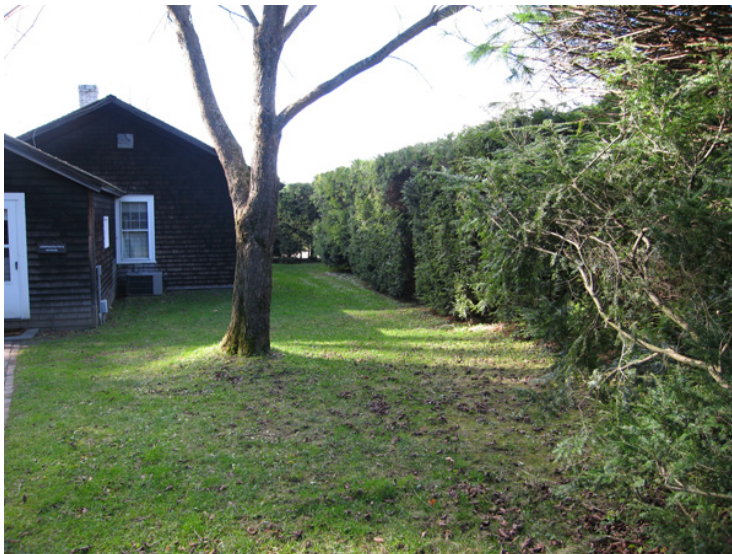
Section H-27, forming the north and west sides of the hedge extending around the curve at the corner of the service drive and Saint Gaudens Road, is mixed white pine and hemlock planted between c.1917 and 1927 with later infill (Figures. 3.47, 3.48). It is 10-12 feet tall and 10 feet wide, planted in a single row with 1 to 3 feet spacing between plants. It is taller than the companion cutting garden hedge on the opposite side of the service drive (see Figure 3.48). The section has three openings: one at the entrance walk to the Caretaker's Cottage, a second to the north of the cottage that is closed by a gate, and a third non-historic narrow arched opening near the east end of the hedge. It has a dense canopy that is mostly full but has some bare spots between the hemlock and white pine. The southeast end of the section, adjoining H-28, was replanted in hemlock in c.2000 as a result of damage from snow.

Figure 3.47: The Caretaker's Cottage hedge, view looking east from the stable, 2006. Note existing height above eaves of the cottage and mixed white pine-hemlock (SUNY ESF).

- Lower Caretaker's Cottage hedge (H-27) to height below eaves of cottage
- Lower Galleries entrance hedge and extend missing part (H-22, 23)
- Lower height of kitchen hedge and address bare understory of dogleg (H-7, 8)

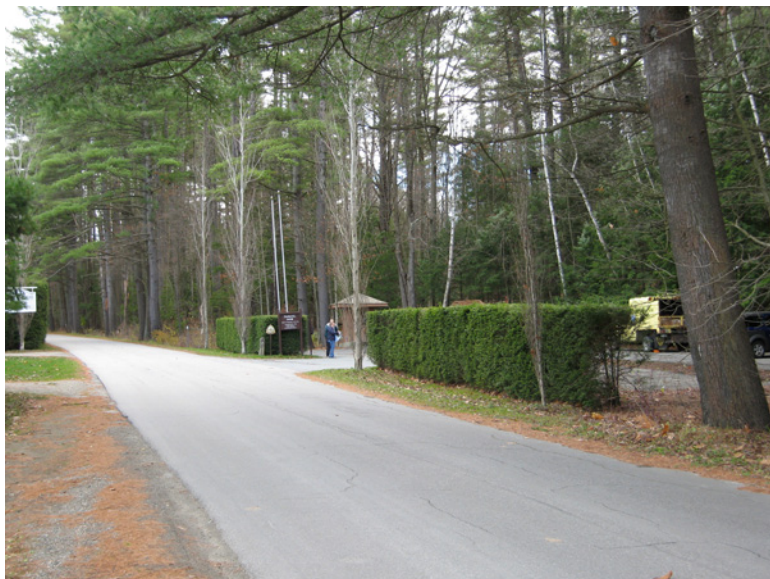
Figure 3.49: The Caretaker's Cottage hedge, view looking west of interior of H-27 showing relationship to scale of cottage, 2006 (SUNY ESF).

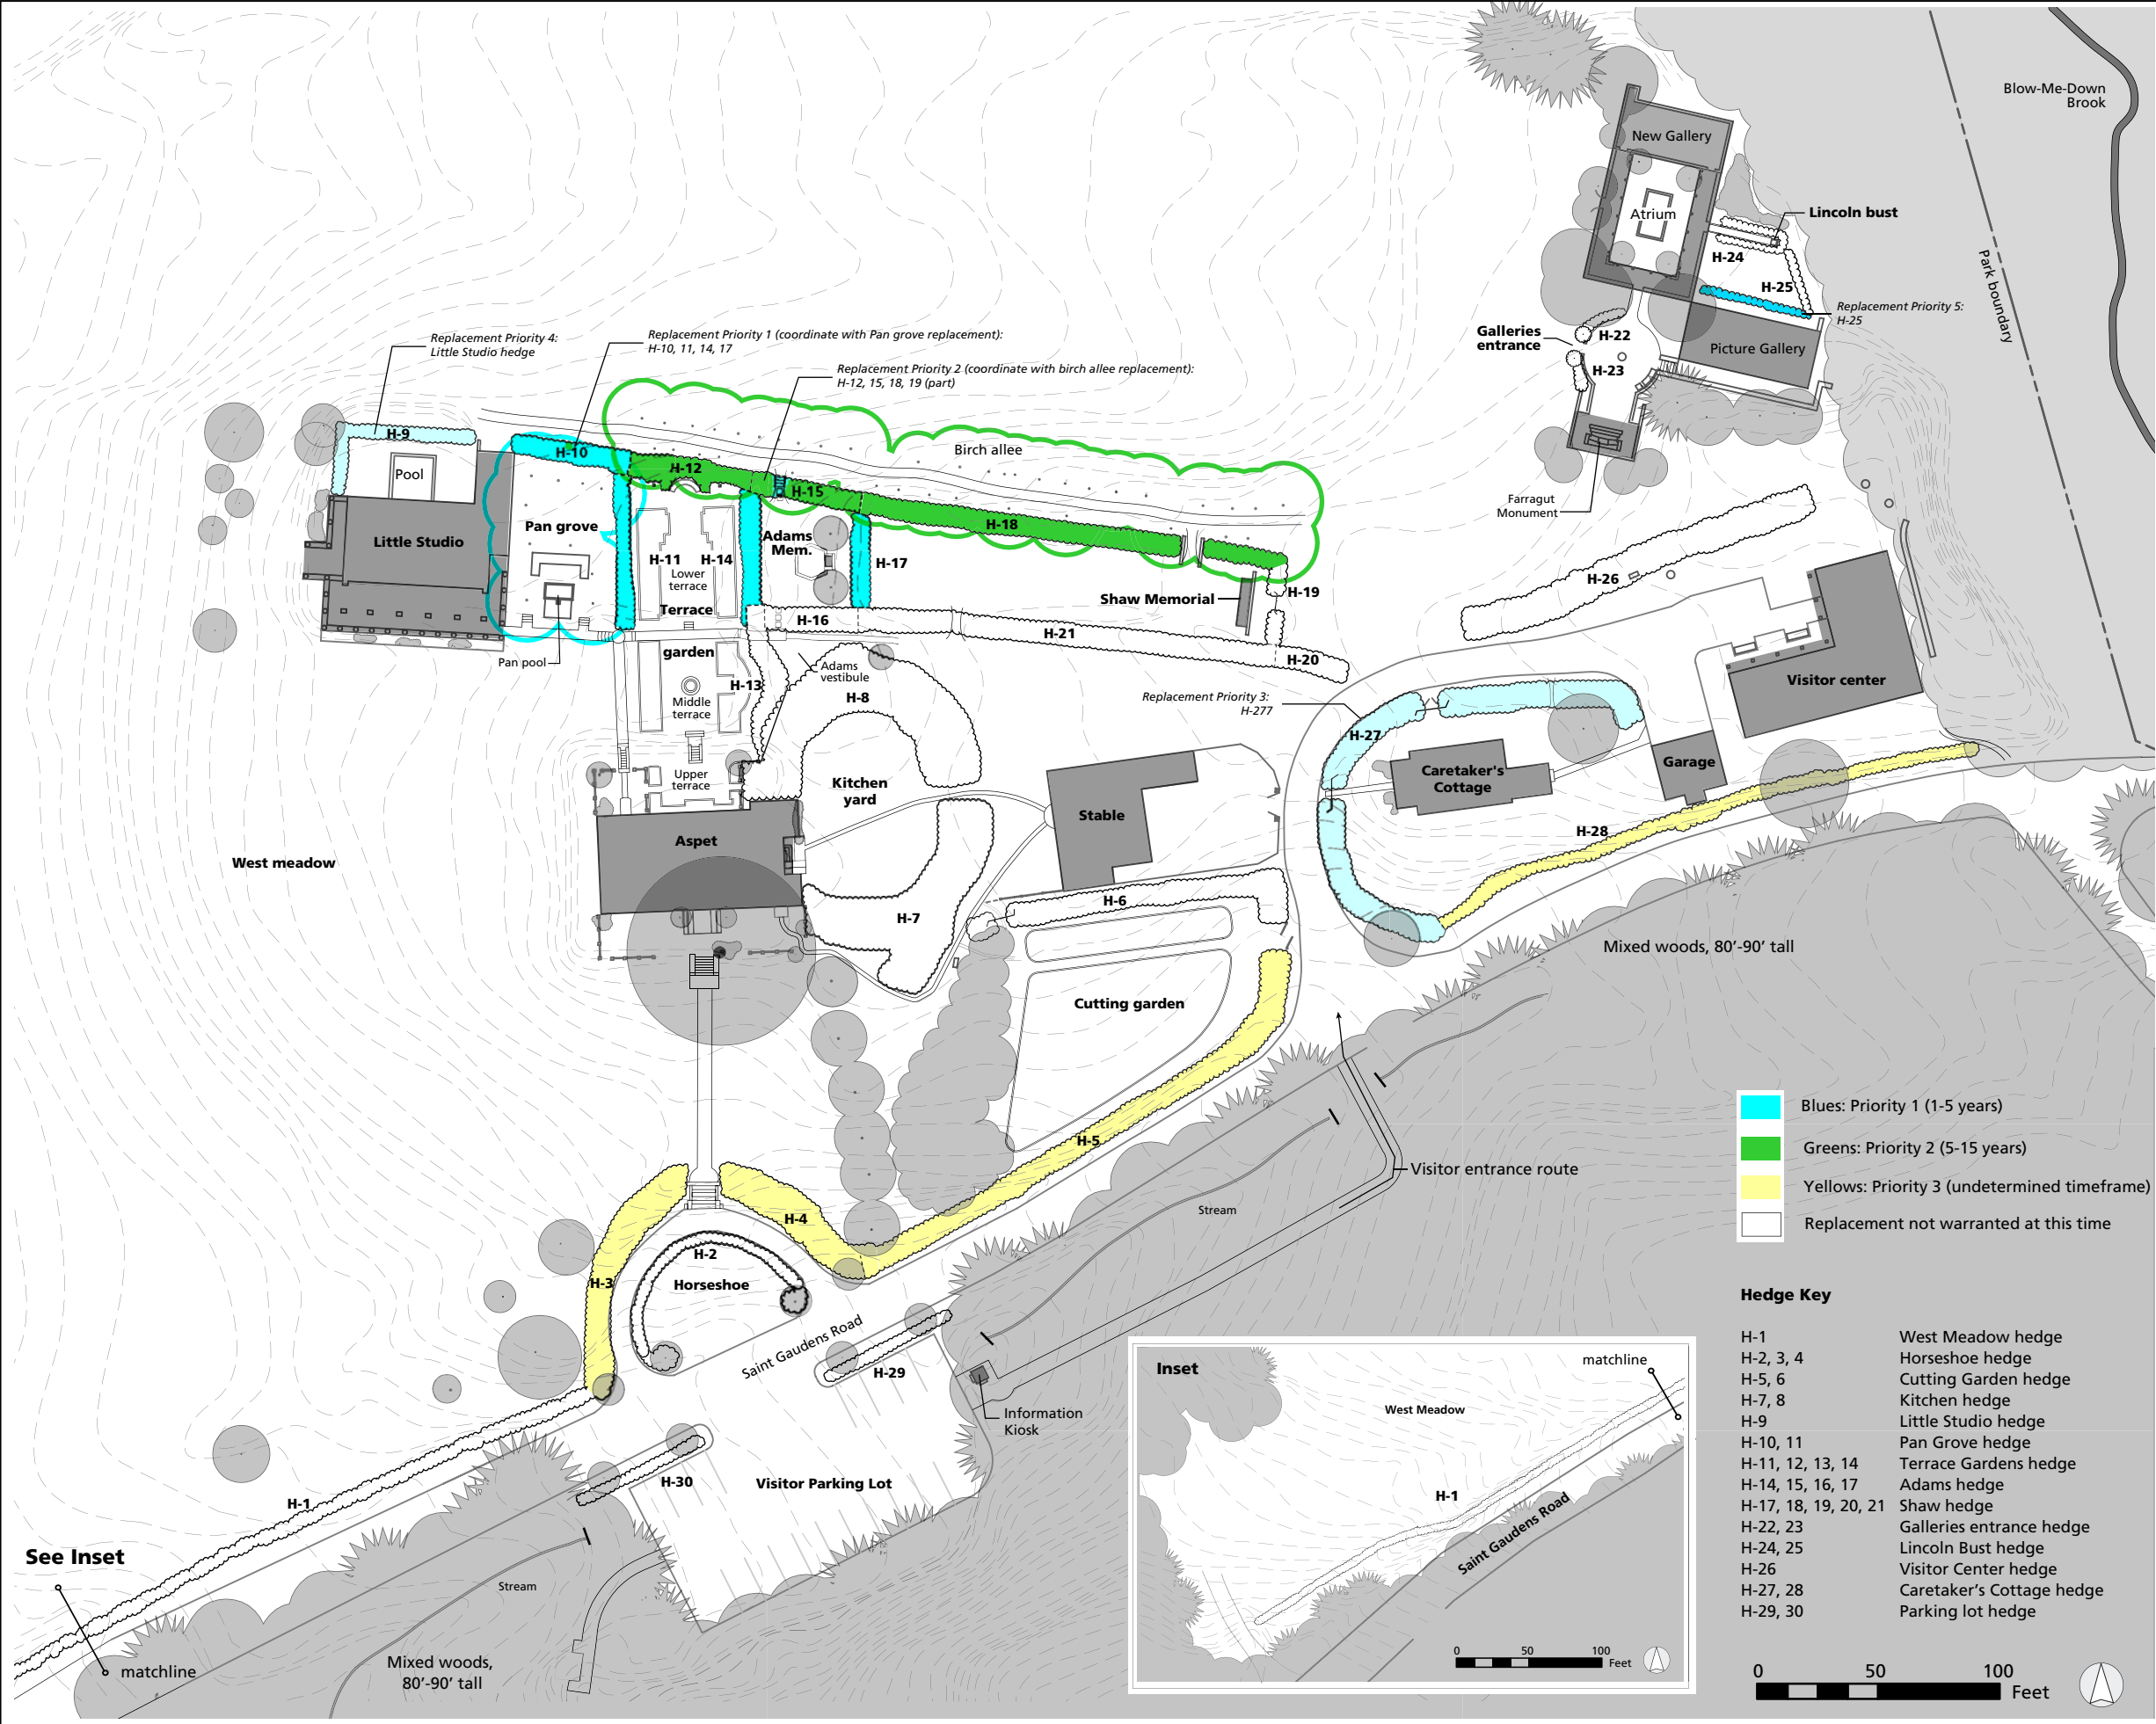
Section H-28, extending along Saint Gaudens Road, is pure hemlock replanted in c.1980 (Figure 3.50). It ranges from 8 feet tall at section H-27 to 5 feet tall to the rear of the garage and visitor center, and averages 4 feet wide. The hedge is full facing the Caretaker's Cottage yard, but is weak on the remainder of the hedge, with gaps and bare areas. The hedge is heavily shaded from the woods south of the road as well as several adjoining trees on the north side, and is situated at the top of a steep bank that is eroding.

Figure 3.50: The Caretaker's Cottage hedge, view looking west from the east end of the hedge along Saint Gaudens Road, 2006 (SUNY ESF).
