Historic Landscape Report
CANFIELD PARK
DENISON PARK
Corning, New York

Prepared For:
Market Street Restoration Agency Corning, New York

Prepared By:
State University of New York
College of Environmental Science & Forestry
Faculty of Landscape Architecture Syracuse, New York
Research Assistant Kenneth J. Allen
Project Director George W. Curry

September, 1994

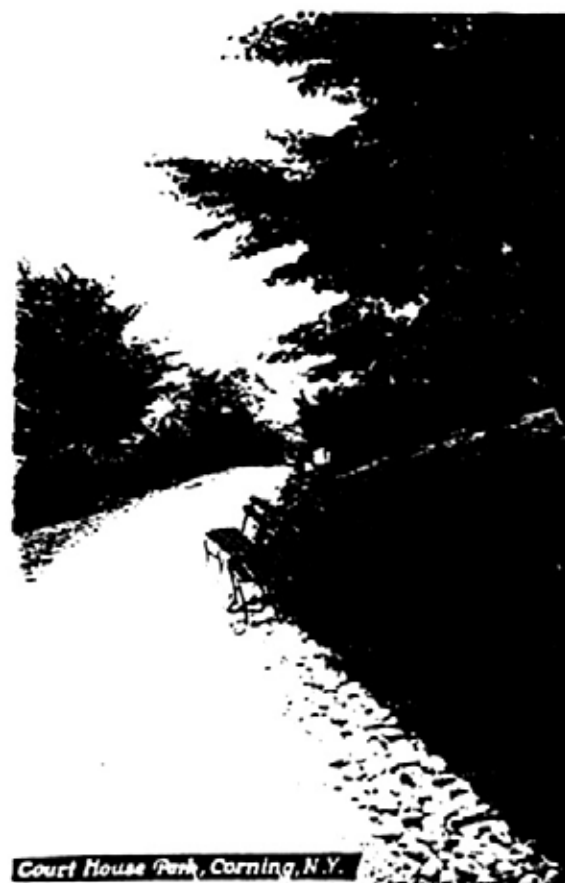
Figure 1.7: Canfield Park, facing east from northwest corner of path (Dimitroff Collection).

Surrounding the park was a 4 foot perimeter sidewalk. There were entrances to the park from all of the corners except the northeastern corner where the court house is sited. The entrance to the park from the northeast was via the staircase off of First Street. Entrances were located at the center point of the east, south and western boarders that lead to three plazas. From the corners ran semi-serpentine, diagonal pathways to the opposite corners. The three plazas were interconnected via short linear paths. The 8 foot wide pathways within the park were gravel with large (2-4" diameter) stones on the uphill edge acting as run-off gutters. Running along the west wall of the Court House was a 4 foot wide cement sidewalk that connected the entry staircase with the western rear entry to the Court House. The perimeter sidewalks were made of concrete. All other dimensions, materials specifications and characteristics are unknown.

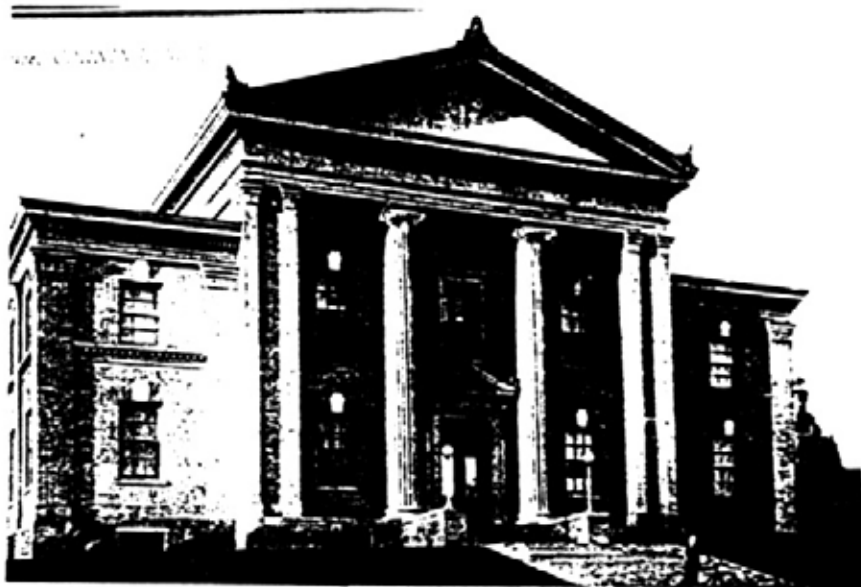
Figure 1.8: Canfield Park, court house, facing southwest (Dimitroff Collection).

The Steuben County Court House was the only building on the property at the time construction began on the park. Several structures in and around the park and court house also existed. The neo-classical court house was rectangular with a small extension on its southern side, creating a truncated T-plan. The front of the building was a total of 84 feet in width. The entrance area was 48 feet in width and dropped back to the south on both ends by 3 feet. Both sides then extended an additional 18 feet to the east and the west. The sides of the court house went south for 59 feet and then nitched in on both sides by 13 1/2 feet. From that point, both sides traveled south for an additional 22 feet. The back of the building extended from the east and west walls, inward by 25 feet. The sides then moved south 3 feet and then made a right angle connecting with one another. This section was 8 feet in length.⁷⁸ A full description of the court house, as noted in the November 10, 1988, Building-Structure Inventory Form, can be found in **Appendix C**.

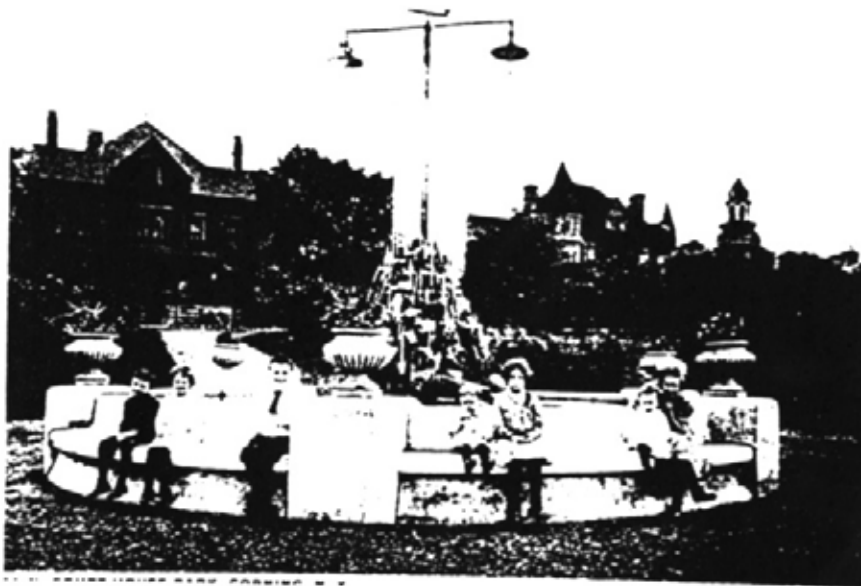
Figure 1.10: Canfield Park, fountain, facing southwest (Dimitroff Collection).

The only water feature within the park was a 25 foot diameter concrete fountain. It was located within the southern, central plaza. The fountain was surrounded with six pilasters that broke up the seating rim on the outer edge. The pilasters were to support large terra-cotta flower vases that were a donation from M. E. Gregory, the proprietor of Corning Brick Terra-Cotta and Tile Company.⁸⁰ In the center of the fountain was a huge, conical stacked pile of sandstone boulders.⁸¹ There was a spray from the top that showered over the mound along with a light to illuminate the fountain in the evening hours.⁸² The sandstone was originally intended to be covered with moss but whether or not this was done is unknown.⁸³ All other dimensions, materials, specifications and characteristics are unknown.

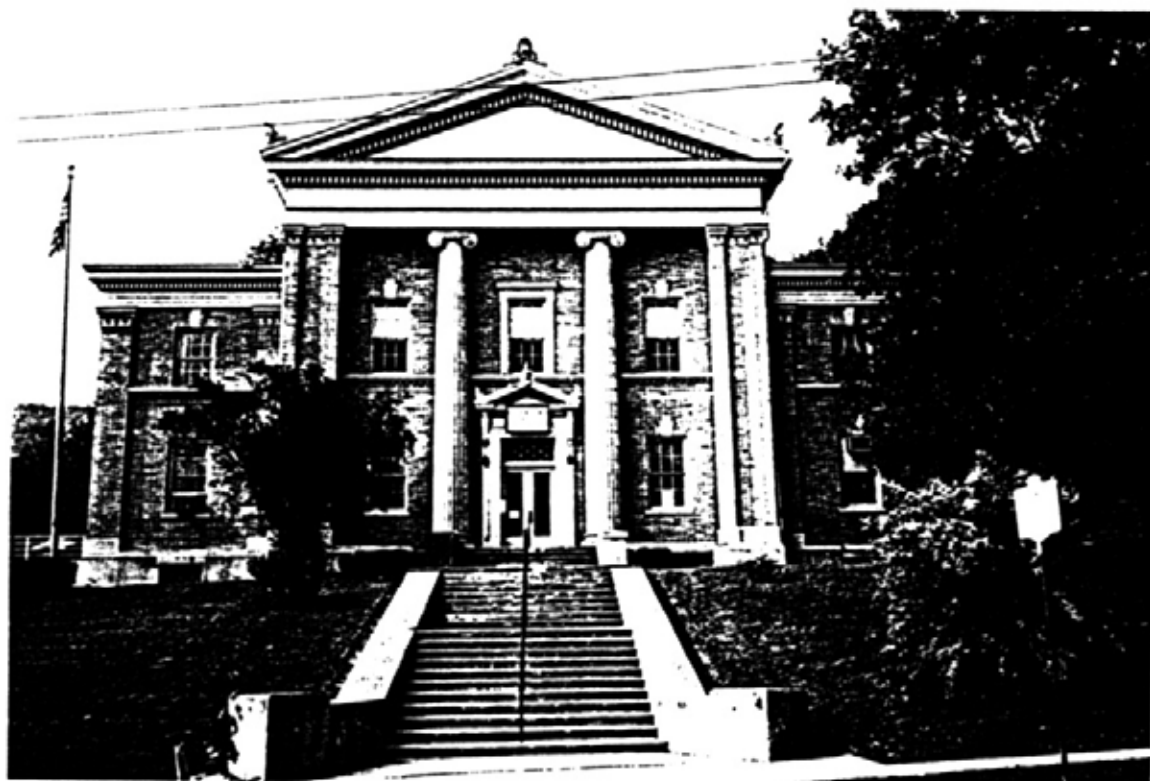
Figure 1.14: Canfield Park, court house, facing southwest (K. Allen. SUNYCESF, 1994).

The Steuben County Court House has not been seriously altered since it was erected in 1903. Currently, there is a small wooden entry way that was added to the north corner of the western wall. Otherwise, the building is existing as described in the previous period's **Buildings and Structures** section and in Appendix C.

The entry staircase was altered at an unknown time during the early to mid-twentieth-century. The staircase exists today with those alterations. The flight of steps was divided at the tenth step with a 13 foot by 5 foot concrete landing. The second rank of steps continues for an additional eight steps before meeting with the large original landing. The steps all have 1 1/2 foot treads, 6 inch risers, and are 13 feet wide with a black tubular metal railing dividing the stairway. The 3 foot by 3 foot boarder blocks were moved and canted north and south so that they created a terminus for the boarder walls. The pyramid shaped tops were removed. The concrete boarder walls are 2 1/2 feet in width and run 33 feet from the major landing to the base of the stairs where they curve outward and continue for 2 feet to meet with the boarder blocks. The original third rank of the staircase remained unaltered except for the removal of the light posts from the base of the boarder walls. All other dimensions, materials, specifications and characteristics are unknown or unrecorded (see fig. 1.14).

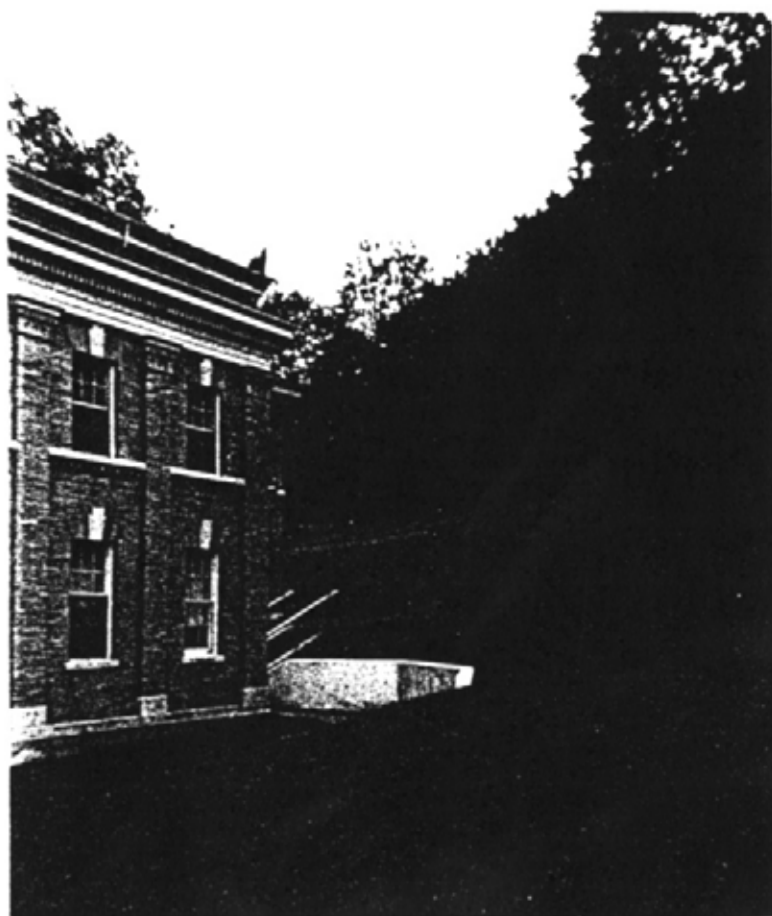
Figure 1.15: Canfield Park, retaining wall, facing southeast (K. Allen. SUNYCESF, 1994).

The western concrete retaining wall exists today but it has been modified and possibly replaced. The wall that stands today is made up of three segments and it measures 14 feet in

length. According to the 1994 Site Survey, the southeastern pointing wall is 3.5 inches high and gradually becomes 2.8 feet in height. The second segment is 10 feet in length, has 2.45 feet of exposed wall at its far end and is located in an east, southeast direction. The third segment of the wall connects with the staircase perpendicularly so that the 14 1/2 foot long section is parallel to the southern wall of the court house. The final segment terminates with a height of 2.45 feet. The wall is painted white. It should be noted that existing conditions photographs (taken on 9/8/94) indicate that the wall is higher than indicated on the 1994 site survey. However, field measurements were not taken. All other dimensions, materials, specifications and characteristics are unknown or unrecorded.

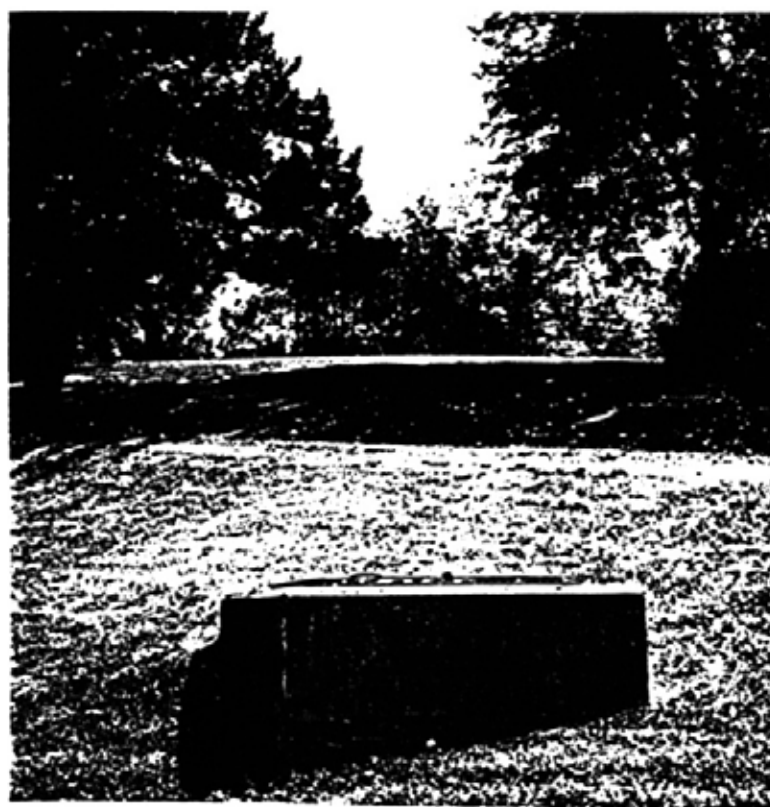
Figure 1.18: Canfield Park, vault, facing southeast (K. Allen. SUNYCESF, 1994).

There is a concrete vault with a door located 35 feet to the east of the northwest corner of the block. The length is 7 feet and the width is 5 feet. The northern portion of the vault is waist high while the southern portion is nearly buried in the slope. The other dimensions and purpose of the vault are unknown. All other dimensions, materials, specifications and characteristics are unknown or unrecorded.

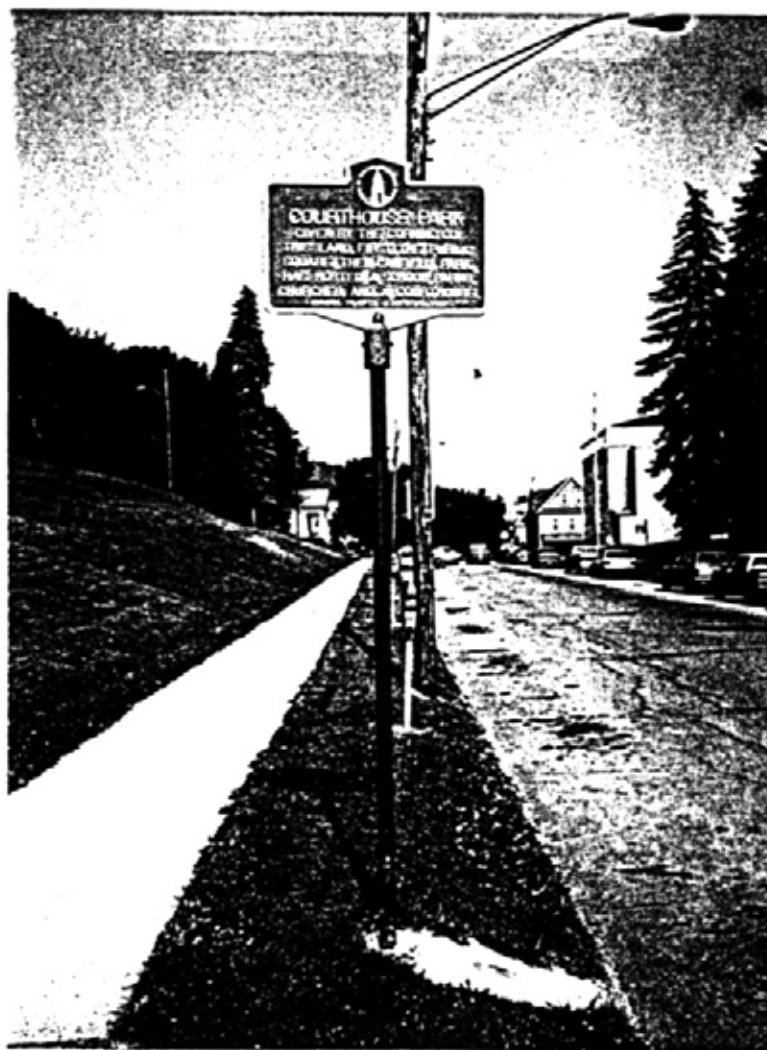
Figure 1.19: Canfield Park, court house signage, facing east (K. Allen. SUNYCESF, 1994).

The block's perimeter is dotted with various signs. Included among them are stop signs, parking signs and a historic site sign referring to the court house. The historic site sign is located to the west of the steps in the curb on First Street. For the locations of all the signs refer to the 1994 Site Survey of Canfield Park by Hunt Engineers and Architects. All other dimensions, materials, specifications and characteristics are unknown or unrecorded.

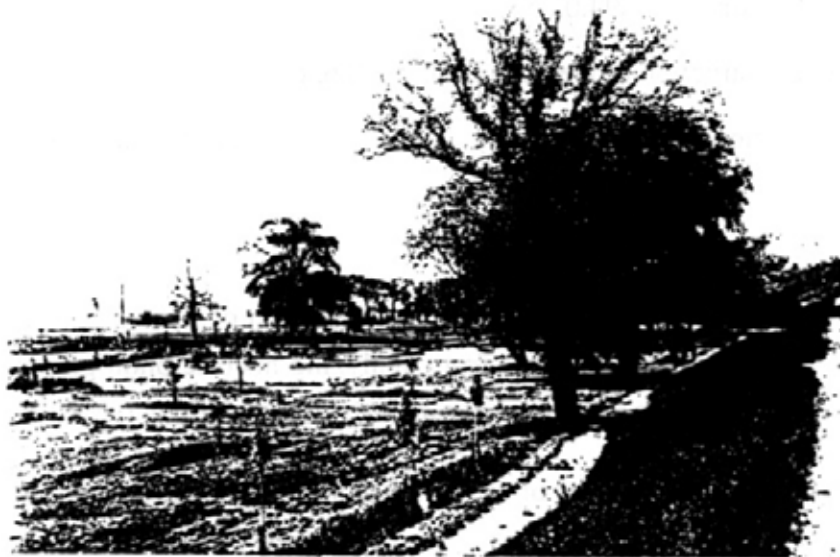
Figure 2.1: Denison Park, vegetation (CPPHS, #94.0.652).

On the northwestern side of the park, low shrubs lined the sidewalk near the children's wading pool. There were numerous deciduous shade trees of approximately 4 to 6 inches in diameter, dispersed around the wading pool and encircling the water feature. The carriage paths in this section of the park were lined with low shrubbery and young deciduous trees.

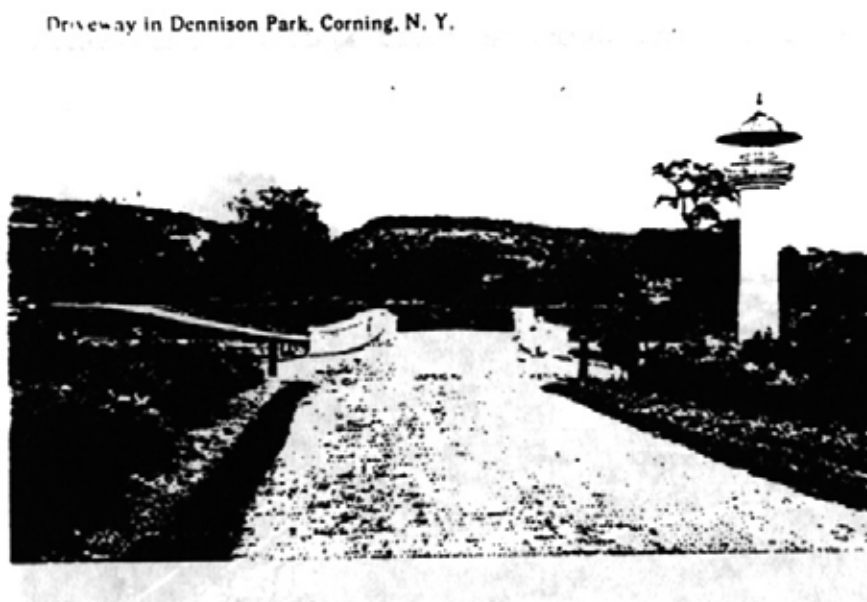
Figure 2.7: Denison Park, west side of tower and bridge (Dimitroff Collection).

Located directly to the west of the concrete bridge was the location of the concrete tower. The tower was cylindrical and included an iron or steel frame basket on the top of the cylinder. The basket was covered with a metal, inverted disk-shaped overhanging roof. All other dimensions, materials, specifications and characteristics are unknown.²⁰¹

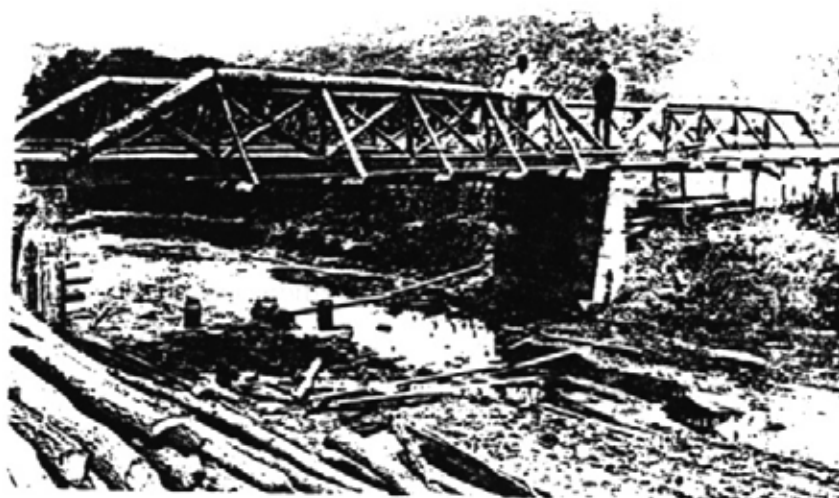
Figure 2.9: Denison Park, Park Ave. bridge facing south (CPPHS, #94.0.653).

There were four rustic, wooden bridges constructed in the park between 1907 and 1910. The bridges were two separate, matched sets. The larger set of bridges were located off of the western central entrance. They spanned the western water features and ended on the island that separated the two. In direct line with one another, the bridges were designed to allow carriages and pedestrians to access the central section of the park from Park Avenue. From historic photographic documentation, the materials of the bridges have been determined to be: steel 'I' beams, supporting the bed, placed on concrete footings and supports; rustic-cut, barked logs for side railings and railing supports, and wooden planks for the bed. The combined length of the bridges was 120 feet.²⁰⁴ All other dimensions, materials, specifications and characteristics are unknown.

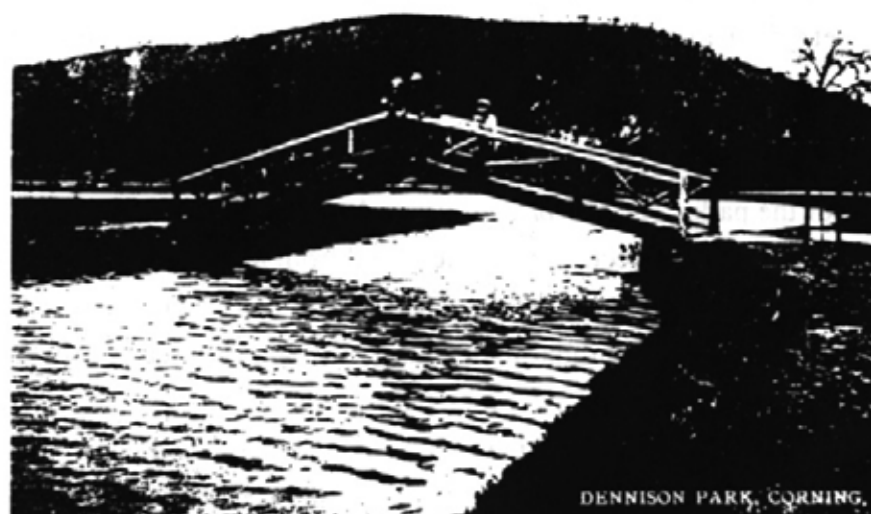
Figure 2.10: Denison Park, Island footbridge, facing east (Dimitroff Collection).

The other bridge set were located in the southern section of the park, connecting the island with the rest of the park. The one bridge spanned the southeastern bank of the levee to the island and the other was located directly across the island from it, to the northwest. Both of these bridges were designed for pedestrian travel only. They were constructed in a similar manner to the other bridges and apparently of similar materials. The main difference between the two sets of bridges, besides the smaller size of the latter pair, is that the second set was designed in a shallow inverted 'V' shape. The spans of the two bridges were 40 feet each. The width of the bridges was 8 feet. All other dimensions and the color of the bridges are unknown.²⁰⁵ All other dimensions, materials, specifications and characteristics are unknown.

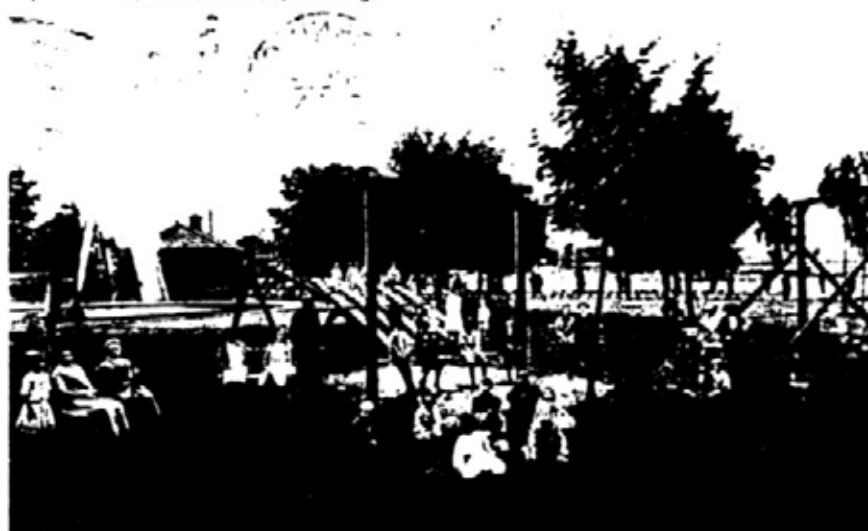
Figure 2.13: Denison Park, wading pool and playground area, facing northwest (Dimitroff Collection).

Play equipment was installed in 1910 and was sited around the children's wading pool, off of Park Avenue. There were several types of swing sets, seesaws and slides. The material utilized for a majority of the equipment was wood. All other dimensions, materials, specifications and characteristics are unknown.²⁰⁹

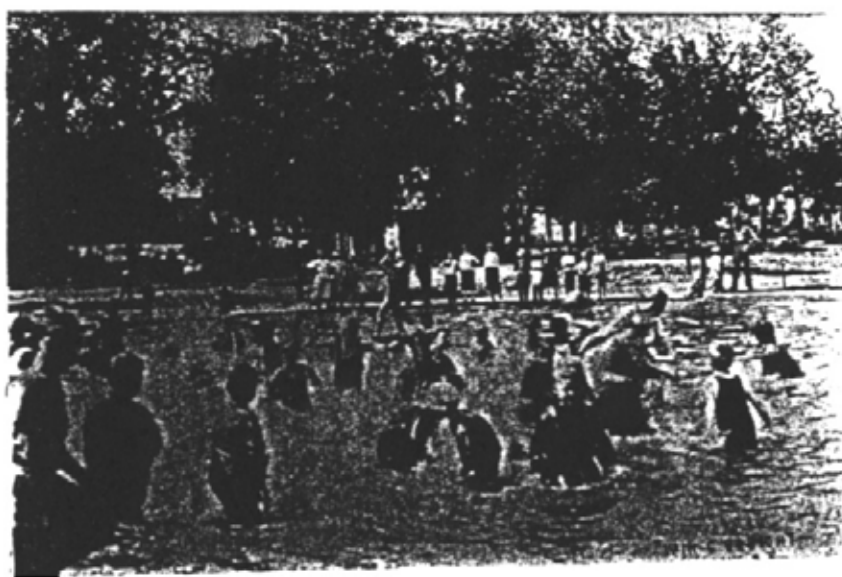
Figure 2.14: Denison Park, wading pool, facing south (CPPHS, #94.0.657).

The concrete wading pool was round with a concrete walk bordering it and was 75 feet, 6 inches in diameter (including the walk). The walk was 4 feet in width. The center of the pool was adorned with a large bronze statue of a child blowing a horn. From the horn sprayed an immense fountain of water. The statue was donated by James A. Drake.²¹⁰ The name of the sculptor is unknown. The pool was located east of the intersection of Conhocton Street and Park Avenue. All other dimensions, materials, specifications and characteristics are unknown.²¹¹

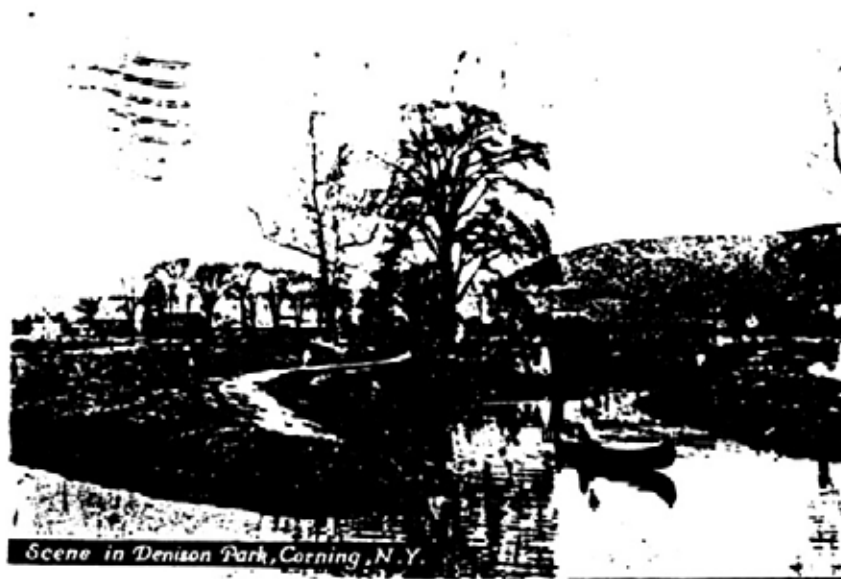
Figure 2.15: Denison Park, West section of park, facing northwest (Dimitroff Collection).

Although the lake in Denison Park was not built until 1927, during the construction period deep and wide swales were dug. This created a few small islands along the western edge and one large island near the southern boarder of the park. The water level fluctuated, leaving the swales full at times and swampy during dryer periods. All other dimensions, materials, specifications and characteristics are unknown.²¹²

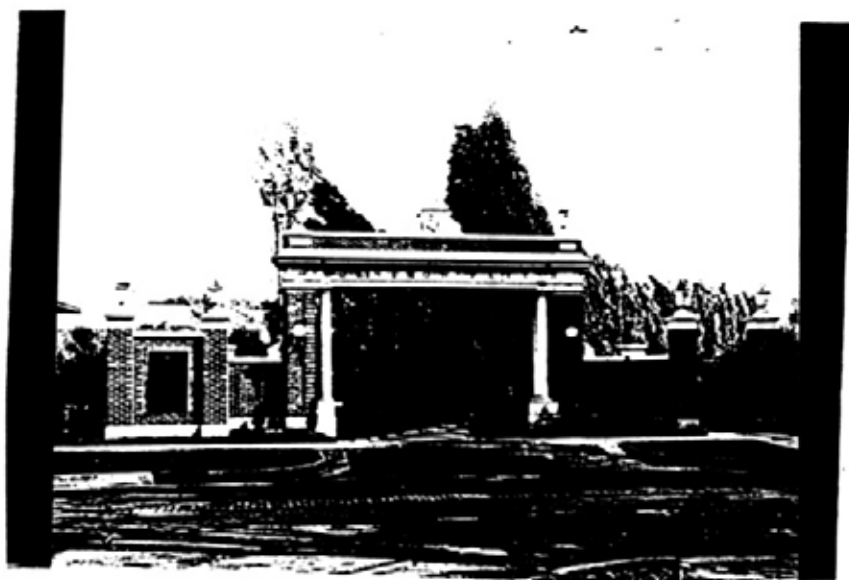
Figure 2.18: Denison Park, Memorial Gateway, facing east (CPPHS, #94.0.662).

The opposite (south) side lacked the connecting wall between the pillars, creating a boarded entrance for pedestrians that was 5 feet in width. The tops of all of the pillars were capped with a raised concrete piece that included an overhang just before the very top of the cap.

The two main columns had metal lighting fixtures about half way up with round white globes. On top of the corners of the overhead section, as well as on the tops of the four outer pillars, were planter urns.²¹⁴ All other dimensions, materials, specifications and characteristics are unknown.²¹⁵

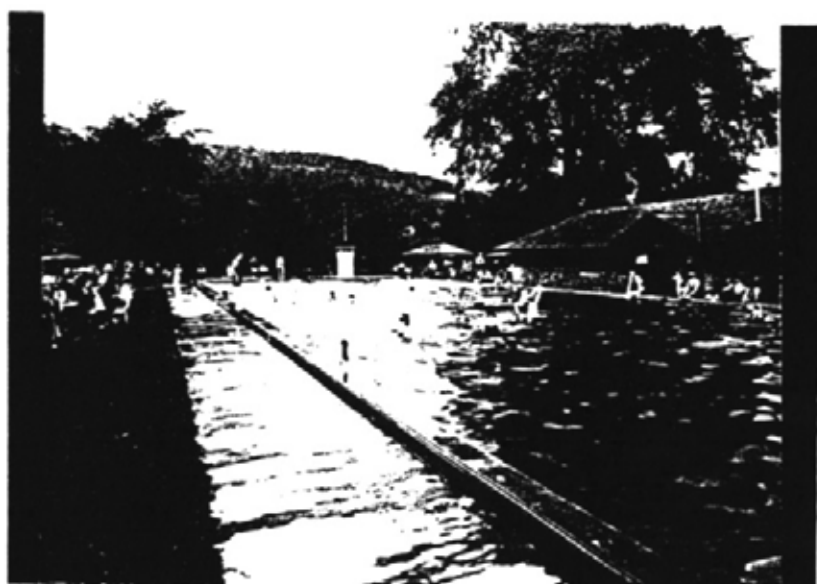
Figure 2.24: Denison Park, pool and bath house, facing northeast (CPPHS, #94.0.661).

The original swimming pool, donated by Charles L. Denison, was built in 1919. The concrete pool measured 120 feet in length and 40 feet in width. The depth of the pool is unknown. The pool was bordered by a raised rectangular edge that measured 1 foot in width and approximately 10 to 12 inches in height with a rounded, formed top outer lip. The entire pool was surrounded by a concrete walk that measured 5 feet in width. The pool area was raised, although the pool itself was in the ground. All other dimensions, materials, specifications and characteristics are unknown.²²⁴

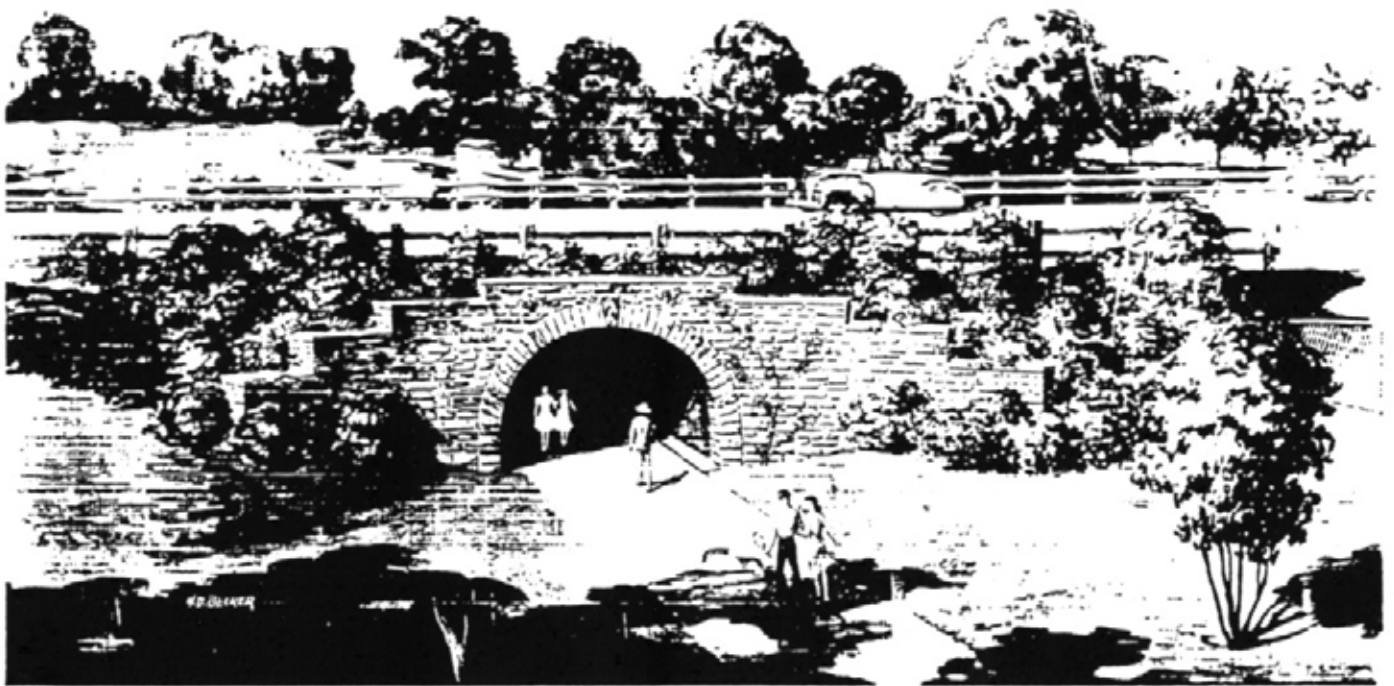
Figure 2.32: Denison Park, pedestrian underpass (MSRA).

The construction of the new highway/bridge bisecting the park made it necessary to provide pedestrian access from one half of the park to the other. Two 100 foot long 10 foot wide arched underpasses were built under the road bed. Each tunnel was faced with a random cut buff sandstone arch with a keystone. The facade, which extended out to both sides of the openings, were faced with the same stone.

The first of the underpasses was located in the northern central section, northeast of the First Street entrance off of Park Avenue and west of the baseball diamond. The second underpass was northeast of the Second Street entrance from Park Avenue and west of the swimming pool. All other dimensions, materials, specifications and characteristics are unknown.

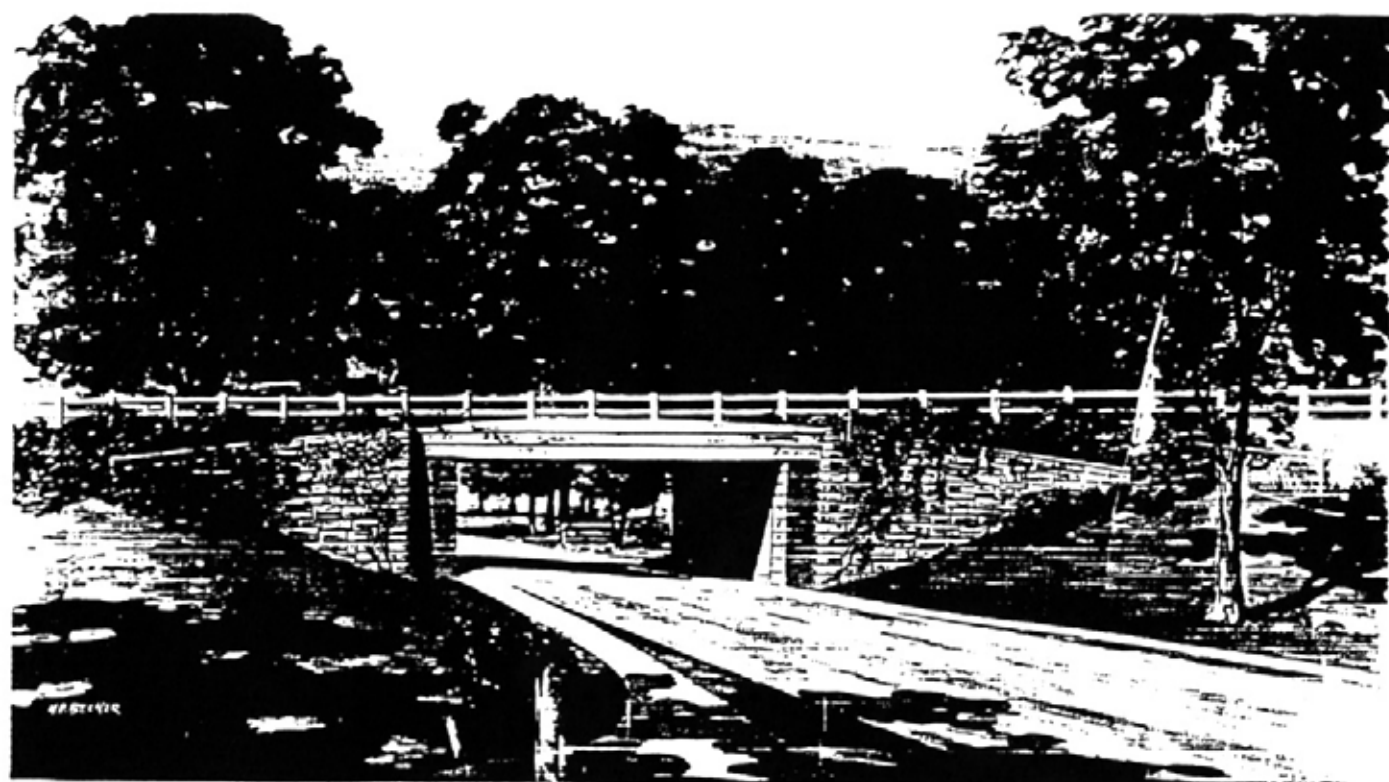
Figure 2.33: Denison Park, vehicular underpass (MSRA).

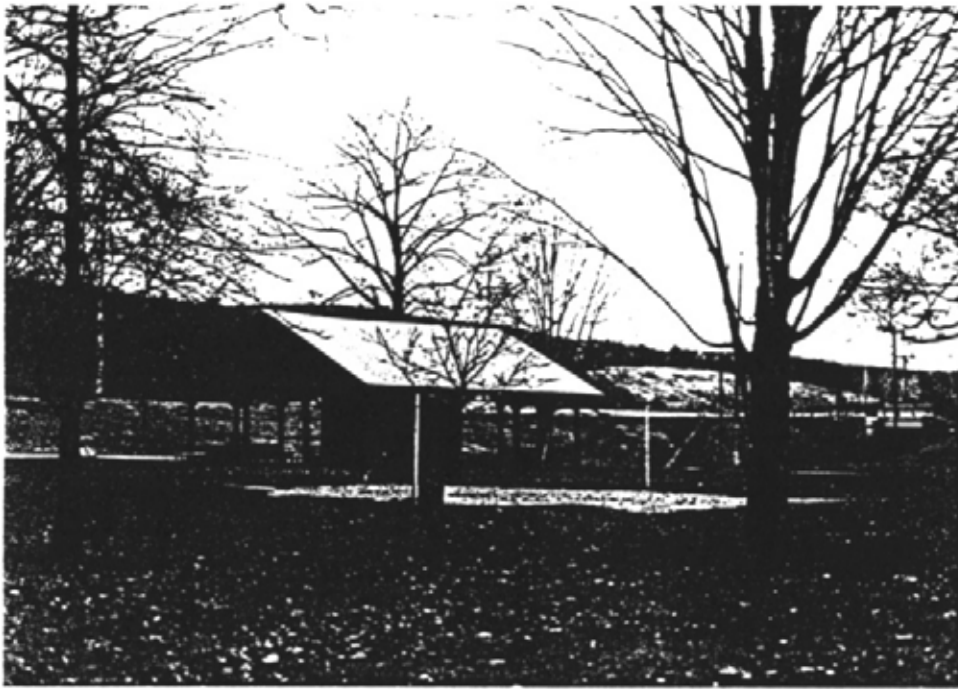
Figure 2.53: Denison Park, large pavilion, facing northeast (K. Allen. SUNY CESF, 1994).

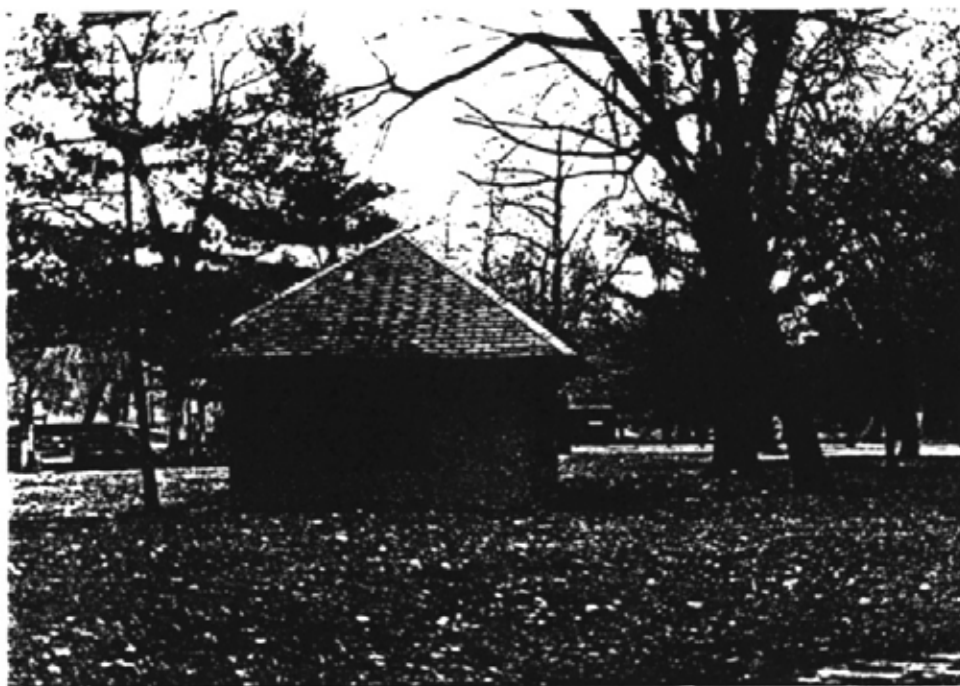
Figure 2.54: Denison Park, Playhouse, facing southeast (MSRA).

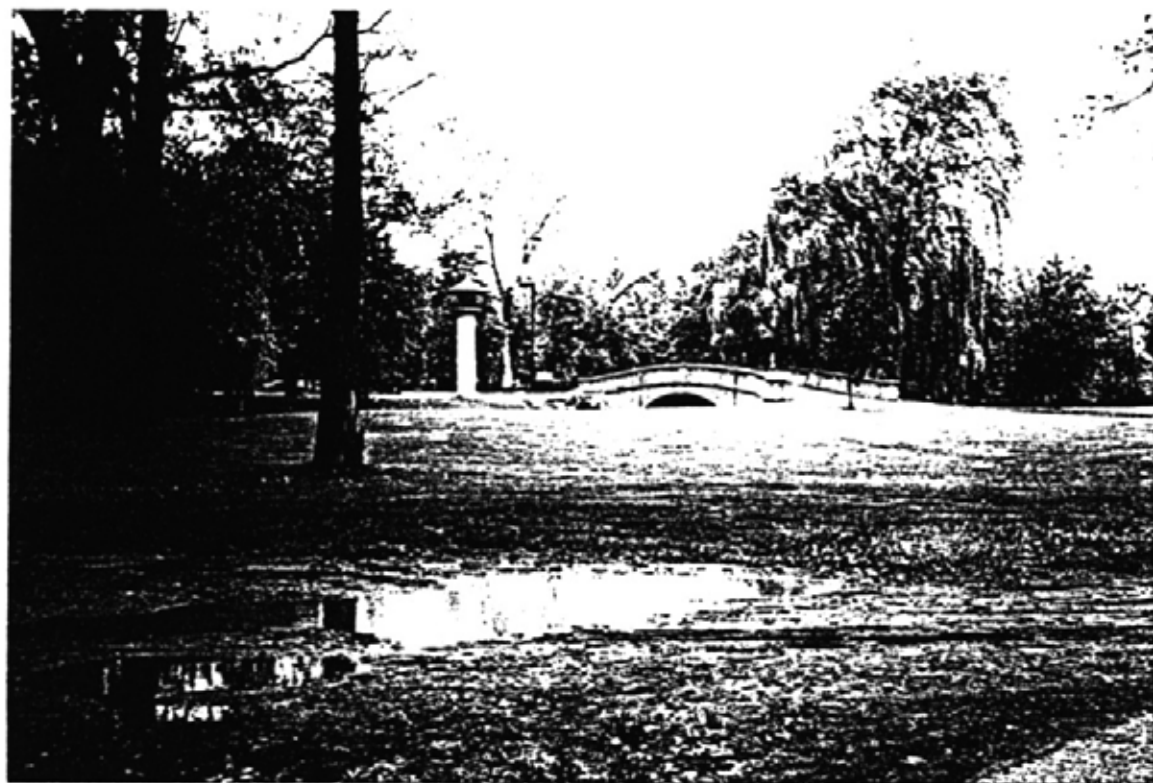
Figure 2.55: Denison Park, Bridge and Tower, facing northwest (K. Allen. SUNY CESF, 1994).

The concrete bridge was located on the 1973 Boundary and Topographic Survey and remained unaltered.

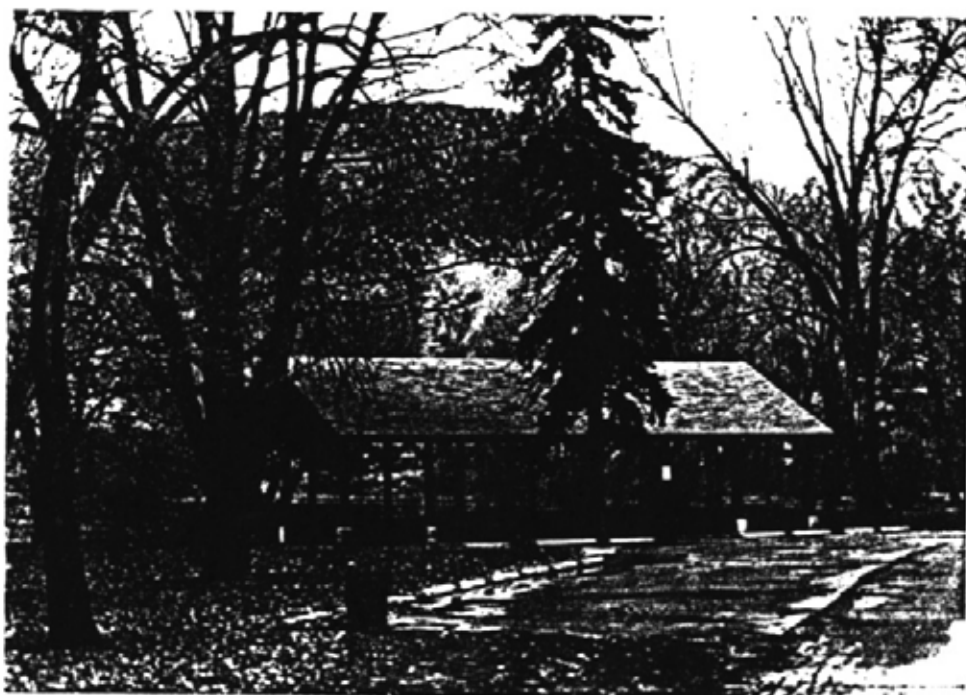
Figure 2.56: Denison Park, Pavilion, facing south (MSRA).

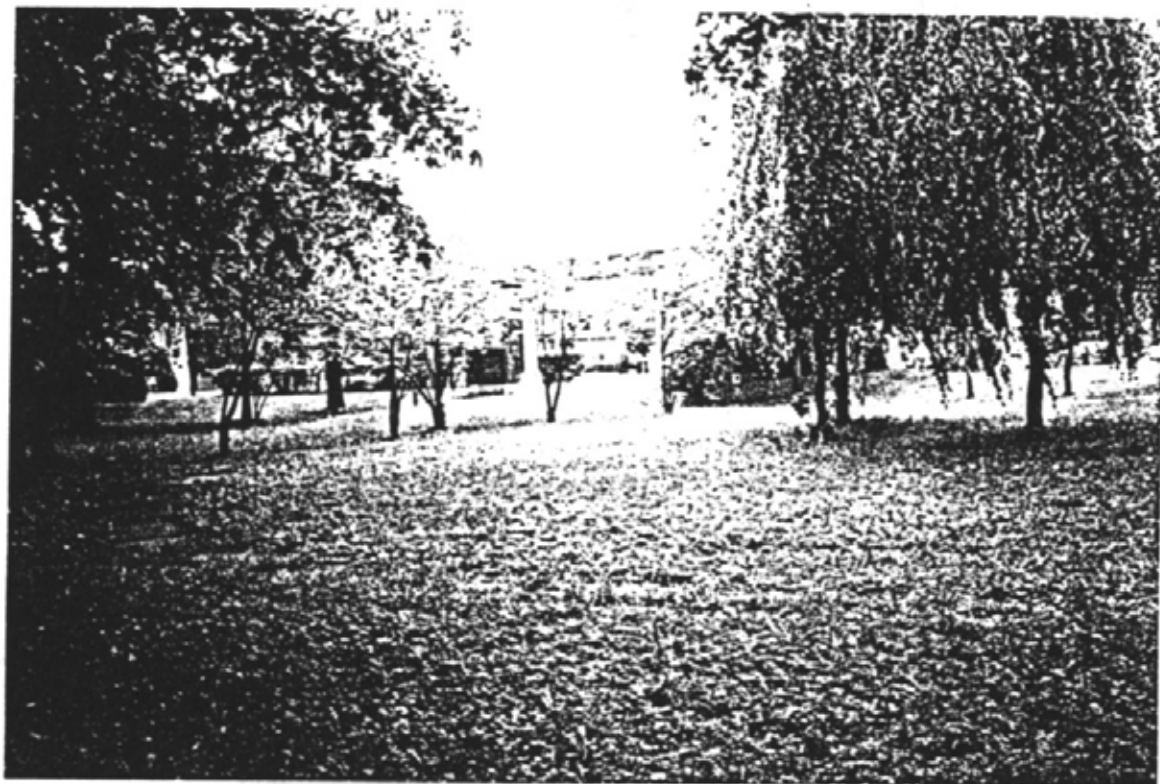
Figure 2.61: Denison Park, remains of walk surrounding the Wading Pool, facing southwest (K. Allen, SUNY CESF, 1994).

The children's wading pool was filled with soil. It is unknown whether the basin remained. The walkway that surrounded the pool was all that remained of the feature.²⁶¹

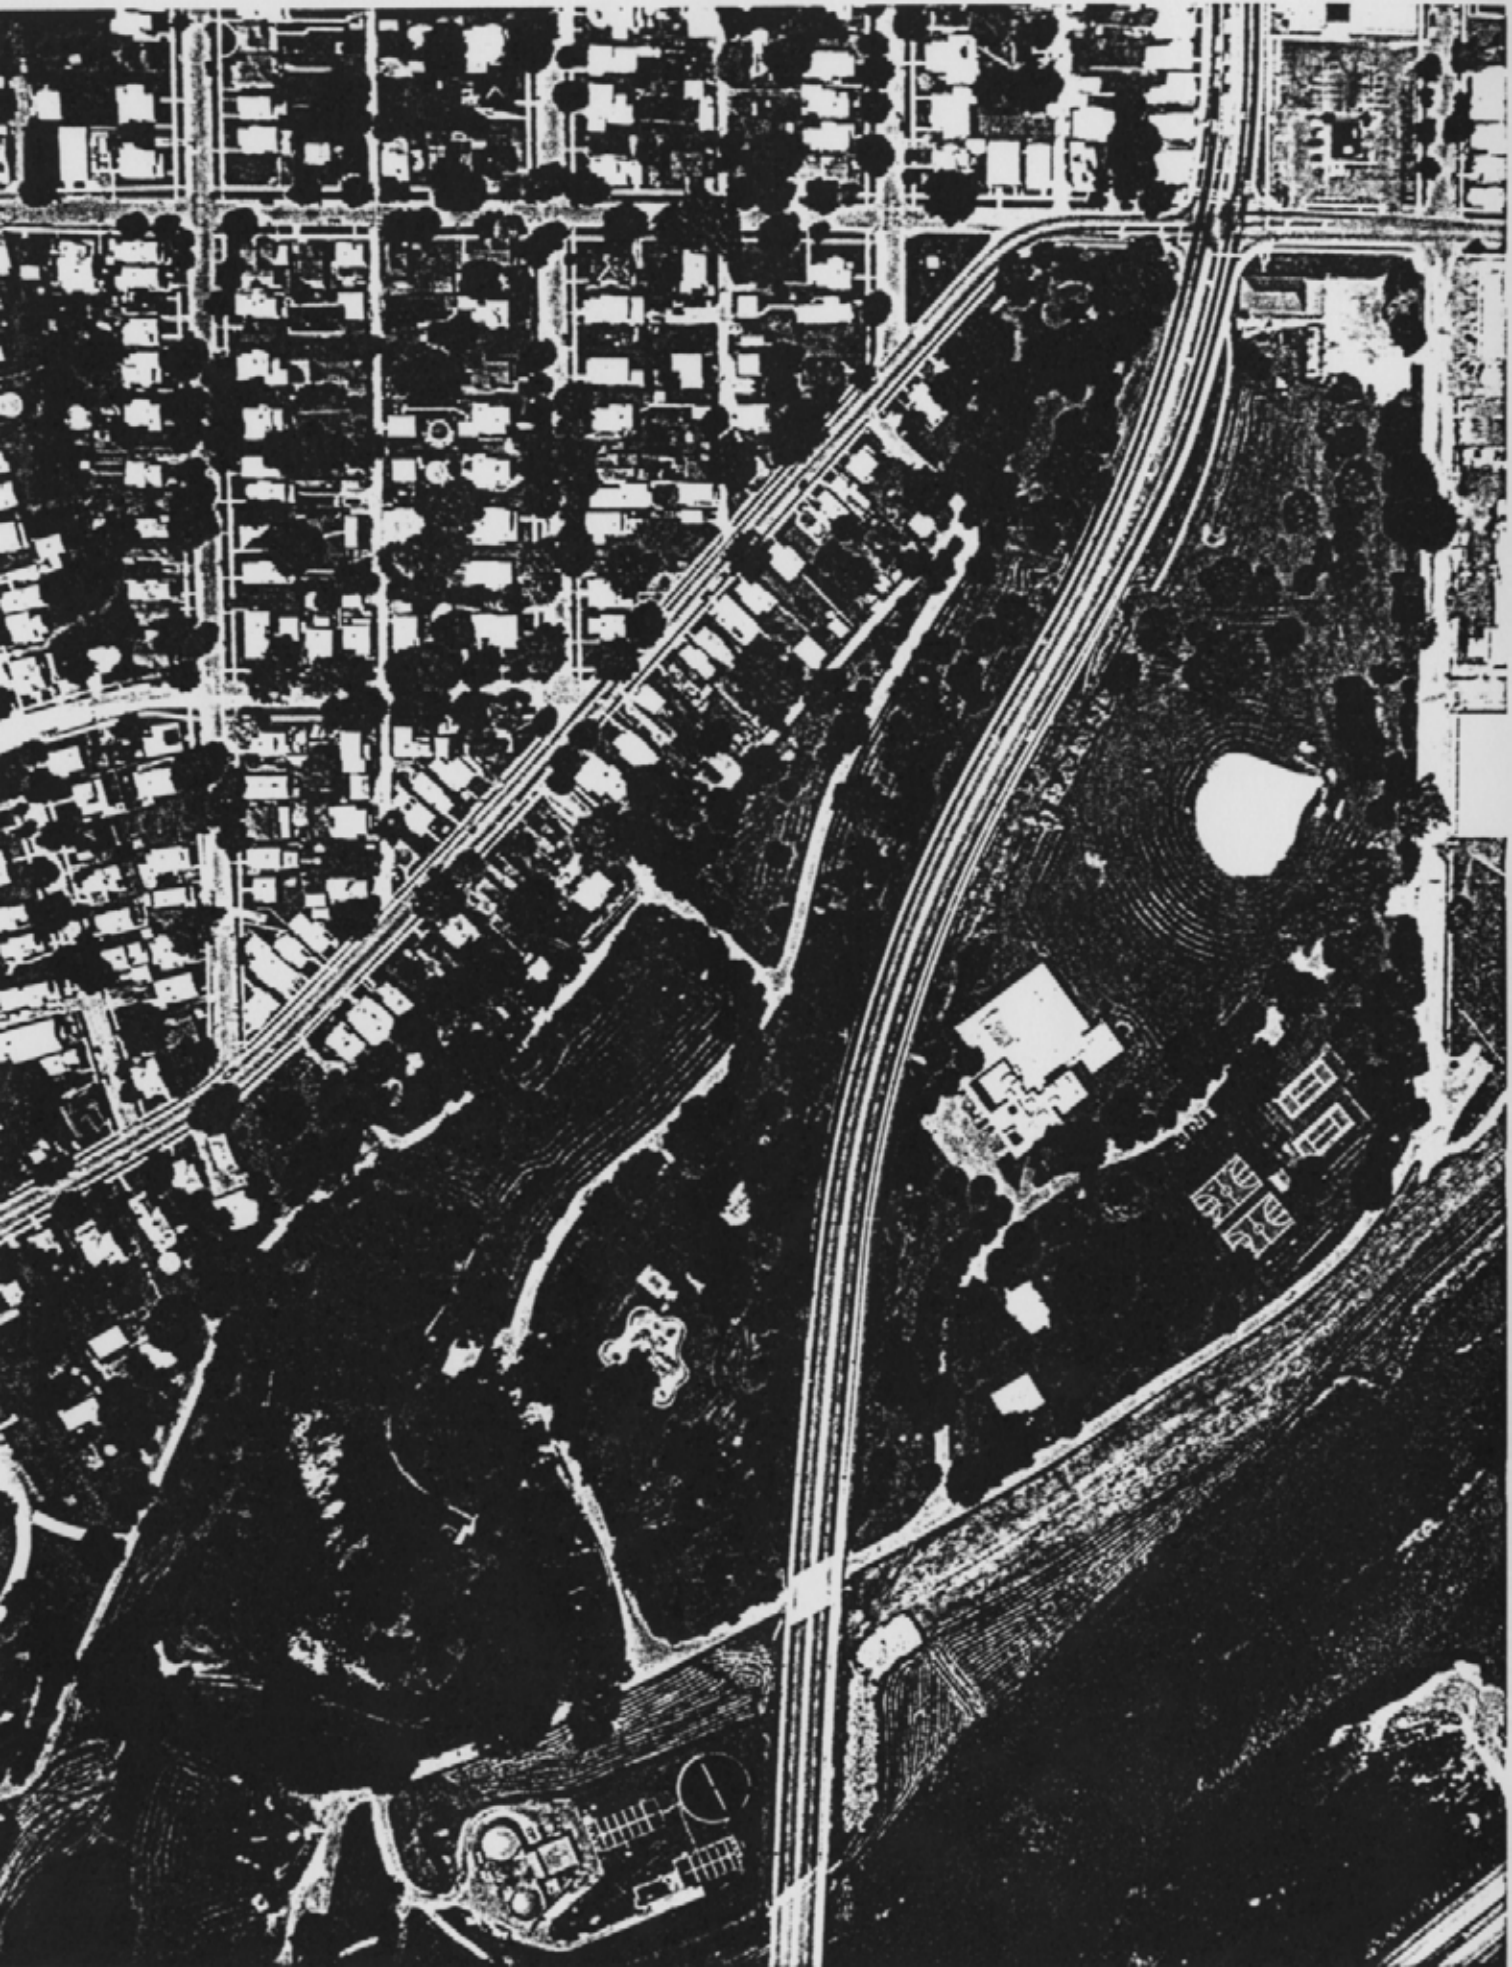
DENISON
PARK

CORNING, NEW YORK

During August of 1994 the Boundary and Topographic Survey, prepared by Ward and Moore in 1973, was updated by Hunt Engineers and Architects. The survey locates all major landscape features. However, it does not identify plant materials. The schedule of this study did not provide the time necessary to complete an evaluation of the existing conditions and an assessment of the extant character-defining features of Denison Park. However, the historic research, the Hunt Survey and a number of site visits to the park provide the basis to offer some initial comments on the significance and integrity of Denison Park.
