**CULTURAL LANDSCAPE REPORT FOR
LORENZO STATE HISTORIC SITE**

Friends of Lorenzo,
On Behalf of Lorenzo State Historic Site,
Office of Parks, Recreation and Historic Preservation, Central Region

State University of New York
College of Environmental Science and Forestry
Faculty of Landscape Architecture, Syracuse, New York
Research Assistant W. Paul Fritz, Project Director George W. Curry

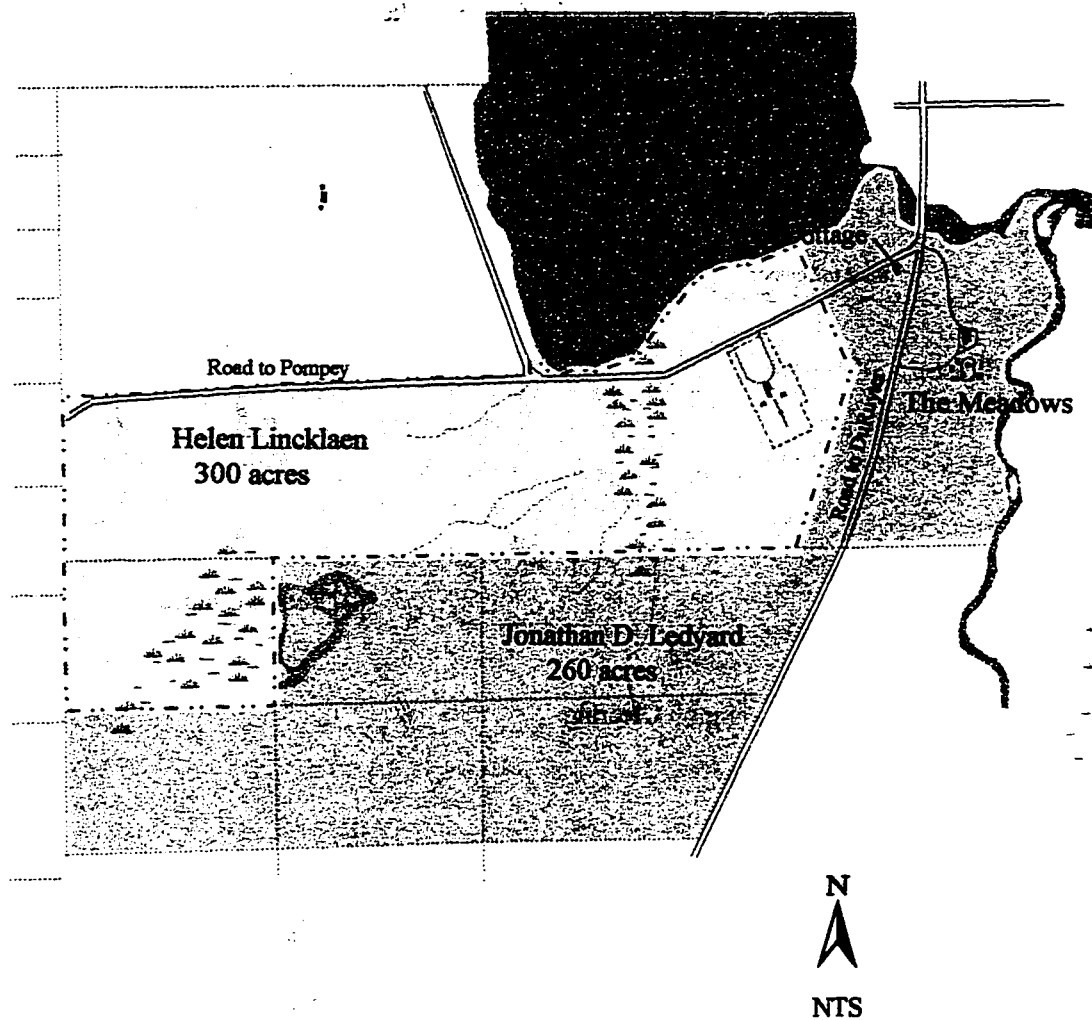
Figure 1.13: The acreage owned by Helen Lincklaen after the division of the property in 1826. (Fritz, 1996. SUNY CESF).

After Lorenzo was divided between Jonathan D. Ledyard and Helen L. Lincklaen in 1826, the property was approximately 300 acres. The property consisted of the bottom section of lot 1 and all of lot 24 (see figure 1.13). Jonathan D. Ledyard owned approximately 260 acres, which included the eastern most quarter of lot 1 bound on the east by Chittenango Creek and all of lots 25, 32, 33, 34, and 41.

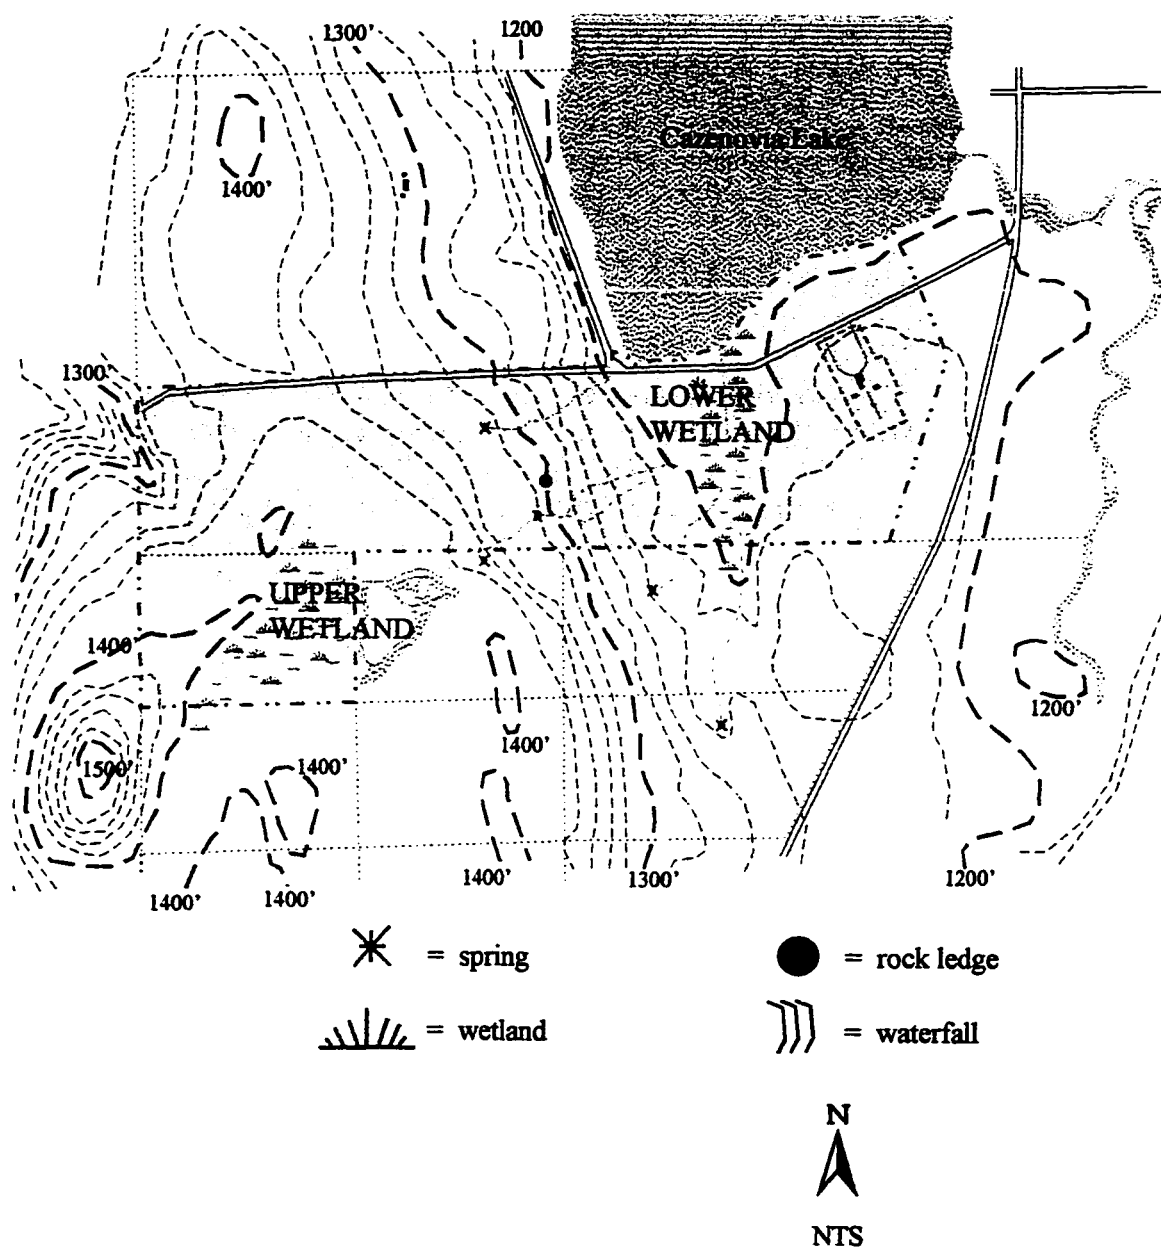
Figure 1.14: The topography and hydrology at Lorenzo during the first historic period. Redrawn from USGS, 1983. (Fritz, 1996. SUNY CESF).

of a significant body of water which flowed into the wetland located approximately 600' west of the mansion. This wetland, henceforth referred to as the lower wetland, was approximately 21 acres (see figure 1.14).

Natural springs were also located on the site. The actual number and exact locations of the springs are unknown, but four springs were identified on the western half of the property owned by John Lincklaen. Streams flowed from these springs and descended into the lower wetland (see figure 1.14).

The mansion and the two flanking barns were located on the subtle ridge that ran in northwest/southeast axis through the center of the property. The highest point on the ridge lay approximately 800' southeast of the mansion at an elevation of approximately 1238'. The topography immediately surrounding the mansion, barns, and garden was generally level, with an average elevation of approximately 1230'.

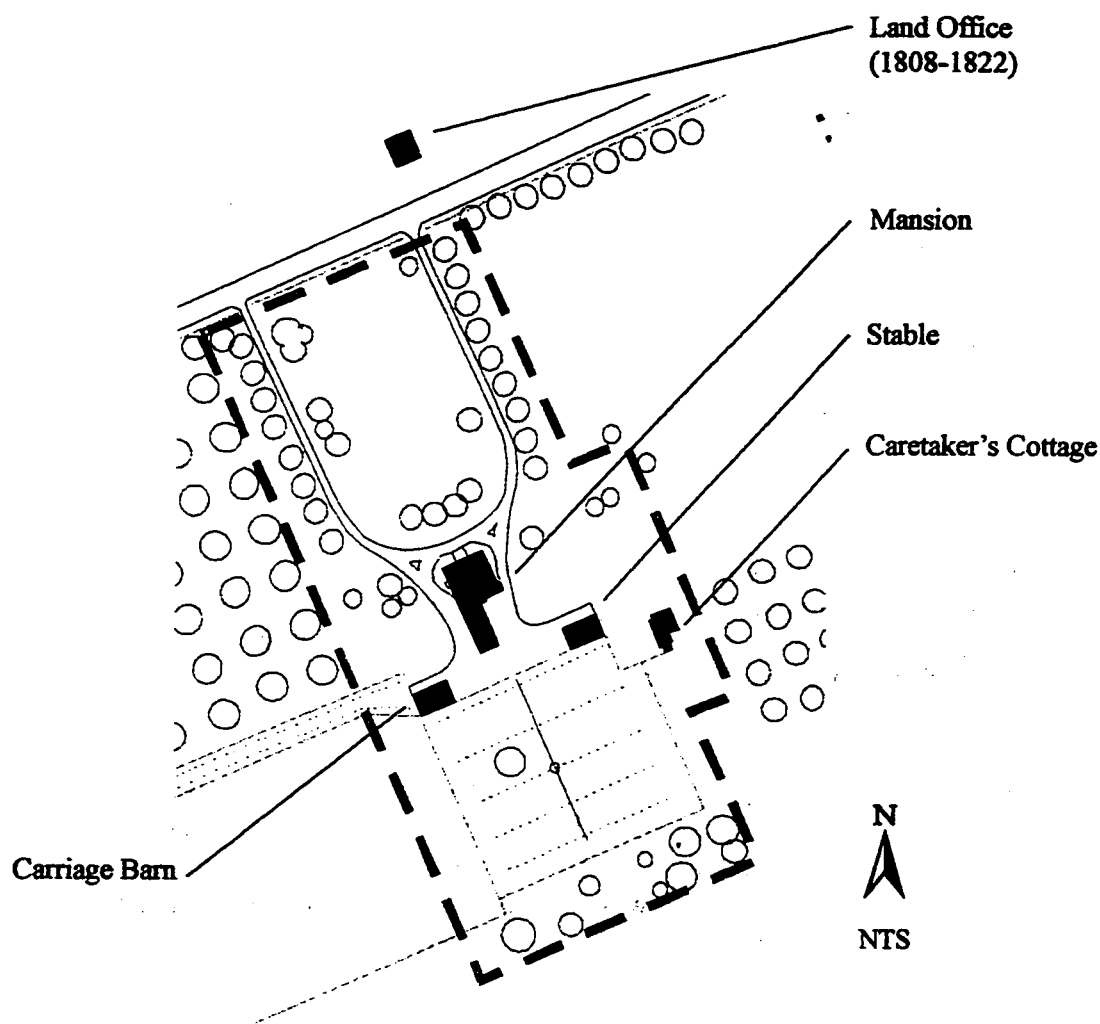
Figure 1.16: Buildings in the central core during the first historic period. (Fritz, 1996. SUNY CESF).

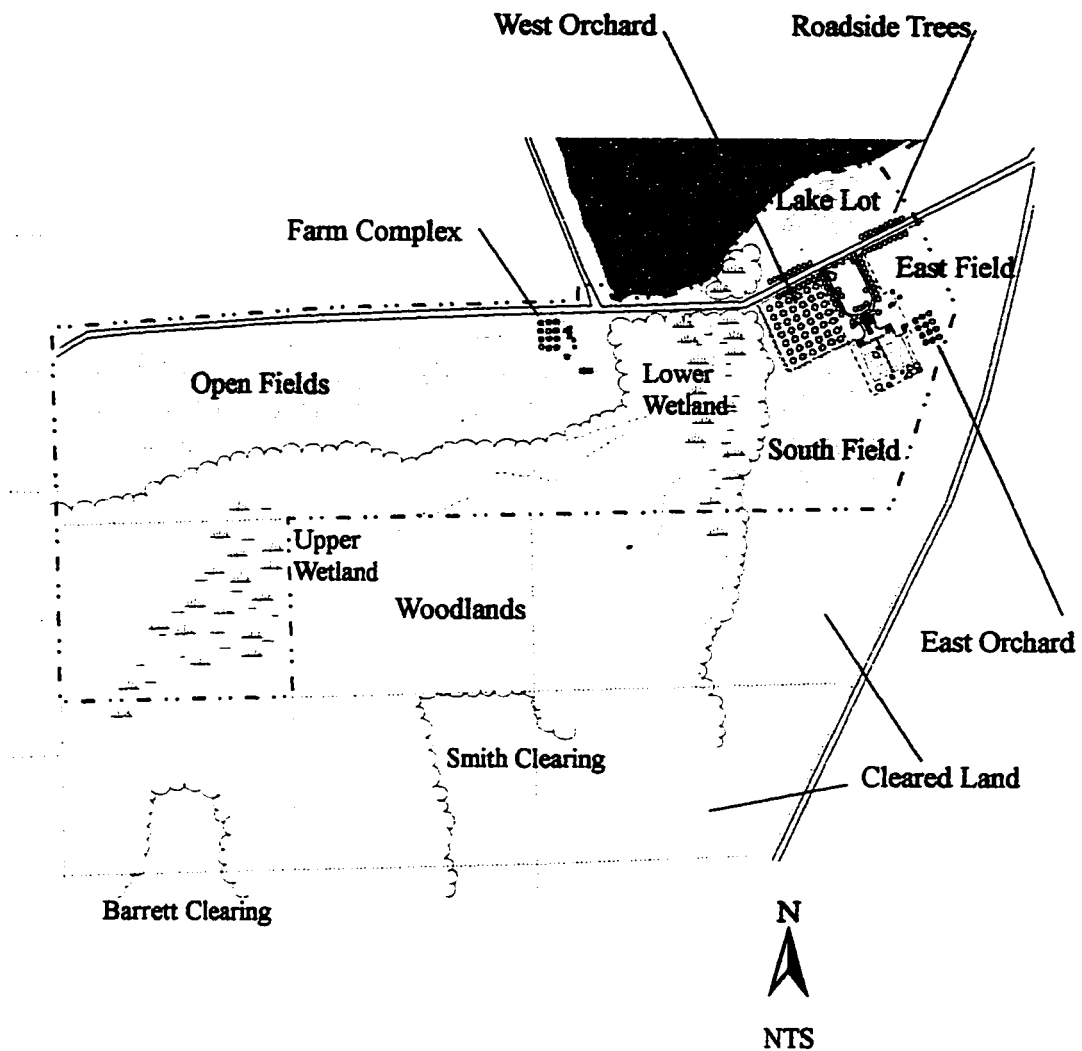
Figure 1.17: Vegetation in the outer acreage: John and Helen Lincklaen ownership period. (Fritz, 1996. SUNY CESF).

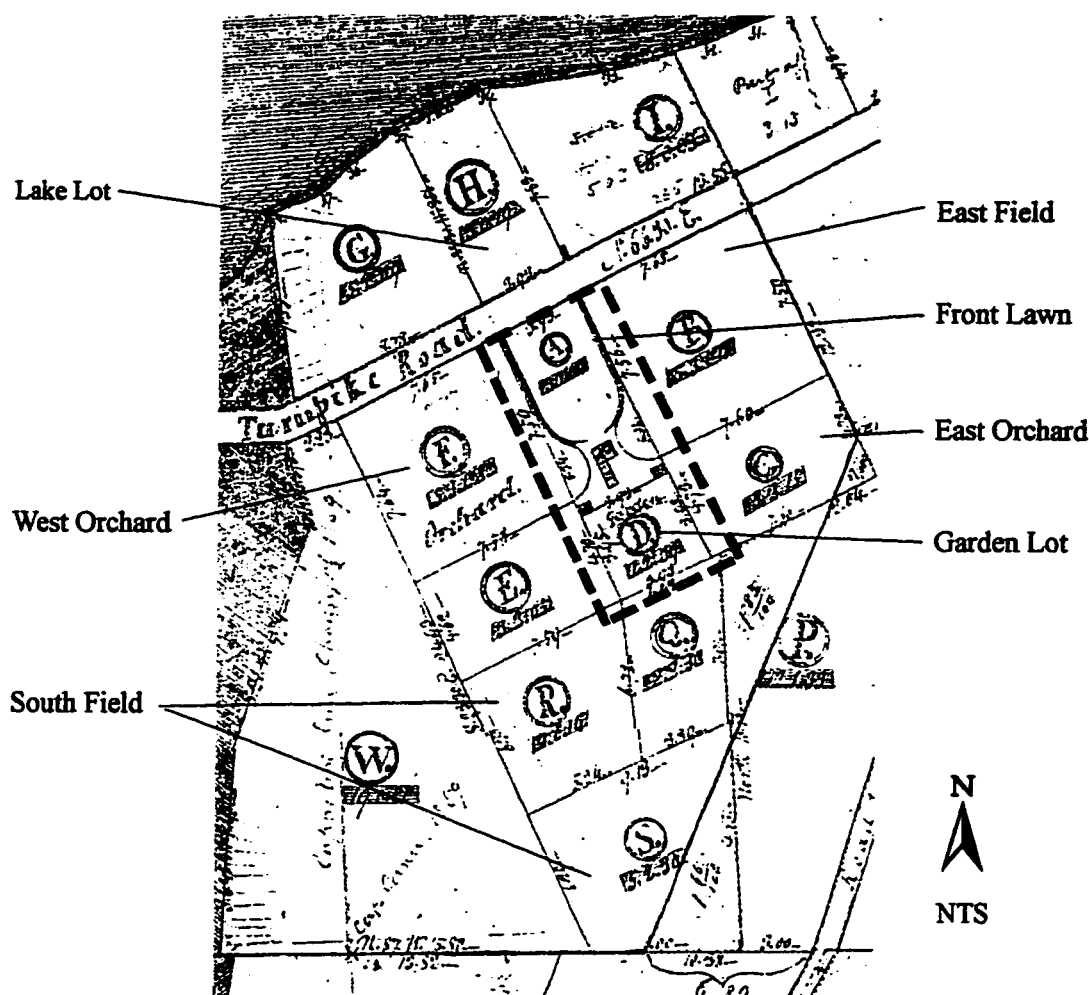
Figure 1.18: Enlargement of *A Map of Col. John Lincklaen's Farm*, drawn by surveyor Enos Cushing, 1814. This map shows the organization of vegetation within the central core and outer acreage during John Lincklaen's stewardship. (LSHS, Map Collection).

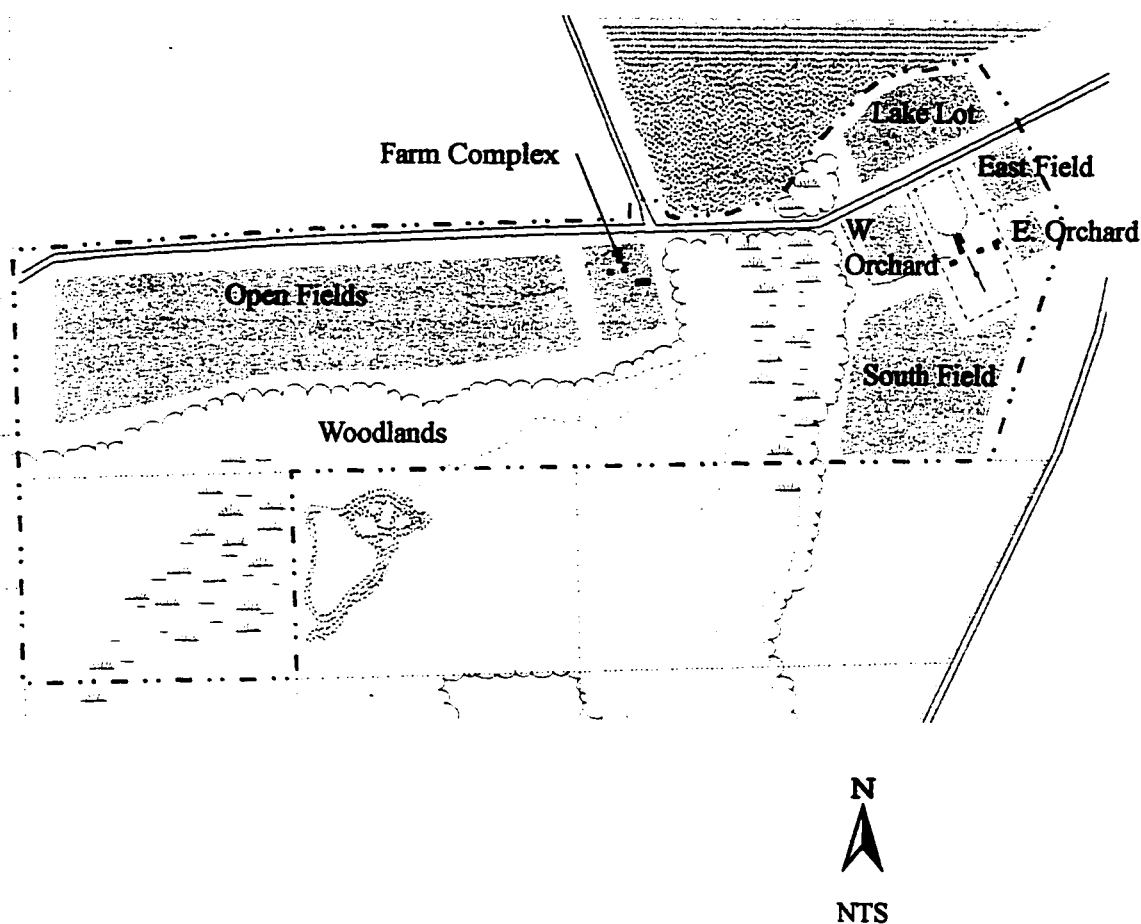
Figure 1.20: Spatial organization of the outer acreage at the end of the first historic period. (Fritz, 1996. SUNY CESF).

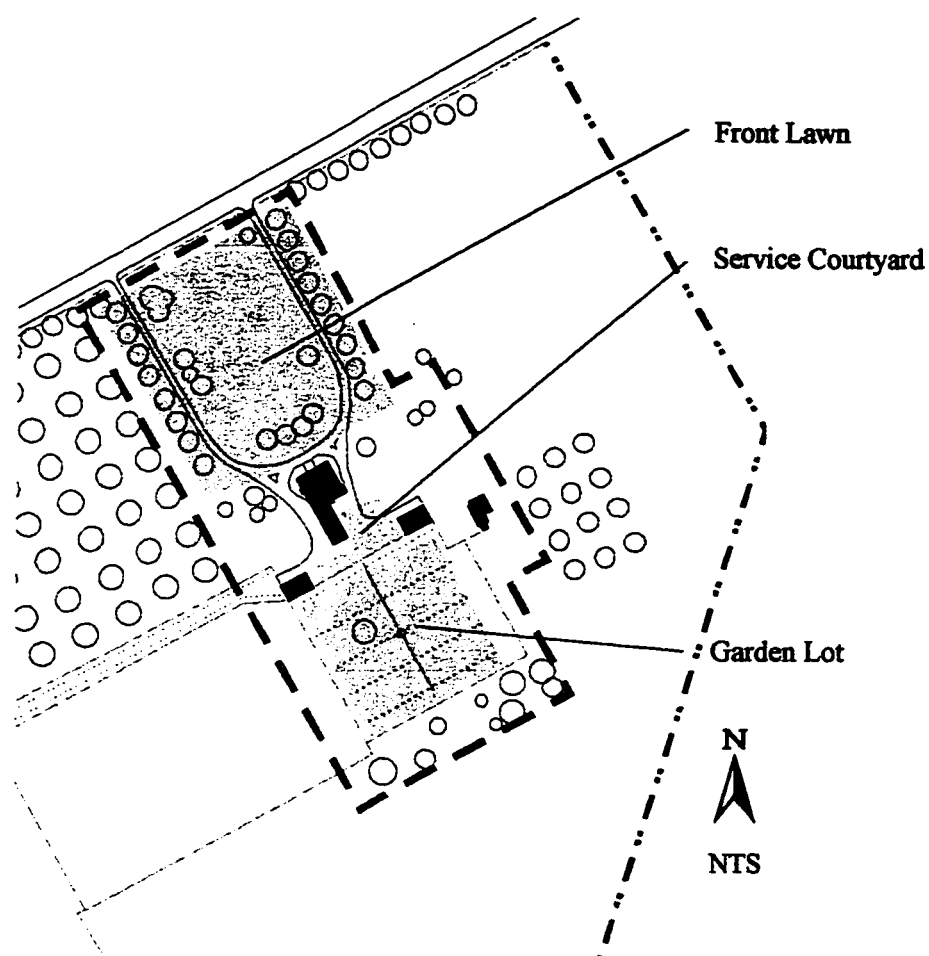
Figure 1.21: Spatial organization of the central core at the end of the first historic period. (Fritz, 1996. SUNY CESF).

The three-dimensional organization of physical and visual forms define the character of an historic landscape. The landscape elements discussed thus far make up the base plane, vertical plane and overhead plane that create spaces in the landscape. The spatial organization of the property is the relationships between these spaces. Throughout its historic development of the property, the organization of the central core was very different from the outer acreage. The spatial characteristics of the central core were highly articulated and consistent. The outer acreage, in general, was less ordered, more natural, and was comprised of the working farm. The landscape features (topography, buildings, vegetation, etc.) played different roles in creating spaces, and therefore, evoked different physical and visual associations within each of these two general areas. During the first historic period, the outer acreage consisted of eight major spaces: the open fields, woodlands, farm complex, lake lot, west orchard, south field, east orchard, and east field (see figure 1.20). The central core consisted of three major spaces: the front lawn, service courtyard, and garden lot (see figure 1.21).

Service Courtyard- The spatial configuration of the service courtyard, established c. 1808, was irregular shaped and was approximately one-half acre. It was defined on the north by the mansion; on the south by the carriage barn, stable, and garden lot; on the west and east by the surface edge of the main entry drive's extensions. The base plane of the space was flat and consisted of compacted soil and sections of turf. The space, with the exception of a few specimen trees, was generally open to the sky.

Garden Lot- The spatial configuration of the garden lot, established c. 1806, was generally rectangular shaped and was approximately 200' x 200'. It was defined on the north by the service courtyard and the stable and carriage barns; and on the south and west by the south field; and on the east by the caretaker's cottage and the east orchard. The entire garden also was apparently enclosed by a fence. The base plane of the space was flat and was planted with vegetation common to a kitchen garden and a variety of trees. The organization of the vegetation was divided into parterres which were formed off a central walk which aligned with the central north/south axis of the mansion. The space, with the exception of a few specimen and fruit trees, was generally open to the sky.

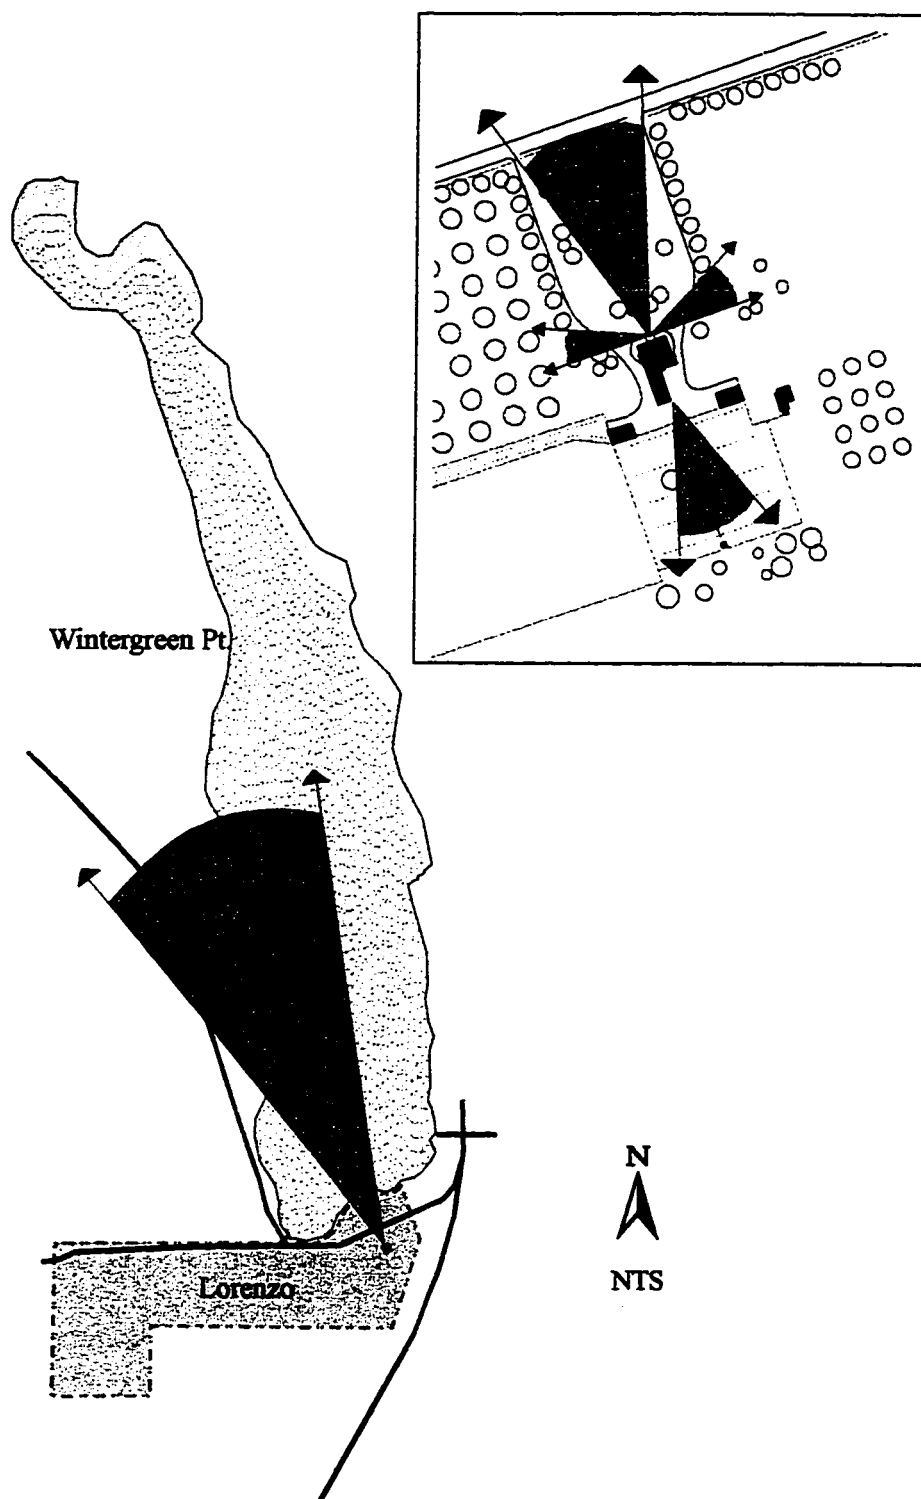
Figure 1.22: Views from the mansion during the first historic period. (Fritz, 1996. SUNY CESF).

There were also views to the east and west from the mansion's front porch. To the east, village landmarks, such as the steeple of the First Presbyterian Church and the Seminary, were visible. To the west, the west apple orchard and the west hill were the dominant features in view from the front porch.

View South from the Mansion- The central axis of the mansion also aligned with the garden in the rear of the mansion and a view was extended in this direction and beyond to the forested hills of DuRuyter. Presumably, the south field was cultivated and opened a wide, clear view to the south.

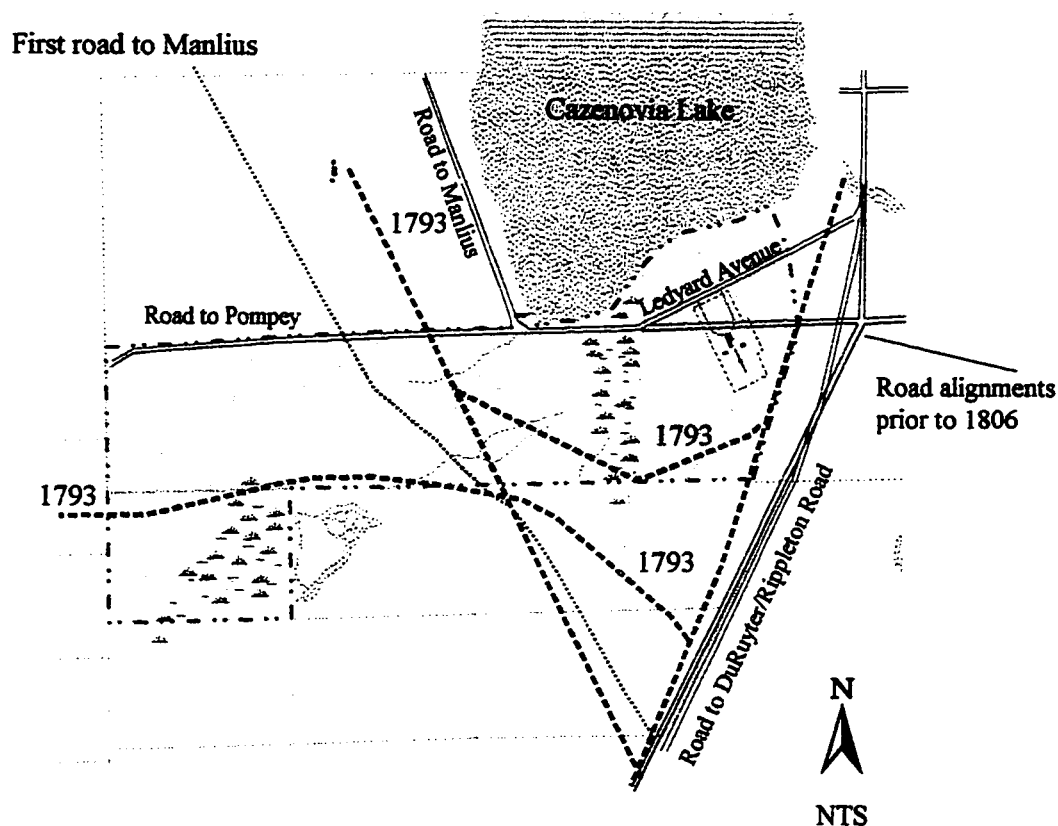
Figure 1.23: Roads through the property prior to the construction of Lorenzo. (Fritz, 1996. SUNY CESF).

For this report, general information concerning the major public roads adjacent to Lorenzo was included. The first maps of the Cazenovia area indicate two different road alignments traversed the property prior to the construction of the mansion. One map (c. 1793) indicates the first east-west road curved around the south end of the lower wetland (see figure 1.23). A later map (c. 1800) indicates the alignment of the Road to Pompey in front of the central core was straight and cut across the northern part of the lower wetland before it intersected with the Road to DeRuyter. Documentation explaining the alignment changes of these earlier roads was not found. Both roads were apparently abandoned before the mansion was constructed.

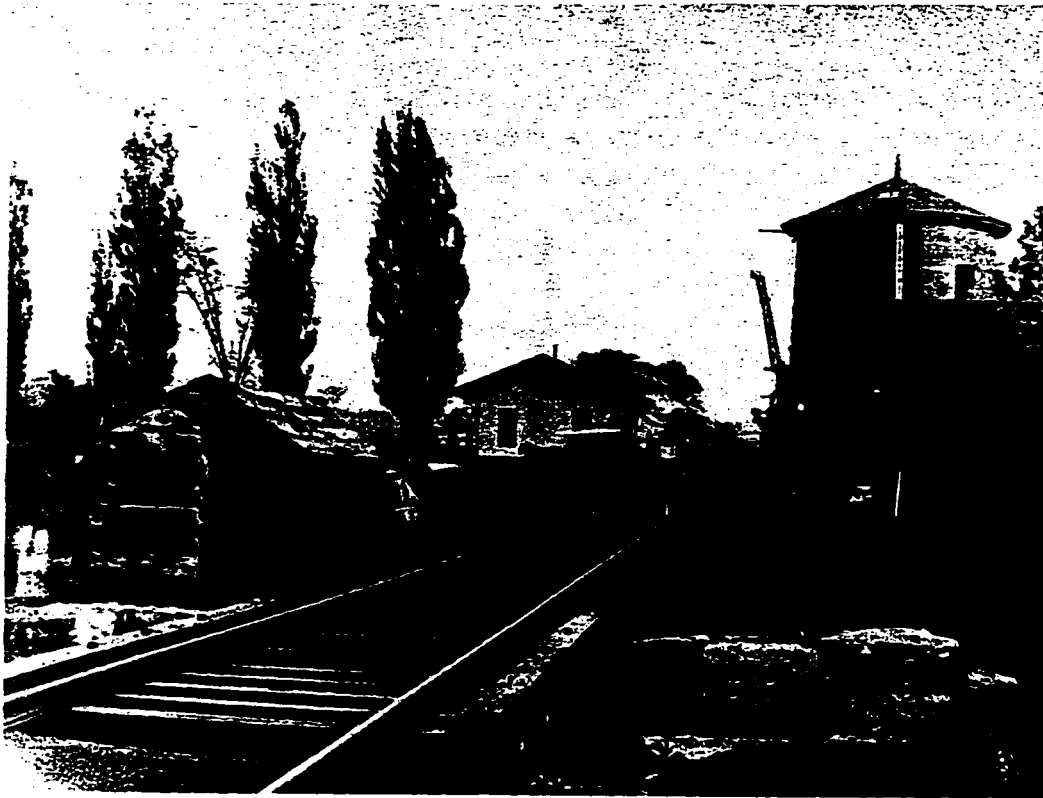
Figure 2.6: View south of the Syracuse & Chenango Valley Railroad and associated buildings, 1875. The train depot (center) was located south of the intersection between the Road to Pompey, Road to Syracuse, and Ledyard Avenue. The water tower and pump house (right) were located north of the intersection. (LSHS, Slide Collection, File C, Item 165).

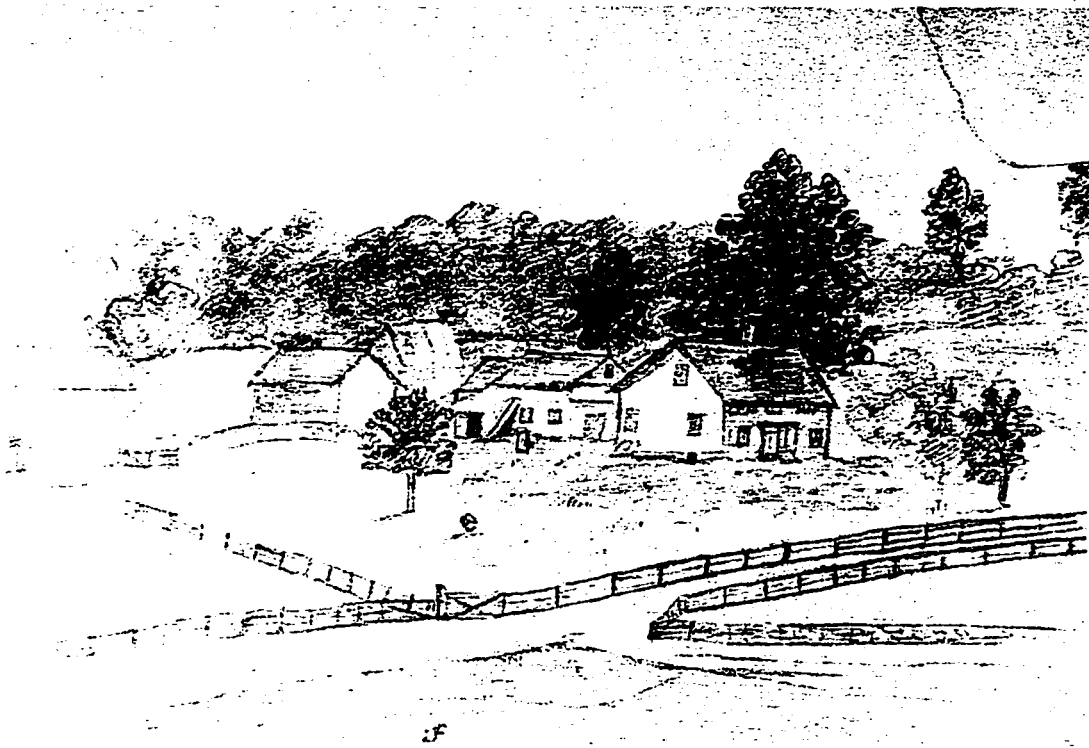
Figure 2.9: The farmhouse (center) and outbuildings within the farm complex at Lorenzo. Sketch by Ledyard Lincklaen, 23 August, 1854. (LSHS, Photographic Album of Ledyard Lincklaen).

Farmhouse- The farmhouse was documented in the farm complex for the first time in an 1854 sketch by Ledyard Lincklaen (see figure 2.9). The sketch suggests the building was rectangular shaped with a gable end roof and a wood house extension off its south side. Documentation of the building's exact location, size, materials, and color was not found during research for this report.

Barns and Outbuildings- The barns and outbuildings at the west farm were documented for the first time in an 1854 sketch by Ledyard Lincklaen (see figure 2.9). The sketch suggests three buildings were located in close proximity to the farmhouse. Documentation of the exact locations, size, shape, materials, and color of the barns and outbuildings was not found during research for this report.

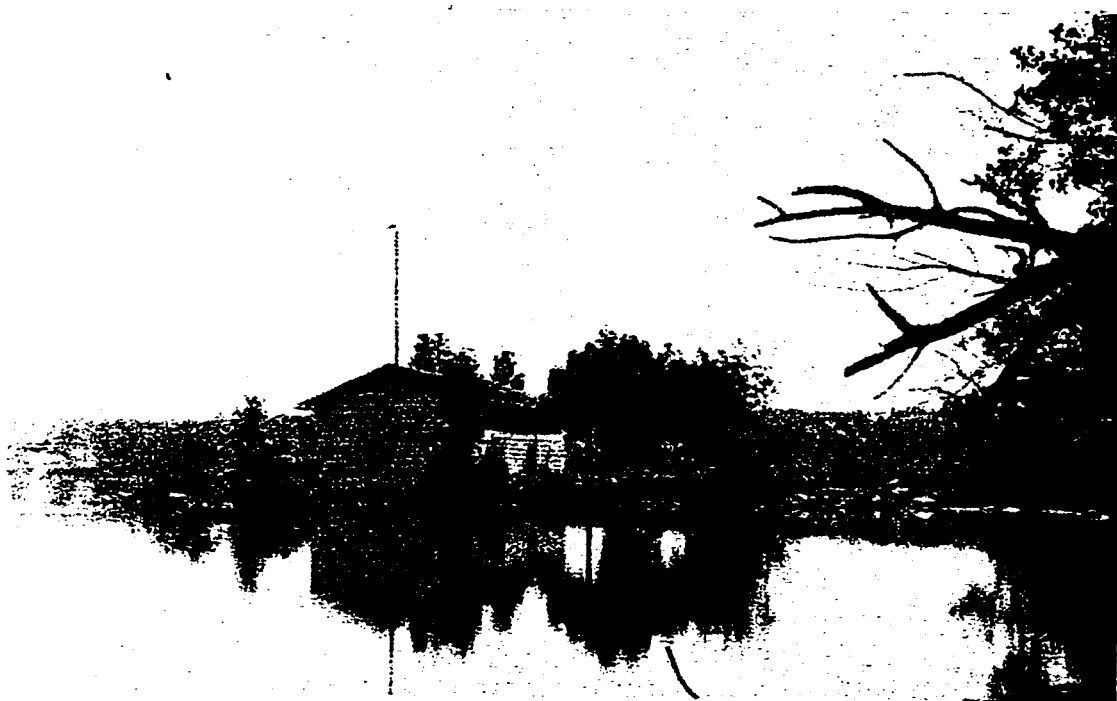
Figure 2.10: The boathouse and protective "island", 1891. From *Lake Owahgena, Southern Shore*, Lake Gems Series 3. Published by Charles P. Marshall, August 1892. (LSHS, Photograph Collection).

Boathouse- In 1851, a boathouse was constructed at the south shore of Cazenovia Lake, directly north of the main entry drive's east entrance (see figure 2.10).¹²⁶ In February 1857, shifting ice severely damaged the building.¹²⁷ In 1858, the building was rebuilt.¹²⁸ In 1873, the boathouse was "improved" by L. Wolters Ledyard.¹²⁹ The extent of the improvements is unknown.¹³⁰ Photographs from the end of the second historic period indicate the rebuilt boathouse was one-story and rectangular shaped. It was a wood construction with a pitched roof, and clapboard siding. The building appears to have been windowless, but two entrances for boat slips, dimensions unknown, were located on the east side of the building. Documentation of the building's exact dimensions and color was not found during research for this report. The building was used for the storage of the Lincklaen/Ledyard family boats.

Boathouse "Island"- Between 1859-1861, an "island" was constructed by Ledyard Lincklaen immediately north of the boathouse (see figure 2.10).¹⁵⁸ The "island" was made of various size stones. Documentation of the "island's" dimensions was not found during research for this report. The "island" was constructed to protect the boathouse from waves and shifting ice.

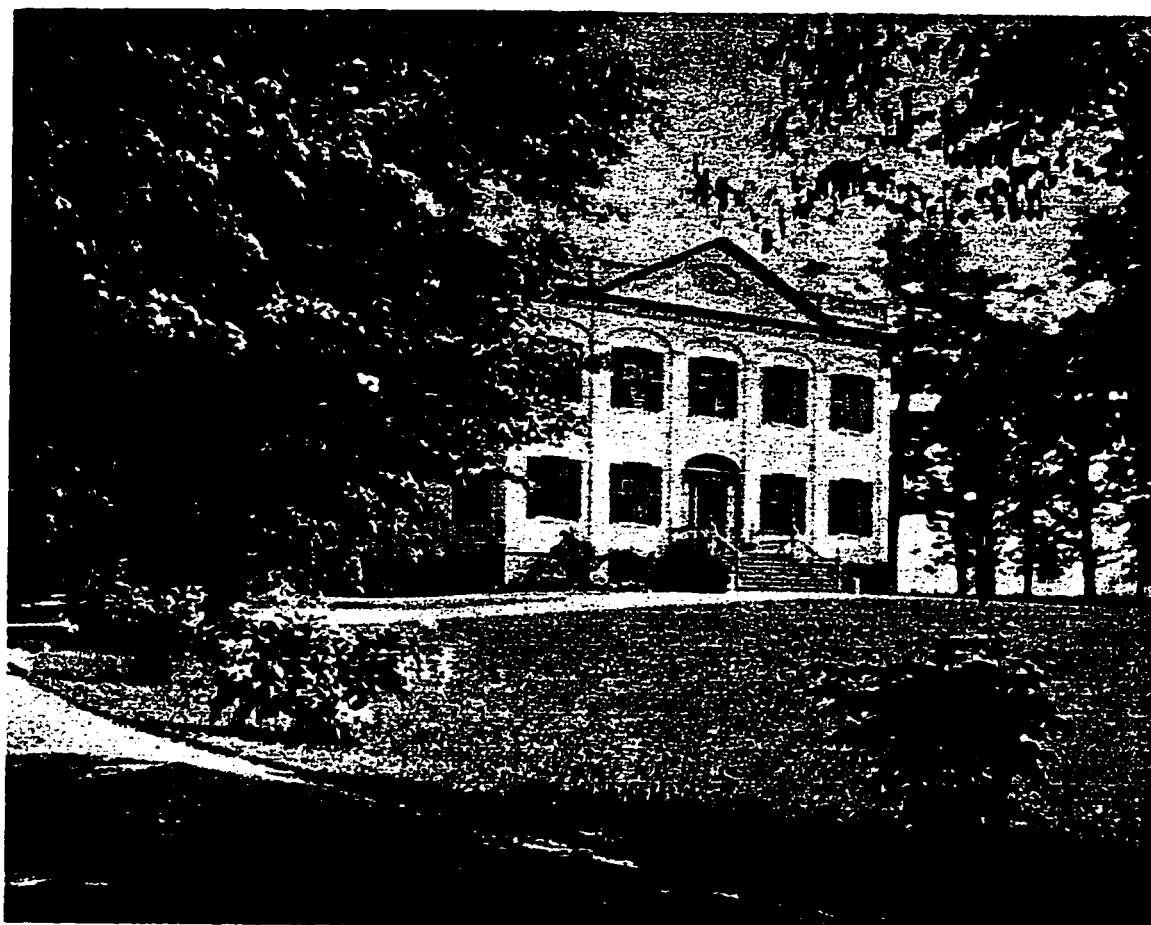
Figure 2.12: View of the front porch from the east lane of the main entry drive, 1891. Note change in design of entrance porch; shrubbery along the foundation of the mansion; and peonies (with supports) along the interior edge of the main entry drive. Photograph by Charles Marshall. (LSHS, Photograph Collection).

In 1892, the main entrance porch was replaced with a new design.¹⁴⁵ The new design consisted of a single flight of eight steps, and a landing bordered by a heavy handrail supported by light, turned balustrades. The handrail was straight at the landing, but curved downward and to the sides along the steps. Heavy newels existed at the bottom of the railing, the beginning of the landing and against the north facade of the mansion. Small oval openings existed on the east and west sides of the landing (see figure 2.12).

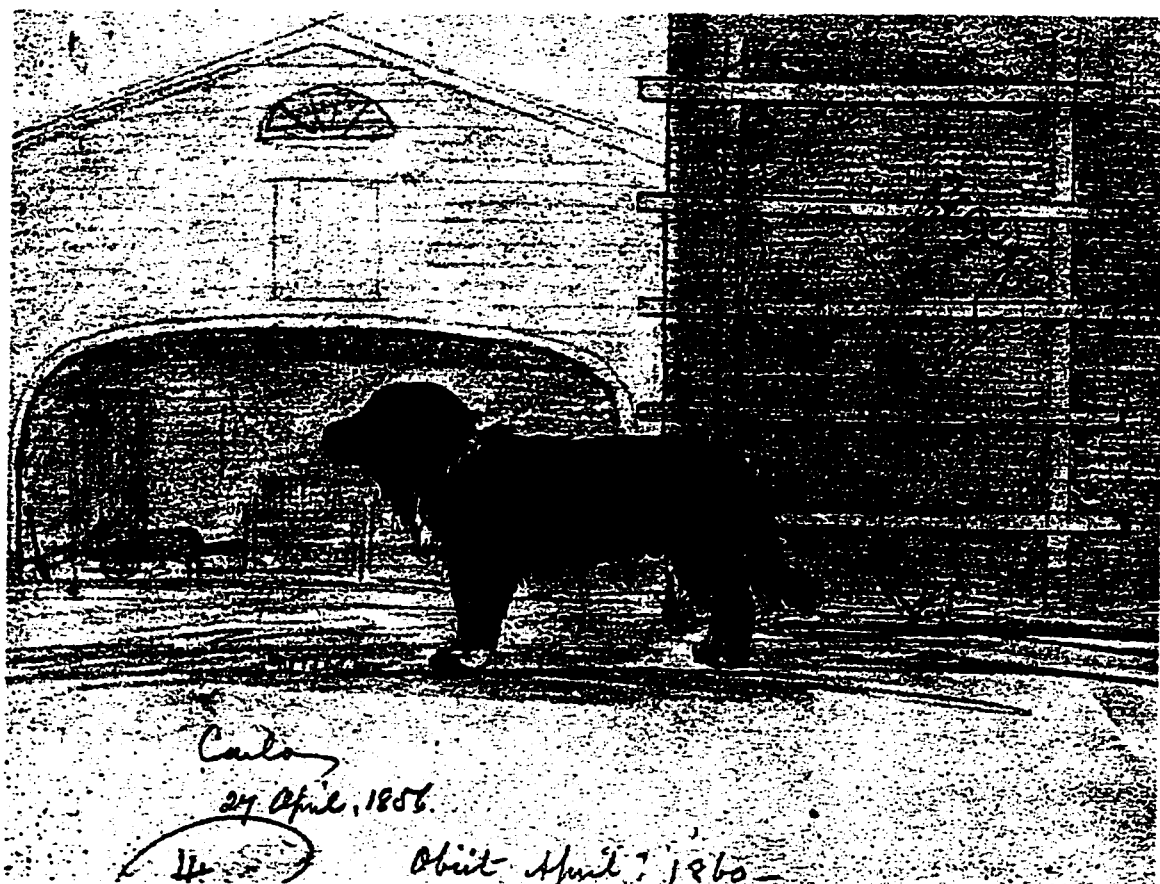
Figure 2.13: View west from the corner of the south wing of the mansion showing the carriage barn (west outbuilding) in the background. Note the trellis and climbing vine on the east side of the south wing. Sketch by Ledyard Lincklaen, "Carla 27 April, 1856." (LSHS, Photographic Album of Ledyard Lincklaen).

Carriage Barn- The carriage barn was documented for the first time in sketch drawn by Ledyard Lincklaen in 1856 (see figure 2.13). The sketch depicts the barn as a clapboard covered frame building with a large arched entrance at its east end. At the loft level of the east facade was a square door and above it a semi-circular window in the gable. The building was painted in 1864; color unknown.¹⁴⁷ The carriage barn was demolished c. 1890; it was not replaced.¹⁴⁸ Further documentation on the carriage barn was not found during research for this report.

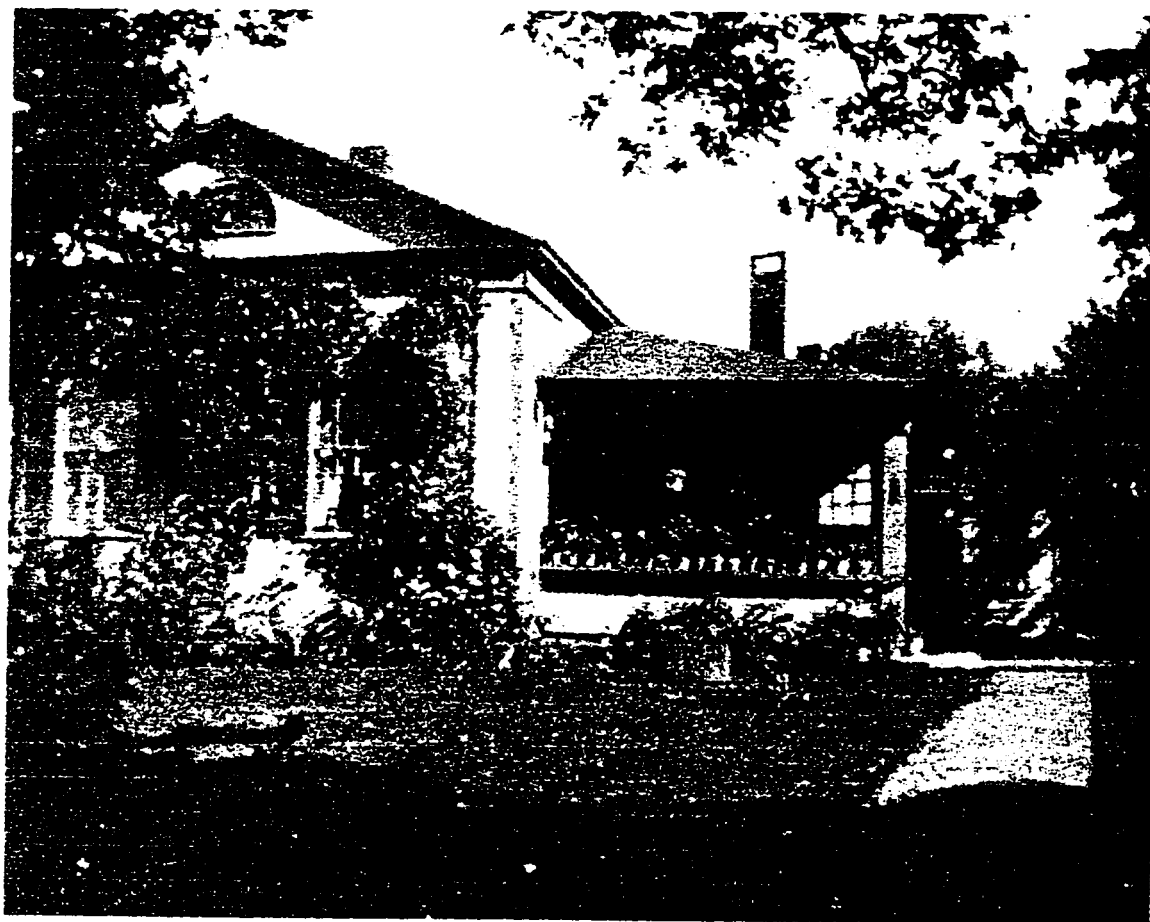
Figure 2.14: The north facade of the caretaker's cottage, c. 1870. Note path to the cottage. (LSHS, Photograph Collection, Box 1F, File 6).

Caretaker's Cottage- In 1853, the caretaker's cottage received two coats of paint and minor masonry work.¹⁴⁹ The color of the paint and the extent of the masonry work were not documented. Presumably, "Old" William Harris lived in the cottage while he was the gardener at Lorenzo from the 1830s through the 1870s (see figure 2.14).¹⁵⁰ Further documentation on the caretaker's cottage was not found during research for this report.

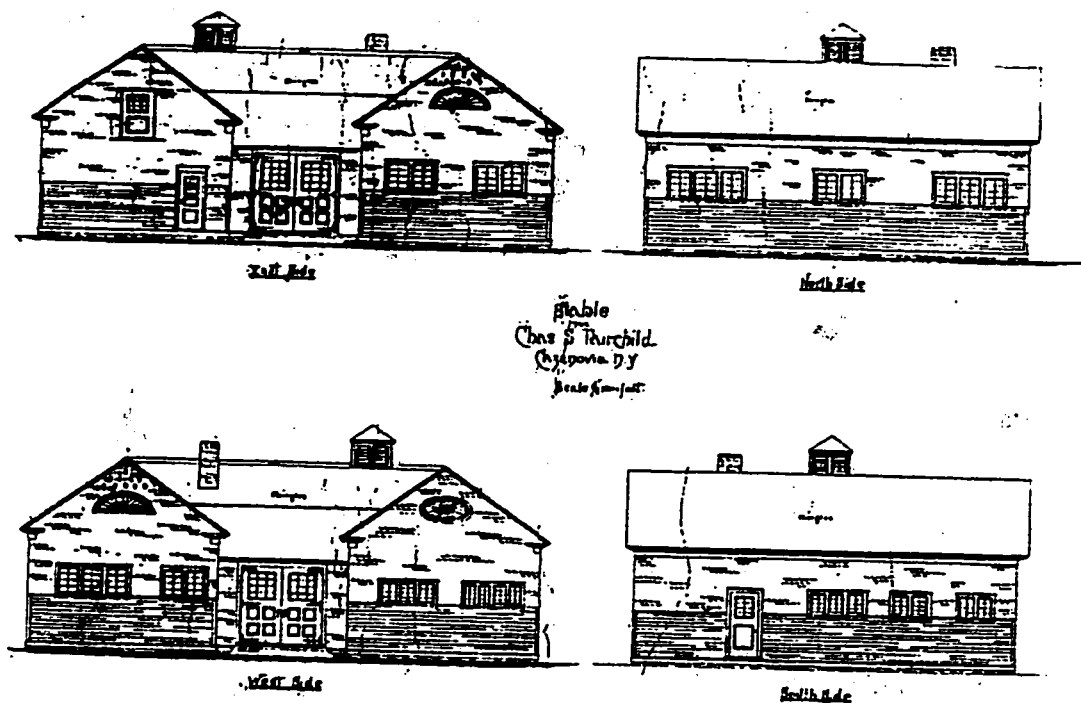
Figure 2.16: Elevations of the carriage house/stables, c. 1892. (LSHS, Blueprint Collection).

Carriage House/Stables- In 1892, the carriage house/stables was constructed on, or in close proximity to, the site of the stable (east outbuilding).¹⁵² It was designed by James Constable, an architect based in Utica, New York (see figure 2.16).¹⁵³ The two-story, "H" shaped building was built on grade with a field stone foundation. The north and south sections were 24' x 48' and the center section was 16' x 42'. The north and south sections of the building had gable roofs whose ends faced east and west; the center section had a gambrel roof with a center cupola (with a hipped roof). Two large access doors were located at the east and west ends of the building's center section. Both the roof and walls had a wood shingle exterior surface. The color of the building was not documented.

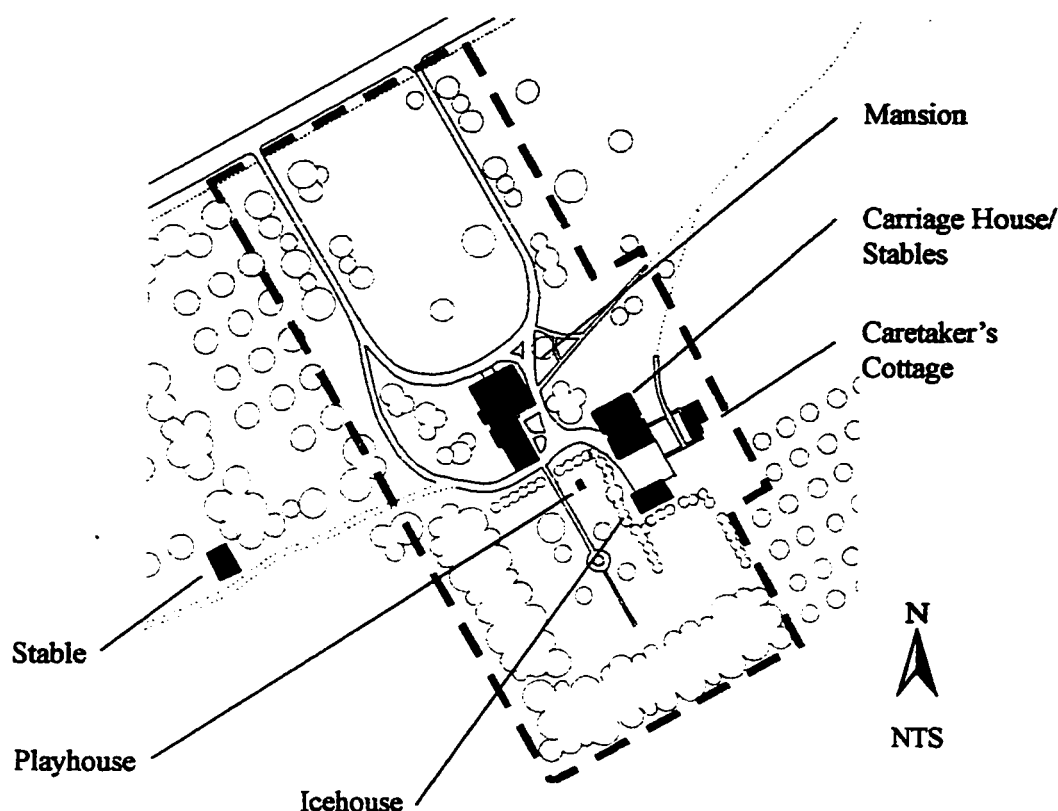
Figure 2.17: Diagram of buildings in the central core during the second historic period. (Fritz, 1996. SUNY CESF).

Garden Shed/Ice House- The garden shed/ice house was built in 1892 and was located approximately 60' southeast of the carriage house/stables (see figure 2.17).¹⁵⁴ The one-story, 18' x 40' rectangular frame building was supported on stone piers. Its gable roof and exterior walls had wood shingle surfaces. The color of the building was not documented. The east section of the building was used for the storage of garden tools and supplies. Physical evidence indicates the building's west section was built as a cart hovel and later rebuilt as an ice house.¹⁵⁵

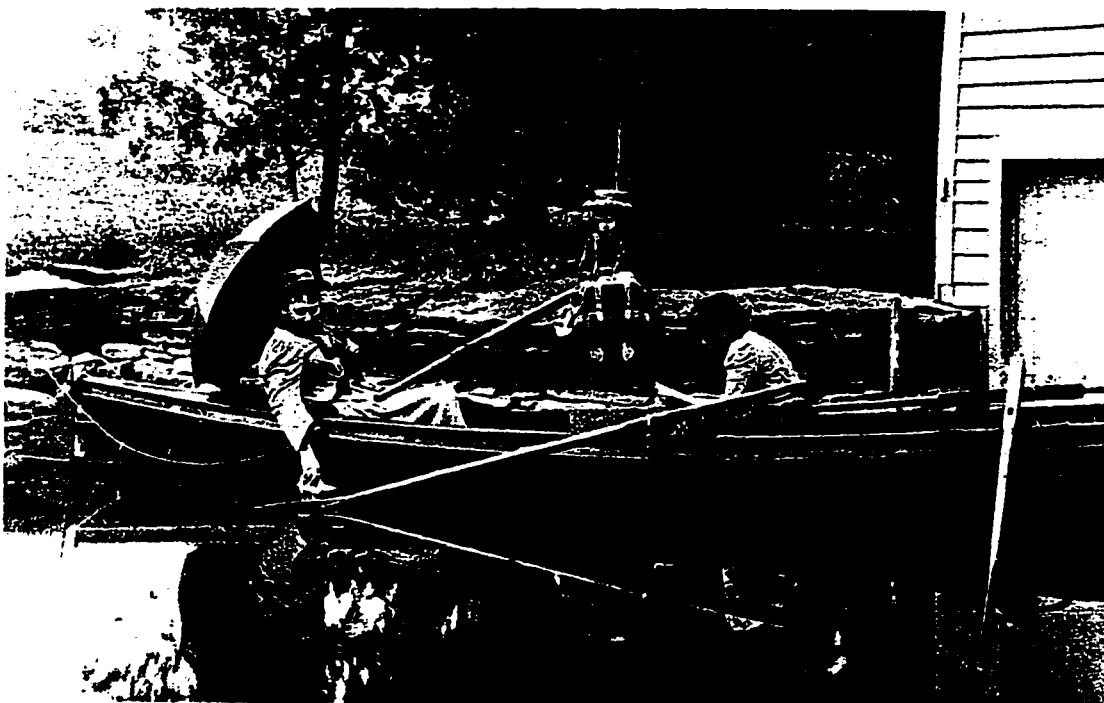
Figure 2.18: The stone retaining wall along the south shoreline adjacent to the boathouse, 1891. (LSHS, Photograph Collection).

Stone Retaining Wall- In c. 1873, a stone retaining wall was built on the south shoreline adjacent to the boathouse (see figure 2.18).¹⁵⁹ The wall consisted of dry-laid field stone. Documentation of wall's dimensions was not found during research for this report. The wall was built to retain the shoreline near the boathouse entry.

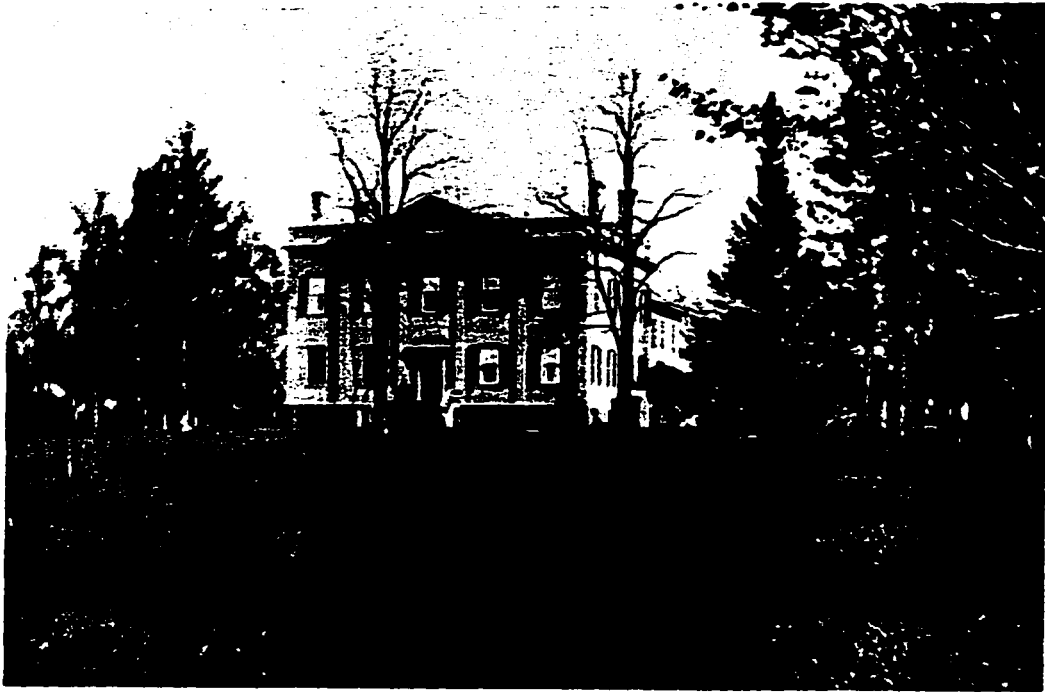
Figure 2.25: One of the earliest photographs of the mansion and front lawn. Note the locusts in front of the mansion and Norway spruce in the west lawn. Photograph labeled: "Residence of Ledyard Lincklaen taken 14 May, 1860 by Albert P. Weld." (LSHS, Photographic Album of Ledyard Lincklaen).
