**CULTURAL LANDSCAPE REPORT FOR
LORENZO STATE HISTORIC SITE**

Friends of Lorenzo,
On Behalf of Lorenzo State Historic Site,
Office of Parks, Recreation and Historic Preservation, Central Region

State University of New York
College of Environmental Science and Forestry
Faculty of Landscape Architecture, Syracuse, New York
Research Assistant W. Paul Fritz, Project Director George W. Curry

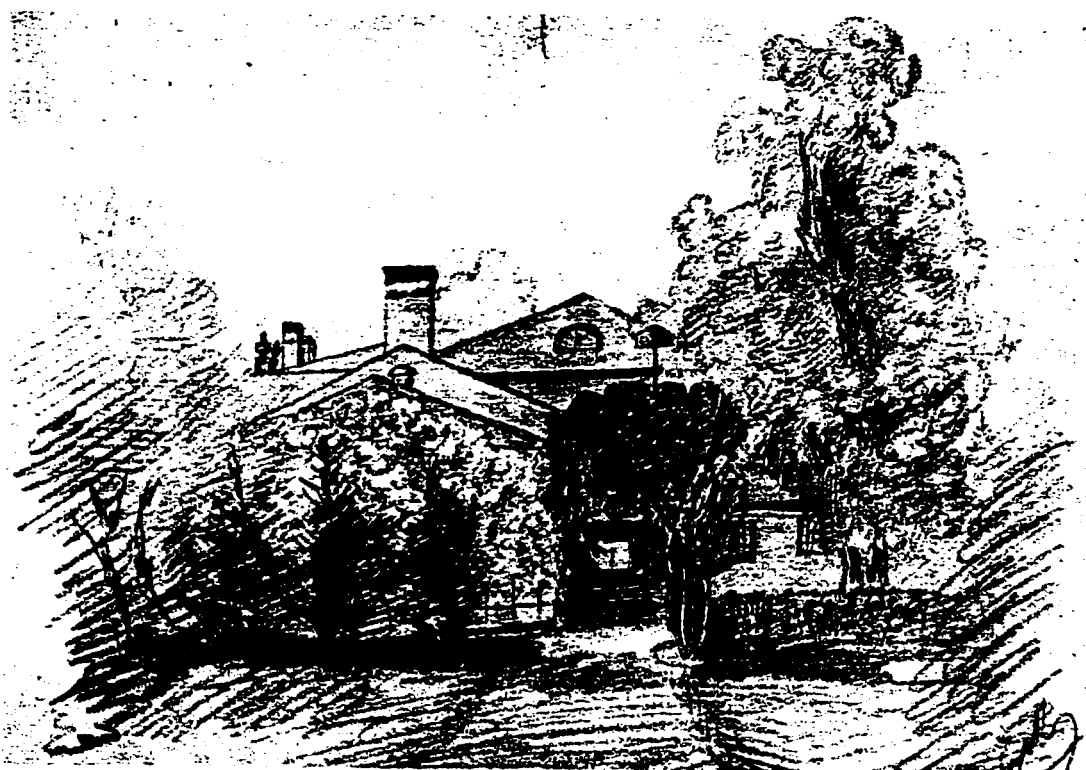
Figure 2.27: View north from the formal garden's central walk. Note hemlocks on the west side of the central walk entrance, climbing vines on the end of the mansion's south wing, and the birdhouse. Sketch inscribed "September 27th, 1865;" probably drawn by George S. Ledyard, Sr. (LSHS, Photographic Album of Ledyard Lincklaen).

Service Courtyard- The service courtyard consisted of a variety of plant material. In c. 1850, a row of Canadian hemlocks (*Tsuga canadensis*) was planted at the southwest edge of the courtyard, across from the end of the mansion's brick woodhouse (see figure 2.27). The number of trees planted is unknown. In April 1858, the first vines documented at Lorenzo were planted by Ledyard Lincklaen at the south end of the brick woodhouse. The vines included a Delaware grape vine (*Vitis labruca* 'Delaware')¹⁸¹ at west side of the woodhouse; a Rebecca rim (species unidentified) at the south end; and a Diana (species unidentified) at the west side.¹⁸² Apparently, The vines were grown on a some sort of trellis or support. In 1855, Concord grapes were planted at the south end of the wood house on its east side (see figure 2.13).¹⁸³

Birdhouse- A martinhouse, constructed c. 1850, was documented for the first time in the service courtyard, immediately east of the formal garden's north entrance (see figure 2.27). The martinhouse sat atop a wood post approximately 20' high.

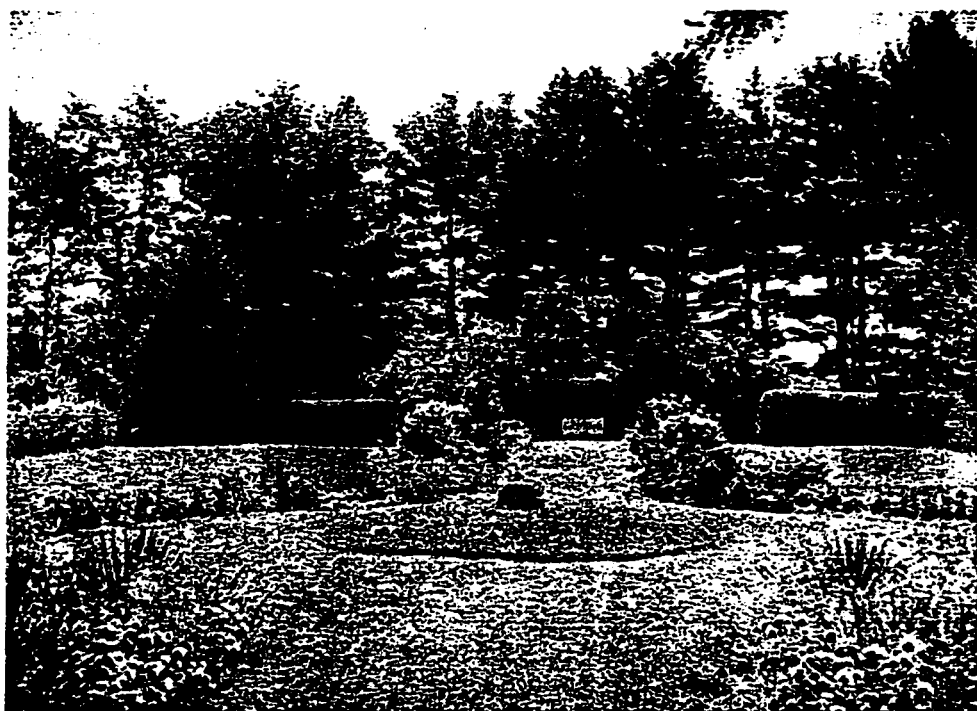
Figure 2.33: View south of the formal garden's central walk, c. 1890. Note hedge in background. Photograph by Augustus Pruyn. (LSHS, Photograph Collection, Box 1E, Folder 8).

Shrubs/Flowers- The central walk was flanked with flower beds, approximately 4' wide, in which both annuals and perennials were planted. Period photographs suggest peonies, iris, and day-lilies were located in the beds flanking the central walk (see figures 2.30 through 2.34). Further documentation of the shrubs/flowers located in the formal garden was not found during research for this report.

Garden Benches- Garden Benches- Several wood garden benches appeared in the formal garden. One wood bench, construction date unknown, was located at the south terminus of the formal garden's central walk (see figures 2.33 and 2.34). Other wood benches, number unknown, often paralleled the north end of the central walk and the north cross-walk (see figures 2.28 and 2.31). Documentation of the dimensions, materials, and color of these second type of benches was not found during research for this report. Apparently they varied in length from 4 ½' to 5' long with a 14" high seat. Unique to these benches was a folding backrest and side handles.

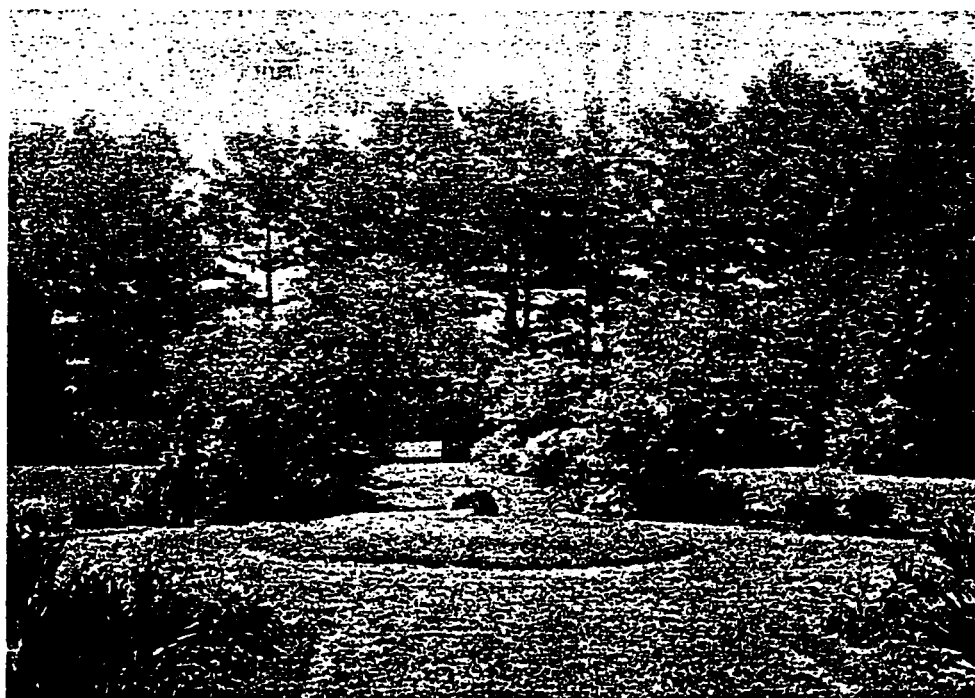
Figure 2.34: View south of the formal garden's central walk, 1895. Helen L. Fairchild wrote on the mat framing the photograph: "Garden in 1895, before Mrs. Shipman improved it." Photograph by Charles P. Marshall. (LSHS, Photograph Collection, Box 2C).

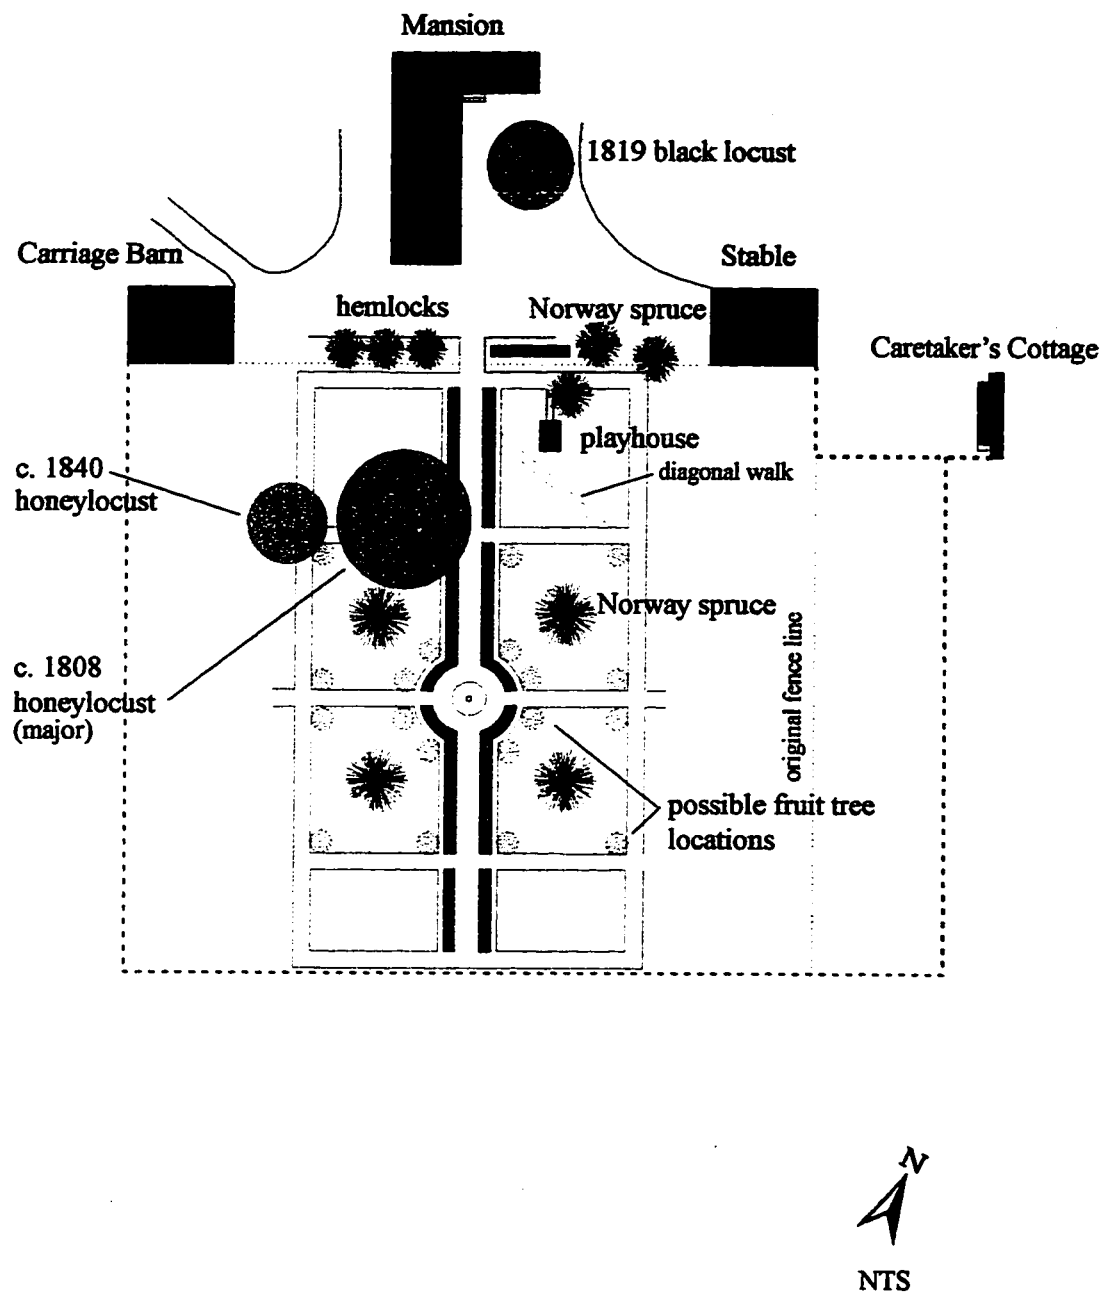
Figure 2.35: Diagram of the formal garden, c. 1858. (Fritz, 1996. SUNY CESF).

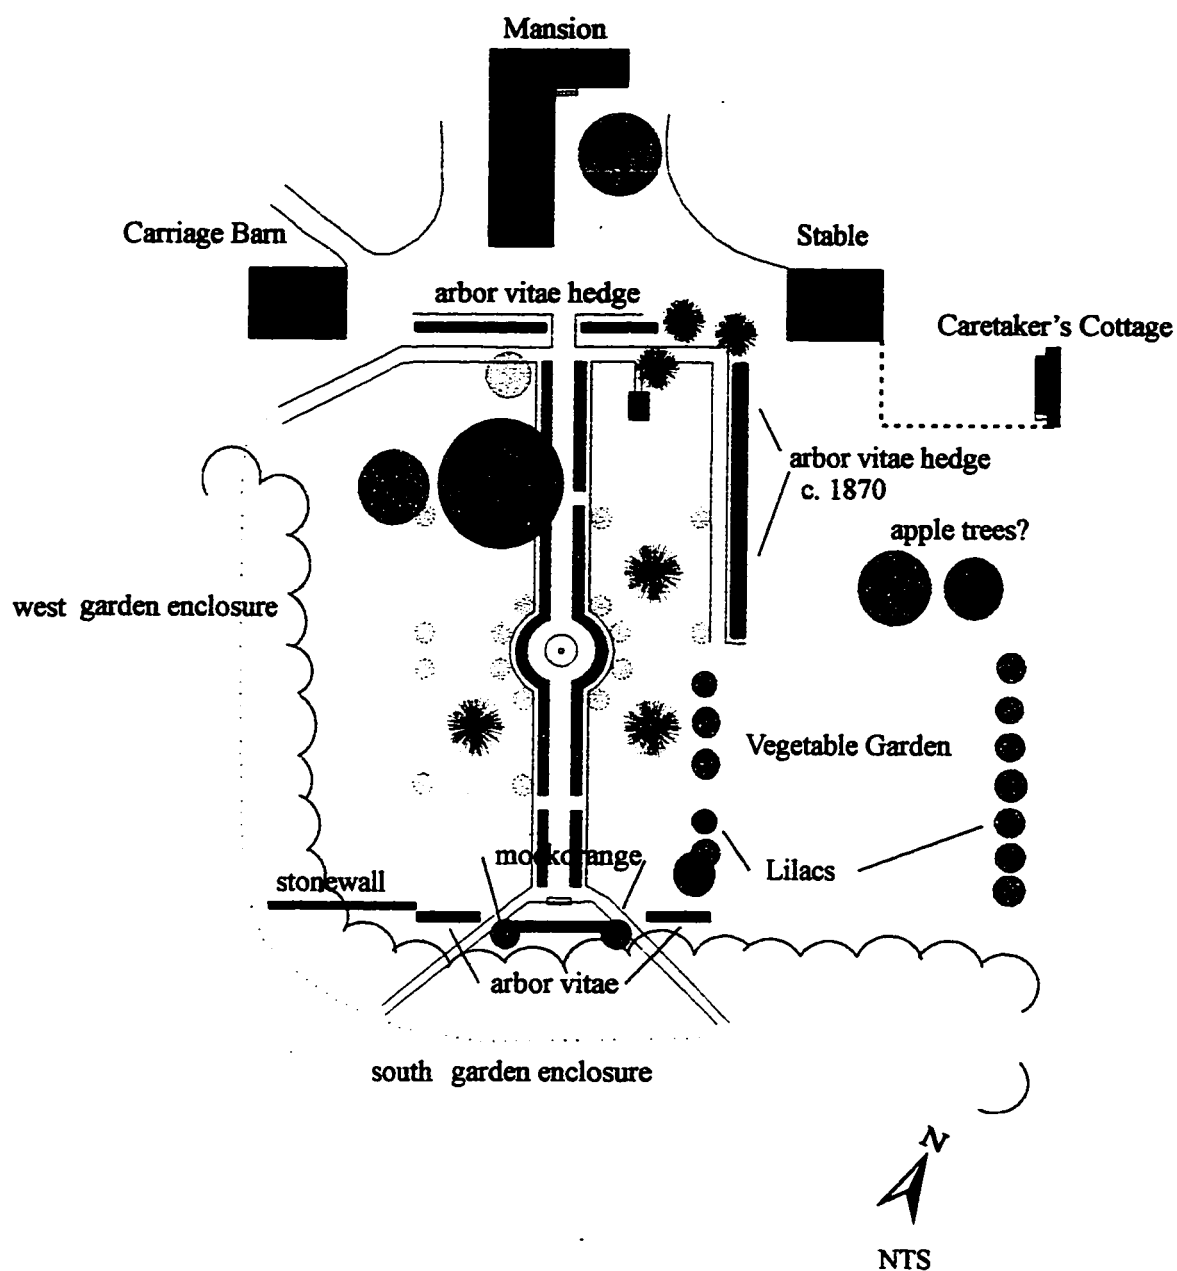
Figure 2.36: Diagram of the formal garden and vegetable garden, c. 1890. (Fritz, 1996. SUNY CESF).

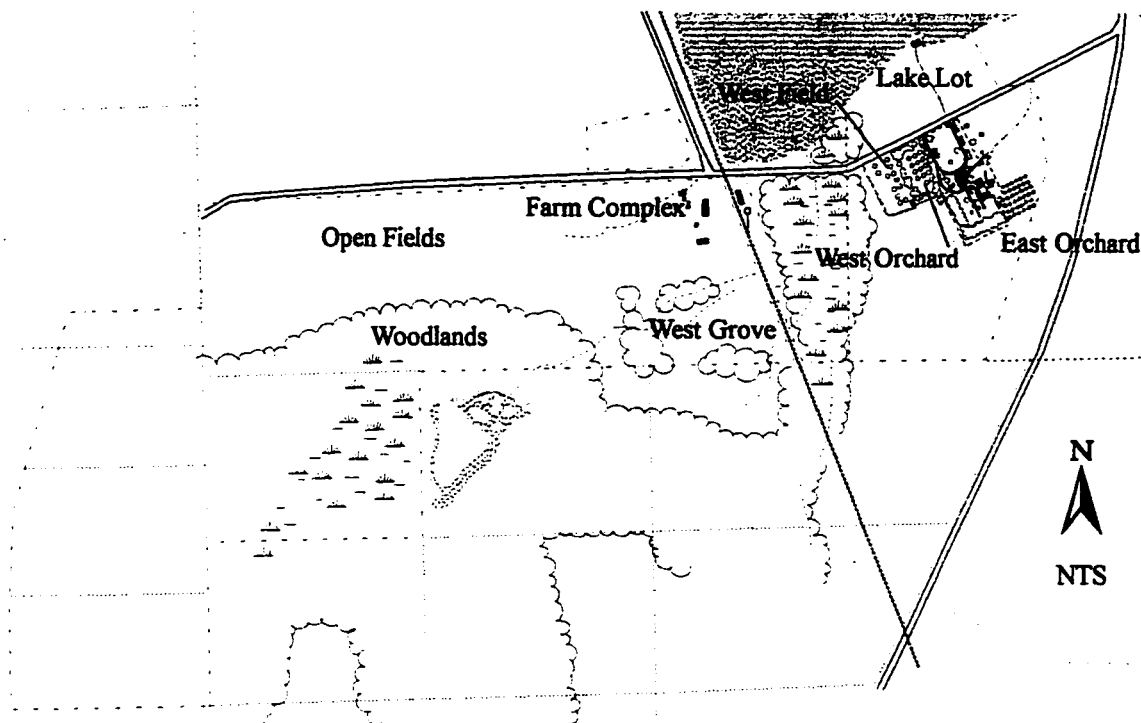
Figure 2.37: Spatial organization of the outer acreage during the second historic period. (Fritz, 1996. SUNY CESF).

West Wood Lot- The west wood lot, established c. 1865, was located on the east half of the previous west orchard. The rectangular shaped space was approximately 240' x 480'. It was defined on the north by a fence (iron) and later by an extension of the ha-ha wall; on the south by the orchard road and south field; on the west by the west field; and on the east by hardwoods planted along the exterior edge of the main entry drive's west lane. The base plane of the space consisted of the flat half of the west orchard. The space remained planted with a few apple trees, but the introduction of a large number of evergreen seedlings generally characterized the space as a wood lot. In general, the vegetation in the west wood lot space created a dense but discontinuous overhead canopy.

East Field- The spatial configuration of the east field remained unchanged in terms of its base plane, materials, and overhead plane. However, the shape, size, and a defining edge of the space changed. The change to the space was created by the acquisition of additional land adjacent to the east side of the space. This adjustment to the boundary of the property increased the size of the space and made it trapezoidal in form. The east edge of the space was defined by a fence and a private road.

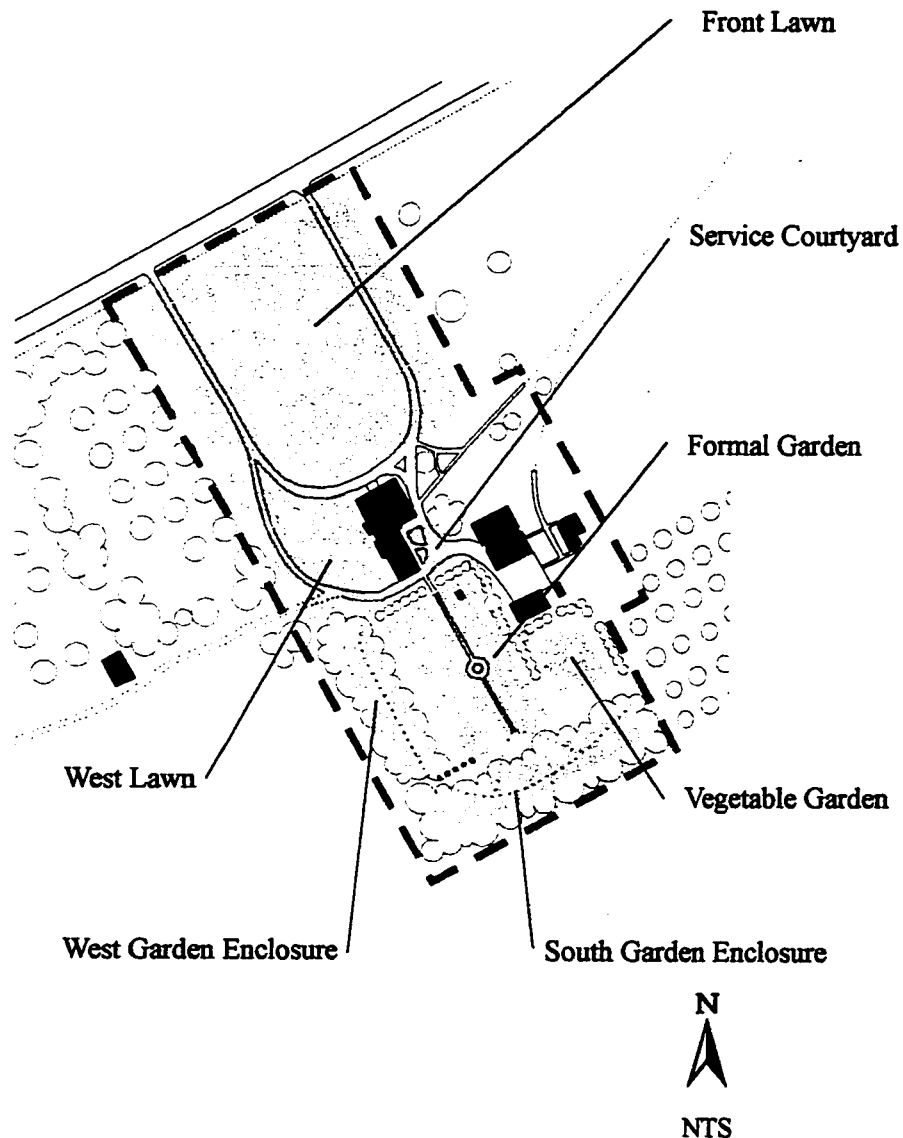
Figure 2.38: Spatial organization of the central core during the second historic period. (Fritz, 1996. SUNY CESF).

Vegetable Garden- The spatial configuration of the vegetable garden, established c. 1850, was located on the east half of the garden lot. The rectangular shaped space was approximately 100' x 140'. It was defined on the north by a hedge; on the south by a fence enclosure and a mass of evergreen and deciduous trees randomly planted; on the west by shrubbery; and on the east by shrubbery and the east apple orchard. Documentation of the plant material organization in the space was not found during research for this report. In general, the overhead plane was open to the sky.

West Garden Enclosure- The spatial configuration of the west garden enclosure, established c. 1855, was located at the west edge of the formal garden. The oblong shaped space was approximately 80' x 250'. It was defined on the north by the west lawn; on the south by the south garden enclosure; on the west by the south field; and on the east by the formal garden. The base plane of the space was flat and was planted with a double row of evergreen trees on a north/south axis and additional randomly planted trees. A path was established within the double row of evergreen trees in c. 1880. Verticality was accentuated with tree trunks (different sizes, close spacing, random spacing, etc.). At the end of this period, the maturity of the trees formed a continuous, dense overhead plane and created a strong sense of enclosure.

South Garden Enclosure- The spatial configuration of the south garden enclosure was located at the south edge of both the formal garden and vegetable garden and was established c. 1865. The oblong shaped space was approximately 100' x 300'. It was defined on the north by the formal garden and vegetable garden; and on the south, west and east by the south field. The base plane of the space was relatively flat and was planted with randomly planted evergreen and deciduous trees. A path was established within the space in 1867. Verticality was accentuated with tree trunks (different sizes, random spacing, etc.). The trees formed a continuous, dense overhead plane and created a strong sense of enclosure.

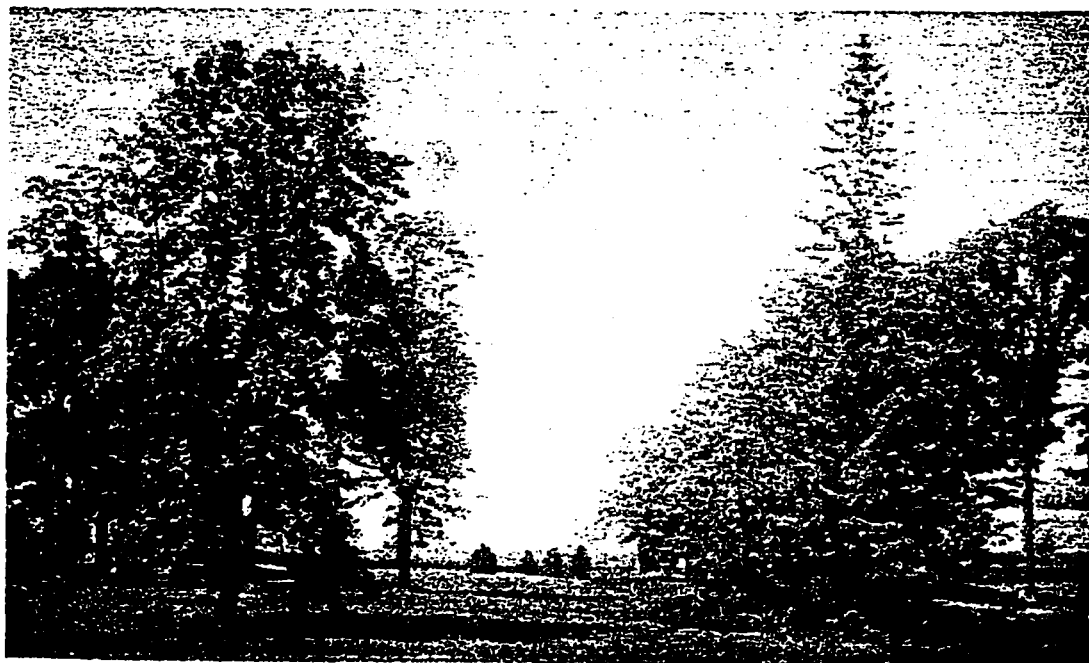
Figure 2.39: View north from the front porch of the mansion, 1880. Note elm along east half the main entry (right), four arbor vitae (center), tulip tree (left). Also note boathouse at the south shoreline. (LSHS, Photograph Collection, Box D, Folder 13, Item 37).

In c. 1875, four arbor vitae (*Thuja occidentalis*) were planted in a row along the south edge of the ha-ha wall, approximately 30' west of the main entry's east gate (see figure 2.39).

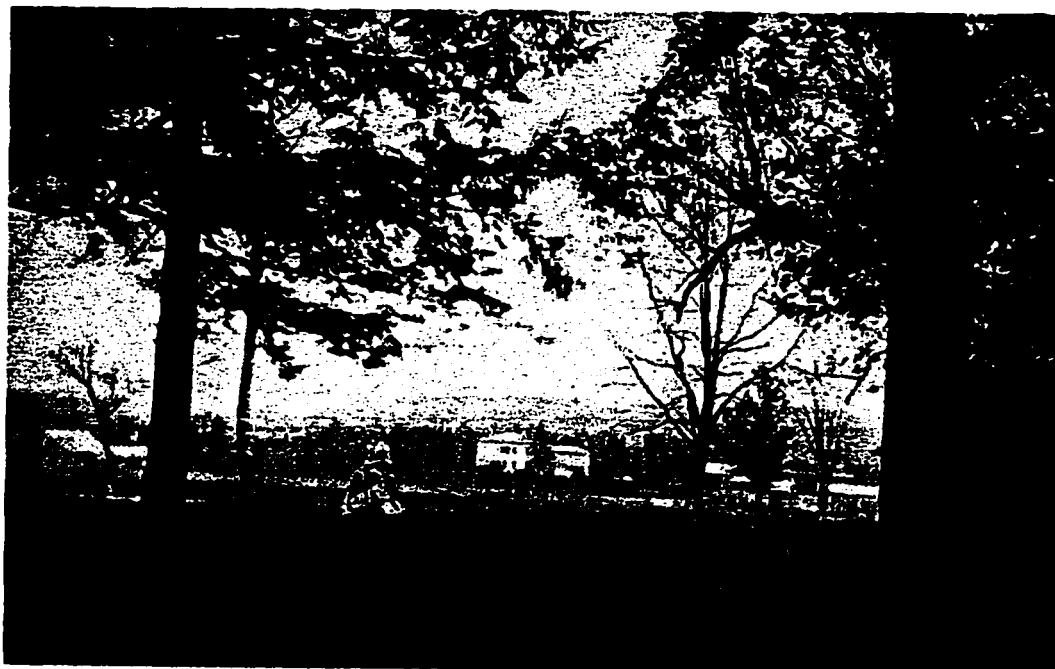
Figure 2.41: View east from approximately the service courtyard, 1860. Note The Meadows in the background (Helen Fairchild as a teenager). Photograph by A. P. Weld. (LSHS, Photograph Collection, Box 1F, Folder 4).

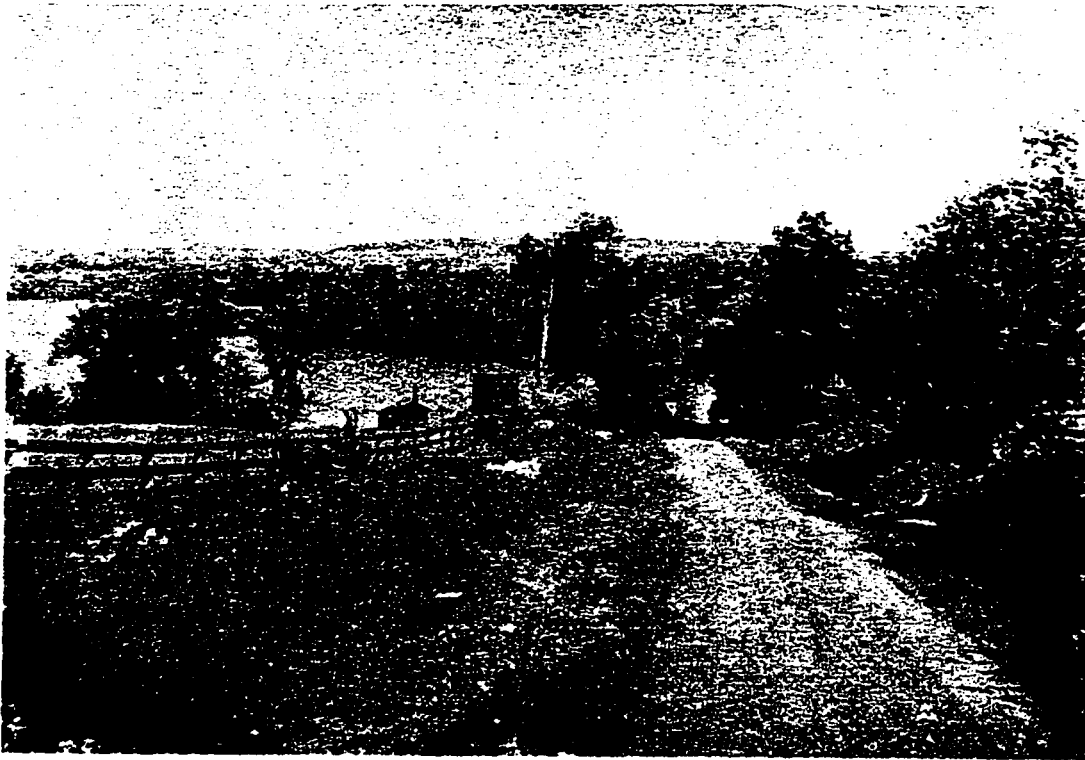
Figure 2.42: View east of the Road to Pompey from the west hill, c. 1890. Note pump house and water tower of the Syracuse & Chenango Valley Railroad. (LSHS, Slide Collection, File C, Slide 141).

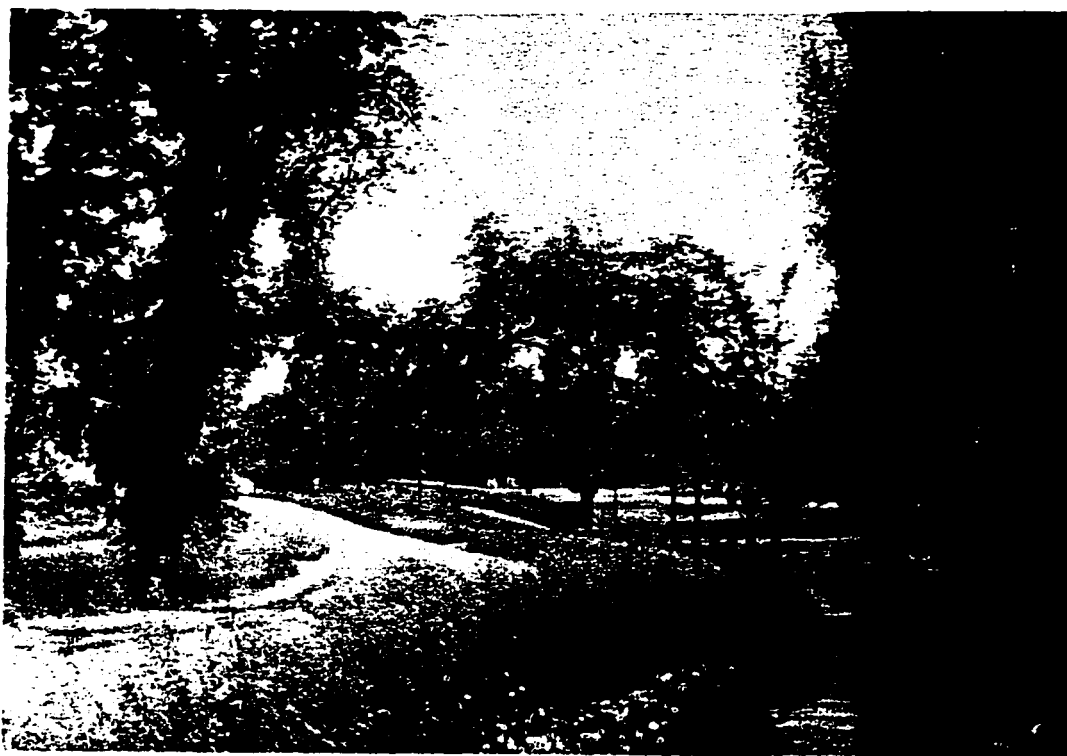
Figure 2.43: View east of Ledyard Avenue , c. 1890. Note pedestrian path (right) and fences on both sides of the road. (LSHS, Photograph Collection, Box C, File 14, Item 12).

Farm/Estate Path- The main farm/estate path, construction date unknown, paralleled the south edge of Ledyard Avenue. The path not only connected the farm complex with the central core, but also extended into the village. The path approximately 4' wide, consisted of compacted soil. Documentation of the path's exact dimensions and materials was not found during research for this report.

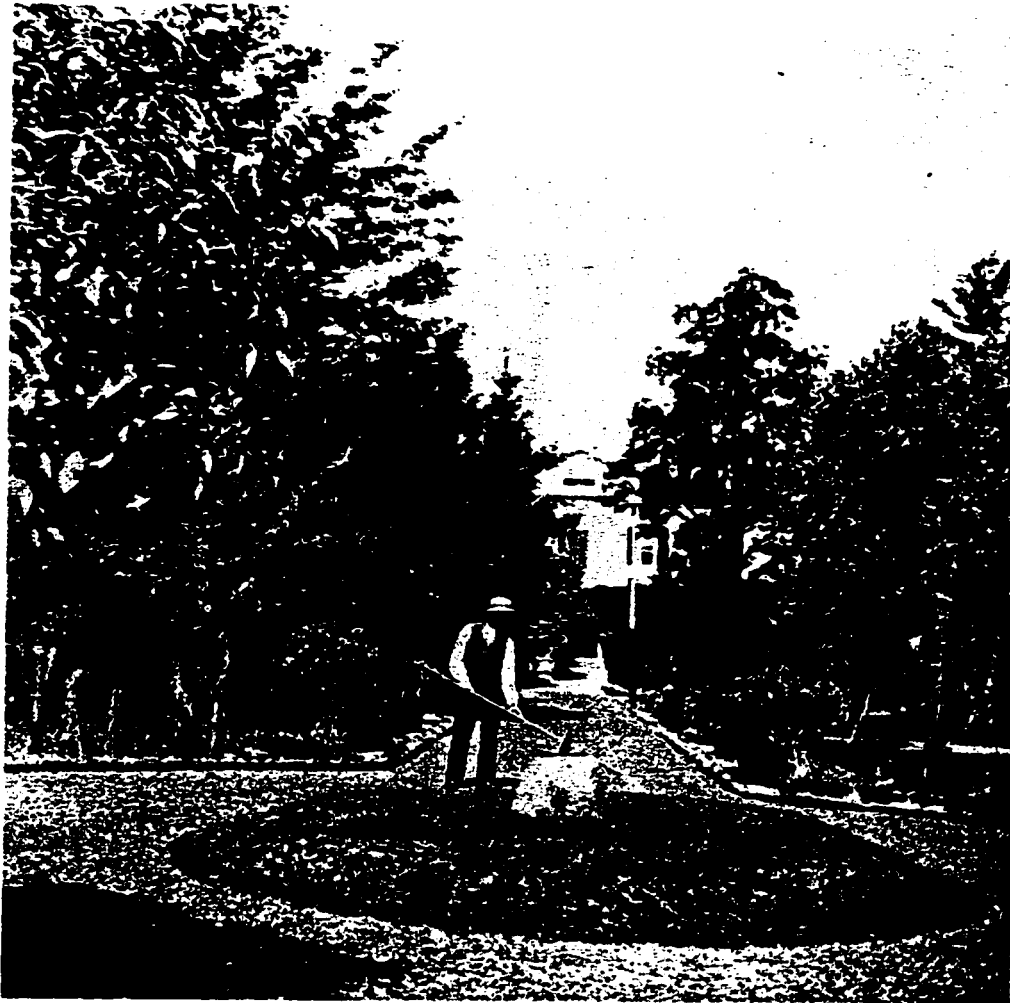
Figure 2.44: View north from the central walk of the formal garden, 1876. Note the central walk's border plantings and the diagonal walk (right). The gardener, William Harris, attends to the center island. (LSHS, Cazenovia Pictorial Records Album, p. 16).

Formal Garden Walks- The layout of the formal garden was documented for the first time in period photographs (c. 1865 to c. 1890). An approximately 8' wide central walk, running north and south on the central axis of the mansion's main hall, was broken in the middle by a circular island approximately 20' in diameter (see figure 2.44). The cross-walks appear to have been the same width. On the outside edge of the flower beds, on each side of the central walk, were parallel walks approximately 2' wide. The surface of the walks most likely consisted of compacted soil over a gravel foundation. In 1850, prior to the earliest photographs of the formal garden, the cross-walk running east and west from the sundial, was filled-in.²⁰⁵

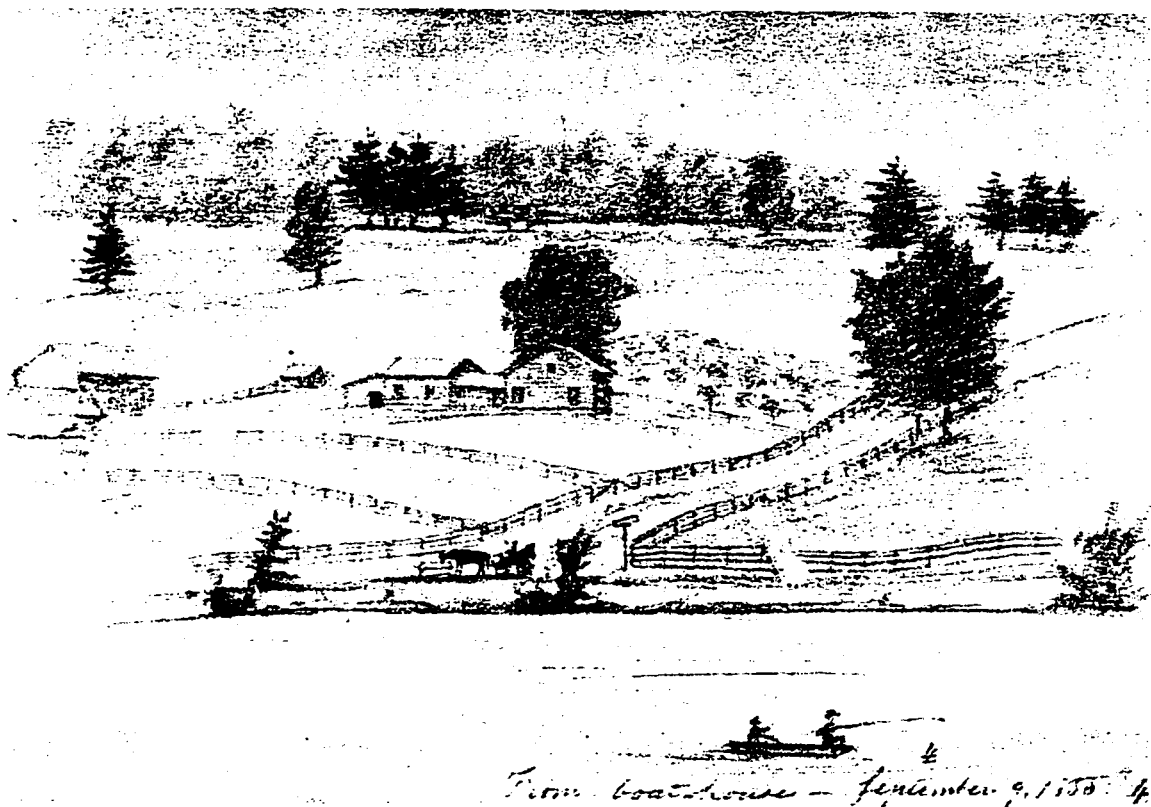
Figure 2.46: The post and rail fence enclosures at the Lorenzo farm complex. View west from the boathouse, 1855. Sketch drawn by Ledyard Lincklaen. Note apple orchard adjacent to the farmhouse. (LSHS, Photographic Album of Ledyard Lincklaen).

Open Fields- The vegetation on the farm's open fields is not well-documented, but an 1858 sketch by Ledyard Lincklaen suggests the open fields surrounding the farm complex generally consisted of meadow grass (see figure 2.46). Further documentation of the vegetation in the open fields was not found during research for this report.

Farm Complex- The vegetation in the farm complex is not well-documented, but an 1858 sketch by Ledyard Lincklaen does illustrate the small orchard, located immediately west of the farmhouse and established during the first historic period (see figure 2.46). Further documentation on the vegetation in the farm complex was not found during research for this report.

Fences- In general, the fences in the outer acreage, including those at the farm complex, remained unchanged except for necessary repairs, maintenance, and replacement (see figure 2.46). The most significant documented change in the outer acreage fences was the addition, in 1874, of a new fence along the northern edge of Ledyard Avenue. The fence, constructed in replacement of a wood post and rail fence,²⁰⁷ consisted of iron pipe posts and four rails and stood approximately 4' high.²⁰⁸ Documentation of the exact dimensions and color of the fence was not found during research for this report.

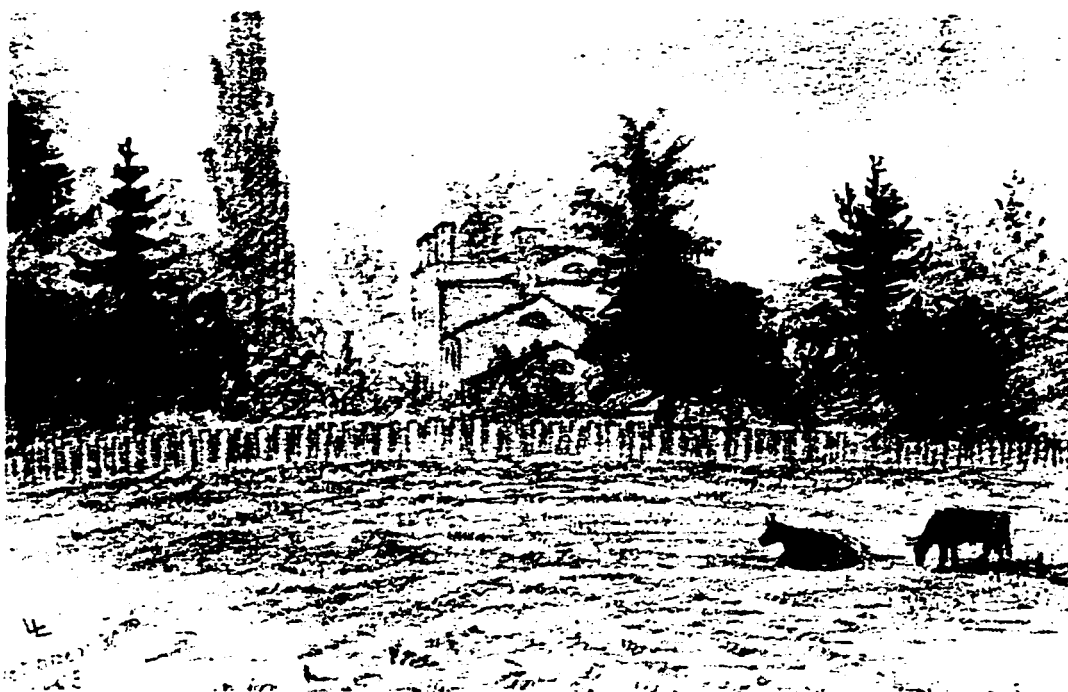
Figure 2.47: View north from the south field showing the fence at the south end of the formal garden and vegetable garden. Sketch by Ledyard Lincklaen, 30 October, 1853. (LSHS, Photographic Album of Ledyard Lincklaen).

In 1844, Ledyard Lincklaen built a post and rail fence around the garden.¹¹³ The fence consisted of locust posts and rails and upright pine boards separated by spaces (see figure 2.47). Documentation of the dimensions of the fence was not found during research for this report. Apparently the fence was built to protect the garden from wild as well as domestic animals.

Garden Enclosures- At the beginning of the second historic period, a few trees were interspersed along the formal/vegetable garden's fence enclosure (see figure 2.47). Changes to the vegetation in this area began in 1854, when Ledyard Lincklaen began to establish an evergreen shelter-belt around the south and west edges of the formal garden. In April 1854, Ledyard Lincklaen planted nine white pines en masse around the southwest section of the fence enclosure.¹⁹¹ A year later, Lincklaen established along the west fence enclosure a hedge of Canadian hemlocks (*Tsuga canadensis*).¹⁹²

Fences- In 1852, eight years after building a post and rail fence around the garden, Ledyard Lincklaen enlarged the fence enclosure by resetting the south fence line.²⁰⁹ The fence remained post and rail with upright wood boards with spaces in between (see figure 2.47). By c. 1880, the fence was replaced with a common post and rail fence. Documentation of the dimensions, materials, and color of this fence was not found during research for this report.

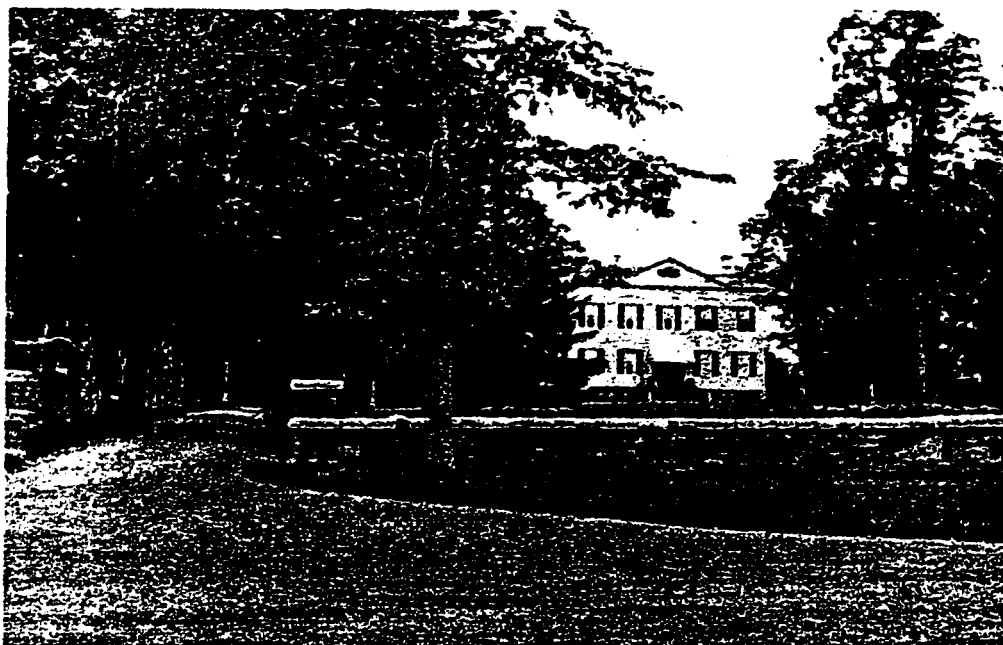
Figure 2.48: The ha-ha wall and the east entrance of the main entry drive. Note the awning above the mansion's main entrance. (LSHS, Cazenovia Pictorial Records Album, p. 30).

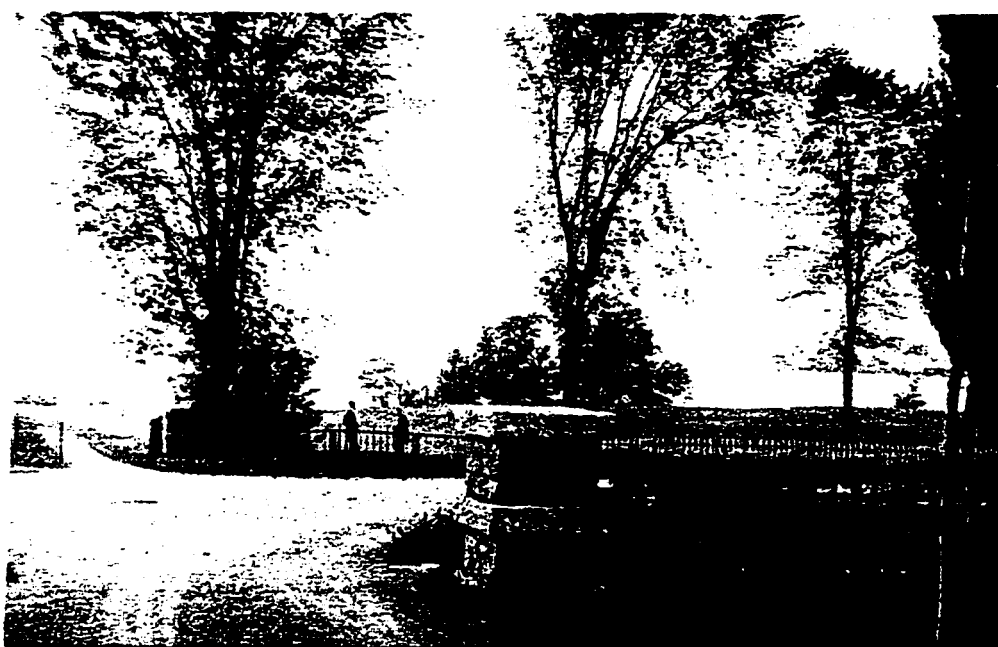
Figure 2.49: View north from east entrance of the main entry drive, 1885. Note the stone gates at the entry to the boathouse path (left) and the east entrance of the main entry (right). Also note vine growing on picket fence and open shoreline. Photograph by Charles Marshall. (LSHS, Photograph Collection, Box D, Folder 13, Item 38).

Boathouse Path- In c. 1852, a path from Ledyard Avenue to the boathouse was constructed. The path started opposite the east entrance of the main entry road and meandered north down the slope to the boathouse. The path was approximately four feet wide and had a soil/gravel surface (see figure 2.49). Although there was a formal path along the south shore line from Willowbank to The Oaks linking boathouses, an extension of this path to the Lorenzo boathouse appears to have never existed.²⁰⁴ If there was a path along the shoreline, in all likelihood it would have intersected the path from the mansion to the boathouse.

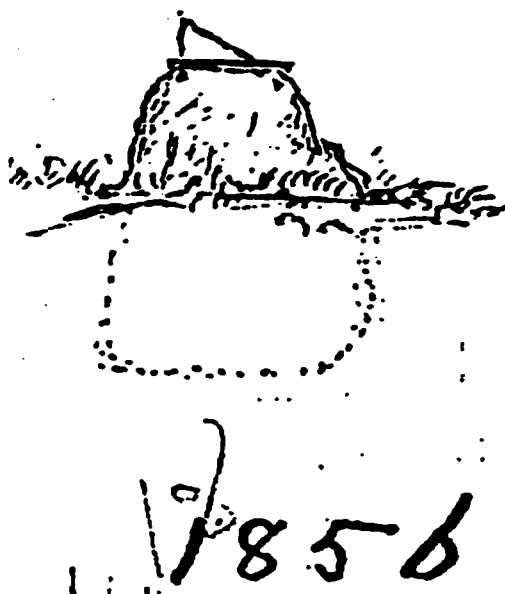
Figure 2.50: Sketch of granite boulder and sundial found in Ledyard Lincklaen's memoranda. (LSHS, Fairchild, Housebook, p. 44).

Granite Boulder & Sundial- In 1856, Ledyard Lincklaen placed a granite boulder on the formal garden's center circle.²¹¹ The boulder, with a 21" diameter, stood approximately 2' above the center circle's low mound. An iron sundial, with a 9" diameter, was mounted on top of the boulder. Ledyard Lincklaen noted next to a sketch of the boulder and sundial that, "the stone is nearly three feet long, and stands on a pile of broken stone in [the] bottom of its bed (see figure 2.50)."²¹² The addition of the boulder and sundial created a new focal point in the formal garden.

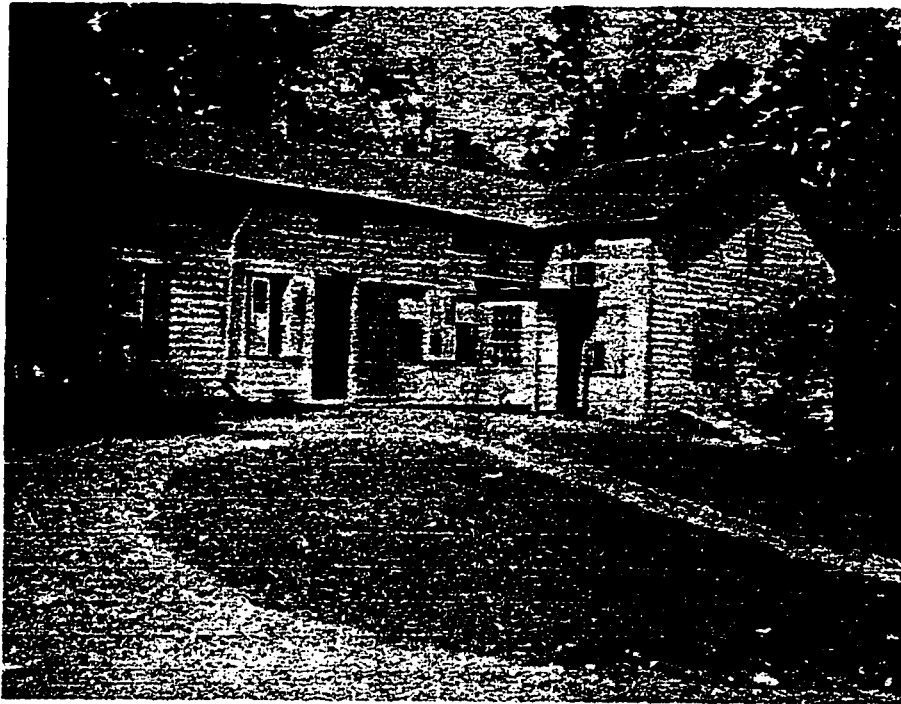
Figure 3.5: The east side of the old farmhouse, c. 1900. (LSHS, Photograph Collection, Box D, Folder 14, Item 2).

Farmhouse- In 1902, the farmhouse was re-built by H. Potter.²²⁵ The two-story "T" shaped main block was modified into an "L" shape and a hipped roof replaced the gable roof (see figures 3.5 and 3.6).

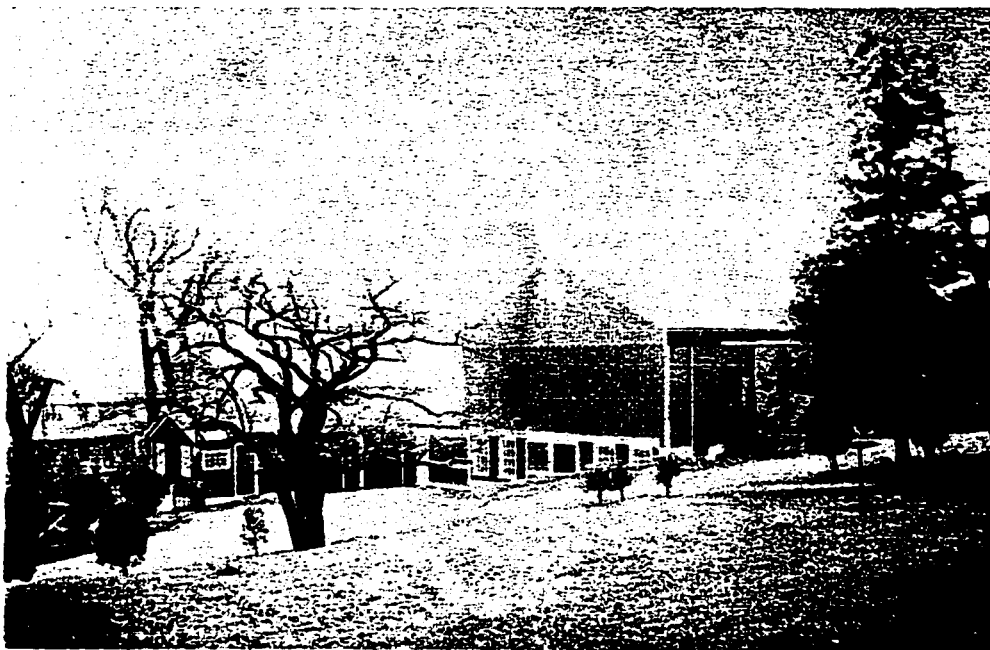
Figure 3.7: View southeast from the farmhouse showing the calf barn and the dairy barn located in the northeast corner of the farm complex. The New York Central railroad station is in the background, c. 1928. (LSHS, Photograph Collection, Box D, File 14, Item 27).

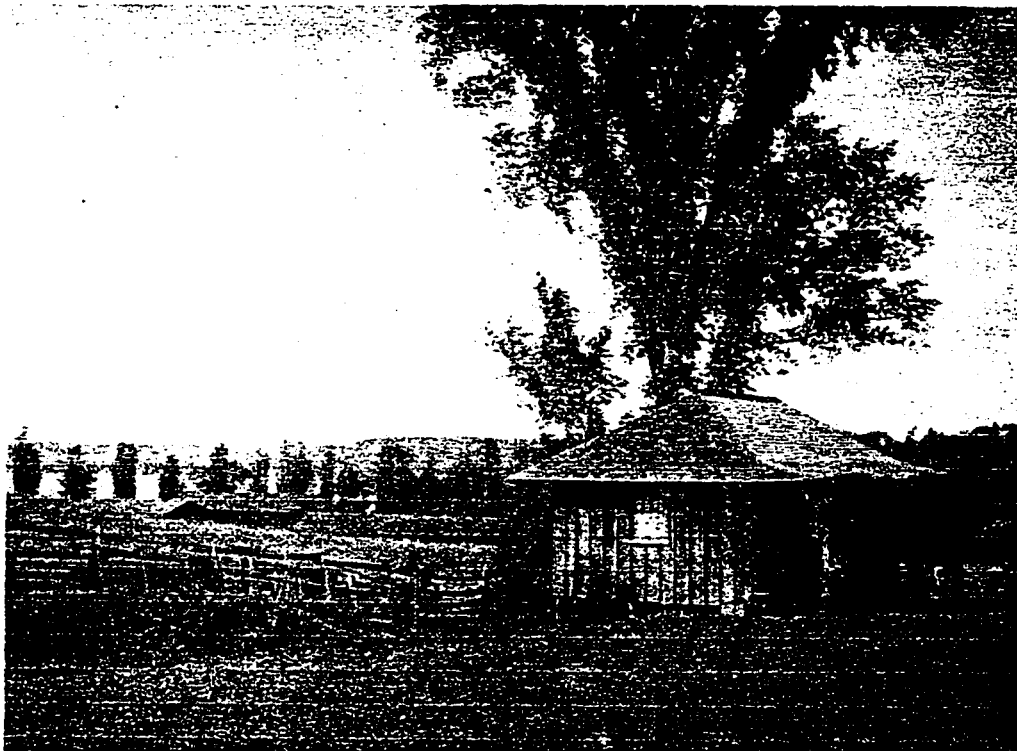
Figure 3.9: The golf clubhouse located south of the farm complex, c. 1900. Note south fence line of the farm complex. (LSHS, Photograph Collection, Box 2C).

Golf Clubhouse- In 1898, a golf clubhouse was built on the golf course. It was located approximately 400' south of the farm house at the south edge of the farm complex.²²⁹ The one-story, rectangular frame building was approximately 25' x 20'. Its hipped roof was covered with wood shingles and the siding was sheathed with board and batten that was allowed to weather gray. The building provided "... accommodations for ladies and gents locker rooms, a workshop and other necessities."²³⁰

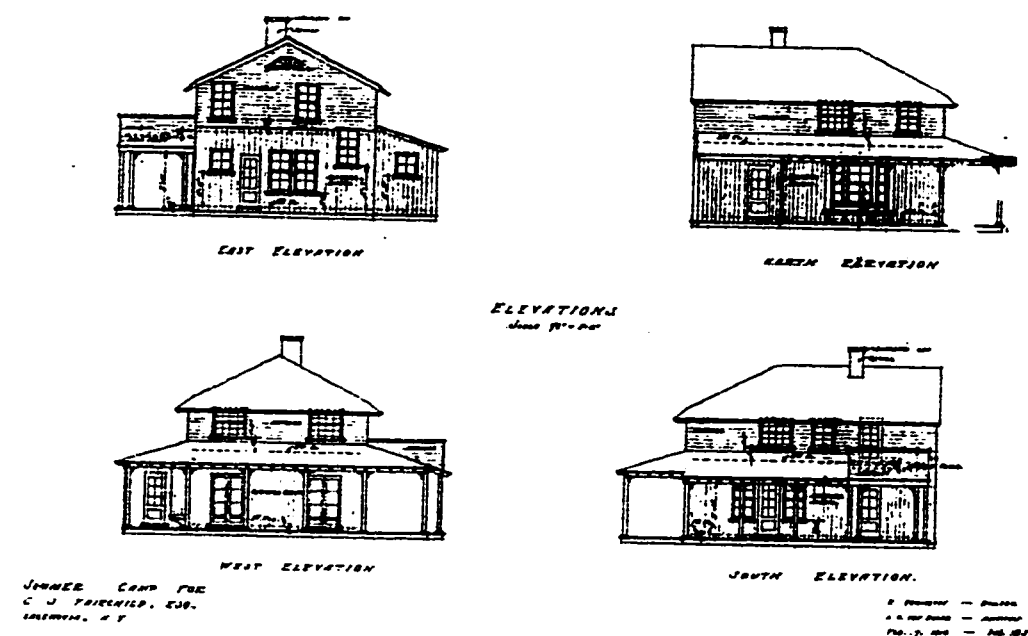
Figure 3.10: Elevation drawings of South Cottage, 1914. (LSHS, Blueprint Collection).

South Cottage- In 1914, South Cottage, also referred to as Ford Cottage or Orchard House, was constructed approximately 500' southeast of the mansion in the southeast corner of the east orchard.²³¹ It was designed by architect I. V. Van Duzer and constructed by Eliphalet Remington. It was a two-story, square block approximately 26' x 36'. A one story 8' x 12' frame entry was located at the northeast corner. A one story 8' wide open frame porch extended from the entry and around the entire west facade. The southeast corner of the building had an additional one story 8' x 12' frame entry. The south side of the building had a 8' x 16' one-story frame addition which had a canopy porch on the second floor. The first story had board and batten siding; the second story was clad with wood shingles. The main block of the building was covered by a hipped roof, with a gable end on the east side. The color was dark brown. The building was constructed for Helen Fairchild's cousin, Mary Ledyard Seymour Ford and her husband W. A. Ford. The Fords used the building as a summer residence.
