**CULTURAL LANDSCAPE REPORT FOR
LORENZO STATE HISTORIC SITE**

Friends of Lorenzo,
On Behalf of Lorenzo State Historic Site,
Office of Parks, Recreation and Historic Preservation, Central Region

State University of New York
College of Environmental Science and Forestry
Faculty of Landscape Architecture, Syracuse, New York
Research Assistant W. Paul Fritz, Project Director George W. Curry

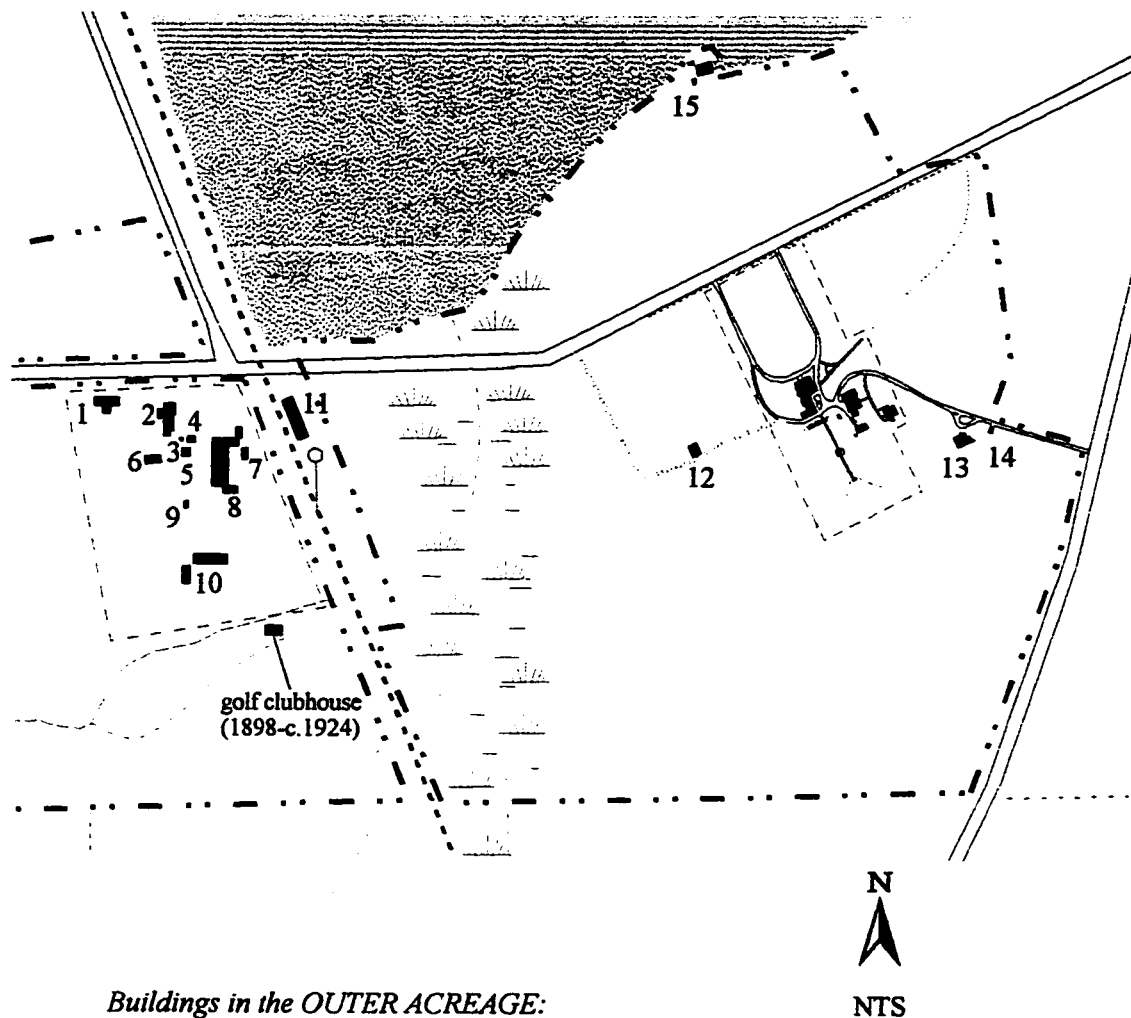
Buildings in the OUTER ACREAGE:

- 1- Tenant House
- 2- Farmhouse
- 3- Smokehouse
- 4- Garage
- 5- Tool Shed
- 6- Work Shop
- 7- Shed
- 8- Dairy Barn & 3 silos
- 9- Shed
- 10- 2 Barns
- 11- Train Depot
- 12- Stable
- 13- South Cottage
- 14- South Cottage Garage
- 15- Boathouse (1852- c. 1905)

Barns and Outbuildings- The approximate size and location of the barns and outbuildings in the farm complex can be documented for the first time during this period.²²⁶ Apparently, major structural work was completed on the barns while they were "renewed" by Eliphalet Remington in 1916.²²⁷ Documentation of the extent of the work was not found during research for this report. The buildings (with approximate dimensions) that existed after this project included: a 7' x 9' smoke house; 20' x 21' garage; 20' x 24' tool shed; 20' x 28' work shop; 20' x 28' shed; 50' x 155' dairy barn,; 24' x 100' barn; 20' x 52' barn; spring house; and 3 silos (see figure 3.12). The height, materials, and color of the buildings were not documented.

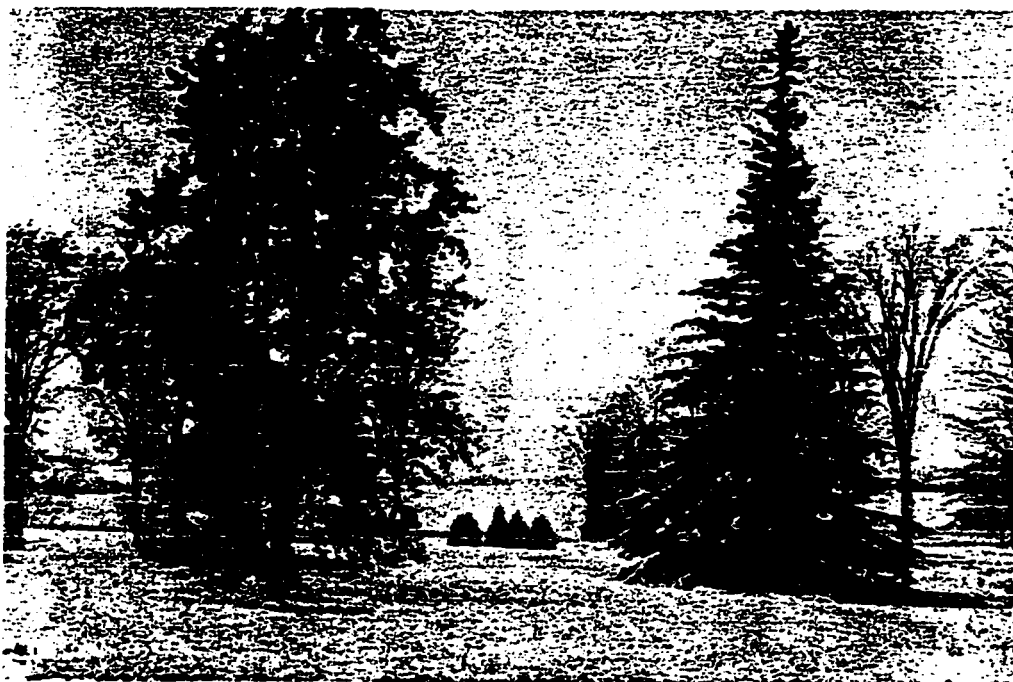
Figure 3.41: The view north from the mansion's main entrance porch. Photograph by Anna R. Fitcher, 1913. (LSHS, Photograph Collection, Box D, Folder 13, Item 36).

Views from Mansion's Main Entrance Porch- The introduction of the arborvitae hedge along the north edge of the front lawn altered the view of Cazenovia Lake from the mansion. The most significant change was the hedge's screening of Ledyard Avenue. The views east and west from the main entrance porch also were altered. The growth of vegetation along the eastern border of the property terminated the view of village landmarks. The view west also was filtered by vegetation growth in the west orchard/west wood lot, but the west hill remained partially visible (see figure 3.41).

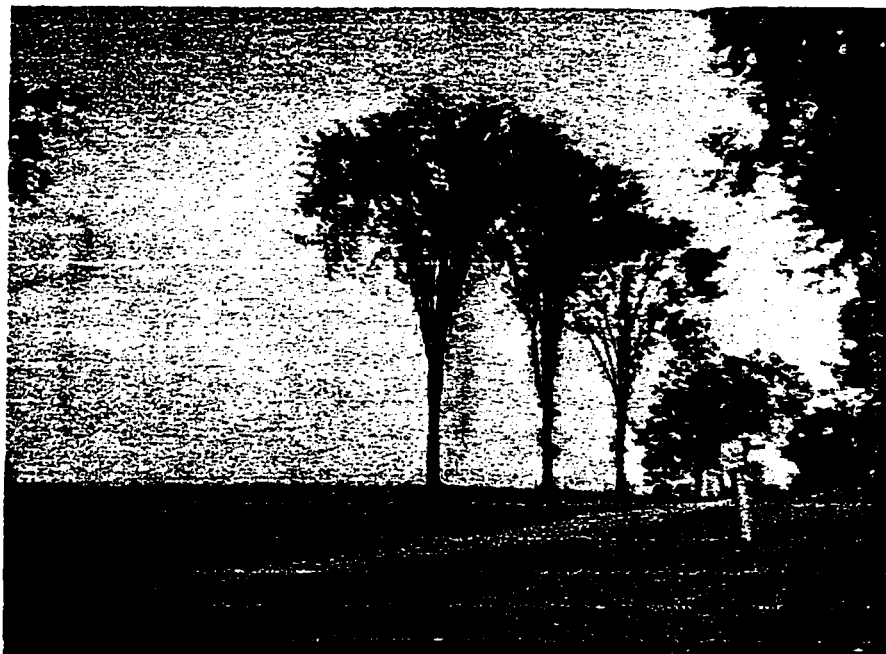
Figure 3.44: View east of Ledyard Avenue , c. 1920. (LSHS, Photograph Collection, Box C, Folder 14, Item 6). Note the iron fence installed in 1874 along the north edge of Ledyard Avenue and the sign along the south edge of the road. (LSHS, Photograph Collection, Box C, Folder 14, Item 7).

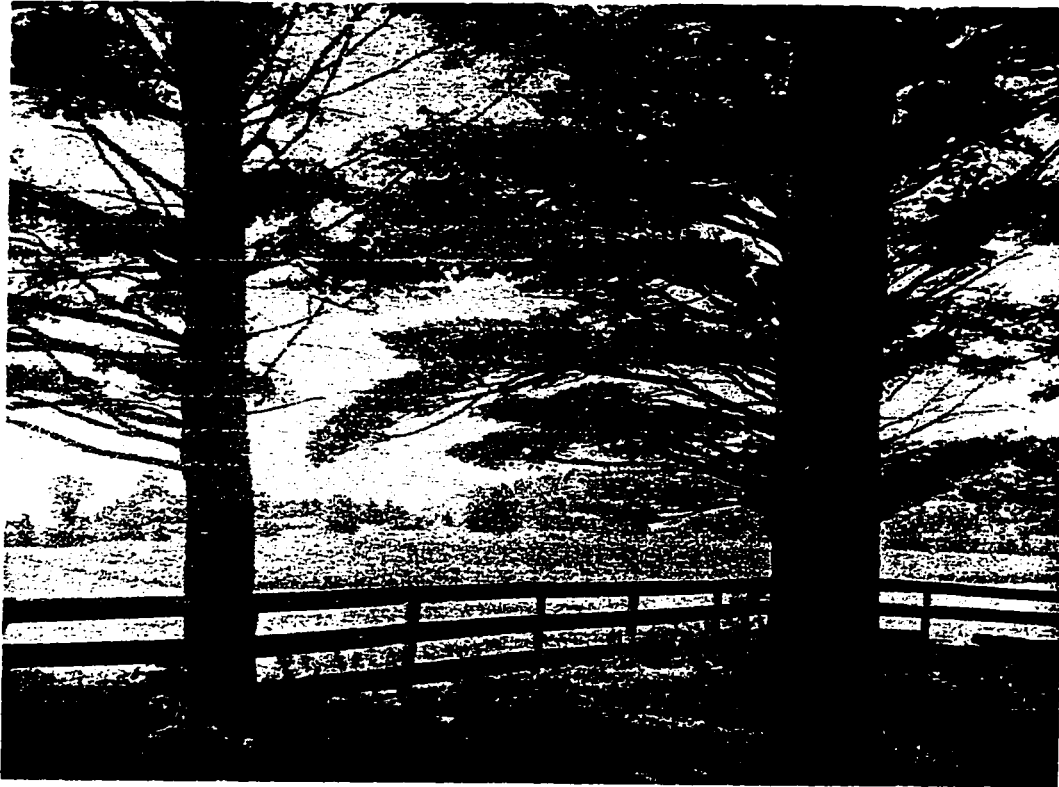
Figure 3.48: The board fence around the garden enclosures, c. 1910. (LSHS, Photograph Collection, Box 1F, Folder 8).

Fences- In c. 1905, an ornamental wire fence was installed along the north border of the formal garden. The exact date the fence was installed was not documented. The fence was approximately 3' ½" high and was painted green. The fence around the garden enclosures was documented for the first time (see figure 3.49). The fence, approximately 3' ½" high, was constructed of wood posts and three parallel boards.

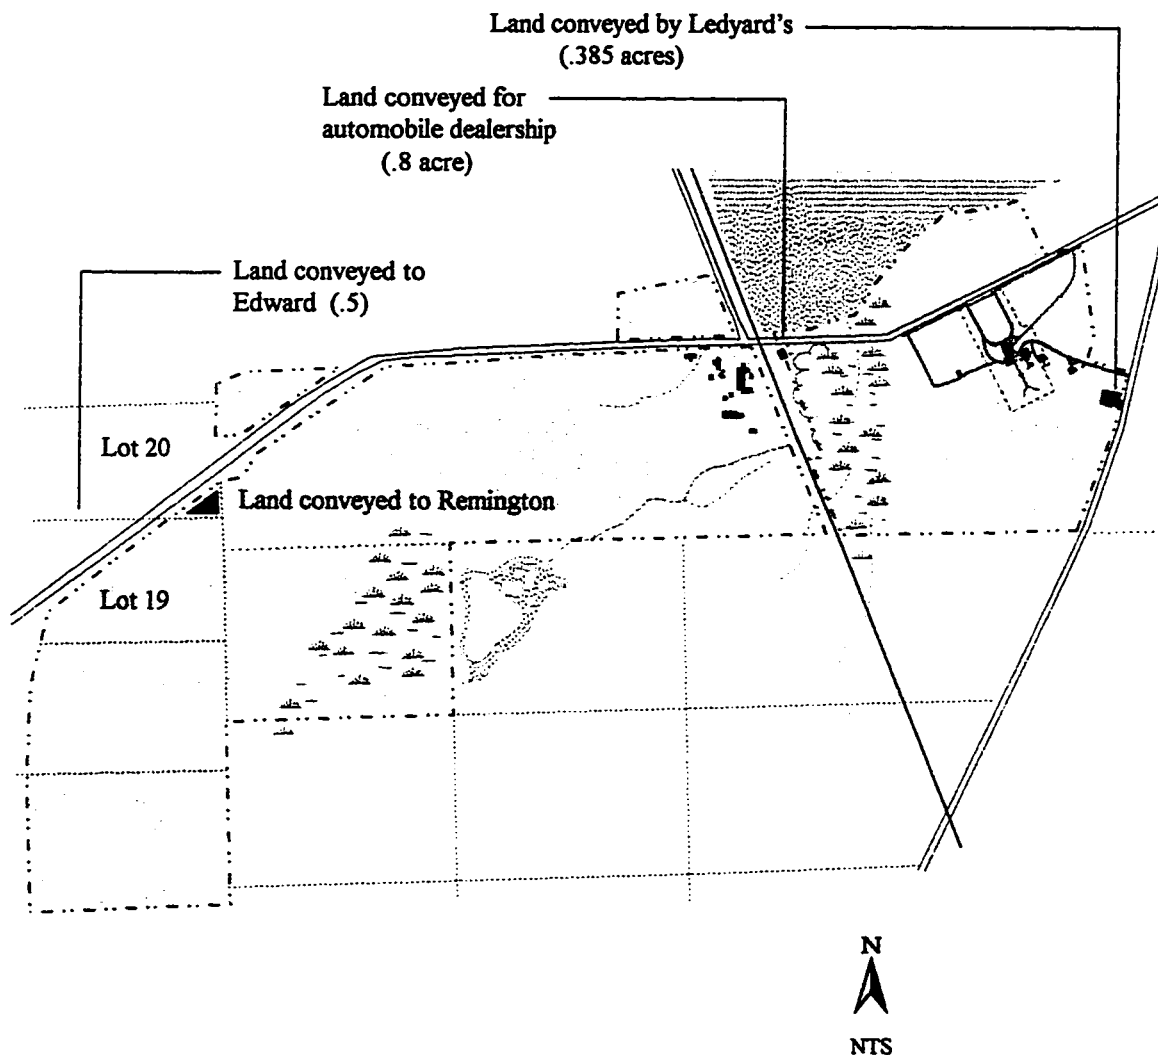
Figure 4.7: Map of the property at the end of the fourth historic period. (Fritz, 1996. SUNY CESF).

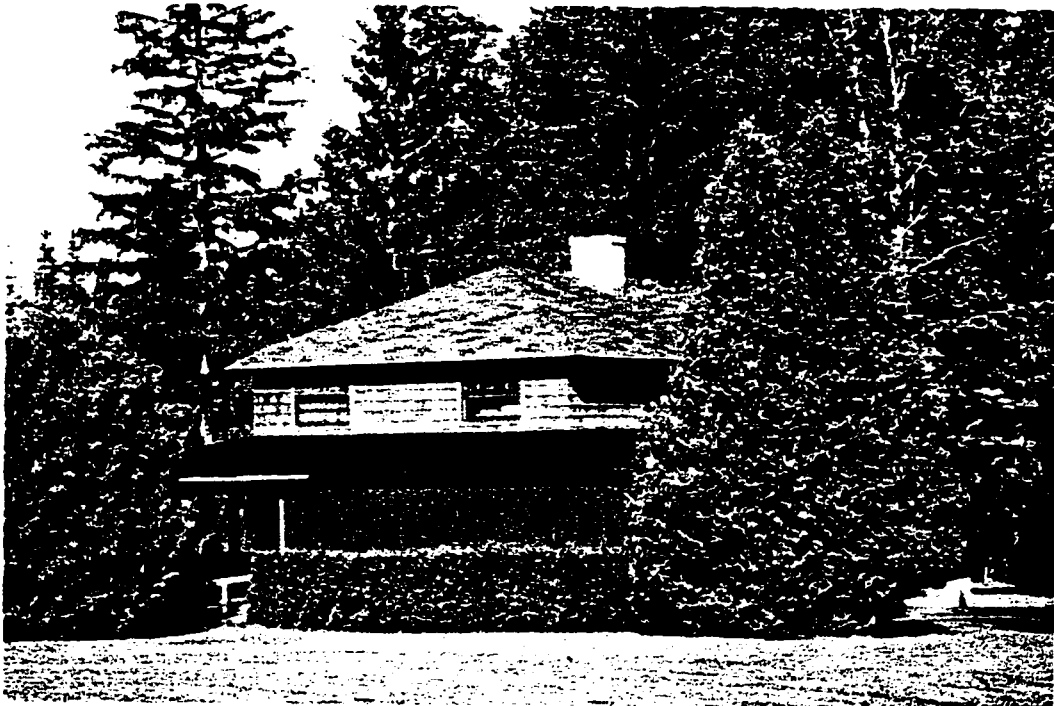
South Cottage- South Cottage received several modifications. In 1974, the foundation and other structural elements were rehabilitated. In 1980, a black asphalt shingle roof was installed. In 1984, the south deck and the west porch were removed to make room for the construction of a single level, L-shaped enclosed addition. The addition serves as a fire resistant document vault and a separate storage room. In 1984, the east porch was also rebuilt. In 1985, the north porch and the north half of the west porch were rehabilitated. The color scheme of South Cottage remains unchanged and compliments the historic paint scheme of the central core.

The first floor of South Cottage currently has a meeting room (29 person capacity), an archive vault, storage room, modern kitchen and three rest rooms. The second floor was modified in 1988/89 and currently provides office space for the site manager and interpretive programs assistant.

Figure 5.3: South Cottage, 1996. (Photograph by the author).

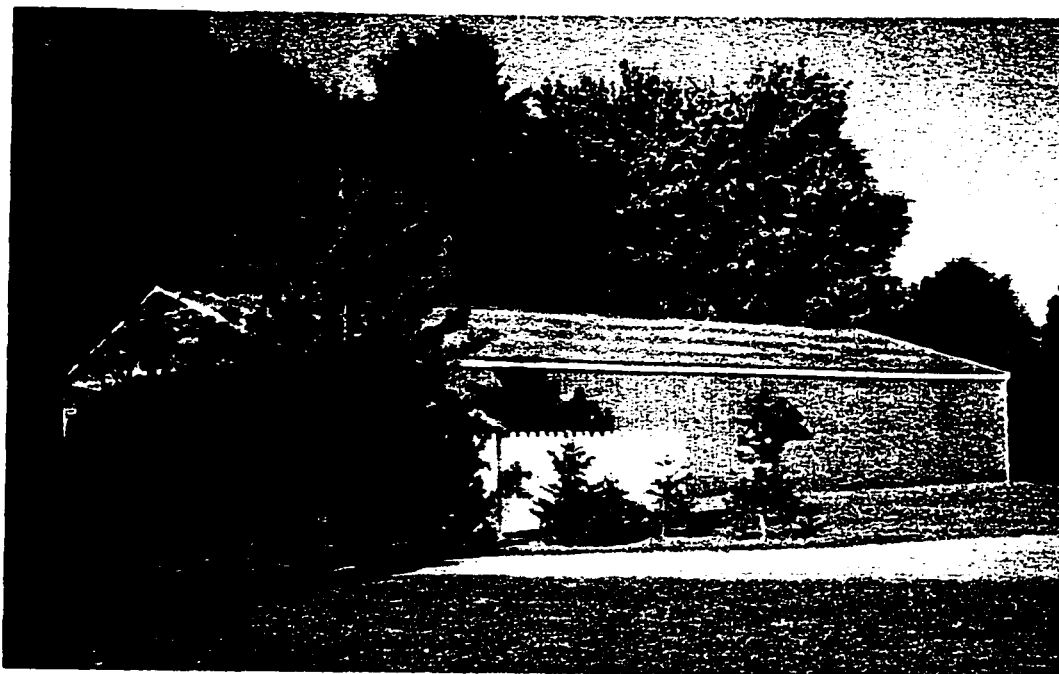
Carriage and Collections Storage Building- In 1980, the carriage and collection storage building (Butler building #1) was constructed at the southwest edge of the east wood lot. The one and one-half story, 40' x 96' building is a typical pole barn construction, with sheet metal walls and roof. Between 1980 and 1985, the building had a white roof and brown siding. In 1990, the roof was painted brown. The west entrance consists of a sliding door for carriage access. The building stores approximately 20-25 vehicles from the Oakman Carriage Collection.

Figure 5.5: Carriage and collections storage building, 1996. (Photograph by the author).

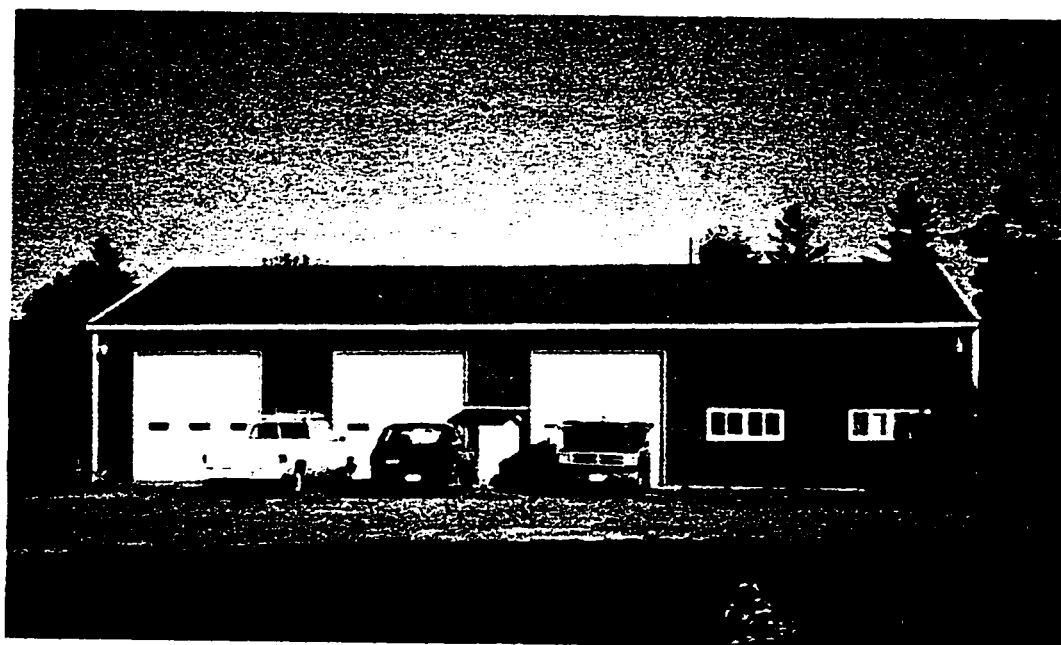
Maintenance and Restoration Crew Building- In 1983, the maintenance and restoration crew building (Butler building #2) was constructed immediately south of the carriage and collection storage building. The one and one-half story, 40' x 80' building is a typical pole barn construction, with sheet metal walls and roof. It is painted brown with white trim. The building currently has three garage doors on its western facade. Originally, the building had four garage doors. In 1994, the southern-most garage door was taken off and replaced with a sheet metal wall (with two windows) in order to incorporate office space for the Building Restoration Specialist and his crew. In 1991, an overhang was installed over the doorway on the west side of the building.

Figure 5.6: Maintenance and restoration crew building, 1996. (Photograph by the author).

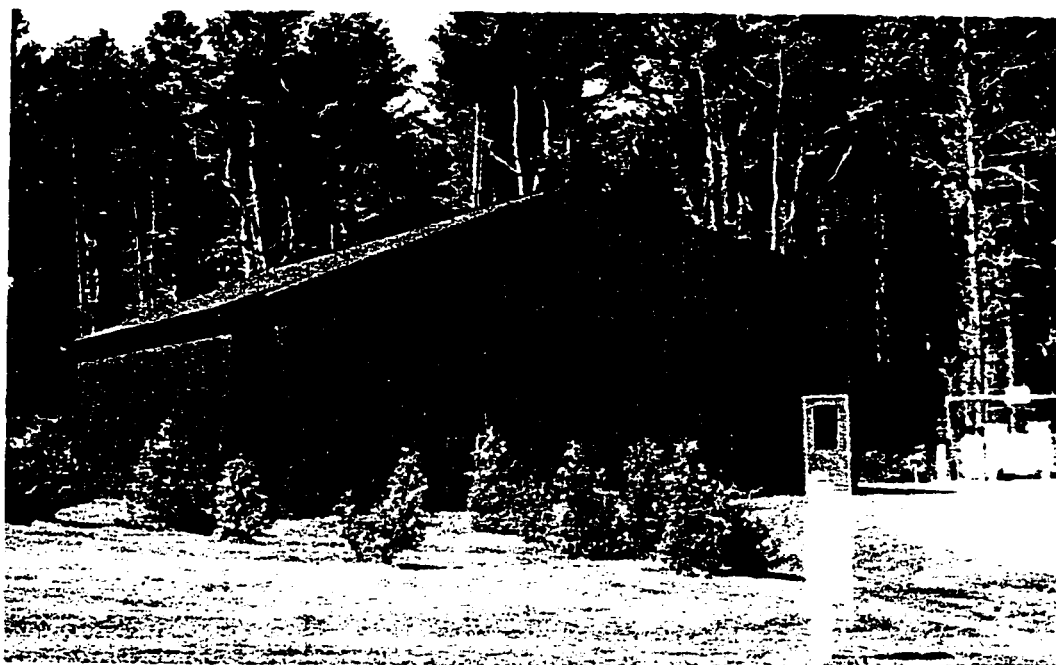
Maintenance and Restoration Storage Building- In 1994, the maintenance and restoration storage building (Butler building #3) was constructed approximately 140' east of the carriage and collections storage building. The one and one-half story, 40'x 88' building is a typical pole barn construction, with sheet metal walls and roof. Its color is dark brown. The building serves as a storage area for supplies, equipment and vehicles for the Central Region Restoration Crew.³³⁸

Figure 5.7: Maintenance and restoration storage building, 1996. (Photograph by the author).

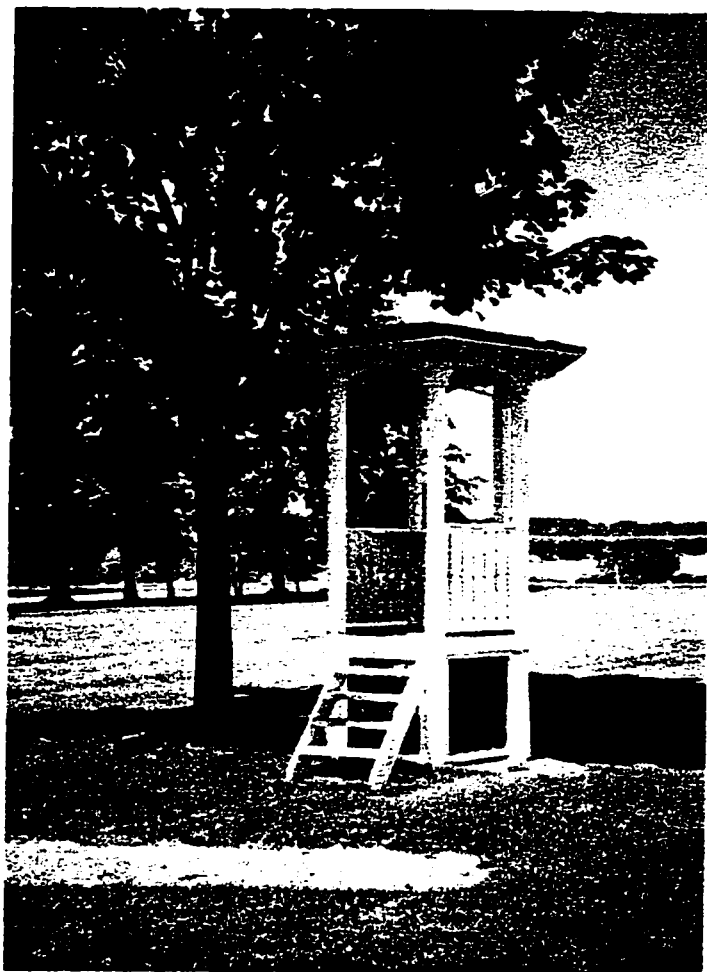
Gazebo/Viewing Stand- A gazebo/viewing stand, constructed by Russell Grills in 1978, is located on the western edge of the east field. The wood construction, approximately 8' x 8' x 12', is painted white with dark green trim. The portable structure is used as an announcing stand for the annual Lorenzo Driving Competition.

Figure 5.8: Gazebo/viewing stand, 1996. (Photograph by the author).

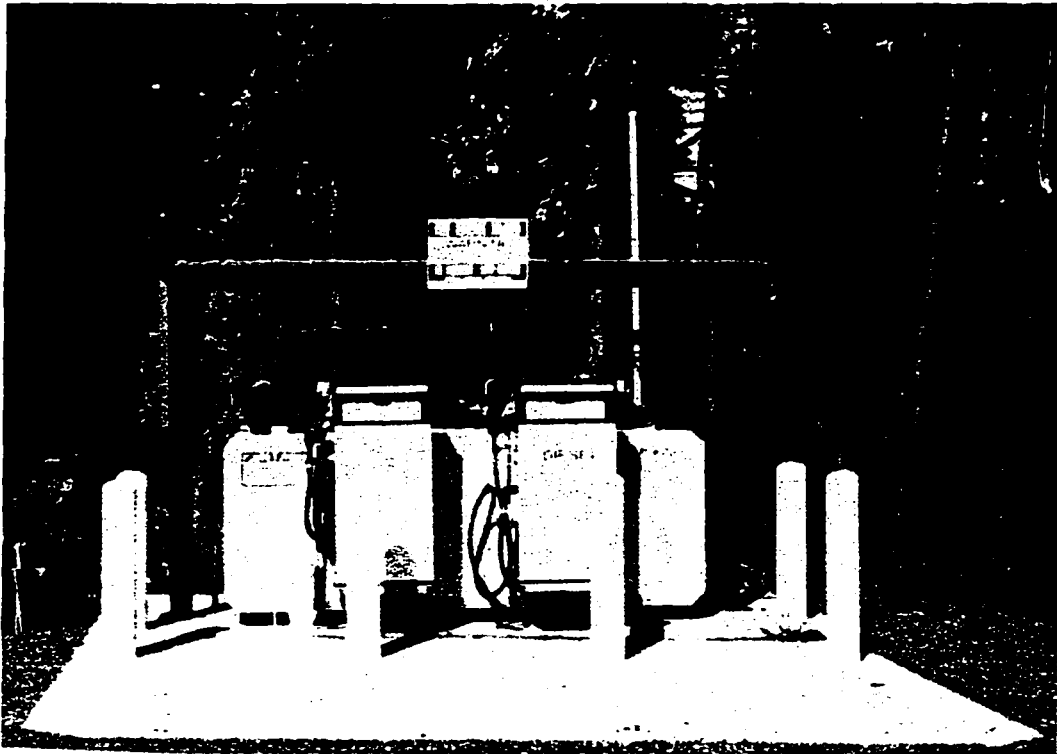
Fuel Station- In 1994, a fuel station was installed at the north end of the gravel lot adjacent to the maintenance and restoration storage building. The station, approximately 25' x 18', consists of an aboveground, two compartment (750/250 gallon) steel tank encased in a monolithically poured reinforced concrete vault; a 18' x 15' concrete vehicle pad; two fuel dispensers; a 10' tall fire suppression system with lighting fixtures, and nine 8" yellow painted pipe bollards placed 3' on center around the station. The fuel station stores unleaded gasoline and diesel fuel.

Figure 5.9: Fuel station in the maintenance/storage complex, 1996. (Photograph by the author).

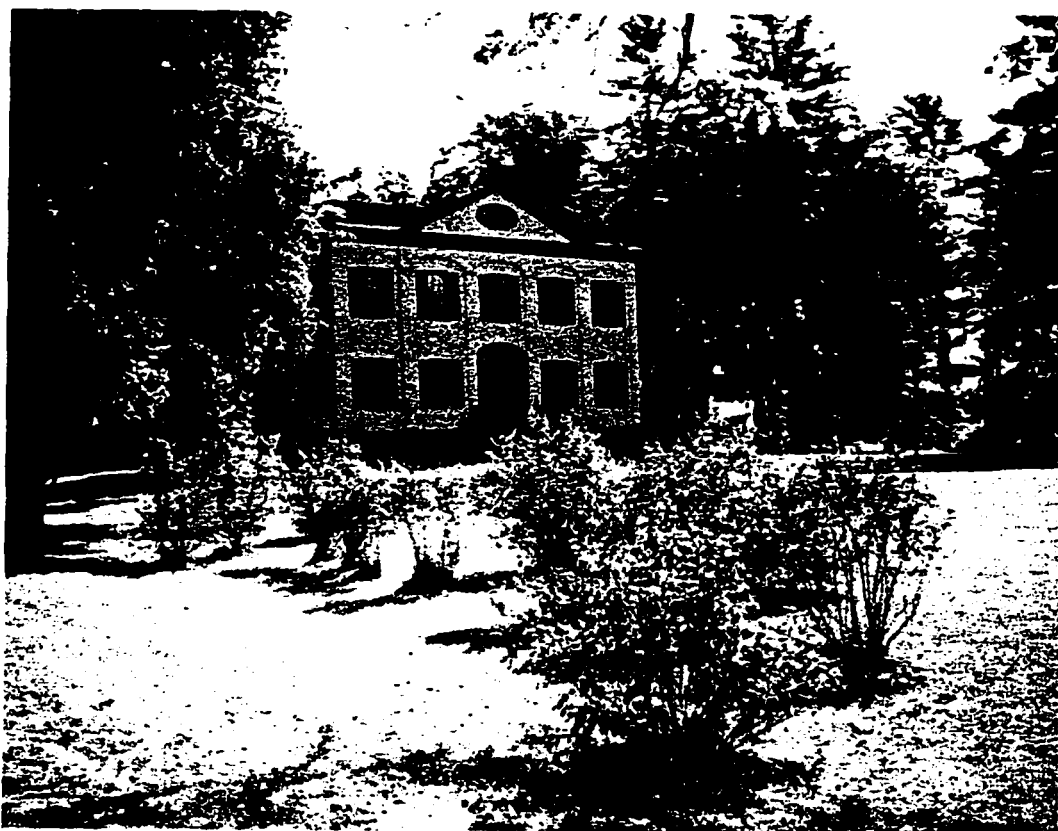
The exterior of the mansion has received several restoration treatments in order to bring it to its c. 1905-1916 appearance. In 1972, one of the first exterior structural elements to be restored was the balcony section of the rear piazza. That same year, work to replace the cedar roof shingles began; the project was completed in 1973. In 1976, the front porch, was rebuilt; the balustrade was replaced later in 1983. In 1994, universal access was made available by the construction of a ramp in the lower hall of the kitchen wing.³³⁹

Based on a historic paint analysis conducted in 1989, 1991 and 1995, the exterior of the mansion was painted in 1992 according to the following color scheme: wood trim, orange-camel; body, yellow-tan; foundation, dark brown; shutters and window trim, dark green.

Figure 5.10: Mansion, 1996. (Photograph by the author).

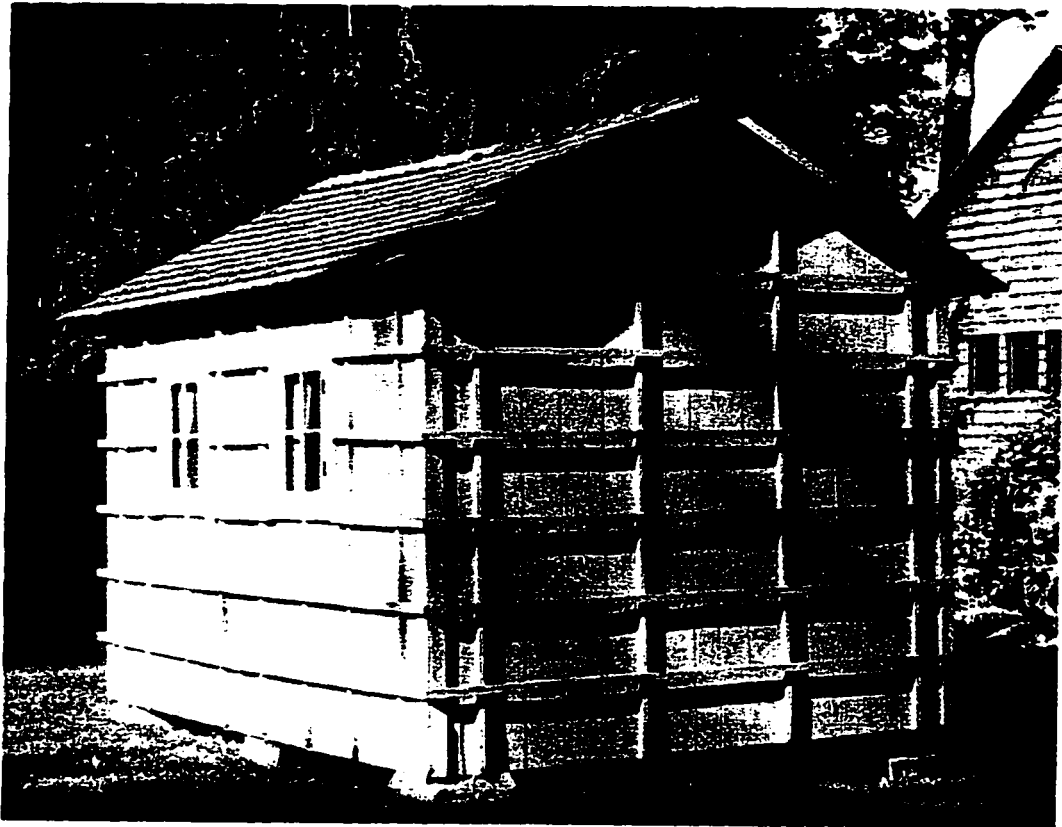
Playhouse- In 1975, all rotted wood members in the playhouse were replaced-in-kind. In 1977, the building was moved to its historic location (c. 1850-1920) in the north-east corner of the formal garden. There are no mechanical systems servicing the playhouse.

Figure 5.11: Playhouse, 1996. (Photograph by the author).

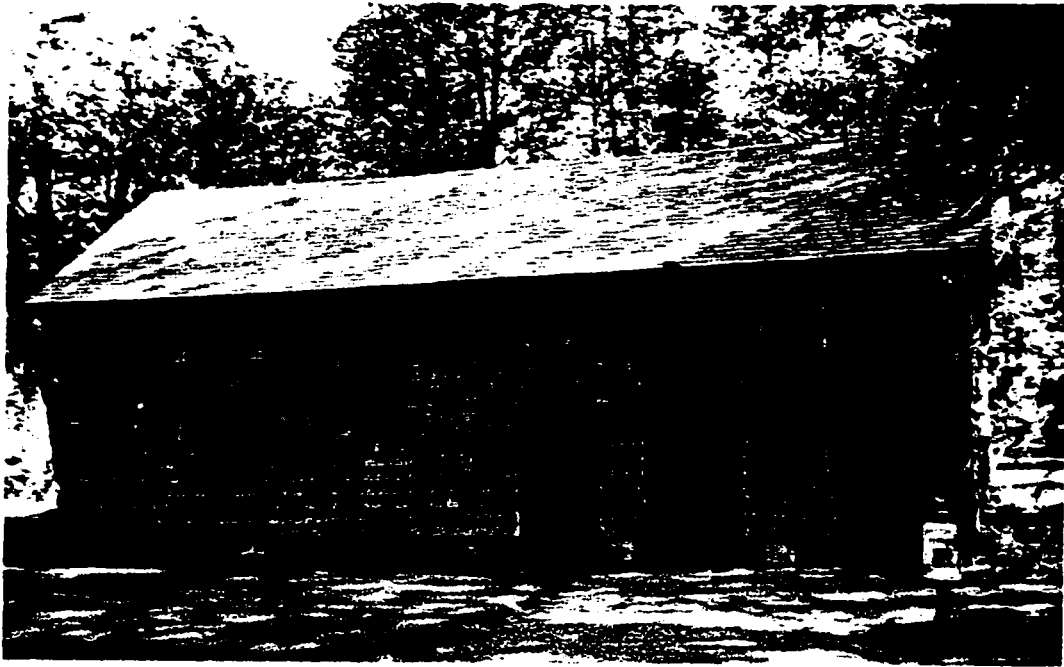
Garden Shed/Ice House- The exterior of the garden shed/ice house first was rehabilitated in 1974. The windows were re-glazed in 1975. Between 1989 and 1995 the cedar roof shingles and siding were replaced-in-kind. In 1994, in preparation for more intensive use, the structural piers of the building were reconstructed.³⁴⁰ In 1995, the building was restored for interpretive purposes. The building has unpainted shingle siding and dark green trim.

Figure 5.12: Garden shed/ice house, 1996. (Photograph by the author).

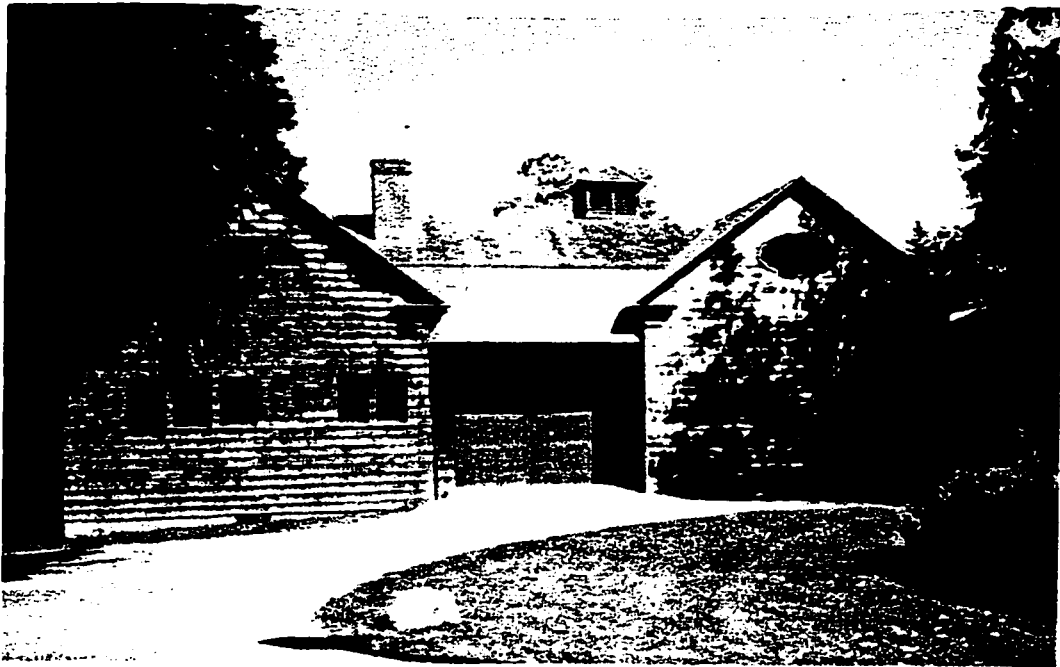
Carriage House/Stables—Visitor Center- The carriage house/stables has received several modifications. In 1986, the interior of the building was rehabilitated to accommodate a visitor center and a carriage exhibition. An interpretive gallery was built within the former stable wing and the tack room was redesigned to accommodate a public contact station. The loft is used for the storage of collections, restoration artifacts, and construction materials. In May 1987, the Visitor Center opened to the public.

In 1987, a temporary universal access ramp was connected to the south entrance. To comply with the American Disabilities Act, the ramp was removed in the spring of 1996 and a new universal access ramp was constructed at the west entrance. The grade of the historic concrete ramp at the west entrance was modified to allow for code compliant access/egress. The stairs at the south entrance were rehabilitated and currently provide a landing for tour guides.

Additional exterior repairs include the replacement of cedar shingles on the sloped roof in 1989 and the replacement of the cupola in 1990. In 1980, the flat section of the roof was covered with lead-coated copper plate.³⁴¹

Figure 5.13: Carriage house/stables—visitor center, 1996. (Photograph by the author).

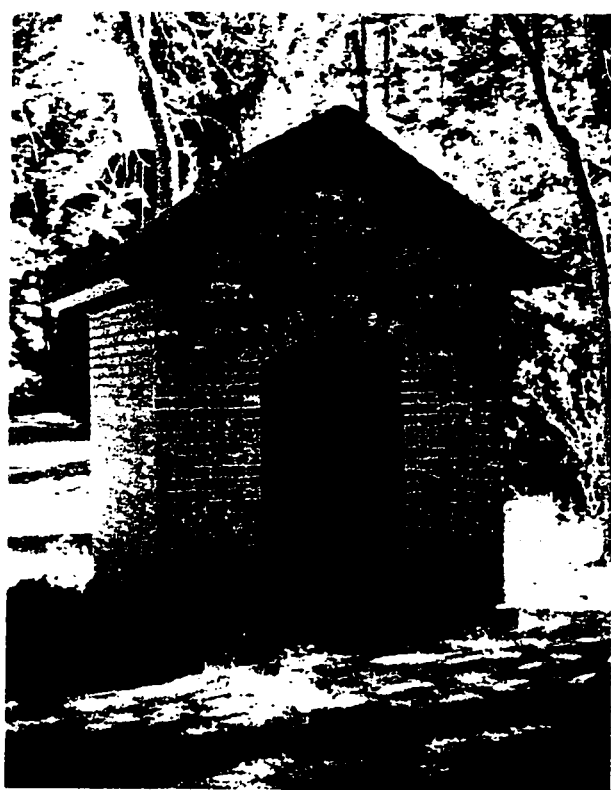
Smokehouse- Between 1985-1991, the smokehouse was used as a tool storage space for the part-time gardener. In 1992, the building was restored; a new roof was constructed and the exterior brick surface was re-pointed. There are no mechanical systems servicing the smokehouse. The building is not open to the public.

Figure 5.15: Smokehouse, 1996. (Photograph by the author).

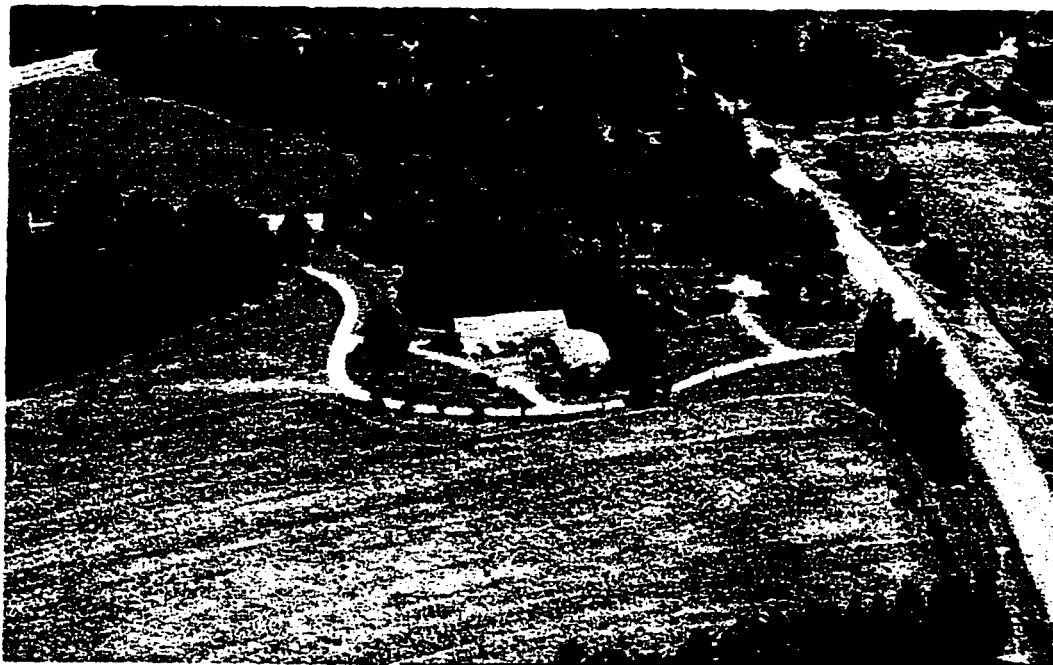
Maintenance/Storage Building Complex- The spatial configuration of the maintenance/storage complex was established with construction of the three Butler-type buildings and the visitor/service drive. The irregular shaped space is approximately 4 acres. The space is defined on the north by the east wood lot; on the south and west by the south field; and on the east by Rippleton Road. The base plane of the west half of the space is flat; the east half slopes negatively toward the northeast. Its surface consists of gravel, lawn, and an interspersed of several deciduous and evergreen trees and shrubs. The space is generally open to the sky.

Figure 5.27: The maintenance/storage complex, 1996. (Photograph by the author).

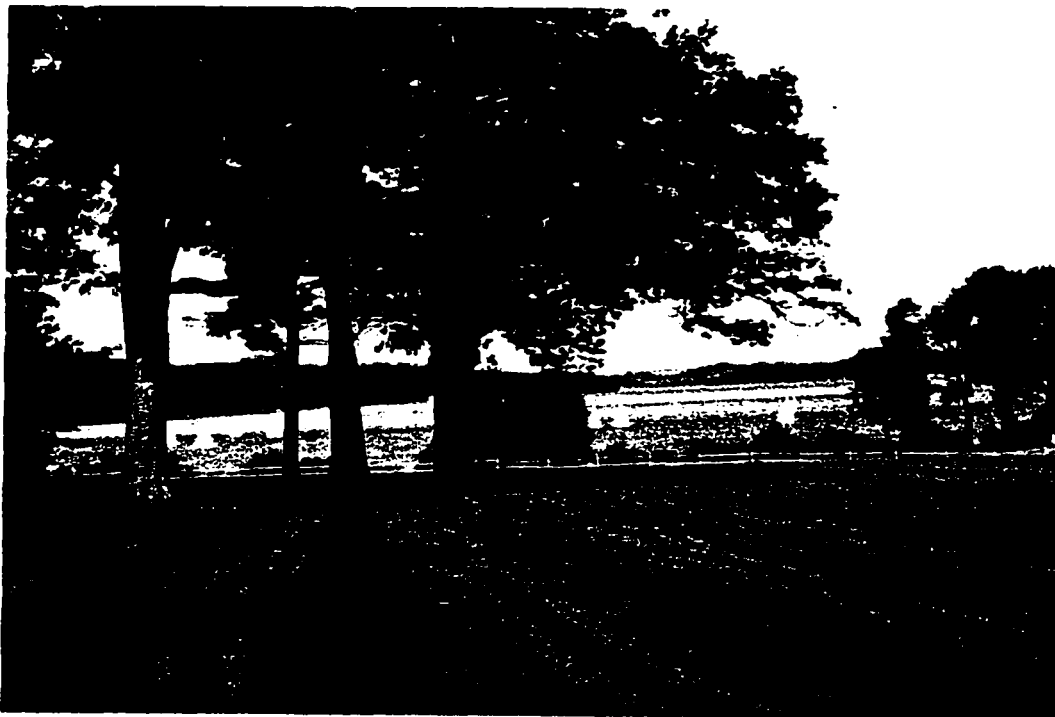
Views from the Mansion's Main Entrance Porch- The view from the main entrance porch to Cazenovia Lake exists. The removal of the arborvitae hedge along the south edge of the ha-ha wall enhanced the view from the mansion to the lake. The tuliptree planted in the front lawn affects the foreground of the view, but a strong relationship with the lake remains. The views east and west from the main entrance porch do not exist. The view west is terminated by mature evergreen vegetation (west wood lot). The view east to the village is terminated by mature evergreen vegetation (spruce row).

Figure 5.29: View north from the main entrance porch of the mansion, 1996.
(Photograph by the author).

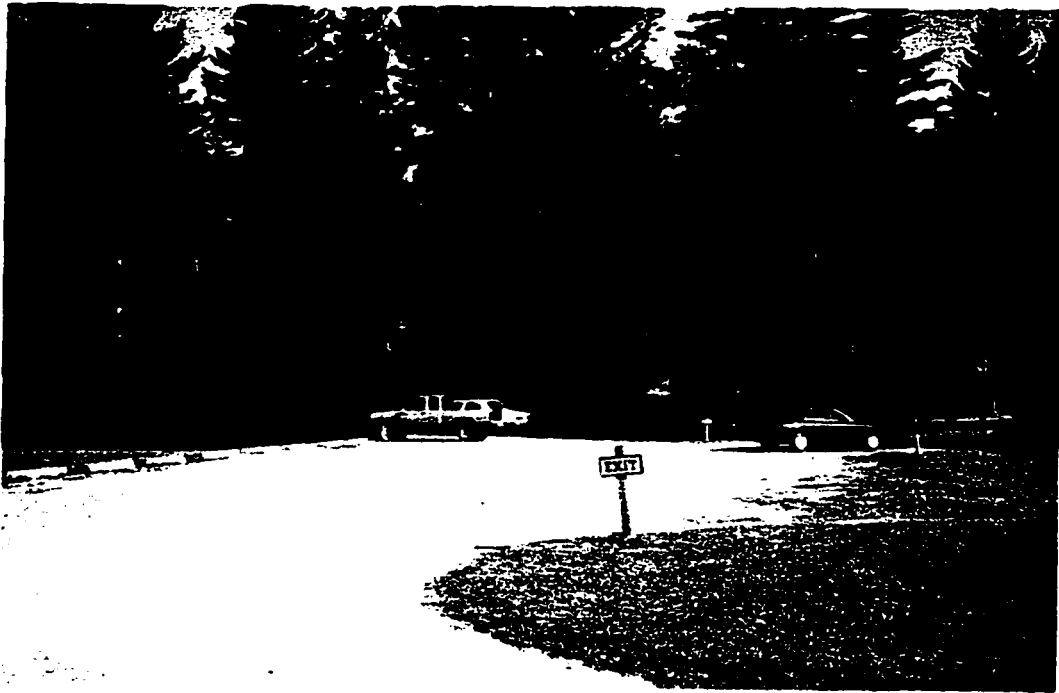
Secondary Entry Drive- In c. 1980, the secondary entry drive was altered with the construction of the visitor parking lot. The turning circle in front of South Cottage was removed and replaced with a rectangular shaped parking lot, approximately 80' x 200'. The surface of the parking lot consists of runner-crushed gravel. The edge of the parking lot is defined by lawn.

In 1980, the visitor parking lot north of South Cottage was expanded to hold thirty automobiles. Buses are accommodated within empty diagonal parking spaces or along the visitor entry drive. A single parking space for universal access is located adjacent to the entrance walk to South Cottage (another universal accessible parking space is located in front of the garden shed/ice house). In 1982, a concrete entrance walk, approximately 4 ½' x 50' was constructed in order to connect the South Cottage front porch and the visitor parking lot. In 1991, the west porch deck of South Cottage was raised, and a universal accessible ramp and landing were constructed.³⁵¹ The concrete ramp is 42" wide and is on a 1:12 grade that required minimal ground disturbance. The 5' x 9' landing and 32" railing were constructed of pressure treated wood.

Figure 5.32: Visitor parking lot, 1996. (Photograph by the author).

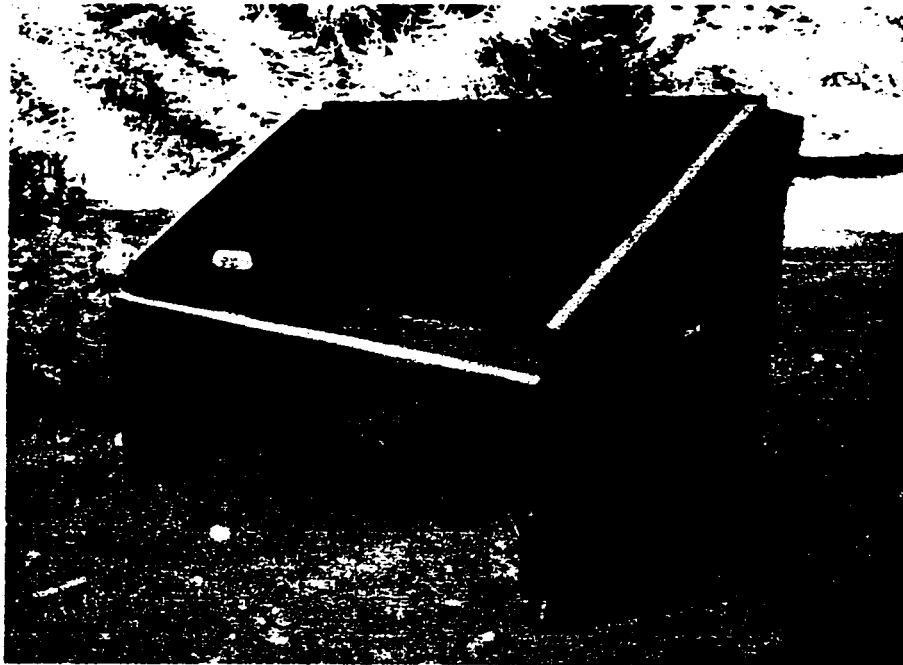
Garden Benches- In c. 1980, all six garden benches were reconstructed from their original designs (see chapter III). Two of the four wood garden benches, first present in the formal garden during the third historic period, are currently located opposite each other along the north end of the central walk; the other two are currently located at the south end of the central walk (see figure 5.38). The two wood benches found on the viewing platform exist at their historic locations on the north and south ends (see figure 5.37).

Figure 5.38: Typical garden bench along the formal garden's central walk, 1996. (Photograph by the author).

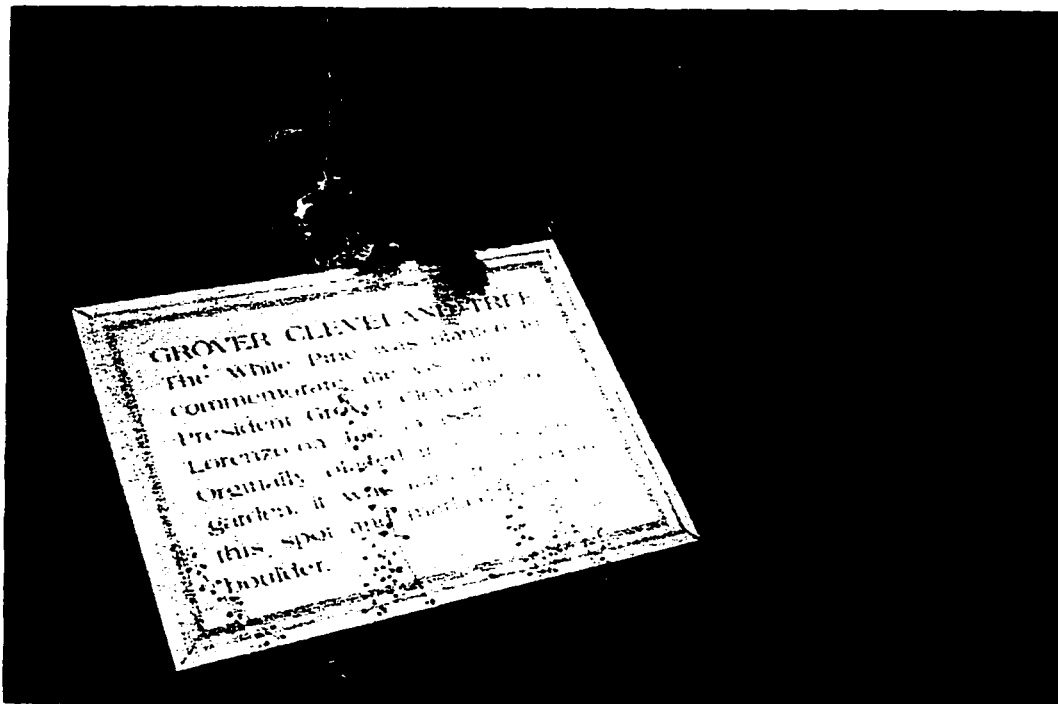
Interpretive Signs- In 1978, six interpretive signs were located in the following positions in the central core: the northeast corner of the mansion (1), the entrance to the formal garden (1), the center island in the formal garden (1), and near the tree planting marker stones (2 in the garden enclosures and 1 in the west wood lot). The signs are constructed of metal and are approximately 2 ½' tall. The color of the signs is gray. Each has a brief message about the feature/object they are located near.

Figure 5.41: Typical interpretive sign at Lorenzo, located adjacent to the Grover Cleveland Commemorative Stone and the white pine tree in the west wood lot, 1996. (Photograph by the author).

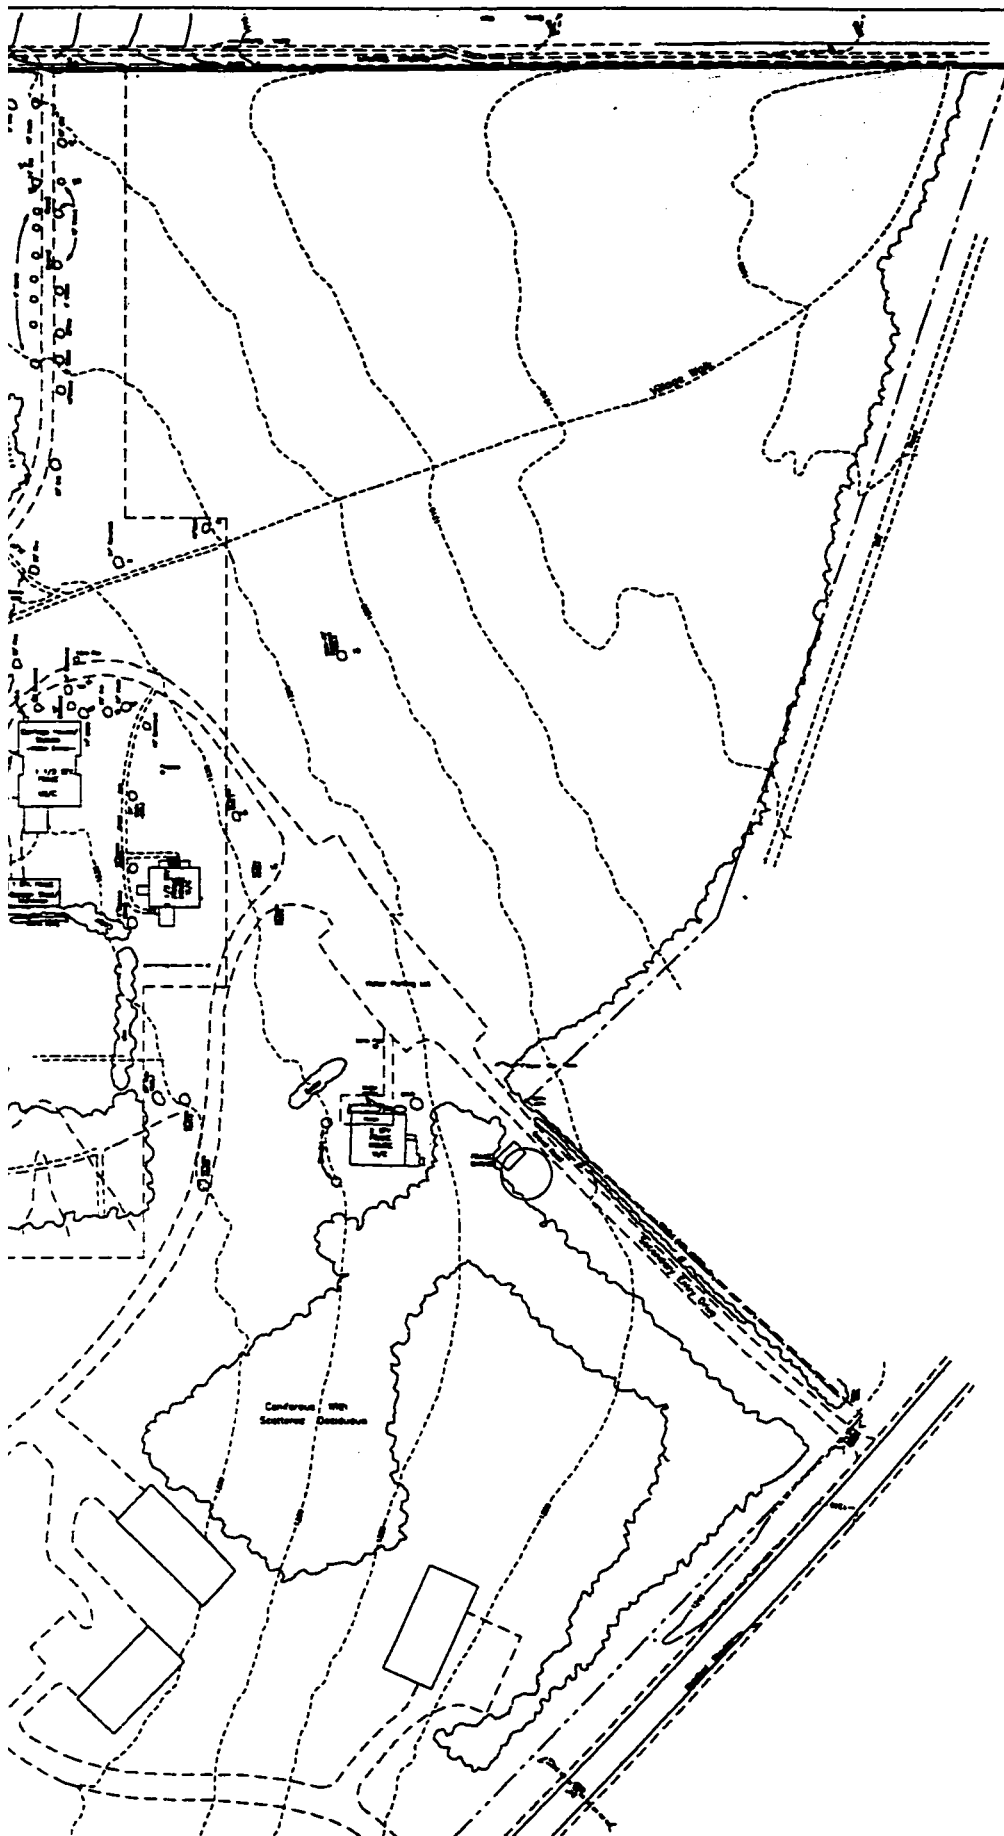
PREPARED BY STEREO-PHOTOGRAMMETRIC METHODS FROM VERTICAL AERIAL PHOTOGRAPHY OBTAINED DEC 1, 1976.

**CENTRAL CORE: NYSOPRHP OWNERSHIP PERIOD
(1968-1996 EXISTING CONDITIONS)**
