**CULTURAL LANDSCAPE REPORT FOR
LORENZO STATE HISTORIC SITE**

Friends of Lorenzo,
On Behalf of Lorenzo State Historic Site,
Office of Parks, Recreation and Historic Preservation, Central Region

State University of New York
College of Environmental Science and Forestry
Faculty of Landscape Architecture, Syracuse, New York
Research Assistant W. Paul Fritz, Project Director George W. Curry

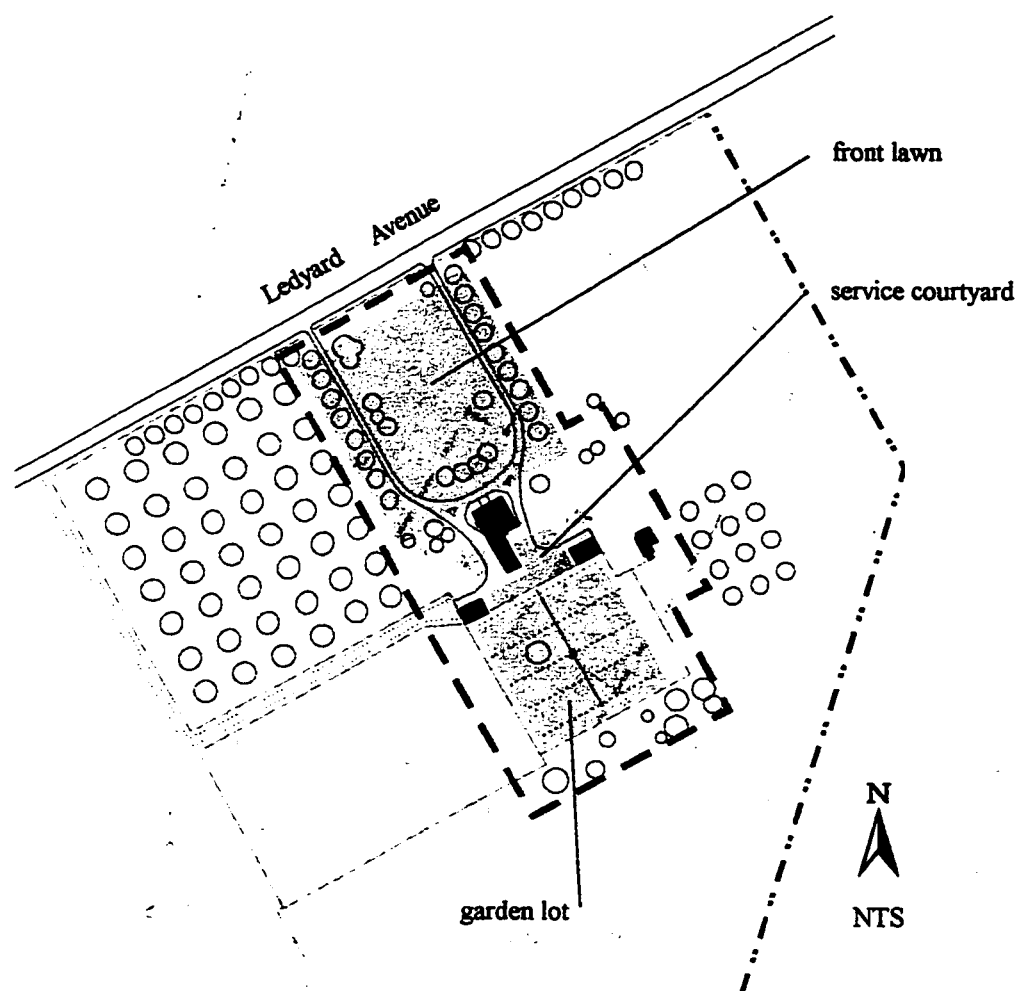
Figure 6.1: Spatial organization of the central core during the first historic period (Fritz, 1996. SUNY CESF).

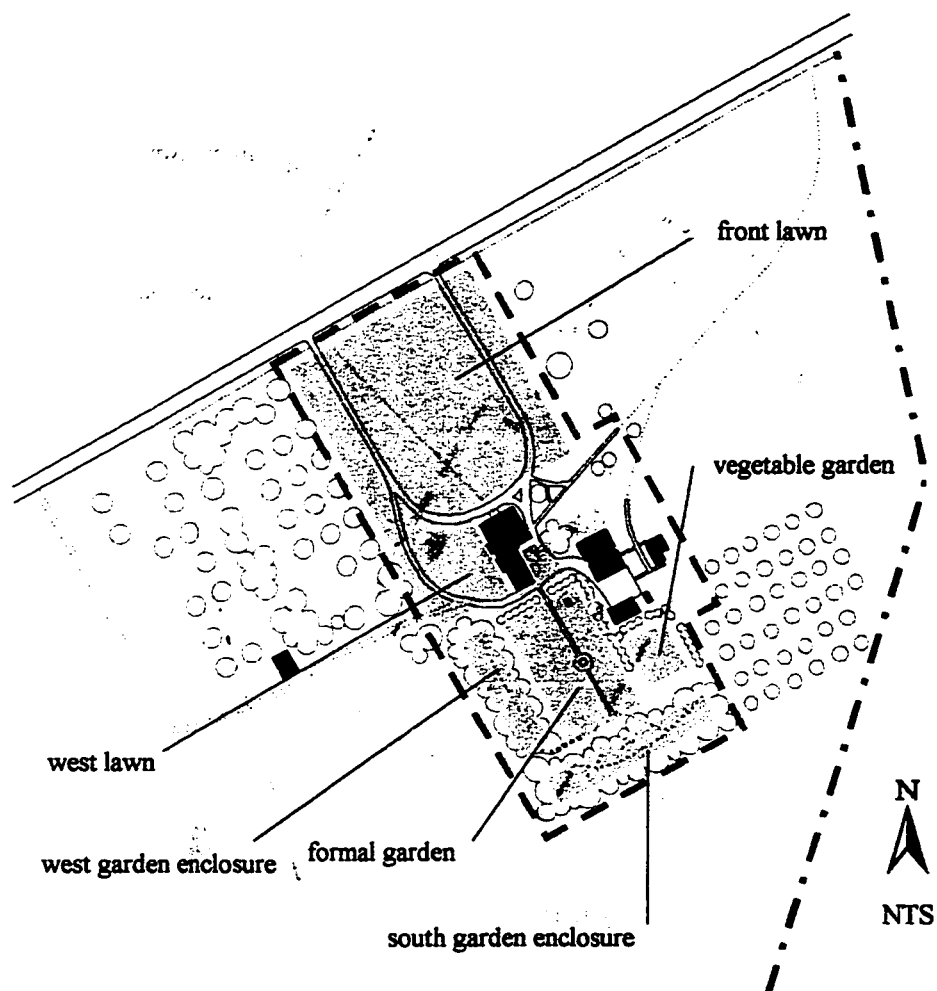
Figure 6.2: Spatial organization of the central core during the second historic period. (Fritz, 1996. SUNY CESF).

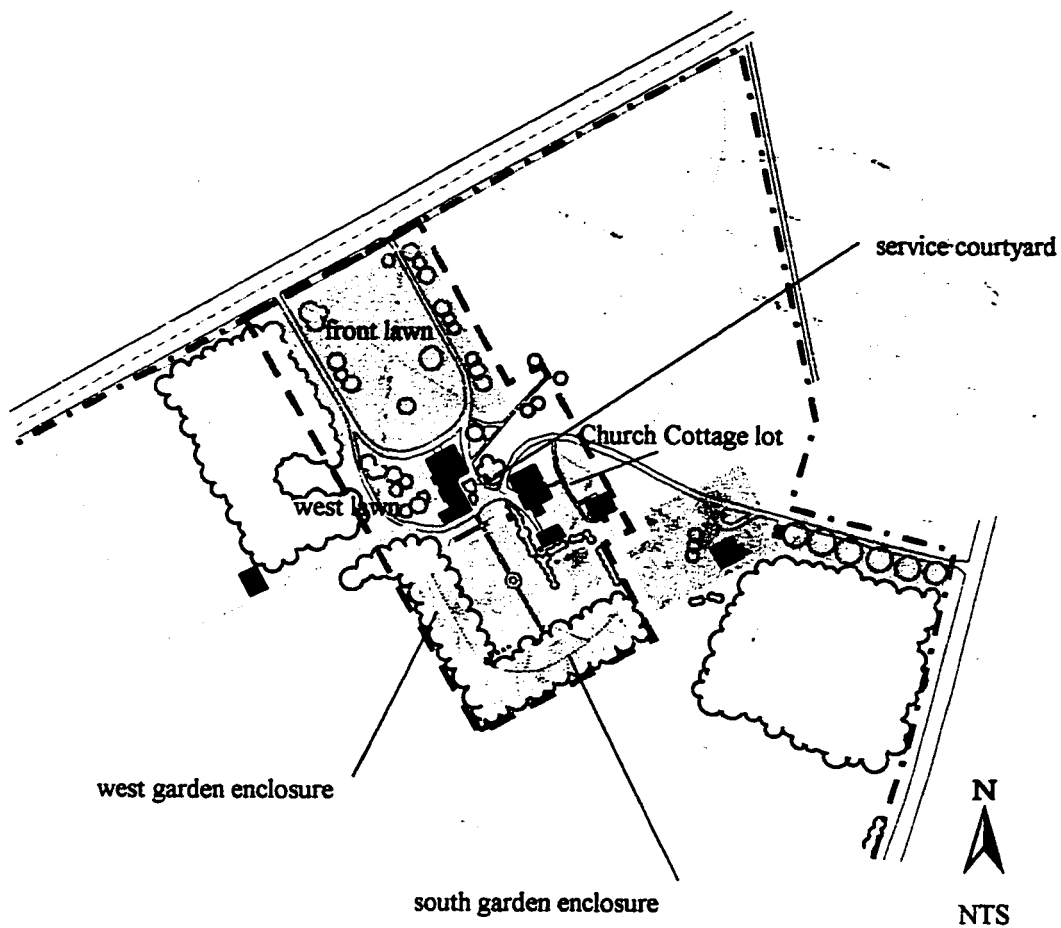
Figure 6.3: Spatial organization of the central core during the third historic period. (Fritz, 1996. SUNY CESF).

By the end of the historic development of the property, the outer acreage consisted of fourteen spatial units: the open fields, woodlands, west grove, farm complex, lower wetland, lake lot, west field, west wood lot, east orchard, east field, south field, east wood lot, secondary entry, and South Cottage lot. The central core eventually consisted of eight spatial units: the front lawn, west lawn, service courtyard, formal garden, vegetable garden, west garden enclosure, south garden enclosure, and Church Cottage lot (see figure 6.3).

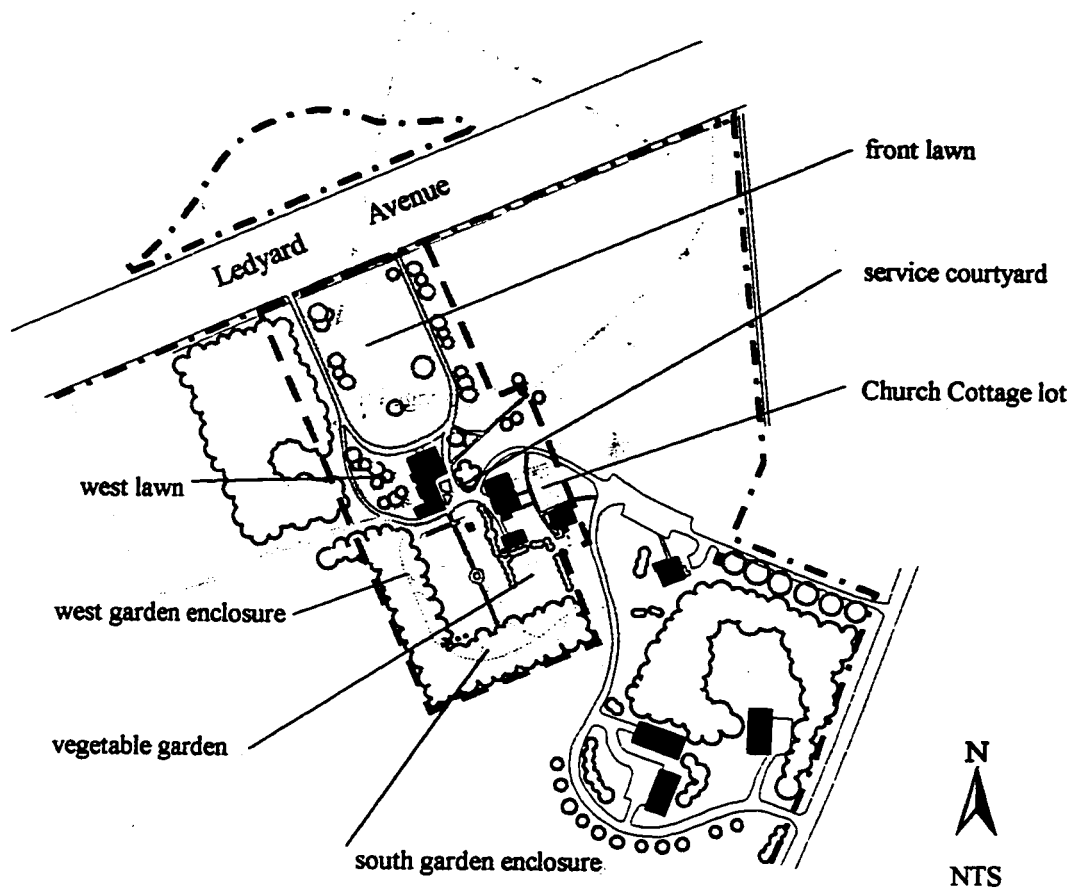
Figure 6.4: Spatial organization of the central core at Lorenzo, 1996.
(Fritz, 1996. SUNY CESF).

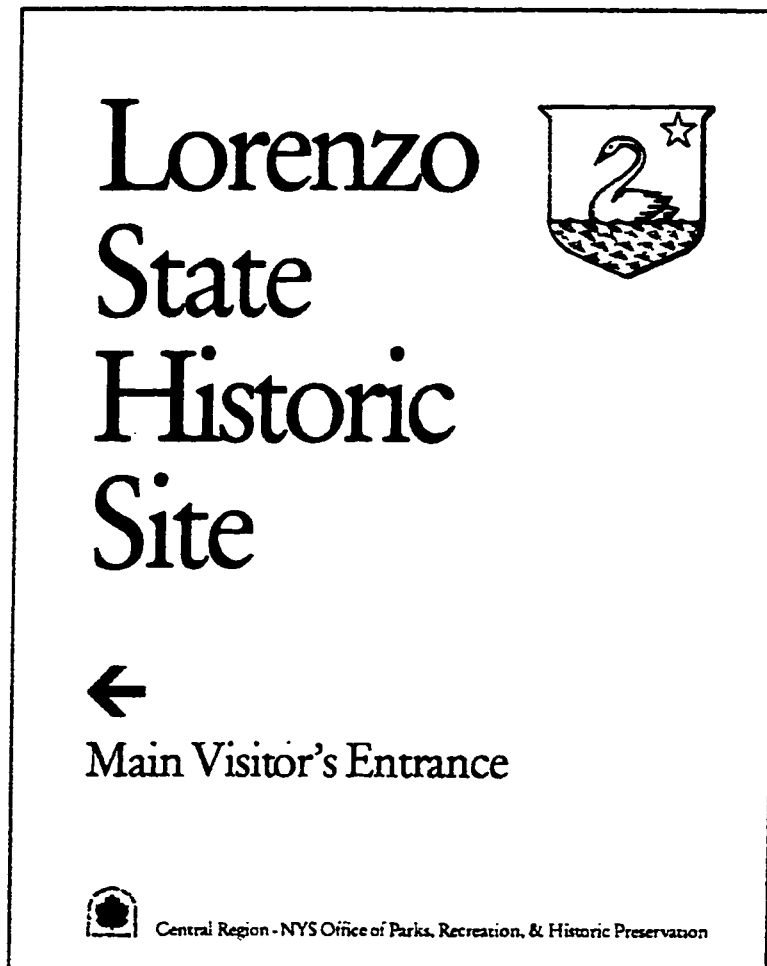
Concurrent with the development of this report, a new design for the directional signage system was completed (see figure 7.1).³⁷⁵ In order to improve visitor orientation, approximately 25 signs were developed and located at strategic locations.

Figure 7.1: Typical new information/directional signage design, 1997. (Scott Shannon, 1997).

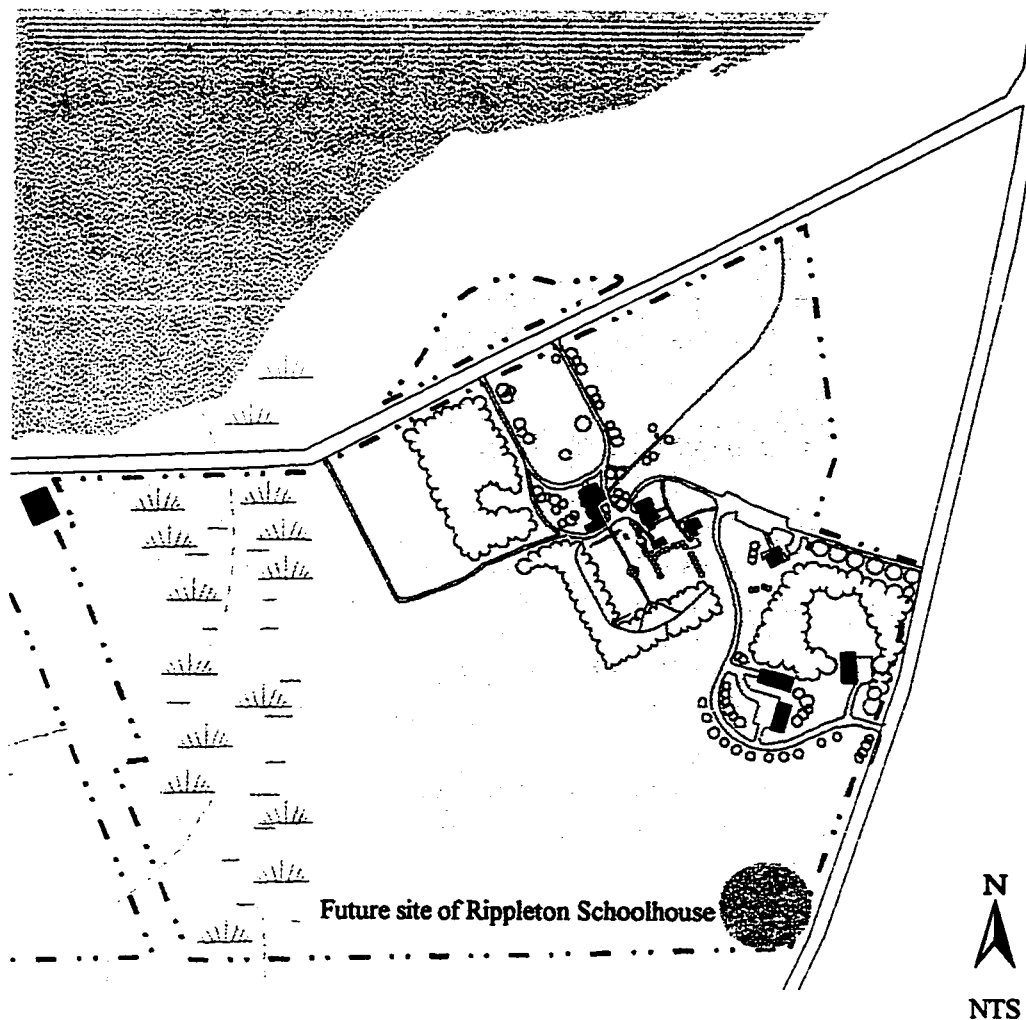
The building should be sited in the southeast corner of the property and be set back at a distance representative of the historic condition between most rural nineteenth century schoolhouses and adjacent public roads. A discernible boundary separating the schoolhouse from the south field should be developed. The defining characteristics of the schoolhouse edge should include a combination of mowed lawn, meadow grasses, and roadside trees (no fence). In order to accommodate visitor needs, a circulation system comprised of a simple drive, turn-around and drop-off should be designed with minimal impact on the topography and vegetation of the south field.

Figure 7.4: Map showing future site of the Rippleton schoolhouse. (Fritz, 1996. SUNY CESF).

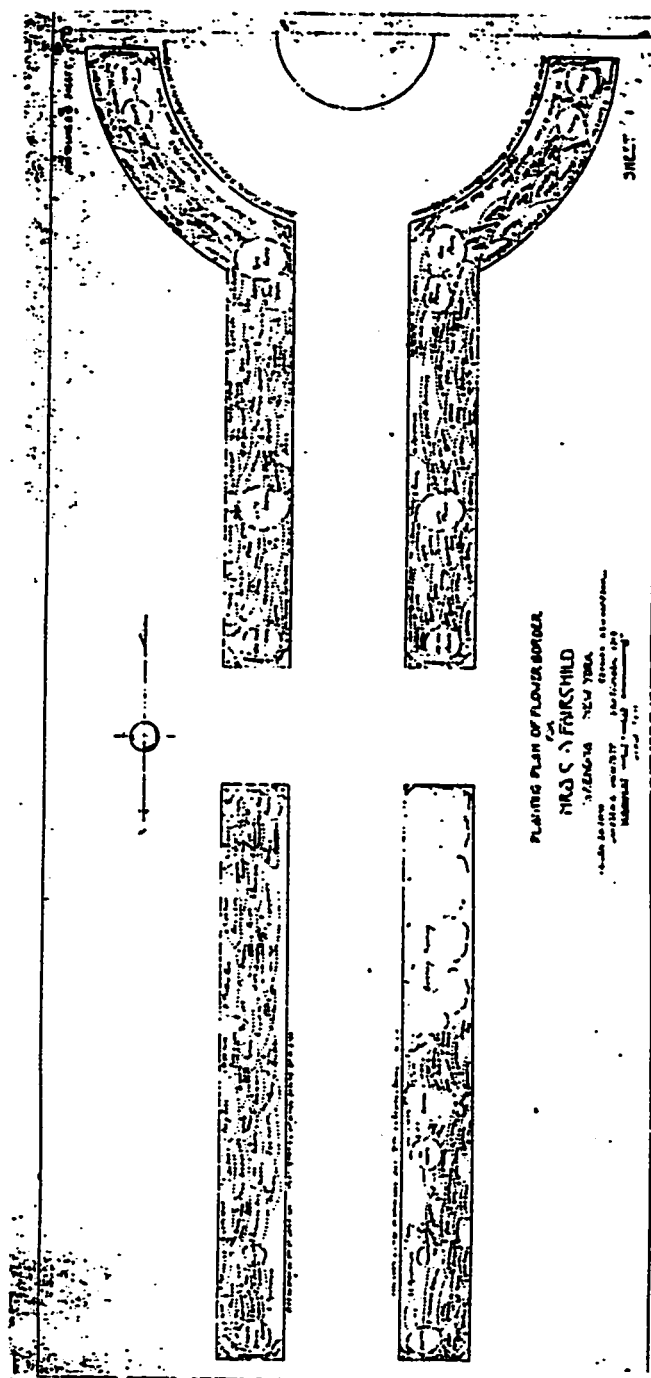
Sheet 1: Planting Plan Of Flower Border For Mrs. C. S. Fairchild, Cazenovia, New York, September 1914.[North half of the formal garden's central walk].

Planting Plan of Flower Border For Helen K. Fairchild, 1914

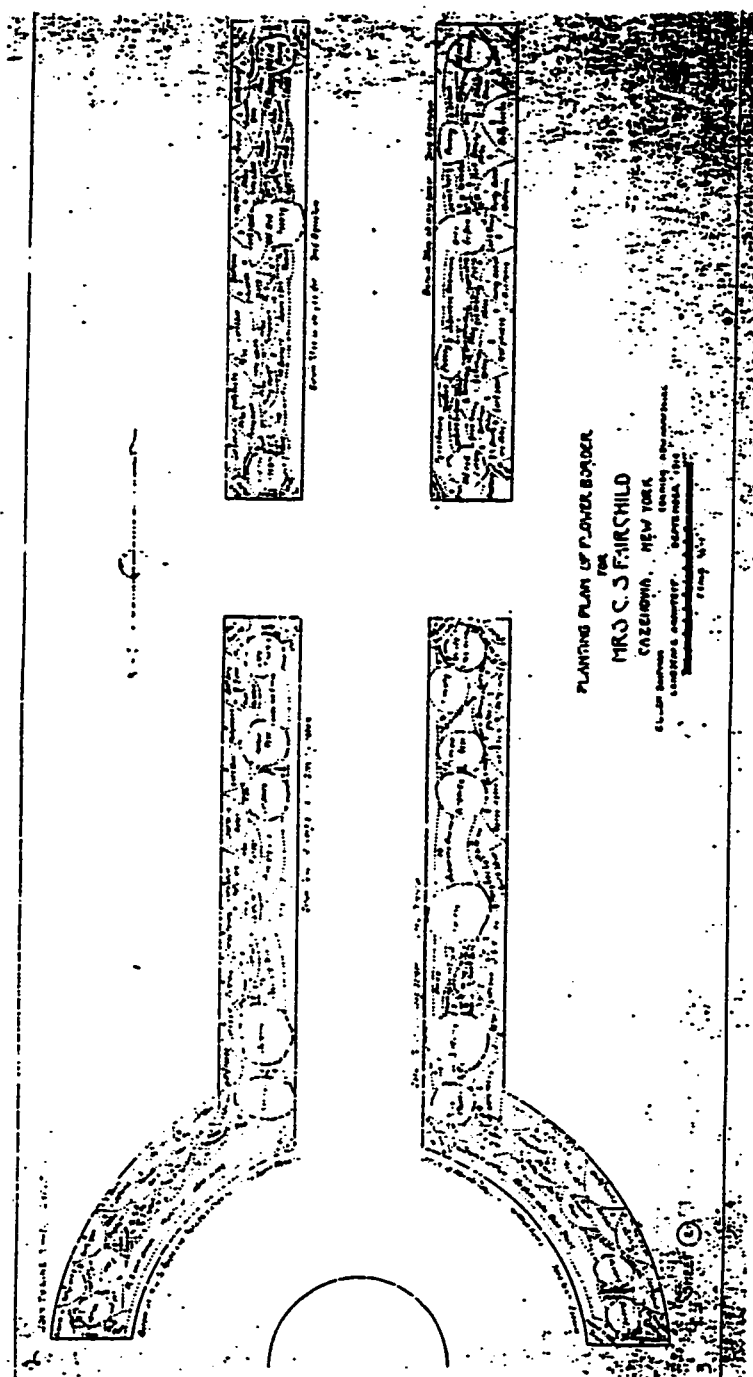
Sheet 2: Planting Plan Of Flower Border For Mrs. C. S. Fairchild, Cazenovia, New York, September 1914.[South half of the formal garden's central walk].

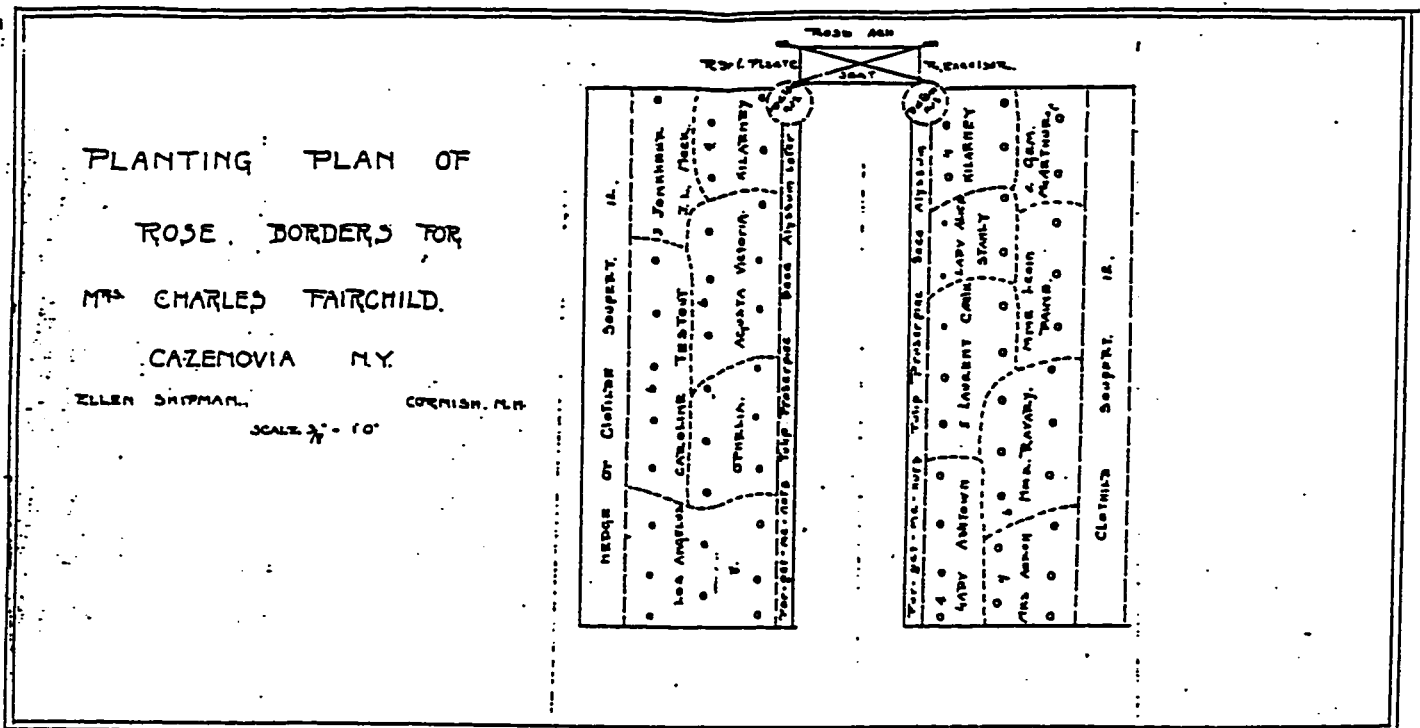
Planting Plan of Rose Borders For Helen K. Fairchild, c. 1914

²⁶⁶ Ellen Biddle Shipman also developed a planting plan of Rose Borders for Helen L. Fairchild (see Appendix H). During research for this report, documentation indicating the rose borders were ever implemented was not found.
