Rehabilitation Treatment Plan for the Historic Designed Landscape at Mauchline, Wilmington, Delaware

REHABILITATION TREATMENT PLAN FOR THE HISTORIC DESIGNED LANDSCAPE AT MAUCHLINE, WILMINGTON, DELAWARE

A capstone studio submitted in partial fulfillment of the requirements for the Master of Landscape Architecture Degree State University of New York College of Environmental Science and Forestry Syracuse, New York May 2002

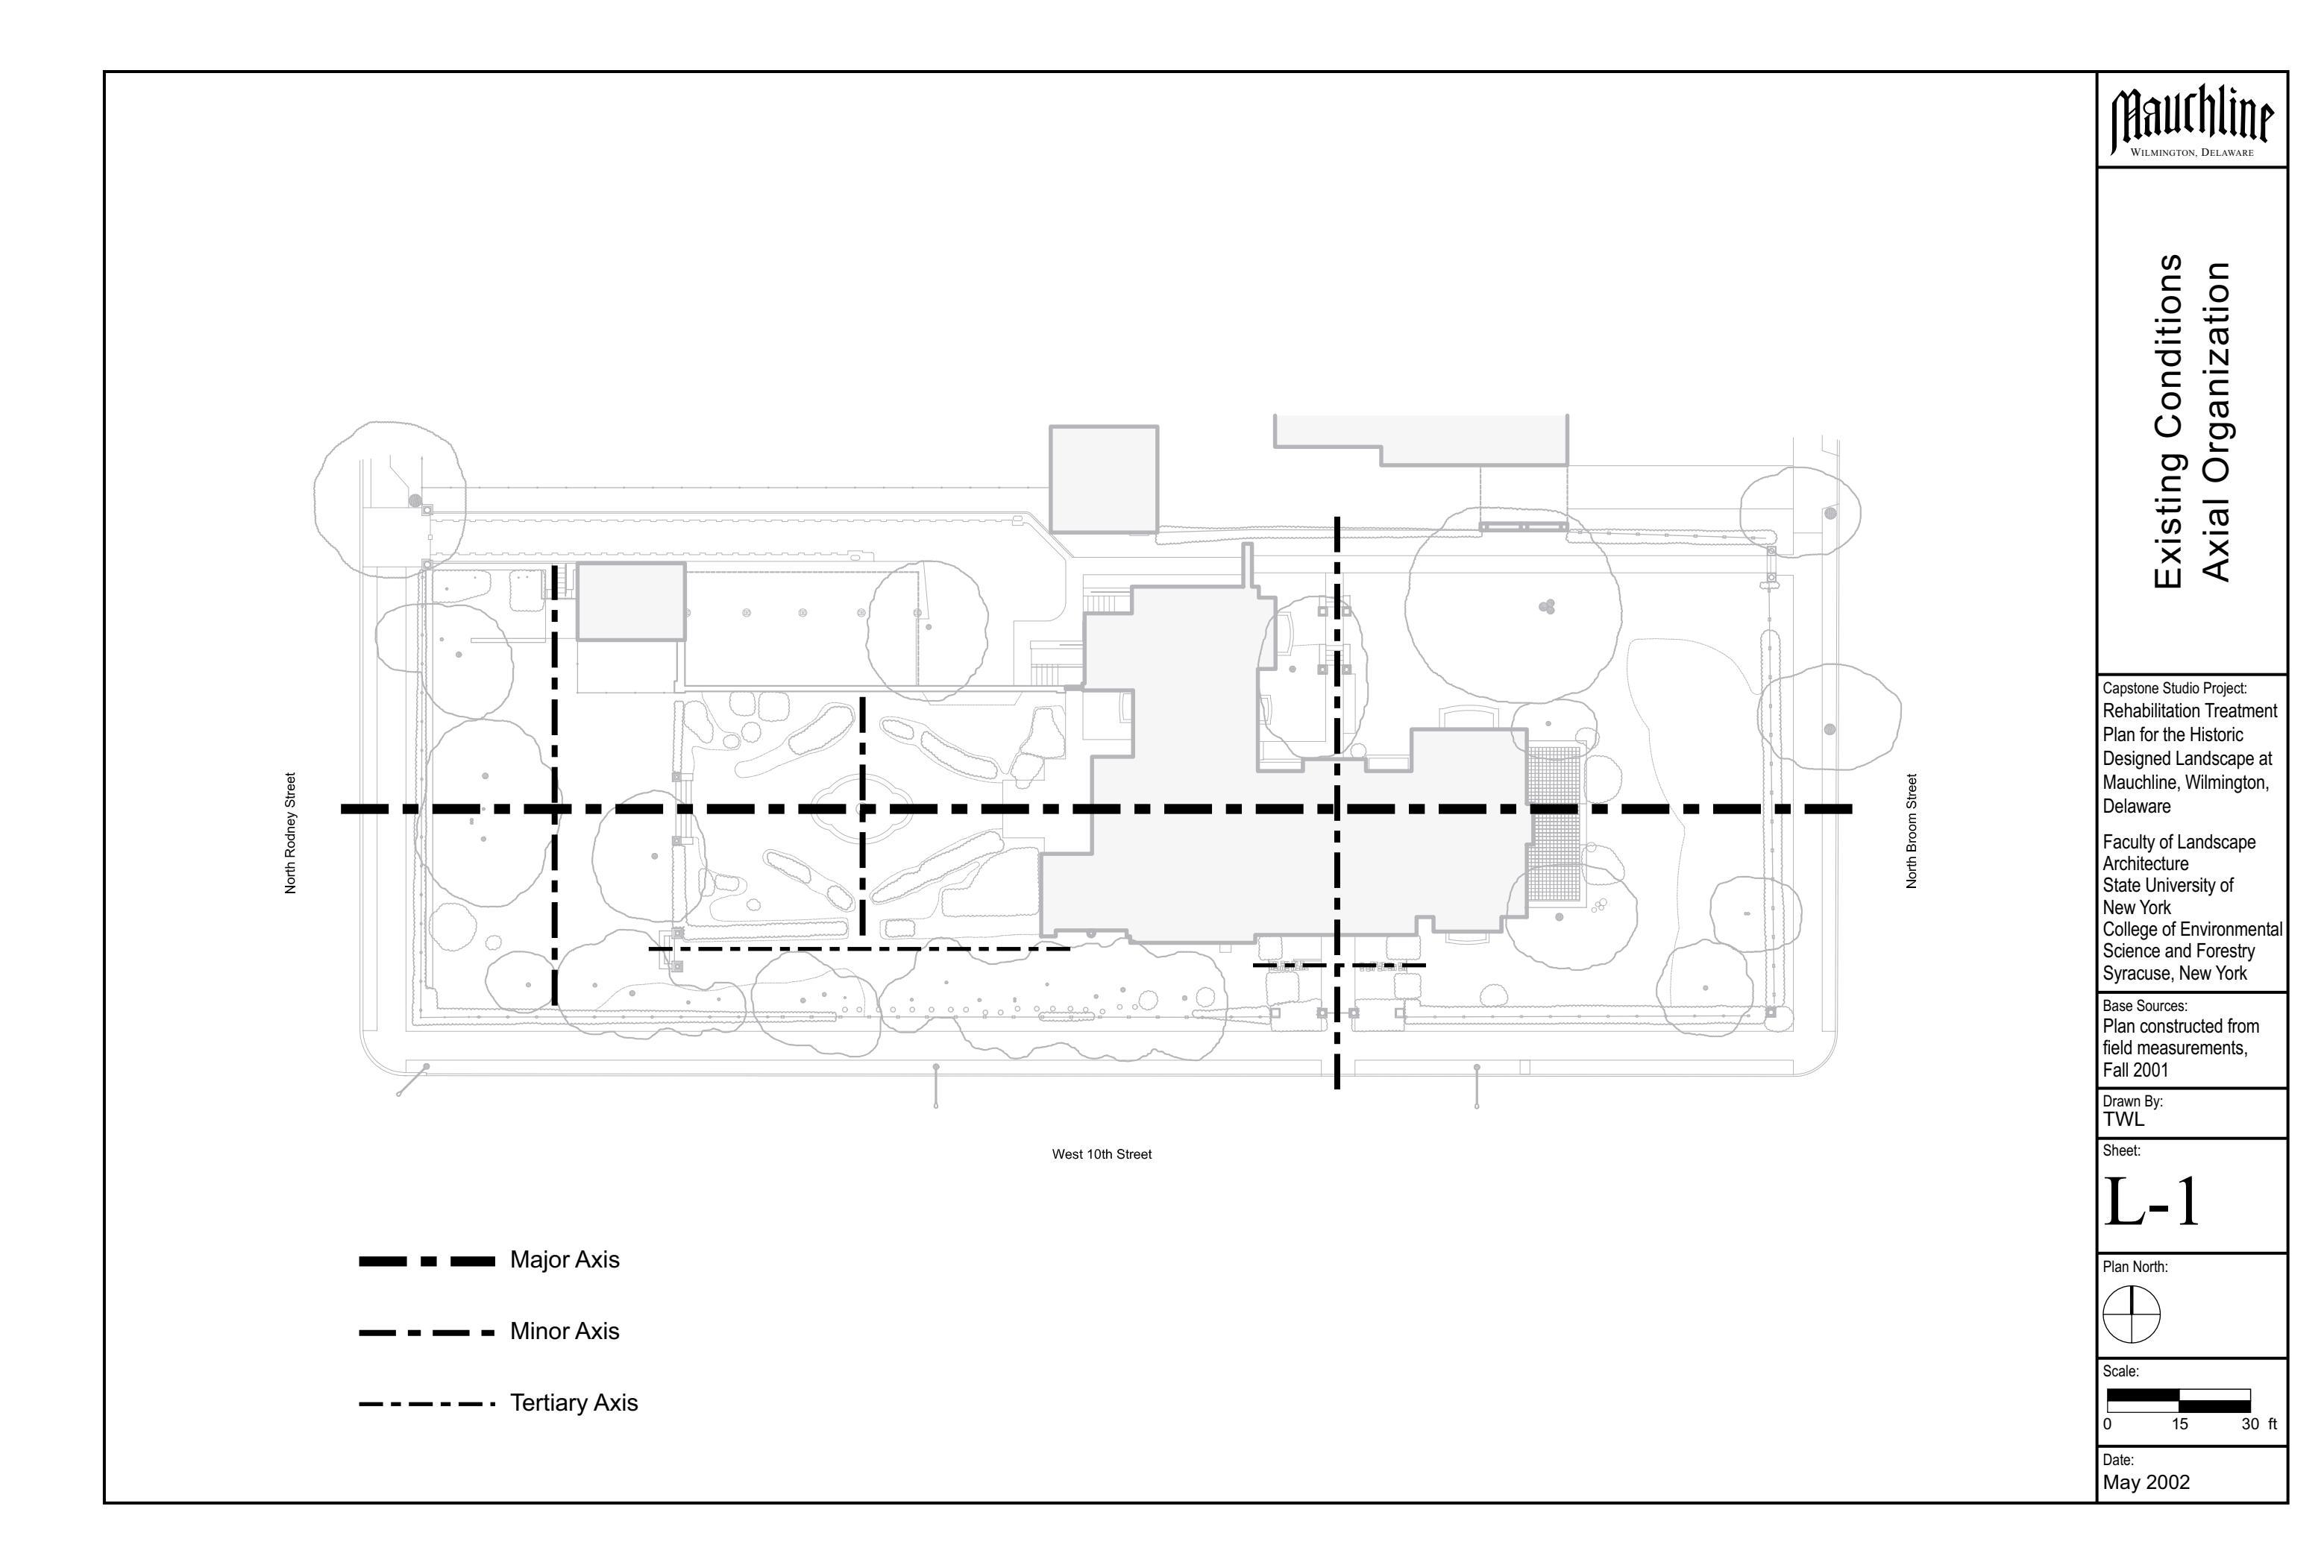
To facilitate a description of the existing conditions, all directions in this section refer to Plan North as illustrated in sheet L-1. With that orientation in mind, the Mauchline property can be defined by boundaries formed along: North Broom Street on the east; West Tenth Street on the south; North Rodney Street on the west; and a neighboring property on the north. The footprint of the house is approximately 5,000 square feet and is roughly L-shaped in plan. The longer leg parallels West Tenth Street and is setback about 30 feet from the street edge. To better understand their arrangement and organization, the house and landscape features on the property can be analyzed according to a series of axes (sheet L-1).

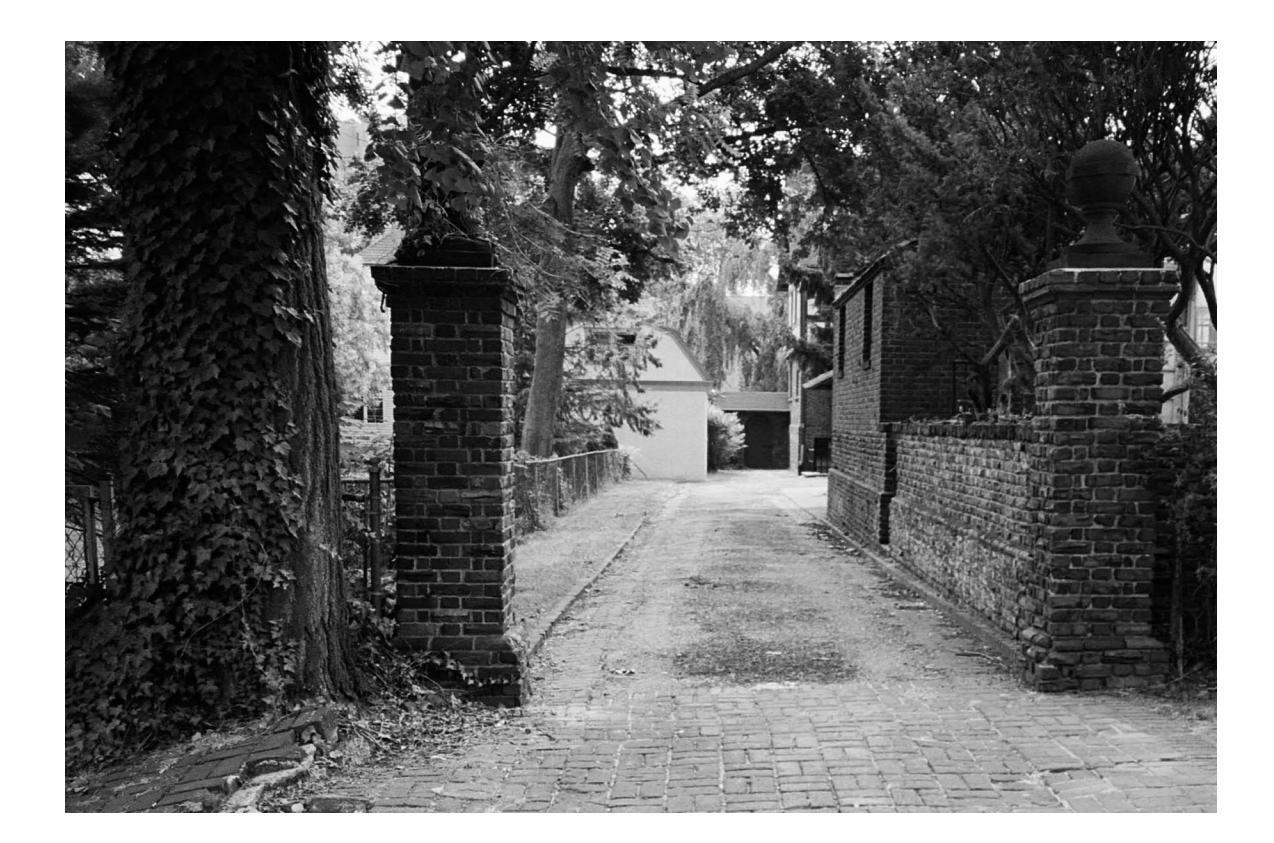
Fig. 9. View Looking East at the Driveway, 4 August 2001. The widest and tallest brick piers on the property mark the entrance from North Rodney Street to the driveway. Note the brick wall (*right*) and back wall of the greenhouse (*middle right*) that separate this space from the upper terrace. Also present is a large ginkgo (*Ginkgo biloba*) that has heaved and damaged the sidewalk (*left*). Photograph by the author.

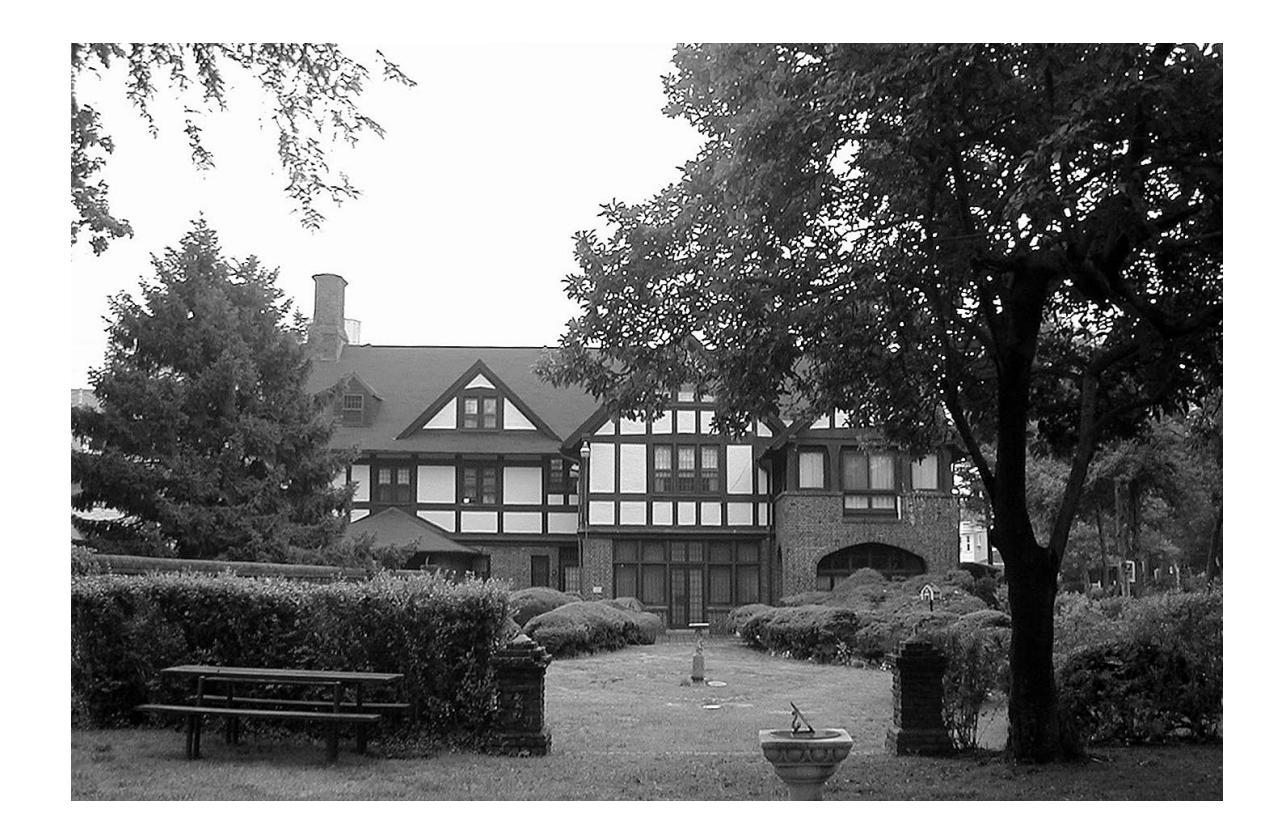
Fig. 10. View from the Upper Terrace Looking East at the Main Garden, 11 August 2001. These two spaces are organized by the property's major east-west axis that extends through the double-doors on the facade *(center)*. The axis bisects an elliptical pool and fountain in the main garden and a sundial in the upper terrace. Privet (*Ligustrum obtusifolium*) hedge and brick piers and stairs mark the transition between these two spaces. Photograph by the author.

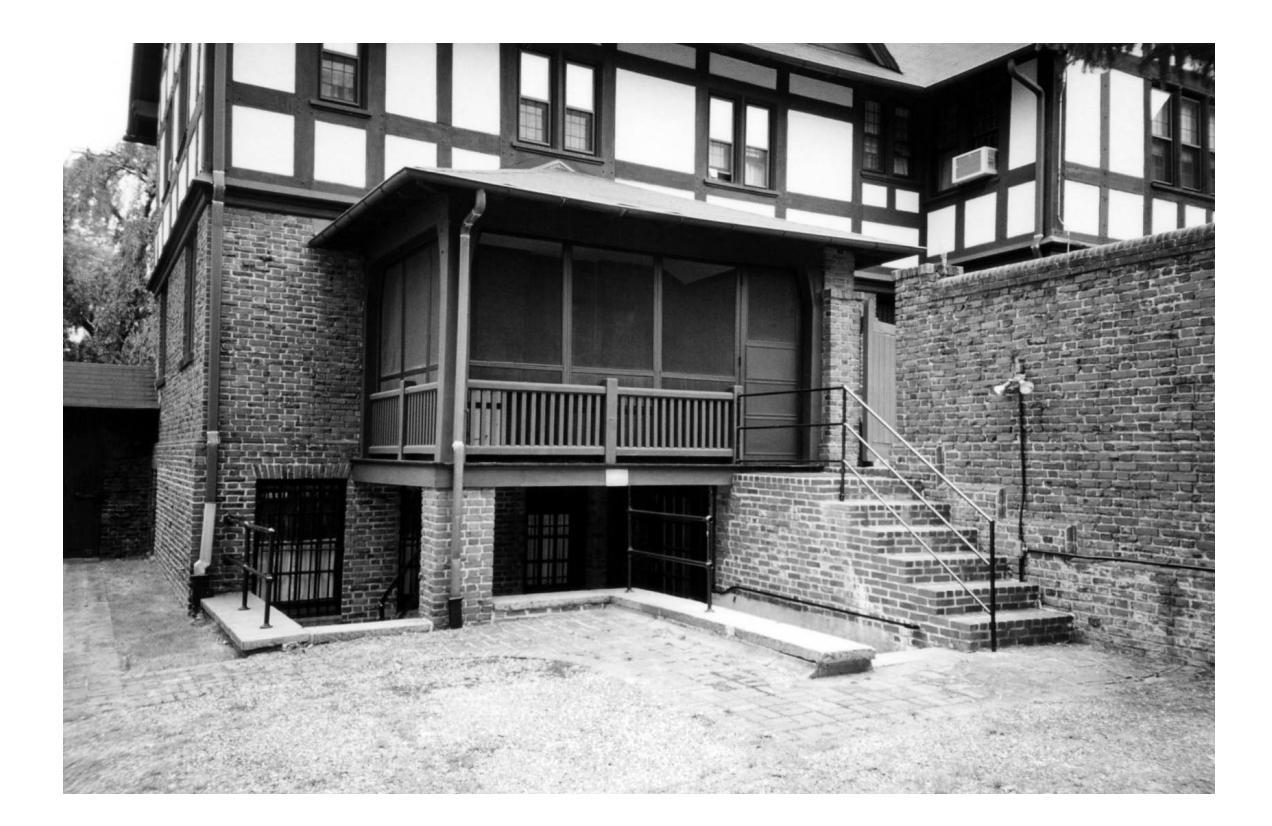
Fig. 11. View Looking Southeast at the Service Area, 4 August 2001. Stairs lead from the main garden and a screened porch down to the service area. A ramp, to the immediate left of the stairs, and a set of stairs beyond the porch provide access down to the basement. The hooded gate can be seen in the middle left of the picture. Photograph by the author.

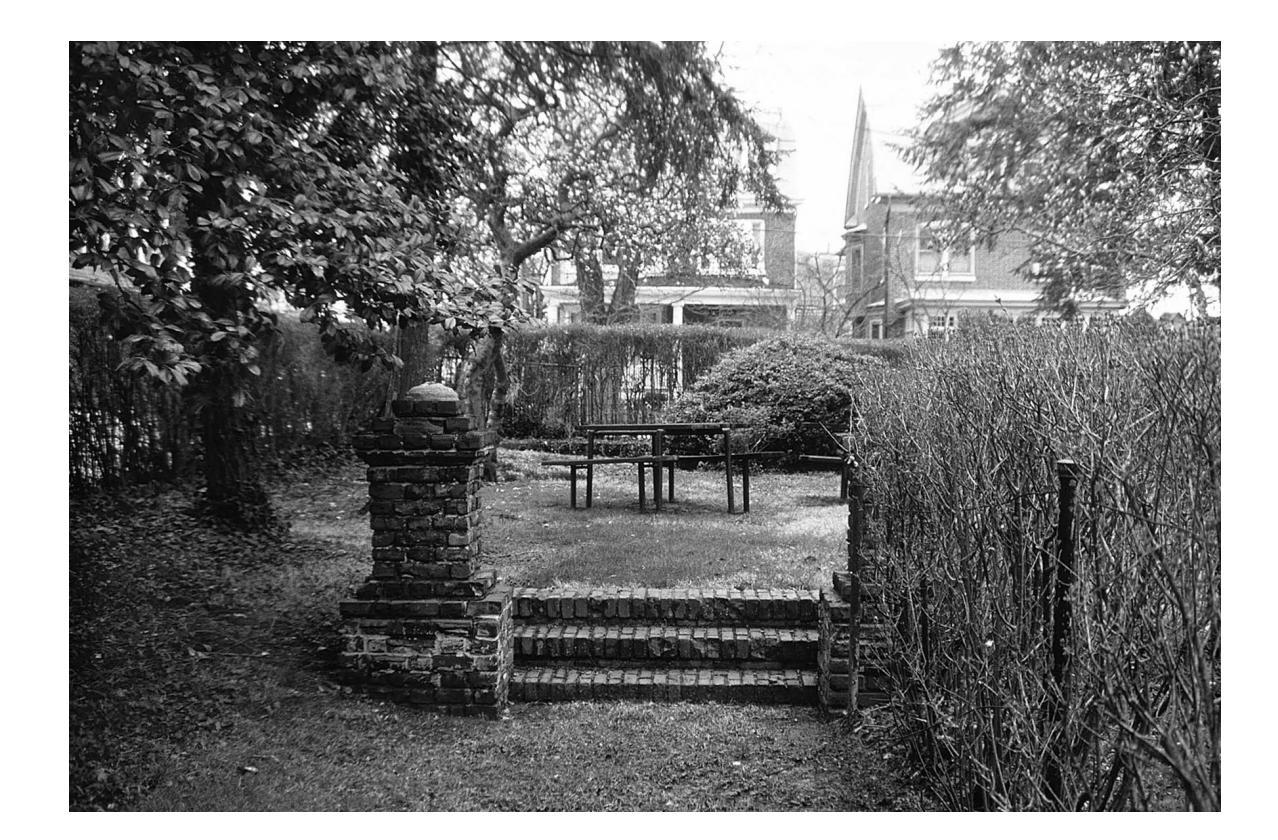
Fig. 12. View Looking West at the Garden Path Stairs, 17 March 2000. The western terminus of the garden path is a set of brick piers and stairs leading to the upper terrace. The definition of this corridor space is achieved by privet (*Ligustrum obtusifolium*) hedge seen on the right and American hollies (*Ilex opaca*) whose lower branches can be seen on the left. Photograph by the author.

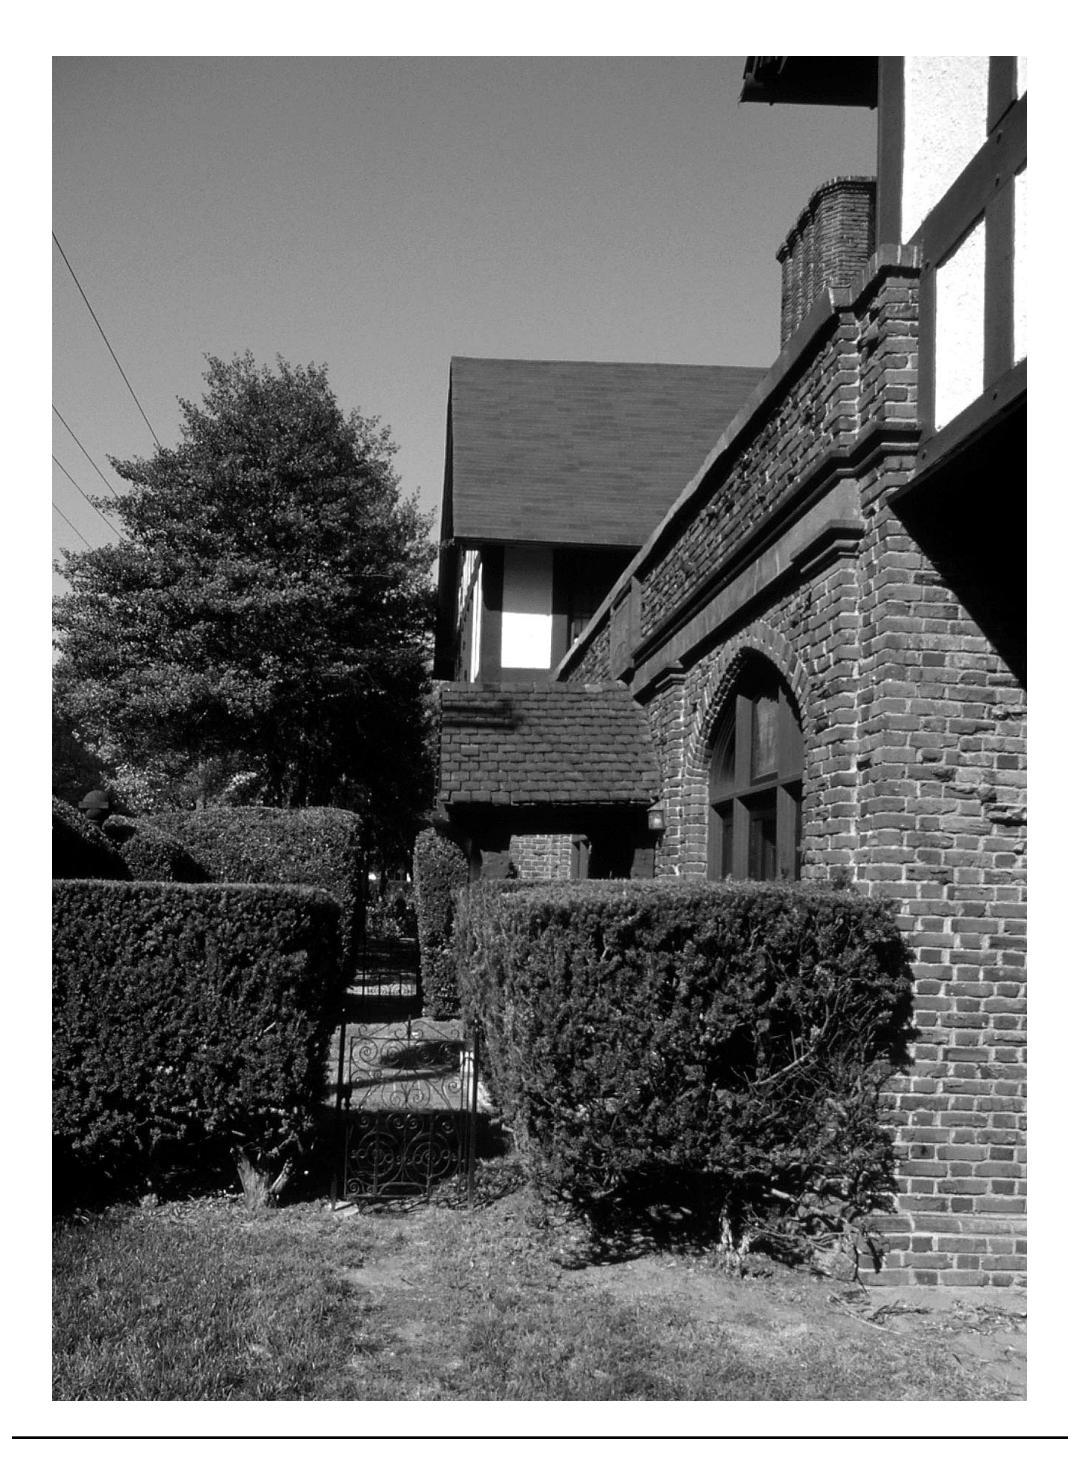
Fig. 13. View Looking East at the Entry Space, 20 October 2001. The transitions from the entry space to the garden path and porch garden are marked by hedges and two, low black metal gates. Photograph by the author.
center. Like the other gates it is constructed of metal and finished with black paint. The gate distinguishes itself as the main entrance to the property with scrollwork and floral motifs above its rails (fig. 14). It is also twice as high as the low gates in the entry space. On either side of the main gate, offset about eight feet from the brick piers, is another brick pier. The four piers in this space are partially or completely concealed by the growth of the hedges. The low gates on the west and east boundaries of this space are along a tertiary axis. This axis intersects a minor axis running from north to south through the north court, house, and entry.

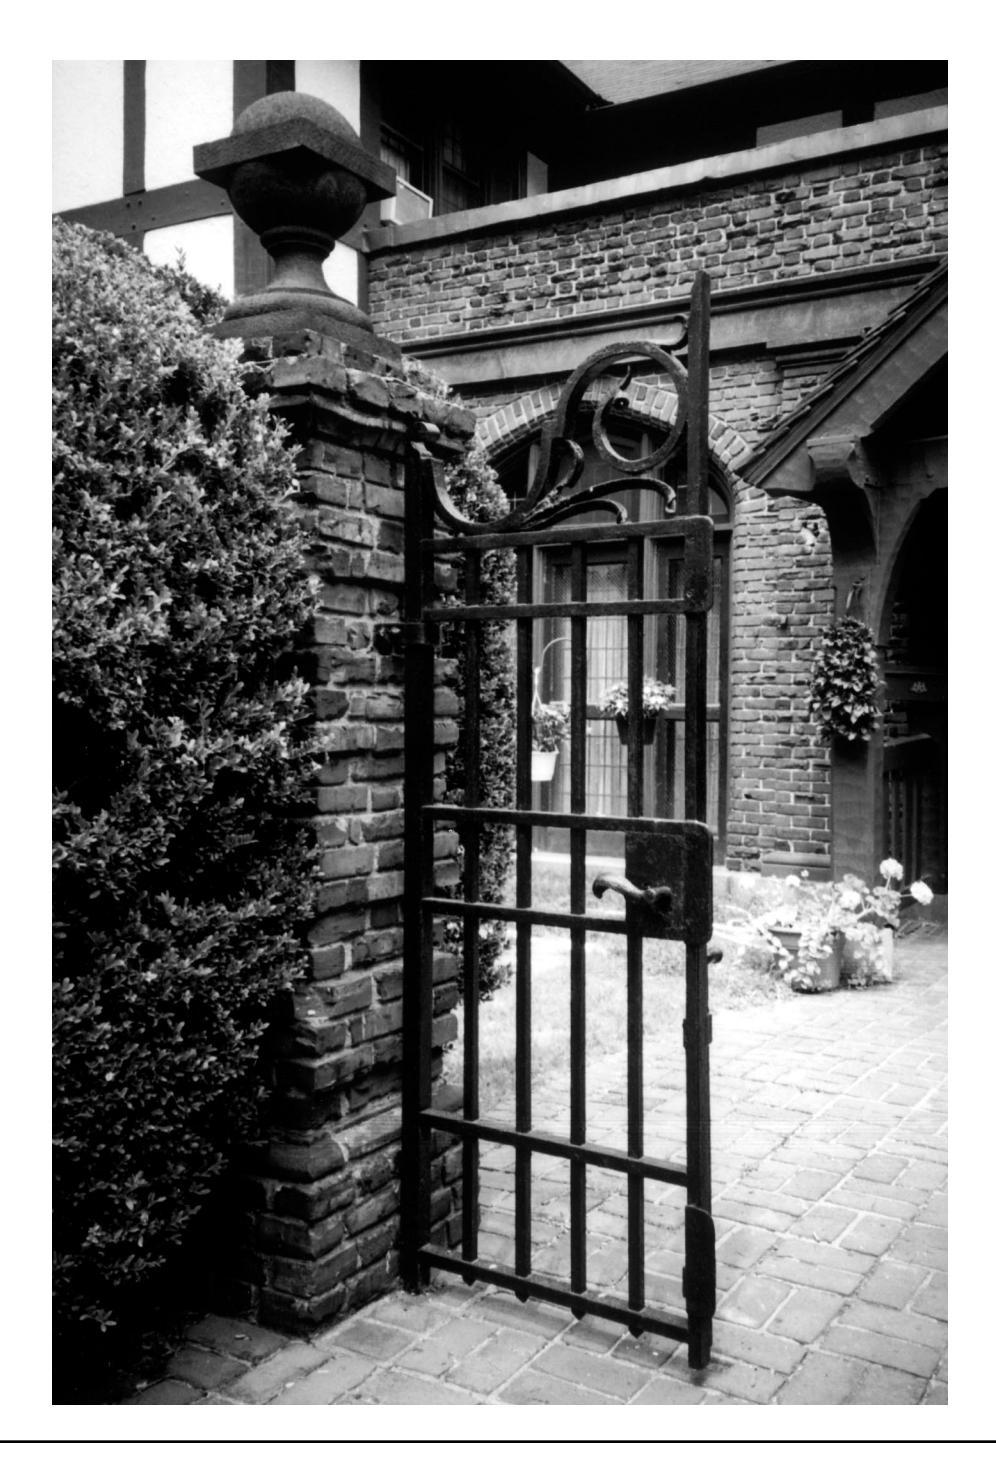
Fig. 14. Main Entry Gate, 4 August 2001. The main gate is taller than the other gates in the entry space and features scrollwork and floral motifs above its rails. The piers associated with this gate are highlighted with recessed brick courses on the columns and a spherical finial circumscribed by a square. Note that the hedge is encroaching on the pier. Photograph by the author.

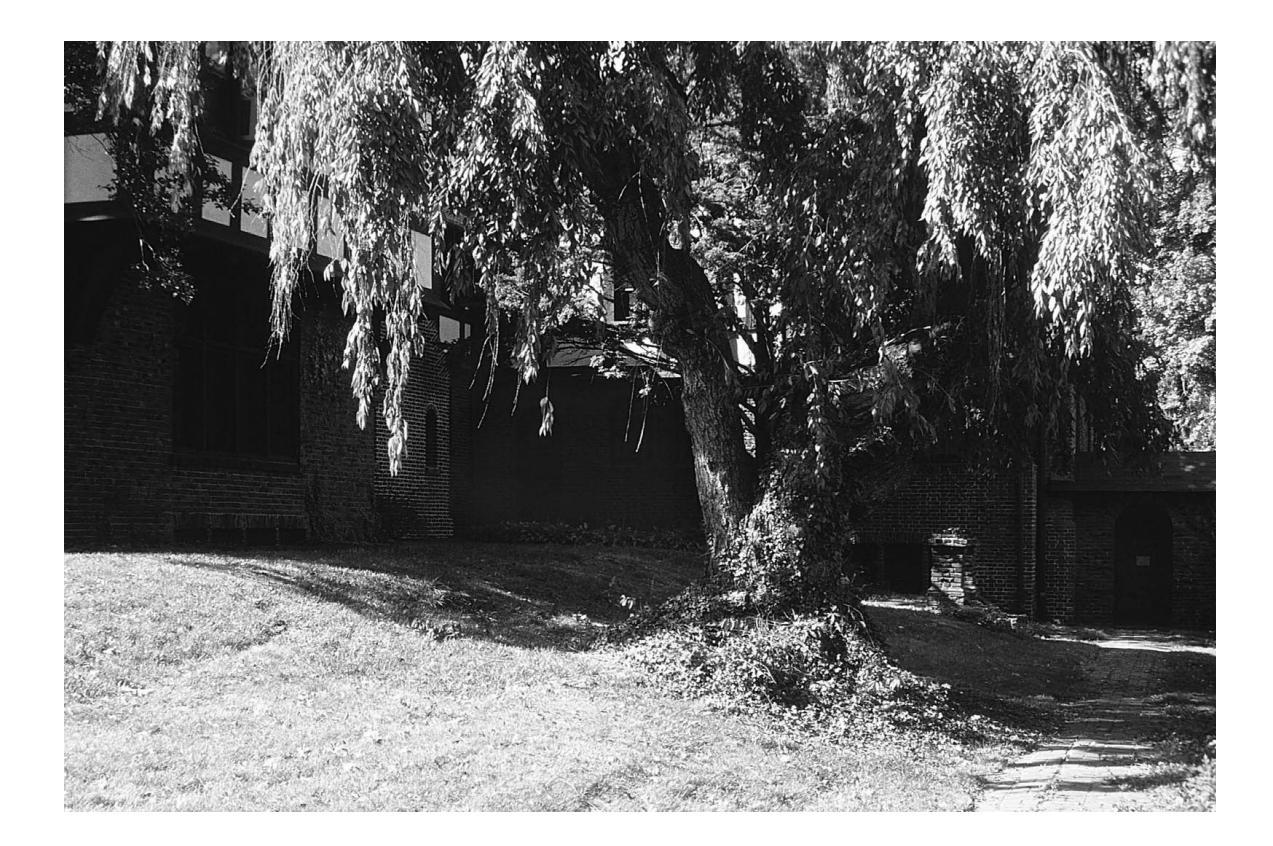
Fig. 16. View Looking West at the North Court, 20 October 2001. A substantial weeping cherry (*Prunus subhirtella* var. *pendula*) creates a separation between the north court and porch garden. A brick walk on the right of the photograph leads to the hooded gate. There is a rise in elevation from this walk to the house. Note also the amount of shade this area receives. Photograph by the author.

On the opposite side of the house from the entry is a space called the north court. The name "north court" is derived from a caption for a picture of this space in the August 1919 edition of *The Architectural Forum* (fig. 15). The southern and western boundaries of this space are defined by the house. The northern boundary is defined by hedge and reinforced by a house on the adjacent property. In the eastern section of this space, a substantial weeping cherry tree (*Prunus subhirtella* var. *pendula*) creates a separation between the north court and porch garden (fig. 16).

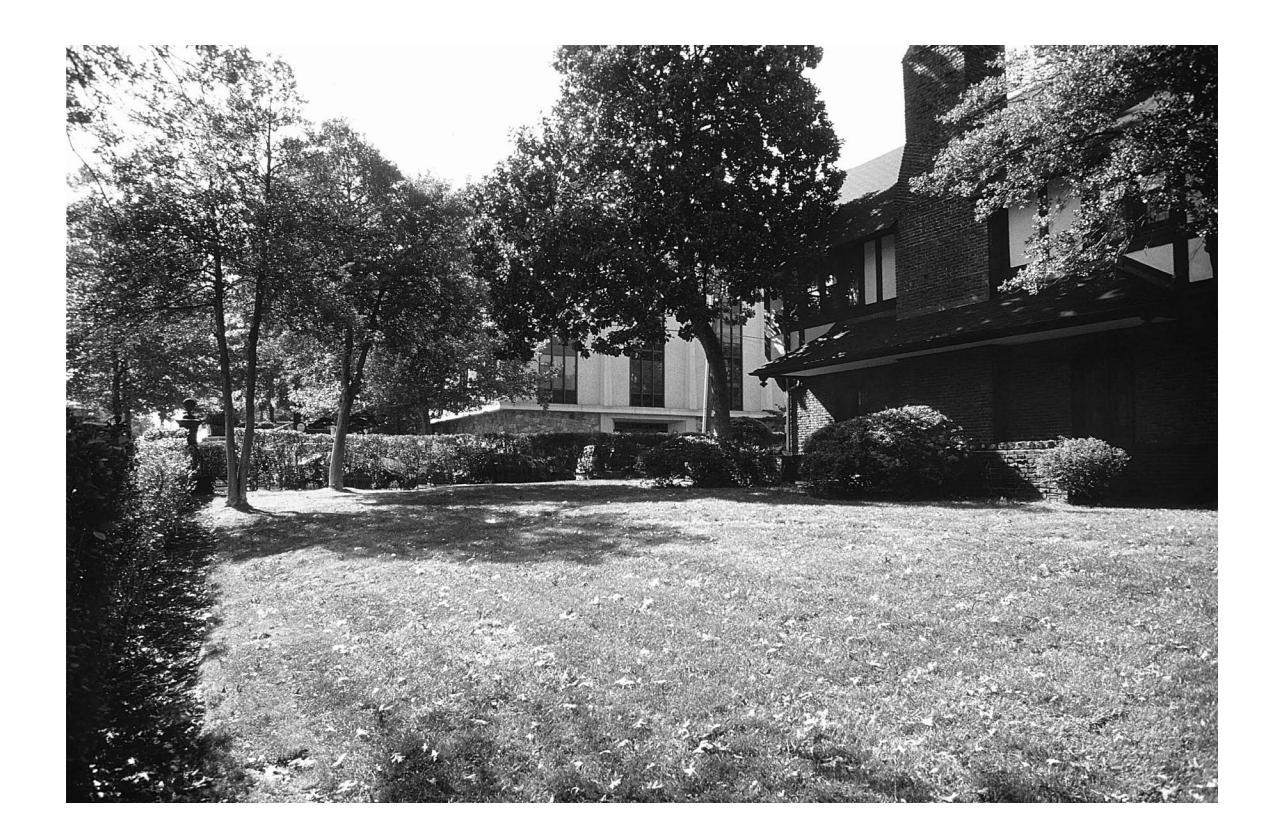
Fig. 17. View Looking Southwest at the Porch Garden, 20 October 2001. This photograph shows the privet (*Ligustrum obtusifolium*) hedge (*left and center*) that defines the southern and eastern boundaries of the porch garden. Note the close proximity of an America holly (*Ilex opaca*) and Southern magnolia (*Magnolia grandiflora*) to the brick wall of the porch (*middle right*). Also notice that an irregular shaped bed edge, shown on sheets L-3 thru L-6, has been replaced by rows of sod. Photograph by the author.

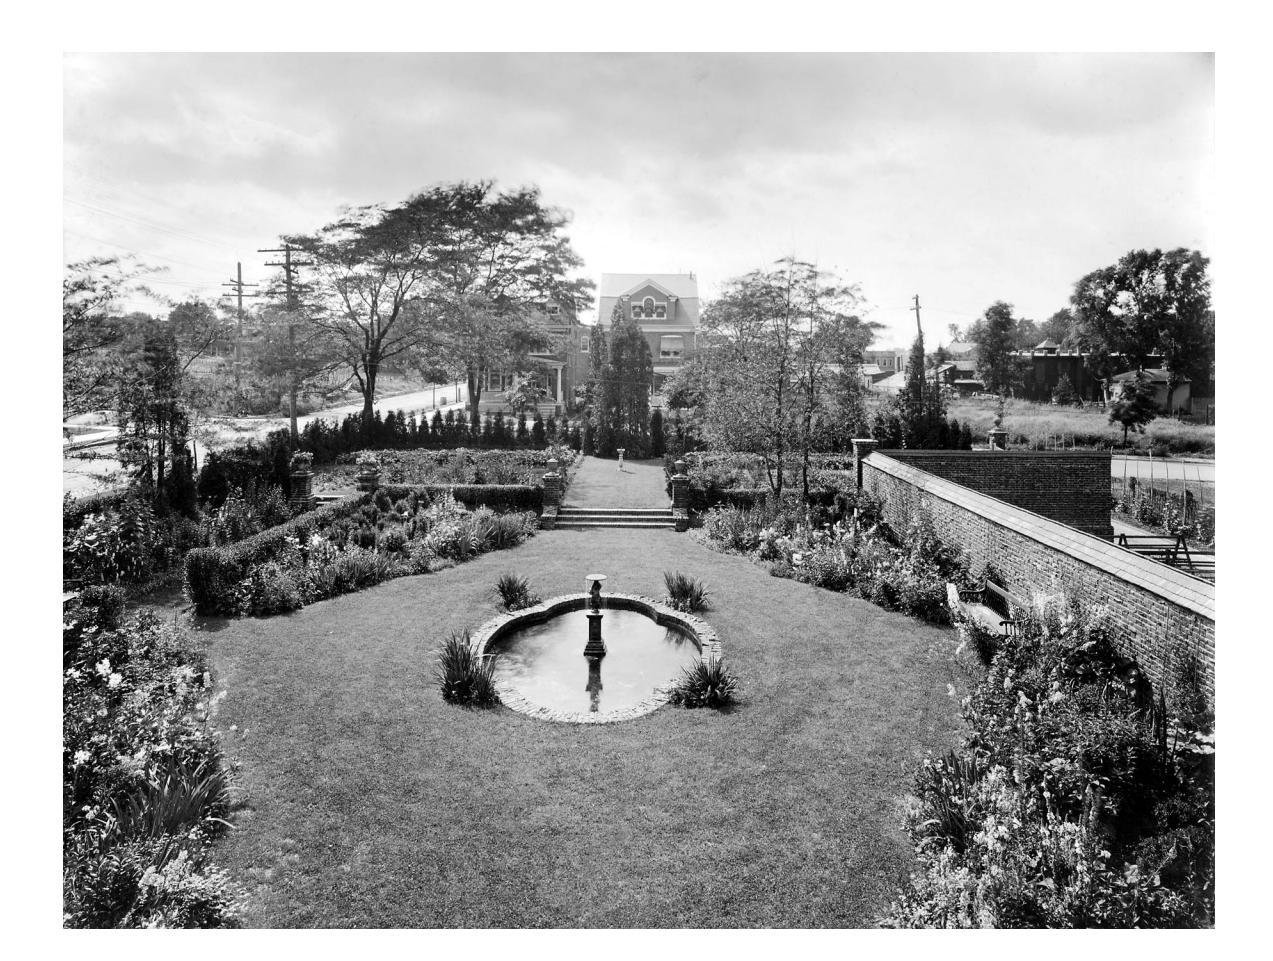
Fig. 22. View from Second Floor Bedroom, circa 1919. In this photograph, the upper terrace is divided into four large planting beds and this configuration is represented on the 1918 Period Plan (sheet L-9). There is no subsequent evidence of this design configuration in the upper terrace. Reprinted from the private collection of the descendents of Mr. & Mrs. Frank G. Tallman.

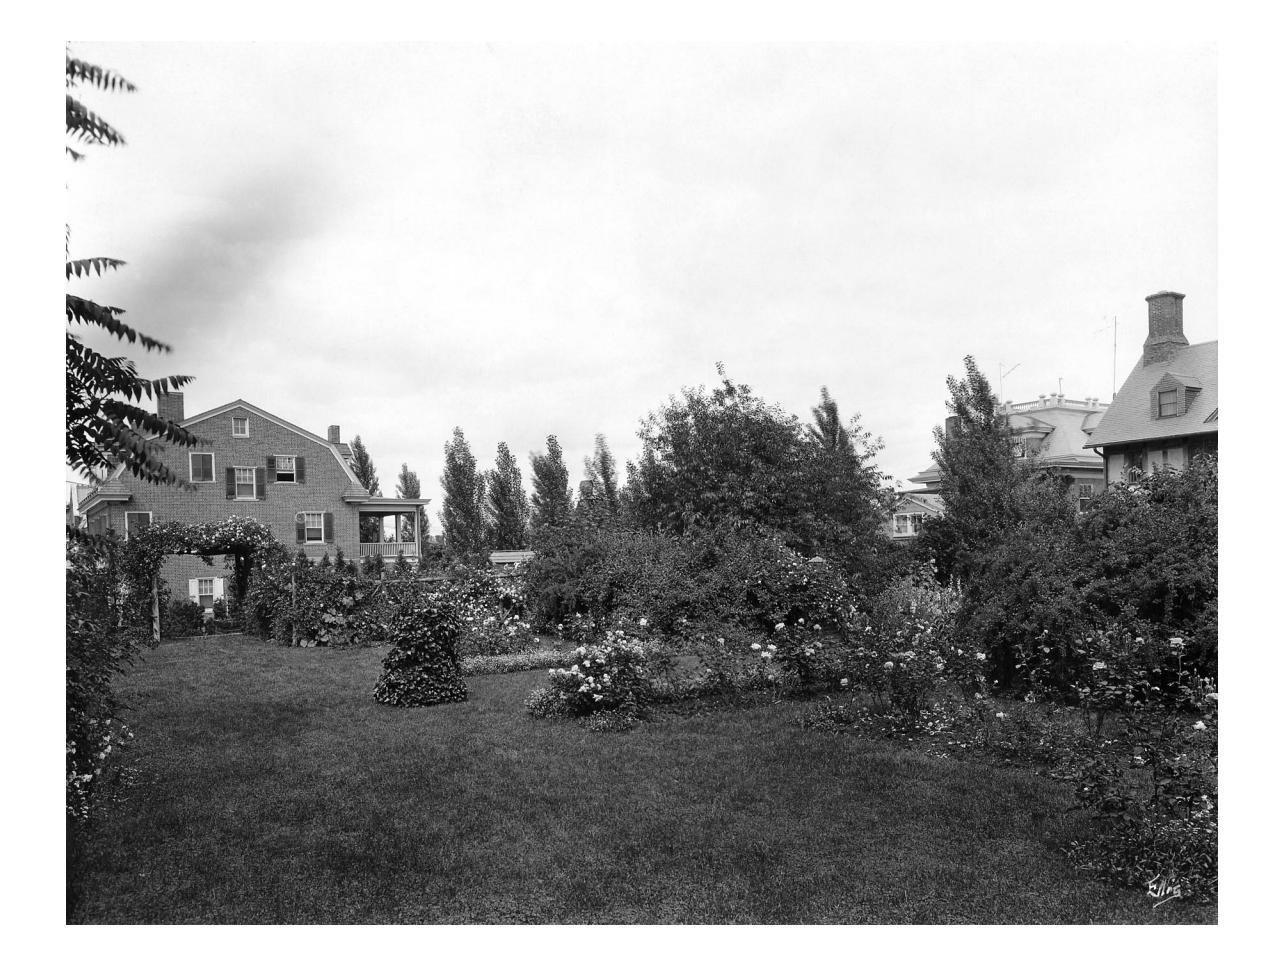
Fig. 23. View Looking Northeast in the Upper Terrace, circa 1920s. Photographs from the 1920s show that the upper terrace was primarily lawn with smaller planting beds filled with roses. Note that the sundial is covered with ivy and the rustic arbor and fence in the middle left of the image. These changes to the landscape are reflected in the 1918-22 Period Plan (sheet L-10). Reprinted from the private collection of the descendents of Mr. & Mrs. Frank G. Tallman.

Comparing the 1918 photographs to the photographs from the 1920s revealed dramatic changes in landscape. One of the most striking changes appeared in the upper terrace. Edges and boundaries that were interpreted as planting bed outlines and paths in the 1918 photographs did not appear in any subsequent photographs (fig. 22). In fact, the 1920s photographs show the planting beds in the upper terrace were relatively small and filled with roses. Also worth noting in this set of photographs is a rustic fence and rose arbor at the northern end of the upper terrace (fig. 23).

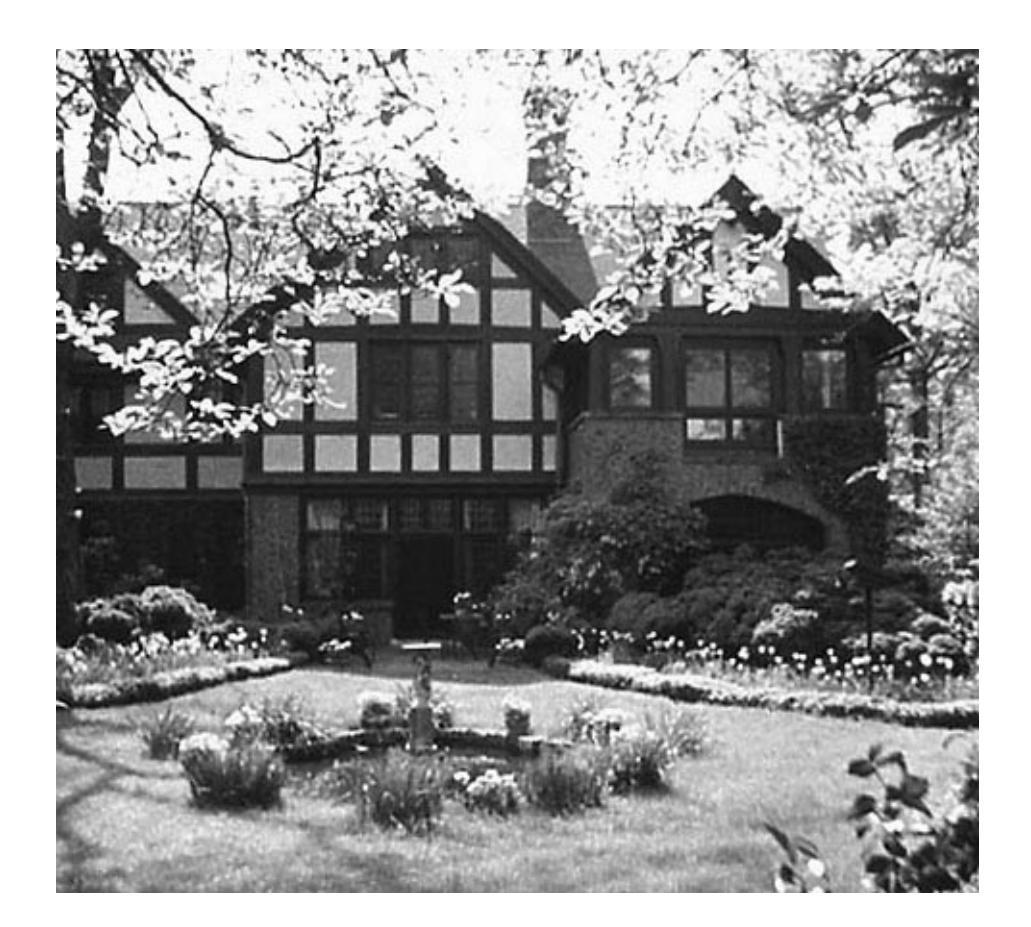
Fig. 25. Main Garden Facade, June 1973. In contrast to earlier photographs of the main garden, this image shows the outer boundary and shape of the planting beds defined by a hedge material. Note too that the pergola has been removed, a honey locust (*Gleditsia triacanthos*) is still present in the northeast bed, and magnolia leaves are visible in the top foreground. Reprinted from Smithsonian Institution, Archives of American Gardens.

notable change seen in these images concerns the planting beds in the main garden. Previously, the outer boundary and shape of these beds was defined by edging cut into the lawn and a low, herbaceous ornamental planting. These two pictures show a hedge material defining the beds' outer edge (fig. 25).

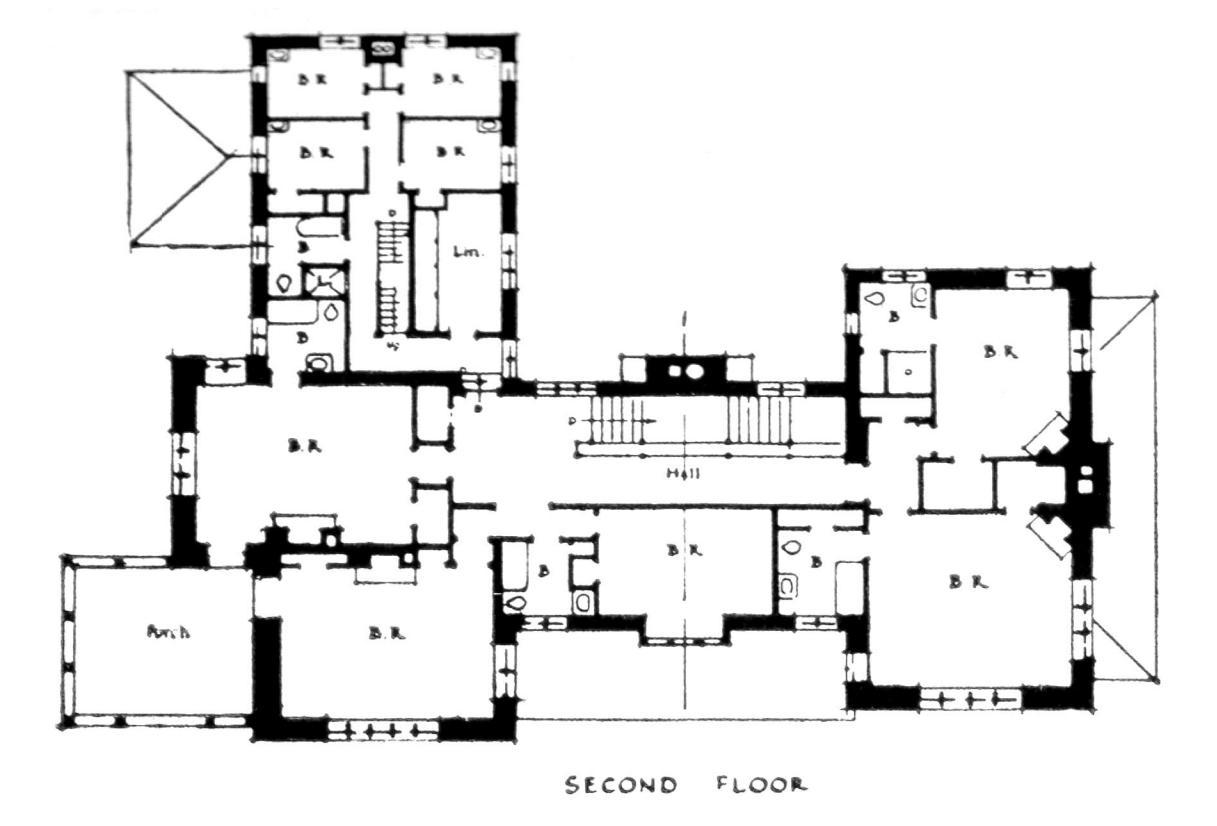
Fig. 26. Second Floor Plan for Mauchline. This plan shows that the original design provided five larger bedrooms in the main block of the house and four smaller bedrooms above the service wing. In addition to the bedrooms, the plan shows five bathrooms. Reprinted from "House, F. G. Tallman, Esq., Wilmington, Del.," *The Architectural Forum* 31 (August 1919): plate 19.
