Rehabilitation Treatment Plan for the Historic Designed Landscape at Mauchline, Wilmington, Delaware

REHABILITATION TREATMENT PLAN FOR THE HISTORIC DESIGNED LANDSCAPE AT MAUCHLINE, WILMINGTON, DELAWARE

A capstone studio submitted in partial fulfillment of the requirements for the Master of Landscape Architecture Degree State University of New York College of Environmental Science and Forestry Syracuse, New York May 2002

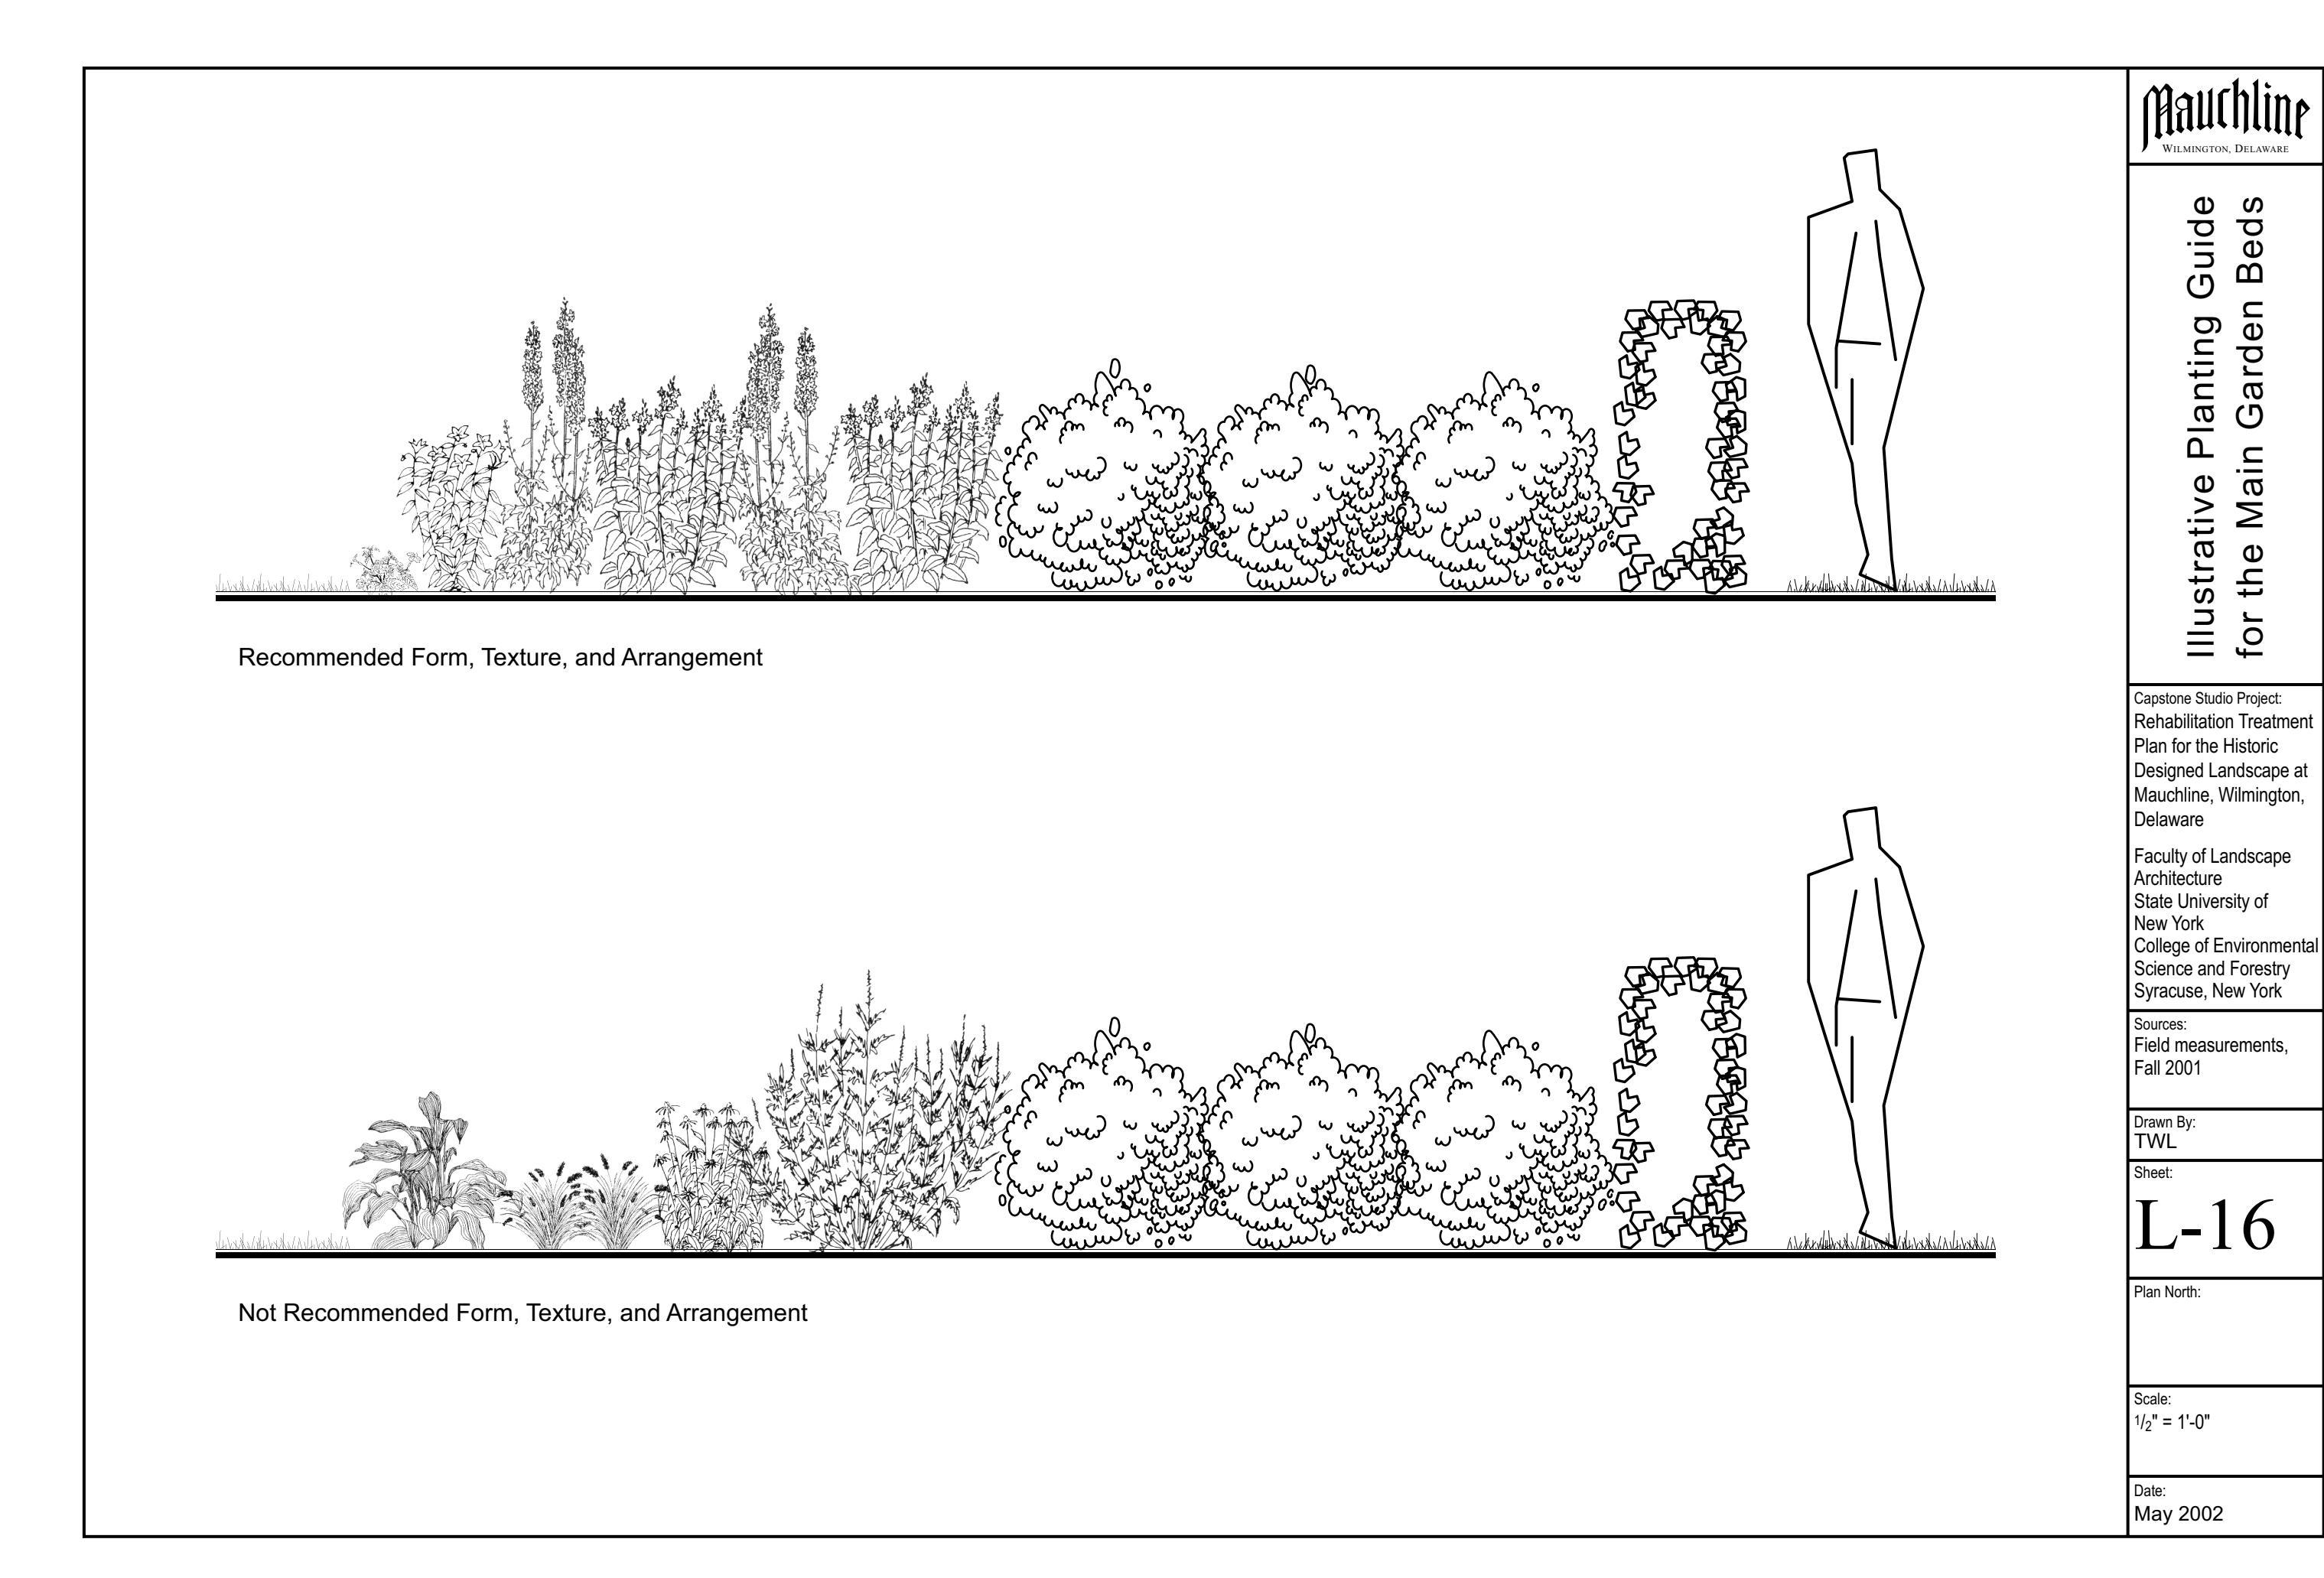
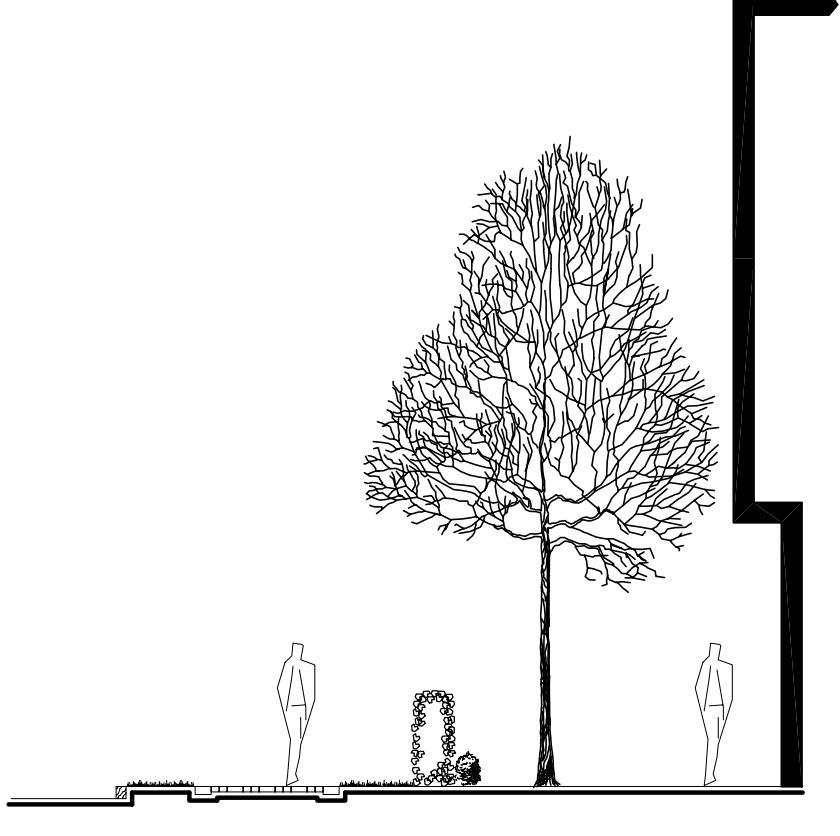
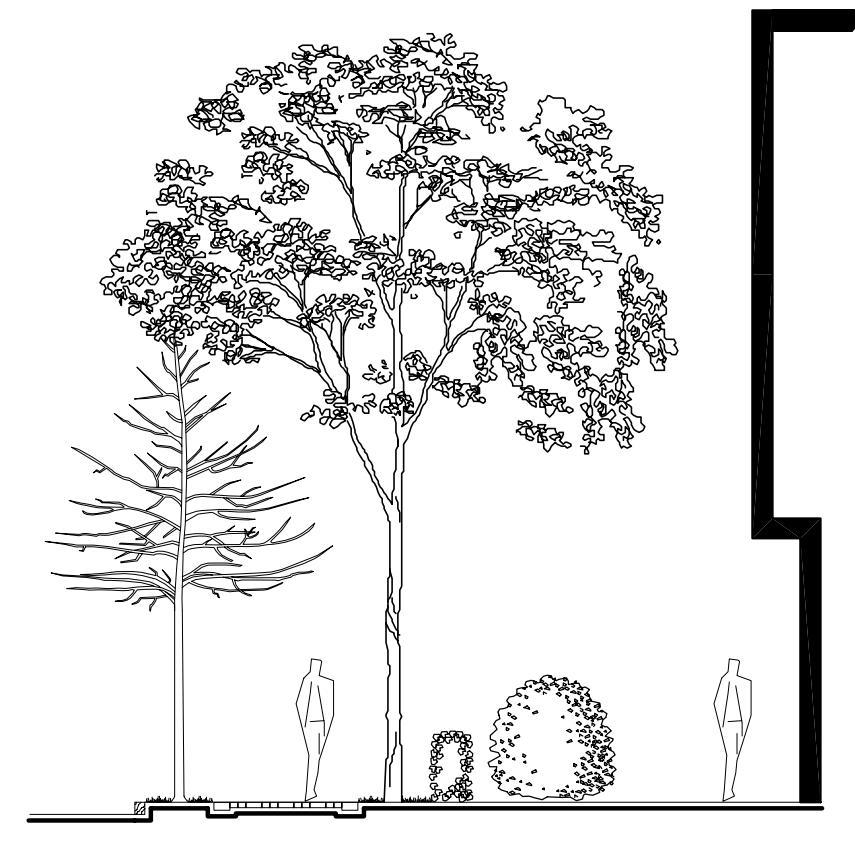
Section through the West 10th Street Sidewalk and Garden Path

Existing Conditions

Recommended Treatment
