### Task 2-B: Training Workshops for Living Snow Fence Design, Installation and Maintenance

Task 2-B: Training for LSF Design, Installation and Maintenance

Designing, Developing, and Implementing a Living Snow Fence Program for New York State

### Workshop 9 Field Tour of Existing Snow Fences

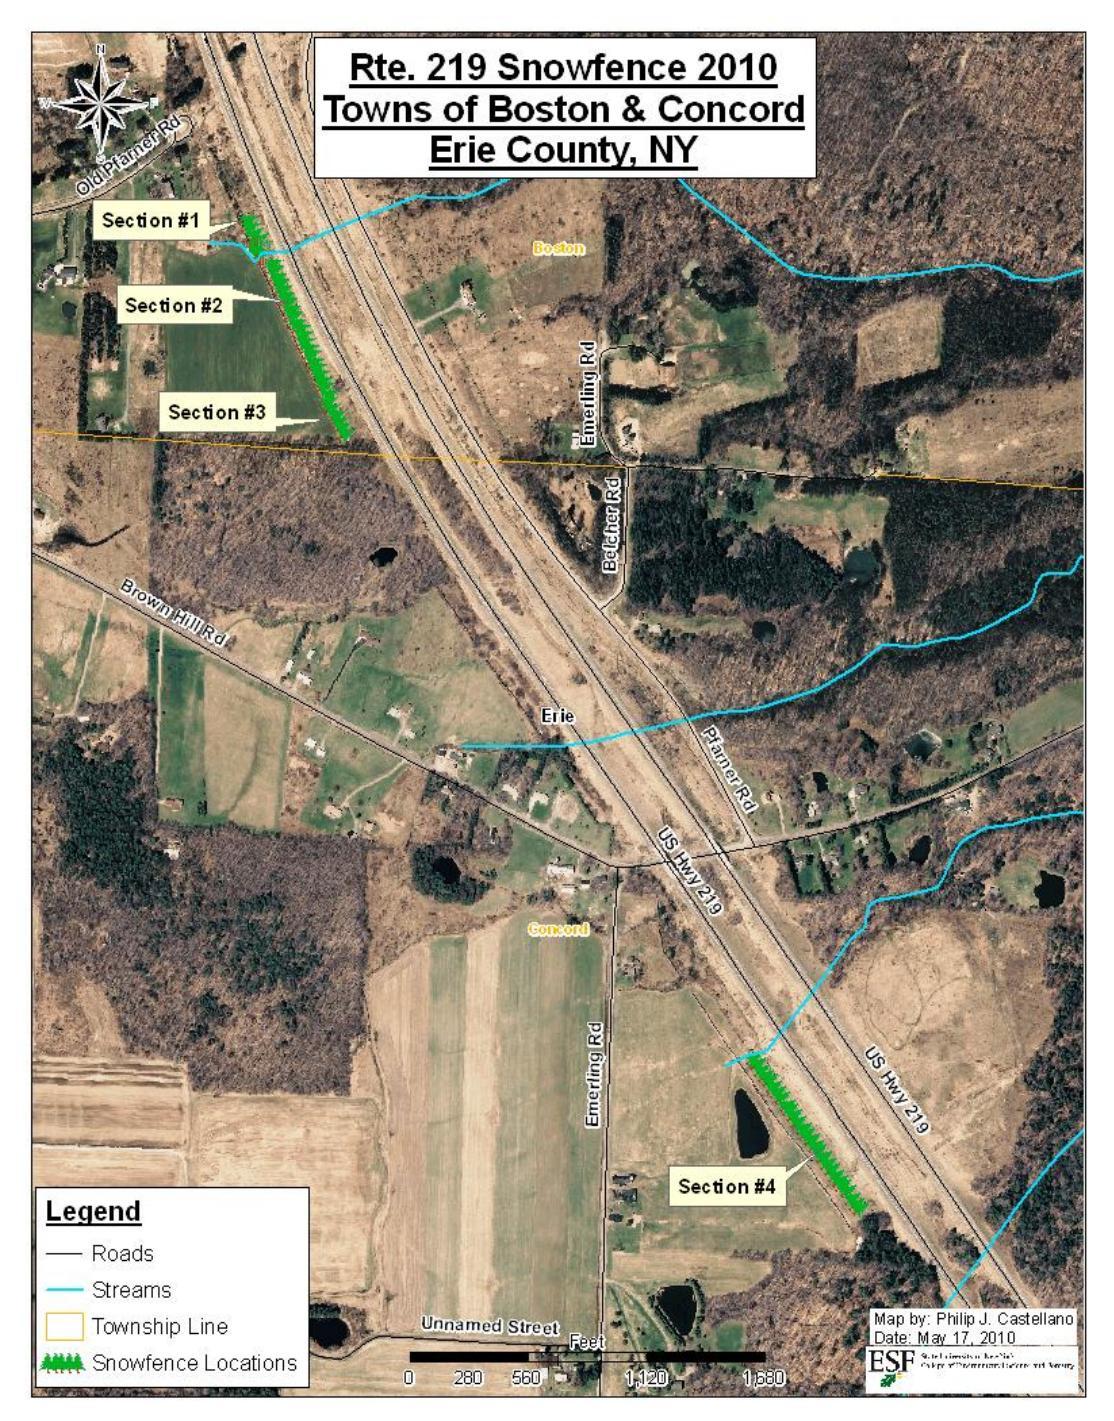
The aerial photograph below shows the planting design. The northern section in the Town of Boston has three segments. The southern section in the Town of Concord has a single section.

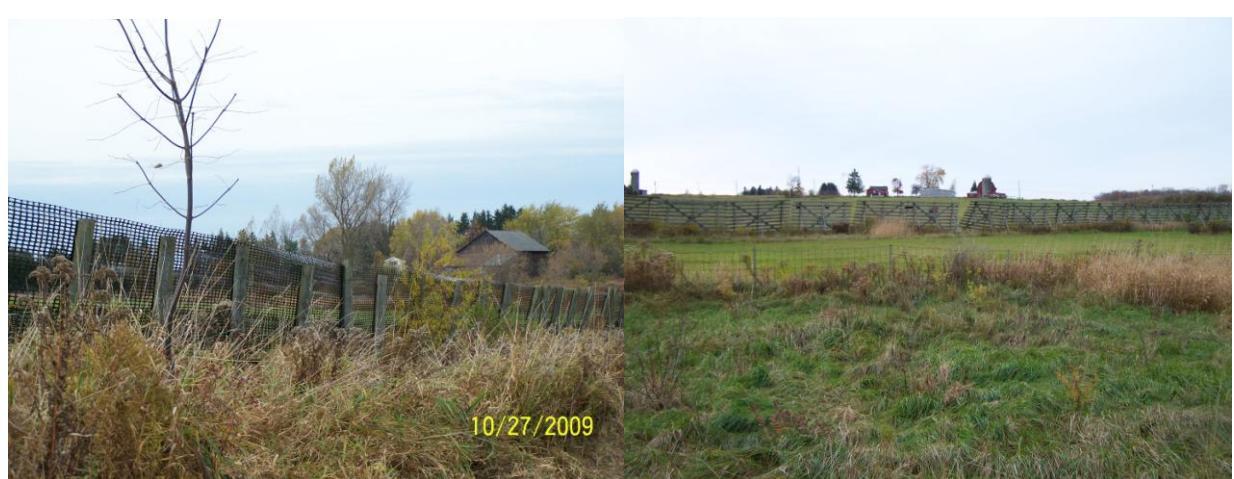
The left picture shows the northern location on Route 219, in the Town of Boston, about a mile south of Rice Hill Road interchange, where a snow fence will be replaced by a living snow fence using willows.

The right picture shows a location on Route 219, south of Brown Hill Road in the Town of Concord, where snow blows across the highway and causes significant road icing and crashes. At this location, willows will augment an existing snow fence which is 10 feet tall.

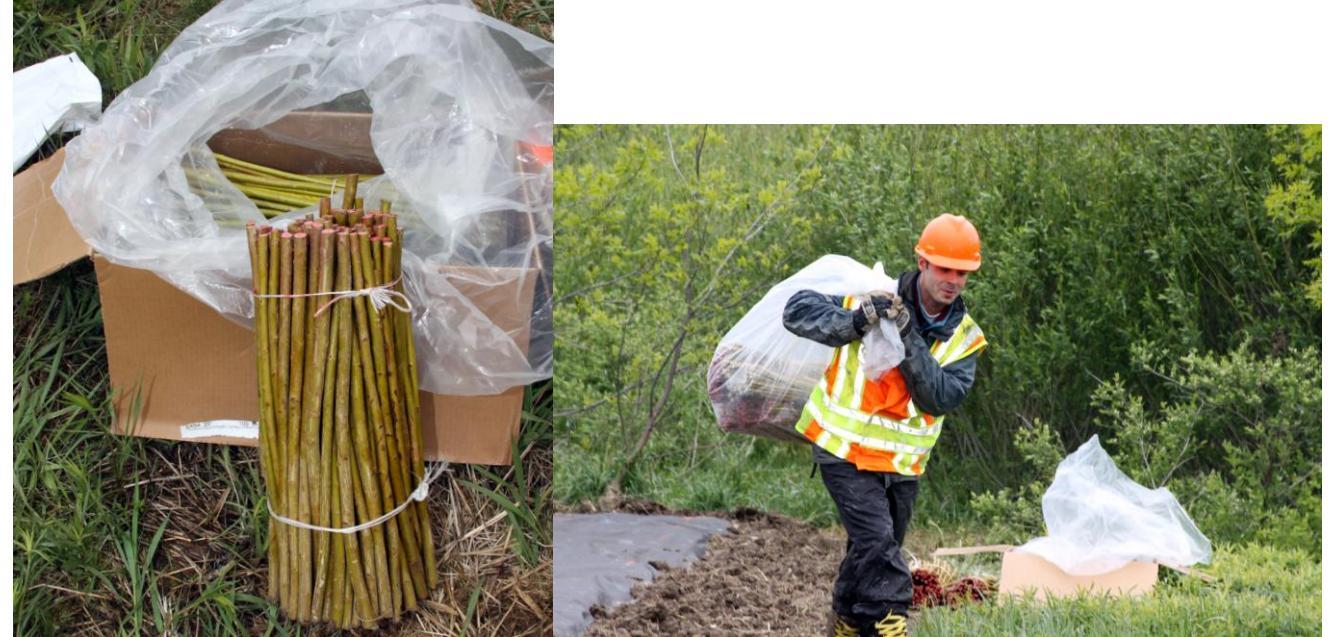
The left picture shows the willow shoots, which are about 24 inches in length. They are kept in cold storage until ready to be used, to prevent sprouting before planting.

The right picture shows researcher Eric Fabio distributing willows along the installation area, in advance, to speed planting.

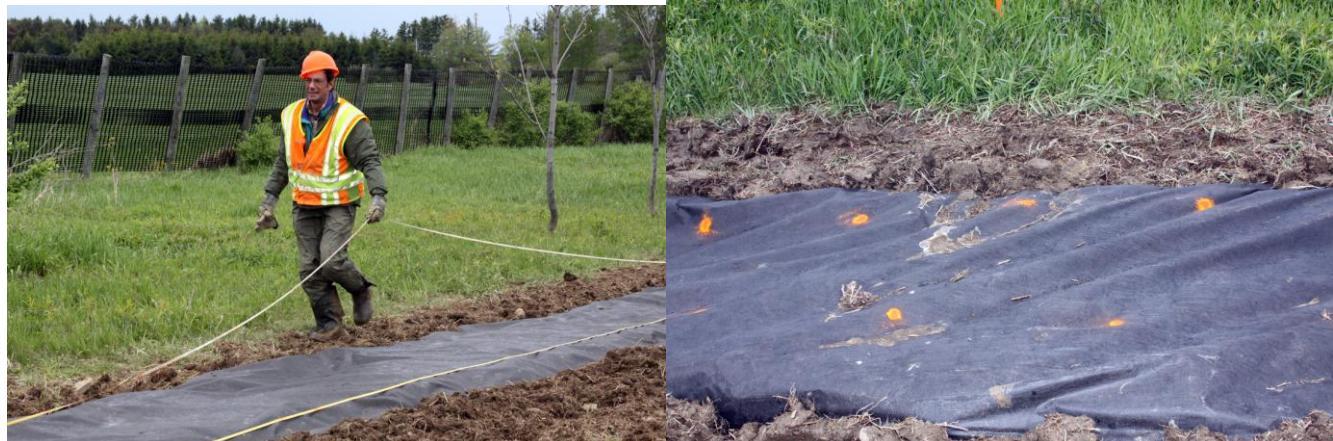
Left picture: Philip Castellano, an ESF researcher, helping set the line for planting. Right picture: Landscape cloth marked with paint for planting. Also, note how tractor attachment anchors cloth with dirt.

Next, landscape cloth is set down over the tilled area and secured on the edge with dirt. Tractor attachments are available to roll out the landscape cloth and plow a line of earth along each edge to hold down the cloth, but the securing process can also be done manually if equipment is not available.

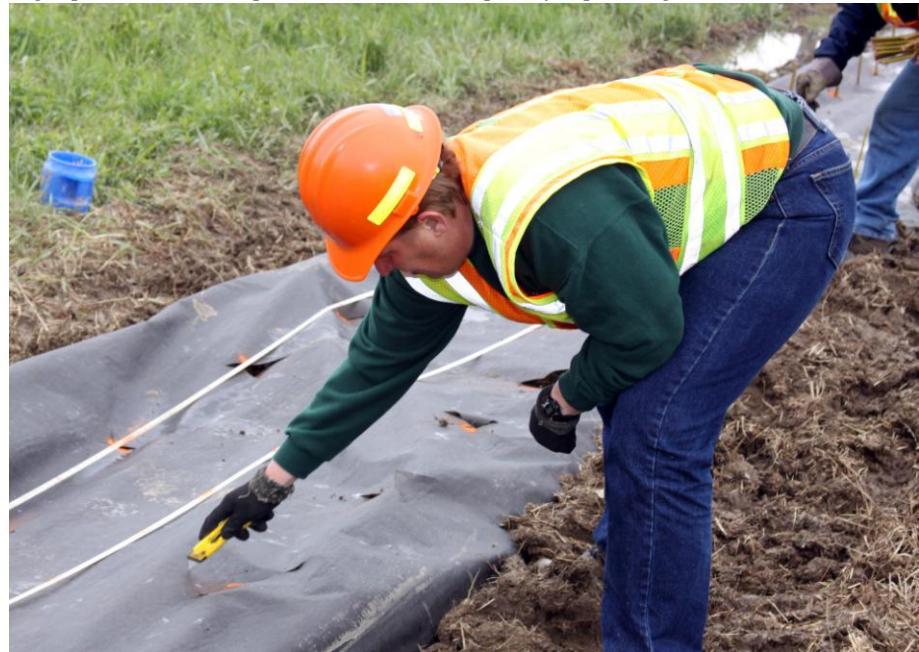
Barb Balcerzak, from Erie South Residency, is cutting the landscape cloth with an "x" pattern in advance of planting the willows.

Cutting an "x" in the landscape cloth is required. A cut in any other shape will result in the cloth constricting the willow trunk and girdling the plant.

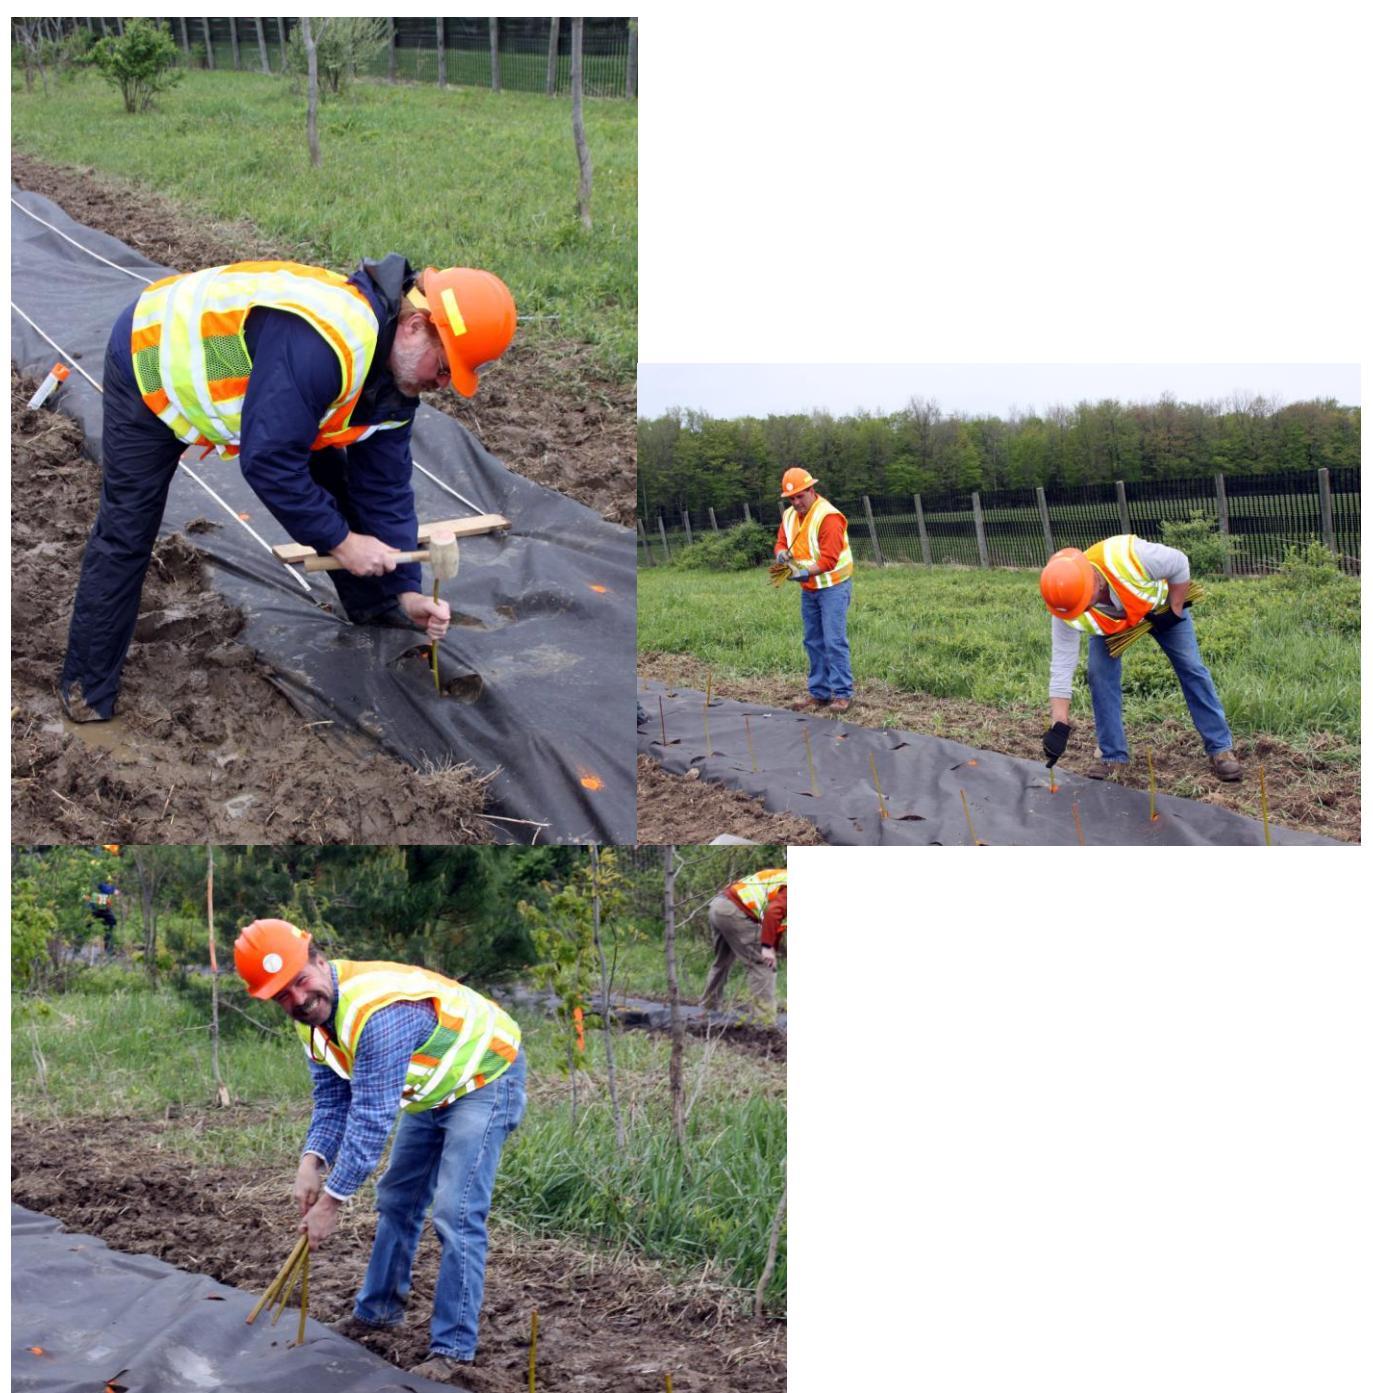
Left and right pictures: depending on the soil, willows may be placed with a mallet or by hand. In the left picture, Tim Volk installs with a mallet; in the right, John Harvey and an unidentified NYSDOT employee install willows by hand.

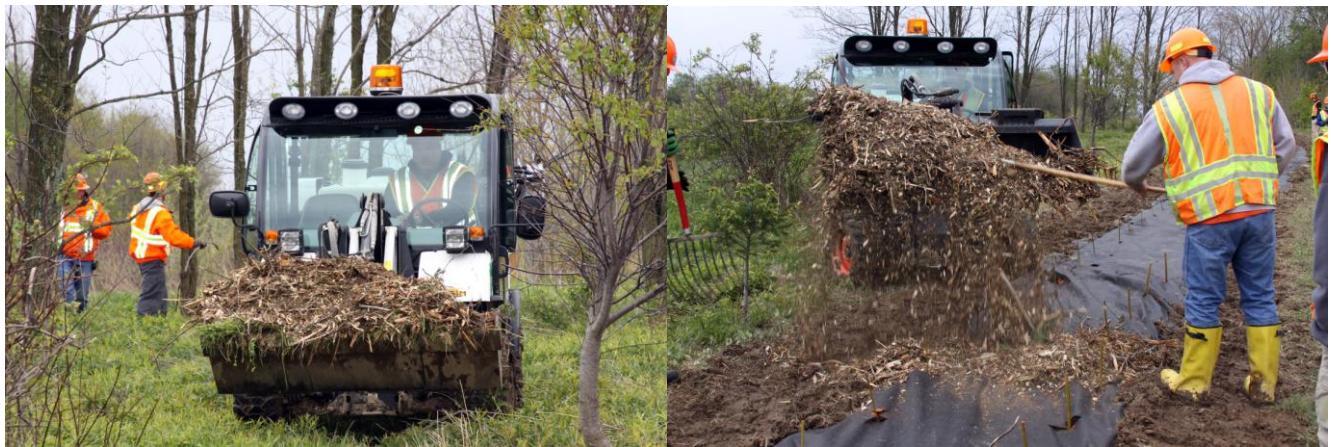
Left picture: Equipment bringing mulch to snow fence from roadside. Right picture: Erie South Residency staff placing mulch, to suppress weeds and to protect plants during summer.

After the site is prepared and the willows are planted, workers come along behind and place wood chips. The wood chips are essential to suppress weeds and to provide moisture if the summer is hot and dry.

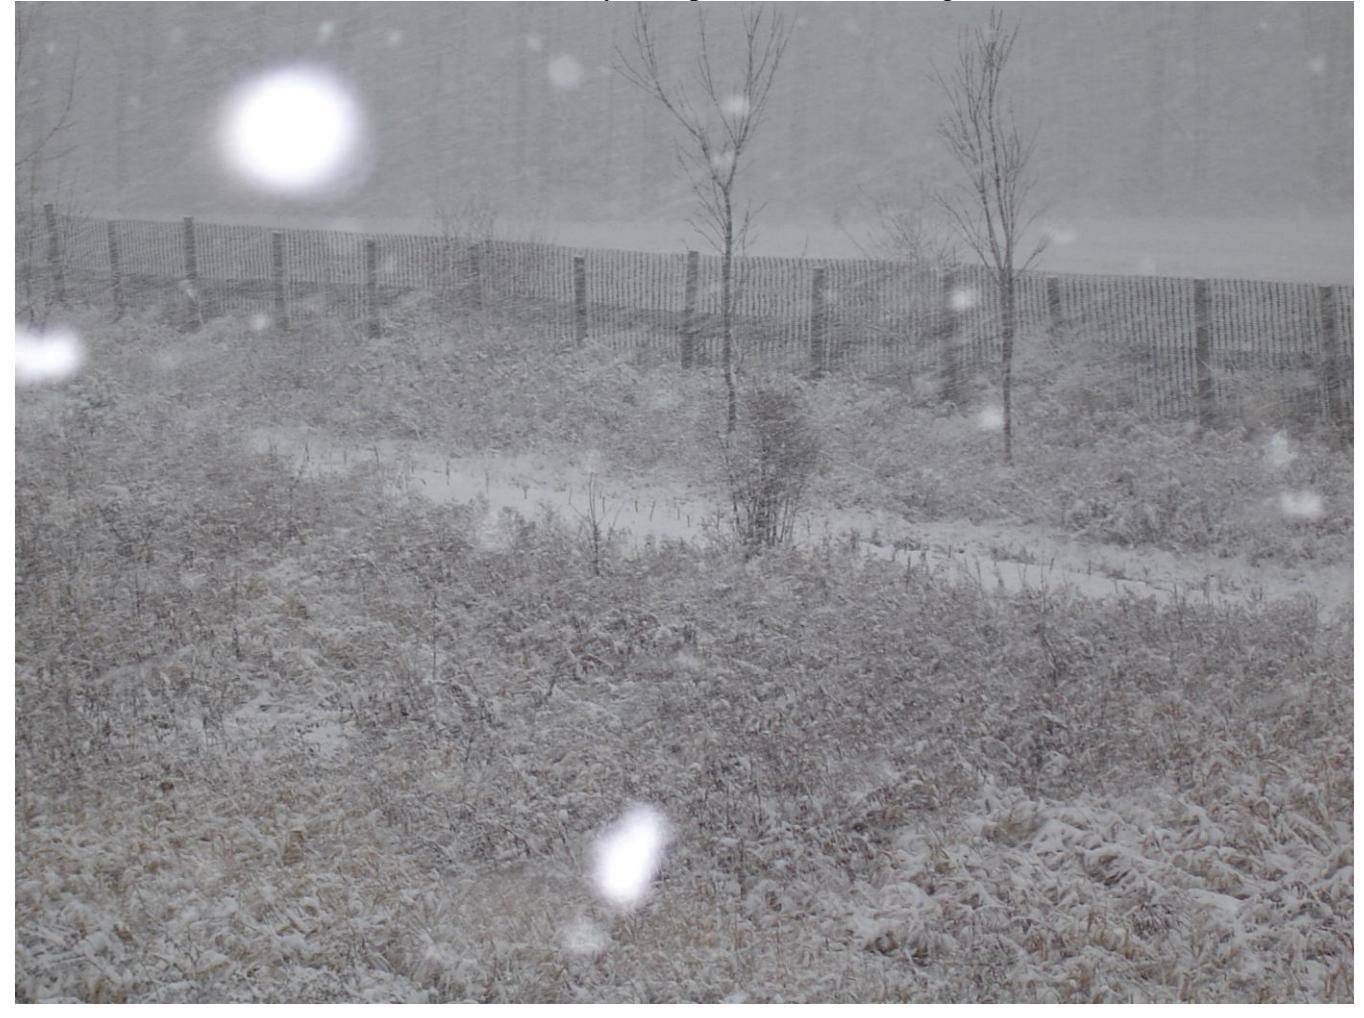
Here is a picture of the installation on December 1, 2010. The photograph shows how active the snow is at this site. Even with the diminished visibility, it is possible to see that growth has occurred.

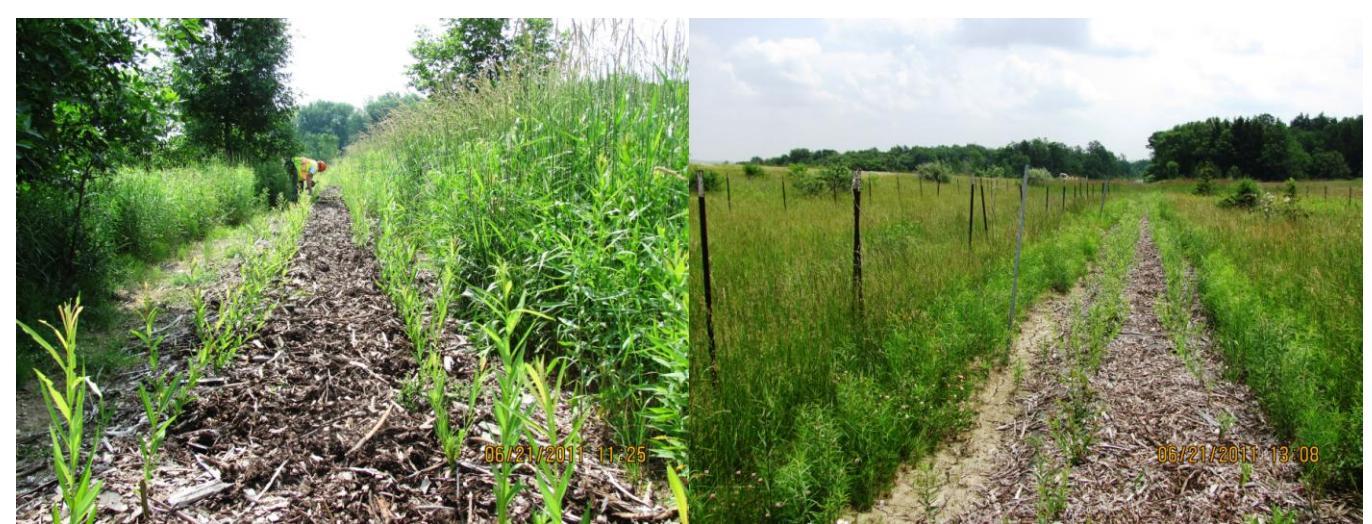
Here are two pictures from June, 2011. Two issues are present in these pictures:

- Growth in the northern segment was diminished by deer eating the willows in some sections of the installation. This is unusual in NYSDOT's experience with willow fences. Growth was relatively even in the southern section, with no apparent deer disturbance.
- Growth of adjoining vegetation provides cover for deer and competes with the willows. As will be seen in the photographs after these, the Residency mowed and addressed this concern.

Left photograph taken in northern segment; right photograph taken in southern section, Town of Concord C-06-09 Task 2-B Training Workshops Page 17 of 62

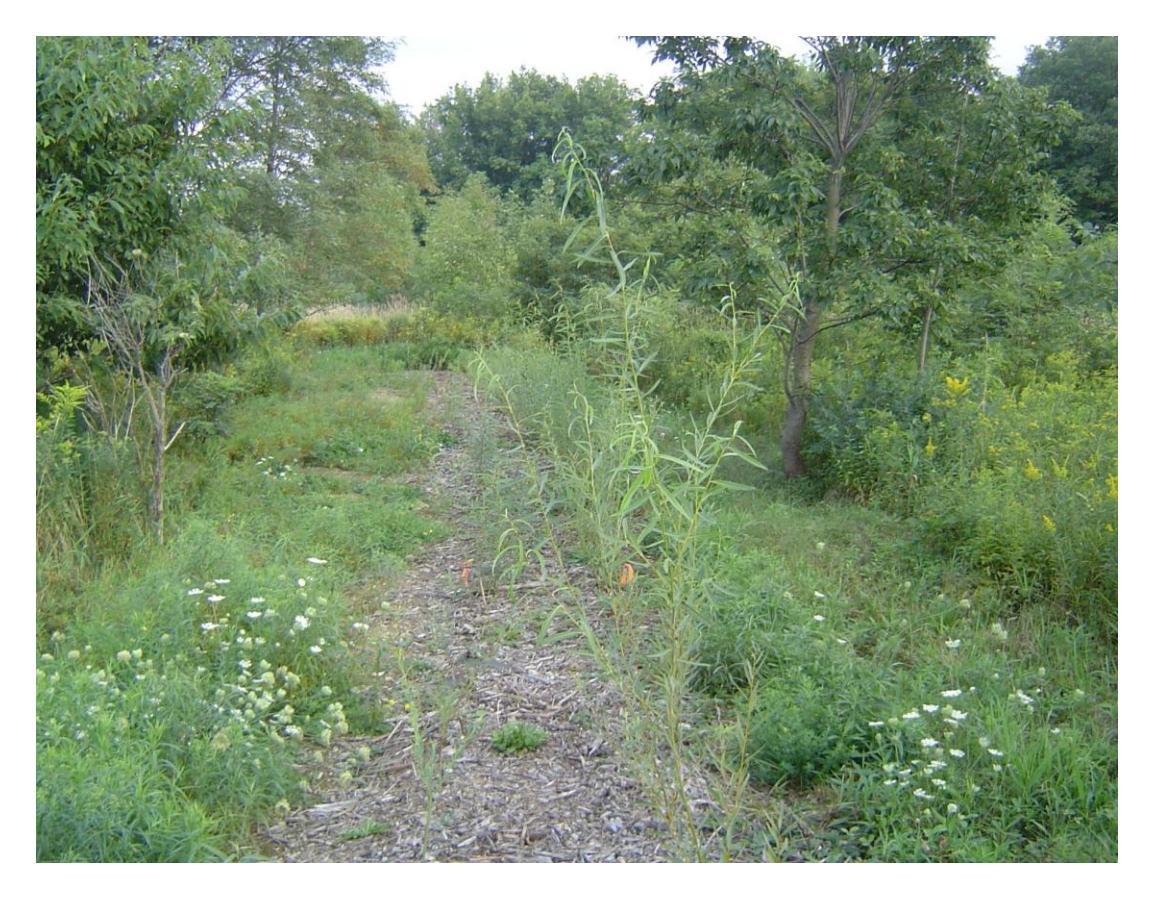
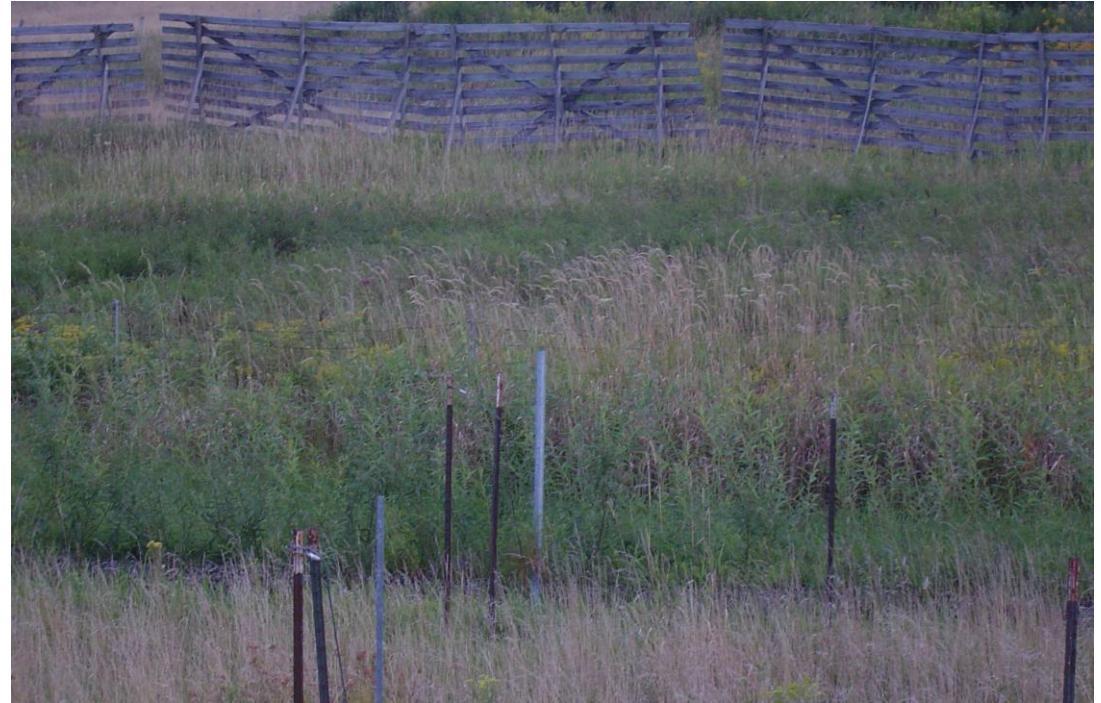
The following two photographs were taken in September, 2011. The Residency mowed adjoining vegetation and that is helping with growth. In the northern section (top photograph), some willows have grown quite high but the growth is till uneven because of deer eating some of the willows. In the southern section (bottom photograph), the willows are growing at a consistent rate. The willows are the uniform line of green vegetation in the middle of the photograph, behind the brown grass.

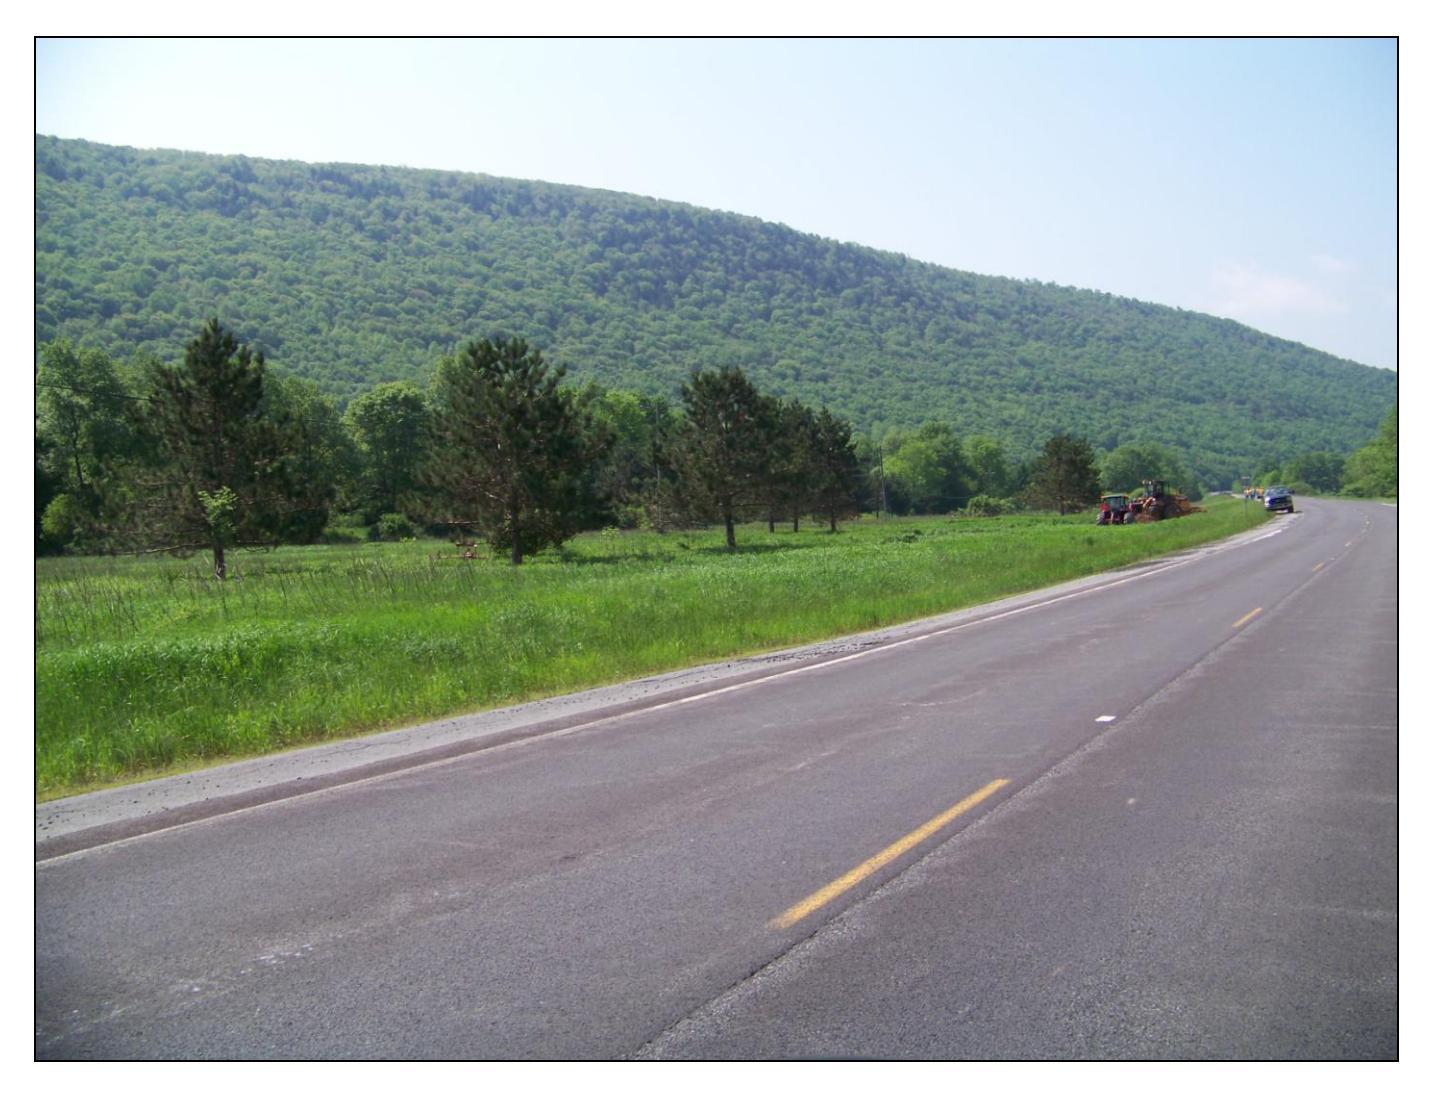
Looking south, photograph one, below, shows the general area of the plantings, and the hill that reverses the snow back across the road.

At the Route 10 site, snow blows west to east, across Route 10, from the direction of the West Branch of the Delaware River. Based on observations by the researcher and residency staff, the snow does not pile up on the road as it blows from in this direction.

The prevailing westerly wind hits the hill and Houck Mountain to the east of Route 10 and then blows west, back towards the road. As the snow is blowing back across the road, it accumulates in the travel lanes. Some snow is considered "far snow," when the snow is blown across an open area that is several hundred feet or more. While there may be some "far snow" at this site, the majority of the problem is related to what is called "near snow." When snow is picked up by the wind close to a roadway and deposited on the road, it is referred to as near snow. At the south end of the site, near snow is probably part of the problem because of the embankment of 6 to 12 feet high at the road's edge.

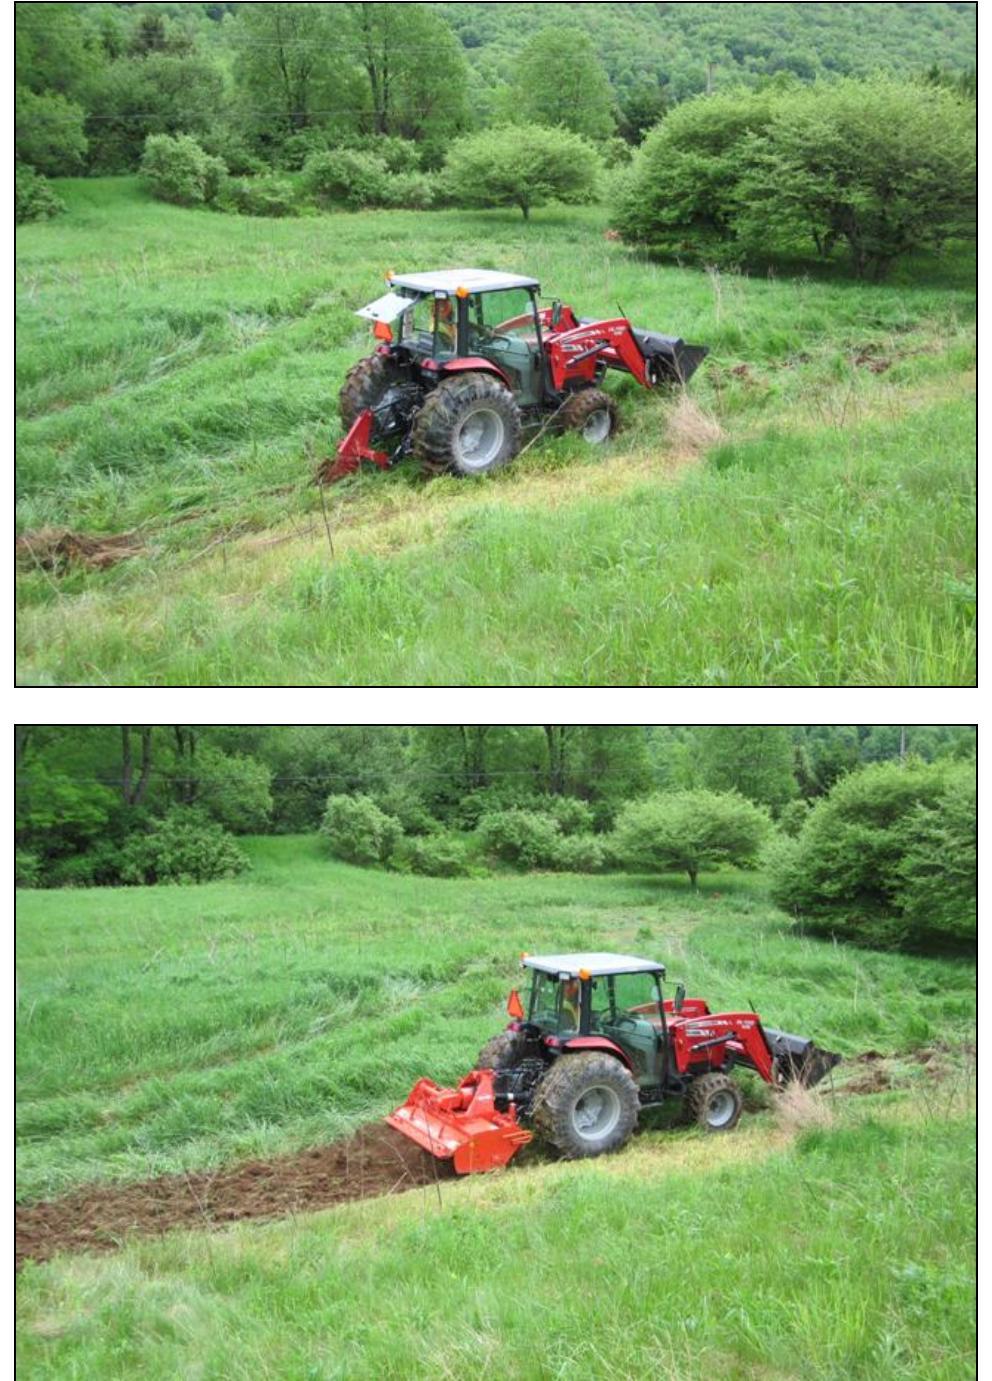
Then the installers prepare the soil. The two pictures below show soil preparation. In the first, a tractor with a ripper attachment breaks up the soil and breaks through any hardpan that might be below the soil. It is important to break through the hardpan as willows will be relatively tall and if hardpan prevents the roots from penetrating deep into the ground, the vegetation could topple.

The second photograph shows a rototilling attachment to further smooth out soil. If soil needed amendments, this is the time to undertake the work. Soil amendments were not used at this location.

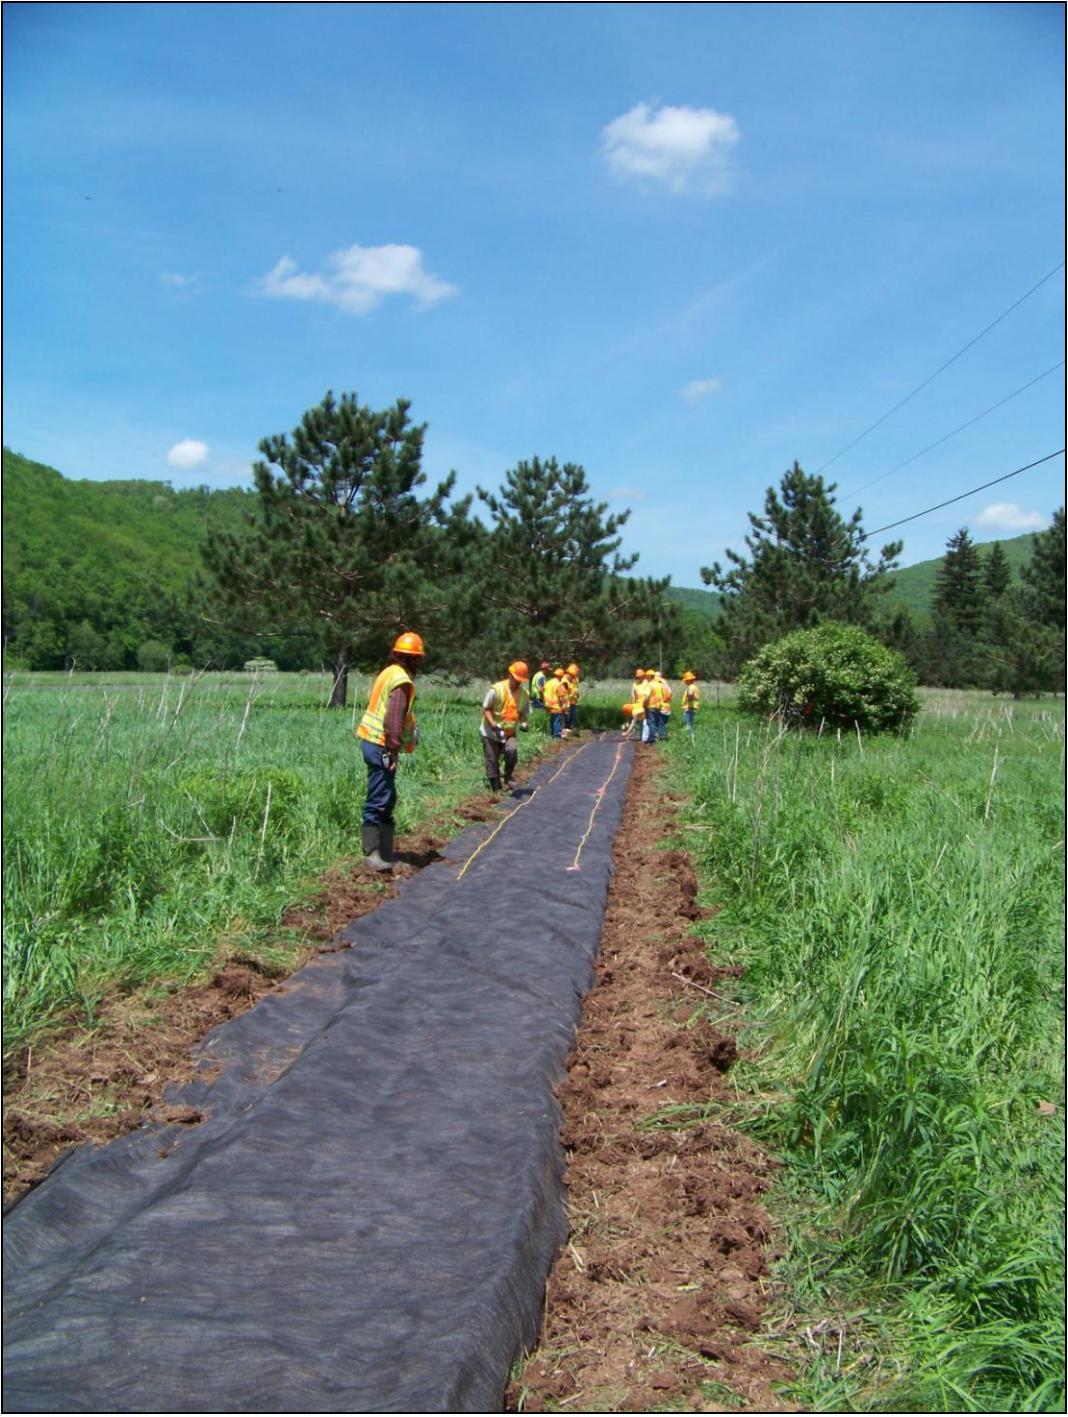
Installation looking north.

In the picture below, the slightly discolored grass on the left side of the landscape cloth shows part of the herbicide treatment to kill the vegetation. A special attachment to the tractor rolled out the landscape fabric and anchored it by tucking it into the dirt on each side of the planting area.

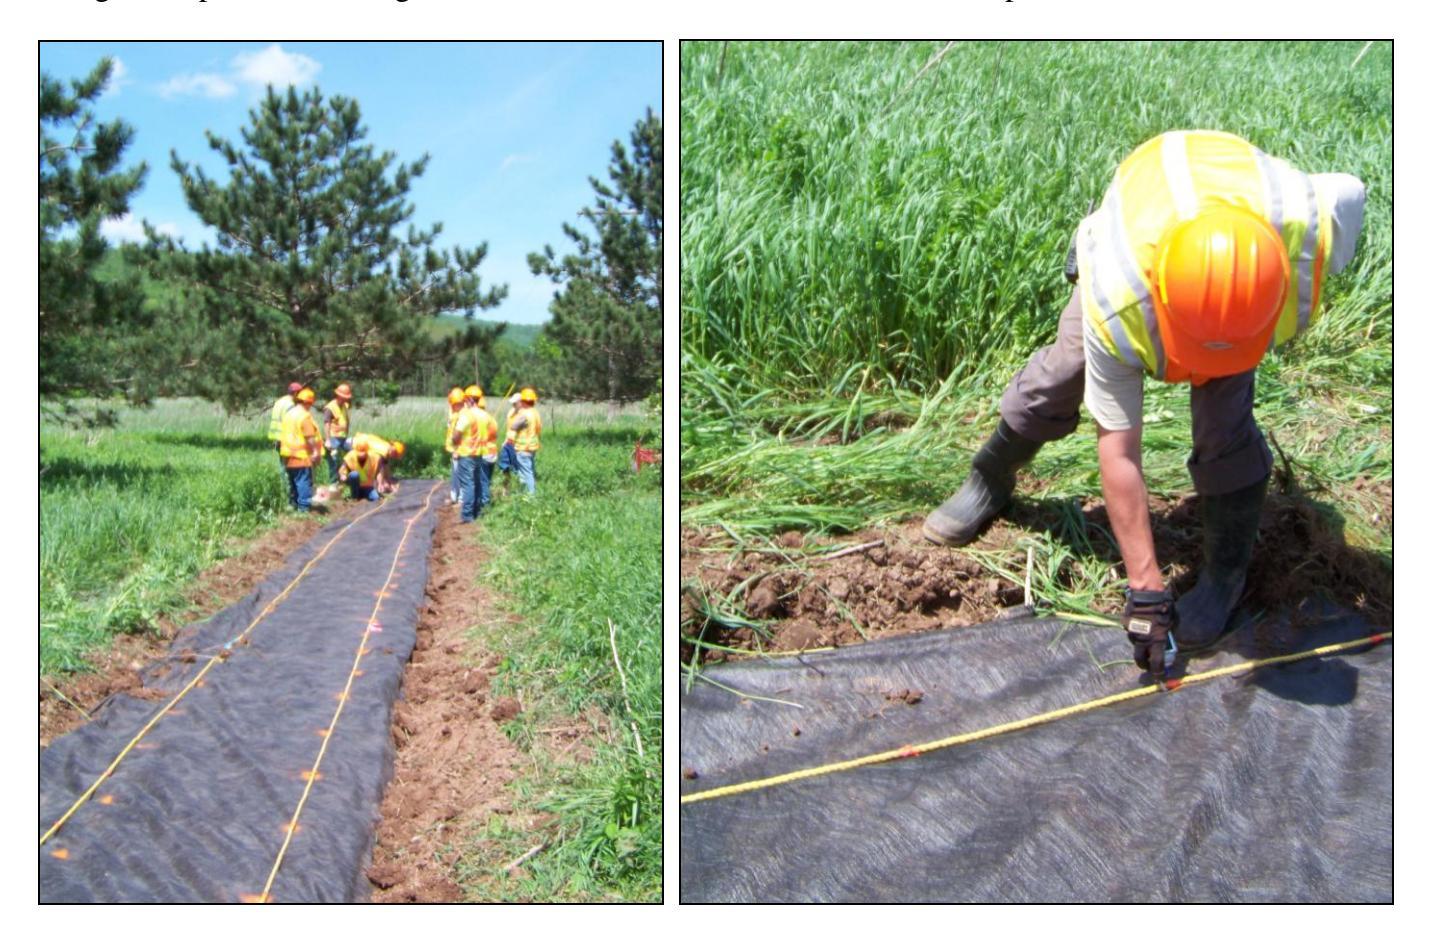
In the first step, workers mark where the cuttings will be placed. As shown in the picture to the left, a straight line, with a rope, is used to mark the rows. Then, as SUNY ESF researcher Justin Heavey is doing in the picture to the right, a worker marks where each willow will be planted.

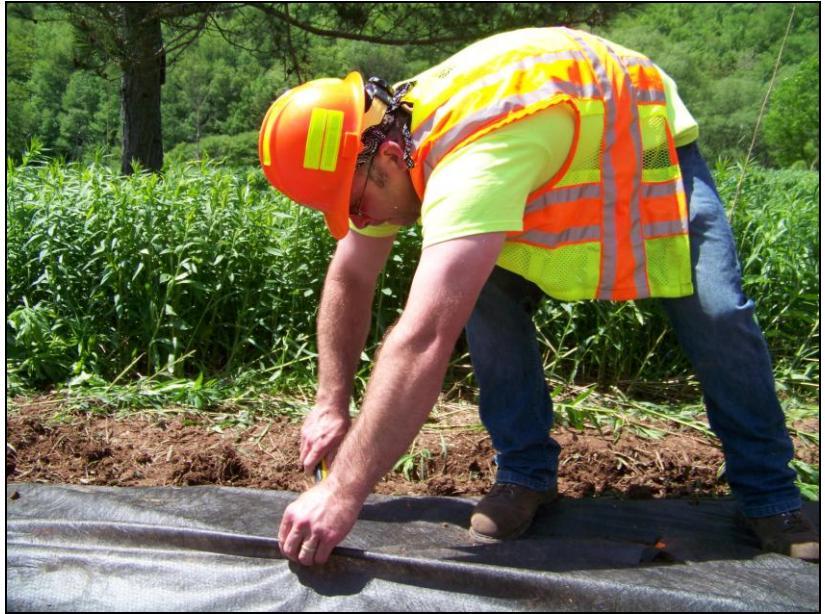
Next, workers slit the landscape fabric, as Brian Robinson is doing in the picture below, to allow the placement of the willows. The holes must be cut as an "x," otherwise the landscape fabric can girdle the plants as they grow. Each side of "x" should be three to six inches long.

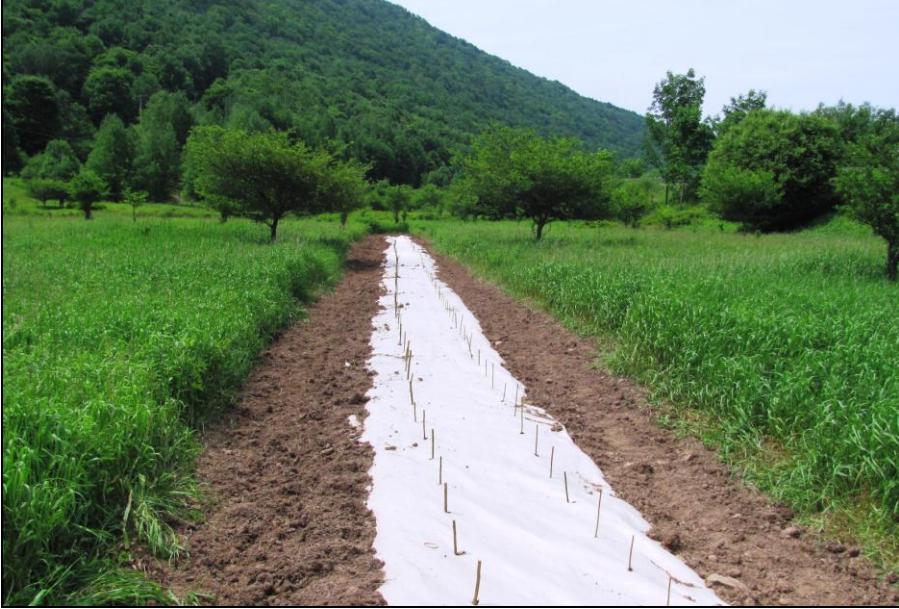
Paper-based landscape cloth used for willow cuttings.

On this installation, Tim Volk purchased a paper-based landscape material, designed to last 18 to 24 months. The hypothesis is that a durable, paper-based material will last long enough to suppress the weeds - - but will decompose and pose no threat to girdling the plants.

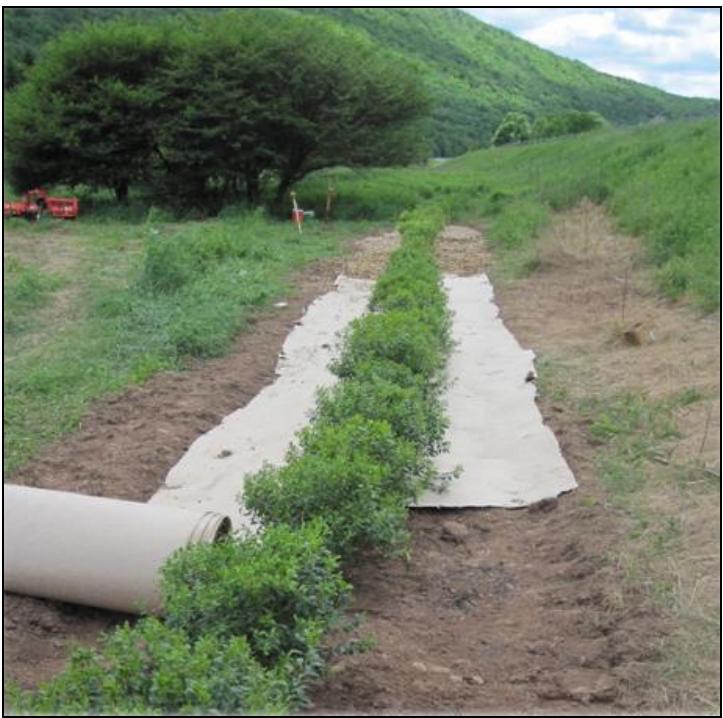
Paper-based landscape cloth used with plants intended to control near snow. Photograph by Justin Heavey. SUNY ESF, 2011

The paper-based landscape cloth did not arrive in time for Day One of the installation. It arrived several days later, in time for planting the second set of the willow shoots, near the southern end of the project, and for the plants at the toe of the slope to address the near snow issue.

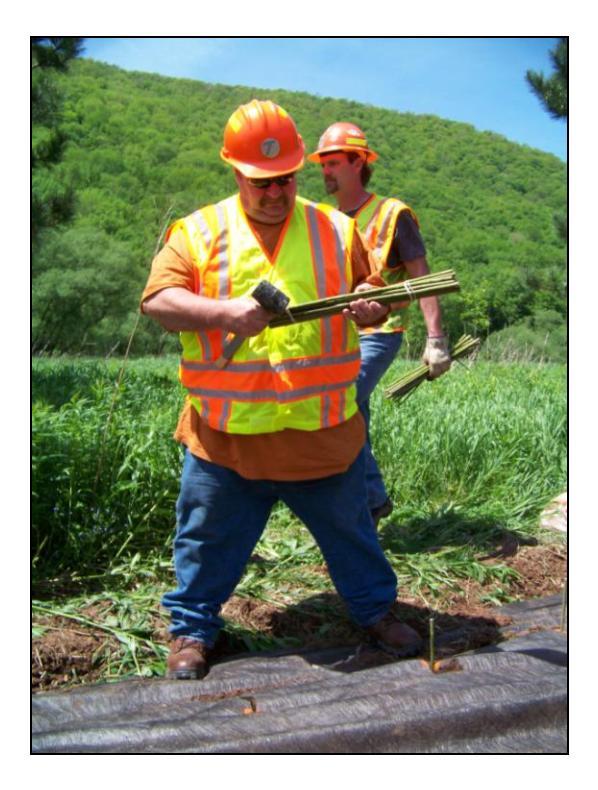
After cutting the landscape cloth, workers put a willow in each hole. Half of the willow should be in the ground, half should be exposed. Rick Ostrander, below, is holding a bundle of willows, about 20 inches long, from this installation.

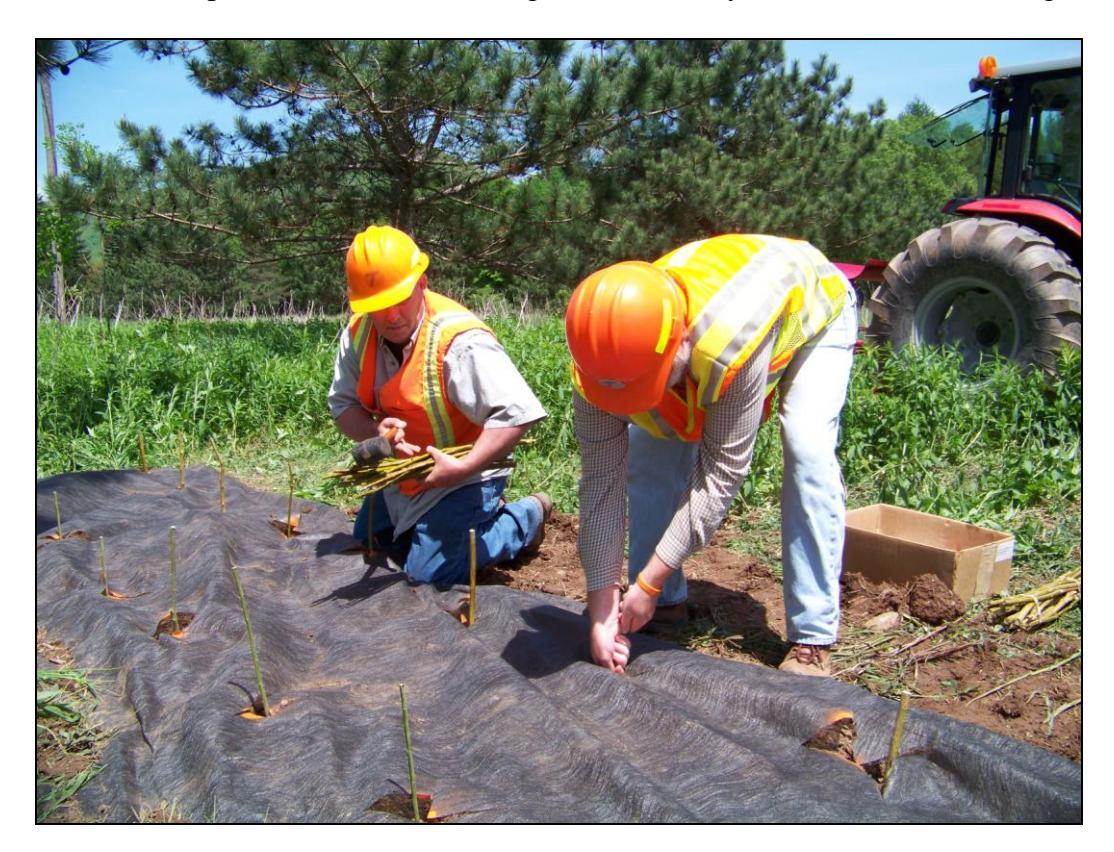
If the soil is soft, one can push in the willow cuttings, as Tom Story and Tim Volk are doing below.
