### Task 2-B: Training Workshops for Living Snow Fence Design, Installation and Maintenance

Task 2-B: Training for LSF Design, Installation and Maintenance

Designing, Developing, and Implementing a Living Snow Fence Program for New York State

### Workshop 9 Field Tour of Existing Snow Fences

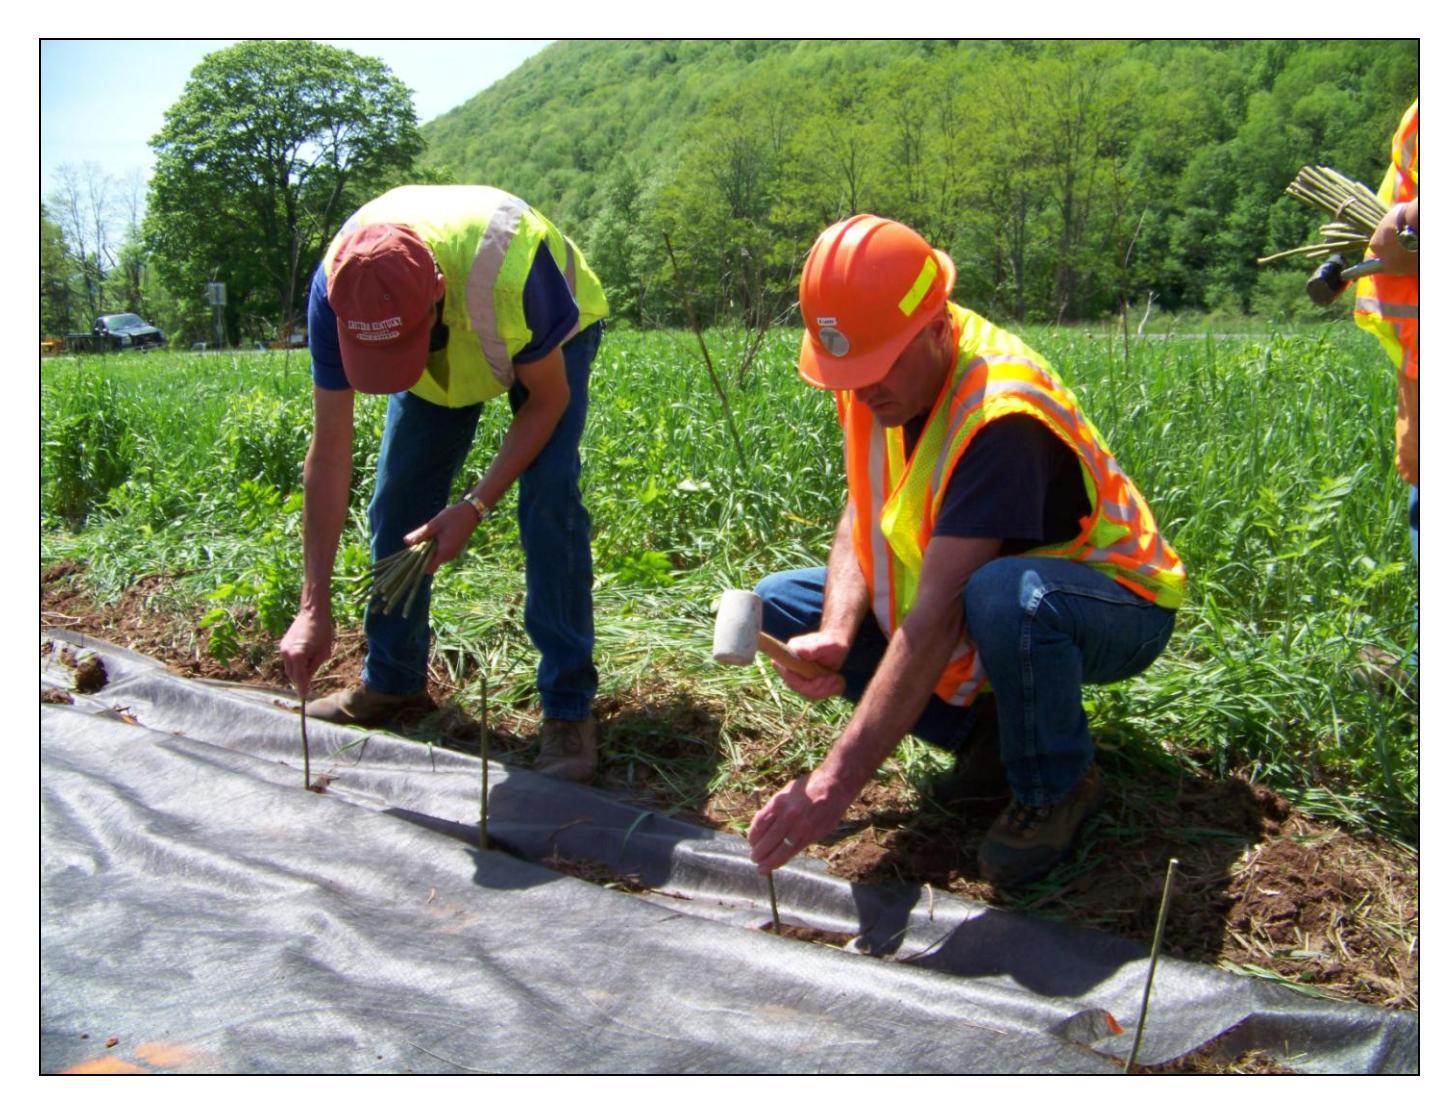
If soil is harder, a few gentle taps with a mallet are needed to get the willow cutting deep enough, as Lewis Lacey and Walter Geidel, Town of Walton Highway Superintendent, are doing.

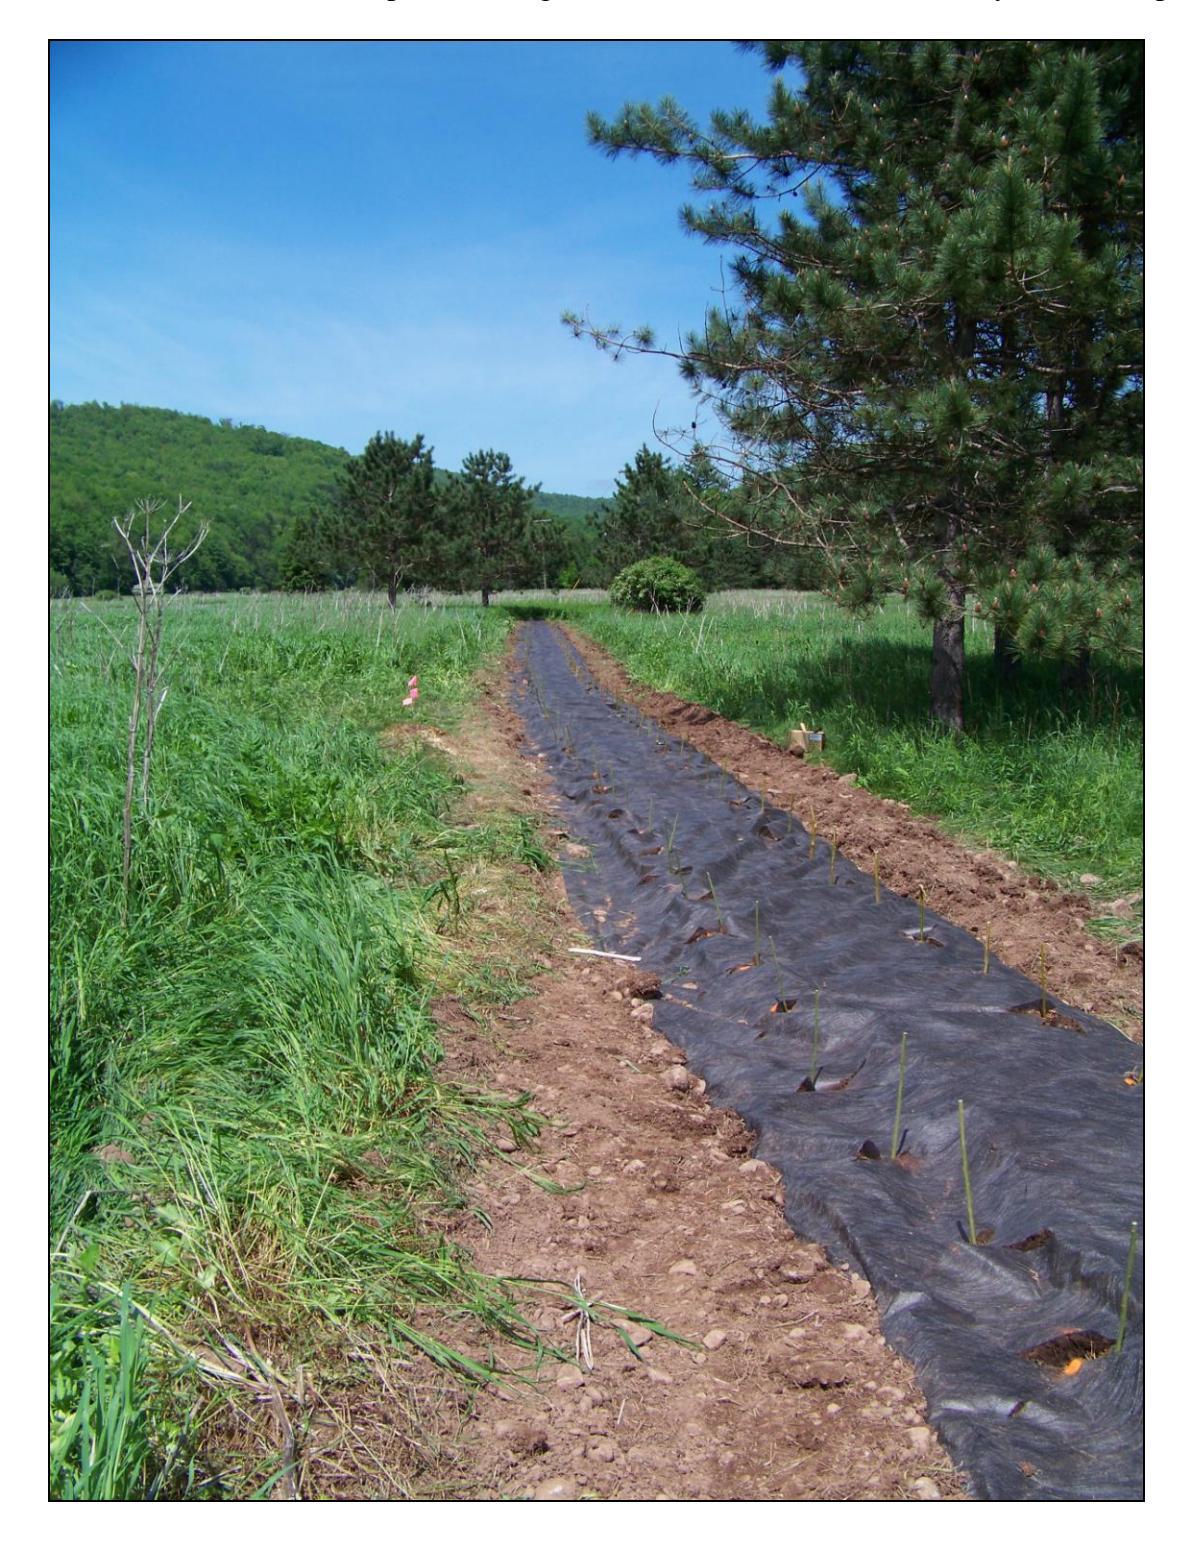
At the end of the first day, the class installed all the willow cuttings. This photograph, looking north, shows the extent of the installation.

This photograph also shows how field conditions affect installations. The dried weeds on the left of the picture are Wild Parsnip, a noxious weed that can cause skin burns. For this class, the planting was early enough that the threat of Wild Parsnip was not significant and workers avoided easily detectable plants.

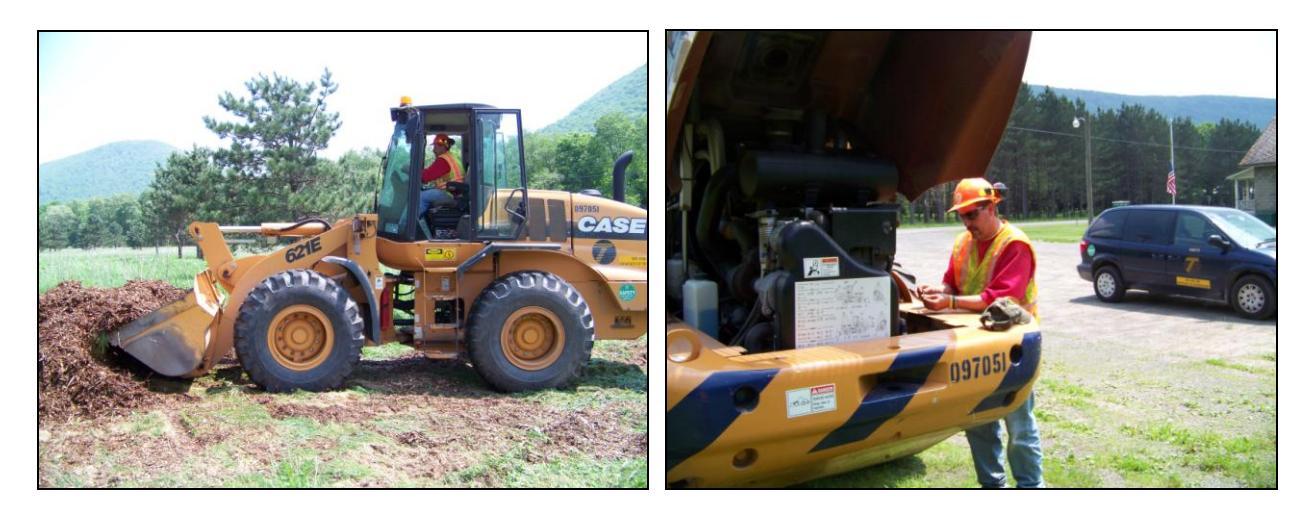
On Day 2 of the class, Steve Dufton, the Delaware South Supervisor for this segment of Route 10, assigned an articulated loader and John Letosky, the operator, to help. The bucket on this loader could hold enough chips to mulch 24 feet of the willow cuttings before returning for another load.

Where site conditions allow, the best practice is to use mechanical equipment to place the chips. For productivity, the largest loader that fits in the setting should be used.

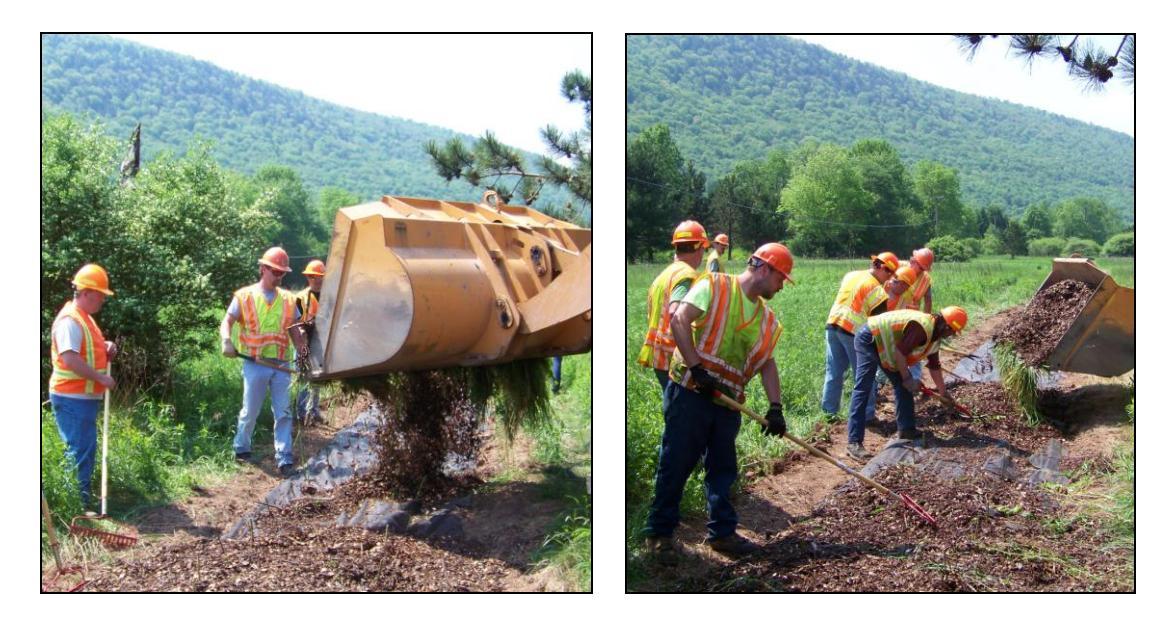
When working with wood chips, it is important to limit the amount of live vegetation in them. A skilled operator will maximize the amount of chips that can be placed in a single trip. In the picture on the left, Tom Story, Everett Cass and Chris Kappeller are unloading chips. In the picture on the right, Peter Norton and Phil Castellano are unloading the chips and trying to keep live vegetation out of the planting.

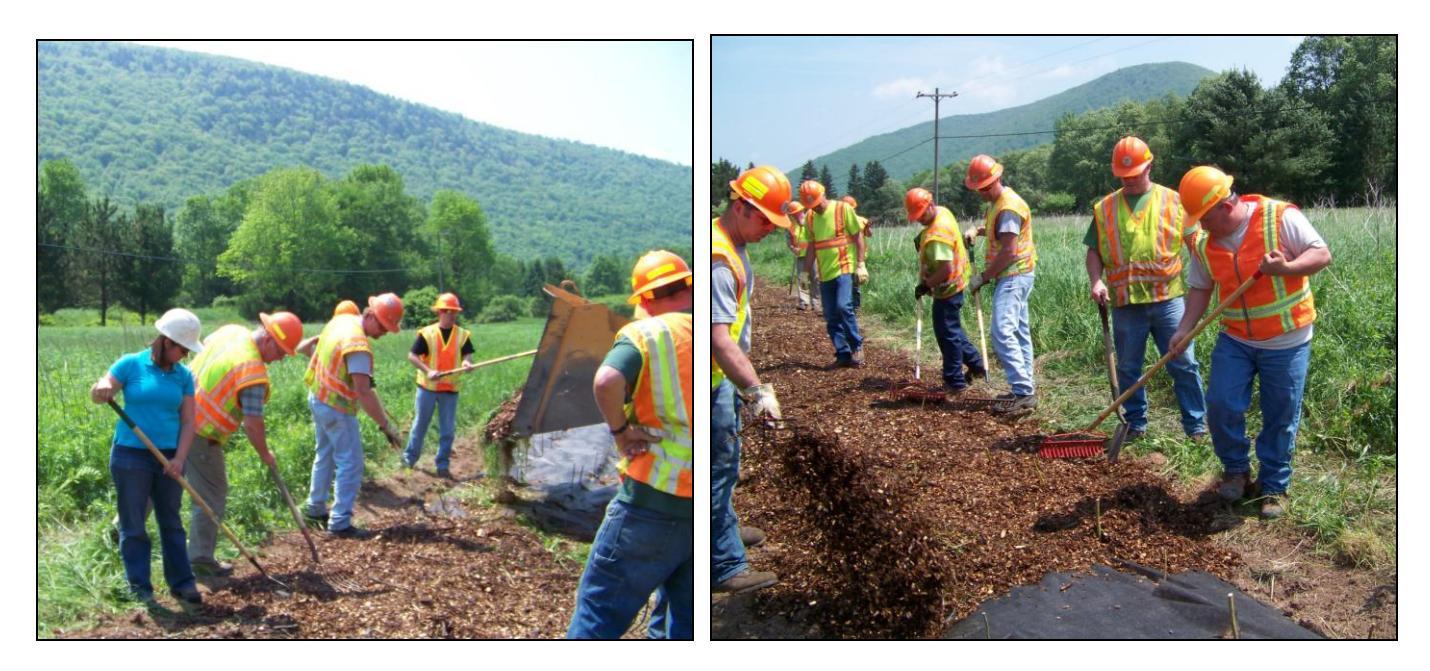
Once the chips are unloaded, workers need to spread them out, to realize the weed control and moisture retention benefits. These pictures show Brian Robinson, Peter Norton, Lewis Lacey, Tom Story, Bob Richter, Paula Bagley and Everett Cass placing chips.

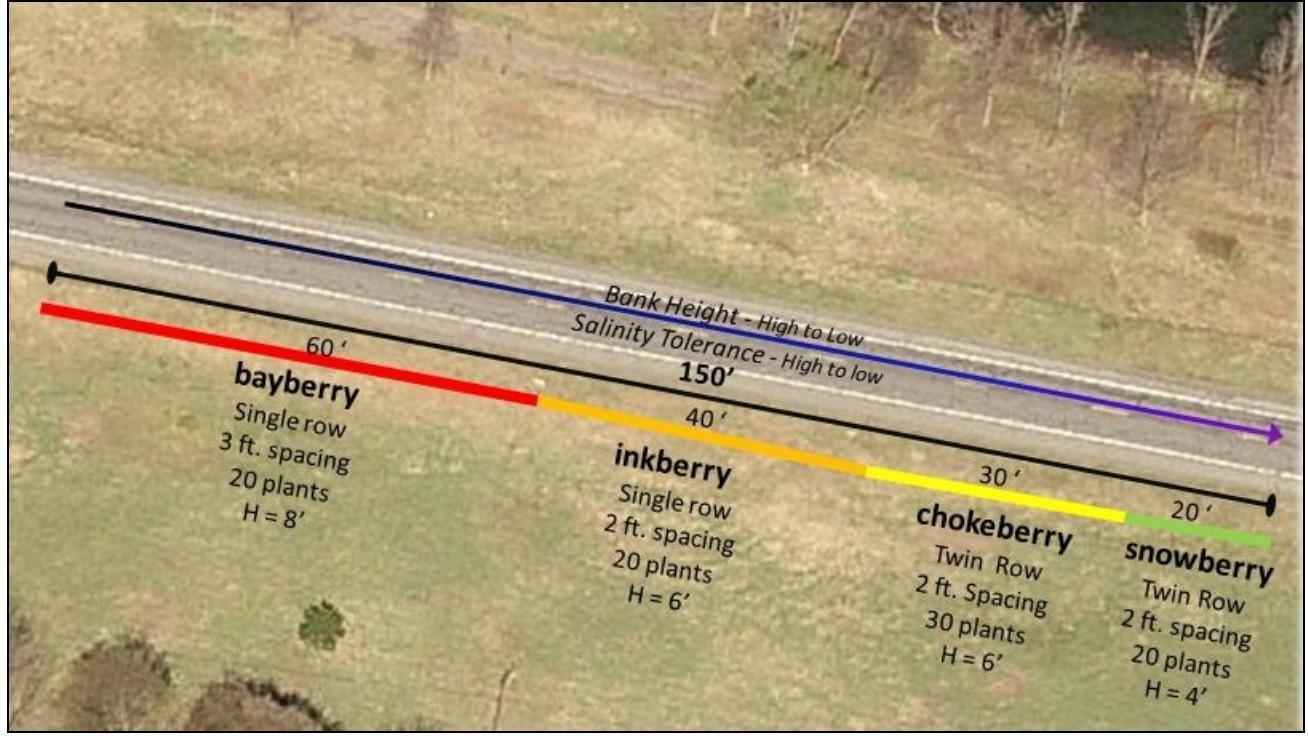
Planting Chart by Justin Heavey. SUNY ESF, 2011

To address near snow at the south end of the project, bushes were planted at the base of the highway slope. The researchers developed the following planting plan, to guide the work in the field.

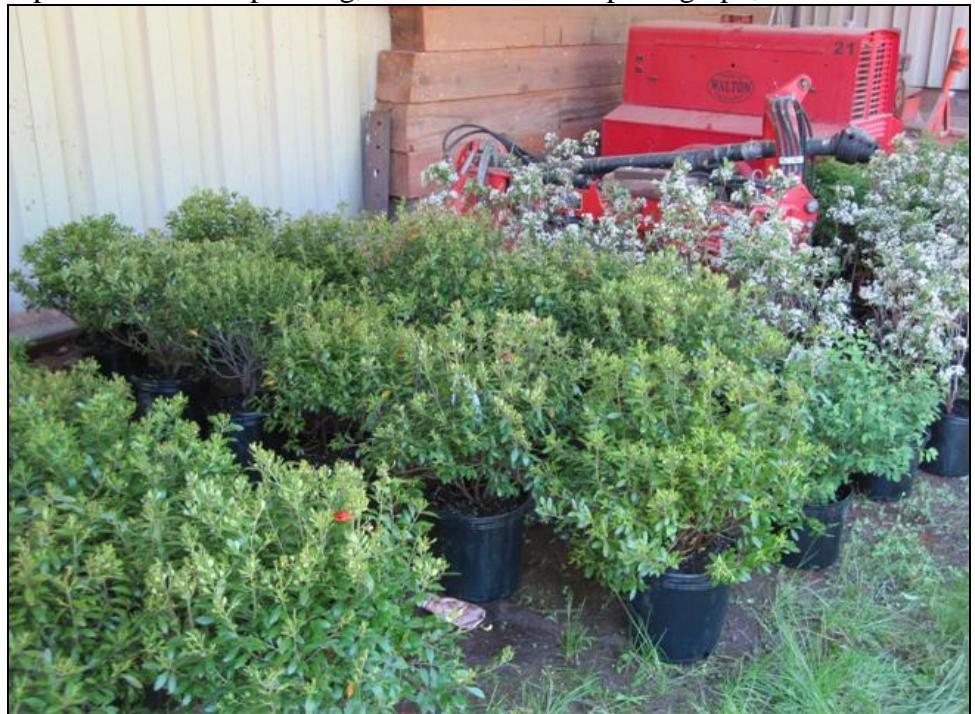
For this installation, the bushes were ordered as potted plants. The benefit is that they are larger and have a higher likelihood of survival once planted. When potted stock is ordered, however, the stock must be kept watered and protected before planting, as is shown in the photograph, below:

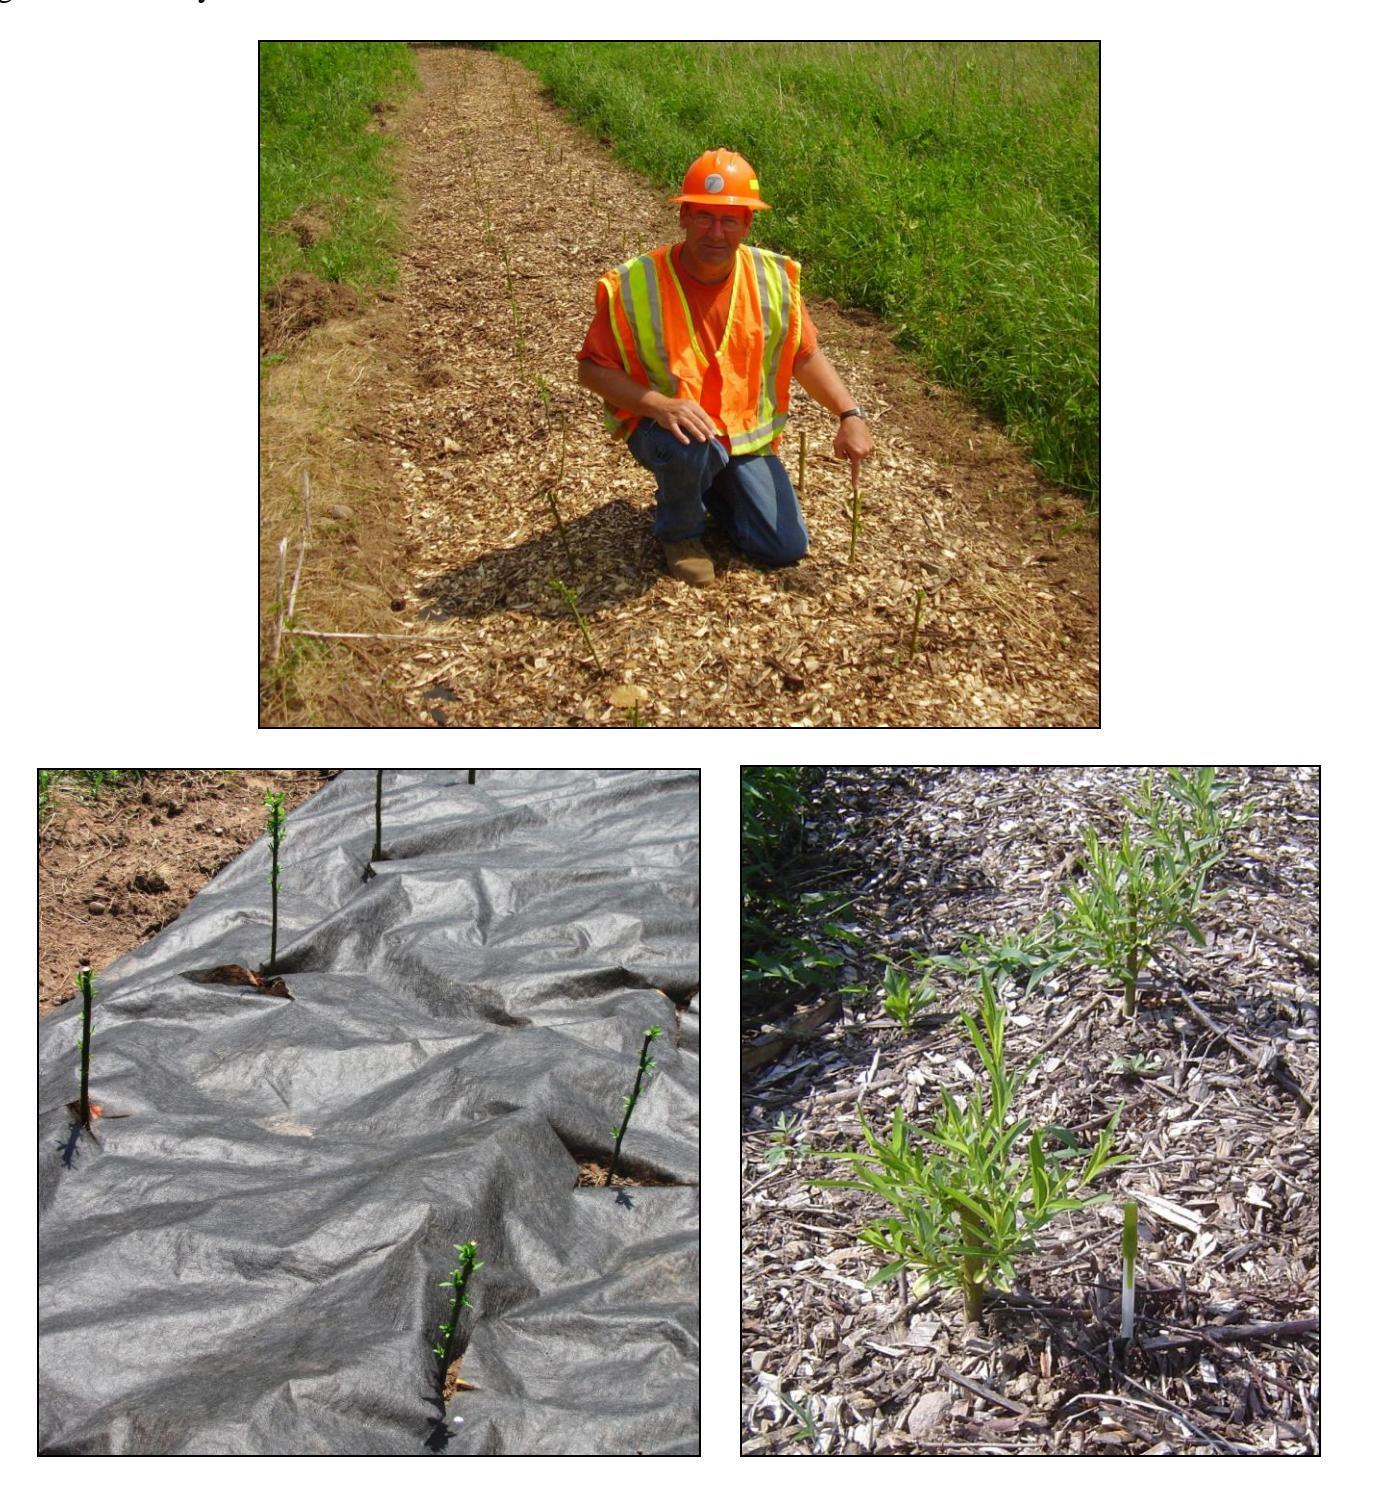
Thanks to good site preparation and regular rain since the installation, the willow cuttings are off to a good start. The top picture shows Mike Darder of Delaware South checking the installation 12 days after planting. Note the leaves starting to appear on the willows. The bottom left photograph shows leaves starting to appear on the second group of willows at 10 days later; the bottom right photograph shows growth at 55 days.

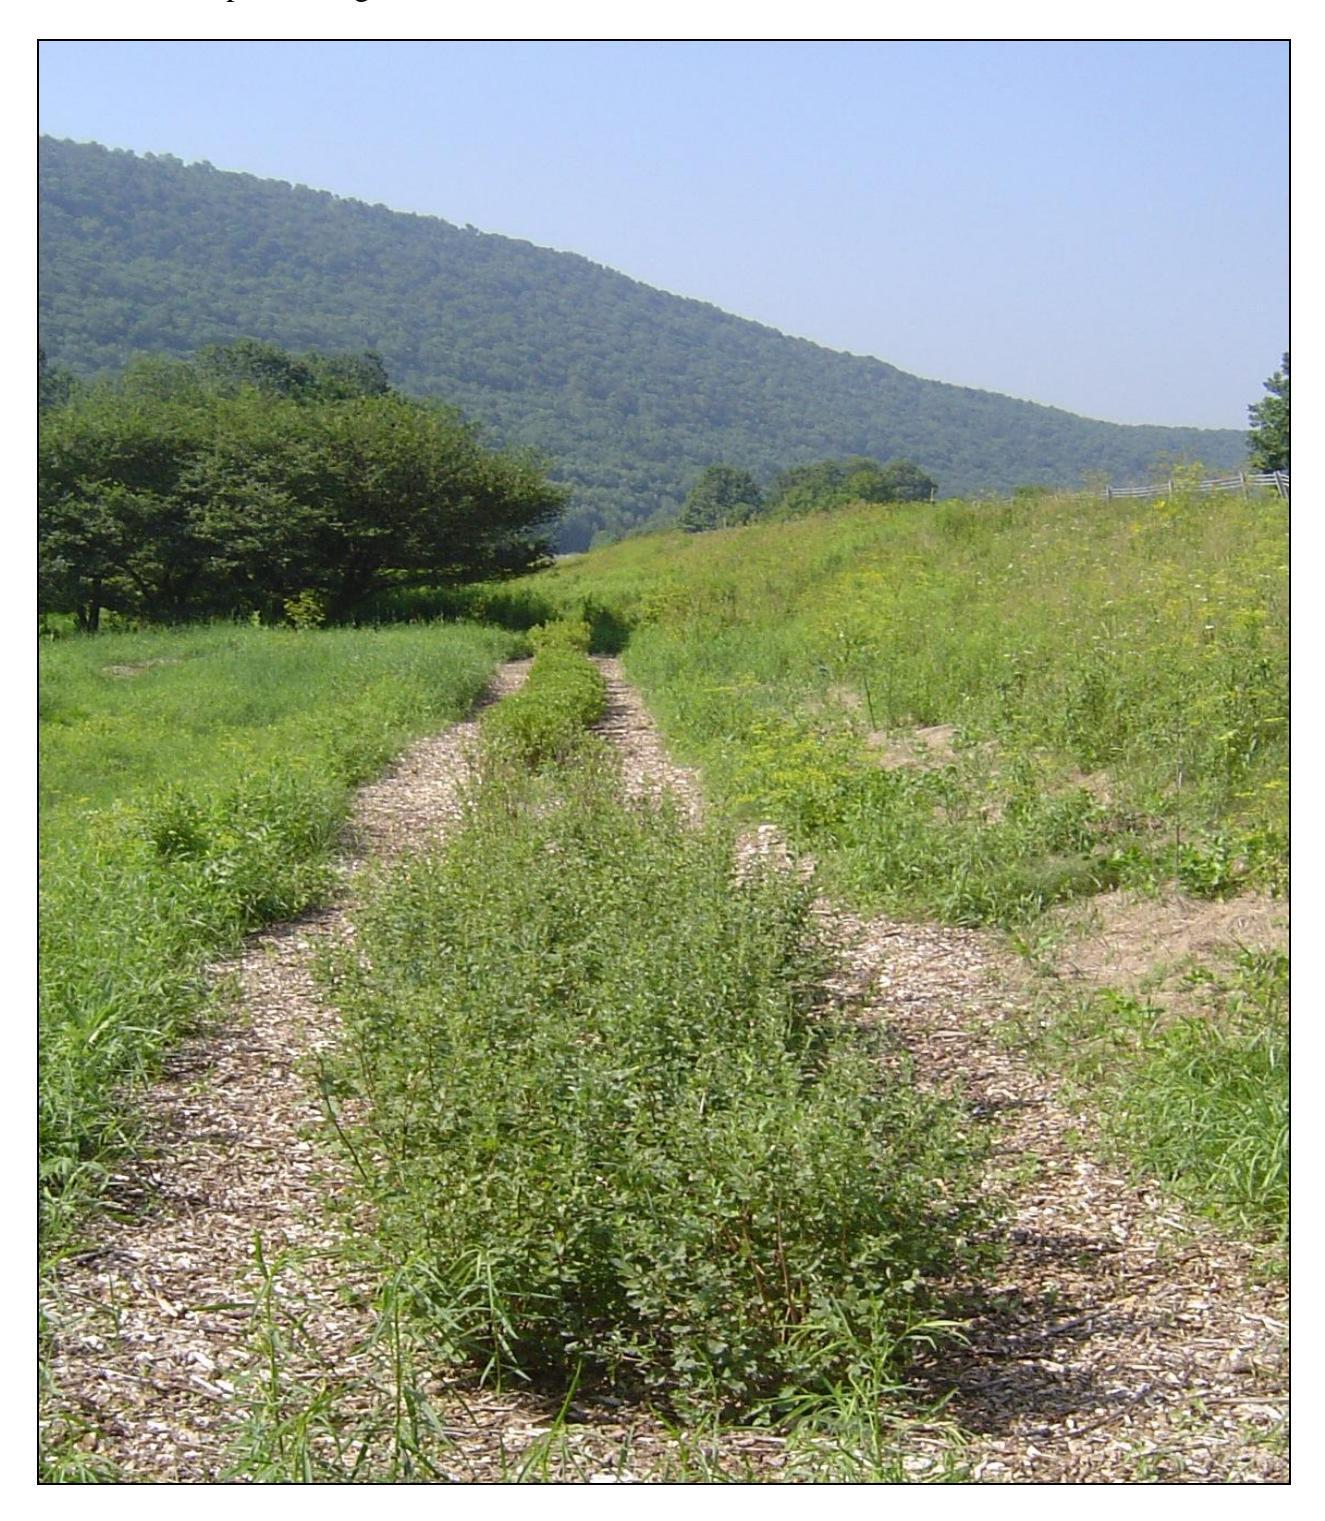
On this page and the following are three panoramic photographs of the willow and bush installation 55 days after the planting. A common factor in all the pictures is good weed control. Below are the bushes at the toe of the slope, looking south

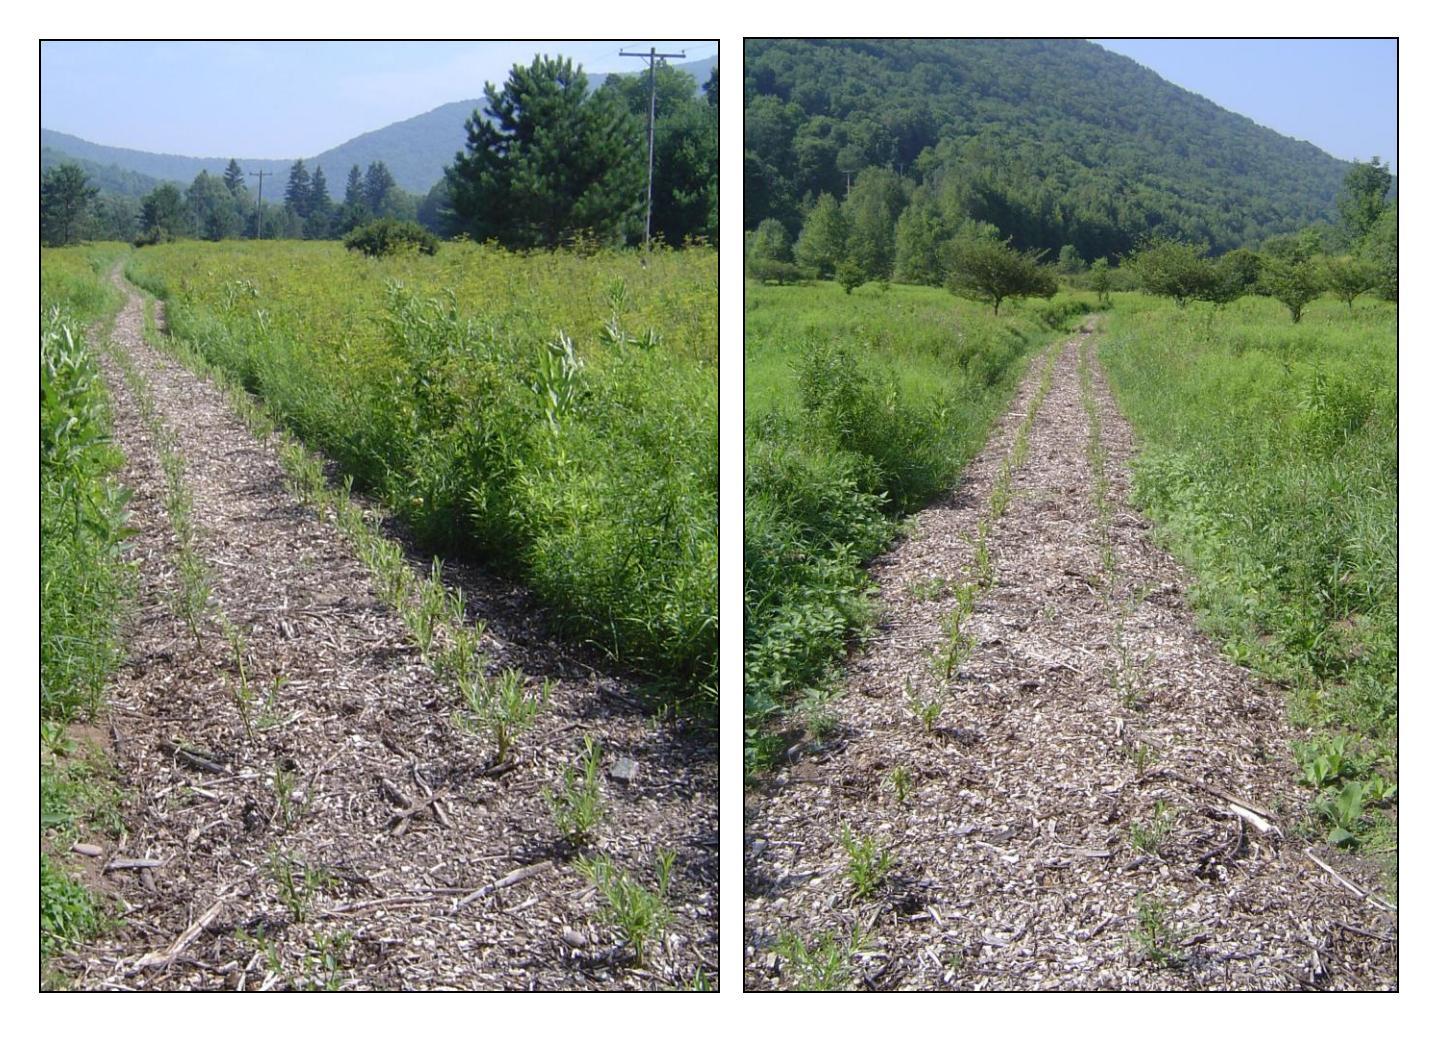
In the photographs below, note good willow survival, good weed control and strong growth in the first 55 days. The lower left picture is looking north at the main willow installation. The lower right photograph is looking south at the installation of the southern rows of willows.

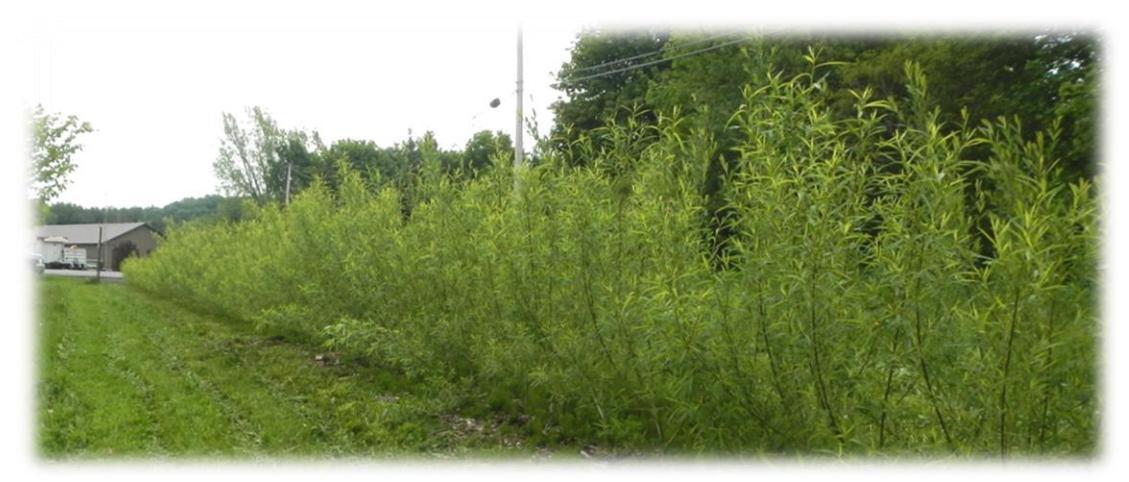
Figure 1: Shrub-willow snow fence at Route 12 Paris in May, 2013 - Photo by Justin Heavey

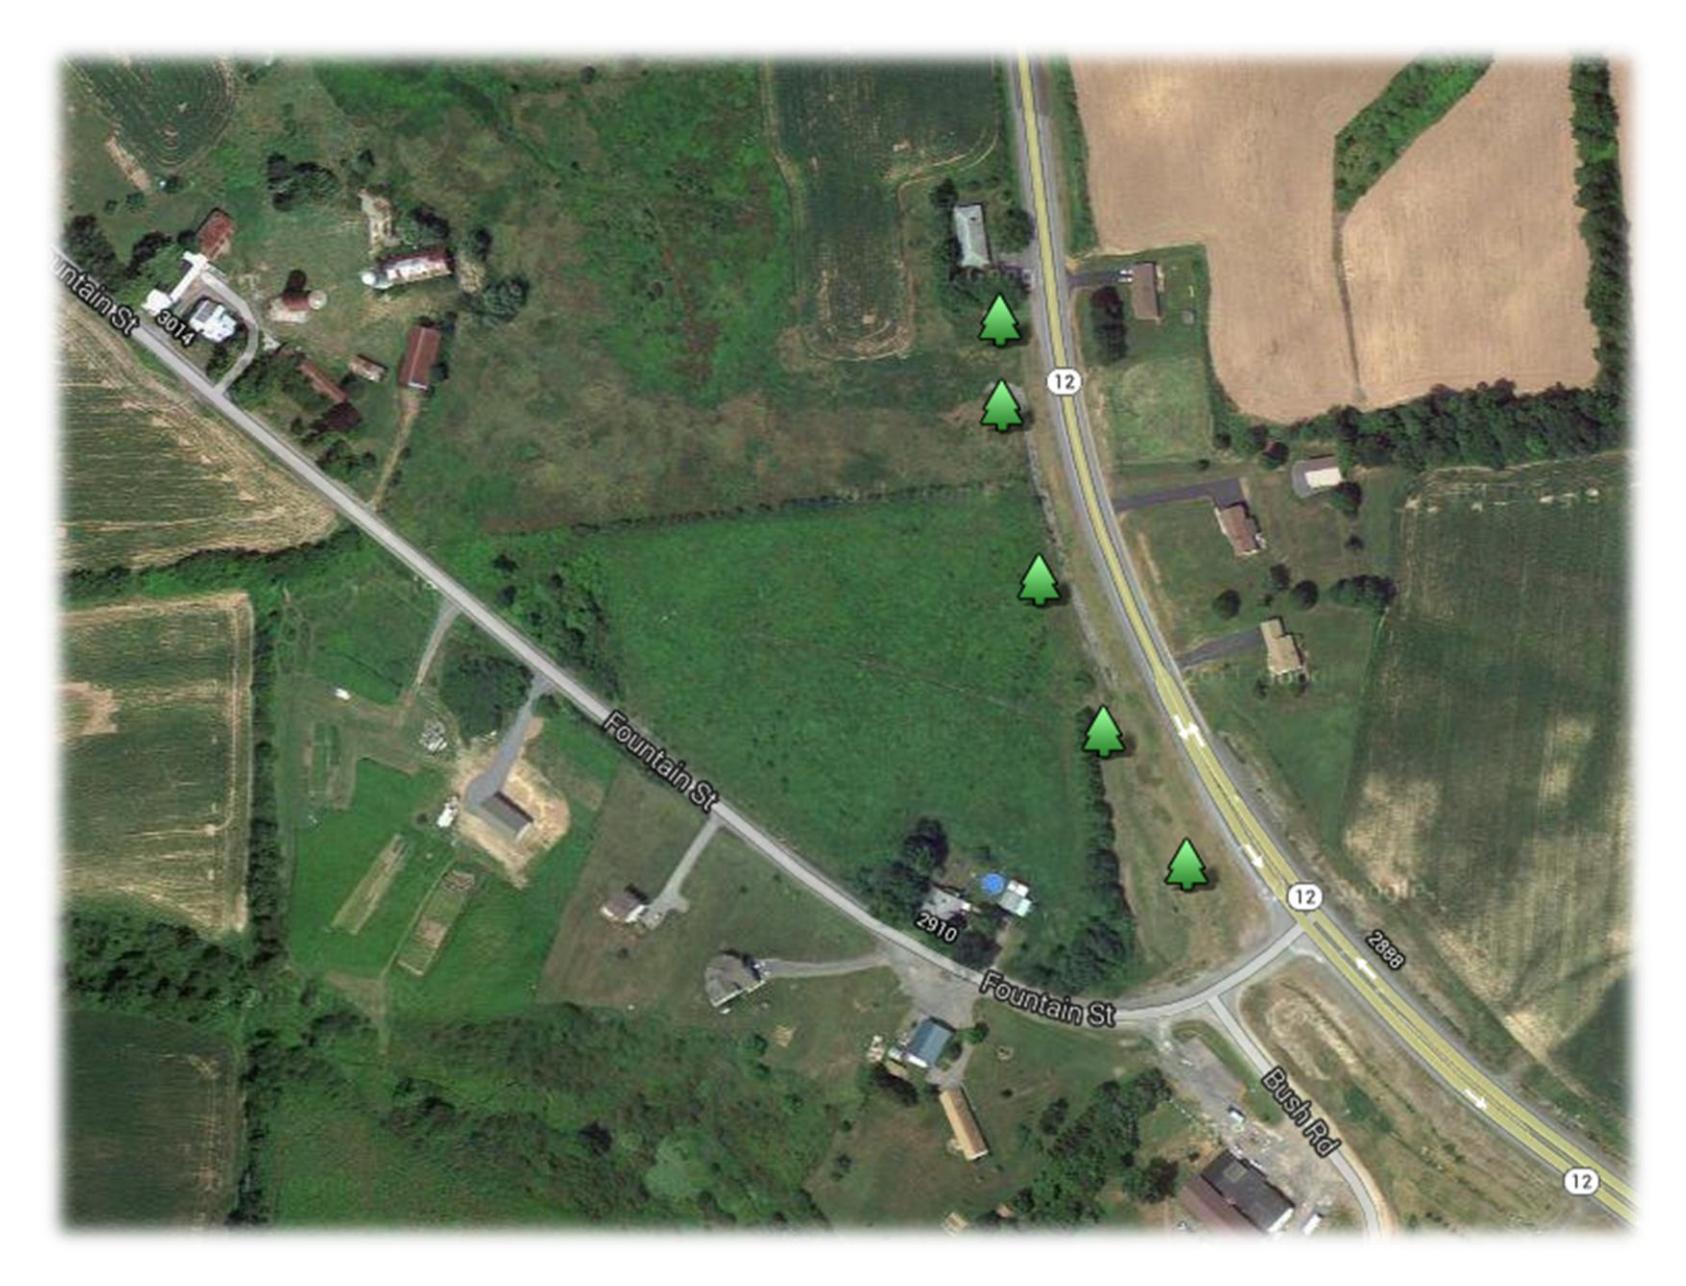
Figure 2: Aerial photo showing locations of shrub-willow snow fence sections planted along Route 12 in Paris, NY

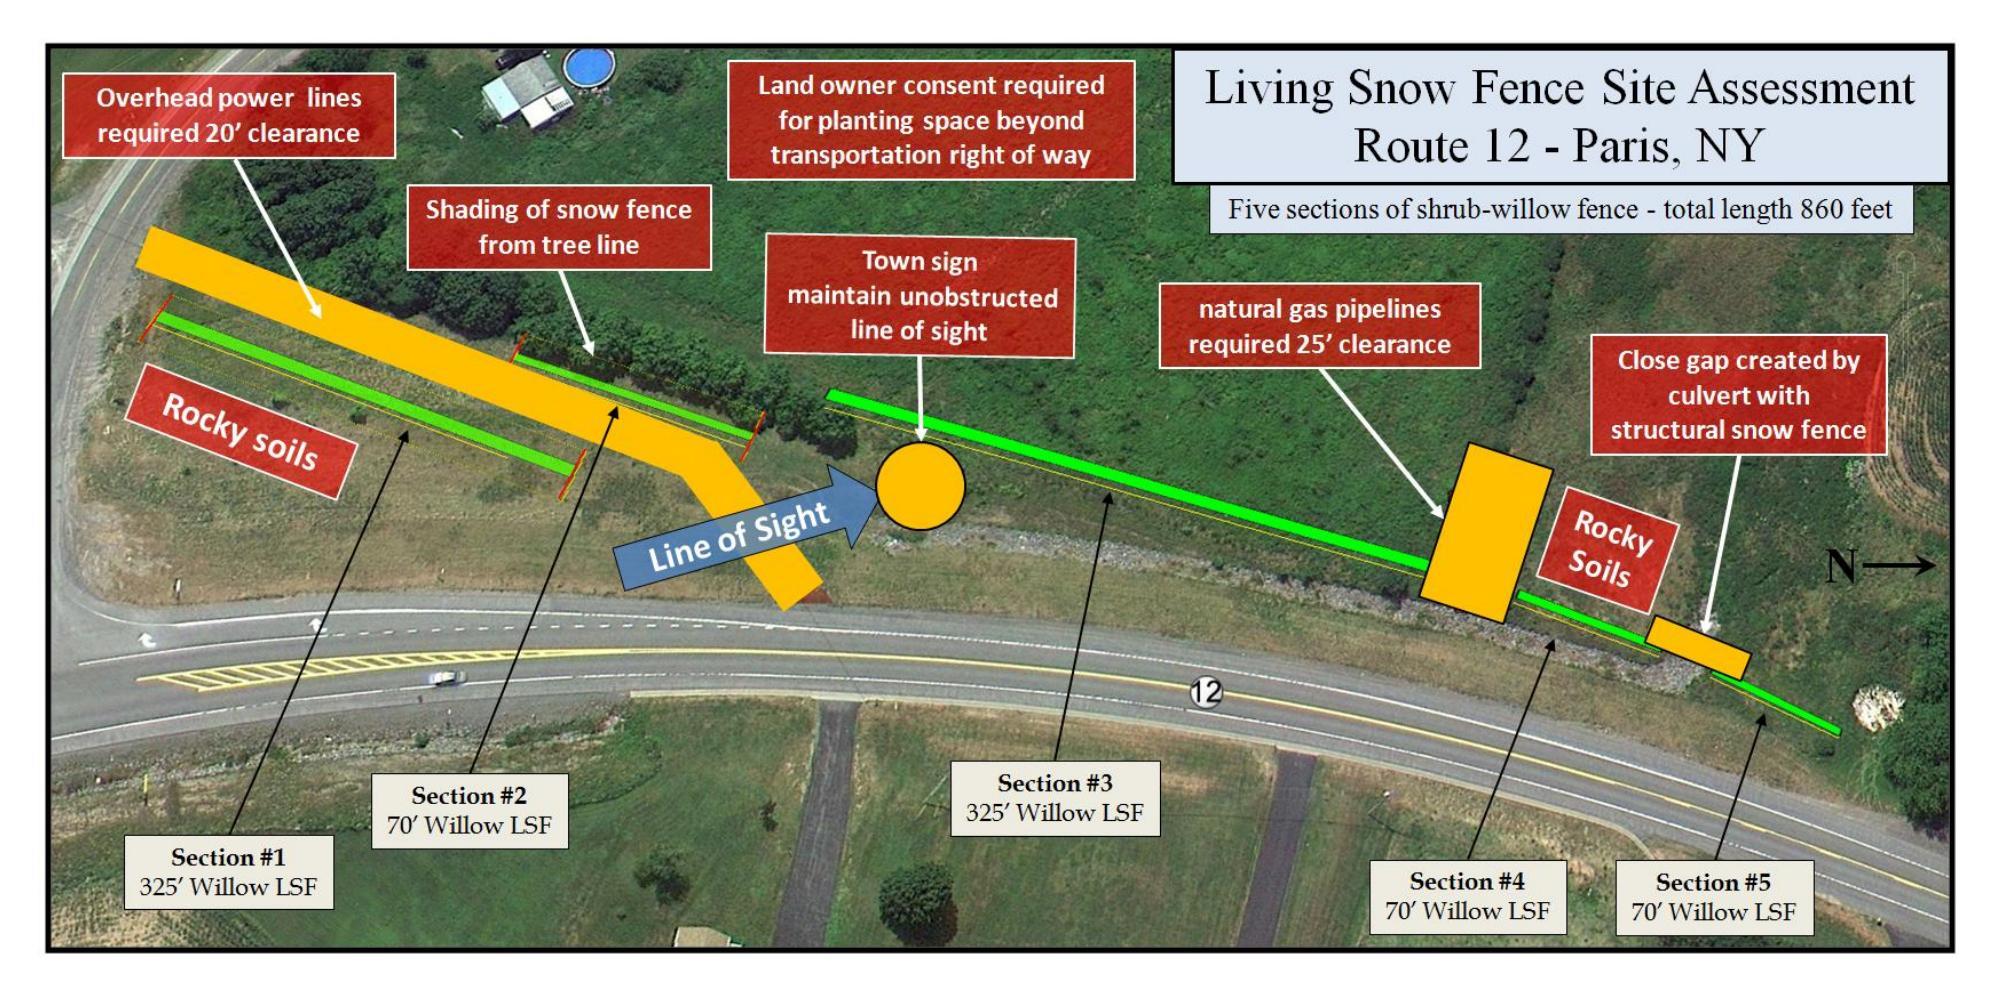
Figures 3: Diagram of fence sections and site challenge for Paris, NY. Diagram by Justin Heavey

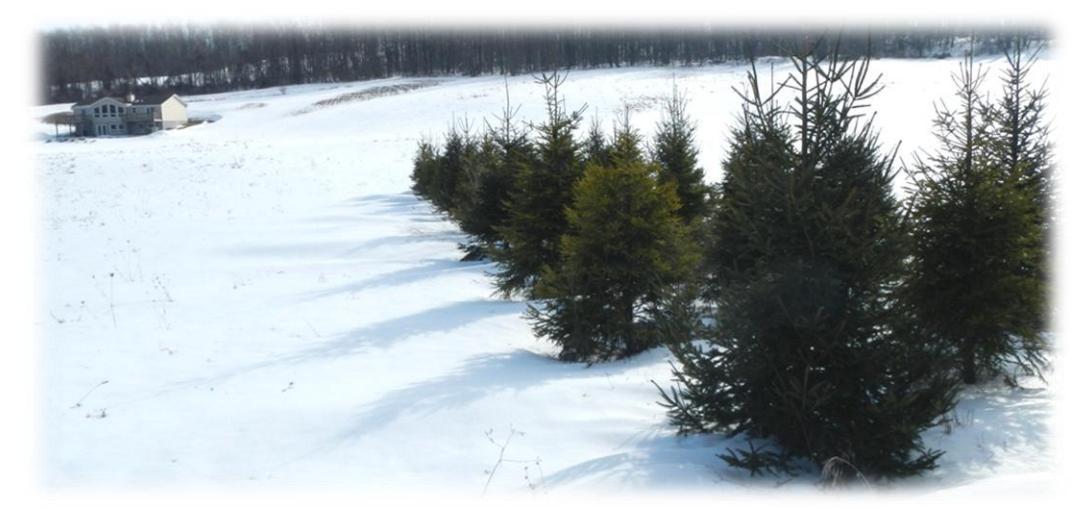
Figure 4: Norway spruce living snow fence in winter 2012/2013 - Photo by Justin Heavey

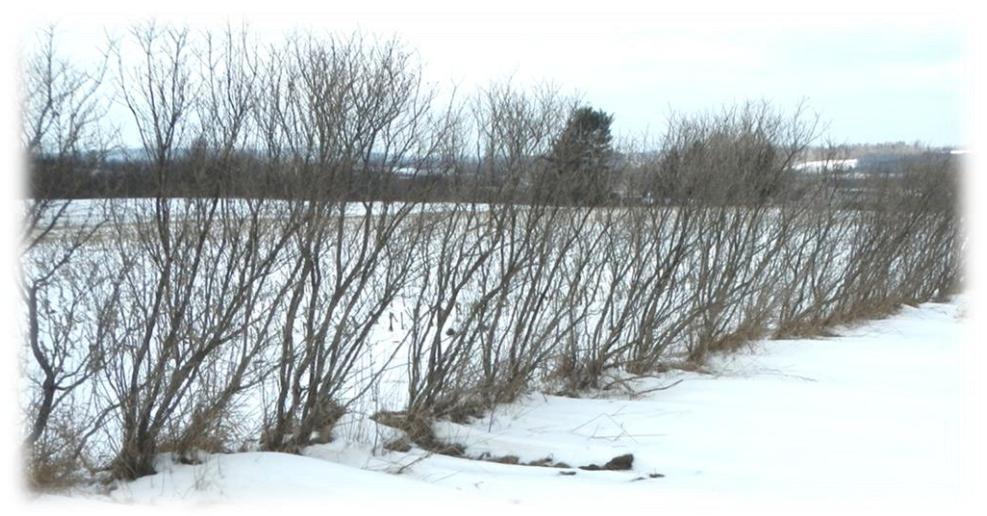
Figure 6: Honeysuckle living snow fence in winter 2012/2013 - Photo by Justin Heavey

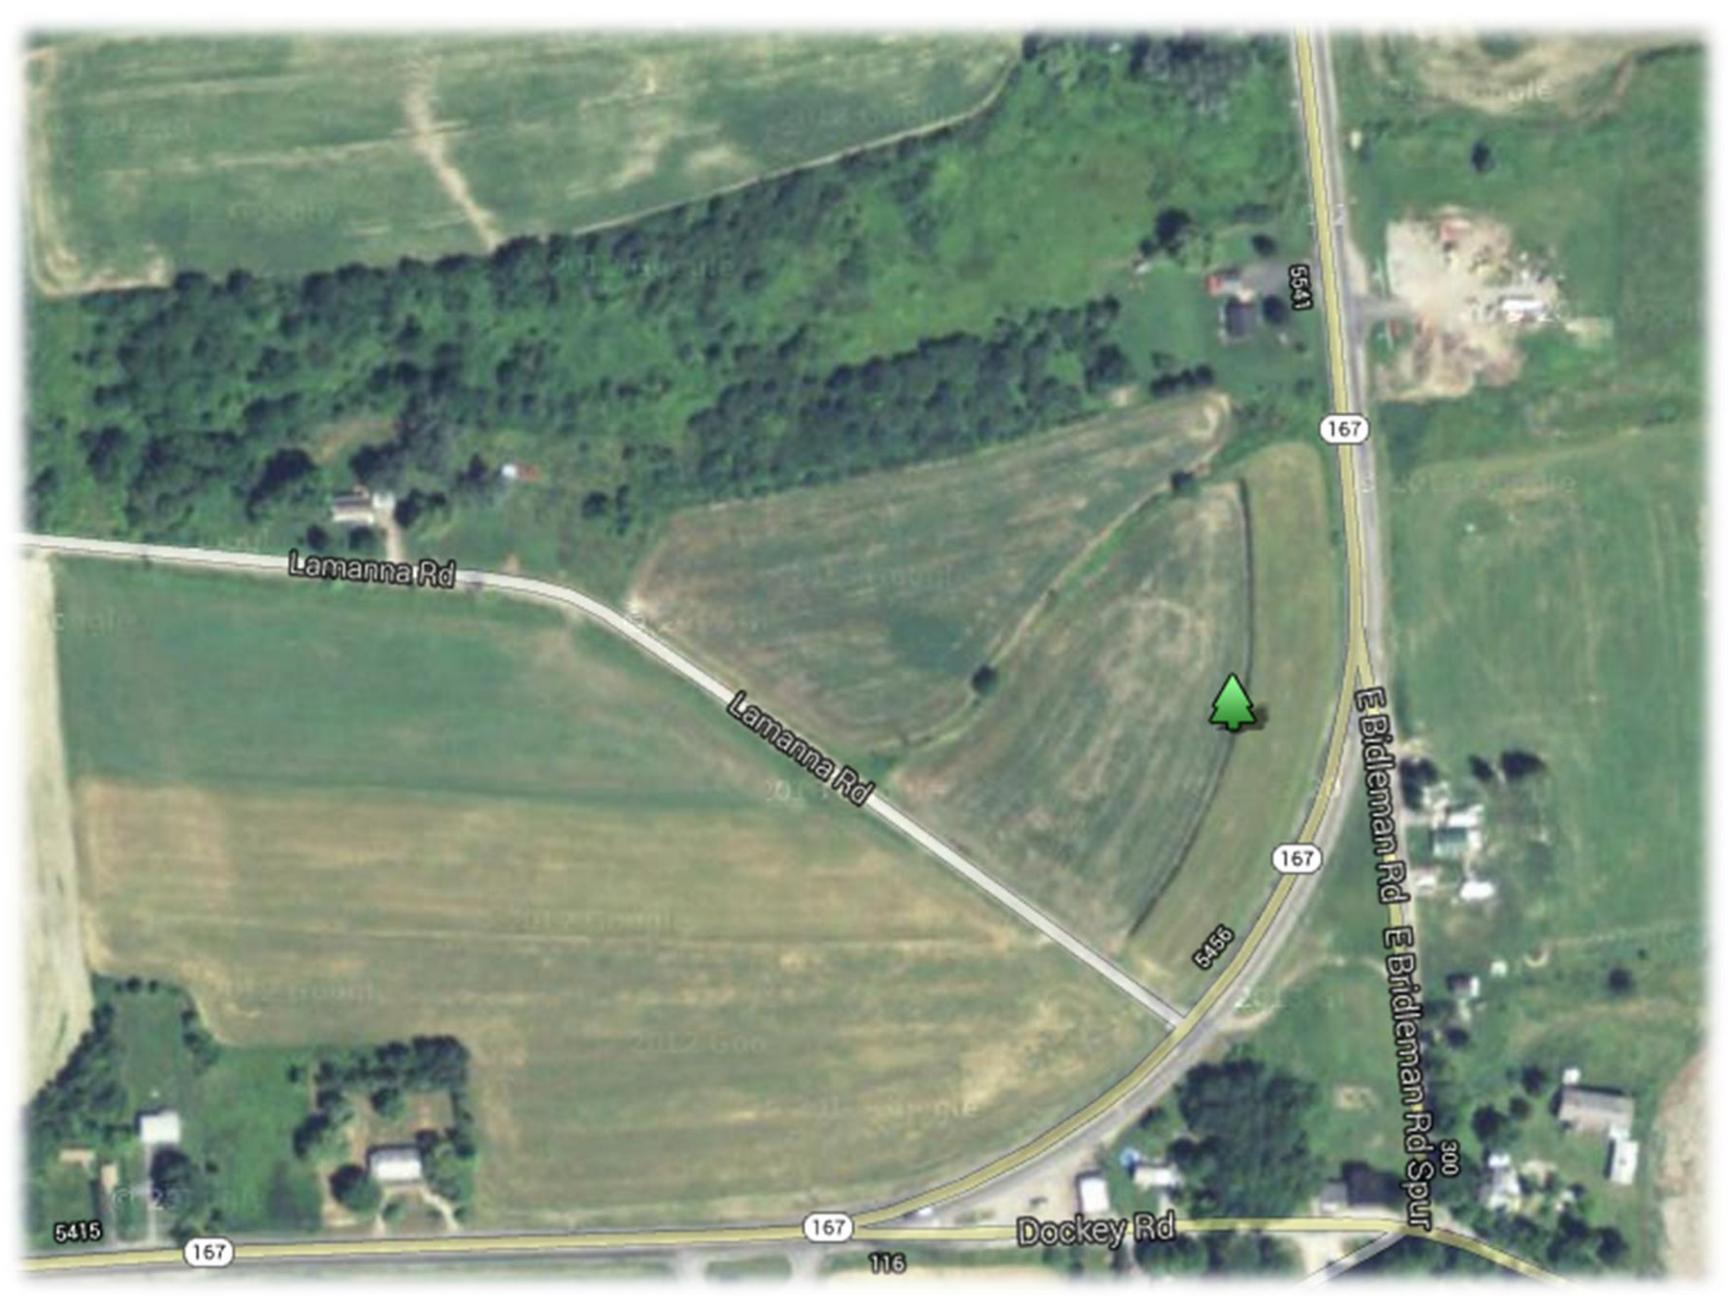
Figure 7: Aerial photo of honeysuckle living snow fence along Route 167 in Manheim, NY

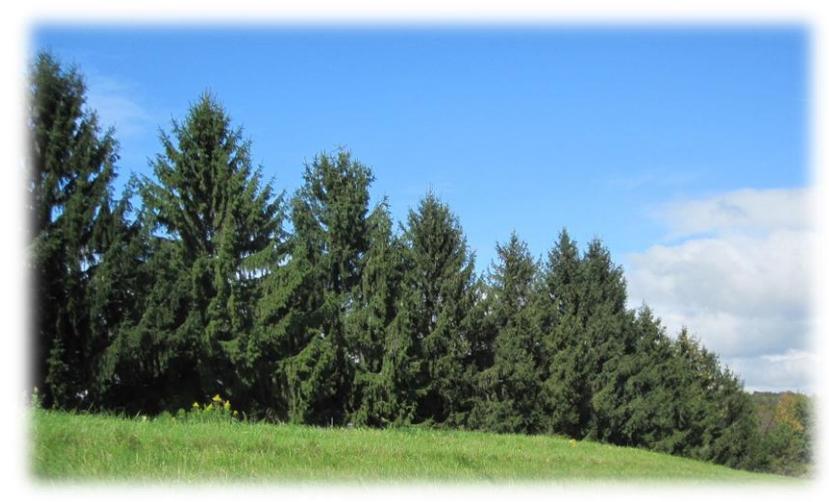
Figure 8: Norway and white spruce living snow fence in fall 2012 - Photo by Justin Heavey
