### Task 2-B: Training Workshops for Living Snow Fence Design, Installation and Maintenance

Task 2-B: Training for LSF Design, Installation and Maintenance

Designing, Developing, and Implementing a Living Snow Fence Program for New York State

### Workshop 9 Field Tour of Existing Snow Fences

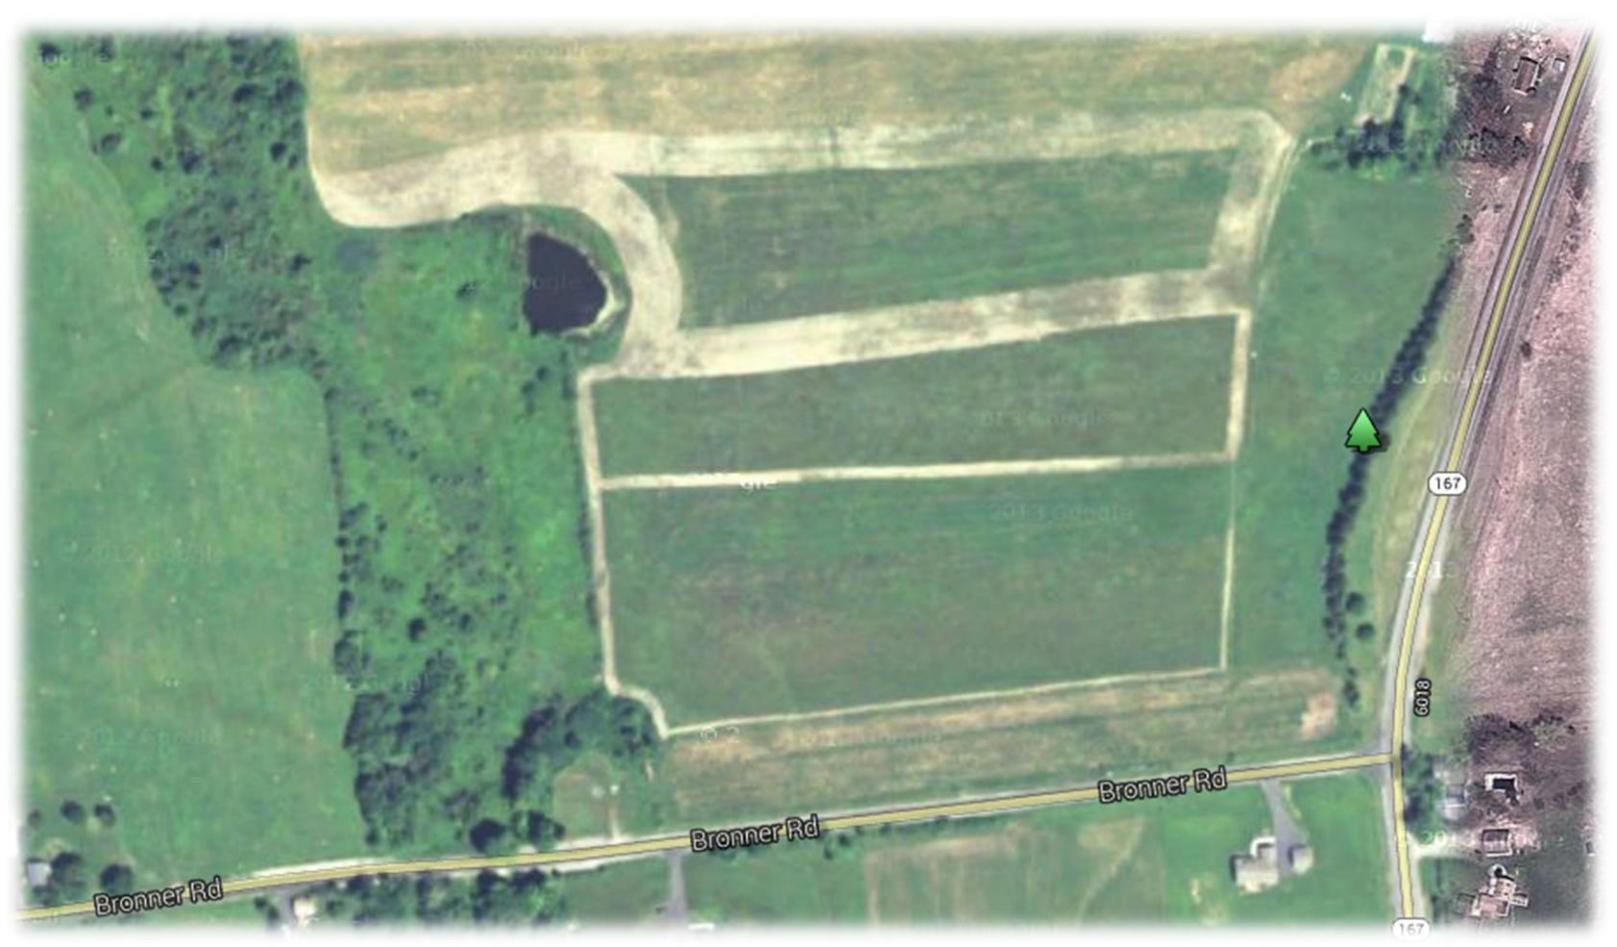
Figure 9: Aerial photo of Norway spruce and white spruce living snow fence along Route 167 in Manheim, NY

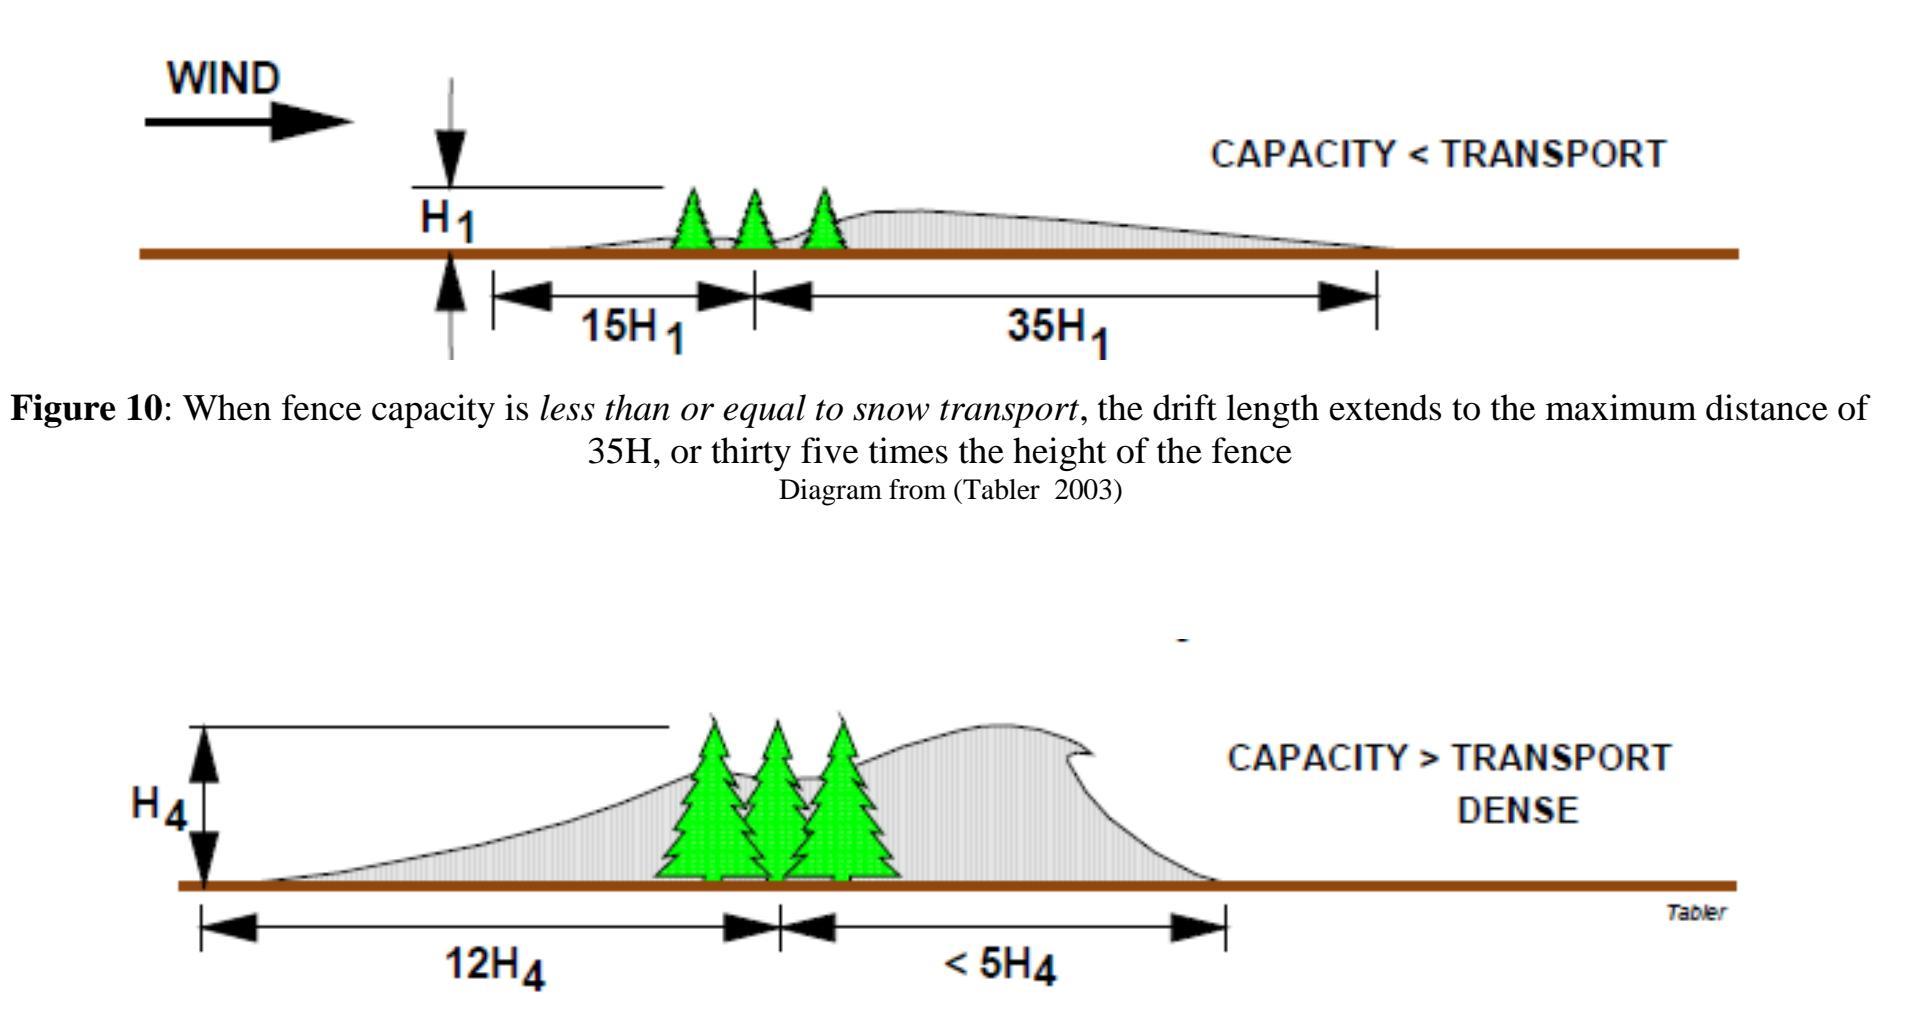
Figure 11: When fences mature and grow to large heights, fence capacity becomes greater than snow transport, the drift is reduced to some fraction of the maximum, and the setback distance can be less than 35H Diagram from (Tabler 2003)

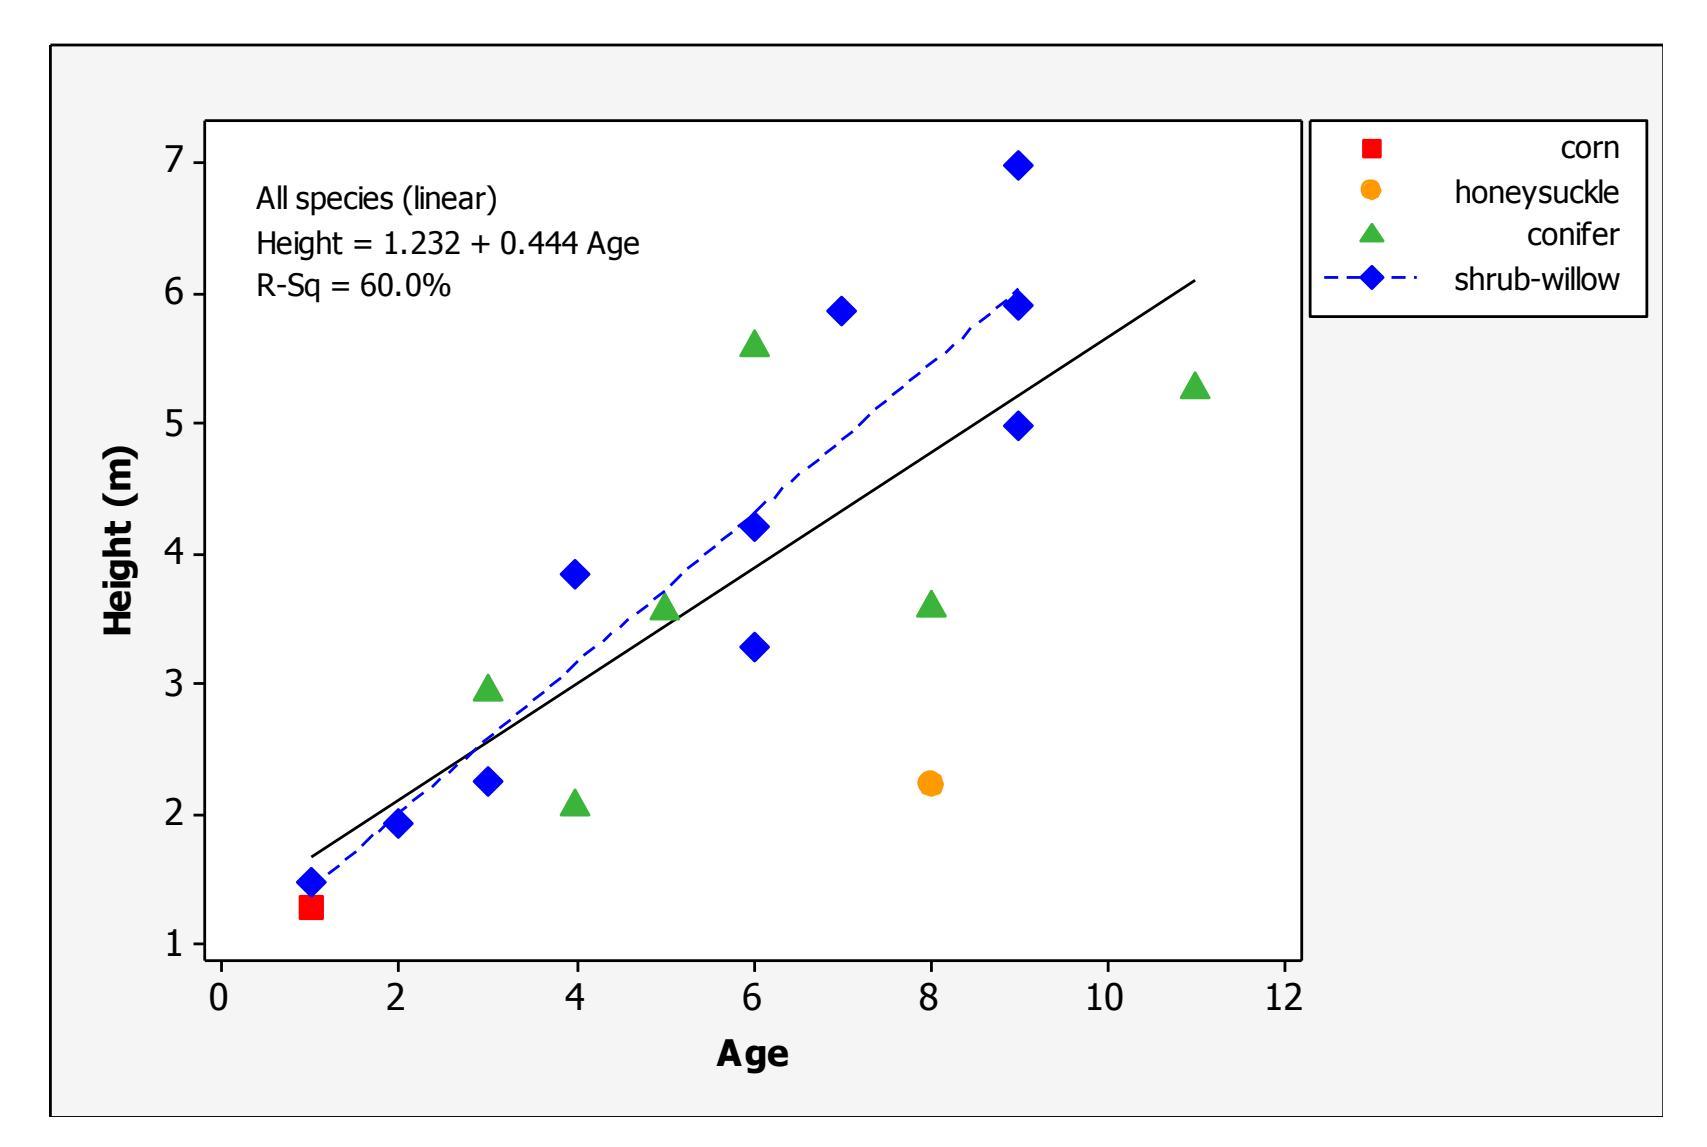
**Figure 12:** Age versus height (in meters) of 18 living snow fences of various species in New York State, grouped by vegetation type. Height increases linearly with time when best management practices are employed. Graph by Justin Heavey

- Structure and Function over time
  - $\circ$  (See Figures 10 14)
- Installation, monitoring, and maintenance
  - Mowing & deer repellent
- Design challenges and solutions
- Biodegradable landscape fabric & pins
- Coppicing or not (benefits/drawbacks)

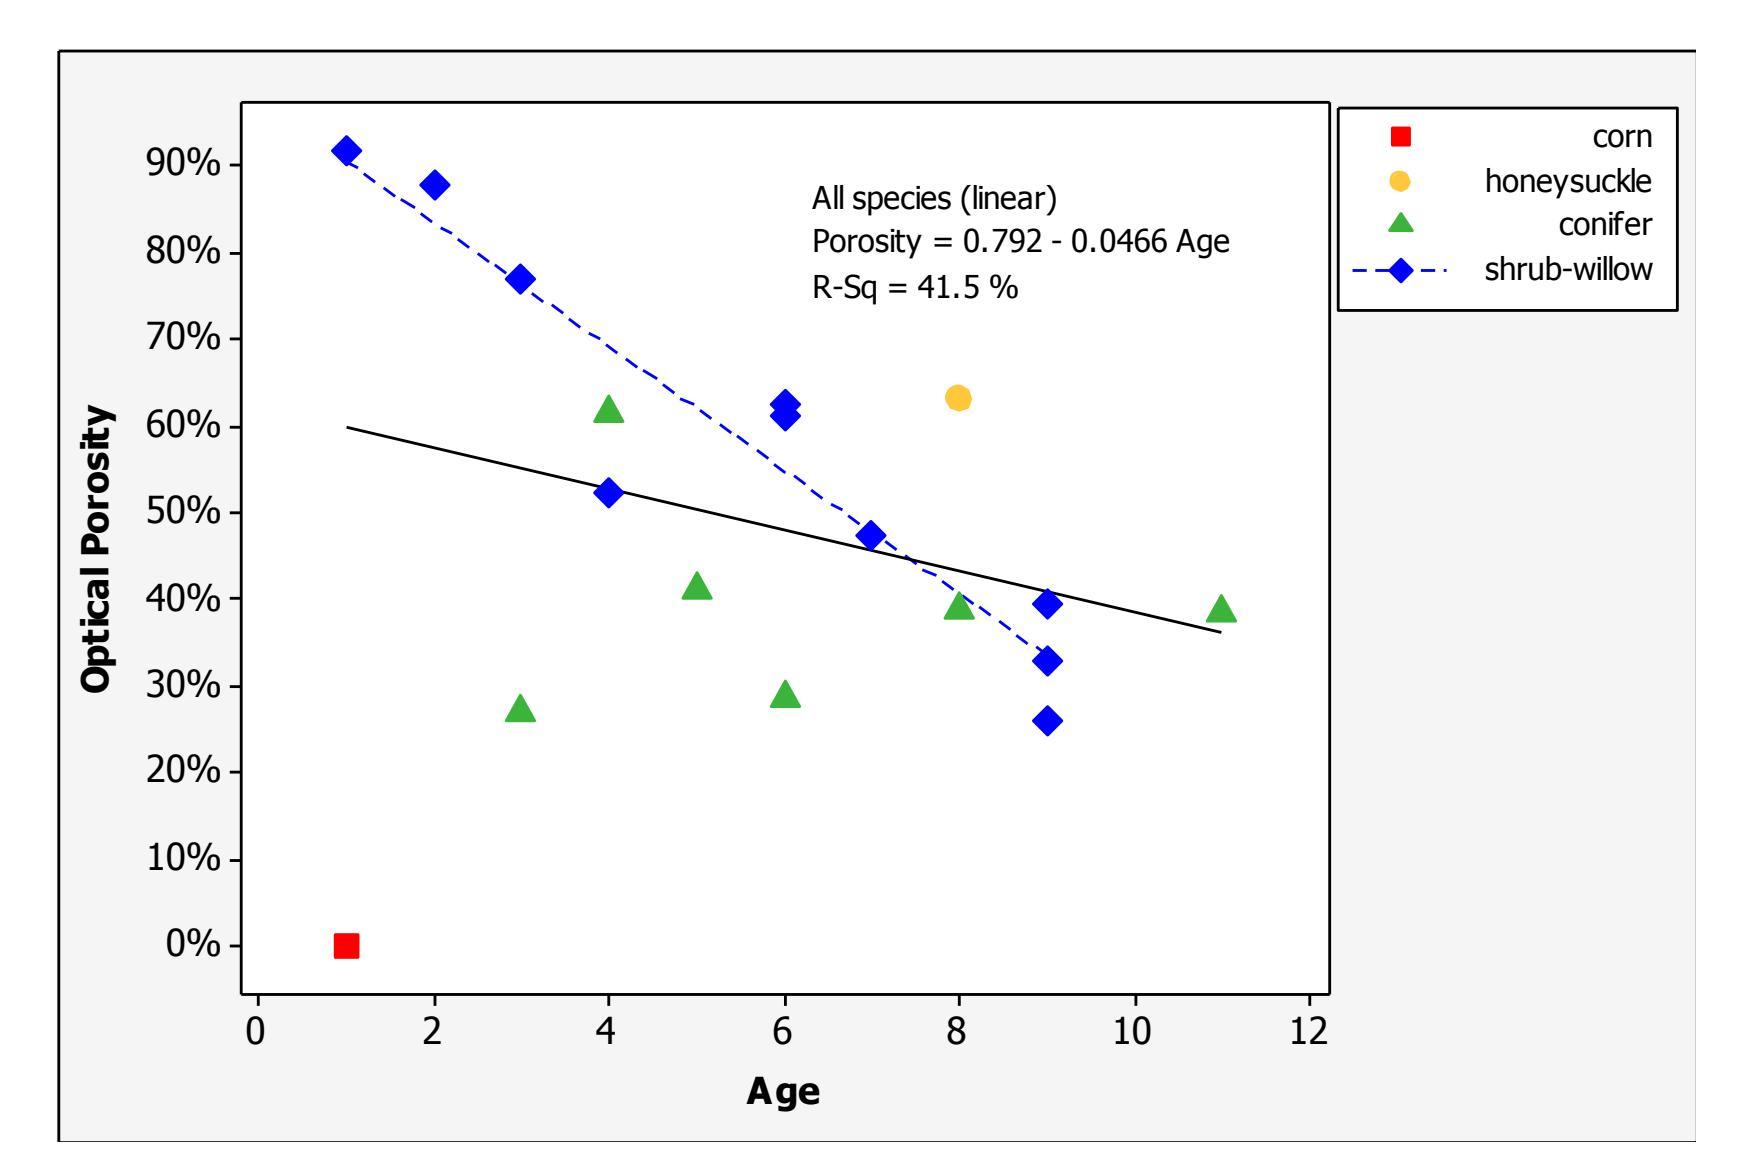
**Figure 13:** Age versus optical porosity of 18 living snow fences of various ages and species in New York State grouped by vegetation type. Porosity decreases linearly with age when best management practices are applied. Graph by Justin Heavey

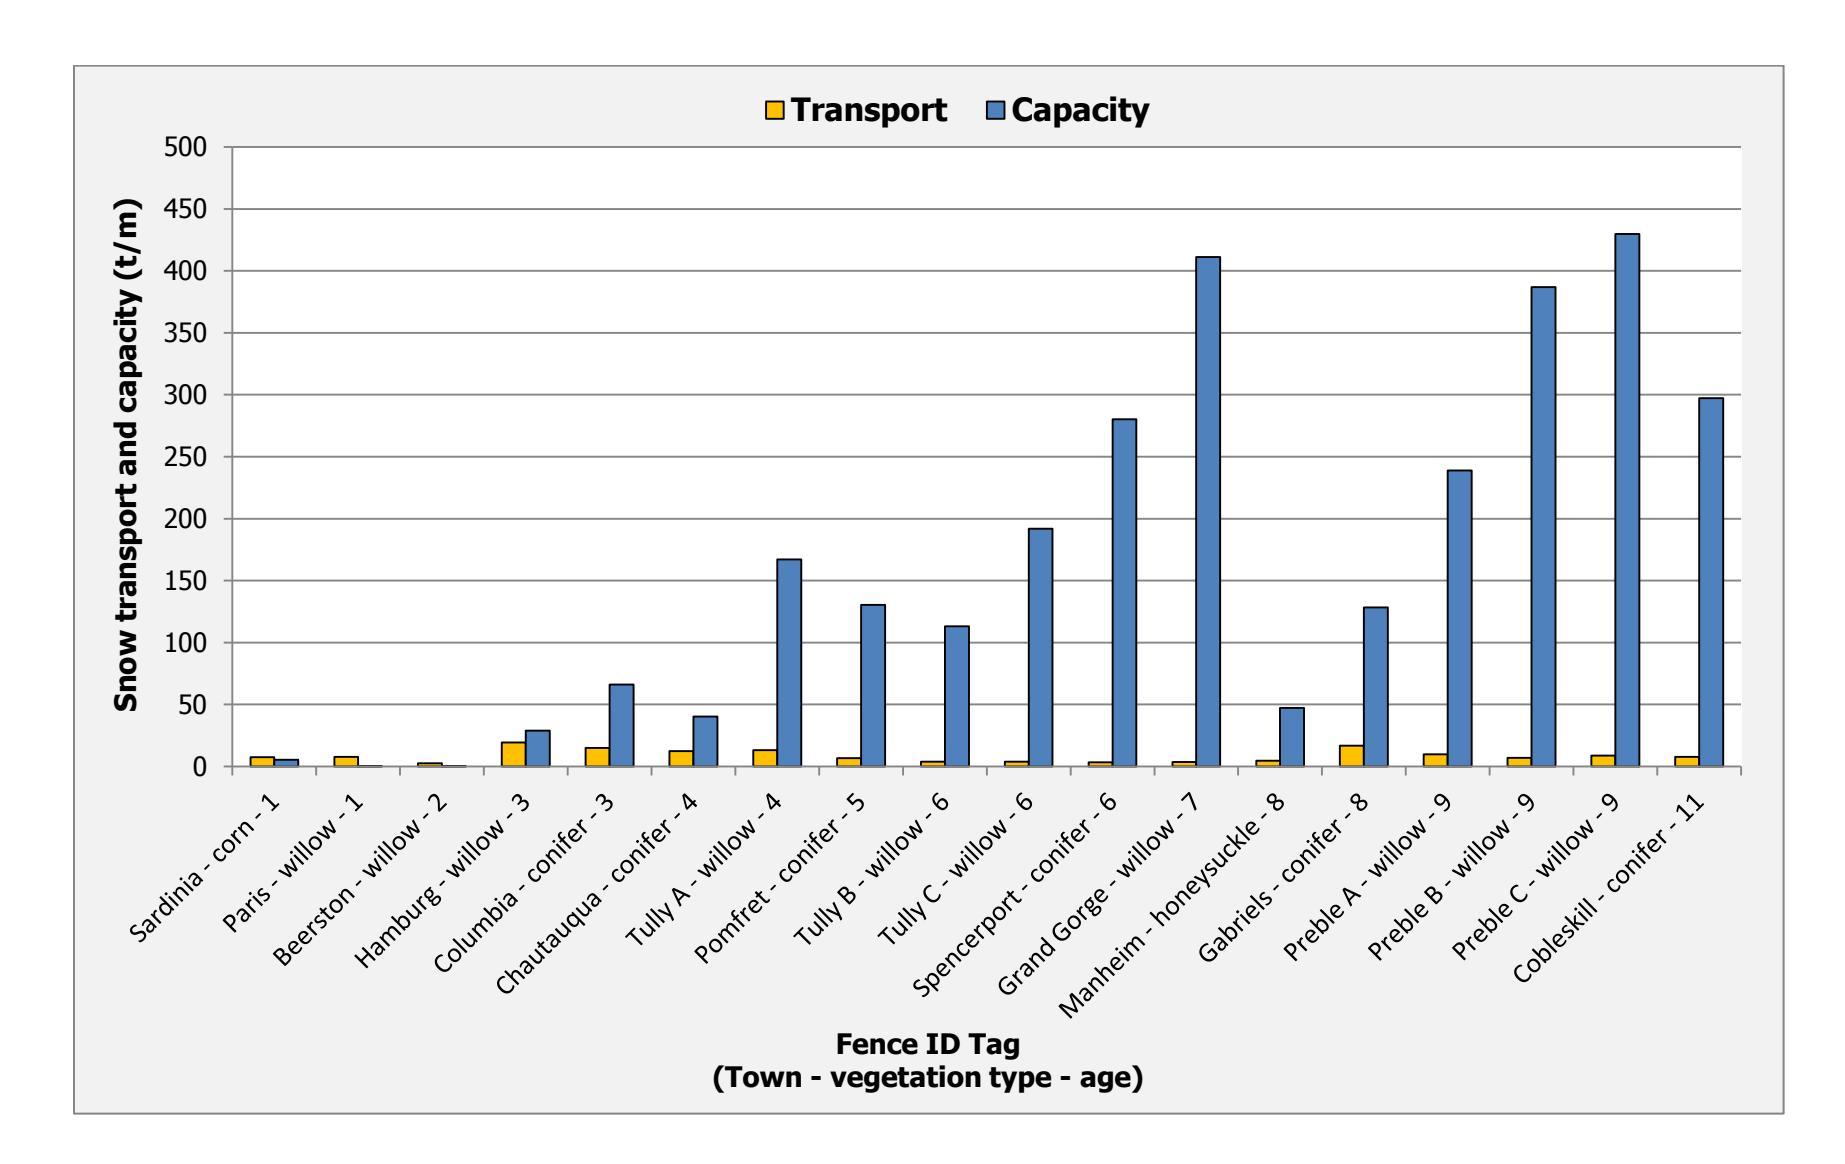
**Figure 14**: Fence capacity relative to the quantity of snow transport at each site for 18 living snow fences of various species and ages in New York State. Capacity greatly exceeded transport for all fences age three and older.
