CULTURAL LANDSCAPE REPORT FOR THE NELSON HOUSE GROUNDS

COLONIAL NATIONAL HISTORICAL PARK
YORKTOWN, VIRGINIA

SITE HISTORY

EXISTING CONDITIONS

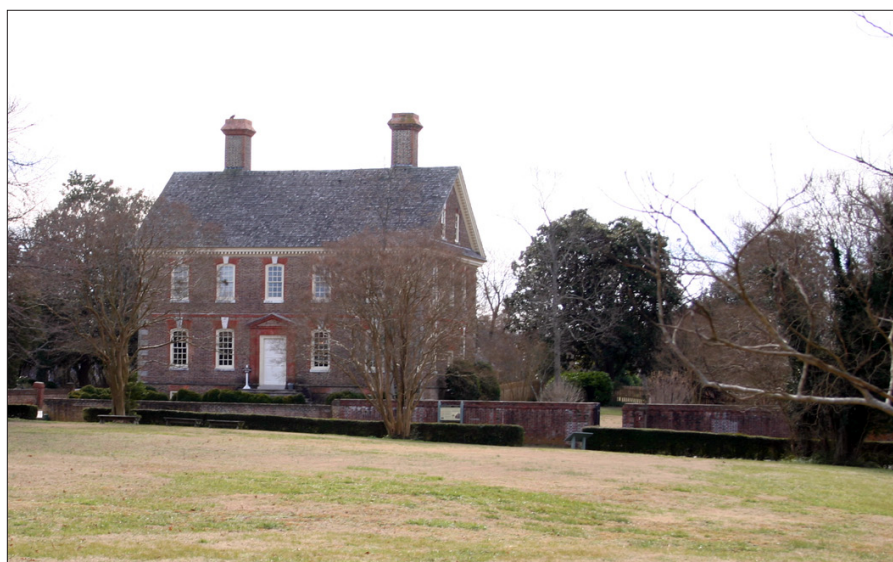
Figure 0.1. The Nelson House grounds looking south across Main Street, January 2010. The open lawn in the foreground (outside of project area), perimeter brick wall, and plantings date to the nineteenth and twentieth centuries. Much of the foreground was occupied by buildings during the colonial period. (SUNY ESF)

Along Yorktown's quiet Main Street of mostly small colonial buildings, the Nelson House and its two-acre walled grounds occupy a prominent place (fig. 0.1). Initially acquired in 1706 by Thomas "Scotch Tom" Nelson, the property reflects the village's eighteenth century prosperity and its early twentieth century revival. Scotch Tom built the existing Georgian-style house in ca. 1730, and during the Revolutionary War and its final major battle, the 1781 Siege of Yorktown, it was the home of Governor Thomas Nelson Jr. His descendents remained through the nineteenth century during a period of marked decline in Yorktown. In 1914, the property was purchased by wealthy industrialist

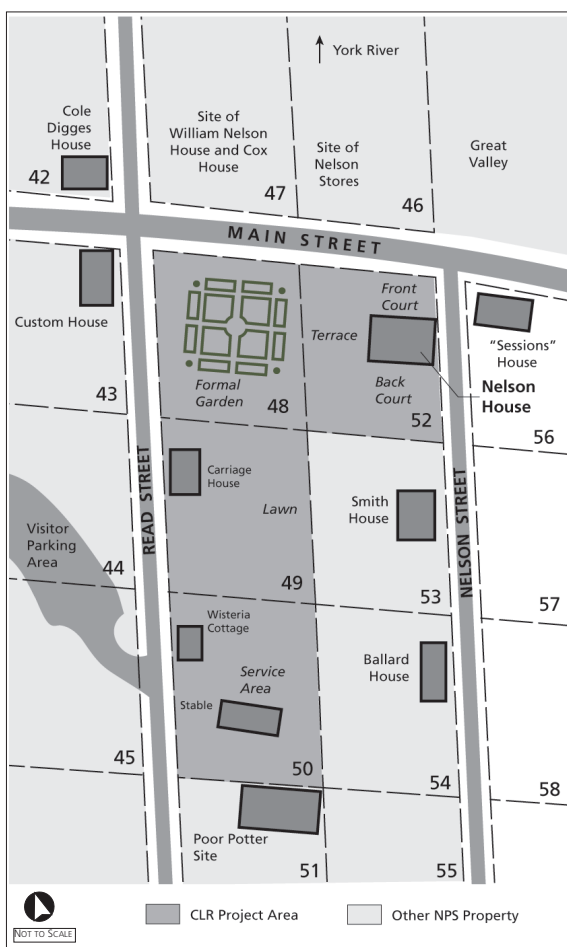
Figure 0.2. Map of the project area for the cultural landscape report showing Yorktown lots, adjoining National Park Service property, and landscape character areas within the Nelson House grounds labeled in *italics*. (SUNY ESF)

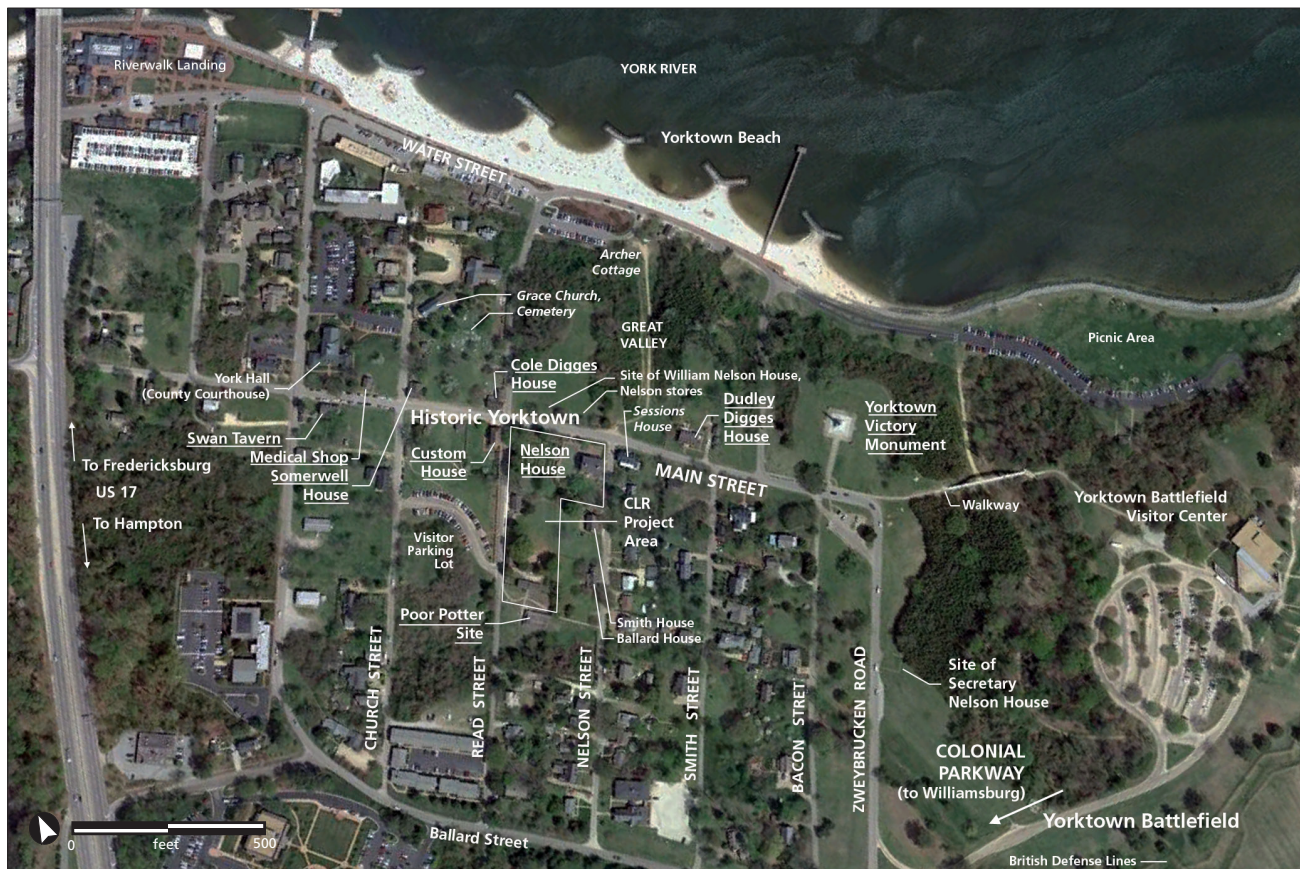
Figure 0.4. Aerial photograph of Yorktown showing the setting of the Nelson House and relationship to Yorktown Battlefield, Colonial Parkway, and historic buildings and sites within the village. Historic sites owned by the National Park Service and open to the public are underlined. Colonial buildings not owned by the park service are labeled in italics. (Commonwealth of Virginia photograph, 2010, annotated by SUNY ESF.)

unit of Colonial National Historical Park that also includes the units of Jamestown, Cape Henry Memorial, and the Colonial Parkway. The Yorktown Battlefield unit features a visitor center and park headquarters east of the village, across a wooded ravine historically known as Tobacco Road, adjoining the Revolutionary War battlefield (fig. 0.4).

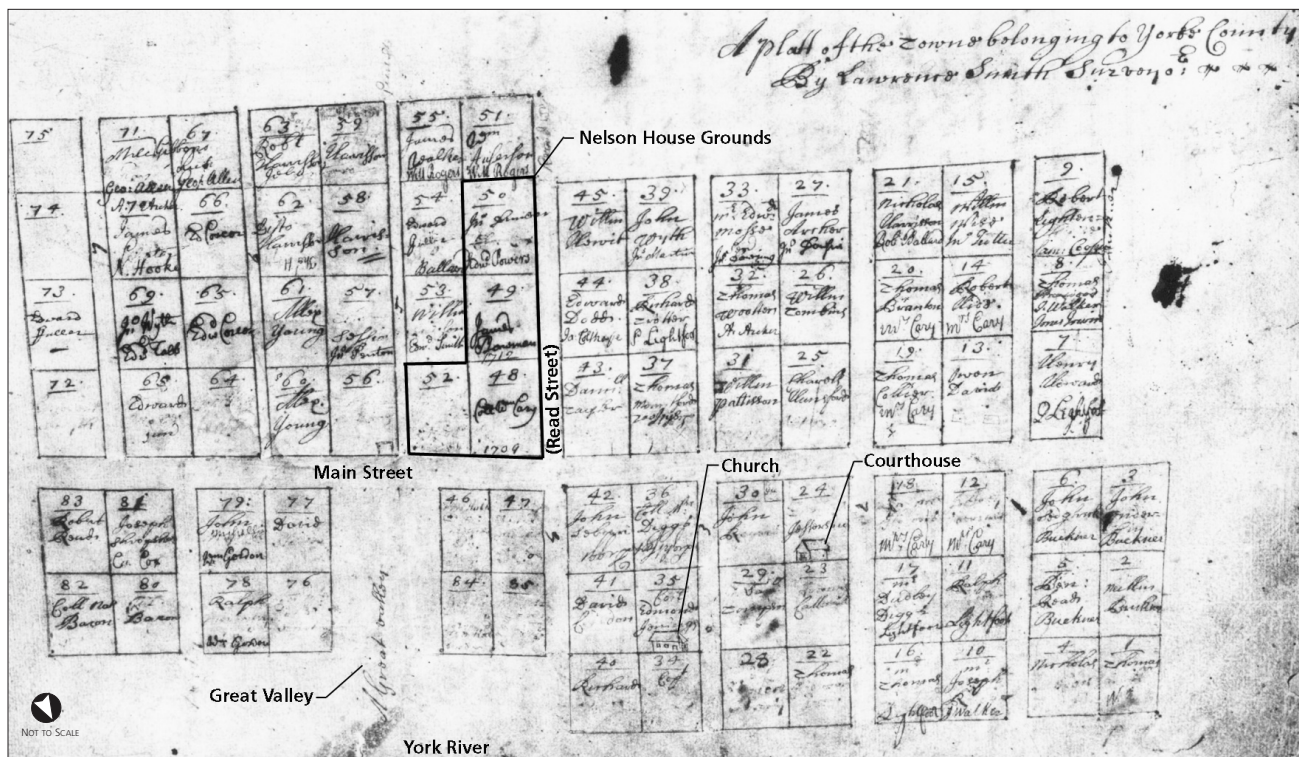
Figure 1.2. A ca. 1705 plat of Yorktown by Lawrence Smith showing the 1691 subdivision into half-acre lots and annotated to ca. 1712. The map is oriented with the York River (north) on the bottom. (Colonial National Historical Park archives, map 2261, annotated by SUNY ESF.)

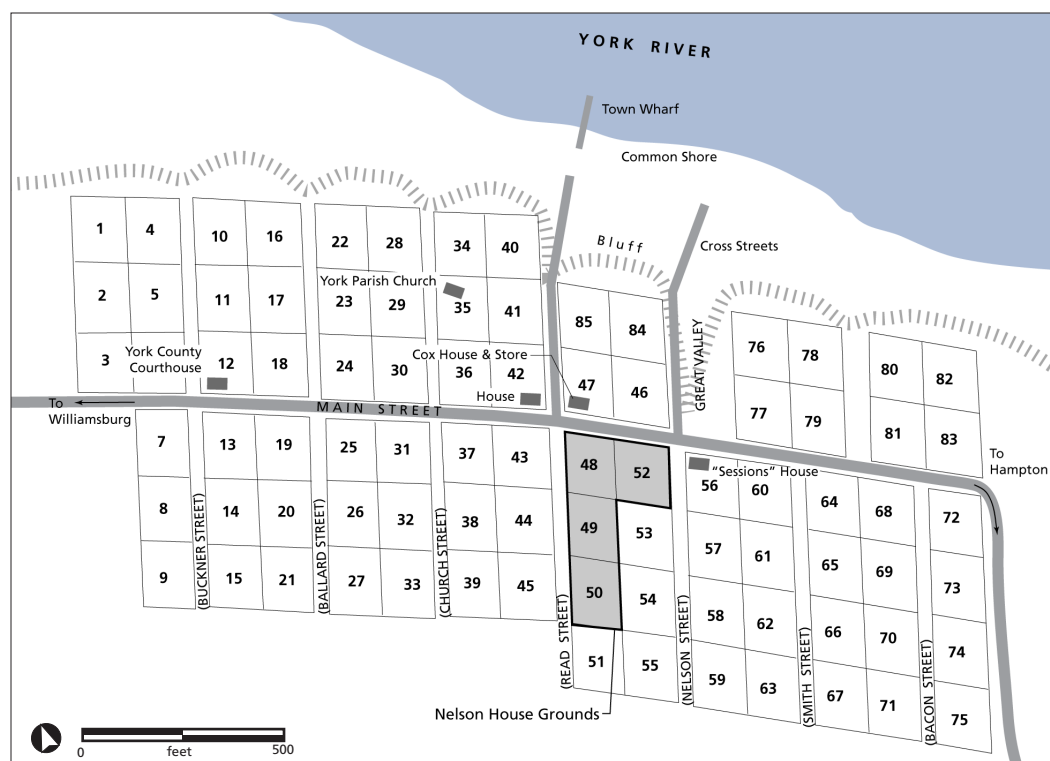
Figure 1.3. Map showing relationship of the Nelson House grounds to the village lots, streets, and buildings in ca. 1705. The map does not show all buildings or streets that existed at the time. (SUNY ESF.)

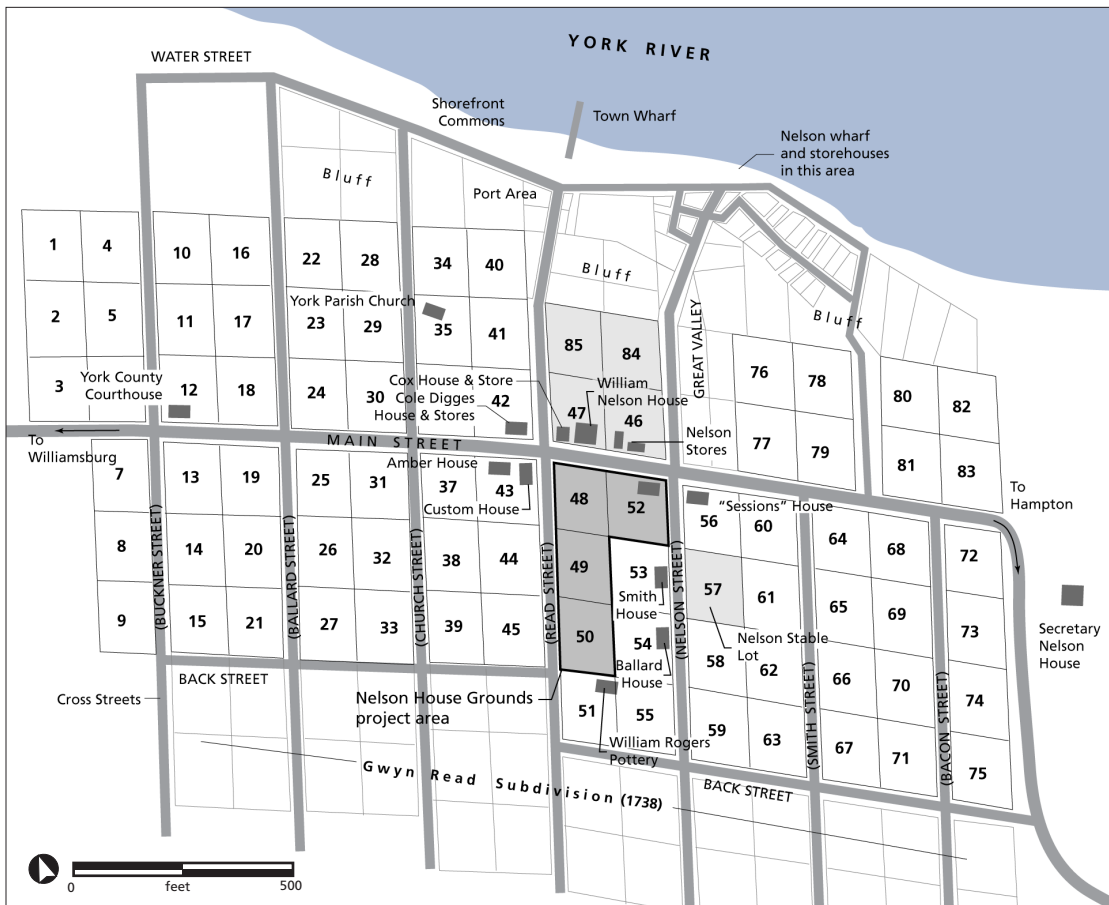
Figure 1.4. Map of Yorktown during the early Nelson period showing expansion of village lots in the Gwyn Read Subdivision, and development neighboring the Nelson House grounds. (SUNY ESF.)

Scotch Tom's success in commerce provided him the means to purchase significant land holdings in and around Yorktown. One of his first investments was the purchase of lot 52 on August 2, 1706 from Colonel Thomas Ballard and Major William Buckner, trustees of the town, for 180 pounds of tobacco (see fig. 1.4, table 1.1). The lot was located on the south side of Main Street and the cross street opposite Great Valley, later known as Nelson Street. A year later, Scotch Tom acquired lots 46 and 48 from the town trustees after their owners forfeited the properties, suggesting that neither had built the required buildings on their lots. Lot 46 provided a strategic location for the Nelson business interests with its ready access to the commercial waterfront through the adjoining Great Valley. In 1712, Scotch Tom purchased lot 49 (to the south of lot 48), another forfeited lot. In 1715, he purchased the next lot to the south, lot 50, which, unlike the others, had been owned for five and a half years by Edward Powers, a Yorktown carpenter. Scotch Tom's purchase must have therefore included a standing house on the lot.⁸ The following year, he acquired lot 57 south of the Sessions House, where he developed his stable yard. This was the last of Scotch Tom's acquisitions along Main Street until 1729, when he purchased lot 47 including the Cox House, built in ca. 1705, and two years later, lots 84 and 85 to the rear that extended to the top of the bluff above the York River. In total, Scotch Tom's nine lots comprised approximately four and a half acres.⁹

Along the cross street south of the Nelson House were two small houses on lots 53 and 54 (see fig. 1.4). The house closest to the Nelsons on lot 53 was home to three generations of the Smith family, beginning with Lawrence Smith, who purchased the lot in February 1706, six months prior to Scotch Tom's purchase of lot 52. Smith, a surveyor for York and Gloucester Counties, built a frame house within the first year of his purchase, and resided on the lot for 28 years with his wife and children until his death in 1734. The lot then passed to his son, Edmund.³¹ Lot 54, south of the Smith's, was owned by Edward Fuller, who built a frame house, stables, and storehouse there in ca. 1709. The lot passed through four owners until John Ballard inherited it in 1727. In ca. 1730, he removed the old outbuildings and most likely enlarged the house.³² Around the same time, Ballard built a dairy, smokehouse, and kitchen at the rear of the house. In ca. 1744, Ballard willed the property to his second son, Robert, who resided there for the next seventeen years.³³ The landscape of the Smith and Ballard lots included yards, service buildings, and domestic gardens most likely at the open back parts of the lots. Ballard also had a small orchard of fruit trees.³⁴

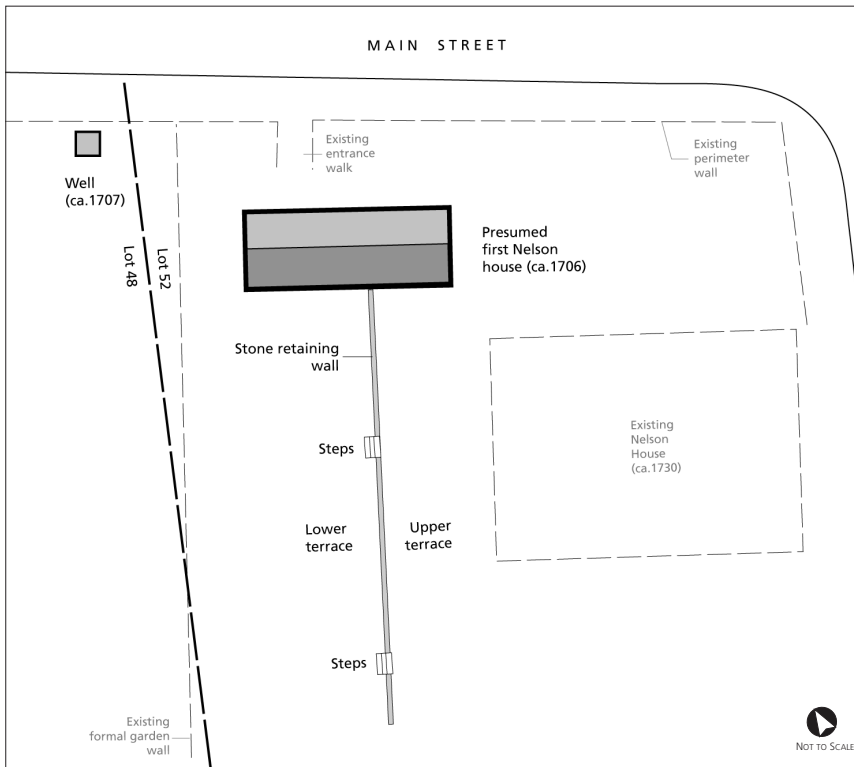
Figure 1.5. Plan showing presumed location of Scotch Tom's first house built in ca. 1706 in relation to the existing Nelson House, perimeter wall, and lot line. (SUNY ESF based on Norman F. Barka, "Archeology of the Nelson, Smith and Ballard Houses, Yorktown, Virginia," 1978.)

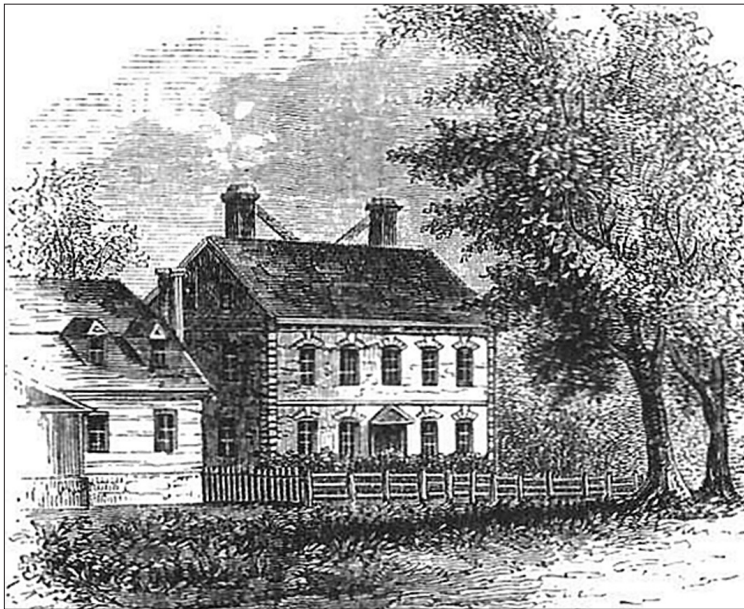
Figure 1.6. The ca. 1730 Nelson House, from the earliest known detailed illustration made in 1848. At left is the “Sessions” House. It is not known whether the fence and hedge in the front court existed in the eighteenth century. The service buildings to the right of the Nelson House are not shown. (Benson J. Lossing, *Pictorial Field-Book of the Revolution*, 1850.)

was also close to the Nelson’s stable yard on lot 57. Not unlike larger houses on rural plantations, the new Nelson House featured a symmetrical five-bay façade with a center entrance, segmental arched windows, two prominent offset ridge chimneys, and such decorative classical details as dentils, quoins, and keystones (fig. 1.6).

showing the front court lined by a plank fence and a hedge that may have existed since colonial times (see fig. 1.6).

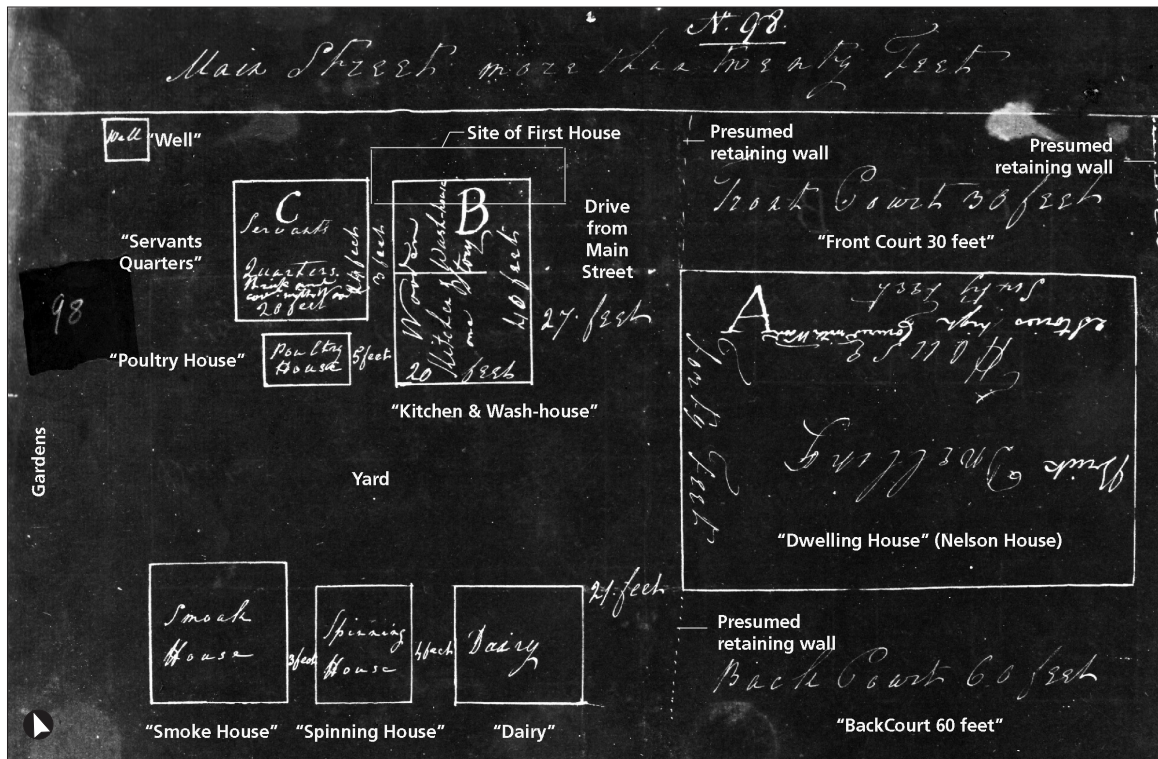
Figure 1.7. A 1796 insurance survey of the Nelson House showing buildings and structures that most likely existed during the colonial period. This is the earliest plan of the outbuildings associated with the second Nelson House built in ca. 1730. (Colonial National Historical Park archives, map 122B, annotated by SUNY ESF.)

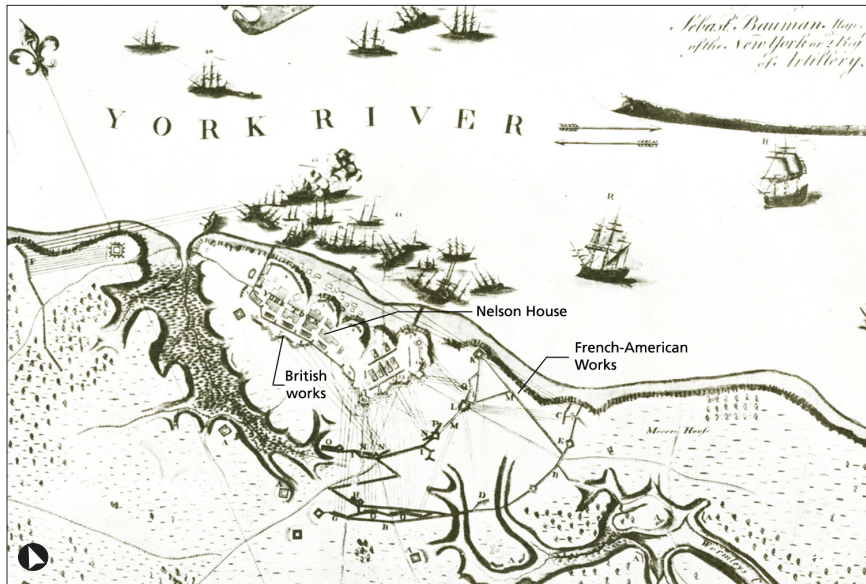
Figure 1.9. Detail, map of Yorktown during the Siege of 1781 showing location of British and Allied (French-American) defensive works around the town. (Detail, Sebastian Bauman, "Plan of the Investment of York and Gloucester," 1781, Colonial National Historical Park archives, annotated by SUNY ESF.)

The early years of the Revolution were restless times in Yorktown, which continued to suffer economically due to the decline of its port trade. These hardships were compounded by the hostilities with Britain. Many residents left Yorktown while American forces built defensive earthworks in the area. British troops, however, did not appear in the area until six years after the start of the Revolution, when British general Lord Cornwallis arrived with troops to establish a naval base. The troops immediately began to fortify Yorktown and Gloucester Point across the York River. Ultimately, the British fortifications created an arc-shaped series of earthworks and redoubts surrounding the southern border of Yorktown (fig. 1.9). These fortifications extended across lots 51 and 55 south of the Nelson House grounds (fig. 1.10).⁵¹

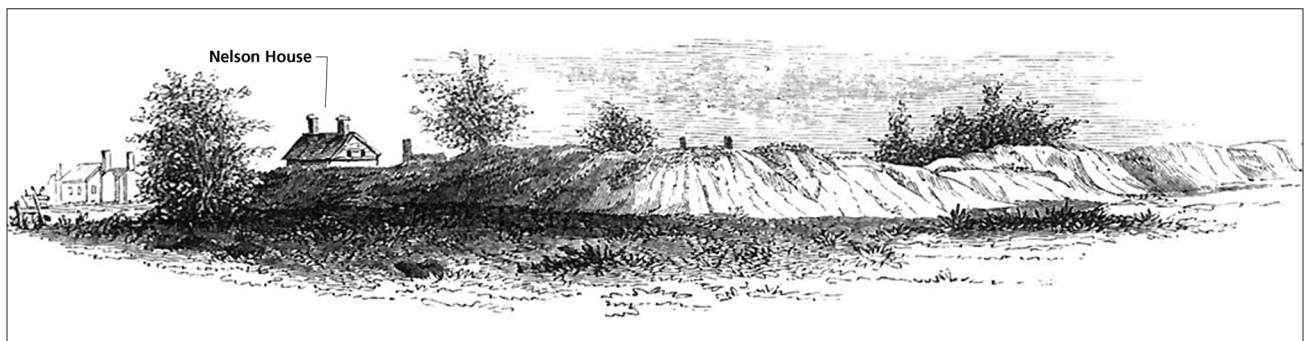
Figure 1.10. A nineteenth-century depiction of the British earthworks south and east of the Nelson House, visible in the background, drawn in 1848. (Benson J. Lossing, *Pictorial Field-Book of the Revolution*, 1850, annotated by SUNY ESF.)

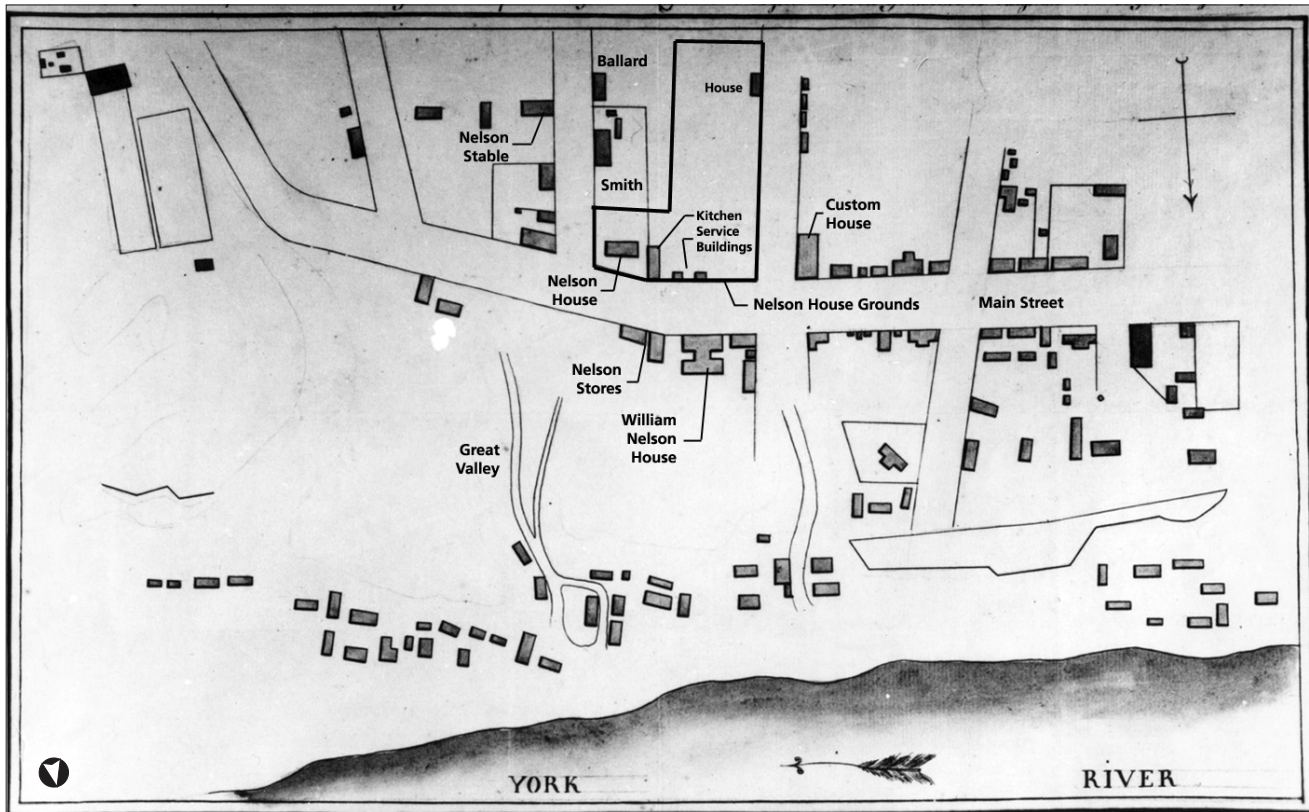
Figure 1.11. Map of Yorktown made in 1781 to identify remaining buildings suitable for use by French occupational troops following the Siege of 1781. The plan is diagrammatic and does not show actual scale and location of buildings in many cases. The meaning of the lines within the lots is not known. ("Plan d' York...1781." Colonial National Historical Park archives, image 2250, annotated by SUNY ESF.)

that were suitable for use by French troops (fig. 1.11). Upon the departure of the French, Virginia-based militia forces controlled the defense of Yorktown. The militia remained in Yorktown until 1783, when the Treaty of Paris ended hostilities between the American colonies and Britain.⁵⁴

of the property, across lots 48, 49, and 50, which were referred to as the “Nelson garden and open lots” in a later insurance survey.⁵⁹ Much of this landscape was probably open field, with outbuildings and wood fences along outer boundaries and streets. By 1789, only the house on lot 50, probably built by the previous owner, Thomas Powers, remained; the presumed houses on lots 48 and 49 no longer stood, since they do not appear on the 1781 French billeting plan of Yorktown (see fig. 1.11).

13 The Powers house on lot 50 appears on the 1781 “Plan d’York” (see fig. 1.11). There is no documentation indicating the presumed houses on lots 48 and 49 remained after the Siege of Yorktown.

- 36 Lisa Fischer, “Yorktown Archaeological/Historical Overview and Assessment” (Unpublished report, Colonial Williamsburg Foundation, Department of Archaeological Research, 2004), 89; “Plan d’York,” ca. 1781, COLO 2250; Hatch, *The Nelson House and the Nelsons*, 76. No graphic record of the William Nelson House survives aside from its footprint shown on the ca. 1781 map (fig. 1.11).

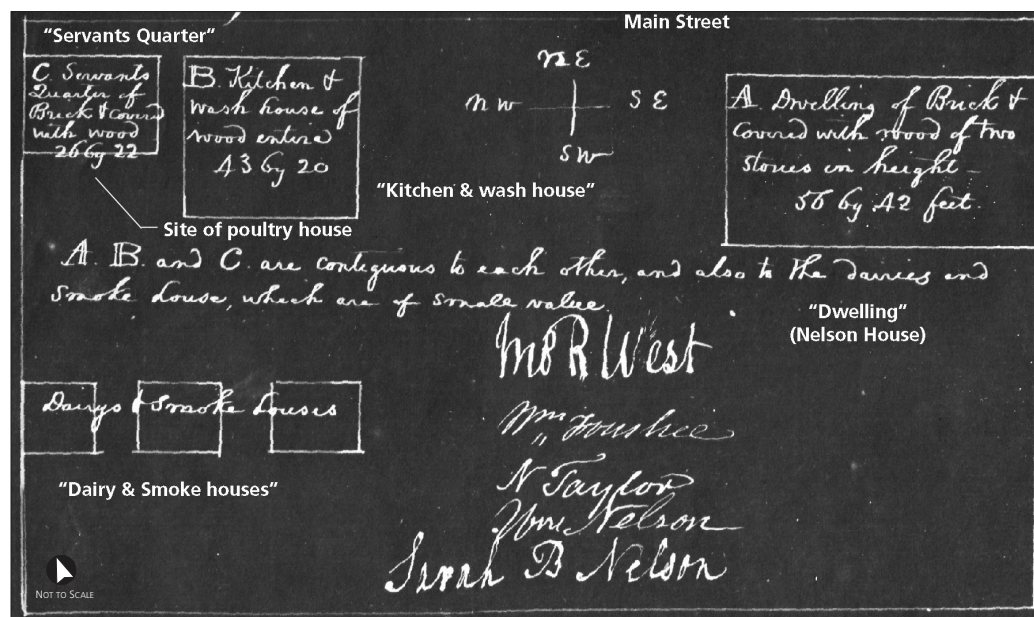
Figure 1.12. An insurance survey of the Nelson House made in 1830 showing retention of all outbuildings except for the small poultry house that previously stood next to the servants quarters. (Colonial National Historical Park archives image 7612, annotated by SUNY ESF.)

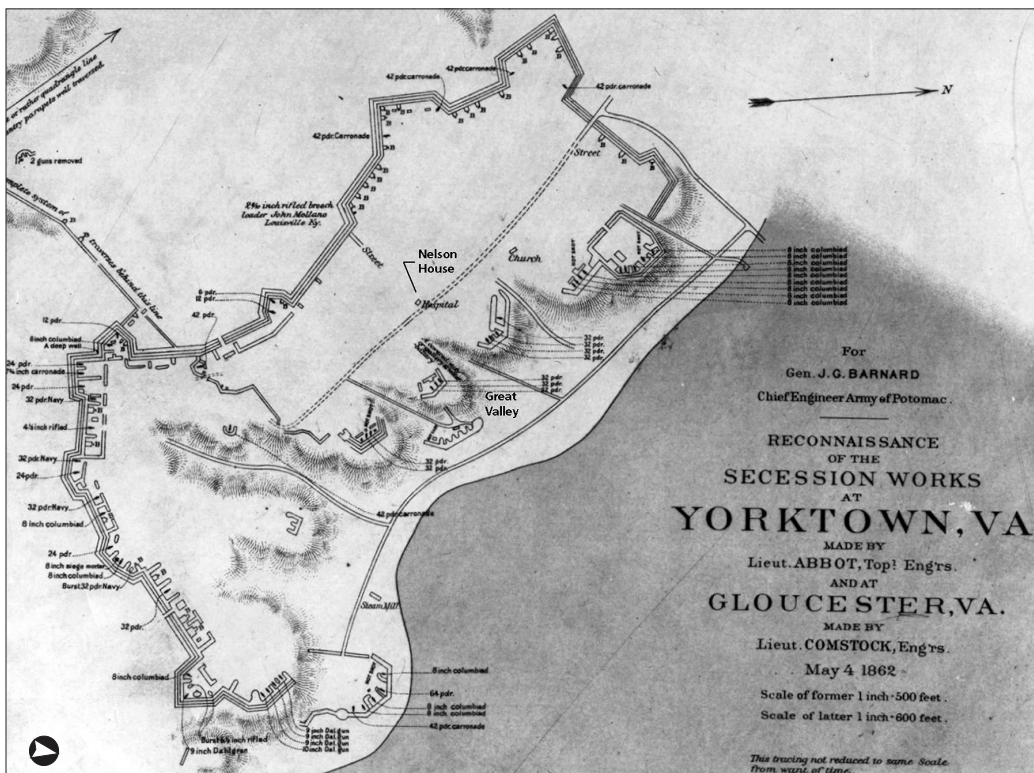
Figure 1.13. An 1862 map showing the extent of Confederate earthworks constructed around Yorktown, including on the bluff north of the Nelson House, labeled as a hospital. (Colonial National Historical Park archives, map 2265, annotated by SUNY ESF.)

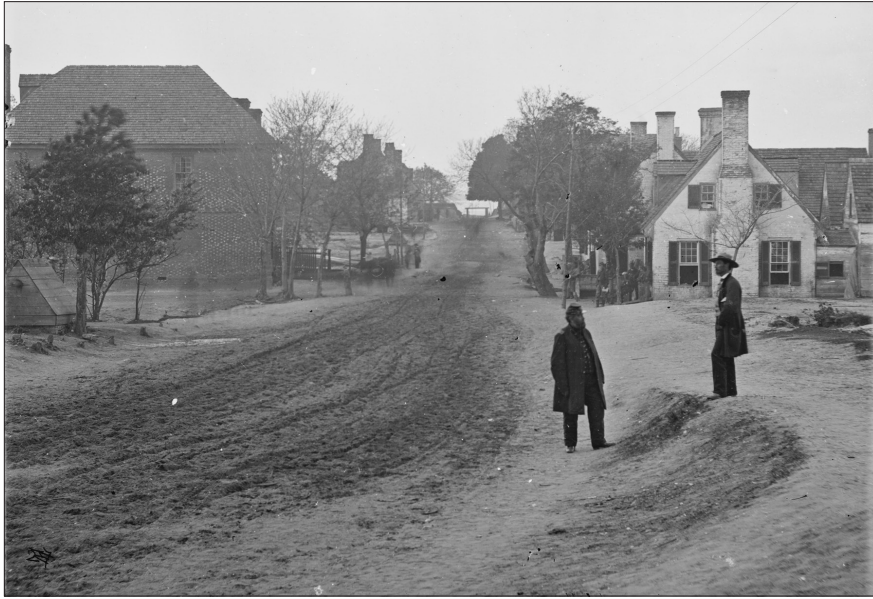
Figure 1.14. Main Street looking west from the Nelson House, 1862. Tree stumps are visible along Lot 48 of the Nelson House grounds at left. The small building is the Nelson wellhouse. Beyond it at left is the Custom House, and across the street is the Cox House. (Library of Congress American Memory Collection, digital ID cwpb 01609.)

28 Documentation of the date of construction for this house, often referred to today as the Nelson tenant house, is found in a comparison of an 1862 photograph showing no house (fig. 1.14) and a ca. 1880 photograph showing the house (fig. 1.18). By ca. 1907, as shown in a period postcard (see fig. 1.8), the tenant house was gone.

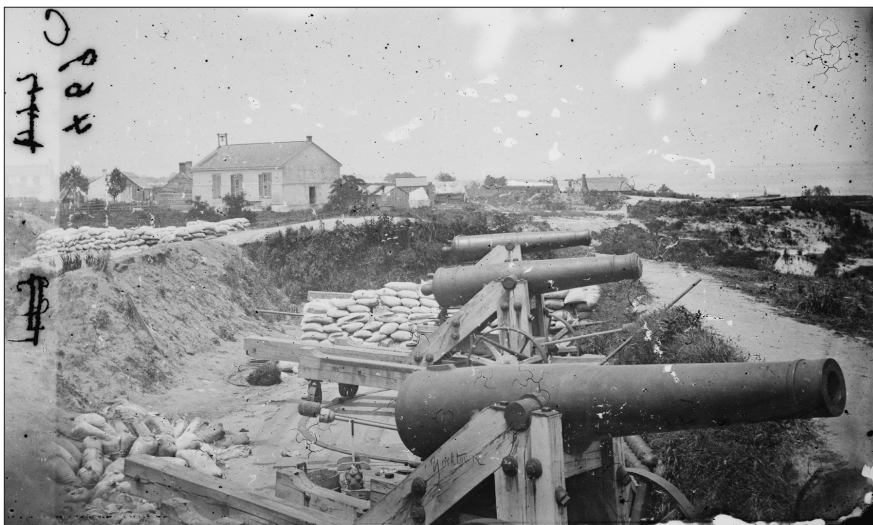
Figure 1.15. Looking west at a Civil War battery on the bluff above the York River north of the Nelson House, 1862. The large building in the background is Grace Church. (Library of Congress American Memory Collection, digital ID cwpb 00188.)

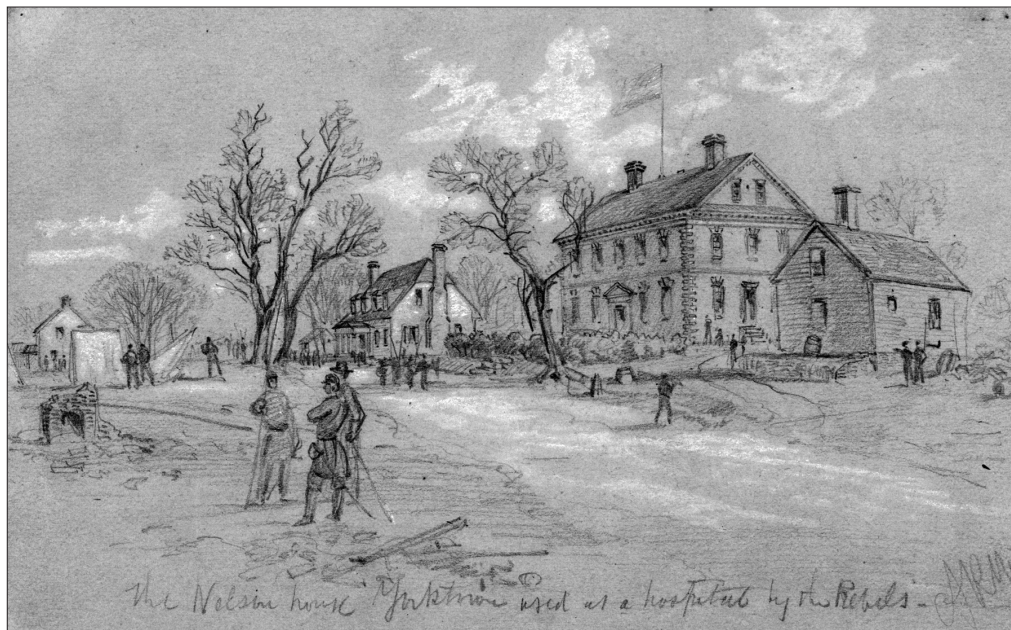
Figure 1.16 (top). Sketch of the Nelson House by Alfred Waud published in *Harpers Weekly*, May 24, 1862, showing its use as a field hospital. At the right of the house is the Nelson kitchen-wash house. This drawing also shows the cut bank along the front court, and the boxwood hedge. (Library of Congress, digital ID 20885u.)

hospital (fig. 1.16). Tents, probably associated with the hospital, were set up across Main Street (fig. 1.17). For a time during the war, Dorothy Dix, Superintendent of Union Army Nurses, oversaw the hospital at the house.¹⁸ Harriet Douglas Whetten, a volunteer Sanitary Commission nurse, wrote about the hospital in 1862. In her letter, she refers to the decline of the village and the legend of the Nelson House's use by Lord Cornwallis during the Revolution:

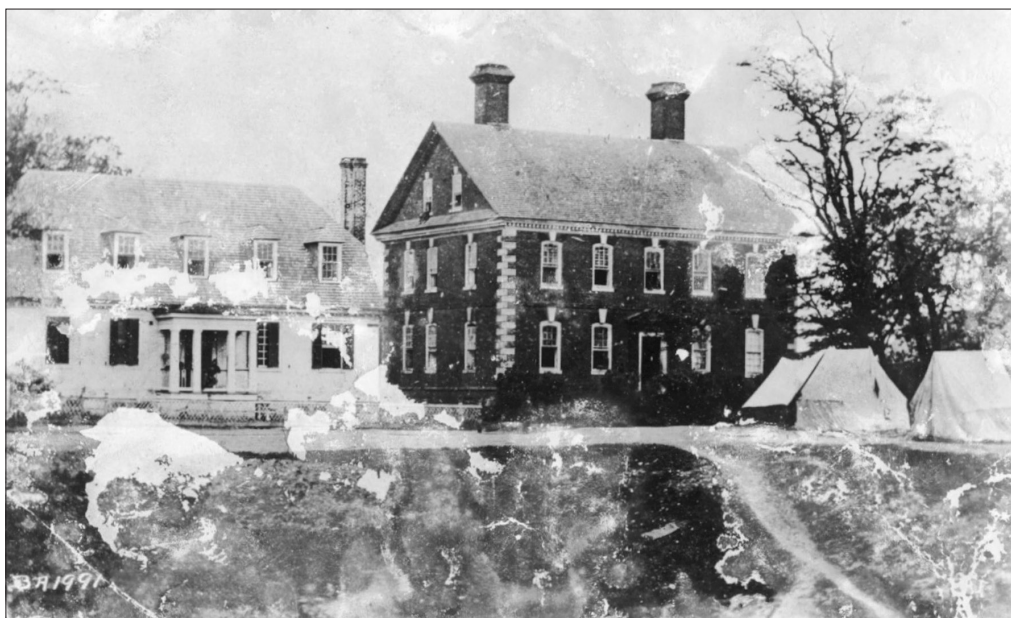
Figure 1.17 (bottom). A wartime photograph of the Nelson House and "Sessions" House looking southwest from the Great Valley showing tents pitched near the site of the old Nelson stores, 1862. (Colonial National Historical Park, image 1875.)

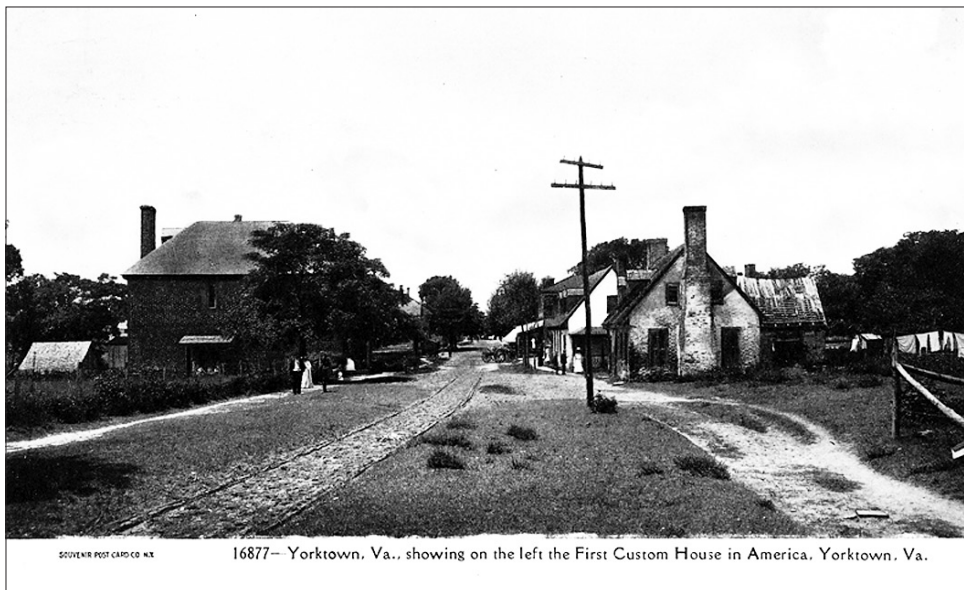
Figure 1.18. A ca. 1907 postcard of Main Street looking west from in front of the Nelson House, with the Custom House at left and Cox House at right. This is the same view as the 1862 photograph in figure 1.14. (National Park Service Library, Harper's Ferry, Virginia.)

Despite the Congressional attention, the Nelson House and many of its Yorktown neighbors continued to languish over the course of the next two decades. The village retained its desolate character, with its rutted main street lined by deteriorating colonial buildings, a picturesque landscape that became the subject of numerous postcards around the turn of the century (fig. 1.18).

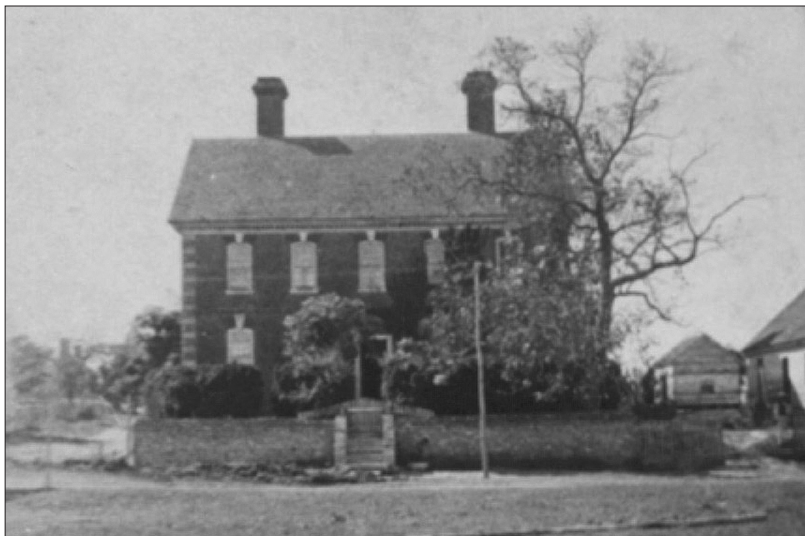
Figure 1.19. Looking south at the Nelson House showing the brick retaining wall and front steps at the front court added soon after the Civil War, photographed ca. 1890. At right is the kitchen–wash house and behind it, the dairy. (Colonial National Historical Park archives, YOR_006.)

During the post-war years, the Nelson–Bryan family oversaw a number of changes to the Nelson House grounds. To replace the cut bank along Main Street that existed during the Civil War, a new brick retaining wall was constructed around the front court in ca. 1870 (fig. 1.19). This wall incorporated or replaced earlier low walls along the east and west sides of the court, and included new or rebuilt steps to the front entrance walk.²⁵ With the new wall, which was upwards of five feet high, there was no need for a fence, but the family maintained a picket gate at the top of the entrance steps.²⁶ The grade of the service yard and back court had also been lowered by this time, probably occurring during the Civil War. This left exposed the foundation blocks on the west and a portion of the south sides of the Nelson House, as well as the brick foundation of the kitchen–wash house.²⁷

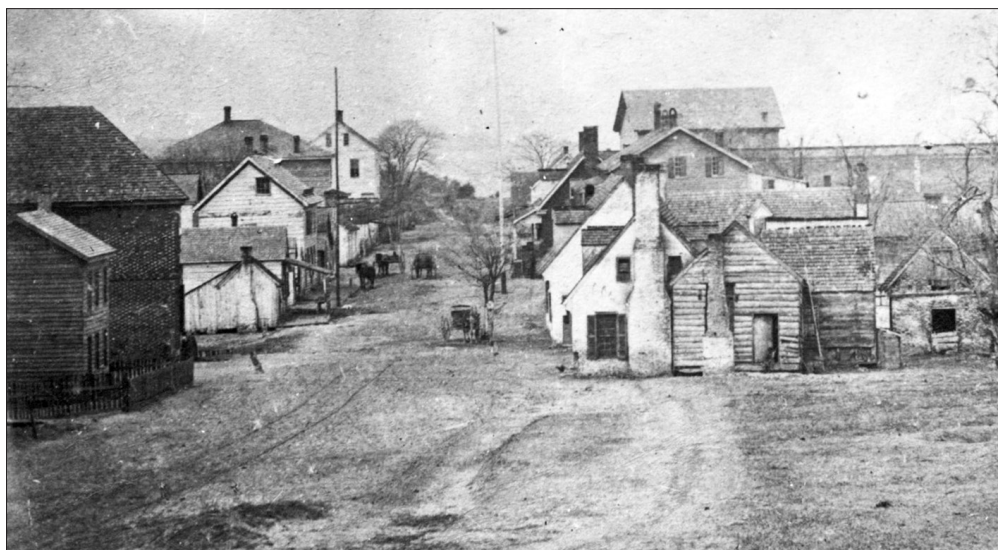
Figure 1.20. Looking west along Main Street showing the two-story tenant house on lot 48 at left (in front of taller Custom House), photographed ca. 1880. The first house on the right is the Cox House. (Colonial National Historical Park archives, YOR_2115.)

1707 to satisfy his purchase requirement for the lot. The new house was a two-story, three-bay frame house with clapboard siding and a low-pitched gable roof (fig. 1.20).²⁸ They may have erected this as a tenant house, or to replace the old brick servants quarters in the service yard that was removed after the Civil War. The Nelson House retained most of its other eighteenth-century outbuildings, including the kitchen–wash house, dairy, smokehouse, and spinning house. Over the next three

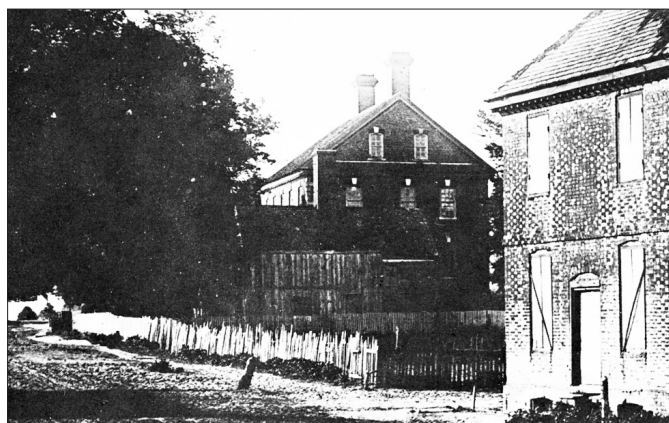
Figure 1.21. Looking southeast toward the Nelson House showing removal of the tenant house and most of the outbuildings, ca. 1900. At right is the Custom House. (Colonial National Historical Park archives, Huestis-Cook negative.)

decades, however, these building all disappeared except for the kitchen–wash house, concurrent with the family’s declining fortunes and shift toward rental uses in the late 1890s (fig. 1.21).

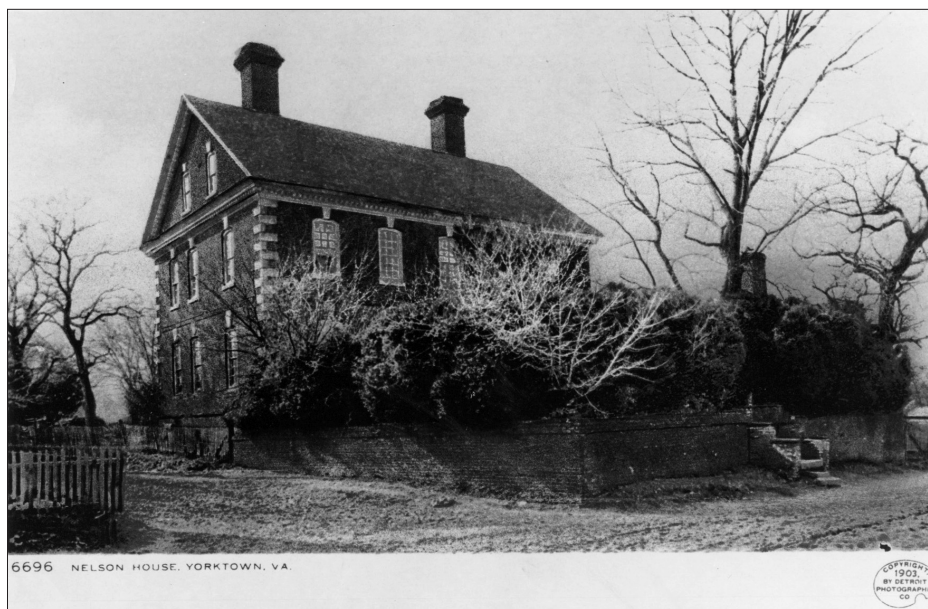
Figure 1.22. A 1903 postcard of the Nelson House looking southwest showing poor and overgrown conditions. (Colonial National Historical Park archives, YOR_6696.)

By the turn of the century, the Nelson House and its surrounding grounds were becoming dilapidated. While the structure was sound, windows were broken, the steps to the front court were falling apart, and weed trees were growing out of the overgrown boxwood hedge (fig. 1.22). The painted clapboard siding on the kitchen–wash house was peeling and its west wall was bowing out (fig. 1.23).

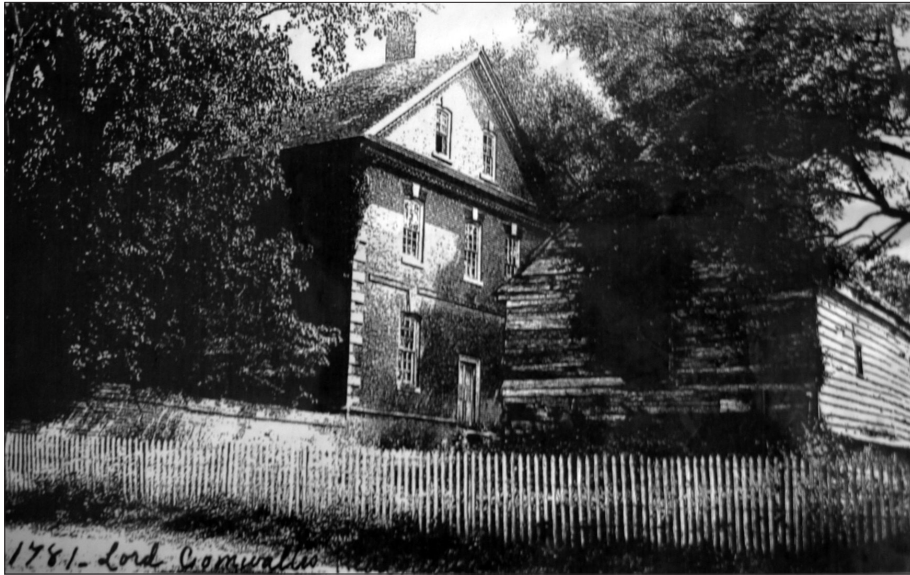
Figure 1.23. The Nelson House and kitchen-wash house looking southeast from Main Street showing dilapidated conditions, ca. 1900. The west side of the front court brick wall is visible at left. The fence enclosed the former service area and adjoining gardens or pasture on lot 48. (Interpretive wayside, Colonial National Historical Park.)

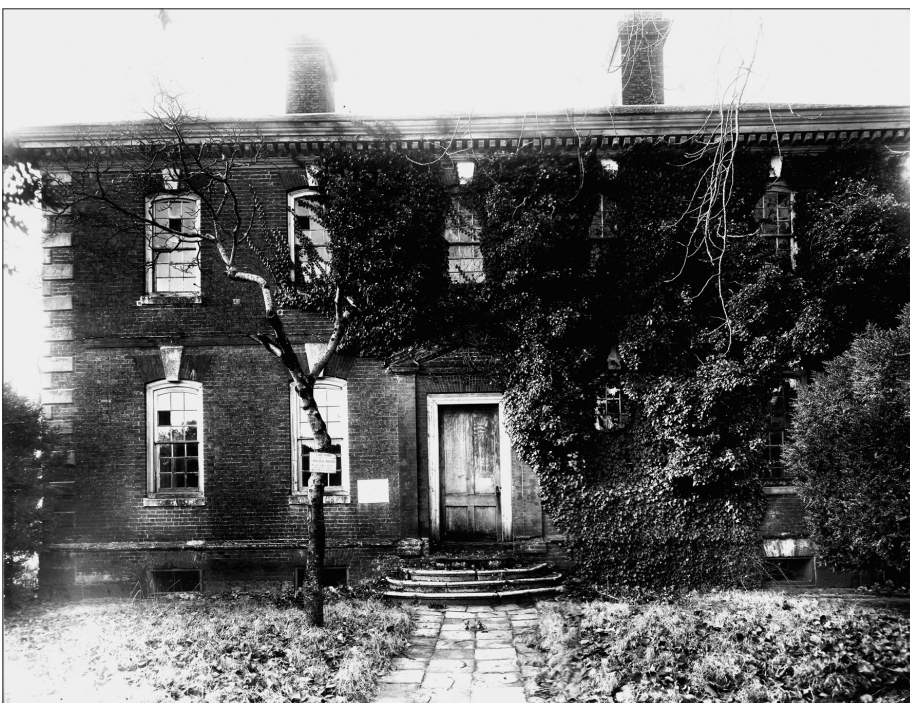
Figure 1.24. The dilapidated Nelson House and its front court showing signs on the house and Lafayette tree, ca. 1914. (Colonial National Historical Park archives, Blow Family Photographs, album 16B.)

laurel tree that purportedly stood during the visit by the Marquis de Lafayette in 1824 (fig. 1.24).³²

In 1914, the Nelson House had numerous broken windowpanes, peeling paint, cracks in the exterior brick walls, and vines covering much of the facade. The steps from Main Street, part of the brick retaining wall around the front court built after the Civil War, were crumbling. A walk paved in four rows of square stone slabs, possibly dating to colonial times, led through the front court to a set of circular steps at the front entrance. To the left of the entrance walk was a decrepit laurel tree that purportedly existed during the Marquis de Lafayette's visit in 1824, marked by a small sign. Another sign was on the house, to the left of the front door. Surrounding the front court was the overgrown, unclipped boxwood hedge that reached the second floor of the house and had weed trees growing through it. The back court was a grass-covered lot used as pasture, surrounded by wood-slat and wire fence. The only trees and shrubs were several mature elm and poplar, and an overgrown boxwood hedge along the boundary with the Smith lot. The grade sloped down to the west to expose the Nelson House's unfinished foundation walls, a condition most likely resulting from grade changes made around the time of the Civil War.

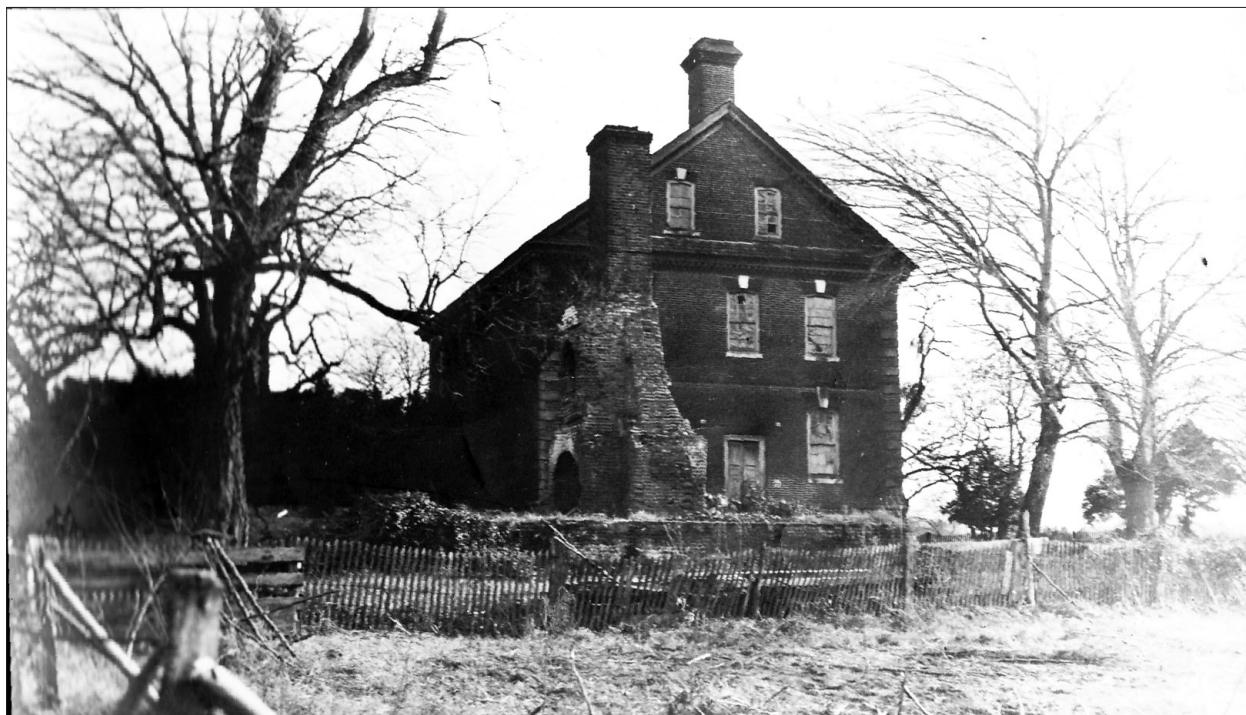
Figure 1.25. Looking east at the ruins of the kitchen-wash house, with fenced pasture on lot 48 in the foreground, ca. 1914. The dark area at left is the front court boxwood hedge. (Colonial National Historical Park archives, Blow Family Scrapbook.)

R. A. Lancaster made an initial investment in the preservation of the Nelson House by installing a new slate roof in 1909.³³ After this, the house was not maintained, leading to continued peeling paint and loss of window glass. In ca. 1910, the last of the colonial service buildings, the kitchen-wash house, burned, leaving just the ruins of the massive center chimney and the brick foundation (fig. 1.25). The back court, which by this time was just open ground with scattered old trees and the boxwood hedge along the Smith lot, was used as pasture, with a temporary wood slat and wire fence lining the cross (Nelson) street (fig. 1.26).

The service buildings on the west side of the house disappeared during this period, except for the ruins of the kitchen–wash house, comprised of a massive brick chimney and foundation. The former marl drive and yard were covered in grass, and the steps leading up to the house's west entrance were a pile of rubble. As with the back of the house, the unfinished foundation walls were exposed along the west side of the house, presumably a result of Civil War-era grade changes. The perimeter wall around the front court extended along the west side, facing the service yard (present terrace).
