CULTURAL LANDSCAPE REPORT FOR THE NELSON HOUSE GROUNDS

COLONIAL NATIONAL HISTORICAL PARK
YORKTOWN, VIRGINIA

SITE HISTORY

EXISTING CONDITIONS

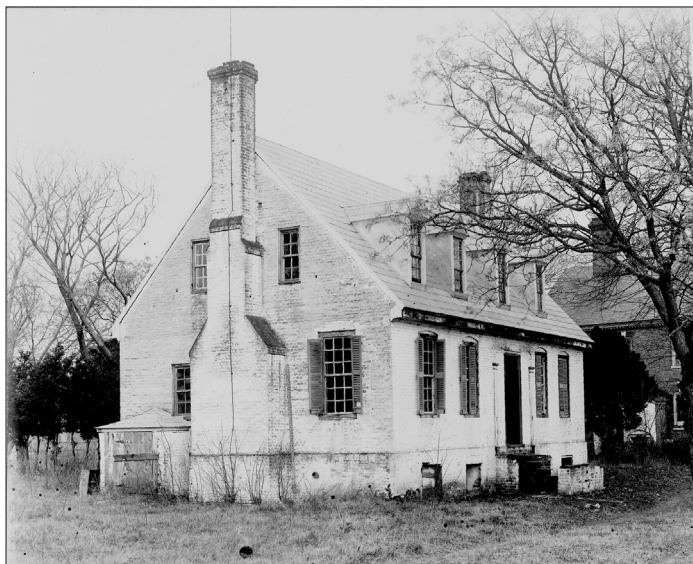
Figure 1.27. Looking northwest at the Smith House with the Nelson House in the background, ca. 1914. The dark shrubs in the right background are the old boxwood hedge along the property line, and at the rear of the Smith House is the old boxwood alley. (Colonial National Historical Park archives, Blow Family Scrapbook.)

across from the Nelson House, formerly site of the William Nelson house and Nelson stores, as open field.³⁴ The Smith House, which had served for a time around 1890 as a school, was in a similar condition to the Nelson House, with its outbuildings gone and the house apparently uninhabited, but with a sound roof and walls (fig. 1.27). In contrast, Henry Ruben maintained the Ballard House as a residence, although the kitchen that was rebuilt after the Siege of 1781 had been removed, leaving a smokehouse and larger unidentified outbuilding that were built prior to the Civil War.³⁵

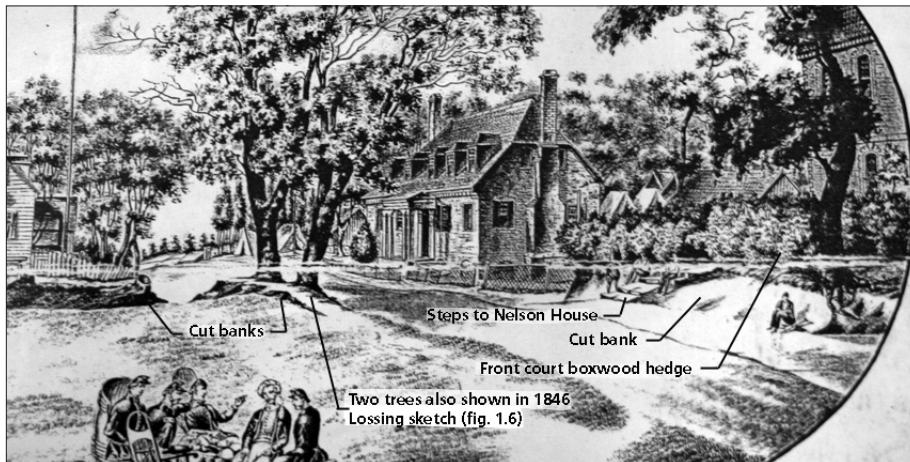
17 The cuts along the front court of the Nelson House and around the trees across the street are also visible in a lithograph of Main Street looking east from the Nelson House, ca. 1865, COLO image 38951.2141 (detail below).

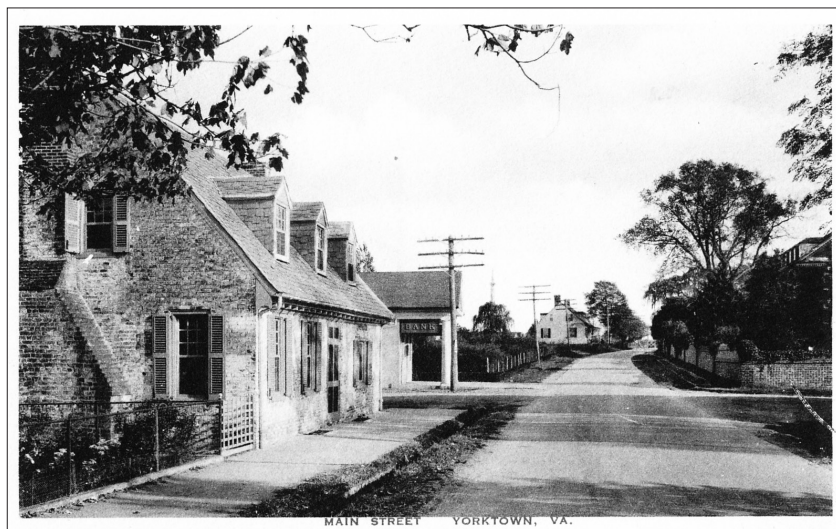
Figure 1.28. Looking east along Main Street showing the new bank building beyond the restored Cole Digges House in the foreground, ca. 1925. In the distance is the Dudley Digges House and at right is the perimeter wall of the York Hall estate. (Postcard, ca. 1930, courtesy of Jane Sundberg.)

Along with the buildings, George Blow had a brick retaining wall constructed along the perimeter of the property on Main, Pearl (Nelson), and Read Streets (see figs. 1.28, 1.30–1.33). Presumably designed by Griffin and Wynkoop and constructed over a number of years beginning in ca. 1915, the wall replaced dilapidated fencing along the roadsides and tied into the existing retaining wall at the front court, which was raised several courses. Incorporating old bricks

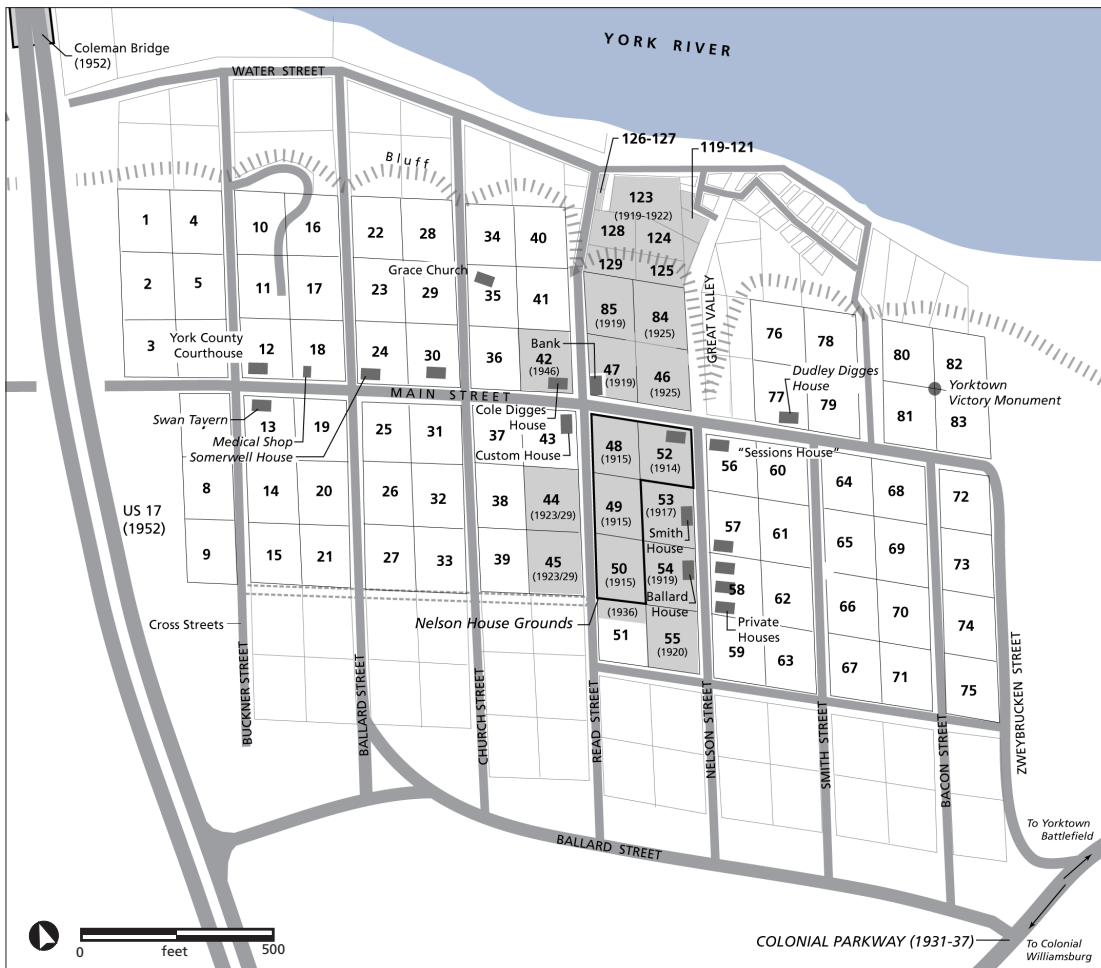
Figure 1.29. Map of Yorktown illustrating location of restored buildings and new construction along Main Street, and property acquired as part of the Blow family's York Hall estate between 1914 and 1946 (shaded in gray with dates of acquisition). The map also shows changes to Yorktown's road through 1968, notably addition of the Colonial Parkway and US 17. Italicized building labels indicate National Park Service property. (SUNY ESF.)

improvements, as well as several additional changes of her own, including acquisition of additional property. In March 1923, she leased lots 44 and 45 located south of the Custom House for the development of the estate's tree nursery and domestic gardens (see fig. 1.29). She bought these lots six years later. In October 1925, Mrs. Blow purchased lots 46 and 84, the two lots her late husband had earlier leased. These lots bordered the Great Valley across from the Nelson House and once contained the Nelson stores.¹⁸

new park was the limited-access Colonial Parkway linking Jamestown, Williamsburg, and Yorktown. The parkway was completed from Yorktown to just outside Williamsburg by 1937, extending west from the Yorktown Battlefield, with access roads at the southeast end of the village (see fig. 1.29).³⁶

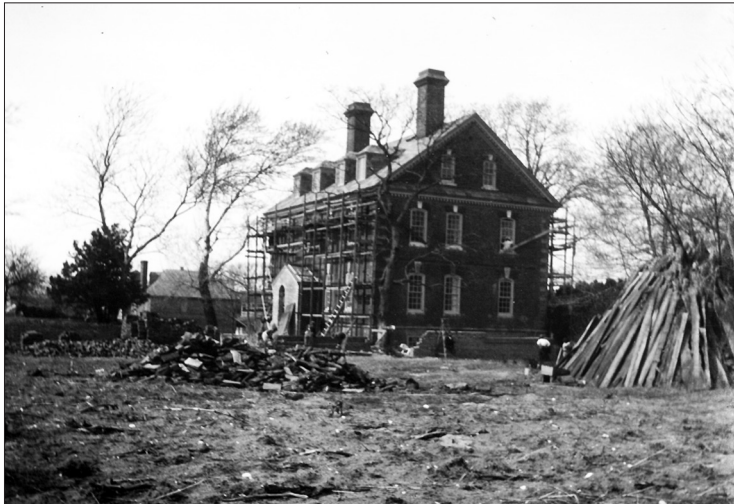
Figure 1.30. The Blows' renovation of the Nelson House nearing completion, ca. 1916. The photograph shows the addition of dormers and a perimeter brick wall along Pearl (Nelson) Street. The property in the foreground, at the rear of the "Sessions" House, was apparently used as a staging area. (Laurence Hall Fowler photograph, Johns Hopkins University Special Collections, photograph LHF-0151.)

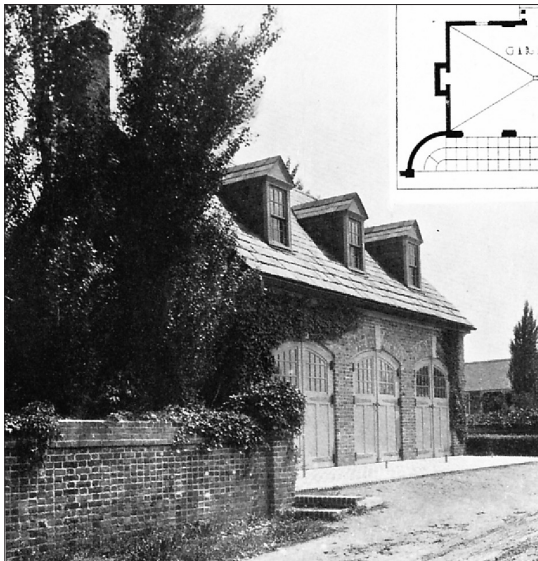
Figure 1.31 (below left). A ca. 1921 photograph of the garage and perimeter wall looking southeast at the Read Street façade. ("Restoration of a Southern Colonial Estate 'York Hall,'" *Architectural Forum*, December 1921.)

Three new outbuildings, completed in 1916, consisted of an automobile garage, gardener's cottage (later known as Wisteria Cottage), and stables. Blow had the buildings sited along the west edge of the grounds along Read Street, near where Scotch Tom Nelson may have had secondary houses during the early eighteenth century on lots 49 and 50. All three Colonial Revival-style outbuildings had brick facades and slate roofs, and faced the interior of the grounds. The garage on lot 49 had a shallow setback from Read Street and a brick-paved apron in front of its three garage bays (fig. 1.31). The front of the building facing the interior grounds was designed in a residential character, with a symmetrical center entrance sheltered by a small porch and flanked by windows (fig. 1.32). The basement of the garage, accessed from an exterior subgrade entrance, housed most of the estate's central utilities.⁸ A Chinese temple bell was later hung on the chimney on the north side, beneath a gable shelter.⁹ The gardener's cottage was similar in character to the garage, but featured an asymmetrical façade and a large offset

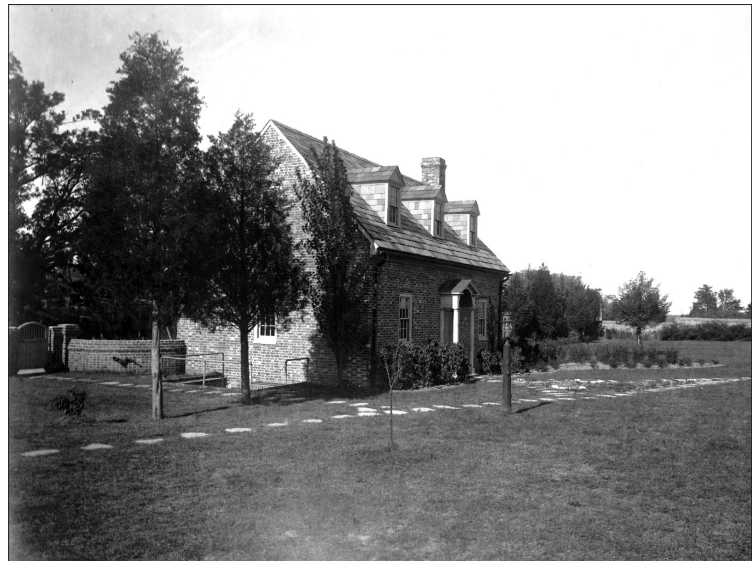
Figure 1.32 (below right). A ca. 1918 photograph of the garage looking north showing the residential character of the interior façade. The stepping stone paths connected the outbuildings with the main house. A lamppost is located at the center of the photograph. (Colonial National Historical Park archives, Blow Family Photographs, album #12.)

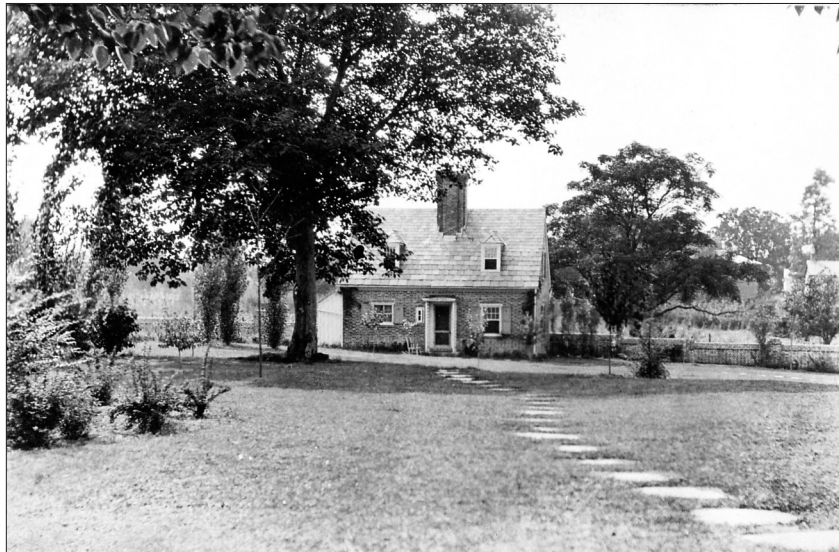
Figure 1.33 (below, top). The gardener's cottage (Wisteria Cottage) looking west, ca. 1920. At left are plantings that screened the stable. (Colonial National Historical Park archives, Blow Family Photographs, album #14.)

ridge chimney, designed to recall old cottages along the Yorktown waterfront (fig 1.33).¹⁰ The house had no entrance to the street. Approximately fifty feet southeast of the cottage was the stable, accessed by a new service drive off Read Street. Built of brick with clipped gables, it featured a slate roof, hay mow, central ventilating cupola, small six-light windows, and a recessed porch (fig. 1.34). The stable housed a carriage room, saddle and tack room, dog pens, four horse stalls, and a hayloft in the attic.¹¹

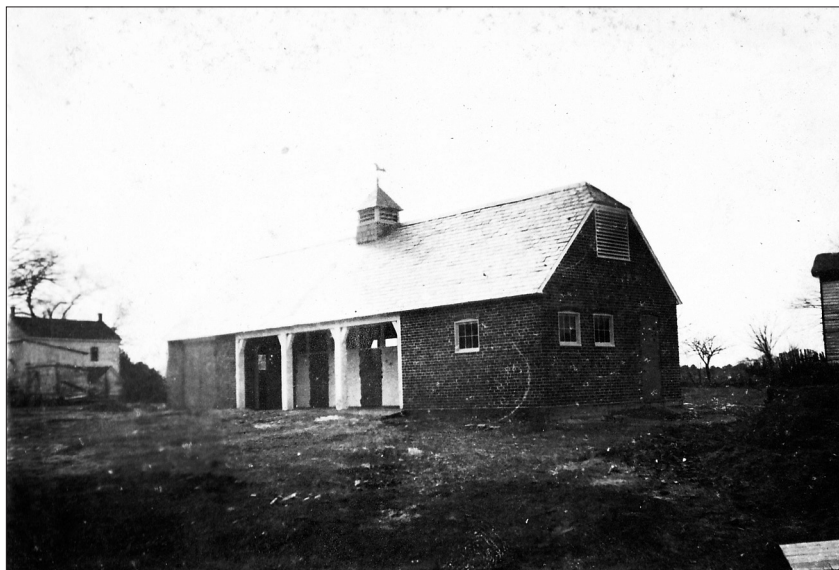
Figure 1.34 (below, bottom). The York Hall stable looking southeast from Wisteria Cottage, ca. 1916. The Blows had not yet built the brick wall along the perimeter of the grounds. The buildings in the background are houses on adjoining lots. (Colonial National Historical Park archives, Blow Family Photographs, album #14.)

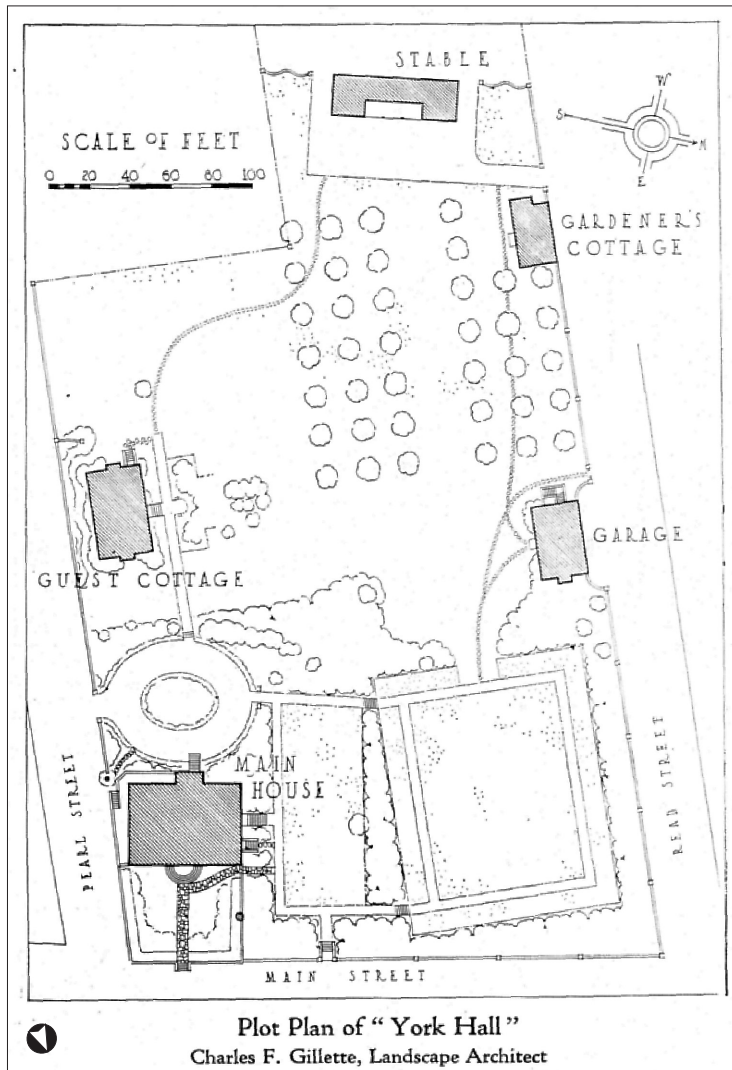
Figure 1.35. An early plan of York Hall by Charles Gillette dated August 13, 1917. Most of the plan was implemented by 1917, except for walks around the perimeter of the lower terrace (later formal garden) and orchard south of the stable. The Smith House (guest cottage) was acquired in 1917; the Ballard House is not shown because it was not acquired until 1919. ("Restoration of a Southern Colonial Estate 'York Hall,'" *Architectural Forum*, December 1921.)

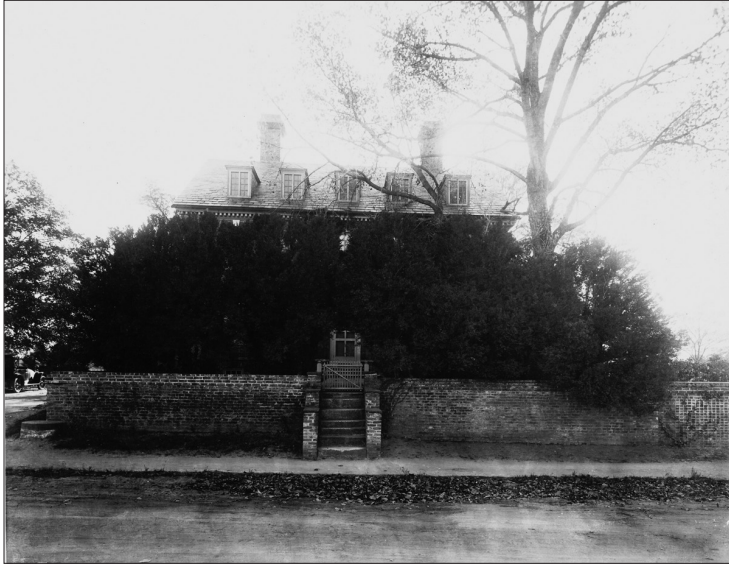
Figure 1.36 (top). The front court looking south from Main Street showing retention of the old boxwood hedge, ca. 1918. (Colonial National Historical Park archives, Blow Family Photographs, album #13.)

In the front court, George P. Blow initially made few changes, apparently considering it the one part of the estate where he would preserve the preexisting landscape. He retained a large tulip tree on the west side, the overgrown boxwood hedge, stone-paved entrance walk, vines on the house, and even the spindly laurel tree near the entrance that purportedly witnessed the 1824 visit by the Marquis de Lafayette (figs. 1.36, 1.37). The only significant change was the addition of a walk connecting with the terrace to the west.

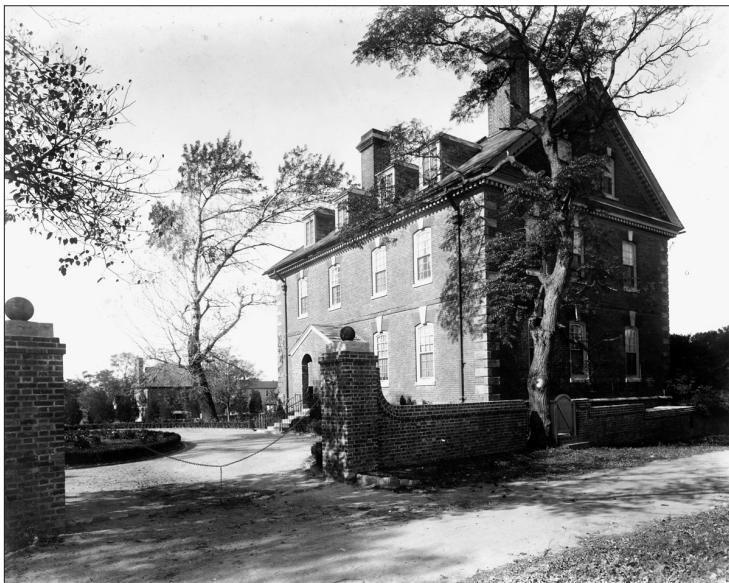
Figure 1.38 (bottom). The redesigned forecourt (back court) looking west from Pearl (Nelson) Street across the marl-surfaced circular entrance drive, ca. 1918. (Colonial National Historical Park archives, Blow Family Photographs, album #13.)

In contrast to the front court, the back court, which the Blows called the forecourt, was transformed from a barren pasture into a formal entrance to the estate, organized around an oval loop drive (fig. 1.38). The entrance, within the perimeter brick wall along Pearl (Nelson) Street, was marked by tall brick piers topped by ball finials. A pair of unpainted wood gates were soon added across the opening. The drive had a marl surface edged by staggered, upright brick and bordered by a low clipped boxwood hedge, surrounding an oval island of lawn. The outer perimeter of the court was heavily planted with shrubs and groundcover. An informal walk of stepping stones led north from the drive to a pedestrian gate along Pearl (Nelson) Street at the narrow space between the perimeter wall and the house. A below-grade brick wall along the west and rear sides of the house created a long well for basement windows. Along the south side of the forecourt was the old boxwood hedge parallel to the Smith lot boundary, the one preexisting feature that George Blow retained aside from several mature trees (fig. 1.39). At the west side of the drive was a brick walk that stepped down toward the former Nelson service area west of the house. A pair of goddess statues on pedestals was added to mark this main entrance

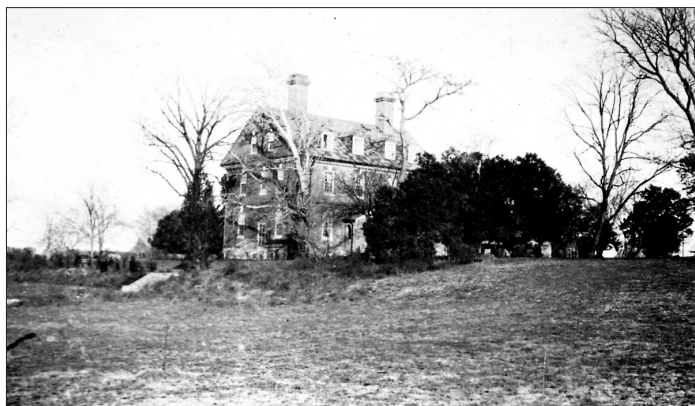
Fig. 1.39 (top). The old boxwood hedge along the south side of the forecourt, looking northeast, ca. 1918. This photograph also shows the original steps to the upper terrace at left and old specimen trees that were retained. (Colonial National Historical Park archives, Blow Family Photographs, album #14.)

lowered around the time of the Civil War. Marl walks edged by staggered upright bricks framed three sides of the terrace and connected to the entrance drive and front court. Brick steps led down a steeper slope that was planted in shrubs to a lower lawn terrace on lot 48 (see fig. 1.39). This rectangular area, later site of the formal garden, was framed by tree and shrub plantings along the perimeter walls and across the open area to the south (fig. 1.42). Although Gillette had designed rectilinear walks to frame this lawn, similar to those on the upper terrace, these were never built.

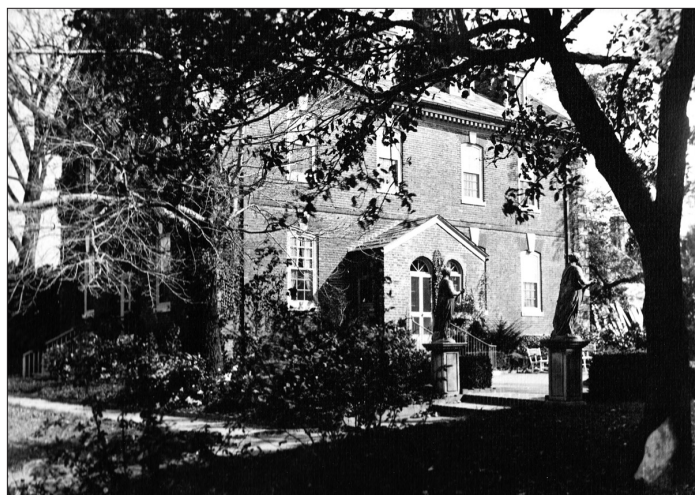
Fig. 1.40 (middle). The goddess figures at the walk to the terrace from the entrance drive, looking northeast, ca. 1920. The arched window in the porch is to the right of the doorway. (Colonial National Historical Park archives, Blow Family Photographs, album #16B.)

into the grounds in ca. 1920, around the same time an arched window was added to the rear entry porch (fig. 1.40).

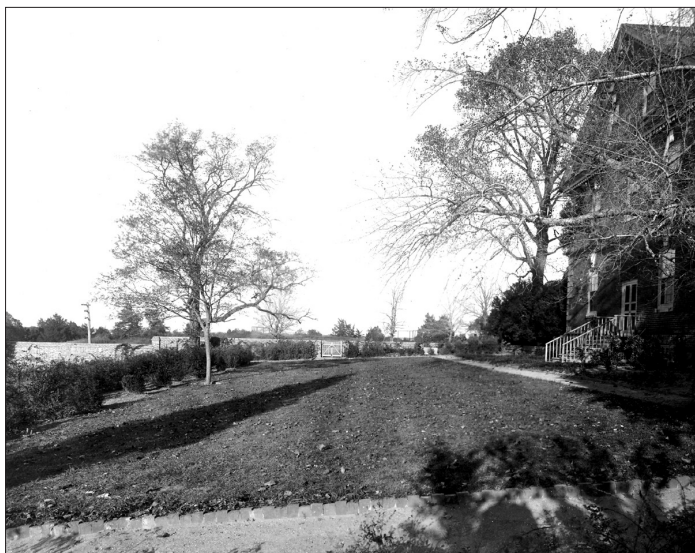
Fig. 1.41 (bottom). The original terrace on the site of the Nelson service yard, looking north toward Main Street, ca. 1920. (Colonial National Historical Park archives, Blow Family Photographs, album #13.)

The old Nelson service yard on the west side of the house was transformed into a lawn terrace that sloped gently toward lot 48 (fig. 1.41). This area required filling over the remains of the kitchen-wash house to restore the grade that had been

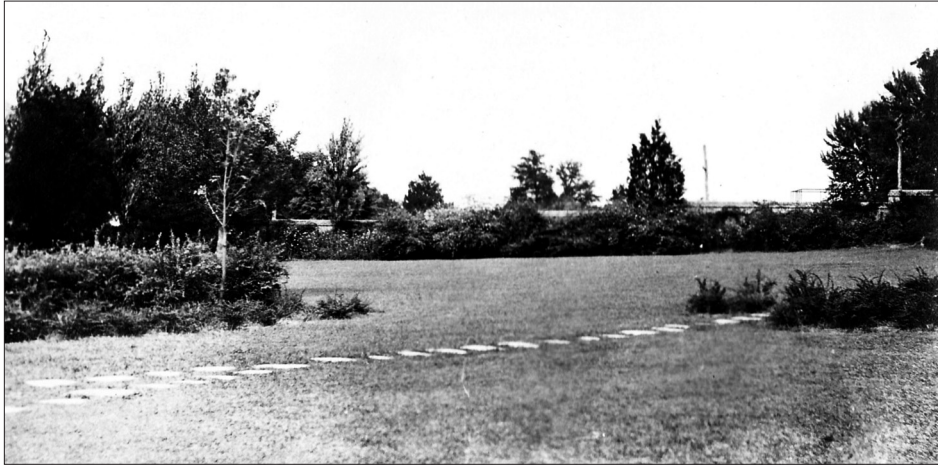
Figure 1.42. The lower terrace (future site of the formal garden), looking southeast toward Main Street, ca. 1920. In the background is the perimeter wall. (Colonial National Historical Park archives, Blow Family Photographs, album #14.)

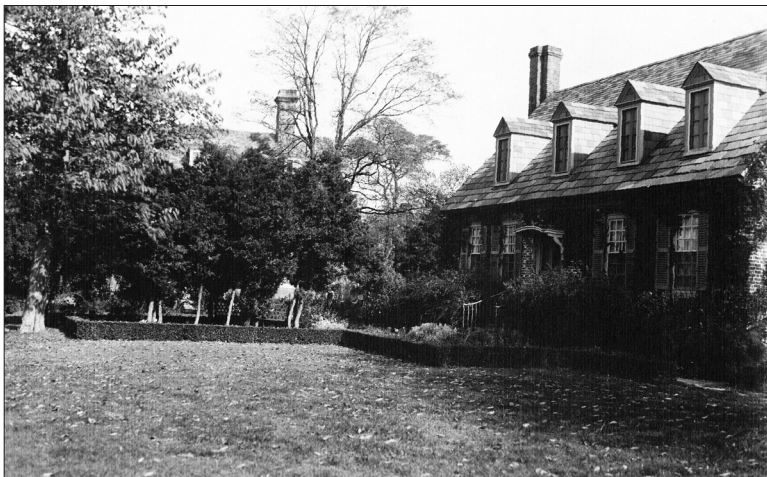
Figure 1.43 (middle). The renovated Smith House and boxwood shelter garden, looking north toward the Nelson House, ca. 1920. (Colonial National Historical Park archives, Blow Family Photographs, album #12.)

entrance to the west side facing the interior of the estate, away from Pearl Street (fig. 1.43). A marl walk edged in brick and with brick steps was extended south from the oval entrance drive in the forecourt (back court), intersecting the preexisting boxwood allee that was on axis with the relocated front entrance of the Smith House. Gillette renovated the allee, with its parallel rows of aged boxwood and mature deciduous tree at the end (species unknown), into an intimate garden space known as the boxwood shelter, edged in clipped boxwood borders and furnished with cast-iron benches.

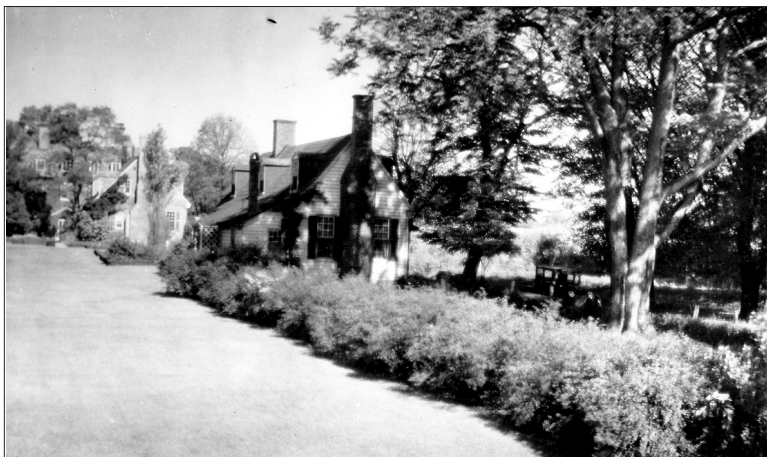
Figure 1.44 (bottom). The renovated Ballard House and hedge-enclosed yard to the south, looking north toward the Smith and Nelson Houses, 1924. (Colonial National Historical Park archives, Bagby photographs.)

George P. Blow's acquisition of the Ballard lot in 1919 completed the interior of the estate landscape. The Ballard House, which served as a staff residence known as Pearl Cottage, remained largely unchanged on the exterior with its original entrance facing the street. The two remaining outbuildings were removed, and the perimeter brick wall was extended along Pearl Street to the northeast corner of the house. The area south of the house was planted with an unclipped hedge that enclosed a small yard (fig. 1.44).

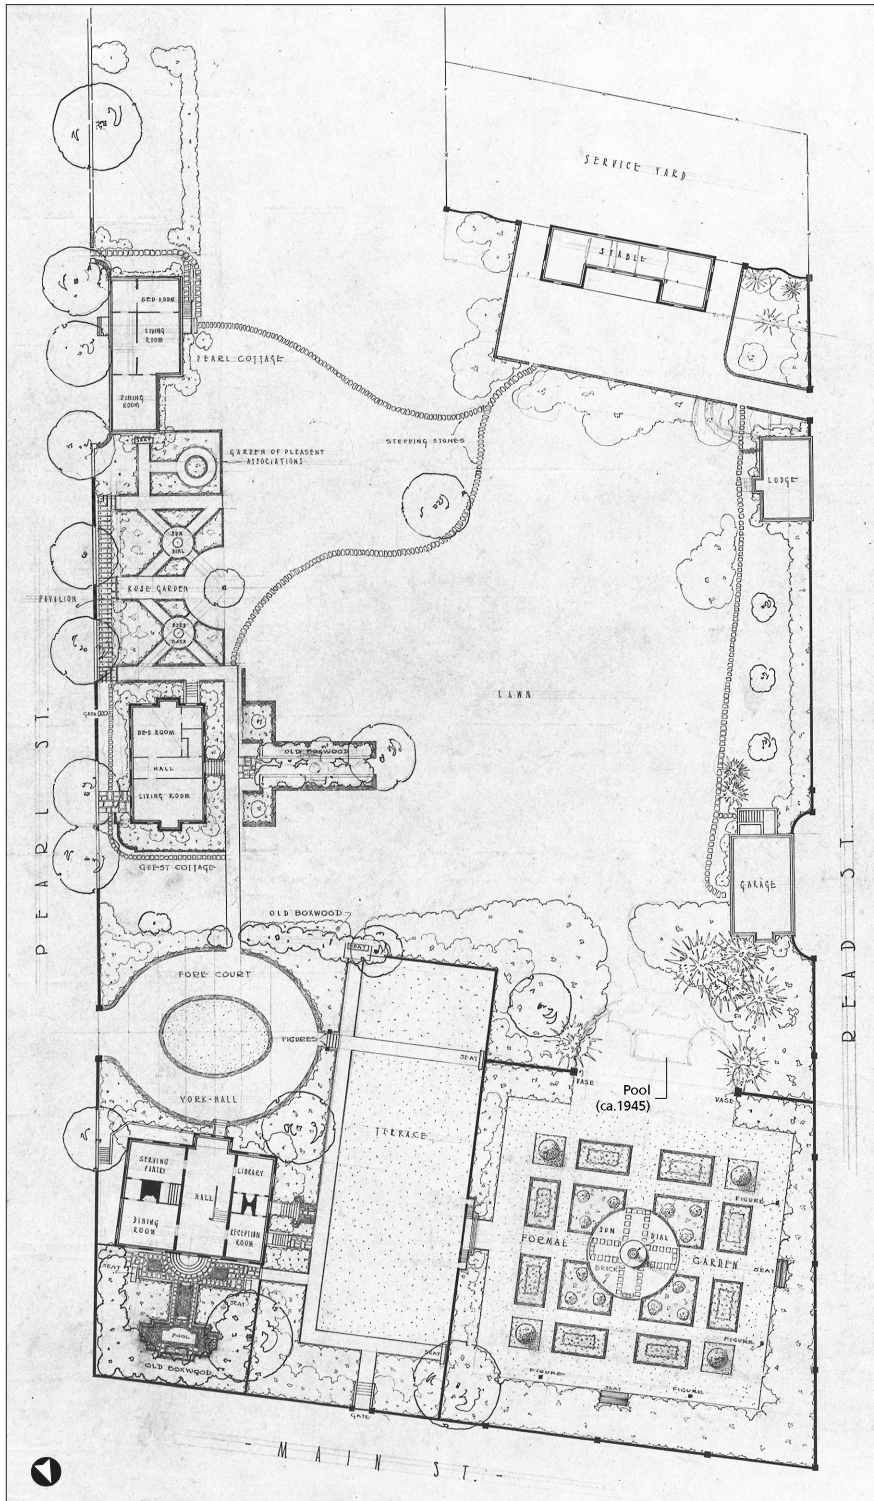
Figure 1.45. Plan of the York Hall estate by Charles Gillette, ca. 1923. This plan shows implementation of the improvements begun in ca. 1921. The pencilled annotation south of the formal garden was for a pool added after World War II. ("York Hall...A Sketch of General Plan of Arrangement, Charles F. Gillette, Landscape Architect, Richmond, Virginia." Colonial National Historical Park archives.)

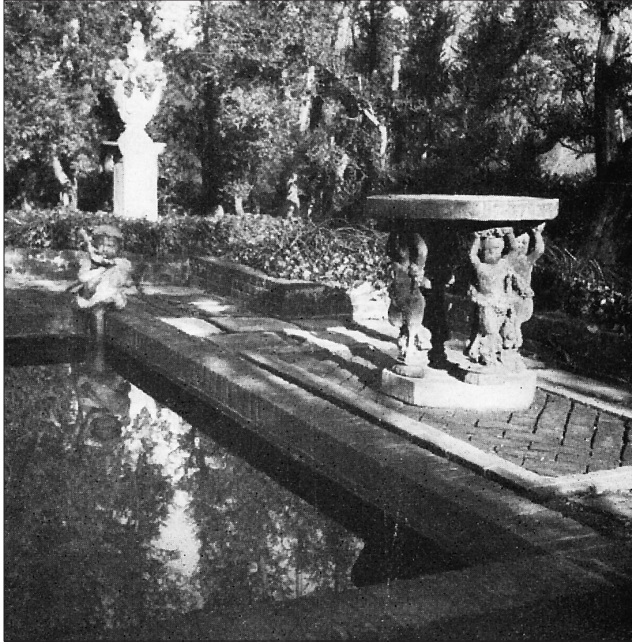
Figure 1.46. Detail of the front court garden looking northwest with the preexisting boxwood hedge in the background, 1921. The old entrance from Main Street was approximately where the cherub table is shown. ("Restoration of a Southern Colonial Estate, 'York Hall,'" *Architectural Forum*, December 1921.)

was centered around a small reflecting pool surrounded by a brick patio edged by plantings (fig. 1.46). The secluded garden was ornamented with urns, cherubs, a cherub table, and benches of cast-iron and stone, in stark contrast to the simplicity of the earlier landscape.

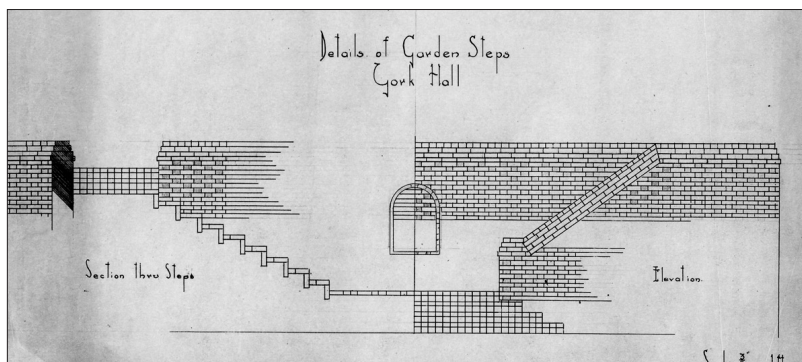
Figure 1.47. Charles Gillette's east-facing section showing the flight of steps in the wall between the terrace and formal garden, ca. 1922. (Colonial National Park archives.)

Construction of the garden wall involved the removal of the brick steps on the slope and relocation of the shrubs to the Ballard lot and other areas within the estate.²² Two symmetrical flights of steps led through the middle of the garden wall (fig. 1.47). These met at a small landing, from which three more steps descended to the lower terrace. For

ornament, Gillette set a decorative lion's head fountain in a niche on the garden wall above the landing.

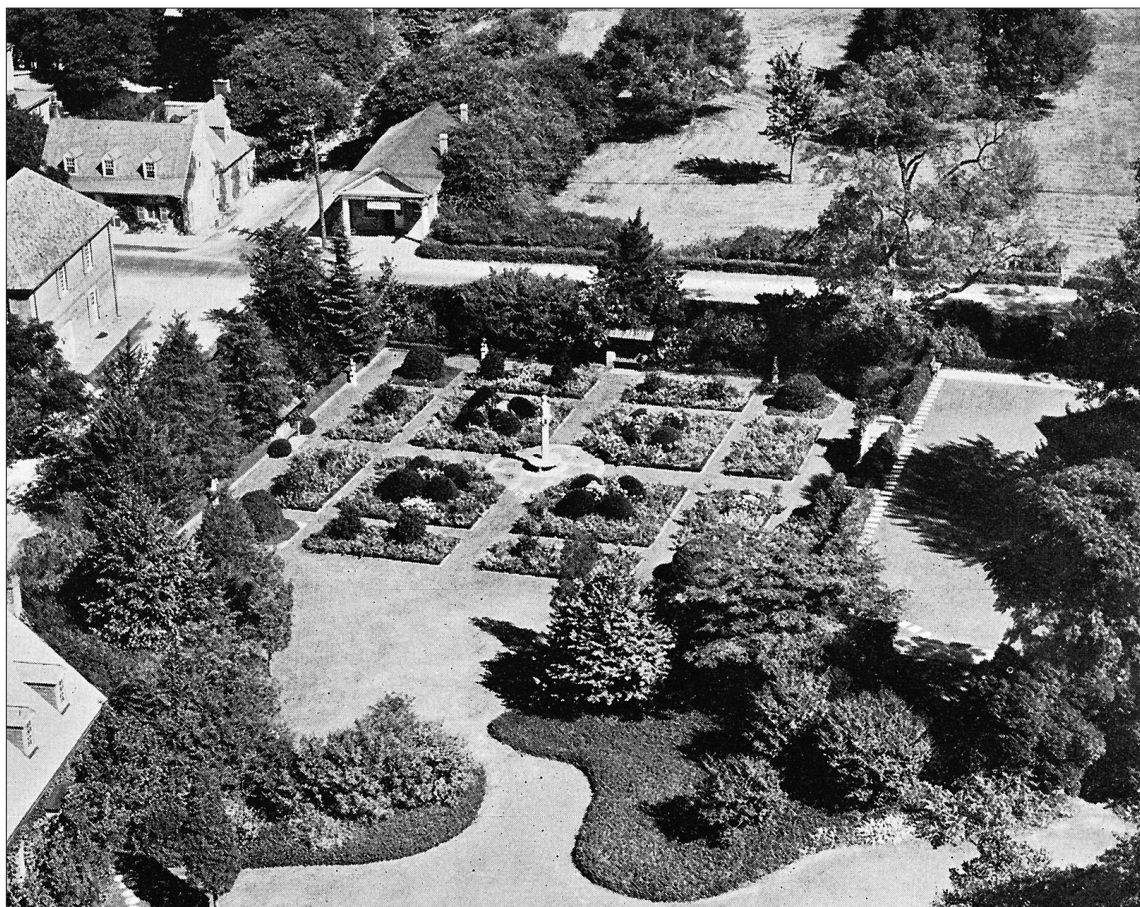
Figure 1.48. The York Hall formal garden built in 1922, looking north, ca. 1930. The lawn at right is the terrace, with the stepping-stone walk that was added in ca. 1930. (Yorktown Sesquicentennial Commission, *The Yorktown Sesquicentennial*, 1932.)

On the lower terrace, Gillette's design for the large formal garden used a classical quincunx plan consisting of symmetrically placed beds divided by two central intersecting walks and parallel secondary walks (fig. 1.48, see also fig. 1.45). Gillette based his design on the formal garden at Groombridge Place in Tonbridge, Kent, England that was the ancestral home of Mrs. Blow's family.²⁴ The design required the addition of low brick retaining walls around the north and west sides to retain the pre-existing grade around the perimeter trees and shrubs that had been planted during the initial development of the landscape.²⁵ The main east-west axis of the garden was aligned with the steps to the upper terrace and

north and west ends of the secondary walks (see fig. 1.48). Two urns on brick piers marked the wide opening to the lawn at the south side of the garden.²⁸

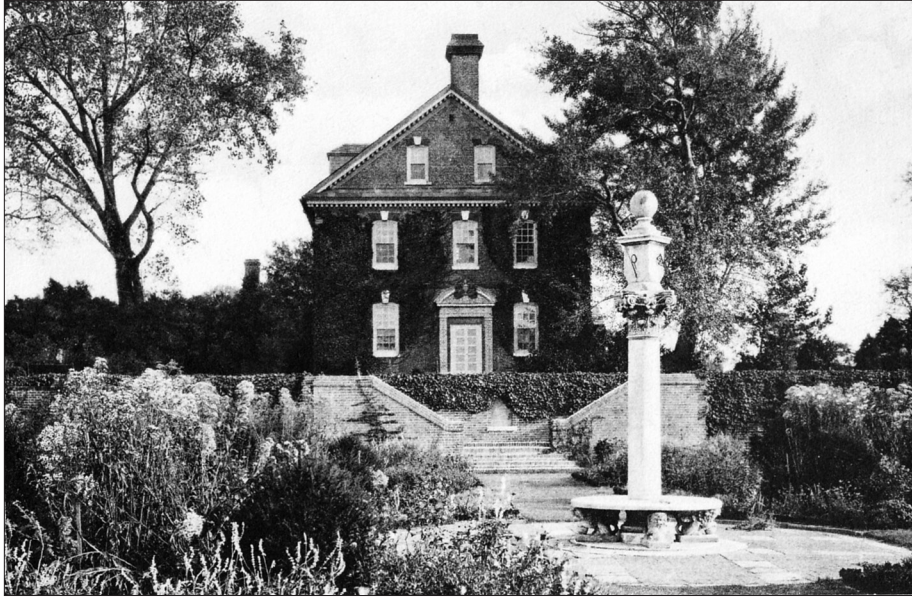
Figure 1.49. A ca. 1927 postcard of the formal garden showing the axial relationship with the stairs to the terrace. The broken-pediment door surround on the Nelson House was added by Mrs. Blow in 1927. (Courtesy of Jane Sundberg.)

In addition to the plantings in the formal garden, Gillette's design included a number of built ornamental features. In the center of the garden was an antique stone column sundial and circular bench that the Blows obtained in England (see fig. 1.49). This was surrounded by circular brick and stone paving.²⁷ Other ornamental furnishings included two Chinese-style covered benches at the north and west ends of the central walks, and stone cherubs on pedestals at the

west entrance of the house (fig. 1.49). Plantings in the beds were an informal, old-fashioned mixture of flowering perennials and roses contained by borders of clipped dwarf boxwood and brick edging. The Blows obtained an extensive assortment of plants from historic places across Virginia, including Monticello, Westover and Tuckahoe Plantations, Mount Vernon, Bruton Parish Church, the President's House at the

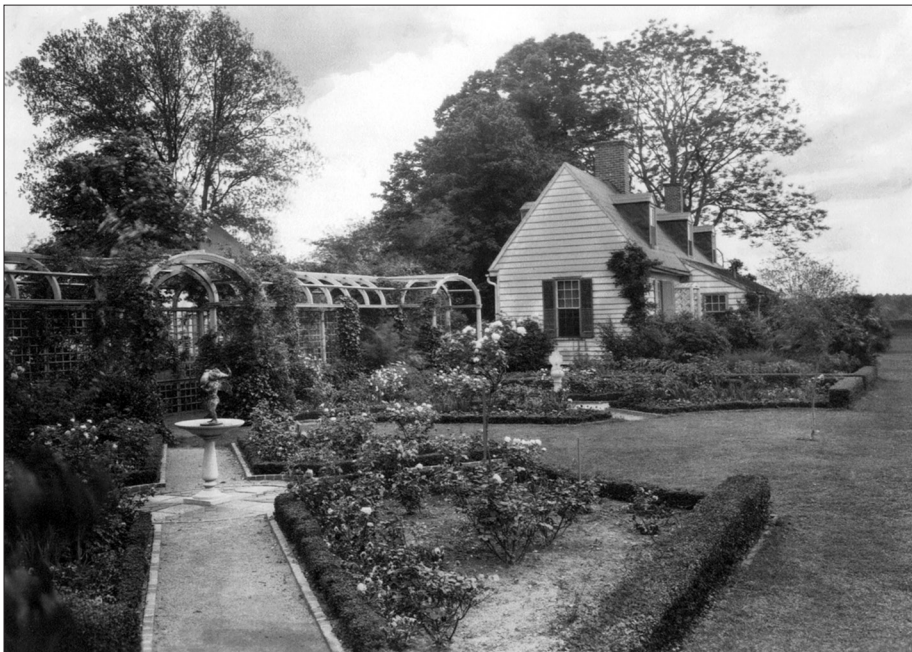
Figure 1.50. The rose garden and arbor between the Smith and Ballard Houses built in 1923, looking southeast toward the Ballard House, ca. 1925. (Colonial National Historical Park archives, YOR 016.)

The smaller formal gardens between the Smith and Ballard Houses, completed in 1923 after George P. Blow's death, included a parterre rose garden that was modeled after another garden at Groombridge Place (figs. 1.50, see also fig. 1.45).²⁹ The rose

garden consisted of symmetrical beds bordered by clipped boxwood and defined by crisscrossing marl paths. At the center of the northern half was a sundial, and in the south half, a birdbath. On the east side of the Rose Garden parallel to the perimeter brick wall, Gillette designed a white-painted wood arbor over a brick walkway to further screen the gardens from the street and provide a structure for climbing roses and other vines.³⁰ On the south side of the rose garden adjoining the Ballard House, Gillette designed a small, hedge-enclosed garden called the Garden of Pleasant Associations. The interior of this garden consisted of marl paths terminating in a circle. According to a February 1923 plant order from the Philadelphia nursery Henry A. Dreer, the two gardens were planted with 1,000 boxwood plants, fifteen varieties of roses, and eight types of vines, including jasmine, akebia, clematis, wisteria, porcelain berry (*ampelopia*), sweet pea, and climbing hydrangea, plus climbing roses.³¹

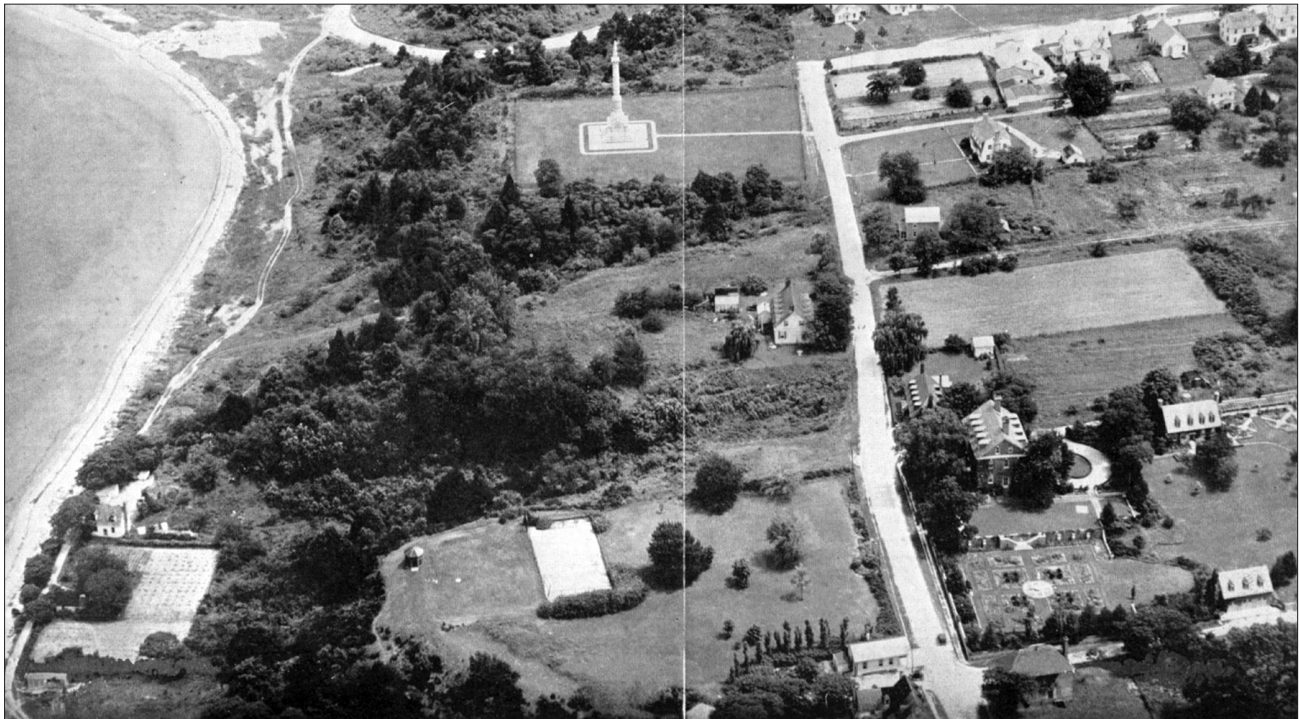
Figure 1.51. Looking east across the York Hall estate showing the tennis court and gazebo on the land east of Main Street, ca. 1925. The gazebo is on top of a Civil War earthwork. In the background is the Yorktown victory monument. (Colonial National Historical Park archives, YOR 1701.)

established along Main Street, with an opening across from the entrance to the terrace. The steep bank down to the river, and the Great Valley along the east side of the property, were left as brush and woods, but the Civil War earthworks were mown. The only structures that the Blows introduced were a fenced tennis court in the middle of the lawn, and a gazebo on top of the earthworks, placed to take advantage of the view across the river.³²

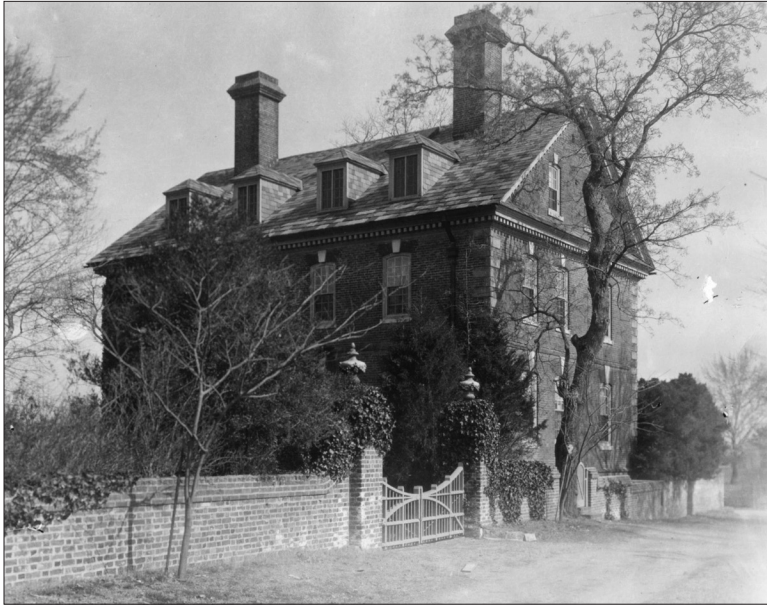
Figure 1.52. The Nelson House looking north along Pearl (Nelson) Street showing urn finials added to the entrance gates in the 1920s, photographed ca. 1930. (Colonial National Historical Park archives, YOR 018.)

Aside from overseeing completion of the gardens and other landscape improvements, Adele Blow made several changes to buildings and structures at York Hall following her husband's death. At the west entrance of the house, facing the terrace and formal garden, she commissioned New York architect William Lawrence Bottomley to redesign the original doorway, resulting in the addition of an elaborate broken pediment surround of molded brick (see fig. 1.49). Mrs. Blow may also have been responsible for replacing the simple ball finials on the main entrance gate with more elaborate garlanded urns (fig. 1.52).³³

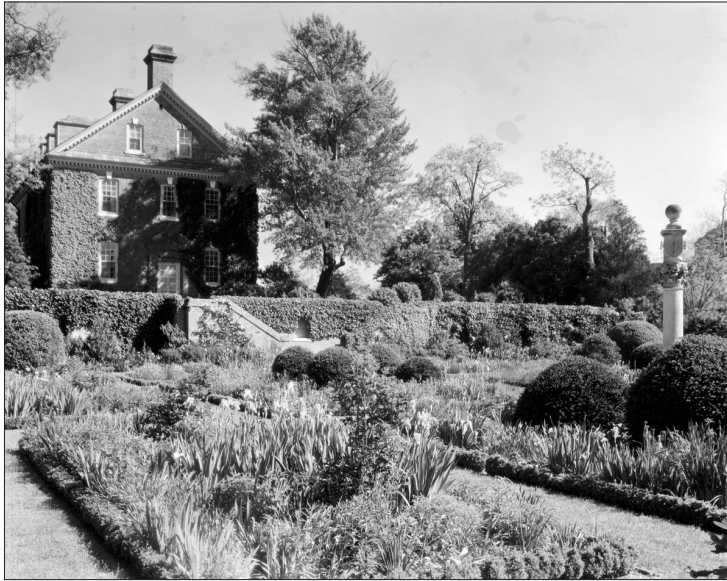
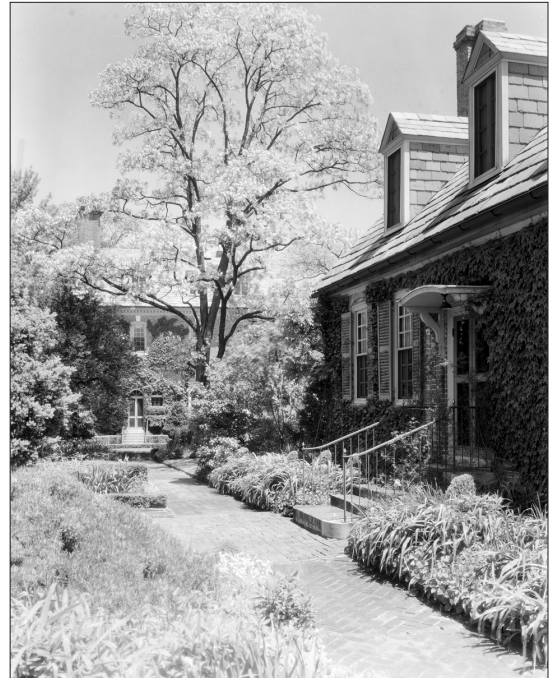
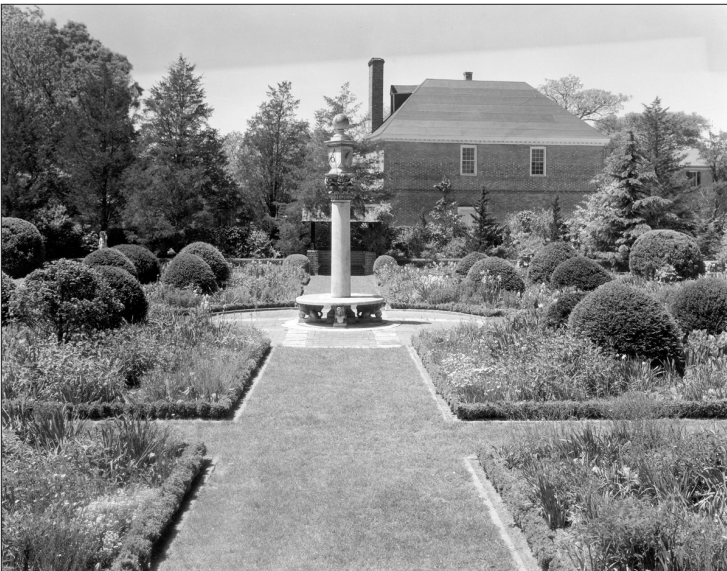
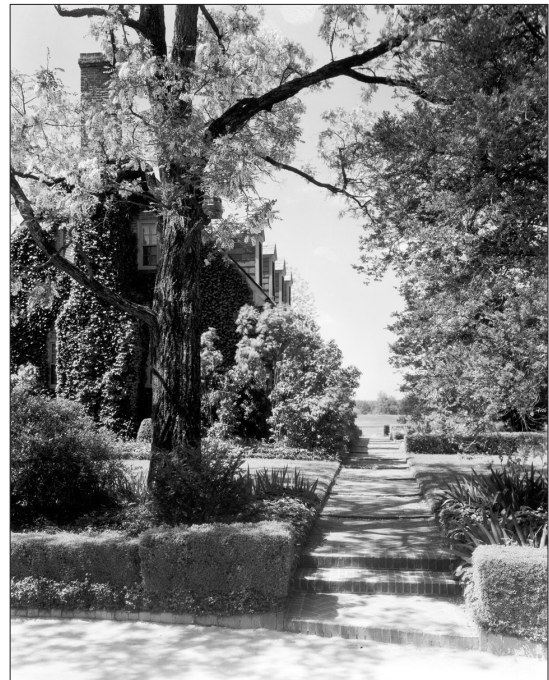
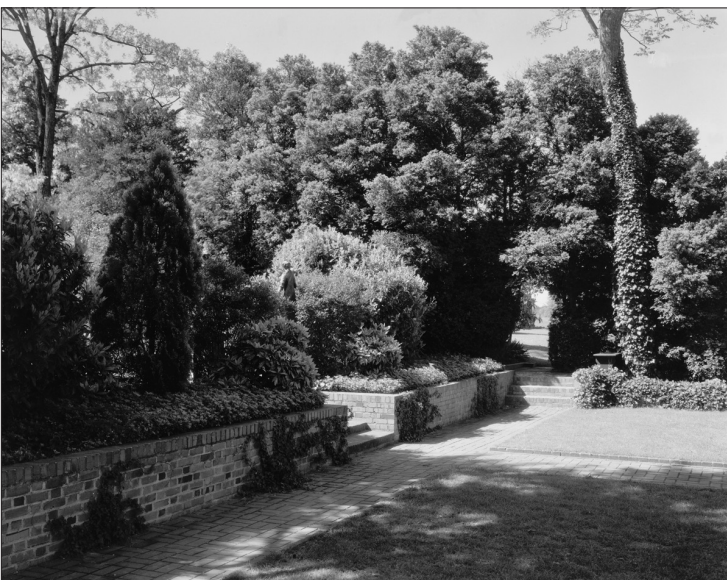
Figures 1.53-1.57. Frances Benjamin Johnston photographs of the York Hall landscape, ca. 1930. Left top: formal garden looking southeast; left middle: formal garden looking west; left bottom: the terrace looking south toward the walk from the oval entrance drive, with the old boxwood hedge in the background. Right top: Looking north along the Smith House (Guest Cottage); right bottom: looking south from the oval entrance drive toward the Smith House. (Library of Congress, Carnegie Survey of the Architecture of the South, images 05724, 05725, 05752, 05753.)

In ca. 1930, Frances Benjamin Johnston photographed the York Hall estate as part of her Carnegie Survey of the Architecture of the American South. She captured the maturation of Gillette's original landscape design for George P. and Adele Blow, and the character that visitors saw during the estate's brief history as a museum during the early 1930s (figs. 1.53–1.62).

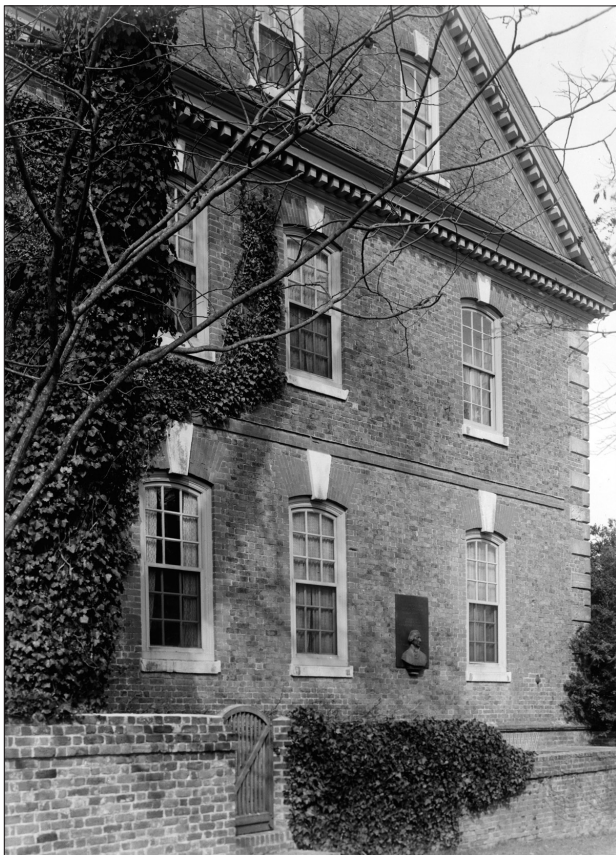
Figure 1.63. The Cornwallis plaque installed on the east side of the Nelson House for the Yorktown sesquicentennial in 1931, looking northeast from Pearl (Nelson) Street, ca. 1931. (Blow photograph, reproduced from Historic American Building Survey, York Hall, HABS VA-100.)

Within Yorktown, federal development of Colonial National Historical Park during the 1930s corresponded with a number of other preservation-related initiatives. Private efforts included the previously mentioned opening of the Nelson House (York Hall), Custom House, "Sessions" House, and Cole Digges House to the public.³⁷ The Yorktown Sesquicentennial Commission also played a major role in preservation and commemoration efforts, including the installation of a bronze plaque on the east side of the Nelson House, facing Nelson Street (fig. 1.63). The plaque, which featured a bas-relief sculpture of Lord General Cornwallis designed by the American sculptor F. William Sievers (1872–1966), was commissioned to

commemorate the house's purported use by the general during the Siege of Yorktown (a fact that has since been discounted).³⁸

At the back court, the park restored the steps and arched openings in the entry porch, and erected unpainted wood fences to set the area apart from Nelson Street and the terrace (fig. 1.72). On the Nelson Street side of the house, the park relocated the 1931 Cornwallis plaque to the inside of the perimeter wall in the formal garden. On the west side of the house, the park replaced the entry steps and removed the 1927 pedimented entrance surround to restore the original flat brick arch (fig. 1.73). At the adjoining terrace, the grade was lowered, requiring removal of the top of the garden wall and steps on the walks to the back court and Main Street. New brick walks were installed in a layout similar to the York Hall design, providing access to Main Street, the front court, back court, and formal garden.⁸
