CULTURAL LANDSCAPE REPORT FOR THE NELSON HOUSE GROUNDS

COLONIAL NATIONAL HISTORICAL PARK
YORKTOWN, VIRGINIA

SITE HISTORY

EXISTING CONDITIONS

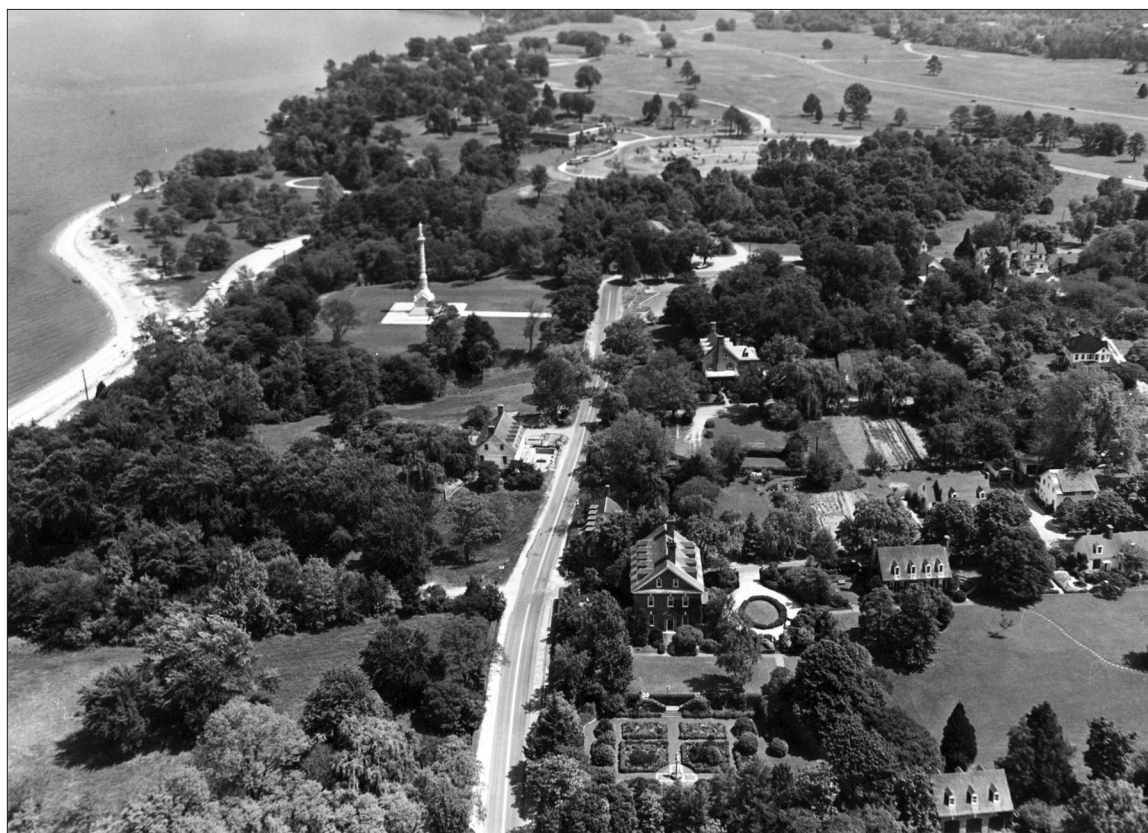
Figure 1.64. View looking east above Main Street with the Dudley Digges House undergoing restoration (white building on left of Main Street) the Yorktown Battlefield visitor center under construction in the background, ca. 1960. The York Hall estate is along the lower part of the photograph (Colonial National Historical Park archives, YOR 1655.)

During the post-World War II period, the park largely abandoned plans for major reconstruction in the village, and instead focused on restoration of the Dudley Digges House east of the Nelson House, and construction of a large visitor center on the edge of the battlefield west of the village built as part of the National Park Service's Mission 66 improvement program (fig. 1.64). The other primary colonial buildings along Main Street—the Nelson House, Custom House, Sessions House, and Cole Digges Houses—remained privately owned. The Cole Digges House was acquired in 1946 by the Blow family.⁴⁰

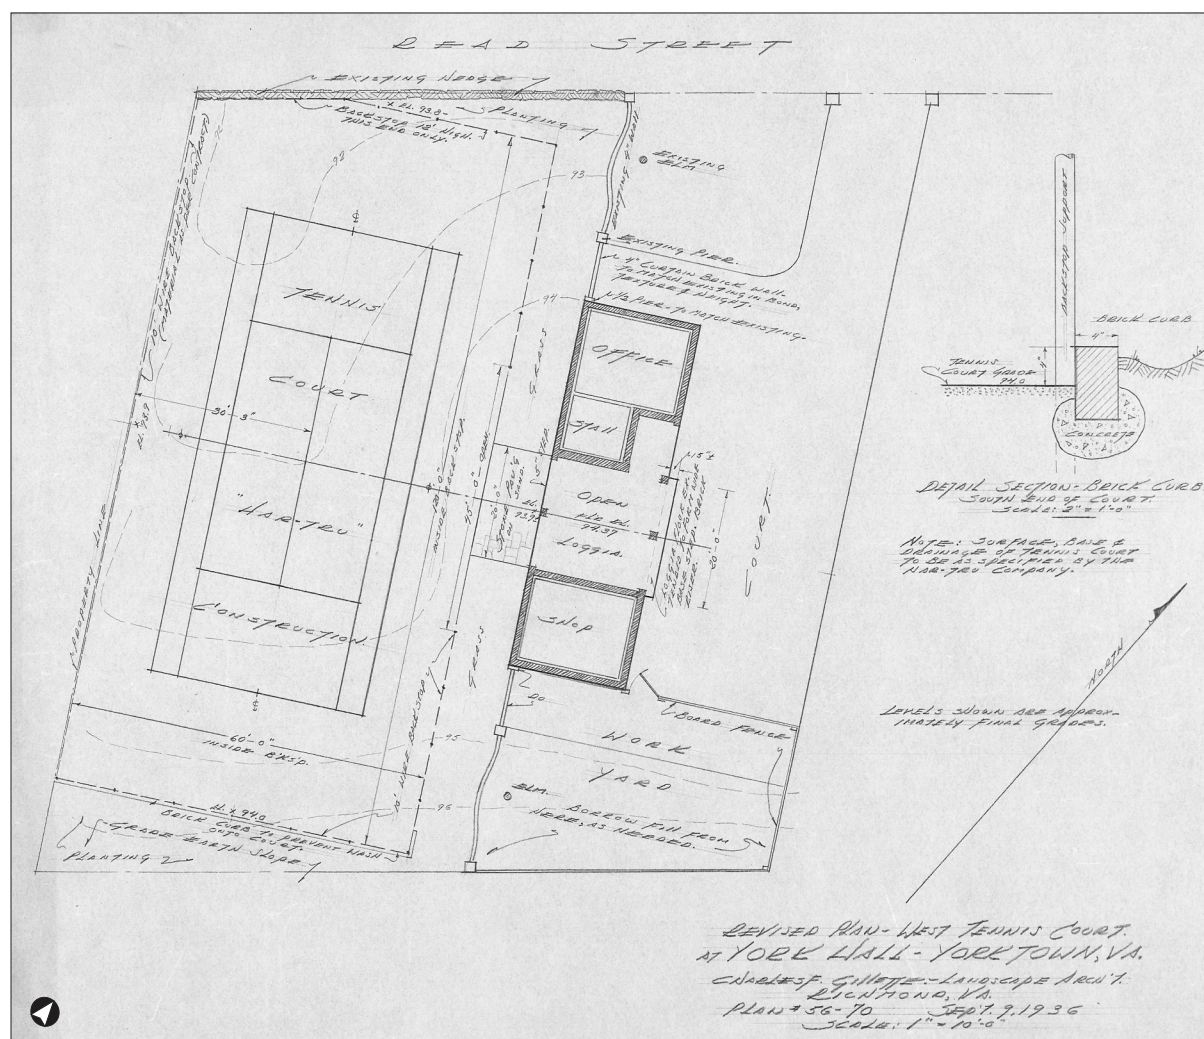
Figure 1.65. Charles Gillette's plan for a tennis court at the former service yard south of the stable, 1936. Brick walls were subsequently built to create smaller work yards at the sides of the stable. (Colonial National Historical Park archives, 990341.)

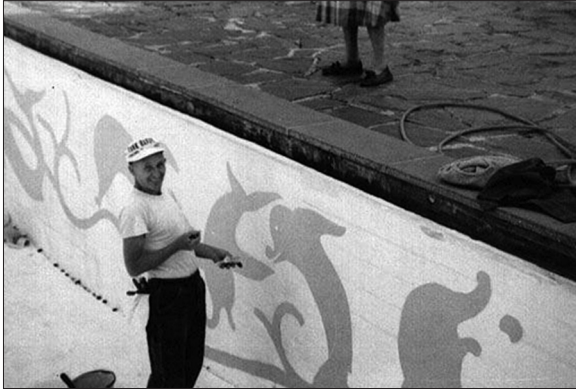
Figure 1.66. Looking southeast across the ca. 1946 swimming pool and flagstone patio south of the formal garden during annual maintenance, ca. 1960. The identity of the person is not known. The murals were purportedly painted by artist Pierre Bourdelle. (Courtesy of Anthony Blow.)

extended and expanded the brick pad from the west bench into a circular brick patio surrounding a red-cedar tree. A fireplace was installed against the perimeter wall, and there was most likely casual furniture set out on the patio. The next year, the Blows built a small rectangular swimming pool at the entrance to the formal garden from the lawn (see pencil annotation on fig. 1.45). The concrete pool walls were painted with murals and a flagstone patio was laid along the south side (fig. 1.66).⁴⁹ A crape-myrtle hedge was planted south of the pool, blocking views from the main lawn. As one of his last garden designs on the estate, Charles Gillette laid out a small pansy garden north of the Smith House, off the south walk from the entrance drive.⁵⁰ Completed in 1946, the pansy garden was shallow sunken rectangular terrace, two steps below the level of the access walk and enclosed by brick retaining walls. A set of steps led to a side door on the Smith House.⁵¹

- 49 George and Anthony Blow, interview by Bryne D. Riley, March 8, 2008. Noted muralist Pierre Bourdelle (1903–1966), an assistant of August Rodin, purportedly painted the murals on the pool walls. Katherine Blow was a patron of Bourdelle’s and had a painting of the Nelson House made by him prior to the pool construction.

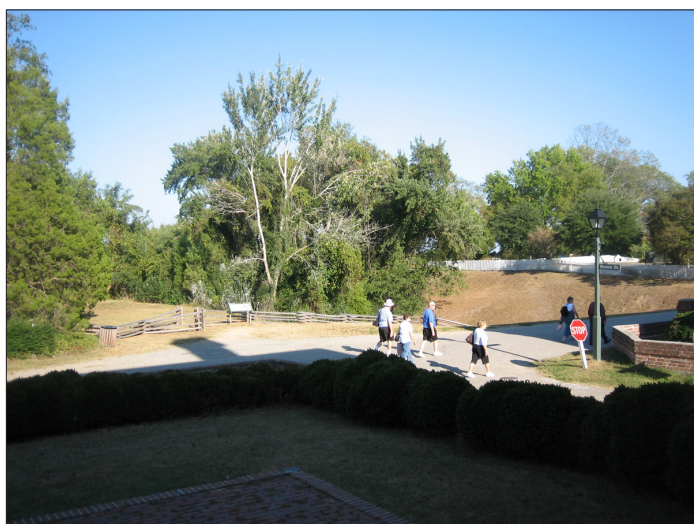
Figure 1.67. Main Street looking northeast from the Nelson House showing park features including lights, street signs, fences, and interpretive signs, 2007. The fencing is at the head of Great Valley. (SUNY ESF.)

Park restoration and rehabilitation in Yorktown continued along Main Street during this period, primarily focused on the York Hall properties. Interpretative signage, benches, trash cans, stacked-rail fences, street signs, and colonial-style lights provided visitor amenities and reinforced Main Street's identity as a historical park area within the village (fig. 1.67). Outside of Main Street, Yorktown remained a mix of past and present during this period—a partially restored Main Street within a largely residential community and a redeveloped commercial area along the waterfront.

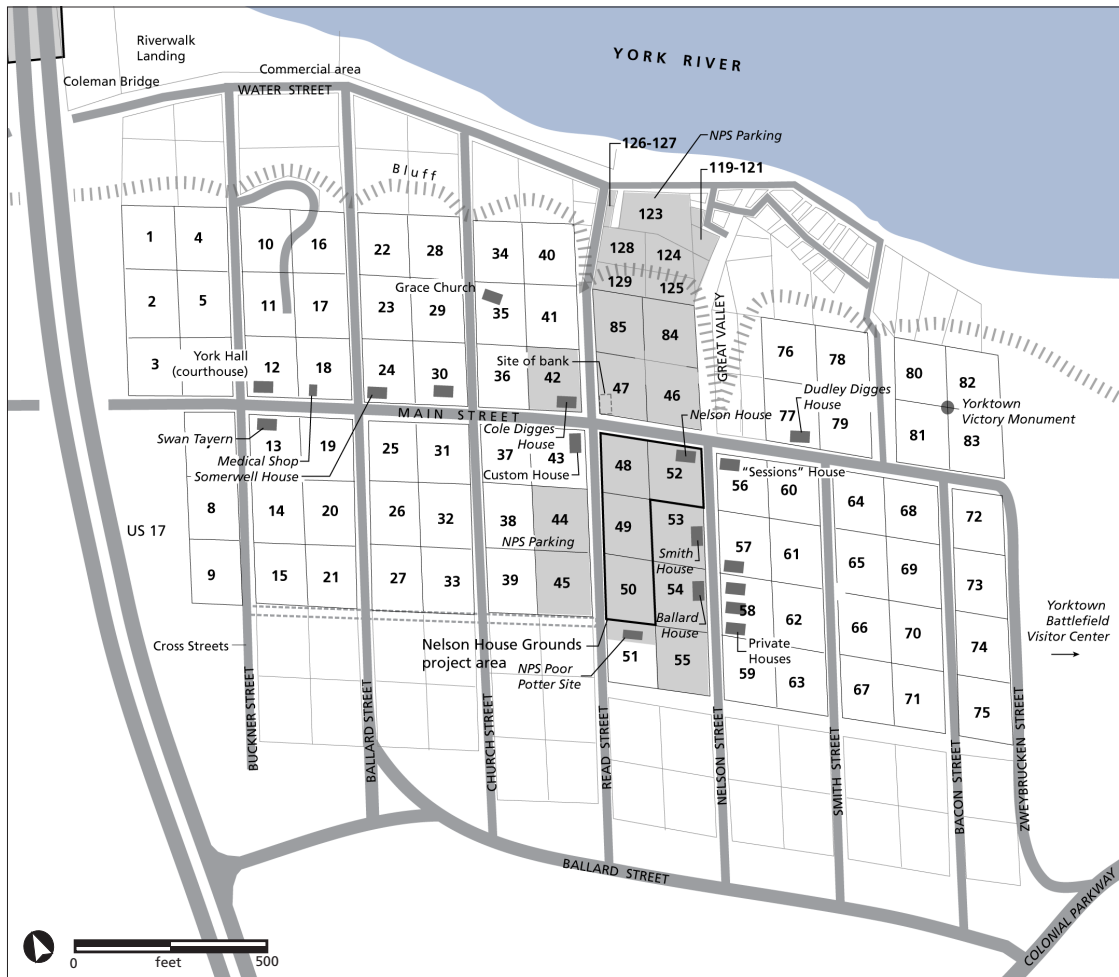
Figure 1.68. Map of Yorktown showing the York Hall property acquired by the National Park Service in 1968 (shaded gray), and location of the parking area and Poor Potter Site developed near the Nelson House grounds. The labels in italics indicate park service-owned property. (SUNY ESF)

The York Hall estate provided the National Park Service with the property it needed to maintain colonial-era continuity in the core of Yorktown's historic district along Main Street.² The park purchased the entire estate from lots 42 to 85 along Main Street, and lots 119 to 129 along the waterfront (fig. 1.68). The Nelson lots, in particular those along Main Street, secured one of the most important village blocks under park control. The remaining lots also allowed the park to expand its interpretation opportunities and visitor amenities. The 1970 unearthing of William Rogers' colonial-period pottery works on lot 51, for instance, provided more detail about Yorktown's colonial history. In addition, the park's acquisition of lots 44 and 45 gave the park space for visitor parking close to the core of the village. The parking lot was completed in ca. 1980 and extended onto the adjoining lots to the west fronting on Church Street. The park leased the Cole

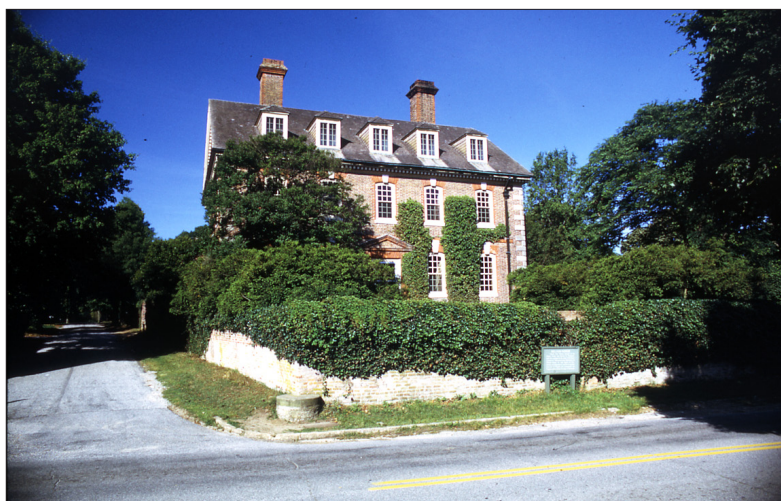
Figure 1.69. The Nelson House and lowered boxwood hedge looking south across Main Street, June 1972. At the front of the ivy-covered wall is a park interpretive sign. (Richard Frear, National Park Service, Harpers Ferry Center.)

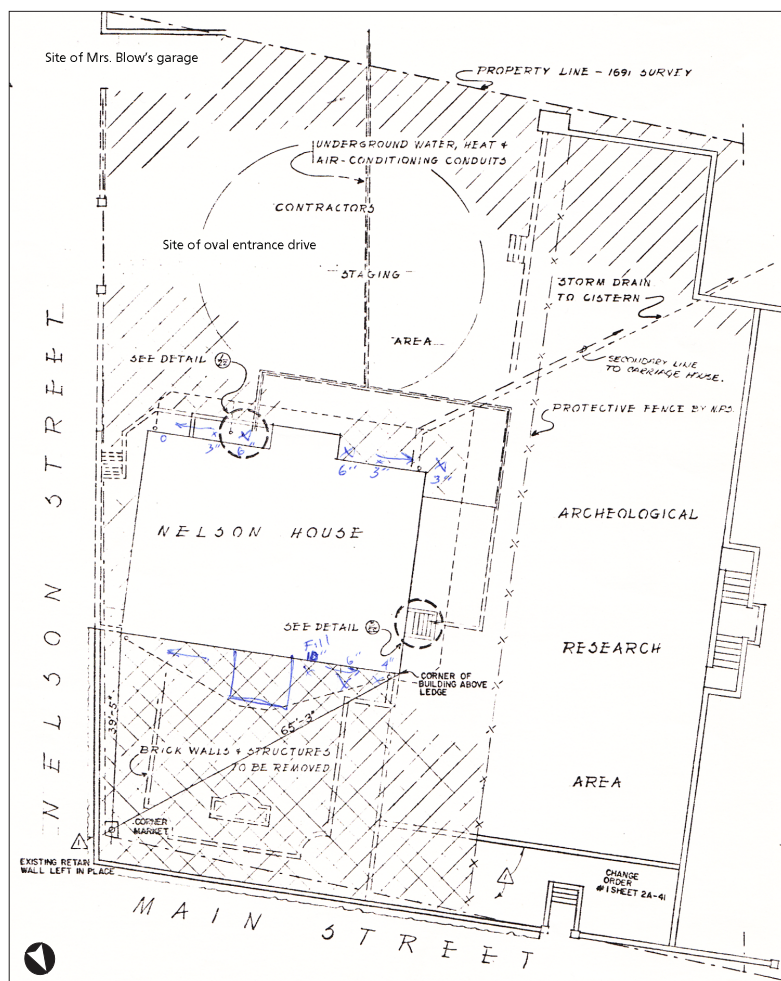
Figure 1.70. National Park Service plan dated 1974 showing the terrace as the site of archeological research, and the extent of planned and completed removals in the front and back courts. The blue notations are later annotations. (Colonial National Historical Park maintenance files, annotated by SUNY ESF).

The first phase of construction involved removal of the entrance drive, Mrs. Blow's garage, wall along Nelson Street, and walks in the back court and terrace (see fig. 1.70). Around the same time, the park removed much of the vegetation surrounding the house, including the remaining boxwood hedges in the front court and in the back court along the Smith lot boundary.

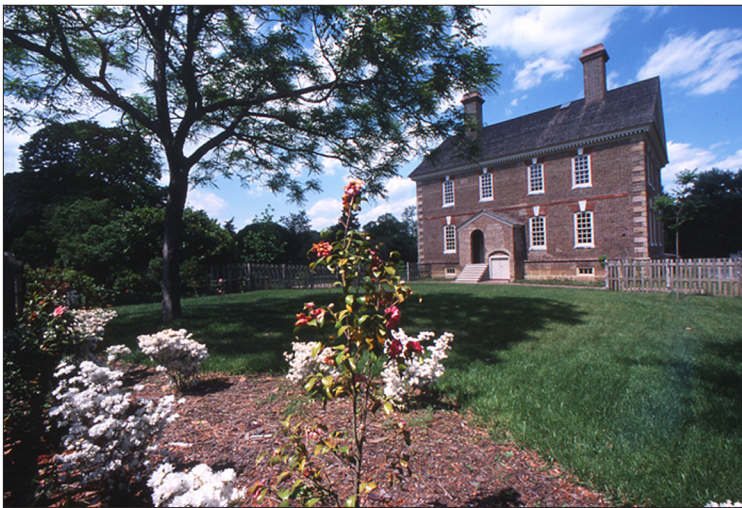
Figure 1.71. The recently restored Nelson House with its front court showing the new steps, walks, and boxwood hedge, looking southwest, ca. 1976. The perimeter brick wall had not yet been lowered. (Richard Freer, National Park Service, Harpers Ferry Center.)

to reveal the full height of the basement windows, which required removal of the circular stone steps (fig. 1.71). The change revealed foundation blocks that were most likely below ground in the colonial period. New rectangular stone steps were installed along with a large brick landing and a brick walk to the terrace. The park did not reestablish the walk to Main Street, but instead maintained the terrace entrance as the main pedestrian access to the site. Boxwood shrubs were planted to reestablish the hedge, and the rest of the court was sodded. Later, the park lowered the brick wall around the front court to its original, ca. 1870 height.⁷

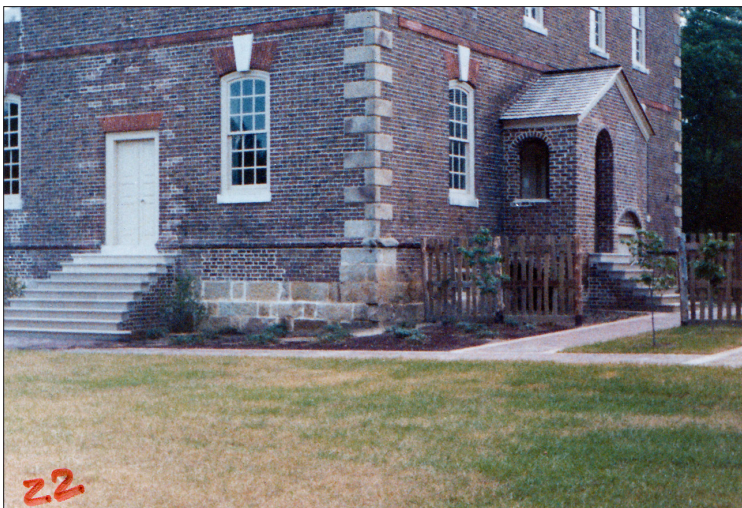
Figure 1.72. The back court and south side of the Nelson House looking northwest showing restored openings in the brick porch, wood fences, and initial plantings, May 1977. (Richard Freer, National Park Service, Harpers Ferry Center.)

At the back court, the park restored the steps and arched openings in the entry porch, and erected unpainted wood fences to set the area apart from Nelson Street and the terrace (fig. 1.72). On the Nelson Street side of the house, the park relocated the 1931 Cornwallis plaque to the inside of the perimeter wall in the formal garden. On the west side of the house, the park replaced the entry steps and removed the 1927 pedimented entrance surround to restore the original flat brick arch (fig. 1.73). At the adjoining terrace, the grade was lowered, requiring removal of the top of the garden wall and steps on the walks to the back court and Main Street. New brick walks were installed in a layout similar to the York Hall design, providing access to Main Street, the front court, back court, and formal garden.⁸

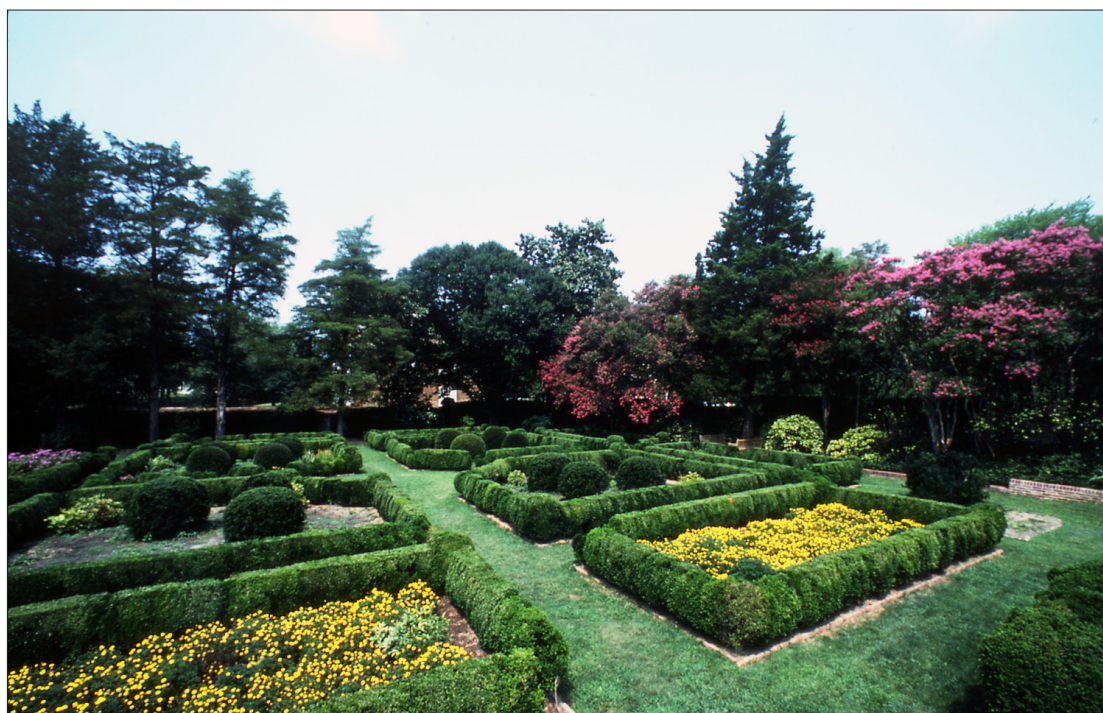
Figure 1.74. The formal garden looking west from the terrace showing replaced boxwood hedges and flowering plants in the beds, September 1979. The groups of yews in the center of the beds were later replaced with rose of sharon shrubs. (Fred Bell, National Park Service, Harpers Ferry Center.)

In the formal garden, the park removed plantings and some built features, but maintained the basic structure of the landscape (fig. 1.74). The swimming pool and flagstone patio were removed, along with the sundial base and the ca. 1946 fireplace, leaving its iron base. The circular brick patio was retained as a platform to view the relocated Cornwallis plaque. In the garden beds, the park removed

the boxwood borders and the overgrown yew shrubs in the center of the beds. New boxwood hedges were planted around the beds, in place of the original dwarf boxwood hedges, and the yews were replanted in the center of the beds. Perennials, including iris, peonies, and narcissus, were retained. Initially, new flowering plants were maintained in some of the beds.⁹

9 No documentation was found on changes to the plantings in the formal garden by the National Park Service aside from the 1979 photograph in figure 1.74.

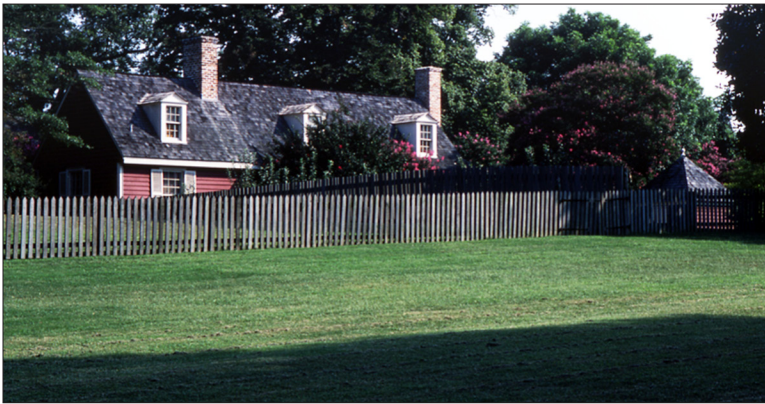
Figure 1.75. Fences erected along the colonial boundaries in the York Hall lawn, looking southwest toward the Ballard House, 1979. The roof of the reconstructed Ballard dairy is visible at far right. (Fred Bell, National Park Service, Harpers Ferry Center.)

In the York Hall lawn, the park divided the space by erecting colonial-style paling (picket) fences along the boundaries of the Smith and Ballard lots (fig. 1.75). The stepping-stone paths were removed along with many of the shrubs along Read Street. The ca. 1946 crape-myrtle hedge was retained, presumably to screen

one-story frame buildings with hipped roofs were built at the rear of the Smith and Ballard Houses, one representing a dairy, and the other a smokehouse (see fig. 1.75). These buildings were not accurate reconstructions, but were located on the sites of historic outbuildings.

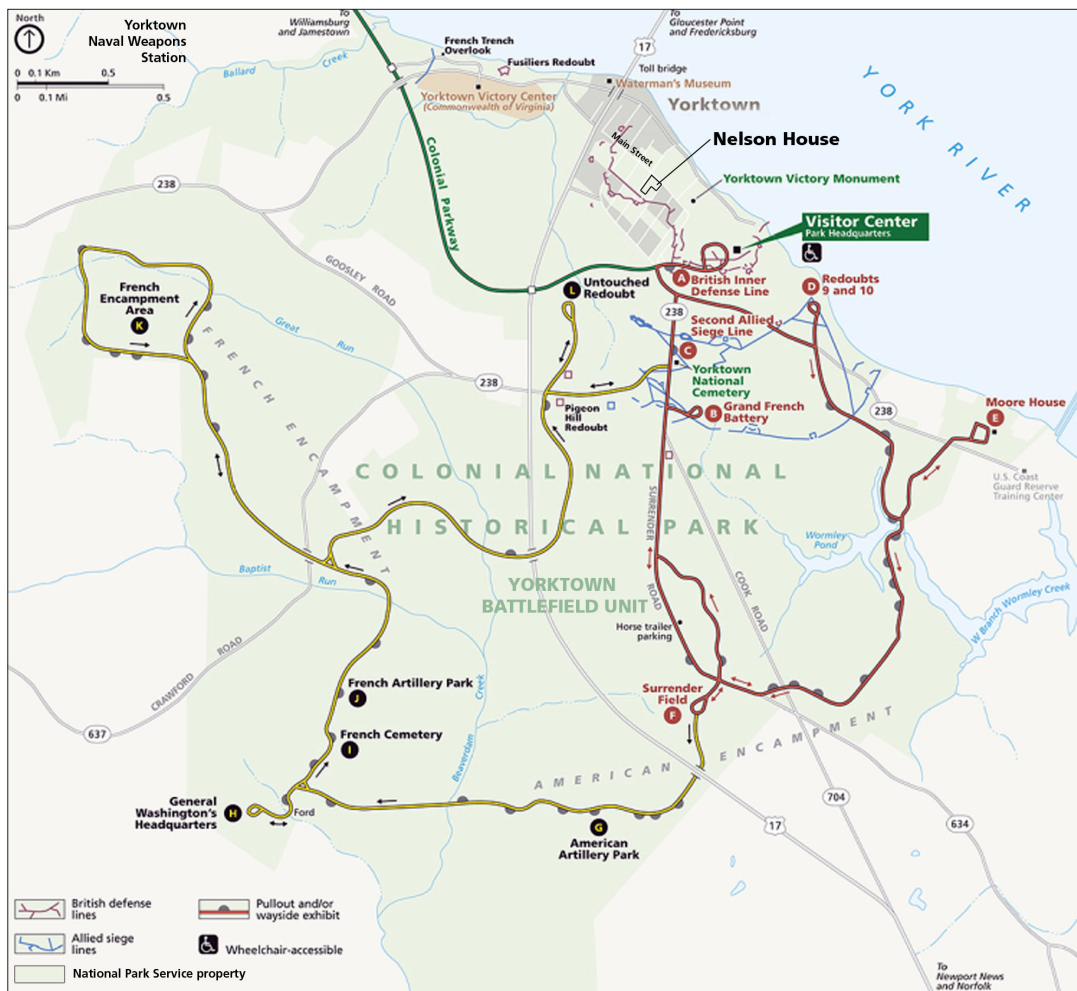
Figure 2.1. Map of the Yorktown Battlefield showing context and relationship of battlefield lands to Yorktown village and the Nelson House grounds. Lands owned by the National Park Service are shown in green. The gray areas within Yorktown are property not owned by the park. (Colonial National Historical Park, annotated by SUNY ESF.)

The Nelson House is administered as part of the Yorktown Battlefield unit of Colonial National Historical Park (fig. 2.1). The unit include Historic Yorktown (Yorktown village), the battlefield, and Yorktown National Cemetery. The Yorktown Battlefield visitor center and park headquarters, located near the southeast side of the village, is at the terminus of the Colonial Parkway, the 23-mile-long limited-access National Park Service road that connects Yorktown and Jamestown. The battlefield features two automobile tour routes, one accessing American and French defenses and encampments, and the other, the British encampments. Within Yorktown village, the National Park Service owns

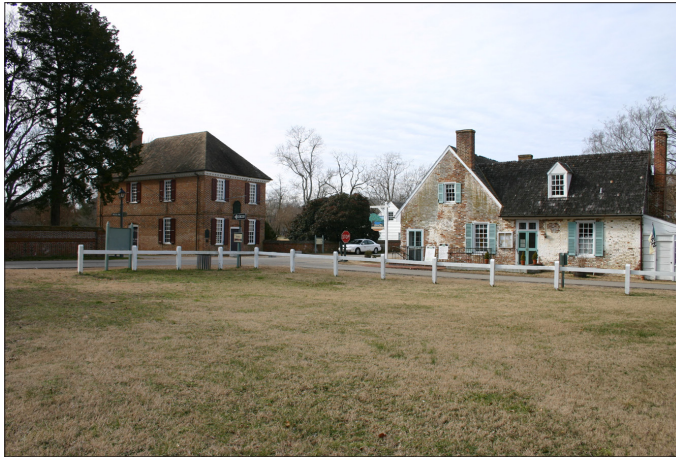
Figure 2.5. The Custom House (left) and Cole Digges House (right), looking southwest with the site of the Cox House and Peninsular Bank and Trust Company in the foreground, January 2010. The trees at left are within the Nelson House grounds. (SUNY ESF.)

The Cole Digges House, also known as the Pate House, is a park-owned one-and-one-half story brick house at the corner of Read and Main Streets (see fig. 2.5). Built in ca. 1720 and restored in 1925, the building presently houses the Carrot Tree Restaurant. The house was owned by George W. Blow as part of the York Hall estate between 1946 and 1968. The adjacent lot 42 is an undeveloped park-owned subdivision of the historic Cole Digges property.

A small temple-front bank building was constructed on the site of the Cox House in ca. 1923 where a white post and rail fence now exists (see fig. 2.5). On lots 84 and 85, the Blows maintained a tennis court and gazebo. Only the gazebo foundation remains from these structures.

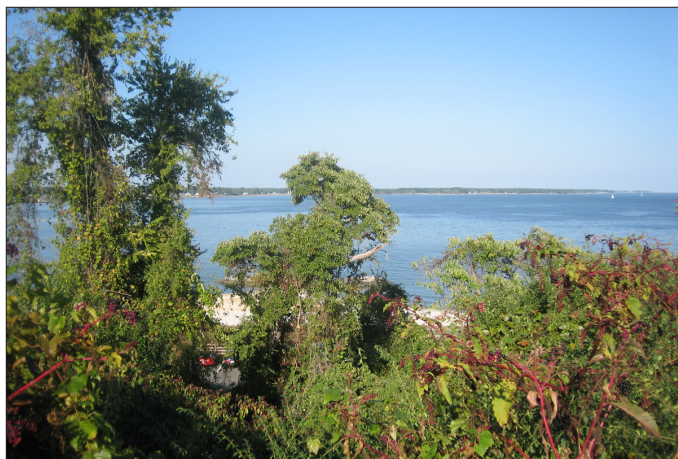
Figure 2.7 (top). The York River, looking north from the brush-covered Civil War earthwork on lots 125 and 129, October 2007. (SUNY ESF.)

owned Confederate Civil War earthwork dating to 1861. The earthwork rises approximately five feet above the level to the south and is covered with brush and scattered trees (fig. 2.7). On top of the earthwork is the foundation of a small gazebo erected by the Blows in the 1920s. From here, there are expansive views across the York River.

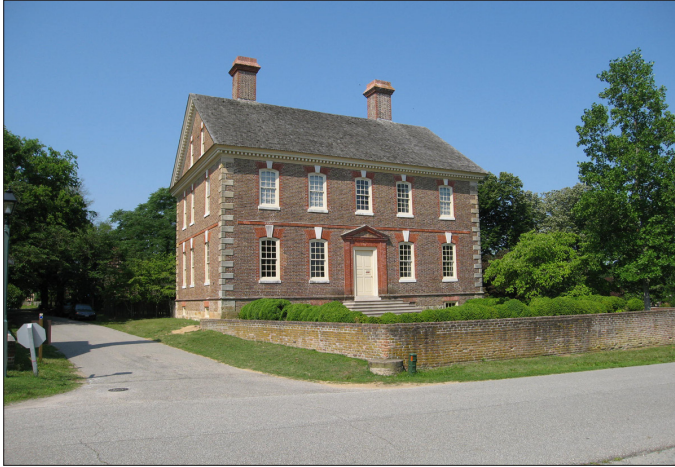
Figure 2.20 (top). The front court of the Nelson House looking southwest from Main Street showing the perimeter wall and boxwood hedge, June 2007. The historic function of the circular feature at the corner of the wall is not known. (SUNY ESF.)

wall along the front court dating to ca. 1870, and a mixed retaining- and free-standing wall with brick piers along the rest of the property that was built as part of the York Hall estate between ca. 1916 and 1920 (fig. 2.20, 2.21, 2.22). Incorporated into the perimeter wall along Read Street are two Colonial Revival-style York Hall estate outbuildings, the carriage house (garage) and Wisteria Cottage (gardener's cottage). Remnants of a low galvanized pipe and wire-mesh fence are on top of the wall along Read Street at the formal garden.

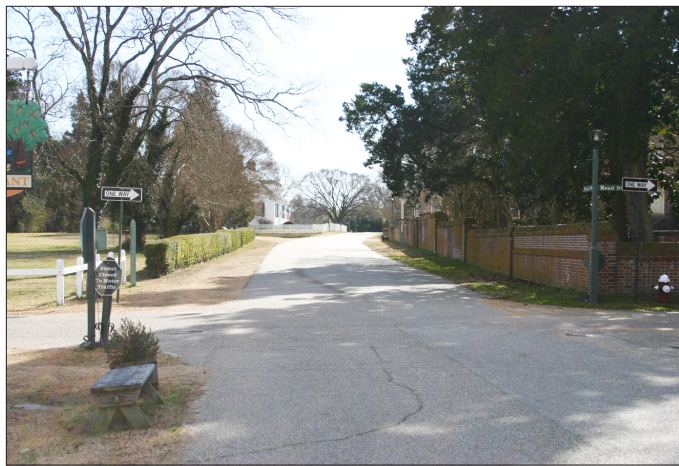
Figure 2.21 (middle). The Main Street perimeter of the Nelson House grounds around the formal garden looking east from Read Street, January 2010. (SUNY ESF.)

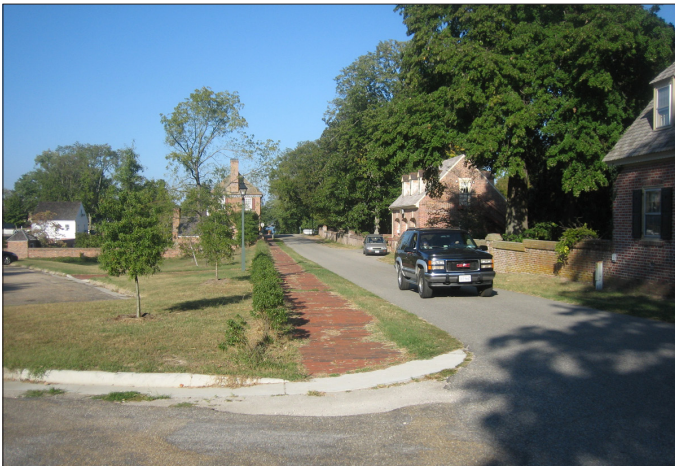
Figure 2.22 (bottom). The Read Street perimeter looking north showing brick wall and two York Hall outbuildings, October 2007. (SUNY ESF.)

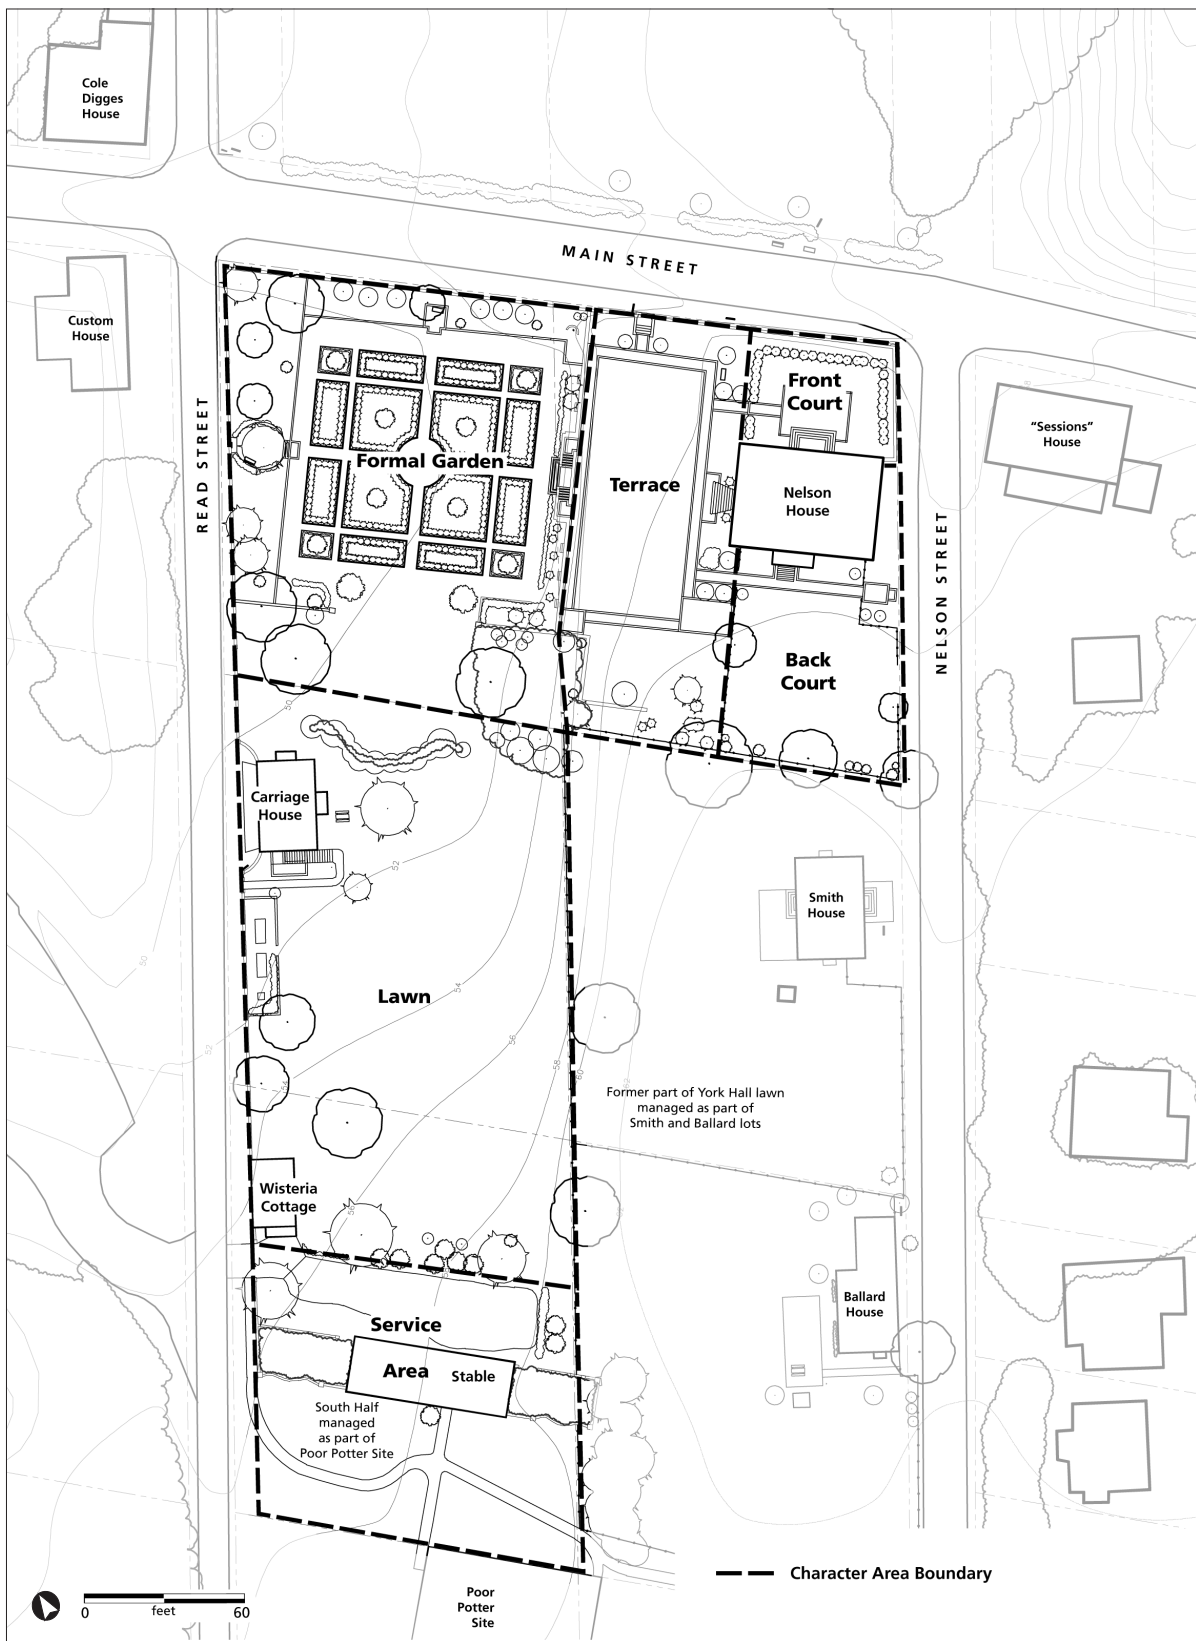
Figure 2.23. Map of the Nelson House grounds illustrating boundaries of six character areas used to inventory existing conditions of the cultural landscape: front court, back court, terrace, formal garden, lawn, and service area. (SUNY ESF)

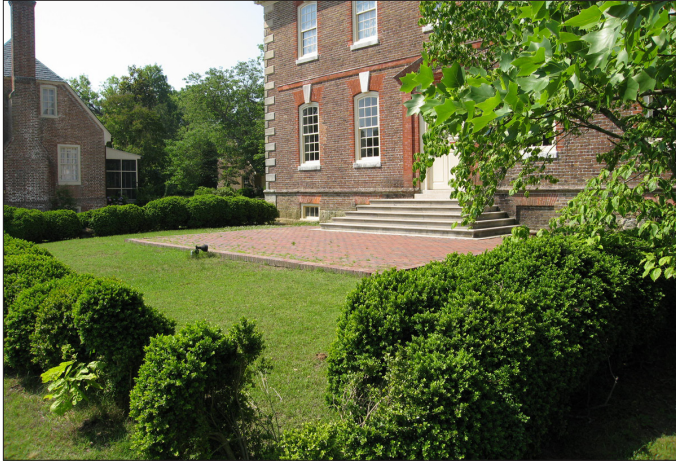
Figure 2.24. The front court looking southeast showing the brick terrace, steps, and lawn, June 2007. (SUNY ESF.)

rehabilitation of the grounds in the 1970s (fig. 2.24). A brick walk connects the patio to the terrace; there is no walk from the front door to Main Street. A low and irregularly-clipped boxwood hedge, a park-service replacement of boxwoods that may have dated back to the eighteenth century, frames the perimeter of the front court. Three floodlights, designed to light the house but presently inoperable, are in the lawn. The hedge has several gaps, including one at the east corner of the house where a desireway leads to Nelson Street. There are no trees within the front court. The view from the front entrance toward the York River, which looks out across undeveloped land north of Main Street, is partially obscured by trees (fig. 2.25).

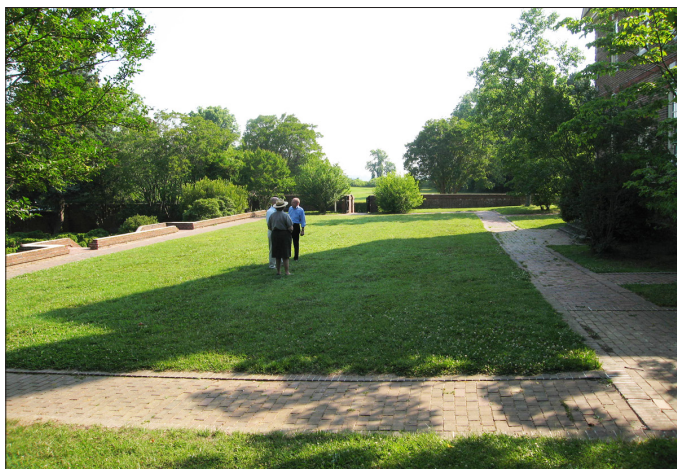
Figure 2.28 (top). The terrace looking north with the Nelson House at right and steps to the formal garden at left, June 2007. (SUNY ESF.)

The terrace is a rectangular lawn along the west side of the Nelson House that was built as part of the York Hall estate (fig. 2.28). During the colonial period, this was the site of the Nelson outbuildings and service yard. The terrace is on the same elevation as the front court, approximately six feet above the formal garden, and is bordered by brick walls. A paired flight of steps leads down to the formal garden, and a single flight of steps to Main Street serves as the main visitor entrance (fig. 2.29). Park service-built brick walks with soldier-course edging frame a large rectangular lawn centered on the side entrance to the house. These connect to brick walks leading to the front and back courts. Plantings, most of which date to park service ownership, are located along the periphery of the terrace and include rose of sharon, dogwood, boxwood, and crape-myrtle, along with a tulip tree at the northwest corner that replaced an earlier tulip tree in the same location.

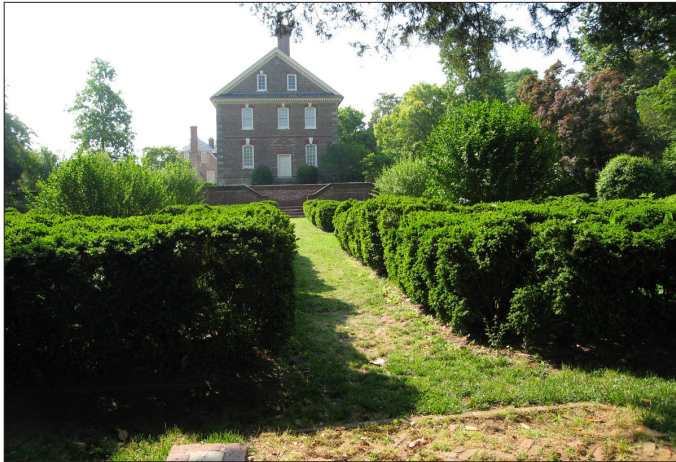
Figure 2.31 (top). The formal garden looking east showing axis with the terrace steps and entrance to the Nelson House, June 2007. (SUNY ESF.)

the steps to the terrace and the west entrance of the Nelson House (fig. 2.31). Most of the garden shrubs were replaced by the park service in the 1970s and 1980s. These include informally clipped boxwood hedges around the beds, boxwood shrubs in the outer corner beds, and rose of sharon in the middle of the large center beds (fig. 2.32). The beds contain scattered perennials and flowering spring bulbs, including peonies, iris, and narcissus dating from the York Hall estate, and more recently planted canna and Yorktown onion (*allium*). Most of the beds are maintained with a mown cover.

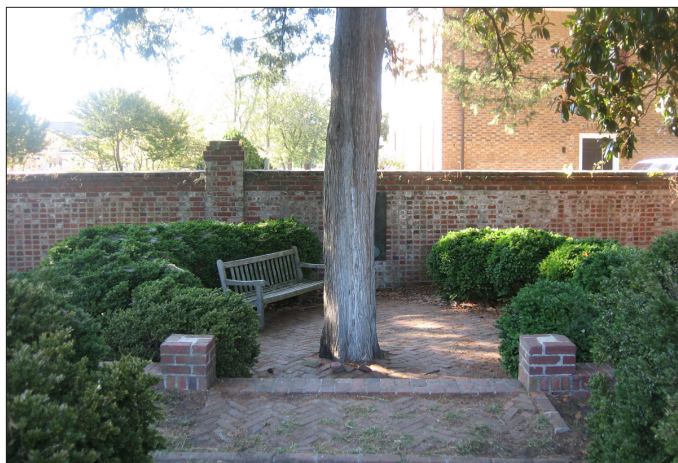
On axis with the central north–south garden walk is a rectangular brick pad that contains a modern wood bench, where a Chinese-style covered bench stood until ca. 1945. Near the wall is a cedar tree that has heaved the brick pad. At the west end of the east–west walk is a circular herringbone-brick patio added in ca. 1946 that surrounds an earlier red-cedar tree and is enclosed by a boxwood hedge (figure 2.34). An iron plate remains from a ca. 1946 fireplace along the perimeter wall, below a bronze bas-relief plaque commemorating Earl Cornwallis, Commander of the British Forces during the 1781

Figure 2.34 (top left). The circular brick patio at the west end of the east-west central garden walk, looking west with the Custom House in the background, October 2007. Just visible behind the cedar tree is the Cornwallis plaque. (SUNY ESF.)

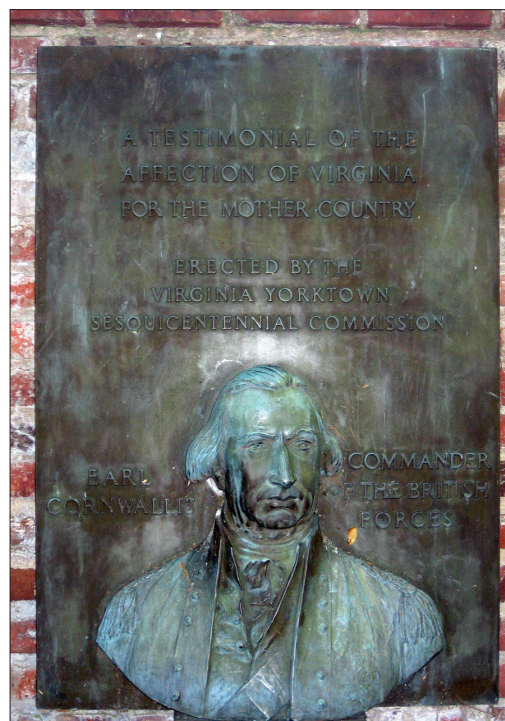
Figure 2.35 (right). The Cornwallis plaque on the perimeter wall in the formal garden, October 2007. (SUNY ESF.)

Siege of Yorktown (fig. 2.35). This plaque was designed by sculptor F. William Sievers and originally installed in 1931 on the east side of the Nelson House.

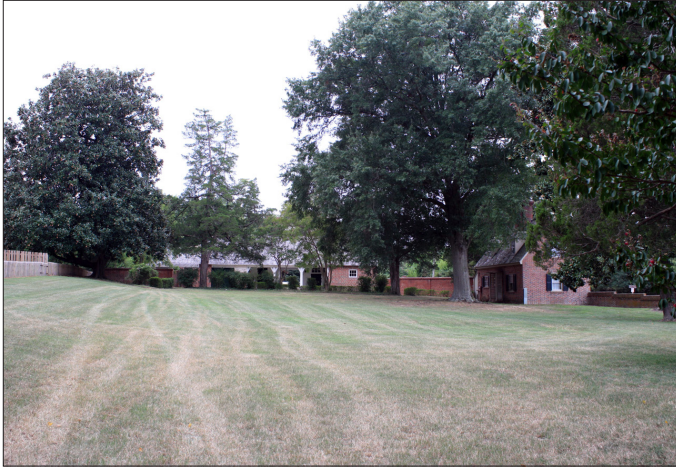
Figure 2.37 (top). The lawn looking south from near the formal garden with the stable in the background and Wisteria Cottage at right, September 2010. (Colonial National Historical Park.)

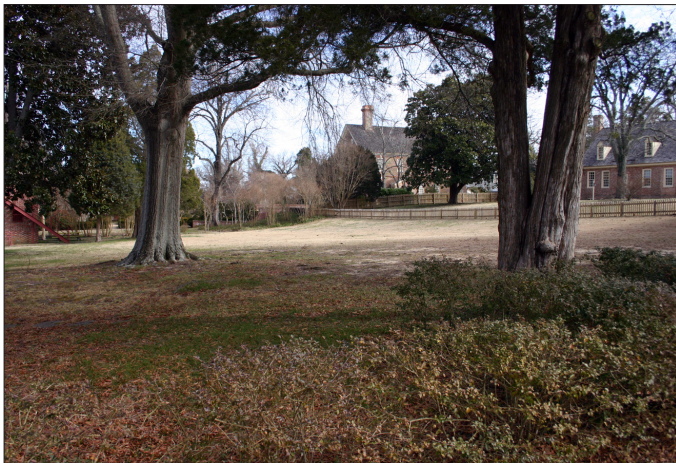
part of the lawn space is within the lots belonging to the Smith and Ballard Houses, which historically defined the eastern edge of the York Hall lawn. A wood paling fence without plantings delineates the colonial boundary of these two lots through the eastern third of the lawn (fig. 2.38).

Figure 2.38 (second from top). The lawn looking northeast from the service area and stable, January 2010. The picket fence divides the eastern part of the lawn along the boundary of the Smith and Ballard lots. (SUNY ESF.)

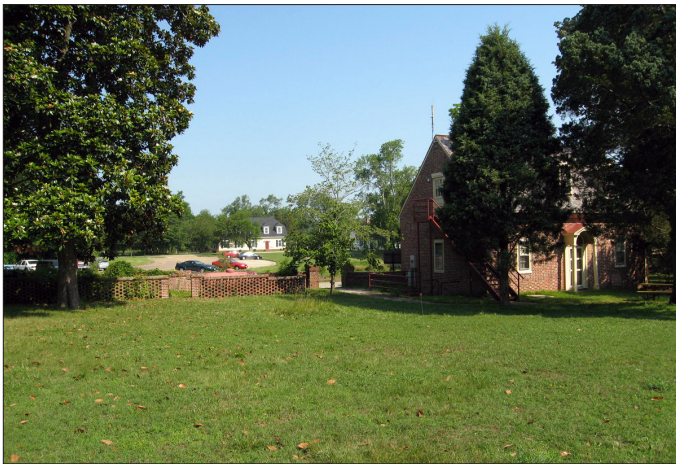
The York Hall garage, now known as the carriage house, was built in ca. 1916 to the design of Griffin and Wynkoop and houses a park ranger station and communications center. It is a three-bay, one-and-one-half story Colonial Revival-style brick building that faces inward toward the lawn (fig. 2.39). This façade has a residential character with a center entrance, classically-detailed entry porch, and flanking six-over-six sash windows. Three dormer windows line the wood-shingle gabled roof. The Read Street façade contains three garage bays with segmental arch openings with infill that replaced the original doors in ca. 1975 (fig. 2.40). An exterior steel staircase on the south side of the building leads to the second floor, and there is an antenna mounted on the chimney. The perimeter wall curves

Figure 2.39 (bottom left). The front of the carriage house (garage) looking northwest from the lawn, June 2007. At left is the lattice brick wall added by the park to screen utilities. In the background is the National Park Service parking lot. (SUNY ESF.)

inward around the apron to engage either end of the building. The park's central cooling units, screened by a lattice-bond brick wall added in ca. 1975, are south of the building along the perimeter wall (see fig. 2.39).

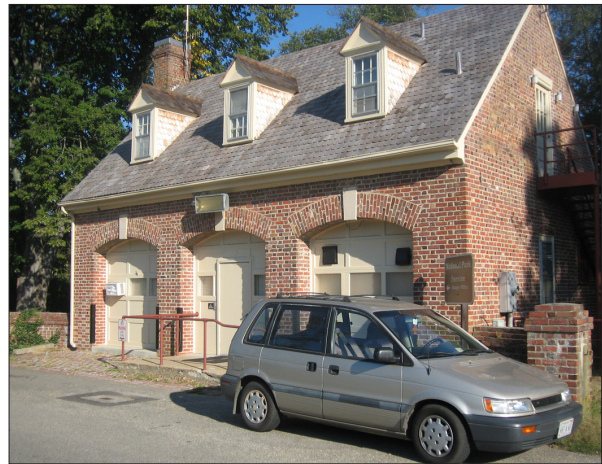
Figure 2.40 (bottom right). The Read Street side of the carriage house (garage) with curved sections of the adjoining perimeter wall, October 2007. (SUNY ESF.)

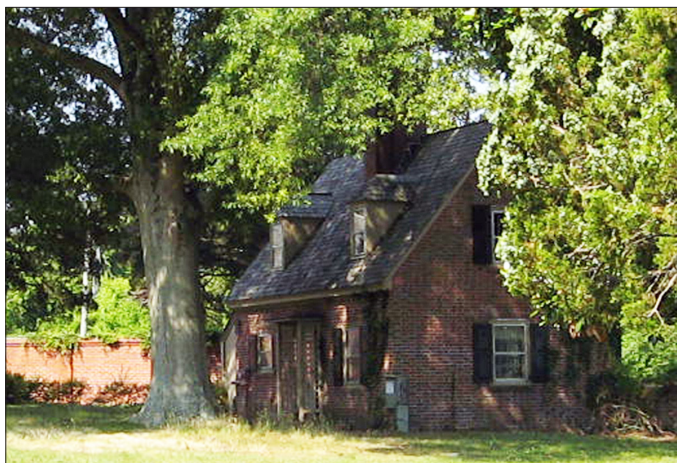
Figure 2.41 (top). The front of Wisteria Cottage looking southwest from the lawn, June 2007. The large tree is a willow oak dating to the York Hall estate. (SUNY ESF.)

Wisteria Cottage, built in ca. 1916 to the design of Griffin and Wynkoop as the gardener's cottage, is a three-bay one-and-one-half story Colonial Revival-style brick building that faces inward toward the lawn (fig. 2.41). This façade, shaded by a large willow oak, has a center door with a trellised entry porch and separate sidelight, and asymmetrical flanking casement and double-hung multi-paned windows with shutters. A frame shed-roof enclosed porch dating to the York Hall estate period shelters the service entrance on the south side. The Read Street façade, which is integral with the perimeter brick wall, contains three windows and no doors (fig. 2.42). The wood-shingled gable roof has hipped-roof dormers and a large corbelled offset-ridge chimney. There are presently no wisteria vines growing on the building.

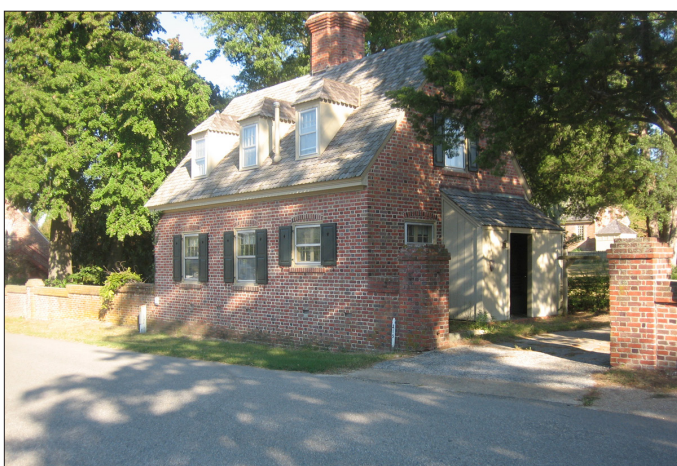
Figure 2.42 (above, bottom). The Read Street side of Wisteria Cottage looking northeast, October 2007. (SUNY ESF.)

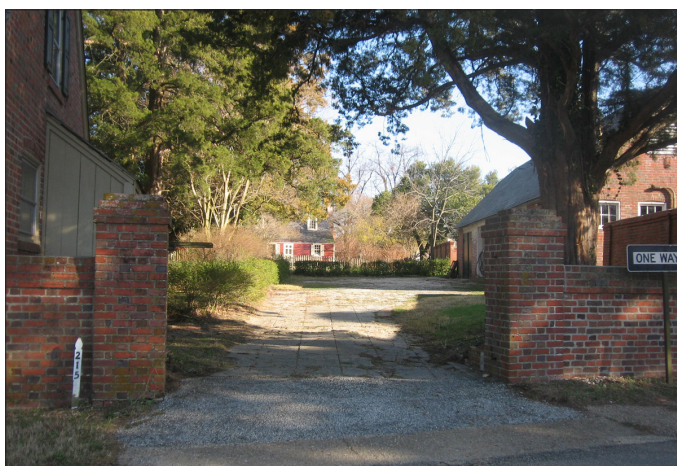
Figure 2.43. The entrance to the service area looking east from Read Street with the stable at right and Wisteria Cottage at left, March 2008. The red building in the background is the Ballard House. (SUNY ESF.)

The service area, developed as part of the York Hall estate beginning in ca. 1916 and part of the Nelson garden lots during the colonial era, occupies the south half of lot 50 and is screened from the lawn by shrubs and trees. The entrance to the service area is by a drive from Read Street flanked by brick pillars in the perimeter wall (fig. 2.43). The drive has an asphalt and concrete-block apron at the entrance and widens into a gravel surface along the front of the stable. A row of shrubs and trees, including a clipped privet hedge, crape-myrtle, deutzia, rose, Southern magnolia, and red-cedar, frames the north and east sides of the yard.

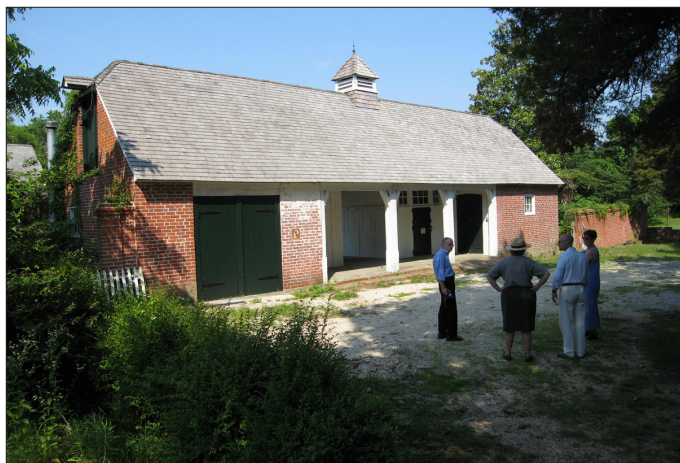
Built in ca. 1916 to the design of Griffin and Wynkoop, the stable is a one-story brick building that faces north toward the service drive and lawn

Figure 2.44 (top). The service drive and stable looking southwest, June 2007. Pictured are staff from the National Park Service and SUNY ESF. (SUNY ESF)

(fig. 2.44). It features a wood-shingled roof with clipped gables, hay mow, and a center ventilating cupola with a pyramidal roof. The front has stable doors in the east bay, and a recessed three-bay porch that contains a passage to the rear of the building. The rear wall is lit by four, six-light windows and contains movable doors on tracks that close off the center bays (fig. 2.45). To either side of stable are small yards enclosed by approximately 6-foot-high brick walls that are overgrown with Virginia creeper vines and vinca (fig. 2.46). Both yards are enclosed on the south side by serpentine walls and have openings in the north wall adjacent to the building. The east yard extends onto lot 54 (Ballard House lot).

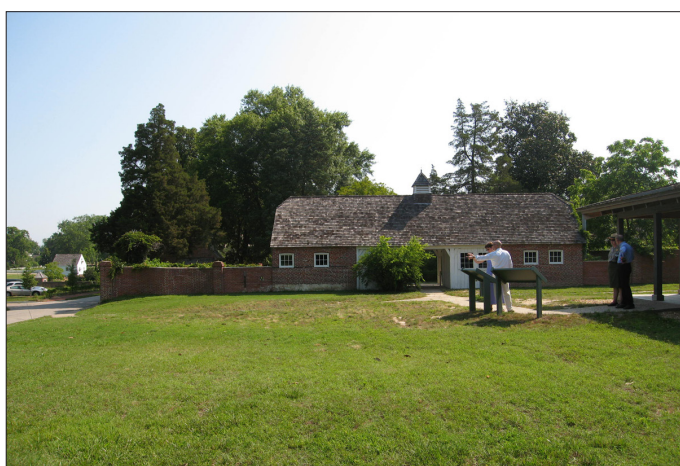
Figure 2.45 (middle). The stable looking north from the Poor Potter Site, June 2007. At right is the Poor Potter shelter. (SUNY ESF)

The mown ground south of the stable within lot 50 is managed as part of the Poor Potter Site on adjoining lots 51/51A (see fig. 2.45). This area was the site of the estate service yard that was replaced by a tennis court in 1936. A paved walk leads from the stable to the Poor Potter building.
