CULTURAL LANDSCAPE REPORT FOR THE NELSON HOUSE GROUNDS

COLONIAL NATIONAL HISTORICAL PARK
YORKTOWN, VIRGINIA

SITE HISTORY

EXISTING CONDITIONS

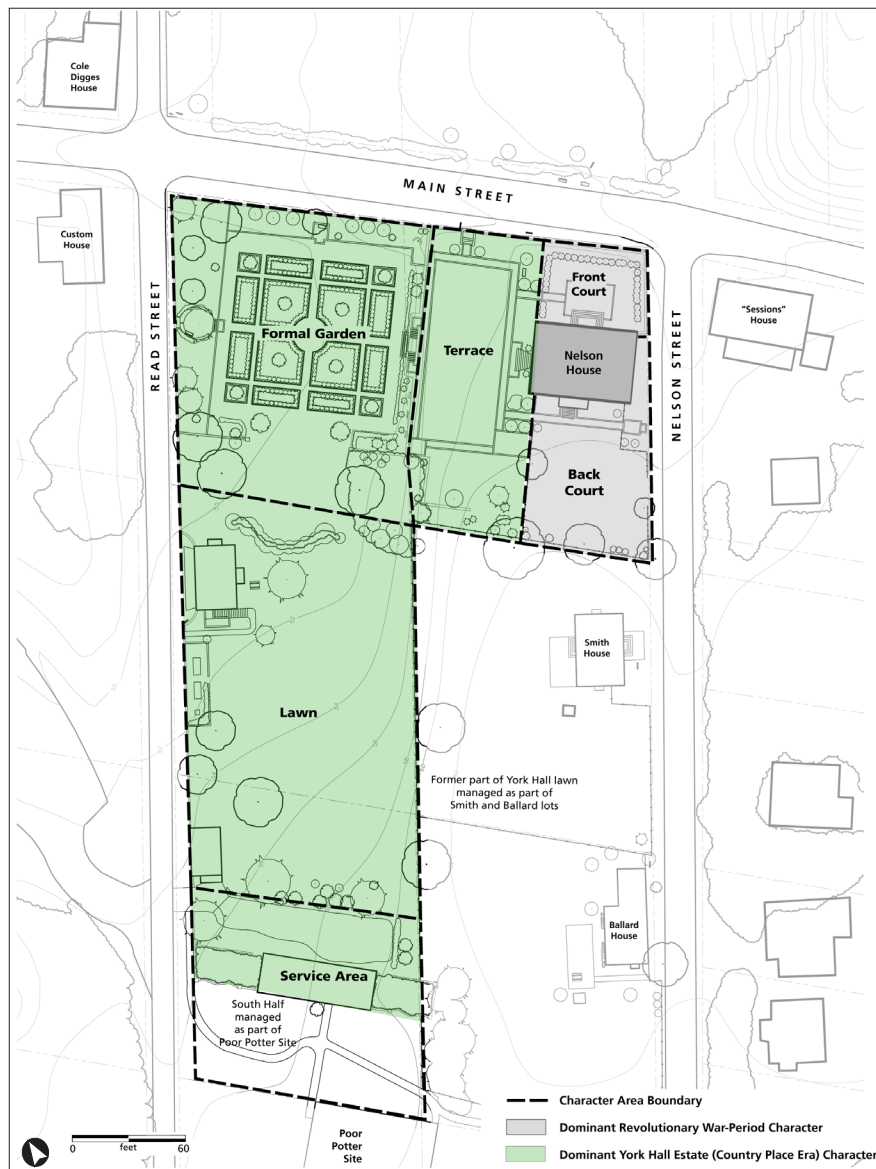
Figure 3.1. Plan of the Nelson House grounds showing dominant historic character in each of the character areas. For the purposes of the cultural landscape evaluation, Civil War-period character is the same as the Revolutionary War-period character (SUNY ESF.)

Overall, the historic character of the landscape from the Revolutionary War period is dominant in the front and back courts (see fig. 3.1). This is the result of National Park Service rehabilitation in the 1970s that removed most of the York Hall estate features from these areas. The historic character from the York Hall estate is dominant in the terrace, formal garden, lawn, and service area, except for the south half of the service area, which is now managed as part of the Poor Potter Site.

This is the landscape between the front of the Nelson House and Main Street (see fig. 3.1). Overall, the front court is a contemporary design that does not reflect the character of the Revolutionary War or Civil War landscape due to changes in grade and addition of the perimeter retaining wall. The Country Place Era-character of the front court is no longer evident due to loss of the ornamental pool, patio, tall perimeter hedge, and furnishings.

The back court is the landscape between the rear of the Nelson House and the boundary of the Smith House lot (see fig. 3.1). The narrow space between the east side of the Nelson House and Nelson Street is also included in this character area. Overall, the back court landscape is a contemporary park service design of open lawn, brick walks, and scattered trees that reflects a lack of documentation necessary to accurately restore its Revolutionary War-period character.

The terrace is the area between the west side of the Nelson House and the formal garden, and from Main Street south to near the Smith House lot boundary (see fig. 3.1). Overall, the terrace retains the character of the York Hall landscape despite modifications to its circulation and vegetation by the National Park Service.

The formal garden is the landscape bounded by the perimeter wall along Main and Read Streets, the terrace, and the lawn (see fig. 3.1). Overall, the formal

The lawn is the area bounded by the formal garden to the north, the service area to the south, the perimeter wall and outbuildings along Read Street to the west, and the fence along the Smith and Ballard lots to the east (see fig. 3.1). The east half of the lawn from the York Hall estate is presently managed as part of the Smith and Ballard lots. Overall, the lawn retains the character of the York Hall landscape despite modifications to its spatial organization and circulation.

The service area is the landscape to the south and north of the stable, bounded by the lawn to the north, Read Street to the west, the Ballard House lot to the east, and the Poor Potter Site to the south (see fig. 3.1). Overall, the service area retains the character of the York Hall landscape, except for the portion south of the stable, historically the estate service yard, that is presently managed as part of the Poor Potter Site.

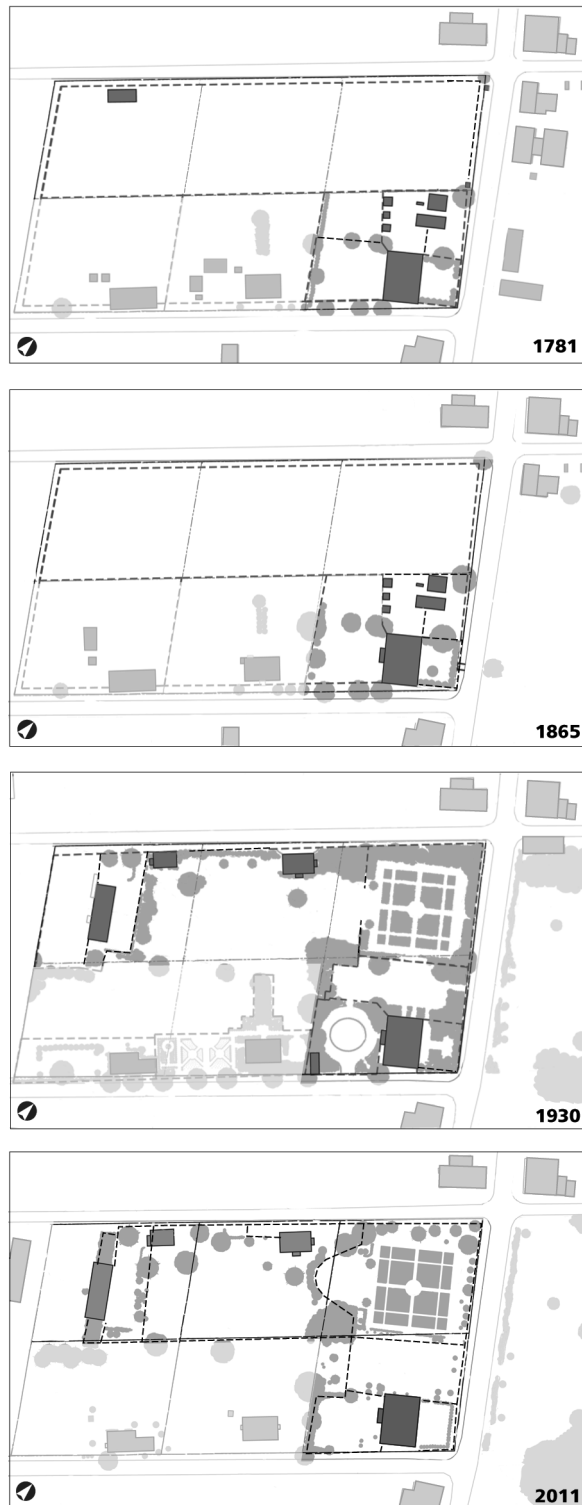
Figure 3.2. Changes in spatial organization within the Nelson House grounds from the end of the historic periods to the present. Gray shading indicates planted areas, and dashed lines show the limits of major spaces. The area outside of the Nelson House grounds is masked. (SUNY ESF)

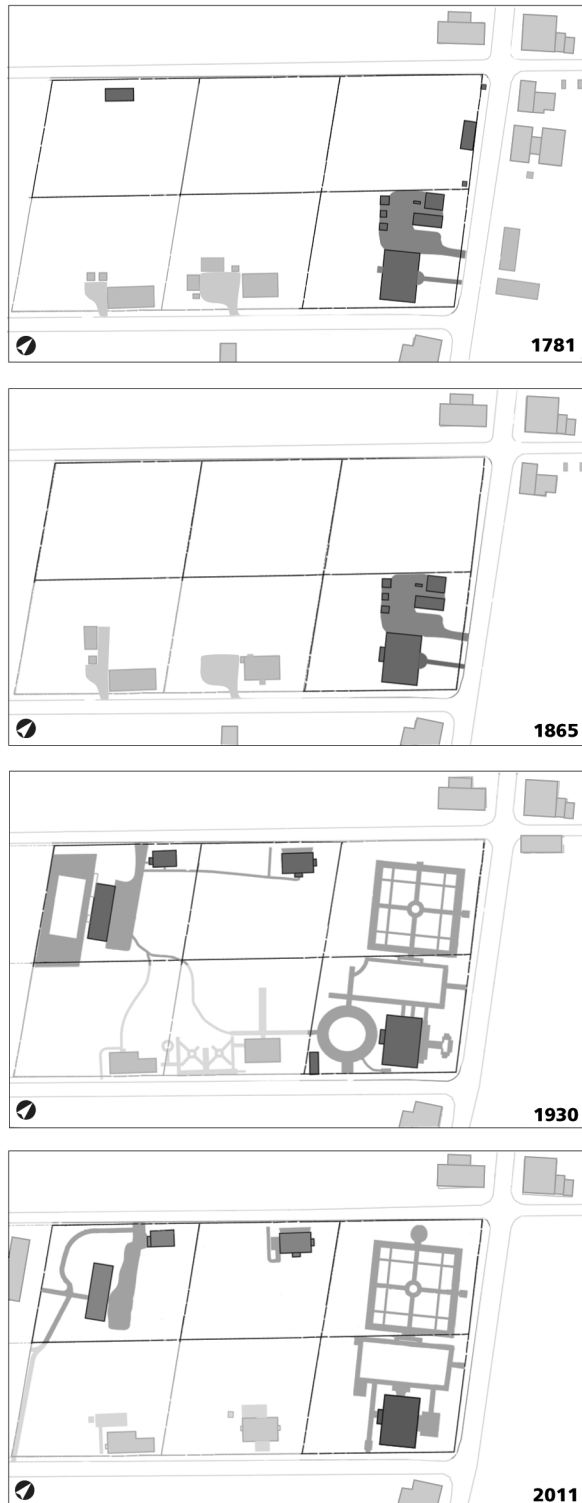
Existing circulation within the Nelson House grounds is characteristic of the York Hall estate period and the non-historic park service period (fig. 3.3). During the Revolutionary War and Civil War periods, formal circulation within the grounds was limited to an axial walk from the front entrance of the Nelson House to Main Street and a service drive to the yard west of the house. If the site had a formal garden (most likely in the back court), there may have been garden walks. Informal

Figure 3.3. Changes in circulation within the Nelson House grounds from the end of the historic periods to the present. The area outside of the Nelson House grounds is masked. (SUNY ESF.)

During the York Hall estate period, circulation was completely redesigned according to plans by Charles Gillette. The old front entrance walk, which remained through ca. 1921, was replaced by a new entrance off Main Street from the terrace, and a walk and patio were built in its place. A set of orthogonal walks bordered the terrace at the site of the old Nelson yard and led down a double flight of steps to grass walks within the formal garden. Access to the garage, Wisteria Cottage, and stables from the house and garden was by a series of informal, winding stepping-stone paths. Two drives, both designed for automobiles, were built into the property: a formal oval entrance drive at the back court off Nelson Street and a utilitarian service drive to the service area off Read Street.

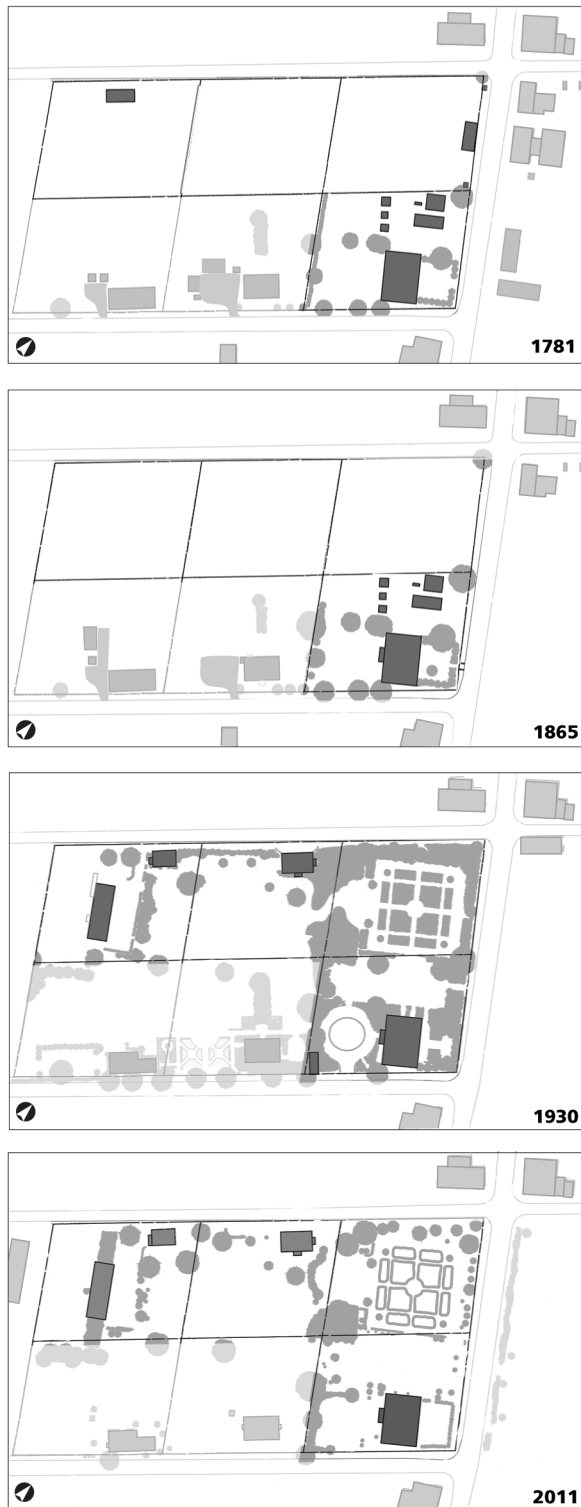
Existing vegetation on the Nelson House grounds is characteristic of the York Hall estate period and the non-historic park service period (fig. 3.4). The Country Place Era character is evident in large-scale vegetation in the formal garden, lawn, and service area. The remaining vegetation with the exception of the front court

Figure 3.4. Changes in vegetation within the Nelson House grounds from the end of the historic periods to the present. The area outside of the Nelson House grounds is masked. (SUNY ESF.)

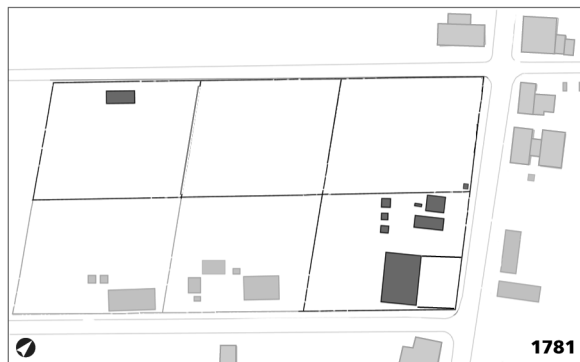
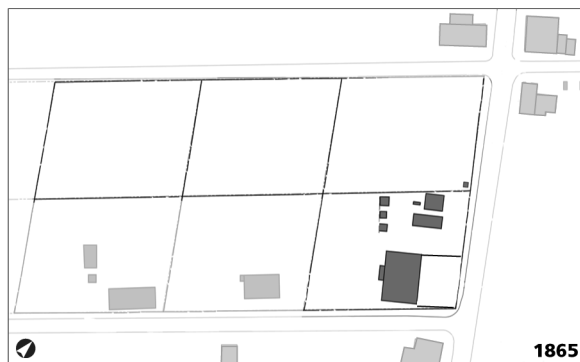
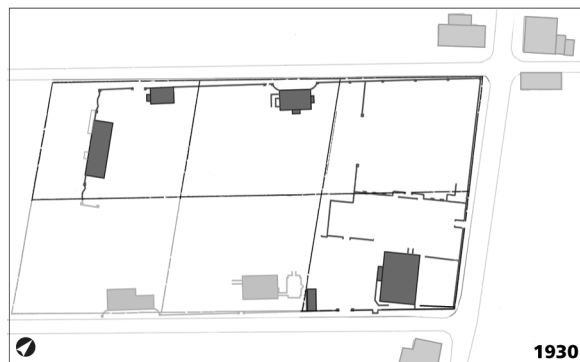
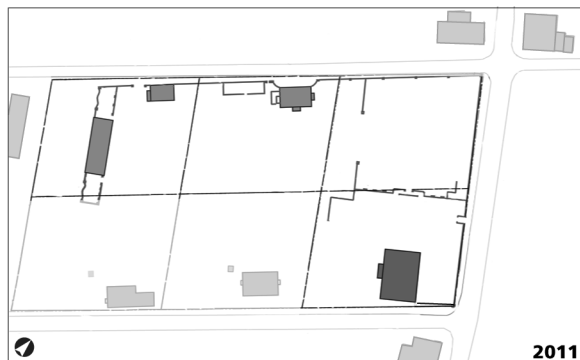
Existing buildings and structures on the Nelson House grounds are characteristic of the Revolutionary War, Civil War, and York Hall estate periods (fig. 3.5). The Nelson House, the second house on the property built in ca. 1730, has remained the most prominent building in the landscape. It is a two-story, Georgian-style brick house measuring approximately 70 feet across the front and 50 feet on the sides. During the Revolutionary War period, it adjoined a complex of five service buildings built around the same time as the house in ca. 1730. The largest of these was the combination kitchen–wash house on the north side of the yard approximately 27 feet west of the house and closer to Main Street. It was a one-story frame building on a brick foundation measuring approximately 40 by 20 feet,

Figure 3.5. Changes in buildings and structures within the Nelson House grounds from the end of the historic periods to the present. Buildings are gray and solid lines indicate walls. The area outside of the Nelson House grounds is masked. (SUNY ESF.)

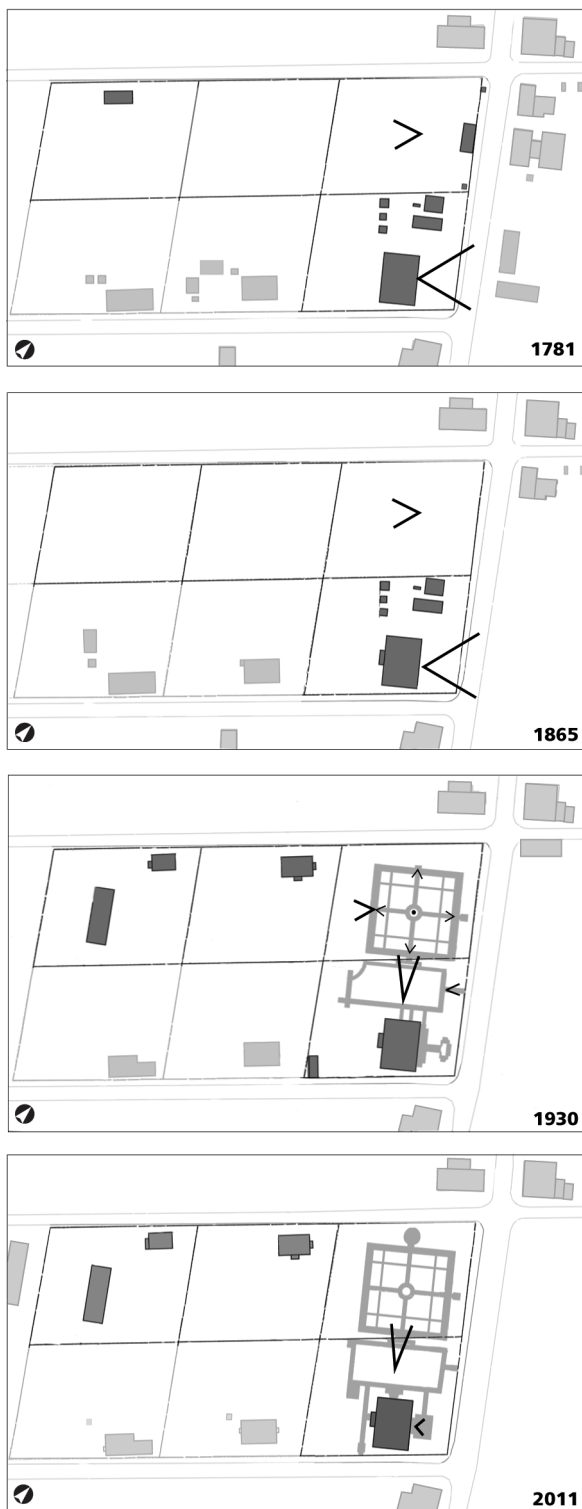
Hall estate periods (fig. 3.6). During the Revolutionary War, the open landscape surrounding the house, including the garden lots, provided views across the site and surrounding village landscape, except where blocked

Figure 3.6. Changes in views within the Nelson House grounds from the end of the historic periods to the present. The V-shaped lines indicate the direction and breadth of view. The area outside of the Nelson House grounds is masked. (SUNY ESF)

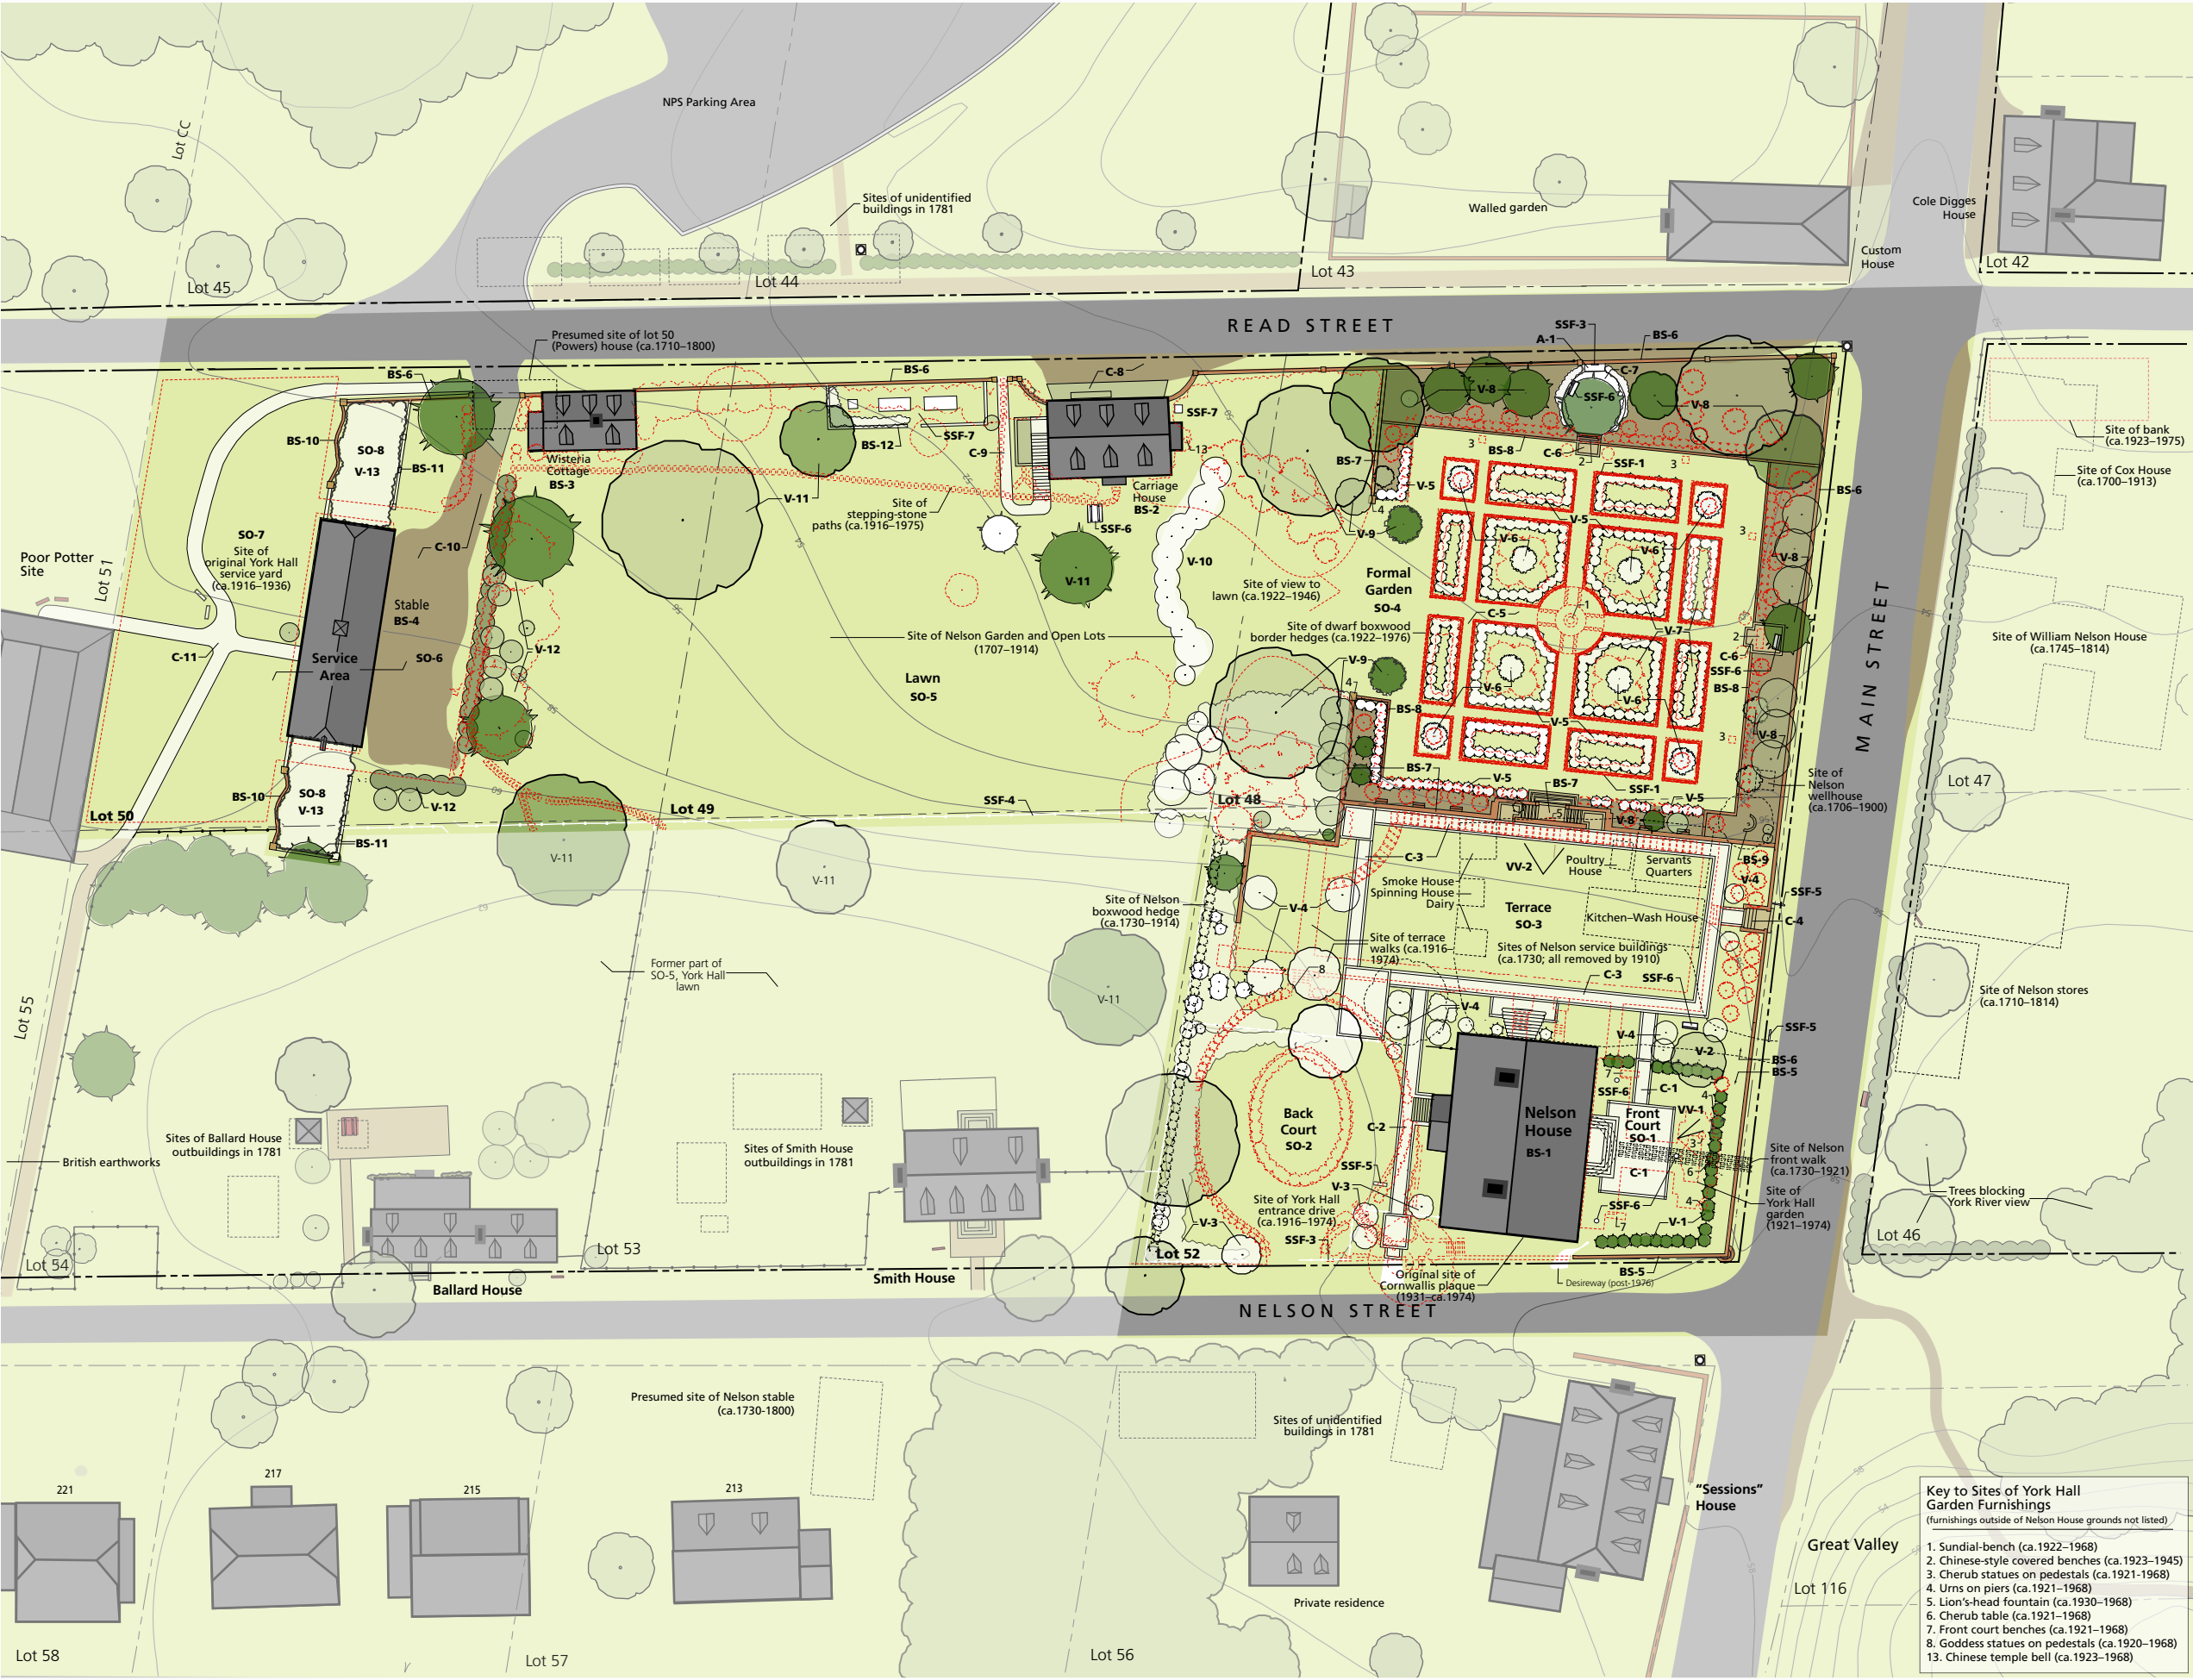
Drawing 3.0

Table 3.2 at the end of the chapter provides a summary of the feature evaluations organized by characteristic. All evaluated landscape features are labeled on the analysis and evaluation plan (drawing 3.0), which contrasts historic (contributing) and non-historic features, and also locates character-defining features lost since the historic periods. Photographs of the existing landscape are in chapter 2.
