CULTURAL LANDSCAPE REPORT FOR THE BATTERY WEED HEADLAND

FORT WADSWORTH
GATEWAY NATIONAL RECREATION AREA
STATEN ISLAND, NEW YORK

Olmsted Center for Landscape Preservation
National Park Service, Boston, Massachusetts, 2008

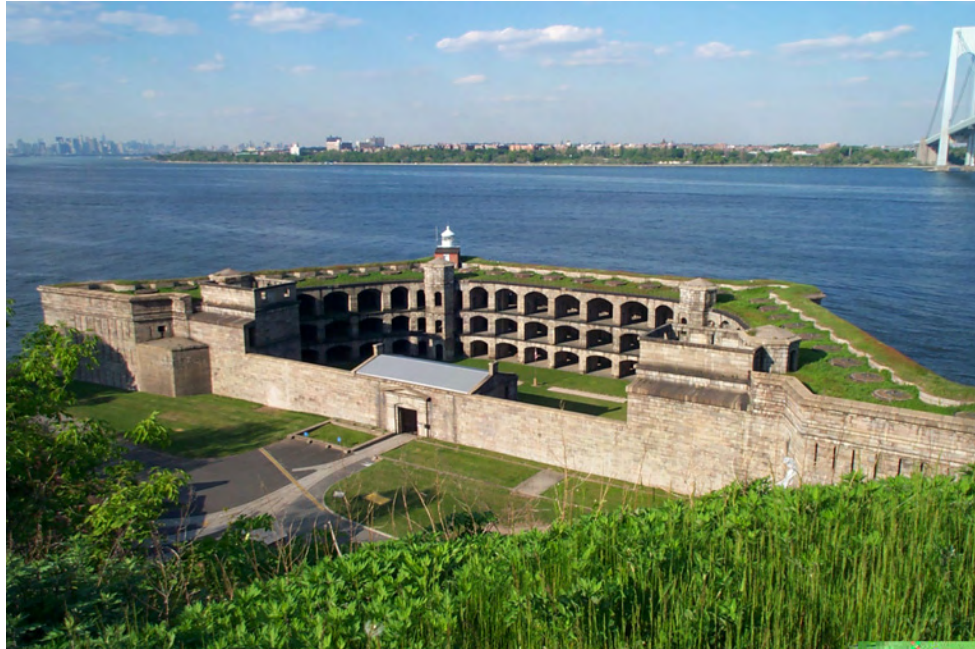
Figure 0.1: Overview of Battery Weed looking northeast in 2006 across the Narrows toward Brooklyn with Manhattan in the distant upper left and the Verrazano-Narrows Bridge on the right. State University of New York College of Environmental Science and Forestry (SUNY ESF).

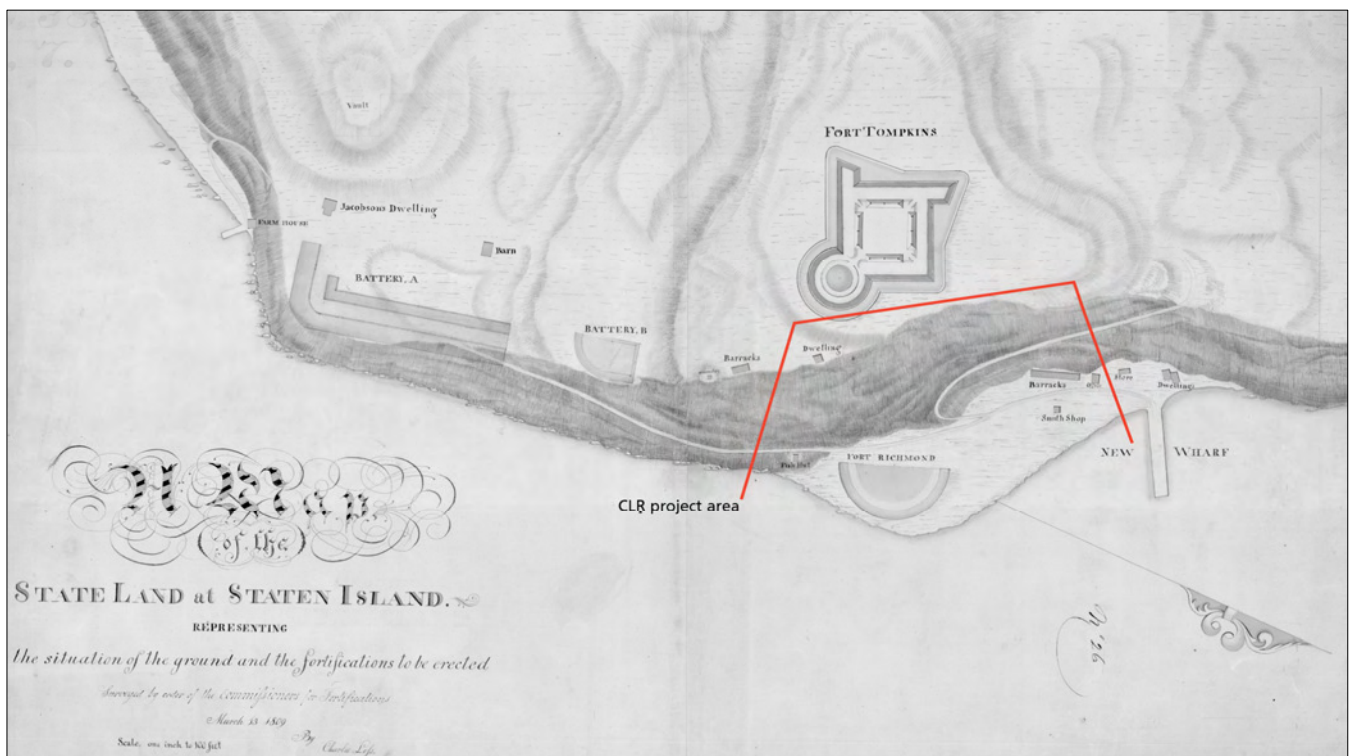
Figure 1.10: Charles Loss, "Map of the State Land at Staten Island Representing the situation of the ground and the fortifications to be erected," March 13, 1809. While the fortifications had not yet been built, the plan does not clearly indicate existing and proposed construction. Farmhouses, dwellings, and barns most likely were preexisting. RG 77, Dr 36, Sht. 17, Cartographic Division, National Archives II, College Park, Maryland, annotated by SUNY ESF.

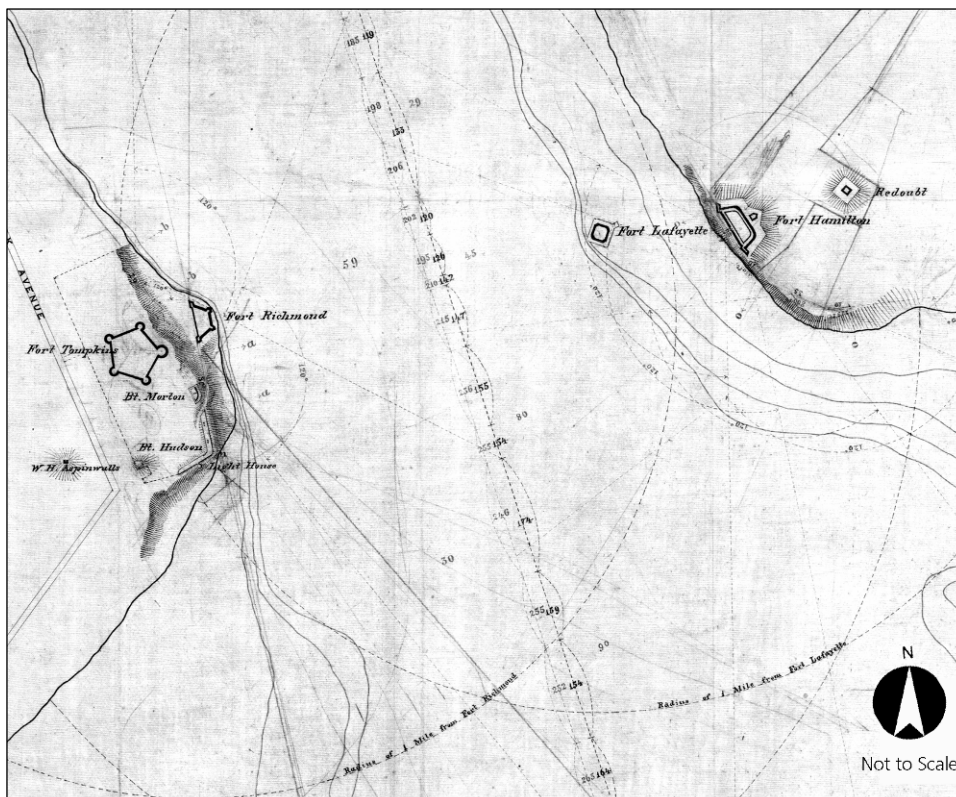
Figure 1.22: An 1857 plan showing the context of the new Fort Richmond as part of a system of fortifications in the Narrows. The old Fort Tompkins had not yet been replaced. RG 77, Dr 36, Sht. 65, Cartographic Division, National Archives II, College Park, Maryland, annotated by SUNY ESF.

With federal refortification of the Narrows that began with the construction of the new Fort Richmond in 1847, the landscape began to shift from its romantic, ruined character in the preceding decades since the end of the war with Britain, to a highly engineered, manicured appearance. The landscape during this time also became an integral part of a larger system of defenses designed by General Joseph G. Totten. The headland was carefully engineered to coordinate not only its site-specific conditions, but also a network of fortifications, particularly those on the opposite side of the channel on Long Island: Fort Lafayette as Fort Richmond’s water-level counterpart, and Fort Hamilton as Fort Tompkins’ upper-level counterpart.²¹ (Figure 1.22)

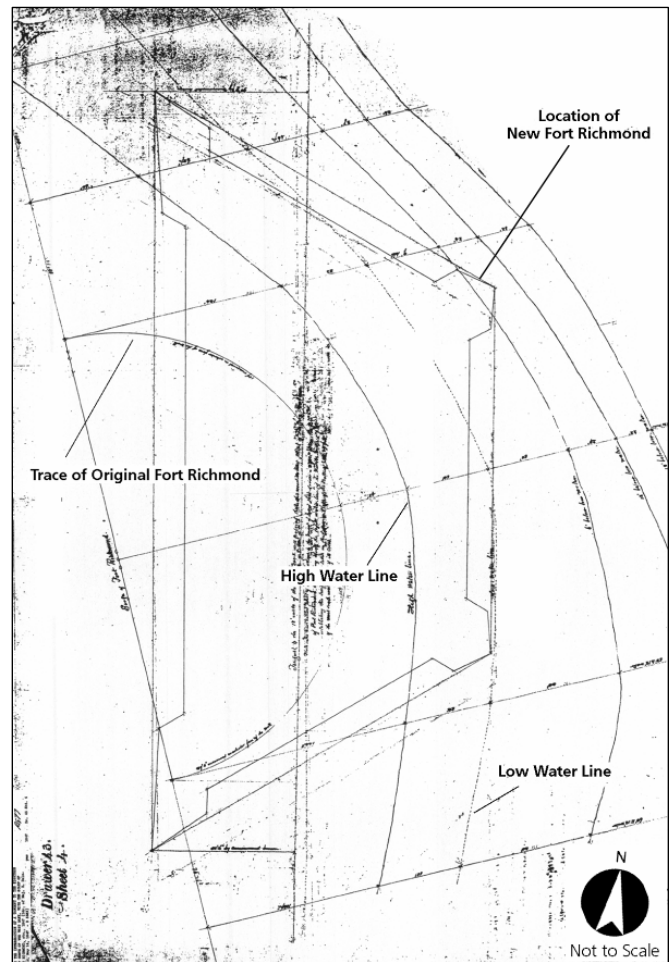
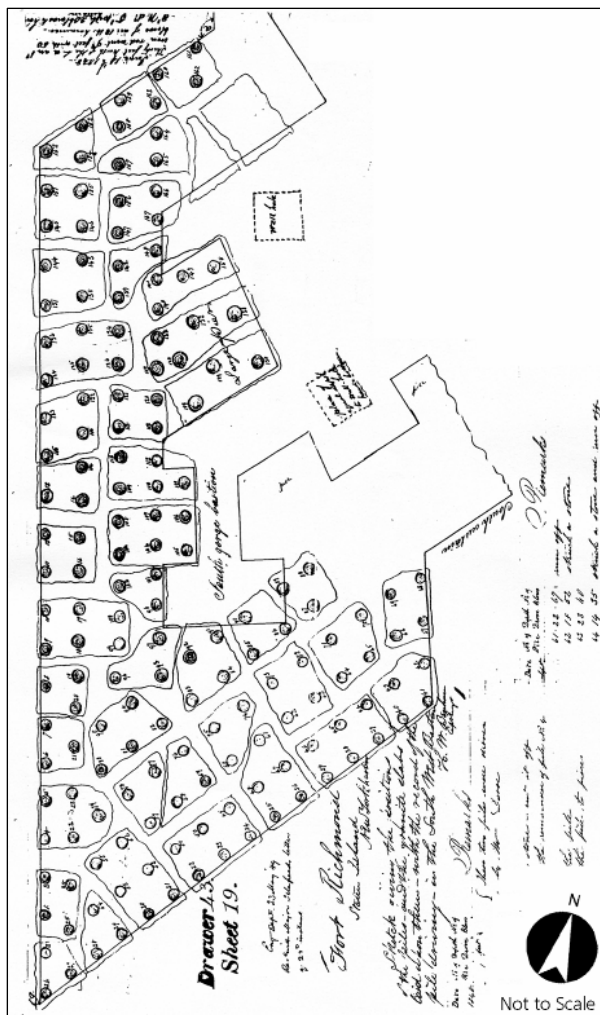
Figure 1.24: An 1849 plan showing arrangement and progress of the wood piles and the large granite slabs set upon them at the southwest bastion. This structure formed the foundation of the new Fort Richmond. The text consists of construction notes. RG 77, Dr 43, Sht. 19, Cartographic Division, National Archives II, College Park, Maryland, annotated by SUNY ESF.

location, the stone structure was built on a network of wooden piles driven into the earth that supported granite foundation slabs. (Figure 1.24)

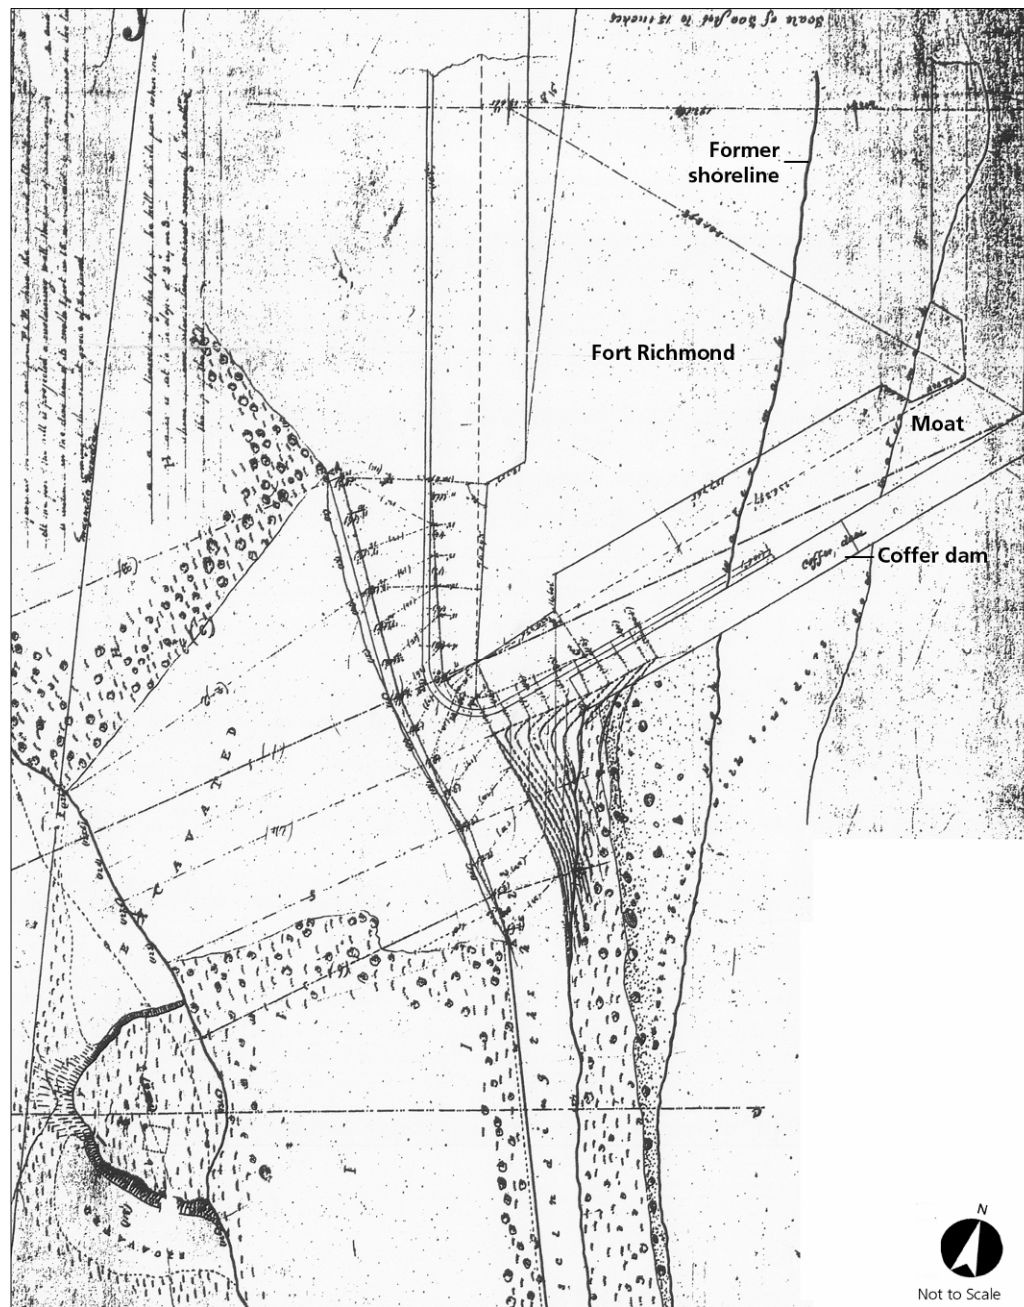
Figure 1.25: Plan titled "Sketch of the ground adjoining the south west salient of Fort Richmond (Staten Island) and the hill with a proposed wall to sustain the foot of the its slope," 1848. The plan shows the proposed graded portion of the bluff above the southwest bastion of the new Fort Richmond. RG 77, Dr 43, Sht. 12, Cartographic Division, National Archives II, College Park, Maryland, annotated by SUNY ESF

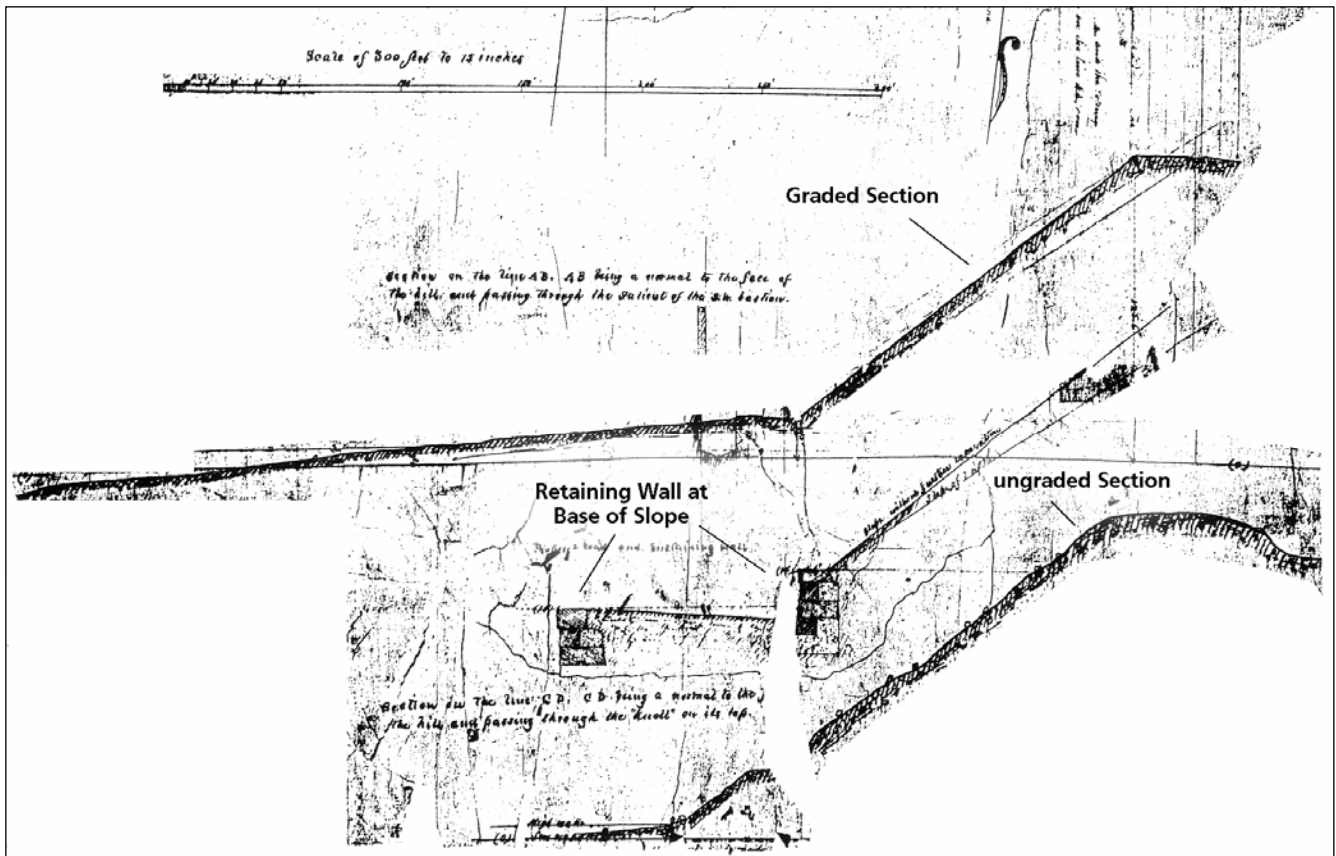
Figure 1.26: Two sections taken across the slope above the new Fort Richmond showing the existing slope and the area to be graded, 1848. The drawing also shows the planned retaining wall to be constructed at the base of the graded area. RG 77, Dr 43, Sht. 12, Cartographic Division, National Archives II, College Park, Maryland, annotated by SUNY ESF.

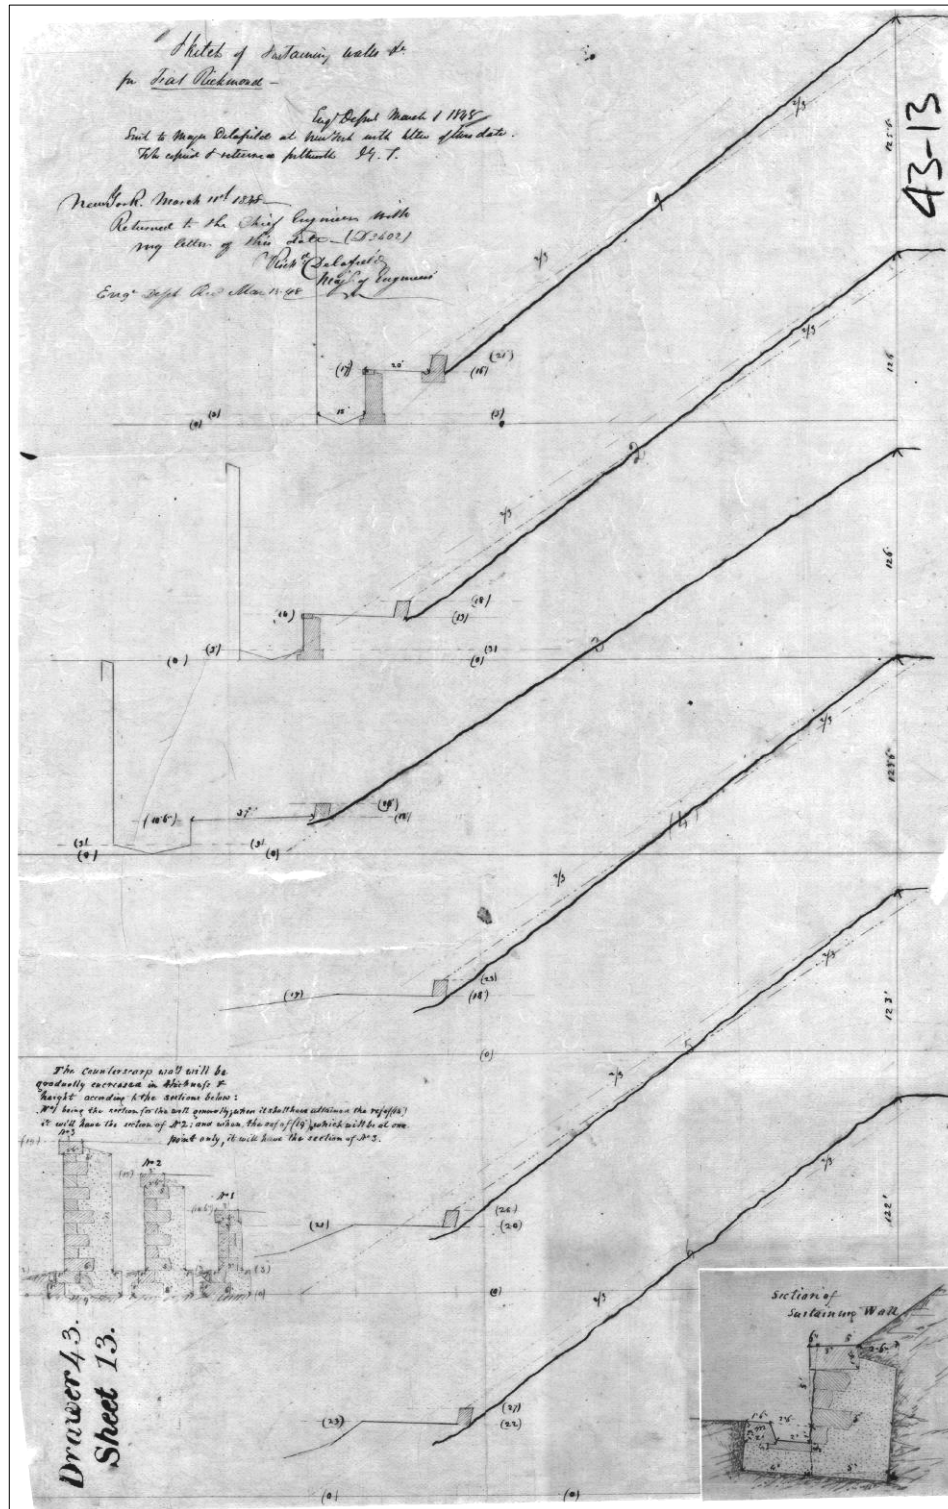
Figure 1.27: Section drawings made in 1848 looking south across the southwest bastion showing proposed grading of the bluff into an engineered slope. The plan gradually increased the thickness and height of the counterscarp (retaining) wall at the base of the slope along the road. The section at the lower right corner shows a detail section of the retaining wall and gutter. RG 77, Dr 43, Sht. 13, Cartographic Division, National Archives II, College Park, Maryland.

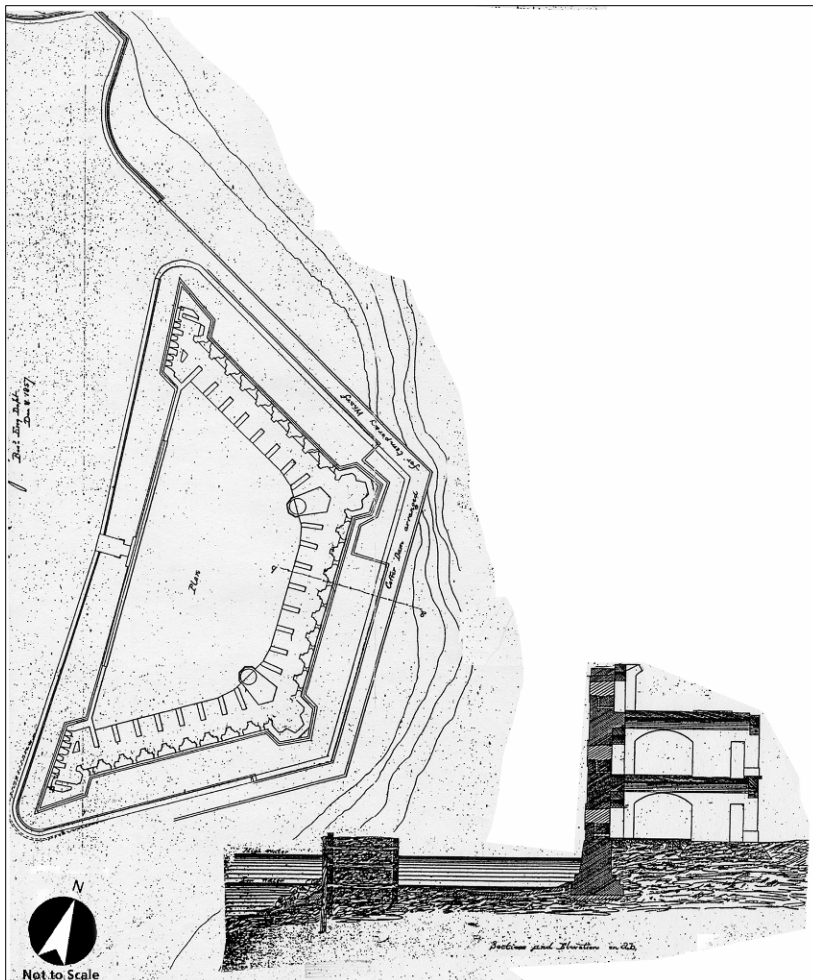
Figure 1.29: Plan and section drawings made in 1857 showing the moat and cobbled timber cofferdam to the east of the fortress built to allow construction of the permanent stone seawall. Note that the dock has not yet been built at the bulkhead visible at the top of the drawing. RG 77, Dr 43, Sht. 46, Cartographic Division, National Archives II, College Park, Maryland, annotated by SUNY ESF.

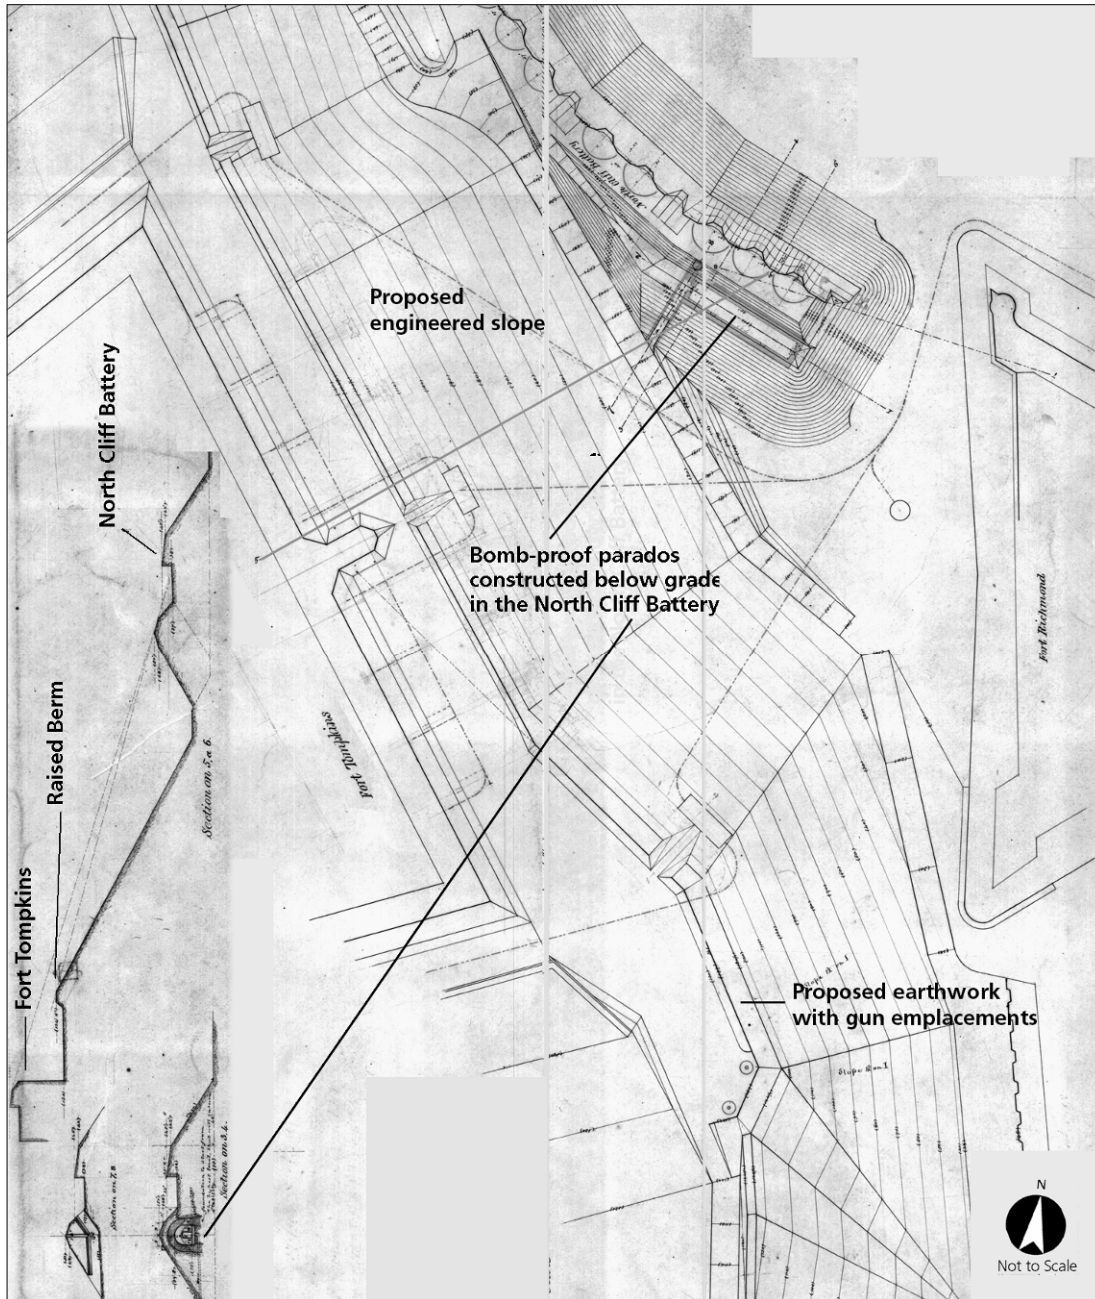
Figure 1.32: Detail of a plan and sections drawn made in c.1863 showing the location of North Cliff Battery with below grade bomb-proof parados in relationship to Fort Richmond (Battery Weed) and Fort Tompkins, realignment of roads, and removal of the support buildings at the base of the bluff. The plan also shows proposed grading of the bluff, and an earthwork with gun emplacements at the top of the bluff. This work was not completed until after the Civil War. RG 77, Dr 41, Sht. 55, Cartographic Division, National Archives II, College Park, Maryland, annotated by SUNY ESF.

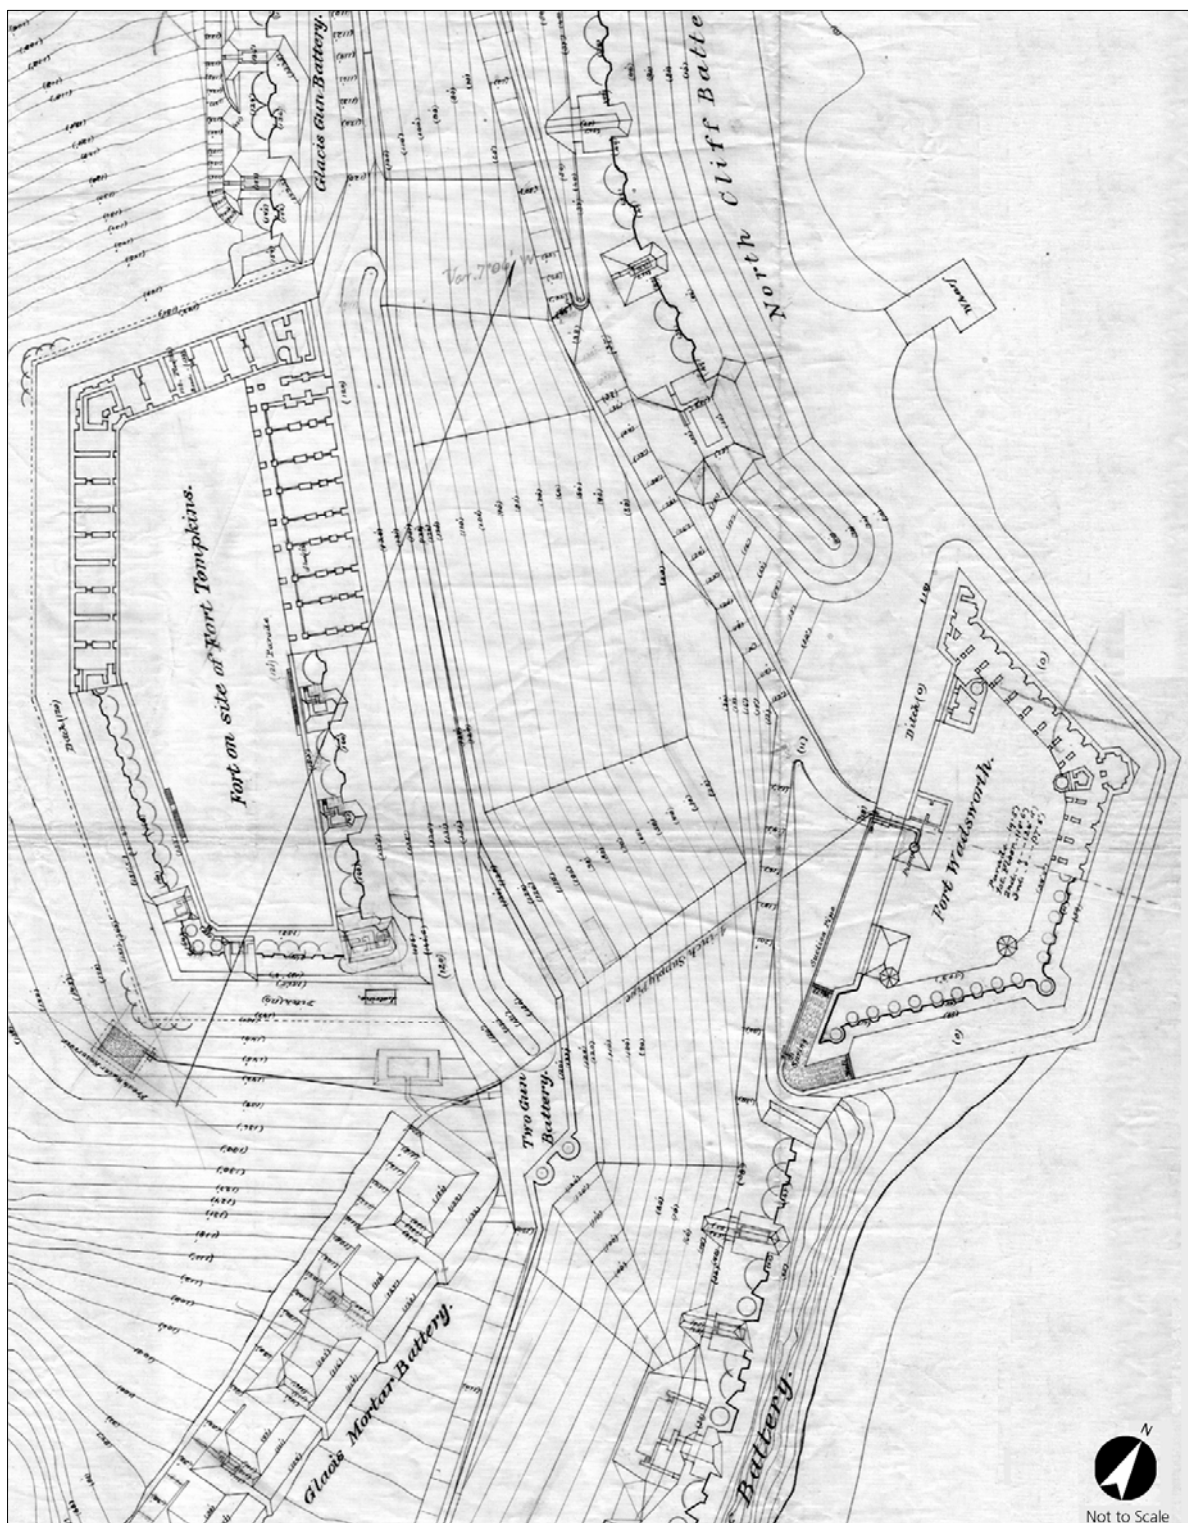
Figure 1.36: Plan drawn in 1886 documenting the landscape of the Battery Weed headland at it had developed through the end of the Third System period following extensive grading work during the 1870s. Documented on the plan are Fort Wadsworth (Battery Weed) and dock (wharf), flanking North and South Cliff Batteries, the engineered slope, earthwork and two gun batteries at the top of the slope below the new Fort Tompkins. The plan was still watered in 1885 prior to completion of this plan. RG 77, Dr 41, Sht. A, Cartographic Division, National Archives II, College Park, Maryland, annotated by SUNY ESF.

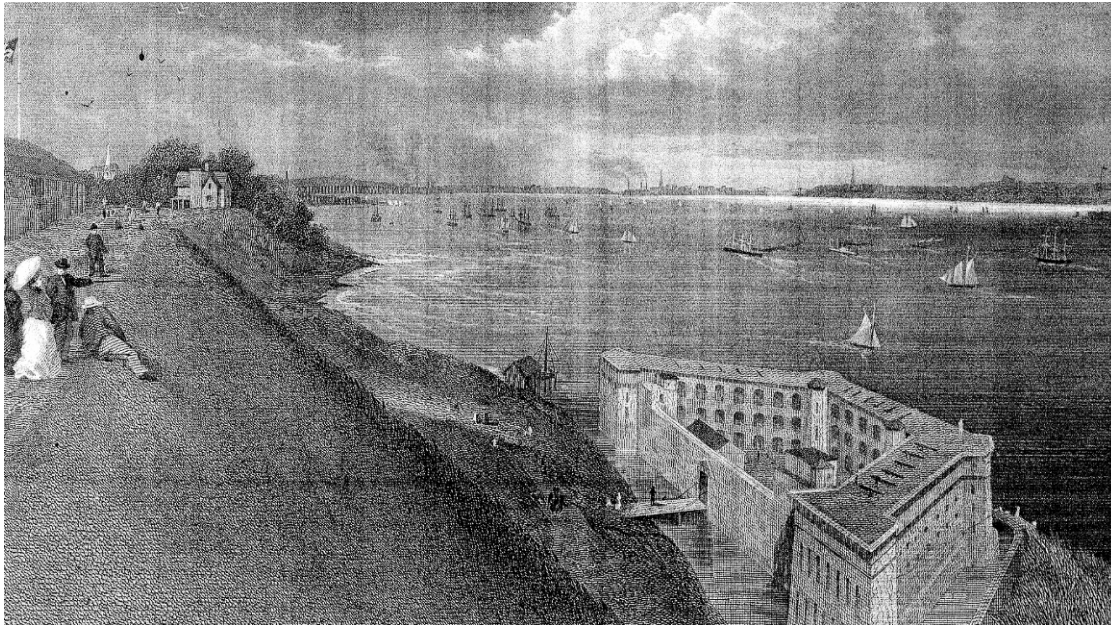
Figure 1.37: Drawing made in c.1880 looking north from the overlook above Fort Wadsworth (Battery Weed) depicting the treeless engineered slope completed in c.1873. The etching also shows the water-filled moat with its drawbridge into the fort interior. Department of Prints, Photographs and Architectural Collections, Image PR 020, Box 1-Staten Island, Waterfront Views, New-York Historical Society, New York New York.

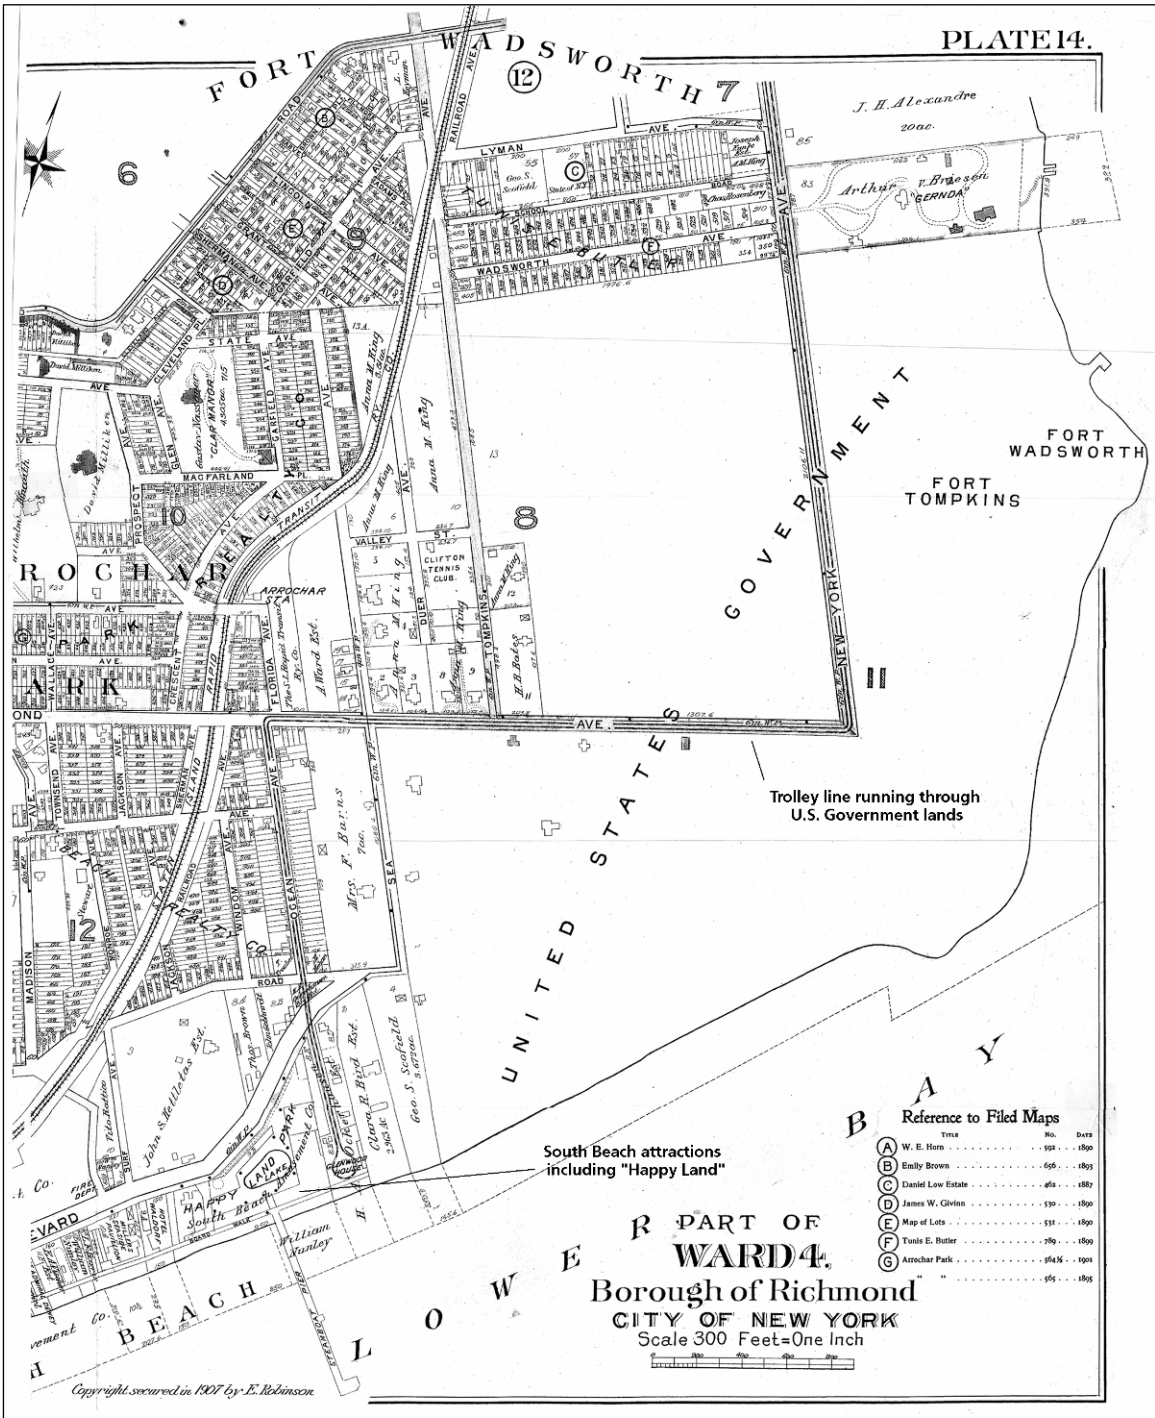
Figure 1.39: Detail of a 1907 atlas of Staten Island showing trolley and railway lines, street-car suburban development, and some remnant country estates surrounding Fort Wadsworth. Collection of the Staten Island Institute of Arts & Sciences, annotated by SUNY ESF.

While regular ferry service to Manhattan continued throughout this period, the shift in the island's transportation network came with the first railroad bridge to New Jersey completed in 1889. The increasing use of automobiles further spurred development and connections to New Jersey, with three bridges to Staten Island opening between 1928 and 1931.¹ Within the island, transportation improvements included a street-car trolley started in 1886, which began at St. George on the northeastern shore of Staten Island, ran south on New York Avenue, and turned west on Richmond Avenue within the military reservation. (Figure 1.39) Here, riders could get off to walk the short distance to the bluff above the Narrows to take in the panoramic views of New York Harbor, or continue to the end of the line at South Beach, a short distance from Fort Wadsworth.² A separate dedicated rail line, the Staten Island Rapid Transit Railway, was built prior to 1907 running roughly parallel to the trolley line (see Figure 1.39).

These changes in transportation and increasing industrialization during the late nineteenth and early twentieth centuries led to continual residential growth, with street-car suburbs replacing many of the former large country estates in the vicinity of the Narrows. The population of Staten Island gained nearly 100,000 people between 1900 and 1930, when it totaled 158,346. Much of this growth was concentrated on the northern side of the island, while the central and southern portions remaining sparsely developed. By the first decade of the twentieth century, the area to the north and west of the military reservation was largely small-lot residential neighborhoods, with a few remnant country estates remaining on larger lots (see Figure 1.39).

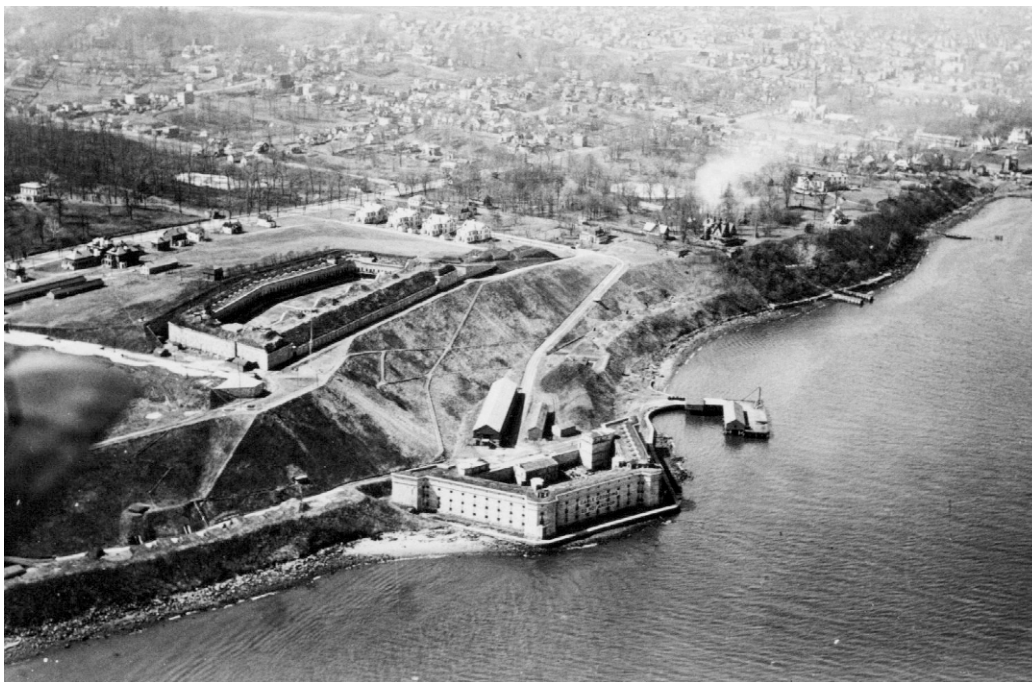
Figure 1.43: An aerial photograph taken in 1923 looking northwest across the Narrows showing the setting of the Battery Weed headland within Fort Wadsworth and adjoining residential neighborhoods that made it a popular recreational spot. This photograph clearly shows the officers' housing along New York and Mount Sec Avenues, earthen batteries, the engineered slope with walks, the north dock with buildings, and open spatial character of the headland. Photograph 19397, Gateway National Recreation Area Archives, Fort Wadsworth.

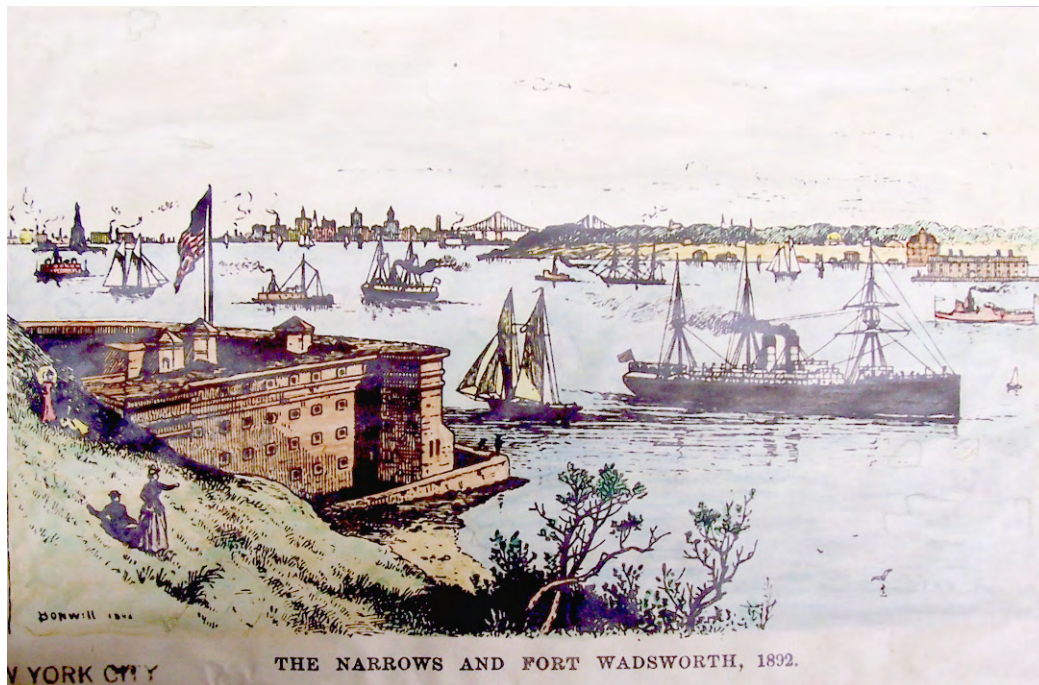
Figure 1.44: Etching published in 1892 depicting the park-like use of the landscape surrounding Fort Wadsworth (Battery Weed) during the early years of the Endicott period. Collection of the Harbor Defense Museum, Fort Hamilton, New York.

As the military redevelopment of the headland got underway in the late 1880s, the landscape continued to be a popular place for visitors to take in the spectacular views of the harbor from the grassy slope above the fortress, despite the earlier grading and removal of nearly all trees. (Figure 1.44) A drawing made eight years later indicates not only the public park-like use of the landscape, but also visitors' enjoyment of the inactive guns, which served not only as benches for reading a newspaper, but even as a children's play ground. (Figure 1.45) Between 1887 and 1892, the Army built three walks extending from the overlook down the steep slope to Battery Weed.¹⁶ (Figure 1.46) While the original intent of these walks is not known, they were probably used by visitors who would have enjoyed a changing panorama of the harbor scene as they descended down the switchbacks. The walks may also have had a military function, to allow personnel to bypass the mine railway at the base of the slope that was begun in c.1887. The walks extended to the south and north of a proposed building for the storage and processing of torpedoes.

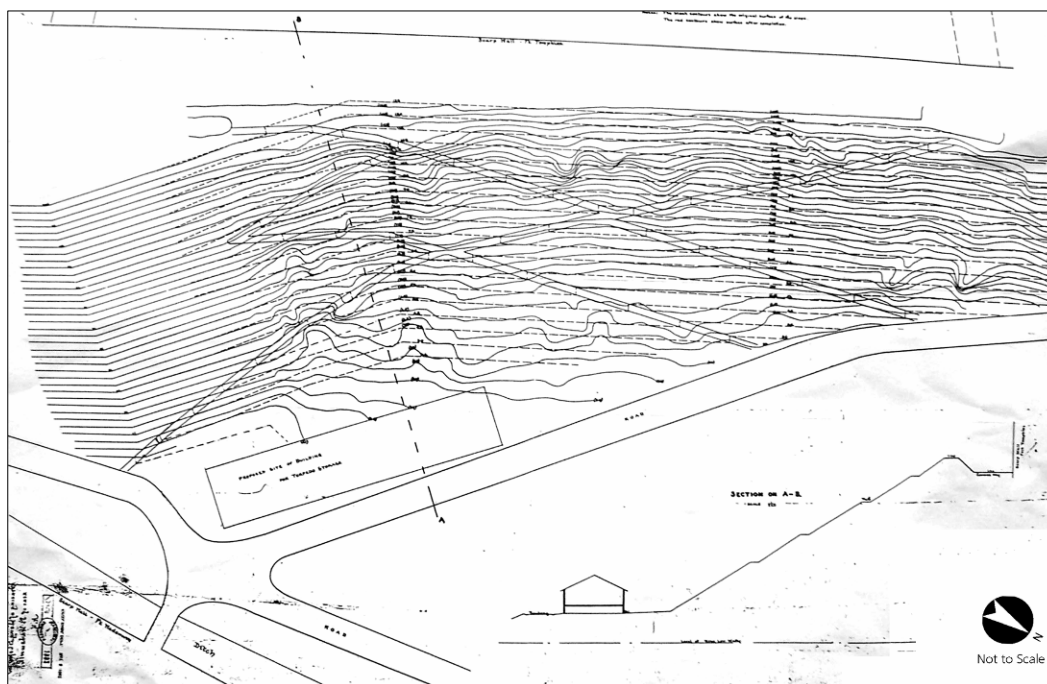
Figure 1.46: Detail of an 1892 survey illustrating the diagonal walks built after 1886 on the engineered slope, showing route that extends to either side of the proposed Torpedo Storage Building at the base of the slope. The plan also shows the former natural contours prior to grading in c.1873. RG 77, Dr 43, 90-2, 1892, Cartographic Division, National Archives II, College Park, Maryland, annotated by SUNY ESF.

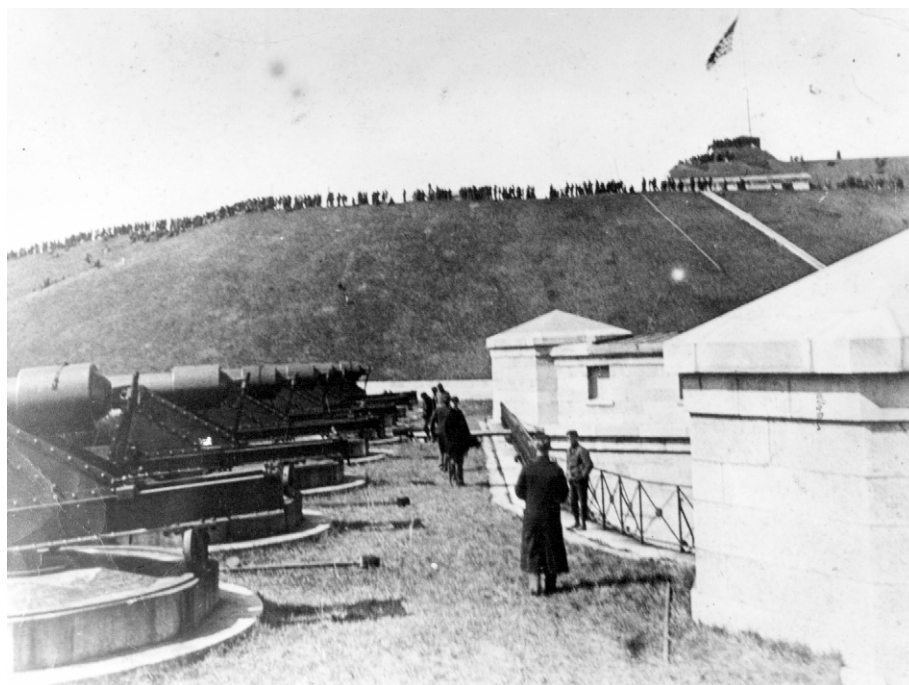
Figure 1.47: A photograph taken in 1890 looking southwest toward Fort Tompkins showing the barbette tier of Fort Wadsworth (Battery Weed) with its rotating guns still in place. The objects below the guns are rammers used to load munitions. Uncatalogued photograph, Gateway National Recreation Area Archives, Fort Wadsworth.

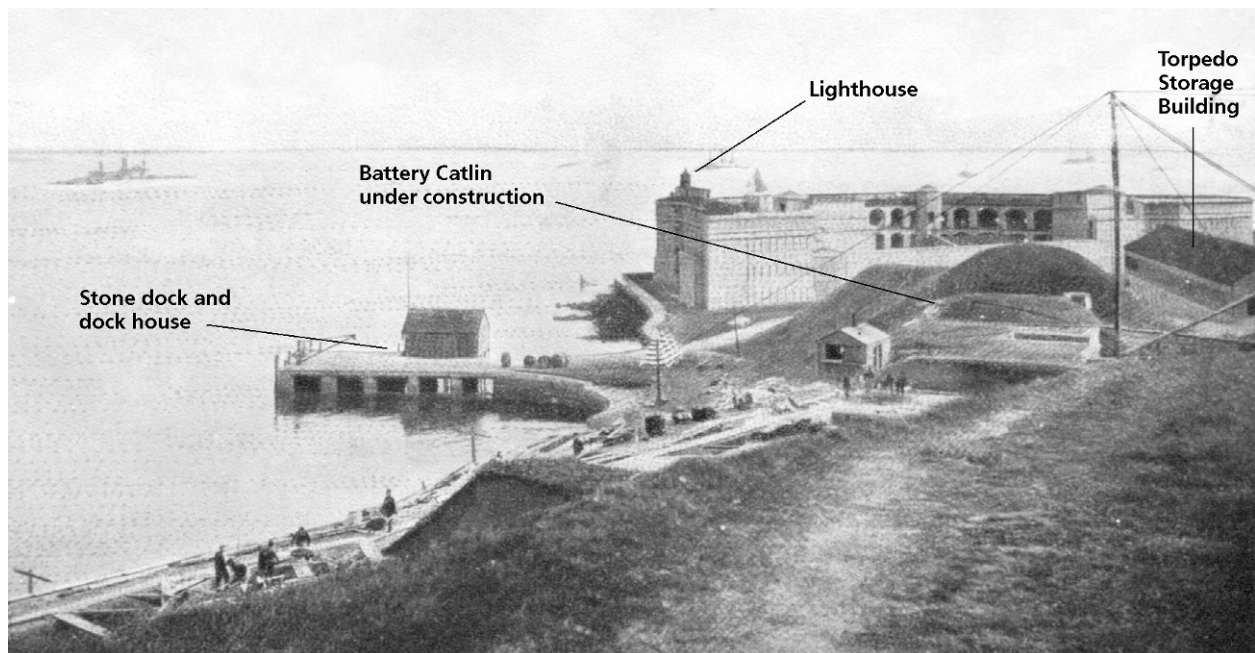
Figure 1.49: Photograph taken in c.1905 looking southeast showing the lighthouse completed on Battery Weed in 1903, and Battery Catlin and the second mine casemate under construction, including large earth mounds and concrete platforms. Photograph 19362, Gateway National Recreation Area Archives, Fort Wadsworth, annotated by SUNY ESF.

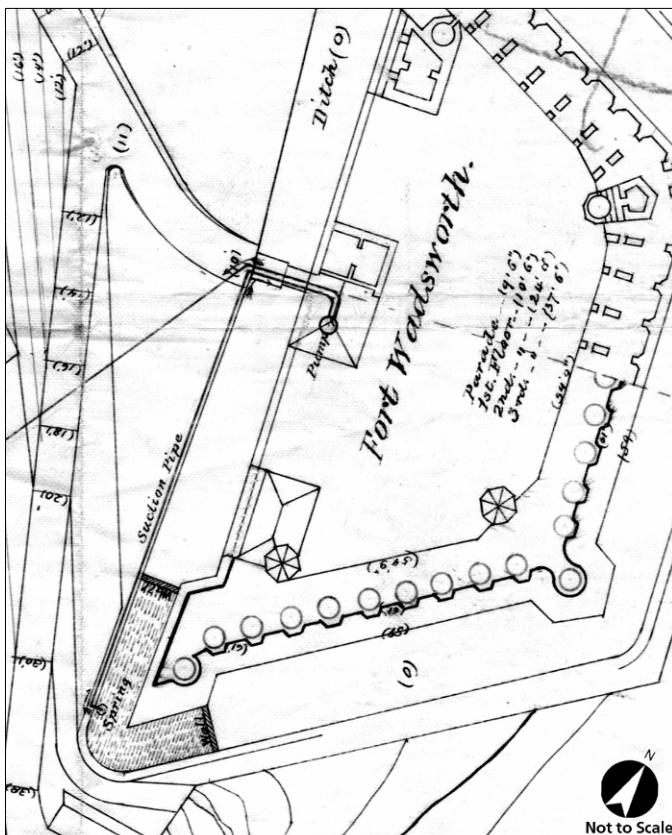
Figure 1.51: Detail of the 1886 plan (Figure 1.36) illustrating the dewatered moat (noted as "Ditch" on plan) and reservoir created at the southwest bastion of Fort Wadsworth (Battery Weed). Water was carried from a suction pipe along the moat wall to a pump in the guardhouse. These changes to the moat were probably the first steps in development of the mine defense system. RG 77, Dr 41, Sht. A, Cartographic Division, National Archives II, College Park, Maryland, annotated by SUNY ESF.

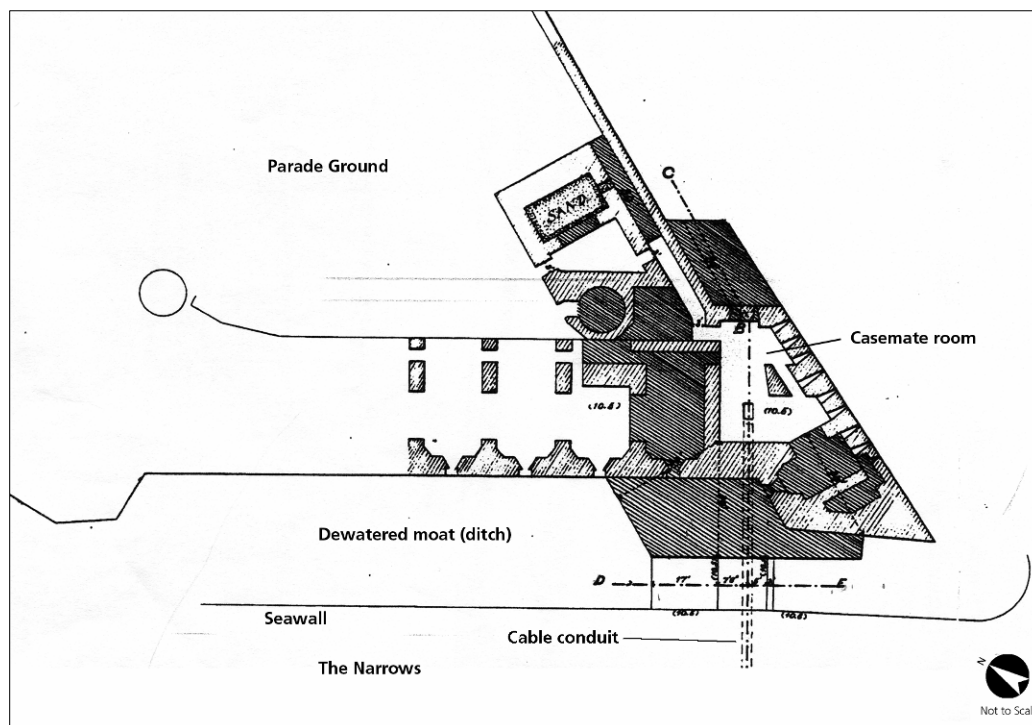
Figure 1.52: Detail of a c.1887 plan showing the first mine casemate located within the northwest bastion and adjoining dewatered moat of Battery Weed. RG 77, Dr 36, Sht. 100-5, Cartographic Division, National Archives II, College Park, Maryland, annotated by SUNY ESF.

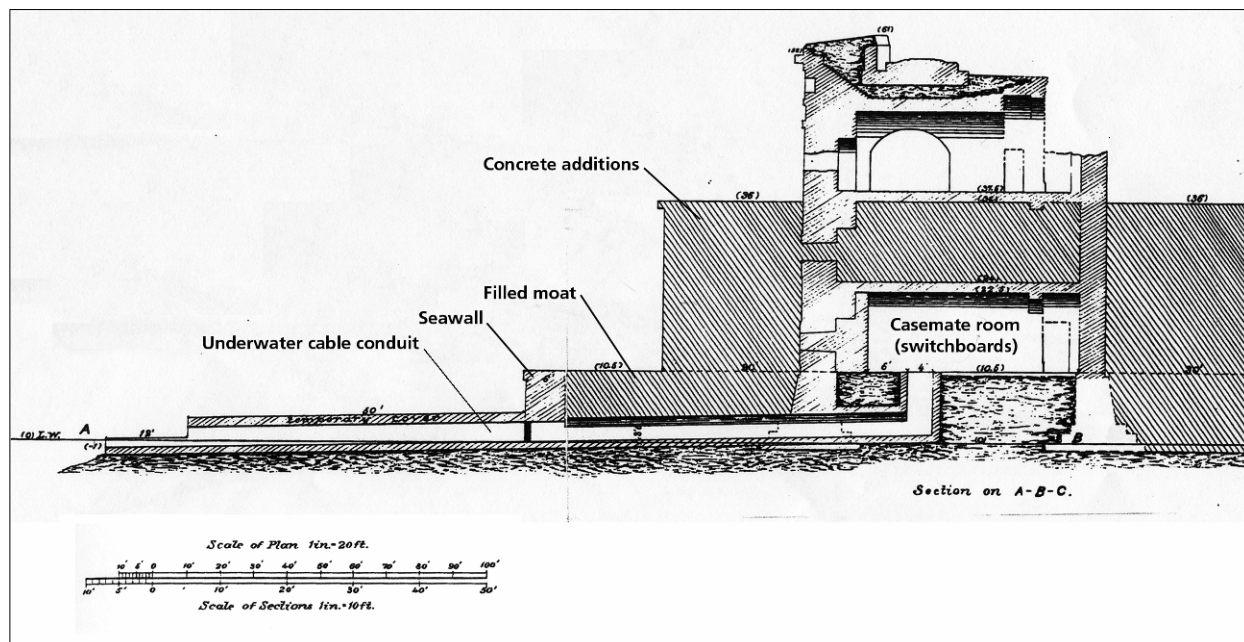
Figure 1.53: Section drawing accompanying plan view (Figure 1.52) showing the concrete additions (hatched areas) built around the original granite bastion within the dewatered moat, and the cable conduit that extended into the Narrows. RG 77, Dr 36, Sht. 100-5, 1887, Cartographic Division, National Archives II, College Park, Maryland, annotated by SUNY ESF.
