CULTURAL LANDSCAPE REPORT FOR THE BATTERY WEED HEADLAND

FORT WADSWORTH
GATEWAY NATIONAL RECREATION AREA
STATEN ISLAND, NEW YORK

Olmsted Center for Landscape Preservation
National Park Service, Boston, Massachusetts, 2008

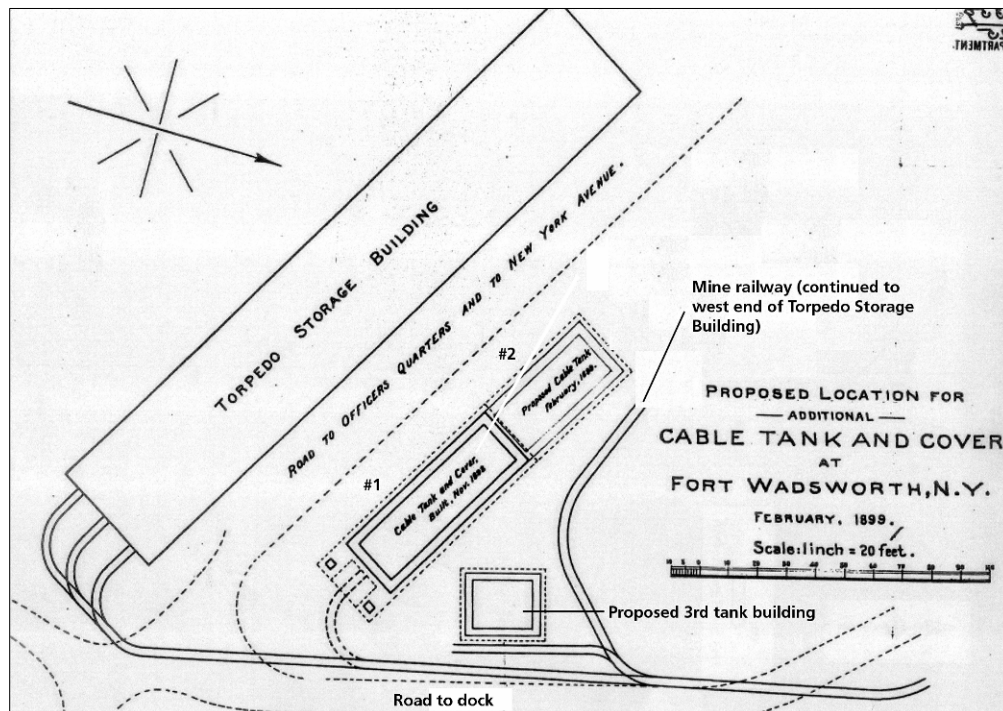
Figure 1.55: Detail of a plan made in 1899 showing the existing cable tank building (#1) built in 1898 and a proposed second cable tank building that was constructed soon after the plan was drawn. The plan also indicates the location of a third cable tank building. National Archives, reproduced from Ingrid Wuebber and Edward M. Morin, "Phase 1A Archeological Investigation Rehabilitate Battery Weed Seawall and Dock" (Unpublished report prepared for the National Park Service by URS Corporation, 2006), annotated by SUNY ESF.

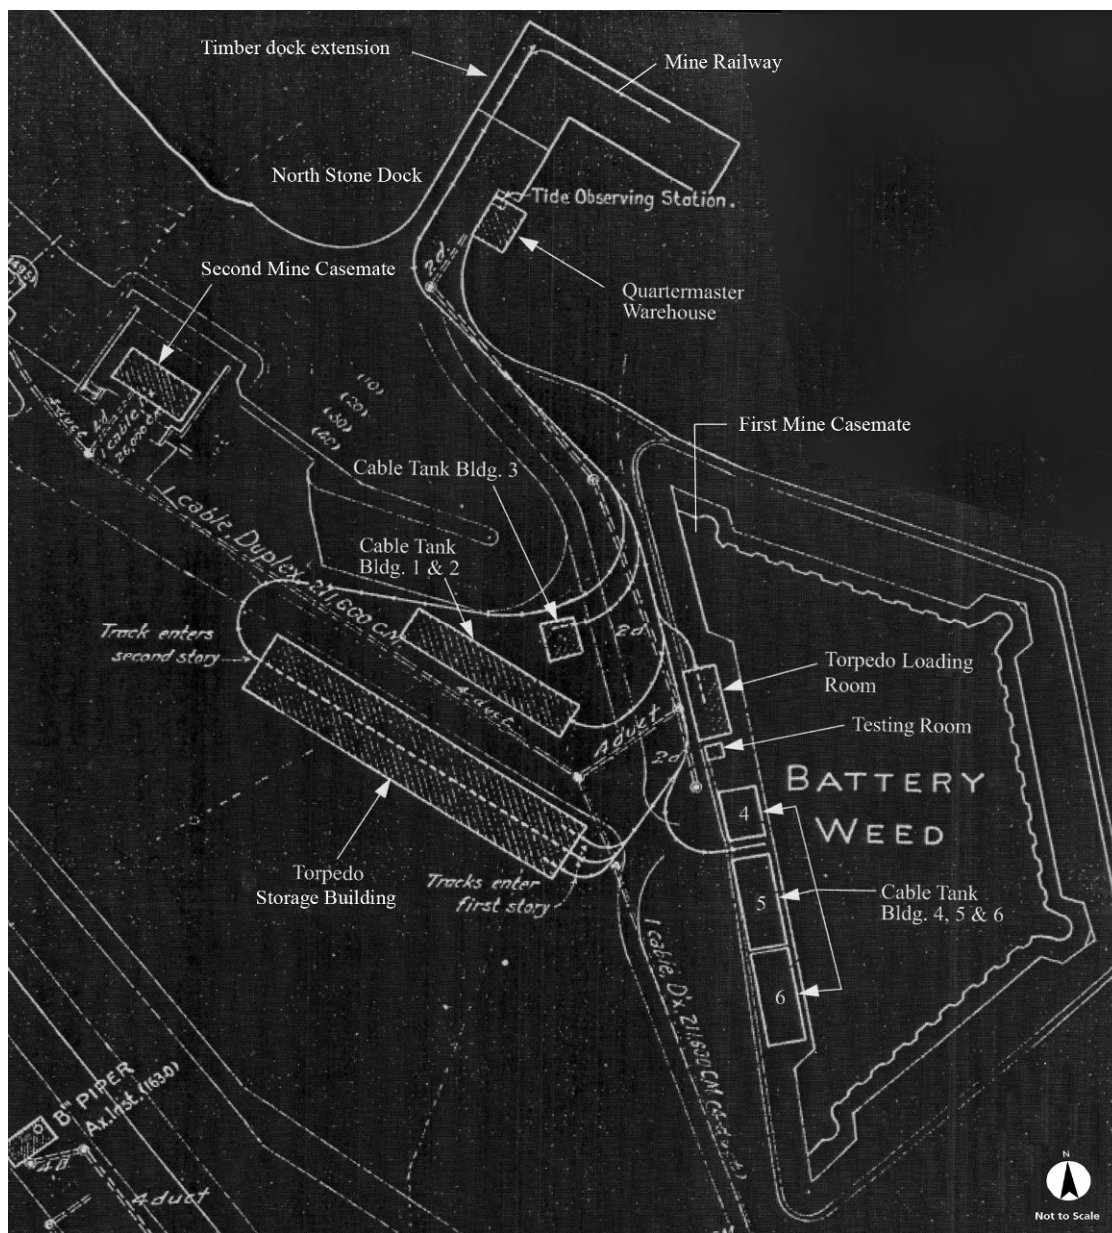
Figure 1.56: Plan drawn in c.1906 showing development of the mine defense system with its numerous support buildings constructed along the west wall of Battery Weed, the second mine casemate on Battery Catlin, and timber extension on the north stone dock. National Archives, reproduced from Ingrid Wuebber and Edward M. Morin, "Phase 1A Archeological Investigation Rehabilitate Battery Weed Seawall and Dock" (Unpublished report prepared for the National Park Service by URS Corporation, 2006), further annotated by SUNY ESF.

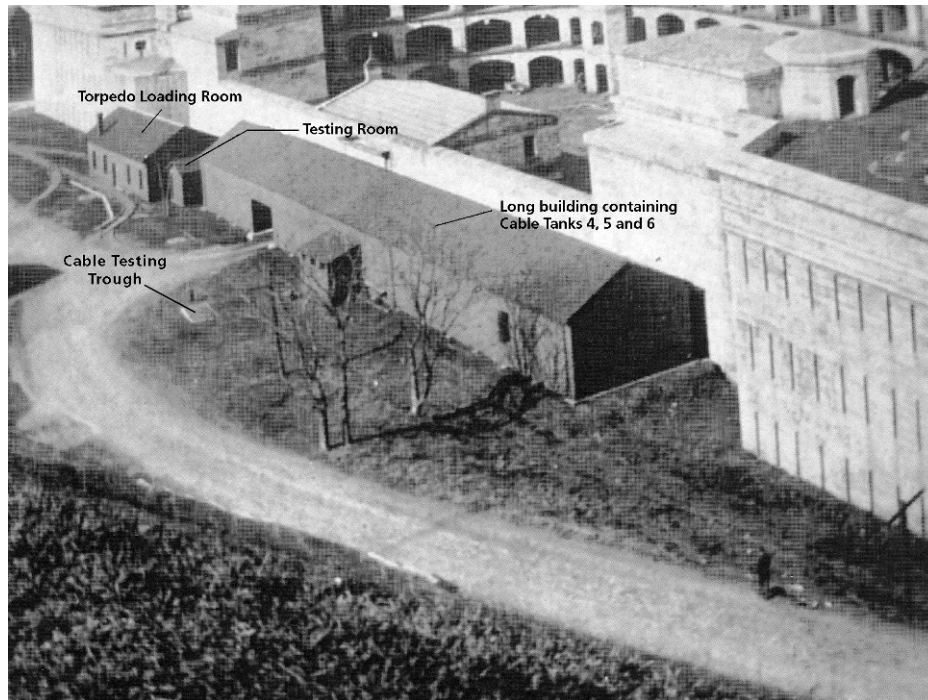
Figure 1.57: Photograph taken in 1907 of the mine defense system support buildings constructed on top of the filled moat along the west side of Battery Weed in 1904-05. The opening at the far end of the building housing cable tanks 4, 5, and 6 is the entrance to Battery Weed. National Archives, reproduced from Ingrid Wuebber and Edward M. Morin, "Phase 1A Archeological Investigation Rehabilitate Battery Weed Seawall and Dock" (Unpublished report prepared for the National Park Service by URS Corporation, 2006), annotated by SUNY ESF.

To provide much-needed space for additional support buildings, the Army filled the west side of the dewatered moat to ground level in c.1904, obscuring the inland moat wall. The reservoir at the southwest bastion was either covered or filled. Between 1904 and 1905, an in-ground cable testing trough and a series of wood-frame gabled buildings were constructed on top of the filled moat, abutting the west wall of Battery Weed. These included a torpedo loading room and testing room, and cable tank buildings 4, 5, and 6. (Figure 1.57, see also Figure 1.56) At some point after 1907, a dynamite testing room building was added in front of the cable tank building. The cable tank building, which was actually one long structure, extended across the main pedimented entrance to Battery Weed. In place of this ceremonial portal, the entrance to the fort became a nondescript opening in a wood-frame building.

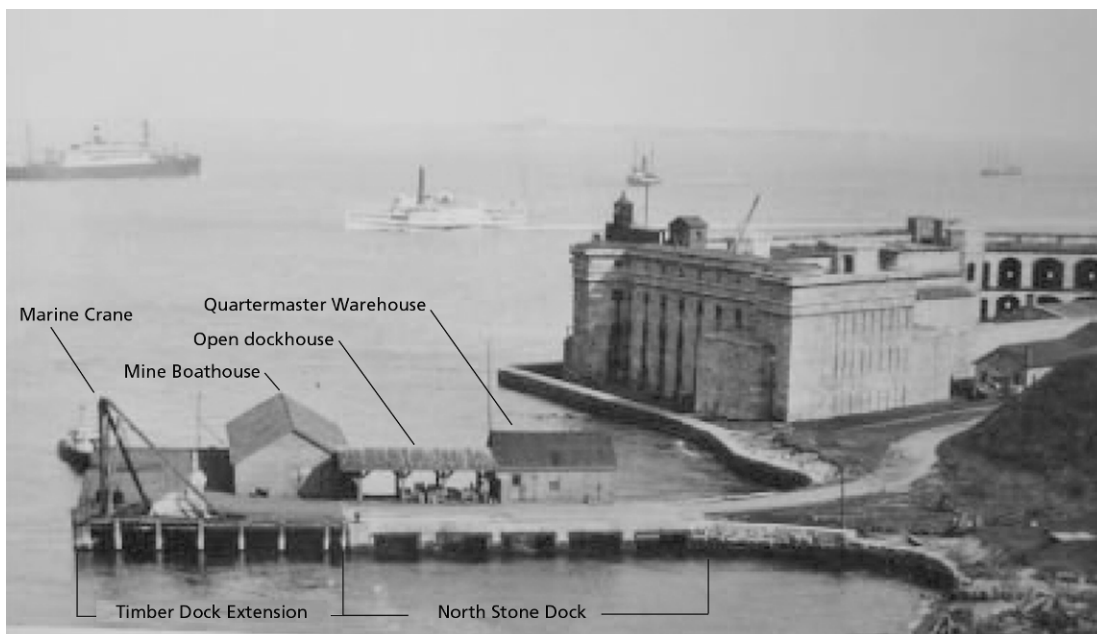
Figure 1.58: Photograph taken in 1907 showing the north stone dock with its recently constructed marine crane, timber extension, mine boathouse, and open dock house. The Quartermaster Warehouse, formerly called a boathouse, was added in c.1877. Photograph 19427, Gateway National Recreation Area Archives, Fort Wadsworth, annotated by SUNY ESF.

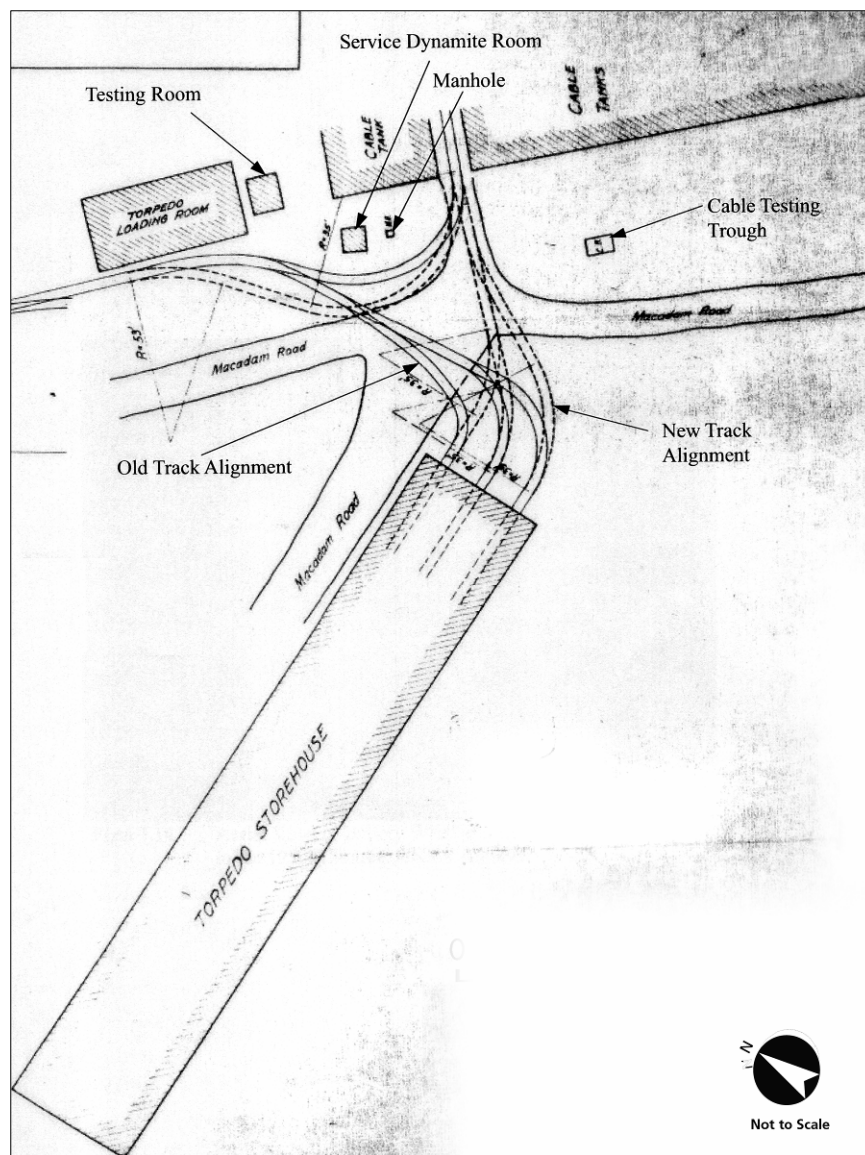
Figure 1.59: Plan made in 1921 showing the preexisting (solid lines) and the proposed 1921 (dashed lines) alignment of the mine railway at the Torpedo Storage Building (noted as Torpedo Storehouse). National Archives, reproduced from Ingrid Wuebber and Edward M. Morin, "Phase 1A Archeological Investigation Rehabilitate Battery Weed Seawall and Dock" (Unpublished report prepared for the National Park Service by URS Corporation, 2006), annotated by SUNY ESF.

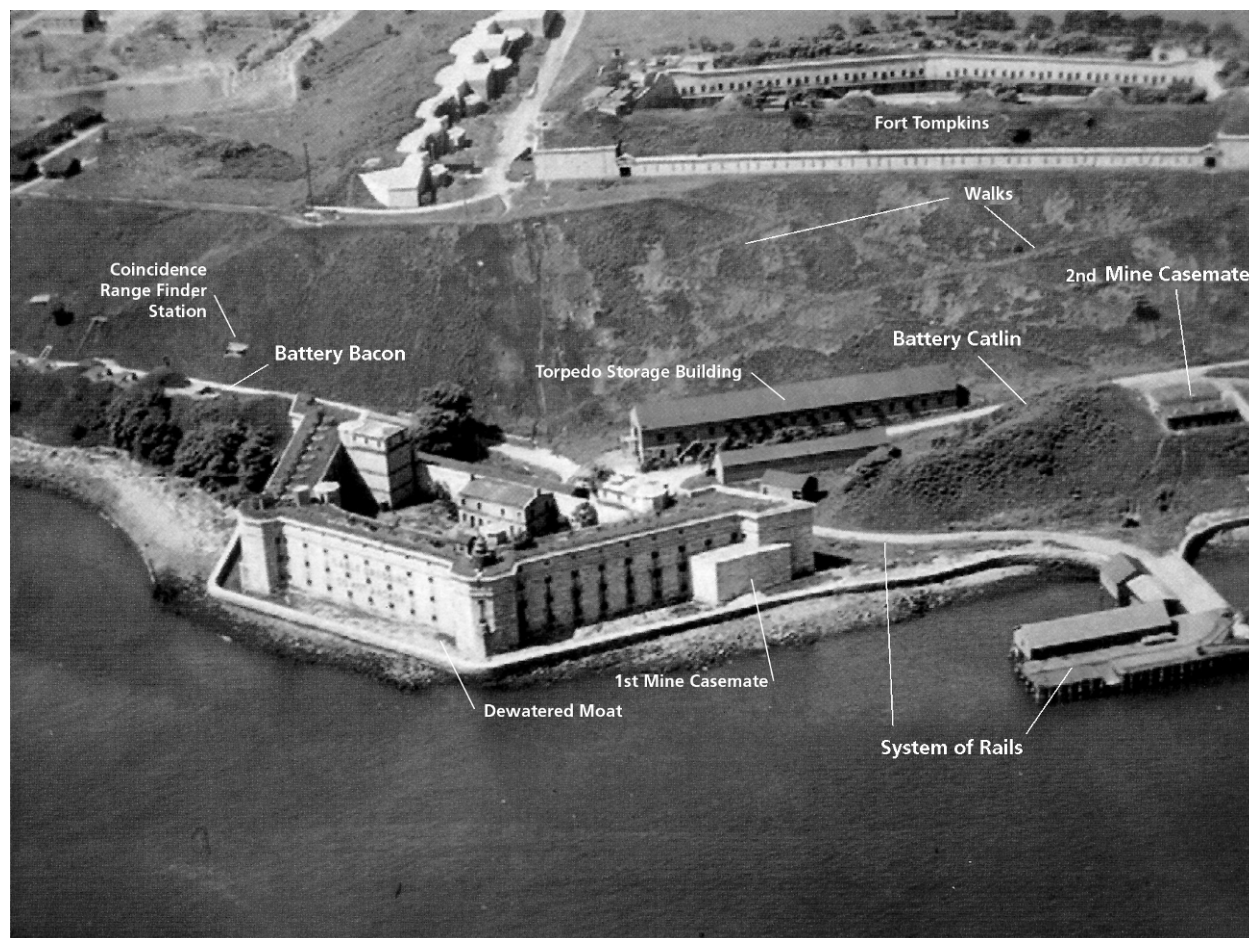
Figure 1.60: A 1924 bird-s-eye photograph looking west across Battery Weed illustrating mine defense components and the overall open character of the landscape. Note some mature trees below Battery Bacon and west of Battery Weed. "Annual Report of Construction and Repair," National Archives, reproduced from Ingrid Wuebber and Edward M. Morin, "Phase 1A Archeological Investigation Rehabilitate Battery Weed Seawall and Dock" (Unpublished report prepared for the National Park Service by URS Corporation, 2006), annotated by SUNY ESF.

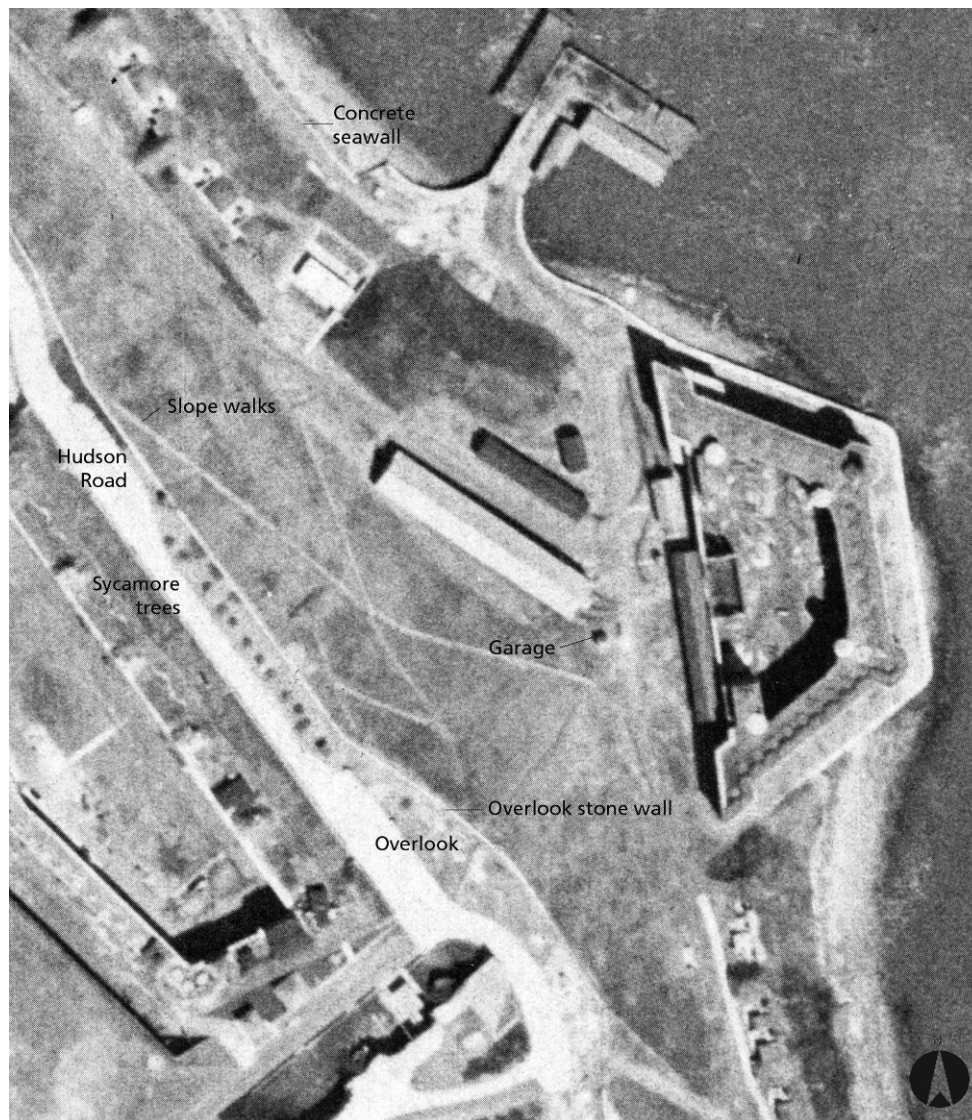
Figure 1.61: A 1940 aerial photograph showing the overall landscape of the Battery Weed headland and changes made over the previous two decades, including addition of a garage near the Torpedo Storage Building, improvement of the overlook with a stone wall and trees lining Hudson Road, and construction of a concrete seawall north of the north stone dock. The walks along the slope were intact at this time, although they had been cut off by the construction of the overlook stone wall. Aerial Viewpoint Aerial Photography, Inc., reproduced from Langan Engineering, "Pier/Seawall Evaluation and Ferry Feasibility Study, Fort Wadsworth, Staten Island New York" (Unpublished report prepared for the National Park Service, 1995).

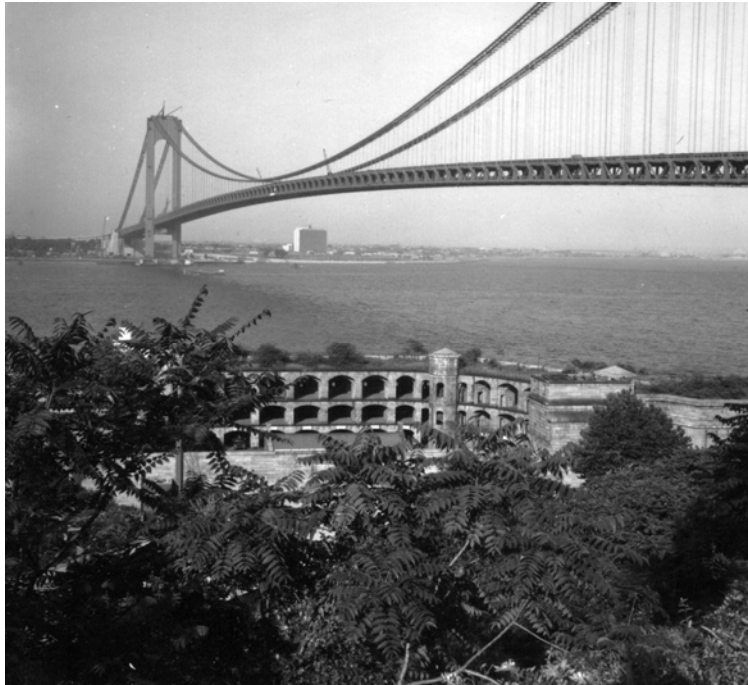
Figure 1.62: Photograph taken in 1964 looking east over Battery Weed showing the Verrazano-Narrows Bridge nearing completion. This photograph also illustrates the advancing natural succession on the formerly open barrette tier of Battery Weed and the engineered slope. Photograph 12C02D, Still Photograph Division, National Archives II, College Park, Maryland.

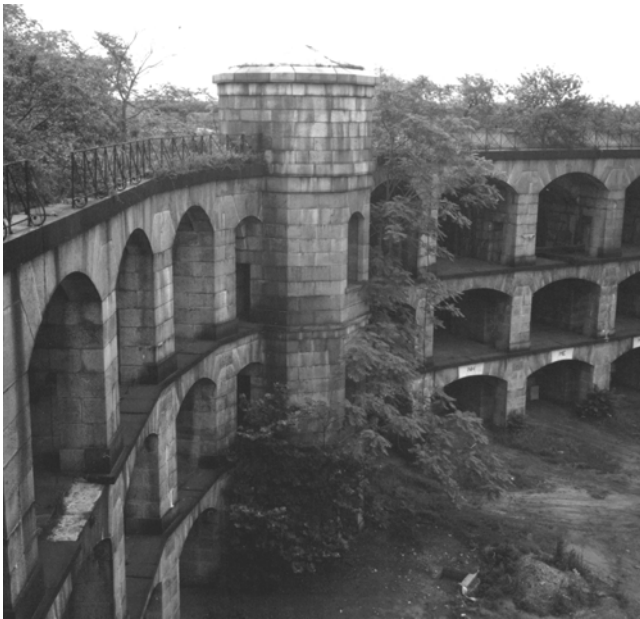
Figure 1.65: Photograph of Battery Weed in 1964 showing poorly maintained conditions that included piles of soil and ruts in the parade ground and volunteer vegetation growing up and over the building. Print 12C02F, Still Pictures Division, National Archives II, College Park, Maryland.

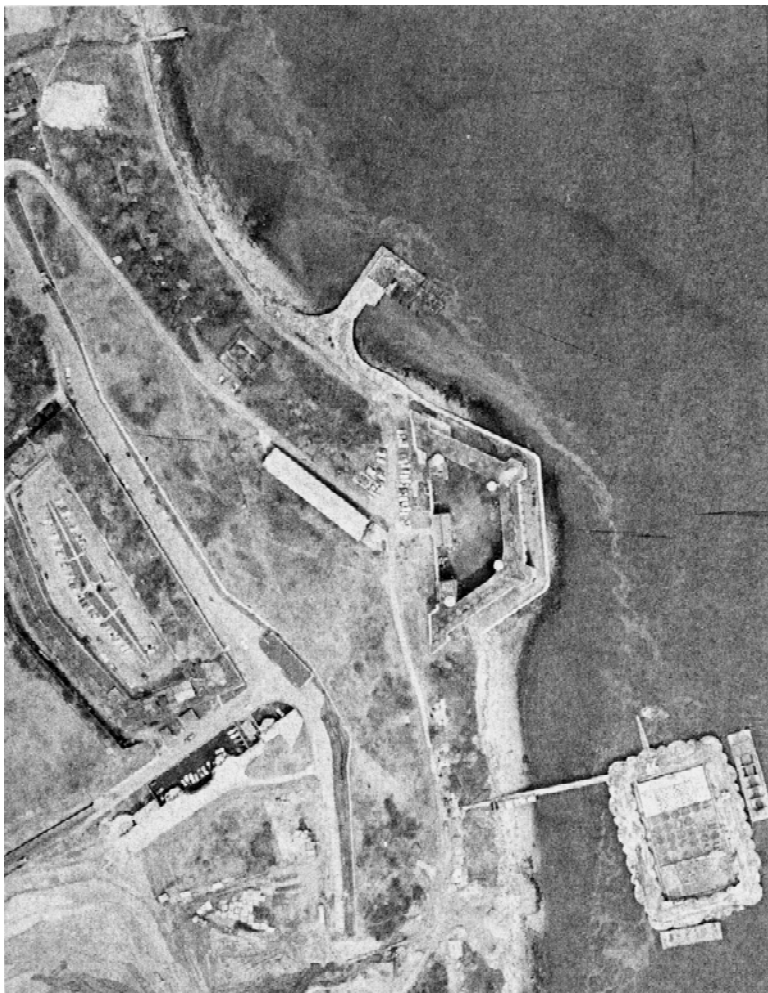
Figure 1.66: A 1961 aerial photograph showing removal of many of the mine defense system support buildings and buildings on the north stone dock. The cars parked near the fort may be part of staging operations for the construction of Verrazano-Narrows Bridge, the footings of which are visible at the lower right. Aerial Viewpoint Aerial Photography, Inc., reproduced from Langen Engineering, "Pier/Seawall Evaluation and Ferry Feasibility Study, Fort Wadsworth, Staten Island New York" (Unpublished report prepared for the National Park Service, 1995).

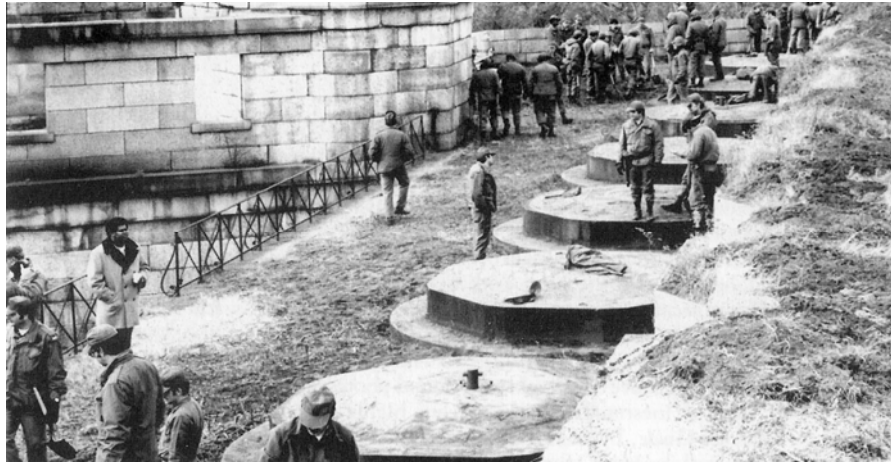
Figure 1.67: A 1970 photograph looking northwest across the barbette tier of Battery Weed showing a National Guard crew completing a landscape maintenance detail. Prior to this work, the barbette tier was overgrown with scrub and trees. Note shell of fort's magazine in the background. Unnumbered photograph, Gateway National Recreation Area Archives, Fort Wadsworth.

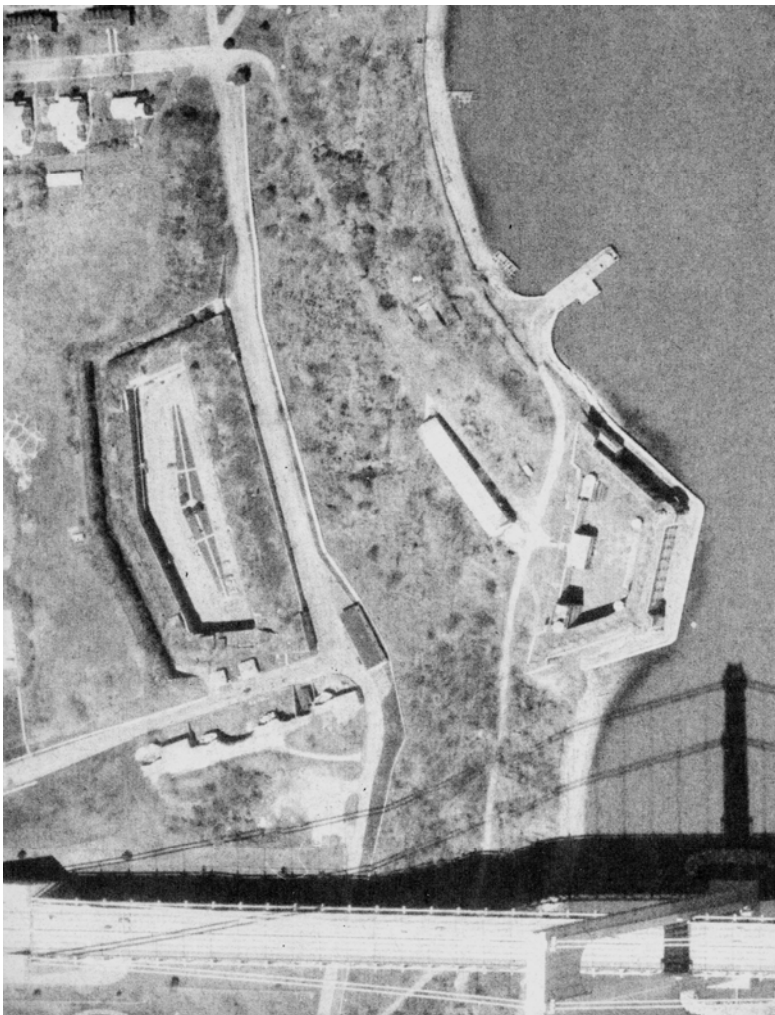
Figure 1.68: A 1980 aerial photograph of the Battery Weed headland illustrating growth of successional woods on the slope and batteries, and loss of a portion of the timber dock. Aerial Viewpoint Aerial Photography, Inc., reproduced from Langen Engineering, "Pier/Seawall Evaluation and Ferry Feasibility Study, Fort Wadsworth, Staten Island New York" (Unpublished report prepared for the National Park Service, 1995).

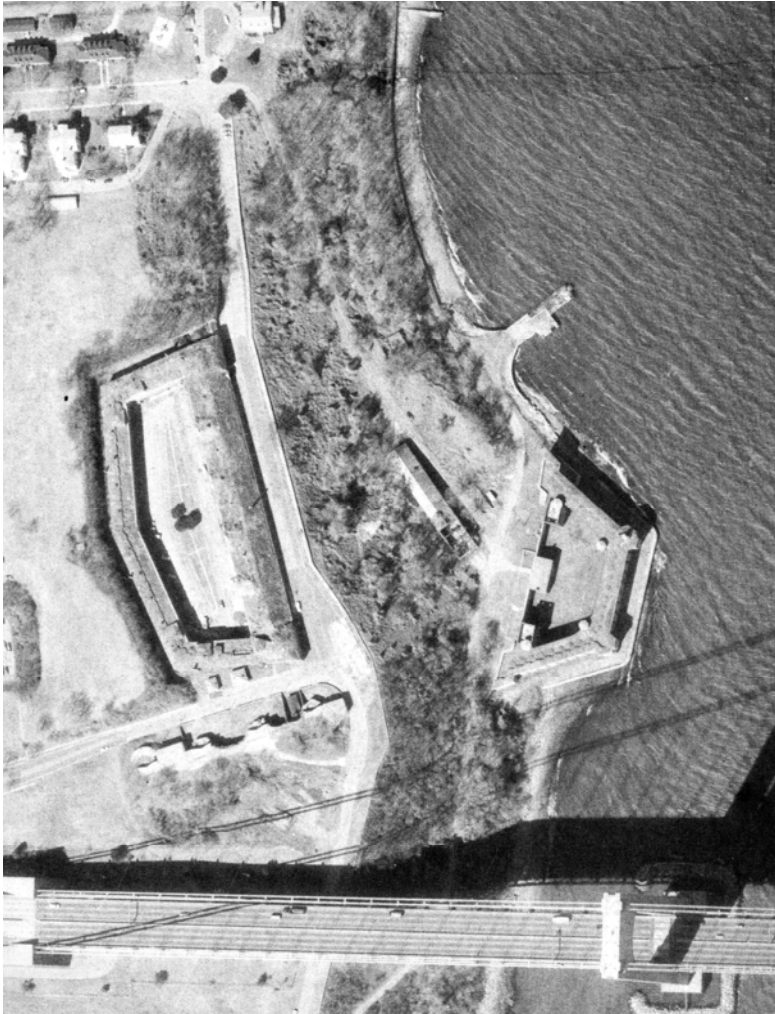
Figure 1.69: A 1990 aerial photograph showing conditions of the Battery Weed headland toward the end of Navy administration illustrating dense woods on the slope and batteries, and fire damage to the lower end of the Torpedo Storage Building. Aerial Viewpoint Aerial Photography, Inc., reproduced from Langen Engineering, "Pier/Seawall Evaluation and Ferry Feasibility Study, Fort Wadsworth, Staten Island New York" (Unpublished report prepared for the National Park Service, 1995).

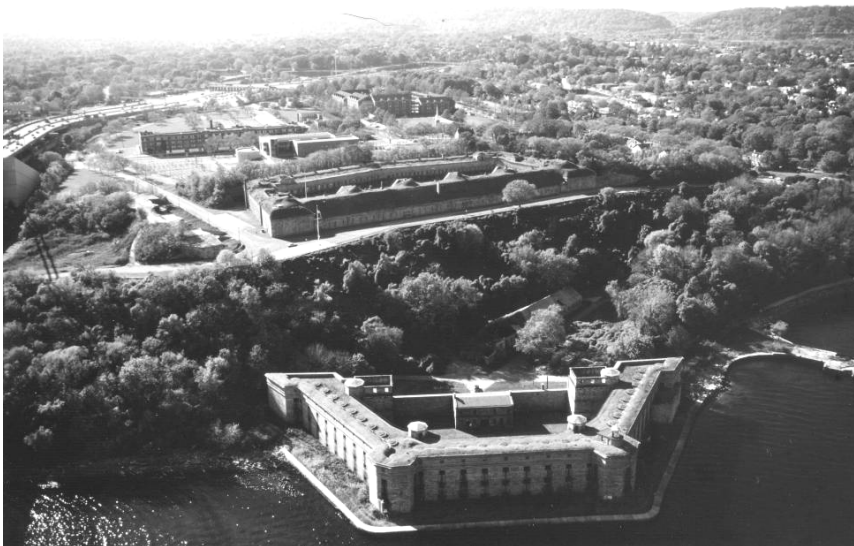
Figure 1.70: A 1994 bird's-eye view of Fort Wadsworth looking west shortly before its transfer to the National Park Service, showing extensive woods on the slope and batteries. The approach to the Verrazano-Narrows Bridge is visible in the left background. Langen Engineering, "Pier/Seawall Evaluation and Ferry Feasibility Study, Fort Wadsworth, Staten Island New York" (Unpublished report prepared for the National Park Service, 1995).

¹¹ The Navy may have made some improvements to the overlook prior to this time. A flagpole is visible on the overlook in a 1994 photograph (figure 1.70).

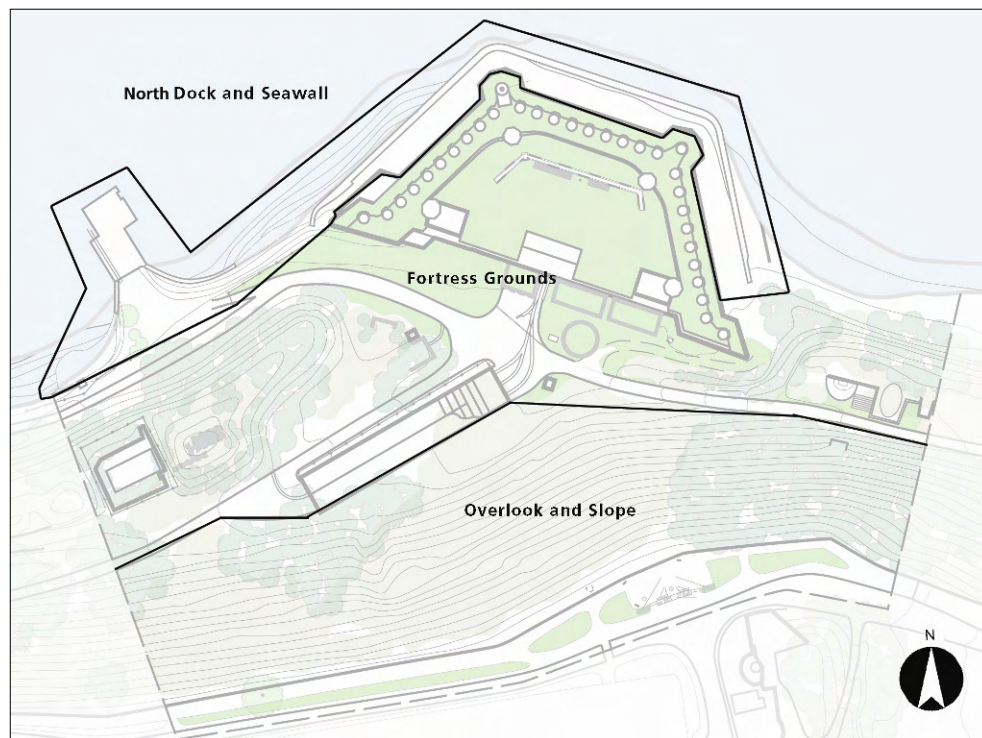
Figure 2.4: Diagram illustrating the three landscape character areas of the Battery Weed headland used to organize description of existing conditions. SUNY ESF.

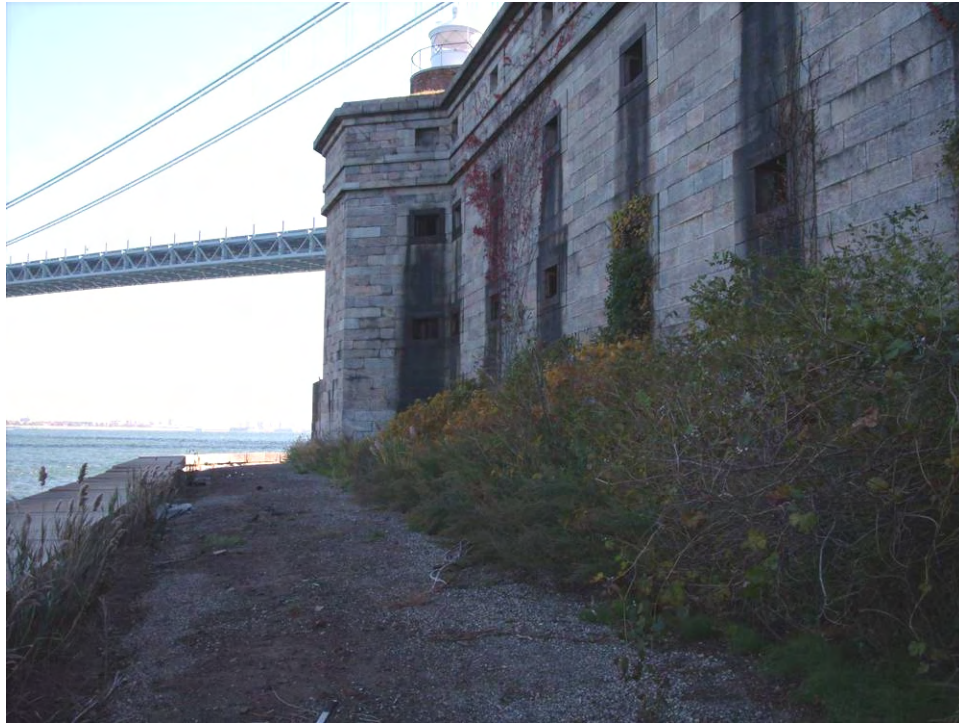
Figure 2.9: View looking southeast in 2007 along the north side of Battery Weed illustrating the filled moat and supporting granite seawall. SUNY ESF.

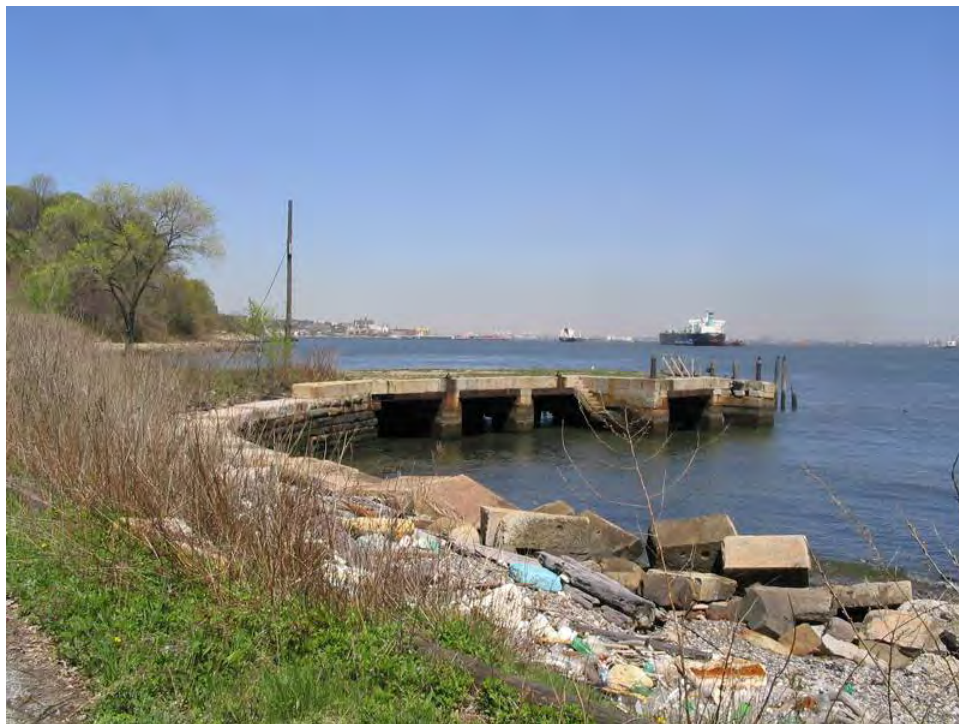
Figure 2.10: View looking north in 2007 showing the collapsed section of seawall and the north dock. The wood piles are remnants from a timber extension to the dock built in c.1907 and lost after 1960. SUNY ESF.

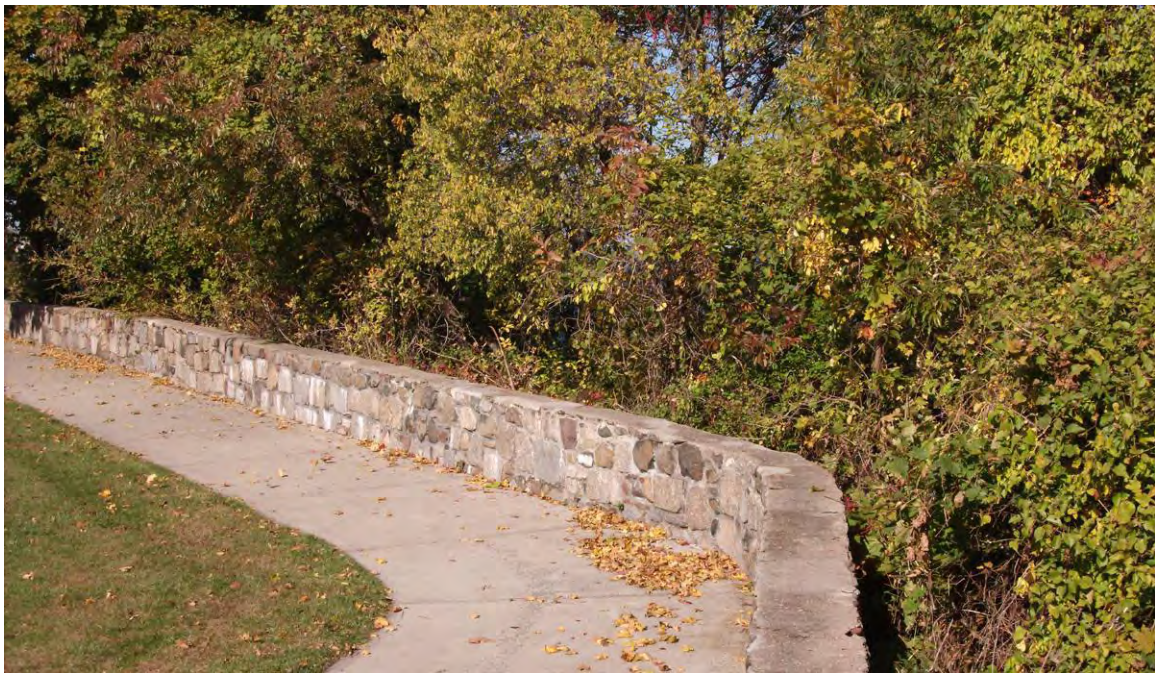
Figure 3.2: Two views taken from the same location in 1900 and 2007 at the overlook above Battery Weed looking northeast illustrating the changes over time in landscape character due to growth of successional woods. This growth has constricted the once expansive views of New York Harbor. The stone wall was added in c.1938 toward the end of the historic period. Above: Photograph 19650, Gateway National Recreation Area archives, Fort Wadsworth; below: SUNY ESF, 2007.

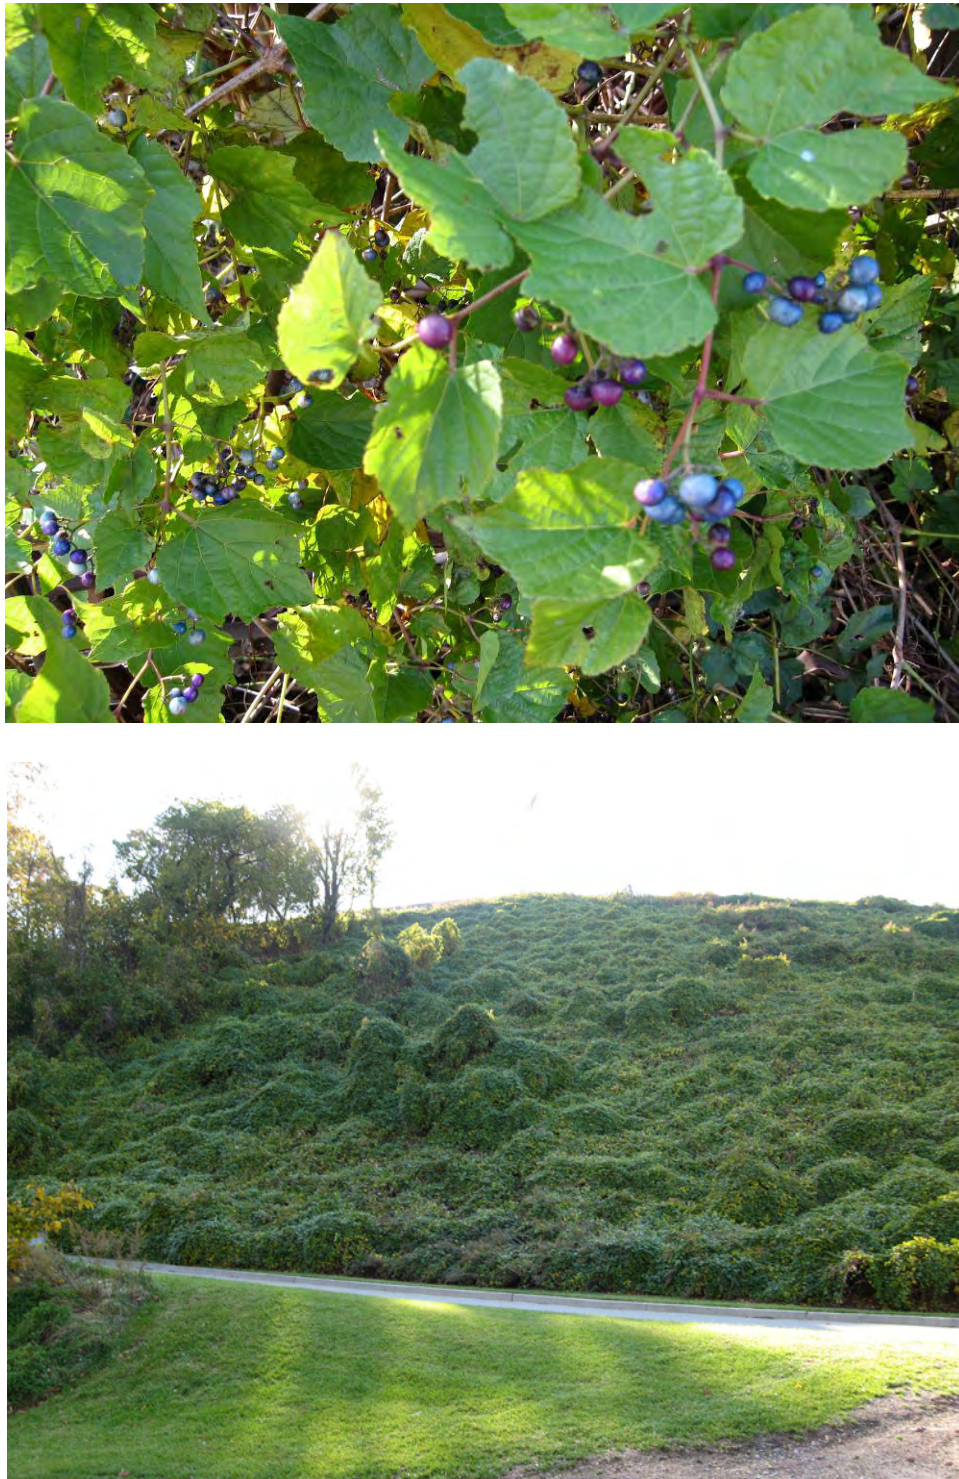
Figure 3.3: Top: Detail of porcelain berry (*Ampelopsis brevipedunculata*). Bottom: View looking northwest across the slope above Battery Weed taken in 2006 showing the blanket of the invasive vine over an area cleared in c.1995. SUNY ESF.

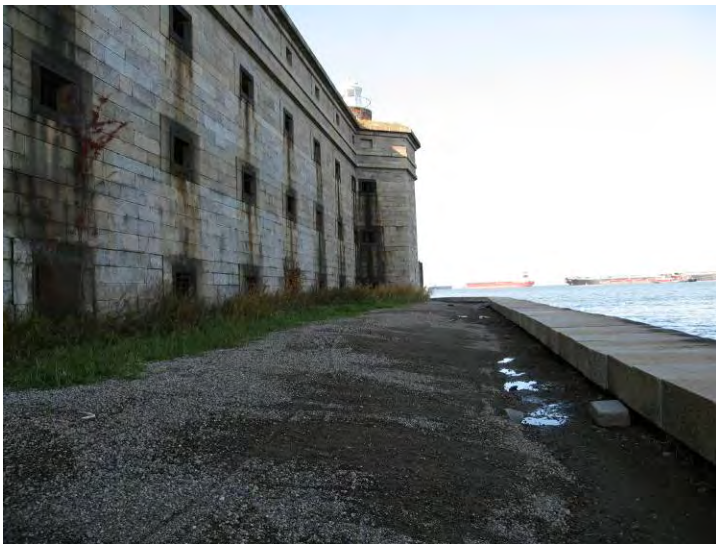
Figure 3.5: The moat space (SO-2), looking north, is filled with earth and rubble and top-dressed with gravel between the granite seawall (BS-2) and the fort walls. SUNY ESF, 2006.

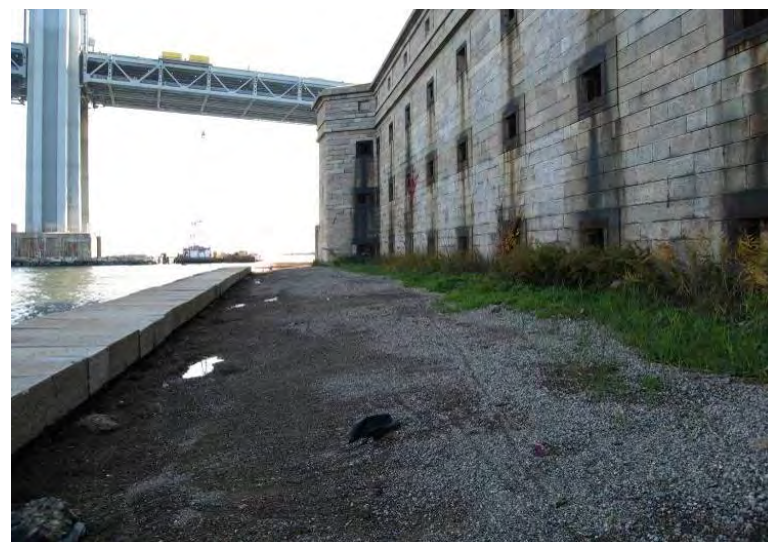
Figure 3.12: The route of the waterfront promenade (C-5), looking south along the granite seawall completed in c.1871 and moat that was partially filled in c.1904. SUNY ESF, 2007.

the top of the granite seawall and the adjoining filled moat. (Figure 3.12) Access to the promenade is presently blocked by plastic fencing at the southwest bastion, and a six-foot high chain-link fence extending from the northwest bastion.

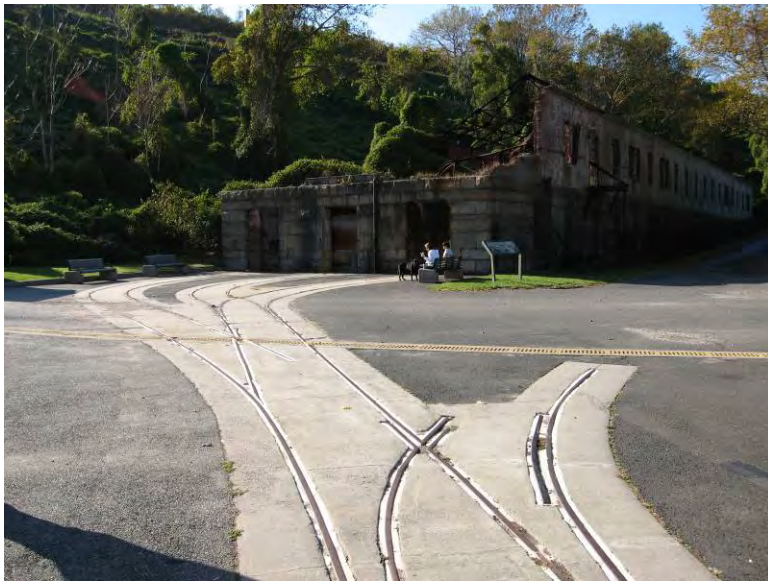
Figure 3.13: The mine railway (C-6), built between c.1887 and 1921 looking northwest toward a section to the Torpedo Storage Building built in c.1896. SUNY ESF, 2007.

Since the end of the historic period in 1945, sections of the mine railway have been lost at the north dock, parade grounds, and along the west side of Battery Weed. Sections remain at Battery Weed Road at the north and south ends of the Torpedo Storage Building, and extending toward Battery Catlin and the north stone dock. The rails are generally set into concrete pavement. (Figure 3.13) In Battery Weed Road, the concrete pavement has been rebuilt and the rails set in a polymer caulk. Where the rails are covered by dense vegetation at the south end of Battery Catlin, it is unknown whether they still exist or have been removed.

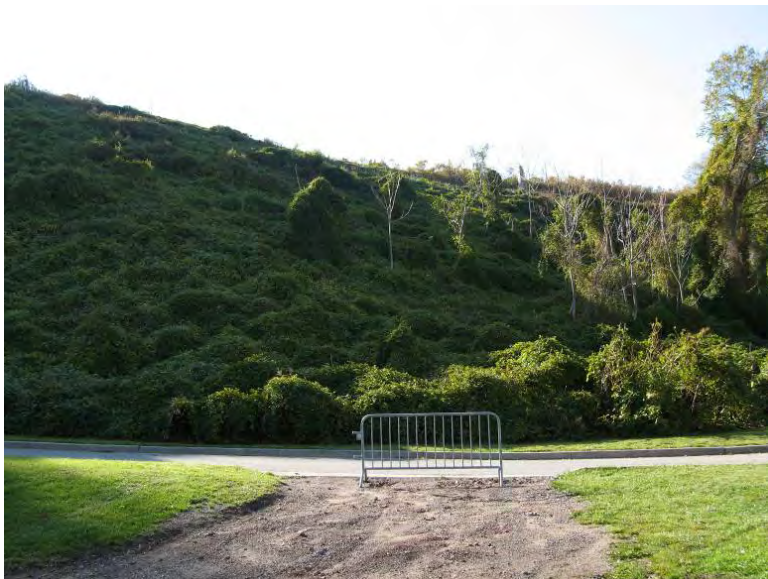
Figure 3.14: The engineered slope (T-1), graded in c.1873, looking northwest from Battery Weed. The slope is concealed by invasive vines and successional woods that have grown up since 1945. SUNY ESF, 2007.

Since the end of the historic period in 1945, some soil erosion has occurred in the slope above the north end of the Torpedo Storage Building where a gully has formed as a result of water runoff. (Figure 3.14) The grade of the slope has most likely become more irregular overall due to erosion and growth of vegetation.

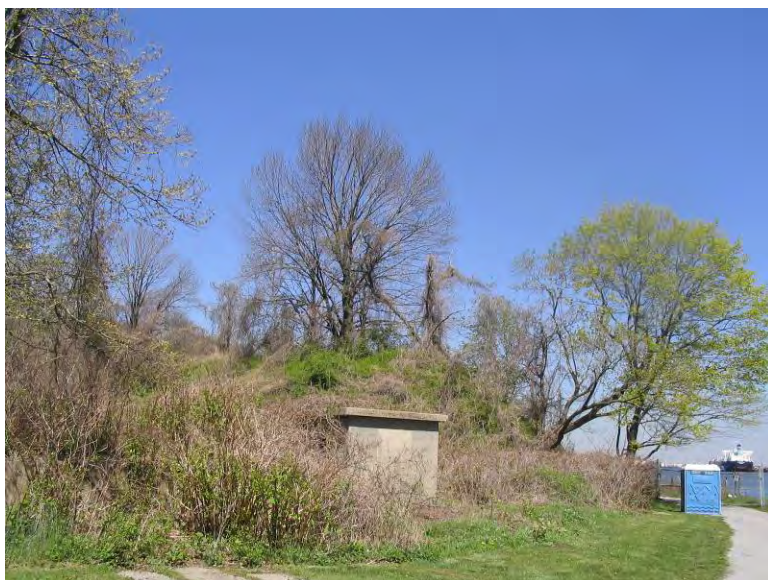
Figure 3.15: The southern end of Battery Catlin (T-2), reconstructed in 1902-1904, view looking northeast showing earth mound concealed by vegetation. The mine railway is visible at the lower left. SUNY ESF, 2007.

With the exception of some erosion and deterioration of structural elements and a dense covering of successional woods, little change has occurred to the Battery Catlin earthwork since the end of the historic period in 1945. The southern end of Battery Catlin consists of a large earth mound measuring approximately 320 feet by 140 feet rising to a height of forty-five feet above the level of the dock road. (Figure 3.15)

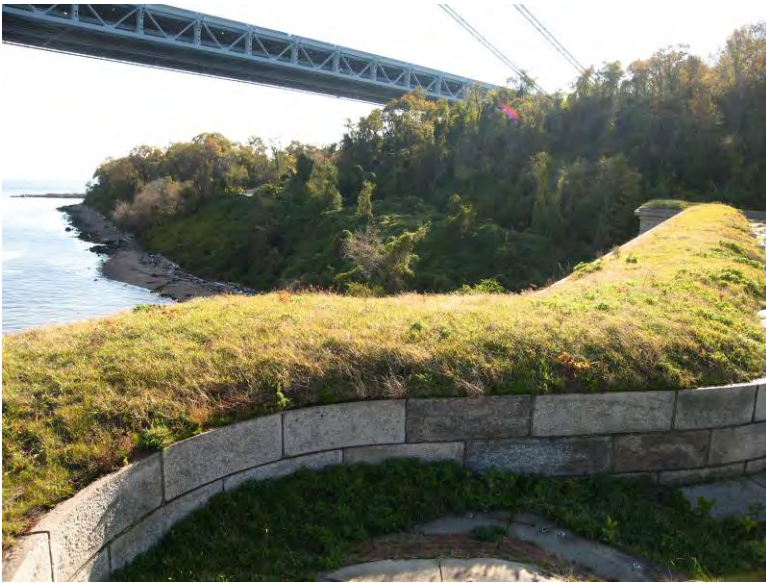
Figure 3.16: The vine and tree-covered Battery Bacon earthwork (T-3) built in c.1898 above the shoreline, looking southeast from the parapet of Battery Weed. The battery is the area above the shoreline. SUNY ESF, 2007.

With the exception of the overgrowth of vegetation on the battery, little change has occurred to the Battery Bacon earthwork since the end of the historic period in 1945. The northern end of Battery Bacon consists of a large earthen mound measuring approximately 200 feet by 80 feet, rising to an elevation of fifty feet above the water level of the Narrows. (Figure 3.16) The only section that has been cleared of heavy vegetation is the north gun emplacement.

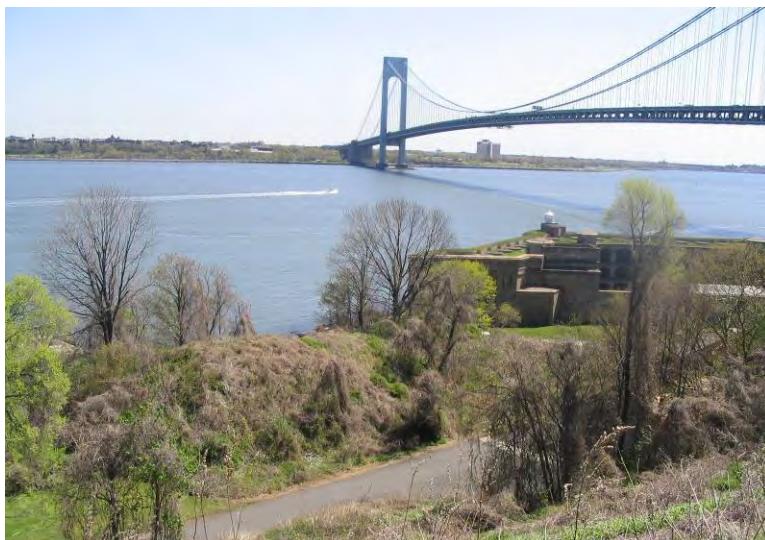
Figure 3.18: View across the former open turf areas on the fortress grounds and slope, including Battery Catlin in the middle ground and the engineered slope in the foreground. The turf has been lost to successional woods and invasive vines. SUNY ESF, 2007.

Since the end of the historic period in 1945, most of the slope & fortress grounds turf (approximately eighty percent) has been lost, except for the area bordering Battery Weed and Battery Weed Road. Most of the former areas of mown turf on the slope and batteries has been lost to successional woods and a blanket of invasive porcelain berry (see also NS-1). (Figure 3.18)

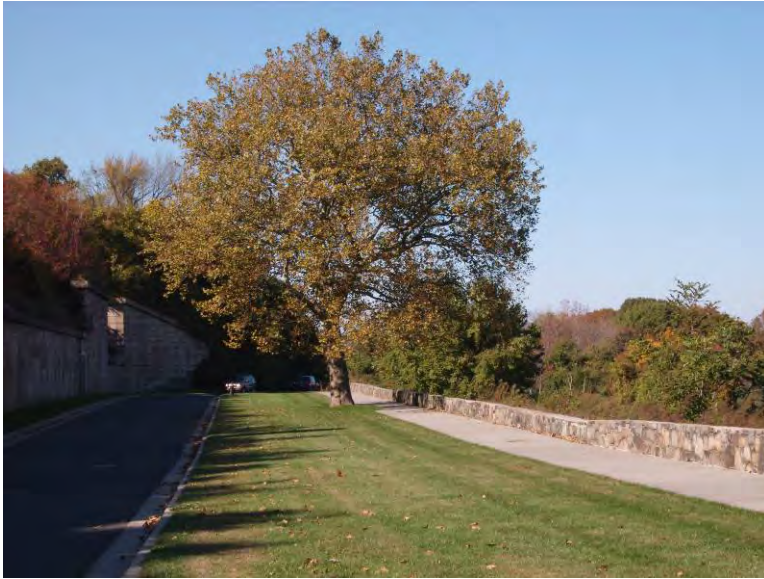
Figure 3.19: View north along Hudson Road at one of the remaining roadside sycamore tree (V-3) at the overlook dating to c.1938. This is a remnant of a row of trees that existed historically. SUNY ESF, 2007.

Since the end of the historic period, most of the roadside specimen trees have been lost. Three sycamore (*Platanus occidentalis*) trees remain. One is located on the east side of Hudson Road across from Fort Tompkins, at a diameter of approximately fourteen inches. (Figure 3.19) This sycamore may be a replacement planting or a remnant of the row of trees that existed during the historic period. Two mature sycamore trees are located along the east side of Battery Weed Road across from the Torpedo Storage Building. (Figure 3.20) One is approximately forty-two inches in diameter, and the other is of approximately thirty-six inches.
