CULTURAL LANDSCAPE REPORT FOR THE BATTERY WEED HEADLAND

FORT WADSWORTH
GATEWAY NATIONAL RECREATION AREA
STATEN ISLAND, NEW YORK

Olmsted Center for Landscape Preservation
National Park Service, Boston, Massachusetts, 2008

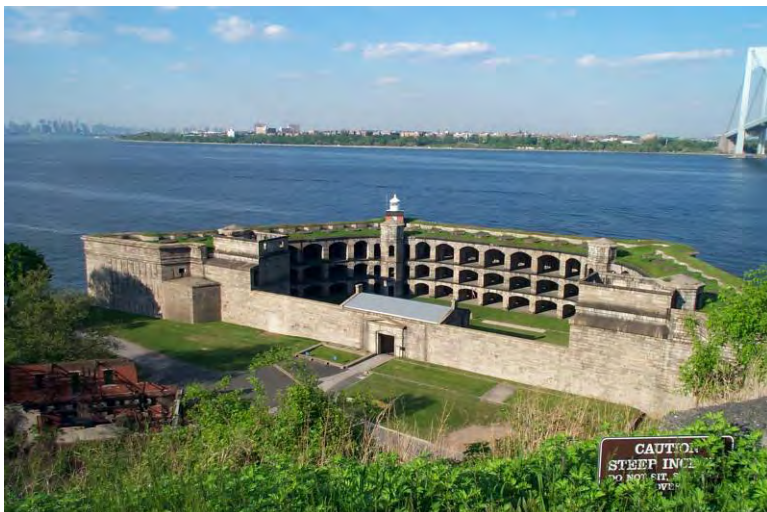
Figure 3.21: Battery Weed (BS-1), constructed between 1847 and 1864, looking northeast from the overlook terrace. The lighthouse was added in 1903. SUNY ESF, 2007.

Since the end of the historic period in 1945, the only substantial change to Battery Weed has been the loss of the roofs of the magazine towers, which occurred prior to 1958. Battery Weed is a massive granite structure measuring 286 feet along each channel-front wall, and 450 feet along the west scarp wall. (Figure 3.21) The fort features three casemated tiers, rising one on top of the other, and an open earth-covered barbette tier with a breast height parapet wall along the channel side that rises sixty-three feet above the Narrows. Thirty-one gun emplacements are located on the barbette tier, each a circular raised brick and mortar pedestal with iron pintles that held rotating canon. The area surrounding the gun emplacements and the area on top of the parapet are planted with mown turf.

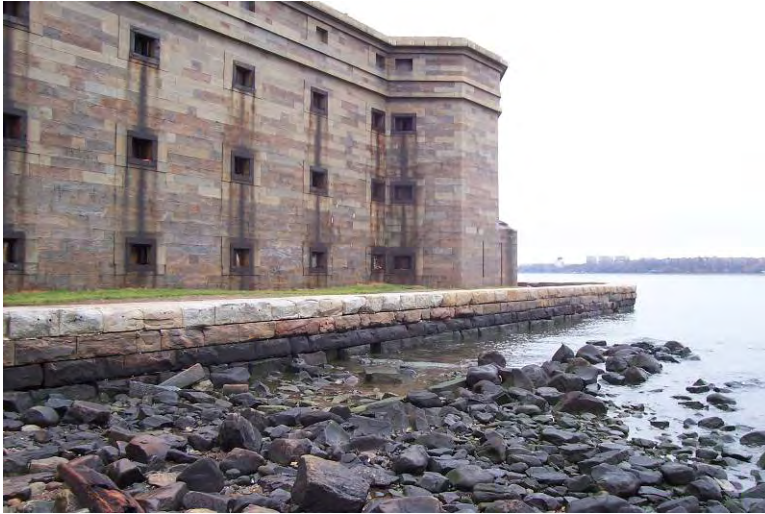
Figure 3.22: The seawall (BS-2) completed in c.1871, view looking northeast at section that forms the outer wall of the moat around Battery Weed. SUNY ESF, 2007.

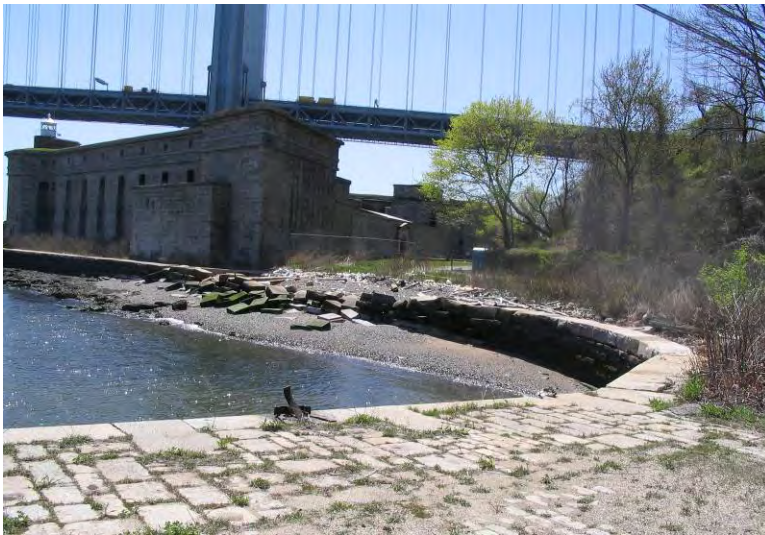
Figure 3.23: A section of the retaining wall section of the seawall (BS-2), looking south from the north dock showing a collapsed section. SUNY ESF, 2007.

Since the end of the historic period in 1945, two sections of the retaining wall section of the seawall have collapsed, one between Battery Weed and the north dock, and the other north of the dock. A portion of the moat seawall along the east side of Battery Weed was rebuilt in 2006. The granite seawall extends for approximately 1,000 feet from the south end of Battery Weed to a point north of the north dock. The moat section of the seawall extends along the entire outer channel-facing sides of Battery Weed and terminates at the rocky beach near Battery Bacon on the south. (Figure 3.22) The retaining wall section of the seawall extends from Battery Weed north beyond the north dock. (Figure 3.23) Both sections are built of coursed quarry-faced granite ashlar.

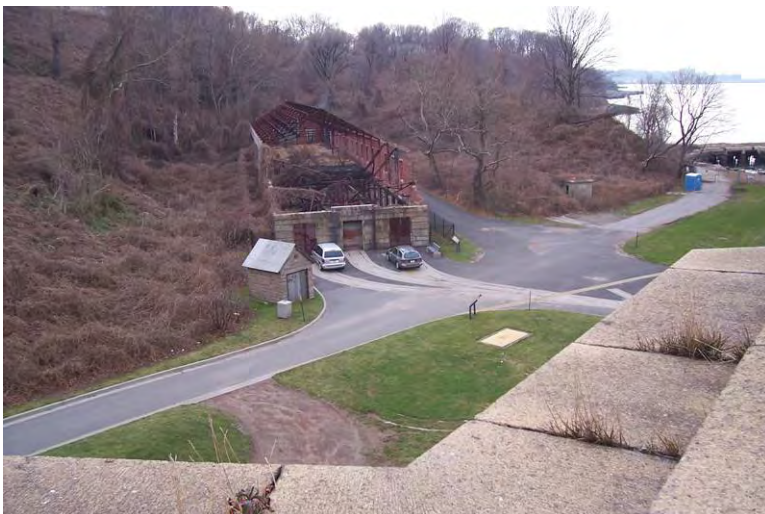
Figure 3.24: The Torpedo Storage Building (BS-3), looking north from the Battery Weed barbette tier, was constructed in c.1894 and was heavily damaged in a fire during the 1980s. SUNY ESF, 2007.

resulted in loss of roof trusses and brick walls at the south end. As a result of this fire, the roof skin was removed and the building left as a shell. Sections of wood structural timbers and window sash remain. Overall, the brick and stone building with a steel-truss gable roof measures approximately 230 feet by 40 feet. (Figure 3.24) Planning is underway to rehabilitate this building for visitor use.

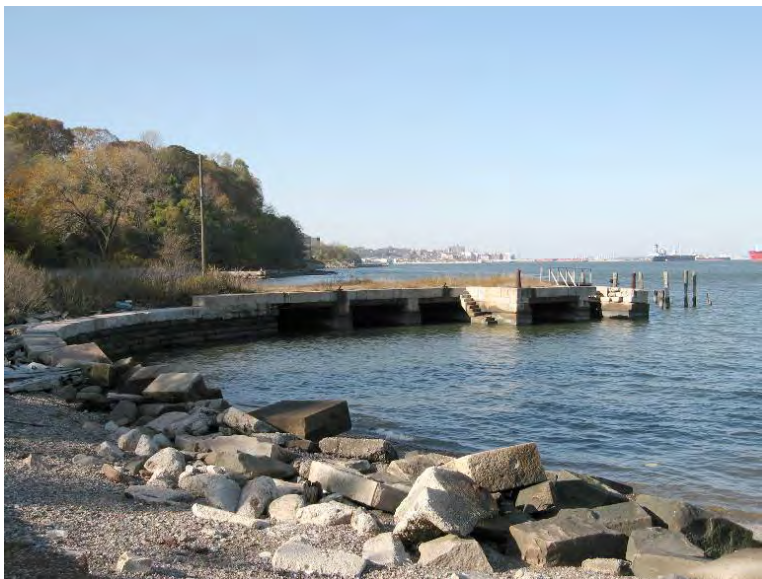
Figure 3.27: The north dock (BS-6), built in c.1859, looking northwest with remains of the 1907 timber extension. In the foreground is a collapsed section of the granite seawall. SUNY ESF, 2007.

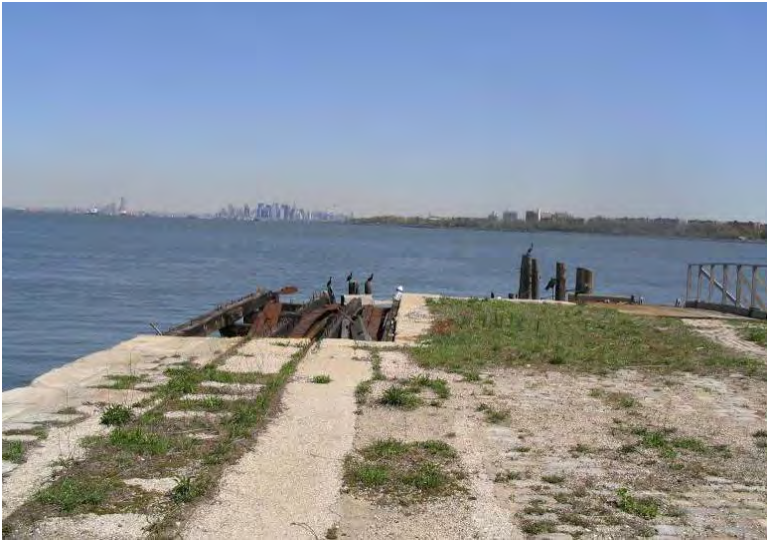
Figure 3.28: The north dock (BS-6), built in c.1859, view looking northeast showing granite and concrete surface, and remnants of the mine railway and timber extension dating to 1907. SUNY ESF, 2007.

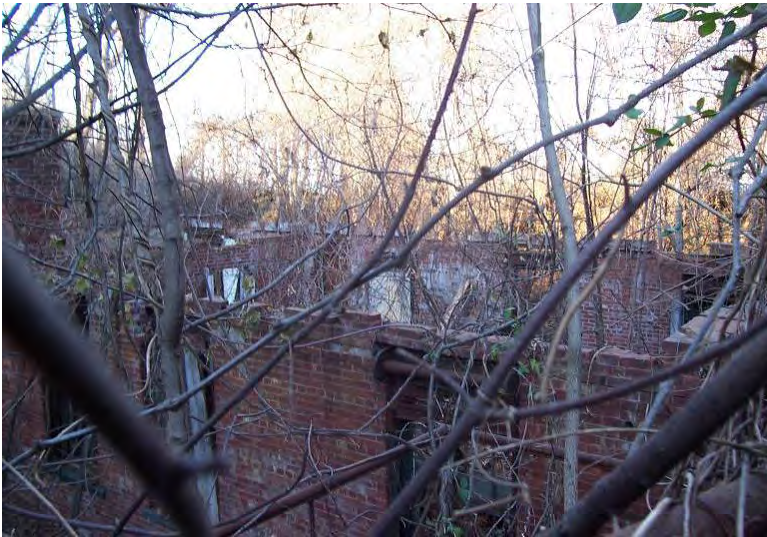
Figure 3.29: The second mine casemate (BS-7), built in c.1905, looking northeast illustrating ruined condition and cover in vegetation. SUNY ESF, 2007.

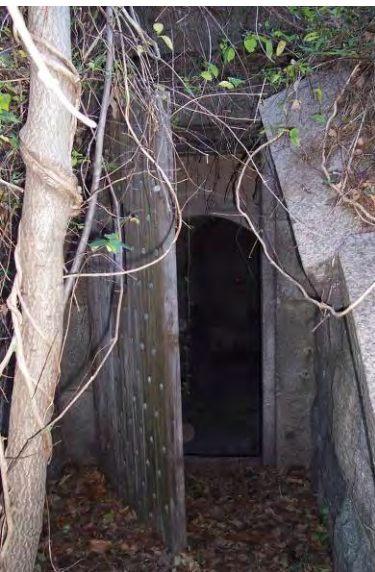
Figure 3.30: The exterior entry of the Battery Catlin parados (BS-8) built in c.1865, looking east showing granite cheek walls and overgrown conditions. SUNY ESF, 2007.

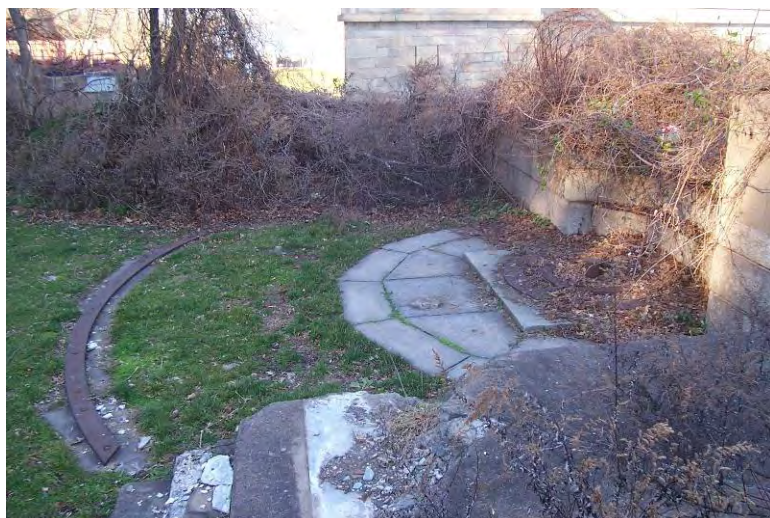
Figure 3.31: The gun emplacement (BS-9) at Battery Bacon (see T-3) built in c.1898 looking north showing concrete platform and parapet walls, iron pintle, and traverse circle. SUNY ESF, 2007.

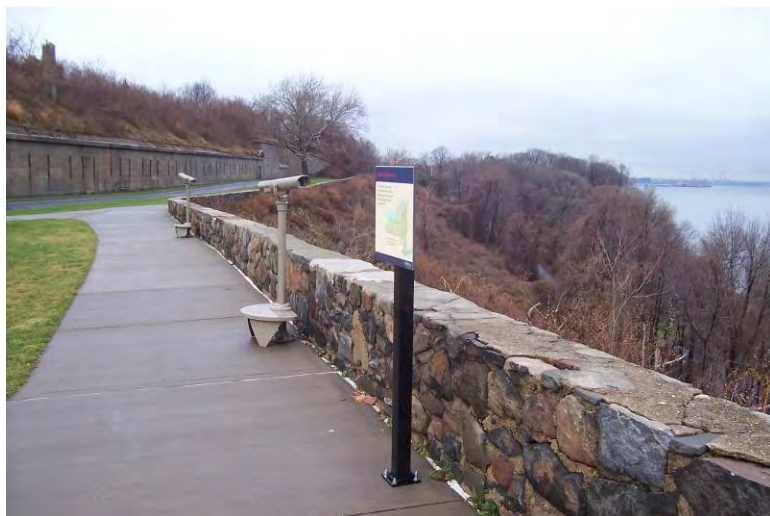
Figure 3.32: The overlook stone wall (BS-10) built in c.1938, view looking north along the overlook terrace. The wall measures approximately 2,000 feet in length. SUNY ESF, 2007.

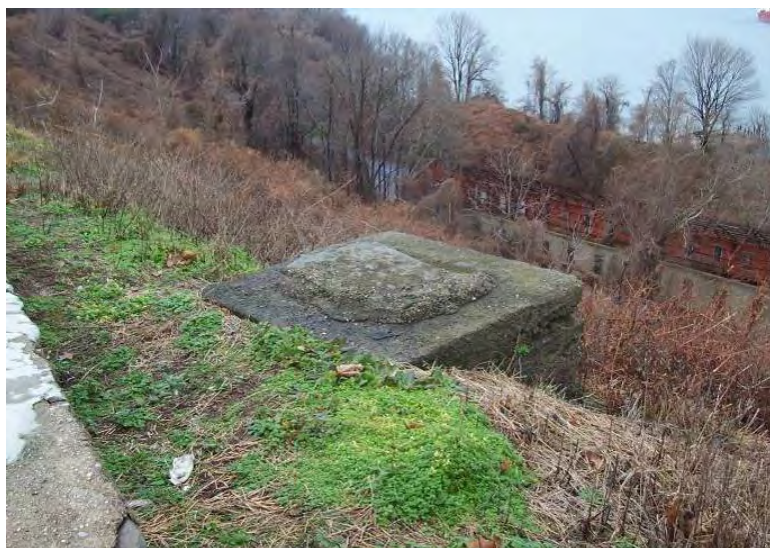
Figure 3.33: A square concrete structure (BS-11), looking north, set into the slope immediately to the east of the overlook stone wall at the top of the slope. The origin and use of this structure is not known. SUNY ESF, 2007.

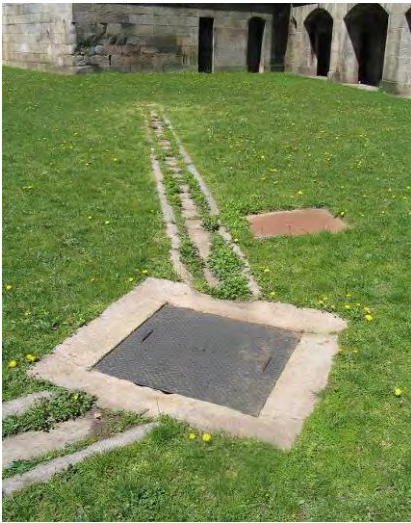
Figure 3.34: The stone gutters and cistern (BS-12), built c.1847-1864, looking west with contemporary cistern hatch in the foreground. SUNY ESF, 2007.

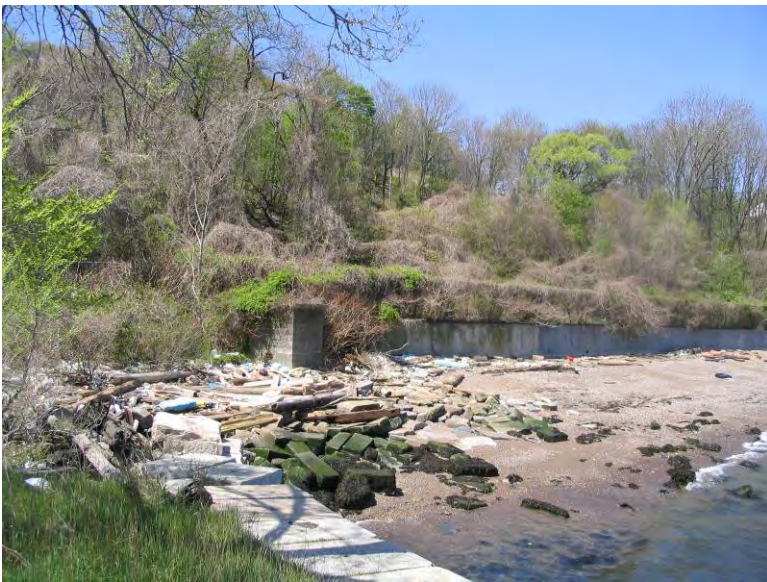
Figure 3.35: The partially vine-covered concrete seawall (BS-13) built in c.1938, view looking northwest with Battery Catlin in the background. In the foreground is a collapsed section of the granite seawall. SUNY ESF, 2007.

As outlined in *PMIS 16634 Rehabilitate Battery Weed Seawall & Dock*, the recommended treatment is *Rehabilitation* with repair of the unstable and collapsed sections of the north dock and the entire seawall. Preservation of existing historic design and materials should be the primary objective. This should include circulation and small-scale features on the dock, notably the iron dock bollards, mine railway remnants, and granite-block pavement. Preliminary plans call for rehabilitation of the dock for water-taxi service to Fort Wadsworth. Since the existing dock is only a small part of the dock that existed in 1945, there is opportunity to accommodate new construction on the historic footprint, provided it follows the location, mass, and scale of the structures that existed at the dock in 1945. (Figure 4.4) The dock historically contained three buildings, the sites of which could be used for new construction housing passenger shelters and restrooms, or for interpretive displays. Reestablishing the historic massing of the dock would greatly enhance the historic character of the landscape.

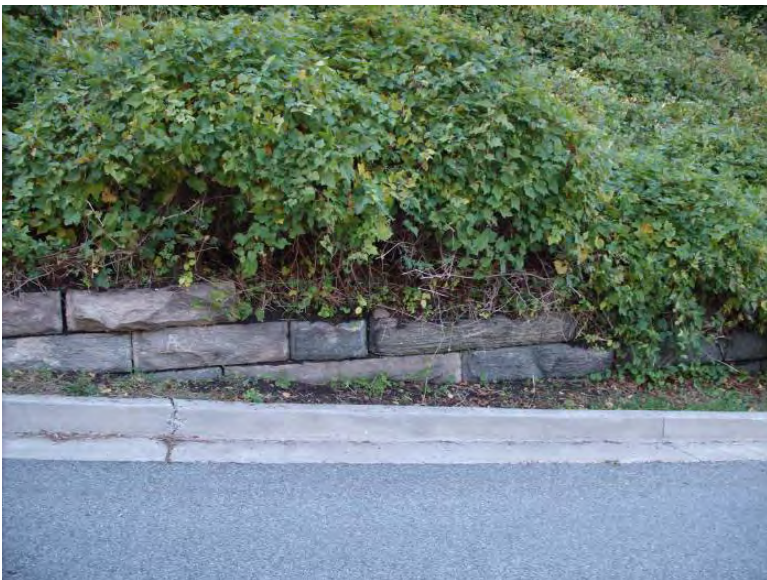
Figure 3.36: The slope retaining wall (BS-14), built in c.1848, view look west with Battery Weed Road in the foreground. SUNY ESF, 2007.

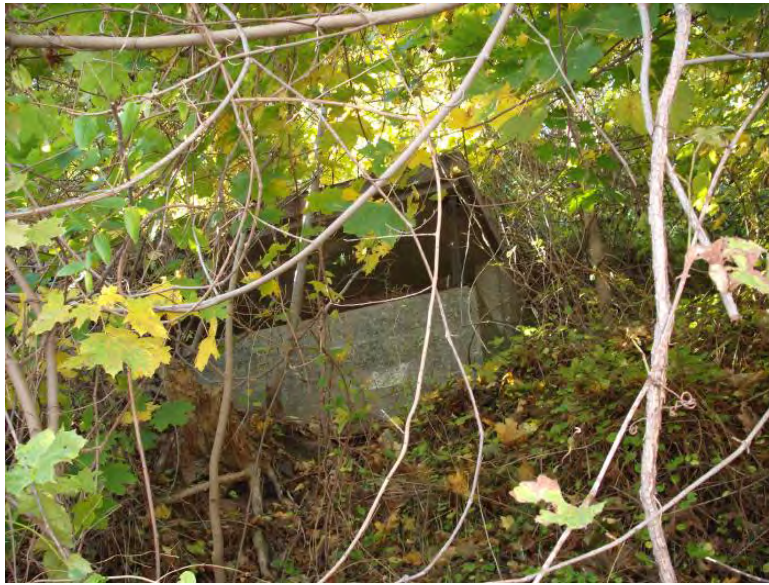
Figure 3.37: The Coincidence Range-Finder Station (BS-15) built in c.1917, looking west from Battery Weed Road through dense vegetation. SUNY ESF, 2007.

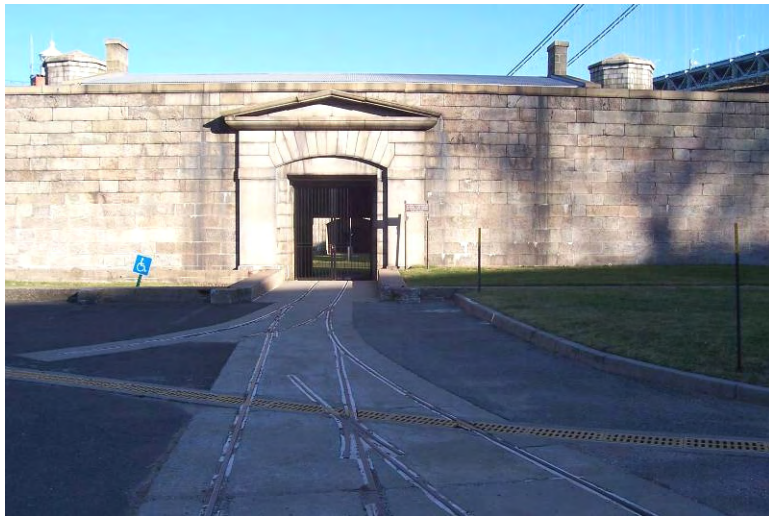
Figure 3.38: Surface drain inlet (BS-16) added in c.1995, looking east toward the entrance of Battery Weed as it extends across the mine railway. SUNY ESF, 2007.

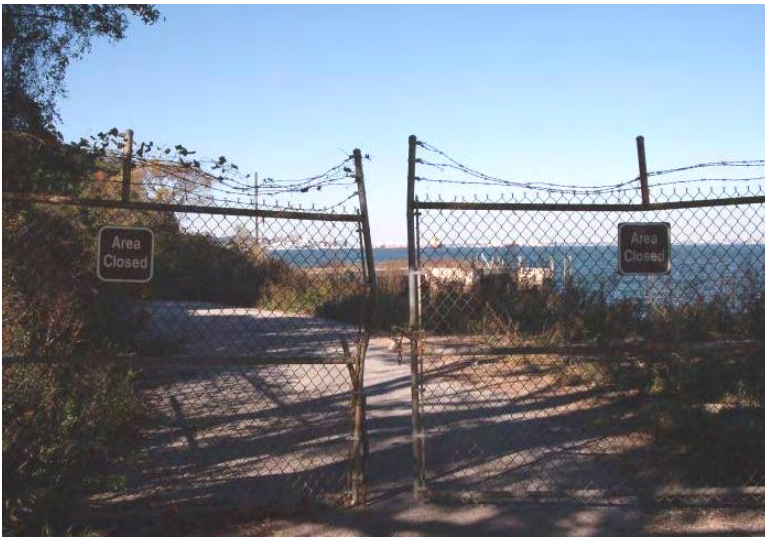
Figure 3.41: Chain link fencing (SS-1) and locking gate installed after 1945 across the dock road, looking northwest toward the north dock. SUNY ESF, 2007.

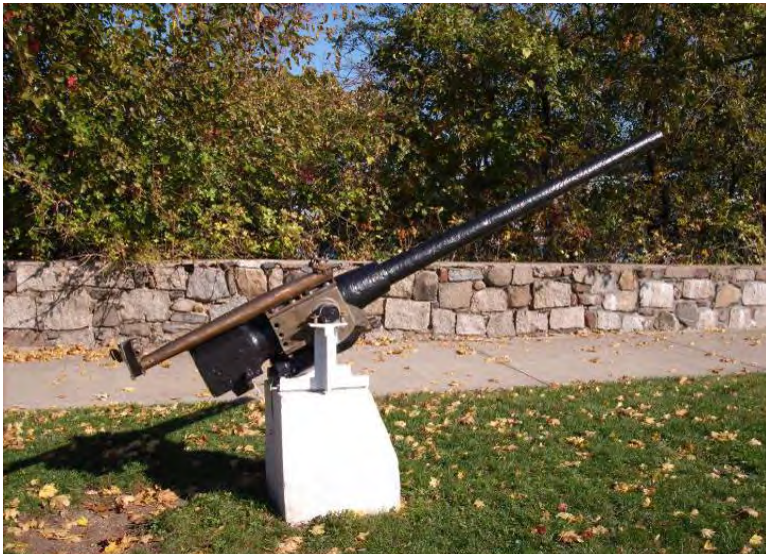
Figure 3.44: The overlook gun (SS-4), installed in c.1995, looking east from Hudson Road. This recalls the guns that existed historically on the overlook. SUNY ESF, 2007.

Alternative 1: Retain overlook terrace in its existing configuration dating to redesign completed in c.1995. Relocate existing gun close to the historic position (Figure 4.2, see also see Drawing 2) and orient toward historic line of fire once obscuring successional woods are removed (OS-1). Provide interpretation that discusses the changing appearance of the overlook.

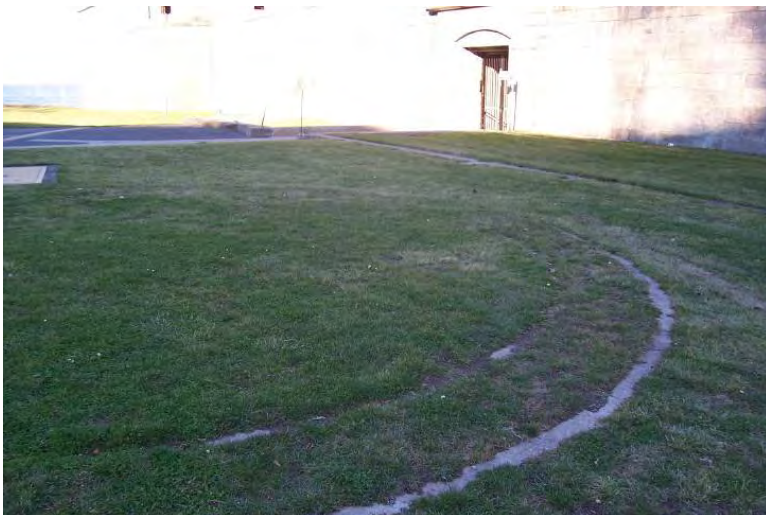
Figure 3.45: The cable testing trough (SS-5) (upper left of photograph) installed in c.1904, looking north with the circular foundations of the c.1921 cable testing tank in the foreground (A-4). SUNY ESF, 2007.

Two concentric concrete footings are located west of cable tanks 5 and 6. These are remains of a cable testing tank added in c.1921 and removed prior to 1945 (see Figure 3.45). The foundations are covered in part by turf.

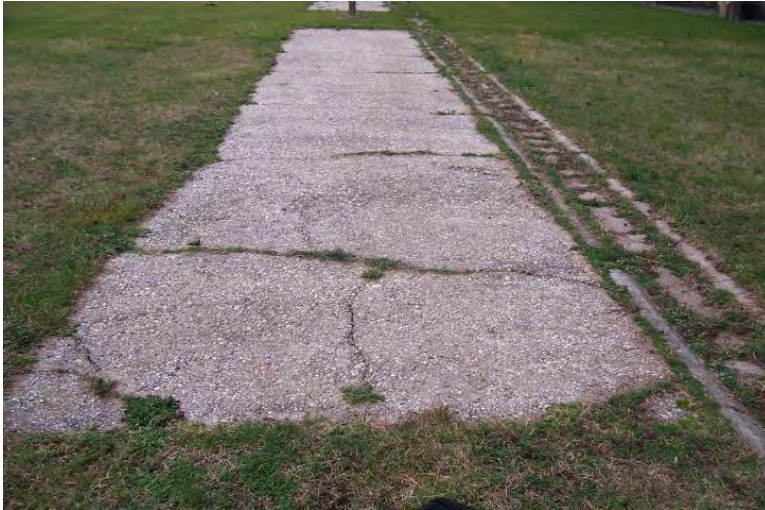
Figure 3.46: Detail of the parade ground munitions pads (SS-6) installed prior to 1893, looking north. At right is the stone gutter. SUNY ESF, 2007.

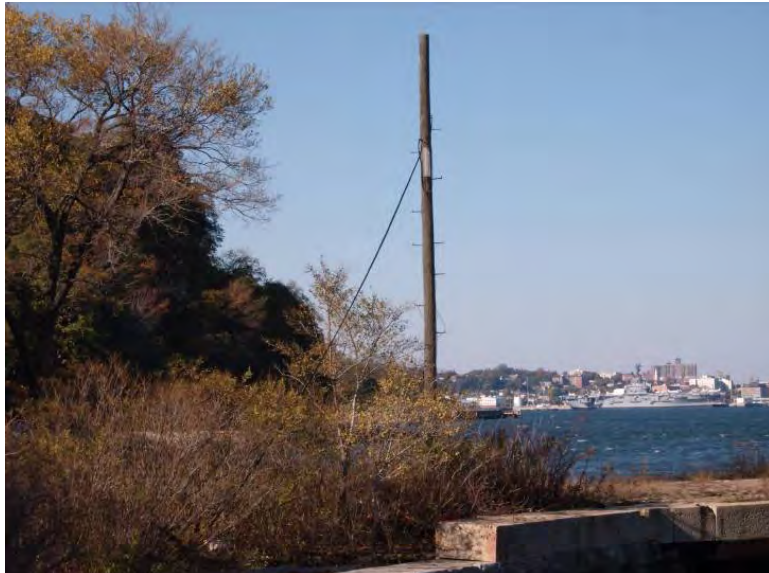
Figure 3.50: The dock utility pole (SS-10) added by c.1907, looking northwest with the seawall and bulkhead for the north dock in the foreground. SUNY ESF, 2007.

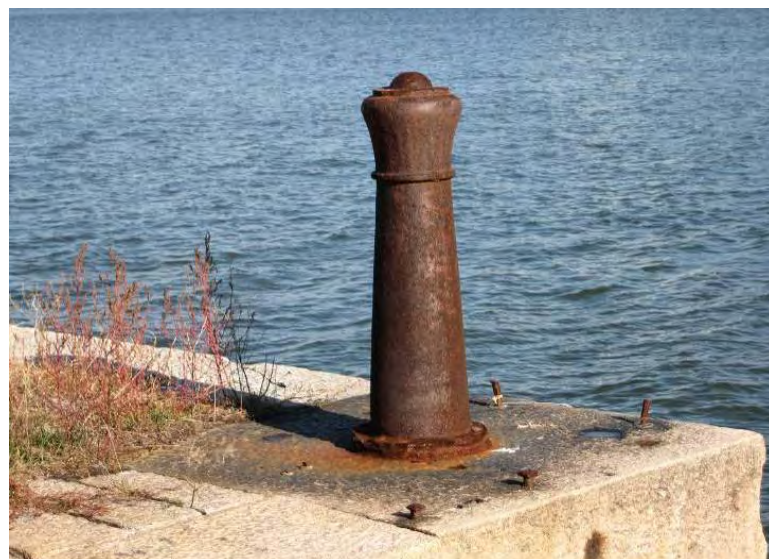
Figure 3.51: One of the two iron dock bollards (SS-11) that probably date to the original c.1859 construction of the north dock. SUNY ESF, 2007.

The two dock bollards located on the southeast and southwest corners of the north dock are made of cast iron, approximately three feet tall in a gently tapered column that has the shape of cannon shafts. (Figure 3.51) The surface of the bollards is lightly rusted and smooth, and they are in good condition.

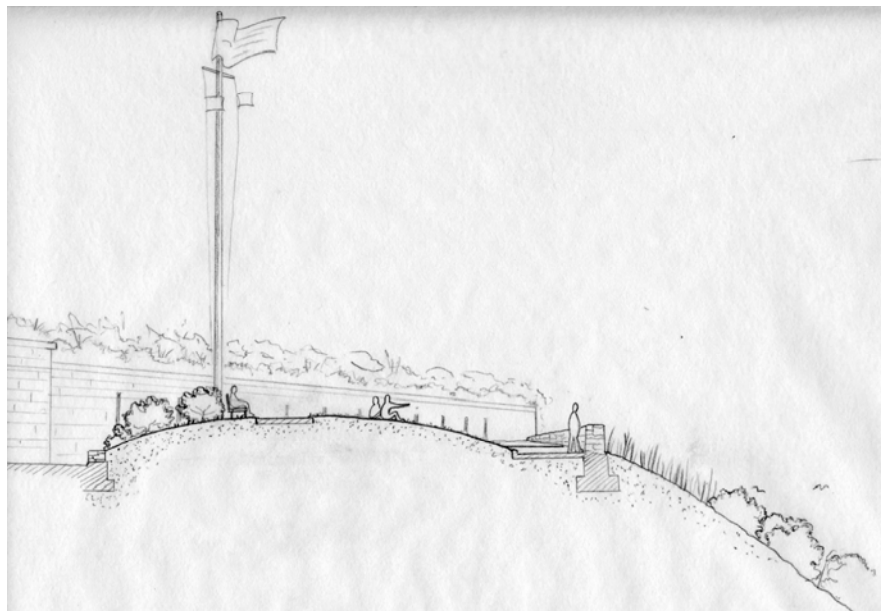
Figure 4.3: OS-Task 3, alternative 2. Rendering of overlook redesign proposed under task OS-3 alternative 2 showing introduction of a gently sloping earthen berm on the overlook terrace that will enhance views and recall the earthwork and grassy slope that existed here prior to c.1908. SUNY ESF

Alternative 2 (see Drawing 8 inset): Redesign the overlook to recapture some of the historic character and enhance interpretation of its historic use and development. Remove much of the concrete in the plaza on axis with Tompkins Road and narrow Hudson Road to avoid the location of the c.1895 gun emplacements. Grade an area of gently sloping earth in a low berm above stone wall and plant with closely mown lawn as a reference to the earthwork (covered way) and grassy area that existed here through c.1873-1908 (Figure 4.3). Add low-growing native shrubs along the road edge. Provide park benches along the west edge overlooking Battery Weed and the Narrows. This redesign will allow visitors to sit on park benches or on the lawn overlooking the fort and the activities on the bay as was done historically (see Figure 4.2). Interpret the historic location of the c.1895-c.1908 gun mounts with a granite paving surface treatment, and install telescopic viewing stations at these locations with interpretive displays highlighting the historic military objectives and resulting military developments across the Narrows. Include in this interpretation waysides that illustrate the approach to the Narrows from the south, and the range of fire relationships to Sandy Hook, Fort Hamilton, the former Fort LaFayette, and reference to Castle Williams, Castle Clinton and other forts of

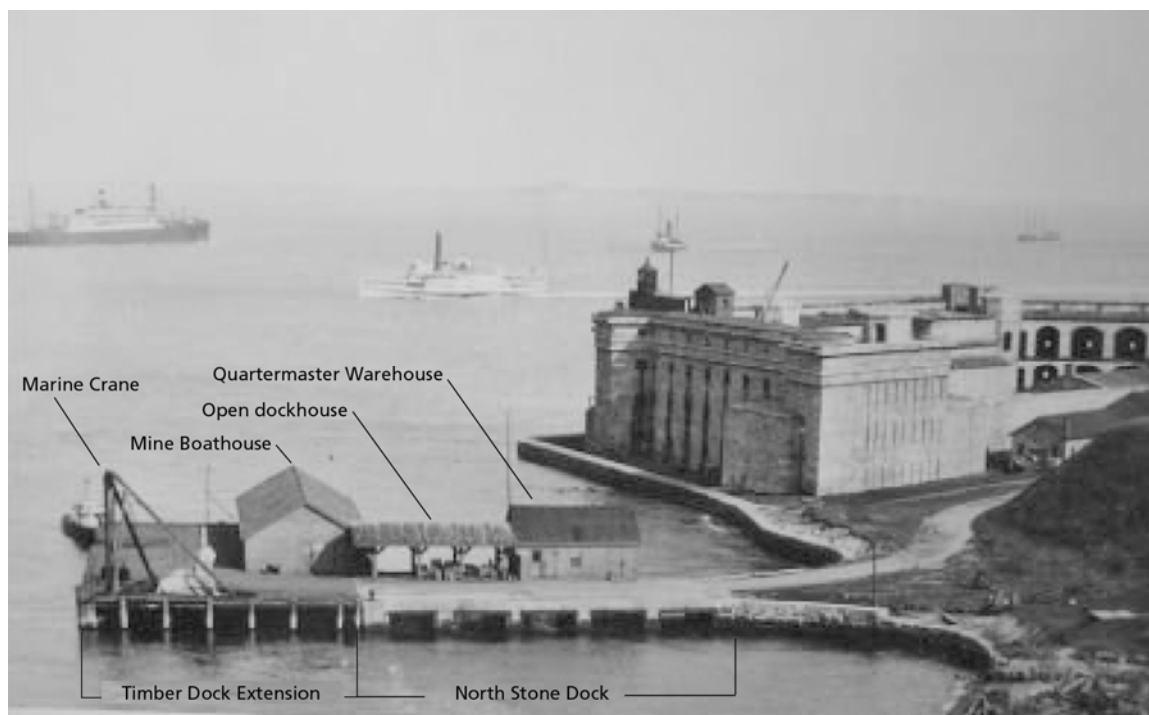
Figure 4.4: NDS-Task 1. This c.1907 photograph shows the timber dock extension to the north stone dock, the dock boathouse, open dock house, and quartermaster warehouse, that should be used to guide the location, design, mass and scale of any new structures at the north dock. Gateway National Recreation Area Archives, Photo Collection, Print #19427, c.1907, annotated by SUNY ESF.

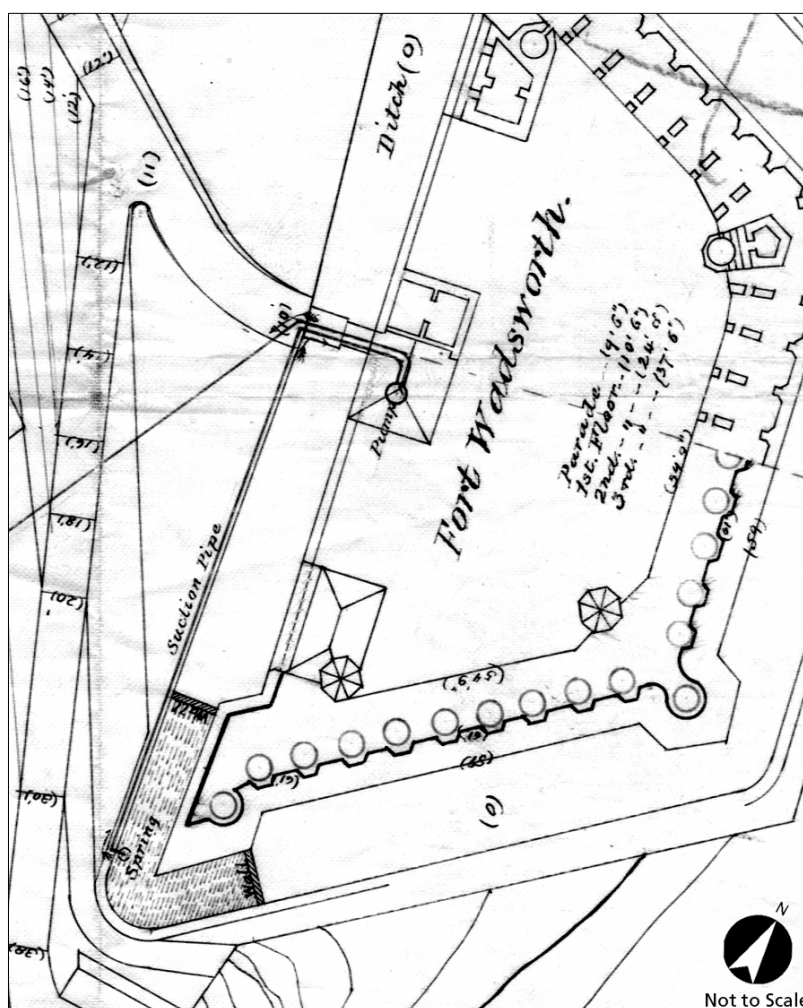
Figure 4.5: NDS-Task 3 (Alternative 1). This detail of an 1886 plan shows the spring-fed reservoir within the moat at southwest corner of the moat (at lower left of the fort) that would provide the historic precedent for reestablishing a section of watered moat for interpretive purposes. This water-filled section survived until c.1904 and possibly later. Note the “Suction Pipe” that carried water into the guardhouse pump at Battery Weed. National Archives Cartographic Division RG 77, Dr 41, Sheet A, annotated by SUNY ESF.

1. As a contemporary interpretive intervention based on historic precedent, reestablish the former reservoir section of the moat at the southwest bastion of Battery Weed that was visible through c.1904 (it is unknown if the reservoir was covered, filled, or removed). Uncover or excavate the fill from the walled-in area, and reestablish as an open, water-filled feature. (Figure 4.5) This open reservoir would provide visitors with an understanding of the pre-1887 character of the moat. Interpretation should address the fact that the reservoir was not visible after c.1904.

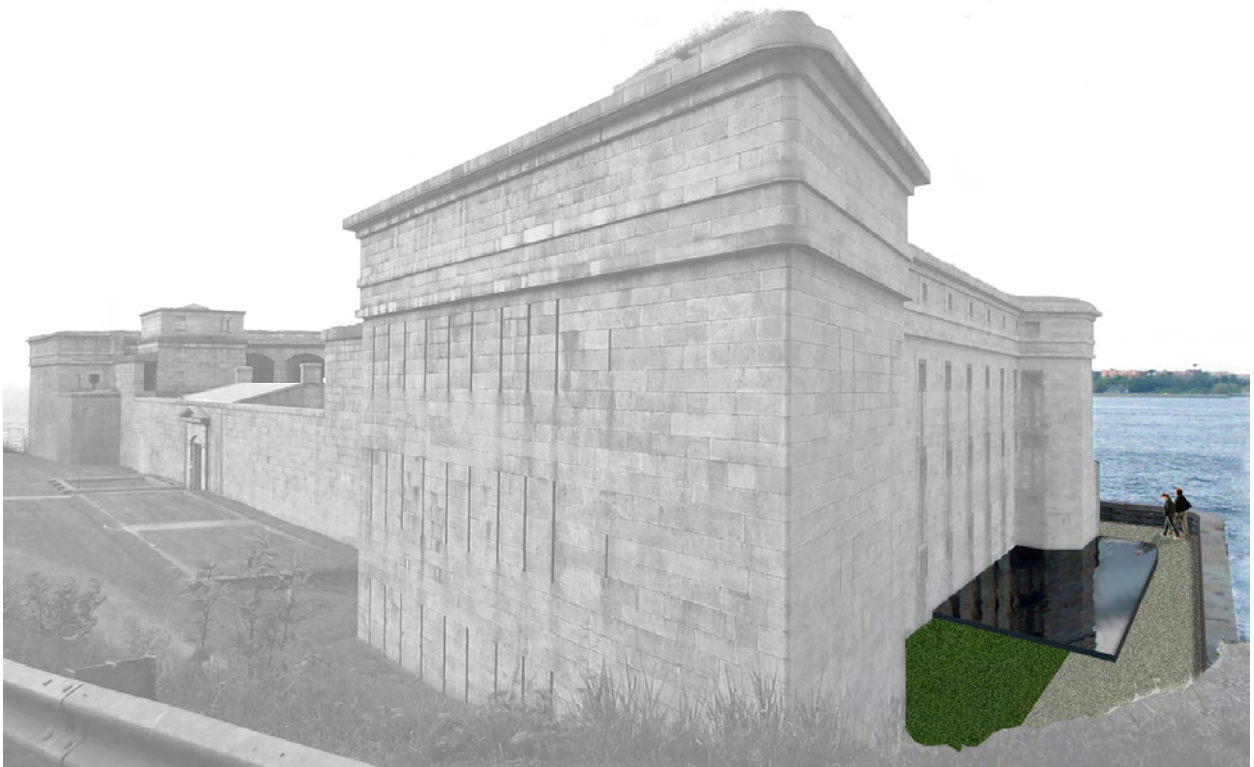
Figure 4.6: NDS-Task 3 (Alternative 2). Photo-simulation of contemporary interpretation of the water-filled moat along the south side of Battery Weed, with defined circulation along seawall. SUNY ESF.

2. Lower the grade of the filled moat on the north, south, and east sides to an elevation of three feet below the top of the seawall, corresponding to the moat's condition in 1945. The section adjoining the first mine casemate addition should not be lowered (the cable conduit runs through this section). Removing fill from the west side of the moat is not recommended because it would disturb remnants of mine defense buildings added beginning in c.1904. As an added interpretive element, install a shallow (twelve-inch deep) edgeless reflecting pool in a rectangular area at the southeast bastion of Battery Weed. This water-filled area will reflect the surrounding landscape and provide visitors with a sense of the pre-1887 water-filled condition. (Figure 4.6)
